# **Highway Geology Symposium**

**"Engineering Geology  
of  
Unconsolidated Materials"**

**April 26-28, 1972**

EMBANKMENT FAILURES ON THE TIJUANA--ENSENADA TURNPIKE IN  
THE LOWER CALIFORNIA PENINSULA, MEXICO

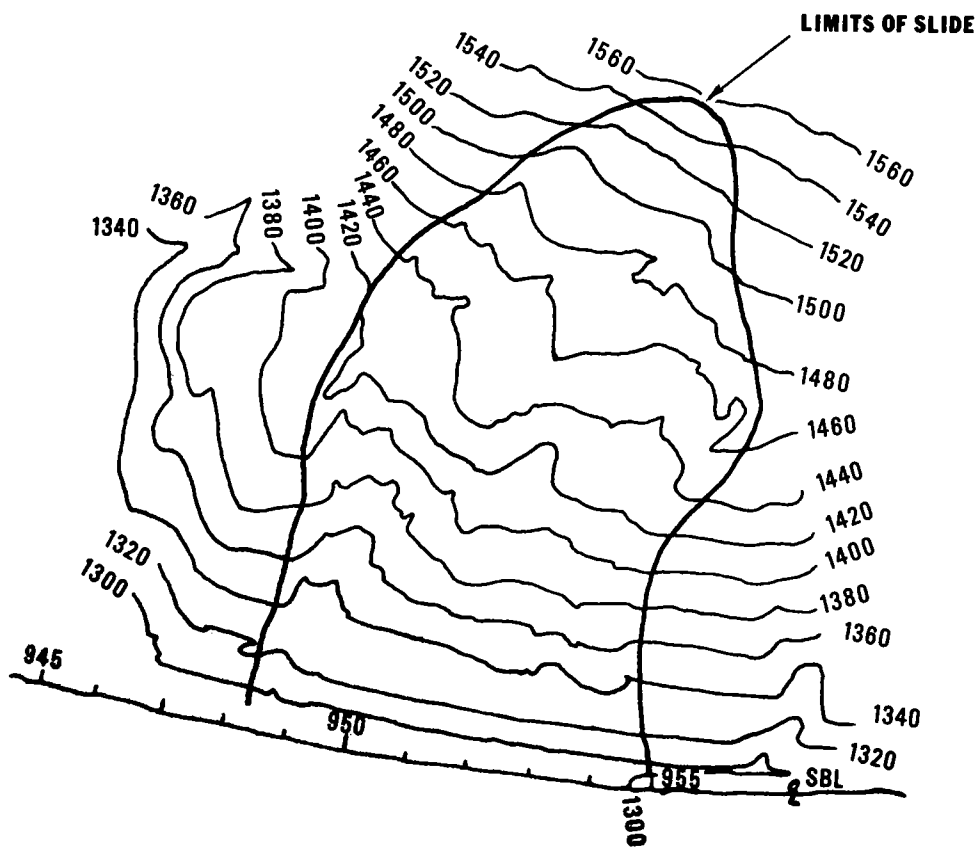
Unfortunately, the movement was not completely arrested by this treatment and periodic maintenance involving an expenditure of about \$35,000 per year was required to prevent slide debris from encroaching upon the roadway. Figures 3 and 4 are aerial and plan views, respectively, of the failure after 9 years of this maintenance activity. By 1971 the headward progression of the slide had necessitated considerable increased right-of-way taking and an unsightly scar had developed on the side of the mountain. A mutual decision was made to seek a permanent repair to the slide. The steps taken to arrive at a satisfactory solution are discussed in the following sections.

Figure 4 . Plan view-1971 .

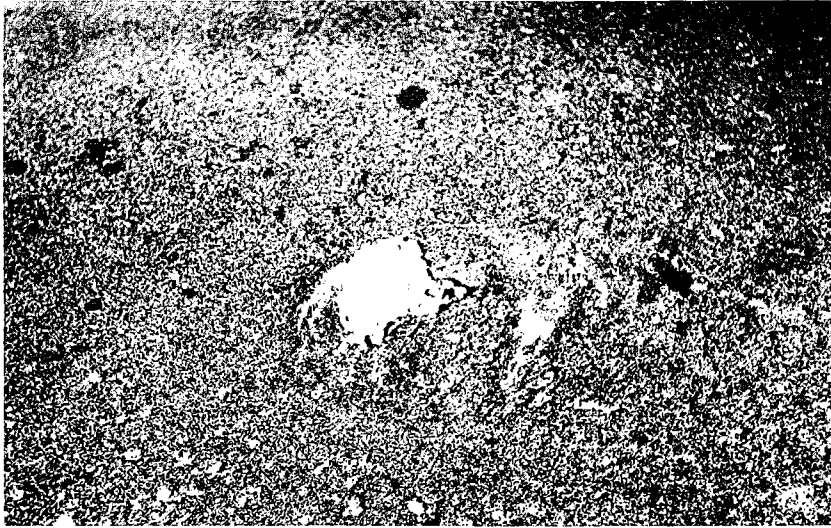
Plate 1. Typical depression failure in concrete bridge deck.

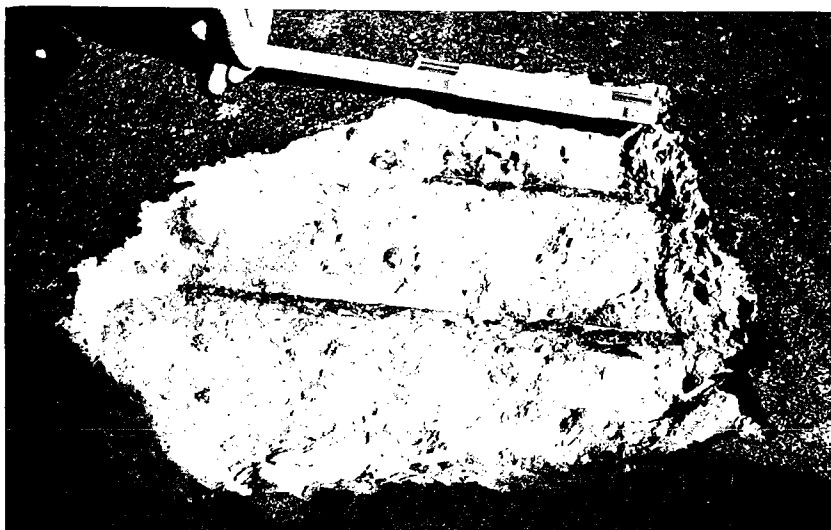
Plate 2. Typical depression shown in Plate 1 after excavation with air hammer. Note darker damp spots in bottom of excavation.

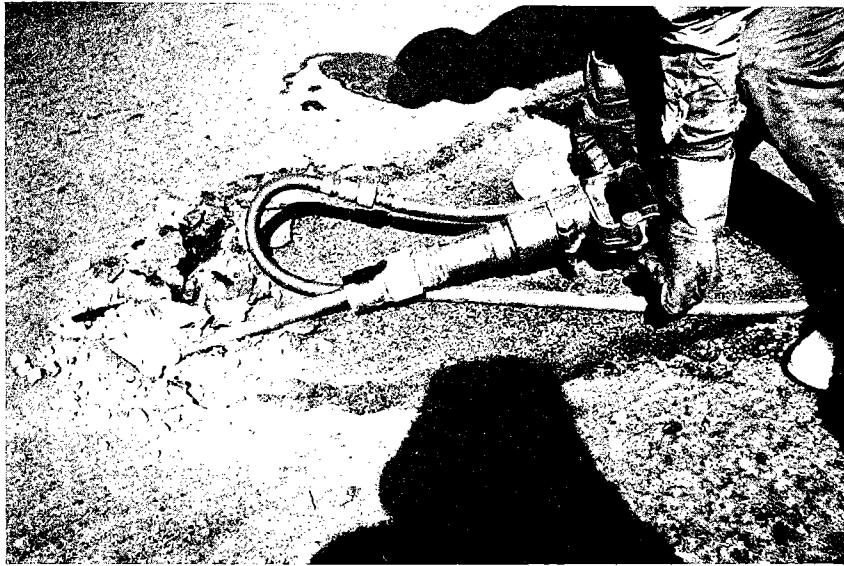
Plate 3. Excavation operation for repair of depression failure. Note failure occurred at periphery of existing patch. Two earlier patches are visible; an original patch and a previous peripheral patch.

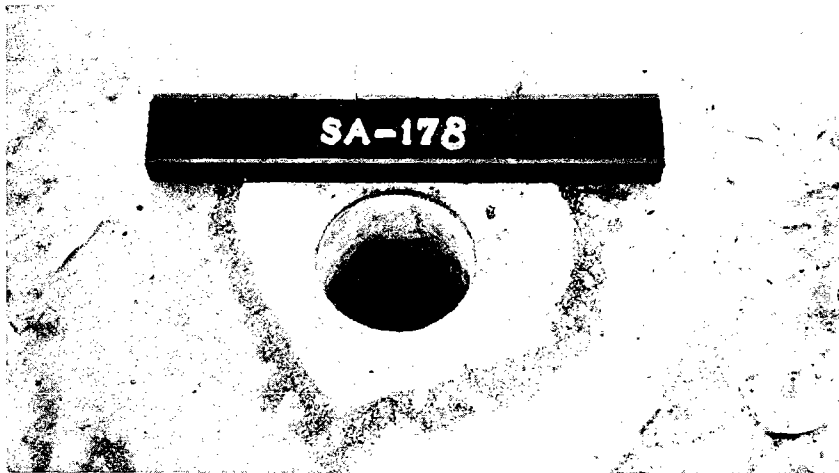
Plate 4. View of bore hole SA-178. Note two open fractures in wall of hole.

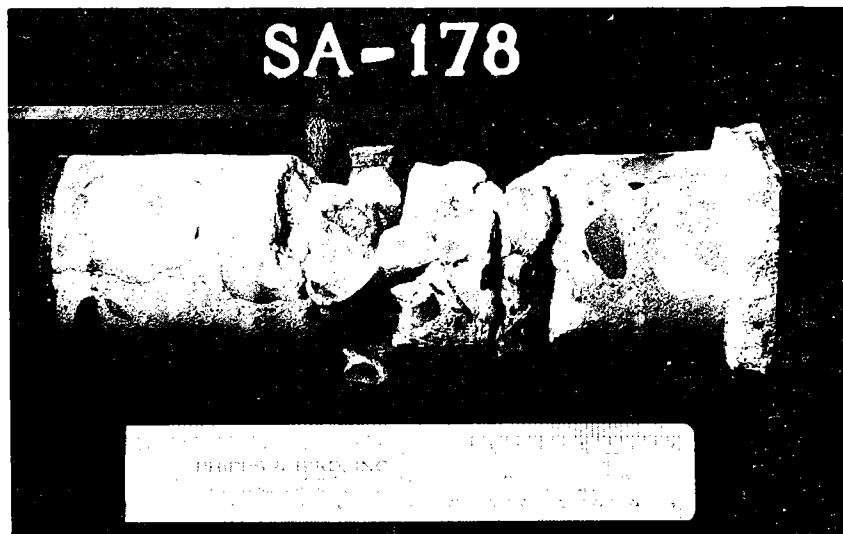
Plate 5. Vertical crack below epoxy surfacing and broken condition at steel. Plate 4 shows the hole from which this core was removed displaying horizontal fractures in the wall.

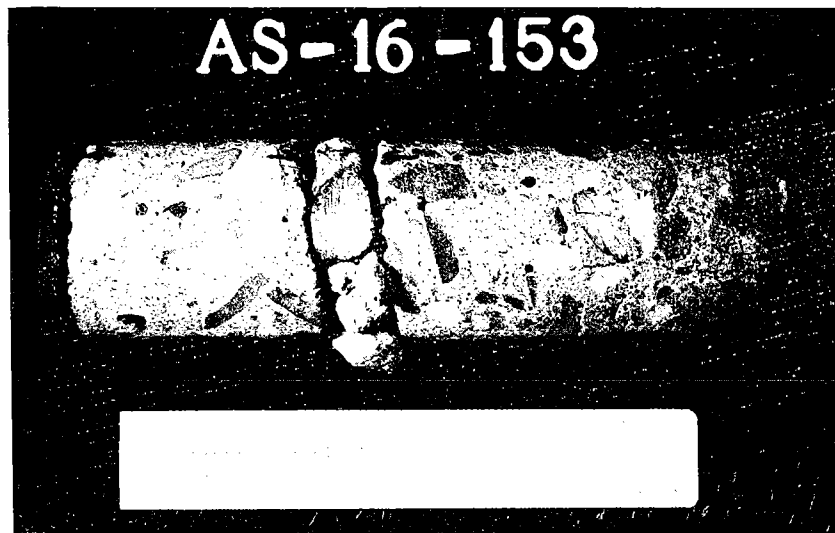
Plate 6. Broken condition at steel, vertical crack extending upward from bottom of core.

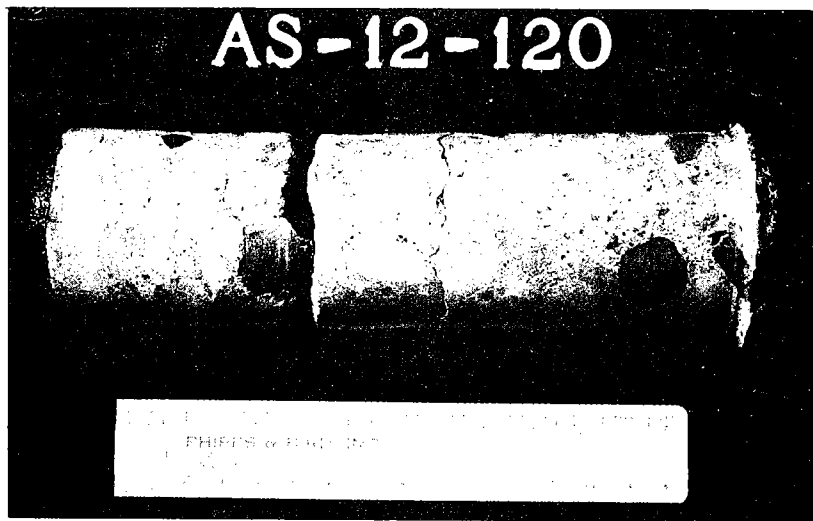
Plate 7. Crack above steel, weak zone at steel; break near middle of core passes around aggregate particles.

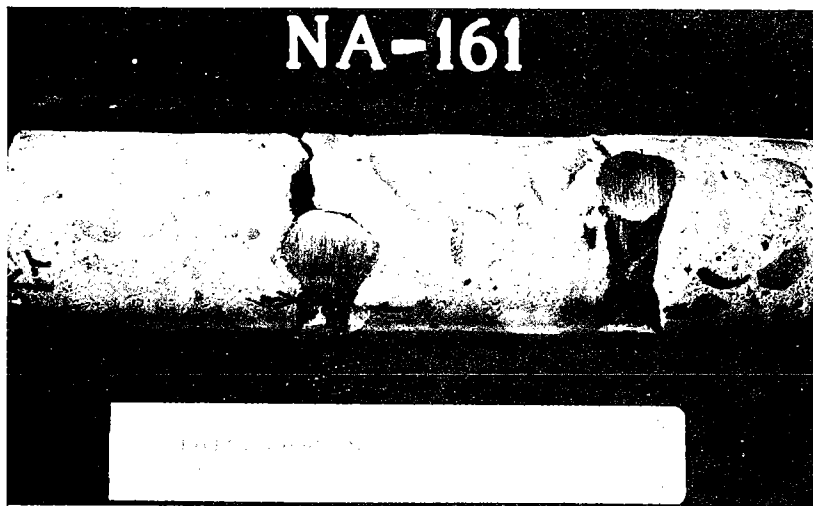
Plate 8. Weak zones at steel; note that the steel did not rotate or chew the surrounding concrete.

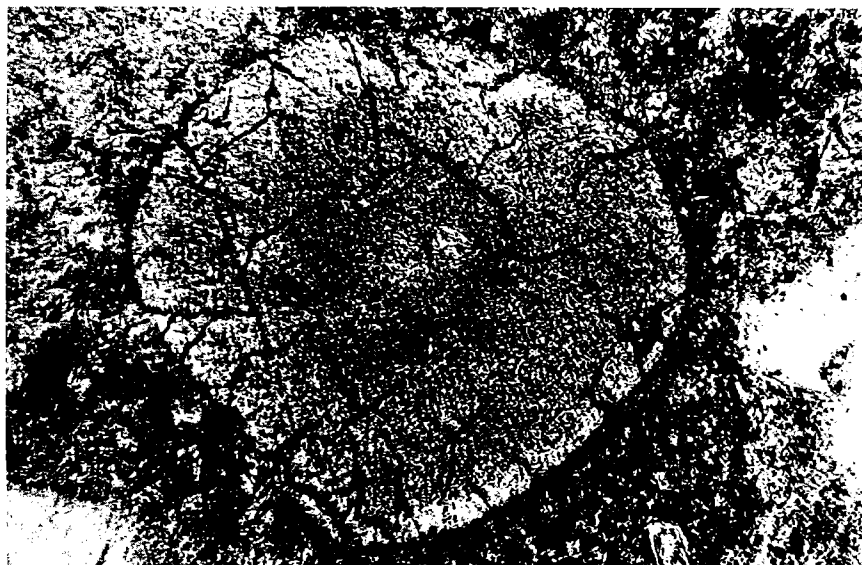
Plate 9. Photomicrograph of a sand grain of chalcedonic chert that has been altered to siliceous gel throughout its diameter. Note the internal fractures that extend into the adjacent cement paste matrix of the concrete. Top portion of core AS-16-153. Magnification X 240.

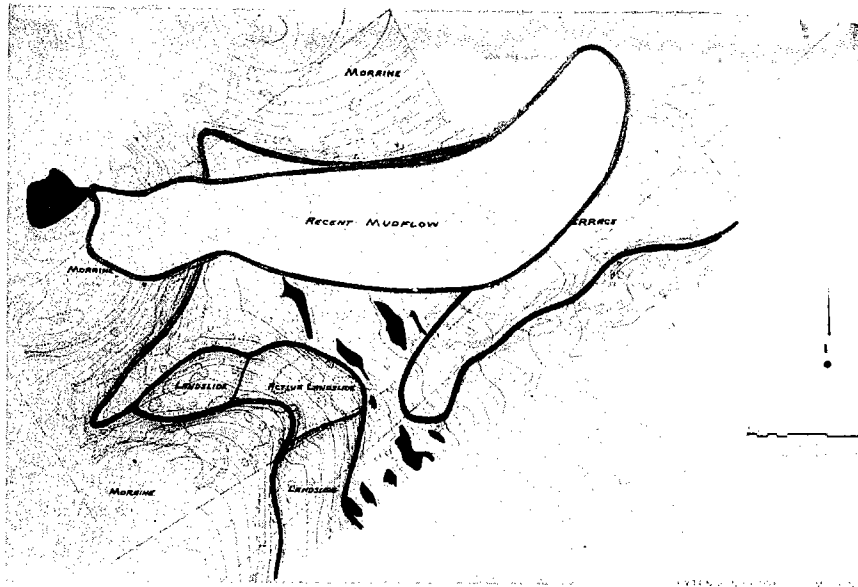
Plate 3 - Surficial geology on property with the most recent mudflow superimposed. This mudslide is approximately 1400 feet long and 200 feet wide. Water from the pond saturated the moraine material and created the mudslide.

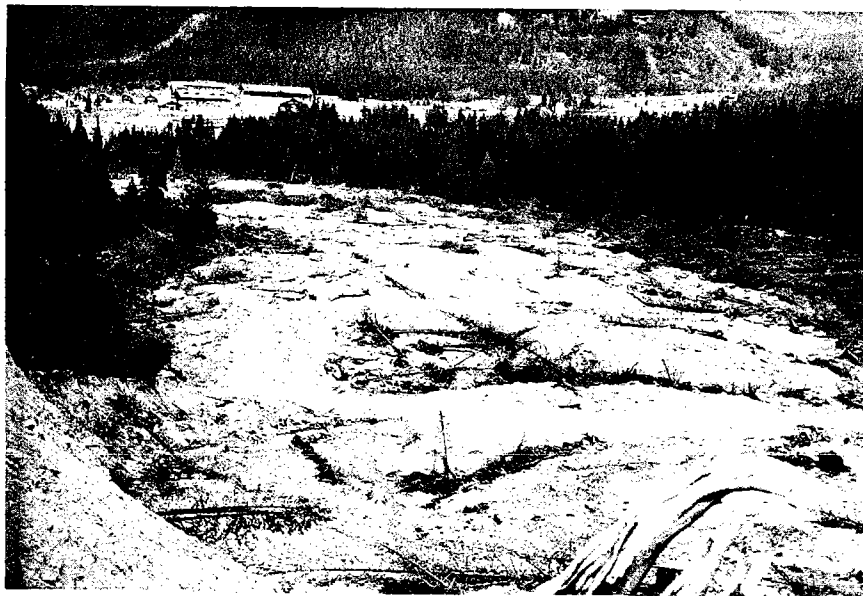
Plate 4 - Mudslide viewed from the scarp.

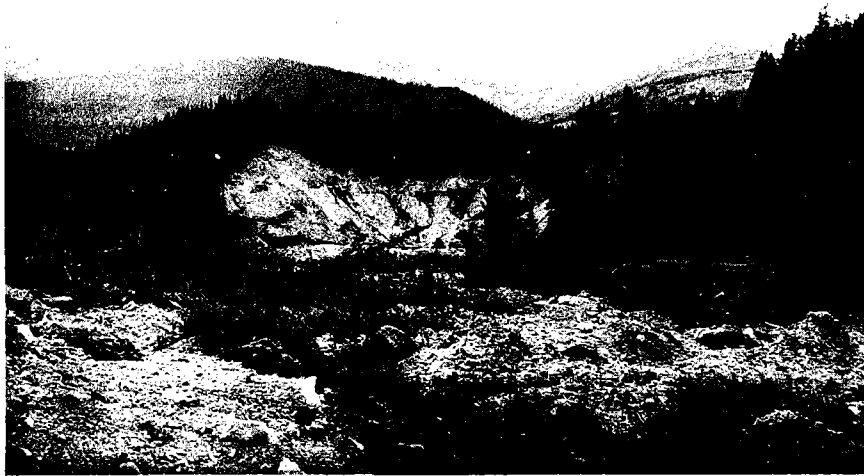
Plate 5 - Mudslide viewed from near the toe.

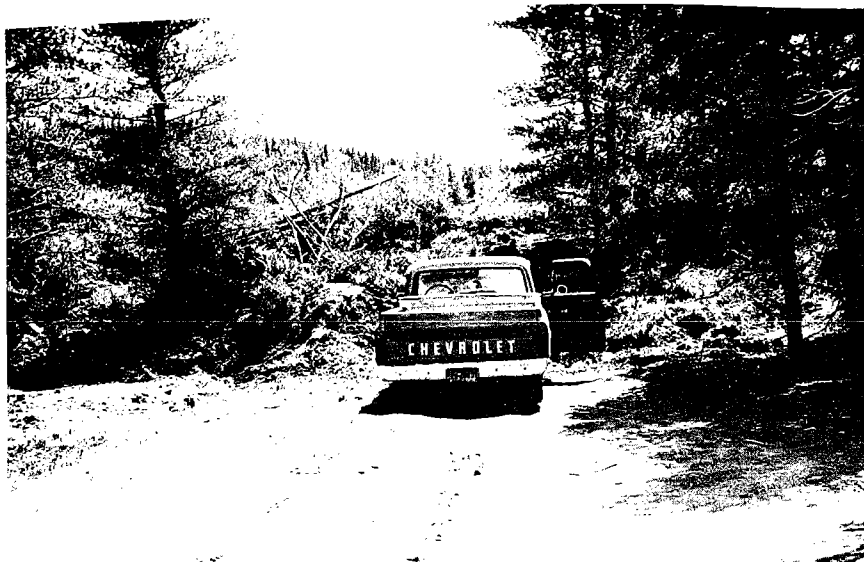
Plate 6 - End of the road, toe of the mudslide in front of truck.

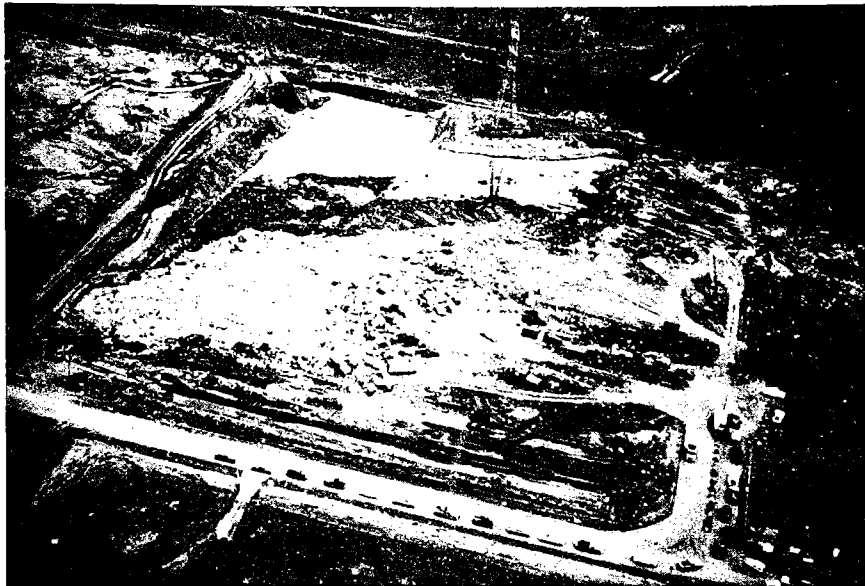
Plate 7 - Land fill in abandoned gravel pit along Clear Creek north of Denver, Colorado. This shows poor, but common practices before new state regulations were enacted, i.e., no impermeable barrier to reduce pollution from trash being dumped in a water filled pit.
