56th HIGHWAY GEOLOGY SYMPOSIUM

WILMINGTON, NORTH CAROLINA, MAY 4-6, 2005

PROCEEDINGS

HOSTED BY
THE
NORTH CAROLINA
DEPARTMENT OF TRANSPORTATION

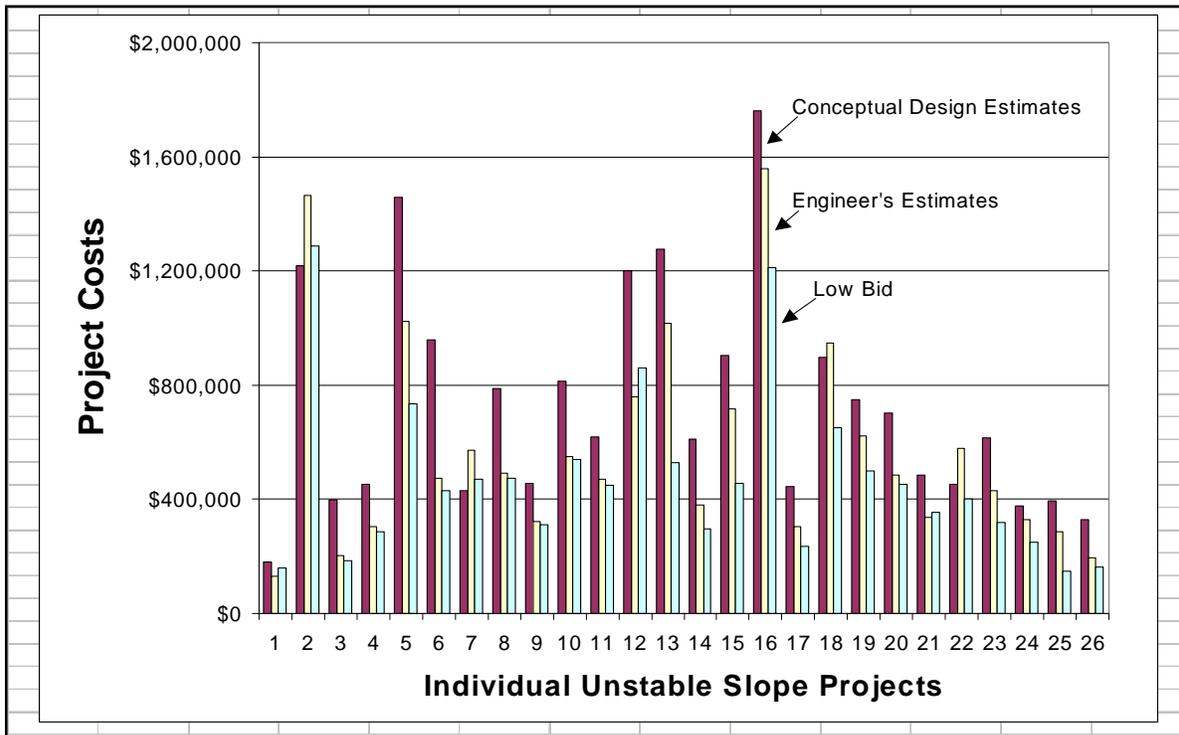
Figure 8: Graphical representation comparing estimates from the conceptual design, Engineer's estimate and Contractor's low bid. The results demonstrate that the conceptual design estimates are generally more conservative than the final cost estimates.

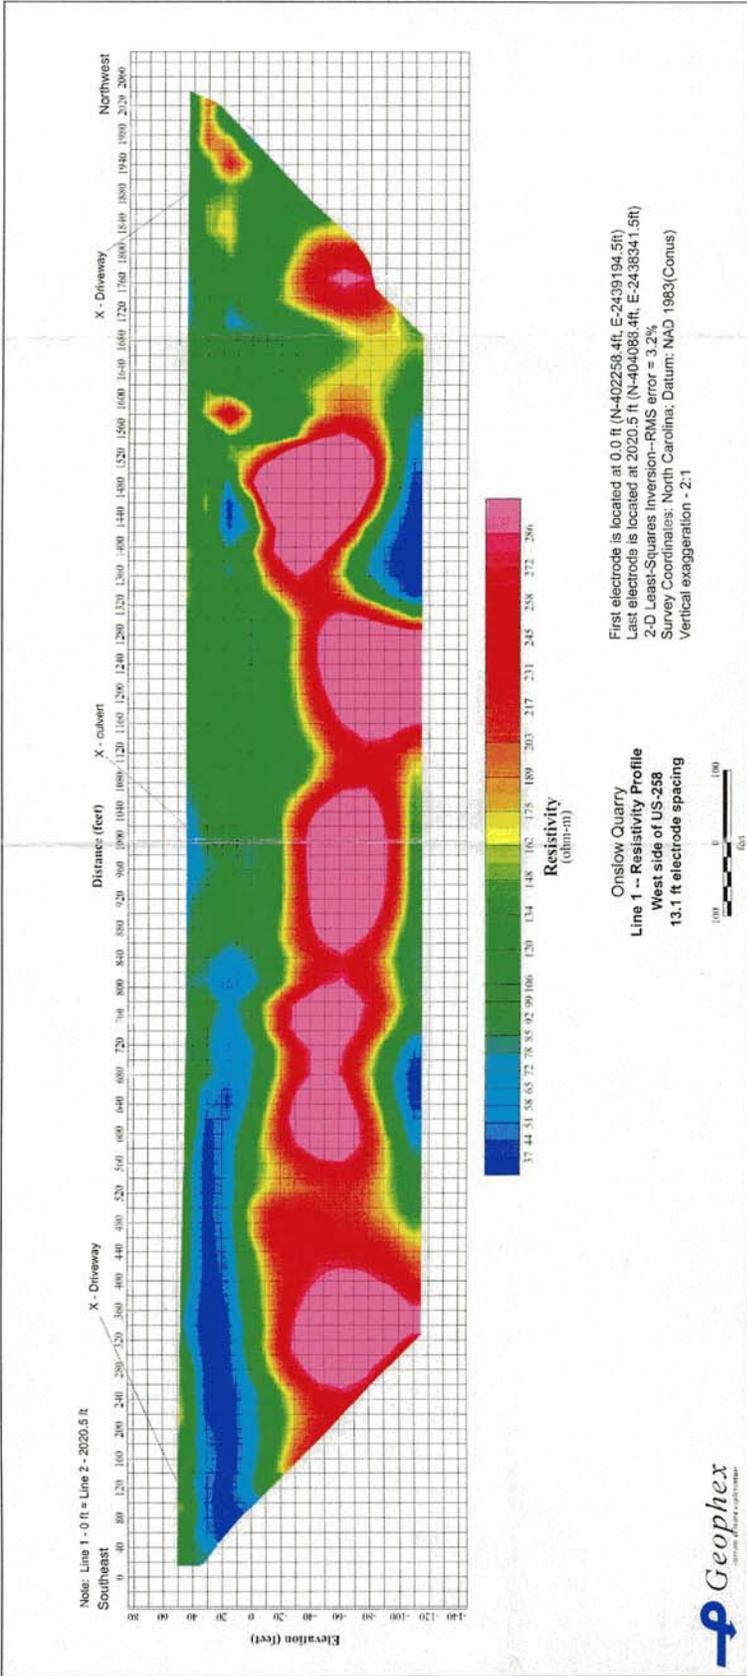
Figure 13. Southeast-northwest resistivity line 1 collected along U.S. Highway 258. Note the difference in resistivities between the lower part of the line and the upper part of the line. The differences are interpreted to represent Castle Hayne Limestone units A and B; note the southeast dip. The northwest end of the line displays resistivities that are significantly lower than those occurring to the southeast. The higher resistivities (>200 ohm-m) and the lateral continuity exhibited to the southeast are missing north of about 1320 ft. This area is interpreted to represent sinkholes where the overlying material has breached into the lower part of the Castle Hayne Limestone.

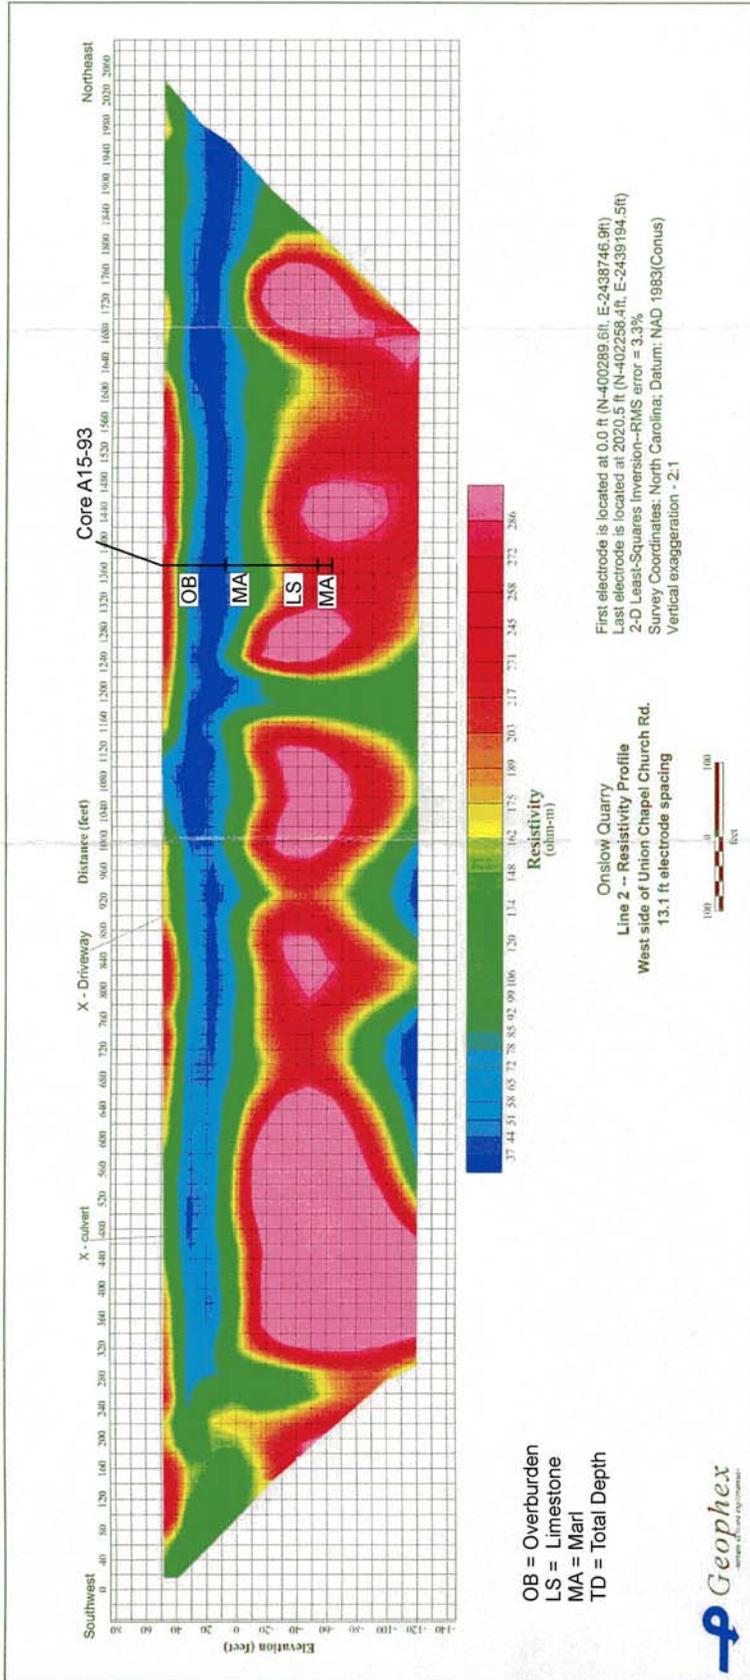
Figure 14. Southwest-northeast resistivity line 2 collected along the west side of Union Chapel Road. Note the differences in resistivities between the bottom and top of the profile indicating the presence of Castle Hayne Limestone units A and B. Core A15-93, which is projected into the line, indicates the division between the two units at approximately the first marl to limestone boundary. Also, note that on the southwest end (0-320 ft) and near the center of the line (1200') resistivities are significantly lower than those lateral (>200 ohm-m). These are areas interpreted to represent sinks where overlying material has beached the lower part of the Castle Hayne.

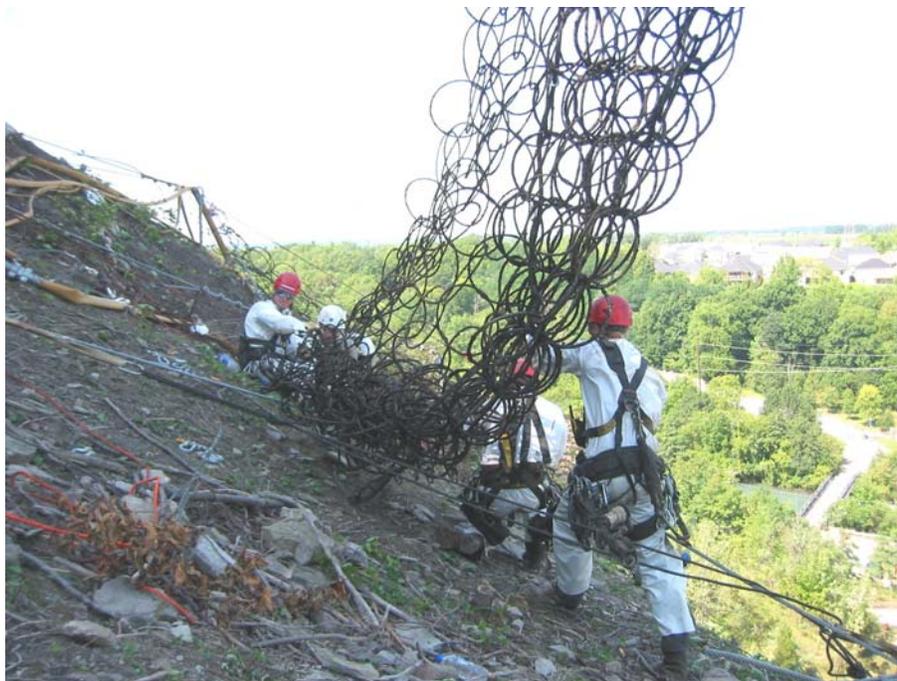
Figure 13. Ring net panel hanging from helicopter while ground crew attaches end of net to anchor cable.

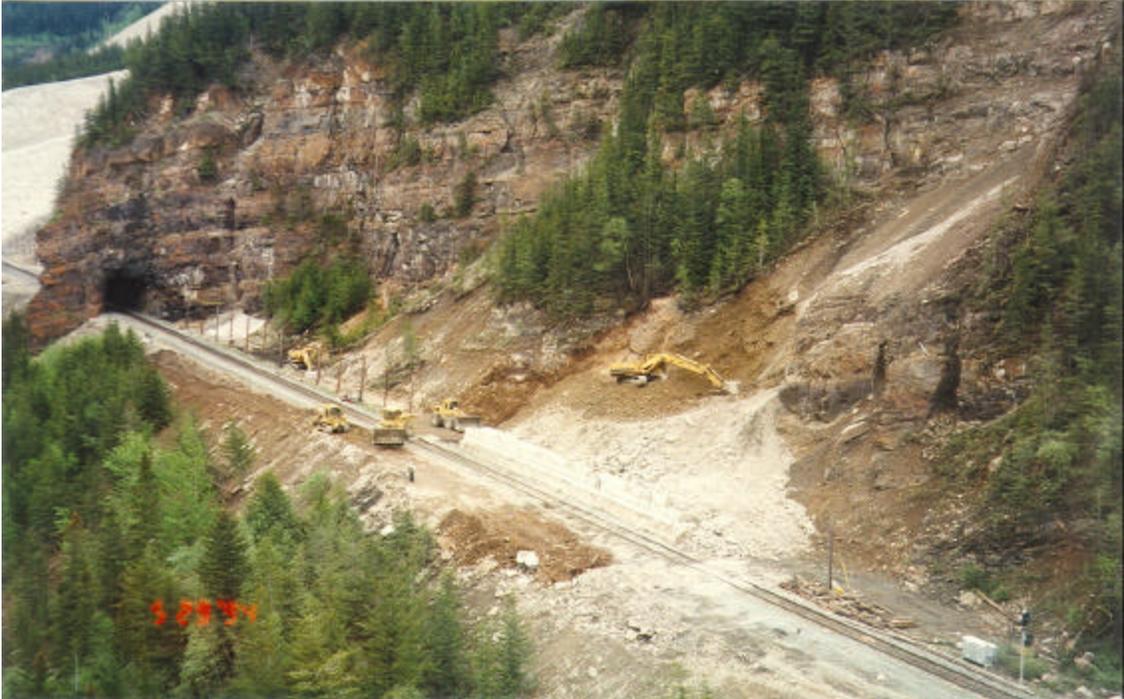
Figure 4: Rock fall May 26, 1994 – An estimated 3,200 cubic yards fell. Most was retained behind the existing 10 foot high lock-block wall. Cleanup took 26 hours.

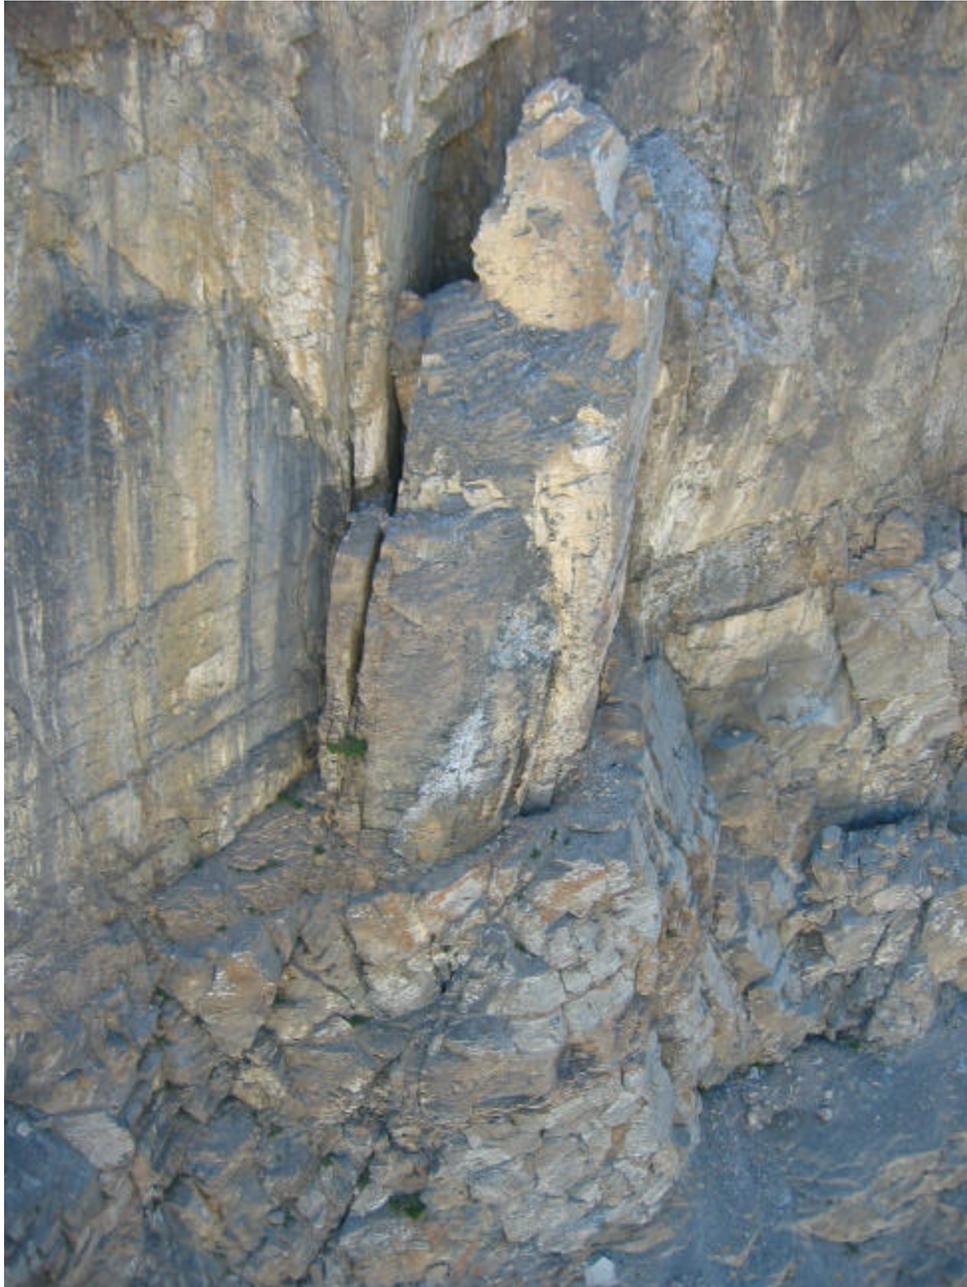
Figure 9 : Vertical fractures in the Cathedral limestone have resulted in the development of features like “the Pinnacle” with estimated volume of 7,000 cu.yd.

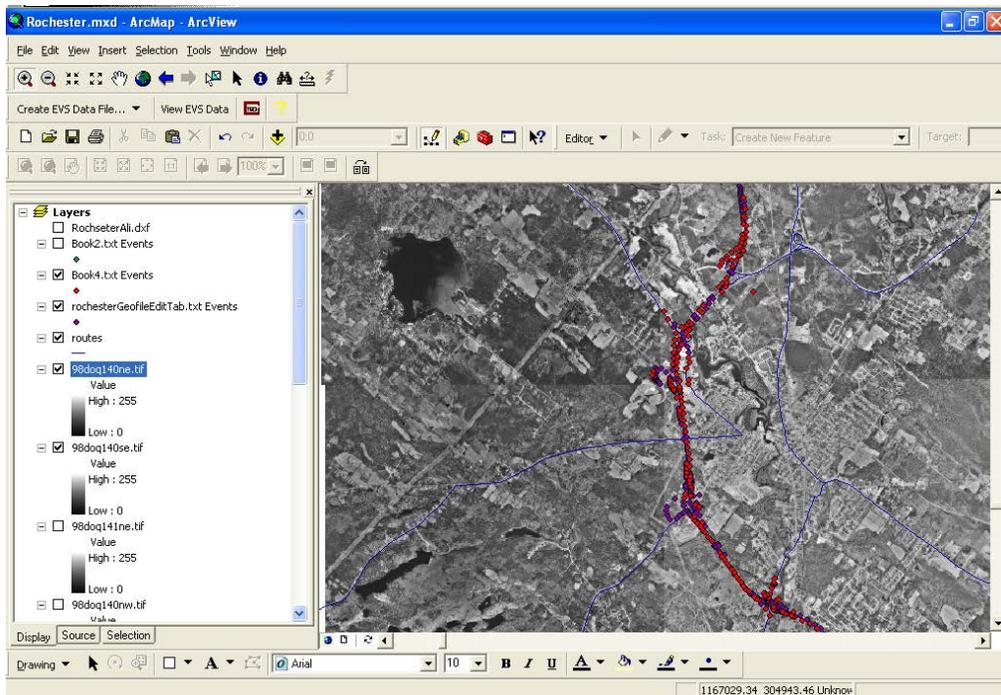
Figure 2: GIS containing the “Routes” layer, the test borings & pits, and digital orthoquads.

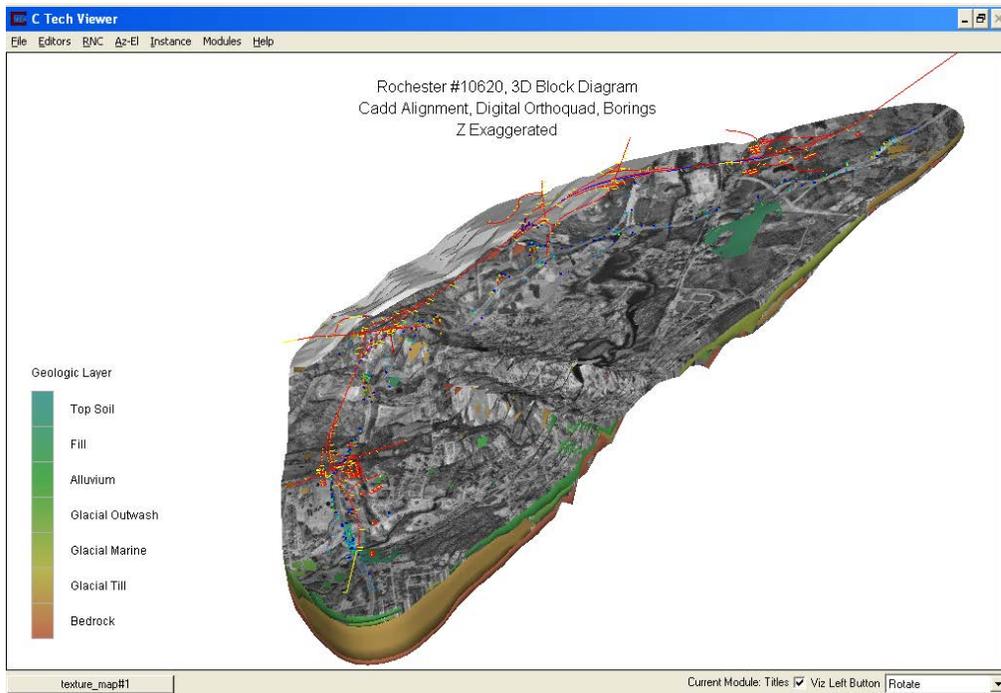
Figure 3: 3D block diagram of the subsurface conditions with 3D borings, digital orthoquad and CAD/D drawing draped onto the surface.

By using different combinations of modules within the three dimensional software extension, three dimensional diagrams were made that display the test borings, the subsurface soil and bedrock diagrams, the project plans and digital orthoquads. Figure 3 is an example of a three dimensional diagram showing the test borings, the soil and bedrock layers, the project plans and a digital orthoquad for the entire Spaulding Turnpike project. The scale in figure 3 makes it difficult to observe the subsurface conditions directly beneath the roadway centerline at any specific location within the project. To look at one specific area within the project the model is “zoomed-in” using a simple “mouse” control. Figure 4 shows a three dimensional block diagram zoomed to a portion of the project in the vicinity of the exit 12 interchange. Just south of exit 12, a new larger bridge is being proposed to replace the existing bridge over the Cocheco River. To recommend a foundation for the new bridge, three phases of drilling were conducted to determine the specific subsurface conditions around this area. The view displayed in figure 4 is derived from a text file that was limited to the exploration locations only in the vicinity of the existing bridge over the Cocheco River. Some of the software’s modules were changed so the road and bridge alignments and the digital orthoquads would not display. Figures 4 & 5 show the subsurface conditions after the first phase of drilling. The view in figure 4 looks directly east and is perpendicular to the bridge alignment and parallel to the Cocheco River. A steeply dipping bedrock surface covered by a thin layer of glacial till and a thick layer of glacial marine silts and clays can be observed. The top surface of the block diagram displays recent alluvial deposits, a man-made fill, and topsoil. The view in figure 5 is from the same direction as in figure 4, but the bedrock and glacial marine deposits are the only layers displayed and the glacial marine deposit is slightly transparent.

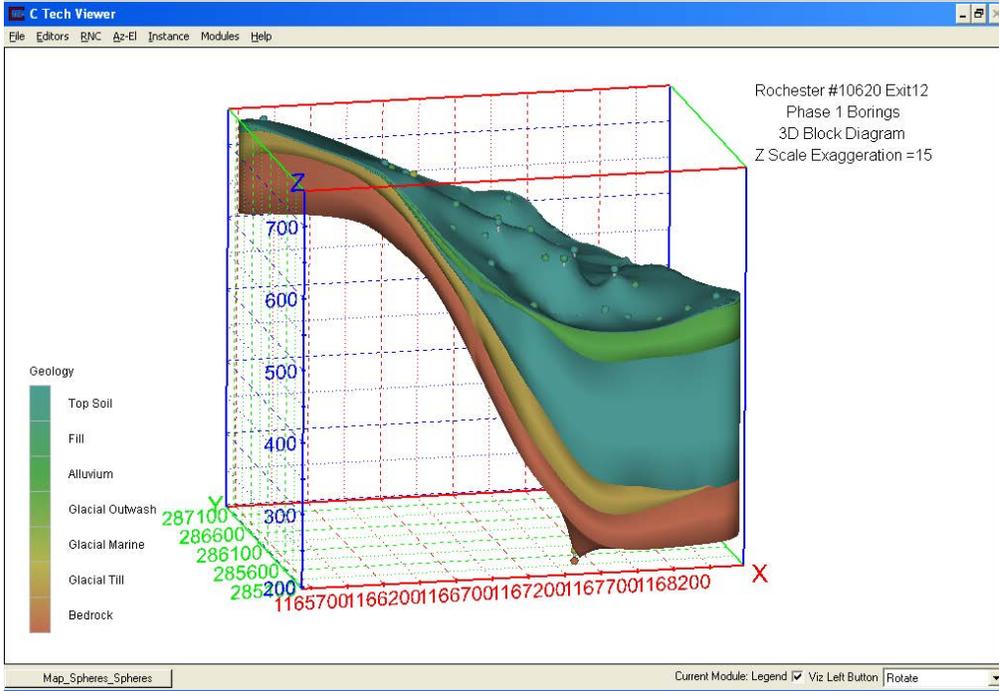
Figure 4: 3D block diagram of subsurface conditions at the Cocheco River Bridge after the first phase of drilling, looking east parallel to the river. Z scale exaggeration = 15.

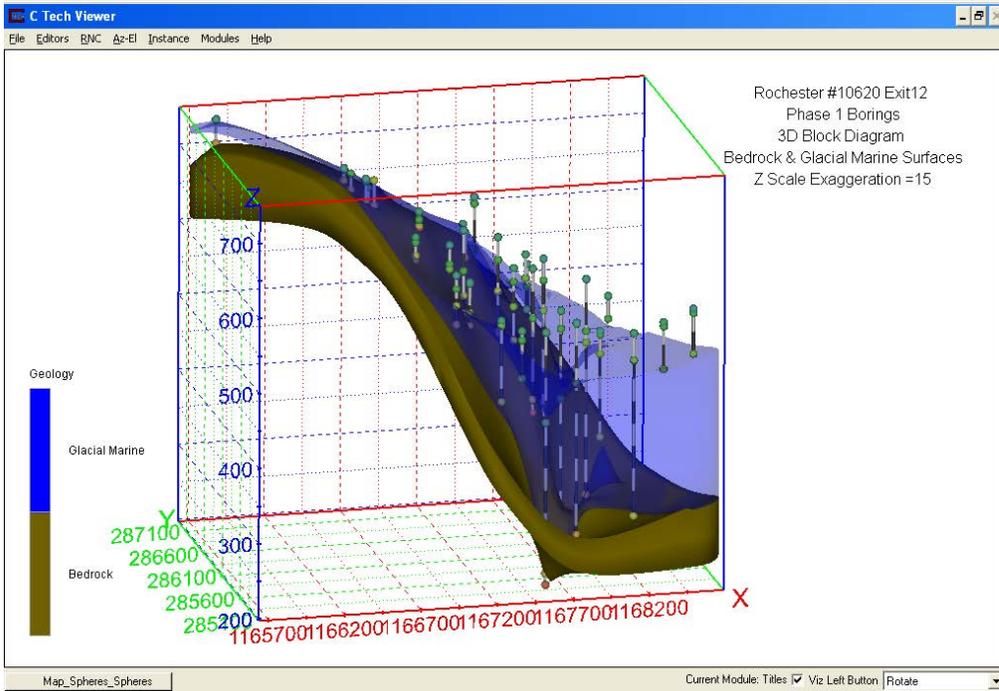
Figure 5: 3D block diagram of subsurface conditions at the Cocheco River Bridge after the first phase of drilling, looking east parallel to the river. This view shows only the test borings, the bedrock surface and the glacial marine deposit. Z scale exaggeration = 15.

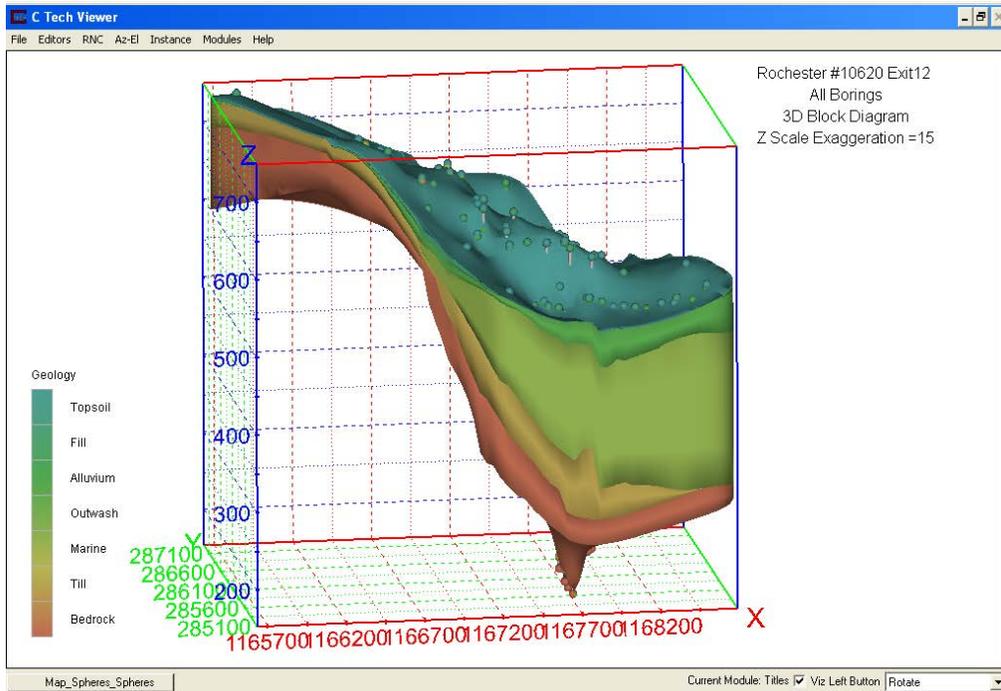
Figure 6: 3D block diagram of the subsurface conditions looking east over the Cocheco River after all phases of drilling. Z scale exaggeration = 15.

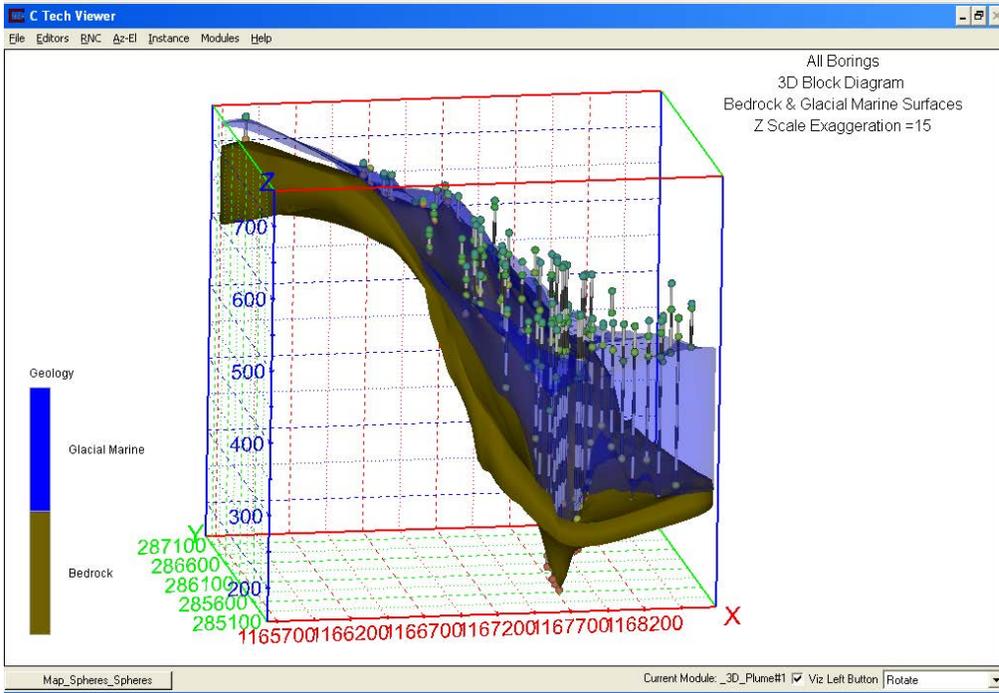
Figure 7: 3D block diagram of subsurface conditions at the Cocheco River Bridge after all phases of drilling, looking east parallel to the river. This view shows only the test borings, the bedrock surface and the glacial marine deposit. Z scale exaggeration = 15.

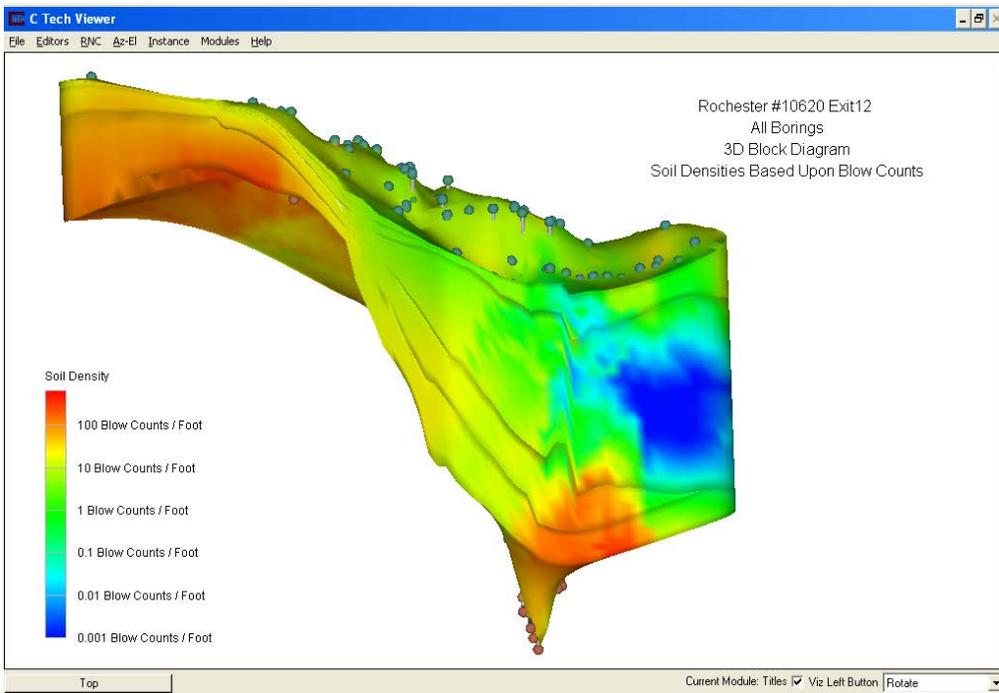
Figure 8: 3D block diagram looking east over the Cocheco River showing the locations of the soft and hard soils. Soil densities are based upon sample blow counts.

It is also possible to construct a three dimensional block diagram based upon the soil densities that are derived from the number of blow counts it takes to drive a two foot, split spoon soil sampler, twelve inches with a one-hundred and forty pound weight. This is accomplished by extracting the sample depths and blow counts, in addition to the other data, from the test boring database. Through a slightly different text file format, a three dimensional block diagram is constructed to display where all the soft and hard soils are located in the vicinity of the existing bridge over the Cocheco River (figures 8 & 9). This three dimensional block diagram can be used to help determine the type and depth of a new bridge foundation based upon the soil densities collected during the subsurface investigation.

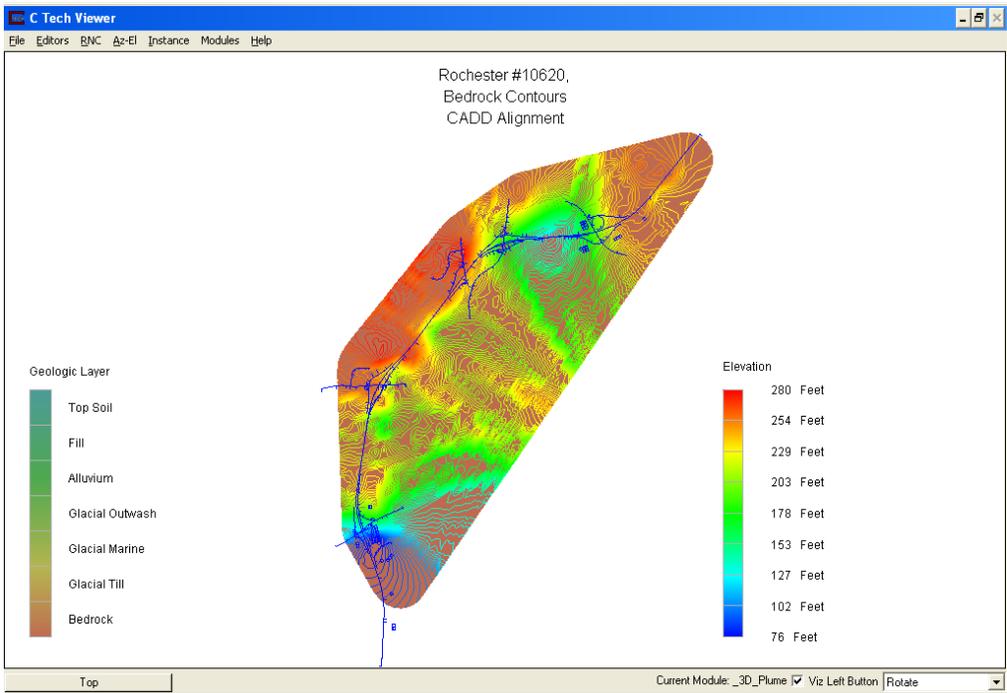
Figure 16: Color coded bedrock contour lines for the entire Spaulding Turnpike expansion project. The contours are draped over the bedrock surface.

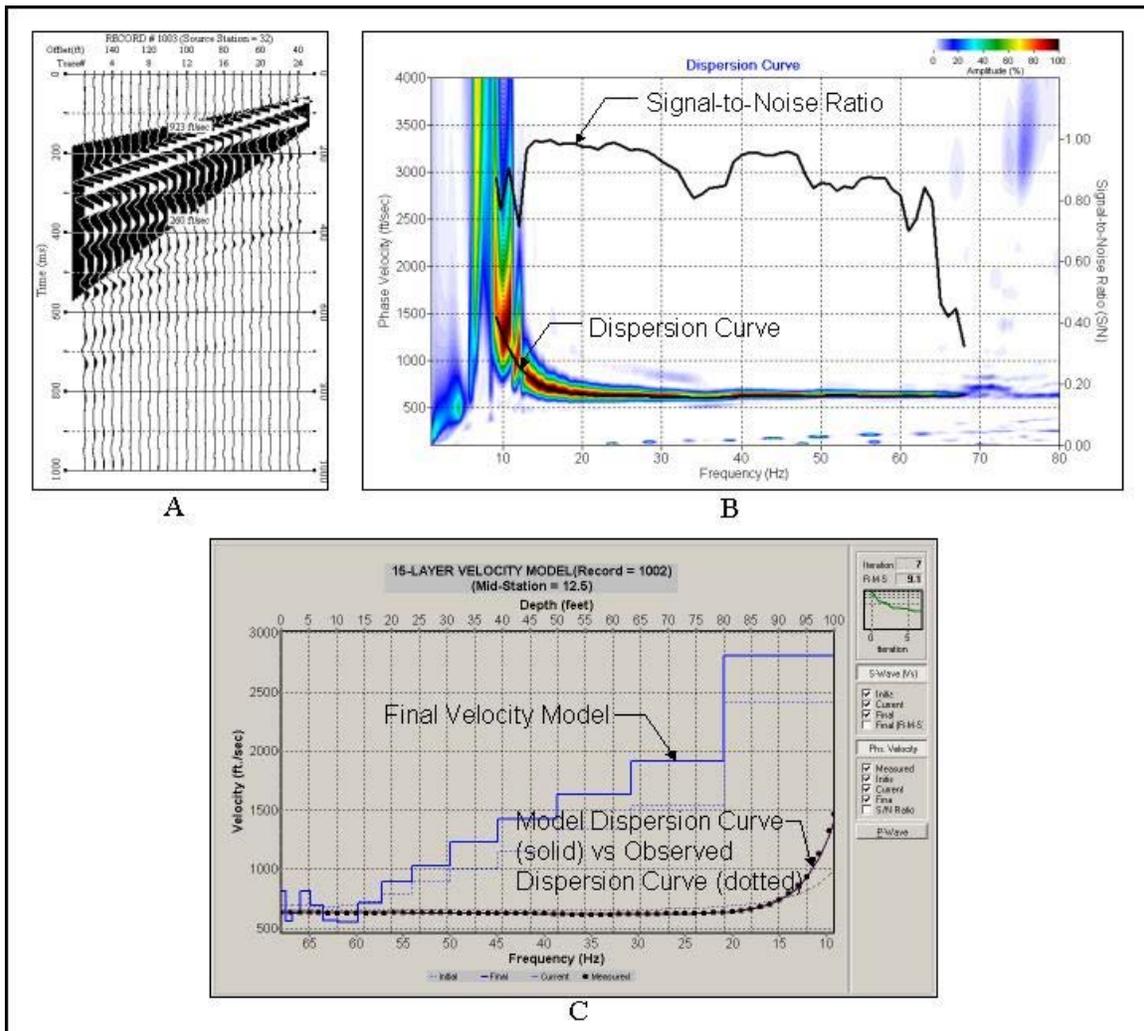
Figure 3 – MASW data processing using Surfseis. A) Seismic Time Series Data with Selected Surface Wave Energy (shaded), B) Surface Wave Energy in Frequency Domain with Observed Dispersion Curve, C) Shear Wave Velocity Inversion Model

The processing steps for MASW data include recognition of the surface wave energy, transformation into the frequency-domain, selection of points of maximum surface wave energy to form the dispersion curve, and inversion to create an earth model of subsurface shear wave velocity (Figure 3). Although the Raleigh phase velocity is a function of five factors - frequency, compressional (P-wave) velocity, shear (S-wave) velocity, density, and thickness of layers, research has shown that shear-wave velocity is the dominant influence on a dispersion curve, so usually only the S-wave velocities are varied during the inversion process (Xia, Miller, and Park, 2002). We utilize the Surfseis software developed by the KGS for our MASW analysis. For multi-array surveys, the individual shear wave models are combined into a 2D data set and then contoured in Surfer to produce a 2D cross-section model.

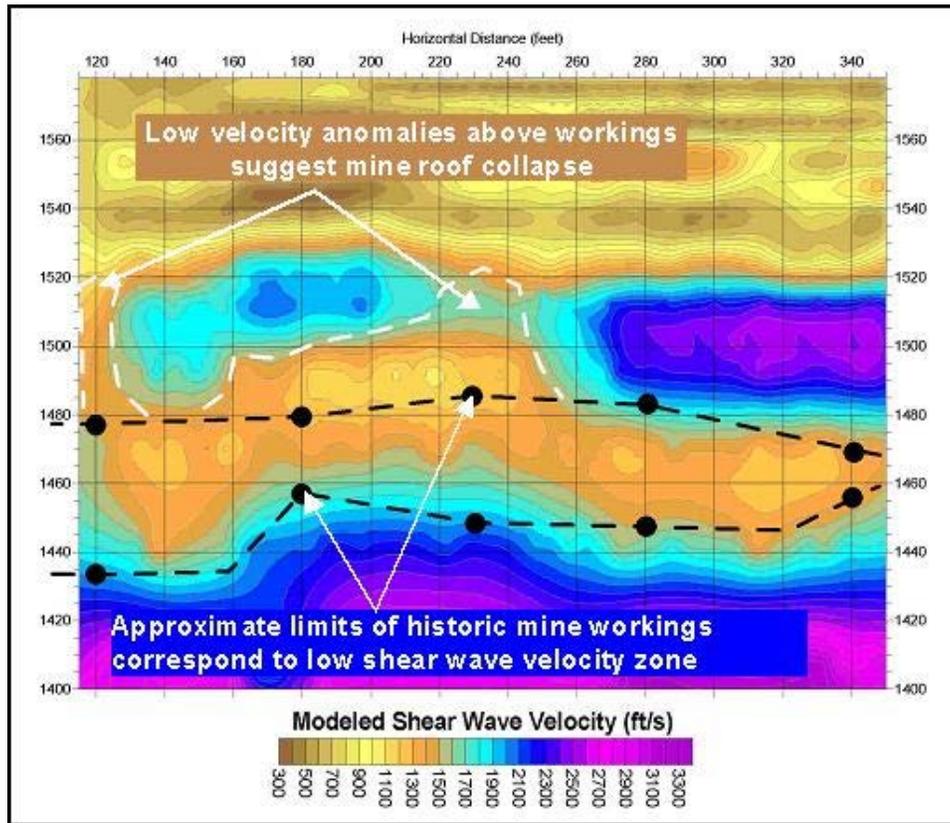
Figure 4— Example 48-channel MASW shear wave velocity model showing low velocity anomalies corresponding to historic mine workings level and to possible roof collapse zones above historic mine workings.

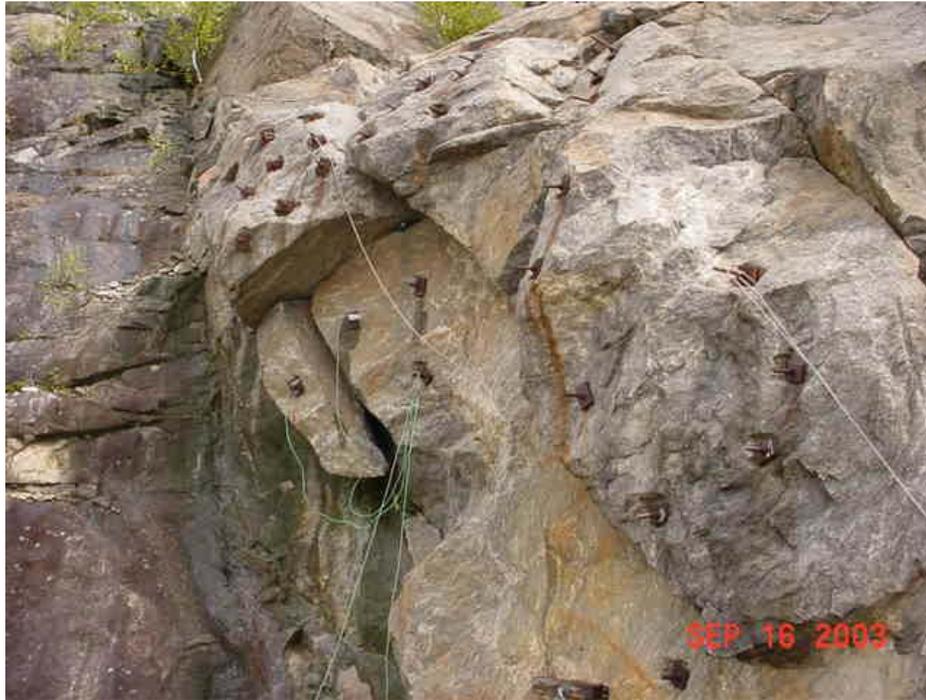
Figure 3. *Pre-stressed, resin grouted rock bolts, center section*

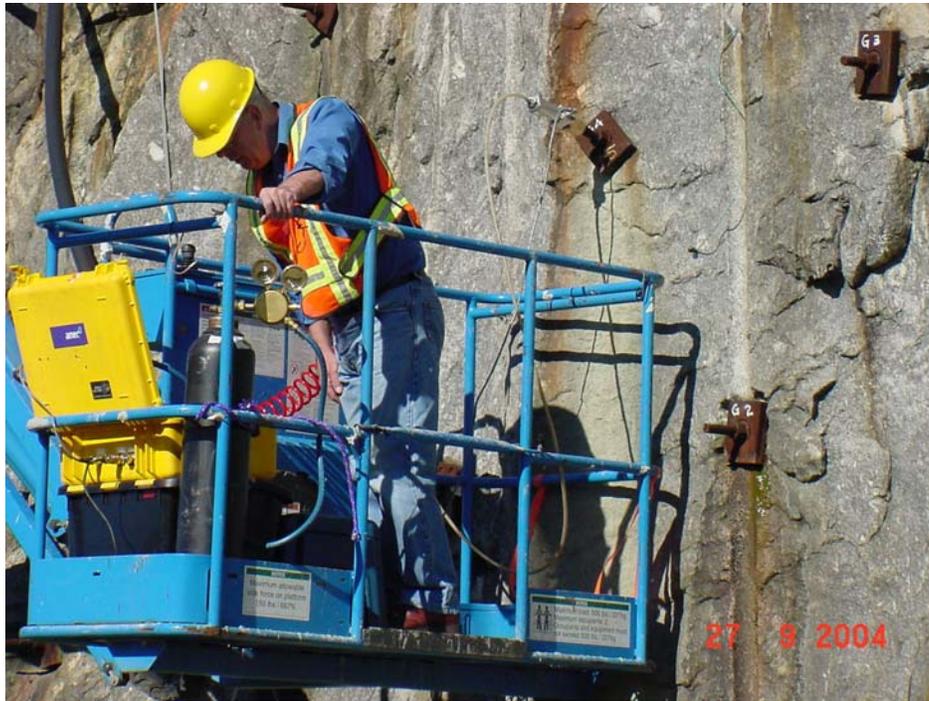
Figure 4. *Non-destructive GRANIT Integrity test*

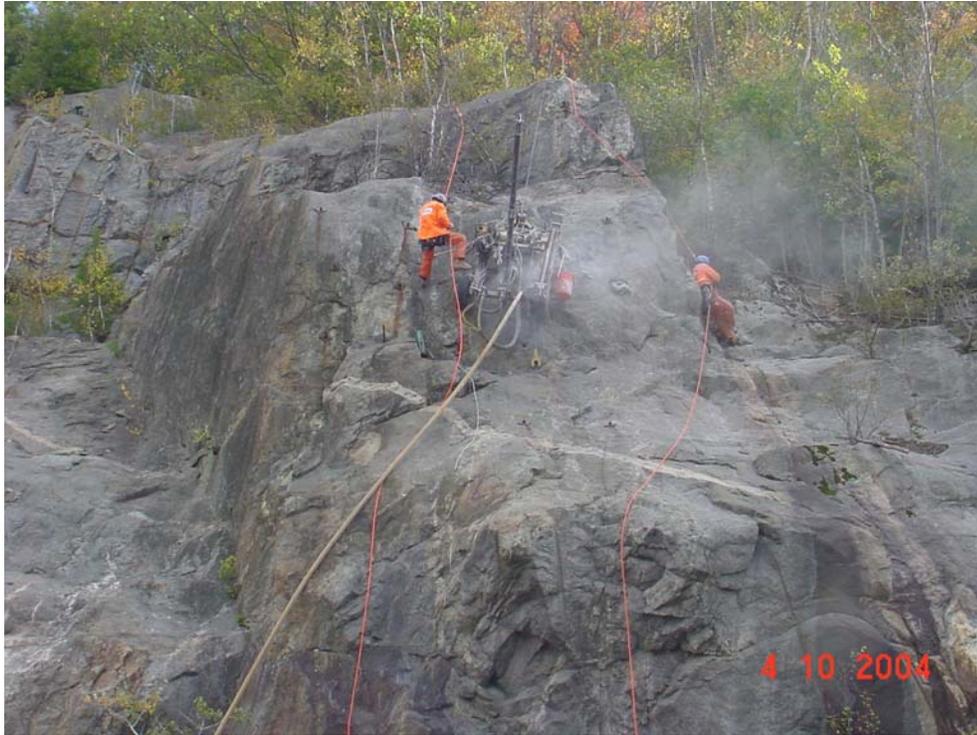
Figure 5. *Drilling replacement holes for rock reinforcement*

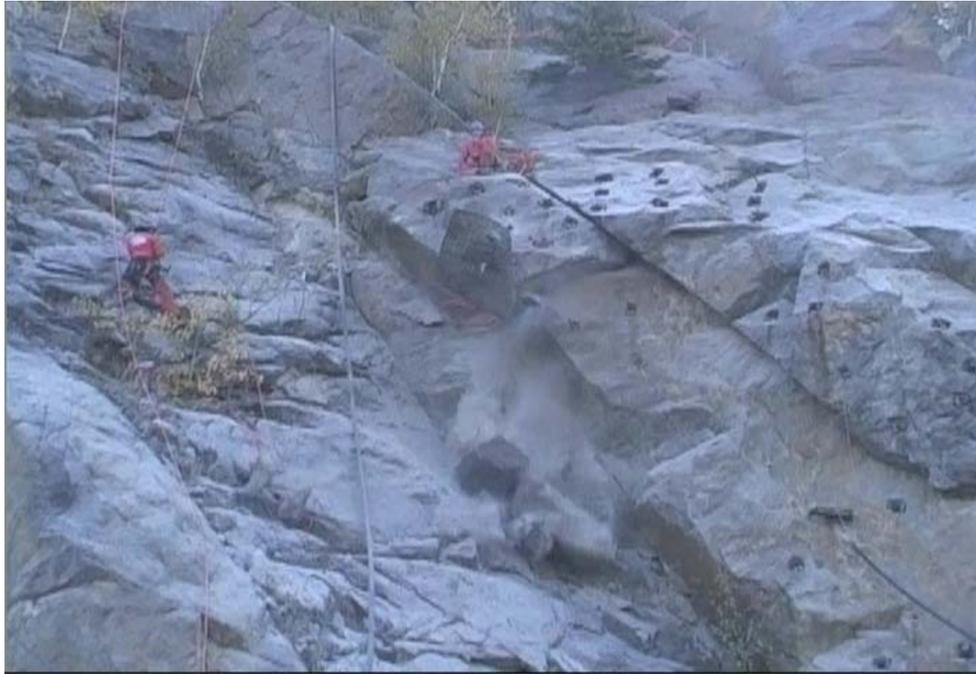
Figure 8. *Splitting the detached block with the Boulder Buster™ device.*

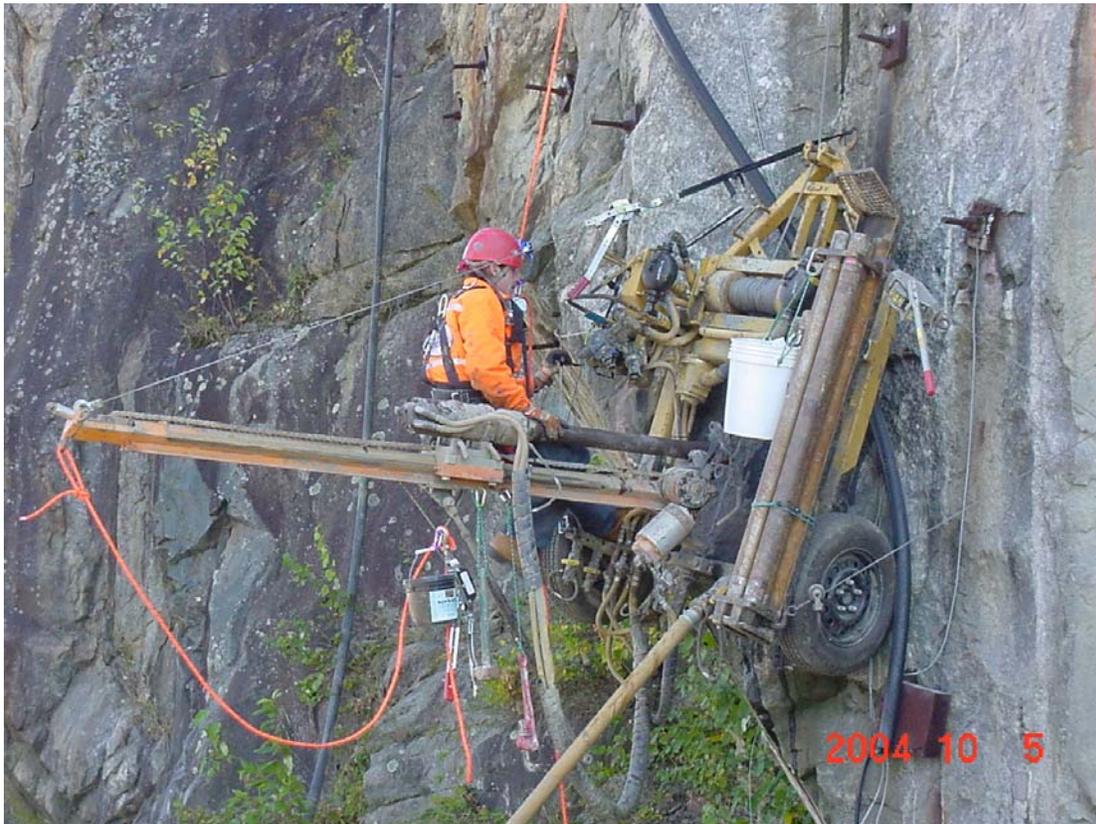
Figure 10. Air track drill with winch mounted on wagon

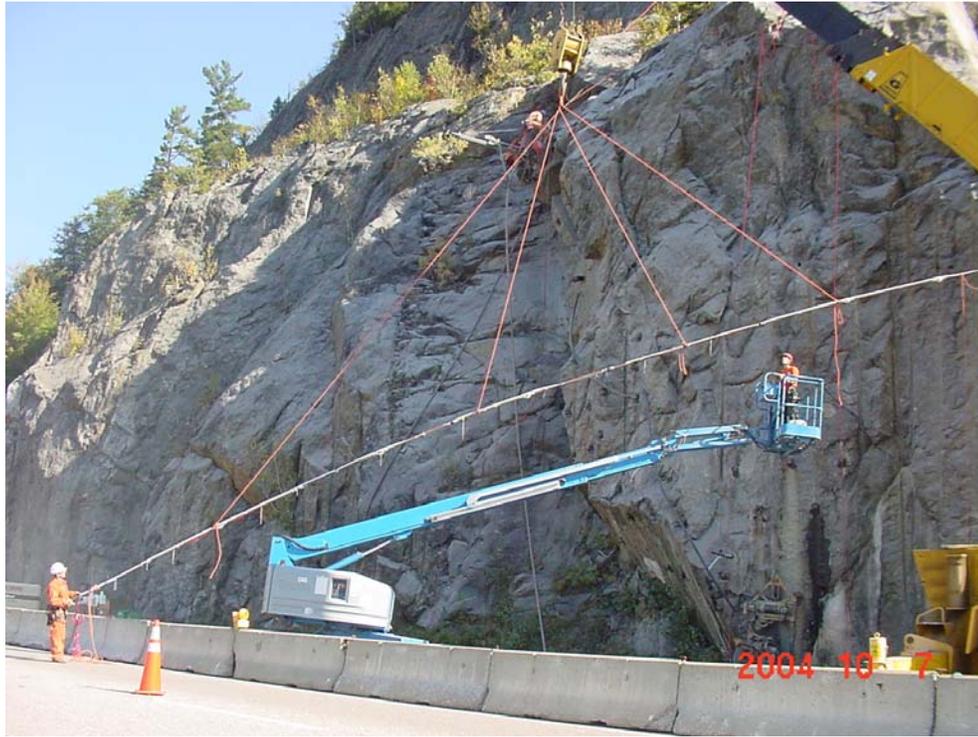
Figure 11. *Installing 60-foot long steel tendon*

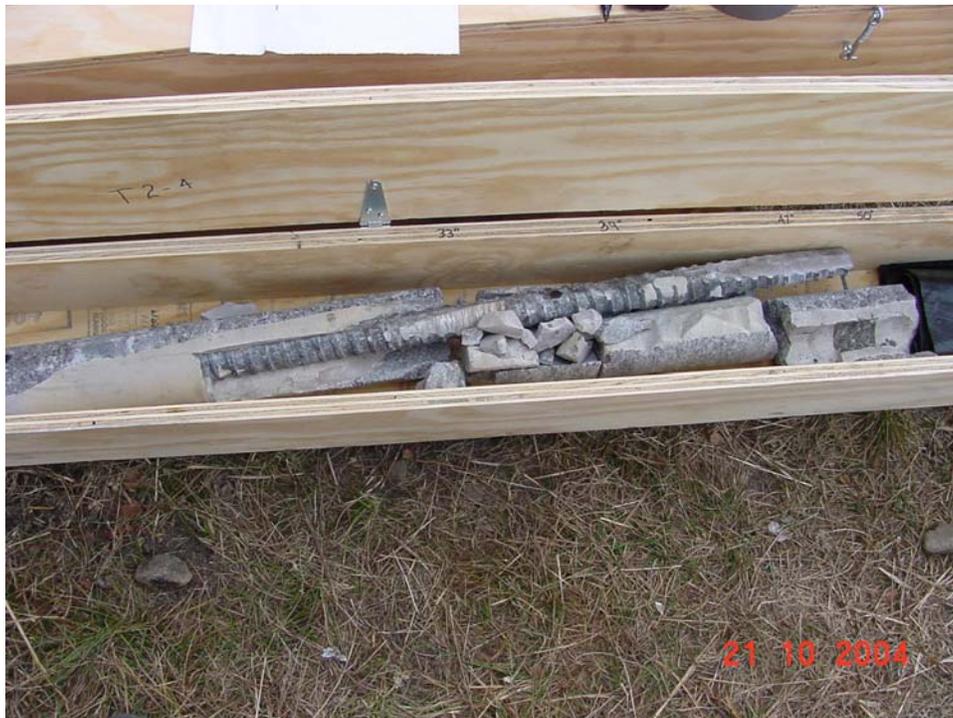
Figure 22. *Recovered 1.25 inch diameter, steel tendon and cement grout*

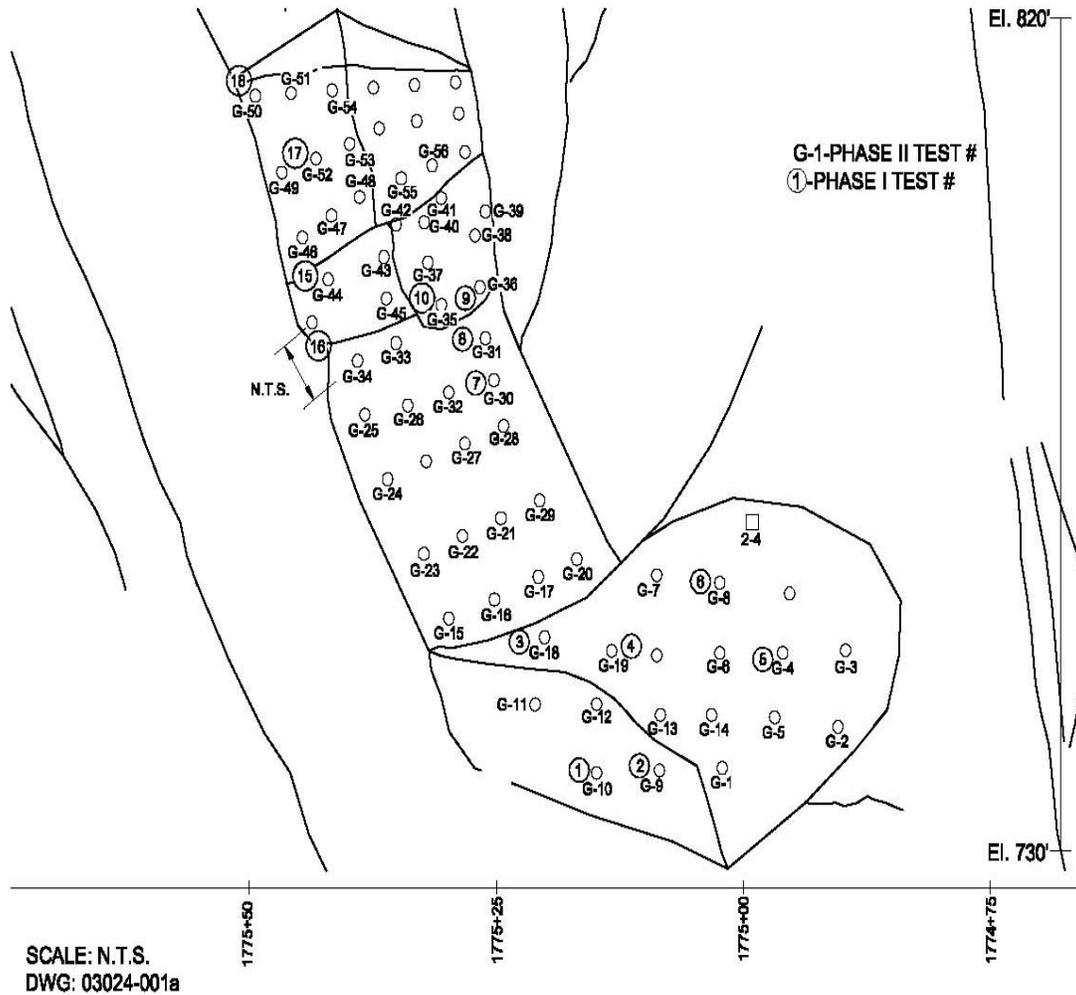
Figure 4. Rock Face Elevation View with Stationing, Reinforcement Locations, and Test Numbers for Phase I & II

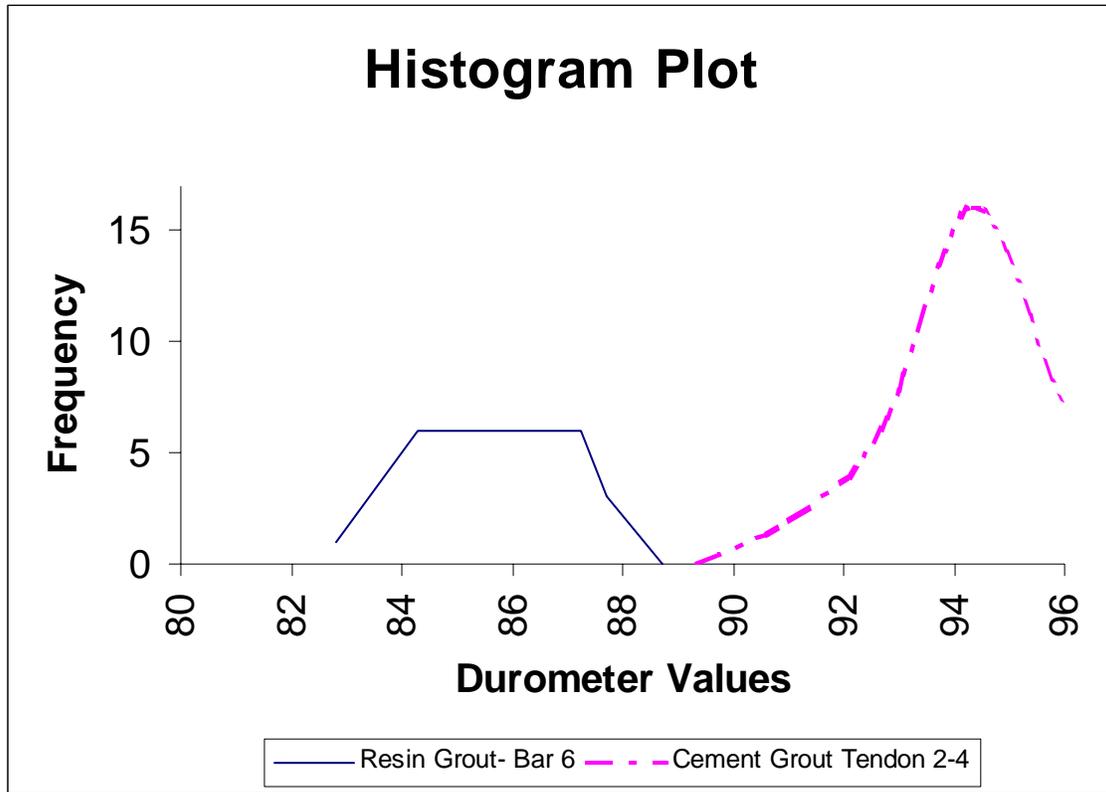
Figure 5. Histogram of Resin Grout and Portland Cement Grout Hardness Measurements.
