56th HIGHWAY GEOLOGY SYMPOSIUM

WILMINGTON, NORTH CAROLINA, MAY 4-6, 2005

PROCEEDINGS

HOSTED BY
THE
NORTH CAROLINA
DEPARTMENT OF TRANSPORTATION

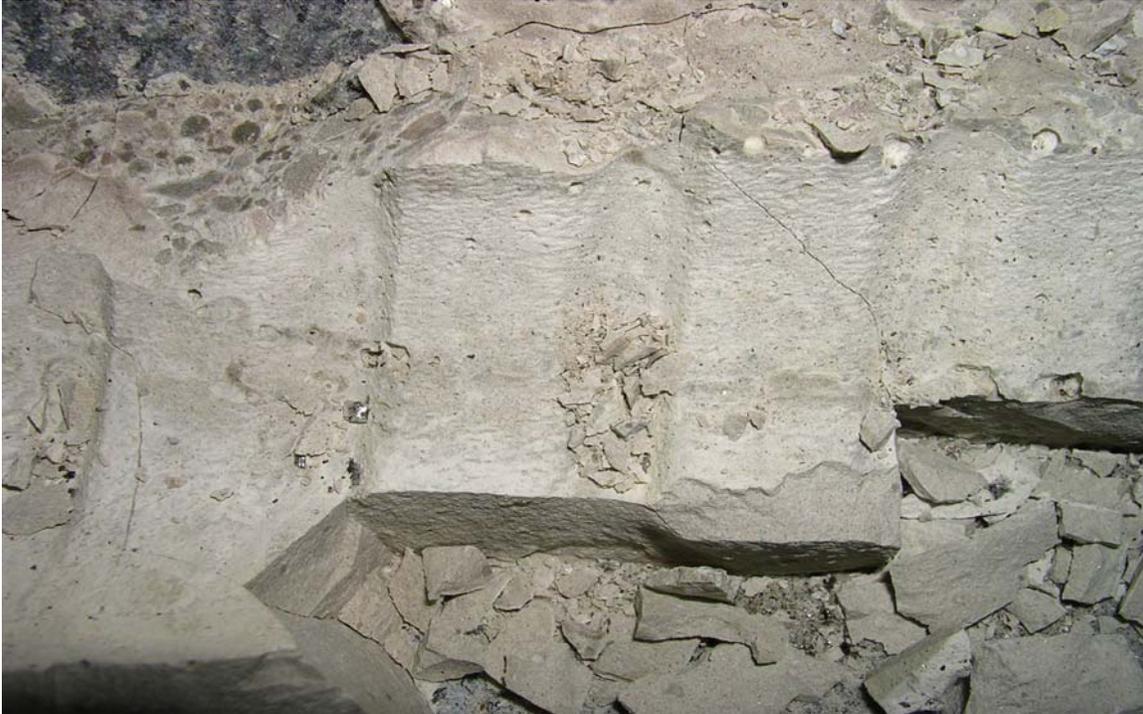
Figure 6. Pores Distributed Throughout Portland Cement Grout Sample.

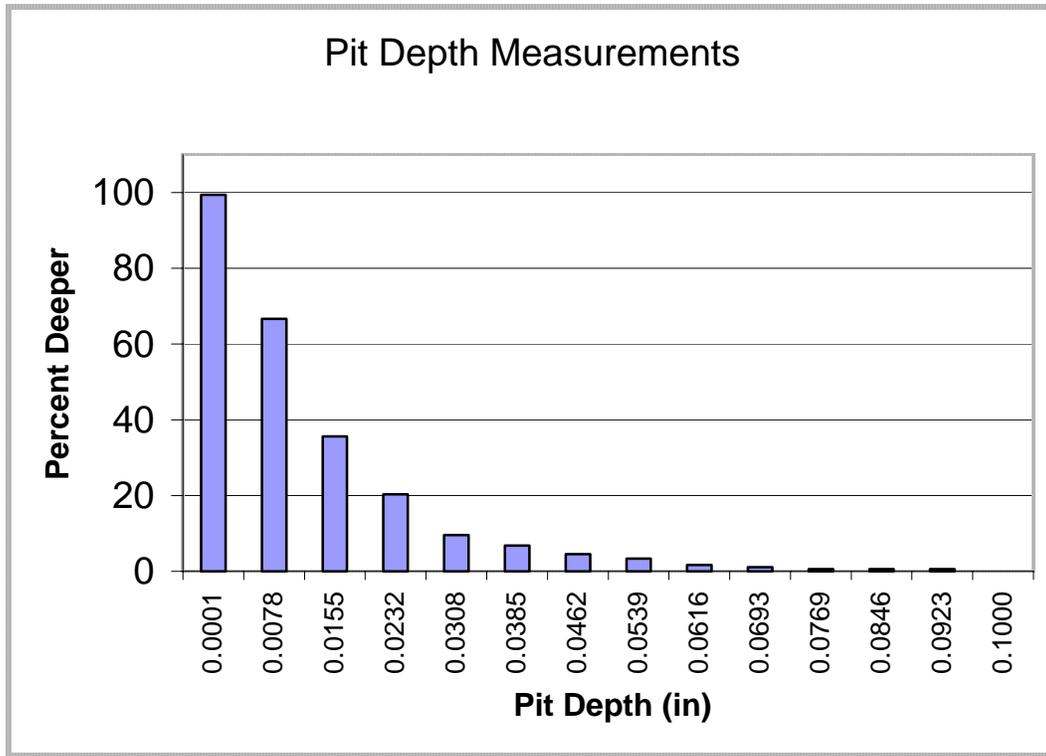
Figure 7. Cumulative Distribution of Pit Depth Measurements

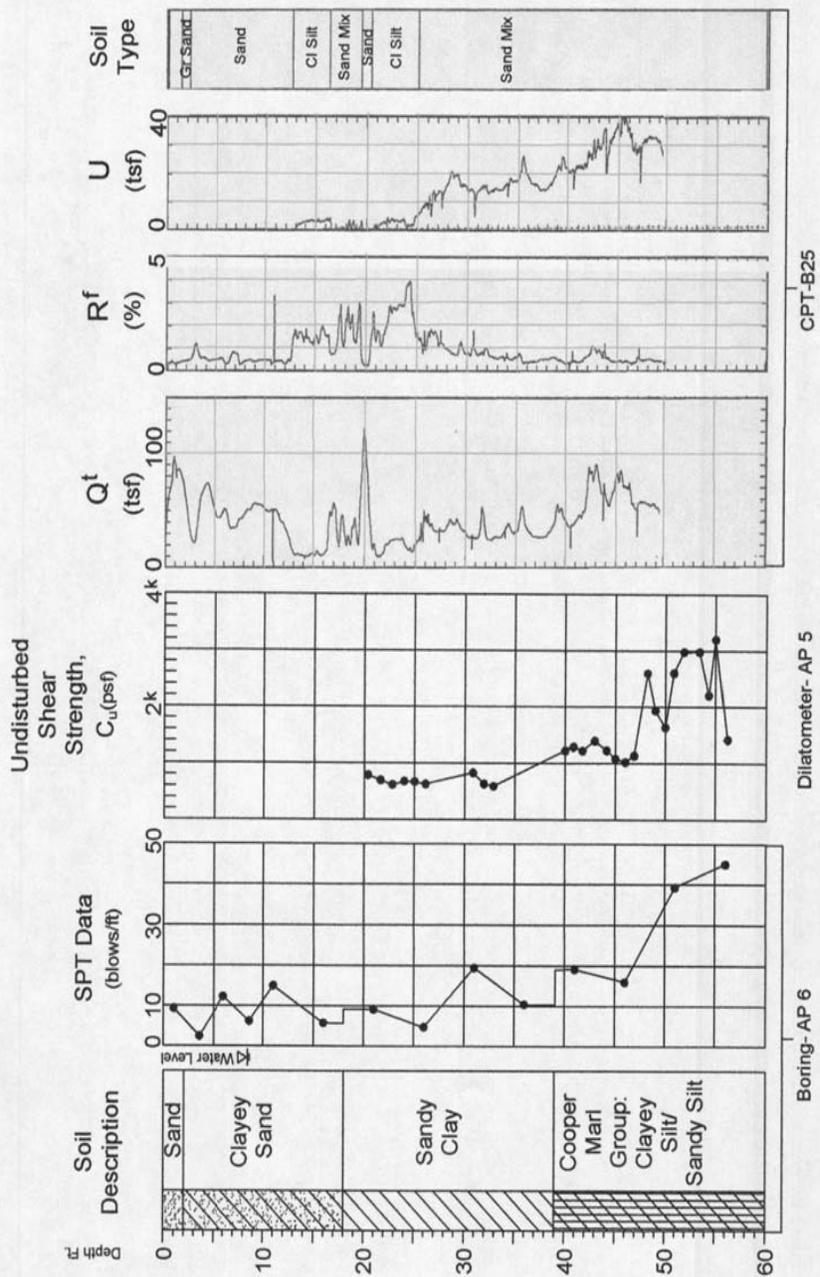
Fig. 2. Typical Generalized Subsoil Profile

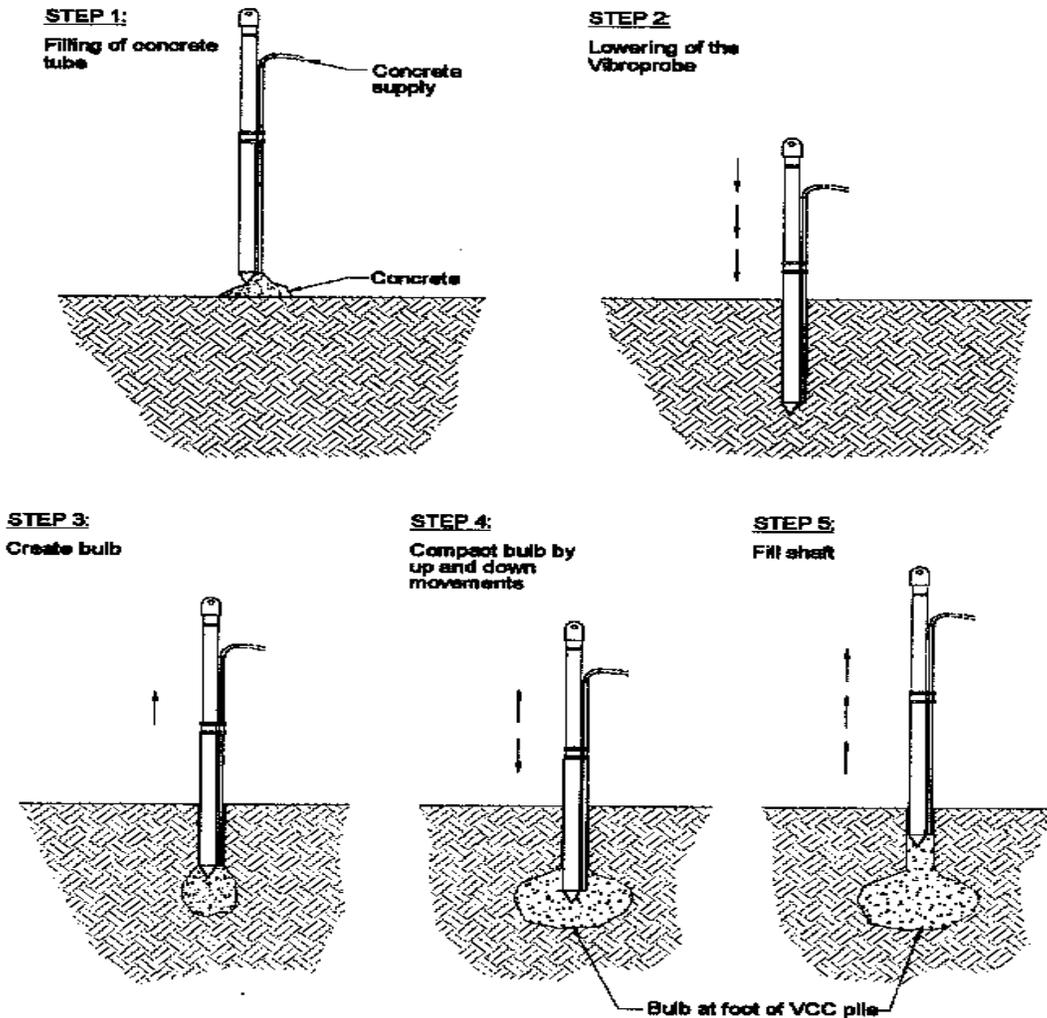
Fig.5. Vibro Concrete Column Installation Process

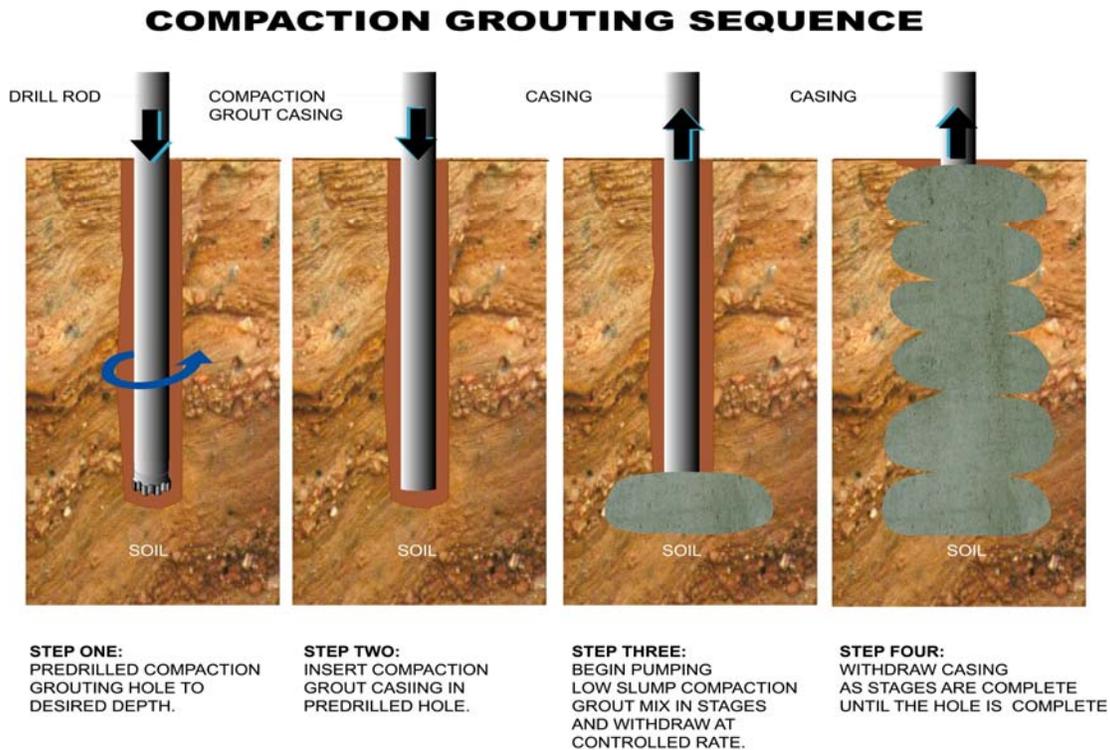
Fig. 6. Compaction Grouting Sequence

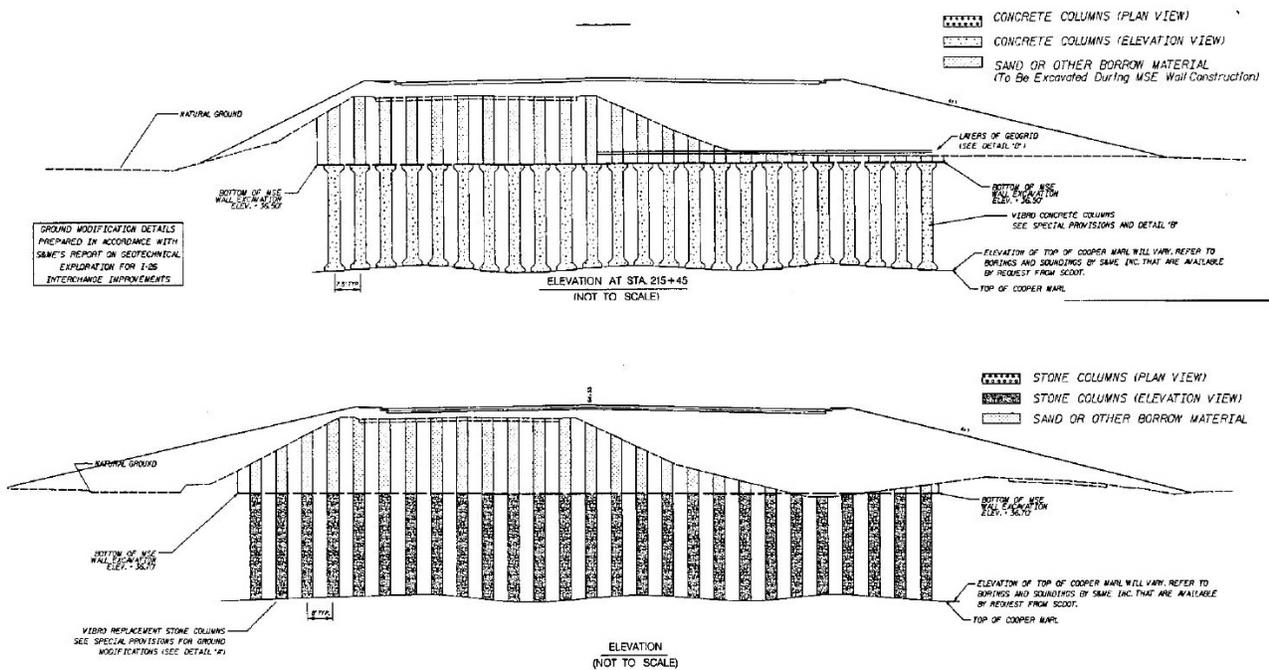
Fig. 12. Cross Section of Vibro Stone Columns and Vibro Concrete Columns

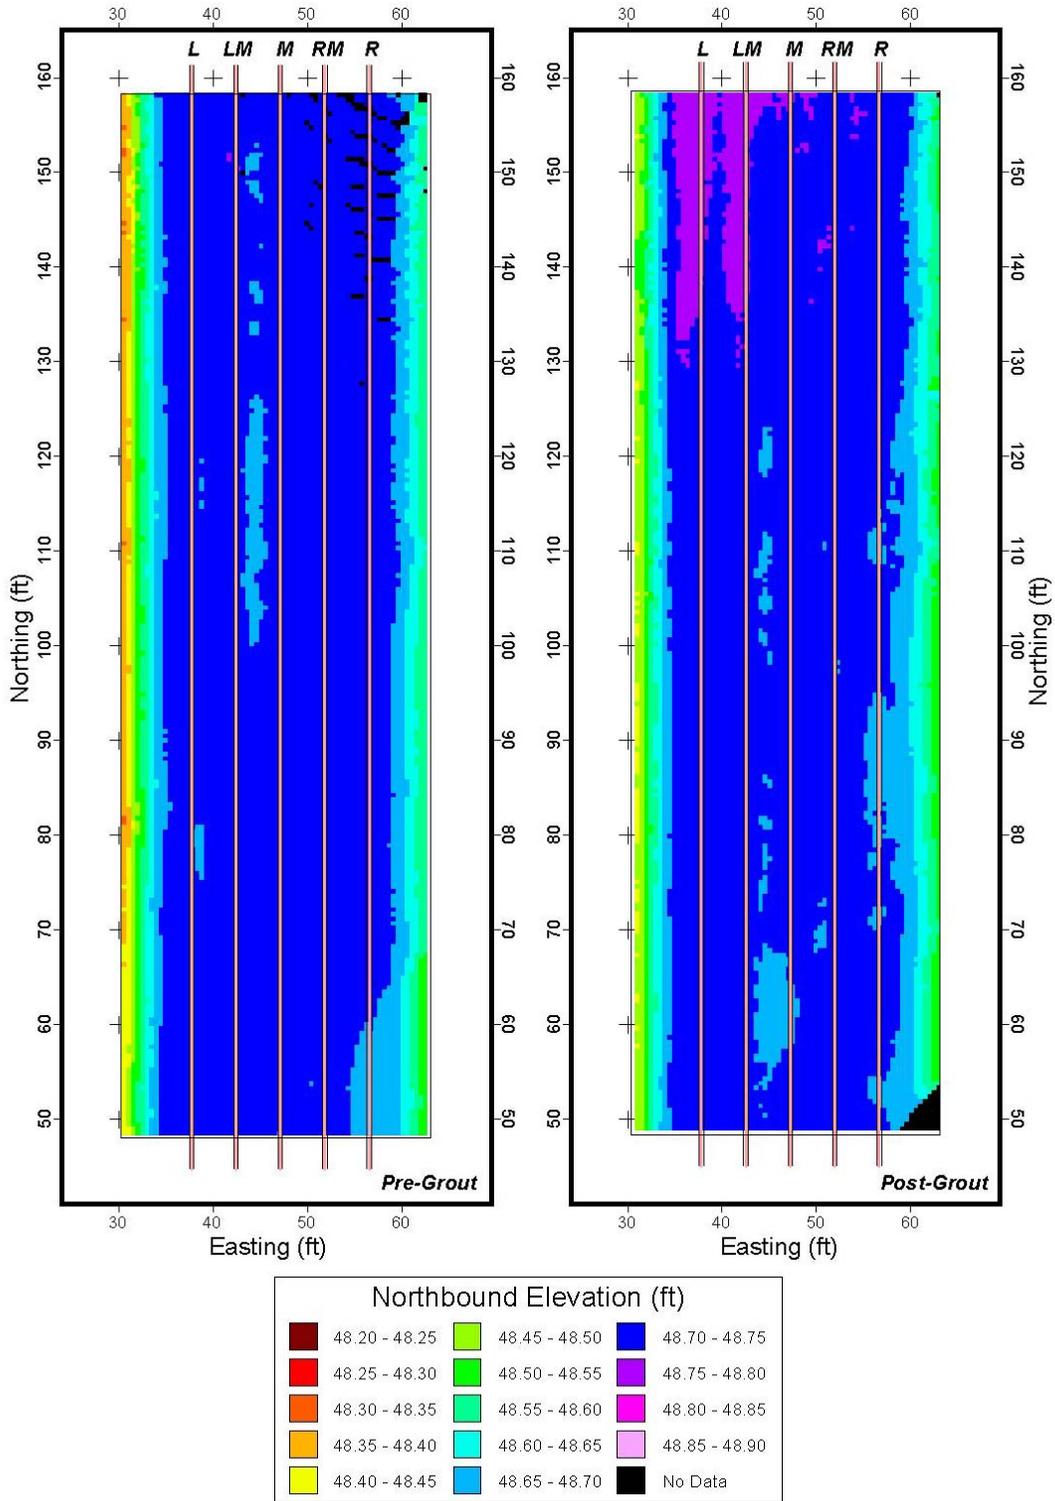
Figure 5. Pre- and post-grouting scanner elevations of the northbound lanes. Buried pipelines are located at approximately Northing Stations 70 and 130.

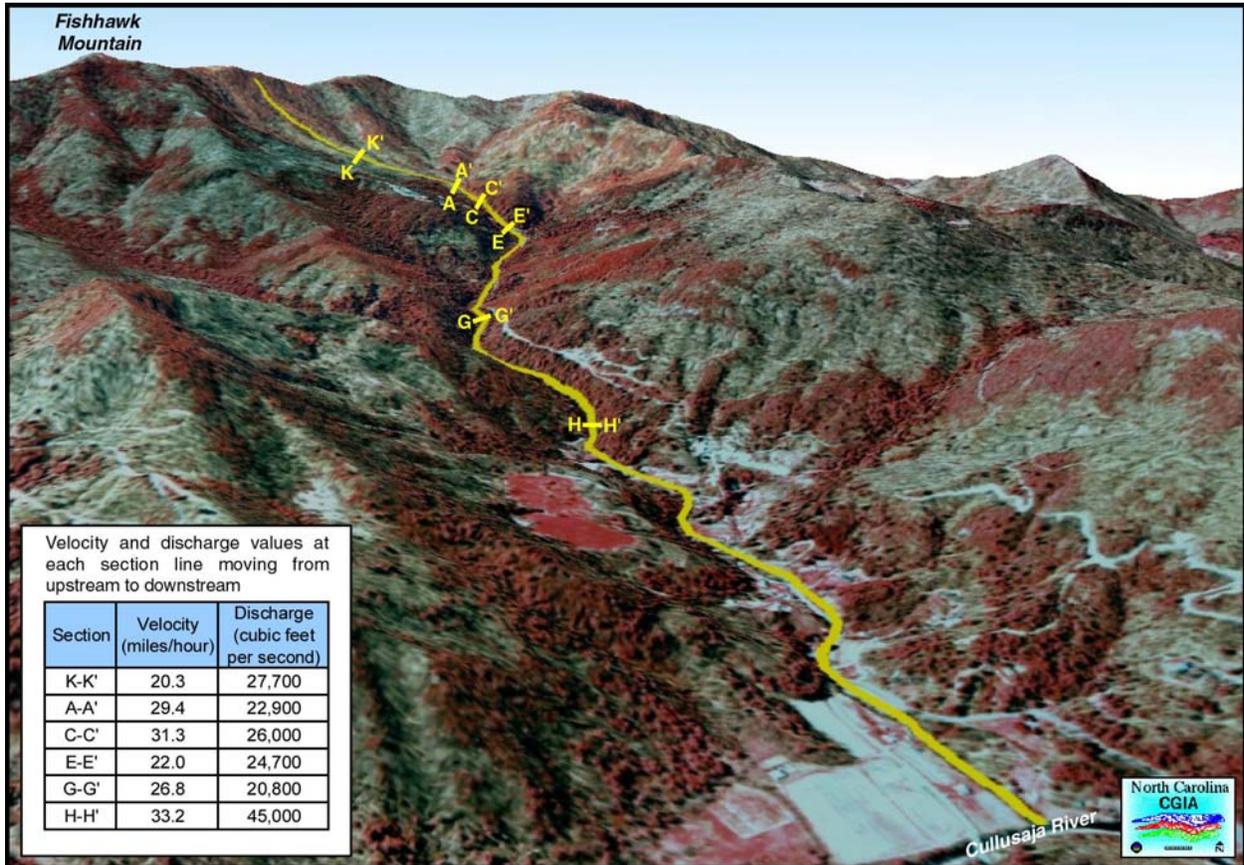
Figure 7. 3-D oblique view of a digital elevation model with a 1998 color-infrared digital orthophoto quarter quadrangle (DOQQ) superimposed. Shown are the locations of six cross sections measured along the debris flow track to compute velocity and discharge estimates shown in inset table. Debris flow track is shown in yellow. Oblique view of superimposed DOQQ courtesy of North Carolina Center for Geographic Information and Analysis. All cross sections were performed by NCGS staff using 100-ft cloth tape, brunton compass, and clinometer.

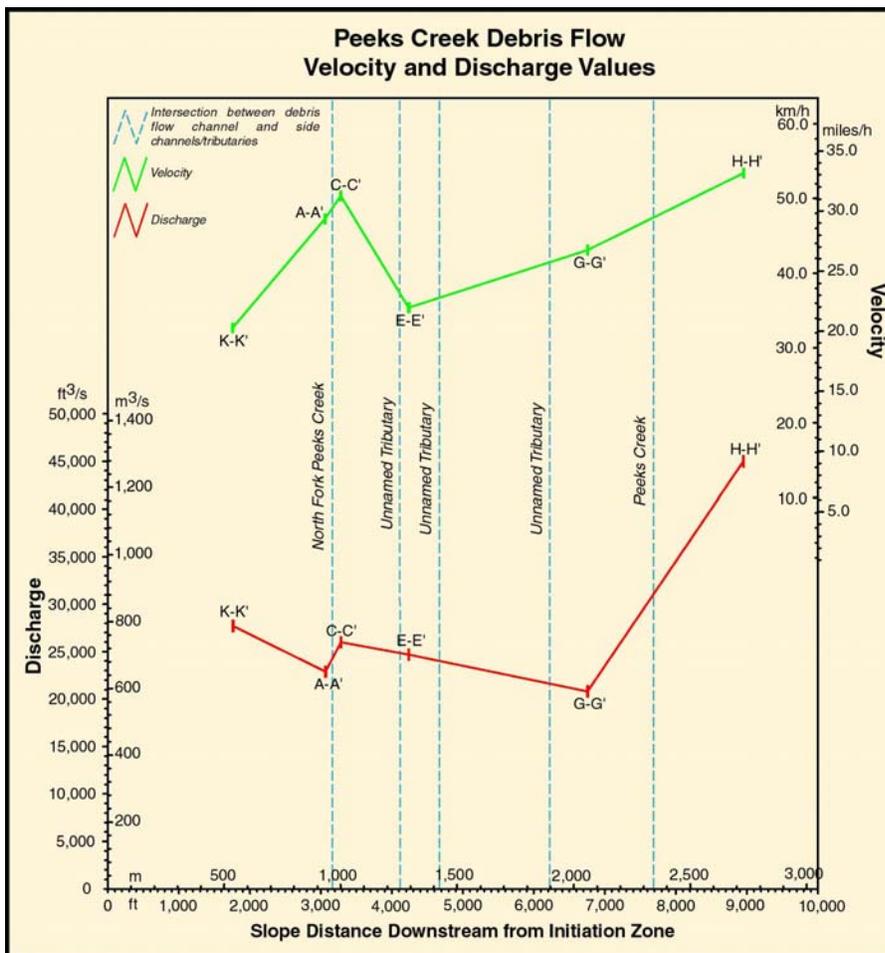
Figure 8. Graph showing a plot of velocity (shown at top in green) and discharge (shown at bottom in red) versus slope distance from the initiation zone. Locations of section lines are shown on each line. Blue dashed lines indicate the locations of side channels that may have contributed significant flow to the debris flow.

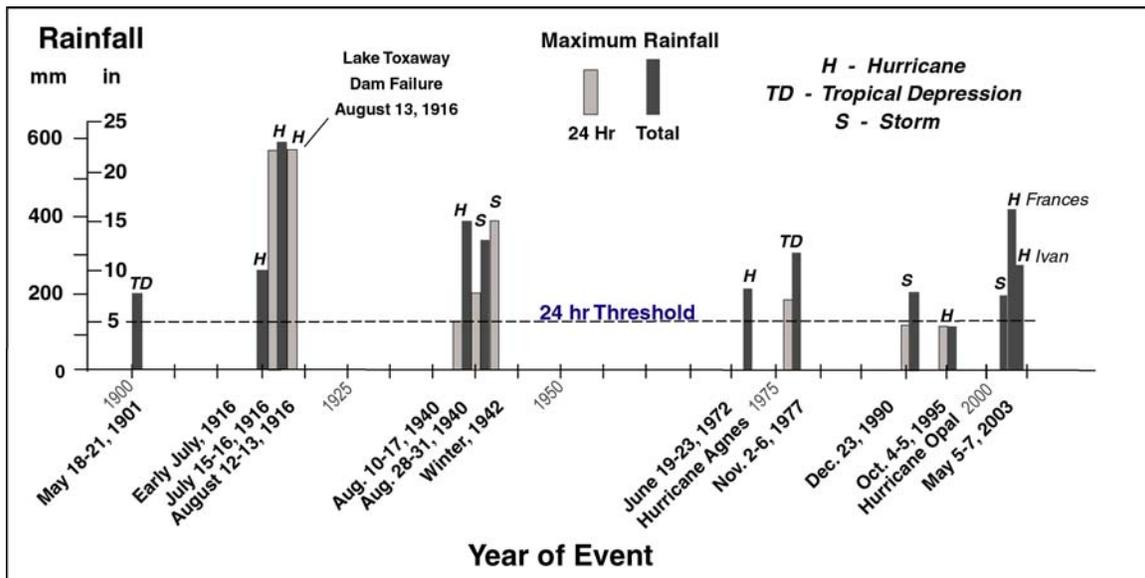
Figure 2. Chart showing rainfall associated with hurricanes and other storms that triggered landslides and flooding in western North Carolina. As a general rule, the 24-hour threshold line shows the minimum rainfall needed within a 24-hour period to trigger debris flows in the Southern Appalachians (Escher and Partic, 1982). The hurricanes of July 1916, August 1940, and Frances in Ivan in September 2004 set off hundreds of landslides causing loss of life and widespread damage in western North Carolina. Primary sources of information: U.S. Geological Survey (1949), Tennessee Valley Authority (1964), Scott (1972), Bailey and others (1975), Neary and Swift (1987); figure modified from Wooten, Carter and Mersch (2003).

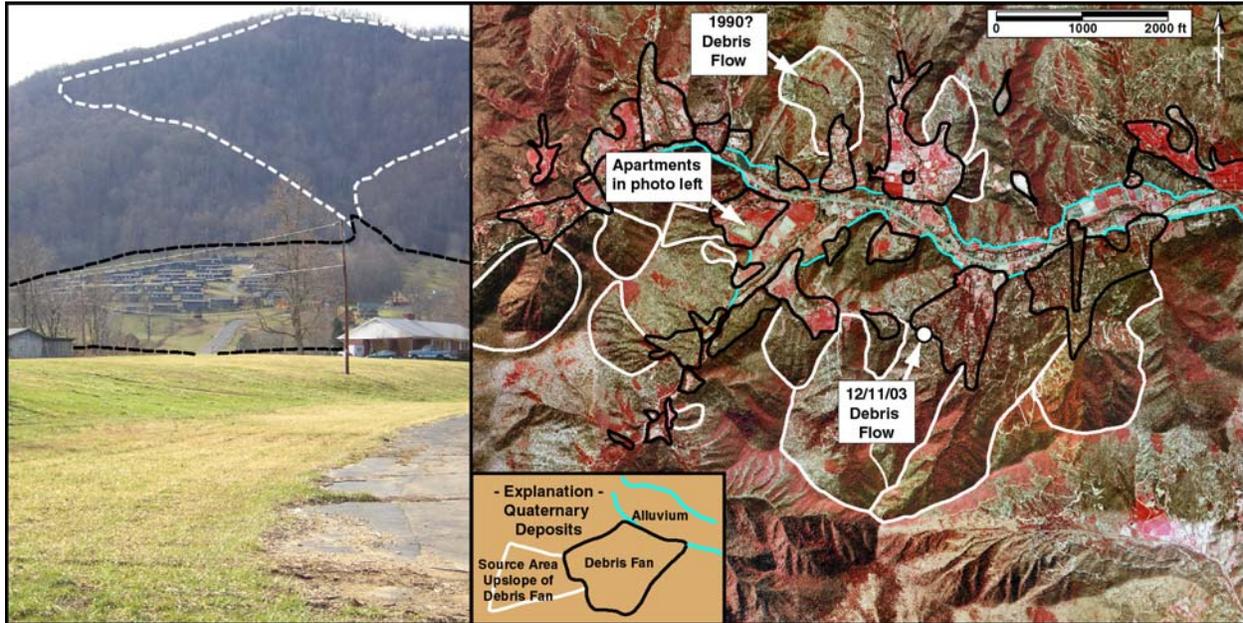
Figure 3. Photo Left. Apartment complex in Maggie Valley built on debris fan deposits (black outline) below a steep source area for the fan (white outline). Developments on the fans are at risk if future debris flows originate in the fan source areas. **Photo Right.** Reconnaissance map of some debris fan deposits and their source areas, and locations of recent debris flows near Maggie Valley. The December 11, 2003 debris flow killed one person and destroyed a home. A 1990(?) debris flow occurred on steep slopes in a fan source area and damaged roads. Map base is 1998 digital ortho quarter quads (DOQQ), Dellwood and Hazelwood 7.5-minute quadrangles. Sources of information: Hadley and Goldsmith (1963), Mills (1982), and unpublished reconnaissance mapping by NCGS, 2004.

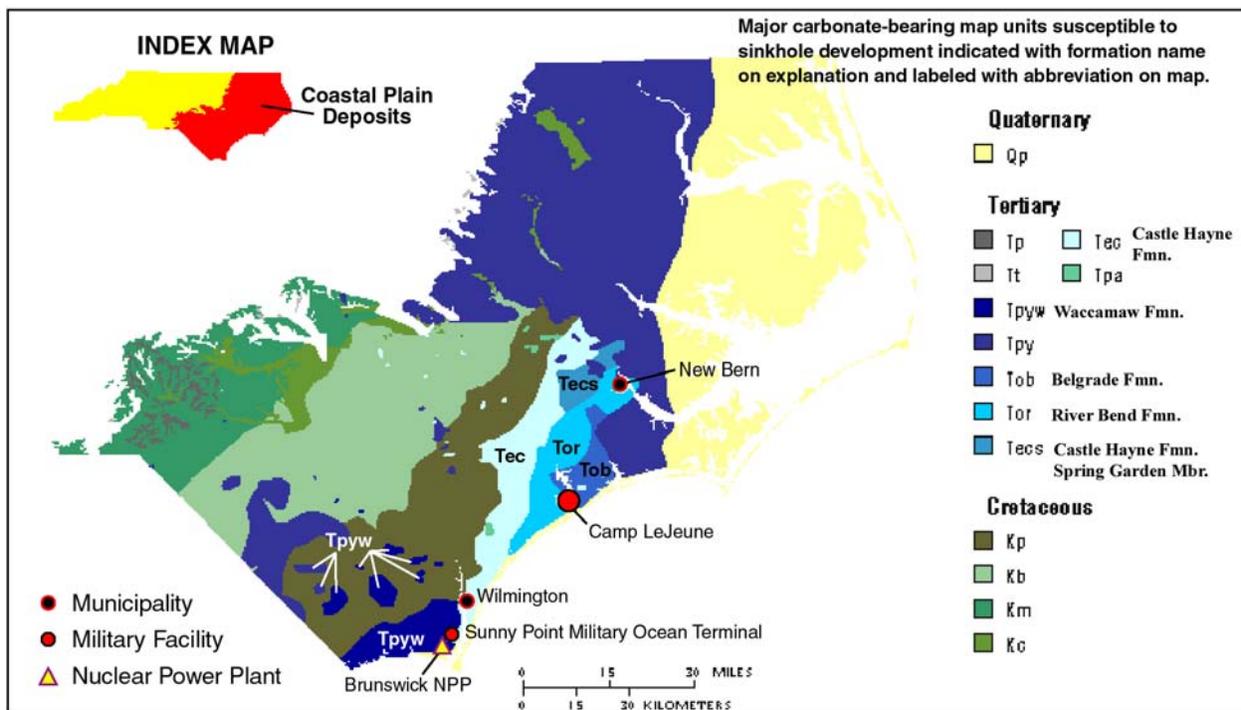
Figure 5. Generalized geologic map of the Coastal Plain showing selected municipalities and critical facilities coincident with major carbonate units susceptible to sinkhole development. In addition to hazards from subsidence and collapse, sinkholes and other karst-related features in carbonate rocks have a direct influence on surface and groundwater contaminant pathways. Carbonate rocks in this region are important aquifers for municipal, industrial, and private groundwater supplies.

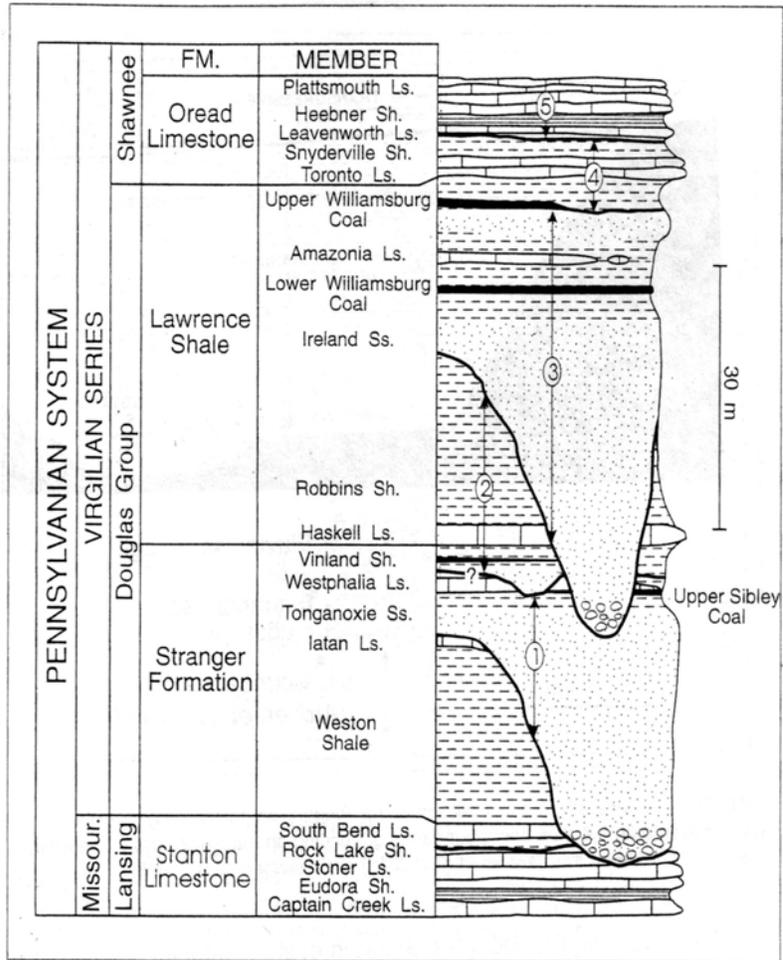
Figure 2. From Archer and Feldman, 1994. Stratigraphic representation of the geologic units found along the new alignment for US-59. The Stanton Limestone is found in the southern part of the project while the Lawrence and Stranger Formations dominate the majority of the near surface rocks and the Oread Limestone Formation is found in the northern part of Douglas County on hill tops.

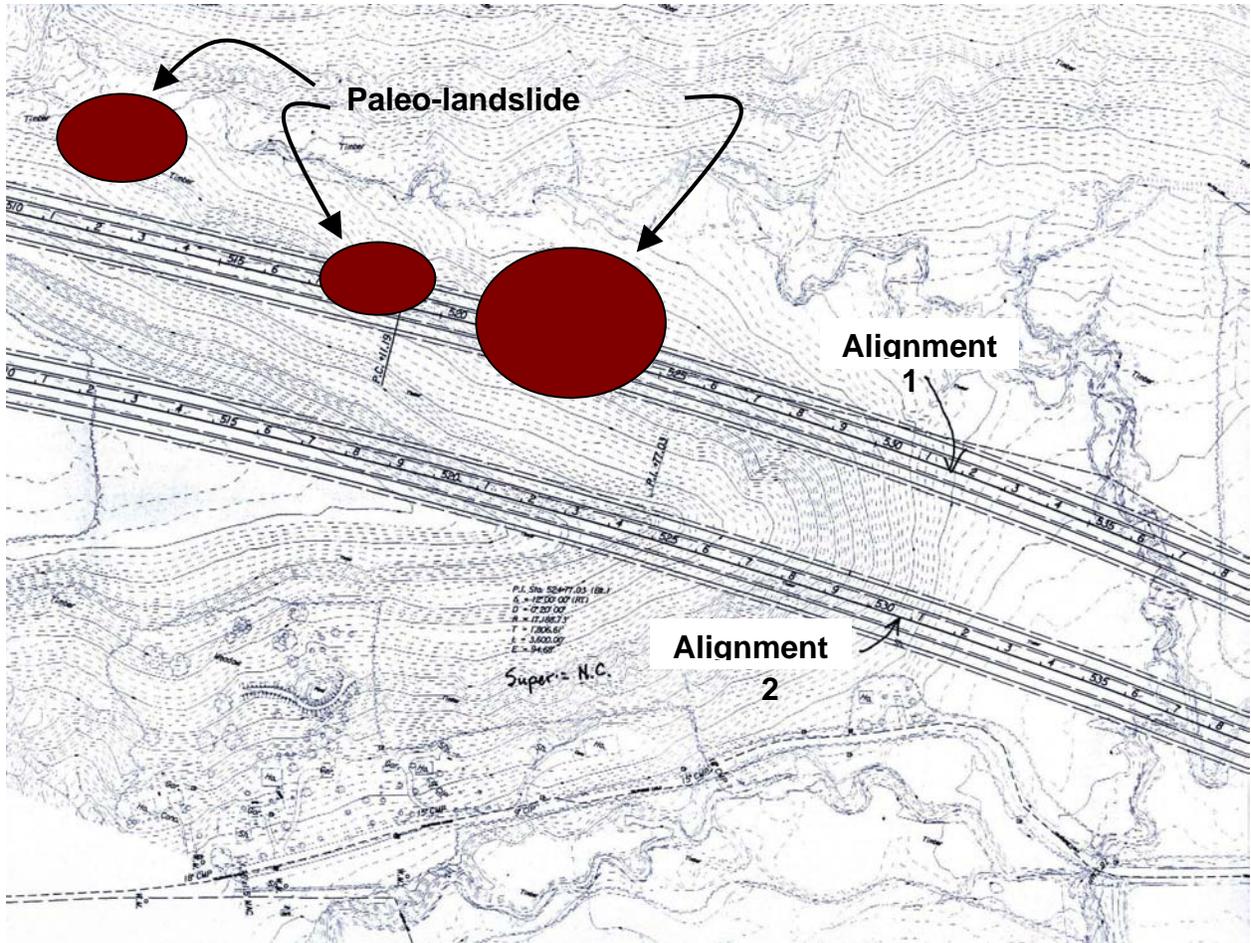
Figure 6. Alignment one was the original one chosen by road design. It poses several geotechnical challenges; large amounts of excavation along the side of the hillslope, exposing sixty or more feet of Lawrence Shale Formation, and crossing over three paleo-landslides highlighted in the figure above. Alignment two was proposed by the Geology section of KDOT to alleviate the problems caused by excavating the side of the hill by lowering the potential for catastrophic failure and avoiding the aforementioned landslides.

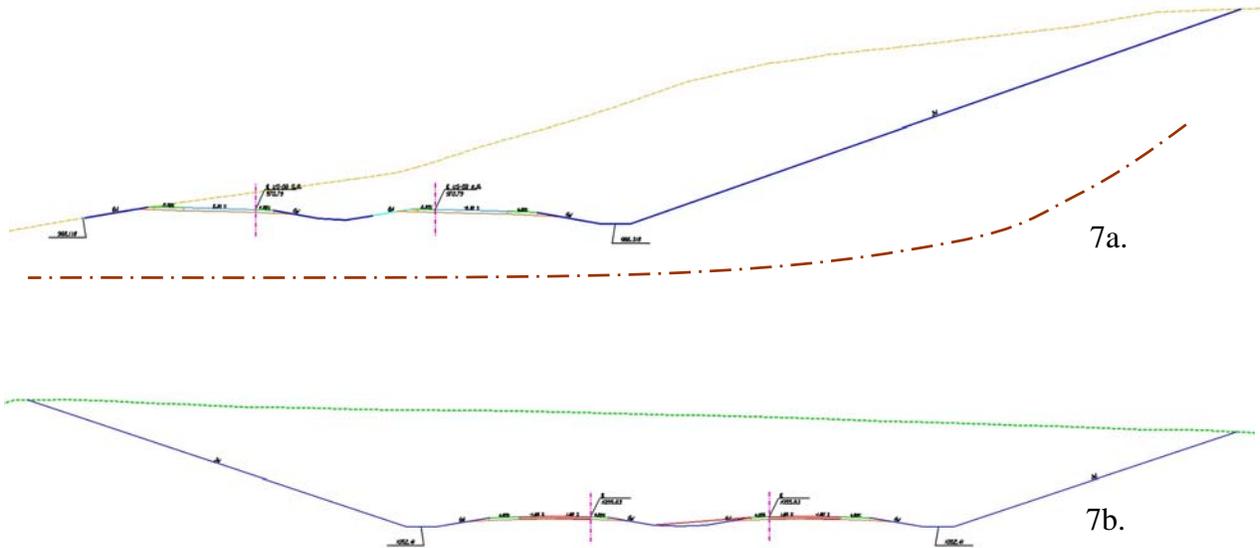
Figure 7a. and 7b. These cross-sections are examples of proposed road cuts on Pleasant Grove hill. 7a. shows the potential slide plane along which a catastrophic failure could take place when clays within the Lawrence Shale are wet and fail, which they have a proven history of in the area. 7b. is an example of the new alignment's road cuts, this will confine the Lawrence Shale within the backslopes lowering the potential for rotational catastrophic failure and total loss of the roadway.

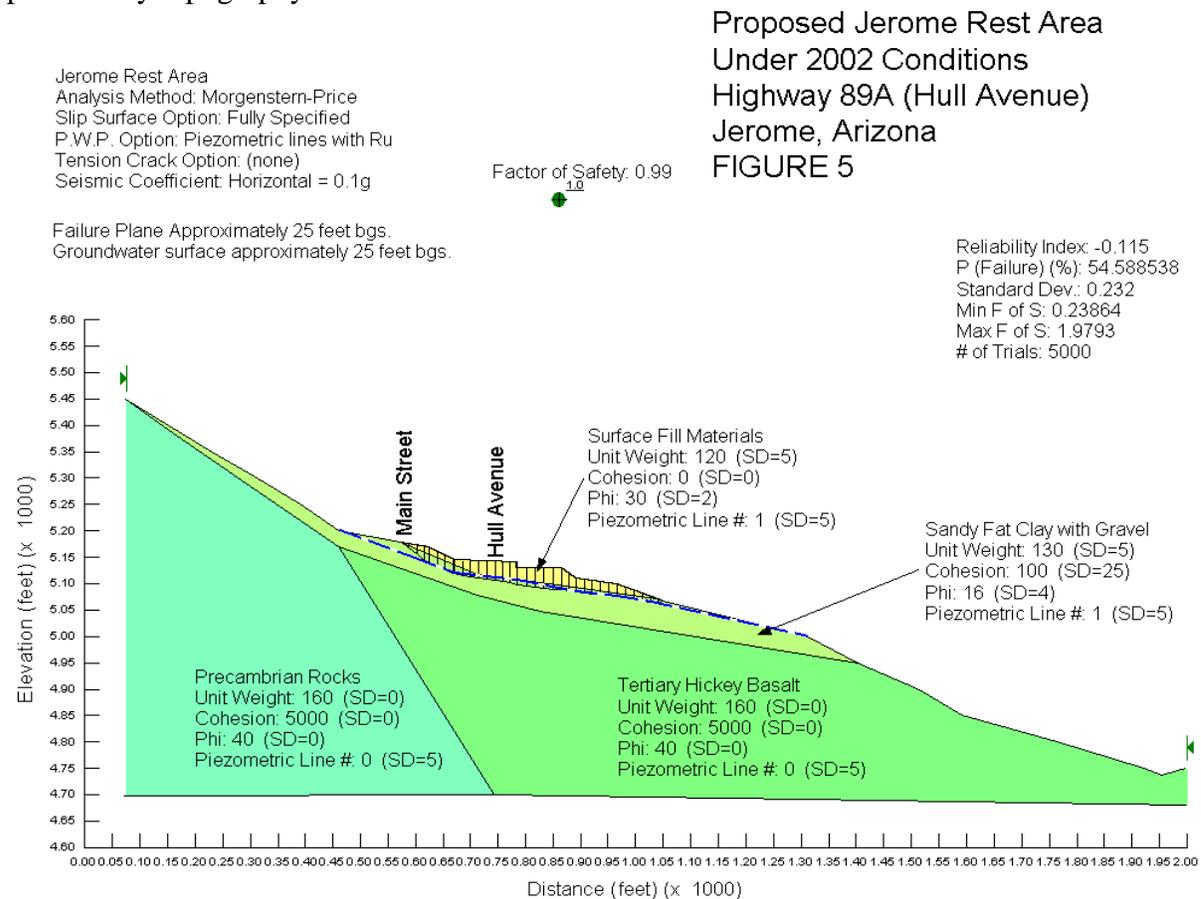
FIGURE 20, Slope Stability cross section; typical.

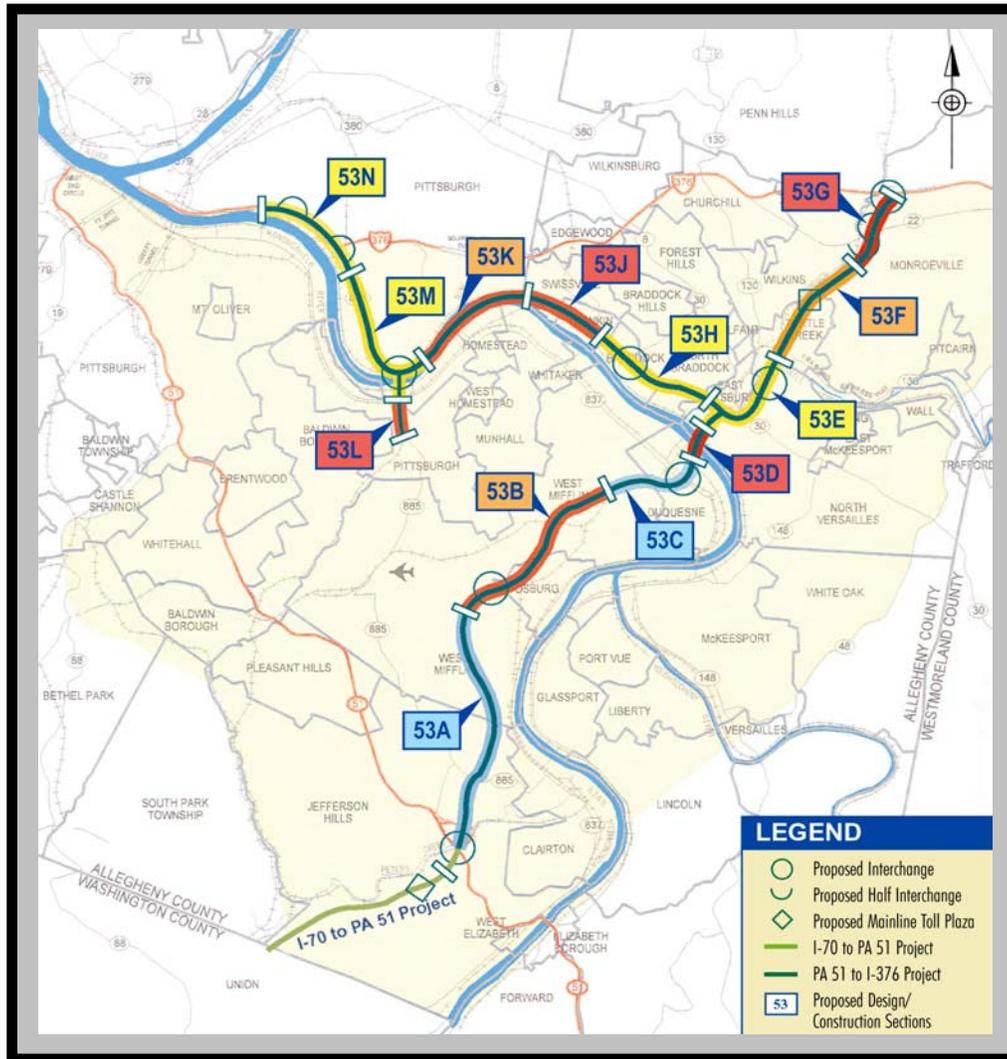
Figure 2 – Project Design Sections

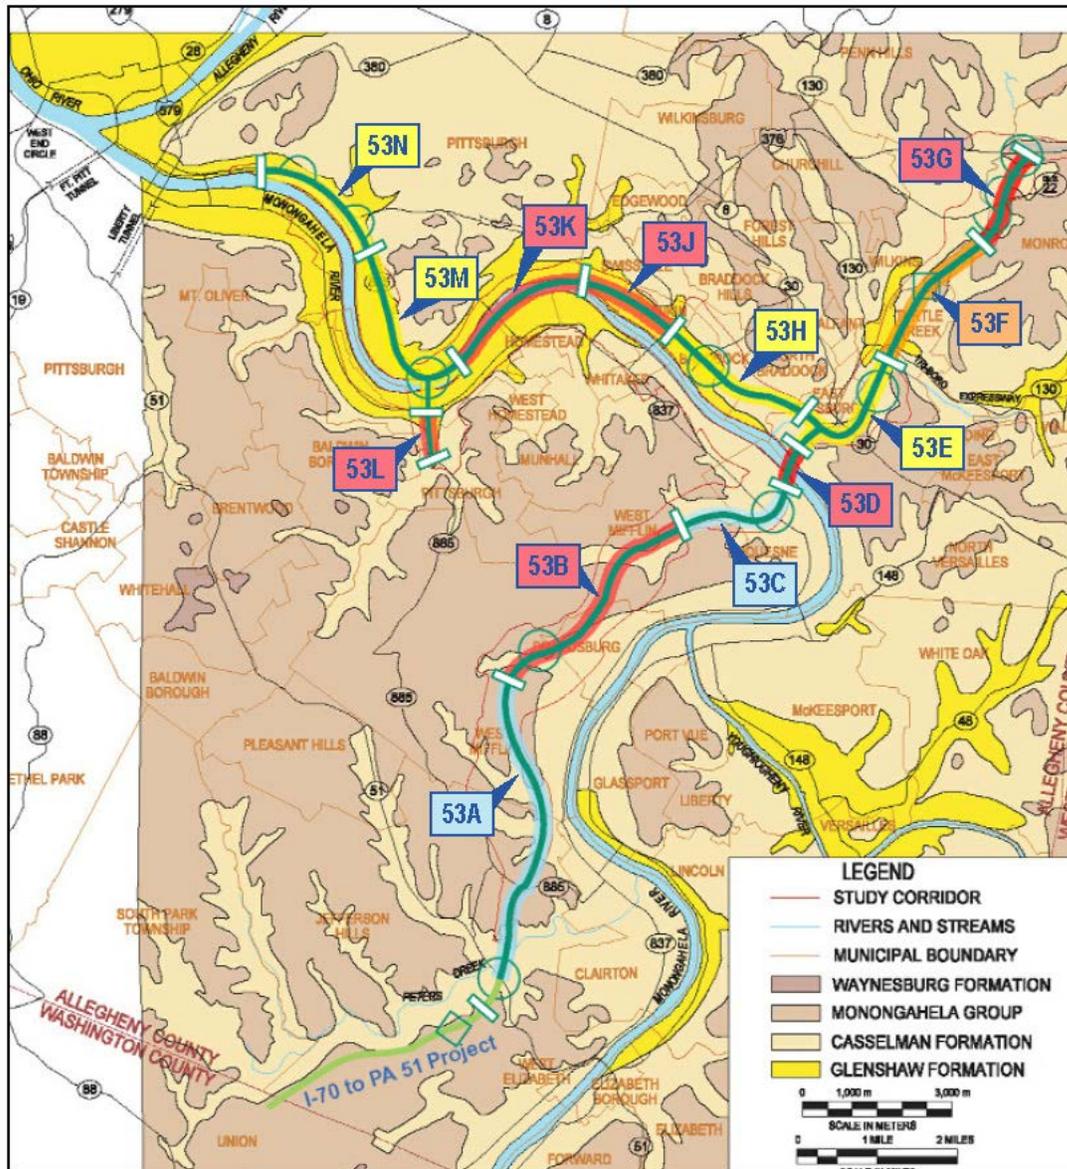
Figure 3 - Project Geological Map

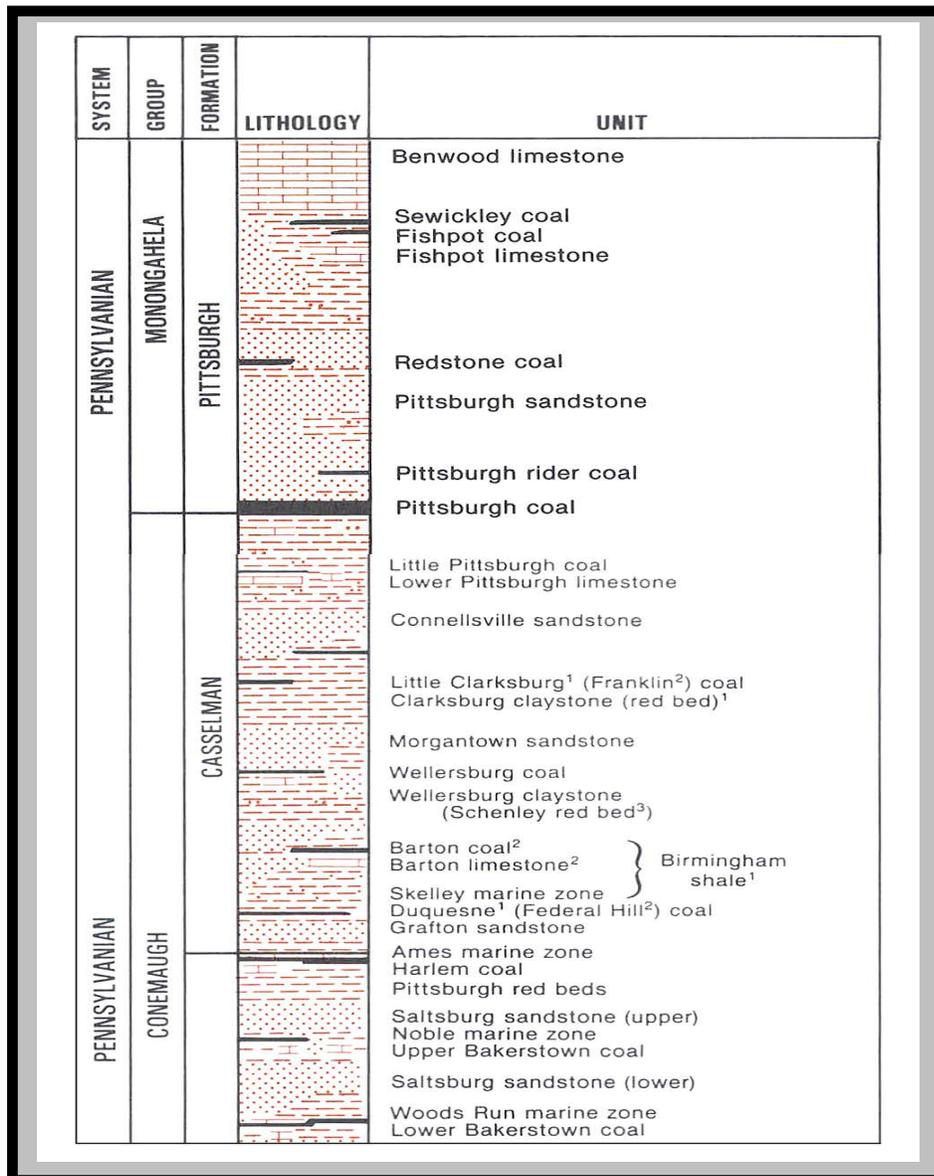
Figure 4 - Project Geologic Columnar Section (showing stratigraphic interval of interest on the project)

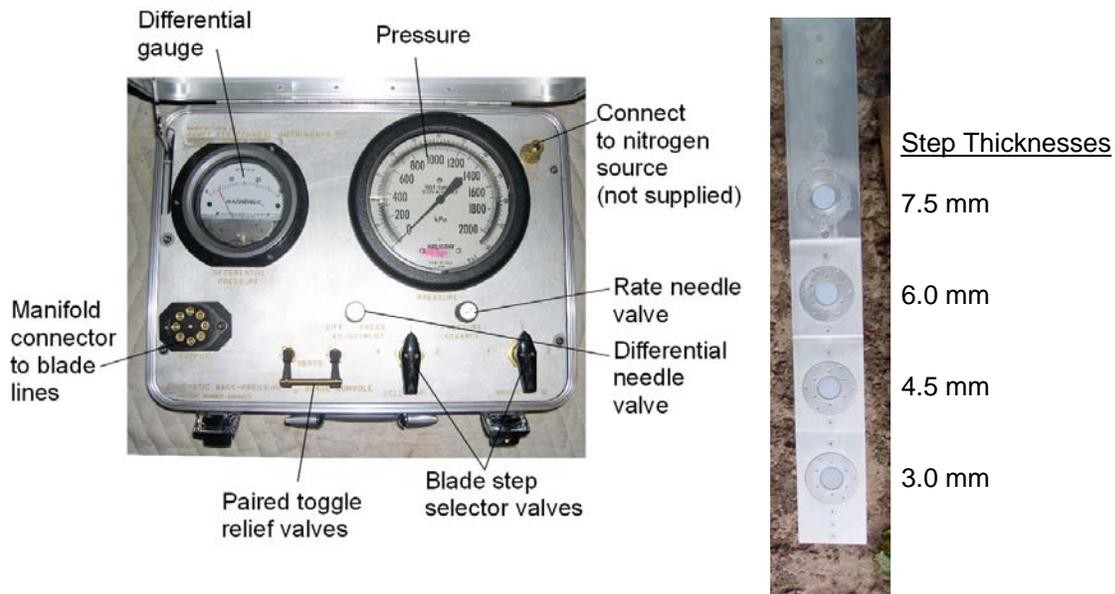
Figure 1. SBT Console and Blade Showing Pneumatic Pressure Cells.

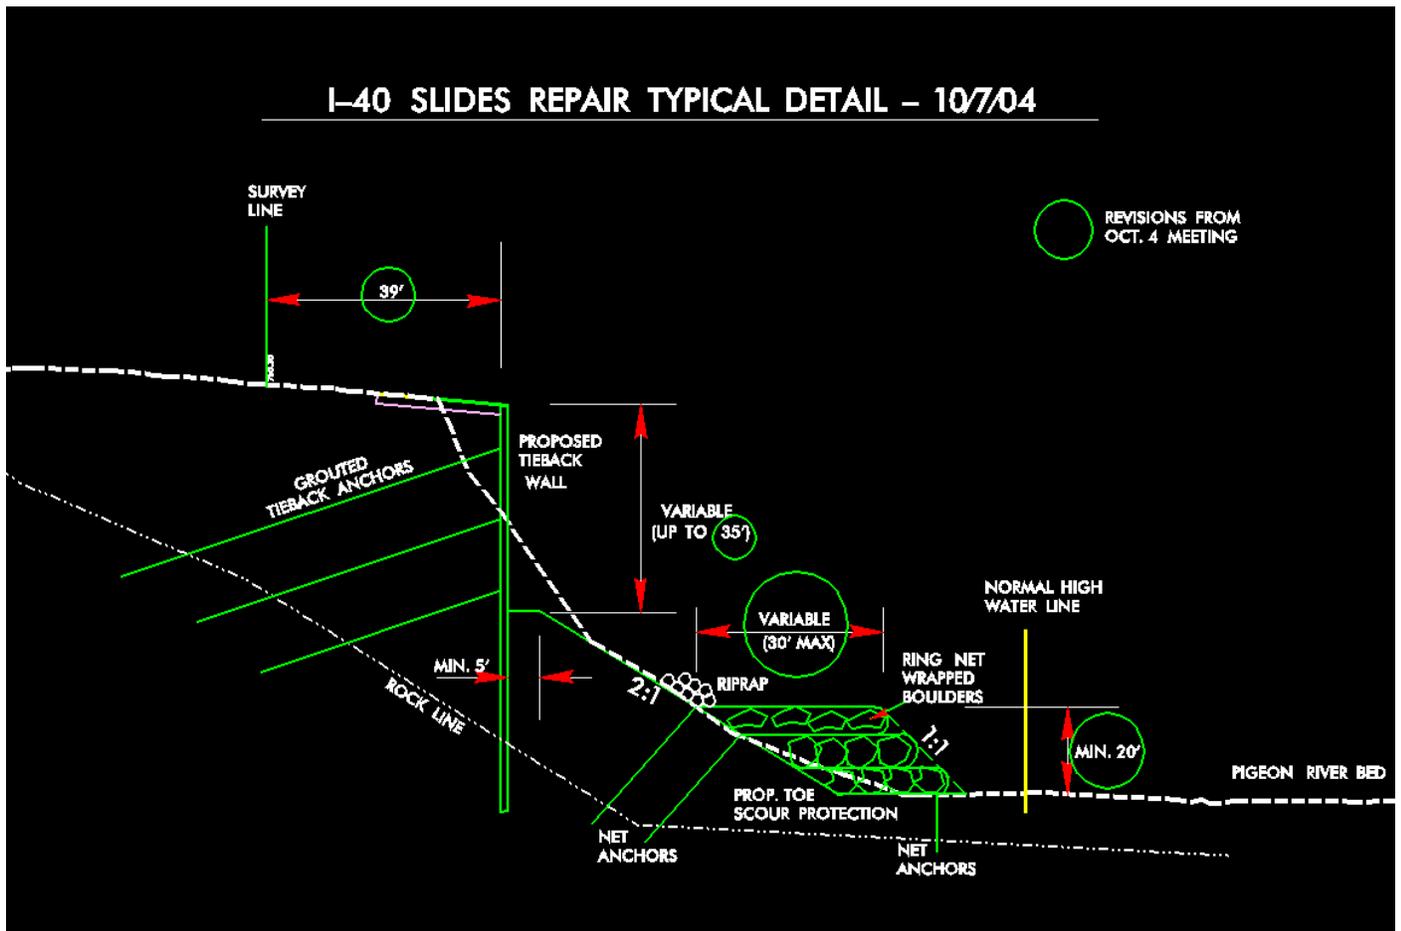
FIGURE 3. Conceptual Design for the repair at top and toe of slope

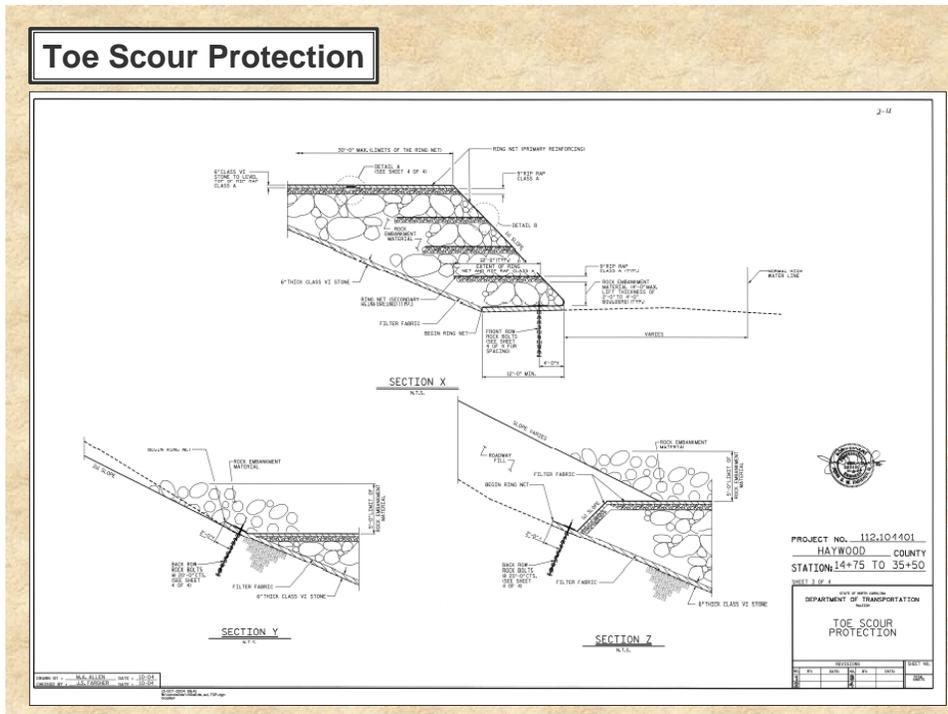
The system has 4 layers of larger diameter rock with a layer thickness of 4 feet and incorporates rock that is 2 feet to 4 feet in diameter. The nets are George North America’s ring nets made with 11.8-inch nominal diameter interlocking rings and the rings are made with 3-millimeter diameter galvanized high strength alloy steel wire. The wire is coiled into rings and each ring has 12 coils of wire.
