56th HIGHWAY GEOLOGY SYMPOSIUM

WILMINGTON, NORTH CAROLINA, MAY 4-6, 2005

PROCEEDINGS

HOSTED BY
THE
NORTH CAROLINA
DEPARTMENT OF TRANSPORTATION

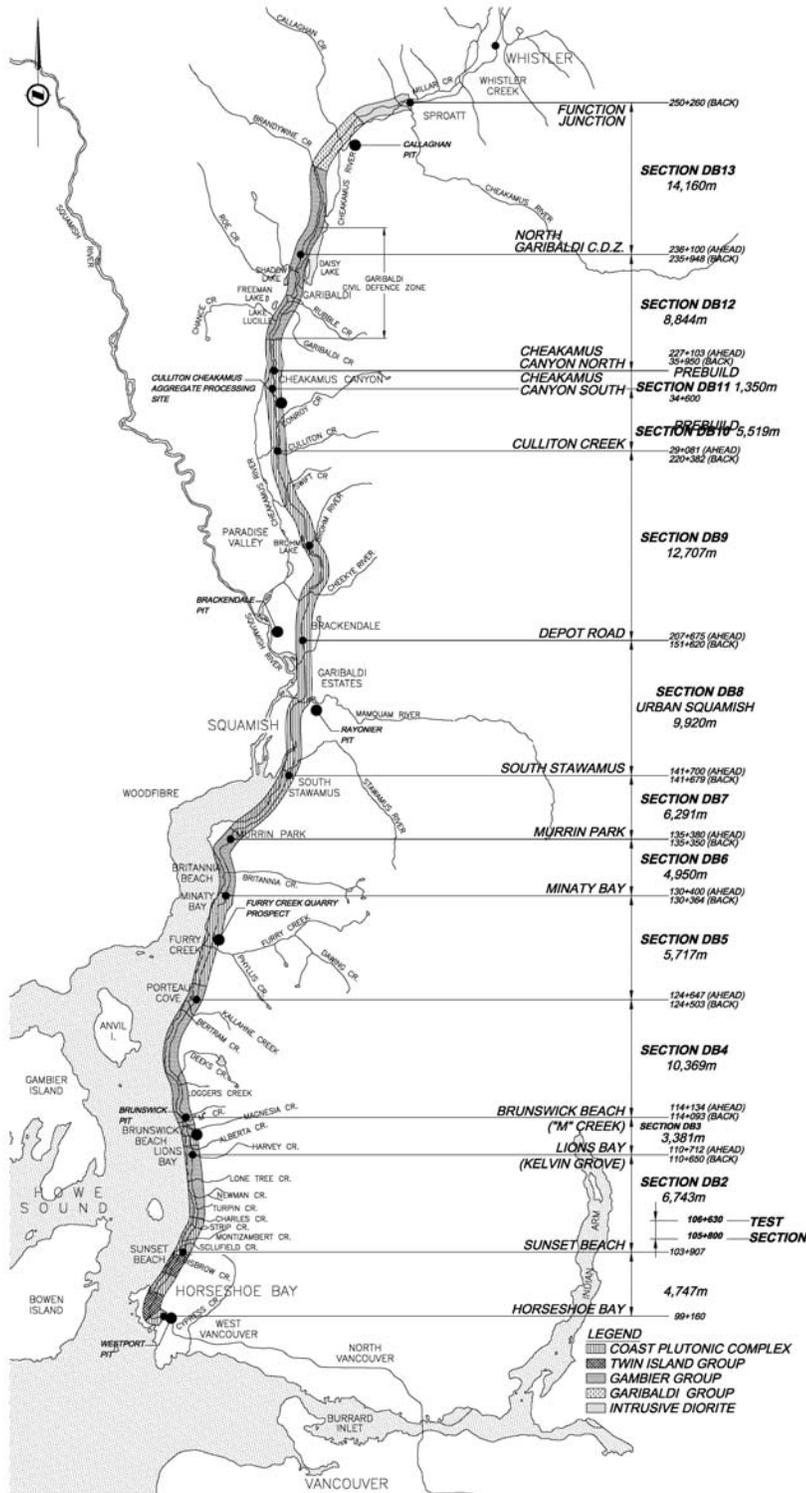
Figure 2 - Simplified Geological Model

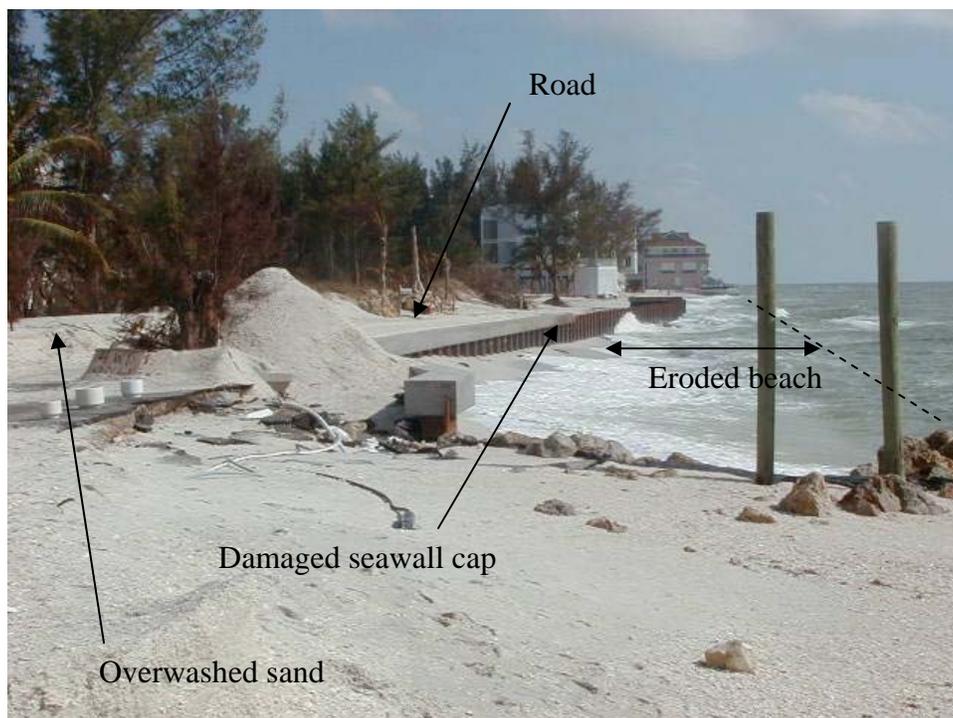
Figure 3: Seawall damage and eroded beach, Siesta Key, Sarasota County, FL.
(Photo Courtesy of FDEP, 2004d)

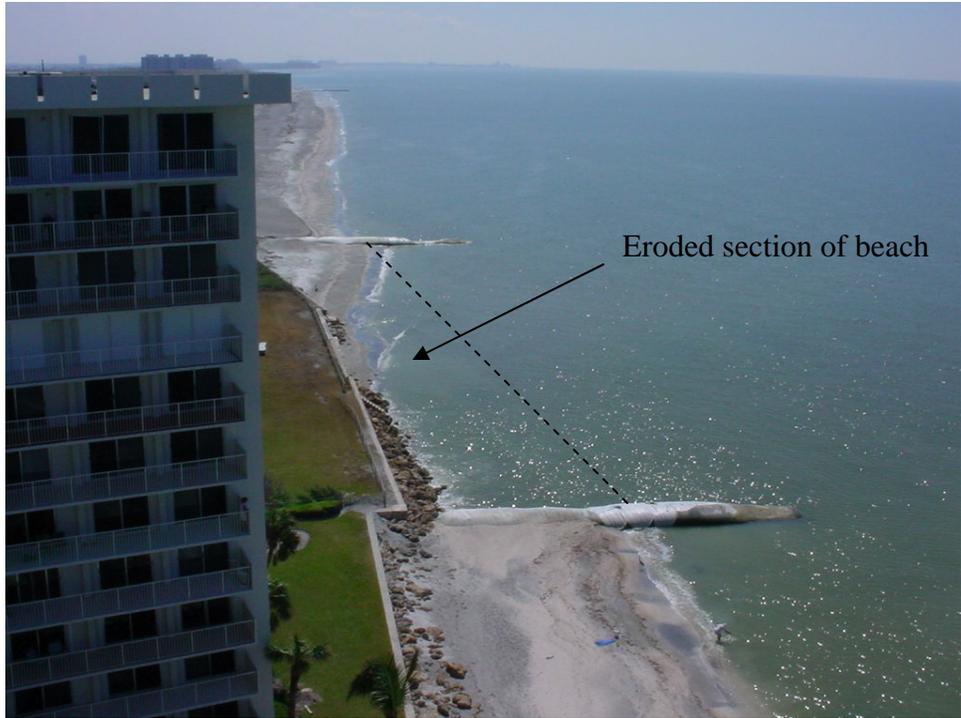
Figure 5: Seawall and groin effects on beach nourishment

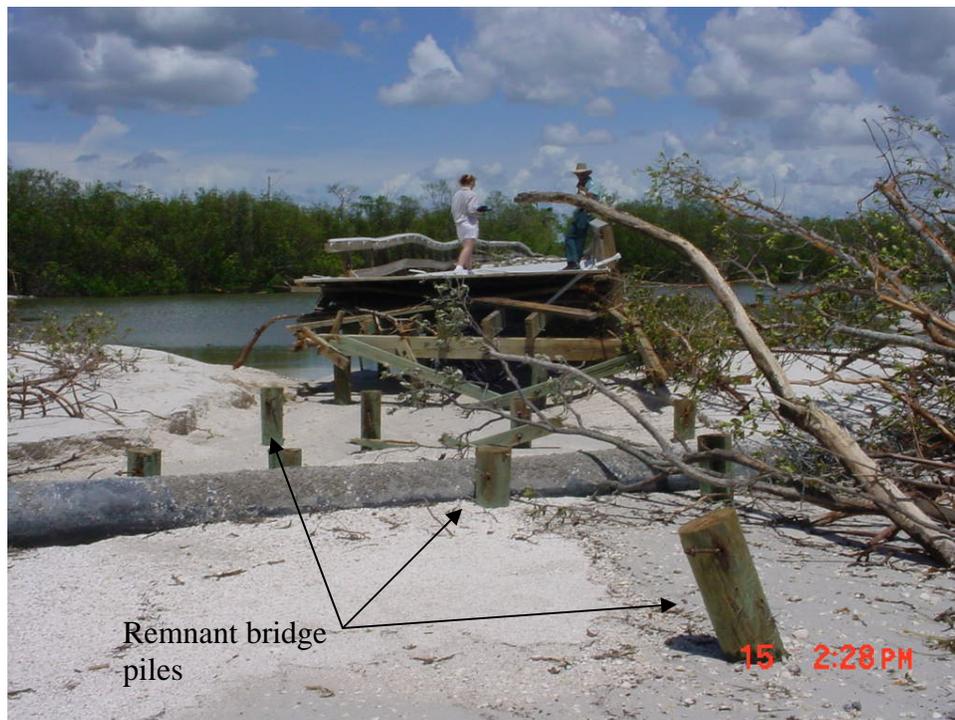
Figure 7: Wooden bridge damaged by hurricanes, Lovers Key, Lee County, FL.
(Photo courtesy of Rob Neal, Lee County)

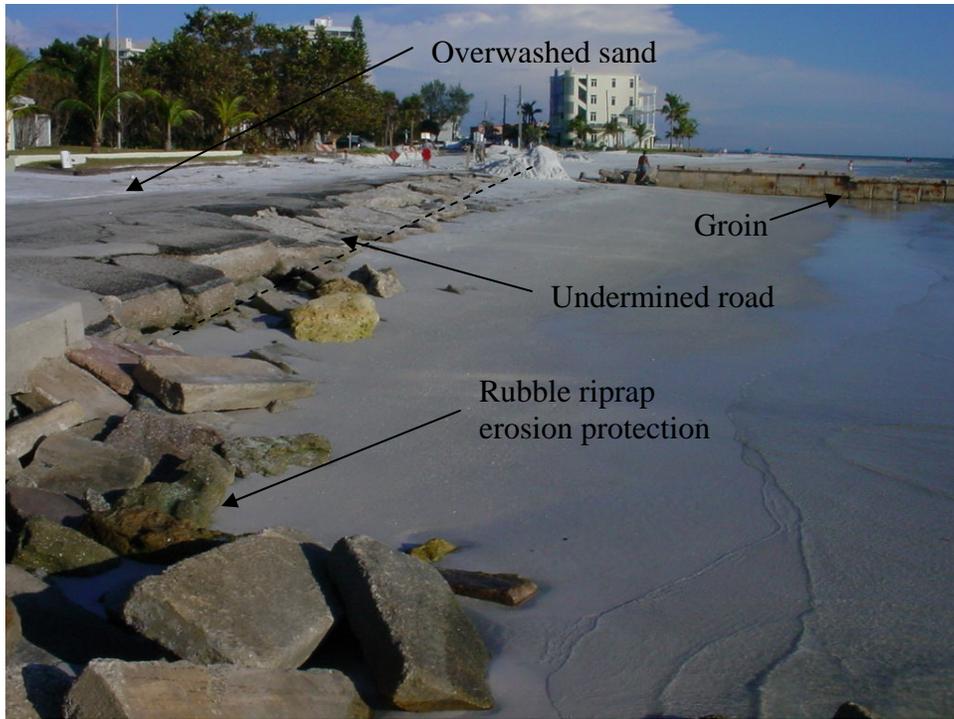
Figure 9: Eroded road on Siesta Key, Sarasota County, FL.
