69TH HIGHWAY GEOLOGY SYMPOSIUM

2018 Proceedings

Assessment and Mitigation Process for Bridge Foundation Reuse - Case Study

Rock Slope Failure Mode Analysis and Mitigation Using LiDAR Data in Fairlee, Vermont

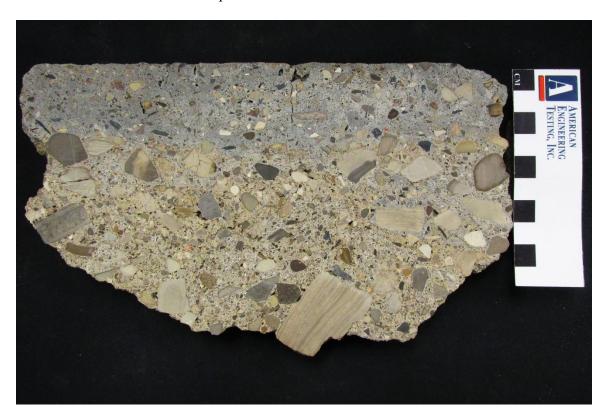
Figure 3 – saw cut and lapped cross-sectional profile of Bellefontaine pavement sample. Note the two-layer construction is evident by both paste coloration and aggregate sizing

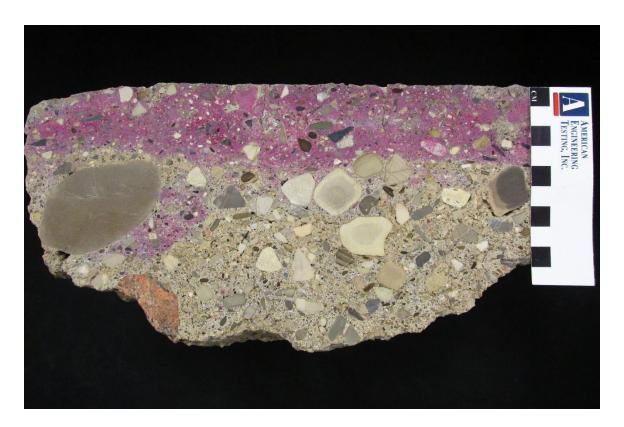
Figure 4 – saw cut and lapped cross section of pavement after application of pH indicator. Magenta stain represents pH levels over 8.3. Note the base concrete exhibited lower pH associated with paste carbonation.

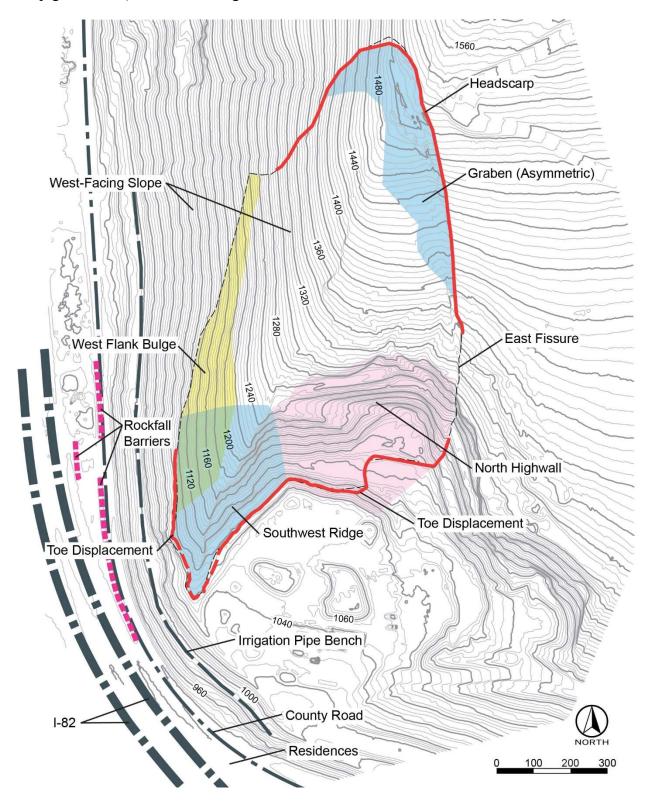
Figure 3 – Site Plan

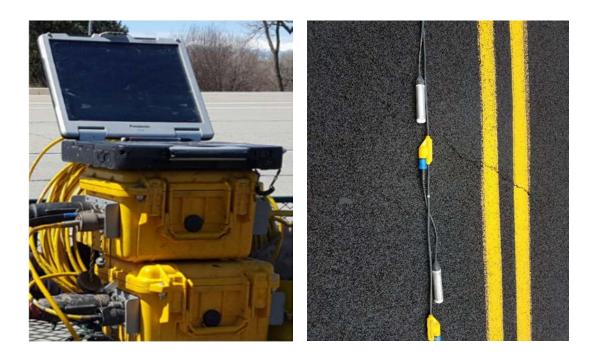
Figure 6: Left – Seismograph and Laptop. Right – Typical Geophone Configuration.

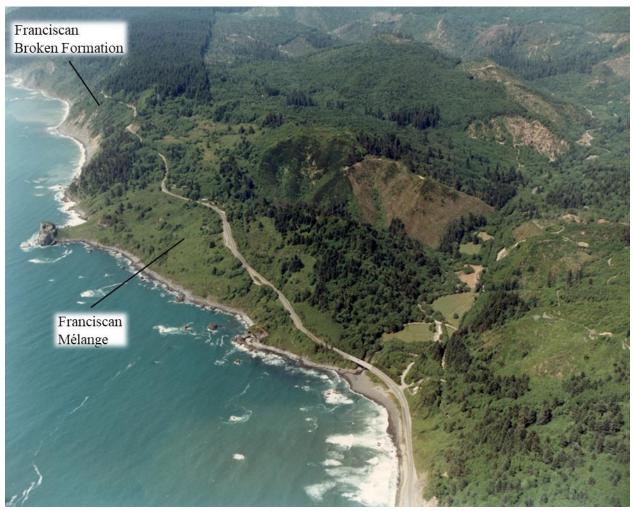
Figure 2 – The Franciscan Mélange and Broken Formation at the Last Chance Grade (1).

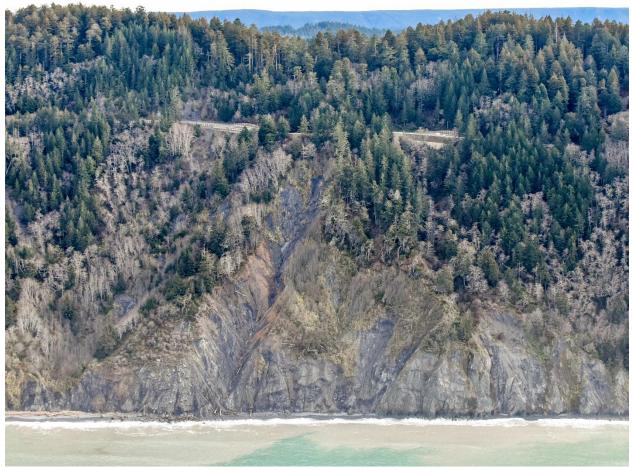
Figure 3 – Steep erosional gulley below US Highway 101.

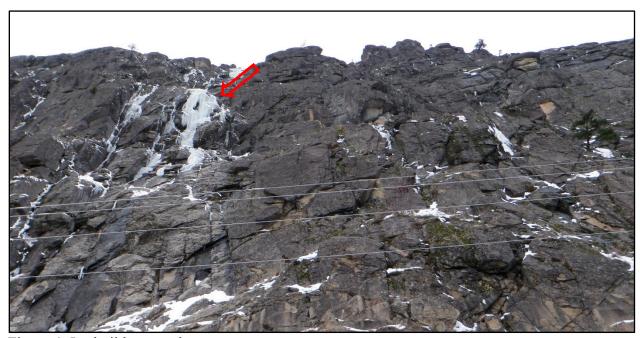
Figure 4: Ice build-up on slope.

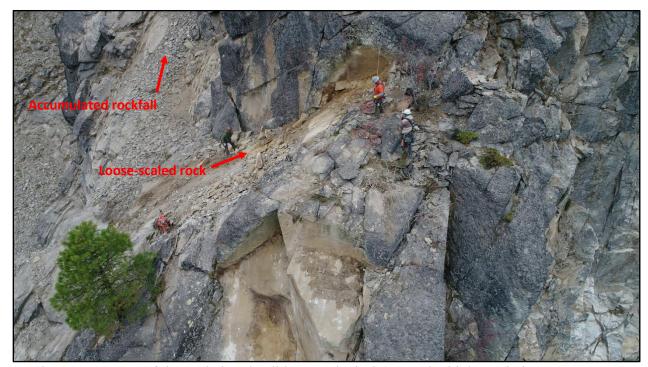
Figure 21: Many of the scaled rocks did not make it down to the highway below.

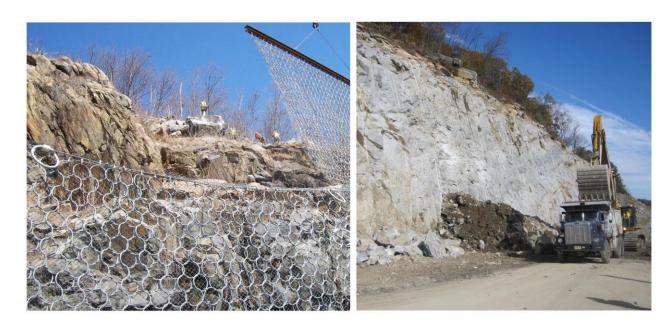
Figure 2. Photographs of rock scaling (left) and a trim-blasted slope (right).

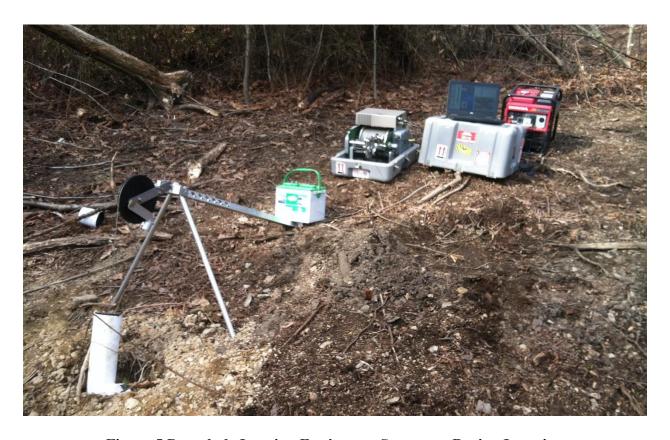
Figure 5 Downhole Logging Equipment Setup at a Boring Location

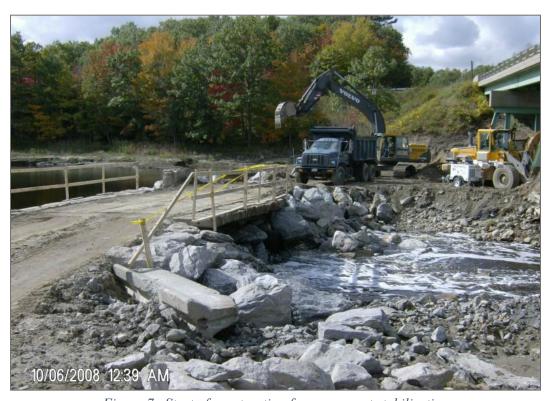
Figure 7. Start of construction for permanent stabilization

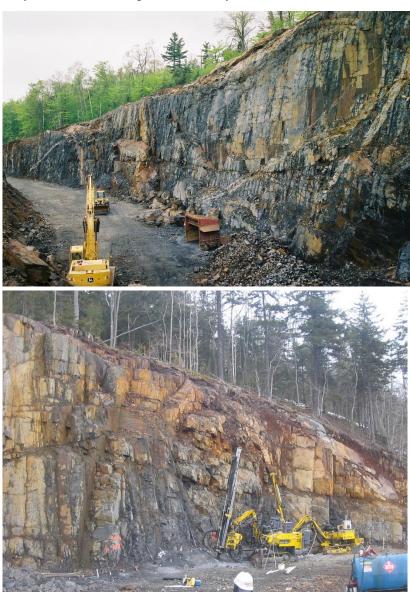
Figure 5 – Blasting and rock slope excavation
