70th Highway Geology Symposium

70th HGS Field Trip Guide

“The Magnificent Columbia River Gorge”

Wednesday, October 23, 2019

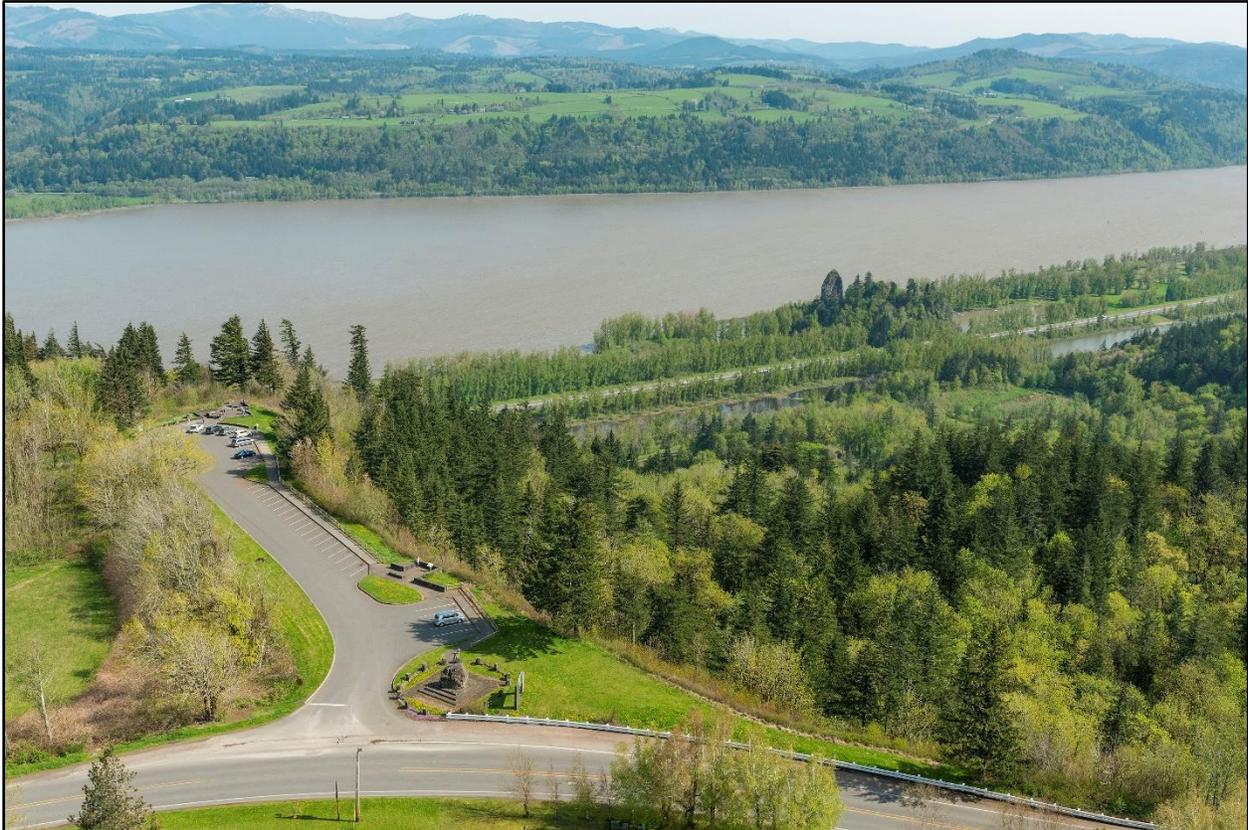
Aerial photograph courtesy of Oregon Department of Transportation (ODOT) of the Portland Women’s Forum State Scenic Viewpoint parking area looking northward.

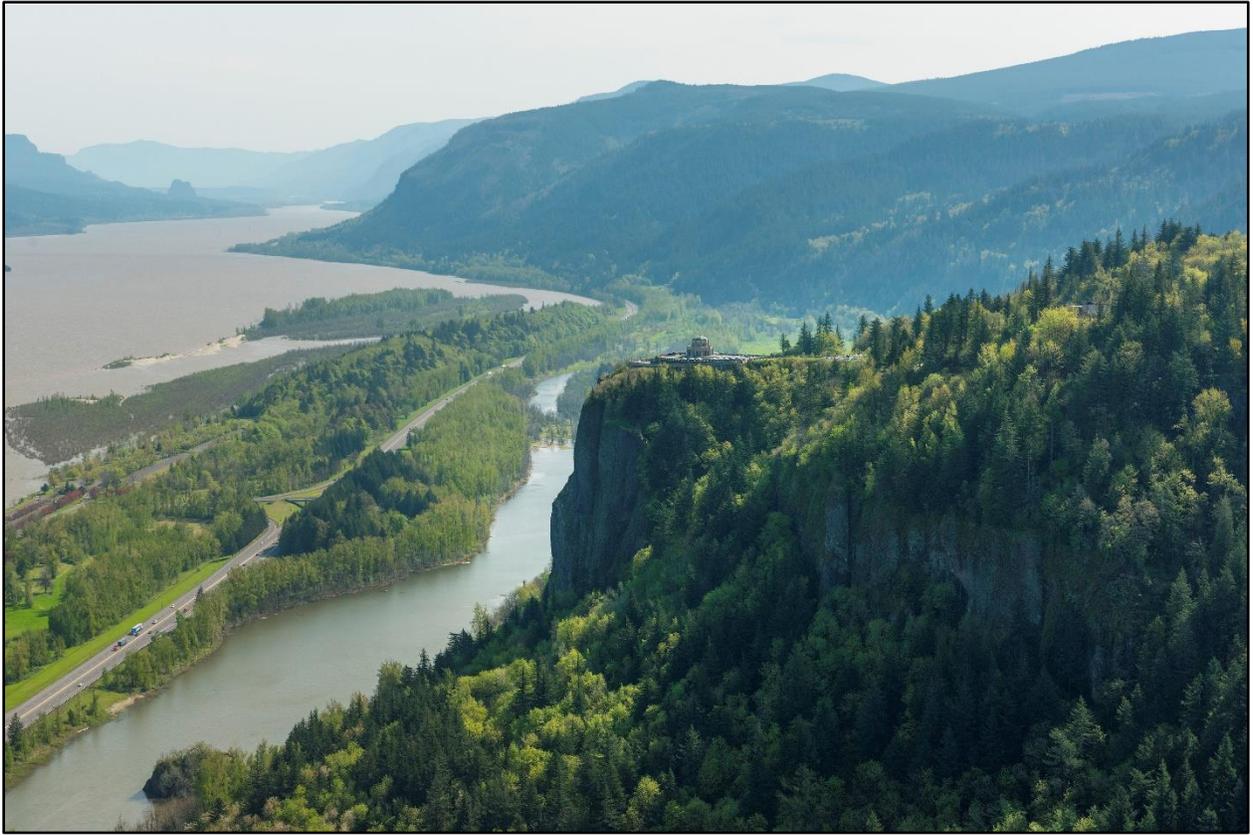
Above: Aerial photograph courtesy of ODOT of the Crown Point Vista House looking eastward.
Below: Historic photograph of Crown Point Vista House.

At Vista House, participants will learn about the significance of this wonderful building that opened on Crown Point in 1918. Vista House is a monument to Oregon Pioneers and its rotunda contains artwork dedicated to their memory. The building also has an outdoor observation deck that offers wonderful views up and down the Columbia River. Finally, Vista House was equipped with the most modern of public comfort stations in its day, when traveling outside cities was very primitive.

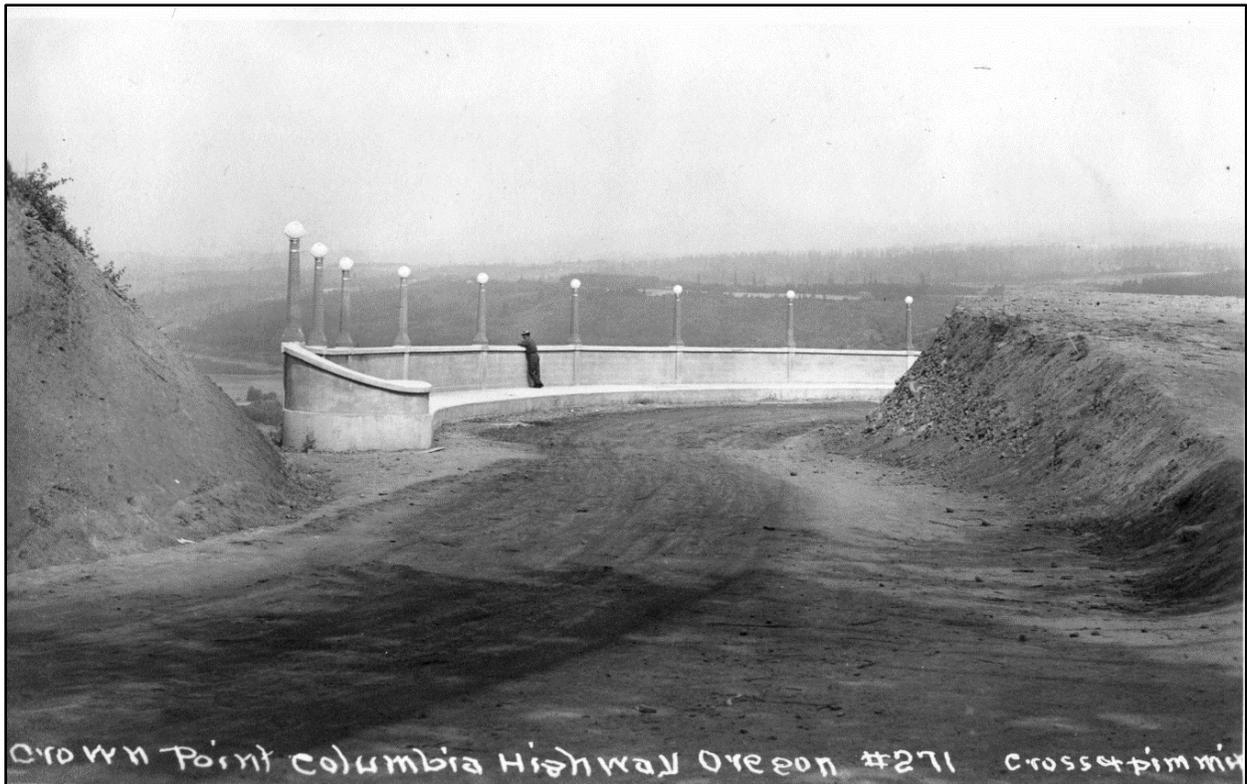
Historic photograph of Crown Point Columbia Highway before Crown Point Vista House construction.

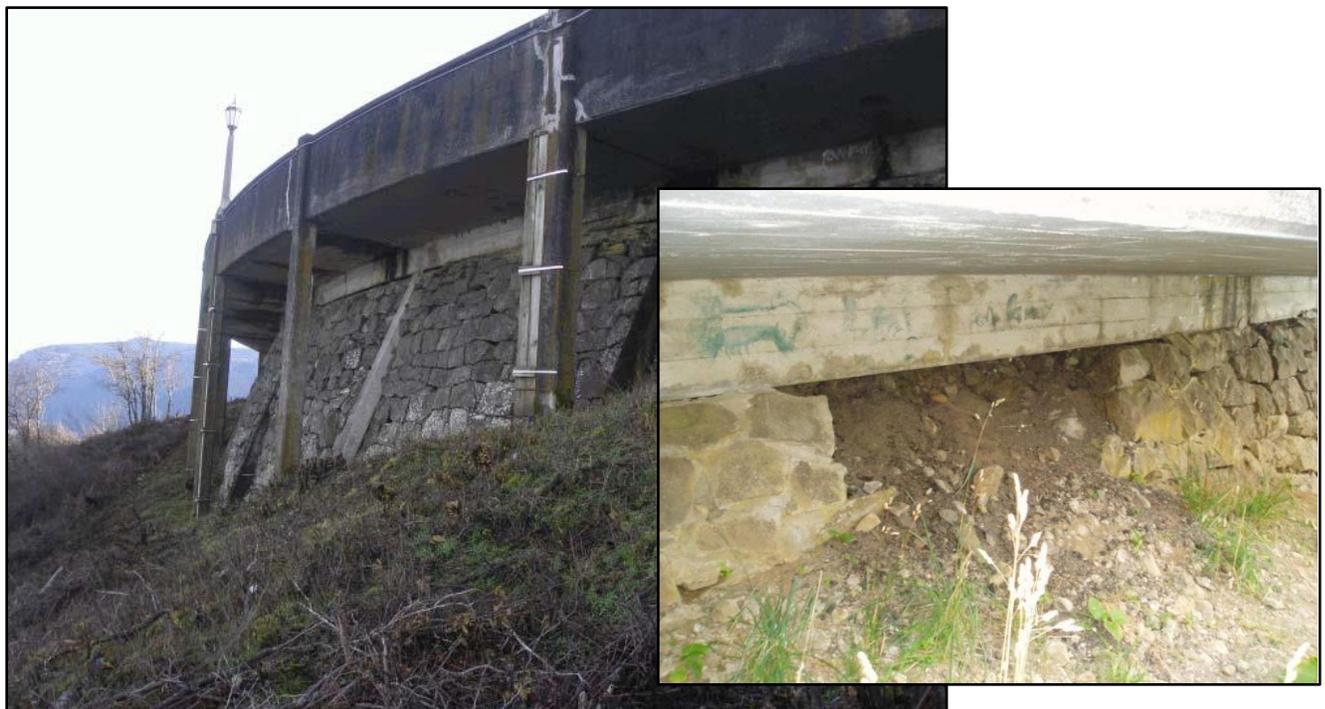
Photos of the viaduct prior to restoration project. Note the additional support at exterior columns in the left photograph on the left and the failed wall section in the photograph on right.

The overall goal of the project was to repair and strengthen the aging viaduct and associated retaining wall while maintaining the appearance and as much of the original structure as possible. The viaduct was in poor condition prior to restoration with cracked and damaged support columns, beams, and deck as well as inadequate foundation support. Portions of the dry-stacked stone retaining wall beneath the viaduct were also in poor condition with failed sections, bulging, settlement areas, and loss of backfill, which in-turn threatened the roadway immediately adjacent to the viaduct.

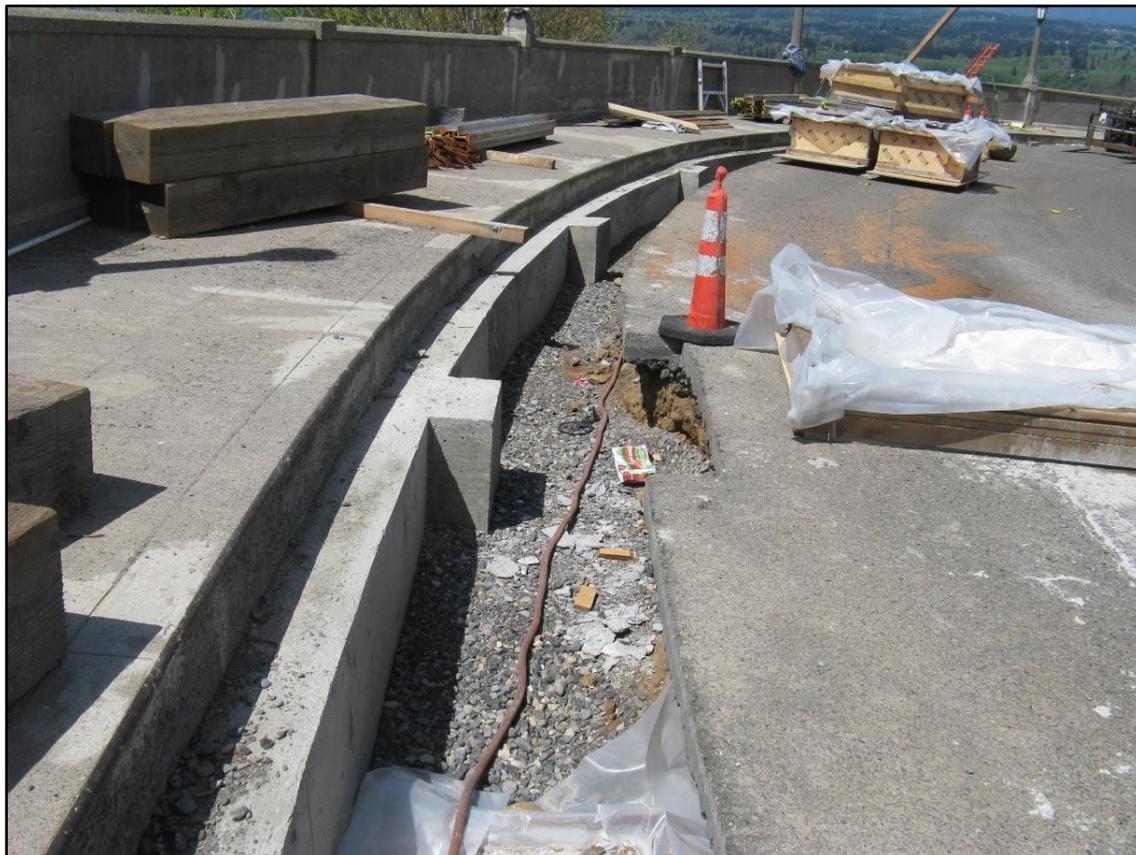
Construction photo showing completed micropiles and micropile cap on the interior side.

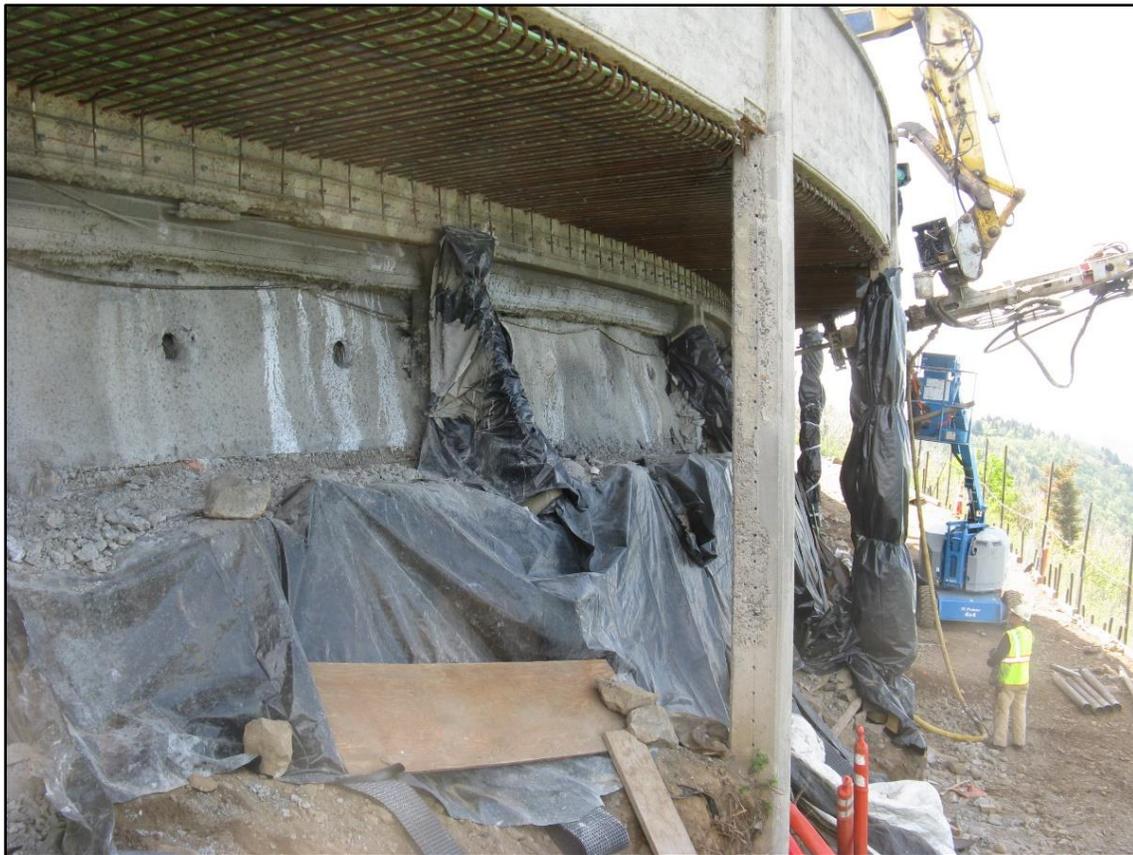
Construction photo showing soil-nail wall construction beneath viaduct on the exterior side.

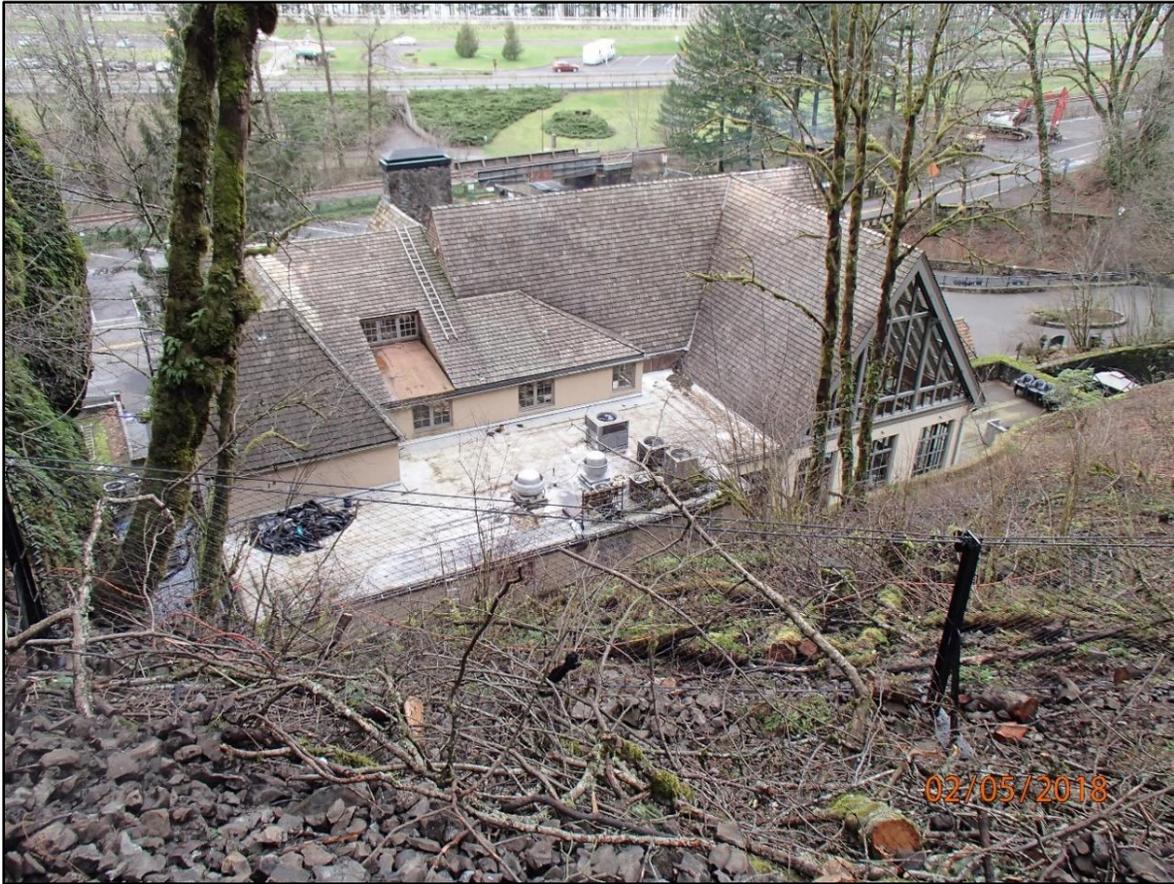
Looking down the rockfall chute where a 10 foot-high flexible rockfall fence was constructed above the historic Multnomah Falls Lodge.

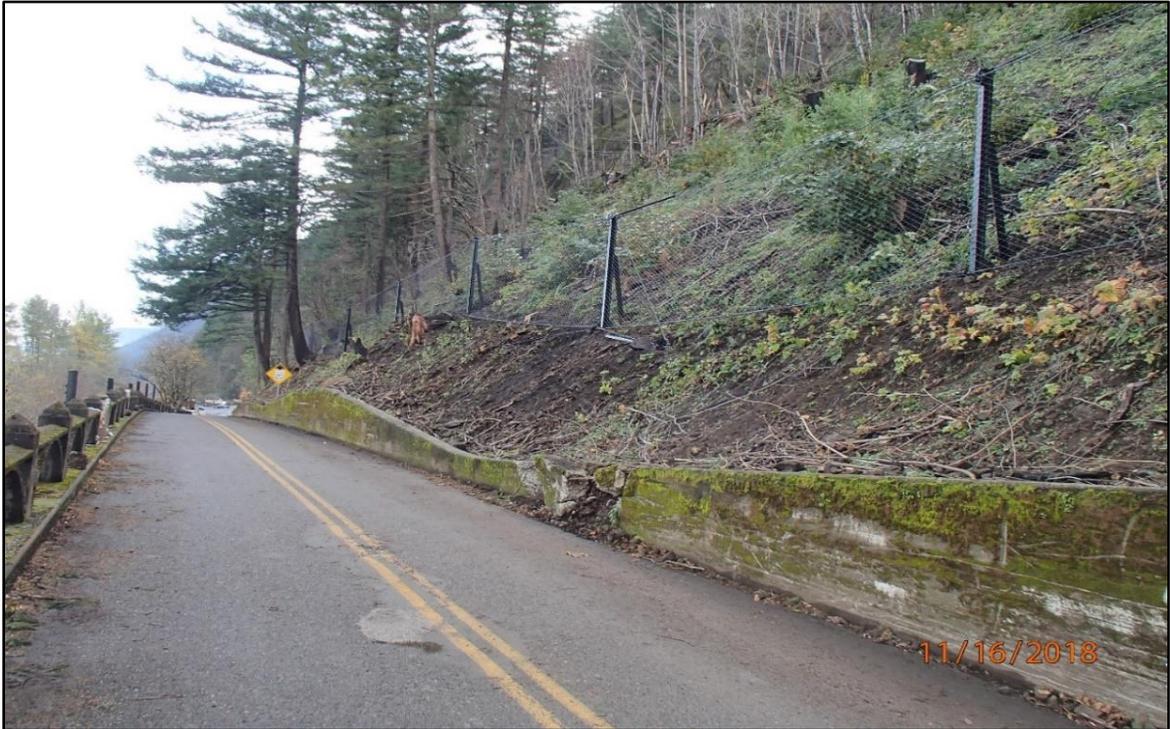
Approximately 3000 linear feet of 10 foot-high flexible rockfall fence along the Historic Columbia River Highway near Multnomah Falls Lodge.

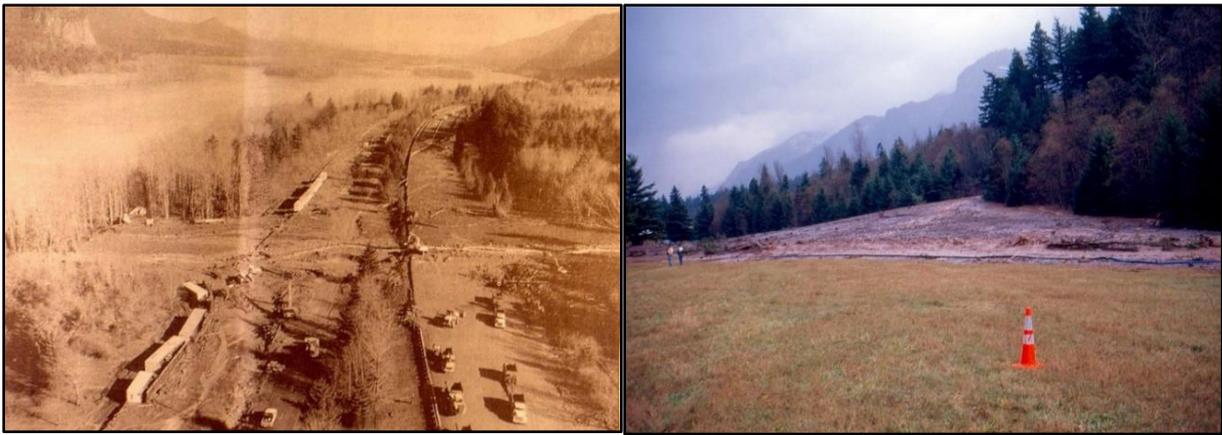
Left: Tumult Creek Debris Flow across I-84 and railroad. **Right:** Royce Debris Flow (west end of fan).

The first one was the Royce Debris Flow which occurred just after noon on the second day of the storm. A house was inundated by at least 4 pulses over the next three days. The debris flow moved about 6.5 miles per hour (mph). This blocked I-84 and the train tracks. Later that same day at 10 PM, another debris flow came from a landslide dammed lake upstream that breached and sent a huge debris flow down the drainage at over 35 mph down Tumult Creek. This debris flow impacted several trucks on I-84 and six cars of a train into the Columbia River. Thankfully, no one was killed. In the intersection near the Royce Debris Flow, where the old highway intersects I-84, another debris flow occurred in 2001 and filled up the whole on-ramp intersection with debris, but did not impact I-84. With the great relief, the presence of colluvium hollows that collect debris during periods of acquiescence between large storm events in the headwaters of several creeks and streams in the Gorge, and the propensity for large tropical storms to impact the NW each year, debris flows continue to be a major geohazard that shapes and impacts the Gorge.

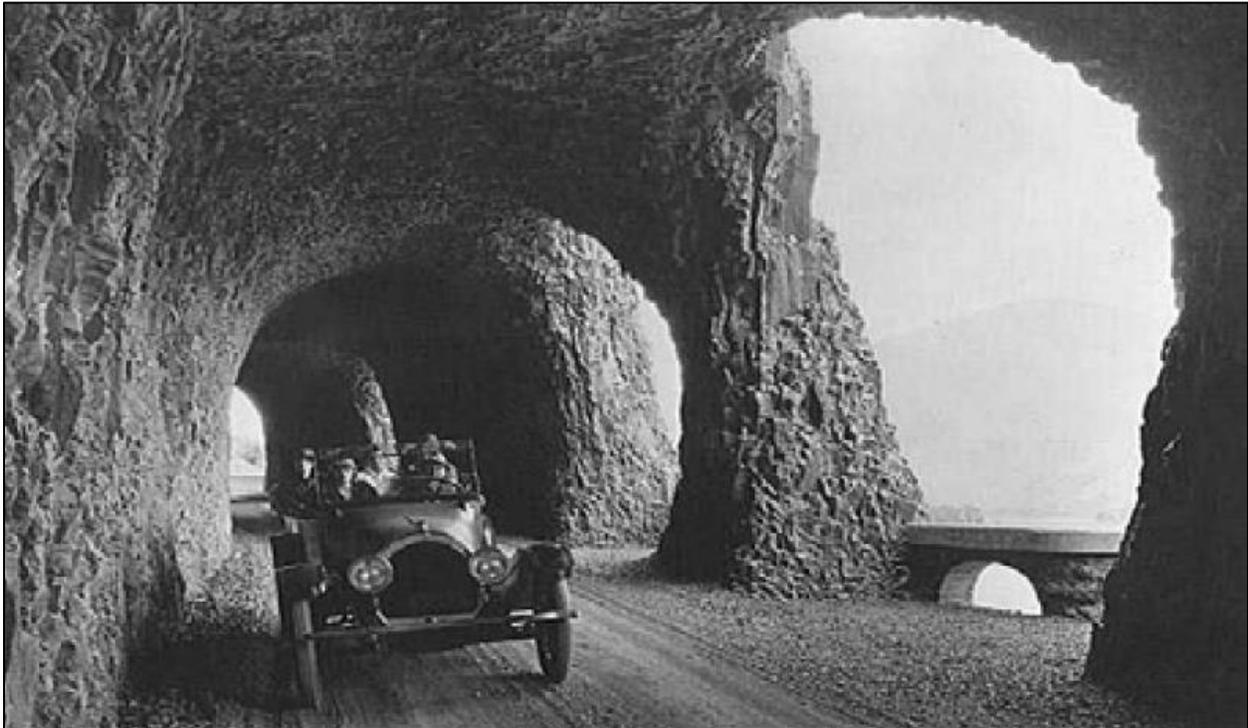
Historic photograph of the Mitchell Point Tunnel with adits. Sources for figures can be found at <https://www.oregon.gov/ODOT/Regions/Documents/HCRH/Trail-Plan-Part-1-Wyeth-Hood-River-HCRH.pdf>

The remaining segments of the trail in design between Wyeth and Hood River, include Segments E, F, G, and H. Numerous challenges faced include rockfall areas adjacent to the trail, bridges over Perham Creek and Mitchell Creek, numerous cut and fill retaining structures adjacent to I-84, and a tunnel through Mitchell Point. The Historic Columbia River Highway formerly was tunneled through the 900-

foot tall basalt promontory, but the tunnel was later blasted away during construction of I-84. The tunnel was famous for its adits or windows cut out of the rock to allow light to the driver and provide views of the gorge. We will discuss current design efforts are focusing on a new tunnel with adits similar to the historic tunnel, as well as balancing rockfall mitigation, and scenic area visual, environmental, and cultural concerns throughout these segments.

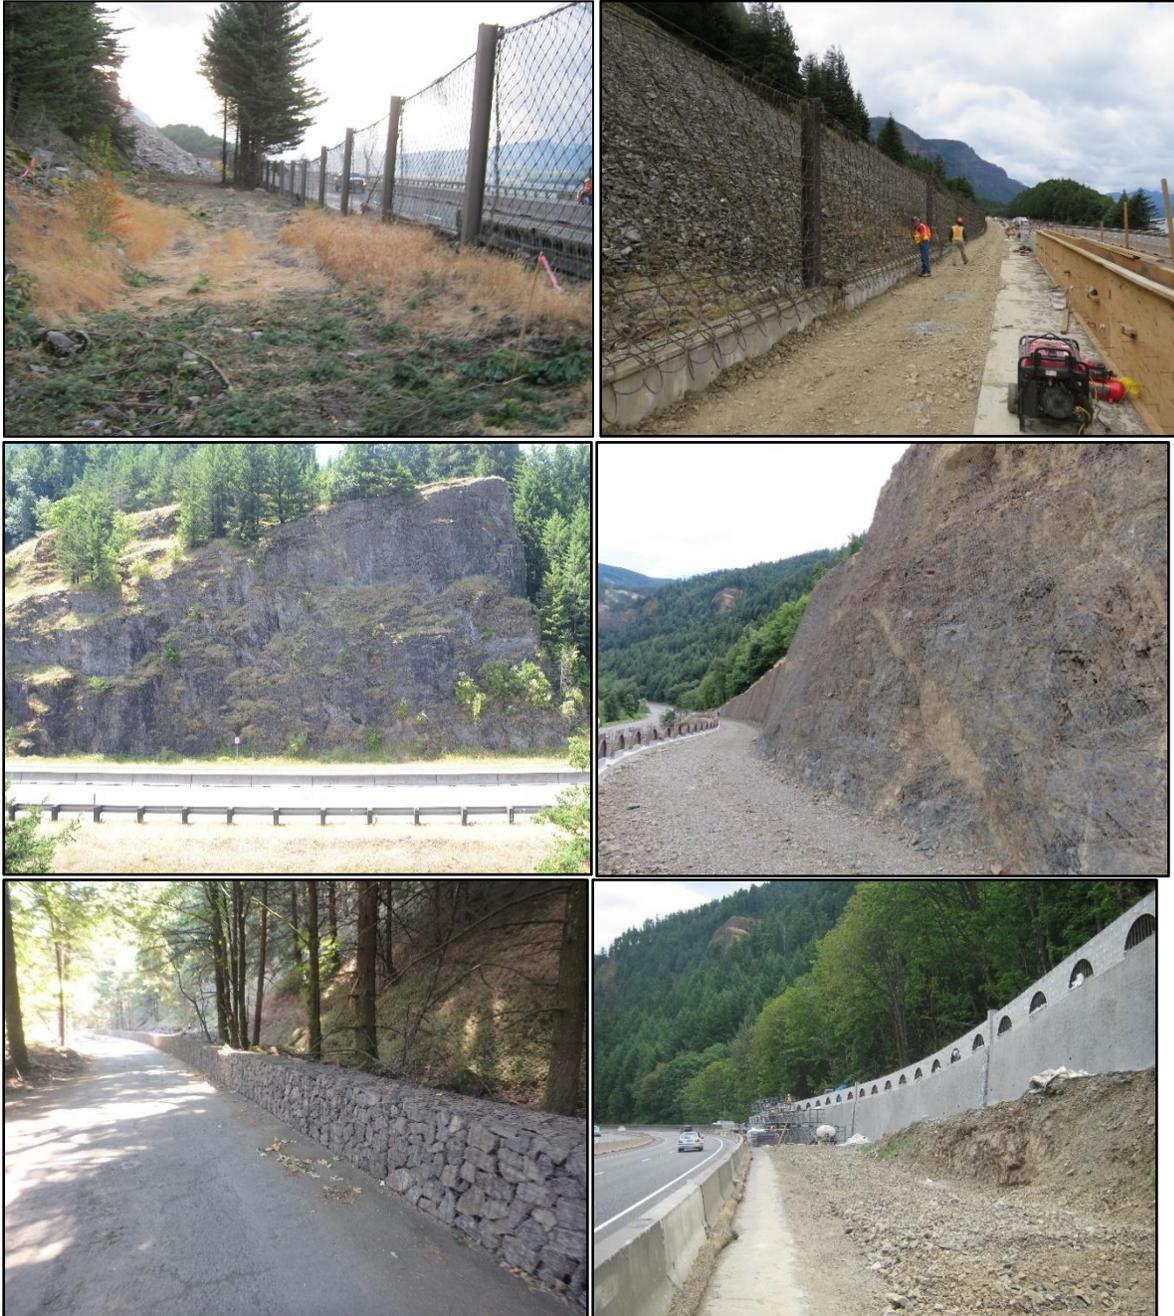
Before and after construction photos from left to right along Wyeth Section from top to bottom.

Rockfall risk reduction designs capable of precluding 99% of impacting rockfalls and 90% of rolling rockfalls from reaching the trail and I-84 were desired (i.e. 90% retention of rolling rocks). This was accomplished using a combination of scaling, rock bolting, gabion basket walls, draped high-tensile strength mesh, mid-slope attenuator fences, and flexible rockfall barriers along the uphill side of the trail depending on site conditions. Context sensitive measures were incorporated into the design to reduce

the visual impacts of the rockfall risk reduction elements. They included the staining of all metal components, rock-faced gabion baskets, and contouring draped mesh sections so it conforms to the slope shape. Over 3,000 linear feet of low-deflection, flexible rockfall fence barrier without upslope tiebacks was constructed. Other challenging geotechnical elements included: over 2,000 linear feet of MSE walls and reinforced soil slopes, a tied-back gravity wall, a 750-foot long viaduct supported on spread footings with micropile and tie-downs, a 400-foot long soldier pile tie-back wall, one micropile supported bridge, and one bridge on conventional spread footings.

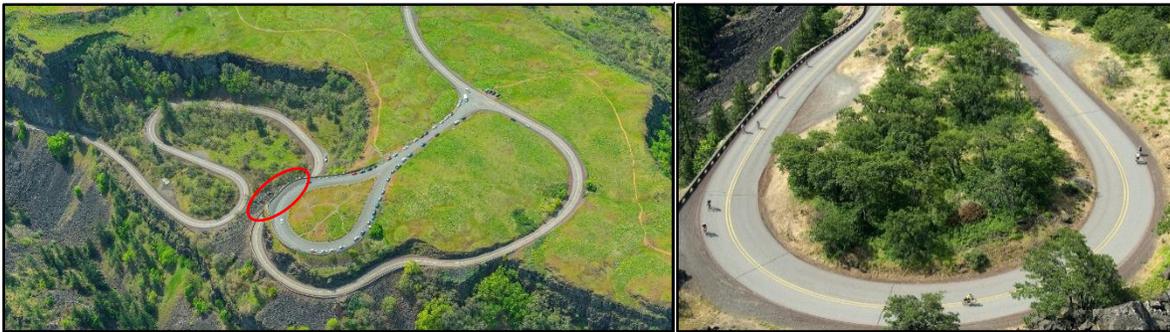
Left: Aerial photograph of Rowena Loops courtesy of ODOT. Red polygon is the location of a risk reduction rockfall project by ODOT. **Right:** Photograph of the lower Rowena Loops taken from the upper viewpoint.

Jamie Schick: The Historic Columbia River Highway (US 30) traverses the Columbia River Gorge along the south side of the Columbia River. Towards the eastern end of the Gorge it passes over the crest of Rowena Bluffs, a broad plateau punctuated with a near vertical 500-foot cliff adjacent to the river. This cliff consists of a series of Miocene-aged Columbia River basalt flows. East of this cliff the highway drops steeply back to the river, passing beneath several steep cliff faces that represent the headscarp of an ancient landslide. This includes a nearly 300-foot-high cliff near mile point 64.7 (red polygon in the picture above).

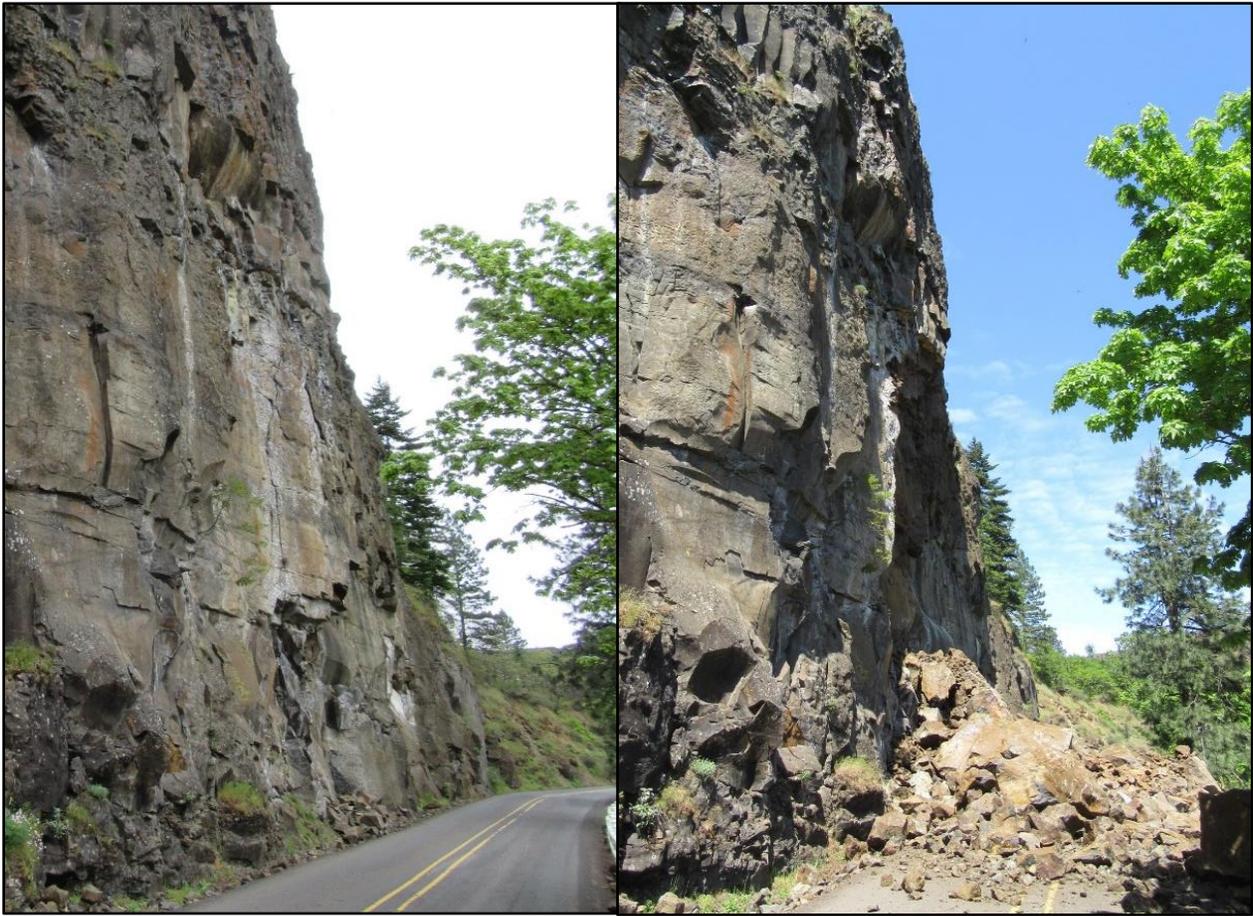
Pre and post rock failure views looking north along the highway.

On May 7, 2017, the lower 75 feet of the cliff failed and fell onto the roadway, burying both lanes for nearly 200 feet with almost 20 feet of debris (figure below). This section of the cliff is dominated by columnar jointing that have developed columns exceeding eight feet in diameter. These columns terminate into a flow contact at approximately 75 feet above road grade. The flow contact includes a five to 15-foot-thick zone of highly weathered, closely fractured vesicular basalt. The failure undermined this flow contact, creating a nearly 10-foot overhang and was at risk of undermining the remainder of the cliff above.

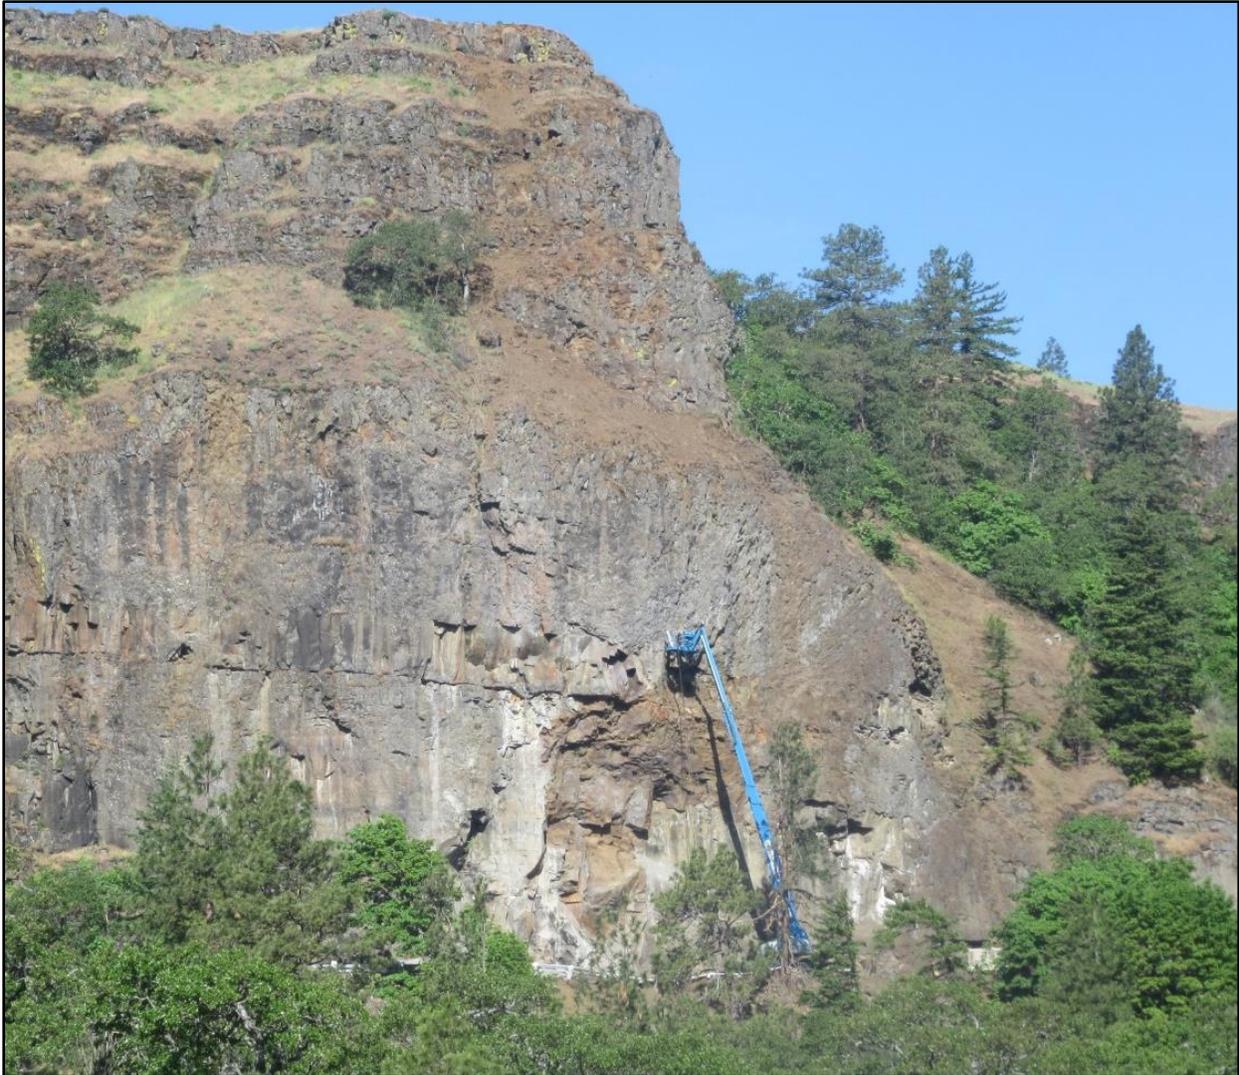
Ongoing installation of rock bolts using 145-ft man-lift.

Initial mitigation response efforts focused on stabilizing the remaining lower columns as well as the columns above the interflow. Approximately 600 linear feet of rock bolts were designed to support this approach and were installed by Rock Supremacy from Bend, Oregon, between approximately May 17th and May 23rd (figure on next page). Rock bolt lengths varied between 10 and 25 feet and were tensioned to 30 kips. Rock bolt heads, nuts and plates were coated with Natina over the galvanization to
