71st HIGHWAY GEOLOGY SYMPOSIUM

2022 Proceedings

**71st ANNUAL
HIGHWAY GEOLOGY SYMPOSIUM
Table of Contents**

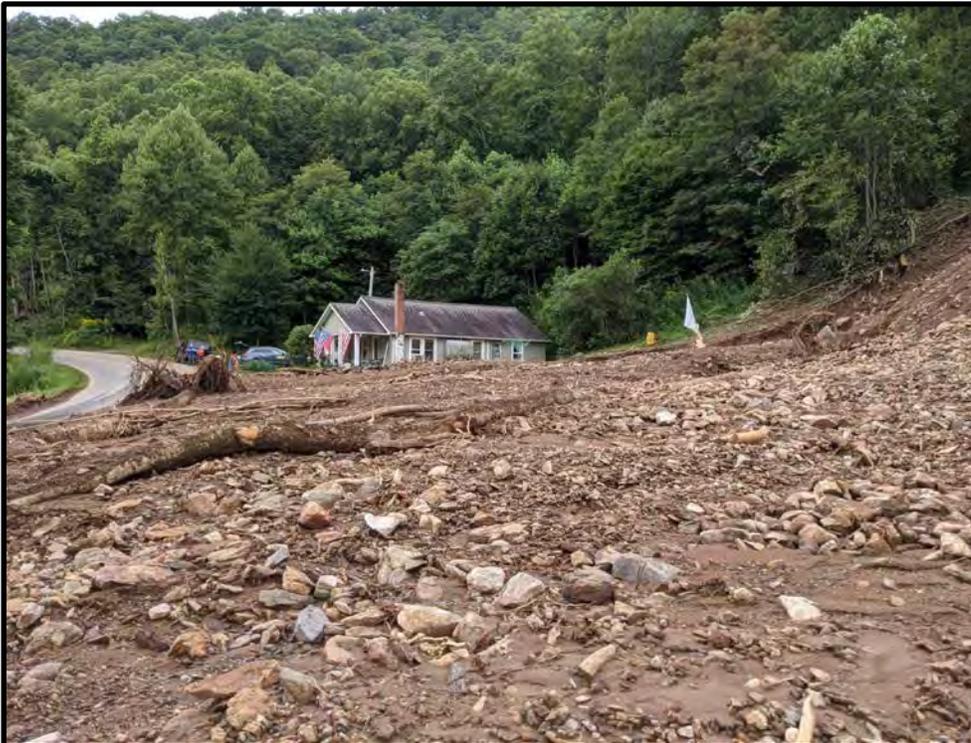
Debris flow in Cruso, NC that occurred during Tropical Storm Fred on August 17, 2021

Oftentimes state roads and interstate highway corridors are impacted by slope movements initiating outside of the right of way, particularly during extreme weather events. This was the case in Western NC during Tropical Storm Fred in August 2021. In many localities, other organizations or agencies have data on landslide occurrence and susceptibility adjacent to highway corridors. Through examples, this talk will focus on how inter-agency collaboration to assist with asset management can help highway departments prepare for, respond to, and mitigate these landslide hazards.

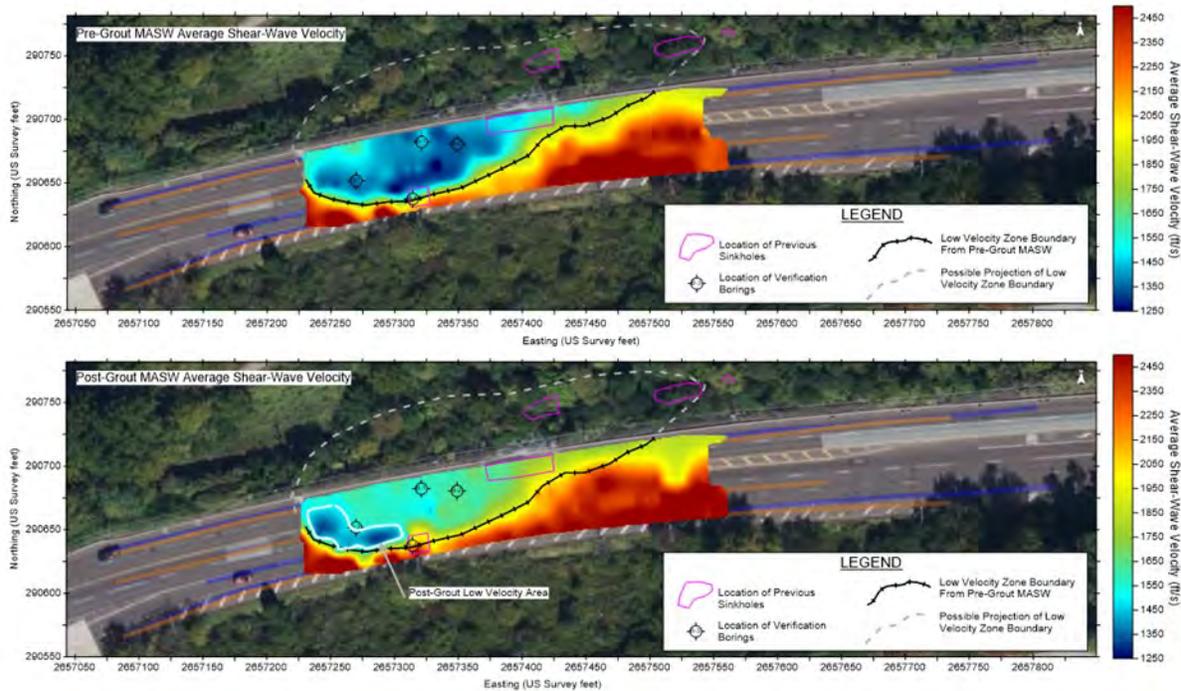
Figure 10 – Shear-Wave Velocity Comparison: Top is Pre-GROUT; Bottom is Post-GROUT.

Figure 9 shows the pre- and post-grout MASW average shear-wave velocity results. In general, within the full area covered by the grouting program, the average velocity increased from 1,970 ft/sec to 2,042 ft/sec, a change of 70 ft/s which is about a 4% increase. Most of the areas with similar velocities correspond with the injection of shallow and gravity-fed grout and are generally to the south and east sides of the grouted area. We interpret the results of this data as showing the grout injected in these areas was not enough to significantly change the velocity.

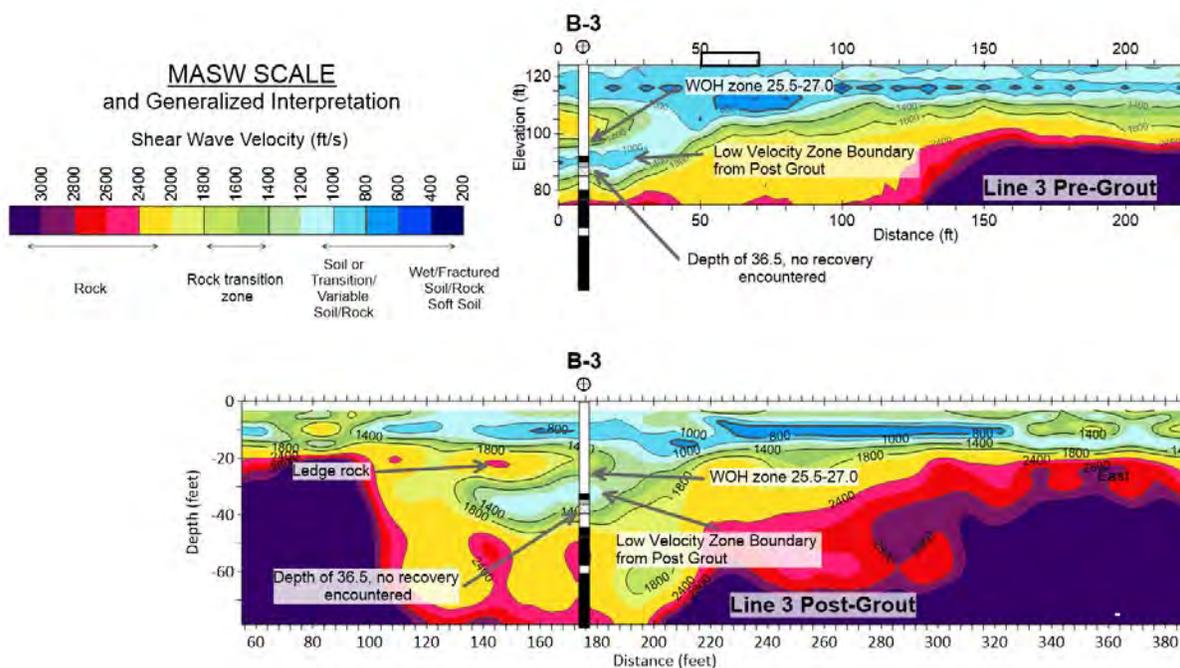
**Figure 11 – MASW Compared to Verification Boring B-3:
Top is Pre-Grout; Bottom is Post-Grout**

Within the low velocity zone, there is a smaller area identified as “Post-Grout Low Velocity Area” in Figure 9, outlined in white, where the velocity did not increase after grouting. This low velocity area is observable in the pre- and post-grout MASW results for Lines 2 and 3 at a depth of about 25 to 40 ft. Figure 10 presents the Line 3 pre-grout and post-grout MASW results with B-3, a verification boring, overlaid. The profiles are aligned with each other and with B-3.

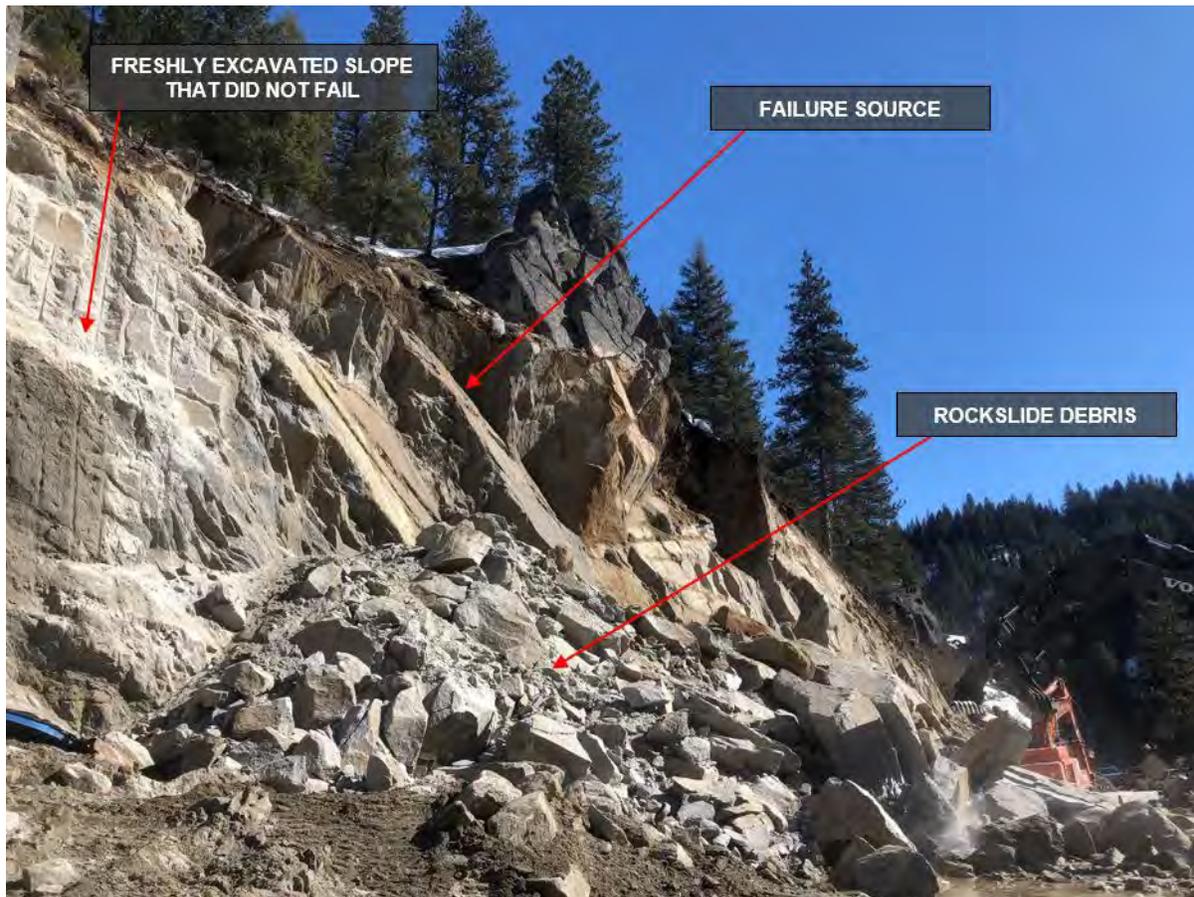
Figure 3 – Rockslide at Cut 9

In the spring of 2021, a rockslide occurred at Cut Slope 9 that was under construction and slide debris impacted the roadway, closing the highway to traffic for over a week while crews cleared the highway of the debris (Figure 3). In a matter of days after this rockslide, another slope under construction, Cut Slope 5, experienced a slope failure that posed a serious risk to workers. The pattern of unintended rockslides prompted ITD to retain McMillen Jacobs Associates (MJA), which was already contributing to the project as a blasting consultant, to redesign the rock cuts and construction sequencing to reduce the potential for additional failures and maintain a safe working environment. MJA mobilized to the site in March 2021, at the beginning of the second construction season, to begin geologic reconnaissance followed quickly by slope redesign.

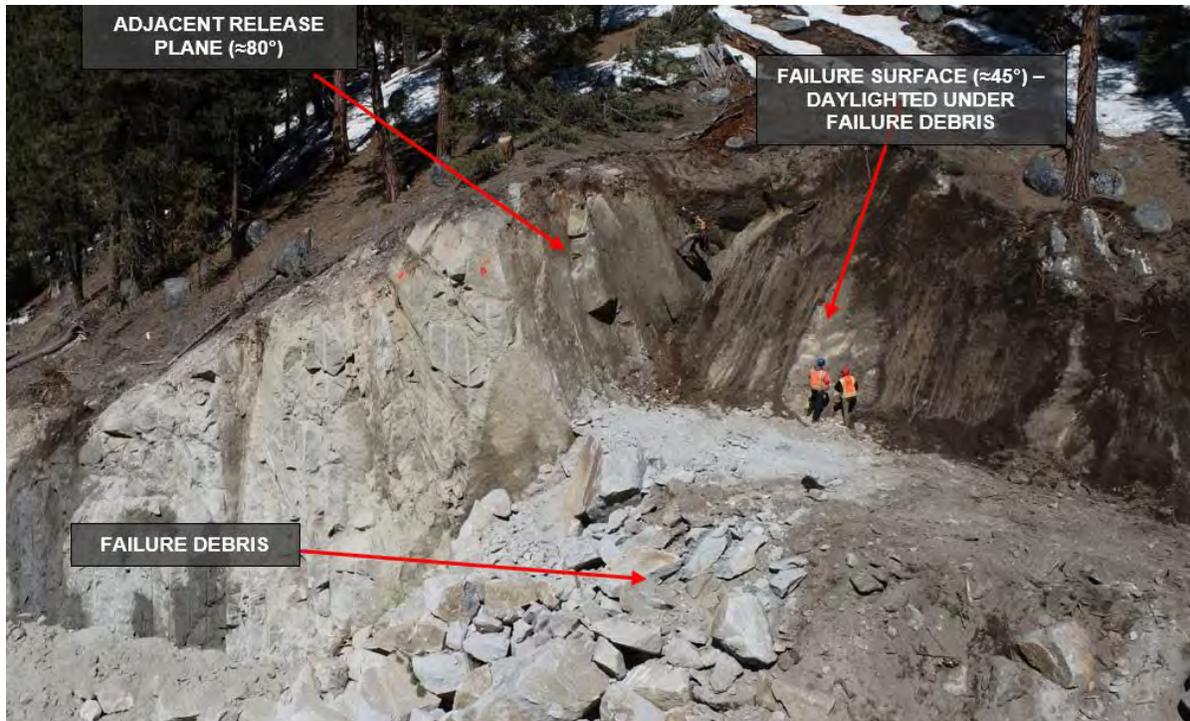
Figure 4 – Partial Slope Failure During Construction at Cut 5

Each of the 9 rock slope cuts was initially designed, bid, and awarded per the contract plans with 0.25H:1V (76°) cut slopes to be achieved by blasting and excavation in order to provide space to widen and straighten SH-55. Construction then began, but as discussed in the “Introduction” above, early attempts at constructing cut slopes according to this design resulted in partial slope failures at multiple locations. This prompted ITD to contact MJA regarding redesigning the cut slopes, without a pause in construction activities. Upon inspection, MJA observed that the rockslides appeared to have failed primarily on adverse dipping joints that had been daylighted by progressive cut slope excavation (an example is provided in Figure 4). After observing exposed fracture planes at multiple cut slope locations, MJA concluded that continuing to excavate the cut slopes at 0.25H:1V would result in additional fractures daylighting, and subsequently additional slope failures.

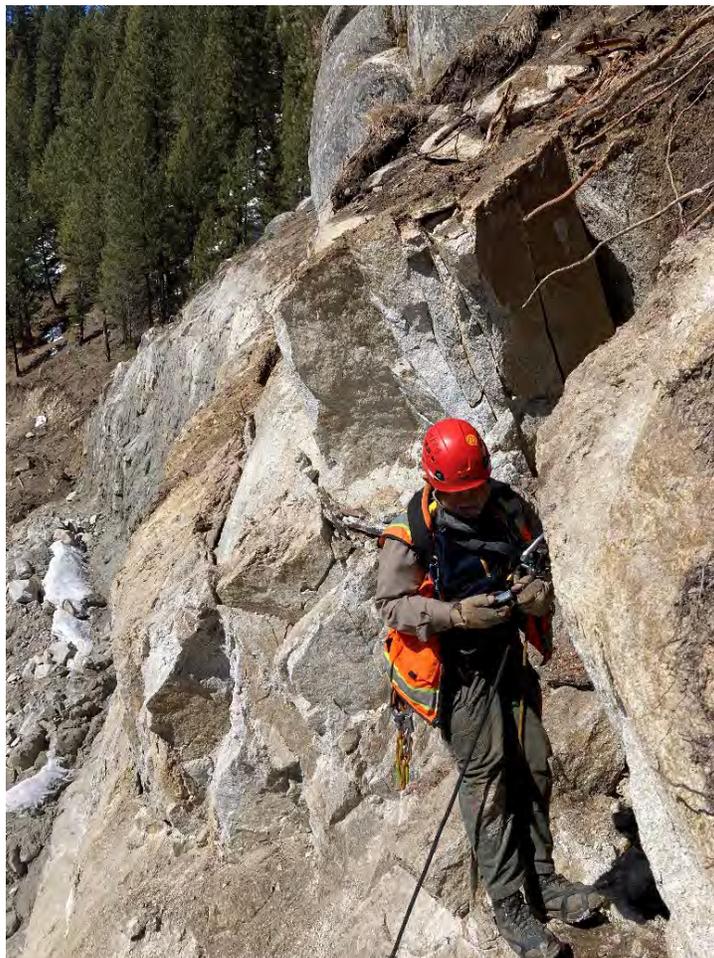
Figure 5 – Utilizing Rope Access Techniques for Field Mapping

In order to field map the proposed cut slope locations, horizontal scanlines were performed from the ground and vertical scanlines were performed by utilizing rope access techniques (Figure 5). The following data were collected during field mapping:

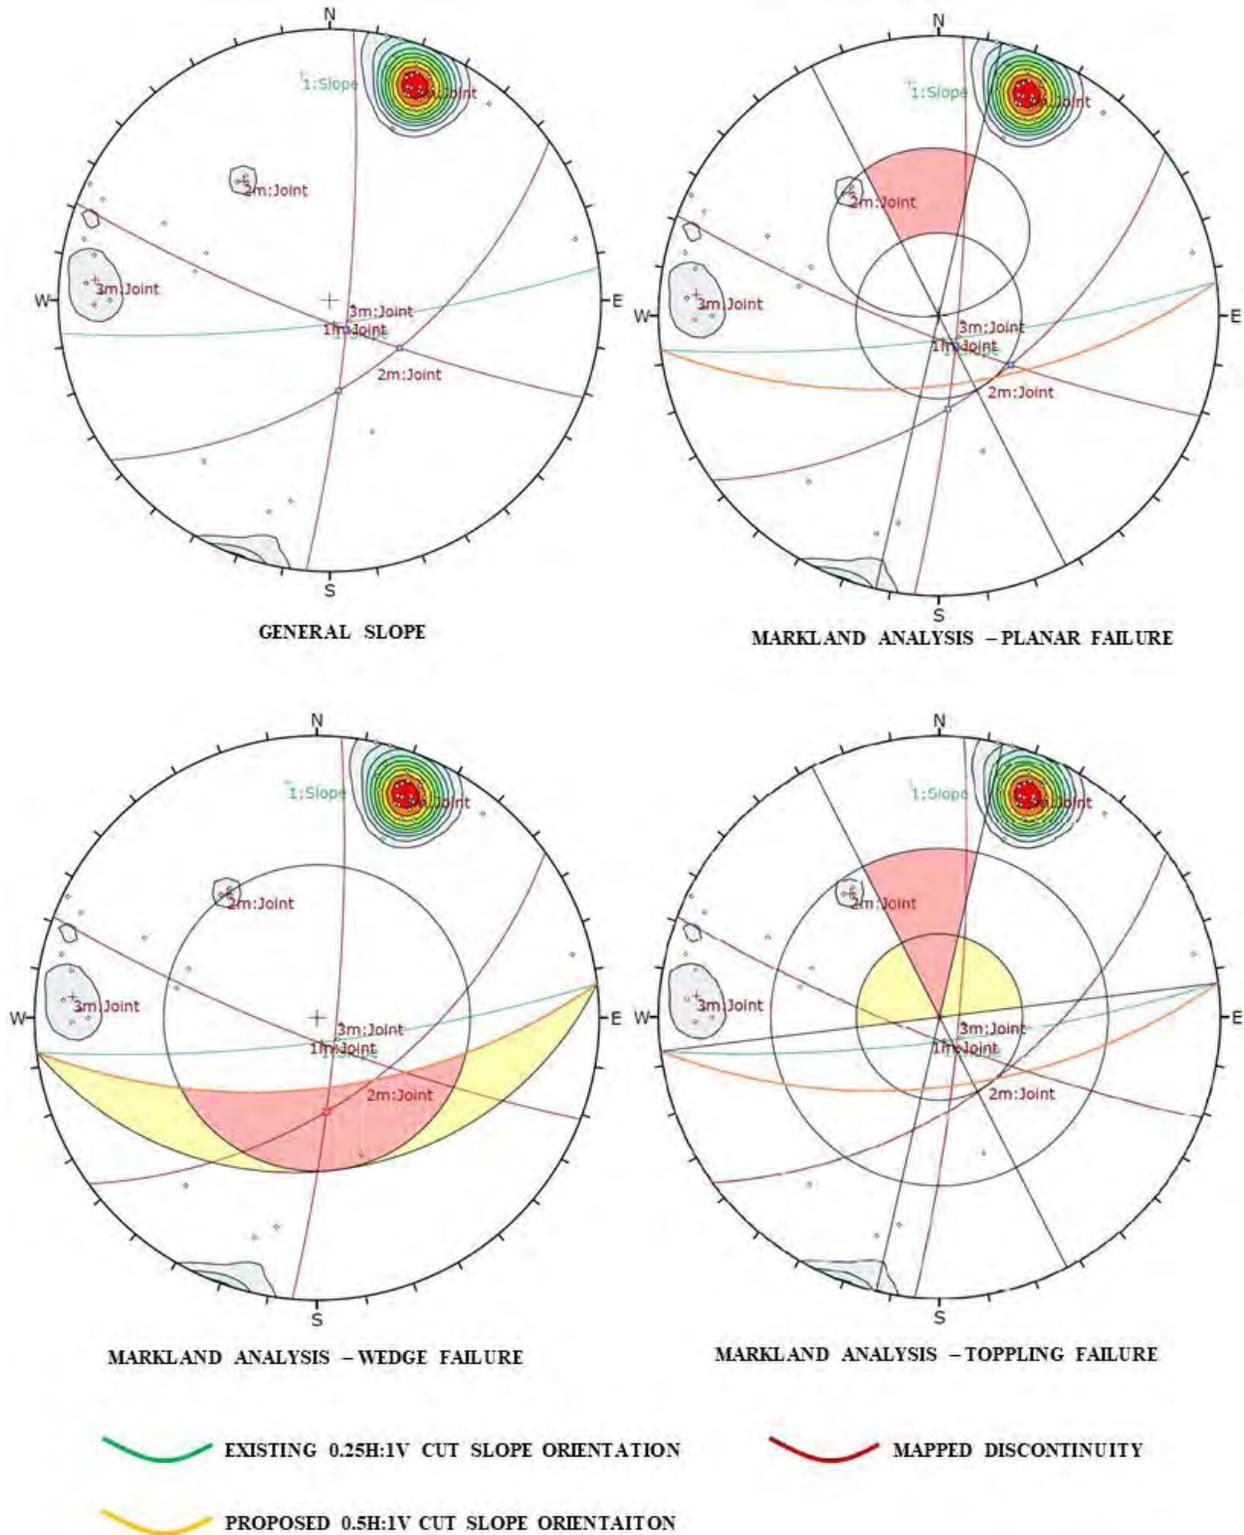
Figure 6 – Markland Analysis Results at Cut 4 with Cut Slope at 0.5H:1V

Results of the kinematic analysis were unique to each of the 9 individual cut slopes, and overall results and a relative example are provided in this section. In general, results of the Markland analysis indicated that excavating the majority of the cut slopes at 0.5H:1V provides a reasonable compromise between slope stability, additional slope stabilization that would be required after excavation, and additional right-of-way property that would need to be acquired. As an example, stereonet of the Markland analysis at Cut 4 are provided in Figure 6.

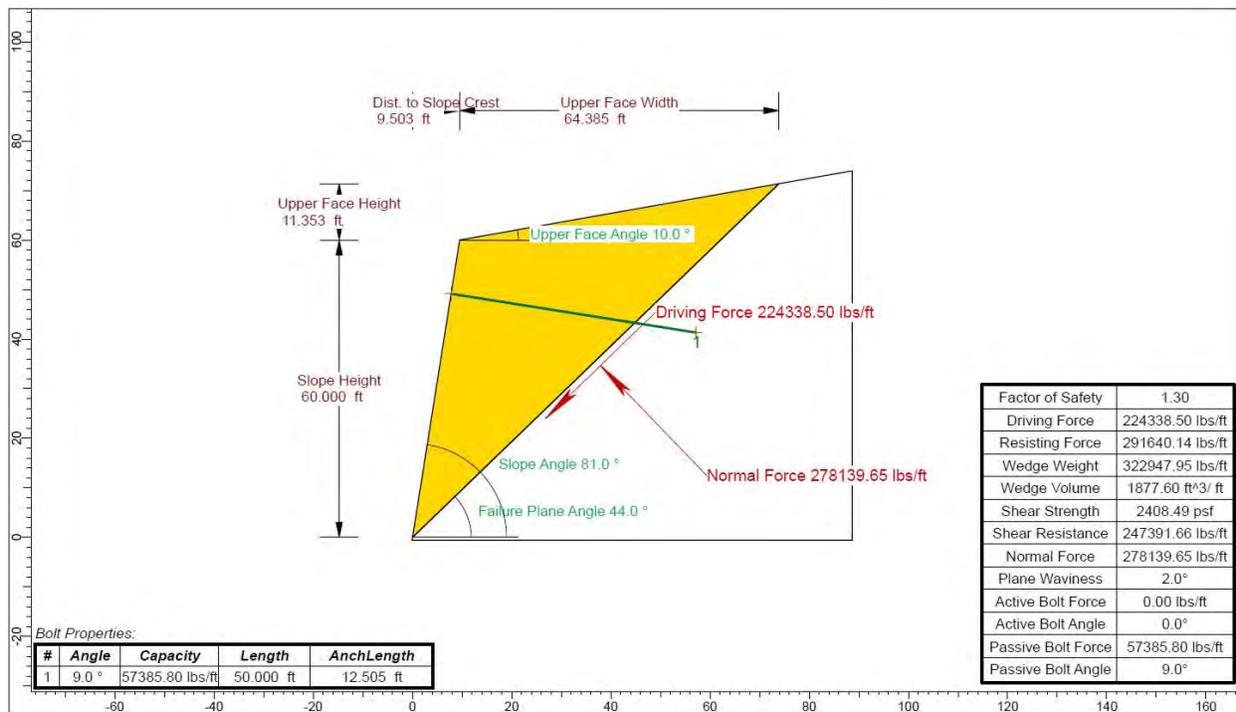
Figure 7 – Limit Equilibrium Analysis for Potentially Unstable Plane at Cut 5

Limit equilibrium analyses were performed on potentially unstable rock blocks using RocScience, Inc. computer software programs; RocPlane® for potential planar failures and SWedge® for potential wedge failures. The objective of the limit equilibrium analysis was to calculate a factor of safety of the potentially unstable block and, if necessary, calculate the required support force to increase the factor of safety to an acceptable value. Figure 7 provides a representative example of a limit equilibrium analysis performed at Cut 5 using RocPlane®. As can be seen in Figure 7, a required support force of 57,386 lb (≈58 kips) is required for every linear foot of the unstable block to increase the calculated factor of safety of the block to 1.30. This support force was multiplied by the length of the block (dimension in and out of the page) and divided by the capacity of an individual dowel to determine the required number of rock dowels to stabilize this block.

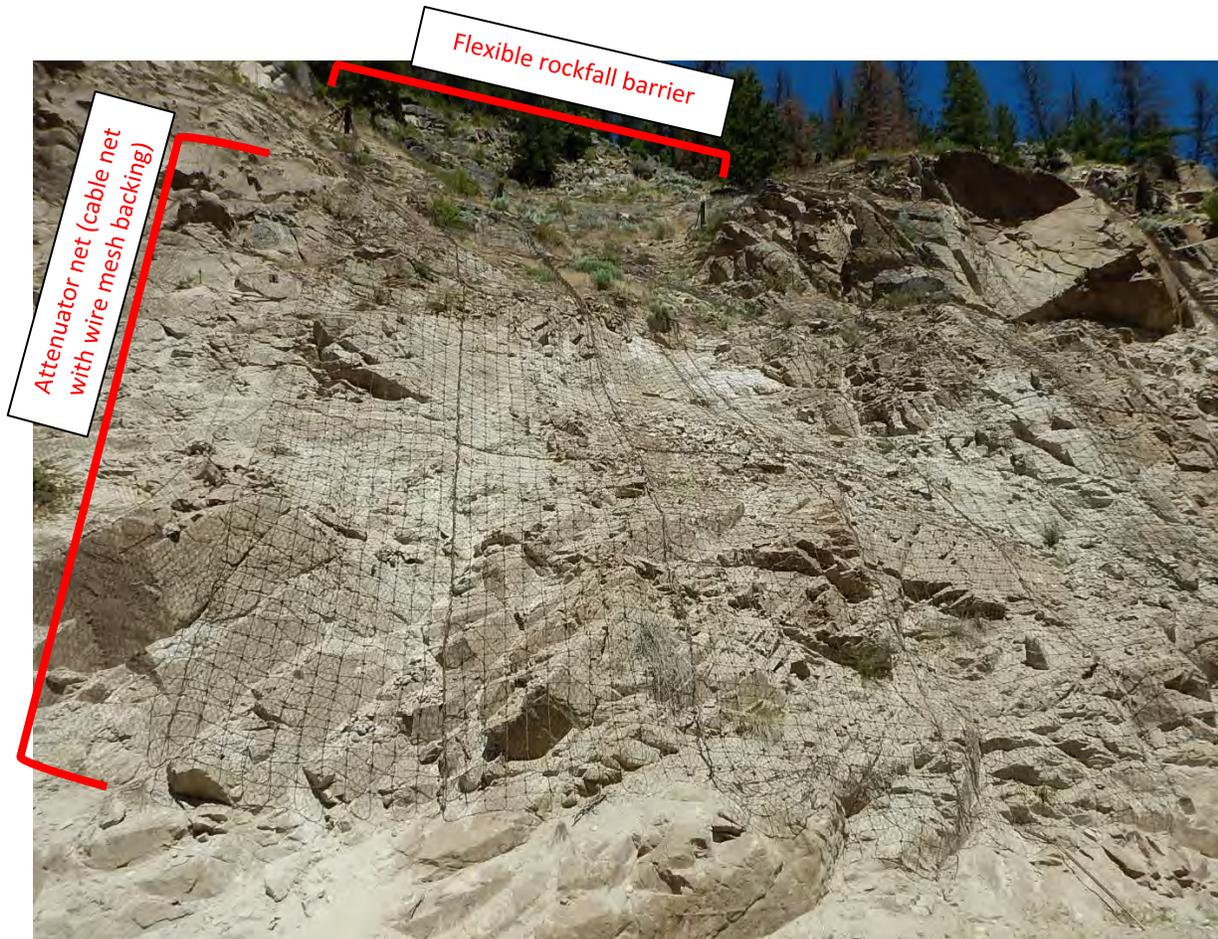
Figure 1 – Midslope rockfall attenuator installed on a WFLHD project in central Idaho.

The height of the barrier portion of the system typically ranges from 5 to 12 feet. The design height of the barrier is informed by rockfall modelling and field observations of rockfall activity. The posts are supported by a series of wire rope anchors, which are a length of wire rope inserted and grouted into a hole drilled into the ground surface. The mesh fabric used in the flexible barrier and attenuator net commonly consists of either a double twist wire mesh, a high tensile strength wire mesh, or a cable net with wire mesh backing, depending on the anticipated block size and kinetic energy of the rockfall debris.

The system is, compared to conventional flexible barriers, relatively self-cleaning, as the debris is not captured but is instead funneled down the attenuator net to the ditchline. Along roadways, the attenuator net is terminated a prescribed elevation above the roadway ditch to facilitate the collection of debris, which is removed during periodic ditch cleaning activities.

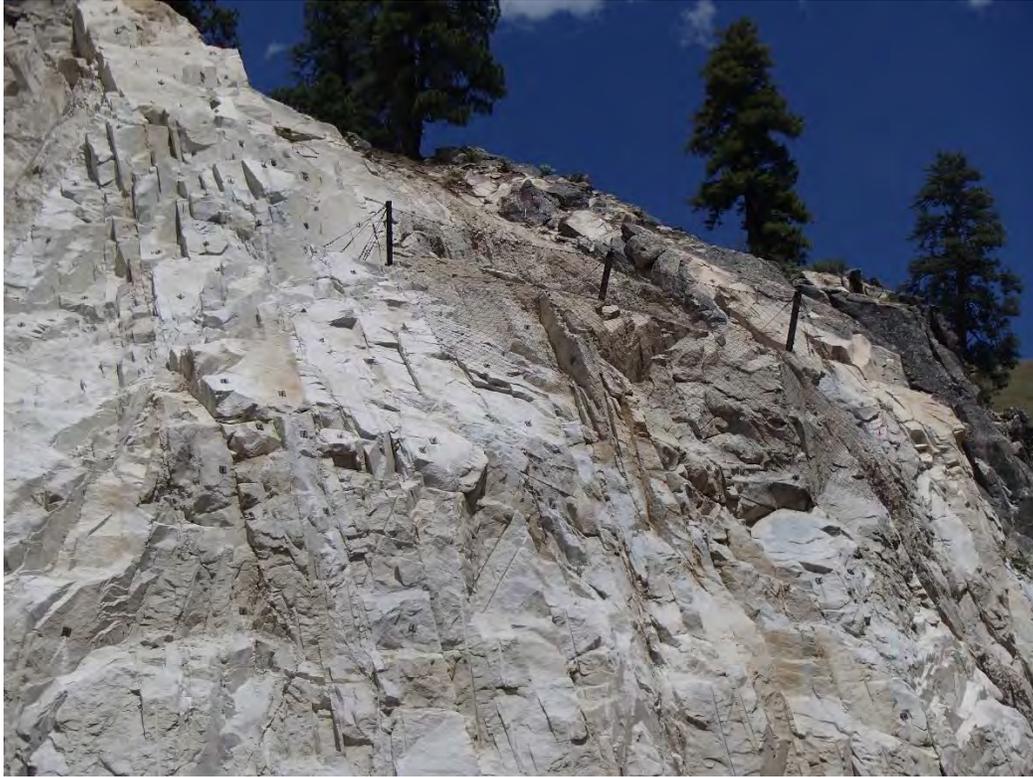
Figure 5 – The midslope attenuator installed at Slope 113 on the Bank-Lowman Highway. Ketchum-Challis Highway

Because this project is inside Boise National Forest, the attenuator systems were stained with a weathering agent called Natina to reduce visual impacts. This product was applied to all exposed steel elements of the systems, which are then allowed to cure prior to being shipped to the project site. During the curing process, the weathering agent reacts to the steel and develops into a rustic, brown color (Natina, 2022). This coloration helps the systems blend into the natural landscapes.

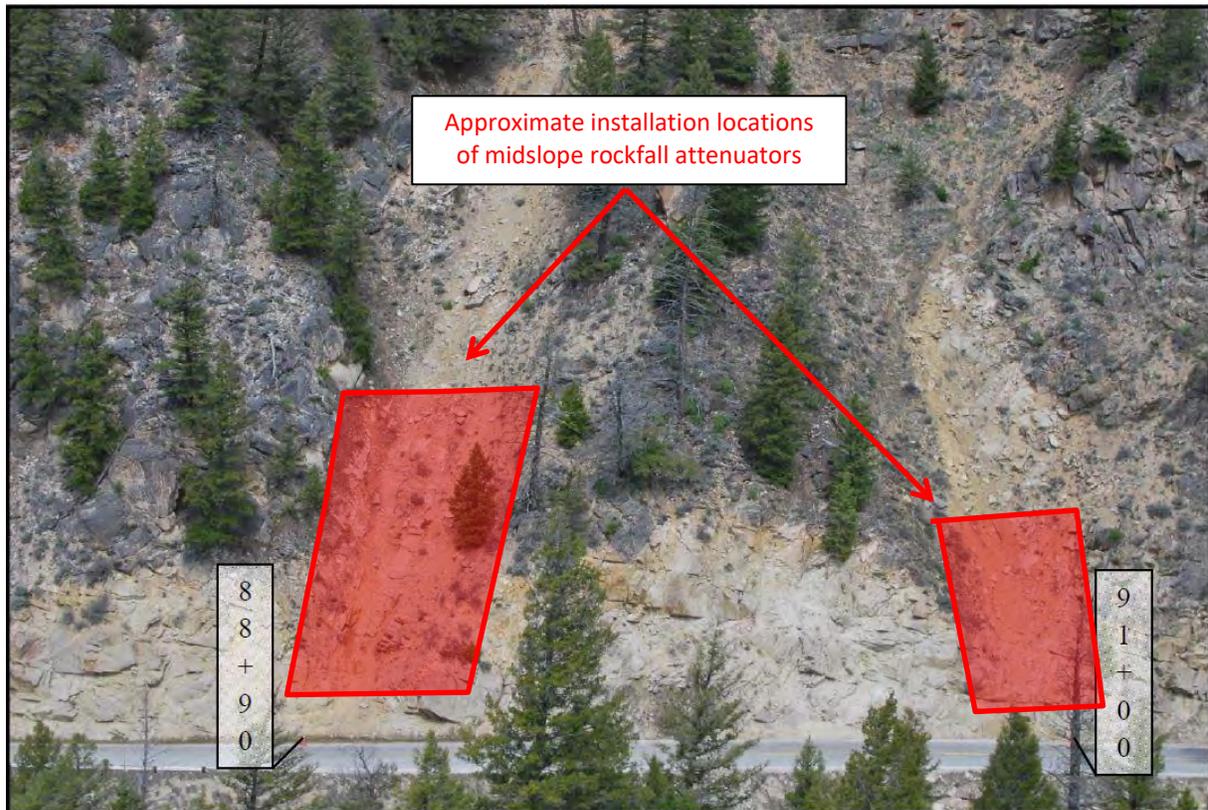
Figure 6 – An example of the rockfall protection scheme utilized for portions along the Ketchum-Challis Highway project. Draped mesh was utilized to capture rockfall originating from exposed competent igneous rock along the road cut, while midslope attenuators were installed at established rockfall chutes above the road cut (FHWA, 2012b).

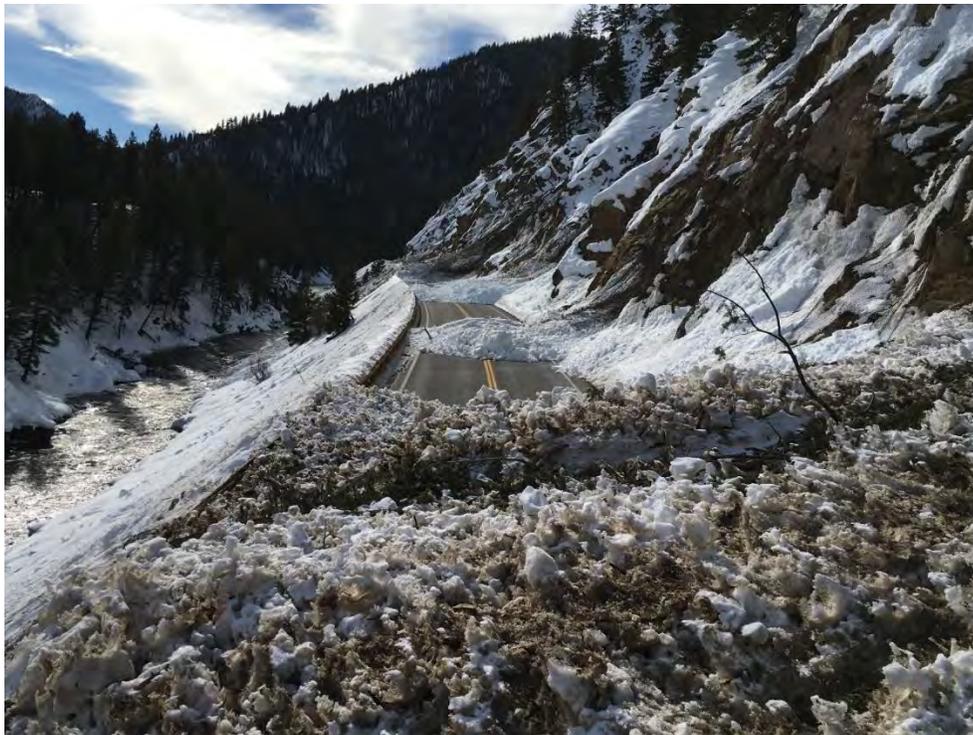
Figure 7 – Debris from snow avalanches along the Ketchum-Challis Highway project in the winter of 2017.

During the winter of 2016 and 2017, the project area experienced a 30-year snow pack, with approximately 6 to 8 feet of snow on the ground. Early in 2017, a period of rapid warming coupled with increased wildlife traffic on the slopes triggered a series of snow avalanches through the project area. See Figure 7. The attenuator nets from four systems were completely ripped away by snow avalanches. Eight other systems were damaged from either snow avalanches or excessive loads from snow creep.

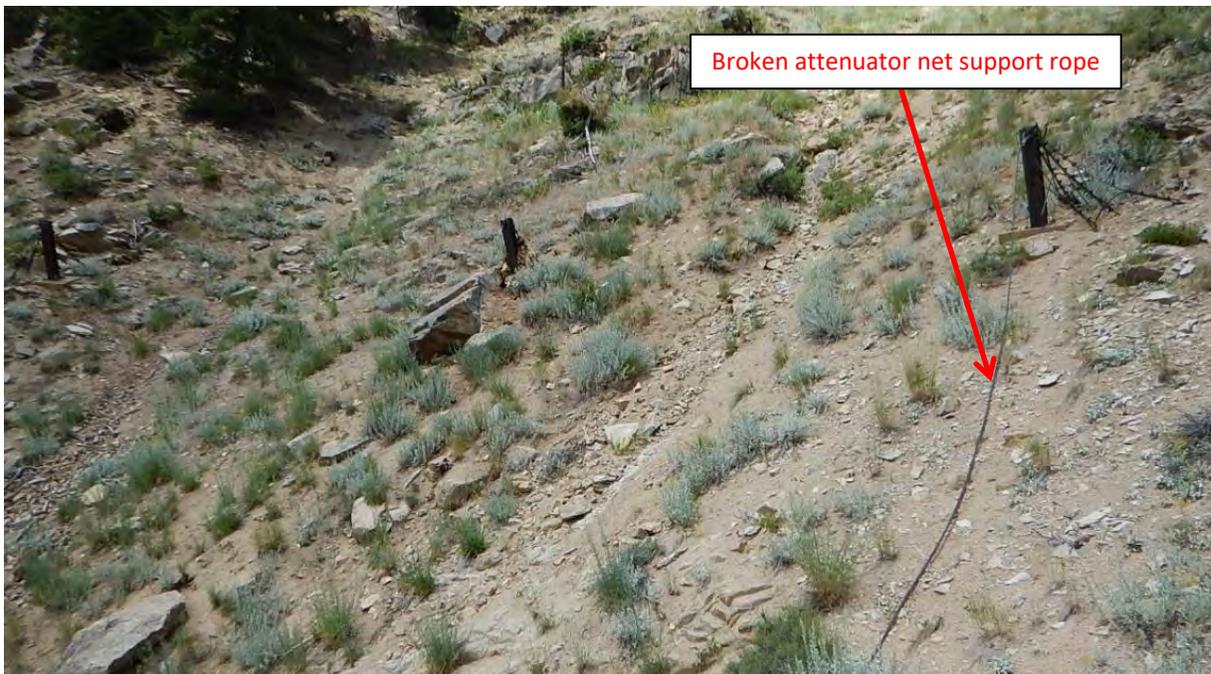
Figure 8 – Ketchum-Challis Highway midslope rockfall attenuator with broken attenuator net support rope. The attenuator net has been ripped away.

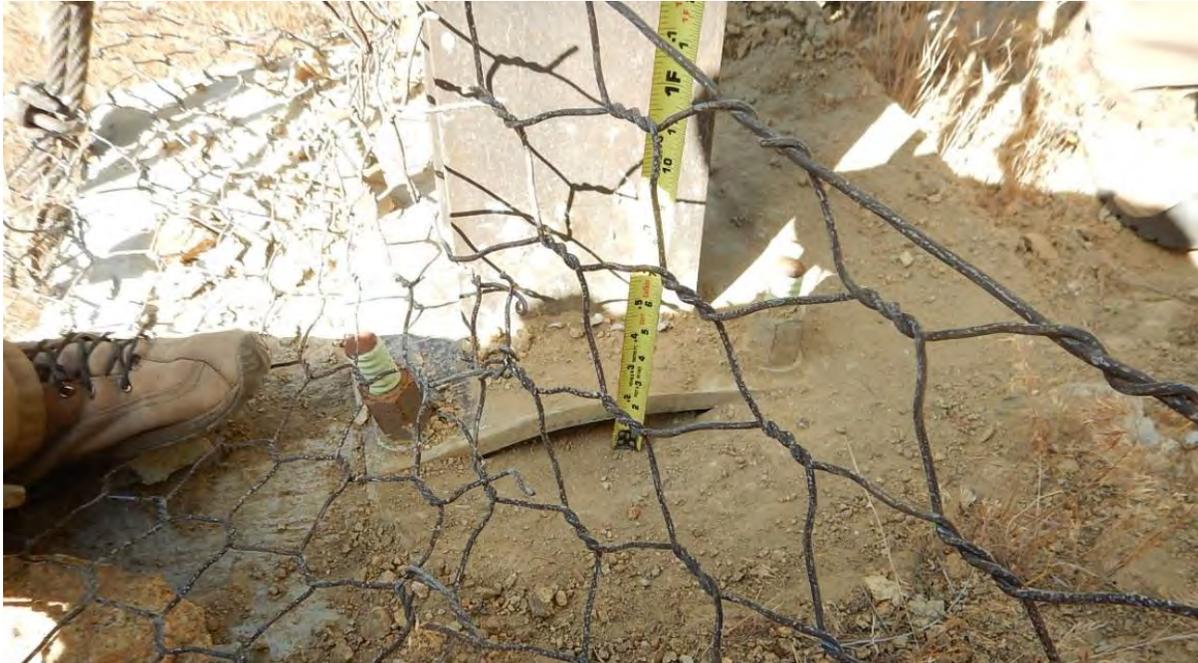
Figure 9 – Bent base plate on midslope rockfall attenuator post on the Ketchum-Challis Highway project.

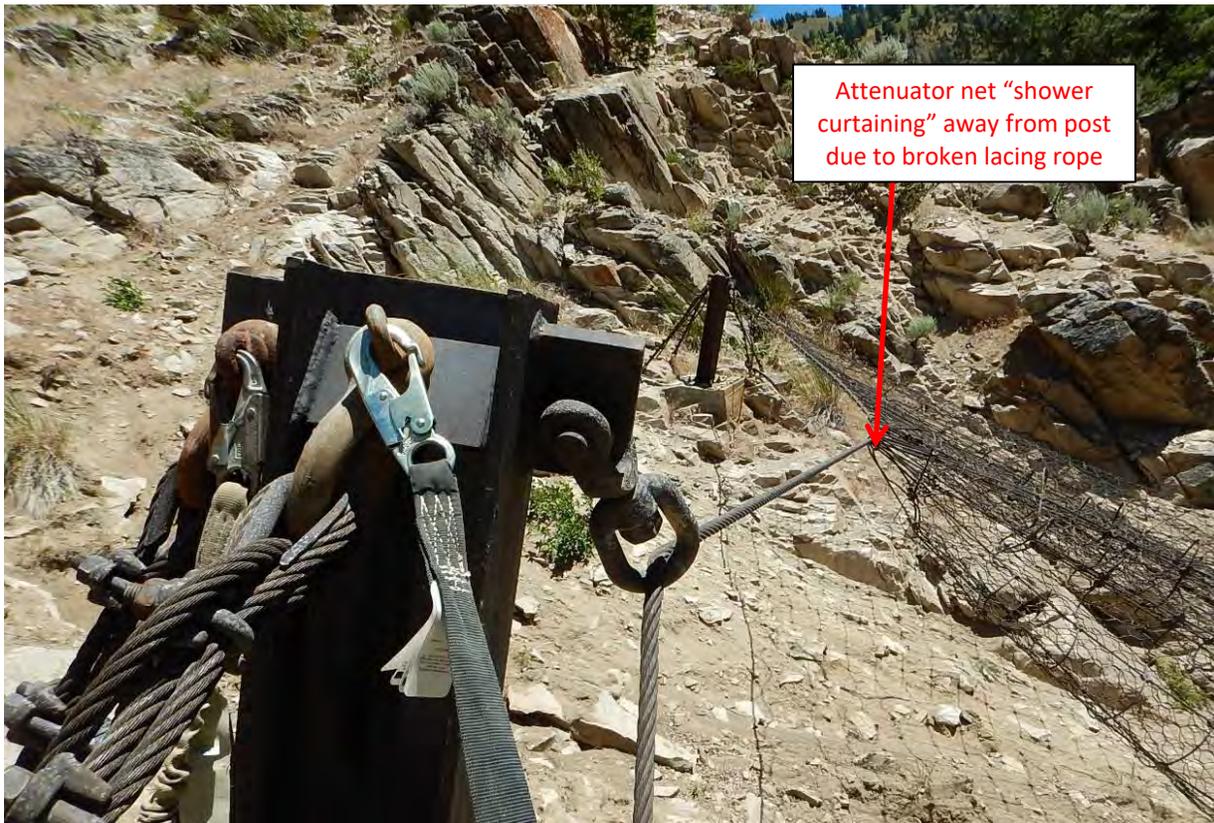
Figure 10 – Attenuator net “shower curtaining” on the Ketchum-Challis Highway project.

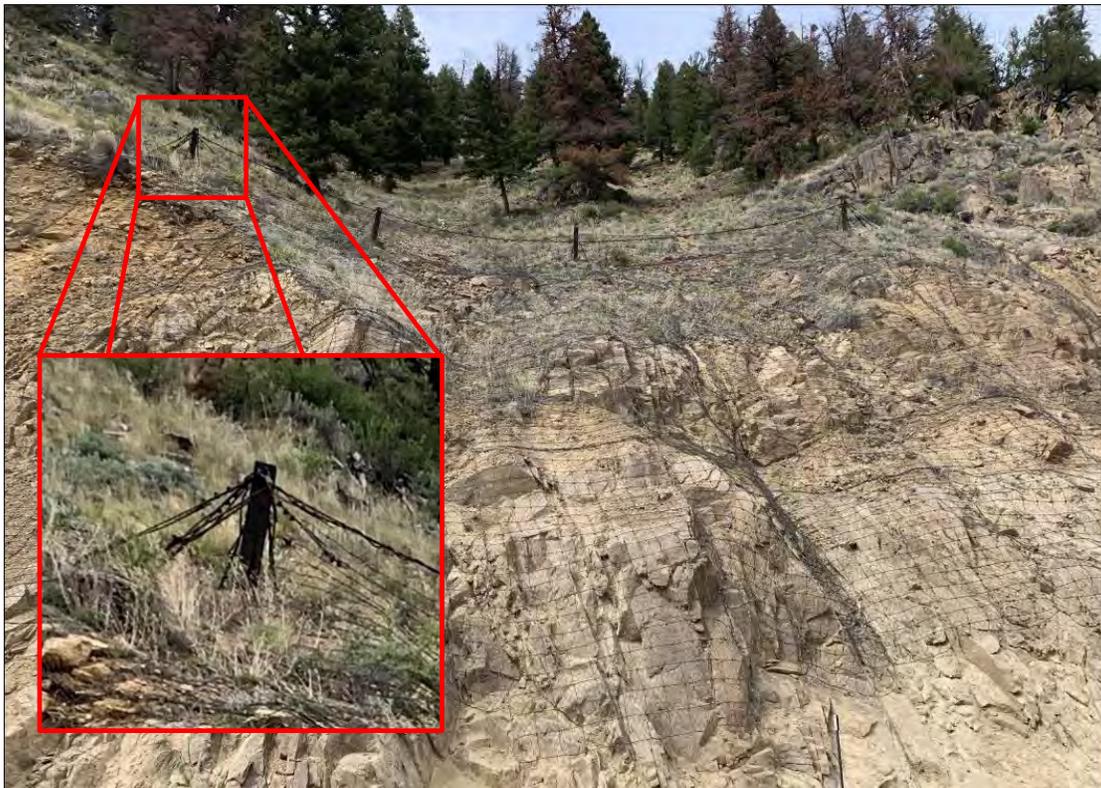
Figure 12 – Repaired and improved midslope rockfall attenuator on the Ketchum-Challis Highway project. The inset picture shows the new “corner cable” improvement.

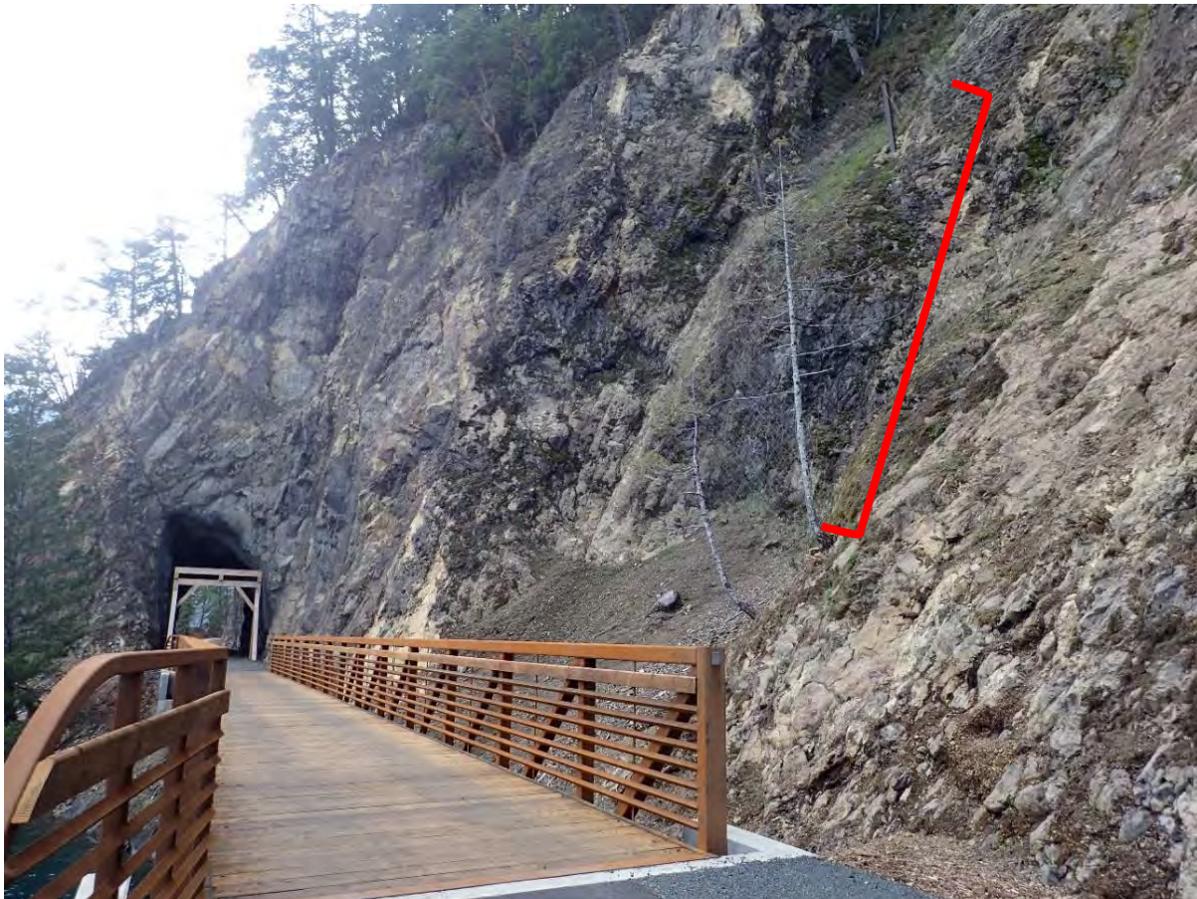
Figure 13 – Midslope rockfall attenuator installed above a pedestrian bridge along Spruce Railroad Trail in Olympic National Park (FHWA, 2018).

The surface deposits along the Spruce Railroad Trail alignment are mapped as the Crescent Formation, specifically marine pillow basalts (Schasse, 2003). A midslope rockfall attenuator was installed on an existing natural rock bench north of the new pedestrian bridge. Field observations and rockfall modeling indicated that the bench served as a launch feature for rockfall occurring from the basalt outcrops upslope, and that, if left unaddressed rockfall from this feature could impact the bridge. The midslope rockfall attenuator addresses this rockfall hazard by intercepting the rockfall and funneling it down into Lake Crescent below. See Figure 13.

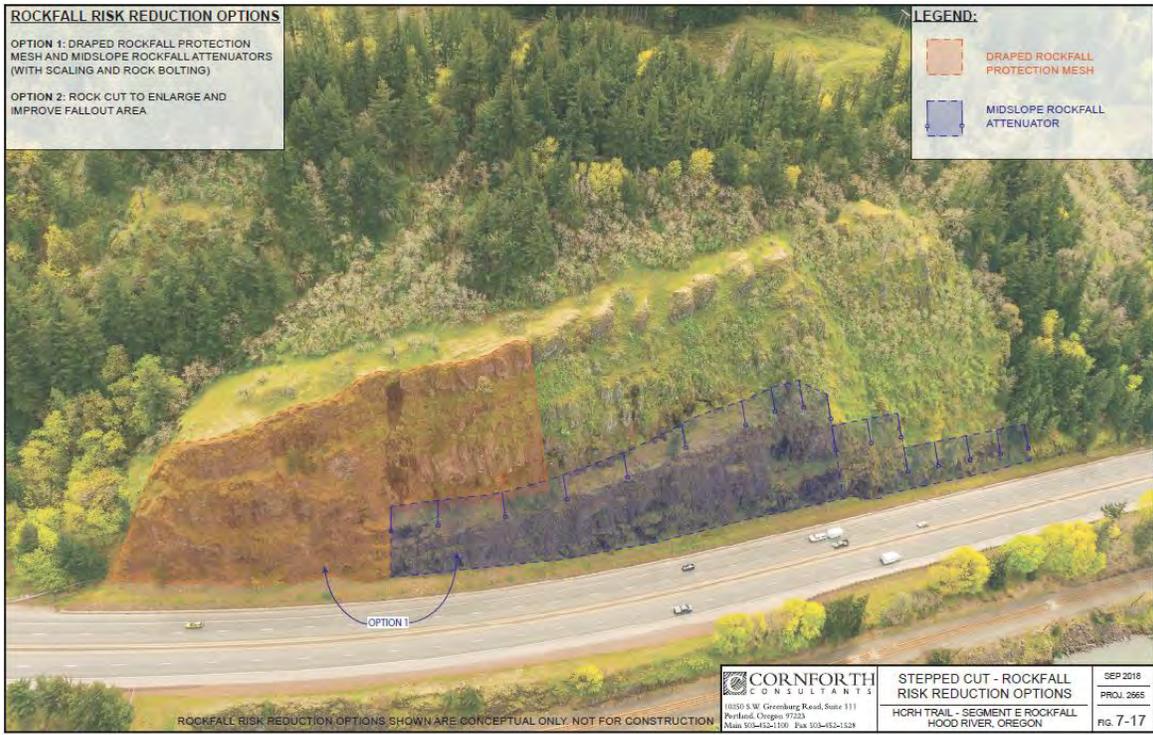
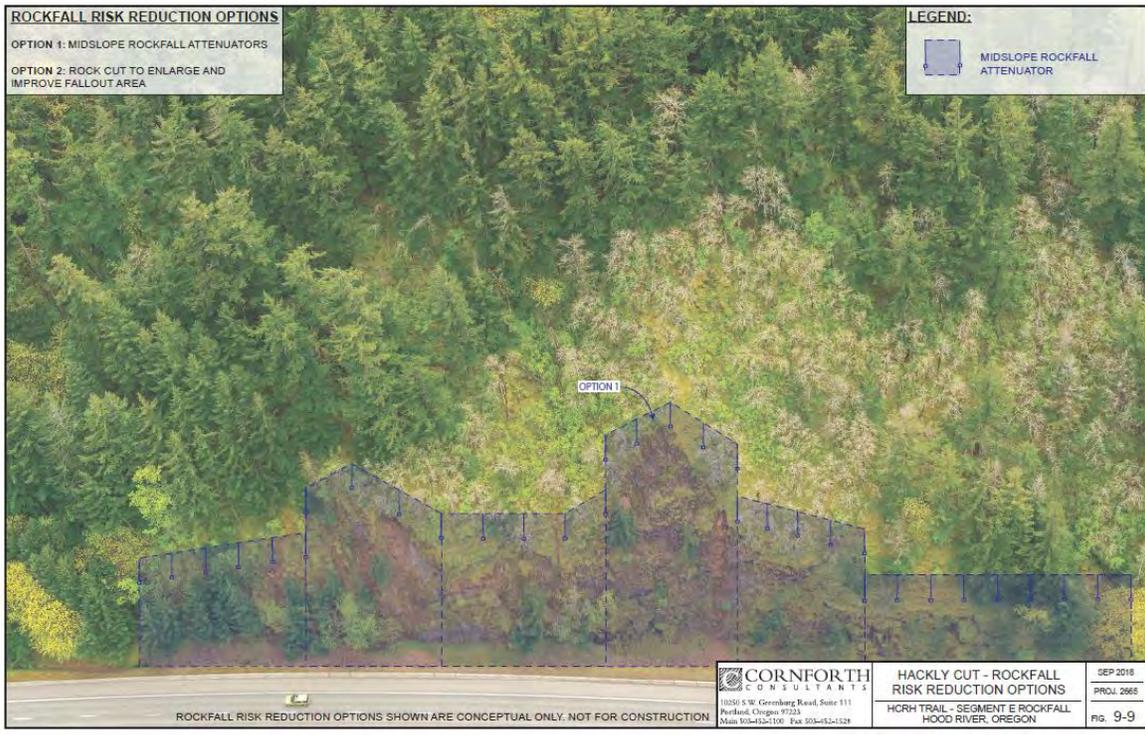
Figure 14 – Proposed midslope rockfall attenuator locations that will be installed along Segment E of the Historic Columbia River Highway State Trail project (Cornforth, 2018).

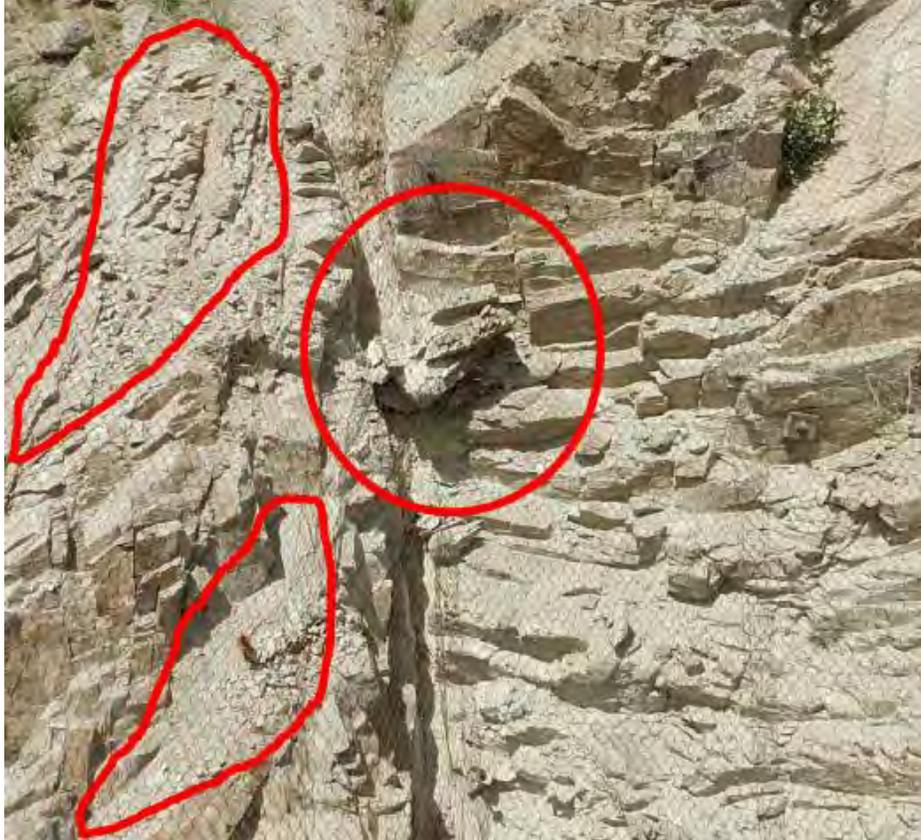
Figure 15 – Trapped rockfall debris behind contoured draped mesh at the Ketchum-Challis Highway project. Notice that the contoured pins are holding up rock blocks.

However, the addition of contour anchors traps rock blocks in both the draped mesh and midslope rockfall attenuator system, hindering the self-cleaning ability. This problem was observed at the contoured draped mesh installed at the Ketchum Challis Highway project. The contouring elements, which in the case of the Ketchum Challis Highway project was rigid steel pins, acted as barriers to the migration of rockfall debris beneath the mesh down to the ditch below. See Figure 15. This trapped material, if left unaddressed, will lead tearing and breaking of the draped mesh.

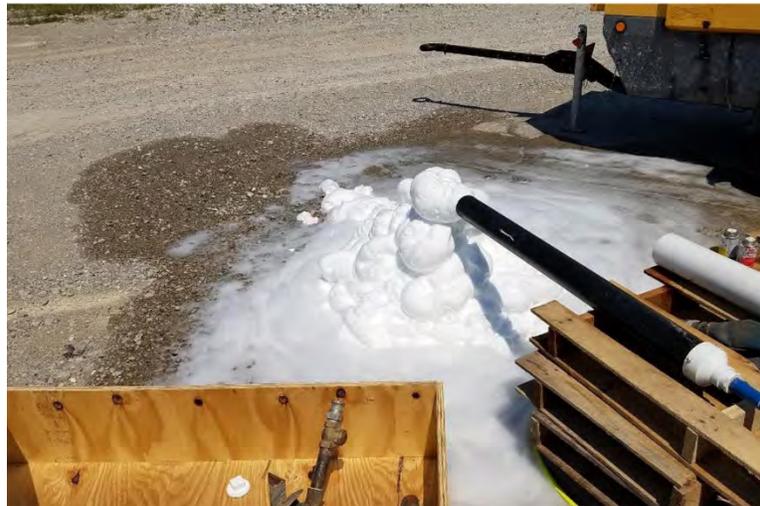
Figure 1: Preformed Foam prepared by GSI

The preformed foam inside of a cellular concrete mix is the component that provides the homogenous air cell structure. In addition, this ingredient will increase the yield of a neat grout mixture by at least three times. The foam is produced by mixing a foam concentrate with water in predetermined proportions in a foam generator (2). The key for the foaming agent is creating the air cell structure that will stay unbroken during field operations. The foam concentrates are mostly protein hydroxylates or synthetic surfactants (1). The reference manuals, including ASTM Standard Method for Testing Foaming Agents for Use in Producing Cellular Concrete Using Preformed Foam (C 796) and ASTM Standard Specification for Foaming Agents Used in Making Preformed Foam for Cellular Concrete (C 869), provide guidance for densities and other specifications.

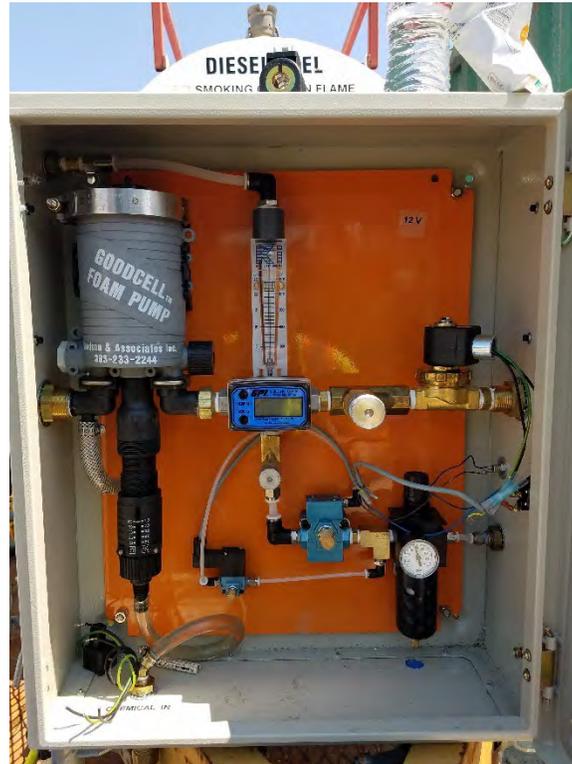
Figure 2: Goodcell Foam Pump

The equipment needed to make the material is a foam machine and, depending on how the cellular concrete will be used and placed, a grout plant, concrete truck, or a specialized mixer.
