71st HIGHWAY GEOLOGY SYMPOSIUM

2022 Proceedings

**71st ANNUAL
HIGHWAY GEOLOGY SYMPOSIUM
Table of Contents**

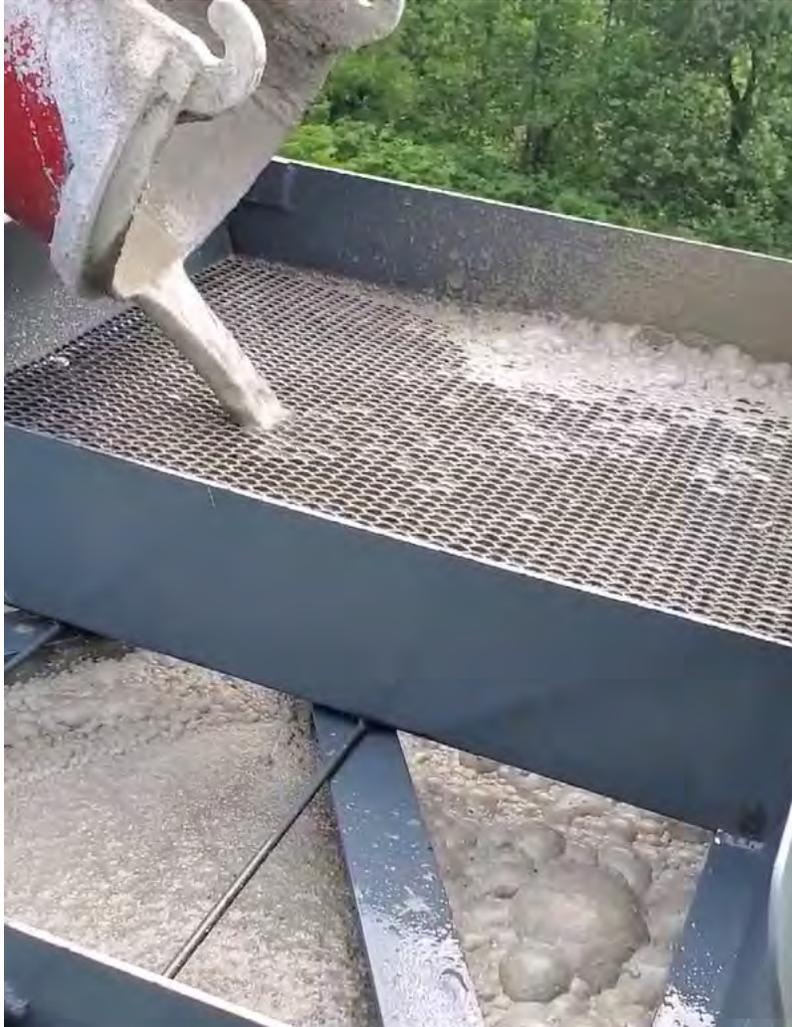
Figure 3: Cellular Concrete Placed Directly into Grout Plant

Mixers capable of high speeds are desirable to appropriately combine the concrete and water. The foam concentrate and water are combined for the desired ratio, typically 1-part foam concentrate with 40 to 100-parts water. The resultant foam is then added to the cement/water mix through means typical of grouting operations with a grout plant or other mechanical mixer. The cellular concrete mixture is ready for pumping with the foam added to the mix. It can be added directly to concrete trucks allowing for placement through gravity directly from the chute, or transferred to a machine for pumping with standard grouting hoses. Although self-leveling lift thicknesses of around three feet should be used when applied as a lightweight backfill.

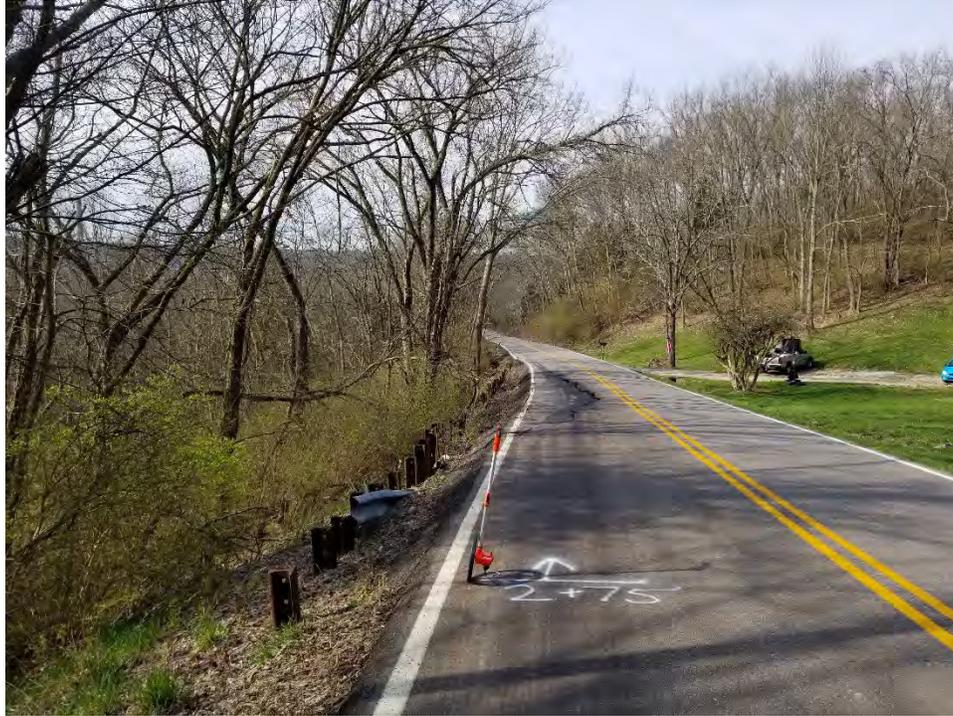
Figure 4: KY 338, MP 14.30 Before Landslide Repair

An active landslide area created a scarp in the pavement and shoulder loss for 275 feet along KY 338, MP 14.30 in Boone County, Kentucky. This site is in an area of Garrard Siltstone, and Kope and Clays Ferry Formations (4) consisting of silty clay derived from a clayey residuum weathered from calcareous siltstone and/or clayey residuum weathered from limestone and shale (5). For the entire length of the repair, an in-place railroad steel retaining wall was not capable of holding back the movement of the slide mass as you could see that most of them were out of plum. Powerful rain events and sloping conditions are the likely culprits that activated this slope failure. The saturated soils on the embankment lost shear strength and could not remain in place. The movement began de-stabilizing the downslope.

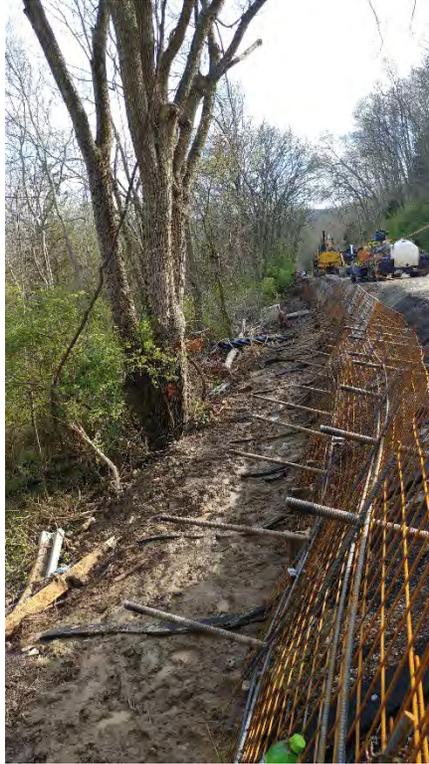
Figure 5: KY 338, MP 14.30 Construction Progress

To stabilize this moving slope, the failing railroad steel system had to be removed, the existing slope excavated and shaped top-down near the edge of the pavement. Next multiple rows of soil nails were installed, along with horizontal drains. Finally, a rigid reinforced shotcrete facing was installed, forming a void for the shoulder restoration.

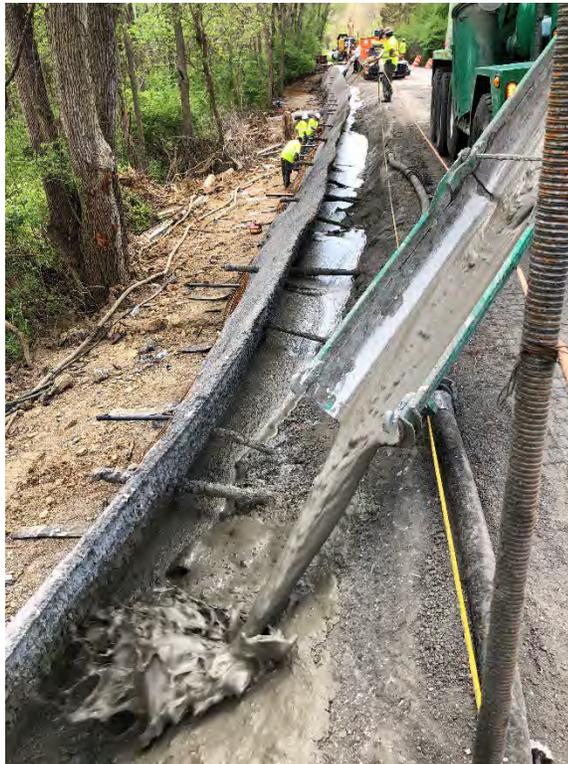
Figure 7: Shoulder Restoration Achieved with Cellular Concrete Placed by Gravity

Flowable fill is a good option, being a self-compacting impermeable material and not creating additional lateral forces behind the shotcrete facing. A downside is flowable fills generally have strengths of 1,200 lbs/in² and may cause future issues if the repair area needs to be excavated or if guardrail posts need to be driven (3). Cellular concrete has the positive attributes of flowable fills, but the air cell structure allows for easy excavating, cutting, and driving operations, making it ideal for this scenario. The impact absorbing properties will enable this material to hold guardrails, maintaining the design considerations set forth by AASHTO. A Kentucky Transportation Cabinet employee described installing the guardrail posts as easy and like puncturing Styrofoam.

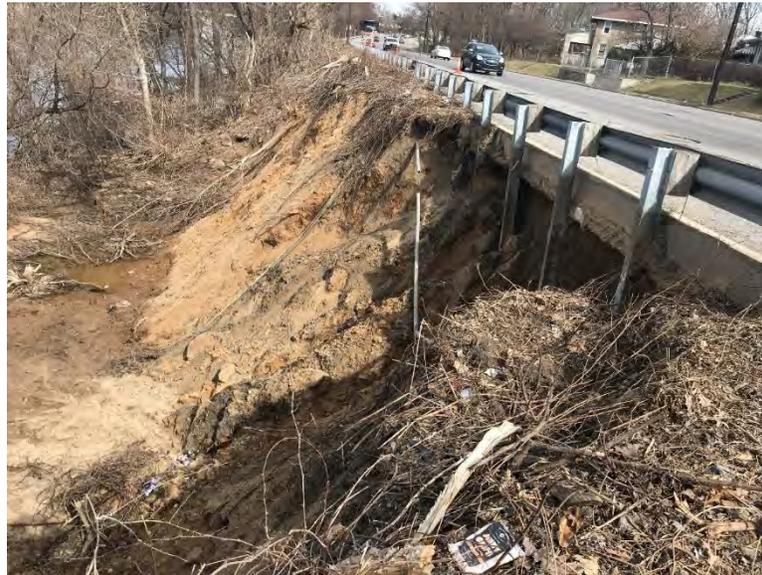
Figure 8: SR 933 undermining of roadway

On State Route 933 in Mishawaka, Indiana, GeoStabilization responded to a slide undermining the roadway. The material loss under the pavement spanned approximately 111 feet. This road was constructed over top of soils from Ellsworth Shale (6), consisting of sandy material with trace clay and gravel. At the time of our response to the geohazard, water was actively flowing from the bottom of the slope. The owner's subsurface investigation showed groundwater present at an approximate depth of 16 feet. The actively flowing water is likely to

cause material loss due to accelerated erosion rates, leaving the roadway without any material underneath it, as shown in Figure 8 below.

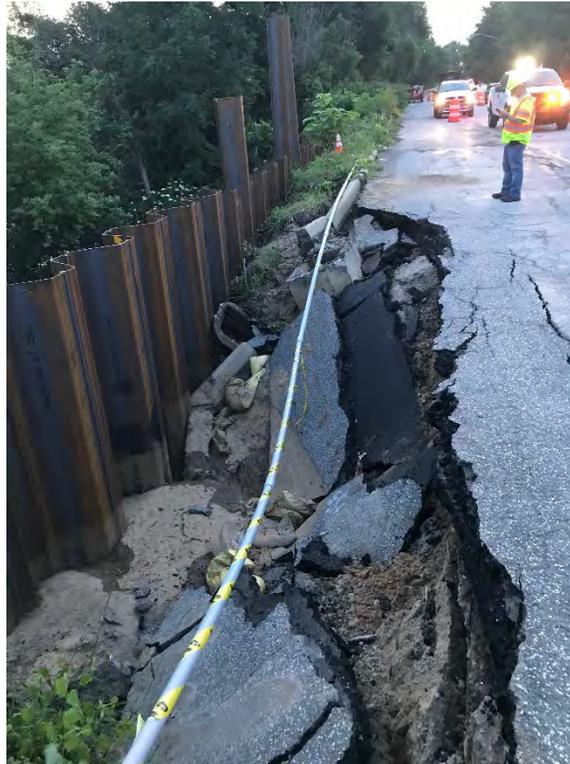
Figure 10: Pavement Damage and Material Loss

During the landslide repair's construction, continued flowing water in the repair area coupled with rain events and erosion of material under the roadway promoted pavement breakage as the weight of the pavement structure had nothing to bear on and failed under its own weight. There was no visible scarp or cracking in the pavement during our initial site visit, and its later presence required some sudden engineering decision-making.

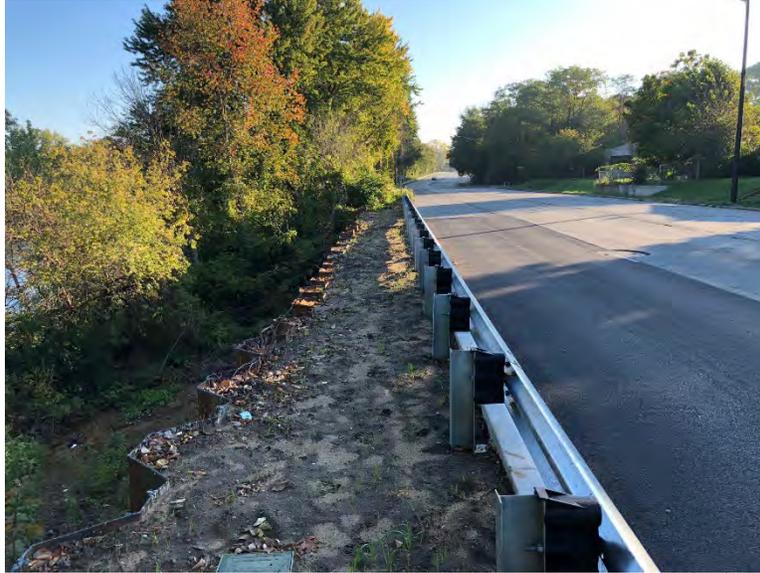
Figure 11: Stabilized Roadway with Cellular Concrete Build Up

Due to the pavement structure's undermining, a large volume of material loss needed to be replaced to achieve roadway reclamation and shoulder rebuilding. With the water being aggressive and damaging on this challenging site, an impermeable material was an ideal choice. The empty space needing to be filled was large in volume, and as this was not initially expected at the project's commencement, an economic choice needed to be made. Cellular concrete once again proved to be a great choice. With its impenetrable nature, water will not be able to build up behind the sheets or under the pavement structure anymore. When creating the cellular concrete on-site, yields of typically around three times the original volume of neat grout is reached when adding preformed foam to the mix. This allows costs to remain low when purchasing material to fill that void space. Additional benefits include:

- Negligible lateral pressure on the sheet piles.
- High bearing capacities for live traffic and other loading conditions.
- The shock absorbing nature for potential guardrail impacts.

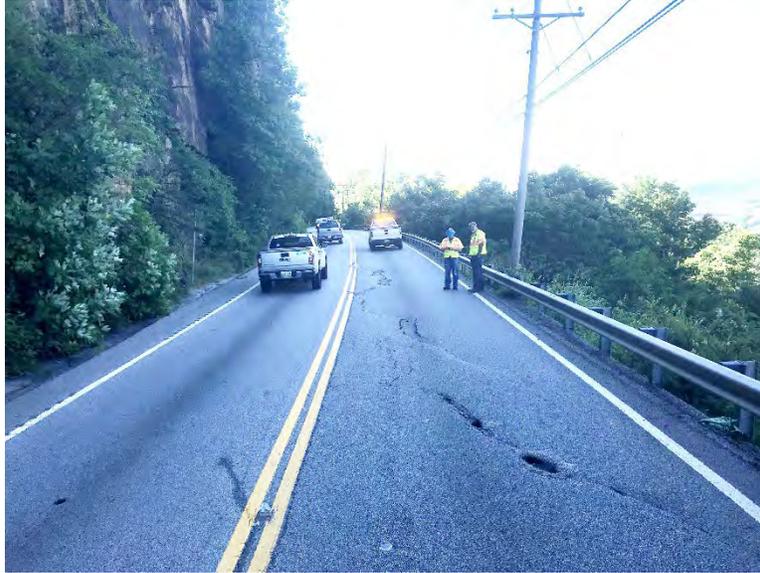
Figure 12: SR 8, LM 15.97 Prior to Construction

State Route 008 in Hamilton County, Tennessee, experienced pavement cracking and settlement extending to the middle of the roadway, linear cracking in the shoulder area, and loss of shoulder and support of the guardrail posts. With the project limits are on the Pennington formation (7) with cobbly and stony colluvium (5), the material underneath the roadway contained a lot of rip rap. A solid rock face is present on the inboard side, draining water toward the road and the outboard slope. With the steep sloping conditions and the rocky material under the roadway, flowing water could damage the material propping up the street, resulting in the activated landslide in this area. With the pavement cracking and dropping, more and more water would infiltrate and lead to more damage. Quickly repairing the slope and repaving was crucial to the project's success and saved State Route 008 before extensive reconstruction and complete road closure would be required on this highly traveled roadway.

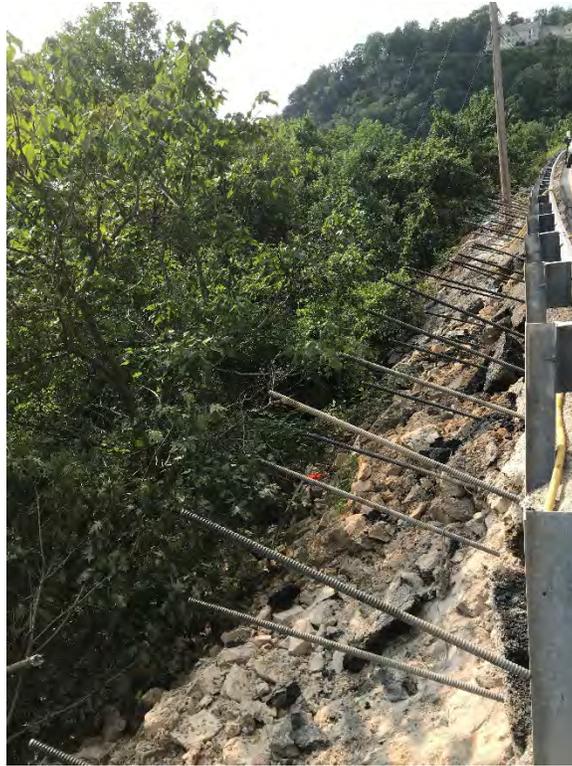
Figure 13: SR 8, LM 15.97 During Construction

Preserving 265 linear feet of road platform along State Route 008 was accomplished with a soil nail wall, and shoulder build-up, similar to KY 338 mentioned earlier in this paper, although taller with more rows of soil nails. Depending on how far into the roadway the scarp line was, our crews could optimize soil nail lengths. While drilling and grouting the soil nails during construction, the construction crew noted that several holes took much more grout than expected. Increased grout uptake became an issue, as the soil nail elements require a set bond strength to provide the industry standard factor of safety of 1.3. As mentioned previously, this roadway was initially constructed with rip rap underneath the pavement structure, encouraging grout to permeate from the borehole column. The area's geology, having the presence of abundant rhombohedral voids indicative of the removal of calcite or dolomite crystals (8), caused additional issues during grouting operations.

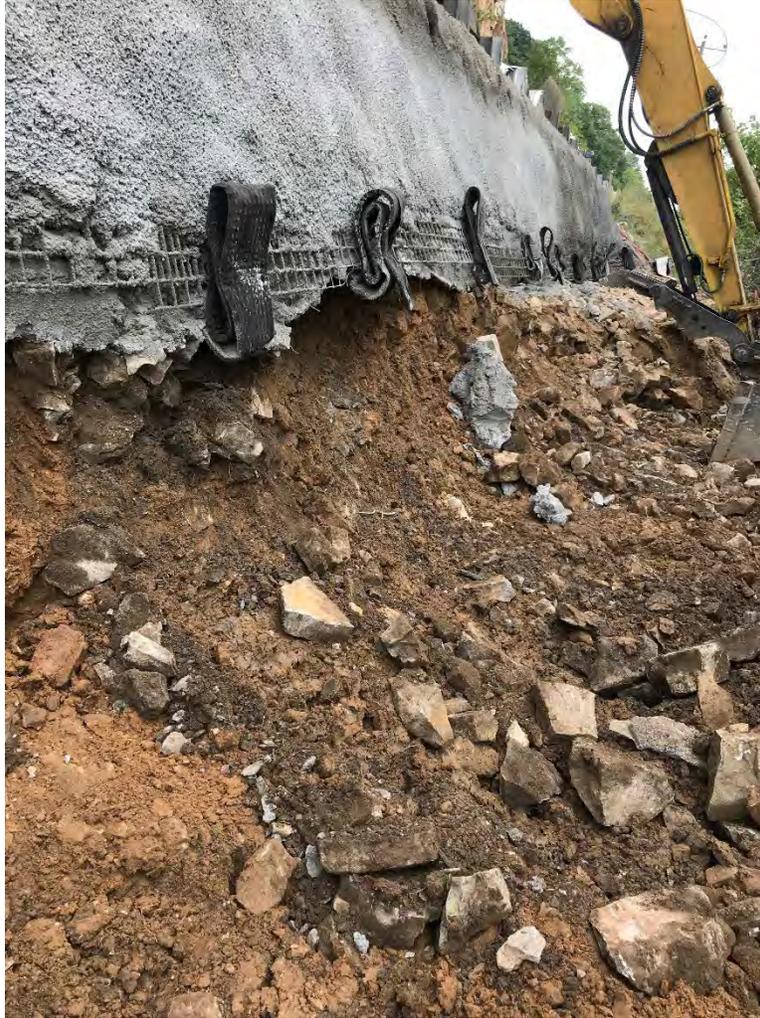
Figure 14: Rocky Grouting Conditions

After understanding that the boreholes drilled from the self-drilling SuperNails® were not providing proper grout coverage and adequate bond strength, alternative operations needed to be considered. Cellular concrete once again became the best available option to this project. What was needed was the soil nail borehole columns to fill up with neat grout and provide enough bond strength to stabilize the landslide properly. Cellular concrete was able to fill the large voids through injection into the landslide mass with self-drilling hollow bar soil nails rather than drilling with air, neat grout, or water. After the cellular concrete set, a switch to neat grout was made to provide higher bond strength than a cellular concrete column would provide. Filling these voids with a granular compacted fill or some other material is impossible. Pullout testing was performed to verify the bond strength and confirmed this void filling method and grouting provided the bond strength needed to stabilize the landslide.

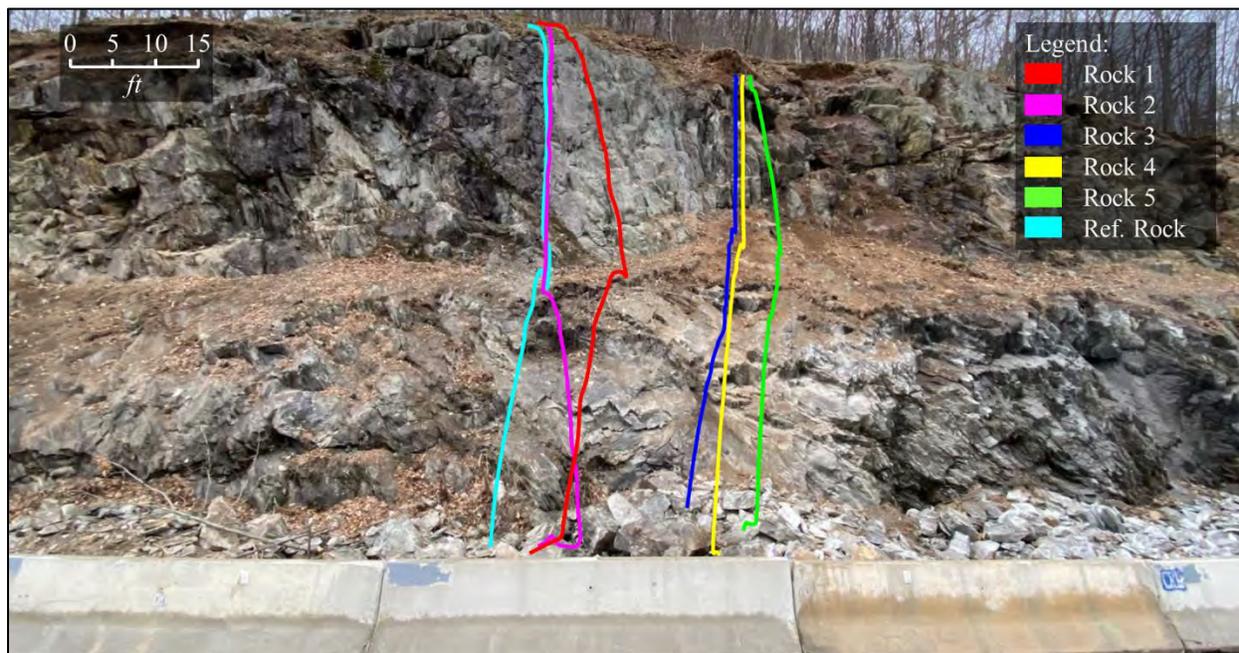
Figure 4 – Rockfall trajectories: Townshend VT. Please note some horizontal distortion in the trajectories due to the camera position and wide lens to capture the entire slope.

All rockfall tests were successfully recorded with the fourth-generation Smart Rock. The rockfall trajectories for the six tests with the smaller rocks are presented in Figure 4. The angle reduction from 80° to 30° in the mid-slope cross-section (approximately 30 ft above the ground level) led the block trajectories to bounce and increase their horizontal dispersion. Bounce heights in this launch feature were as high as 3.3 ft for the reference rock.

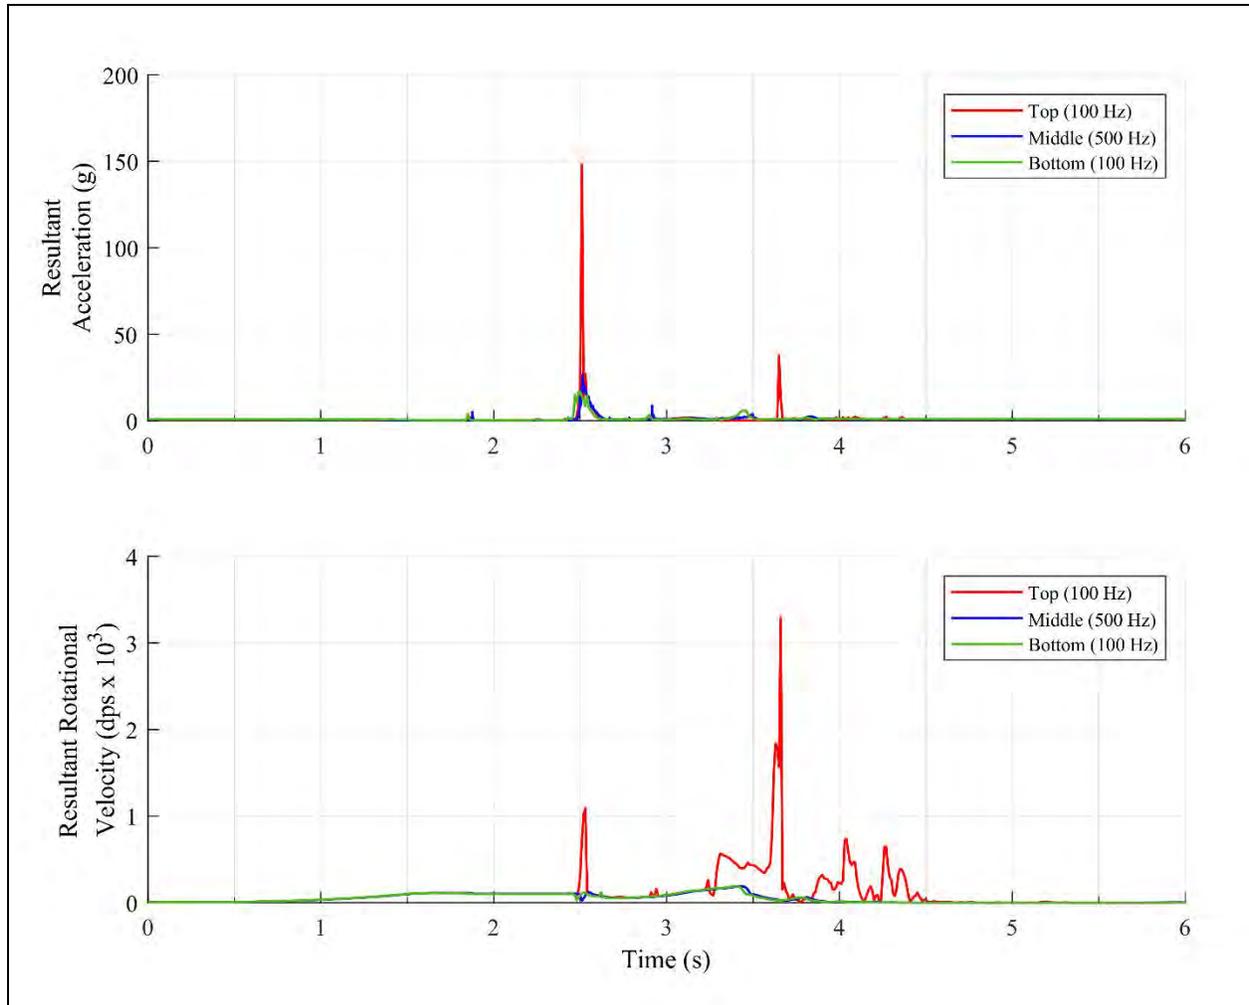
Figure 11 – Combination of the resultant data for the three SRs in the second scaled block, Townshend VT.

Finally, for the lower SR, a lower acceleration of 17 g was recorded during ground impact, exerting an impact force of approximately 350 kips. The block rotation during free fall was also equal to 100 dps, and block rotation during bouncing behavior was very similar to the measured data with the middle sensor.

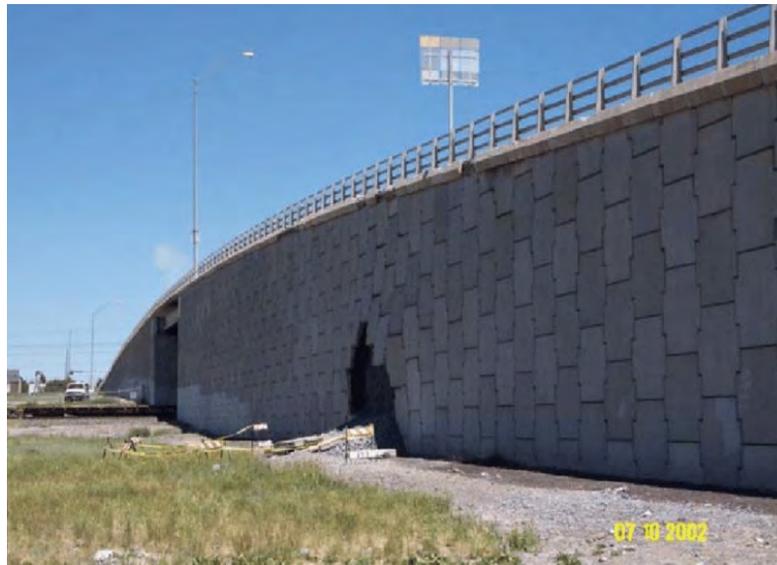
Figure 1. Localized failure within a mechanically stabilized earth mass (8).

Mahmood (2009) presented a case history of the failure and rehabilitation of an MSE bridge abutment constructed in Soda Springs, Idaho in 1978 (9). 24 years after construction, six of the precast concrete facing panels “popped out” in a localized area of the walls. Corrosion of the galvanized steel soil reinforcing strips was determined to be at fault; lateral earth pressures exceeded the connection’s remaining capacity. Horizontal drilled and grouted crosstie ground anchors were installed in the approach walls, anchored soldier piles at the abutments, and a reinforced shotcrete facing was installed to the existing MSE facing panels. Each drilled anchor

was subjected to a class one corrosion protection system. Strands were coated with a corrosion inhibitor and encapsulated in plastic shells. The corrosive nature of the fill material, coupled with the use of metallic strip reinforcement, contributed to this MSE failure.

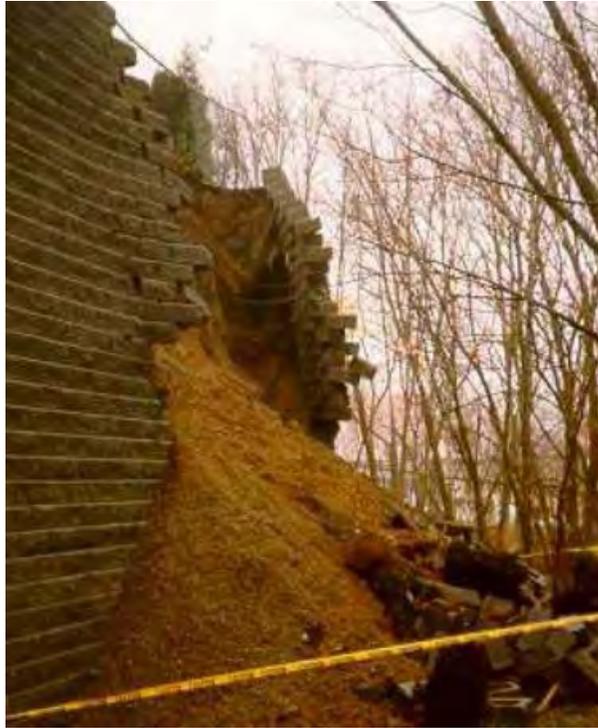
Figure 2. First failure of SRW constructed in southeastern Pennsylvania (Paxson et al. 2004).

Paxson et al. (2004) detail the failure of a geogrid-reinforced segmental retaining wall (SRW) constructed in southeastern Pennsylvania (10). 5 months after construction, a failure occurred; prior to this failure, no signs of distress were reported. This failure occurred after several significant rain events, as well as testing of a fire protection system that drained into the parking lot above the wall. The failure was relatively shallow, and most of the reinforced zone remained intact. However, the wall was dismantled in the presence of several geotechnical engineers. Laboratory testing indicated that the material was not adequately compacted and was wet of optimum. While observations during wall removal suggest that the geogrid reinforcement was placed in the general location and length as specified on design drawings, the drainage stone at the face did not appear to have been placed as specified. Removal of a stormwater pipe that flowed from a stormwater inlet in the parking lot supported by the wall revealed that the joints were not sealed; both the pipe and inlet were bedded on stone that was likely connected to this facing drainage layer. Two months after the first failure was repaired, tension cracks and settlement of the pavement above a separate section of the SRW were observed. Over the following months, the cracks opened wider, and settlement continued to nearly 8 inches of vertical displacement. Shortly after this was observed, the wall completely collapsed. Repair of the wall was valued at roughly \$150,000. A post-failure analysis indicated that hydrostatic pressure, coupled with poor compaction of reinforcement material was to blame for both failures.

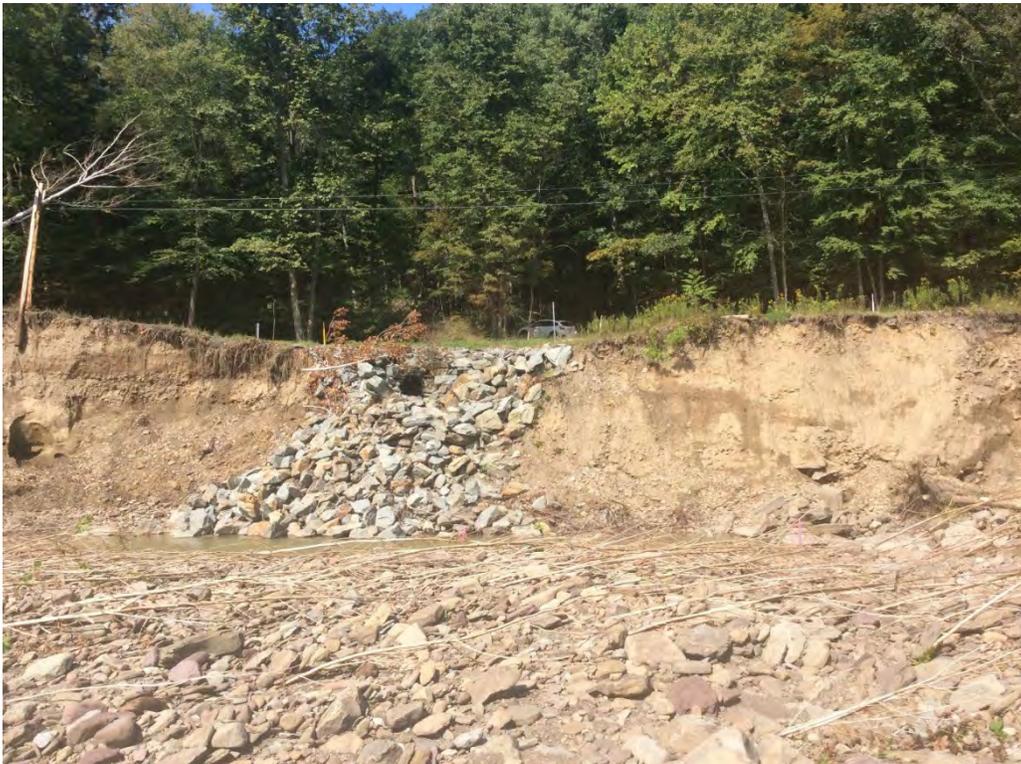
Photo 2: SR 187, Section 079 Landslide – Durable Rock at Pipe Outlet

- Durable rockfill has been placed in the area of the 48-inch pipe where it outlets to the slope as shown in Photo 2. This rockfill appears to not have been affected by the recent flooding.

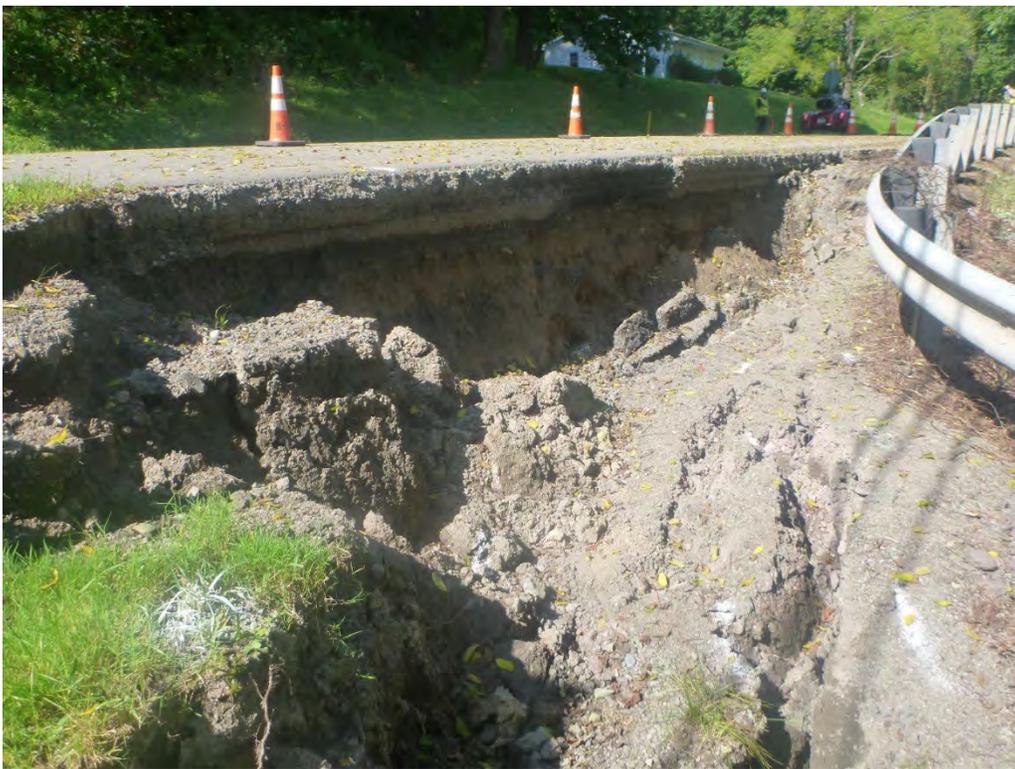
Photo 3: SR 187, Section 080 Landslide – Site During Field View

- The landslide has impacted approximately 40 feet of the northbound shoulder of SR 187, and has moved the guiderail toward the Susquehanna River, resulting in a single lane closure as shown in Photo 3. The total length of the landslide is approximately 150 feet in length.
- Approximately 4.0 to 4.5 feet of displacement was measured at the crown. The pavement section consists of about 1.5 feet of asphalt underlain by 3.5 feet of tan clayey sand with some rounded to subrounded gravel as shown in Photo 3.
- A toe bulge and overturned tree was observed within the slide mass. The toe bulge was on the riverbank, just above the water level of the Susquehanna River.

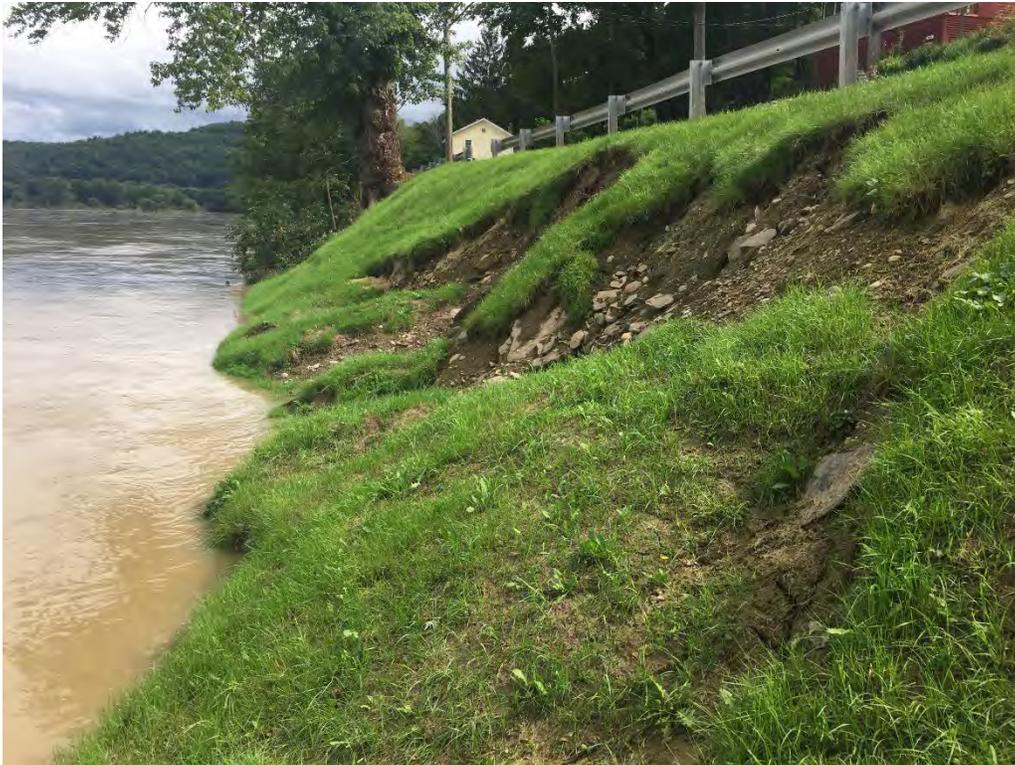
Photo 4: SR 187, Section 088 Landslide – Slumps Observed at Site

- The landslide consists of a series of shallow, generally less than 2 feet deep slumps or shallow soil slips.
- The roadway and guiderail directly above the slide area appear to be unaffected by the soil sloughage.

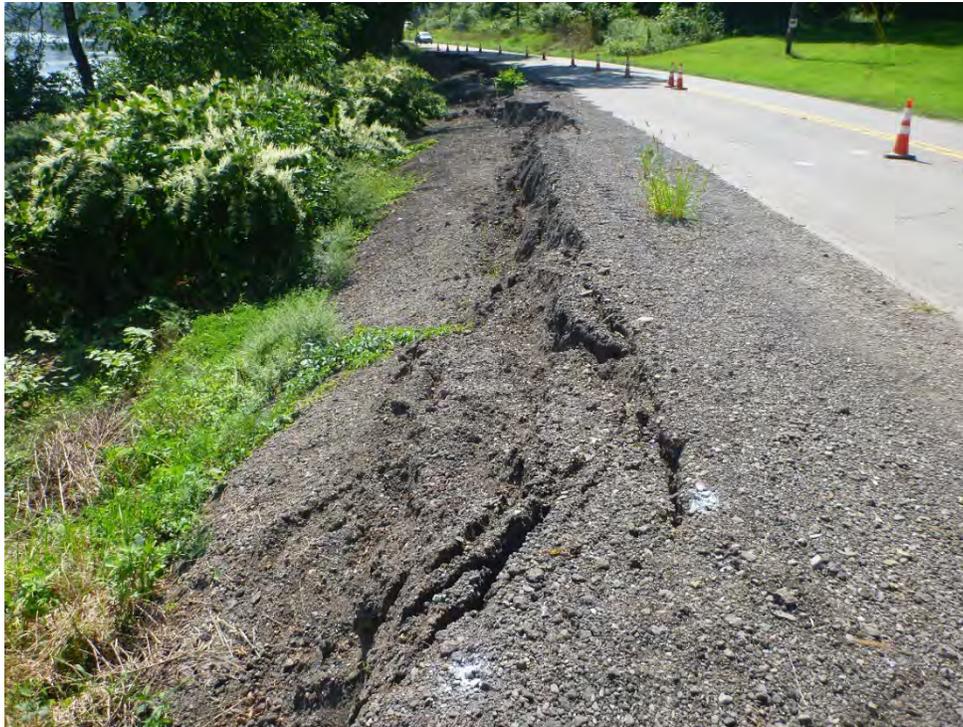
Photo 5: SR 187, Section 081 Landslide – Scarp Along NB Lanes

- The landslide is approximately 230 feet in length and impacts the roadway and shoulder of the northbound lane of SR 187 resulting in closure of the northbound lane as shown in Photo 5.
- Approximately two to three feet of vertical displacement along the headscarp was measured as shown in Photo 5. The headscarp is primarily located within the shoulder and the material observed is comprised of asphalt millings, possibly indicating past movement was observed in this area based on the fill placement.

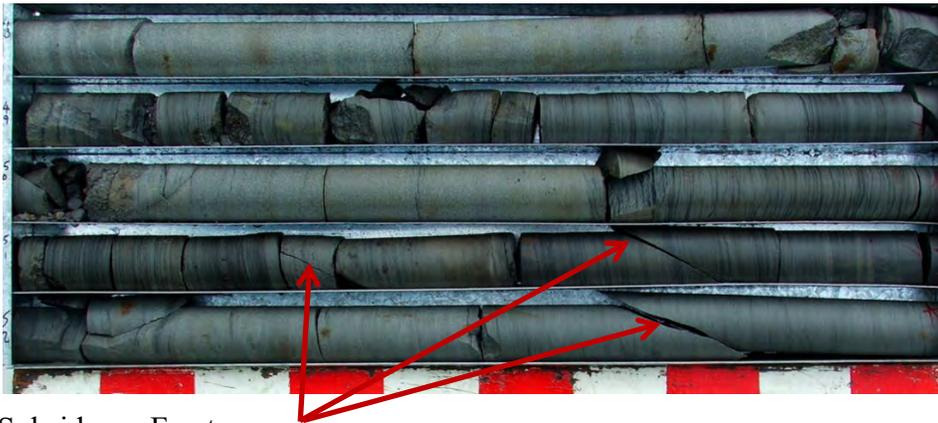
Figure 3 Typical trough subsidence fractures above Borehole Coal Seam, Newcastle, Aus where a trough subsidence event occurred in 1896, shortly after mining, Core depth is 157.5 ft to 173.9 ft (48 to 53m), with the top of the seam at 212.8 ft (64.87 m) (Knott et al, 2012)

this information as indicated below. Figure 3 illustrates an example of rock cored where a trough subsidence event has occurred. The boring encountered fracturing above the coal due to pillar crushing at mine level.

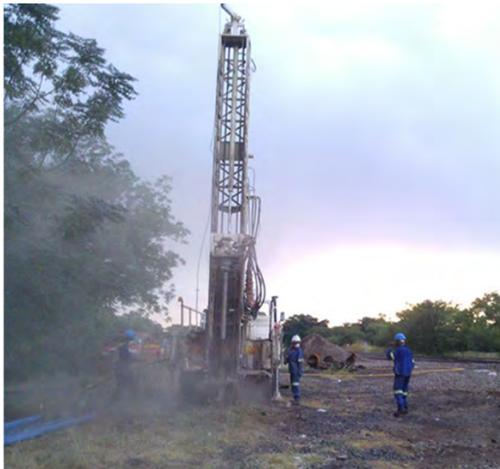
Figure 4 Air rotary drilling Note, in many cases a water well drilling rig is used (note dust) Aqua earth website

As the drill bit grinds up the rock with air rotary drilling, only chips of rock or dust may be recovered; which is why they typically have a lower cost than cored borings. However, they are beneficial in helping to provide data on coal depth, voids, and overburden conditions. An example of air rotary drilling is provided in Figure 4.

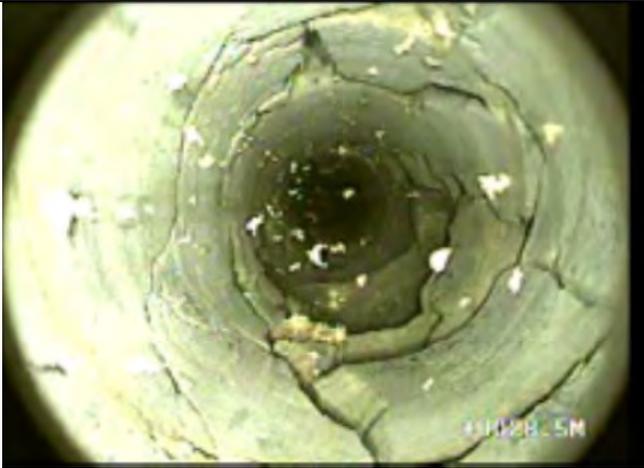
Figure 12 Underwater image of broken rock due to caving (Note suspended particles)

The camera is useful during the investigation phase to assess caving and mine level conditions, such as the orientation and openness of the workings, and pillar integrity as shown in Figure 12 through Figure 16. The camera also allows the true height of open voids to be assessed, as the roof rock may be pushed down as a result of drilling pressure. Borehole cameras are also of use to assess the effectiveness of grouting as illustrated in Figure 17. Millar and Holz, (2011) also have images of mine level grout placement.

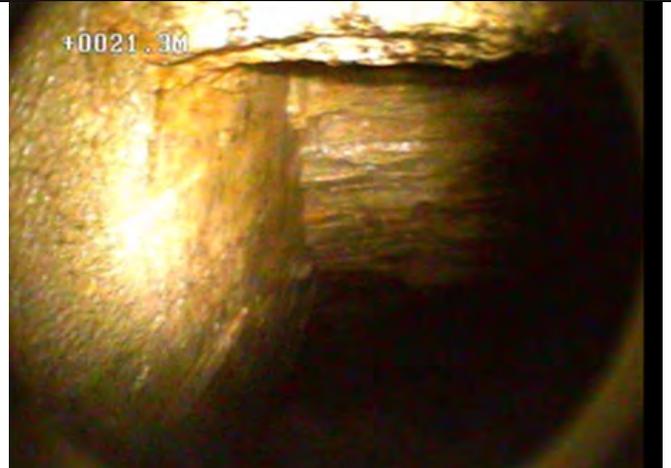
Figure 13 Side view of roof joint intersection in unflooded workings

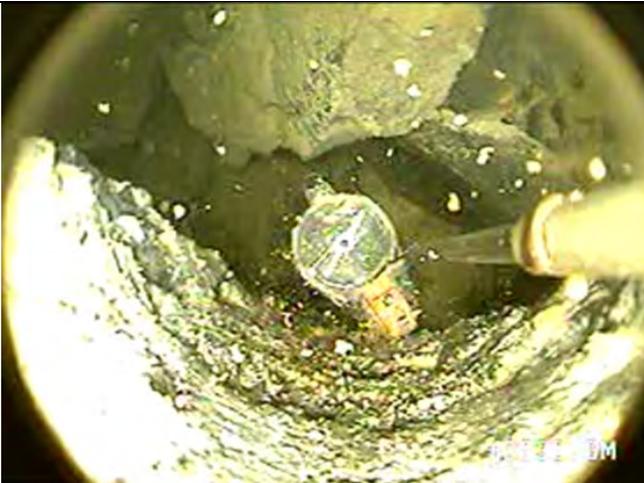
Figure 14 Borehole encountering edge of pillar and room (underwater)

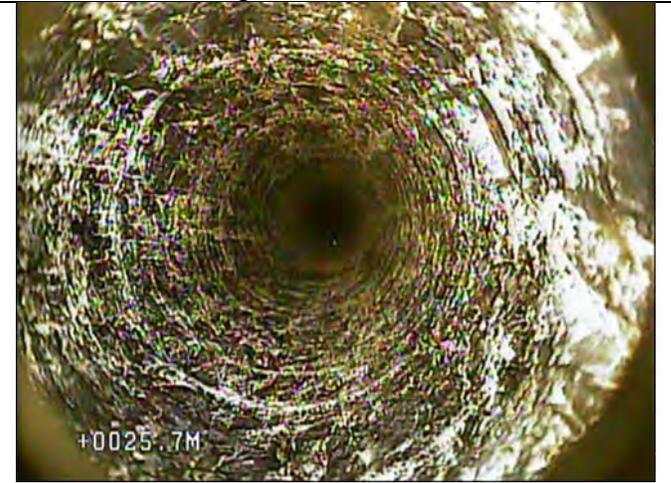
Figure 15 Downward looking underwater view of in place coal in Yard Seam, Newcastle, Aus at 84.3 ft (25.7 m) depth (borehole encountered)

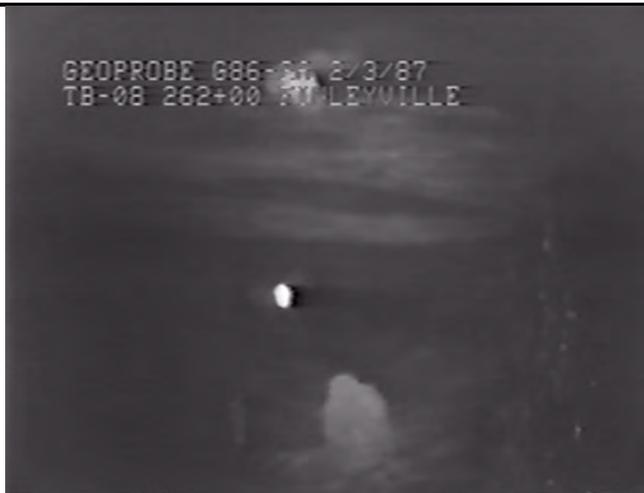
Figure 16 View of light lowered into another borehole about 100 ft (30m) away indicating open haulageway

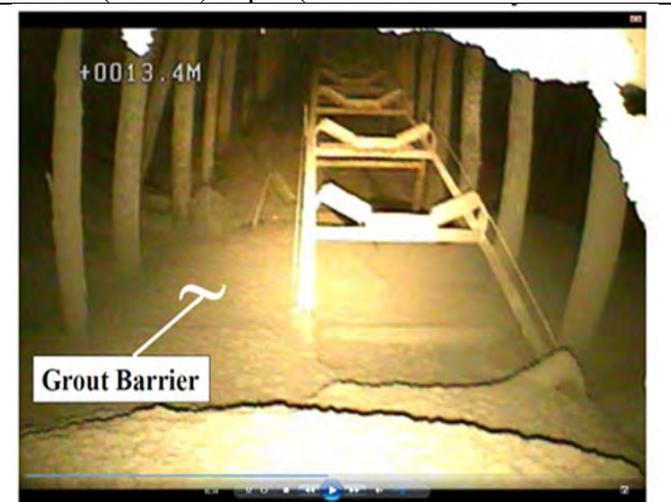
Figure 17 Grout enveloping conveyor in haulageway (Knott et al, 2013)

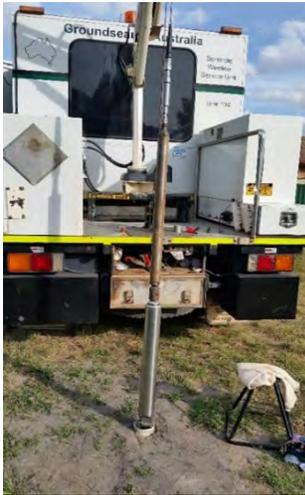
Figure 18 Logging unit setup with laser / video

A Flodim SARK high-definition, color video camera and 3D laser tool was used in a 3-3/8 in (96 mm) diameter borehole drilled into the cavity, with the setup of the tool prior to deployment in the cased borehole as shown in Figure 18 and a diagram of features in Figure 19. A sinker bar is attached to the top of the tool to prevent rotation during horizontal section surveys. The data were acquired using a truck-mounted, Century Geophysical LLC-equipped, slimline logging unit.

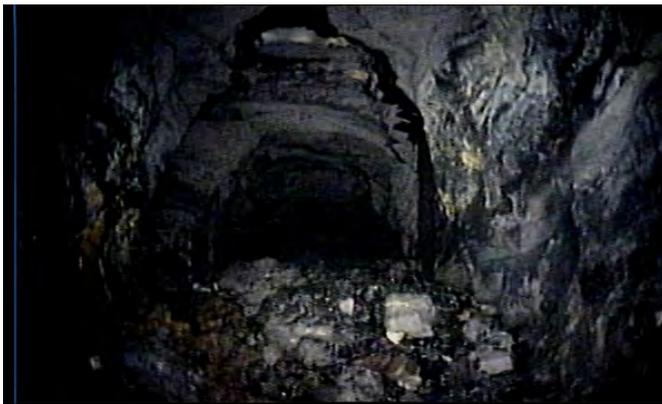
Figure 20 Image from laser / video looking down-gradient from the west.

Video and still images were recorded concurrently with the 3D laser survey which provided valuable information on the physical condition of the slope in real time. Figure 20 indicates physical deterioration with spalling of the slope roof and walls and fallen material on the floor.

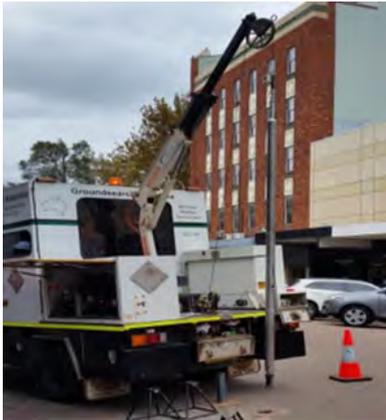
Figure 28 Sonar survey equipment before borehole deployment.

As an example, the device was used in the assessment of a void in abandoned mine workings in the about 20 ft (6 m) thick Borehole Seam, in Newcastle, Australia (Figure 28). The mine workings were completed prior to 1908 and are below sea level and therefore flooded, as mining ended prior to about 1916 (Hawkins and Harvey, 2001). The 3D sonar survey was performed using Flodim SARRL 3D sonar technology since the workings were underwater and it could

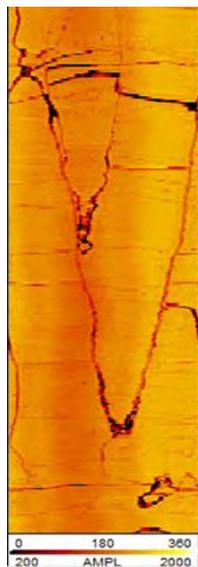
Figure 34 Flattened, 360° ATV image showing fractures in coal measures interburden.

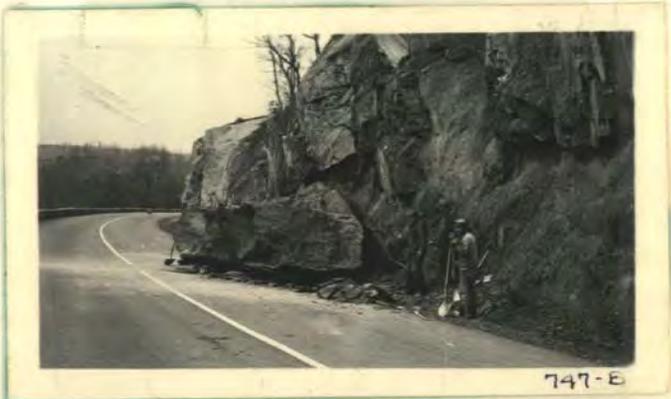
Figure 1 - “Rock slide with maintenance worker” by KCM, unknown date. MP 239.6.

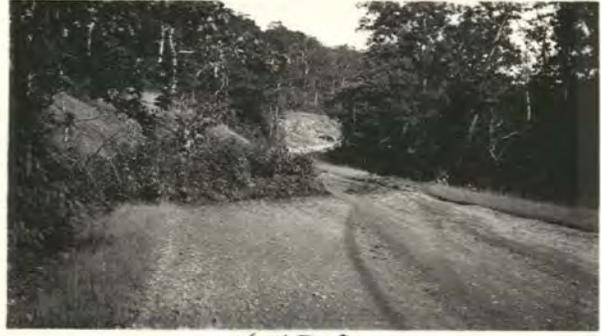
Figure 2 - “Landslide near Milepost 320” taken August 16, 1940 by Liles. MP 320.3.

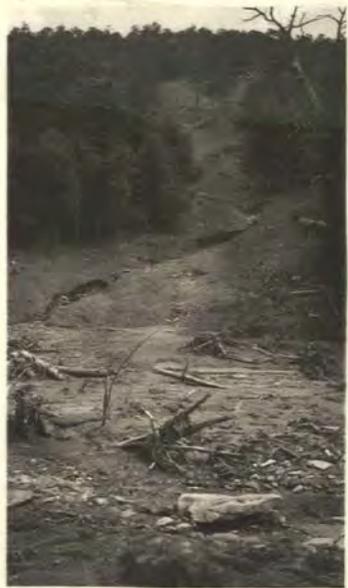
Figure 3 - “Flood damage showing slide above Parkway” by Albert S. Burns. MP 276.4 in Deep Gap, taken August 17, 1940.

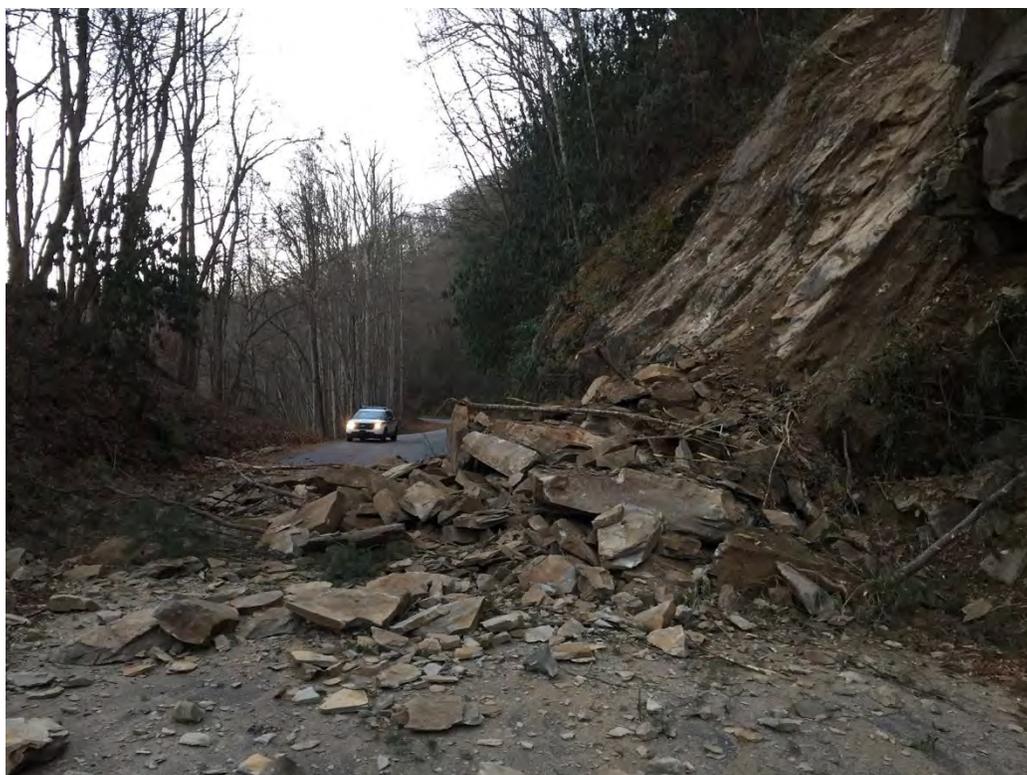
Figure 7 - Rockslide near MP 467 taken November 24, 2015. Photo is from Blue Ridge Parkway Facebook page.

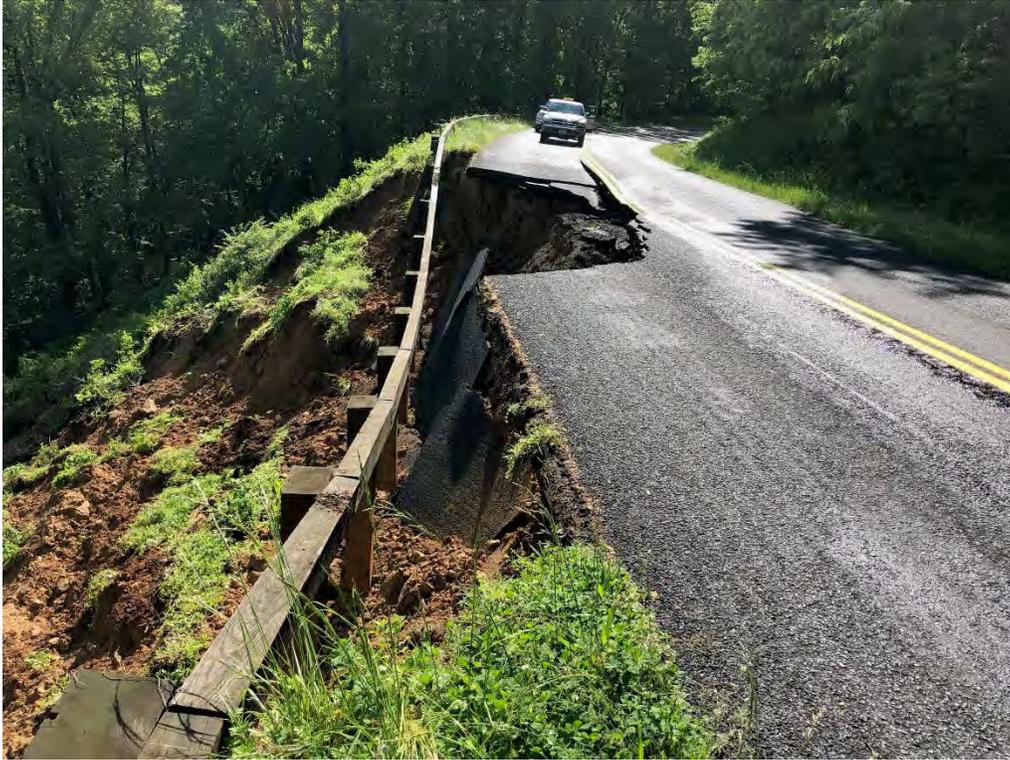
Figure 8 – Embankment failure near MP 128 in May 2020. This section of the Parkway remains closed. NPS Photo.

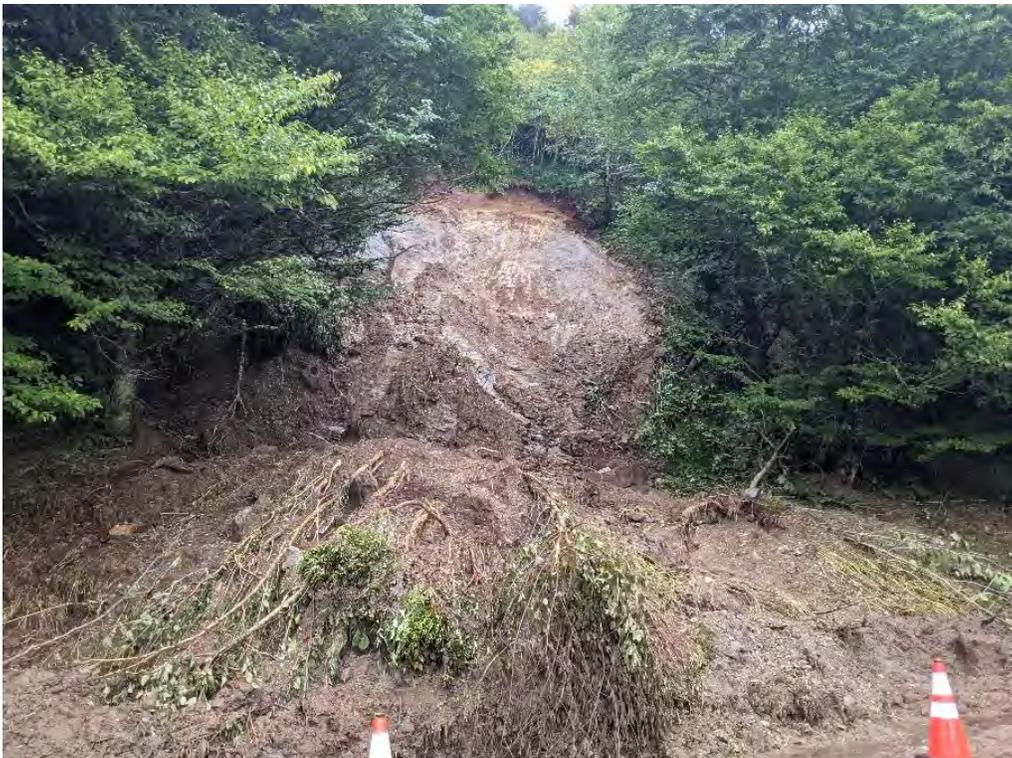
Figure 9 - Debris flow at MP 421, photo August 20, 2021 by Majed Abdelhadi. Several debris flows and slides were triggered by rains from Tropical Storm Fred, August 17, 2021.
