71st HIGHWAY GEOLOGY SYMPOSIUM

2022 Proceedings

**71st ANNUAL
HIGHWAY GEOLOGY SYMPOSIUM
Table of Contents**

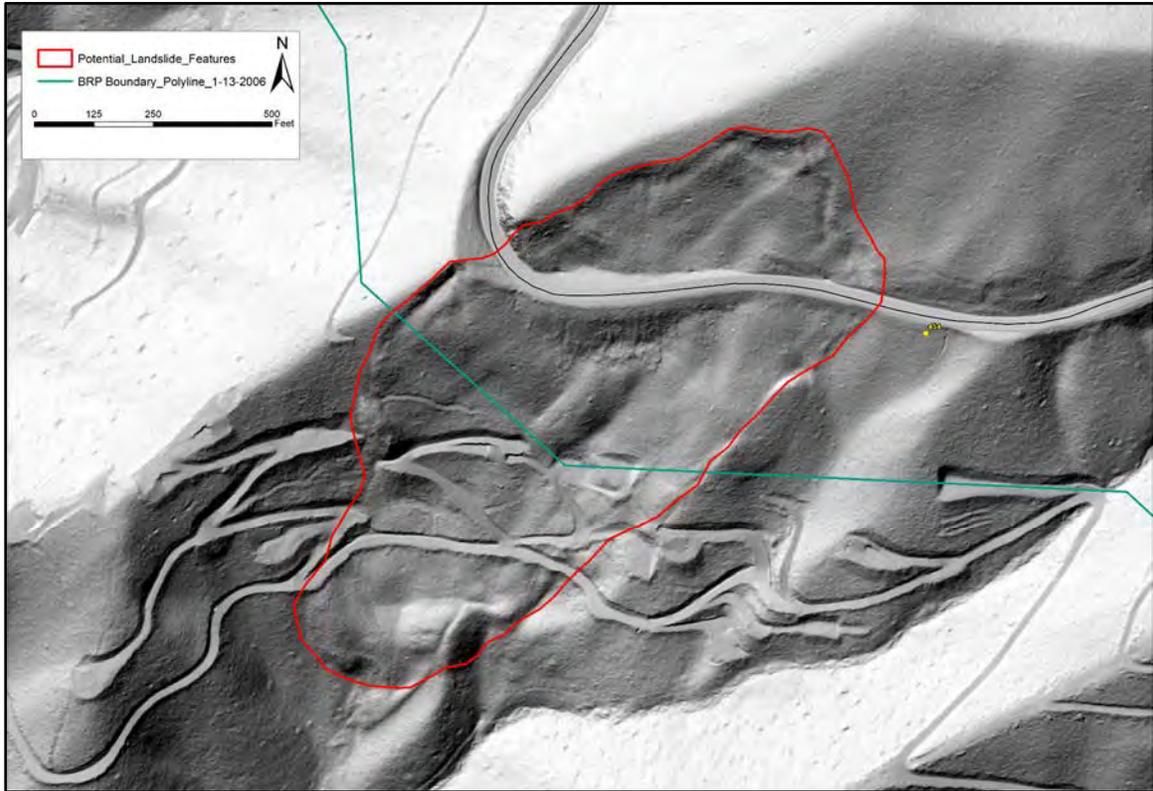
Figure 12 - Map of the “Thunderstruck” landslide near MP 454. Basemap is 2017 QL1 LiDAR hillshade. Red outline defines the extent of the landslide based on LiDAR. Teal line indicates the extent of the Blue Ridge Parkway property.

Prior to fieldwork, ALC reviewed the hillshade figures and identified features that had geomorphic characteristics of landslides. These features were added as polygons to the geodatabase and shared with field teams. As an example, one landslide near MP454 had created two bumps in the road that were repaired multiple times and continued to emerge. When viewed in the hillshade, it was apparent that these two bumps marked the right and left lateral scarps of a large landslide that extends almost to the top of the ridge and down into the neighborhood below the roadway (Figure 12). The LiDAR data helped the project team recognize the extent of the landslide so that it could be communicated effectively in the database and when making decisions about possible mitigation strategies.

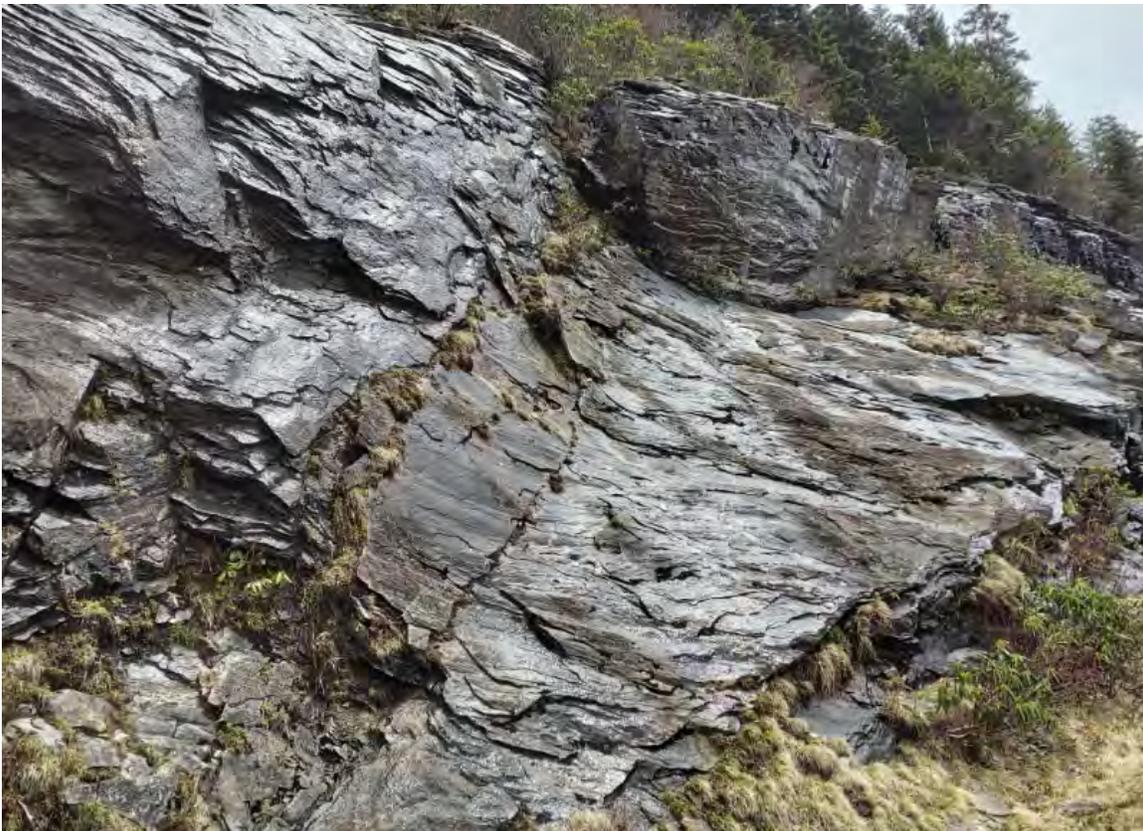
Figure 16 - Photo of Rock Slope at MP 356.4

USMP rating 833. Rock slope with large blocks and limited catchment (Figure 16). Maintenance personnel did not indicate this as an area of concern, which emphasizes that high-risk slopes don’t always catch the attention of maintenance personnel.

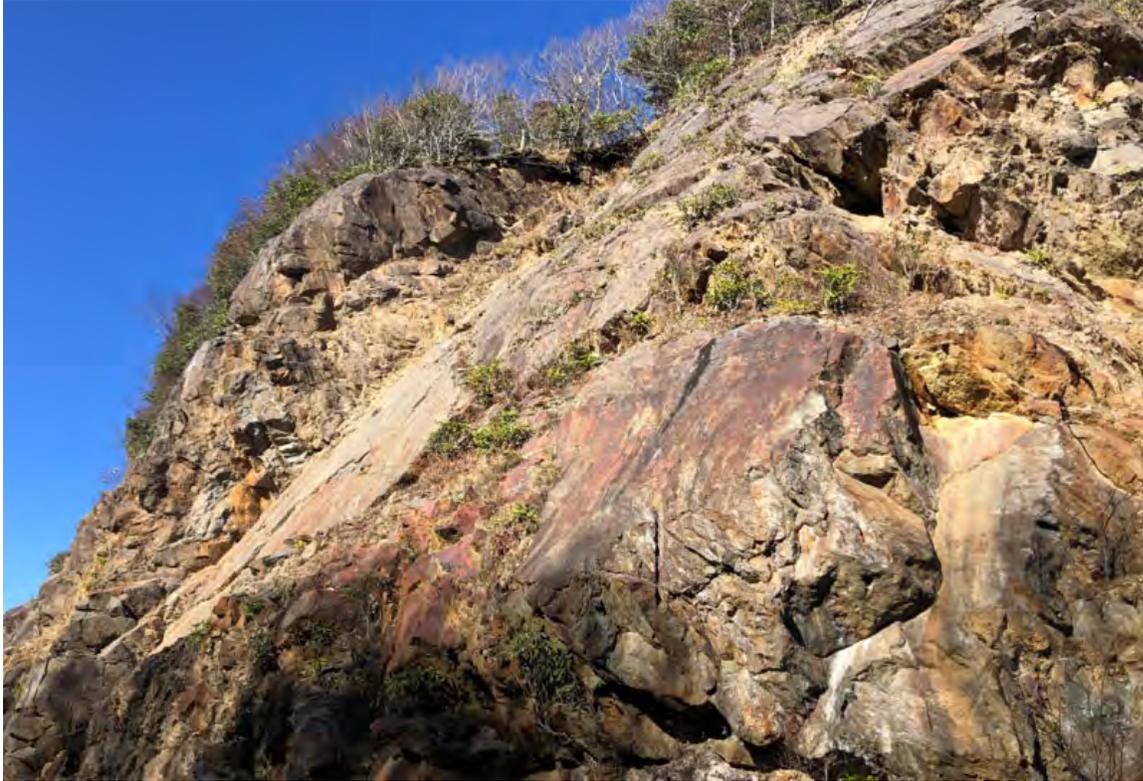
Figure 17 - Photo of Rock Slope at MP 434.2

USMP rating 817. Tall slope with weathered, loose blocks. Slope wraps around the nose of a ridge, which contributes to instability. Maintenance personnel stated this was one of the most active rockfall slopes (Figure 17).

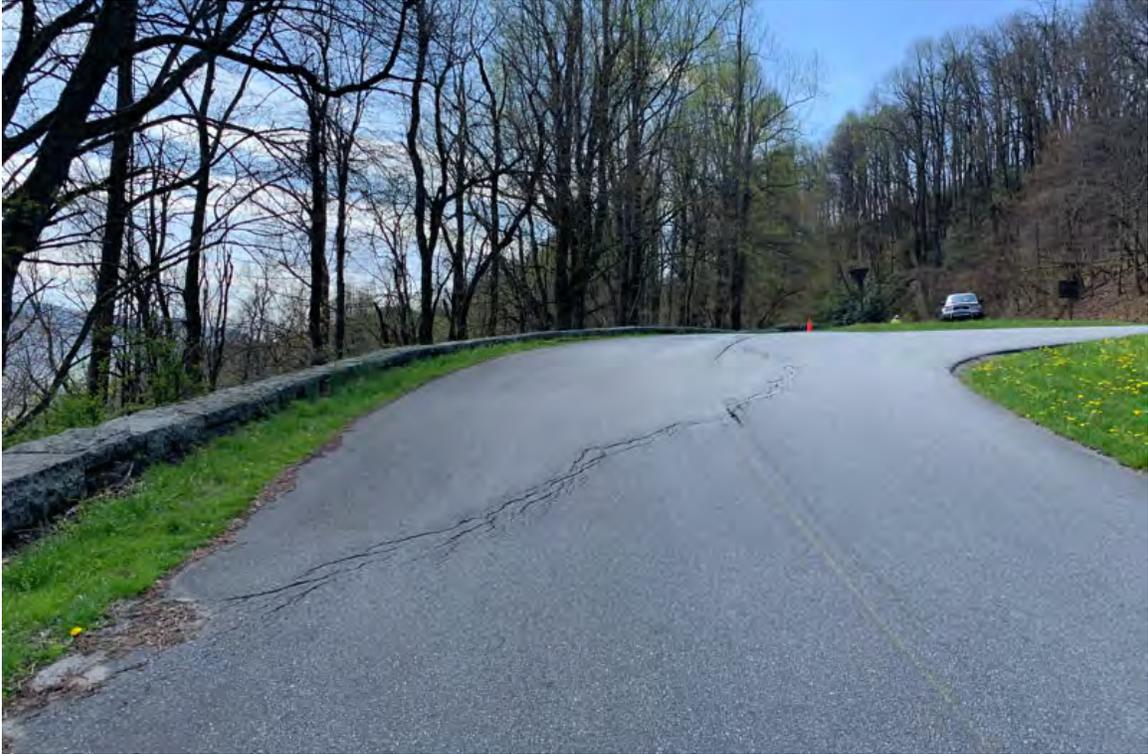
Figure 18 - Photo of Landslide tension cracks in the roadway embankment at MP 344.1

USMP rating 815. Active landslide with cracks in the pavement. The landslide is also affecting a barrier wall (Figures 18 and 19). Maintenance said this was one of the slopes of highest concern due to the offset and damage to the barrier wall.

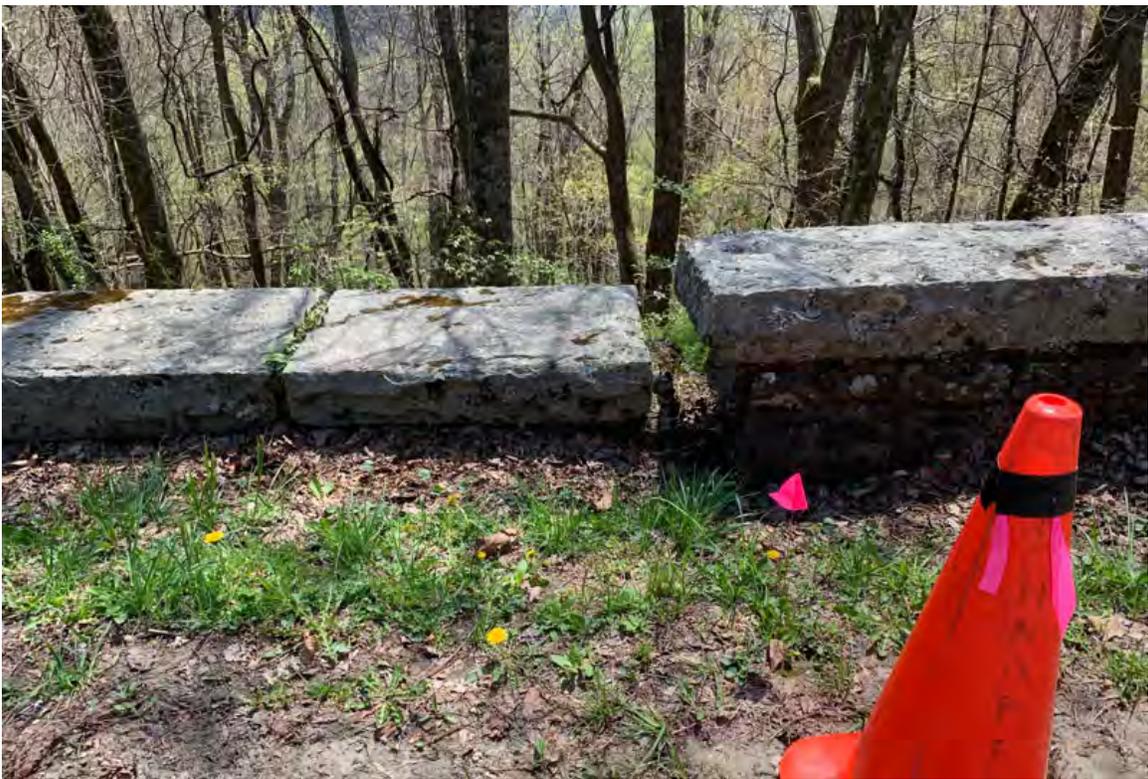
Figure 19 - Photo of offset stone barrier wall at MP 344.1

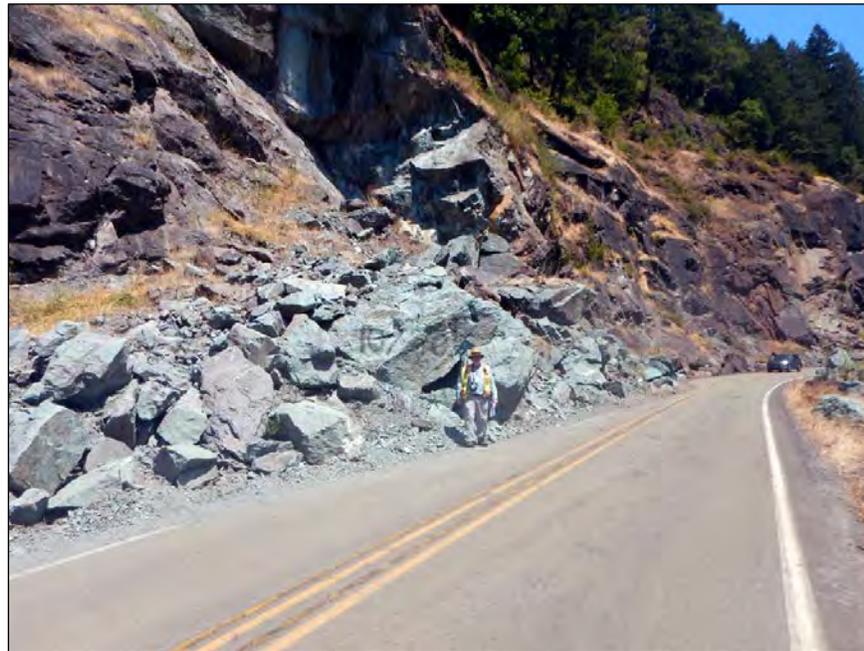
Figure 1: View looking northeast at rockfall debris in roadway from large failure at approximately station 65+61 at section US-01.

This site originally had a rockfall catchment area that ranges from 12 to 14 feet wide. The rock slope was excavated at an inclination of $\frac{1}{2}H:1V$ to $\frac{1}{4}H:1V$; however, it appeared that the western portion of the cut slope failed back to a flatter slope inclination of approximately 53° ($\frac{3}{4}H:1V$). What appeared to be a remnant of the 2012 failure was observed at the east end of Section US-01 (see Figures 1 and 2). The rock block is approximately 15 ft. tall x 20 ft. wide, x 20 ft. thick. Large planar and sliding block failures associated with the December 2012 event appear to have failed on southerly dipping planes that have left large overhanging and unsupported rock blocks along the top of the cut slope crest. The rock consists of medium hard to hard (R3-R4), green-gray, slightly weathered welded tuff with localized zones of volcanic conglomerate. This rock is moderately jointed to massive (joint spacing $1\frac{1}{2}$ to 20 feet). Numerous seeps and springs were observed throughout the US-01 rock slope section, particularly along the eastern portion of the slope section. The near vertical to overhanging upper portion of the slope is composed of large blocks similar in size to the blocks that failed and are not well supported. The potential for planar failures on the slope and a larger-scale failure from the upper zone was considered high (see Figure 3).

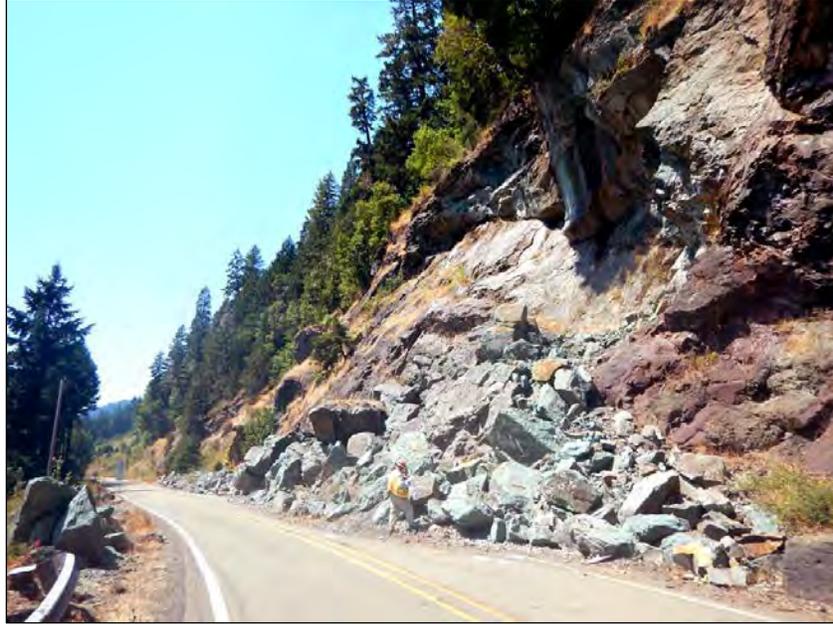
Figure 2: View looking northwest at rockfall debris in roadway from large failure at approximately station 65+61.

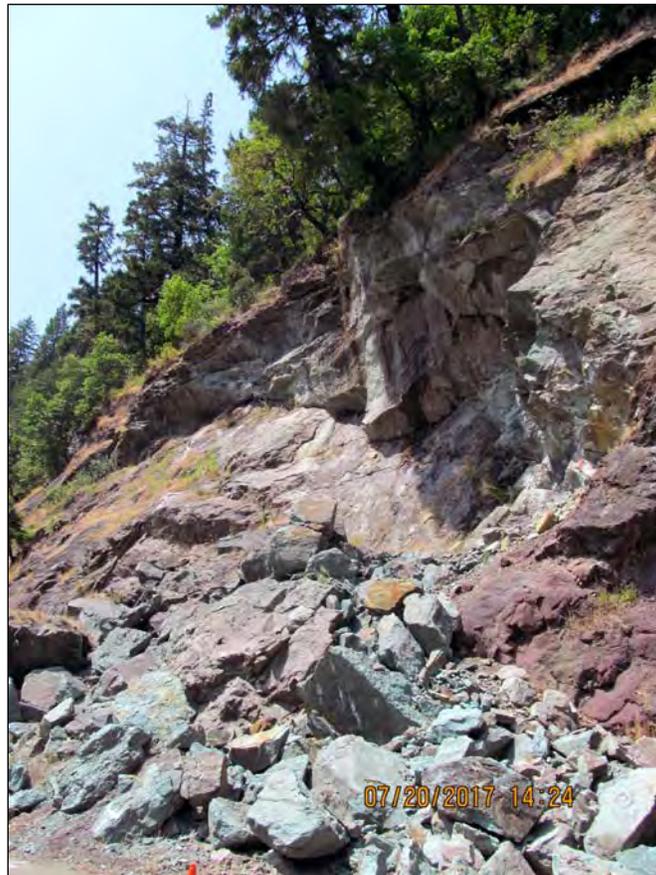
Figure 3: View looking northwest at overhanging rock slope on eastern end of section US-01.

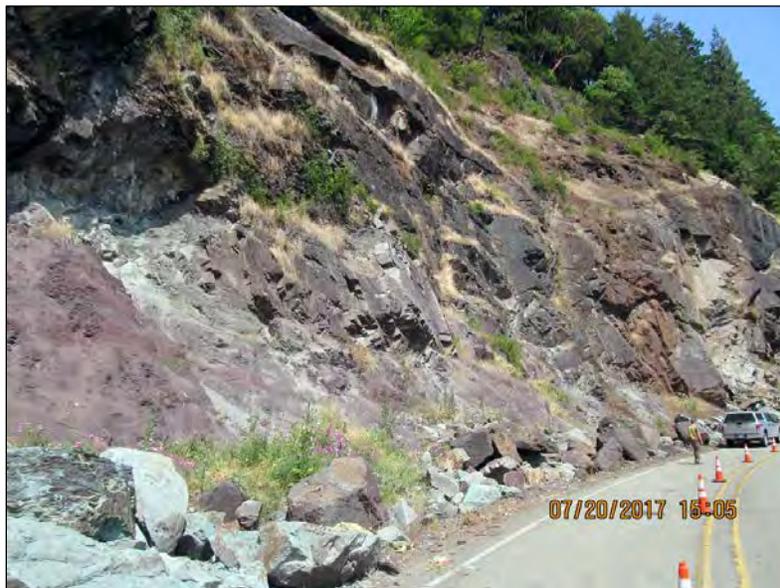
Figure 5: View looking northeast at rock cut slope along section US-02.

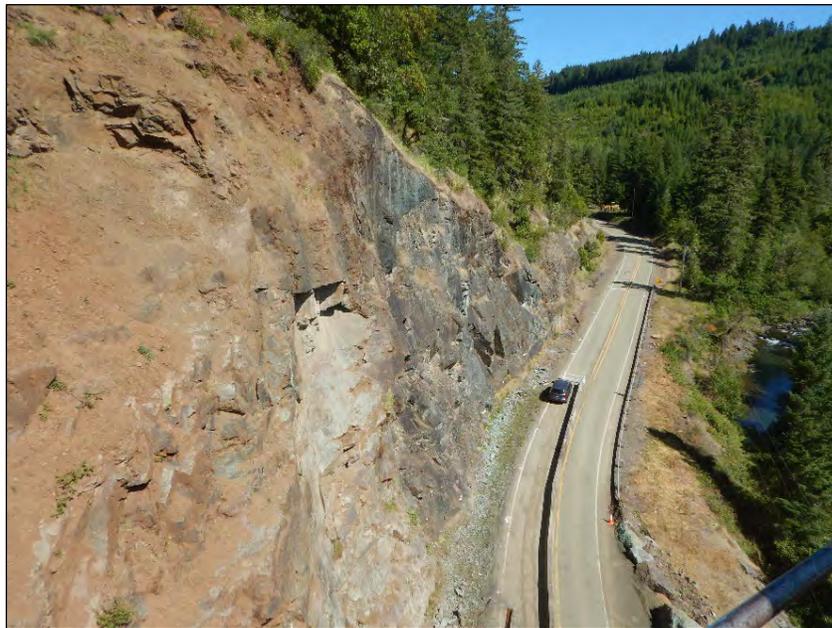
Figure 6: View looking east at rock cut slope along section US-03.

Section US-03 is approximately 236 feet long and 150 feet tall (see Figure 6). This slope section received an USMP Rating of 1,082. According to Douglas County, the site requires a relatively high maintenance effort due to its history of large failure events. In June of 2017, this section of roadway was blocked by a large wedge failure at approximately Station 67+80 that reportedly deposited over 250-300 cubic yards of material in the westbound travel-lane. Portions of the rock outcrop above this section of the roadway also failed on November 24, 2017. This event generated approximately 10 to 15 cubic yards of rockfall debris, up to 3½-foot in size, that landed in the roadway. Representatives from FHWA and Douglas County observed the slope above the cut after the failure and identified a shallow slump feature just west of the upper rock outcrop that was also contributing to rockfalls. This landslide feature was measured to be roughly 45 feet wide by 50 feet long in slope distance. The western portion of the shallow landslide is in Section US-02.

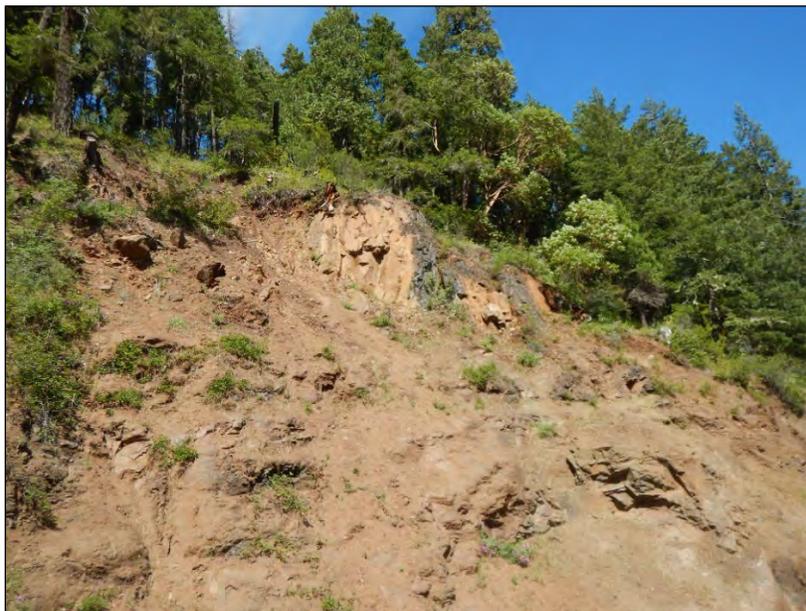
Figure 7: View looking northeast at rock outcrop above the cut slope in June 2018 after a failure event and subsequent scaling in the fall of 2017.

In February 2018, LT performed a site reconnaissance of the slope above the crest of Sections US-02 and US-03 using rope access techniques. At that time, the County had performed interim rockfall risk reduction measures discussed above. The outcrop had been heavily modified by scaling efforts since our site reconnaissance in July 2017 (see Figure 7). The top and bottom of the outcrop are located at approximate elevations 1,387 feet and 1,350 feet, respectively. It appeared that the main source of the continued rockfalls at the site was the shallow landslide feature to the west of the outcrop. The landslide feature appeared to be a slump failure in a mixture of residual soil and colluvium. Large rock blocks, up to 3½-foot in size were observed in the slide debris. The slump measured approximately 70 feet across (west to east) in February 2018. The top of the headscarp was measured at approximately elevation 1,410 feet. The depth of the slump was estimated to be 10 to 20 feet. The base (or toe) appeared to be located at, or below, the elevation of the base of the adjacent rock outcrop to the east (approximate elevation 1,350 feet). Based on field measurements, the failure had increased in size since observed by WFLHD, retrogressing upslope and expanding to the west. With this retrogression, existing trees would continue to be undermined and represent a hazard to the roadway. Approximately 50 cubic yards of rockfall debris was observed behind the 12-foot tall MRB that was installed by the County to help reduce the risk associated with falling debris from the upper active slope that produced the rockfall in November of 2017.

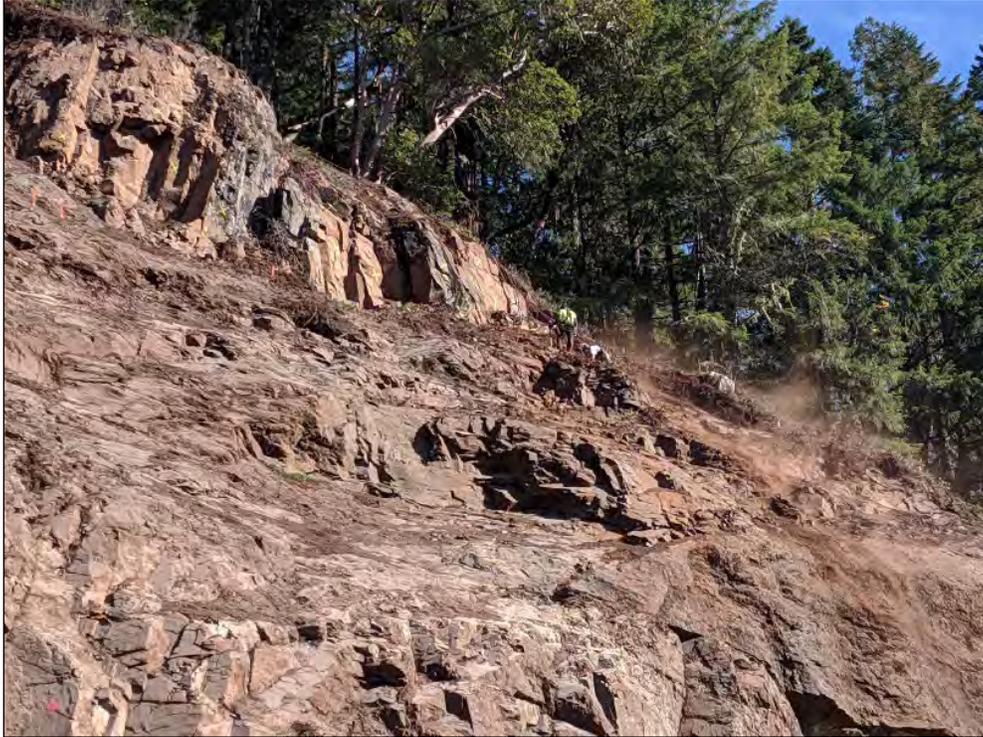
Figure 8: View of scaling on slope above US-02 and US-03.

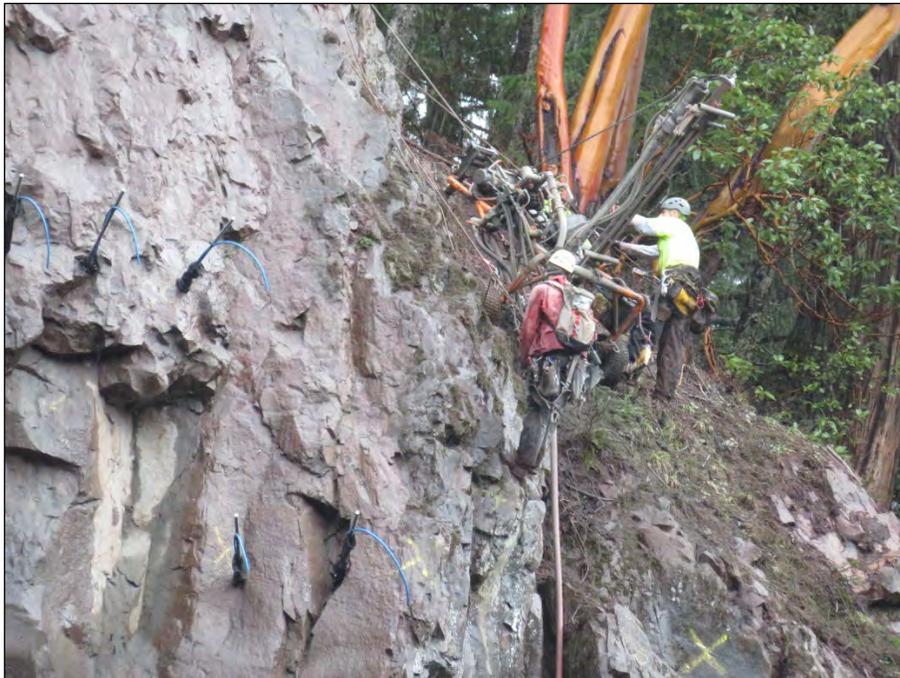
Figure 10: Rock bolts being drilled with a wagon drill.

reinforcement load can be distributed over a larger area of the rock mass. Rock dowels consisting of Grade 75, No. 8 all-thread bar, generally 15-feet long were used. Rock bolts consisting of both Grade 75, No. 8 and No. 14 all-thread bar were used to obtain design loads of 40 and 80 kips. Based on rock block dimensions, rock bolt lengths ranged from 20 to over 35. As previously discussed, in order to enhance drainage and reduce the effects of porewater/groundwater pressures on stability, a significant number of unlined drain holes were installed in the rock slope. The drain holes were unlined 3-inch diameter holes drilled at an upward inclination of 3° to 5° above horizontal to a length of 30 feet. The drains were drilled in a pattern, nominally spaced on 40-foot centers. However, a tighter pattern (30-foot center to center) was used between stations 64+60 and 66+05 of Section US-01 due to the size of the potential rock blocks needing additional reinforcement using rock bolts. The rock dowels, bolts, and unlined drains were installed using a combination of techniques including drilling by hand and both crane-support and buggy drills.

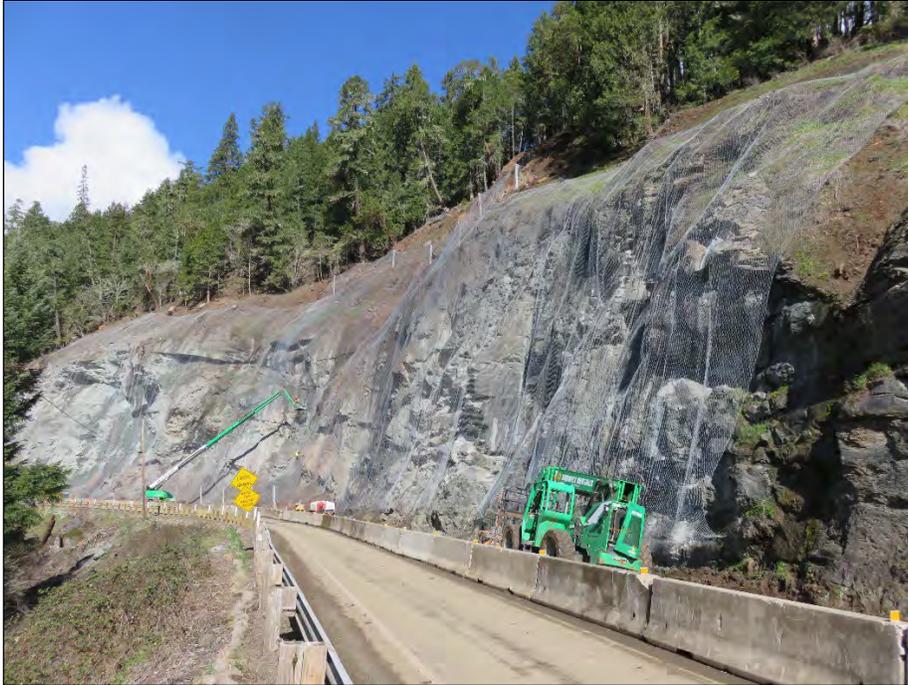
Figure 11: View looking northwest at upper attenuator fence and draped mesh installed.

The rockfall attenuator fence installed at US-03 between Stations 66+83 and 68+29 was based on a new FHWA design consisting of six, 12-foot-tall posts with a suspended cable net. These systems typically have higher energy absorption capacity than draped mesh but lower than flexible barriers. Attenuators intercept rockfalls similar to flexible barriers and control the rock's movement similar to draped mesh. Attenuators are typically located on the slope, particularly at launch features, and limit the amount of draped mesh required.

Both double-twist and high tensile-strength draped mesh was used for this project. Given the potential for large volume failures, 3mm high tensile-strength mesh was used for rock slope design Section US-02. Draped wire mesh is an effective and economical method of controlling rockfall trajectory and energy. The mesh retards the rate of descent of falling rocks as they work their way down slope behind the mesh. As a result, when the rocks exit the bottom

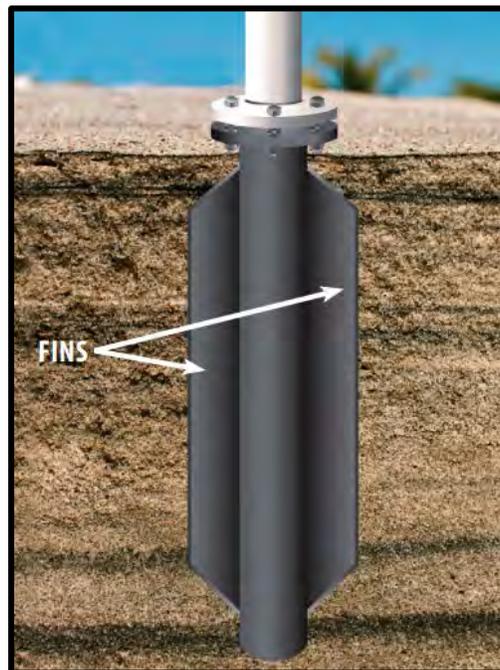
Figure 1. Example of Steel Fin Pile Foundation Design (Schumaker, 2012)

Steel fin piles utilize fins on the side of the piles, as shown in Figure 1 and Figure 2, to increase the circumference in order to develop additional frictional resistance between the soil and pile. The fins also increase the flexural stiffness of the pile, therefore increasing the flexural and torsional capacities. These steel fin pile foundations are installed into the ground in minutes using a vibratory hammer and are immediately weight-bearing. As a result, they are an attractive option when compared to alternatives such as drilled shafts, which need time to cure prior to application of loads. Steel fin piles are relatively new to the industry, therefore the case history and performance data versus conventional alternatives is lacking in the literature which focuses on laboratory models (Dührkop and Grabe, 2008; Bienen et al., 2012; Azzam, 2017) or numerical analyses (Babu and Viswanadham, 2018; Pei et al., 2020). This paper summarizes scenarios where steel fin piles may be applicable in highway transportation infrastructure. Benefits of steel fin piles and comparisons with conventional alternatives is discussed. Additionally, data from proof-of-concept load tests for a typical 35-foot light pole structure in Pennsylvania will be presented.

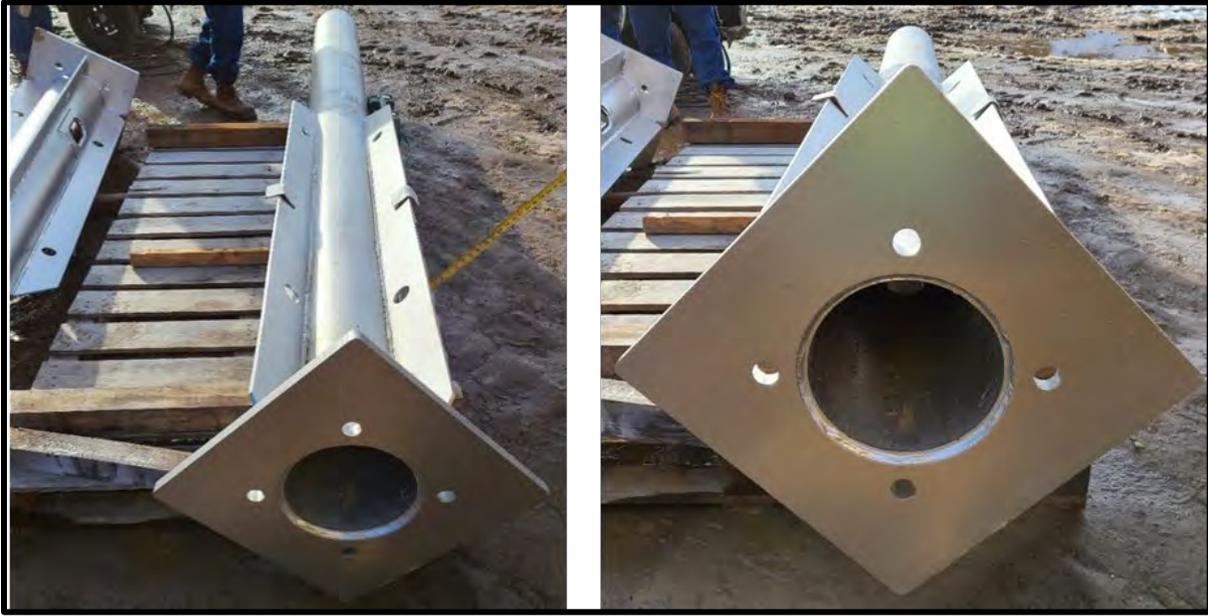
Figure 2. Photographs of Steel Fin Piles prior to Installation

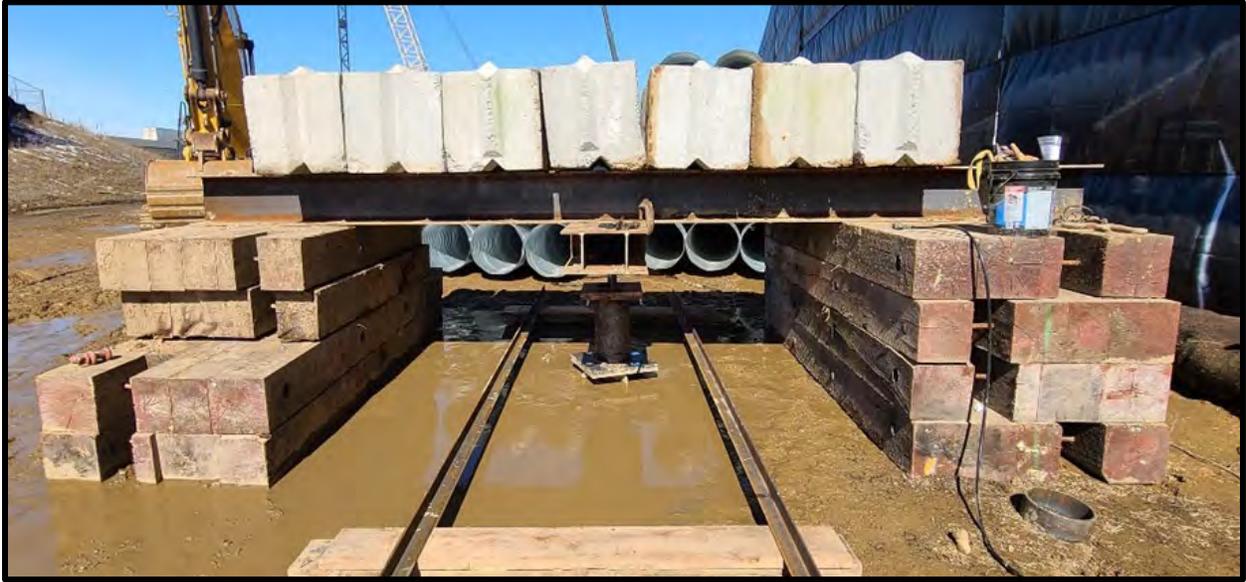
Figure 5: Axial Load Test Setup for Fin Pile

Axial and lateral load tests were conducted on two MCS steel fin piles (P1 and P2) with a length of 12 feet and 3 inches to evaluate their performance as a typical 35-foot light pole structure foundation. The pipe portion of the pile is 10.75 inches in diameter with a 0.5 inch wall thickness. The pile fins are 5 inches wide, 0.375 inches thick, and 6 feet long with a spacing of 90° between each fin for a total of 4 fins on the pile. The piles are covered with a top plate to attach structural elements to the pile such as the driving equipment or the light structure. The steel used for the top plate of the piles and the fins have a yield strength of 36 ksi, per ASTM A36. The fins are welded to the pipe portion of the pile with a yield strength of 42 ksi, per ASTM A500. These piles are approved for use by PennDOT Publication 72M.

The test program consisted of installing two piles and performing axial and lateral load tests on each pile. Installation was carried out using a Dawson EMV 450 vibratory hammer. It took approximately 15 minutes to install each pile, highlighting the benefit of fast installation time for these piles. The testing was performed in early March 2021. Figure 5 shows a photograph of the axial load test setup, and Figure 6 shows a photograph of the lateral load test setup. The governing design criteria for the piles is their lateral capacity in this scenario; therefore, axial capacity does not govern pile design. Axial load testing followed ASTM D1143 Method A: Quick Test, and the load was applied in 0.5-kip increments (ASTM, 2013a). These increments were held for 5 minutes before moving onto the next increment. The lateral load testing followed the loading schedule Method A from ASTM D3966 (ASTM 2013b).

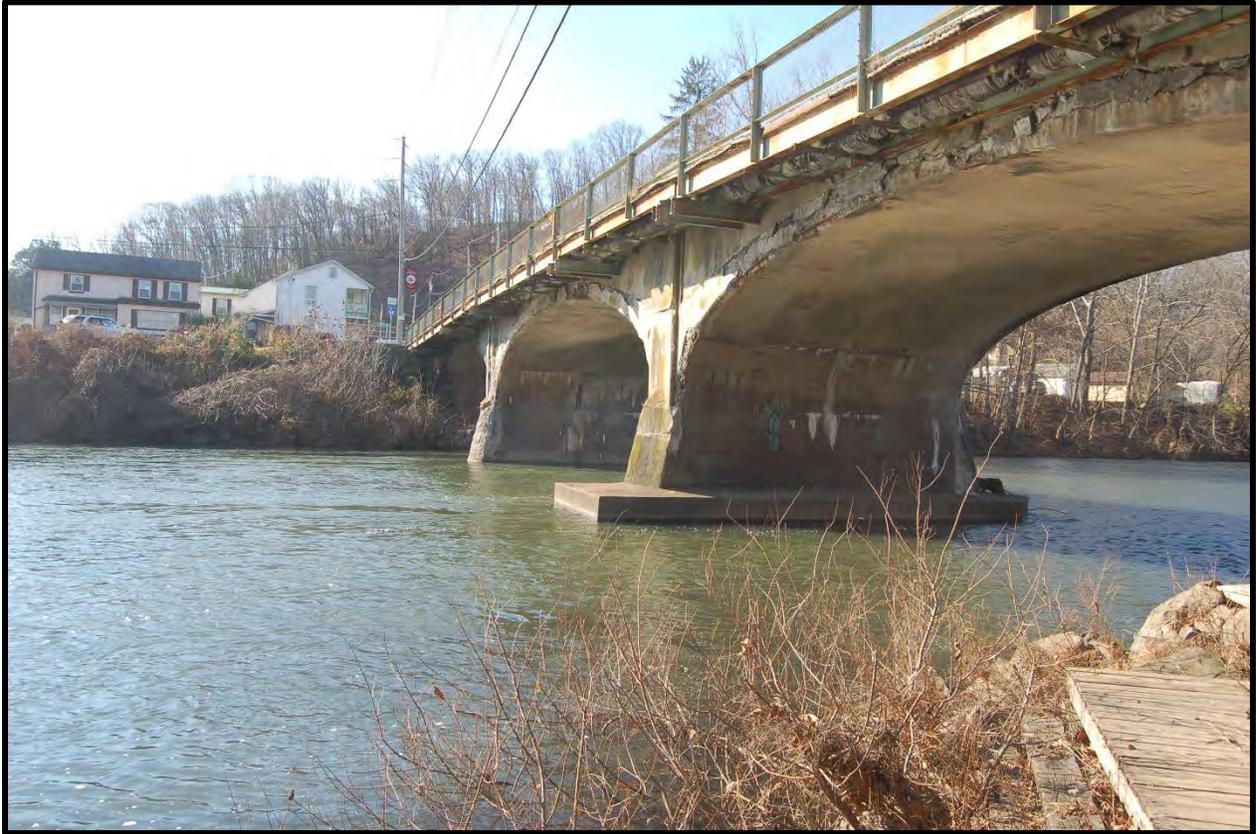
Figure 2: Existing Structure

This Bridge is owned by the Pennsylvania Department of Transportation (PennDOT) in Engineering District 5 which is on the eastern side of the state between Philadelphia and Scranton. The project design team was led by Michael Baker, International with the subsurface investigation and foundation design performed by the geotechnical subconsultant, Geo-Explorers, Incorporated. The Department used an open-end agreement with AECOM and consultation with the District Geotechnical Engineer from adjacent PennDOT District 6 to review the Foundation Submission and design. The existing bridge was constructed in 1915 as a three-span reinforced concrete closed spandrel arch bridge with a total length of 213' and a total width of 24' (Figure 2) and a sidewalk was cantilevered on the south side of the bridge in 1950. The existing plans of the original structure are unavailable but the structure plans for the addition of the sidewalk in 1950 indicates all substructures are spread footings. There was no known subsurface exploration.

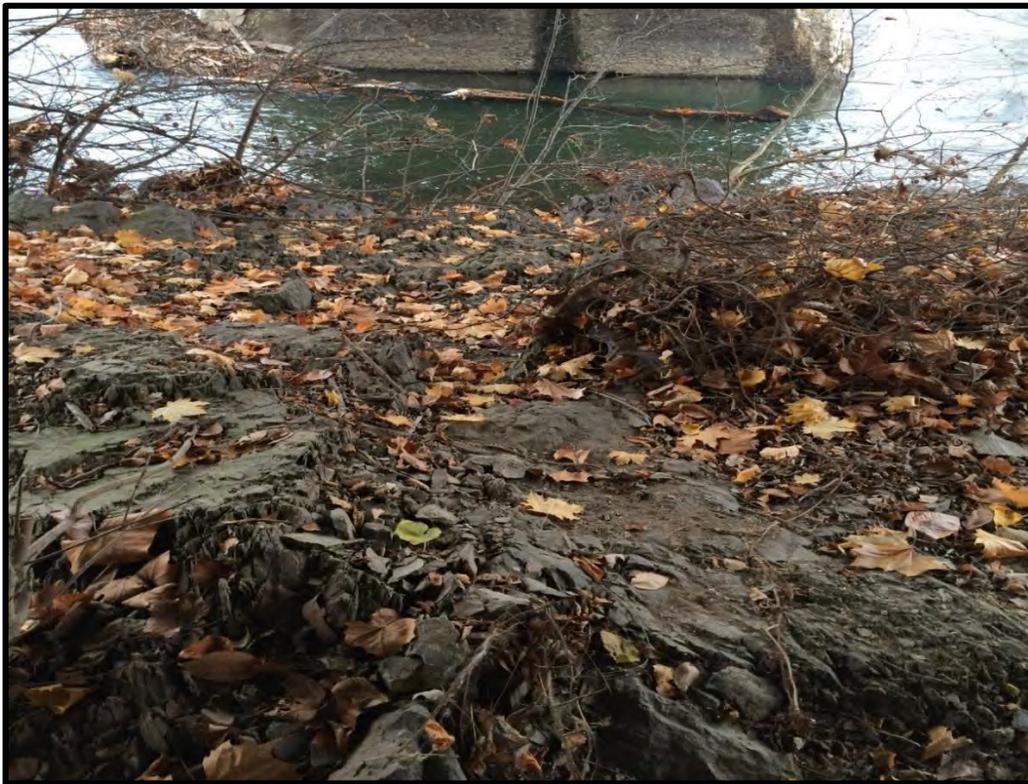
Figure 5: Existing Outcrop in Front of Abutment 1

With the geologic concerns at the project site and unknowns related to the existing bridge, an extensive site investigation was made. The visual site inspection verified the abutments, wings and piers had large horizontal and vertical cracks, spalling, and exposed rebar however, no horizontal or vertical movement was observed as well as no geotechnical related instability. There was no evidence of surface or subsurface drainage problems. Concrete pours around the existing Pier 2 appeared to be scour/structure related. A large outcrop of dolomite bedrock was found completely around and presumed to be beneath the entire Abutment 1 (Figures 5 & 6). No evidence of closed depressions, ground subsidence or sinkholes were observed at the project location.

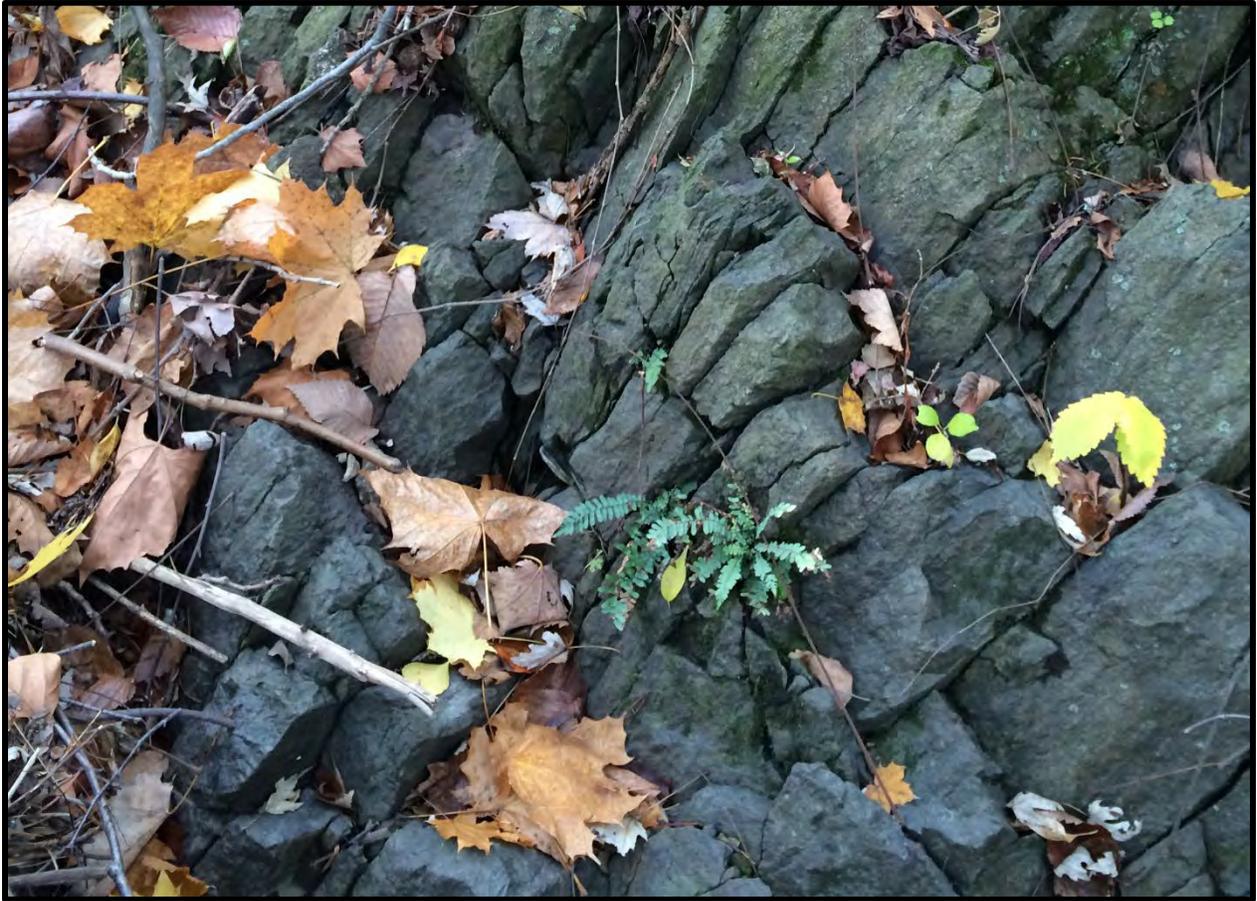
Figure 6: Vertical Bedding Evident in the Outcrop

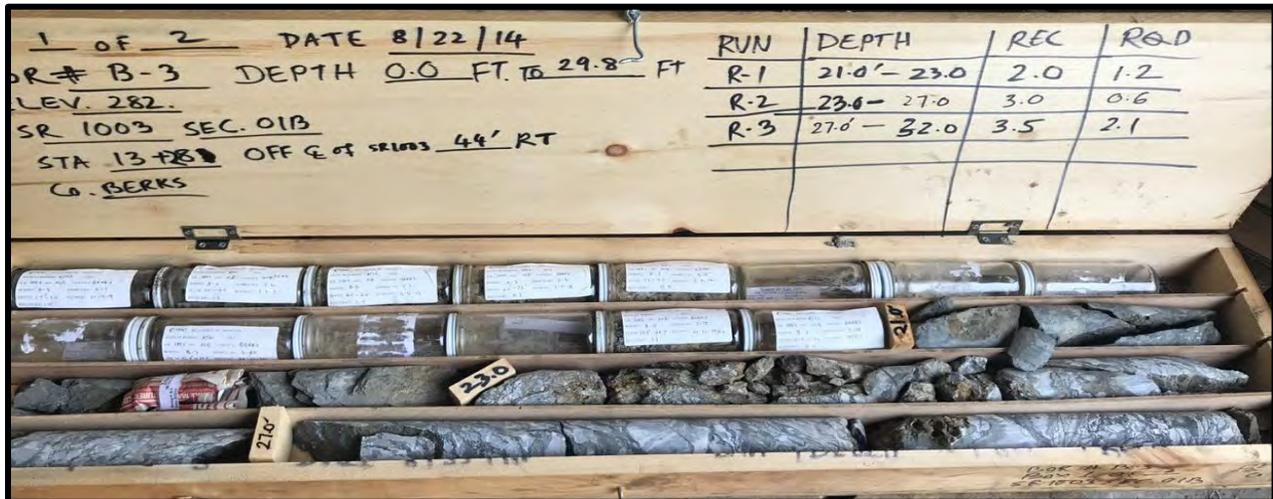
Figure 8: Corebox Photograph

The test borings revealed shallow dolomite bedrock at all the substructure locations at the preliminary proposed bottom of footing elevations. In general, the rock showed less recovery in the epikarst (approximately 10 to 20 feet below top of rock for the abutments and piers respectively) than in the deeper bedrock. The core box (Figure 8) shows a typical rock section. This typical profile does point out some concerning features including low recovery, numerous soil seams and possible voids. Notably, extreme karst features such as top of rock variability, large voids (noted by drill rod drops) and loss of drill water were not observed. The top of bedrock elevation in the structure borings ranges from 257.2 to 272.0 feet in elevation and the existing streambed elevation ranges from 260.0 to 273.0.

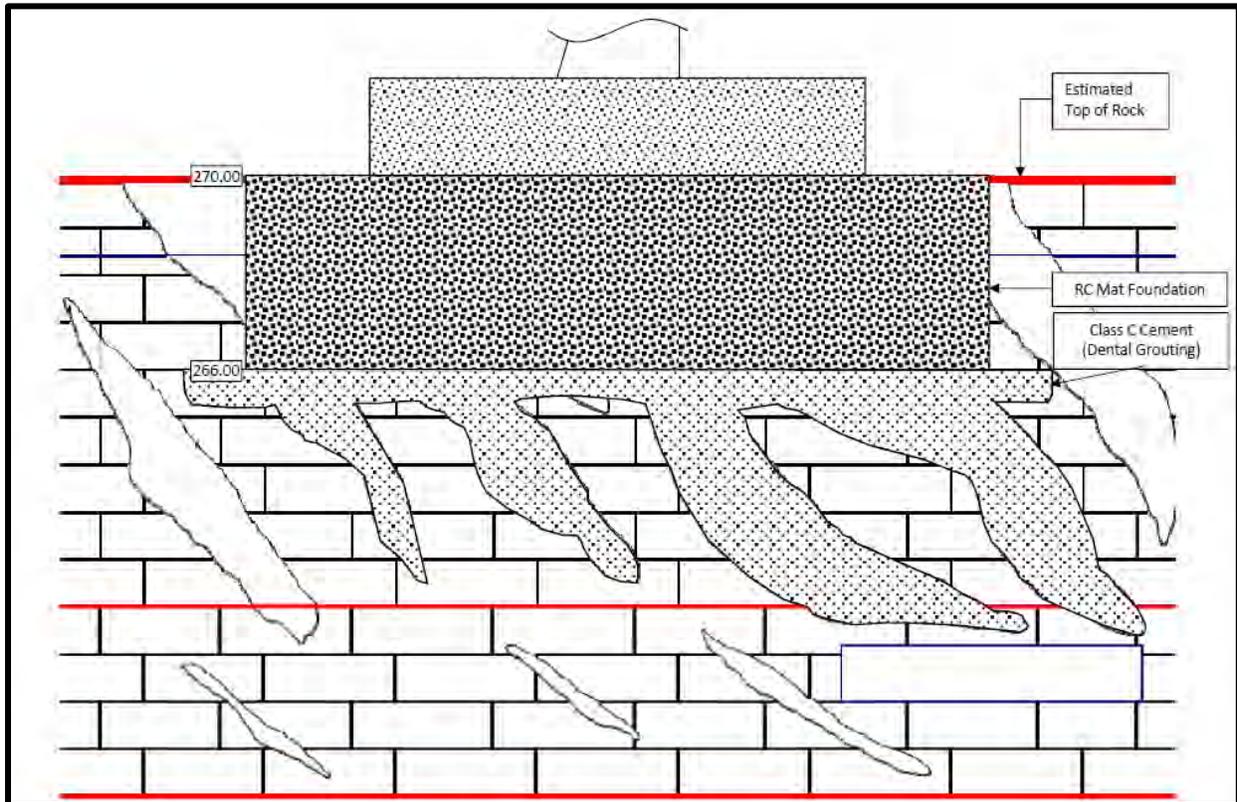
Figure 10: Conceptual Drawing of Subsurface Conditions

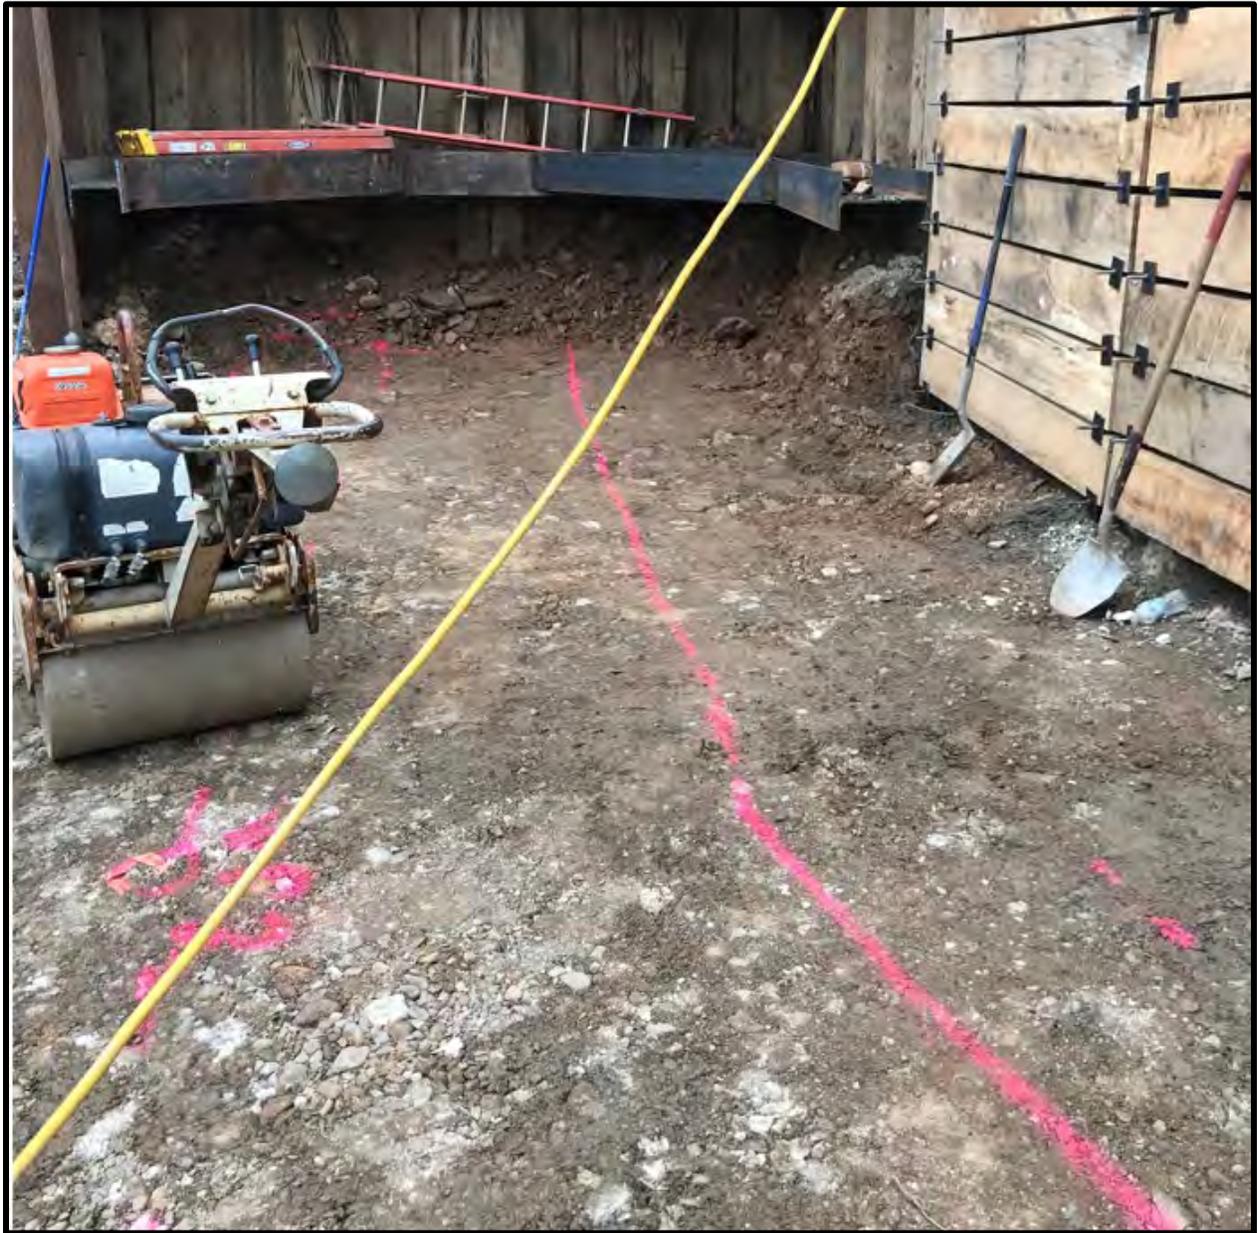
Figure 12: Abutment 1 Subgrade

A portion of the Abutment 1 excavation subgrade was inspected at the bottom of footing of elevation of 270.0'. The contractor was asked to excavate a test hole at the other end of the excavation and the bucket was only able to dig a few inches before a rock layer that seemed difficult to remove was encountered. The compacted areas appeared competent (Figure 12) and the remaining portion of the excavation had the same rock layer as described on the test hole. A soil layer approximately 3 inches thick was in the remainder of the excavation and the contractor was directed to remove any soil and place the foundation directly on the rock leaving a thickened footing. Based on the observed subgrade it was determined the mat foundation could be eliminated and the spread footing foundation could be placed on the prepared subgrade without the mat foundation and the footing was noted to be embedded at least two feet into rock.
