71st HIGHWAY GEOLOGY SYMPOSIUM

2022 Proceedings

**71st ANNUAL
HIGHWAY GEOLOGY SYMPOSIUM
Table of Contents**

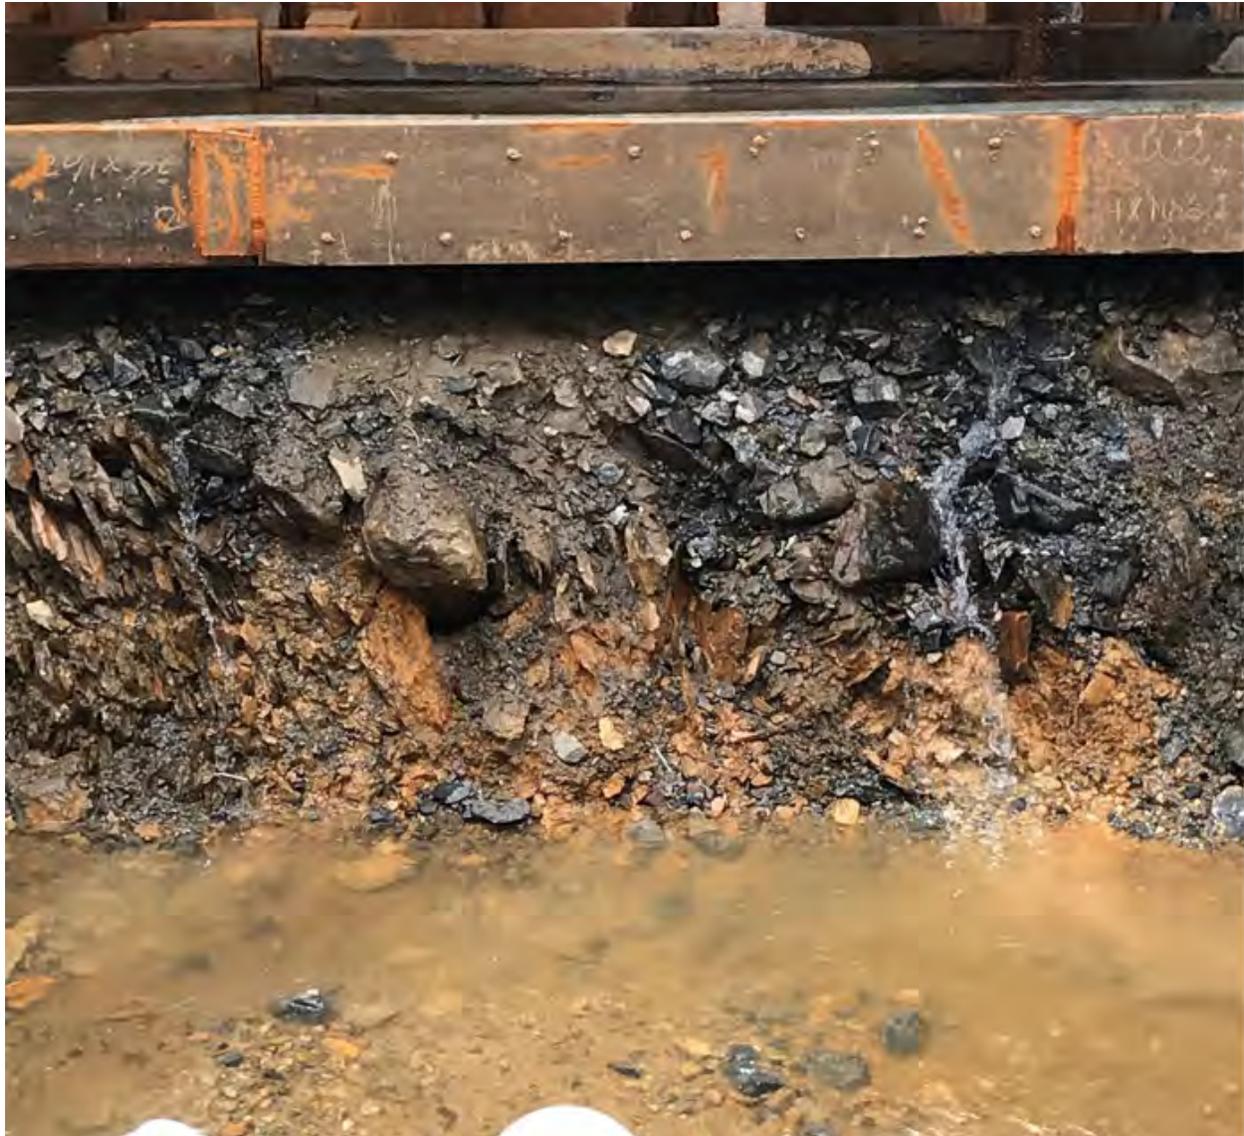
Figure 13: Pier Excavation

District 5 staff and a design reviewer inspected the subgrade at the bottom of footing elevation of 258.0 ft. There appeared to be more soil material (clay and silt) and weathered rock in this excavation but top of weathered rock was visible a minimum of one foot above the bottom of footing. A few small pools of water existed and appeared to be percolating from the river. Because the bearing rock did not appear to have the quality of the rock subgrade it was recommended to require the load distribution mat foundation installed per the plans. Excavated between the bottom of footing elevation and bottom of mat elevation was a mix of boulders, cobbles and weathered

rock with silt-clay soil. No signs of depressions or sinkholes were observed. Notable in Figure 13 is the near vertical bedding of the bedrock which likely contributed to the low recovery during drilling.

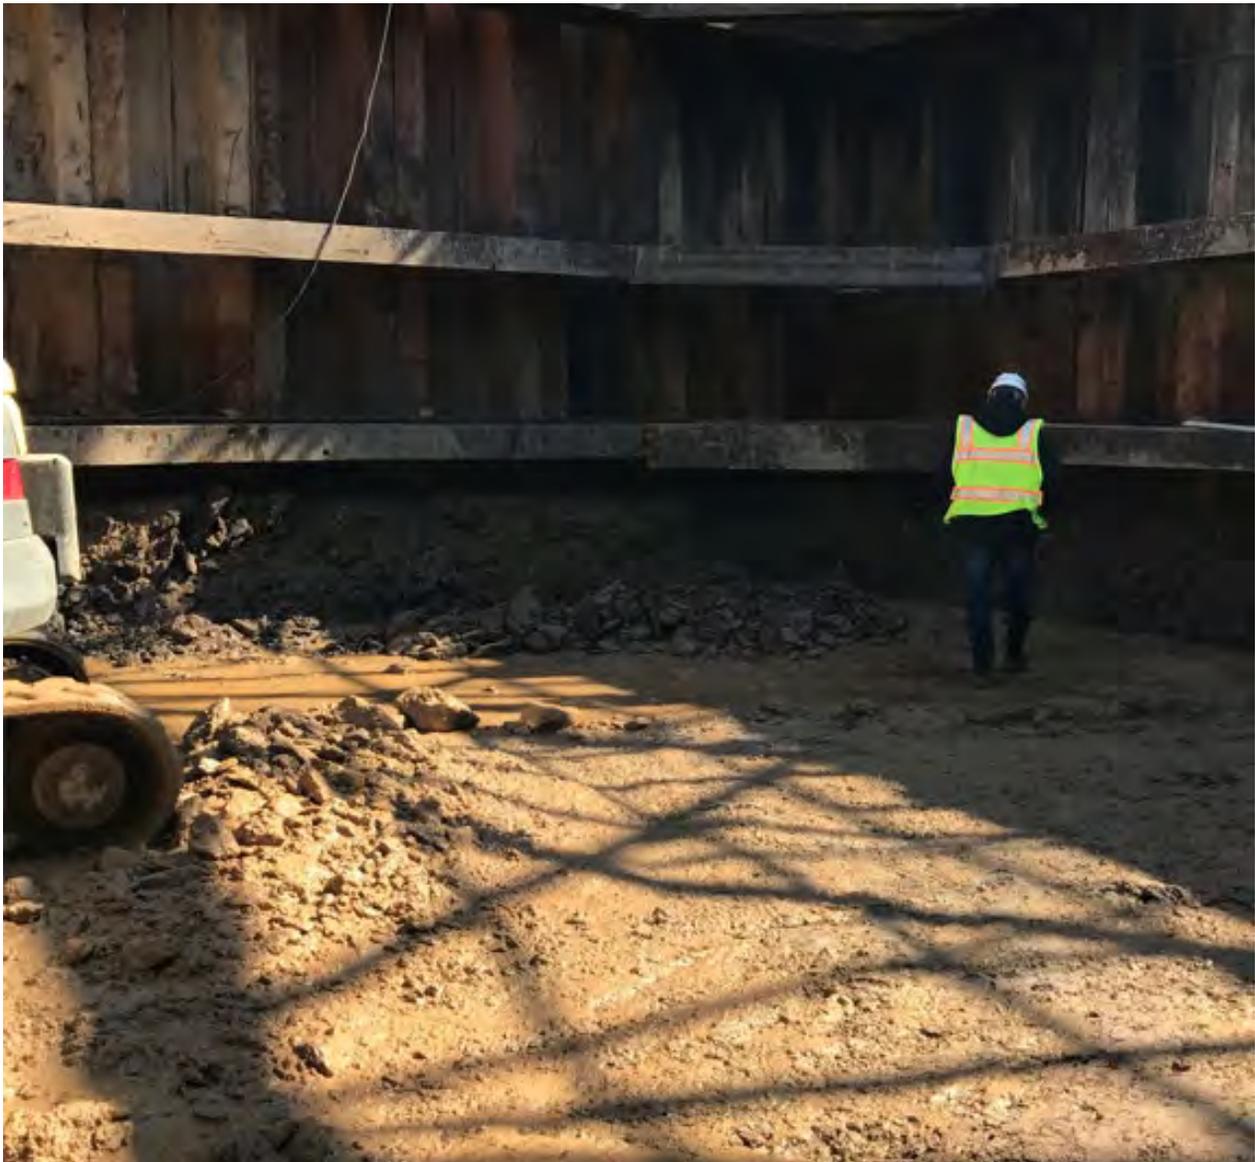
Figure 14: Abutment 2 Excavation

The inspection of the Abutment 2 excavation did not indicate any voids or sinkholes in the footprint of the Abutment 2 foundation area. The subgrade consisted of weathered rock with some soil or clay, and the subgrade appeared to be capable of supporting the design loads. Because of the presence of a relatively thin layer of soil (Figure 14) it was recommended the subgrade preparation at Abutment 2 could proceed by over-excavating an additional 6" as well as removing any pockets of soil using dental excavation up to an additional 2 feet in depth. This allowed a mudslab to be

placed using a minimum 6" thick Class C concrete. It was determined the load distribution mat was not required.

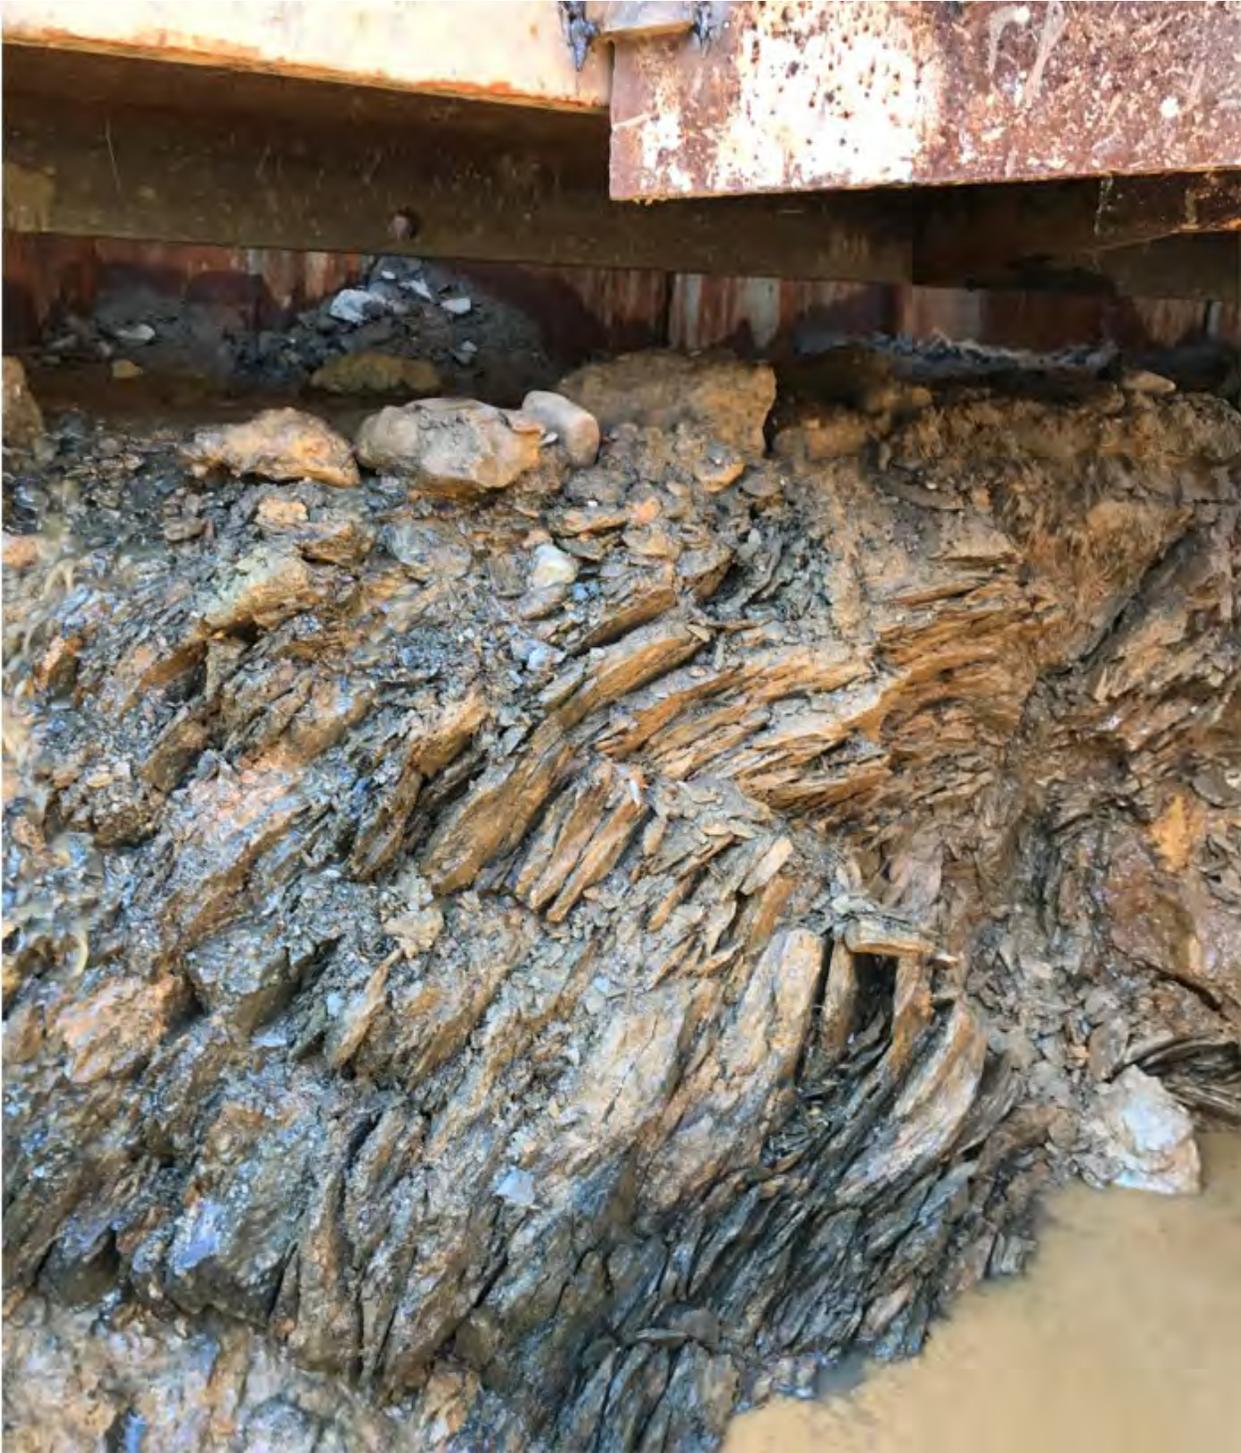
Figure 15: Near Vertical Bedding in Abutment 2 Excavation Side

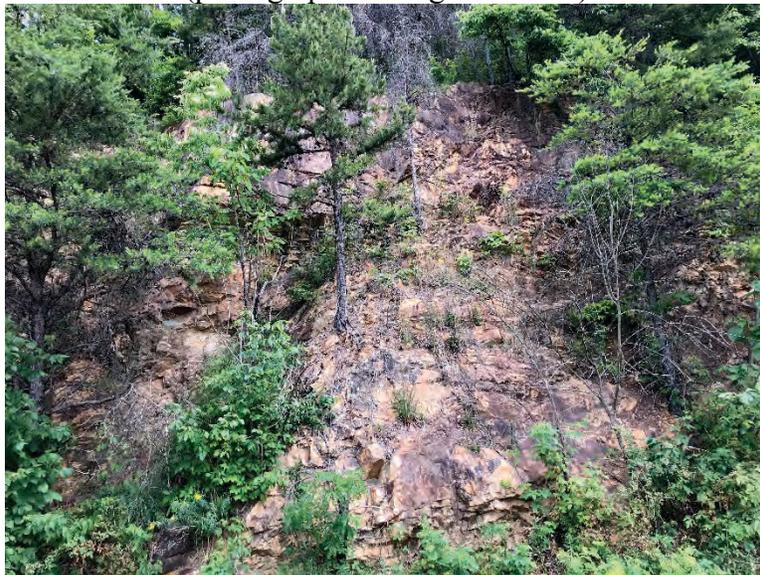
Figure 5: Photograph of the Pennington Sandstone member along the westbound lane.
(photograph looking northwest)

Borehole recoveries were typically over 60% with rock quality designation (RQD) usually between 40% and 60%. Occasionally, the sandstone was recorded as weak and could be interbedded with weathered clay beds (shale). Defining the boundary between the overlying Colluvium and Pennington Sandstone member was difficult in boreholes through the slide mass above the westbound lane due to the size of large, detached blocks of Pennington Sandstone within the Colluvium, which can appear as in-place bedrock.

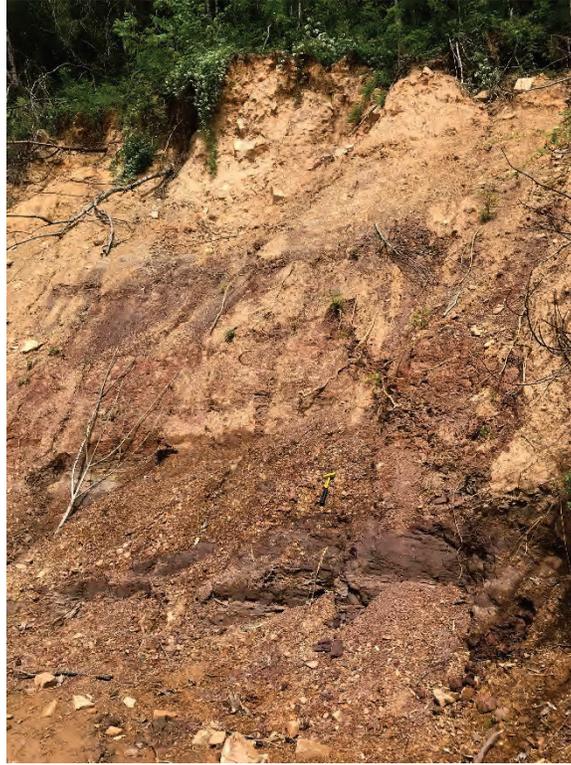
Figure 6: Photograph of an outcrop of the weathered Pennington Shale member in a roadcut along the westbound lane. Seeps and ravelling can be seen in the outcrop (geological hammer for scale).

The Pennington Shale member is exposed north of the westbound lane towards the eastern boundary of the study area, **Figure 6**, and was encountered in borings below the Colluvium or Pennington Sandstone member along the westbound lane and in the median. Throughout the region, the Pennington Shale member is comprised of shale, mudstone, claystone, limestone and

The Pennington Shale member is variable in composition and weathering characteristics. Highly weathered shales, recorded as clay and similar to residual soils previously described, are commonly observed between more competent Pennington shale beds. The Pennington Shale member was observed as red brown, tan, gray, and usually described as a very weak to weak or weak to medium strong shale. RQDs ranged from <10% at a depth of over 100 feet, to >80%. Typically, RQD ranged from 15% to 45%.

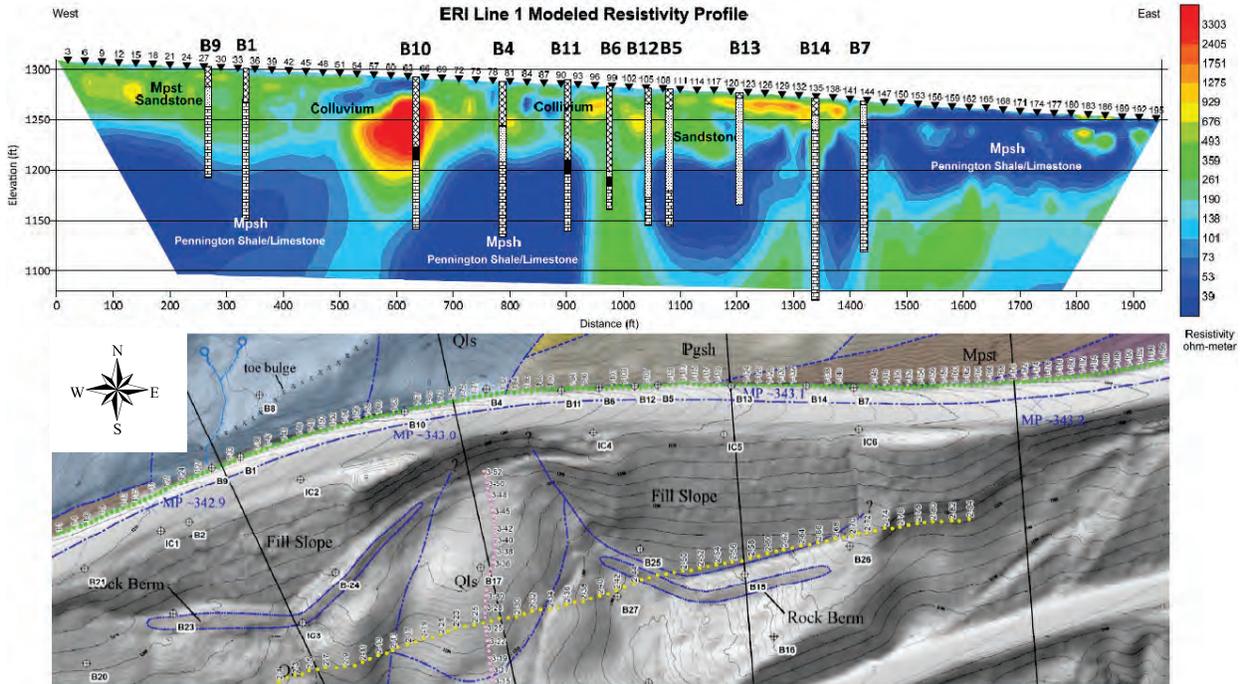
Figure 7: Geophysical ERI results compared to geologic map and boring data. The ERI profile showed a good resolution and correlation with physical data and was used as part of the 3D geological model.

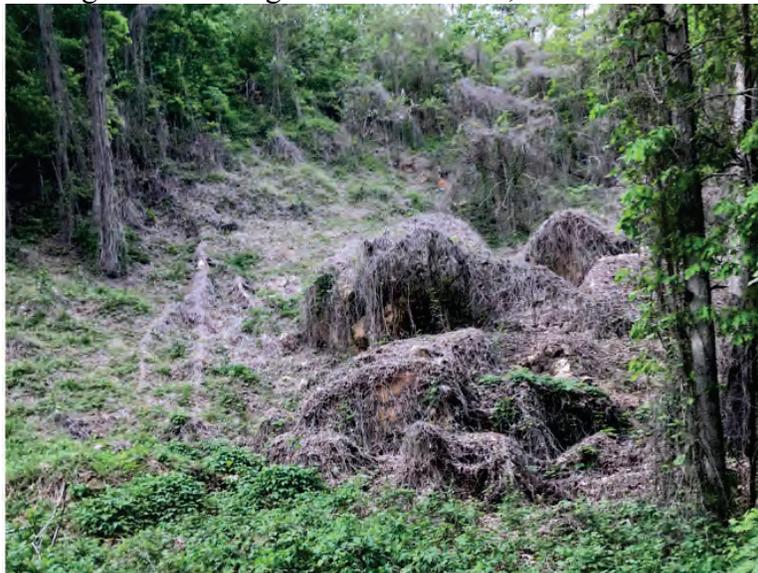
Figure 9: Large blocks of Suwanee Conglomerate from rockfall at the crest of the Slide IV. Blocks are overgrown with vegetation. For scale, the blocks are mini-bus size.

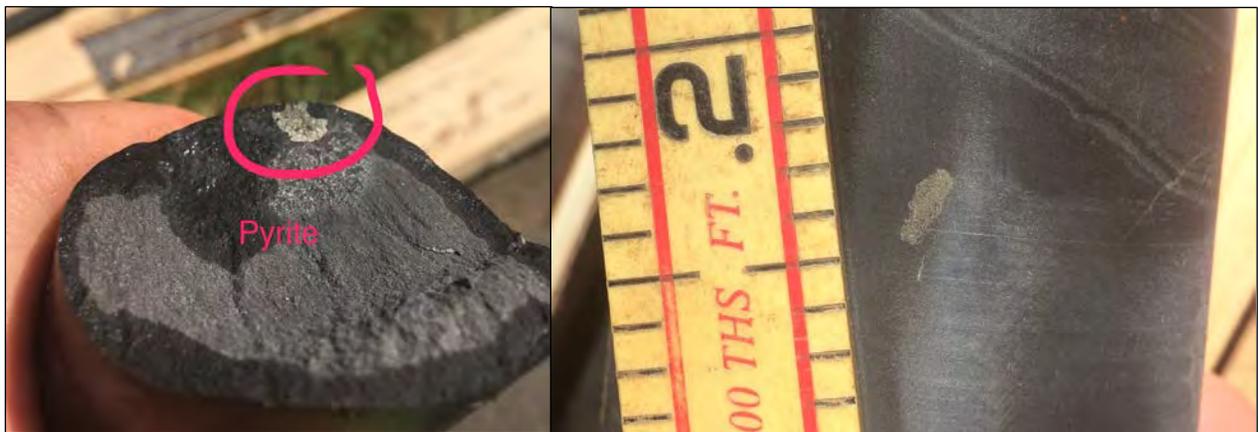
Figure 3 – Observed pyrite in Marcellus Shale Formation

In 2016 during the final design boring program, pyrite was observed during examination of rock cores. A typical occurrence of pyrite in recovered core is presented in Figure 3. A total of 26 borings consisting of 1,450 lineal feet of rock core and 481 Acid Base Accounting (ABA) tests were completed to obtain an initial assessment of the presence of APR and evaluate the extent of oxidized caprock, along a nearly 1.5 mile alignment. The laboratory results confirmed that sulfide bearing rock would be encountered during excavation, and after discussions with PADEP and PennDOT District 3-0 it was decided to move the alignment between 50 and 100 feet to the south of the original alignment to reduce the depth of excavation and anticipated excavation quantities by approximately 0.75 million cubic yards.

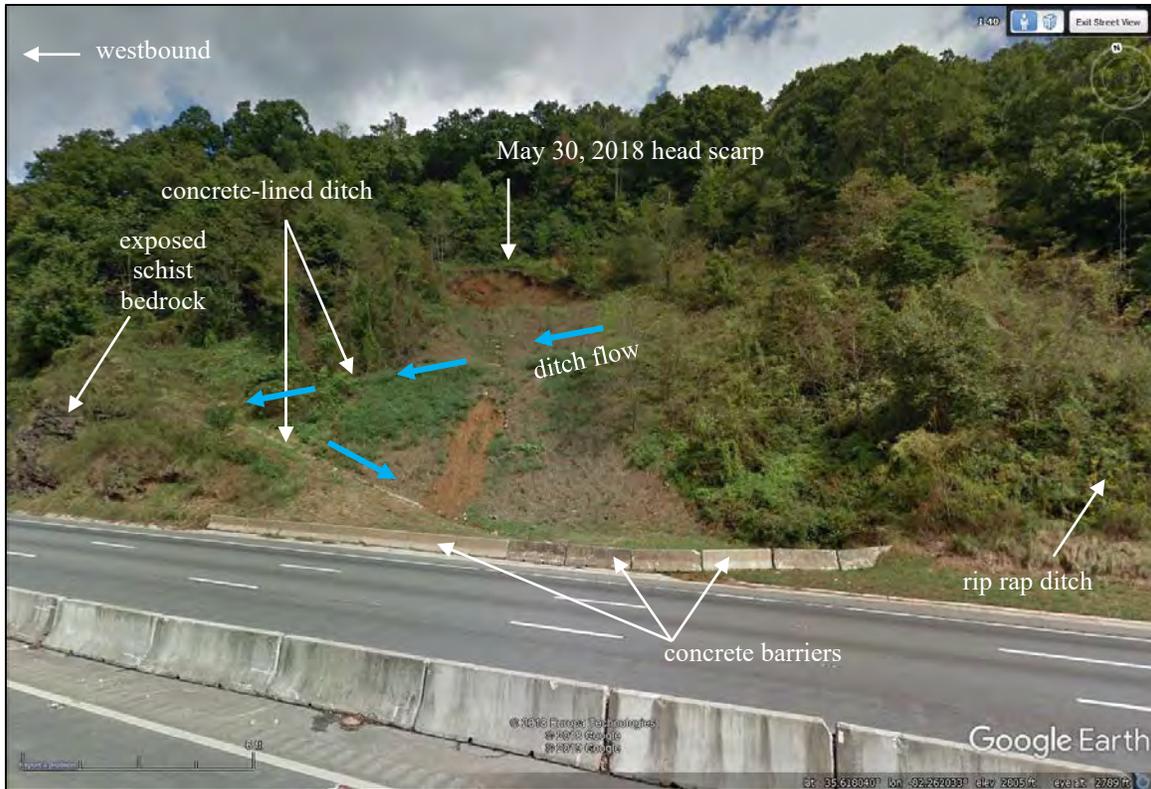
Figure 2. View of slope showing reoccurring debris flows and key mitigation features (Google Earth Image, 2018).

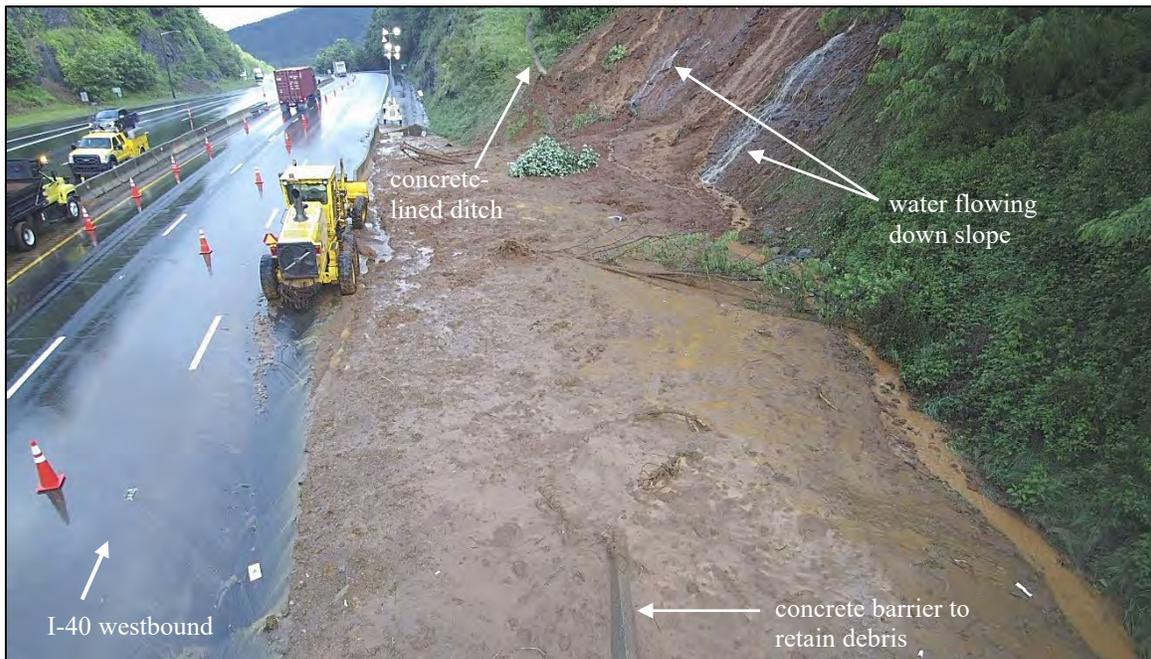
Figure 4. Debris flow cleanup on I-40 westbound at the base of the slope (NCDOT image from May 30, 2018 drone video).

The most recent debris flow occurred on May 30, 2018. Figure 4 shows the base of the debris flow after partial cleanup to remove soil from the roadway. Figure 5 shows the middle and upper portions of the debris flow. Figure 5 shows both the upper portion of the debris flow near the head scarp and middle of the debris flow. Notice the water flowing down the debris flow surface in both Figure 4 and Figure 5. During site reconnaissance, we identified “soil pipes” with diameters ranging from 0.5 feet to 1.0 feet near the head scarp that are shown in Figure 6. These pipes likely played a role in saturating the colluvial soils and formation of the debris flow. NCDOT reported they removed between 1000 cubic yards and 2000 cubic yards of soil from the roadway following the debris flow.

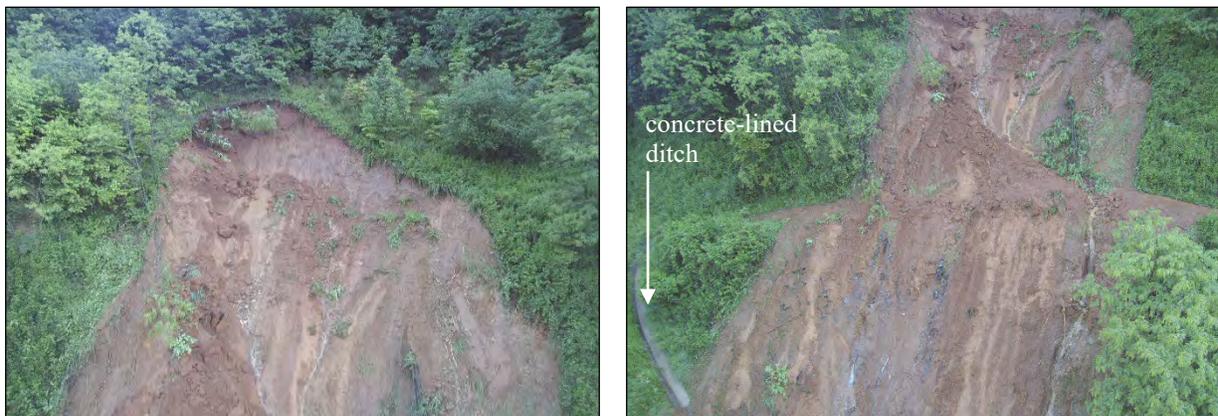
Figure 5. Debris flow at the head scarp (left) and mid-slope (right).

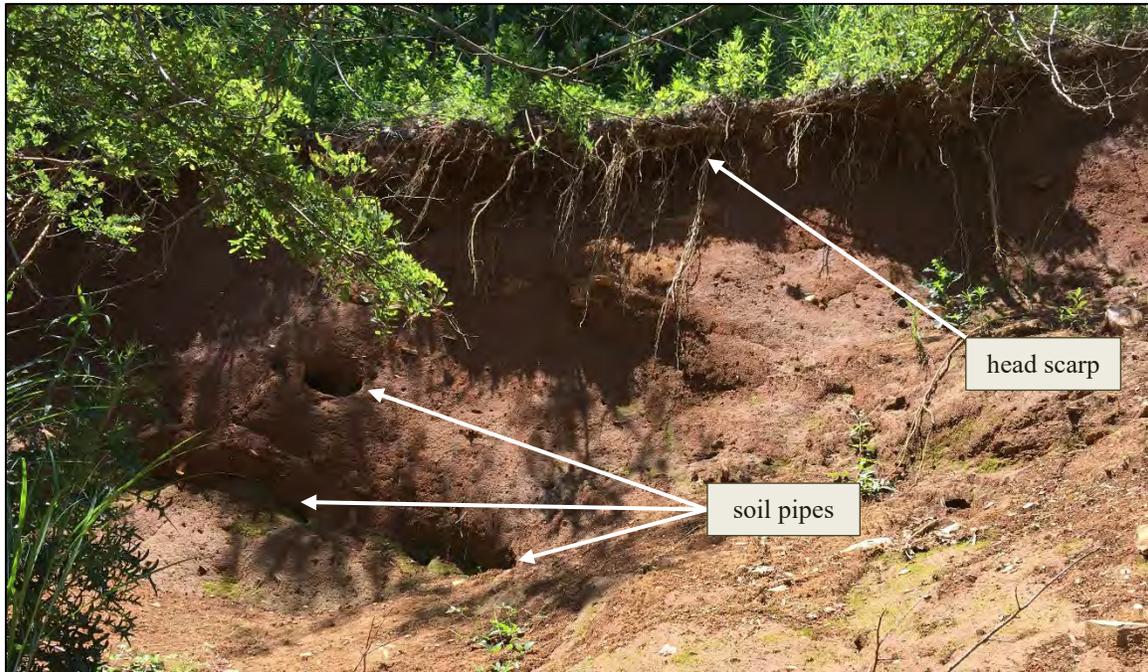
Figure 6. Soil pipes exposed at head scarp from May 30, 2018 debris flow. (Photograph from June 27, 2019).

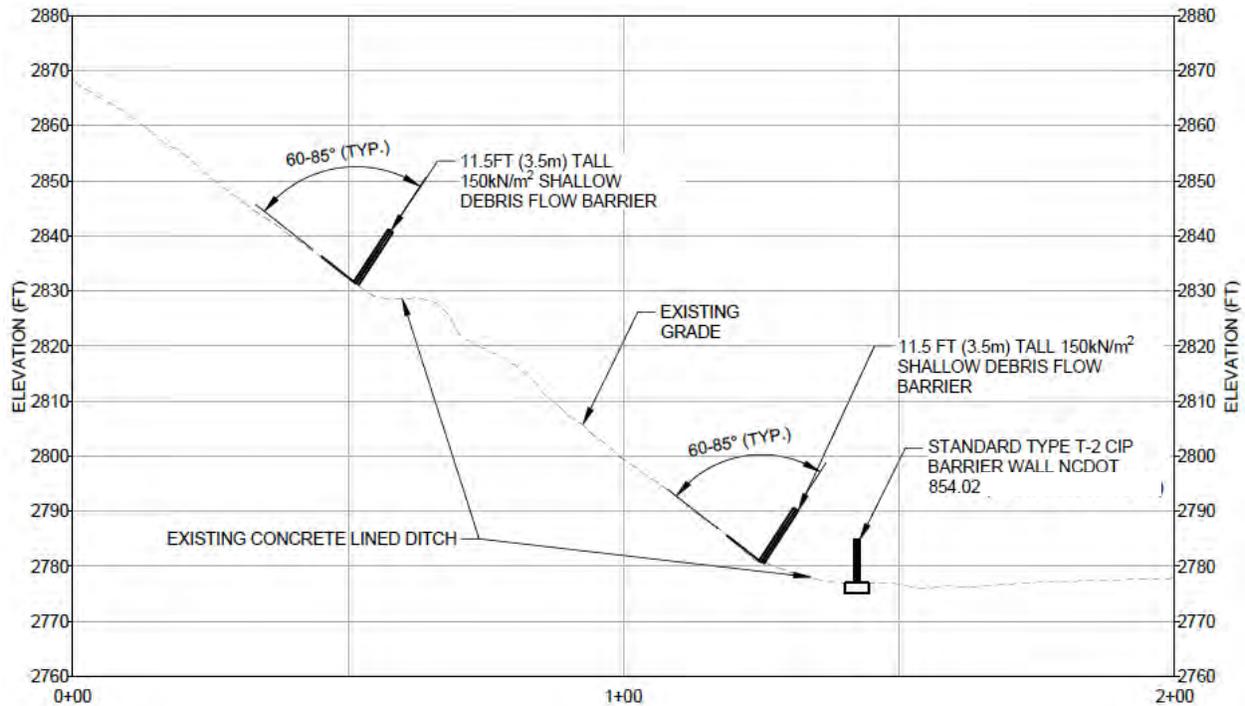
Figure 11: Cross section of the double barrier system.

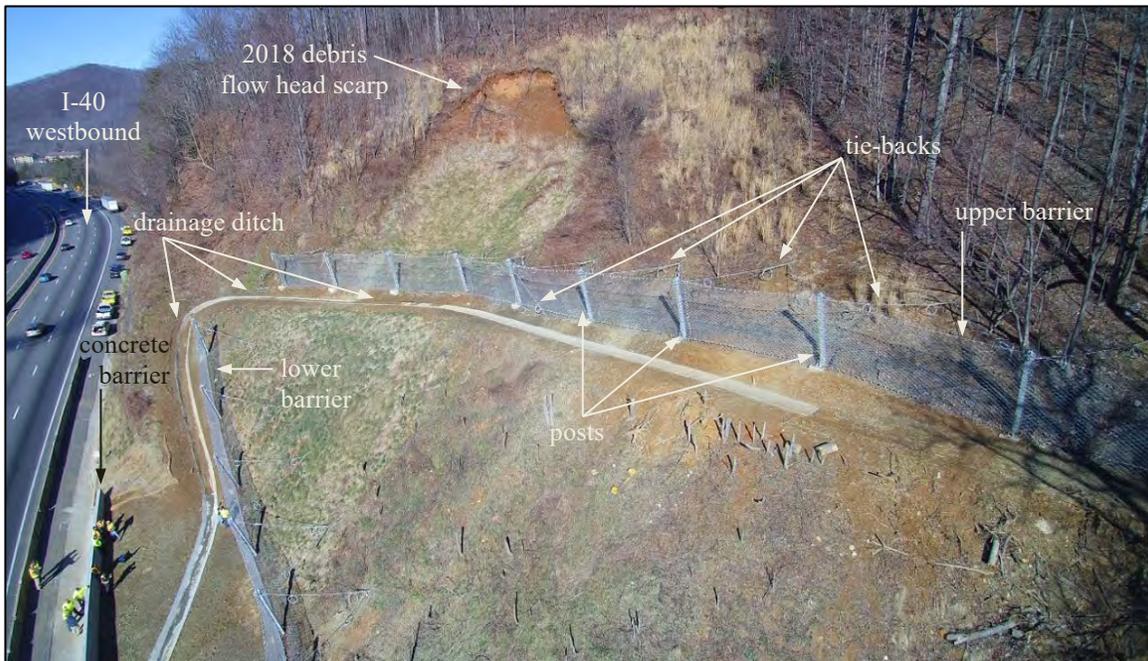
Figure 12: Aerial View to the West of the Barrier System (Drone Image from Fall 2019/Winter 2020).

The double barrier system was constructed at the site between August and September 2019. Figure 12 illustrates the installed system during colder months when vegetation is sparse. The image shows the major features of the system installed, mainly the upper and lower barriers and the associated mesh, fence, and tie-back anchor lines, as well as the concrete barrier at the base of the slope adjacent to I-40. Figure 13 shows a closeup of the components of the barrier system, mainly the mesh, posts, and lines with breaking element loops to the tie-back anchors.

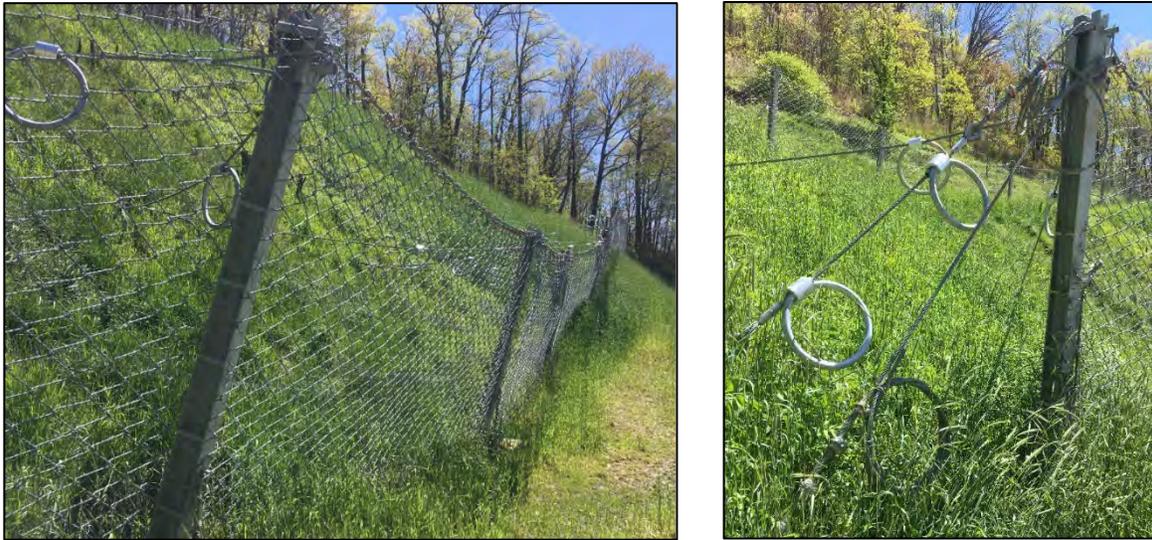
Figure 13: Completed Debris Flow Barrier System: a) View of Mesh and Post and b) Typical End Post showing Braking Element Loops in the Two Lateral End and Rear Lines to the Tie-back Anchors. (Photographs from April 27, 2020.)

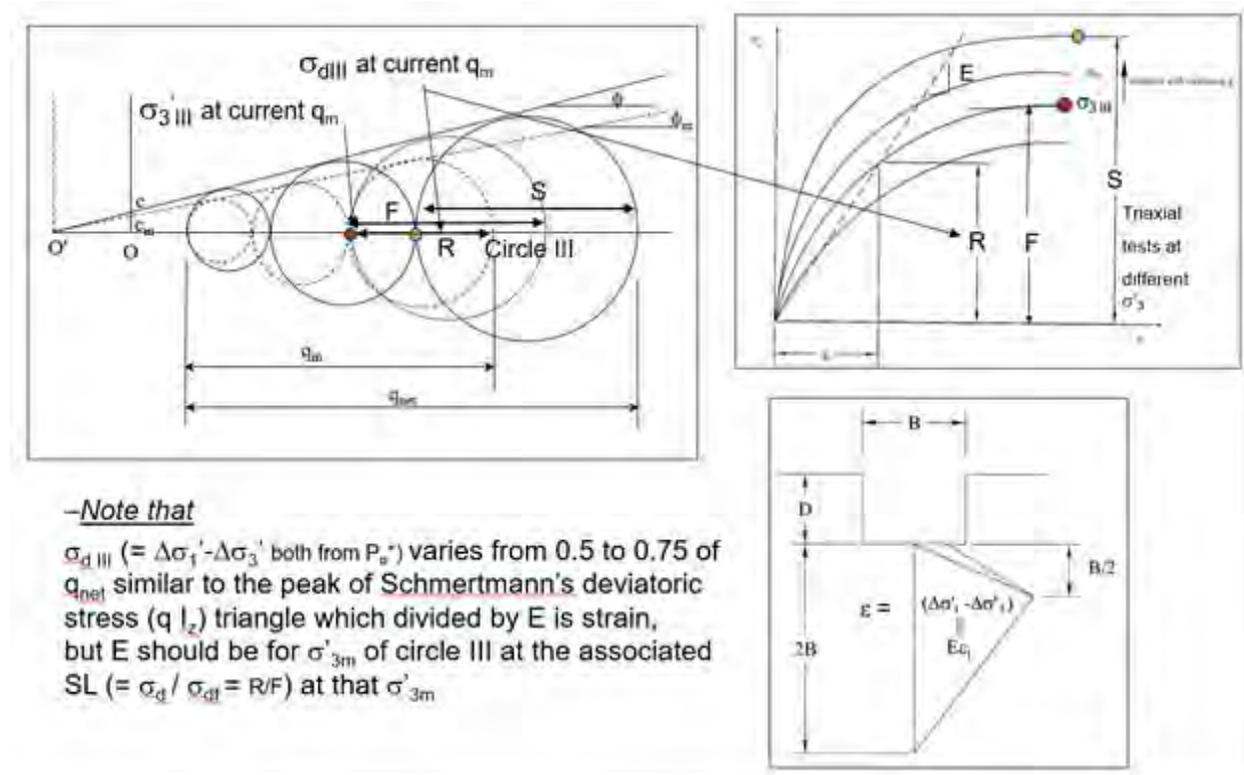
Figure 5 - Deviatoric Stress at Current Confining Pressure of Zone III and the Corresponding Strain at $\frac{1}{2} B$ of the Schmertmann Triangle

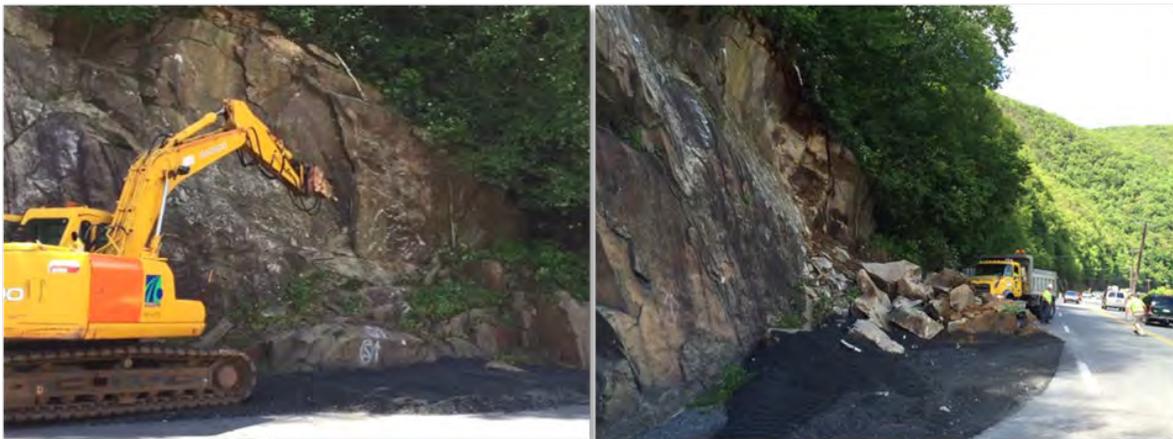
Figure 2 – Mechanical Scaling of Unstable Rock Mass (July 11, 2016)

On July 11, 2016, Carbon County Maintenance mechanically scaled and removed a large, visually unstable rock mass identified as Area of Concern (AOC) No. 9 (as identified during the field reconnaissance activities) from the slope face (Figure 2). The maintenance crew utilized an excavator equipped with a hydraulic hammer to pry the mass from the rock slope. According to PennDOT personnel onsite during the work, the rockfall was initiated after using only a small amount of force applied by the excavator, using the hammer tip to wedge an open vertical joint near the top of the rock mass. The work was performed under a temporary single-lane closure of the S.R. 209 northbound right-ahead travel (climbing) lane, and a temporary (approximately 30 minute) closure of all travel lanes (two northbound and one southbound) during the induced rockfall event and subsequent clean-up of the rock debris on the roadway.

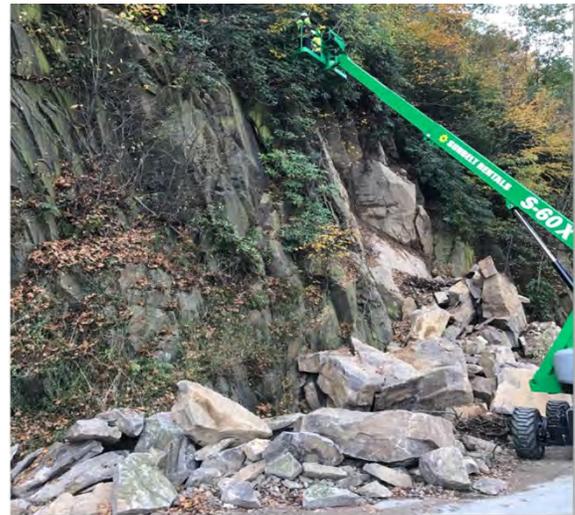
Figure 3 – Conditions at AOC-6 following the September 8, 2017 Rockfall Event

During the evening hours of September 8, 2017, a large rockfall event occurred at an area designated as AOC-6. The slope condition following the rockfall event at AOC-6 is shown in Figure 3. This event occurred after a total of 3.1 inches of precipitation fell between September 2 and 6, 2017 (7). It is likely this precipitation event contributed to the rockfall event. The rockfall closed all lanes of the road for several hours while District Maintenance pushed rockfall debris into the northbound right ahead travel lane. Following this event, PennDOT initiated an accelerated construction procurement process to engage a contractor to stabilize the remaining loose material on the slope and remove the rockfall debris from the site. The contract was awarded to New Enterprise Stone and Lime, who teamed with specialty subcontractor Apex Rockfall, LLC. Approximately 55 cubic yards of rockfall material and associated debris were removed from the site.

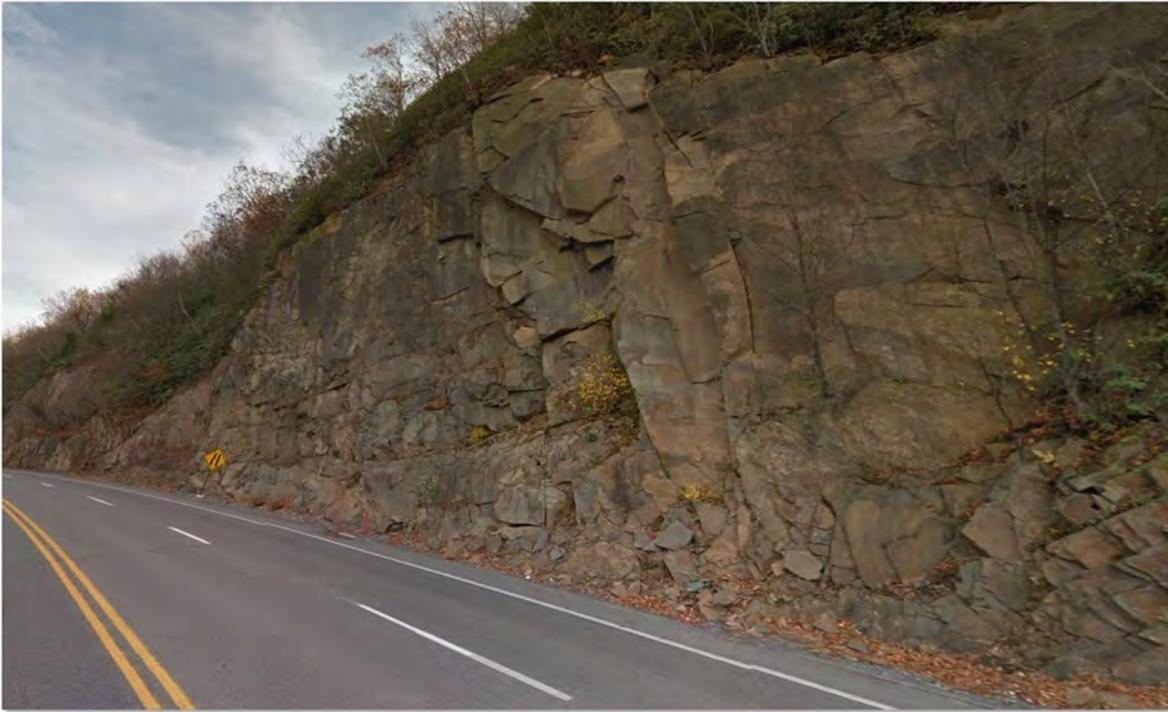
Figure 4 – SR 209 Rock Cut along the Eastern Portion of Project Site Displaying Typical Joint Patterns (bedding is steeply dipping toward roadway)

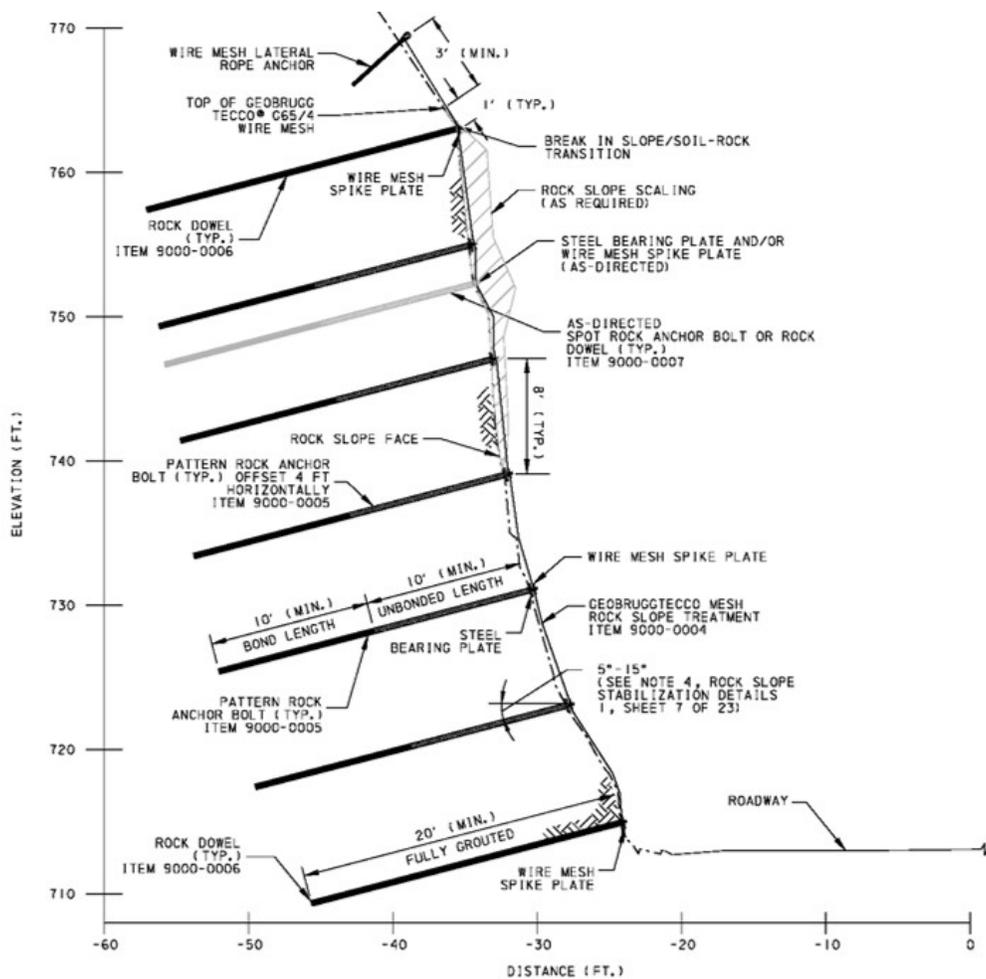
Figure 8 – Typical Design Section

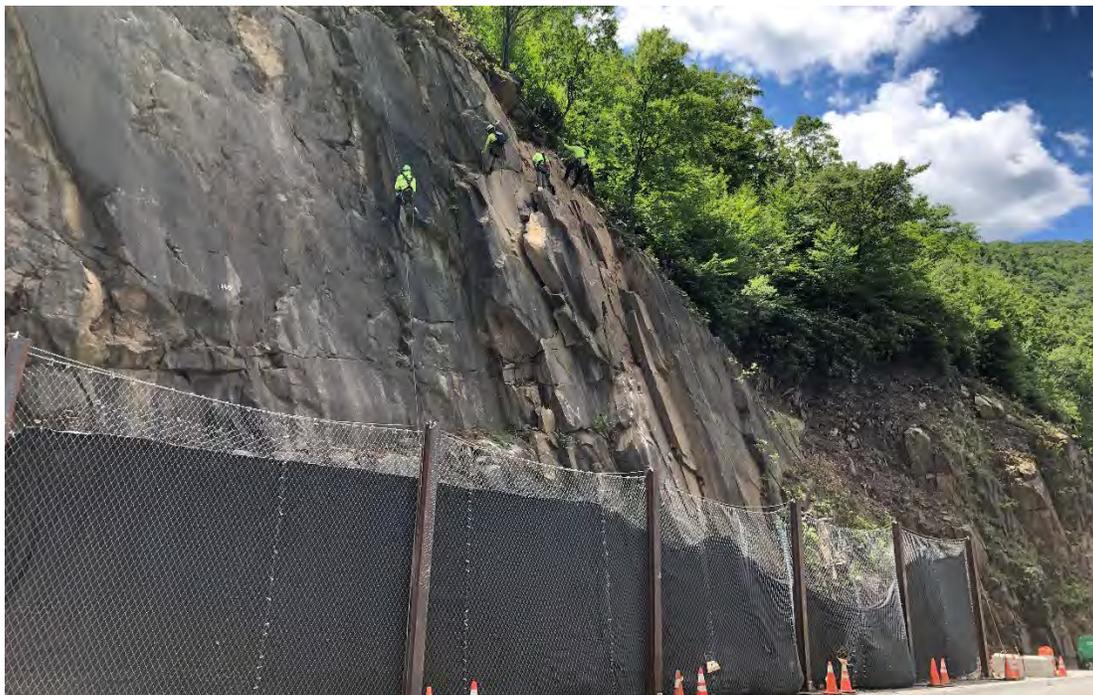
Figure 9 – Scaling Operations Above Mobile Rockfall Shielding System

In order to protect the historic masonry wall along the southbound shoulder and the Reading Blue Mountain and Northern Railroad downslope of the roadway from rockfall material, Ameritech used a temporary, 12-ft high, mobile rockfall shielding system (Figure 9). The system consisted of high-tensile strength steel wire mesh and geotextile facing, supported via wire ropes and steel H-beams resting on concrete deadman anchored pedestals.

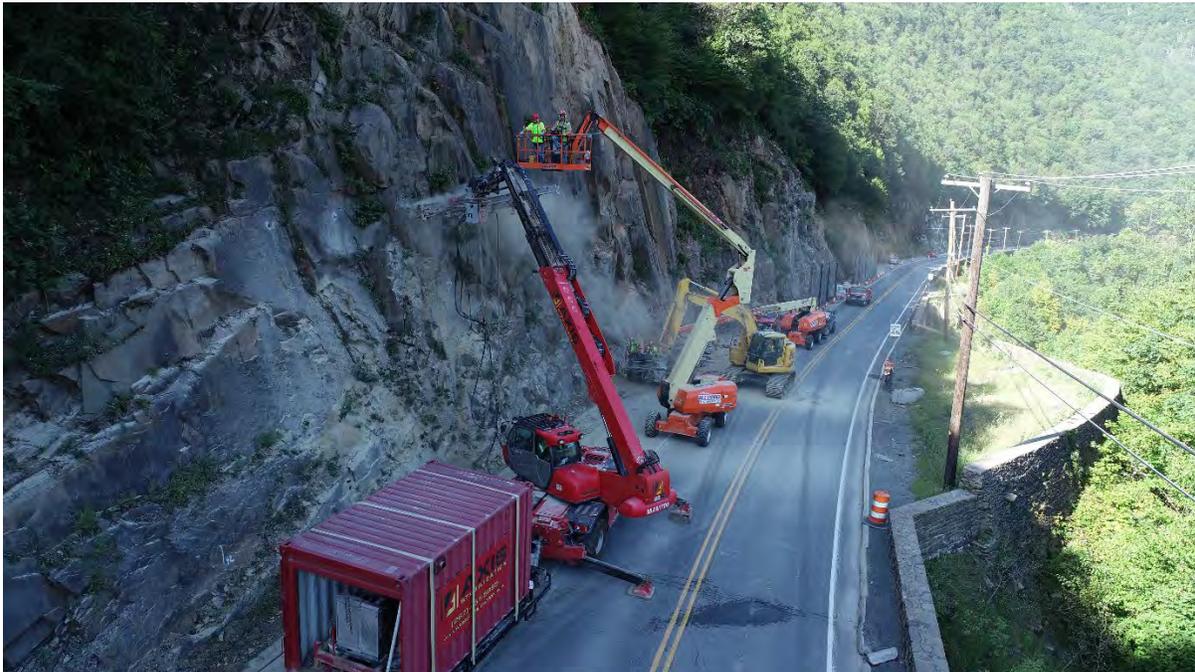
Figure 10 – Concurrent Drilling Operations

Axis performed the drilling work using excavator- and telehandler-mounted TEI HEM550 rock drills. In order to meet the project schedule and to optimize working hours during road closure, multiple operations were performed concurrently (Figure 10).

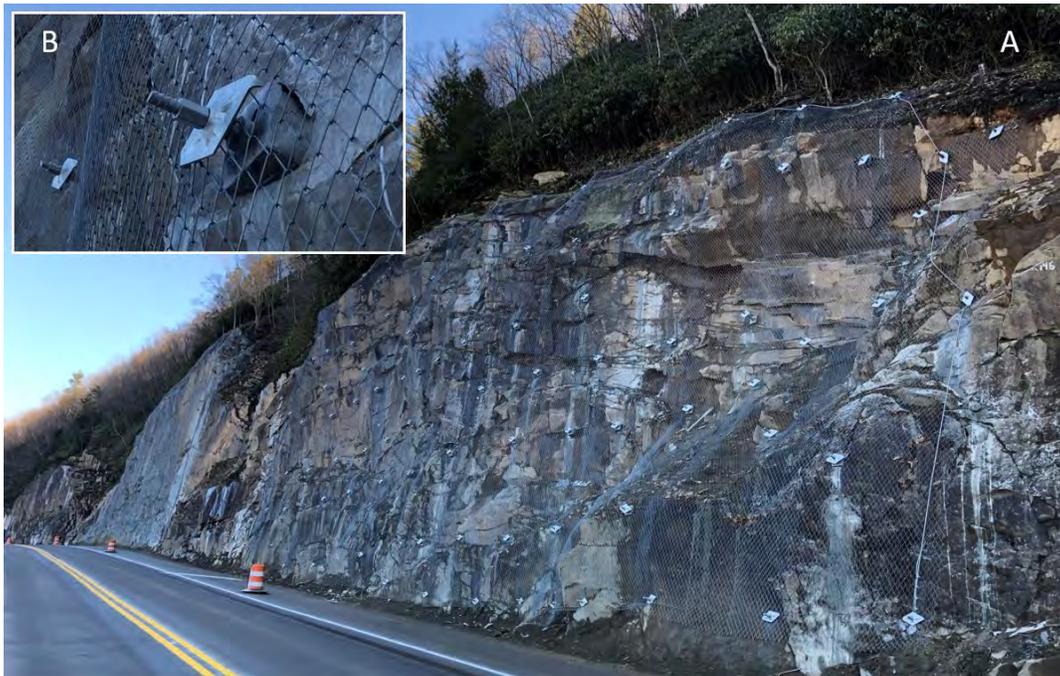
**Figure 11 – (A) Completed Slope Section with Anchored Wire Mesh
(B) Close-Up View of a Post-Tensioned Rock Bolt Head Section Assembly**

Due to the variable sizes of rock blocks and unfavorable joint patterns observed during the field investigation, high-tensile strength steel wire mesh was installed over the areas of pattern rock bolting as a means of protection from rock-breakouts and potential surficial movements between rock bolts. The project specified GeoBrugg TECCO® G65/4 high-tensile strength steel wire mesh. TECCO® products perform as an integrated, homogeneous system, where the components work uniformly across the stabilized area ensuring forces are transferred over the entire system. Upon the completion of bolt/dowel installation and testing, Ameritech hung and secured the mesh facing panels. This work was accomplished using a combination of aerial man lifts and rappelling techniques to perform the work. A completed slope section with anchored wire mesh including a close-up photo of the post-tensioned rock bolt head section assembly consisting of a spike plate overlying a standard bearing plate is included in Figure 11.

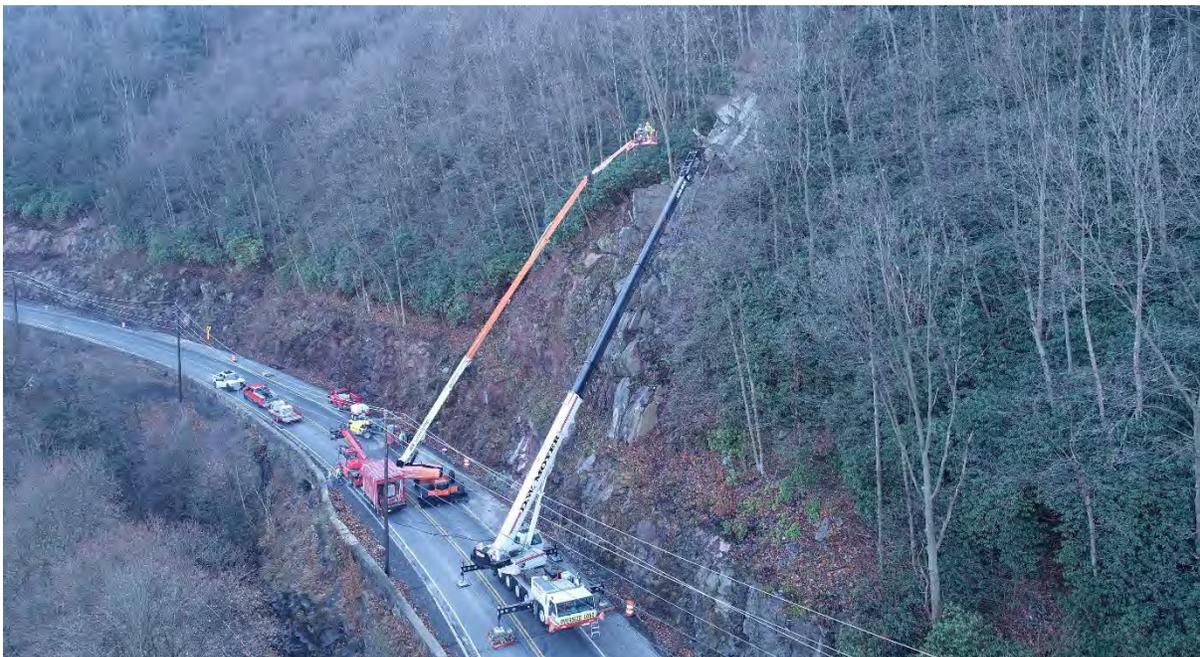
Figure 12 – Drilling Isolated Rock Mass Approximately 120 Feet Above Roadway

In order to reach the additional soil nail and rock bolt locations greater than 70 feet above the roadway, Axis brought in a crane with a specialty designed flange to mount the TEI rock drill directly to the boom. Drilling operations within the isolated rock mass located more than 120 feet above the roadway is presented in Figure 12. The hybrid elevated rockfall barrier and drapery system is shown in Figure 13.
