71st HIGHWAY GEOLOGY SYMPOSIUM

2022 Proceedings

**71st ANNUAL
HIGHWAY GEOLOGY SYMPOSIUM
Table of Contents**

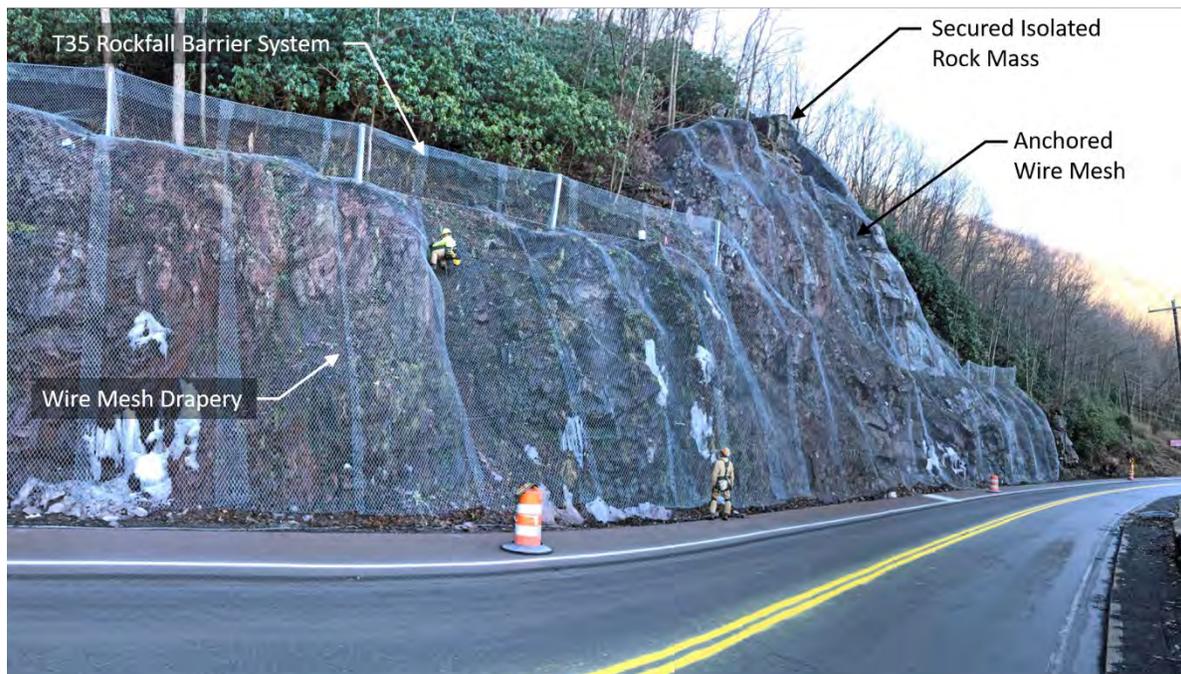
Figure 13 – Overview of Hybrid Elevated Rockfall Barrier and Drapery System. Additional Area of Anchored Mesh and Location of Upper Isolated Rock Mass also Shown.

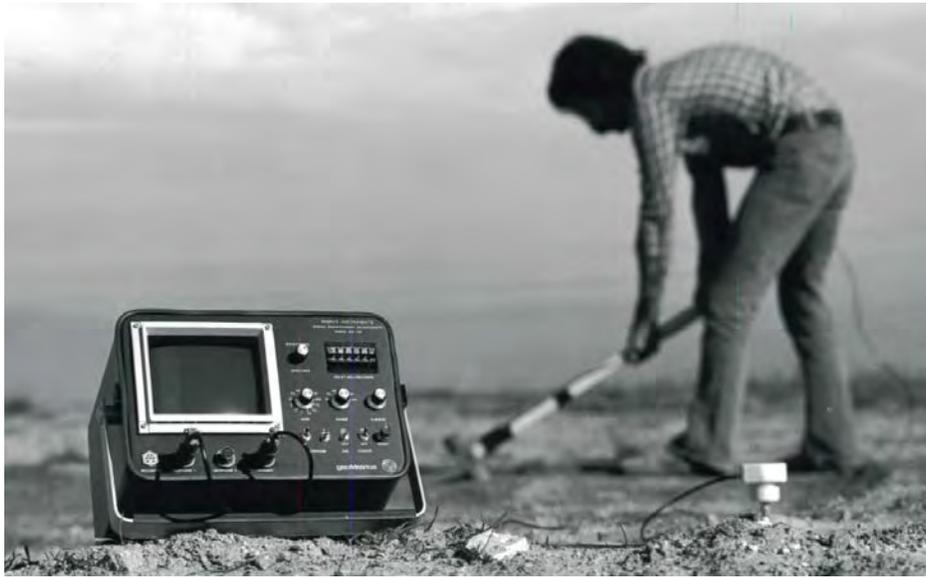
**Figure 5 – An Early Single-channel Digital Seismograph (ES-125), Circa 1978
(Courtesy Geometrics)**

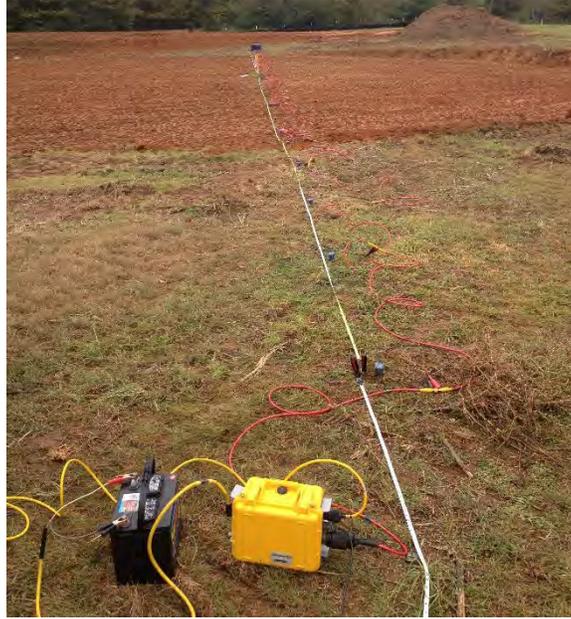
Figure 6 – 24-Channel Seismograph (Geometrics Geode, yellow case) with 8Hz Geophones Spaced 5 Feet Apart, 2014.

Seismic refraction data is collected using a linear array of vertical geophones connected to an engineering seismograph to record first arrivals (first breaks) of compressional wave energy from a weight drop or explosive source. (Although not as common, shear wave refraction can also be performed using horizontal geophones and a shear wave energy source.) A typical data acquisition system consists of 24 geophones (8 to 12 Hz response) spaced at intervals of 5 or 10 feet with a total array (spread) length of 115 or 230 feet (Figure 6). The geophones are connected to a geophone cable that is connected to an engineering seismograph. Energy sources range from sledgehammers for shorter arrays and shallower depths to explosive sources for longer arrays and deeper depths.

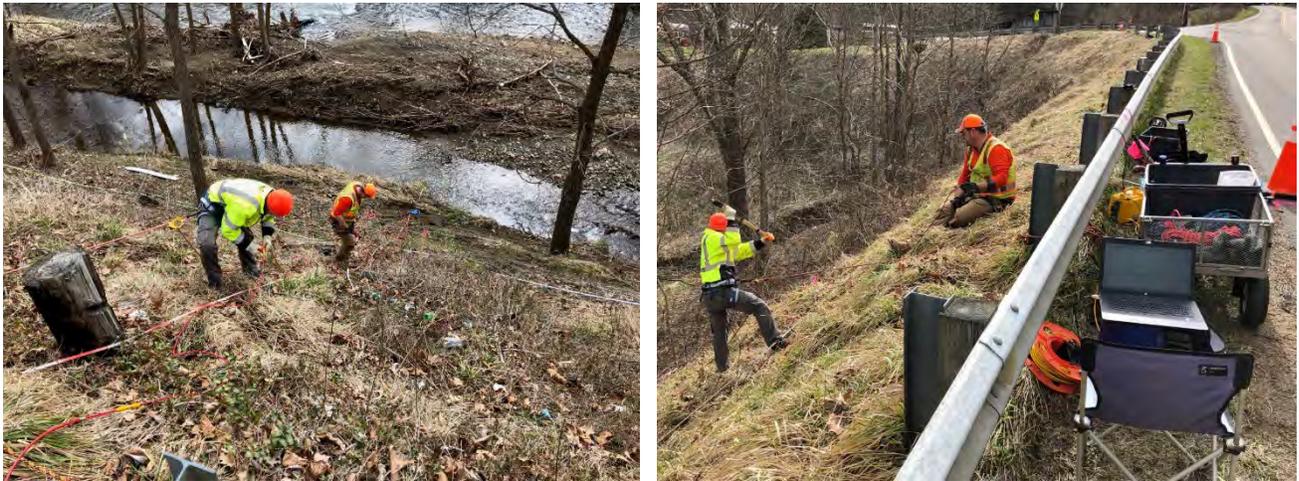
Figure 9 – Photographs of Setting Up Array for Downslope Line (L) and Swinging Sledgehammer Source (R).

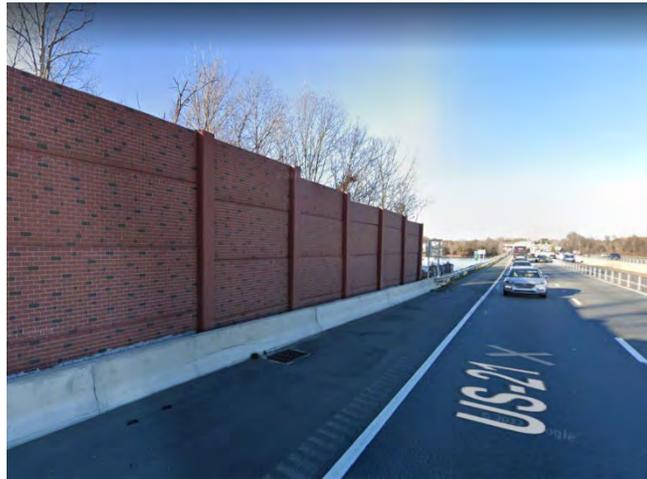
Figure 13 – Section of Noise Barrier Wall Constructed along I-77 by Lake Norman.

In 2013, the NCDOT was planning the addition of High-Occupancy Toll (HOT) lanes to I-77 north of Charlotte. As part of the design, noise barrier walls were proposed for some sections, including in and adjacent to the rock embankment causeways in the Lake Norman area (Figure 13). The NCDOT requested that ESP collect geophysical data to help determine the approximate subsurface extent of the buried rock embankments in 5 sections, ranging from 200 feet to 400 feet in length. ESP recommended collecting surface wave seismic data to try to image the buried rock. It was expected that the shear wave velocity of the buried rock would be higher than the surrounding residual soil and roadway fill.

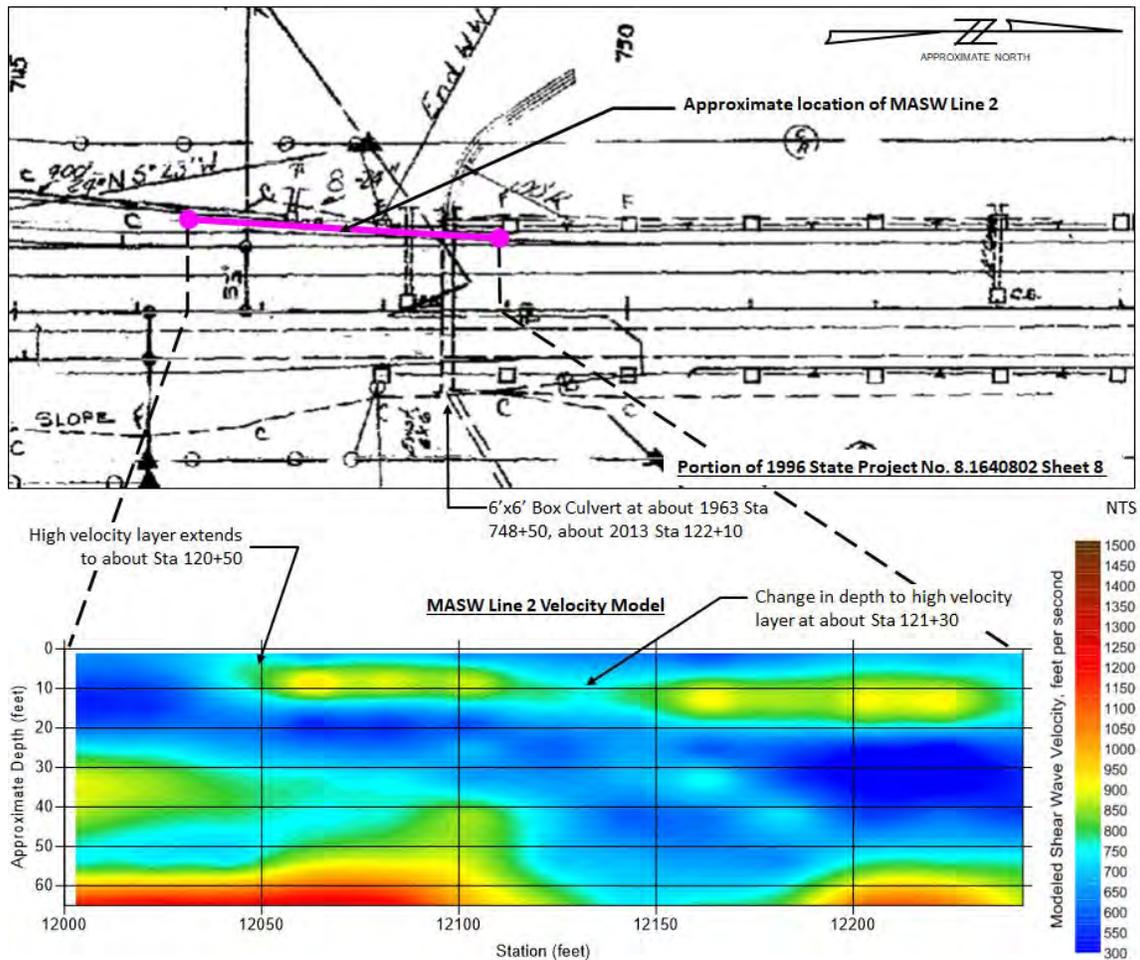
Figure 17 – MASW Line 2 Velocity Model Showing Shallow High Velocity Layer (Bottom) with Line Location Shown on 1966 Plan (Top).

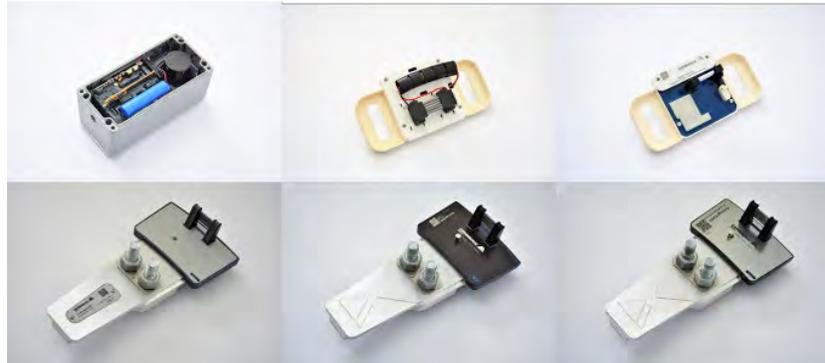
Figure 1 - GUARD hardware development over the last few years

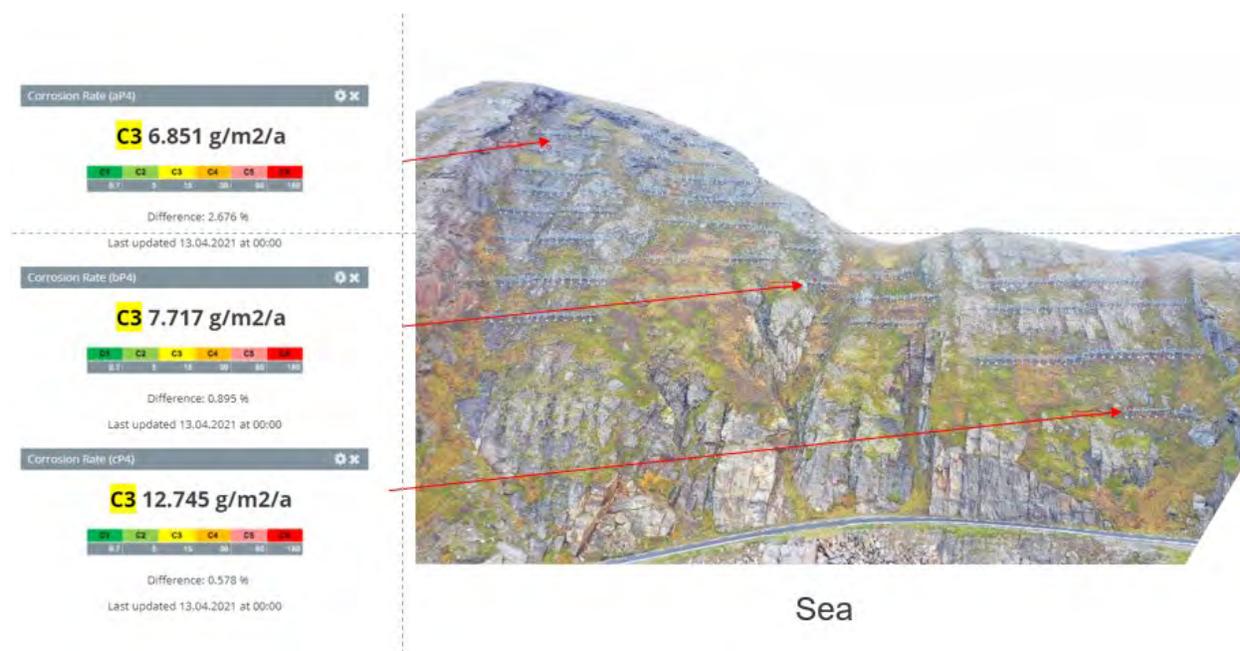
Figure 5: Example of corrosion sensor data showing microclimate variation of estimated galvanization coating loss with elevation and proximity to the sea, as well as variability of corrosion rates in a single installation.

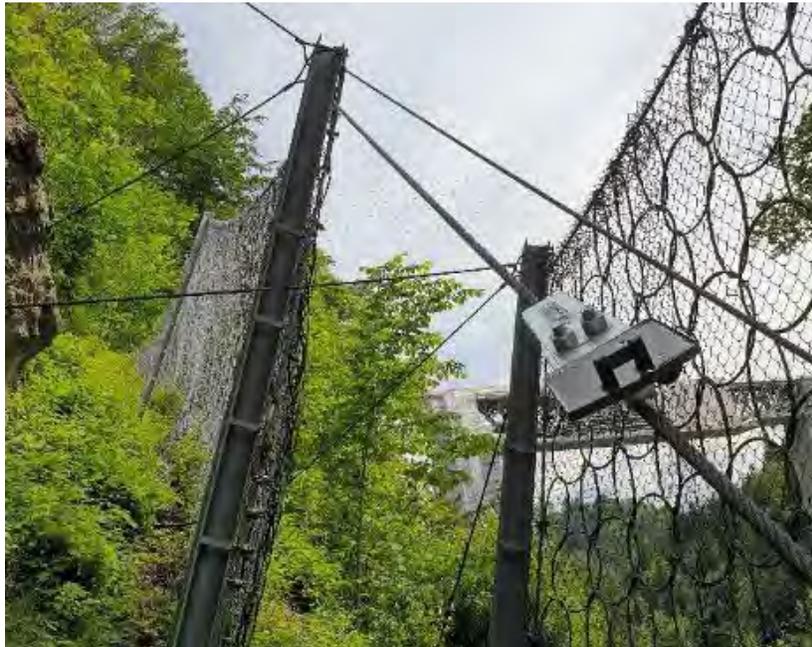
Figure 6 – GUARD mounted on the support rope of a rockfall protection structure

A rockfall protection net protecting a road in Switzerland was equipped with three guards in 2020 (Figure 6). As can be seen in the figures, this flexible protection system is a typical example of vegetation overgrowing a protection system. Despite the barrier's proximity to the infrastructure being protected, it is increasingly disappearing under the growing vegetation and is slowly being filled with small debris and foliage (Figures 6 and 7). Figure 8 shows a filled barrier with a sizable tree growing through the primary ring net and a lack of access or a forgotten protection system and the need for remote monitoring.

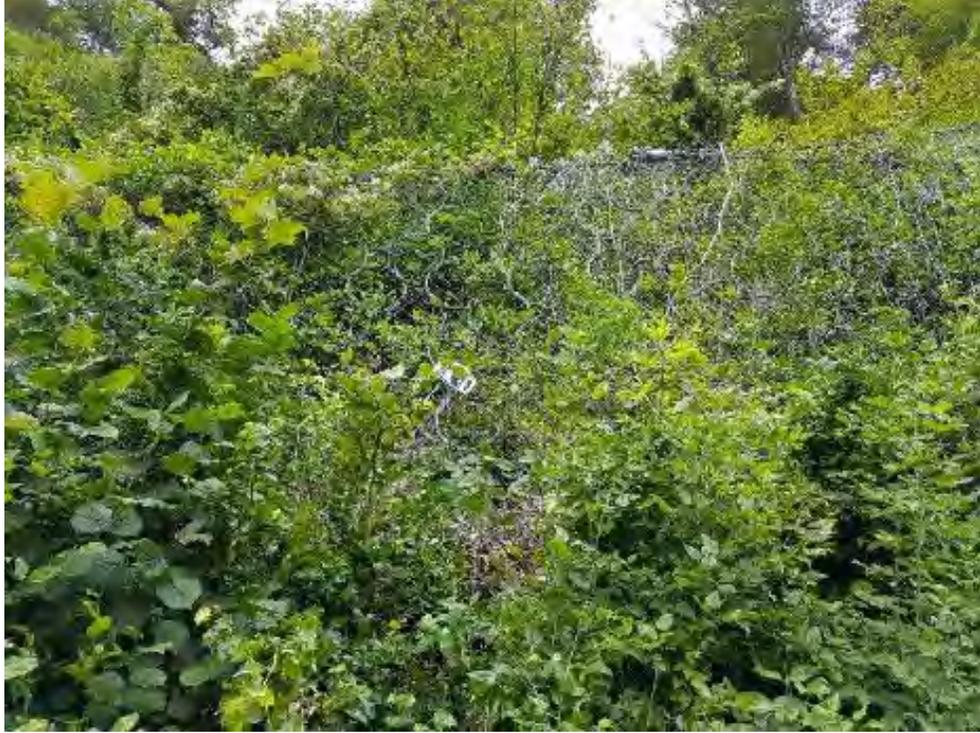
Figure 7 – Rockfall protection barrier disappearing into the vegetation

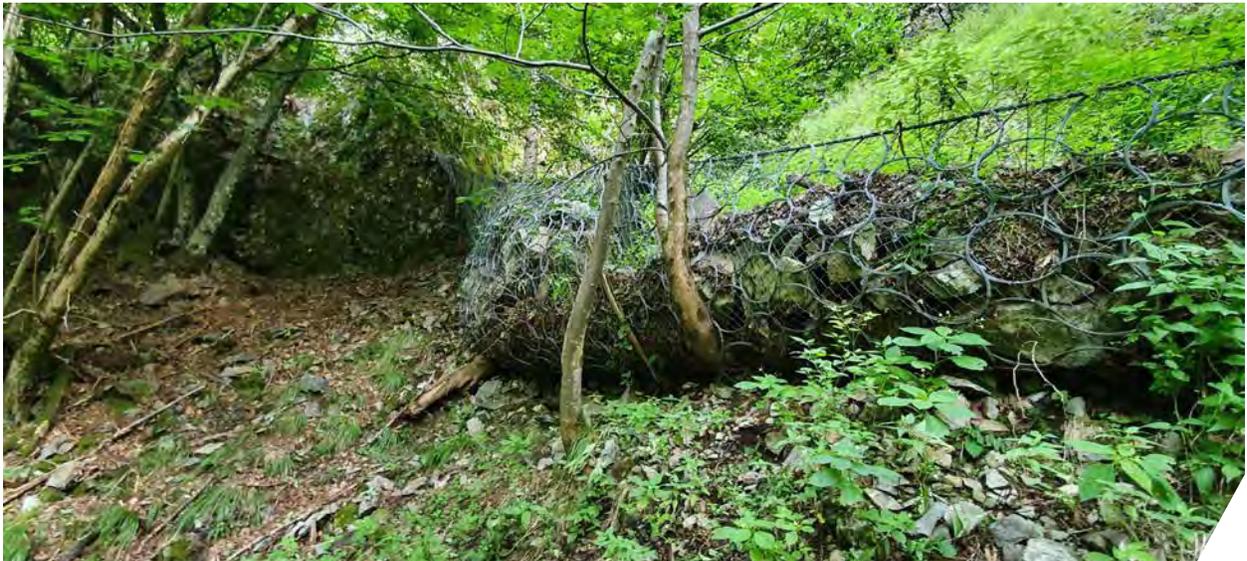
Figure 8 – Barrier filled slowly over time without regular inspections. Note bent tree growing through ring net.

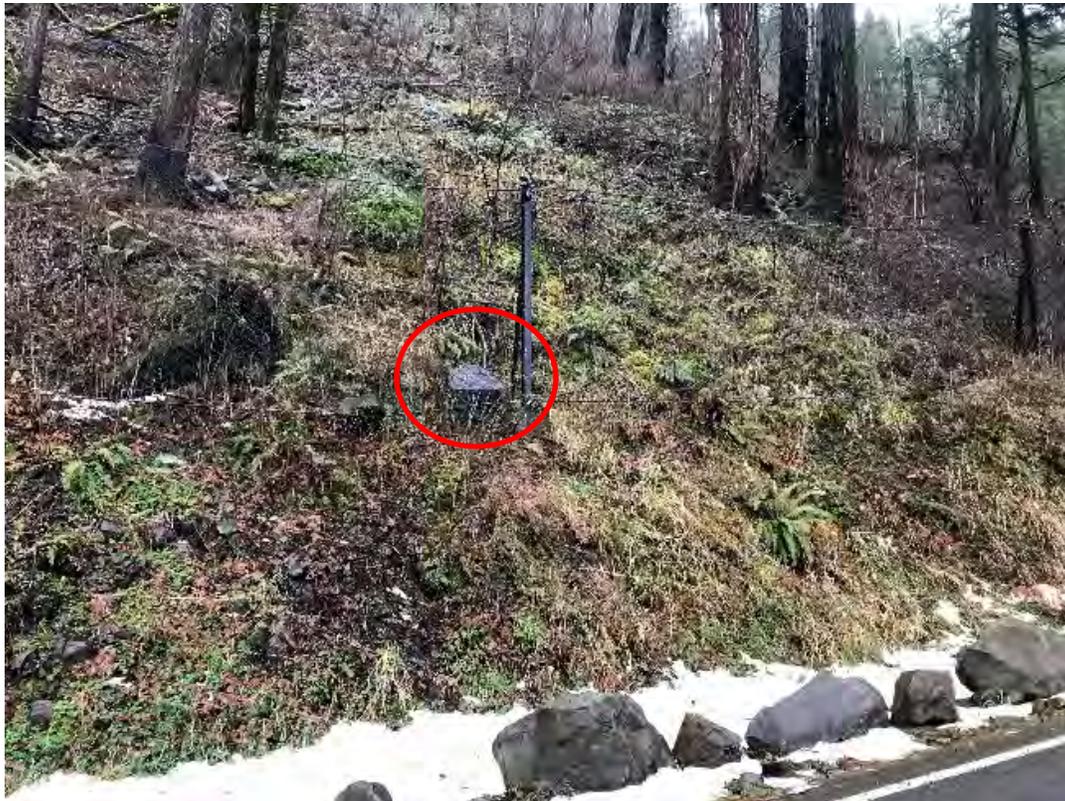
Figure 13 – Impacts on the 04.01.2022. Note rock next to the support post. Rocks in foreground are not rockfall, but placed to block parking.

On the 4th of January 2022, an impact alarm was registered in a protection system along the Columbia River Highway in Oregon that turned out to be a 3ft and a 2ft block. A GUARD installed in the field adjacent to the impacts recorded the rockfall event: Highest detected acceleration 5.5 g, at 01:09:20 (Figure 13 and 14). The events immediately triggered SMS and e-mail messages about the impact via the online platform. The intensity of the acceleration peak allows a decision regarding whether to visit the site rapidly and whether maintenance is needed, such that the barrier is always able to resist a potential subsequent design load impact.

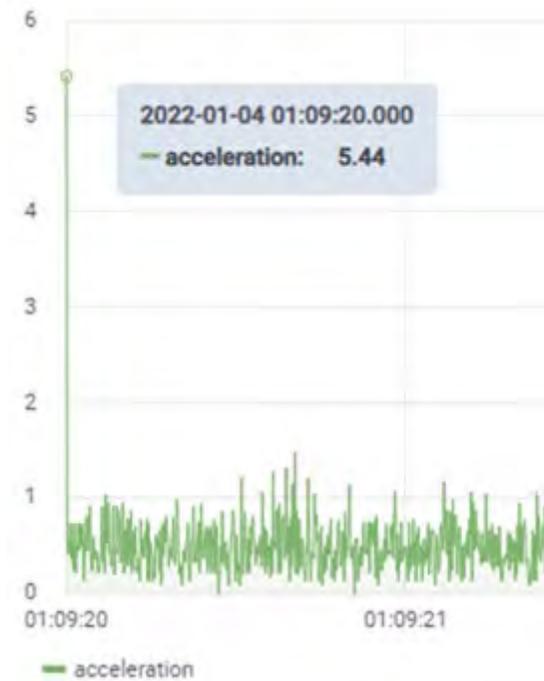
Figure 14 - Absolute acceleration (g) of rockfall on 04.01.2022

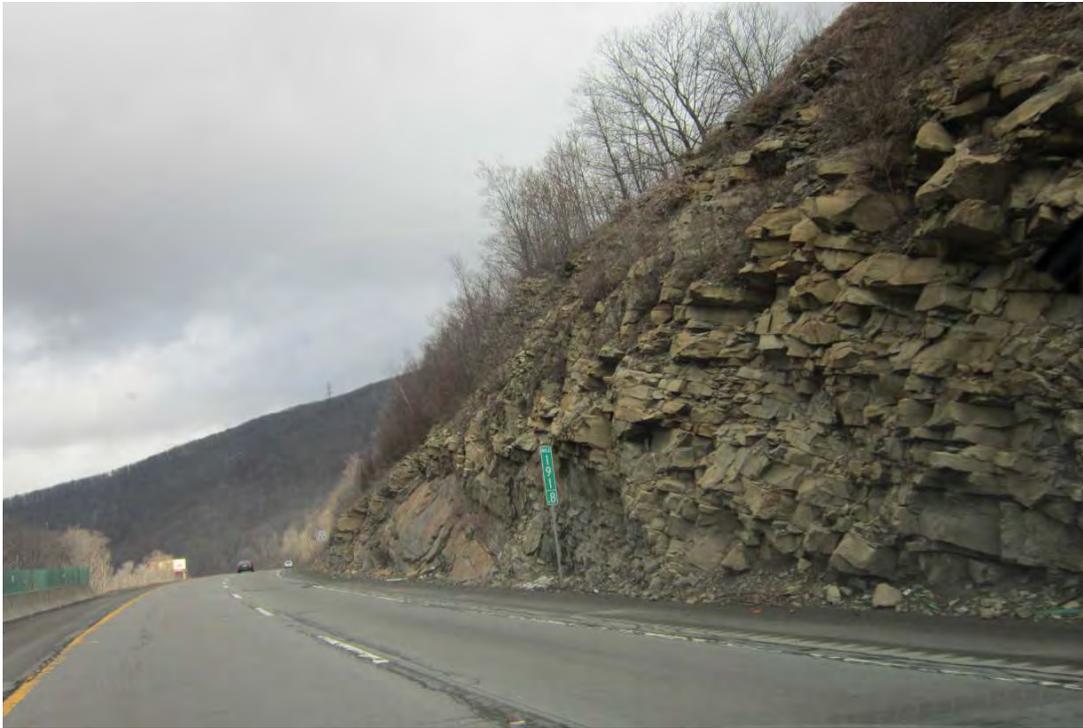
A photo (Figure 3) taken in 2009 shows the proximity of the northbound lanes to the unstable rock slope, as well as an overall view of the cut along the slope. The crests of the rock slopes were covered in colluvium and rockfall debris that fell on the shoulder and occasionally on the highway. A steep cut at the edge of the shoulder, restricted site distance, and minimal rockfall protection presented an unacceptable risk to the traveling public. For this reason, a study by the Pennsylvania Department District 4 was started in 2009 to develop a slope remediation option.

FIGURE 3 VIEW OF NORTHBOUND LANE OF S.R. 0081

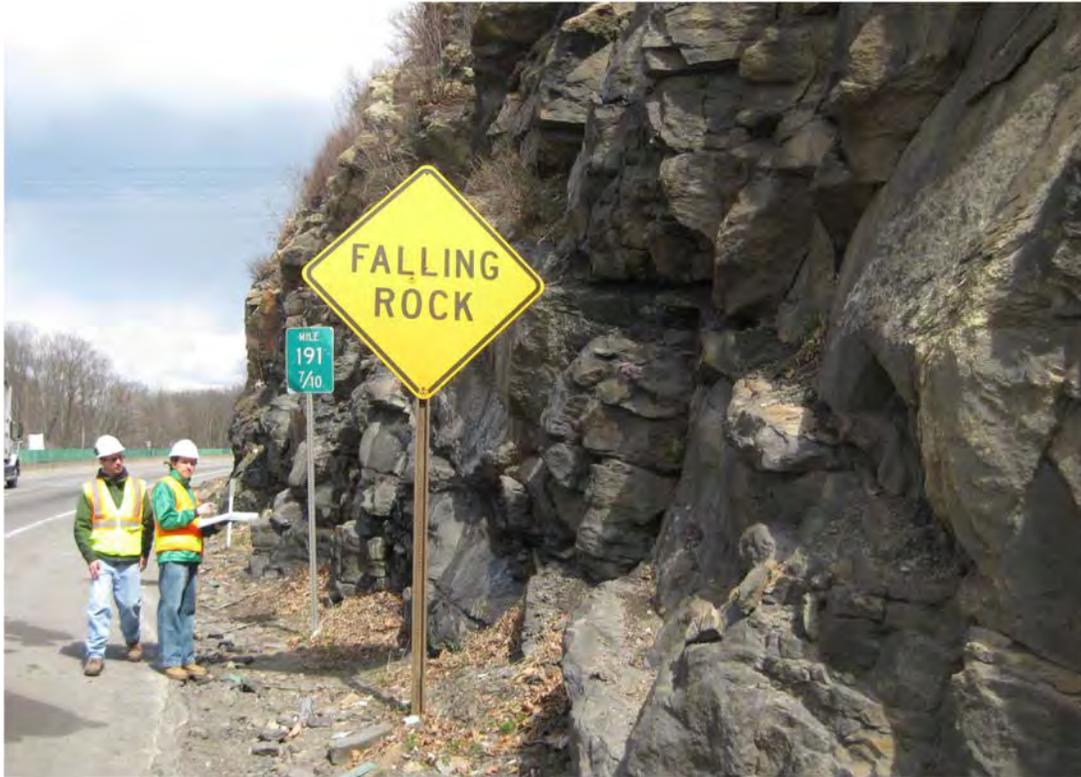
FIGURE 4 FIELD DISCONTINUITY SURVEY

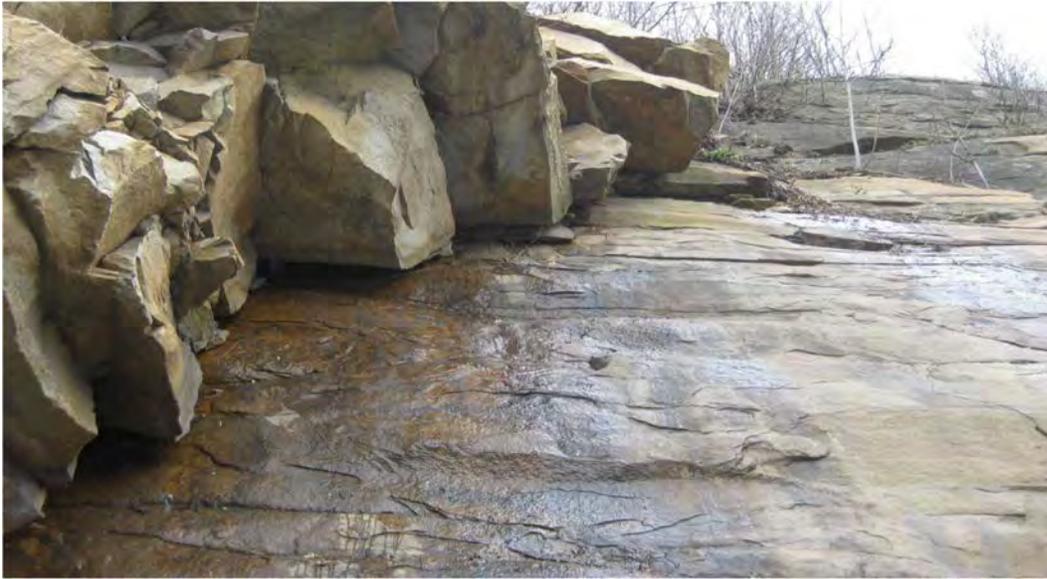
FIGURE 6 PROMINENT JOINT 2 AT STATION 300+00

- Upon viewing the site in the field, 6 segments, based on joint orientation and height of slope were selected.
- Segments 1, 2, 3, 5 & 6 have discontinuities of similar orientation.
- Some prominent slope joints are visible in all the segments (Example, Joint 2, Figure 6).
- Segment 4 is tightly folded and faulted and has overhanging strong rock over weaker beds.

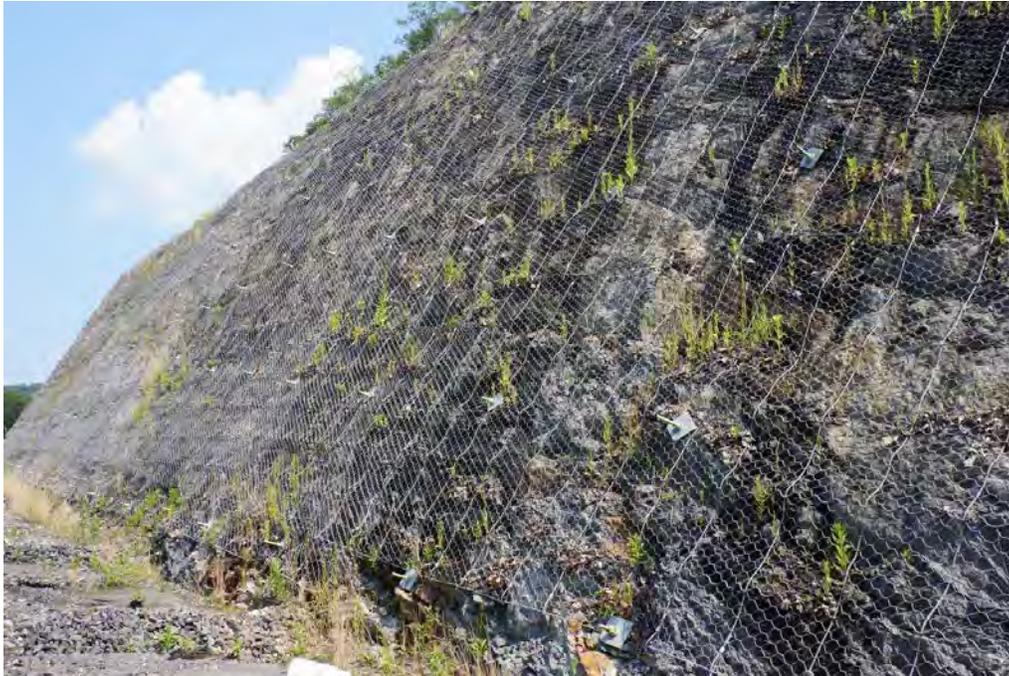
FIGURE 16 COMPLETED PROJECT IN SEGMENT 3

Approximately 13, 200 liner feet of soil nails were installed. Five percent of the production was tested to twice their design bond strength, and ten nails were evaluated to more than their ultimate strength.

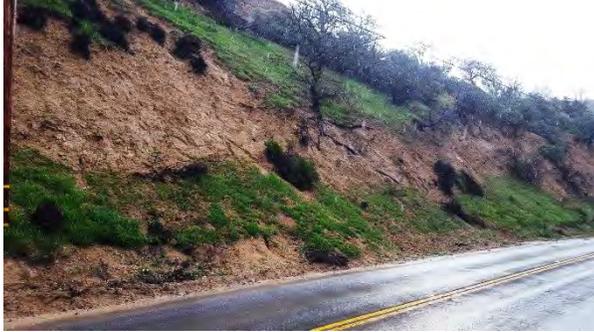
Case	Example
<p><i>φ-c Soil: Stiff clay, clayey sand or gravel, some silty sand with inherent cohesion or cementation.</i></p> <p>Slope has factor of safety of at least 1.0 at design slope inclination. Slide debris and unstable material (observe along base of slope) is removed prior to placing the mesh.</p> <p>Critical failure surface is typically from surficial instability or toe failure. Ground anchor spacing and depth can provide additional stability to meet slope stability criteria; however, overall approach is to develop a weather-resistant facing on the slope using wire mesh and vegetation.</p> <p>Wire mesh may be combined with temporary erosion control mats placed below the wire mesh and vegetation to stabilize slope face and provide long-term stability.</p>

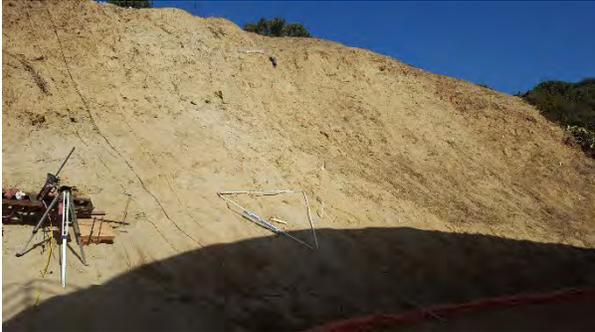
<p><i>Cohesionless Soil: Clean sand or gravel with no cohesion or cementation.</i></p> <p>Slope has factor of safety of 1.0 at the angle of repose. Vertical slopes are only temporarily stable from moisture and vulnerable to collapse.</p> <p>Critical failure surface is surficial instability commonly manifested as sand flows near the slope face and generally long shallow surfaces.</p> <p>Wire mesh combined with rolled erosion control products and planting help stabilize sandy soil and resist long term erosion.</p>

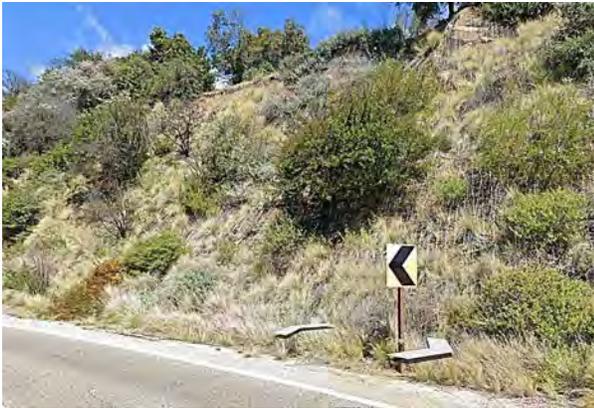
<p><i>Severe erosion in rocky ground in colluvium, residual soil or weathered rock.</i></p> <p>Slope has factor of safety of at least 1.0 at design slope inclination. Slide debris and unstable material is removed prior to placing the mesh.</p> <p>Slope is inherently stable but erosion around blocks of rock and weathering results in slipouts and rockfalls.</p> <p>Ground anchors are primarily used to anchor wire mesh to the slope face. Wire mesh holds blocks, boulders and rock in place helping to reduce erosion and rockfall.</p>

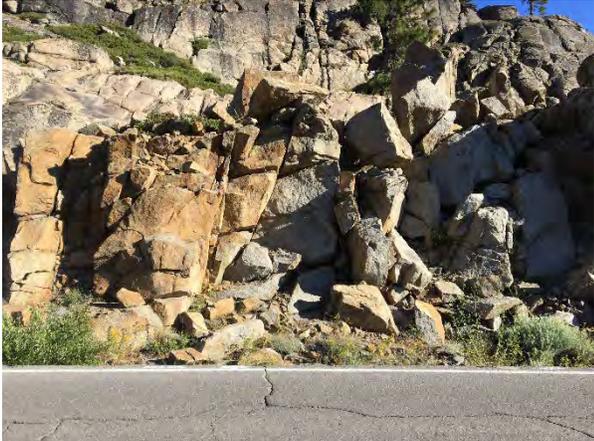
Case	Example
<p><i>Rock Slopes: Fracture rock of various types and hardness with stability primarily controlled by rock strength and discontinuities.</i></p> <p>Instability is mainly manifested by rockslides and rockfall associated with structural discontinuities within the rock (joints, fractures, bedding) or unstable wedges and blocks of rock.</p> <p>Analyze slope with discontinuity and rockfall analyses. Anchored mesh is typically not appropriate for these slopes because catchment of rockfall within the wire mesh above the road is problematic to remove and maintain. Rock bolting, doweling, and slope drapery systems can be designed to improve slope stability and provide catchment for rockfall.</p>

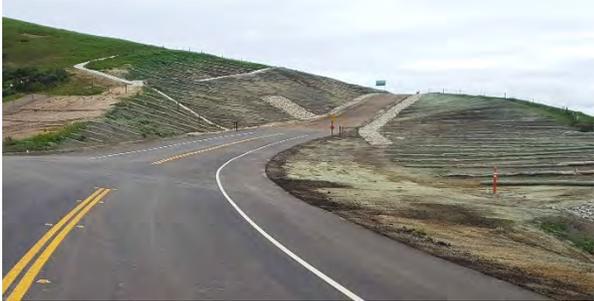
<p><i>Slopes well below angle of repose: Graded or soil slopes that are relatively stable but may have isolated erosion or instability due to concentrated runoff, severe storm event, springs, or saturation during spring thaw.</i></p> <p>Employ typical erosion control, surface drainage and methods appropriate for stable or graded slopes. Consider need for maintenance (mowing) that may not be conducive to wire mesh or other methods.</p>

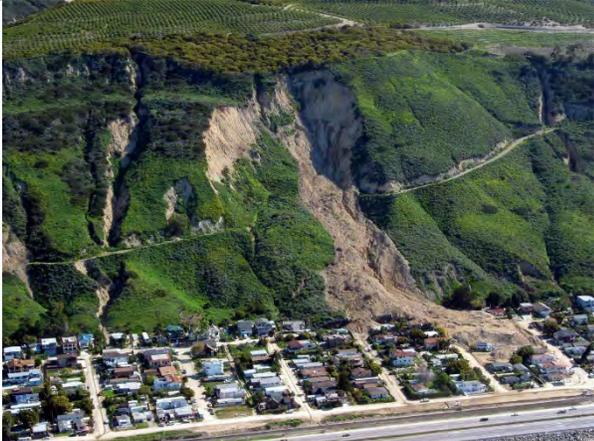
<p><i>Deep-seated Landslide: Large, deep-seated landslides and earth flows</i></p> <p>Slide is characterized by deep-seated movement, may have multiple failure plains, is active and may be moving.</p> <p>Stabilization is not appropriate for an anchored wire mesh system. Characterization and analysis is complex and requires a more comprehensive engineered solution than provided by a typical anchored wire mesh system design.</p>

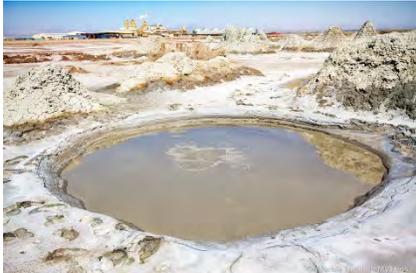
Figure 2: Typical mud pot

Just east of the Salton Sea, two heavily used railroad tracks move freight from the ports of Southern California south and east to other parts of the country. This seismically active area is located at the southern end of the San Andreas Fault. Associated with the seismic activity are gas driven features called mud pots, or mud volcanoes (Figure 1).

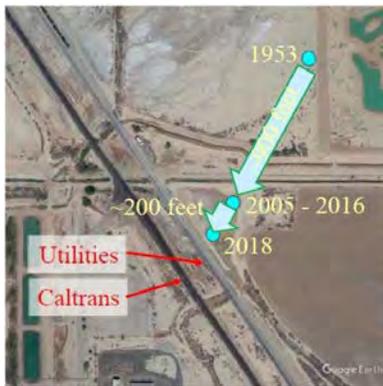
Figure 3: Mud Pot Migration

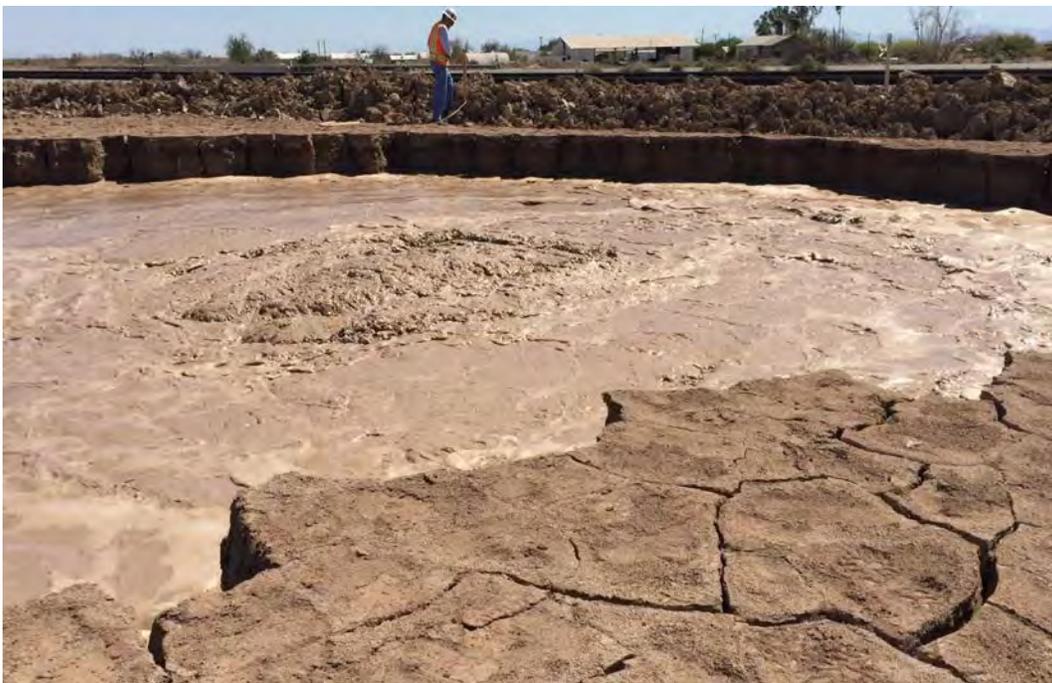
In May of 2018 the mud pot was a large actively bubbling feature approximately 80 feet from the active rail line (Figure 5). Concerns about erosion to the rail bed necessitated efforts to mitigate or control the mud pots movement until a permanent solution could be developed.

Figure 5: Mud Pot Approaching Tracks May 2018

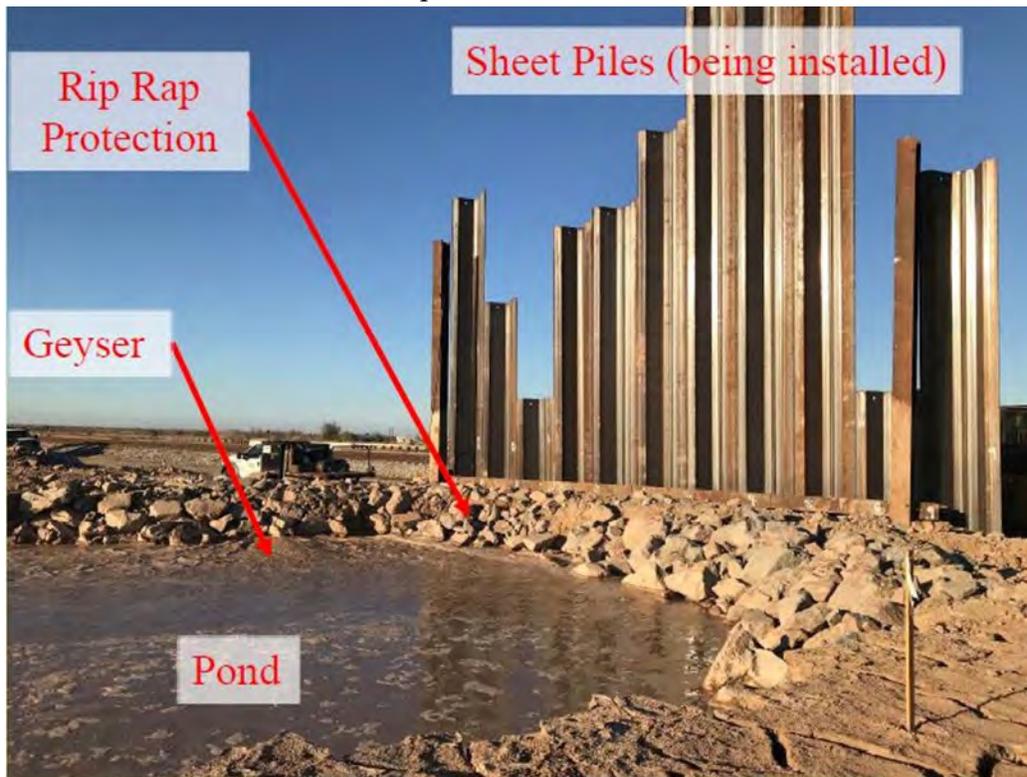
Figure 6: Installation of Sheet Pile Barrier

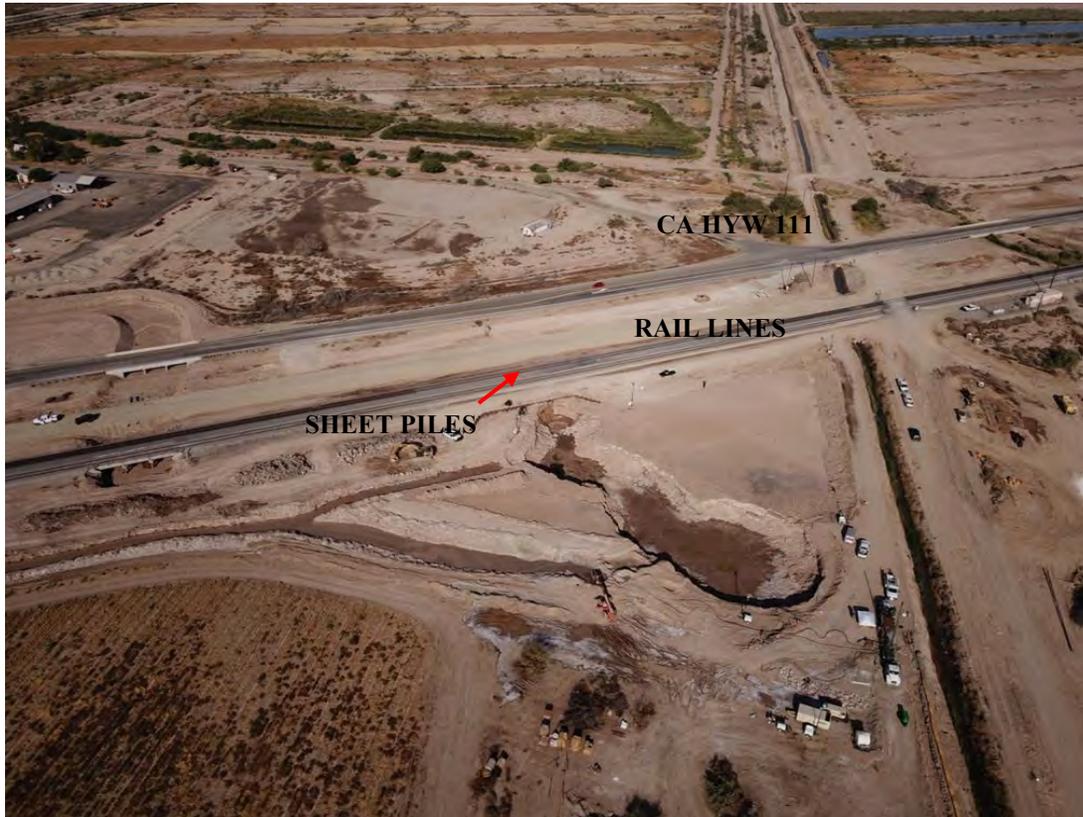
Once the sheet piles were in place the water in the Caldera was lowered approximately 25 feet using large centrifugal pumps at rate of up to 30 gallons per minute, 24-hours a day. The pumping resulted in a large, dewatered basin where the mud pot had been and was currently located (Figure 7). The mud spring approached the sheet piles in mid-July 2018 and remained contained behind the sheet piles for over three months. During this period three pressure relief wells were installed in an attempt to decrease the volume of water being expelled from aquifers near the surface by the high-pressure CO₂ gas.

Figure 7: Dewatered Mud Pot Caldera

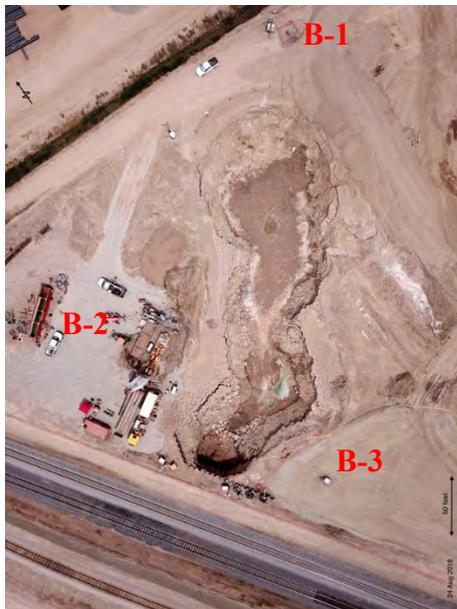
Figure 8: Location of Pressure Relief Wells

were installed. There appeared to be a slight decrease in activity from the adjacent mud pot after installation of the first relief well. Two additional relief wells B-2 and B-3) were then installed as close as feasible to the active face of the mud pot near the sheet pile wall (Figure 8). The second well B-2 was drilled to a depth of 800 feet but did not encounter any water bearing zones, just high-pressure CO₂ gas. The third well B-3 was drilled to a depth of 600 feet but no water was encountered.

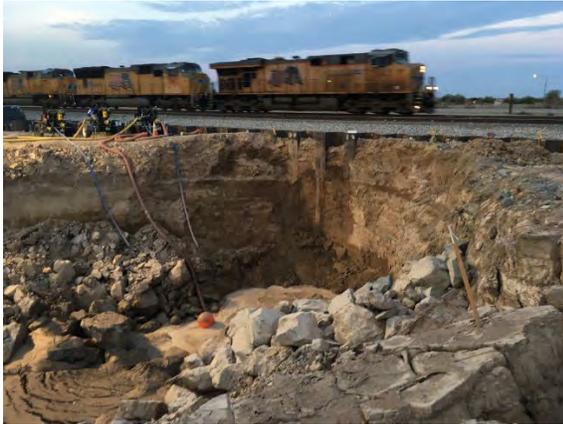
rip rap and eroded all the soil in front of the sheet piles after three months (Figure 9).

Figure 9: Mud Pot September 2018

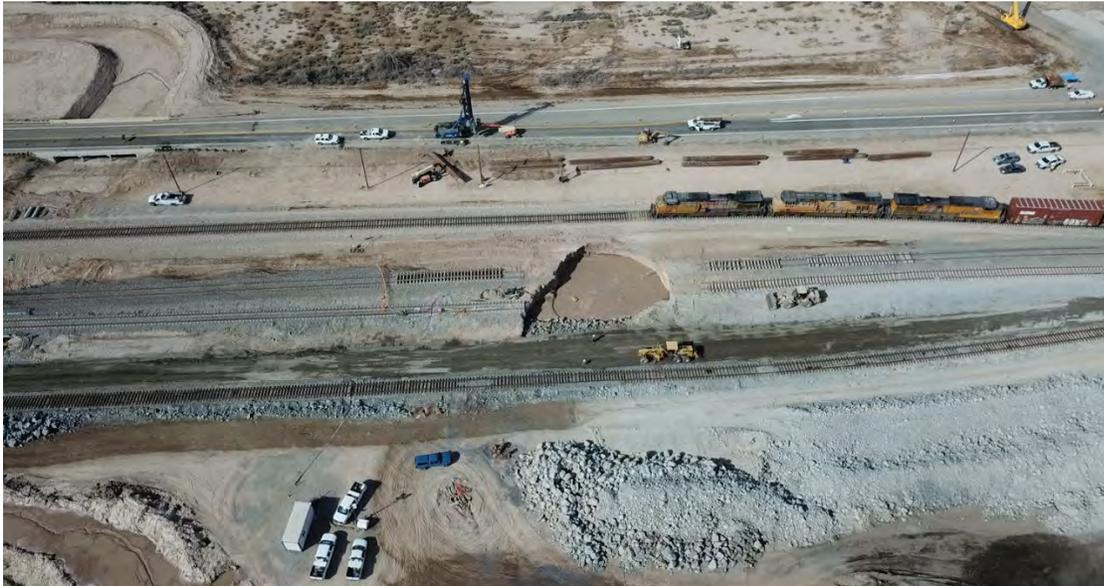
The mud pot continued its mostly westward movement the remainder of 2018 and into 2019. By July of 2019 the mud pot was centered over the former western main line rail track (Figure 10).

Figure 10: Mud Pot July 2019

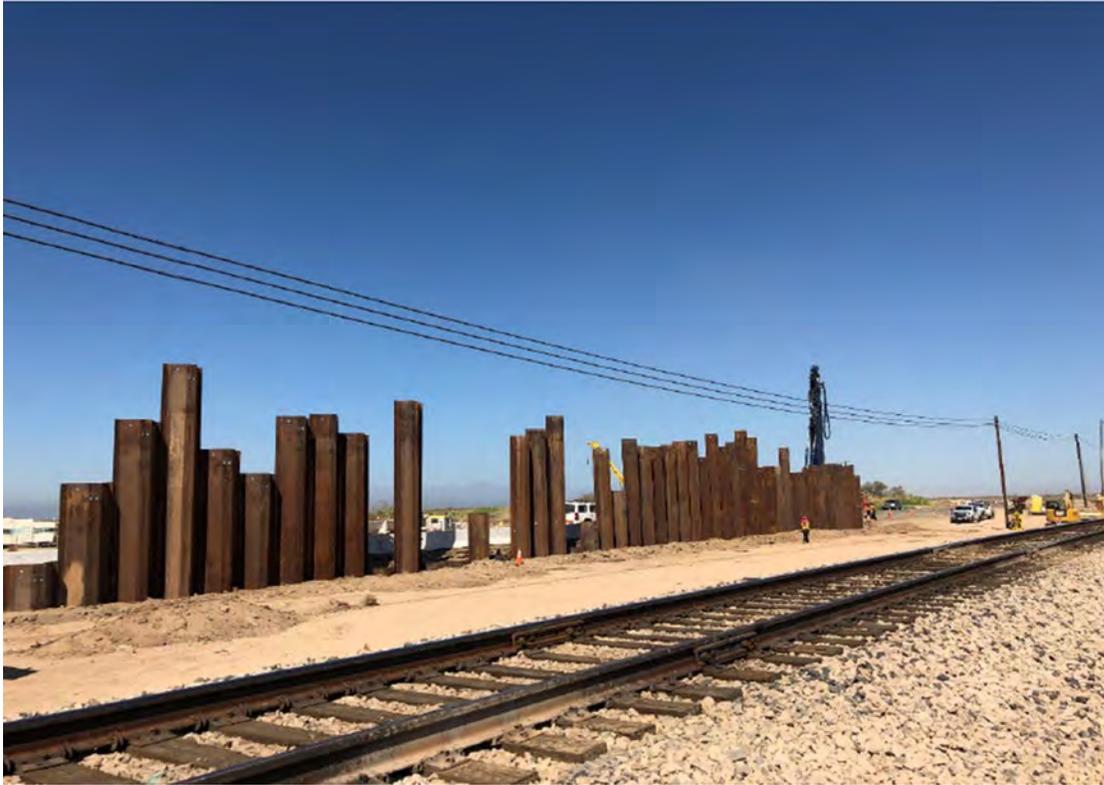
spring of 2019, CALTRANS began installation of a sheet pile wall on the east side of the highway right of way (Figure 11).

Figure 11: CALTRANS Sheet Pile Installation

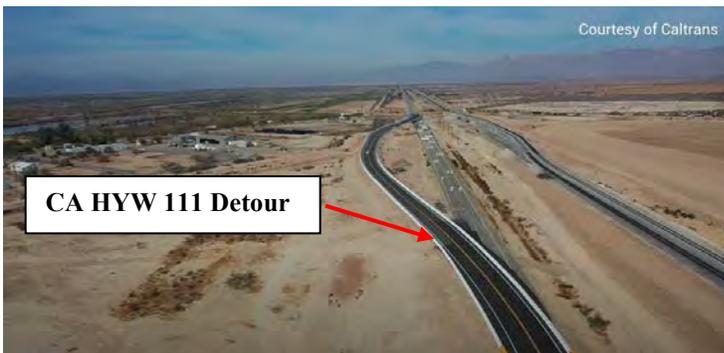
Figure 12: California Highway 111 Detour

western edge of the railroad right-of-way by the end of January 2020. In August 2020, Caltrans closed the state highway for several weeks while a detour road was constructed to the west (Figure 12). As it had done to the railroad sheet pile wall, the mud pot breached the CALTRANS sheet pile wall in the fall of 2020.

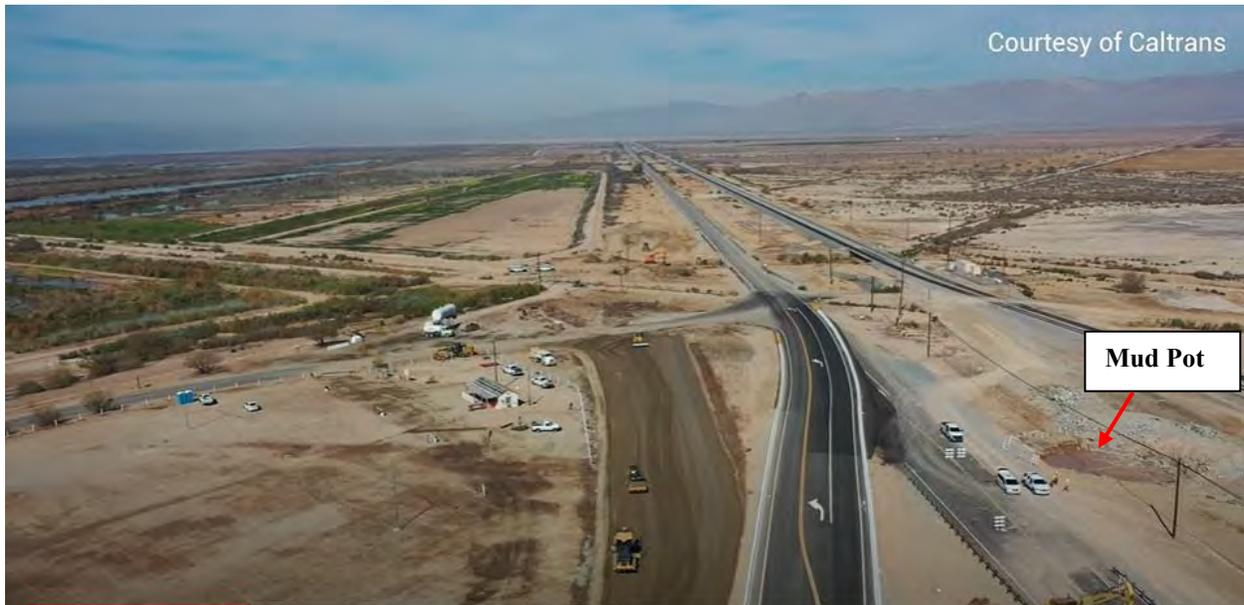
Figure 13: Mud Pot Position March 18, 2021

detour (Figure 13). The mud pot movement had now slowed to a forward rate of about 3 feet

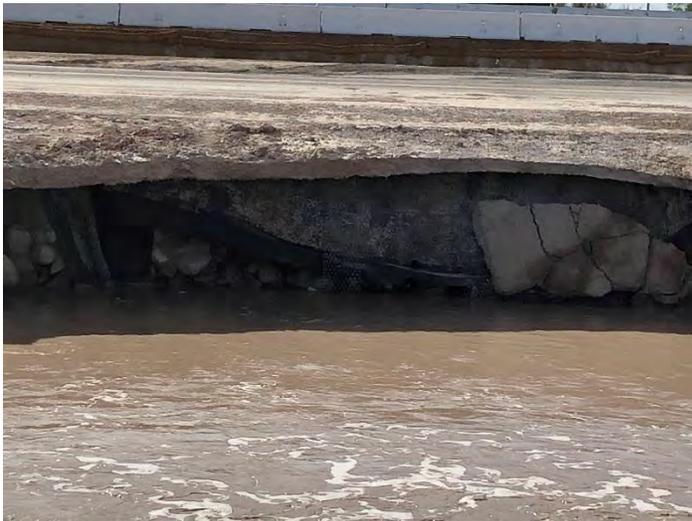
Figure 14: Mud Pot December 2021

per month. This rate was down from a rate of about 10 feet a month in 2018 and 2019. By December of 2021 the mud pot had moved to just under the paved section of the original Highway 111 alignment (Figure 14). At the current rate of movement, the mud pot will likely cross the old highway 111 road in 2022 and once this happens CALTRANS plans to rebuild SR-111 back to the east close to the original alignment for Highway 111. Of course the mud pots movement is still not well understood and it could decide to change direction or become stationary like all the other mud pots in the area.
