71st HIGHWAY GEOLOGY SYMPOSIUM

2022 Proceedings

**71st ANNUAL
HIGHWAY GEOLOGY SYMPOSIUM
Table of Contents**

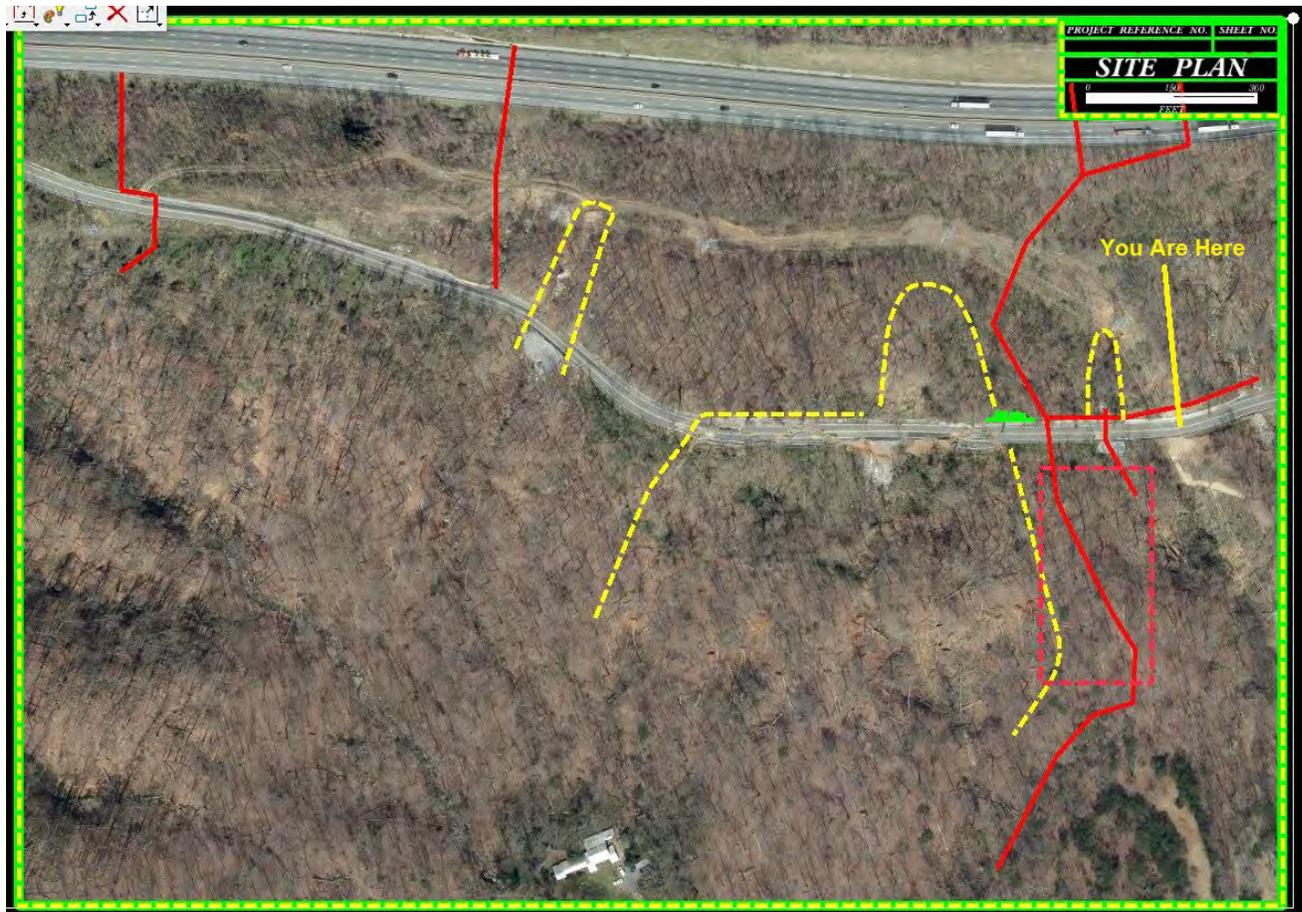
Overview: Yellow are slide areas, solid red is new drainage for the interstate. Dashed red box is location of pipe-jacking section under rare and endangered plant locations. It was vital to map out slide areas, for routing new drainage in stable locations.

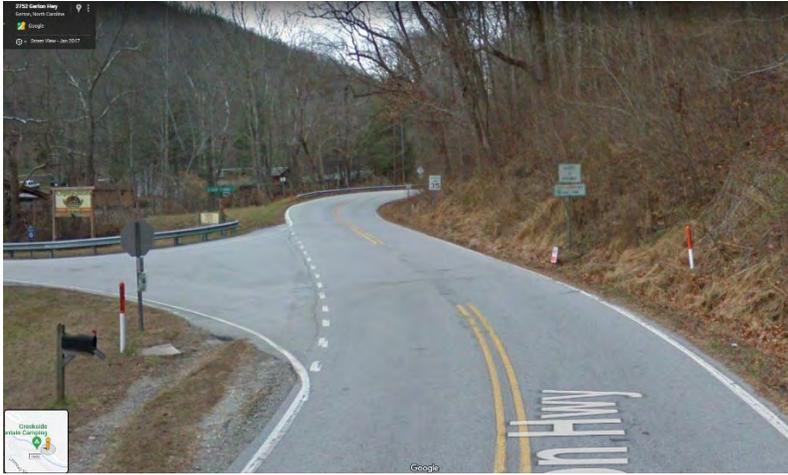
2017 Streetview showing minor ditchline creep. Generally stable for decades. After record rainfall in 2018 this developed into a slow rotational colluvial slide with continuous water and pavement uplift.

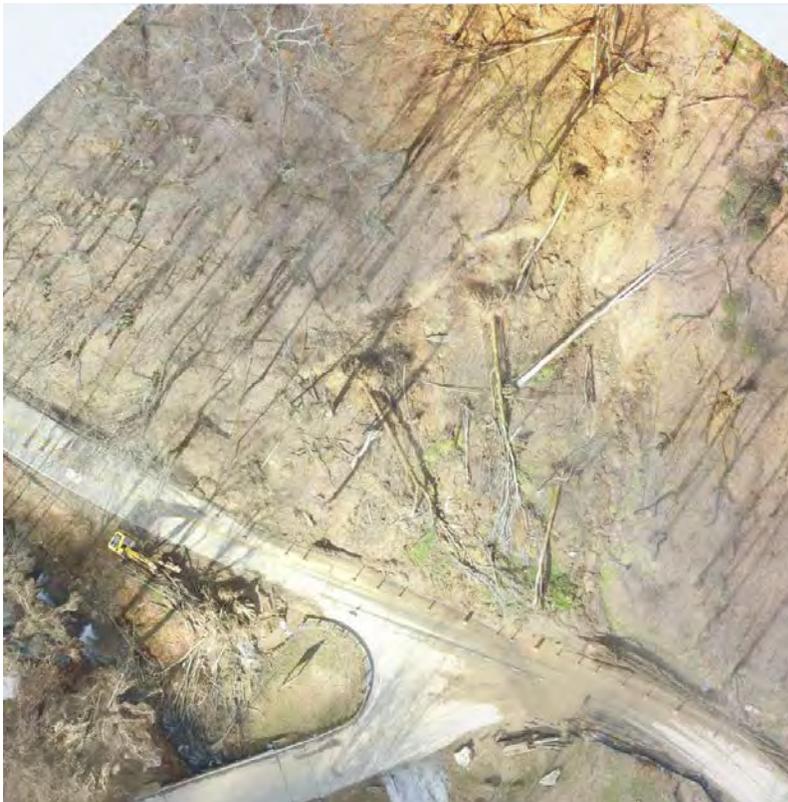
Slide mobilized and now consuming the road...Required multiple maintenance cleanups over a year.

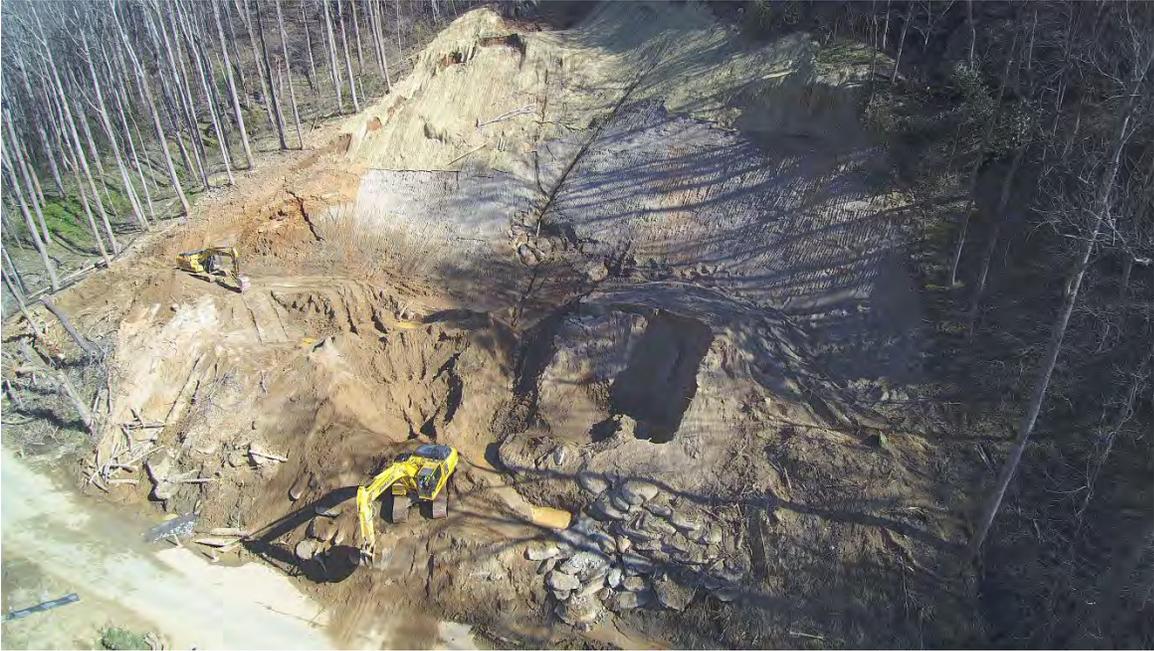
Due to the size of colluvial deposit and steepness; design decisions were rock buttress, shear key, subsurface drainage and generous catchment bench with cleanout access.

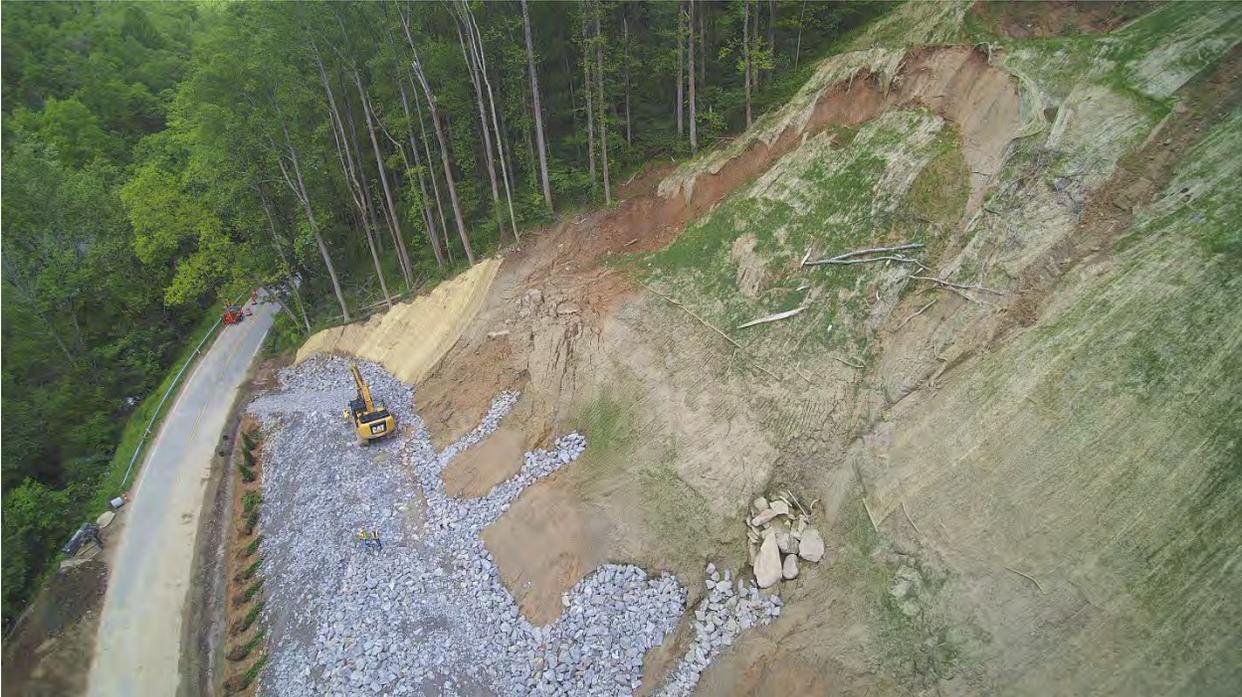
Finished product with scarps developing above.

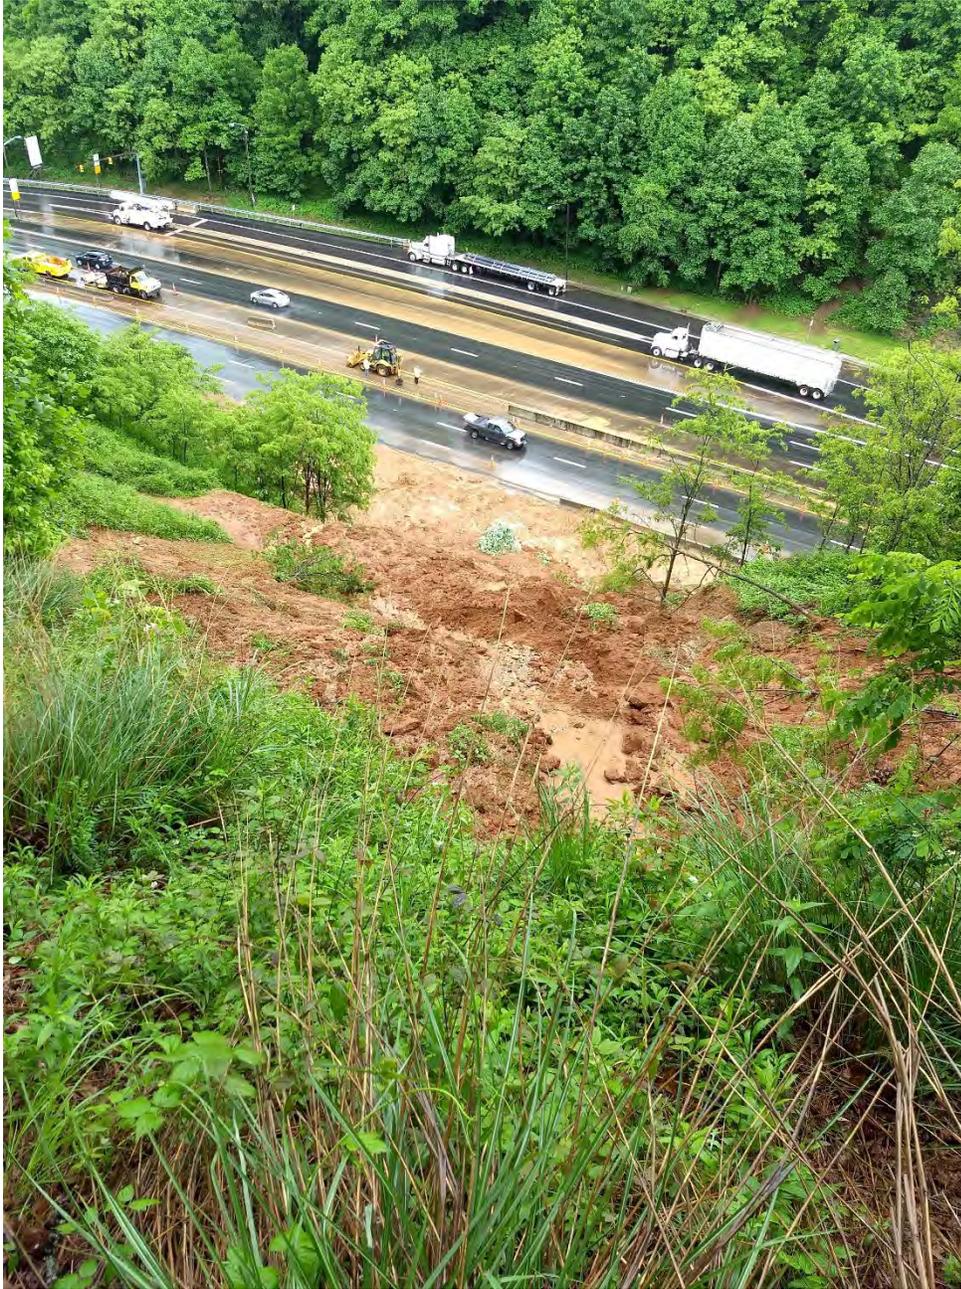
May 30, 2018. Top of current scarp. Slide blocked WB lanes and jumped barrier to EB lanes.

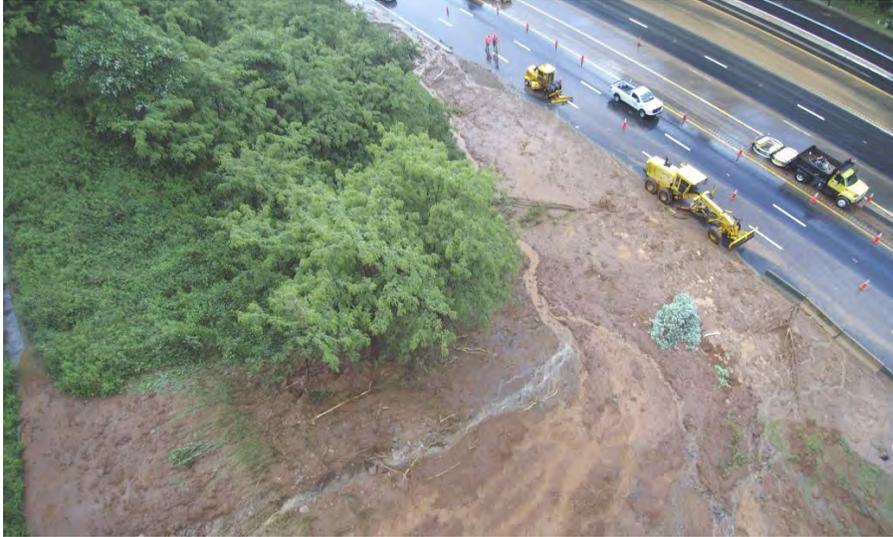
Slide runout with groundwater, mud, and weathered rock.

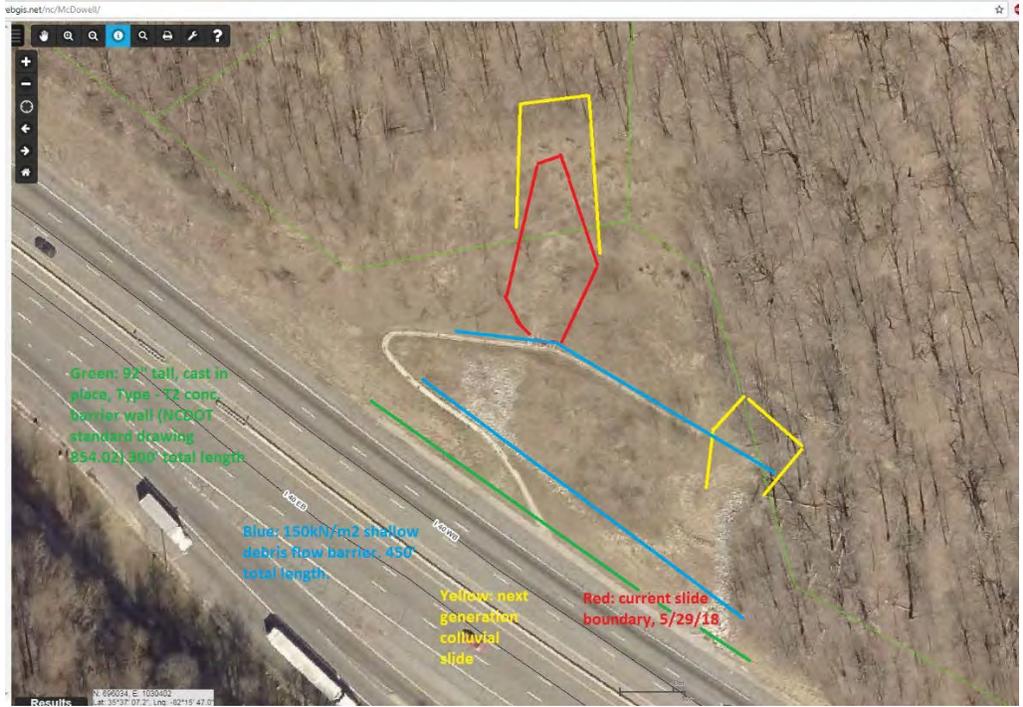
Mitigation design called for double landslide debris barriers with fixed shoulder barrier and access for cleanout.

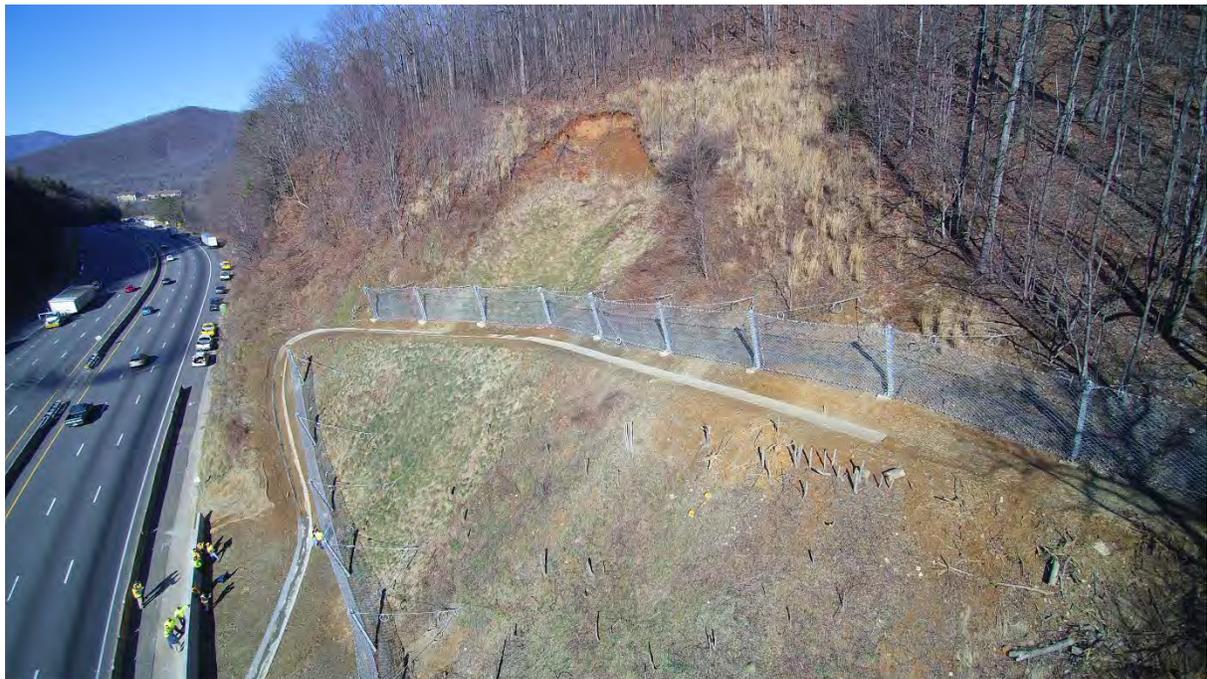
June 22, 2020. Final installation of elements

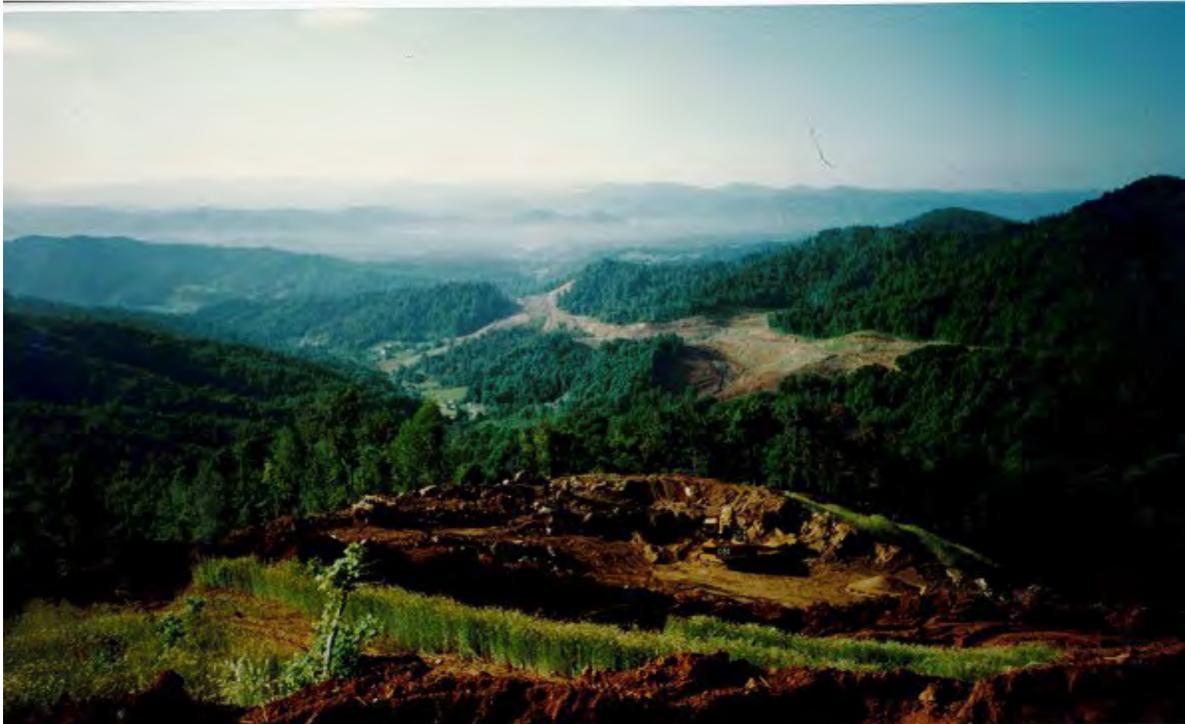
Top lift of Buckner Gap cut construction, looking South toward Asheville.

This cut section is the largest single excavation by NCDOT at nearly 4 million cubic yards. Investigation involved difficult roadbuilding access with surface mapping and multiple oriented core holes. Originally intended as a probabilistic design, ultimately deterministic was used yielding 1:1 on the west and 0.5:1 on the east. 70 tensioned rock anchors and an entire anchored shotcrete bench add stability on the east slope.

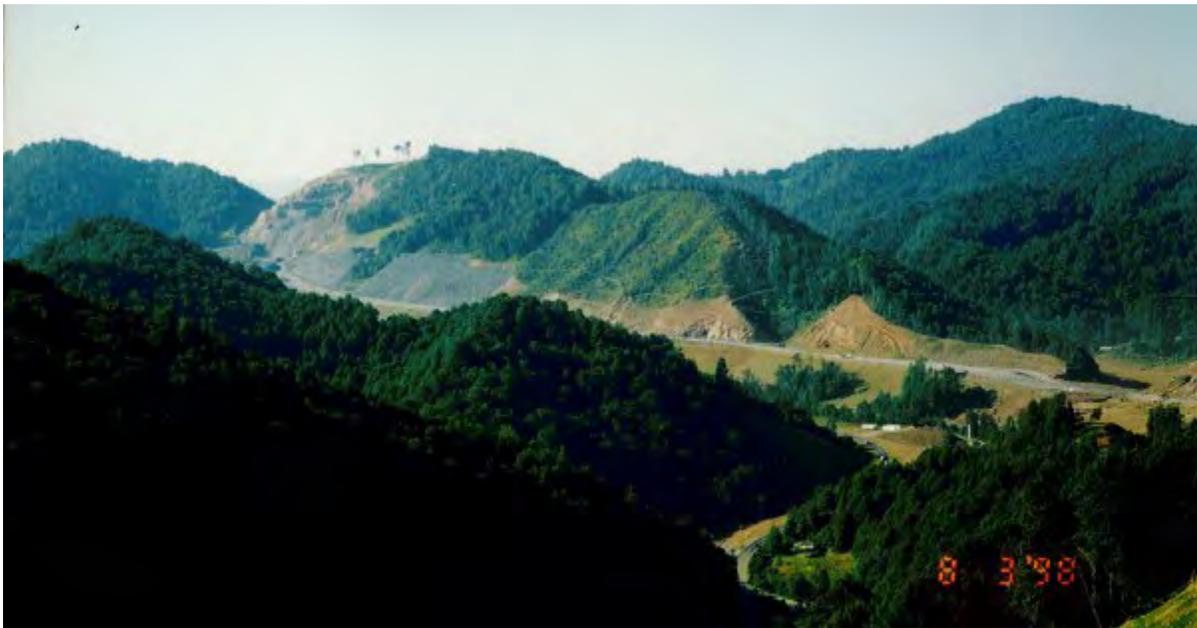
Looking toward Buckner Gap from the north. Cleared gap in distance. Large rock buttresses visible for soil slope support between rock cuts.

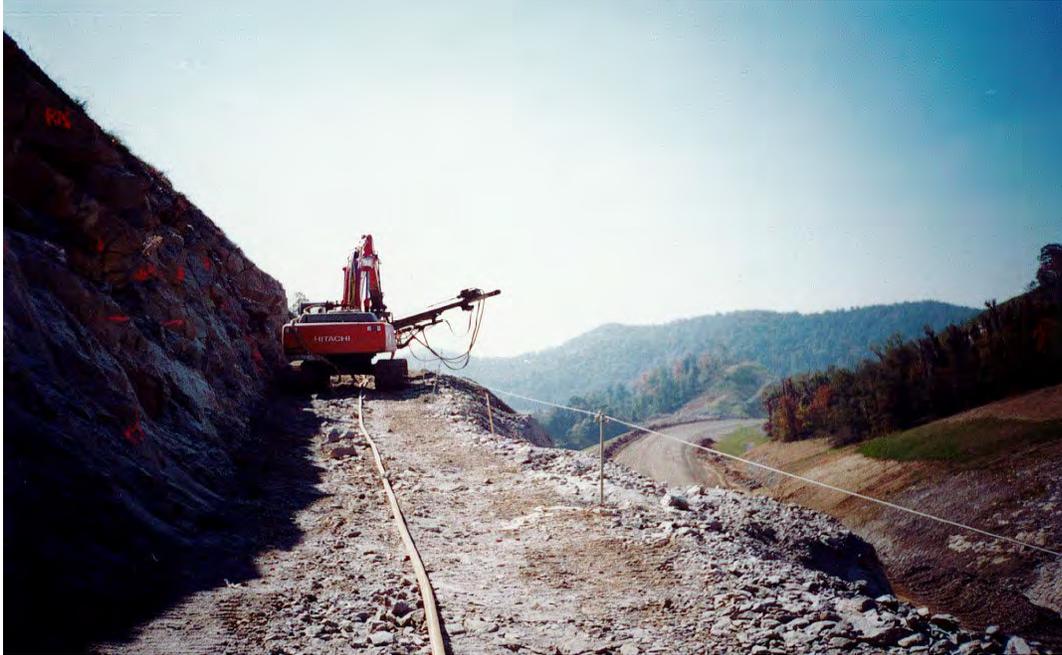
Buckner Gap, east face. Anchor and shotcrete stabilization.

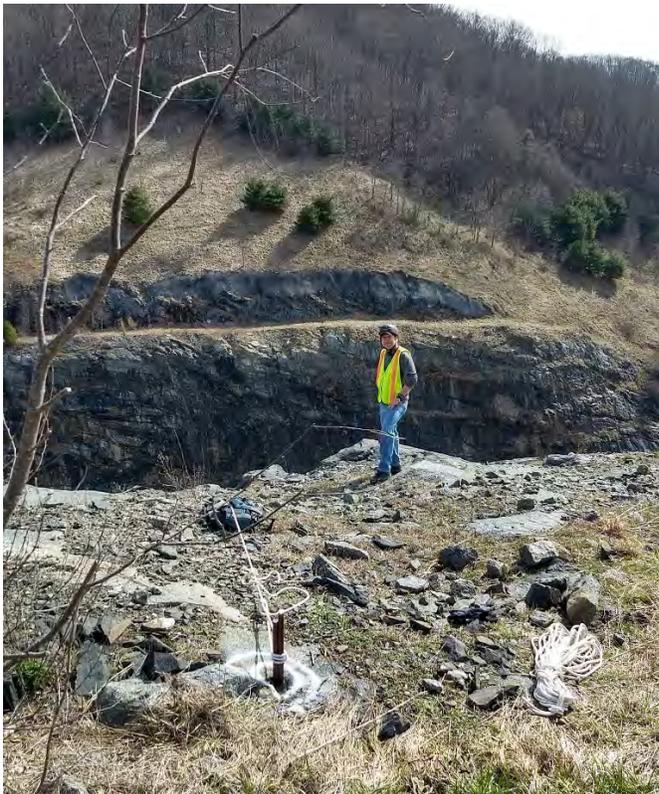
During construction holes were drilled across the benches to provide future rope access points, such as this Lidar study in 2020.

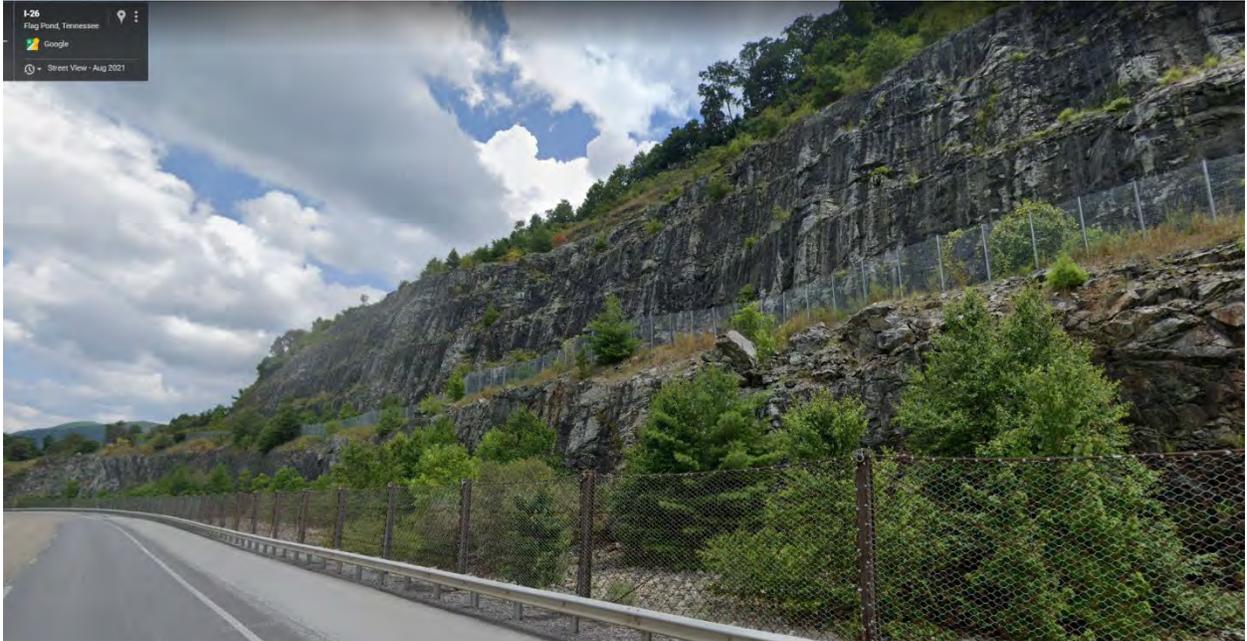
The Tennessee section of I-26 was completed 4 years before NC. Notable difference is the use of benched slopes and stacked rockfall fences.

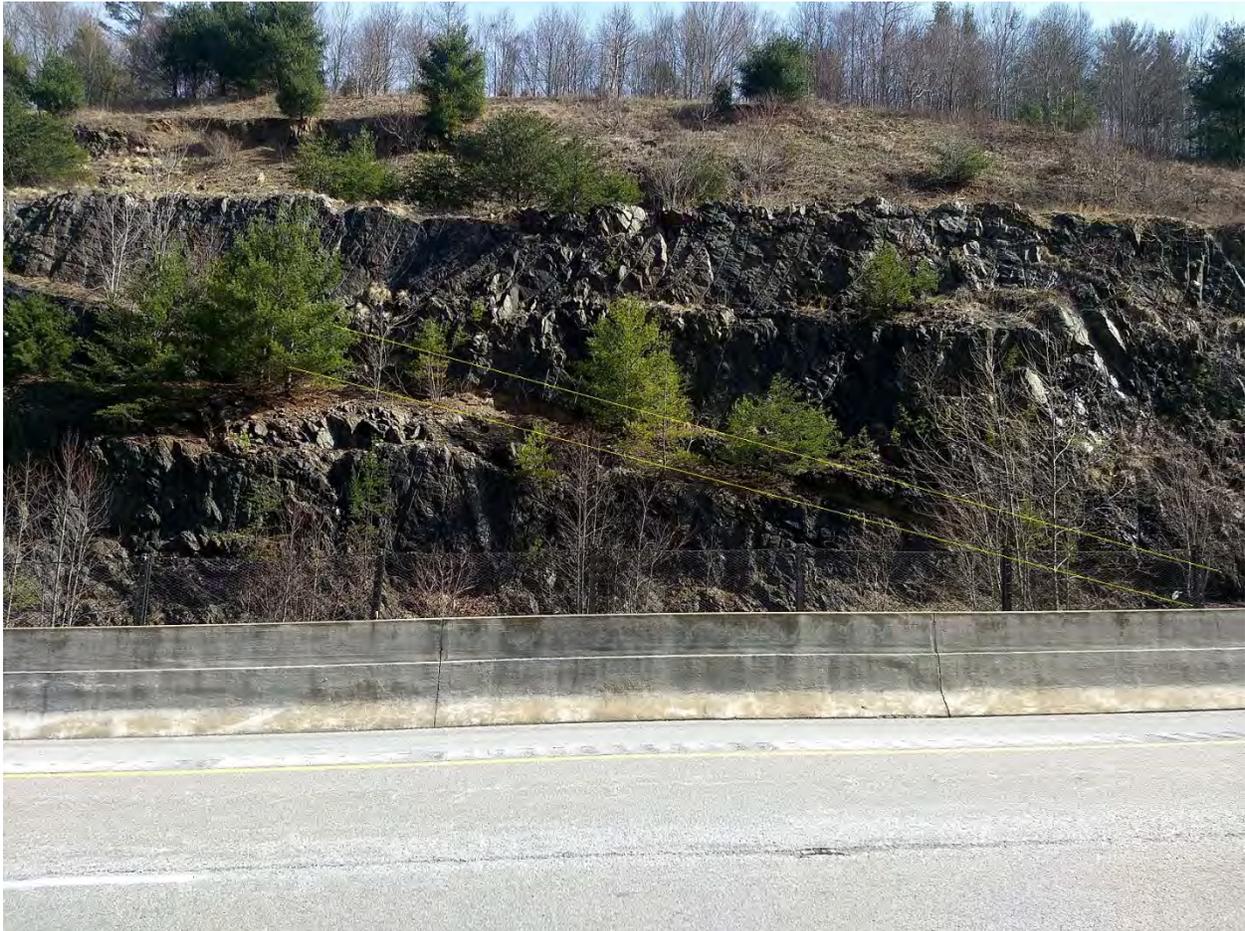
Flag Pond Cut (East face). Well exposed Blue Ridge thrusting within gneissic unit.

1,000' south of the turnaround at Flag Pond (back toward Asheville) is good exposure of a thrust fault on the left side large cut. Iron sulfates at the base of the hanging wall required treatment and encapsulation within the Flag Pond exit embankment (Harry Moore).

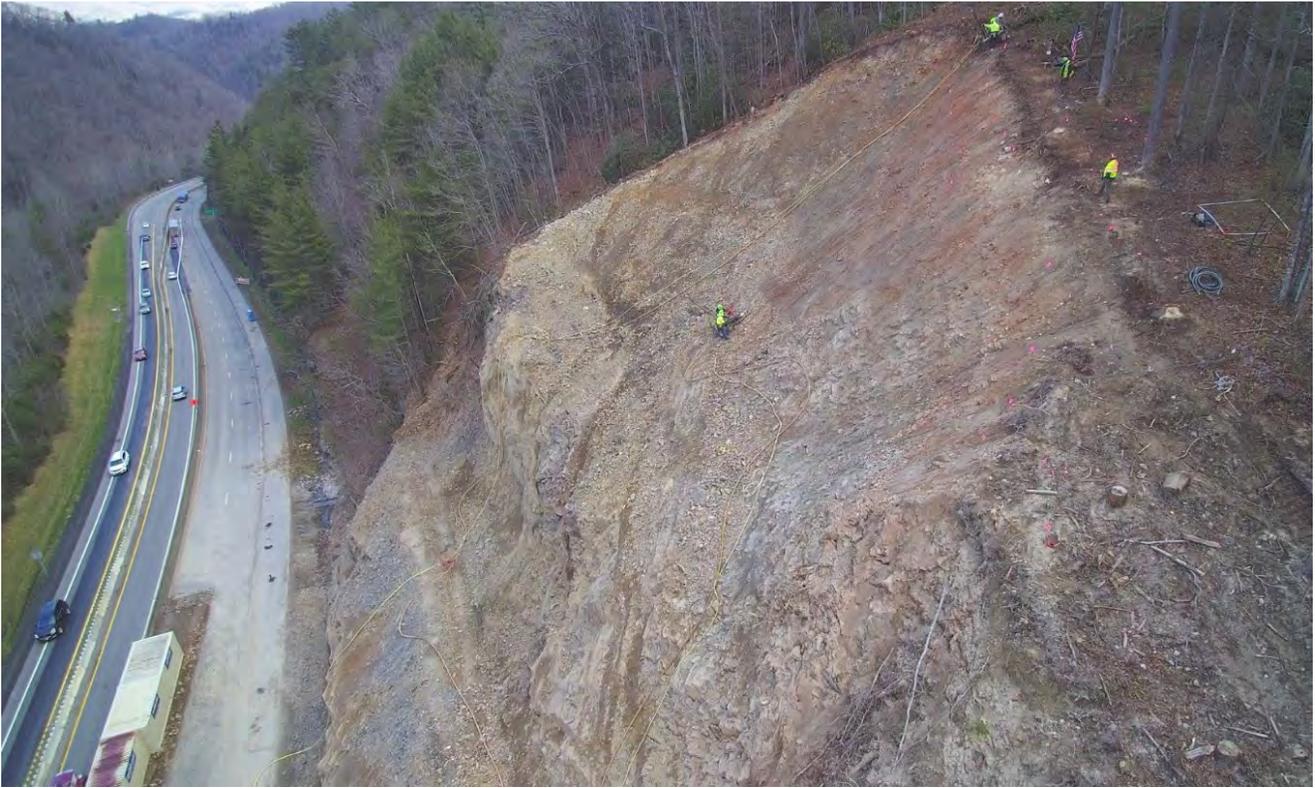
I-40, MM 7.5, Anchor installation

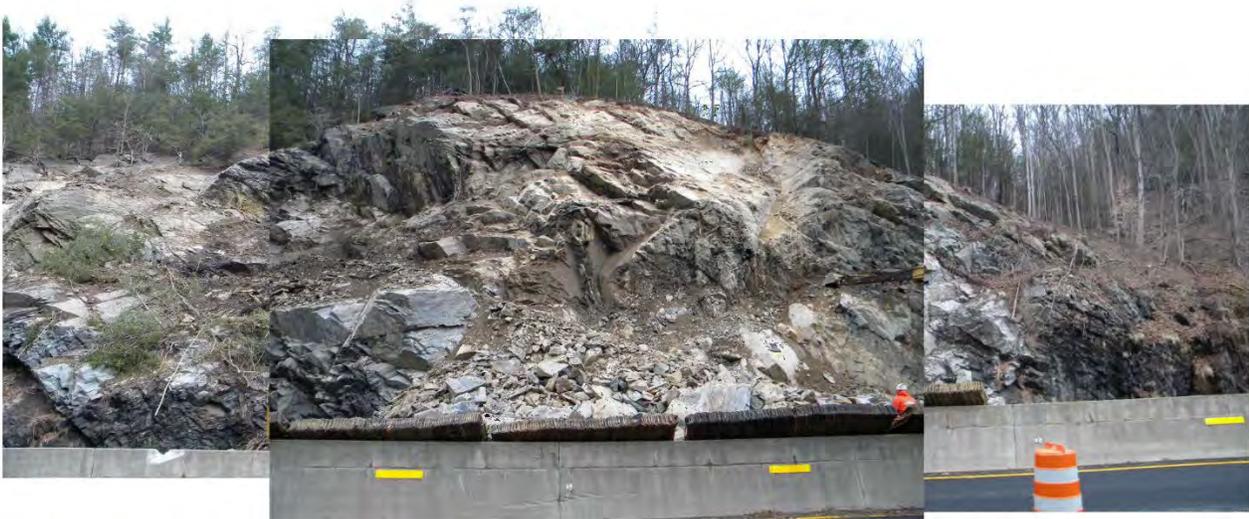
I-40, MM 7, January 2010, Complete blockage of WB lanes, median matted for scaling. Eventually covered with drape and a bench attenuator.

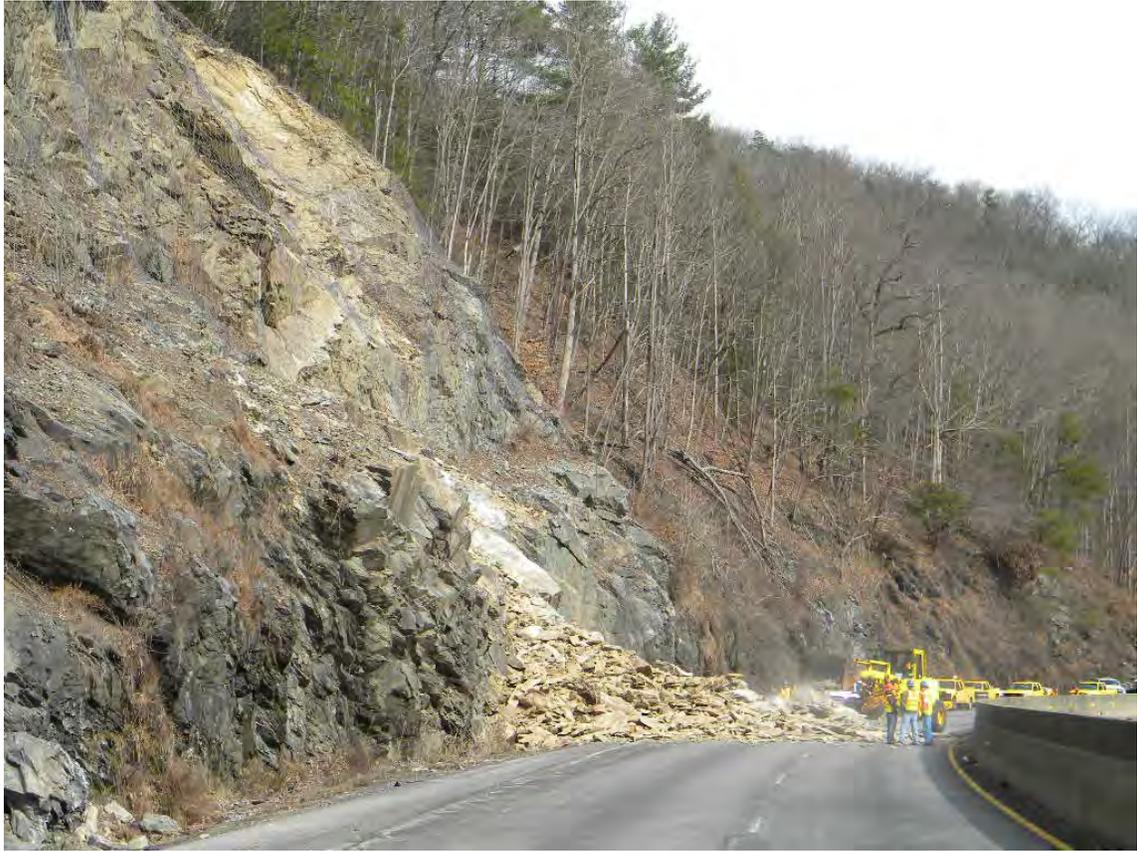
I-40, MM 7, Failure in 2012

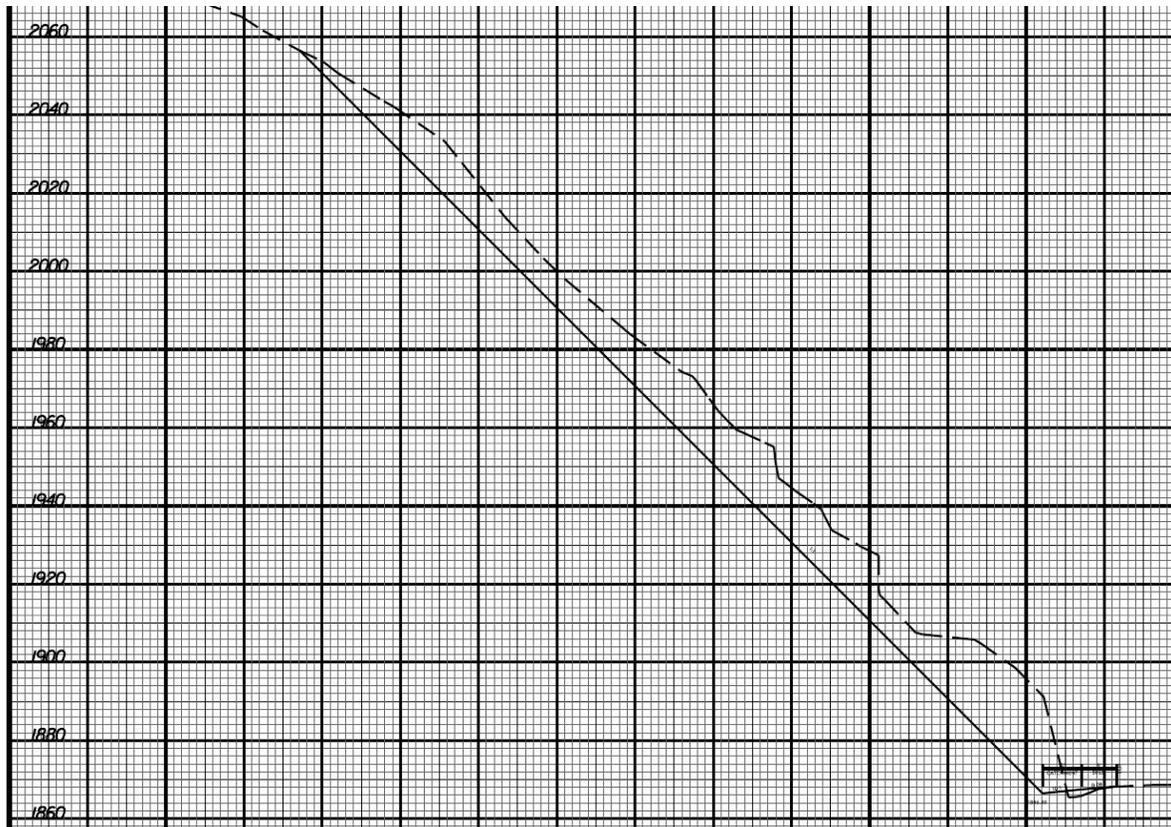
Typical XSC with 10' catchment, rockfall fence and new shoulder.

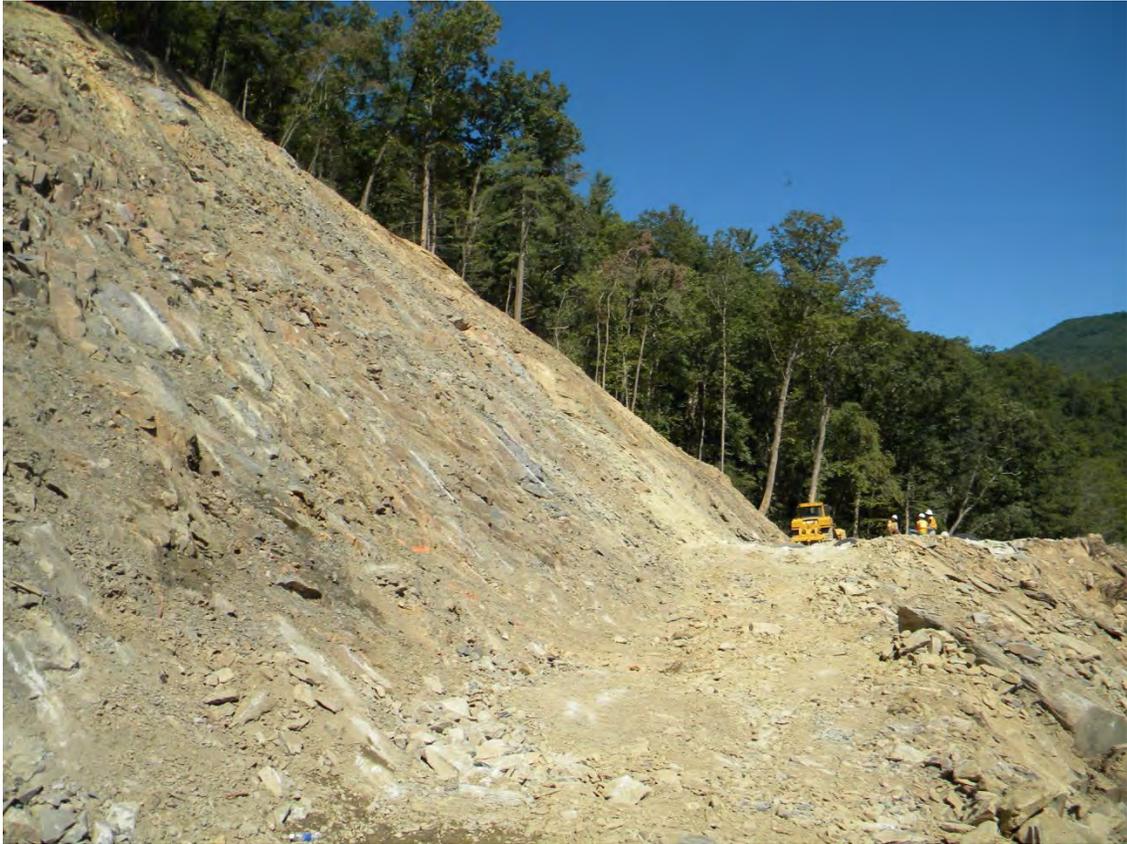
I-40, MM 7, top lifts at 1:1

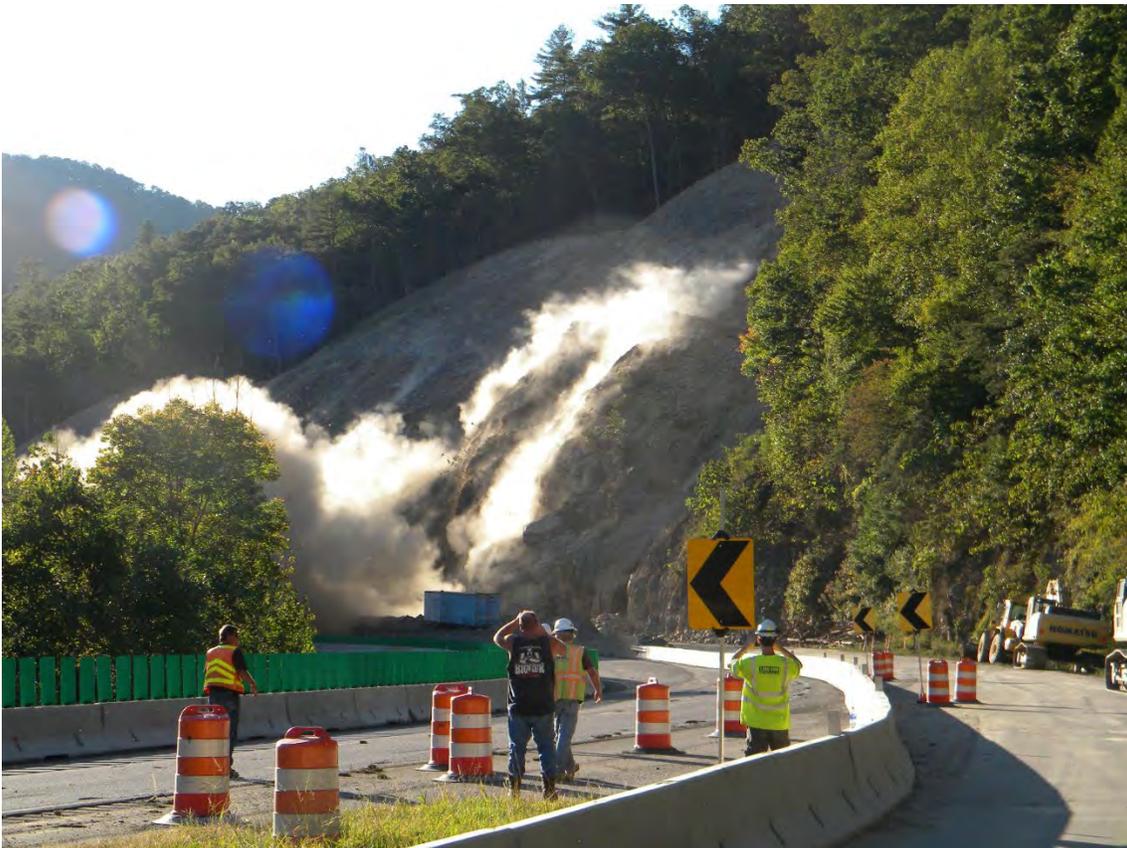
Blasting conducted with a 15 minute clearing window for traffic

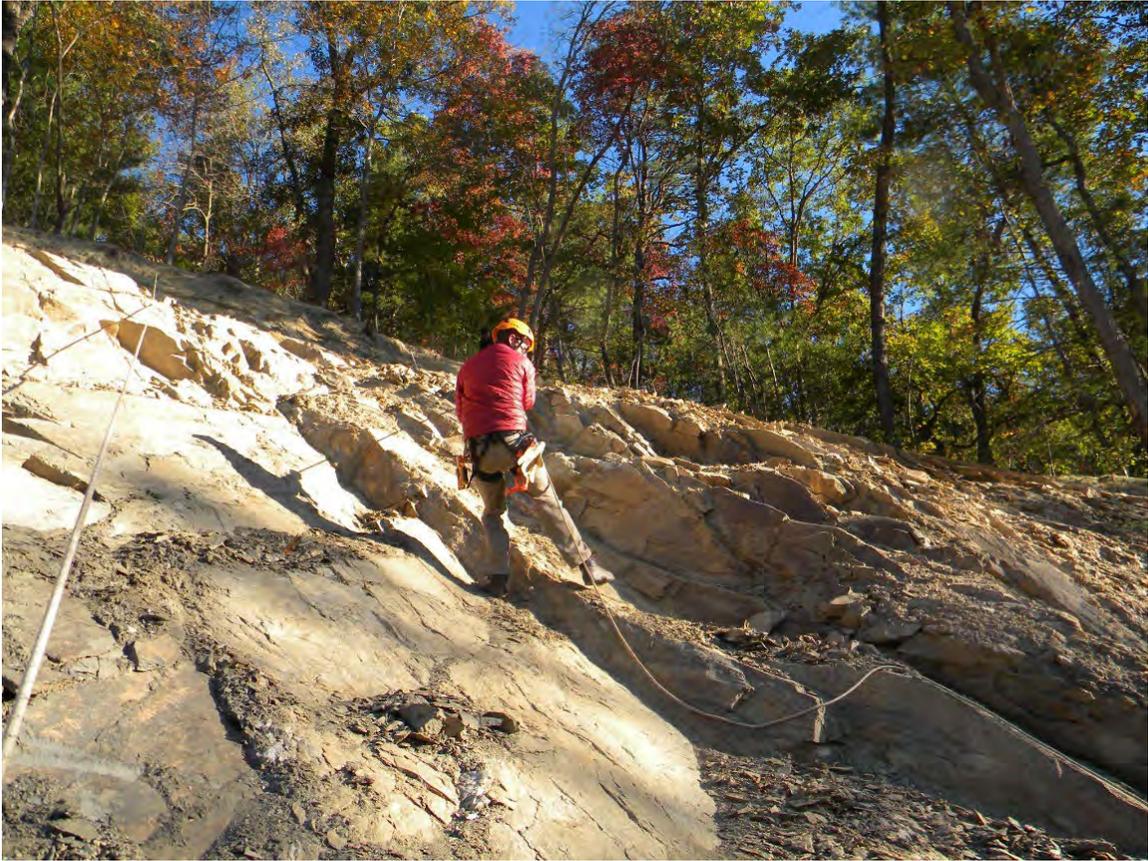
Marking anchored mesh for weathered top interface

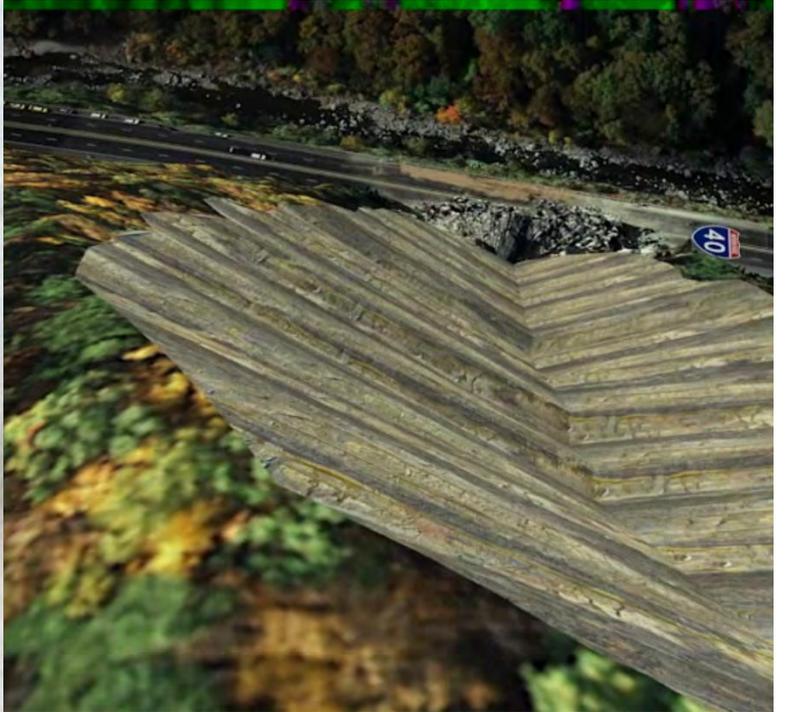
Survey of wedge edges w/ waviness

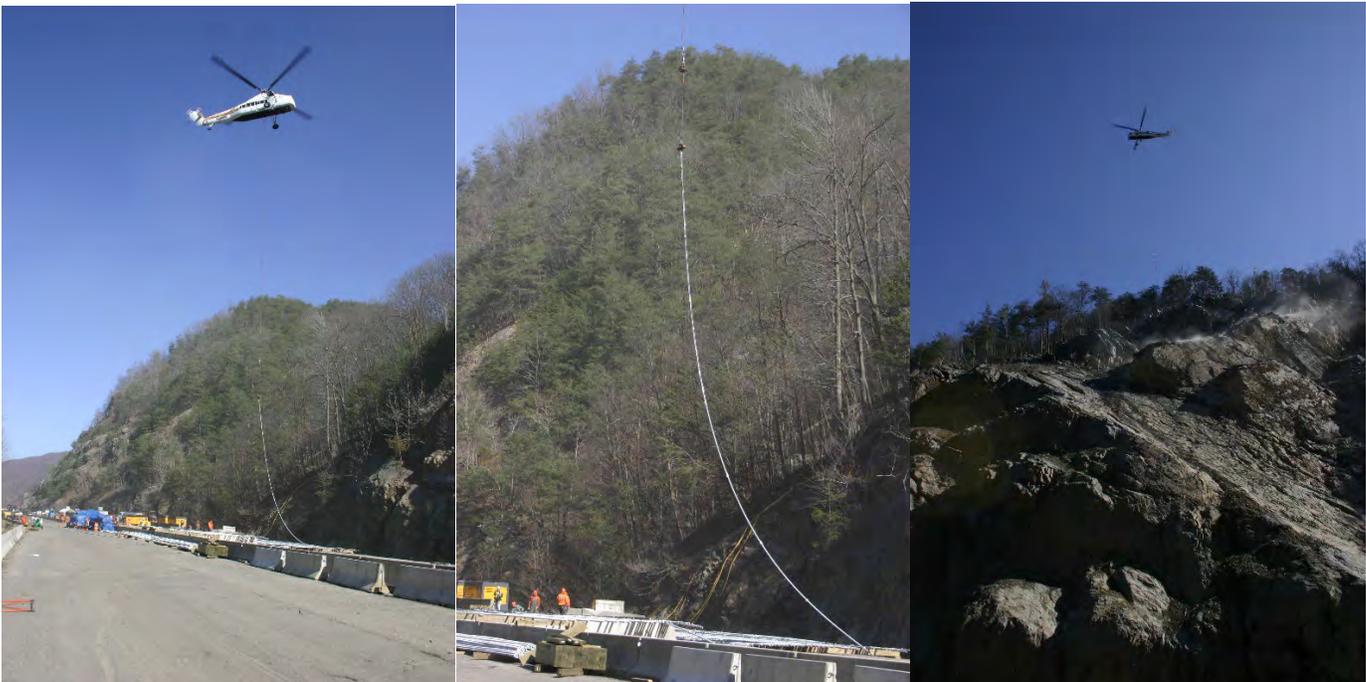
Helicopter anchor pickup and installation. 592 anchors up to 150' in length.

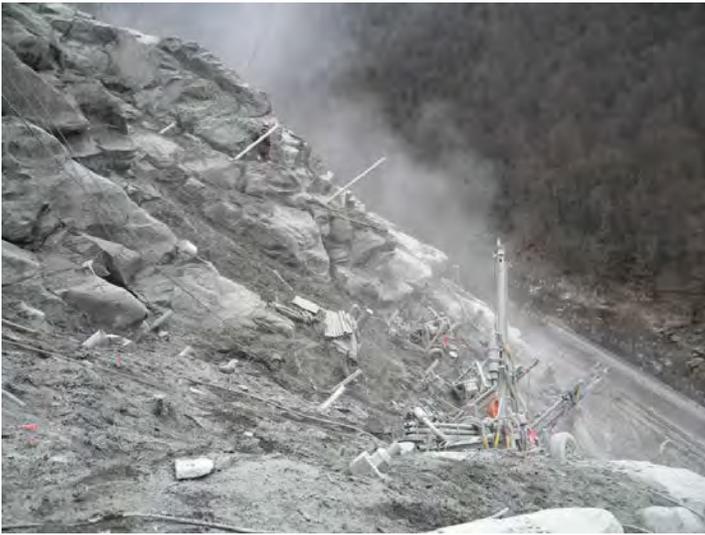
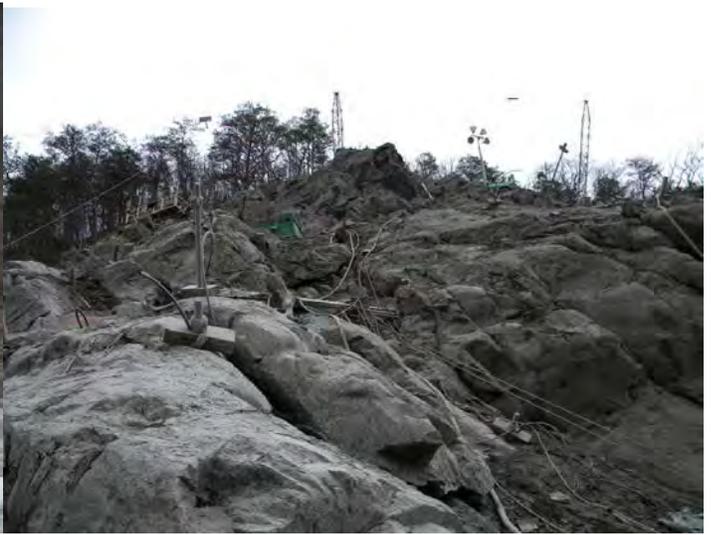
Site drilling: 10 drills, 24 hours per day, 3 months...

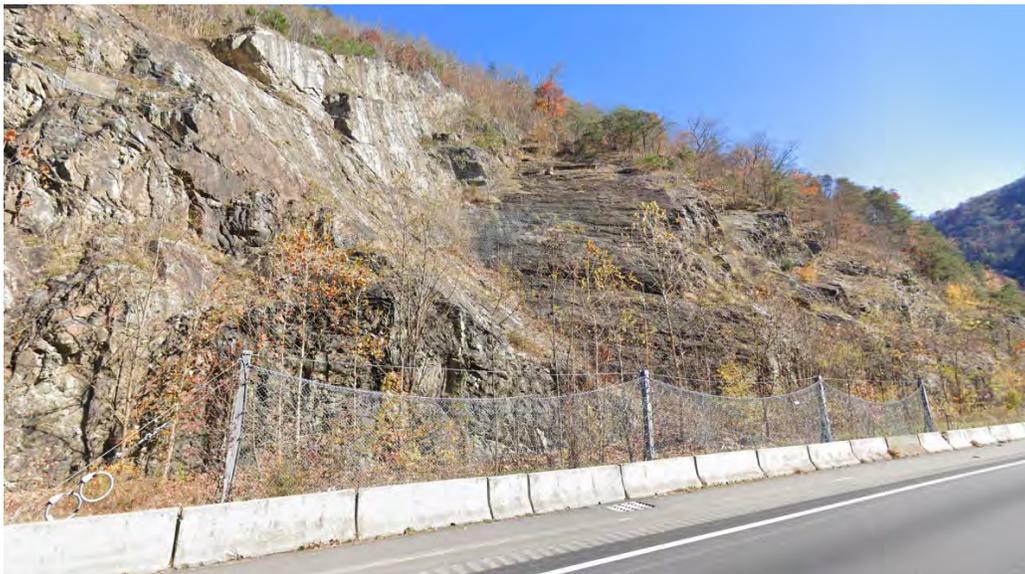
Verifying and testing-

Final slope today, home of the hardest working rockfall fence in NC.

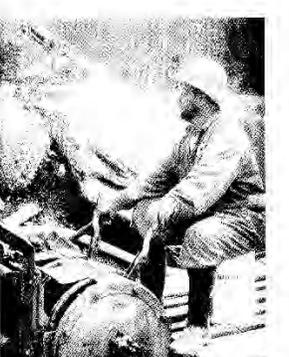
Use of a 25 HP Air Winch for Movement of Materials up the Slope

Special air winches and power saw winches were used to move heavy chain blocks weighing 1,570 pounds (709kg), and five rock fall mats weighing 600 pounds (270kg) per roll up the slope.
