71st HIGHWAY GEOLOGY SYMPOSIUM

2022 Proceedings

**71st ANNUAL
HIGHWAY GEOLOGY SYMPOSIUM
Table of Contents**

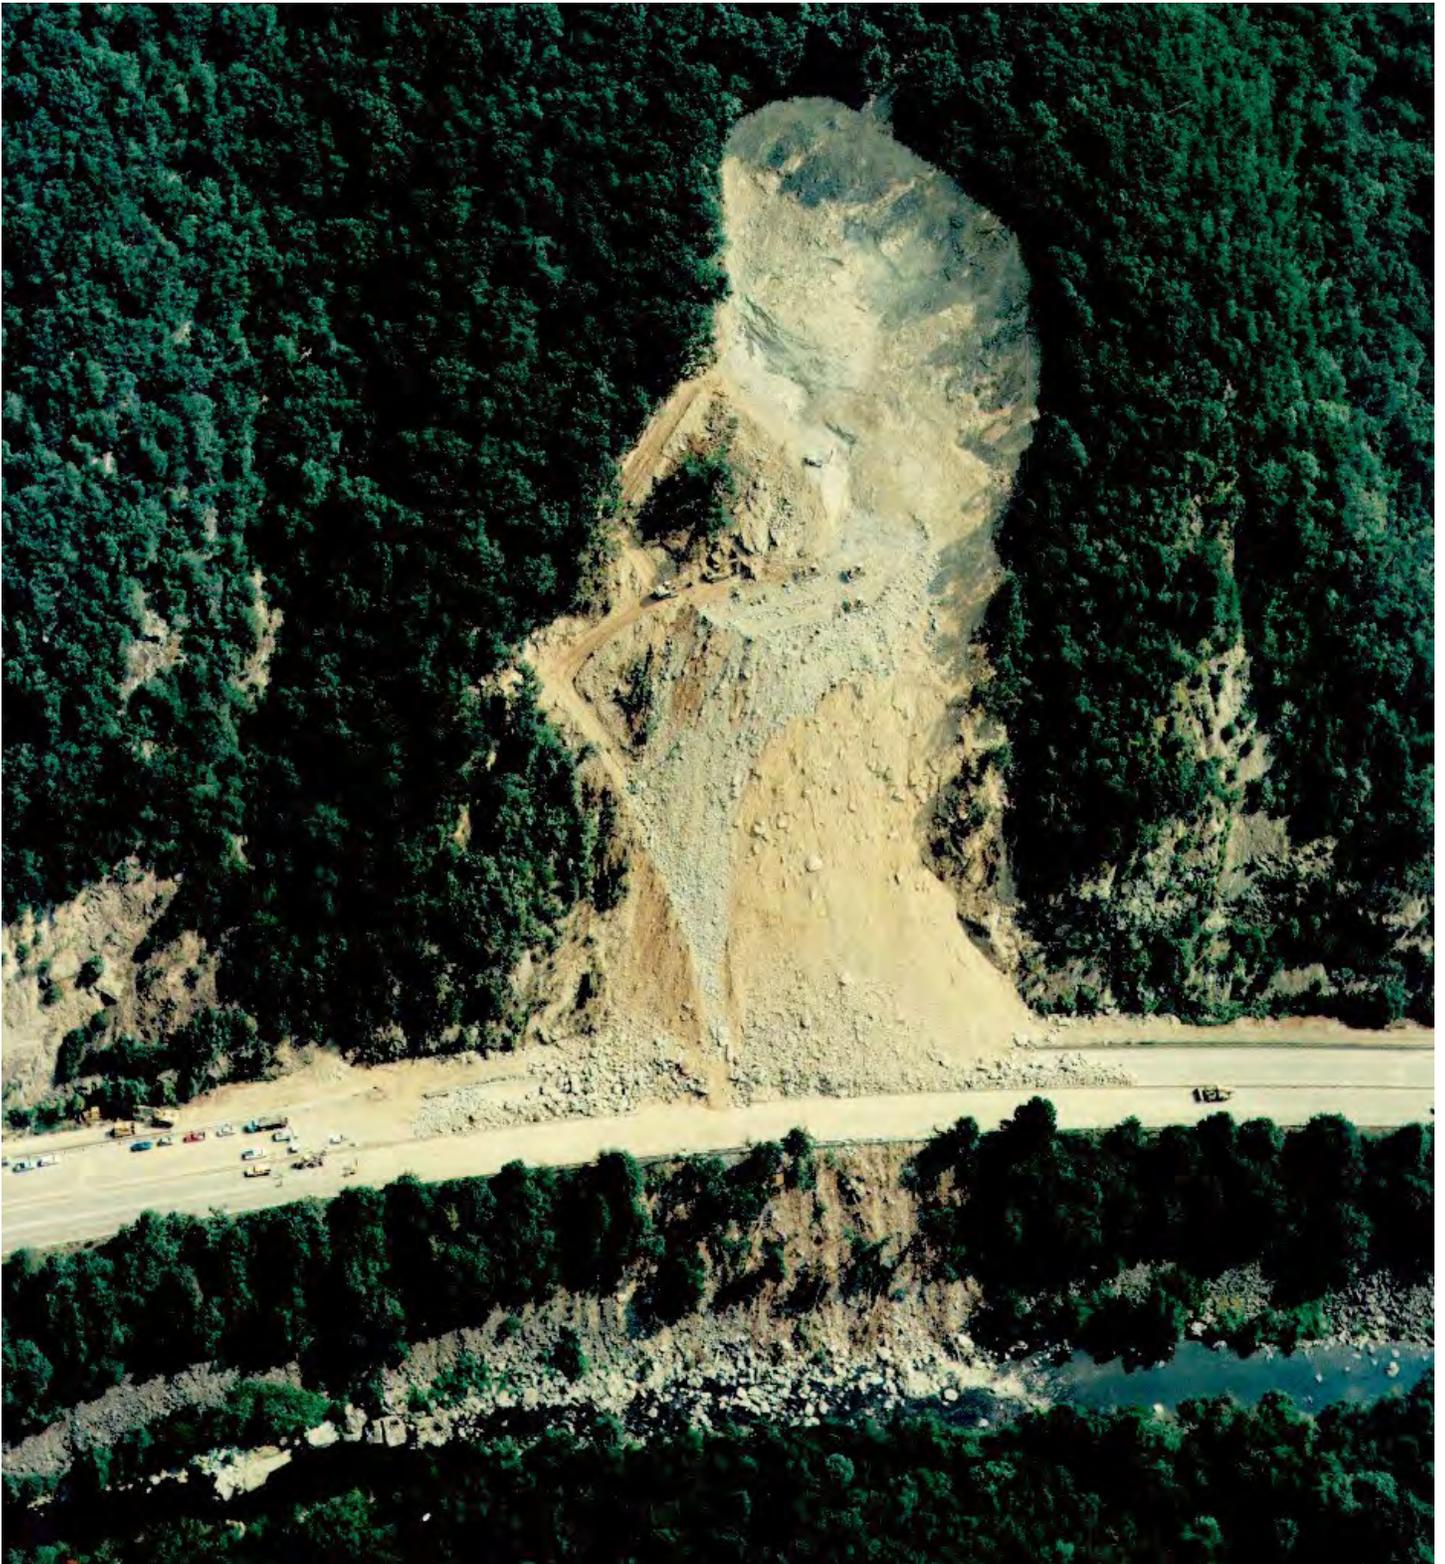
I-40, MM 0.5, 1997. Halfway through blasting and excavation

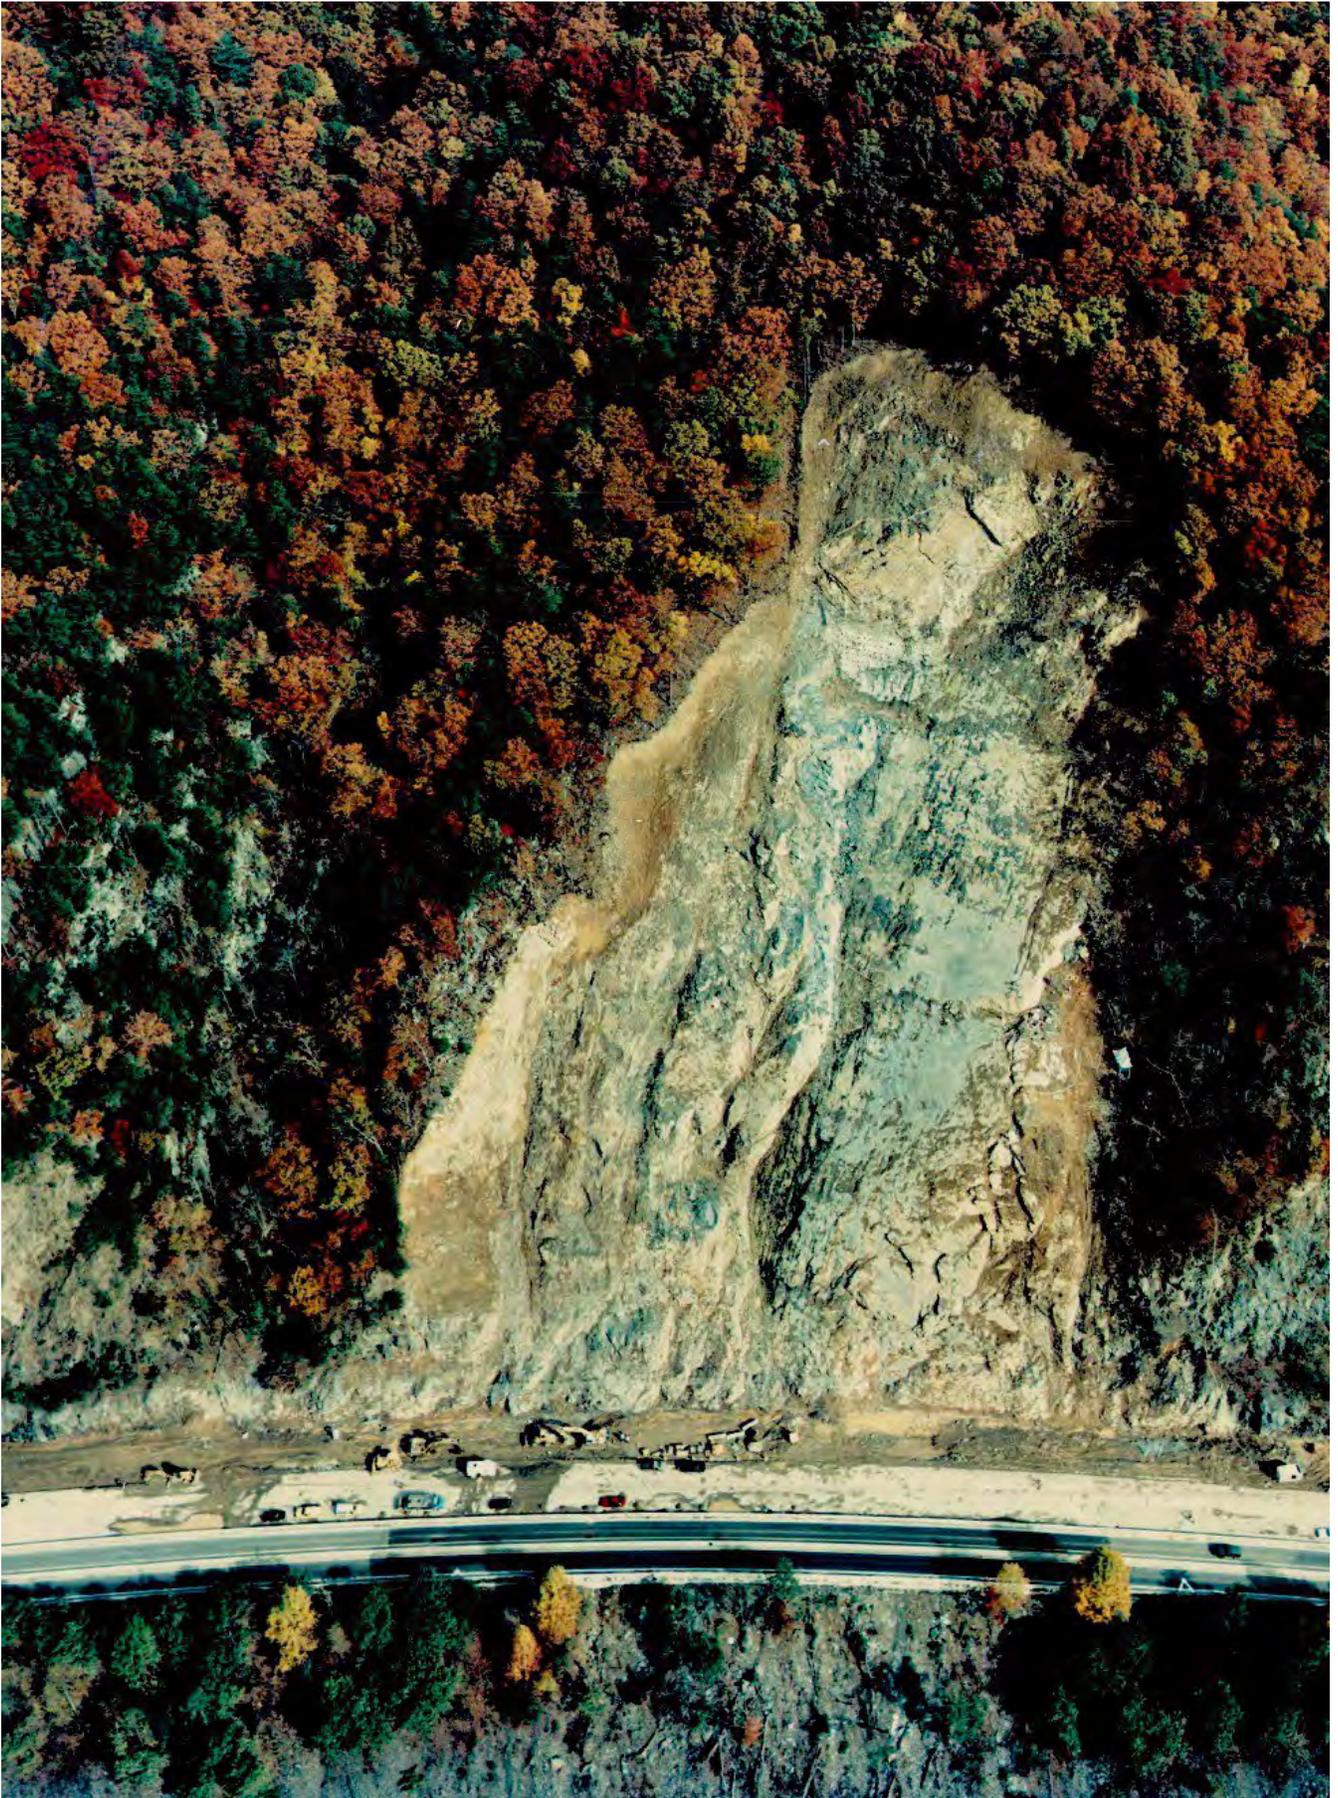
I-40, MM 0.5, 1997 Slide. Completed excavation

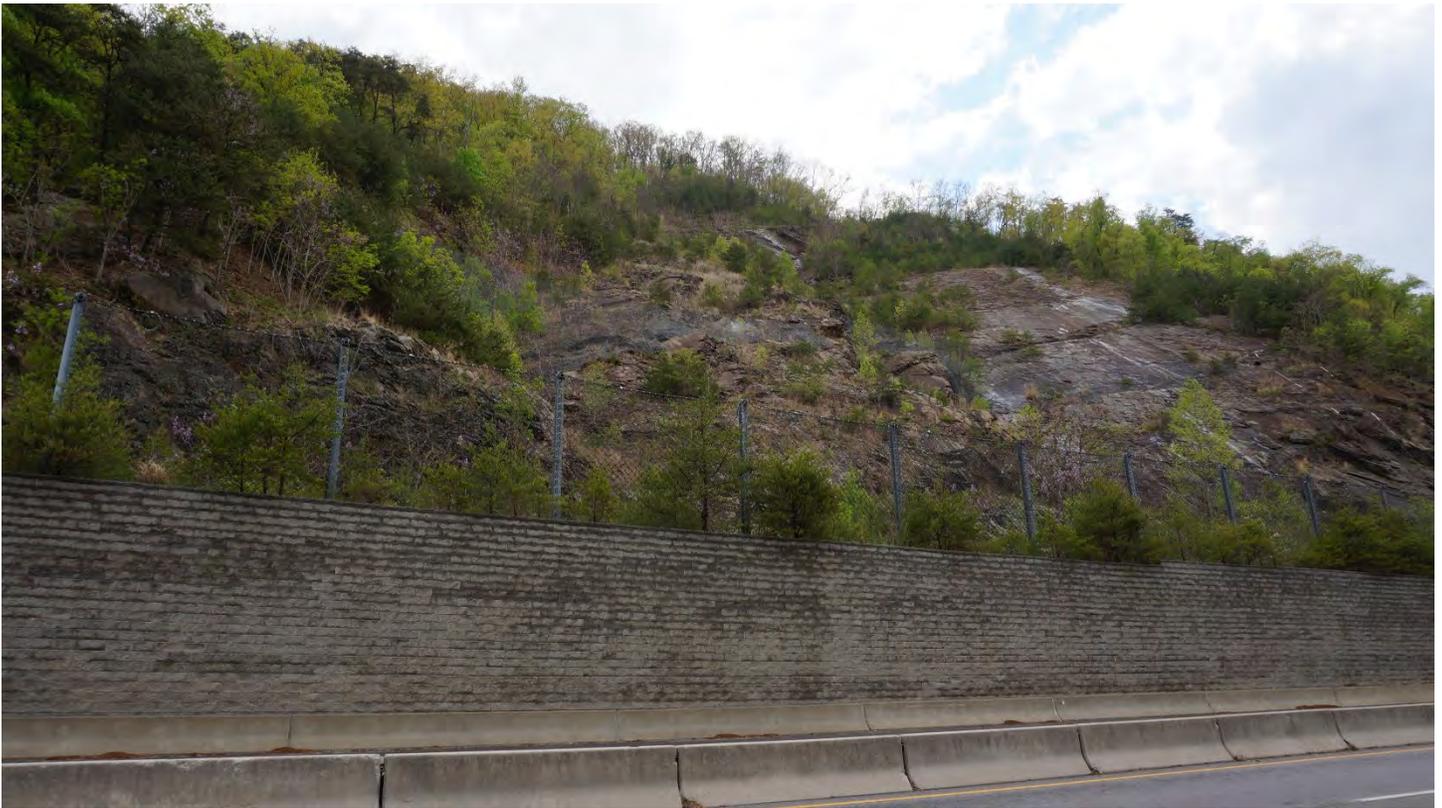
I-40, MM 0.5, 1997 slide. Excavation, trim blasting, rock bolts, suspended attenuation system, and the Great Wall of Barry Berkowitz (RIP)

An excavation and blasting operations were ongoing, additional sealing was performed and rock dowels were installed along the joint surface. Because of the natural condition of the slope above the highest point in the northeast corner of the slide zone, this area continued to fail. With the potential of rock still sliding down, it was decided to put up a bluff rock control net. This net would slow down the momentum of any rockfall that might occur when it rained.
