PROCEEDINGS OF THE 36TH ANNUAL HIGHWAY GEOLOGY SYMPOSIUM

BUILDING ON/WITH SEDIMENTARY BEDROCK

**CLARKSVILLE, INDIANA
May 13-15, 1985**

TERRY R. WEST, EDITOR

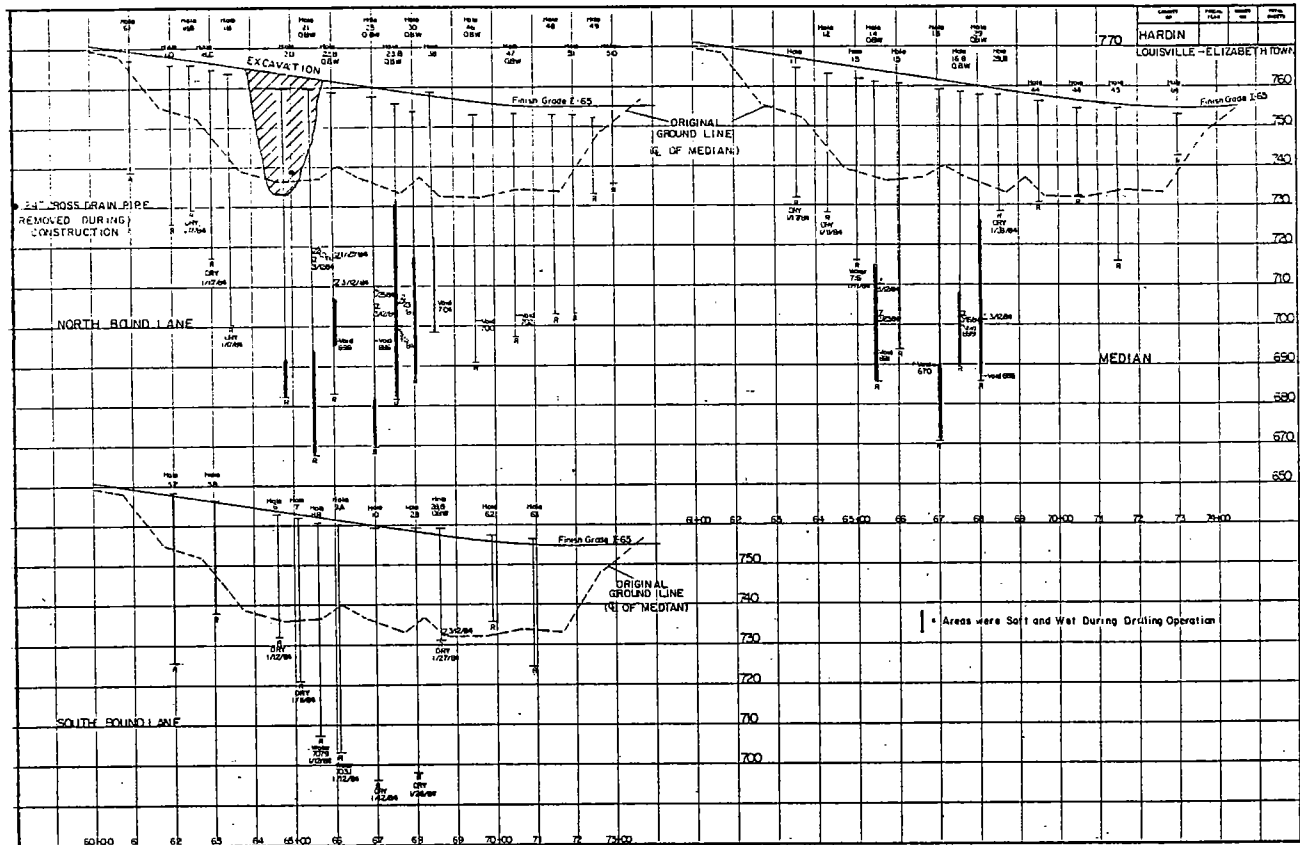
Figure 4. Subsurface Data For Mainline
Plotted on Profiles.

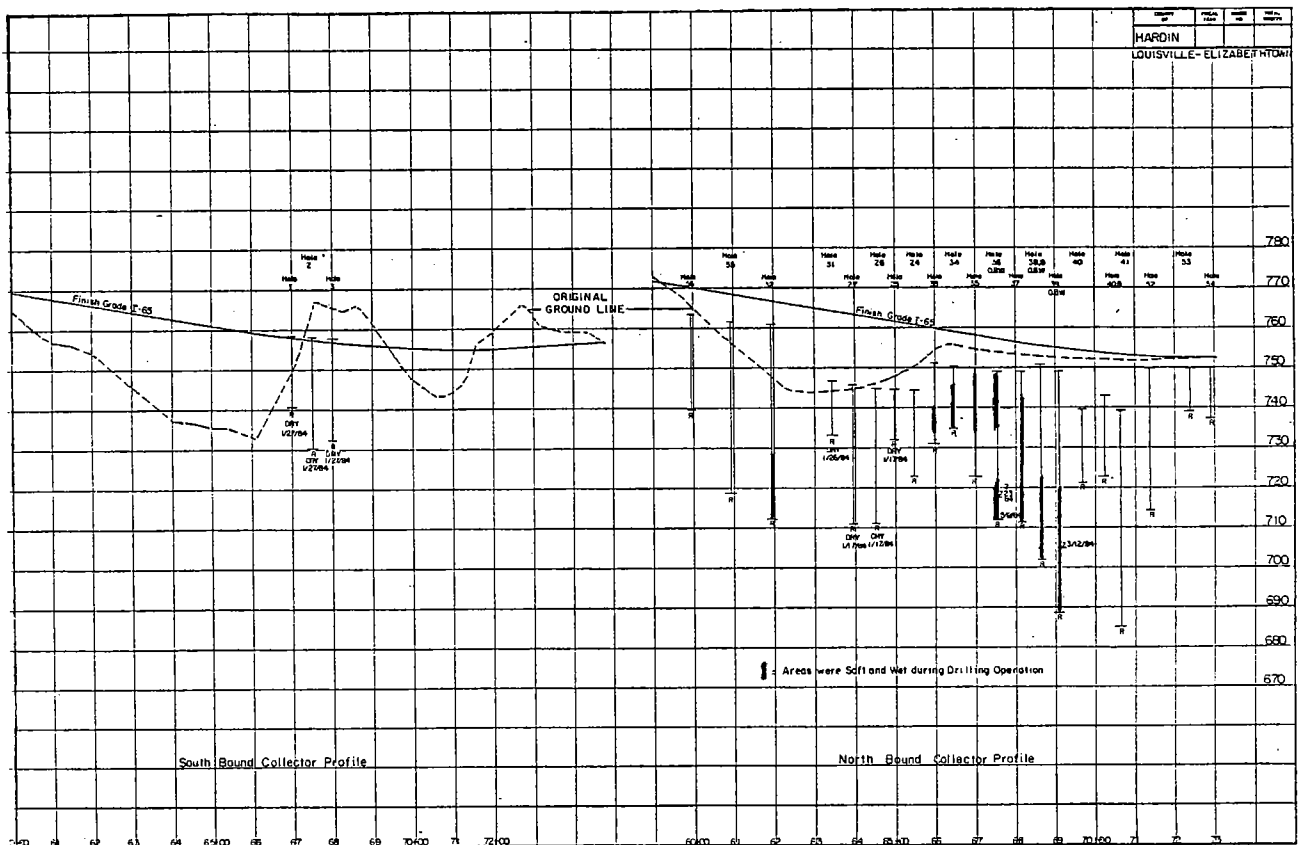
Figure 5. Subsurface Data For Collectors
Plotted on Profiles.

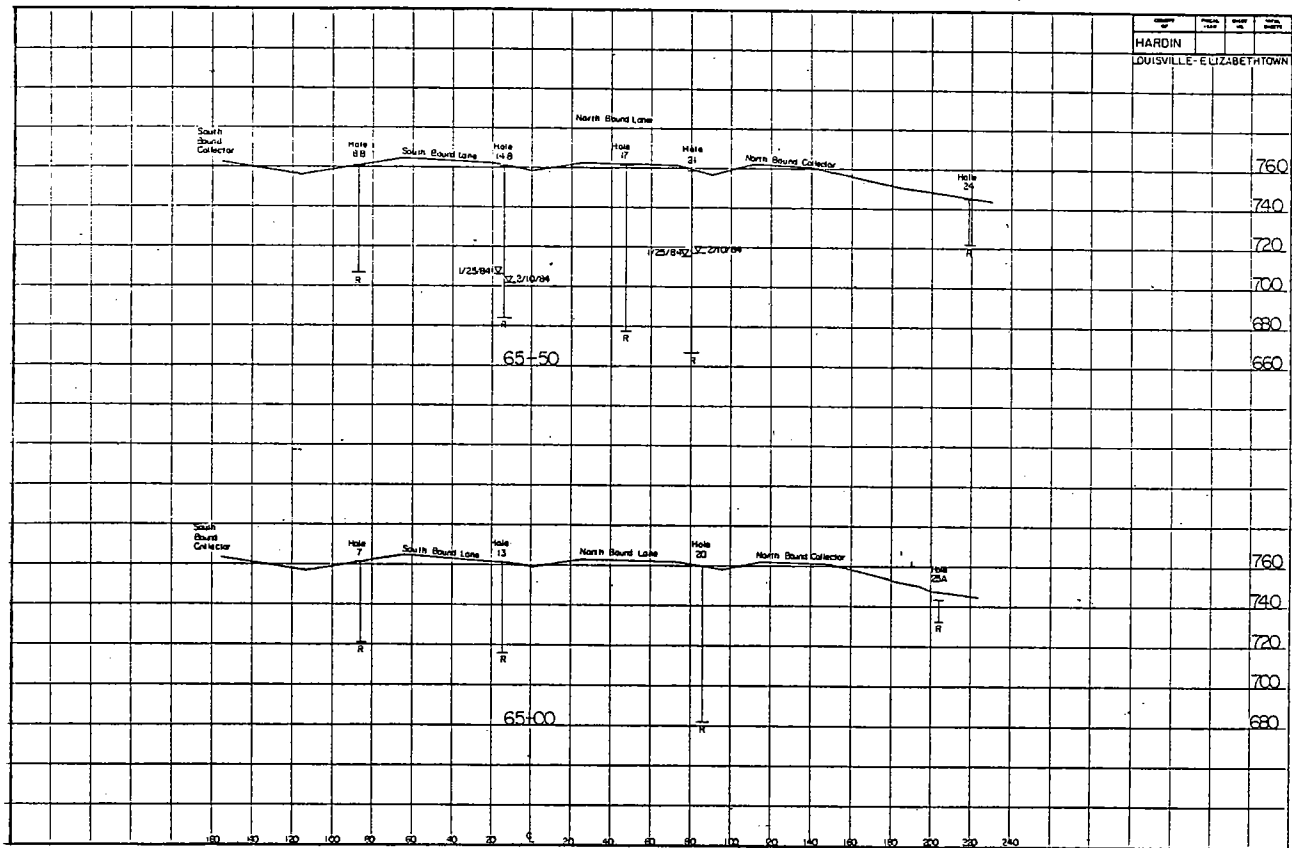
Figure 6. Subsurface Data For Roadway Plotted on Cross-Sections at Stations 65+00 & 65+50.

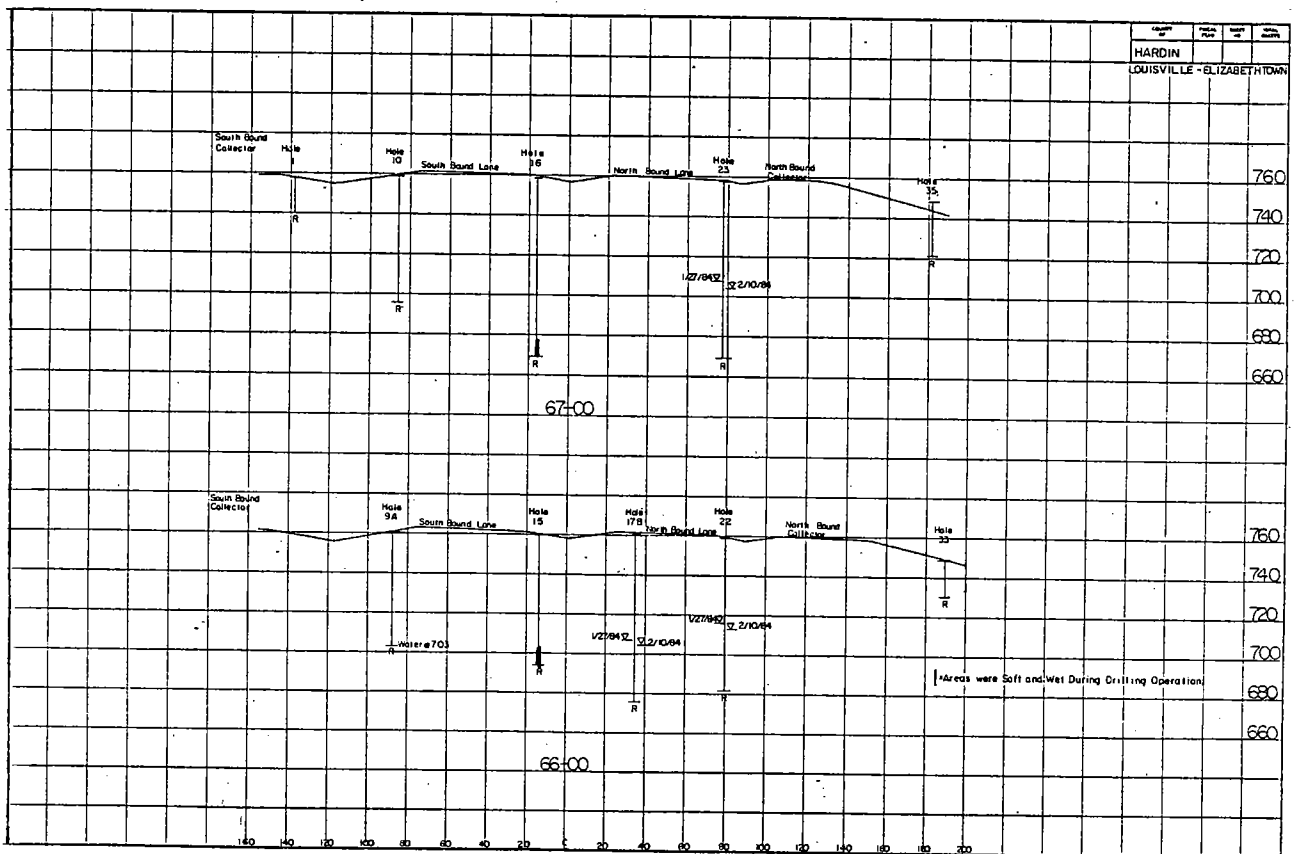
Figure 7. Subsurface Data For Roadway Plotted on Cross-Sections at Stations 66+00 & 67+00.

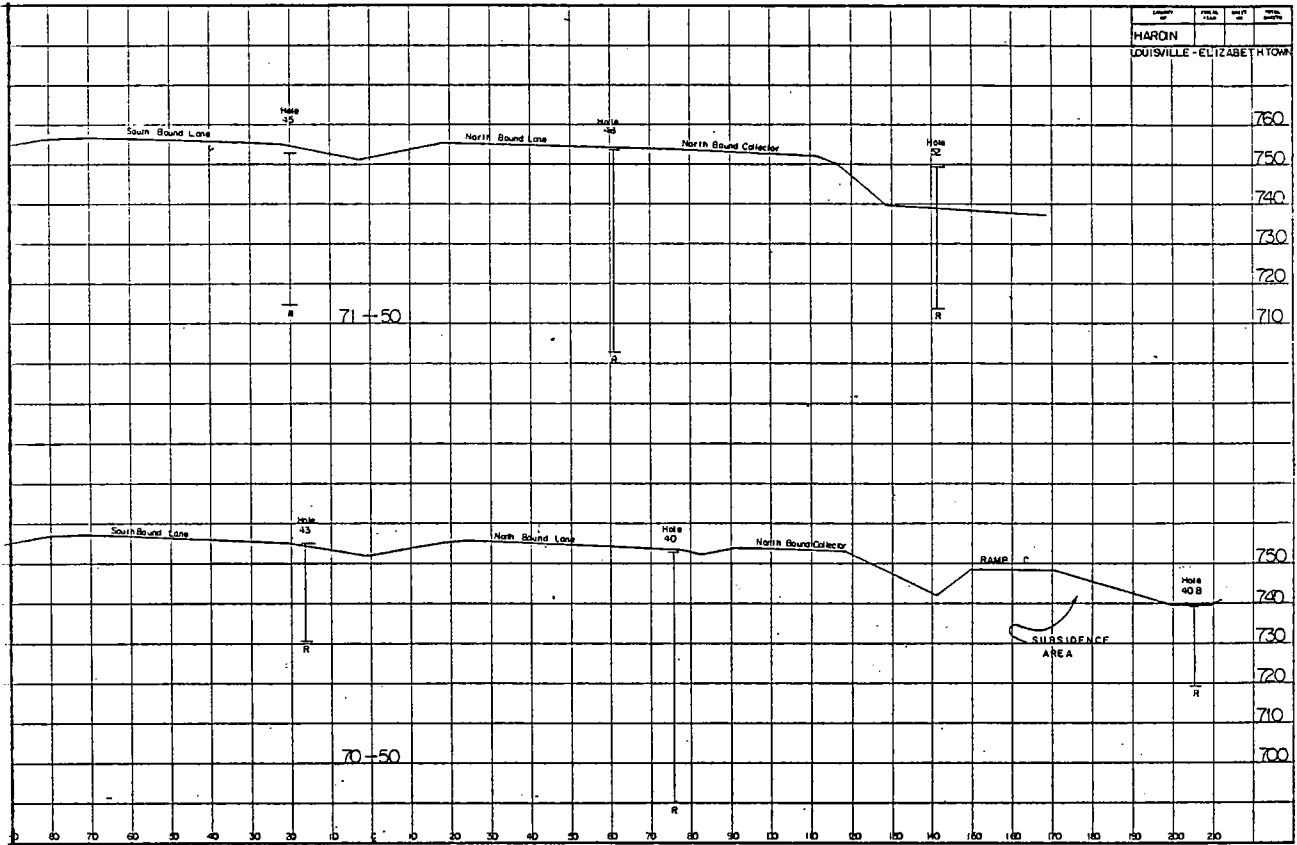
Figure 8. Subsurface Data For Roadway Plotted on Cross-Sections at Stations 70+50 & 71+50.

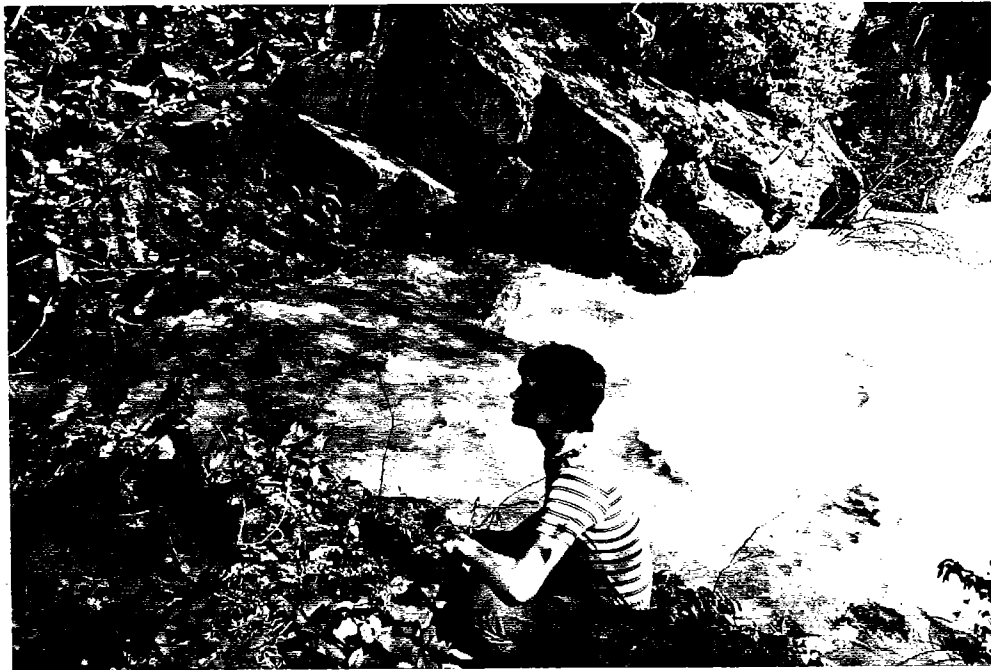
Figure 5 - Resurgence of Ten Mile Creek from Ten Mile Creek Cave System (photo made during May, 1984 flood.

Alternate "B" crosses the Ten Mile Creek and Sinking Creek drainage basins while Alternate "A-B" crosses the Sinking Creek drainage basin. The largest negative drainage basin within the study area is the Ten Mile Creek drainage basin composed of an area approximately 42 sq. kilometers (15.8 square miles) in size and characterized by sinkholes, depressions and cave systems. An extensive cave system (composed of over 4.8 kilometers (3 miles) of mapped passageways) carries Ten Mile Creek underground (Figure 4) in a SW direction from the south end of the basin to nearby Fort Loudon Lake where Ten Mile Creek reemerges as a large spring (Figure 5). During periods of heavy precipitation the basin often floods covering existing roads and property with as much as 15 feet of water (Figures 6, 7).

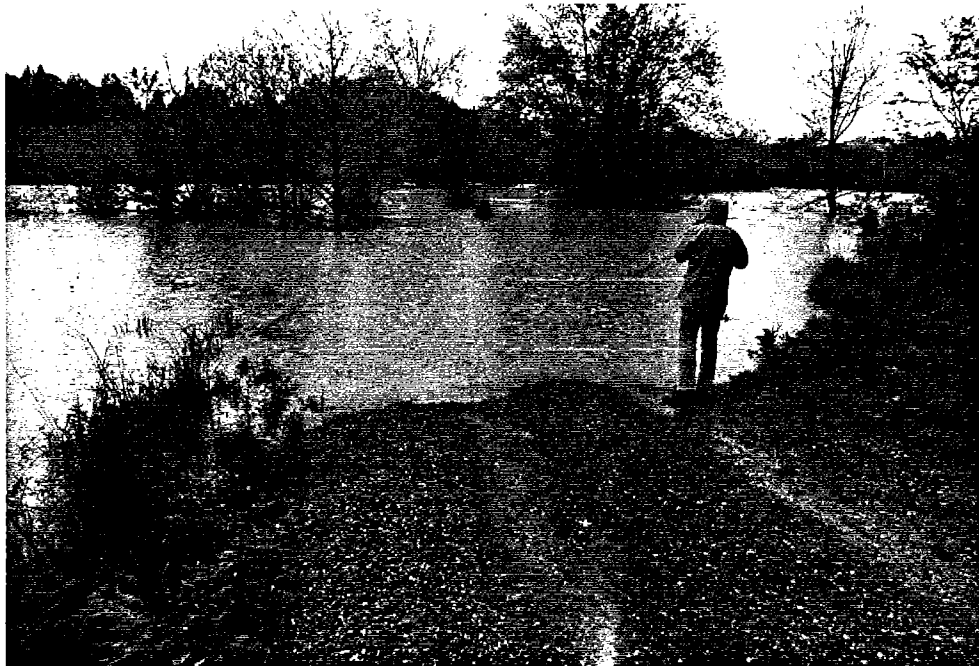
Figure 6 - Flooded Road in Ten Mile Creek Negative Drainage Basin, Knox County.

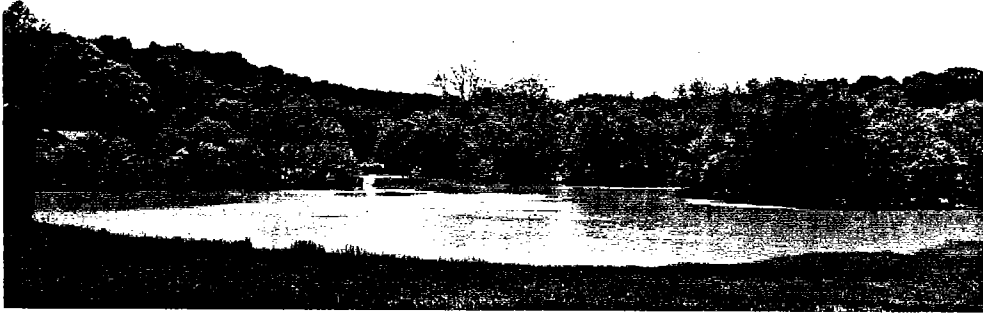
Figure 7 - Flooding Conditions at the Ponor Location of Ten Mile Creek, Knox County (water is 10-15 feet deep-May, 1984 flood).

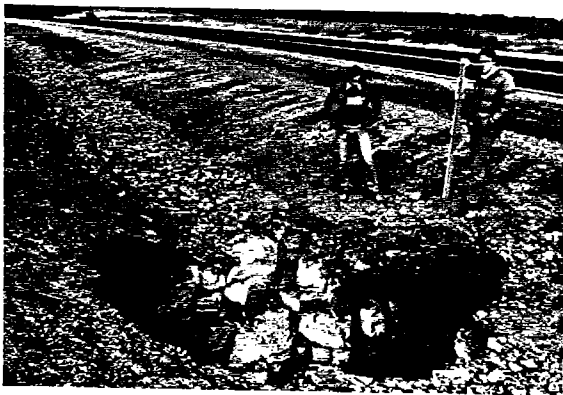
Figure 8 - Collapse Structures such as this along S. R. 72 in Loudon County, TN, usually occur along unpaved ditches in karst areas.

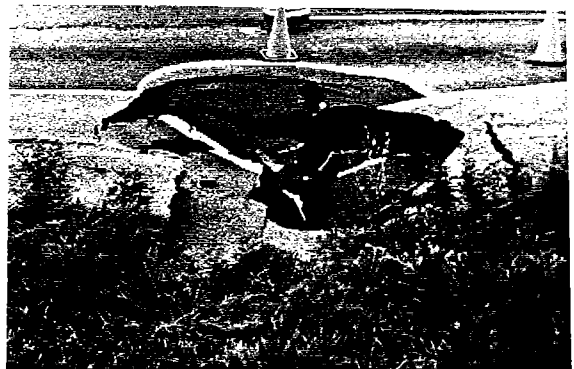
Figure 9 - The Prevention of Karst Related Subsidence and Collapse of Highways is centered around controlling the Drainage; I-40, Loudon County, TN.

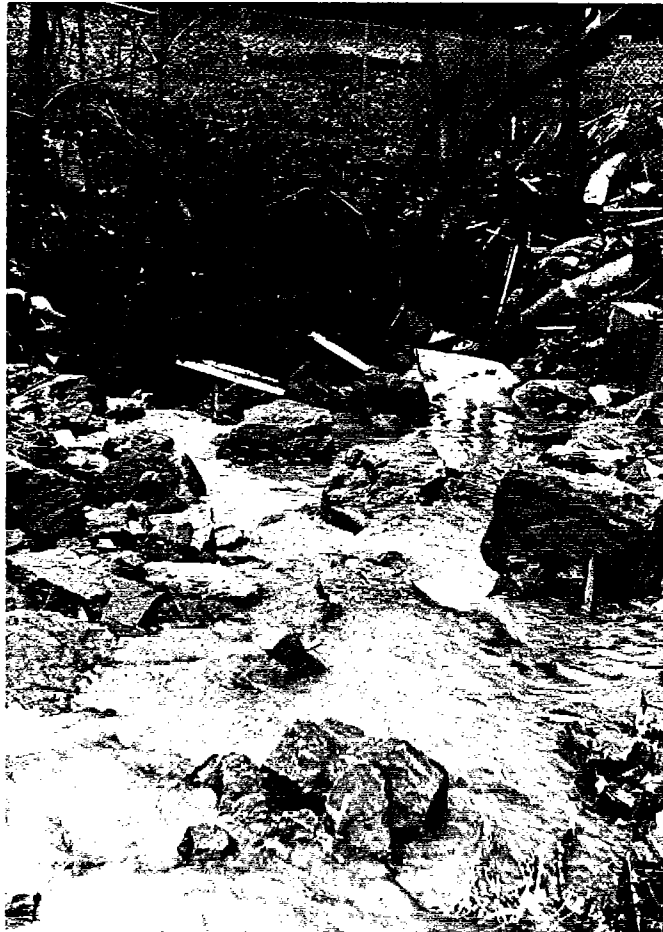
FIGURE 7

This photograph shows heavy run-off flowing into the larger of the swallets being used as drainage facilities for the I-640/I-40 interchange in east Knoxville.

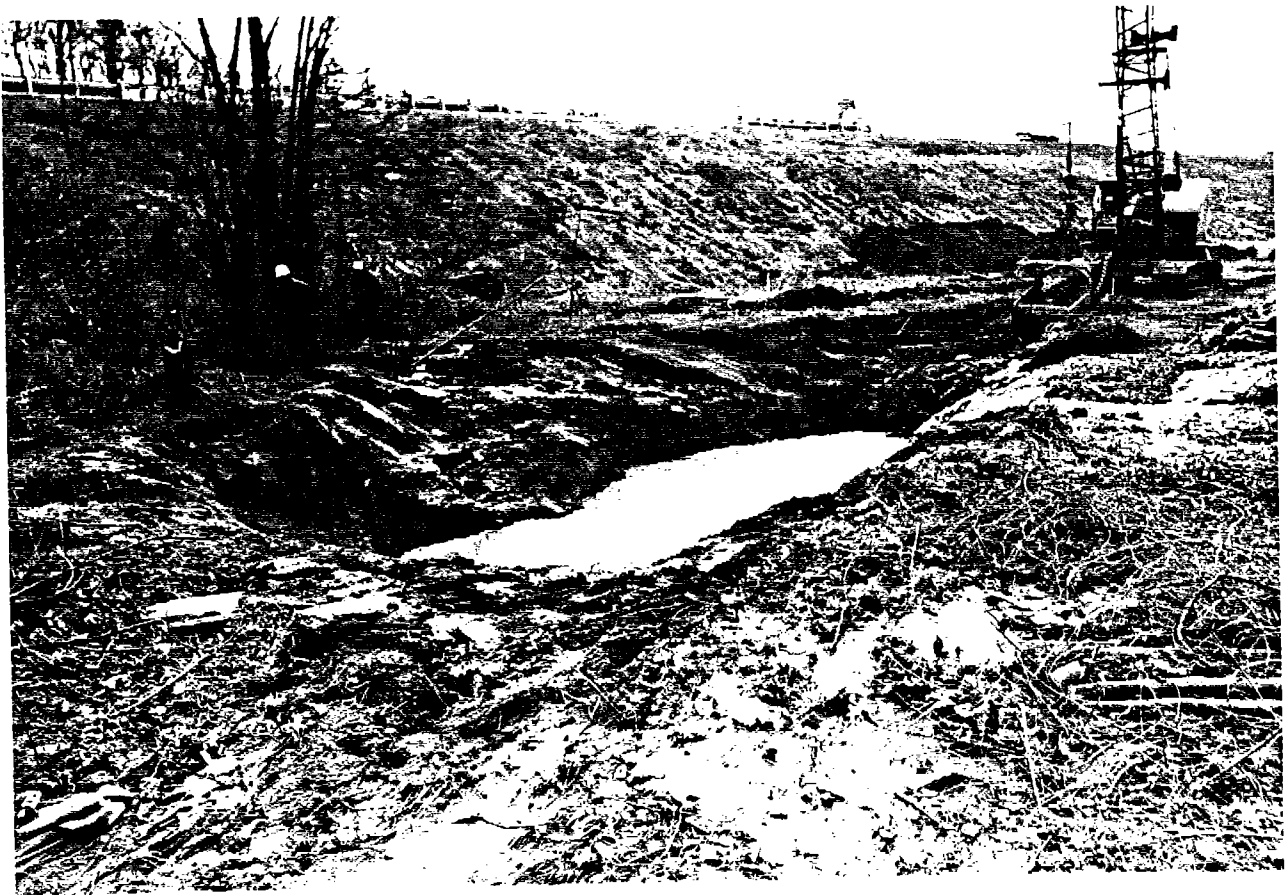
FIGURE B

The initial swallet, as discussed in Case II, was enlarged to create a combination sedimentation/retention pond. The gabion wall was later constructed in the lower portion of the area shown in this photograph.

The initial swallet was cleaned out and enlarged to provide both a siltation and retention pond. The ditch leading into the swallet was concrete riprapped providing for energy dissipation and erosion resistance. (Figure 11)

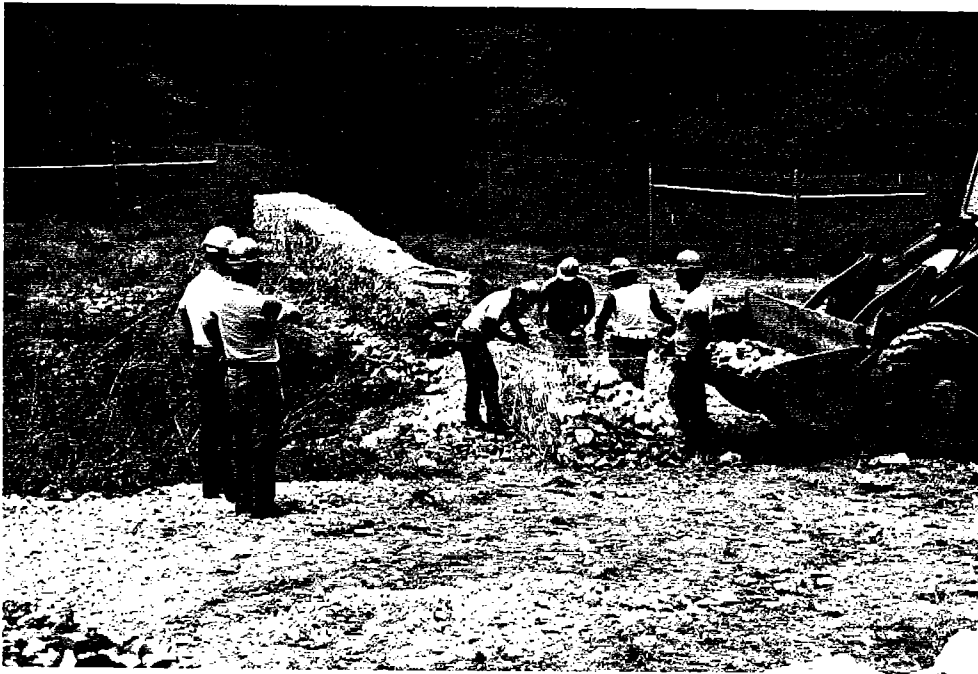
FIGURE 9

Construction of the gabion wall was performed by Region I maintenance personnel.

The gabion protection wall was constructed between the initial swallet and the 'overflow' swallet. (Figure 9) The purpose of the gabion wall was to protect the swallet from debris and excessive siltation generated during flooding conditions. The permeability of the gabion wall permits trash and other debris to be filtered out while transmitting the water through the gabion wall and into the swallet. (Figure 10)

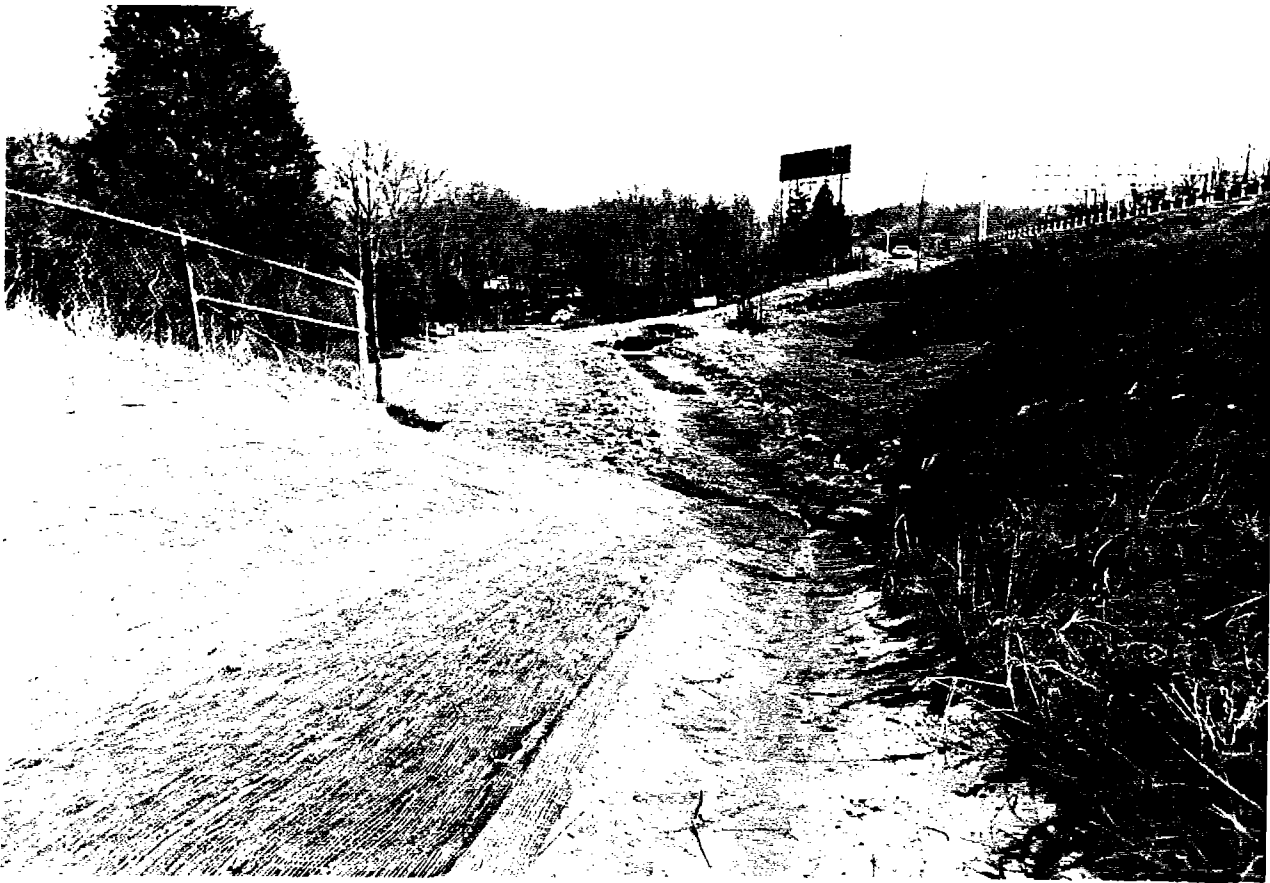
FIGURE 11

The riprapped concrete ditch is shown leading to the newly-constructed pond (in background).

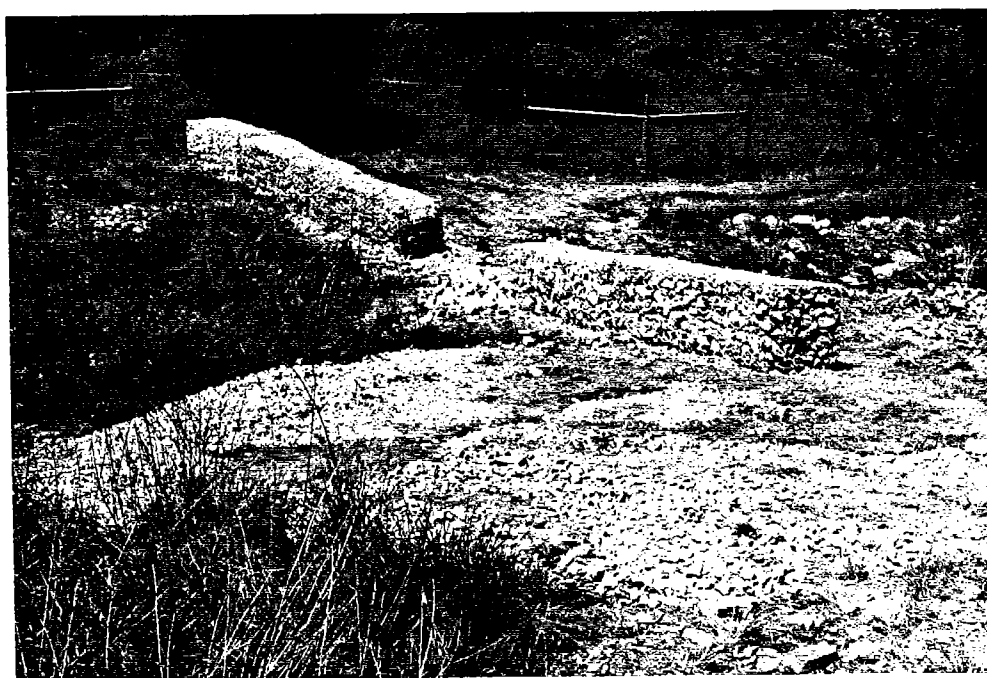
FIGURE 12

The completed gabion wall provides erosion-free energy dissipation between the retention basin(to left) and the free-draining sinkhole to the right.

At present run-off is channeled into the retention pond where most of the debris and silt are deposited. From there the runoff flows down a riprapped channel into the larger sinkhole. During flood conditions, high water is impeded by the gabion wall which acts as a filter for the debris-laden run-off protecting the sinkhole drainage facility. (Figure 12)

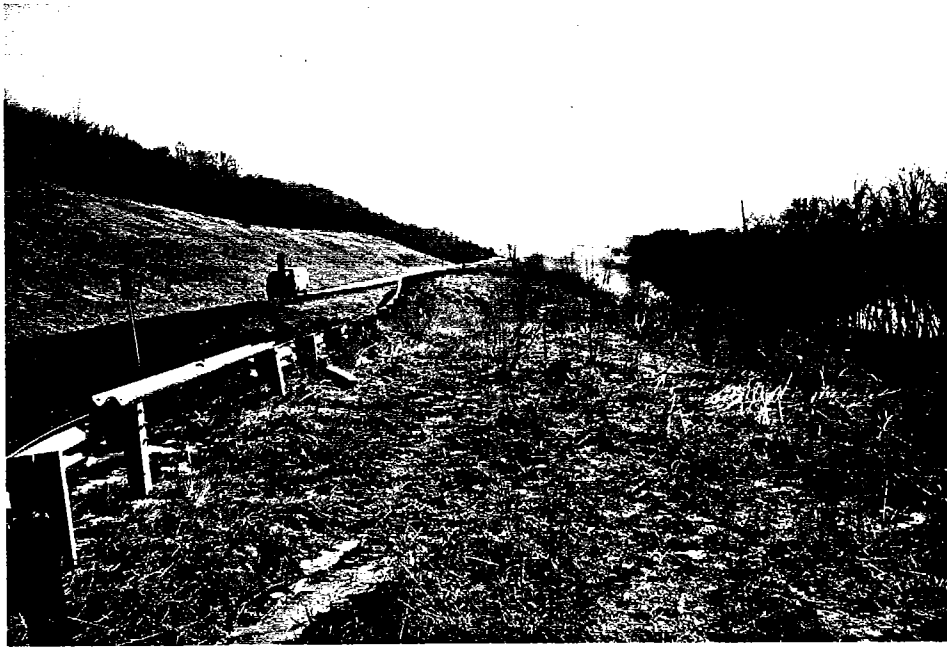
Figure 1. KY 227 Slide Area Prior to Stabilization

An unstable landslide area was located on Kentucky Route 227 (Carrollton-Worthville Road in Carroll County) approximately eight miles southeast of Carrollton, Kentucky. The slide affected approximately 1000 feet of roadway and embankment between Station 234+25 and Station 244+25. A railroad track is located on the same hillside just below the roadway and must be periodically realigned due to the slide. Figures 1 and 2 respectively, show a photo of the slide area prior to stabilization and a plan for the section of KY 227 under consideration. Horizontal drains and relocation of the highway were also considered as corrective measures, but the 1000-foot-long by 14-foot-high tiedback wall was chosen as the most cost-effective solution.

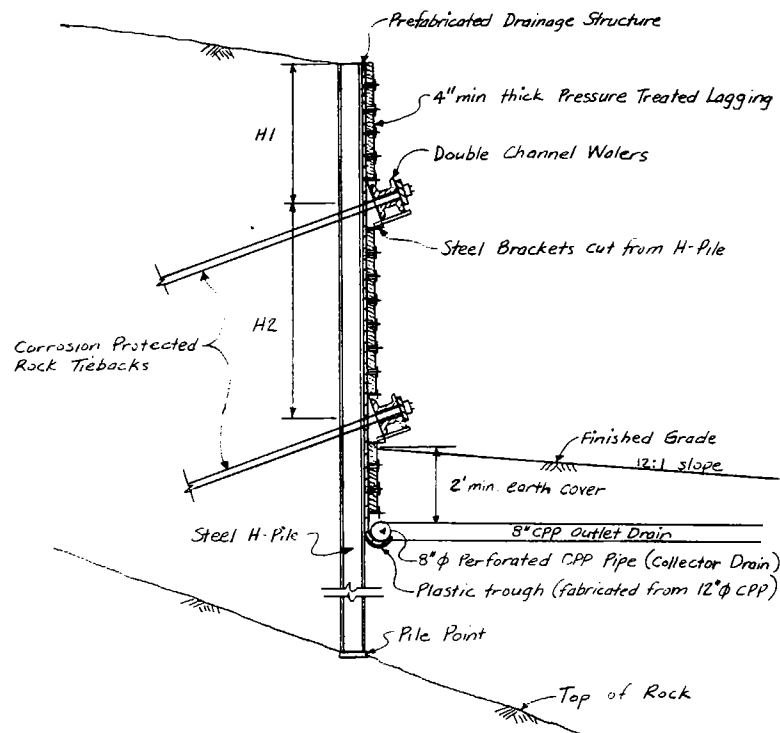
Figure 7. Typical Wall Section

External walers, consisting of two channel sections placed back-to-back with spacers in between, transferred the load from the tiebacks to the soldier beams. For long-term protection of the exposed steel, the face of the H-piles, wales, brackets, lagging plates, studs, and nuts were covered with a Tapecoat TC Mastic protectant applied in the field.

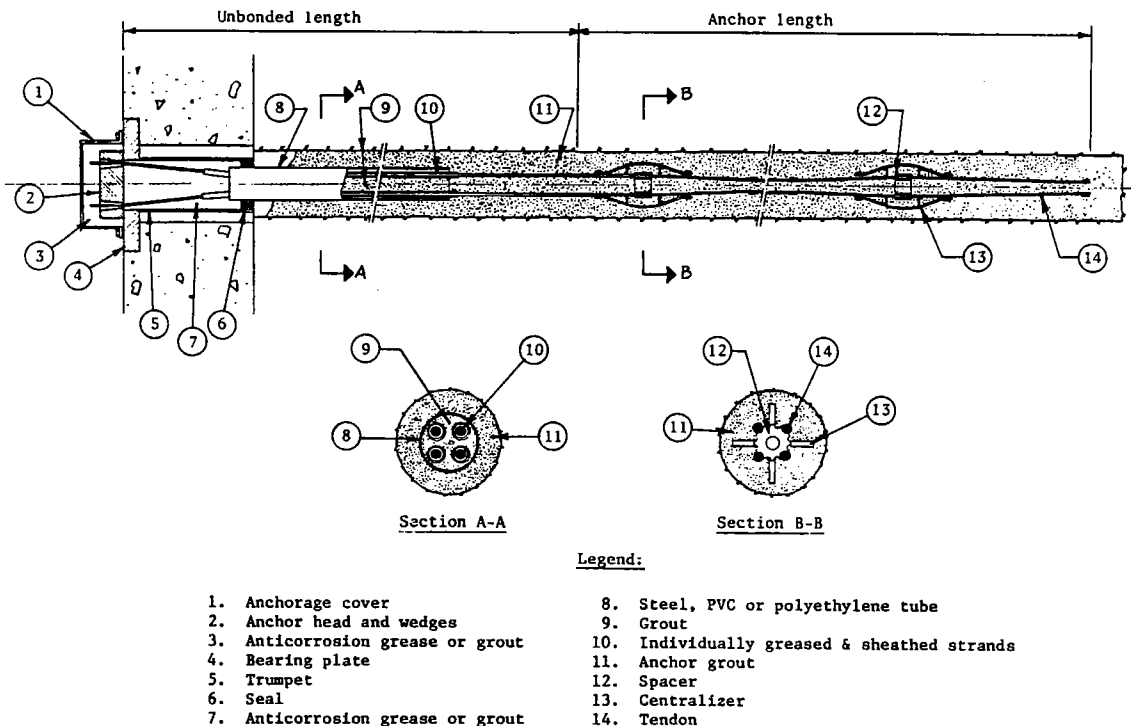
Figure 8. Simple Corrosion-protected Strand Tieback

The critical area of the tendon below the bearing plate was protected by a steel trumpet filled with an anti-corrosive grease as illustrated in Figure 8. In order to interrupt potential long-line differential aeration and stray-current corrosion systems, electrical isolation was provided by an insulation pad below the bearing plate.

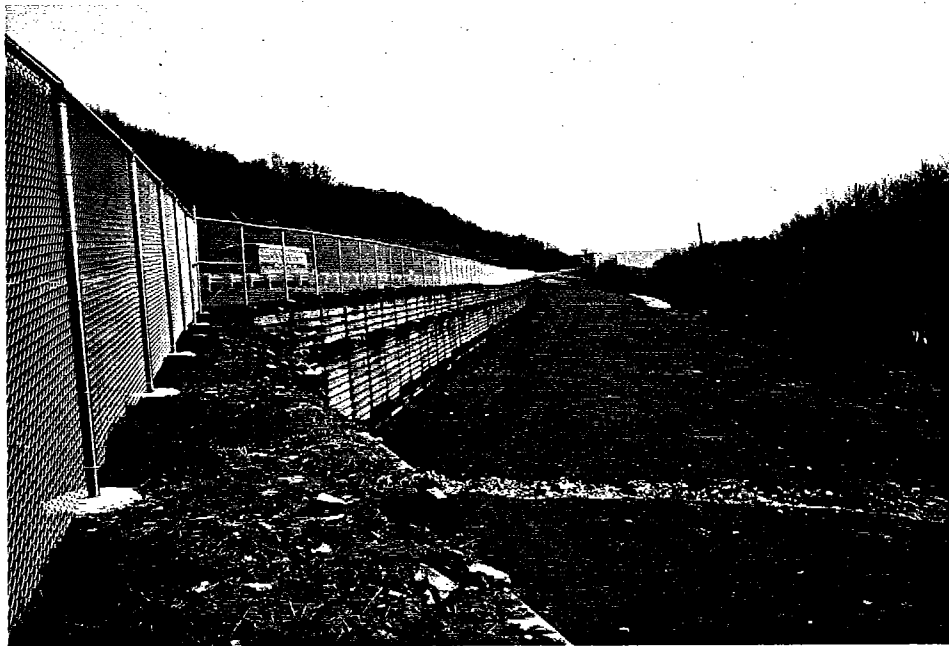
Figure 9. KY 227 Completed Tiedback Wall

Figures 9 and 10, respectively, show photographs of the completed tiedback walls for the KY 227 and U.S. 27 projects.

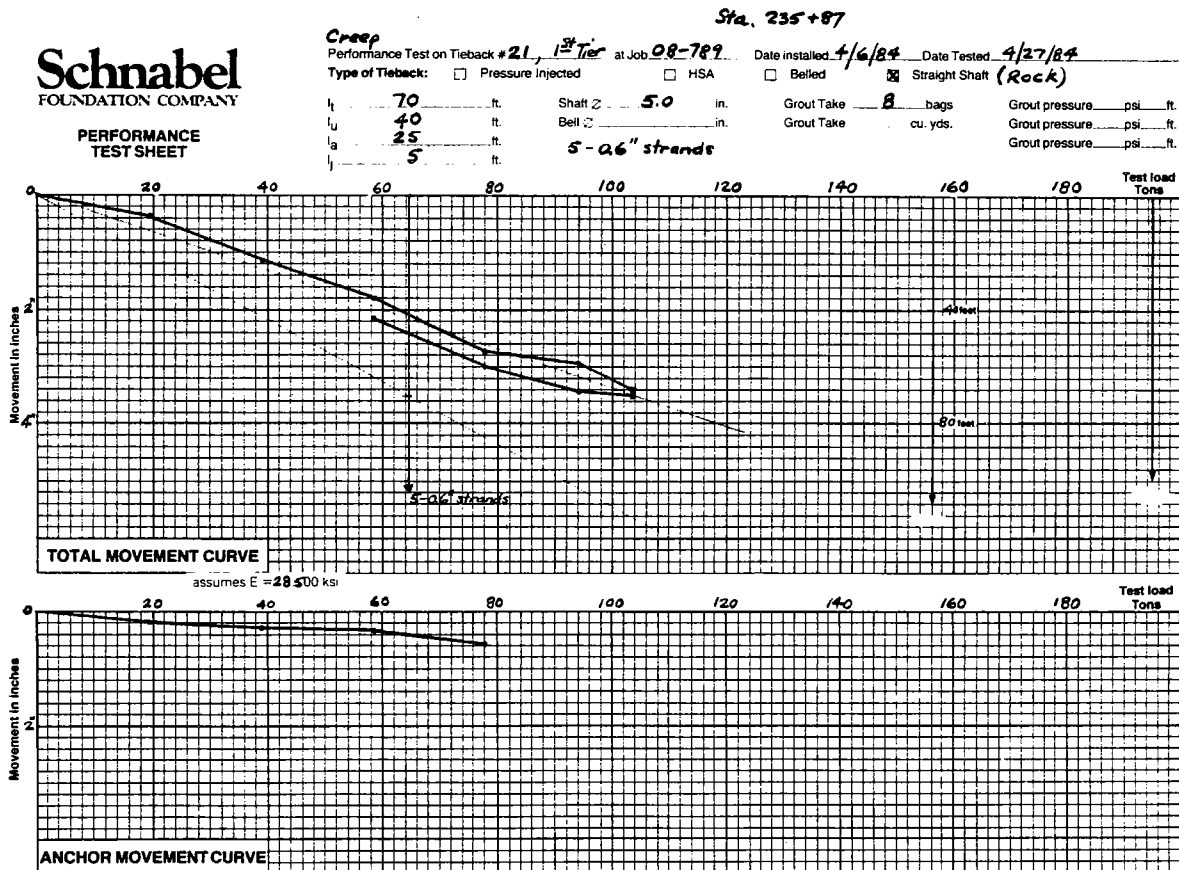
Figure 11. KY 227 Creep Performance Test

At least four tiebacks on each wall were creep tested. During the creep performance test, the tieback was incrementally loaded and unloaded up to a maximum of 133 percent of the design load. Each load increment was held constant using an electrical resistance load cell for ten to 60 minutes, with the exception of the final load which was held for 300 minutes, and the elongations recorded. Figure 11 shows the plot of one of the creep performance tests. The upper graph in this Figure shows the total tieback movement as a function of load, while the lower graph shows the residual movement of the anchor as a function of load. The residual movement (permanent set) of the anchor is the nonelastic or unrecoverable movement of the anchor which is measured when the load is released after each loading increment.

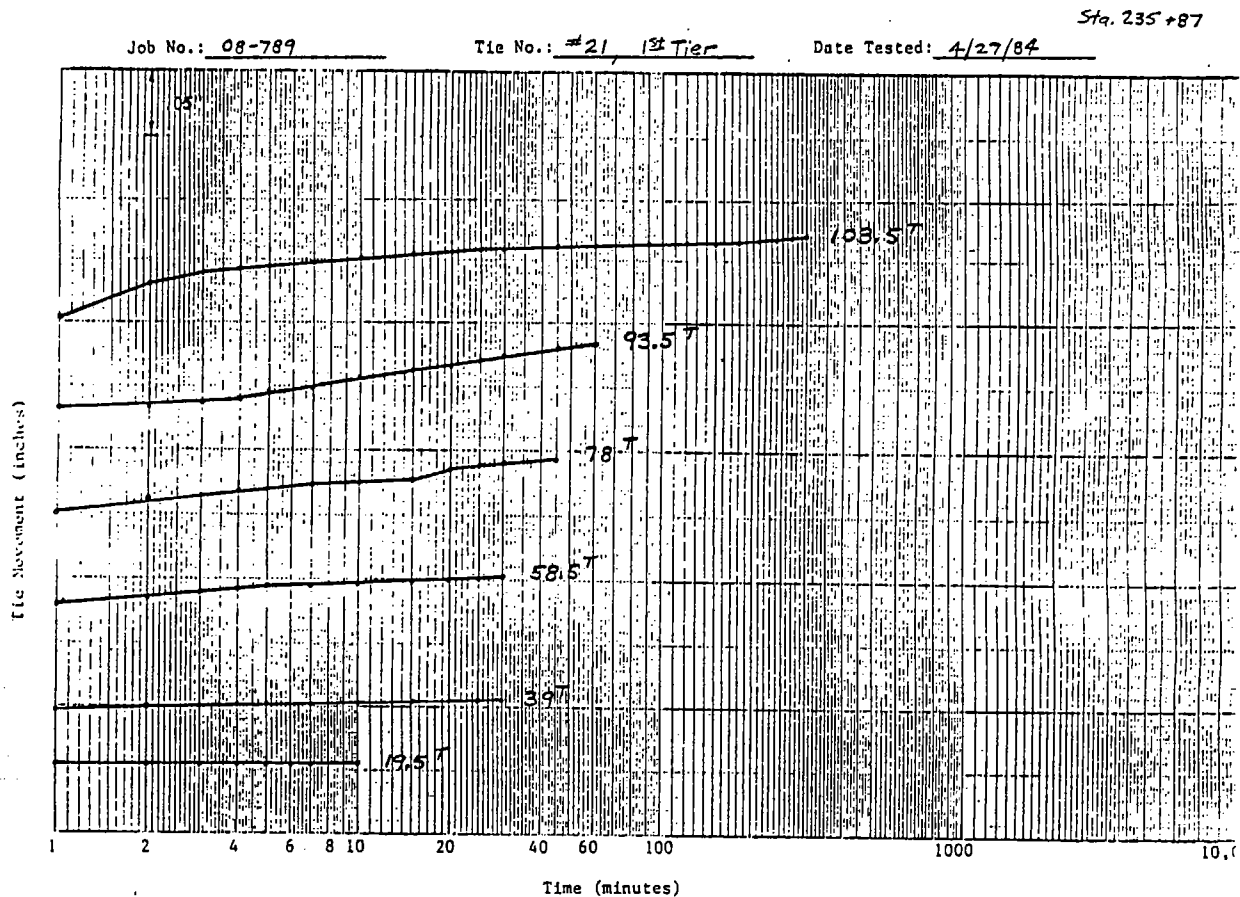
Figure 12. KY 227 Creep Test Movements

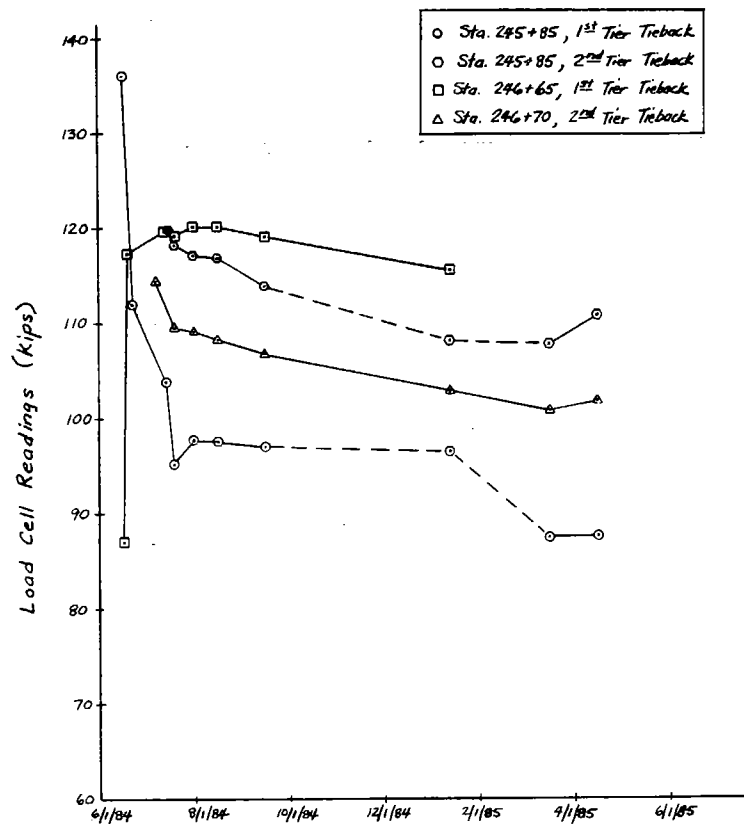
Figure 14. U.S. 27 Load Cell Readings

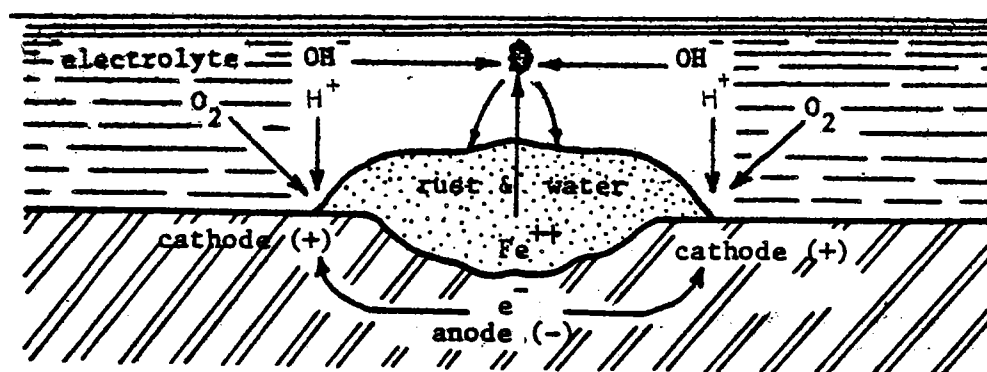
Figure 1. Galvanic corrosion by a local differential aeration cell.

Galvanic corrosion occurs when steel rusts or corrodes. The differential aeration cell, cathode, and anode connected by steel and immersed in an electrolyte (See Figure 1) causes galvanic corrosion. A potential difference between the electrodes caused by free oxygen at the cathode provides the energy to oxidize iron at the anode and disassociate the electrolyte into hydrogen ions (H^+) and hydroxyl ions (OH^-). Iron ions (Fe^{++}) enter the electrolyte, create a pit in the metal surface, react with the hydroxyl ions and become rust. Free electrons (e^-) move through the body of the metal to the cathode where hydrogen ions capture the electrons and form atomic hydrogen, hydrogen gas and water. This corrosion will continue unless the metallic path is interrupted.

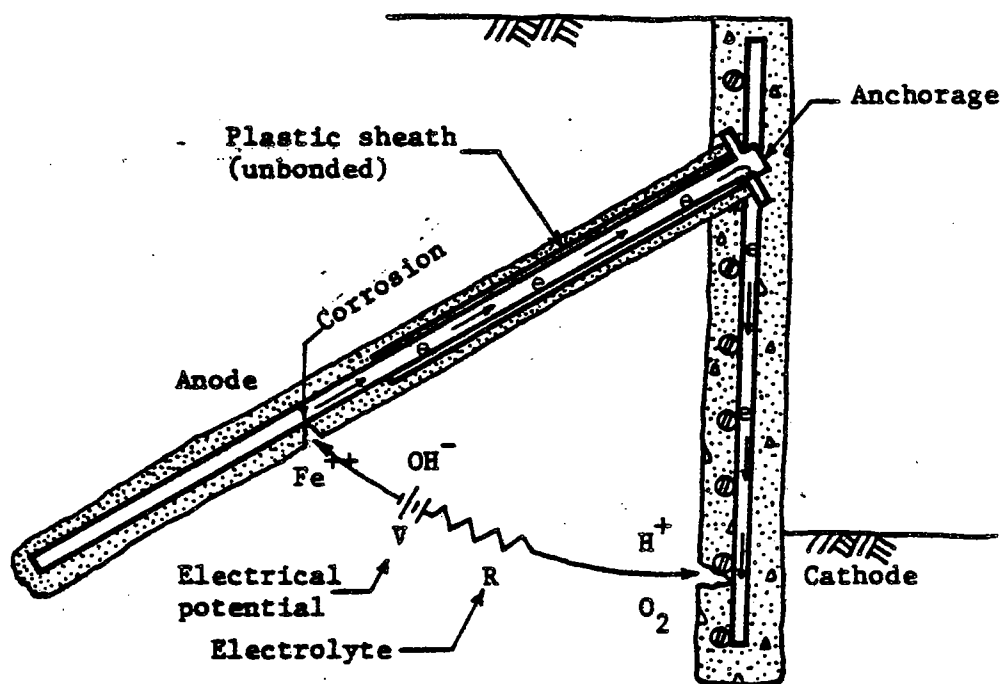
Figure 2. A long-line corrosion cell.

The local differential aeration cell shown by Figure 1 becomes a long-line corrosion cell when corrosion-free metal separates the anode and cathode. The long-line cell shown by Figure 2 may develop on a simple corrosion-protected tieback. The ground conditions depassivate the prestressing steel in the bond-length. Oxygen at the structure supplied by the atmosphere makes the steel in the structure cathodic with respect to the prestressing steel in the bond length. A continuous metallic path exists between the anode and the cathode. Groundwater disassociates and supplies hydroxyl ions to the anode and hydrogen ions to the cathode. The conditions necessary for galvanic corrosion exist, and the rate of metal loss at the anode (bond length prestressing steel) will depend on the strength of the electrolyte (ground resistivity) and the potential difference between the cathode and the anode. This cell could cause severe pitting because the exposed surface at the structure (cathode) is usually much greater than the anodic area.

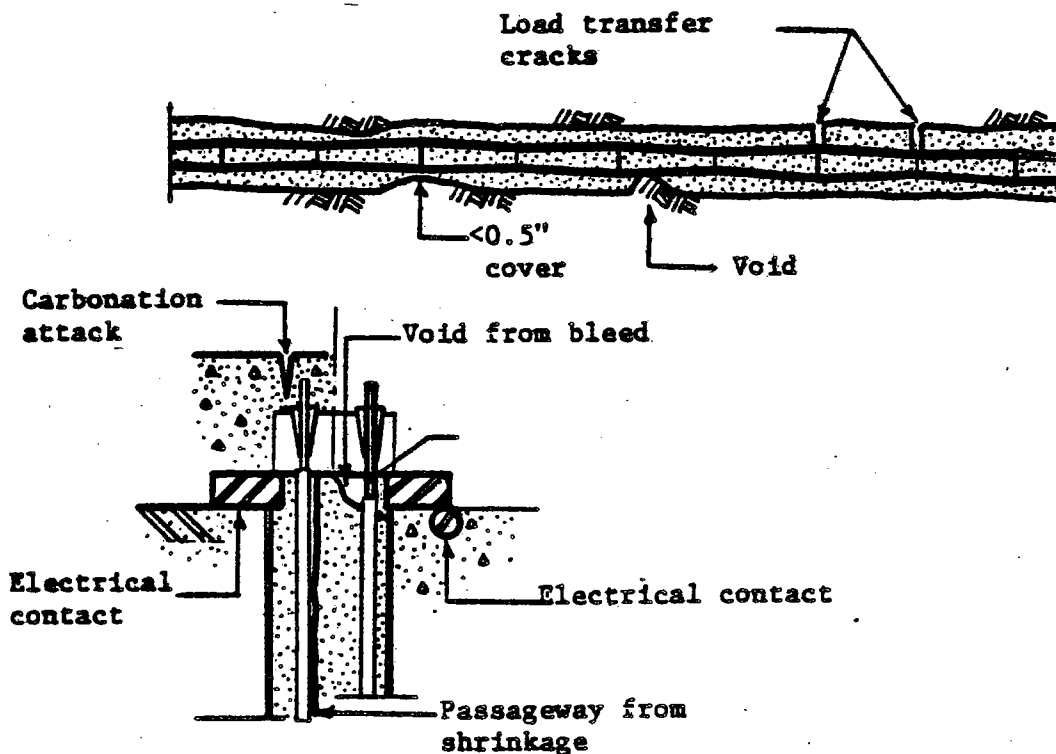
Figure 3. Defects in installation of simple corrosion-protected tendons that could cause failures.

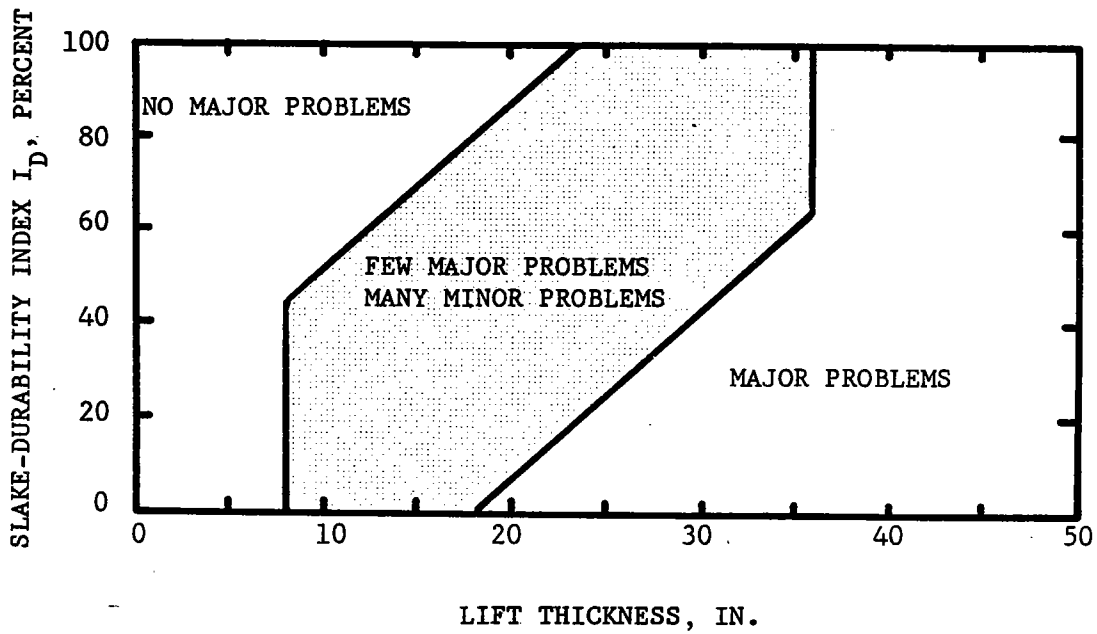
Figure 1. Preliminary criterion for evaluating embankment construction on the basis of slaking behavior.
(after Strohm et al., 1978)
