PROCEEDINGS OF THE 36TH ANNUAL HIGHWAY GEOLOGY SYMPOSIUM

BUILDING ON/WITH SEDIMENTARY BEDROCK

**CLARKSVILLE, INDIANA
May 13-15, 1985**

TERRY R. WEST, EDITOR

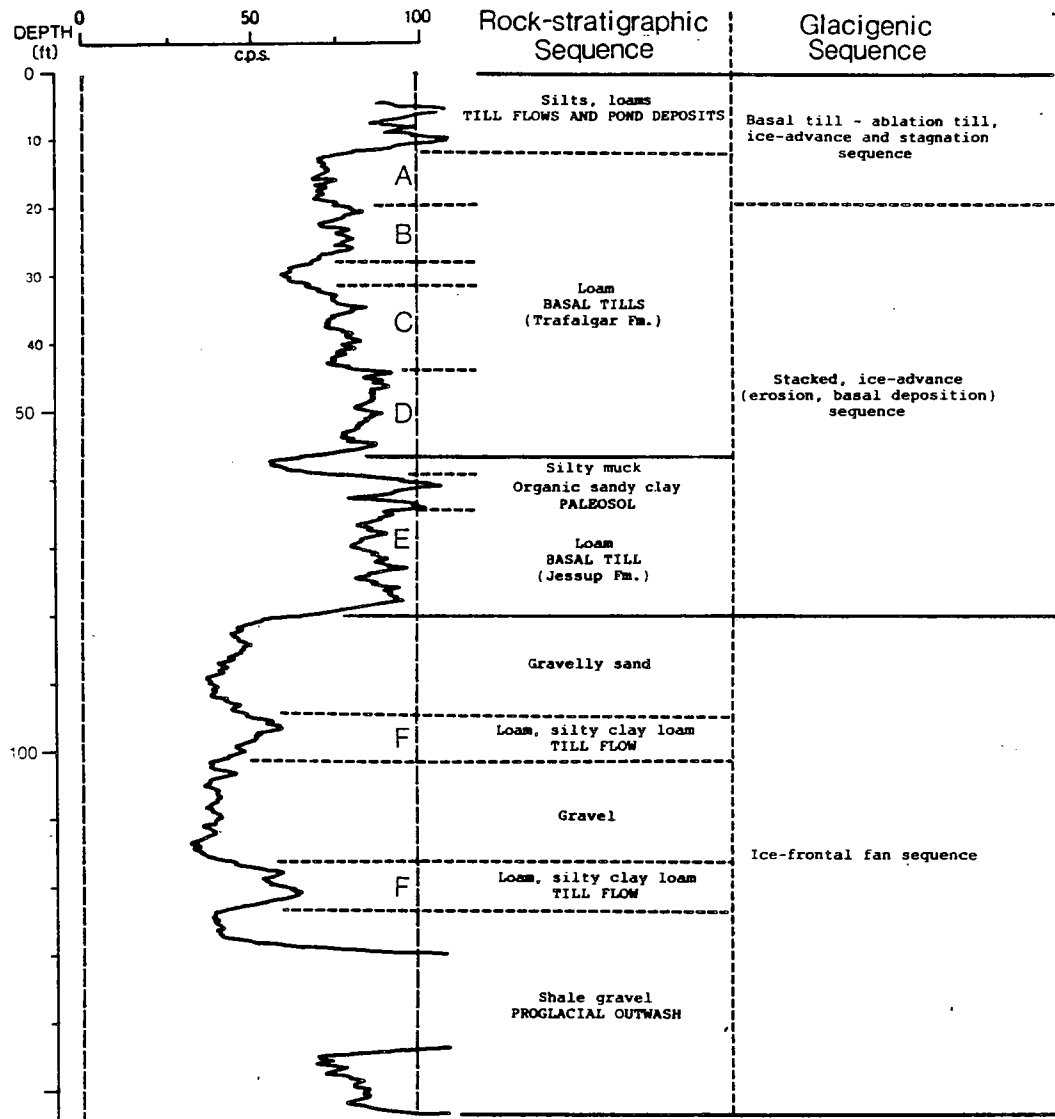
Fig. 2 Regional till-stratigraphic sequences and glacial sequences: log of PVC-cased test hole west of Kokomo, central Indiana. Note upper ablation sequence, multiple loam-textured tills (intermediate count rates, crew-cut form) and clayey paleosol (high count rate) capped by silty muck (low count rate); also nature, of interpreted till flows in outwash, and for basal gravel rich in Devonian black shale (high count rate) (access courtesy of U.S. Geological Survey).

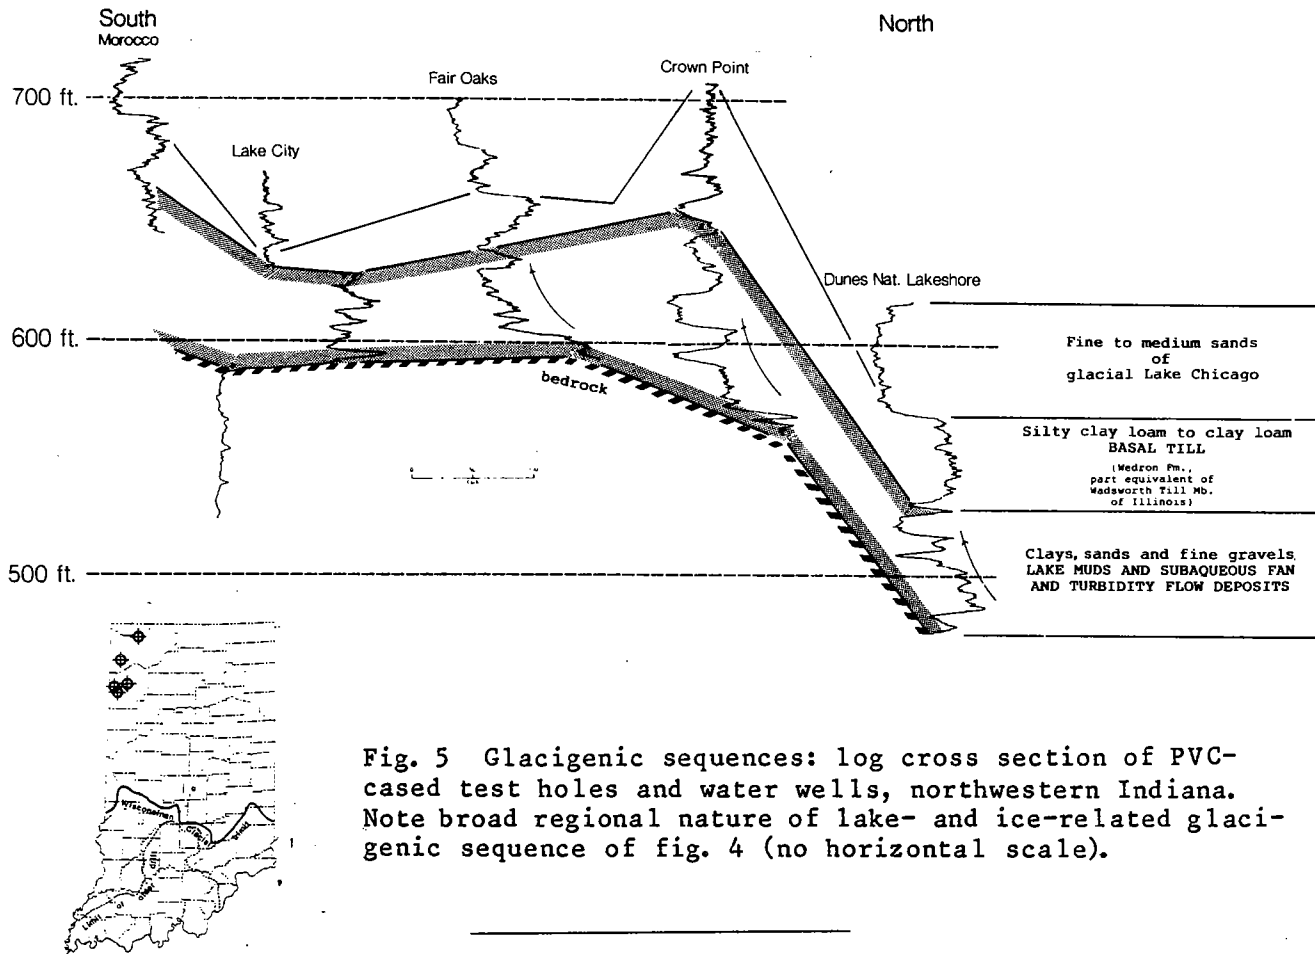
Fig. 5 Glacigenic sequences: log cross section of PVC-cased test holes and water wells, northwestern Indiana. Note broad regional nature of lake- and ice-related glaciogenic sequence of fig. 4 (no horizontal scale).

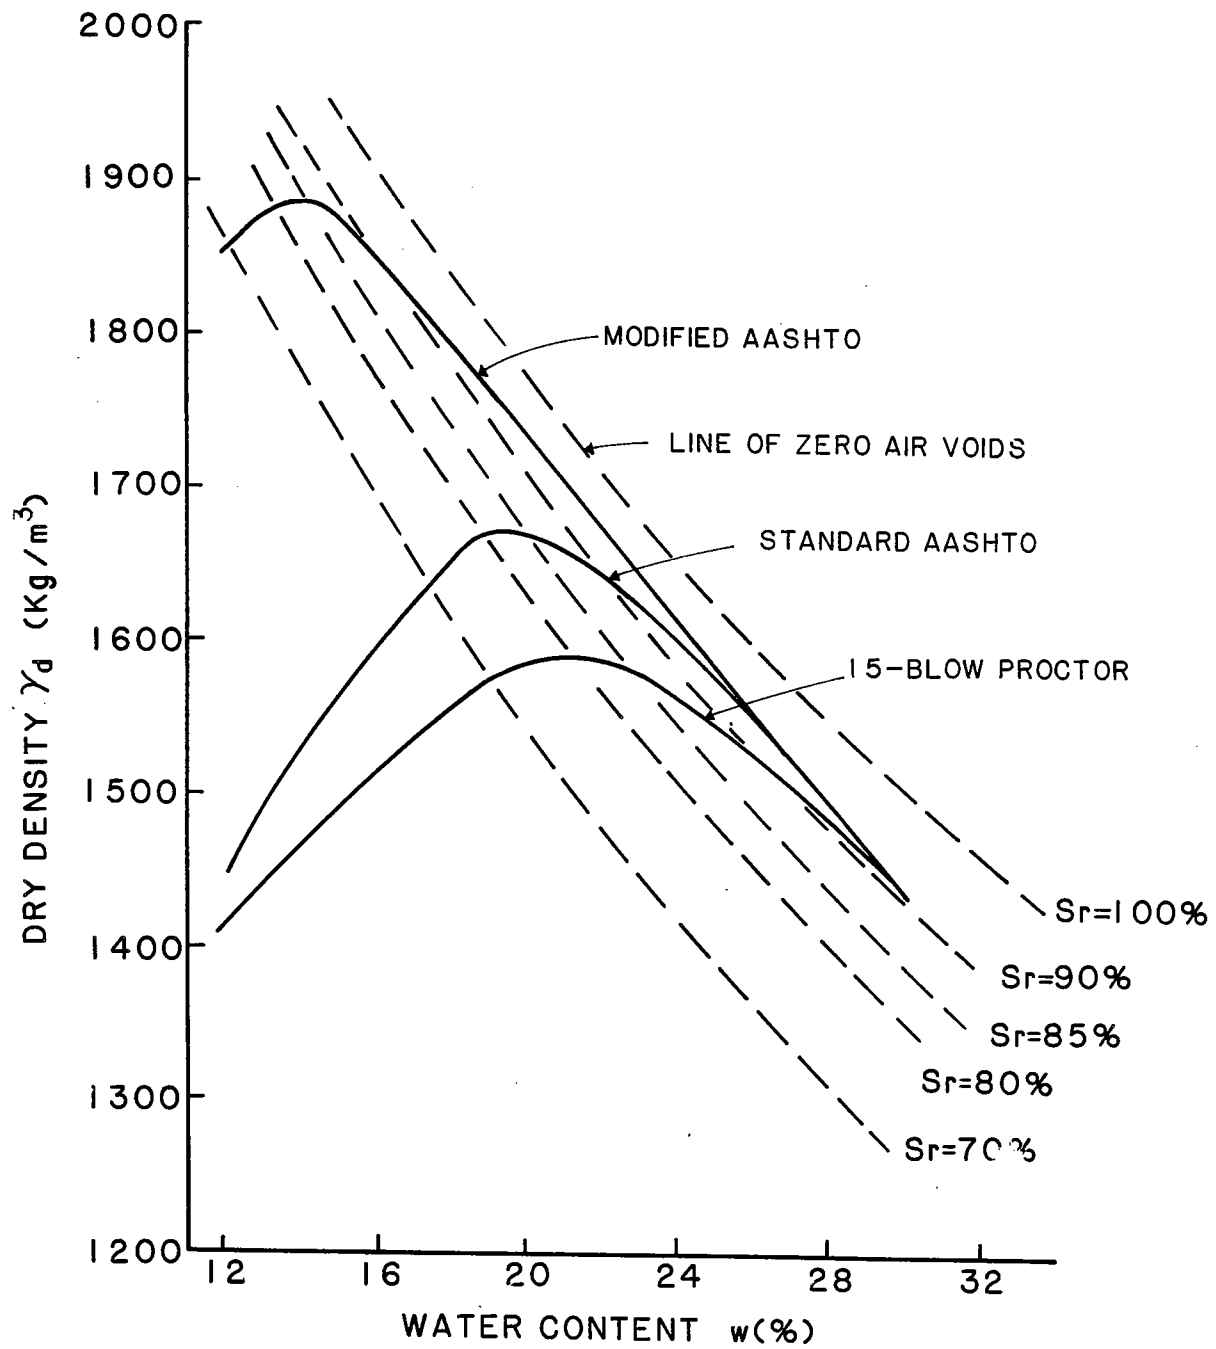
Figure 1 Dry Density vs. Moisture Content
For The Lacustine Clay.

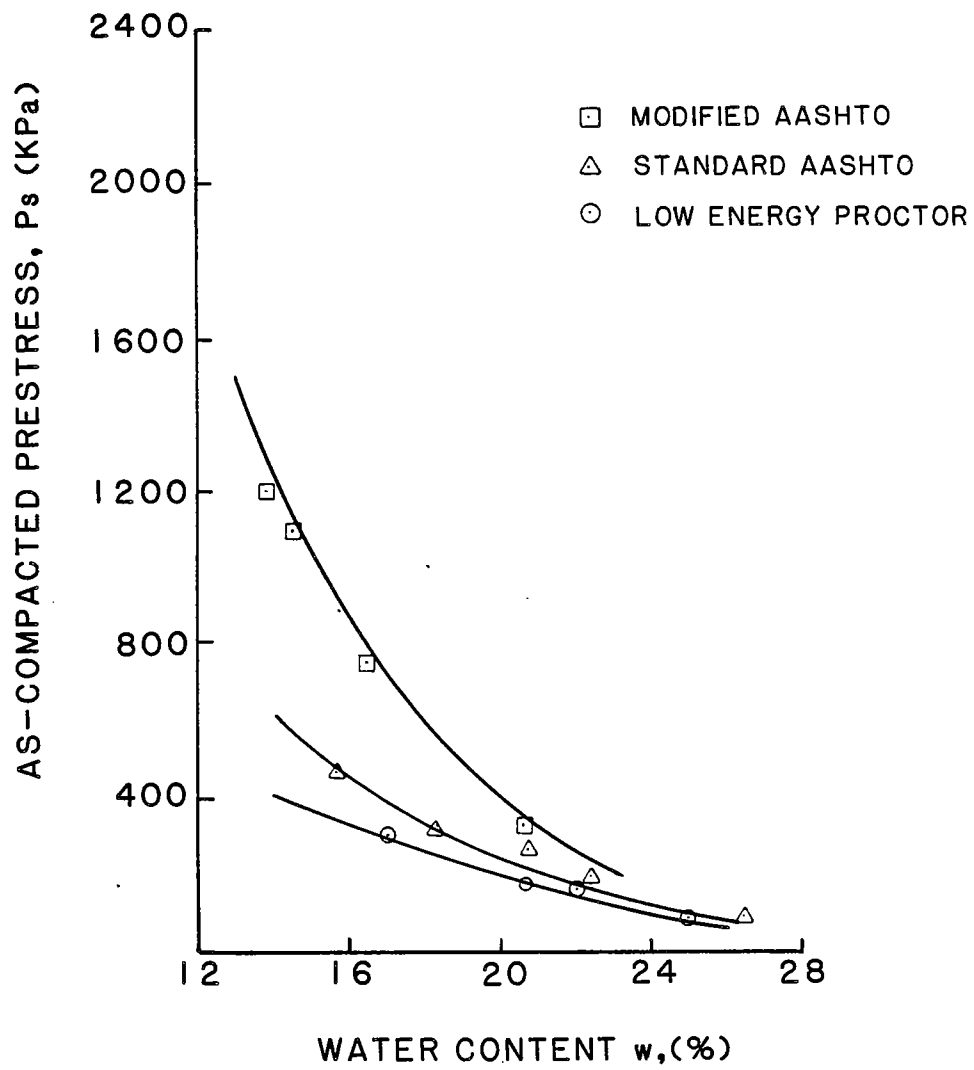
Figure 2. As-Compacted Prestress vs. Water Content

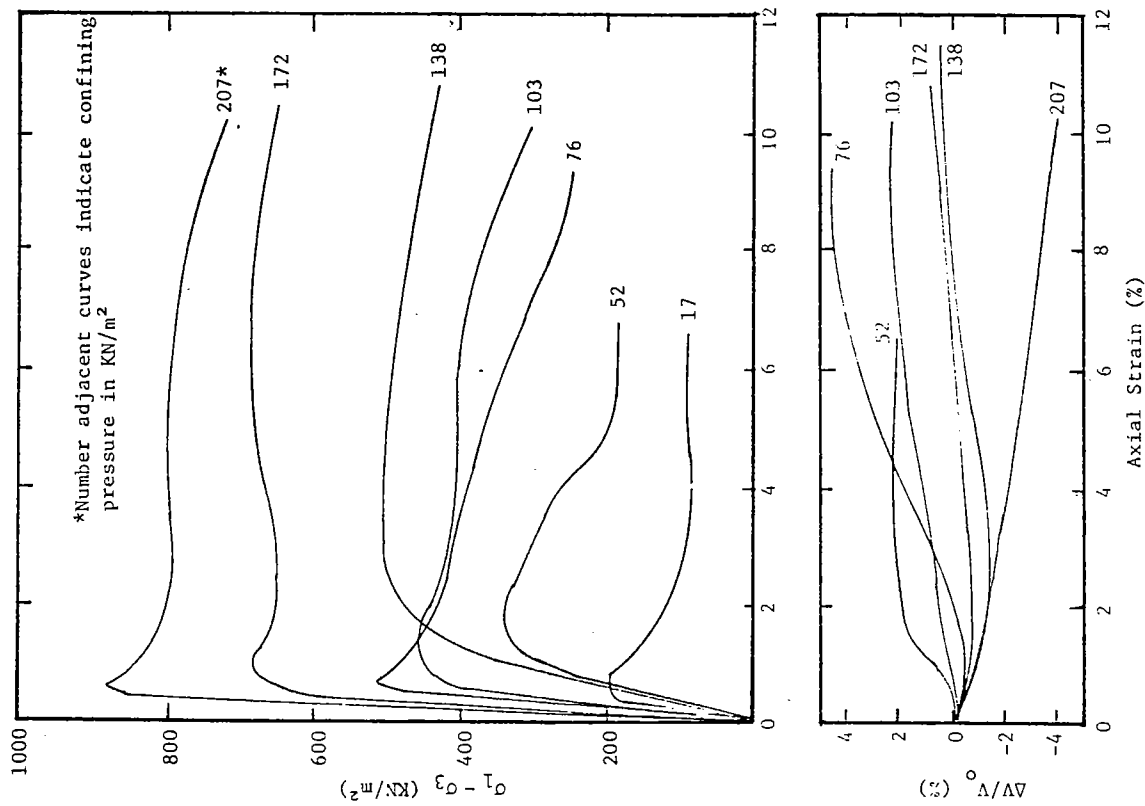
FIG. 3. STRESS-STRAIN PLOTS FOR CONSOLIDATED DRAINED TRIAXIAL COMPRESSION TESTS CONDUCTED ON BLOCK SAMPLES FROM PACIFICA.

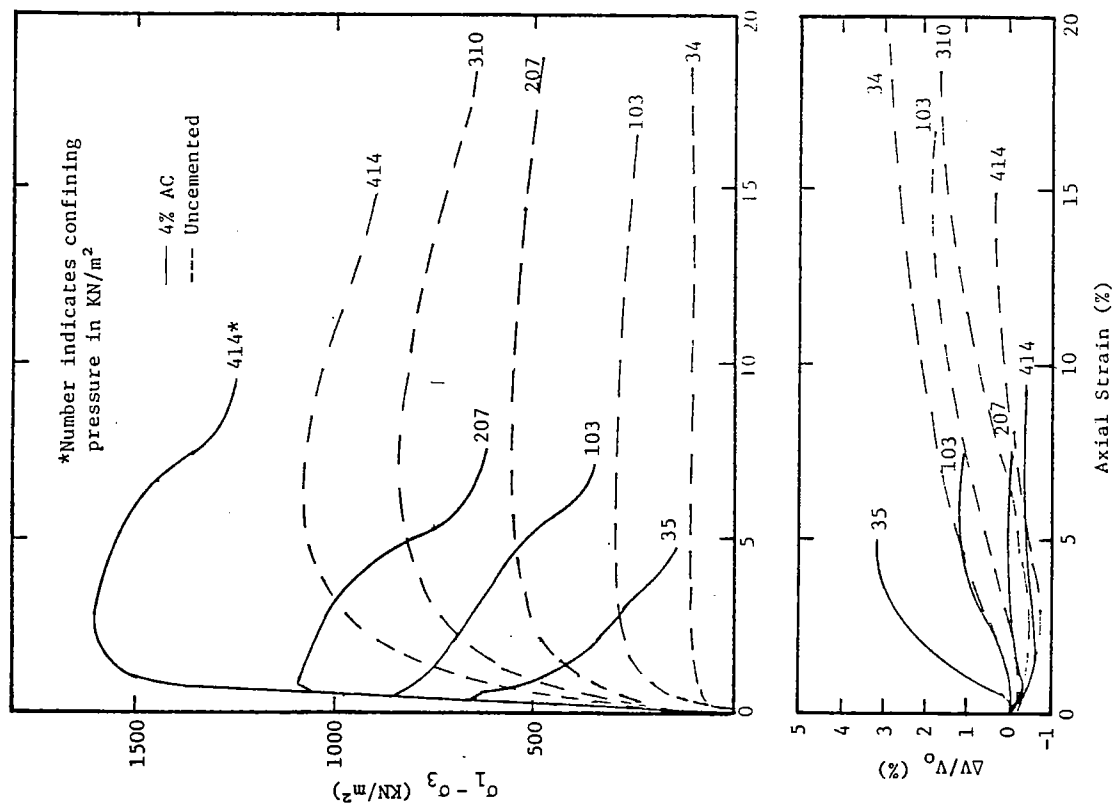
FIG. 4. TYPICAL STRESS STRAIN PLOTS FOR CONSOLIDATED DRAINED TRIAXIAL COMPRESSION TESTS CONDUCTED ON 4% ARTIFICIALLY CEMENTED AND UNCEMENTED SAND.

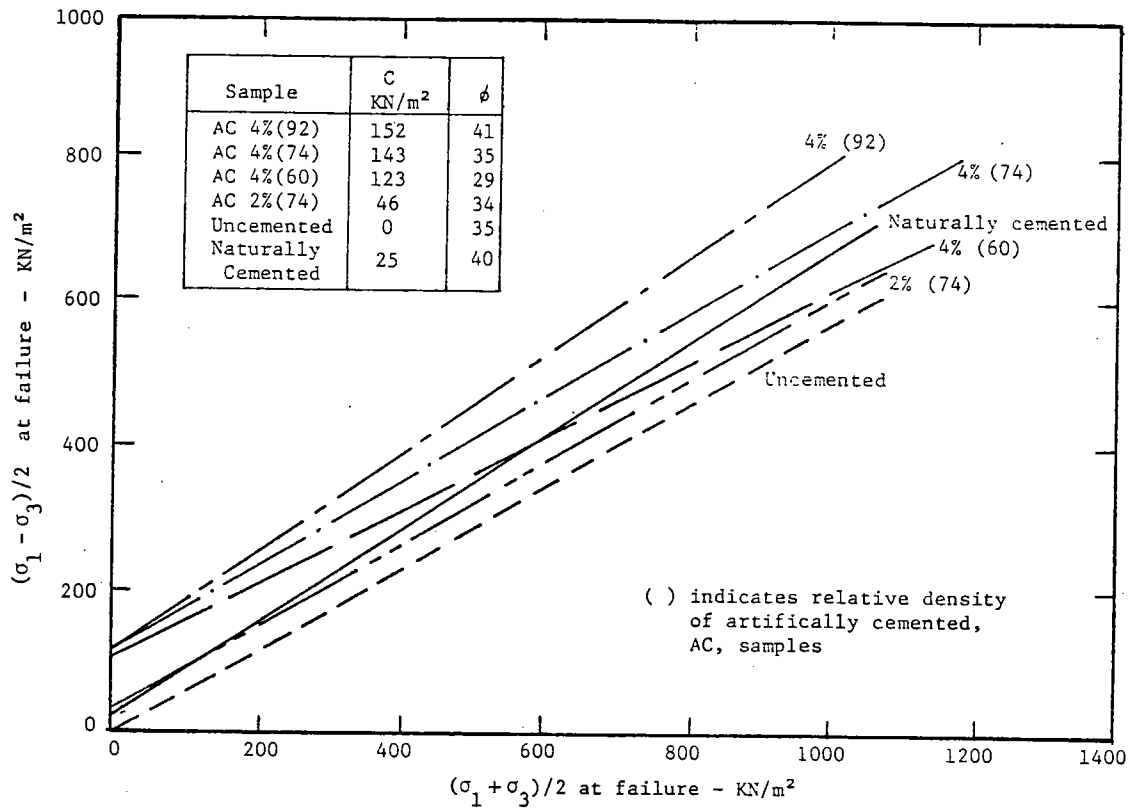
FIG. 5. PEAK STRENGTH VALUES FOR ARTIFICIALLY CEMENTED SAND, UNCEMENTED SAND AND BLOCK SAMPLES.

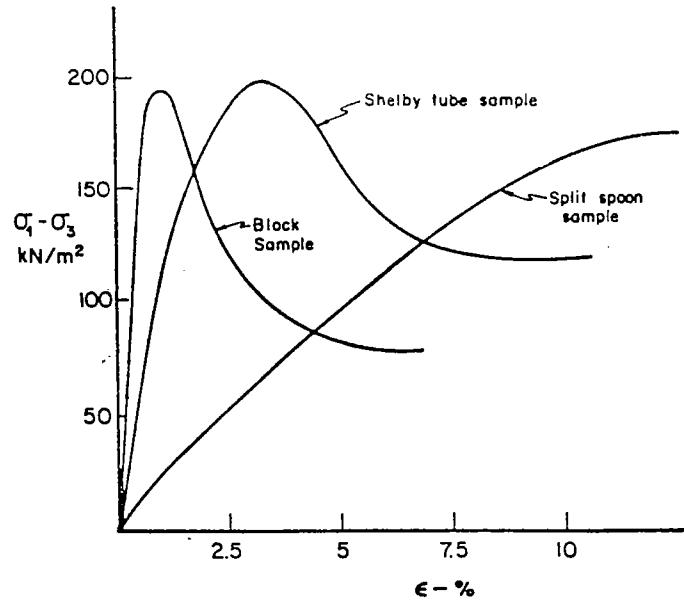
FIG. 7. TYPICAL STRESS-STRAIN RESPONSE OF DIFFERENT SAMPLES OBTAINED AT THE PACIFICA SITE.

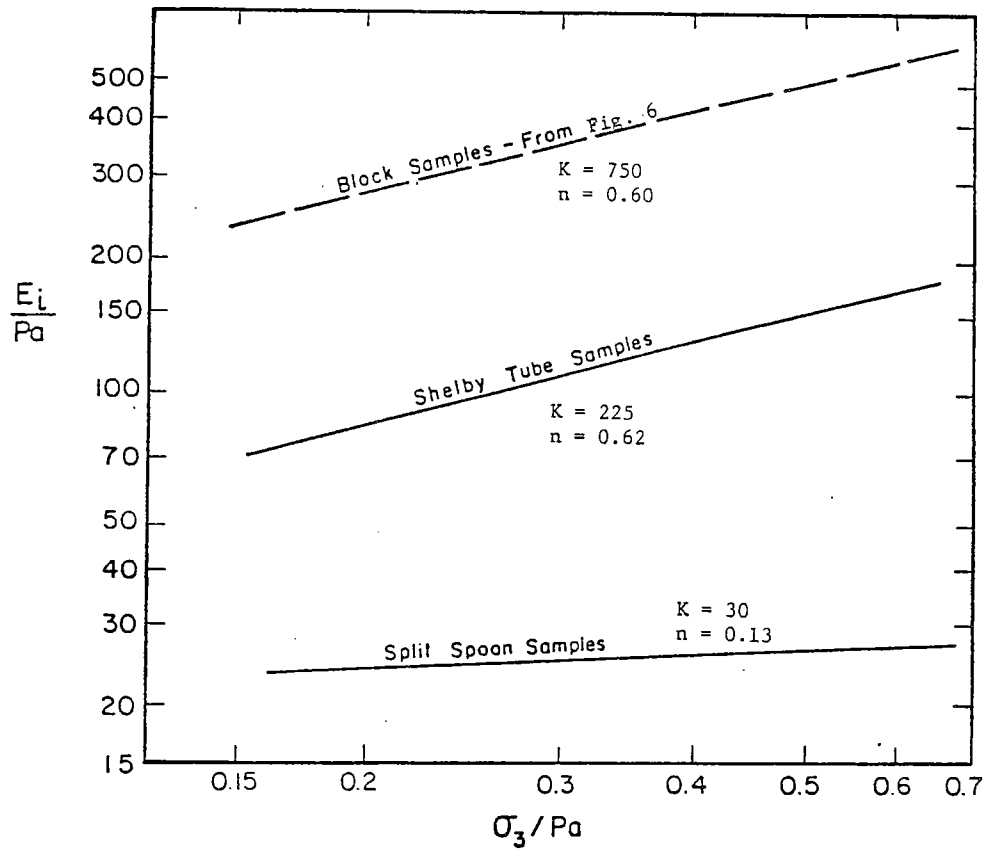
FIG. 8. VARIATION OF INITIAL TANGENT MODULUS WITH CONFINING PRESSURE FOR DIFFERENT SAMPLES OBTAINED AT THE PACIFICA SITE.

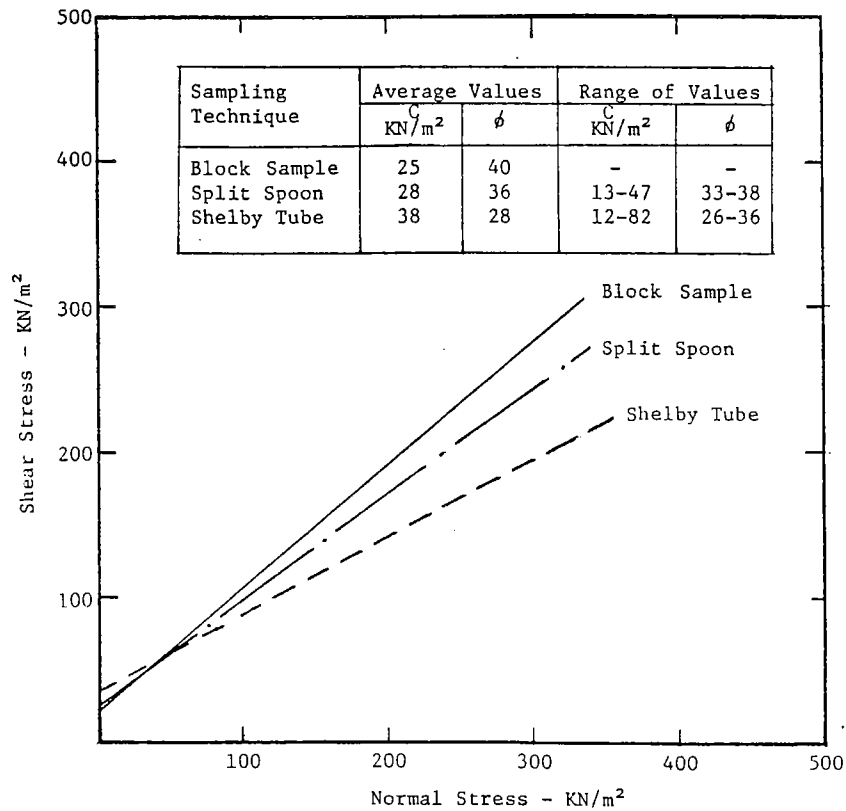
FIG. 9. AVERAGE MOHR-COULOMB FAILURE ENVELOPES FOR BLOCK, SPLIT SPOON, AND SHELBY TUBE SAMPLES.

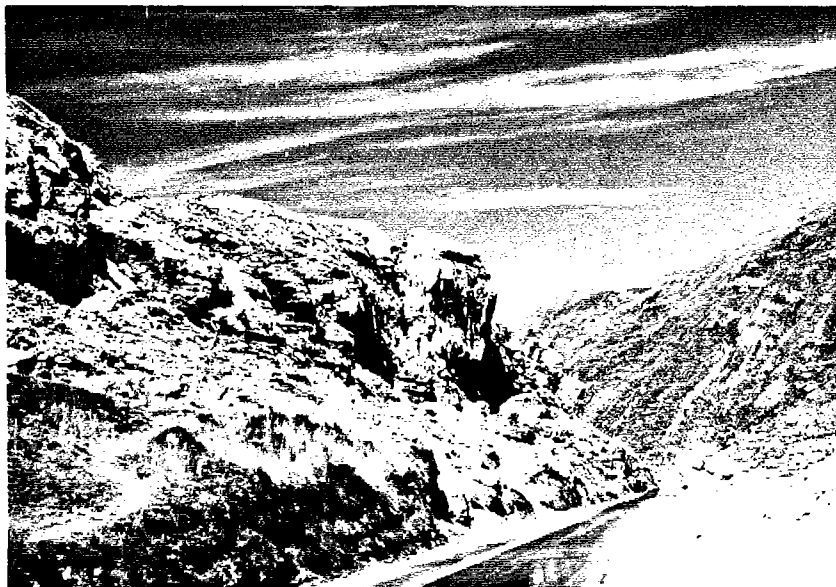
FIGURE 2. INCIPIENT TOPPLING FAILURE IN STEEPLY DIPPING SEDI-MENTARY ROCKS ALONG CENTRAL HIGHWAY; PERU; 125 KM EAST OF LIMA.

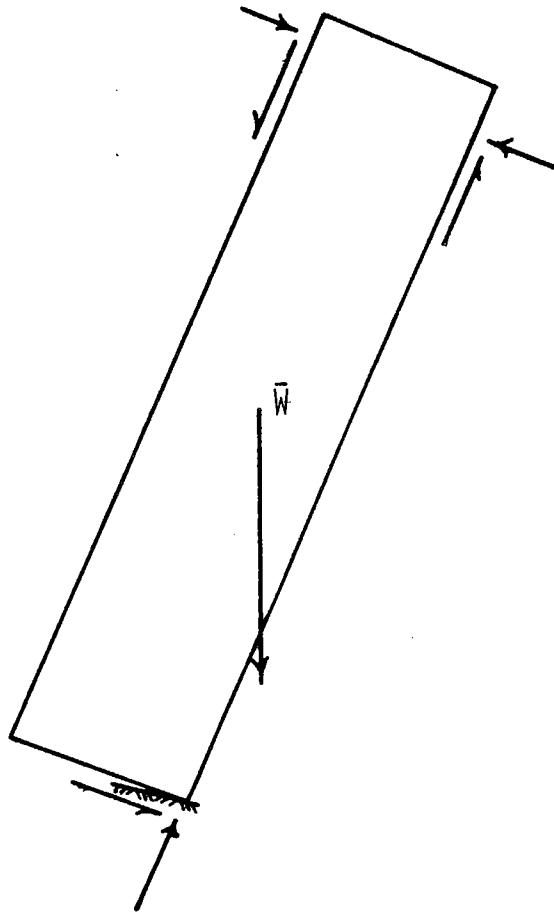
FIGURE 3. FREE-BODY DIAGRAM OF TALL ROCK COLUMN WITH OVERTURNING TENDENCY.

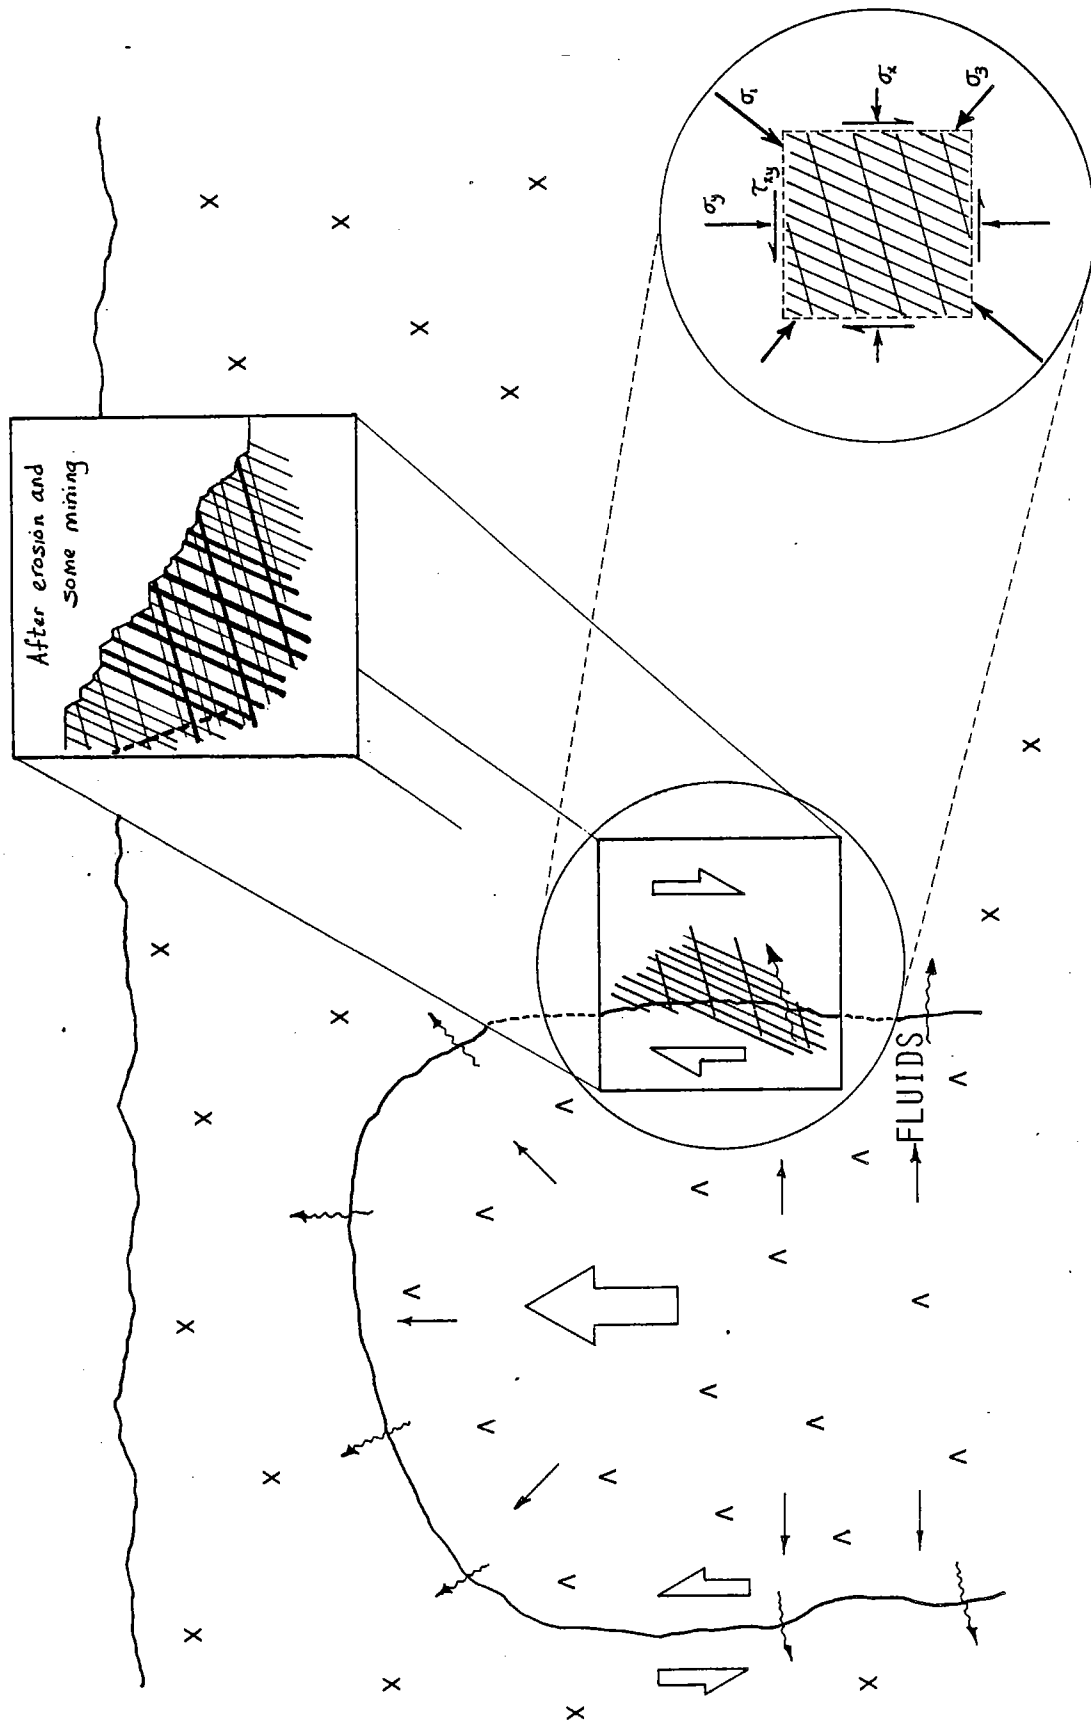
FIGURE 4. FIELD RELATIONS FOR CONJUGATE SETS OF SHEAR DISCONTINUITIES NEAR AN INTRUSIVE CONTACT; ACCOMPANYING STRESS SYSTEM AND MINE SLOPE SUSCEPTIBLE TO TOPPLING.

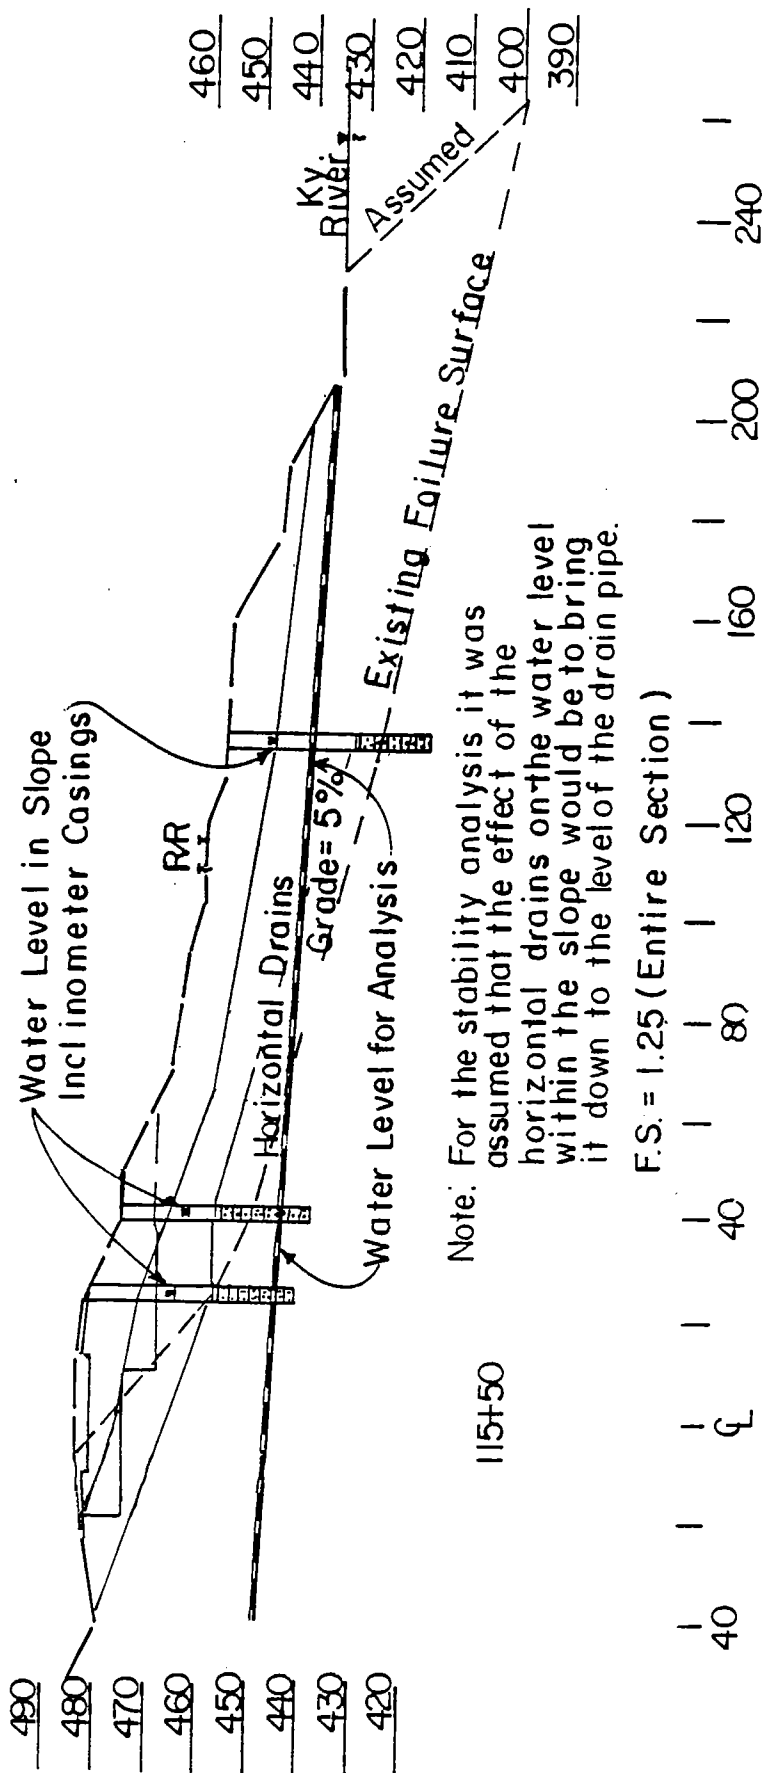
FIGURE 7 - HORIZONTAL DRAINS FOR LANDSLIDE STABILIZATION

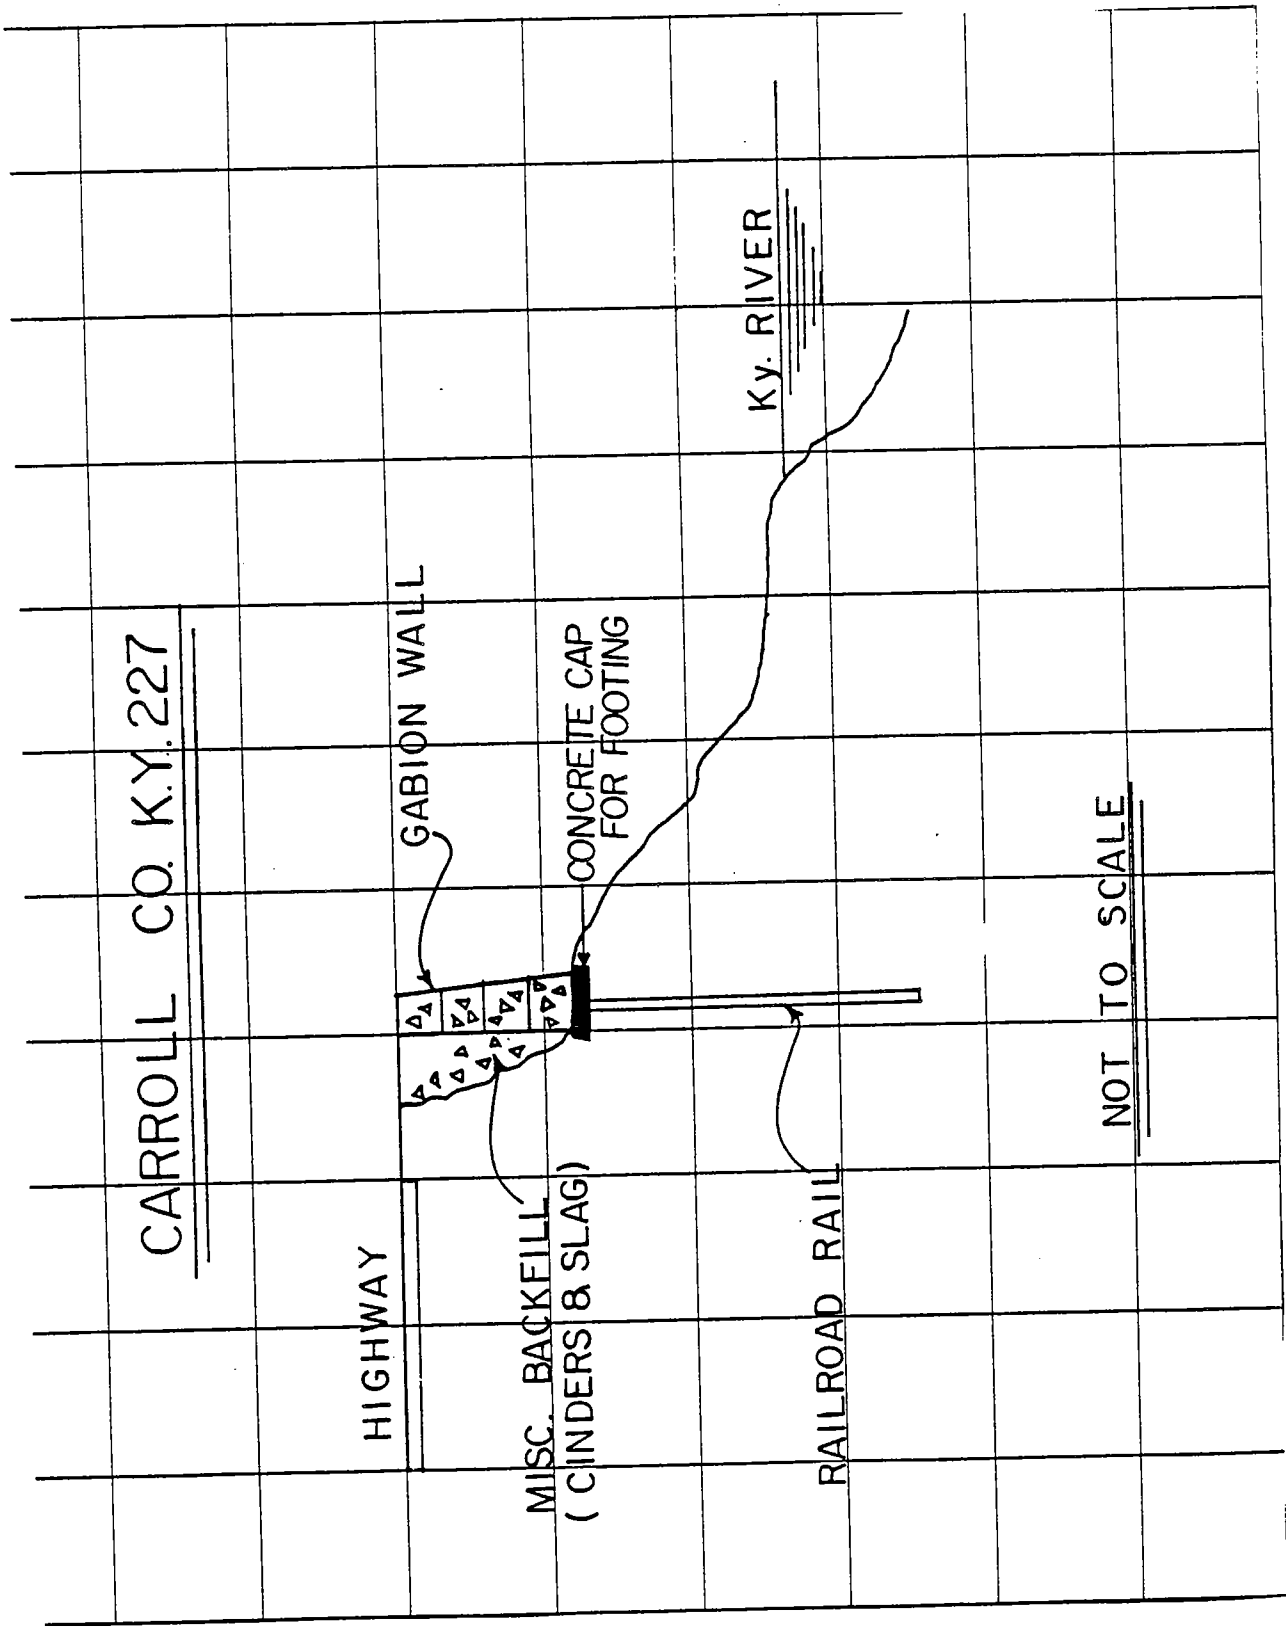
FIGURE 9 - MAINTENANCE CORRECTION

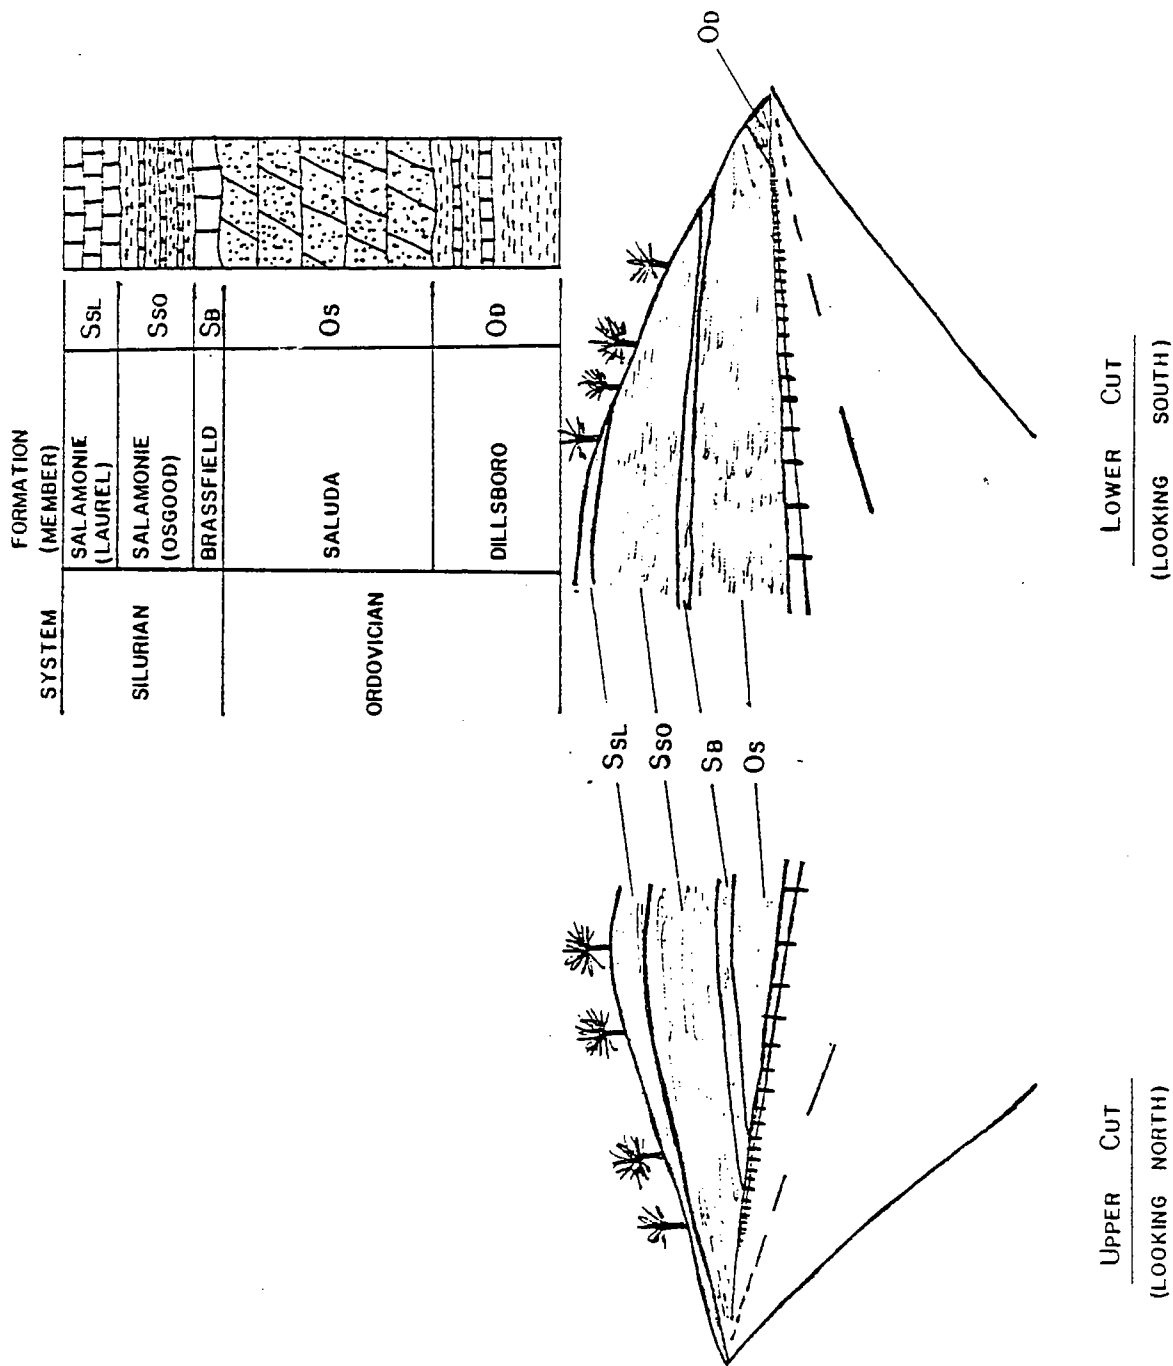
FIGURE-10
Geologic Section of a Highway Cut on US-421
