PROCEEDINGS OF THE 41st ANNUAL HIGHWAY GEOLOGY SYMPOSIUM

AUGUST 15 - 17, 1990. Albuquerque, New Mexico

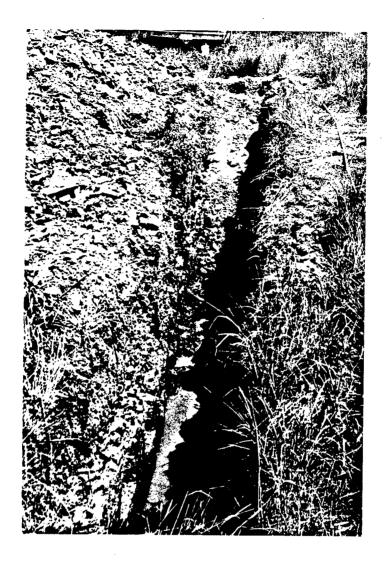
FIGURE 3. View looking east along trench T1 in borrow ditch on south side of U.S. Highway 14. Length of trench is 27 ft. Height of north wall is 6 ft. Water depth in trench is as much as 2 in.

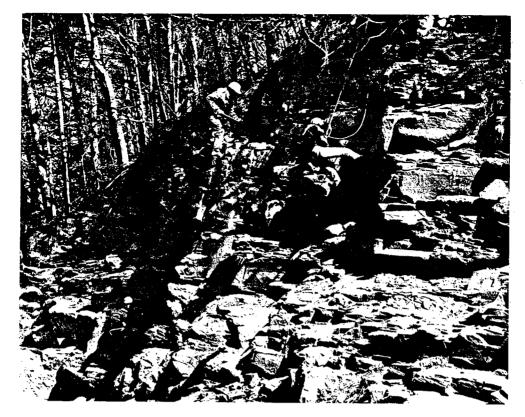
Figure 6. Hand scaling along I-40 in Cocke County helps to remove possible rockfall debris.

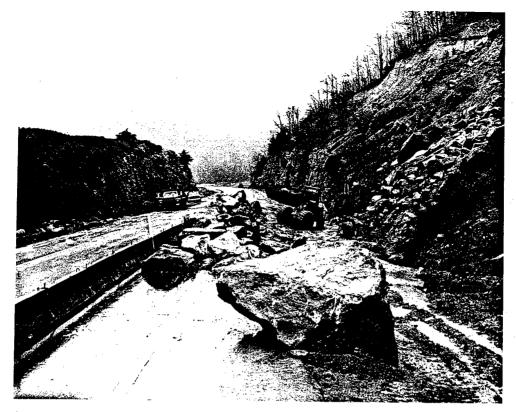
Figure 14. Rockfall events along I-40 in Cumberland County have caused injury and property damage.

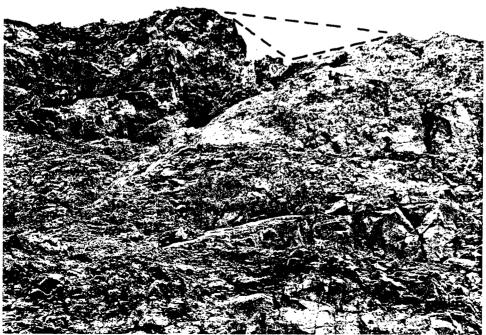
Figure 3. Failed unstable bench above underground excavations.

Figure 3 illustrates an unstable bench, part of which has already collapsed. The dashed outline shows the failed area immediately above exposed workings. To the left of the collapsed area a further rock mass can be seen to contain open fissures and is undergoing deformation. Typical unstable rock blocks are highlighted in Figure 4.

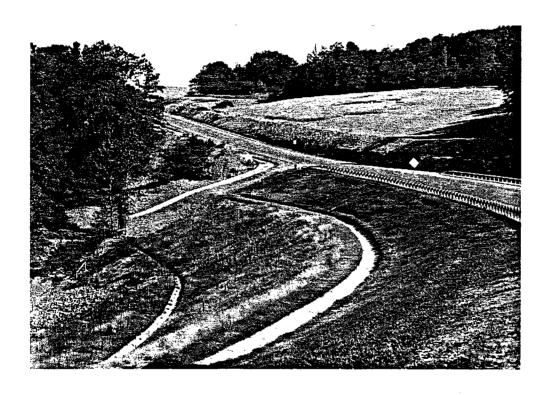
Figure 5
Embankment and Failed Backslope

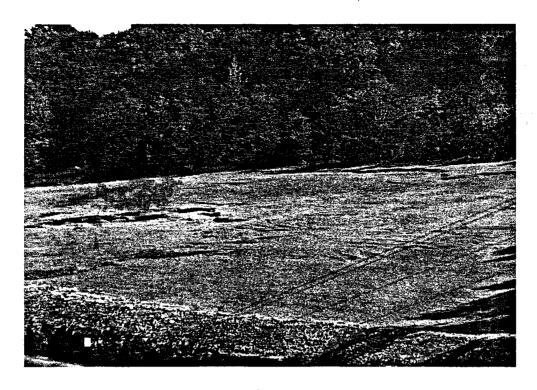
Figure 6
Failed Backslope

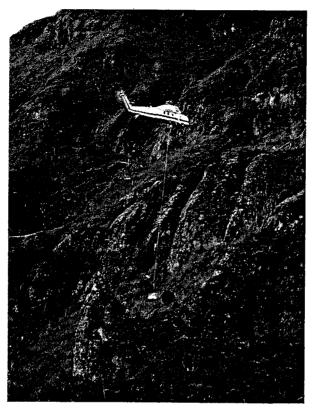
Figure 4. Helicopter Fly Hole Set-Up at Base of Hoffstadt Mountain

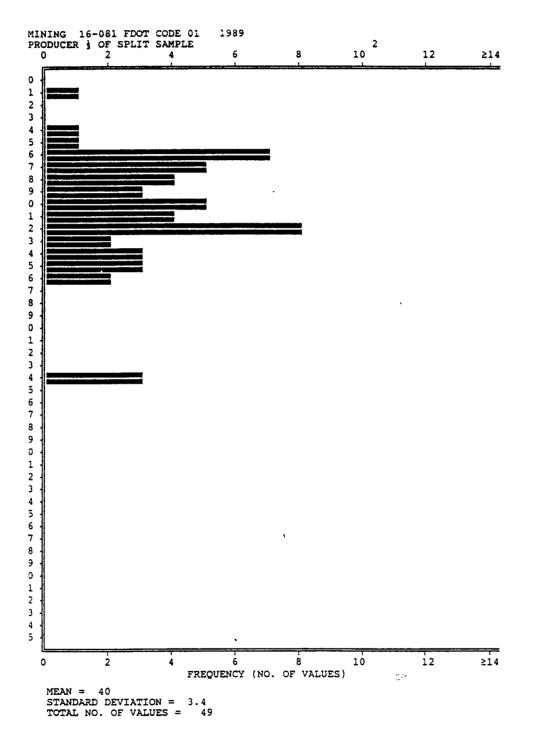
Figure 5. Histogram on Number 30 Sieve for Silica Sand(Producer Half of Split Sample).
