# "Geologic Complexities in the Highway Environment"

*Proceedings of the  
42nd Annual  
Highway Geology Symposium*

Robert H. Fickies, Editor

May 28-31, 1991  
Albany Hilton Hotel  
Albany, New York

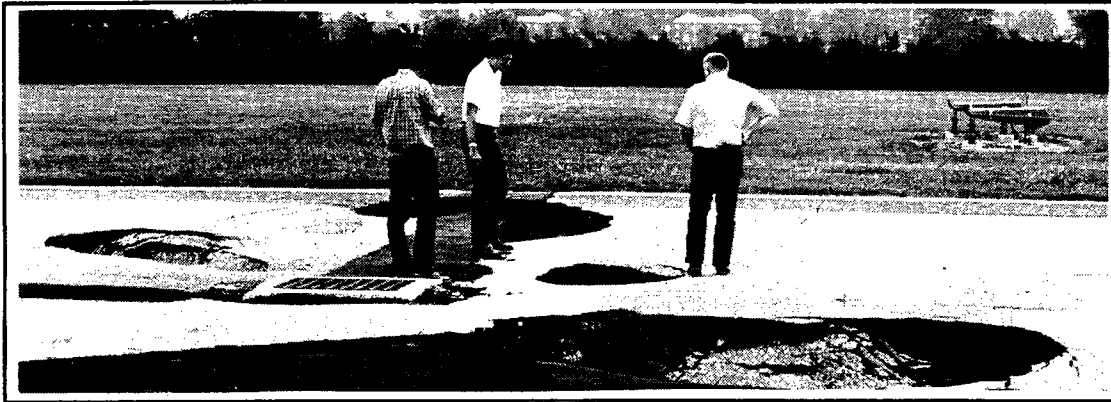
**Figure 15:** Section of Airport Runway Showing Effects of Sinkhole Activity.

The Capital City Airport, located near Harrisburg, Pennsylvania, has experienced a large number of sinkhole occurrences throughout its existence. Figure 15 shows a section of one runway, prior to remedial grouting and resurfacing, illustrating the effects of extensive sinkhole activity. Geotechnical investigations have confirmed the presence of highly eroded, cavity-ridden strata beneath the airport property. In the past, several engineering alternatives were proposed ranging from relocation of the facility to major reinforcement of the underlying strata and subsequent replacement of the runway pavement. Due to social, economic and political factors, the selected

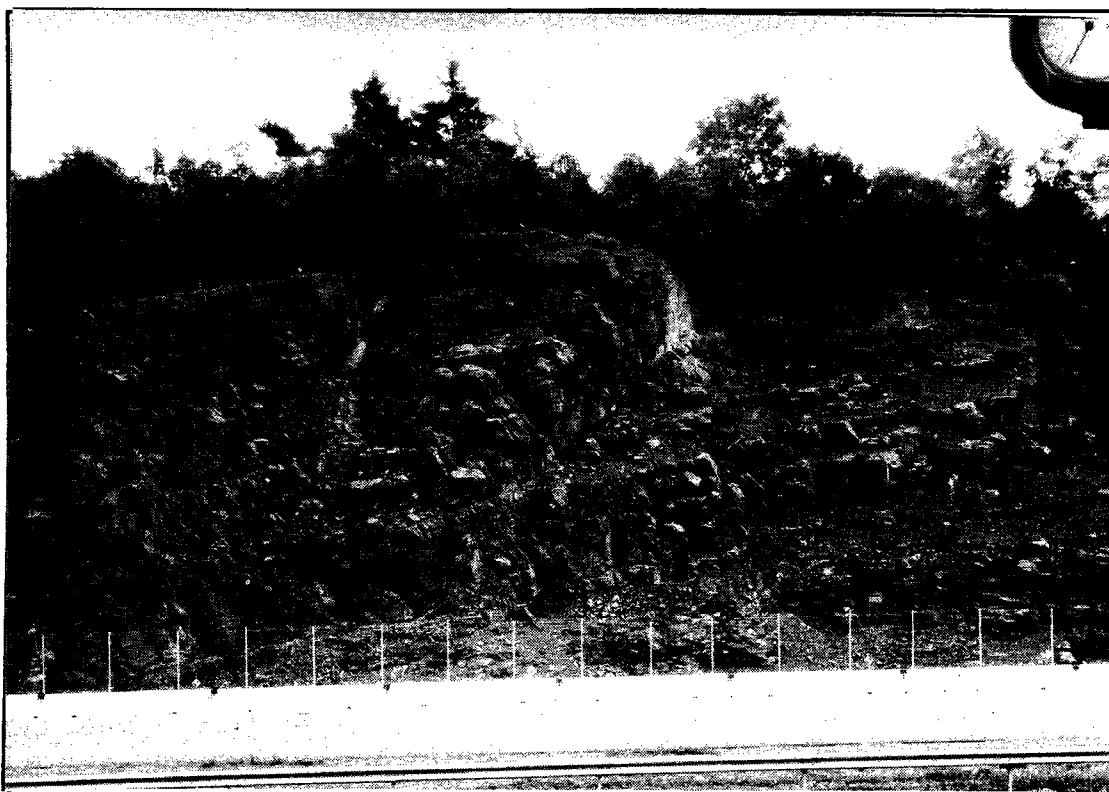
**Figure 6:** Photograph at milepost 81.2-81.4 showing numerous loosened and detached blocks; view looking east.

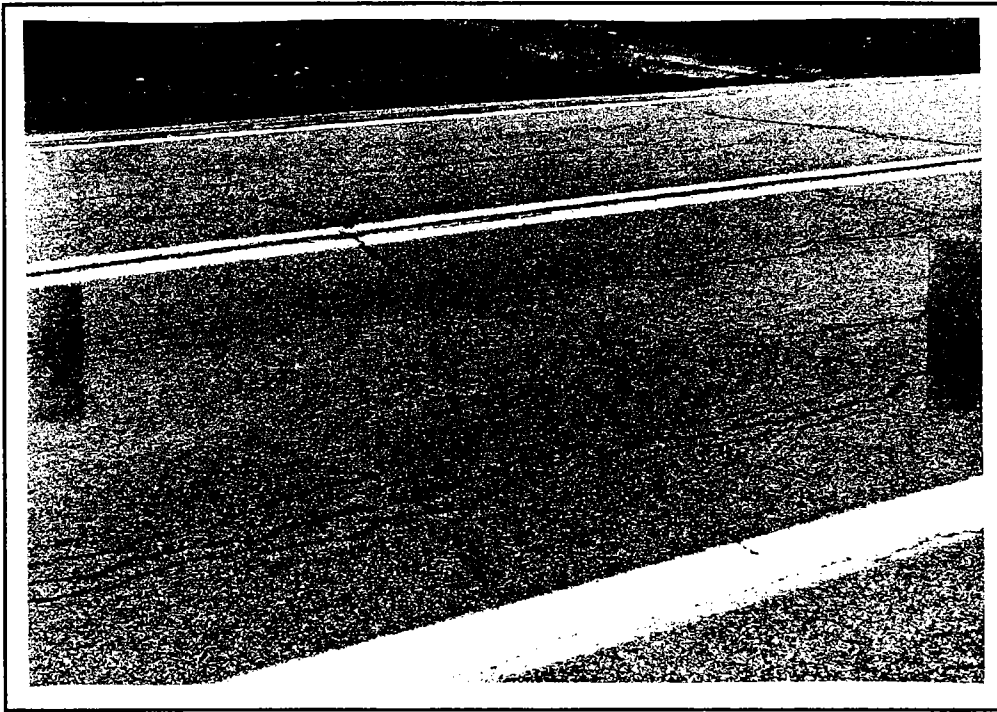
**Figure 5:** Pavement with untreated aggregate 7A gradation foreground, 6A background; wheelpath and other cracking.

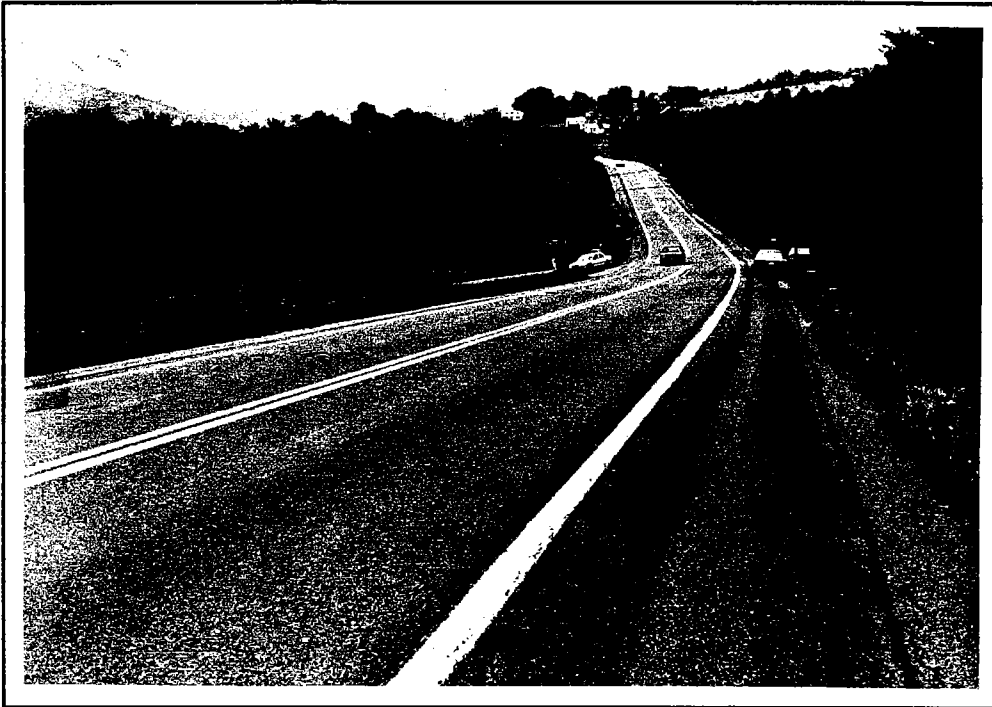
**Figure 7:** Typical pavement with treated aggregate, 6A gradation in foreground, 7A gradation background. Test pavement starts adjacent to the automobile on the right.

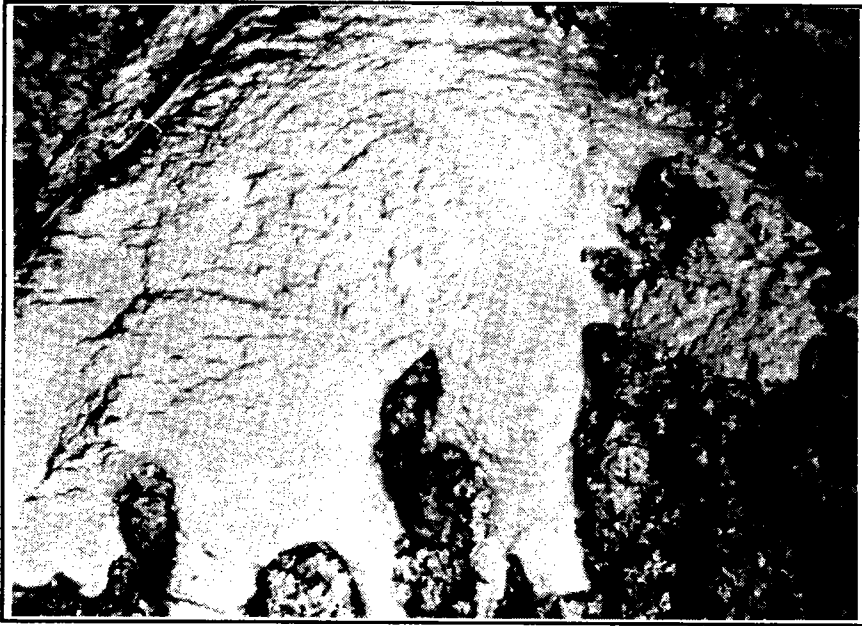
**Figure 6a: SEEPAGE OUTFLOW EFFECTS;** Soil-water flow out of bank (Coin for scale is a U.S. dime).

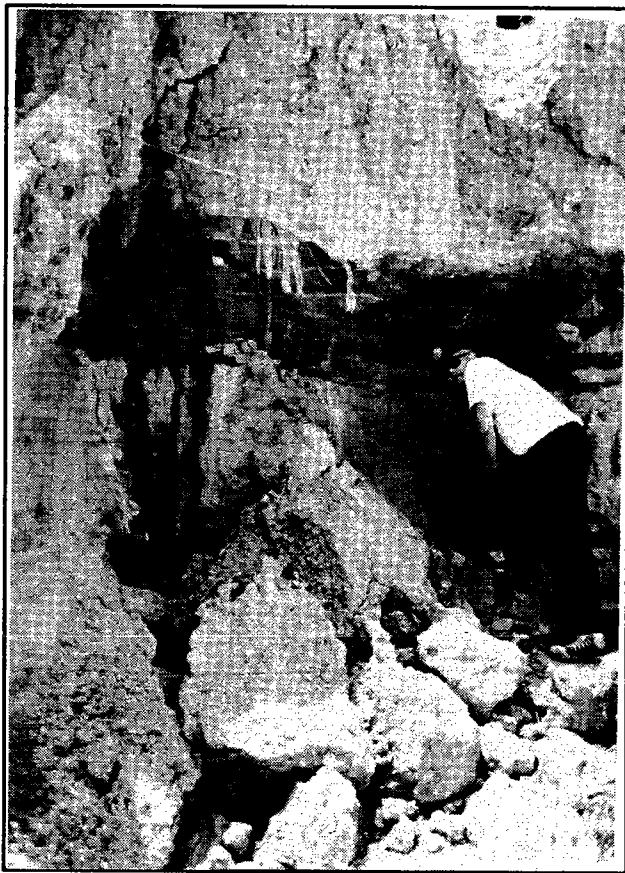
**Figure 6b: SEEPAGE OUTFLOW EFFECTS;** Collapse caused by seepage outflow.

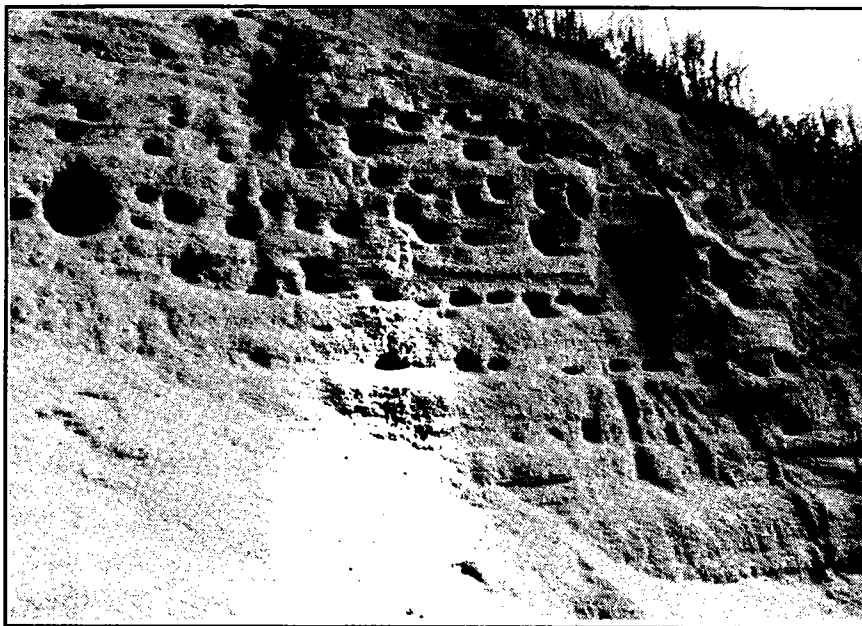
**Figure 6c: SEEPAGE OUTFLOW EFFECTS;** cavities caused by seepage outflow.

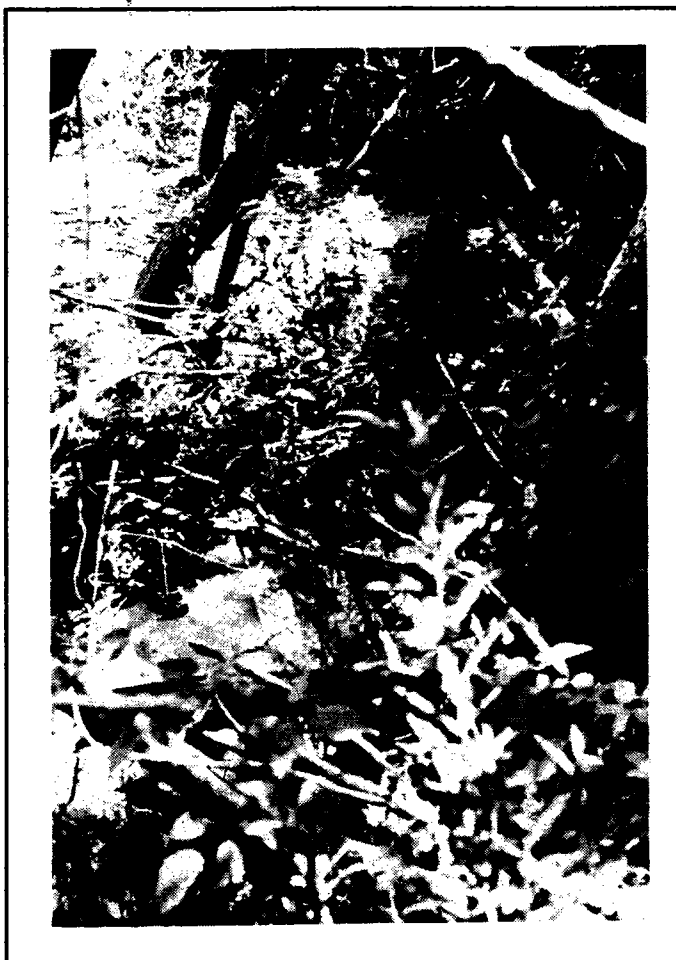
**Figure 2B:** Sag pond and backward leaning trees in rotated block. Uphill is to the right.

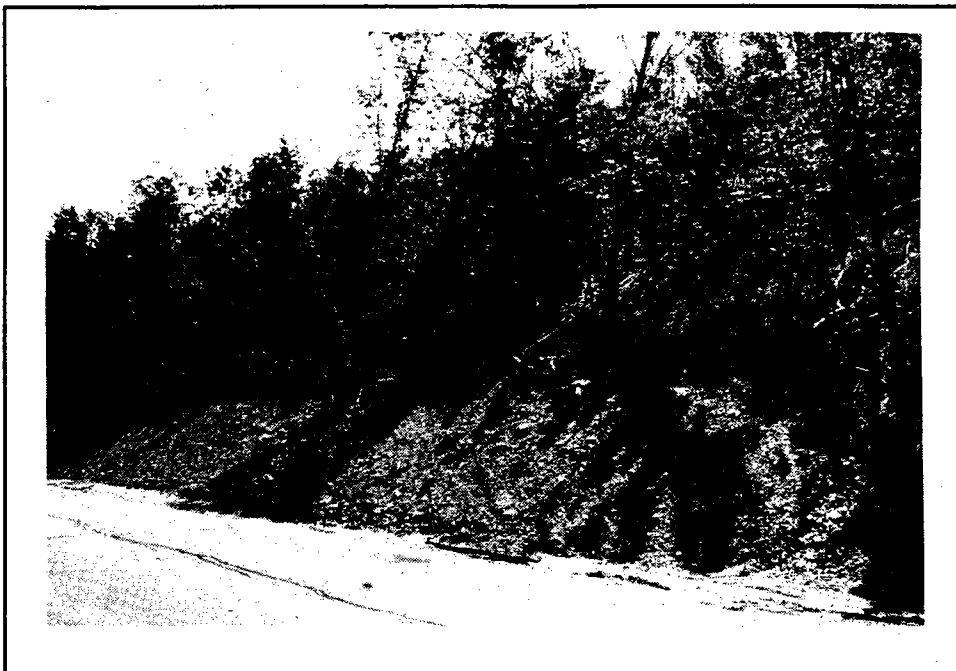
**Figure 3:** Vermont Route 4A looking east. North is toward road shoulder. Slide material has been cut back by the highway department. Expressions of the slide surfaces are the cracks in the pavement, one along the centerline, the other near the pavement edge to the left (see fig. 2a).

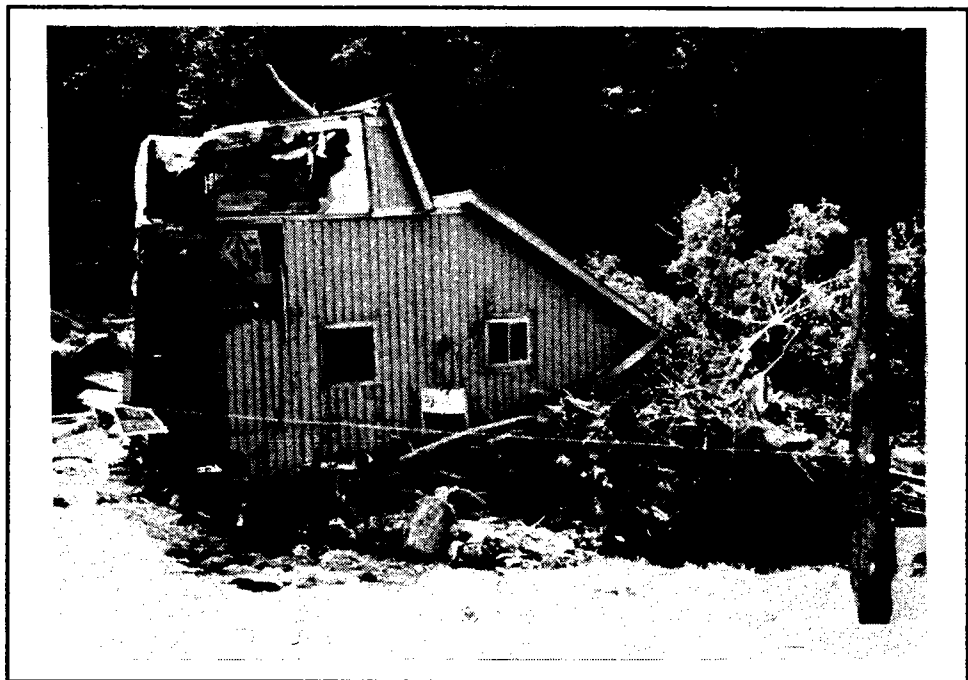
**Figure 8:** This house has been torn from its foundation and rolled over on its side by the Great Brook rain created torrent of 1989.
