45 TH  
HIGHWAY GEOLOGY  
SYMPOSIUM

PORTLAND, OREGON  
August 17-19, 1994

*PROCEEDINGS*

Scott F. Burns, Editor

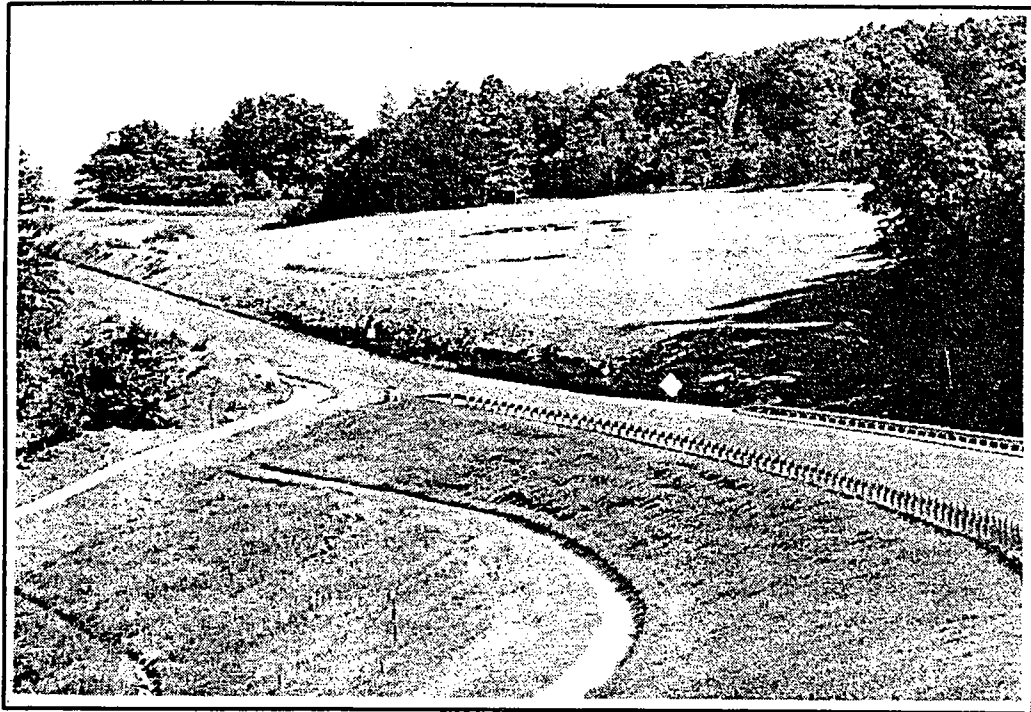
**FIGURE 1.** Initial Slope Failure in July, 1989 (McGuire, 1990).

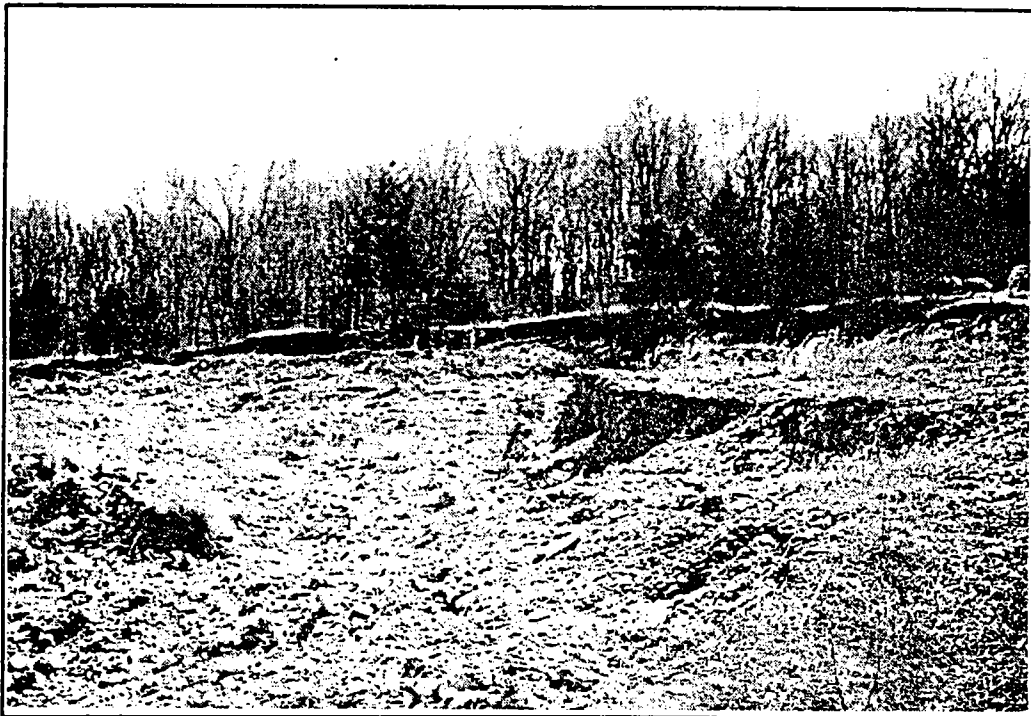
**FIGURE 2.** Slope Failure in April, 1994.
