47th Highway Geology Symposium

Cody, Wyoming
September 6-9, 1996

PROCEEDINGS

Sponsored by:
Wyoming Department of Transportation
Wyoming Geological Survey

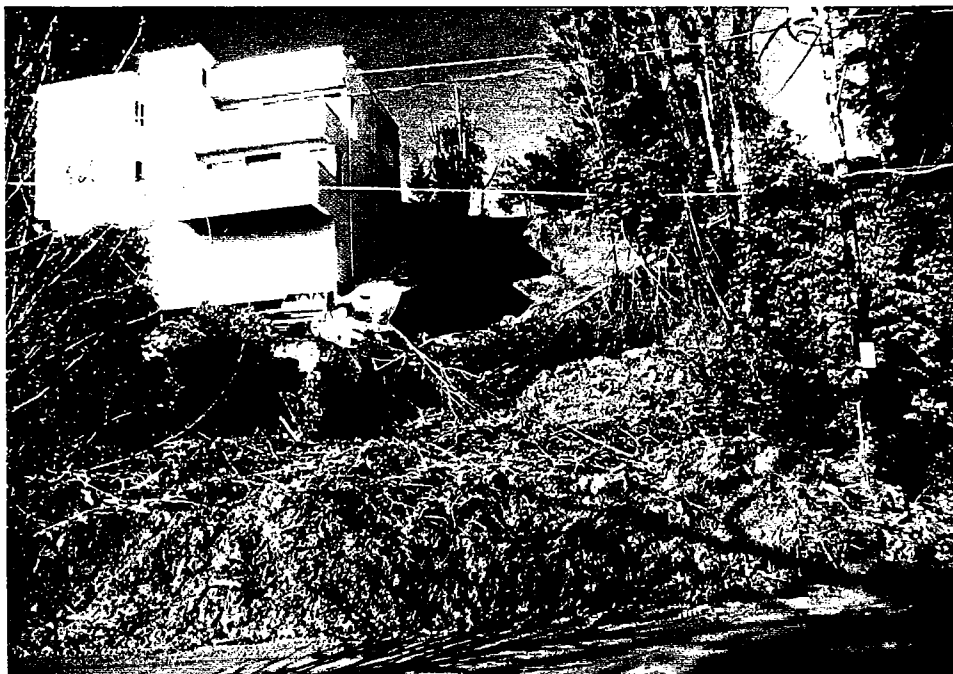
Figure 2: Earthflow in loess. Runoff from street above concentrated water on the slope and caused the failure.

Figure 2 depicts another earthflow that happened between two homes. The earthflow was greatly enhanced by runoff from the unimproved road above the slide. The only place for water to leave that small street was over the slope face, thereby saturating the loess. The earthflow covered the street below for four days. The slide has not been repaired yet.

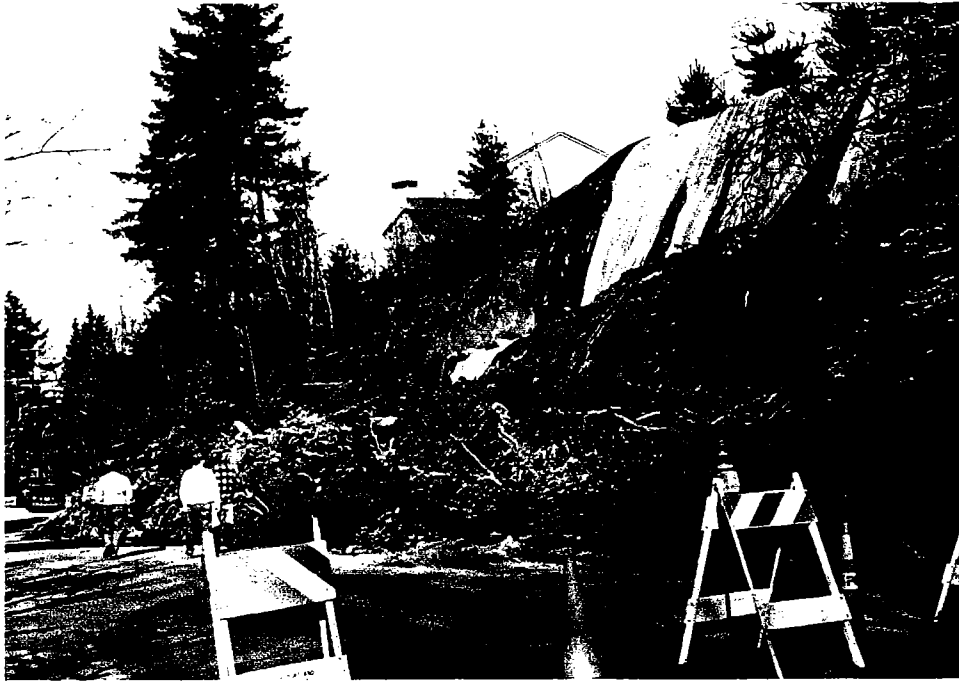
Figure 3: Earthflow in loess where failure surface is on a paleosol in the loess.

Figure 3 shows another earthflow in another neighborhood. This failure occurred on a paleosol within the loess deposit of another older loess unit. Many such failures were encountered in the West Hills. Highway officials have noticed that if they see a red zone daylighting in the side of the roadcut that they are about to have problems in the rainy weather. This slide was repaired by removing all of the colluvium, putting in a geotextile base, filling with rockfill, and then covering the site with loess soil and barkdust. They also put a retaining wall in at the bottom of the slope.

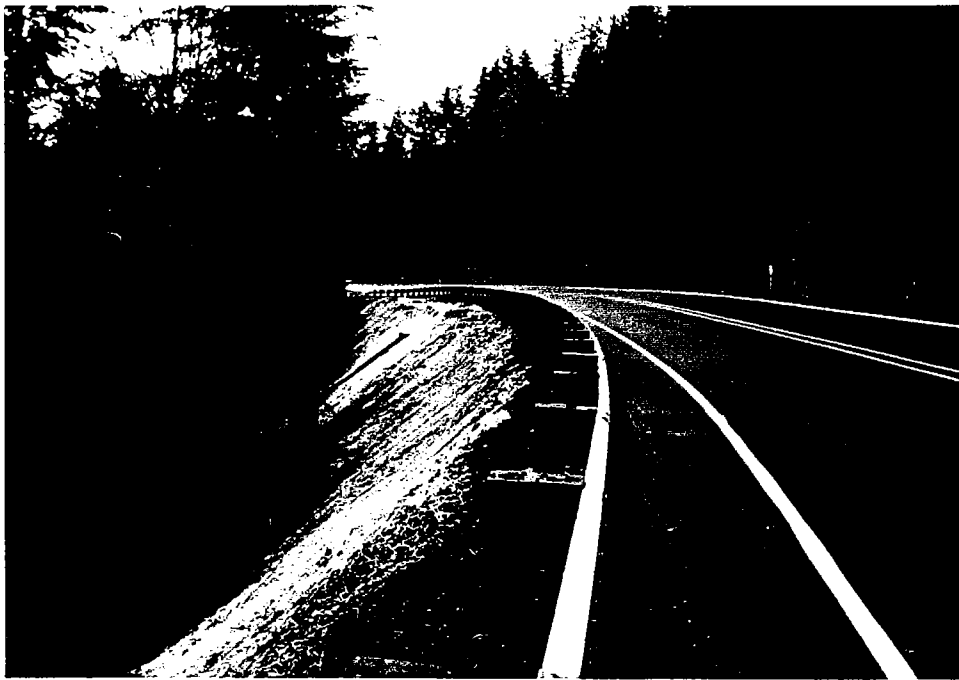
Figure 8: Use of wood chips for light-weight fill on Highway 6 failure.

Another set of debris flows occurred to the west of Portland on Highway 6 to the beach. Just to the west of the summit, there were over 10 debris flows that had come down the slope and had washed out the fill under the road. Most of these failures were fixed by putting in lots of light-weight fill, wood chips (Figure 8). The highway was closed for over three months.

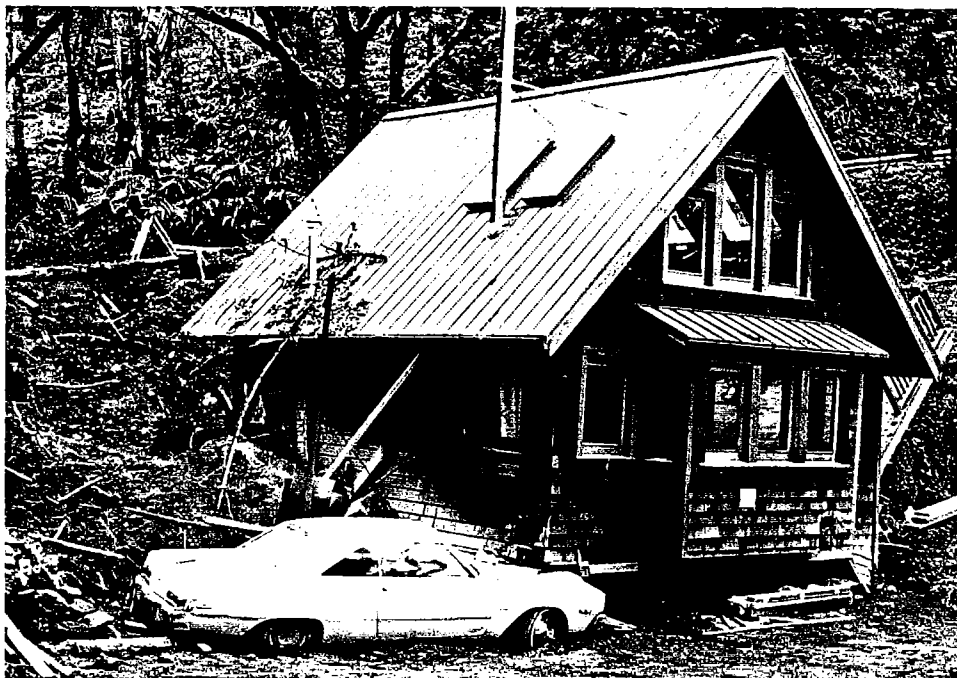
Figure 9: Debris flow knocks house off of its foundation.

One debris flow occurred just outside of Portland on Germantown Road. A landslide in the upper drainage came to rest in the bottom of the drainage. The heavy rainfall mobilized the colluvium and turned it into a debris flow which wiped out a house built in the valley bottom (Figure 9). The house was knocked off of its foundation and crushed the owner's car which was parked in front of the house. As most homeowners in

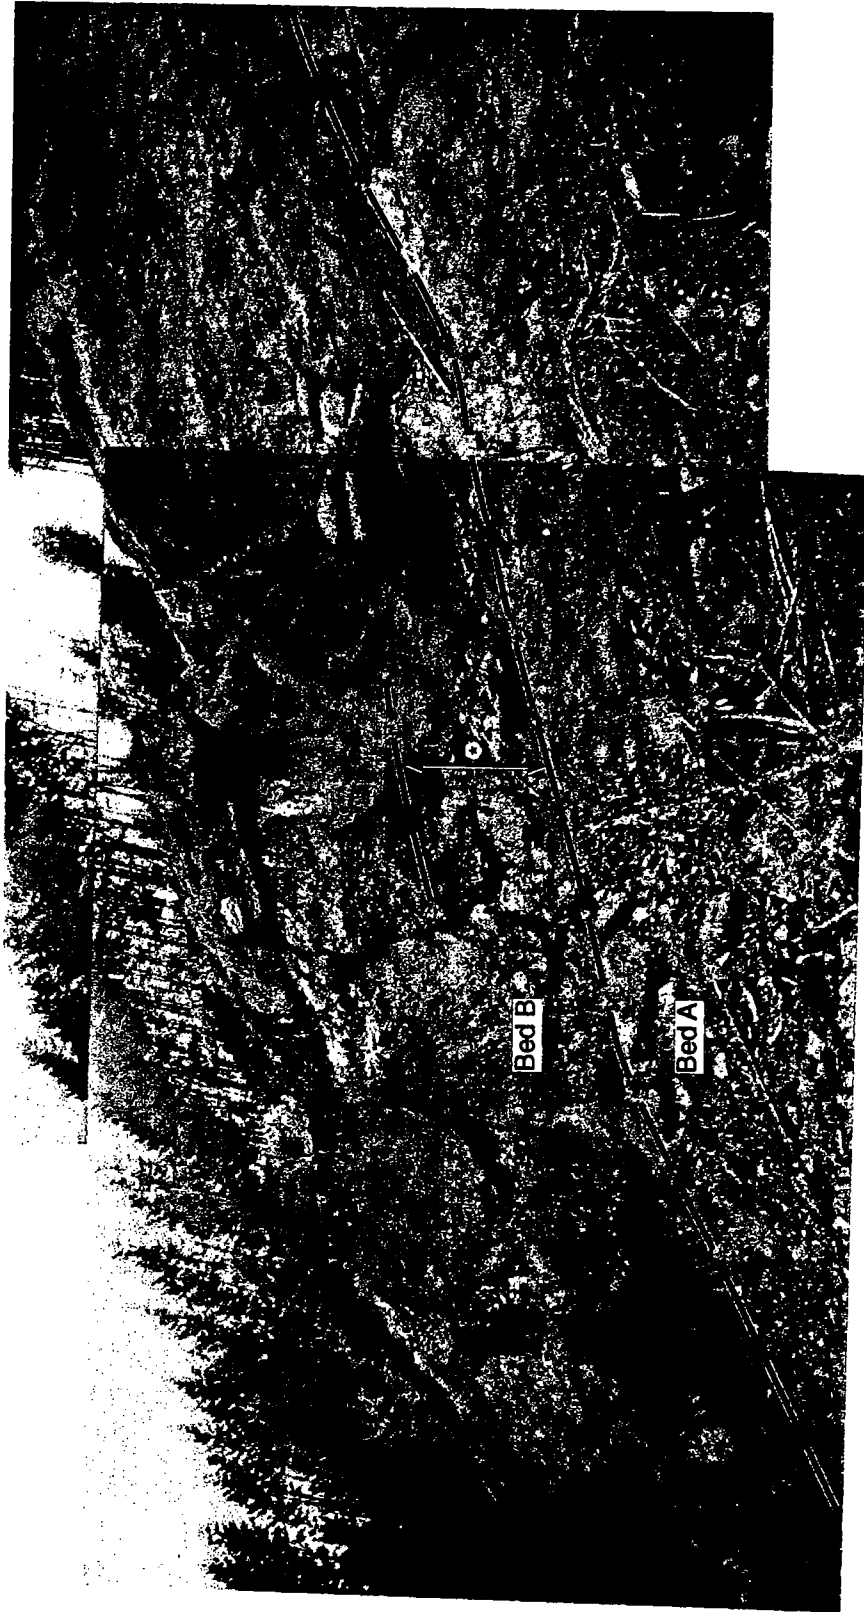
* Section of "missing" rock mass after January 12, 1996 failure.
See Figure 10 for post failure comparison.

Figure 9. Photograph of west lateral scarp area of unstable block
taken on Jan. 3, 1996.

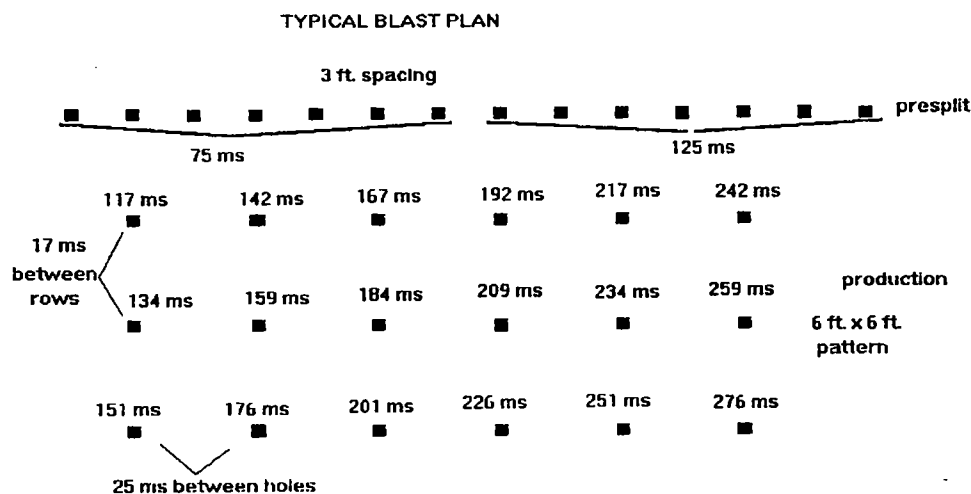
Figure 7 Typical ignition pattern for a presplit blast.

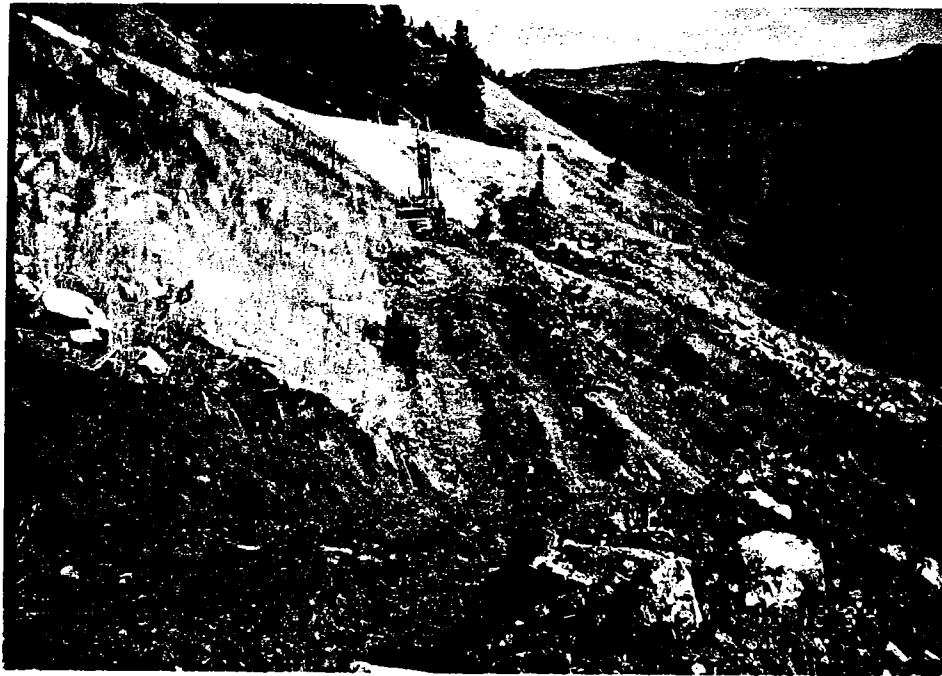
Figure 2. Investigation of the Blue Trail Slide, October 1994

Additional drilling was conducted by WYDOT to identify the slide plane, establish depth to bedrock, and obtain samples for laboratory testing. From the information gathered, an integrated slope stability analysis was performed using the program XSTABL. Assuming that the slide is close to a state of limit equilibrium (factor of safety ~1.0) stability analyses were conducted to develop realistic effective stress strength parameters for the failure surface. These analyses yielded a residual cohesion $\bar{c} = 0$ and friction angle $\bar{\phi} = 14$ degrees. Subsequent analyses utilizing these parameters were then conducted to assess various means of increasing the stability of the slide.

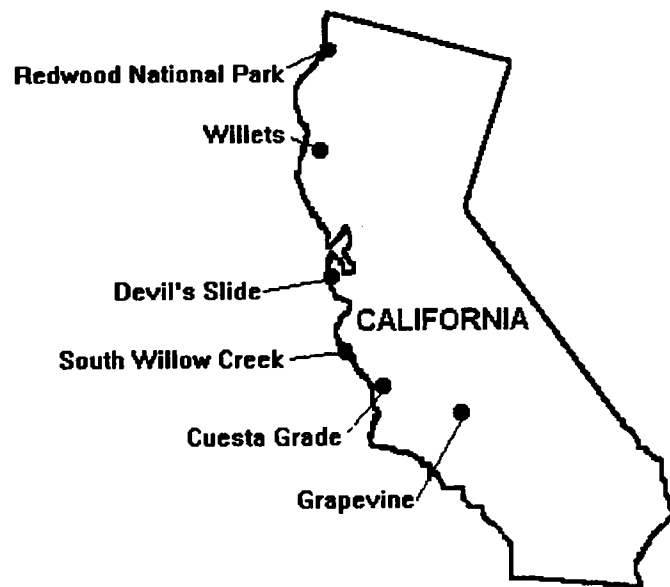
Figure 4. Locations Where Coaxial Cables Were Installed For TDR Measurements

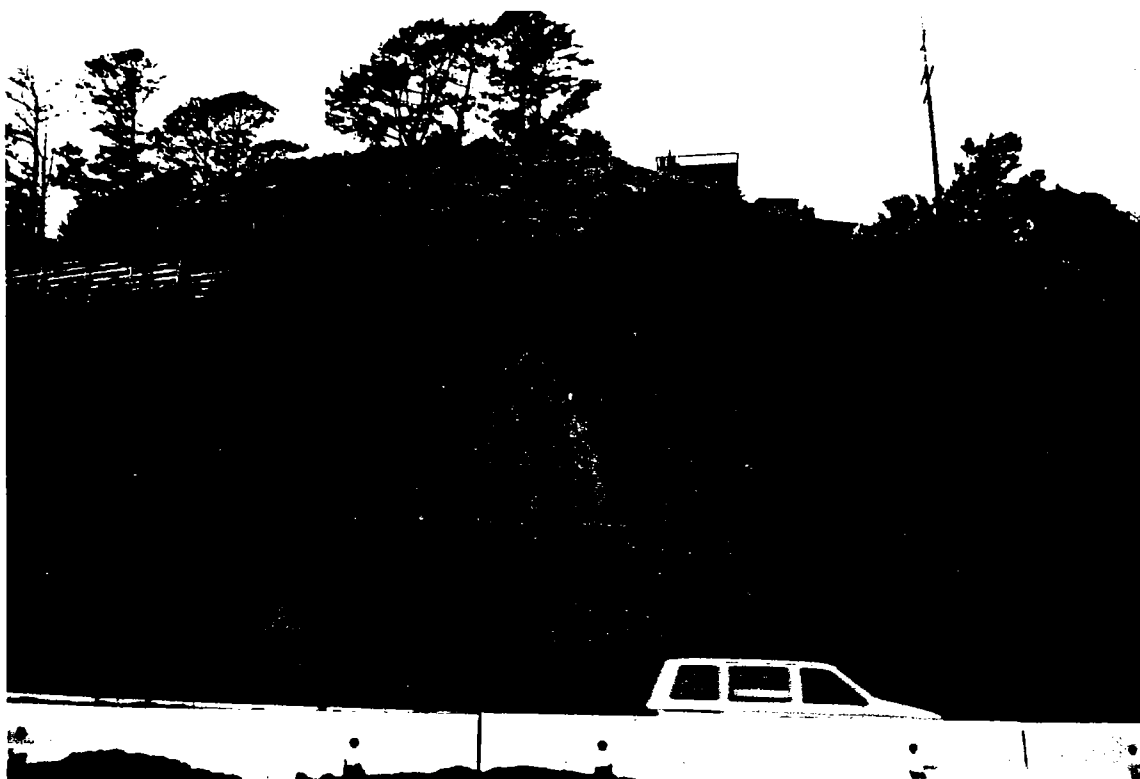
FIGURE 1: MARIN COUNTY SLIDE

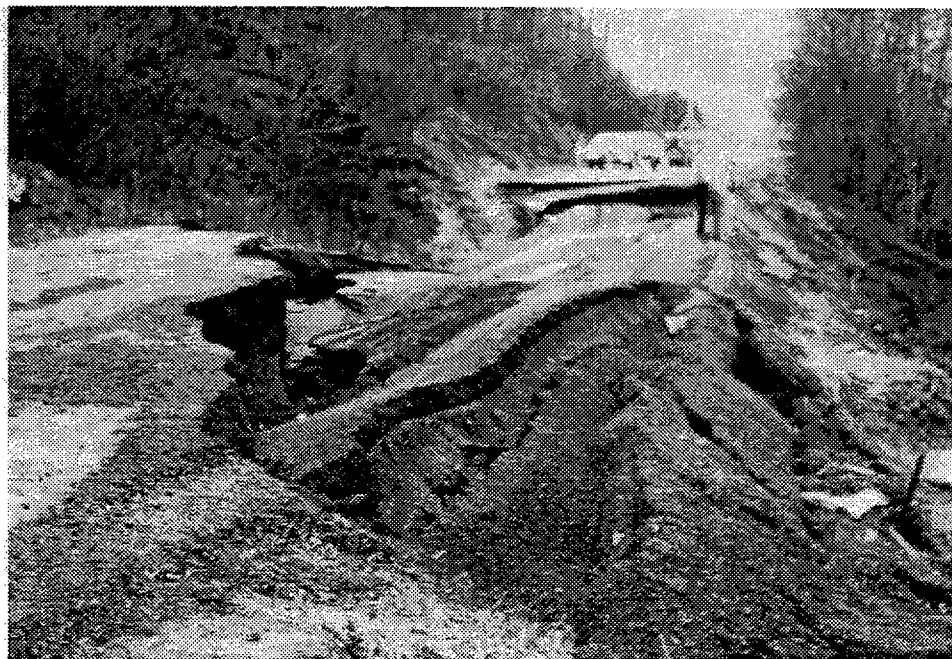
Figure 6: Actual roadway embankment failure due to unstable foundation material (S.R. 61, Union Company)

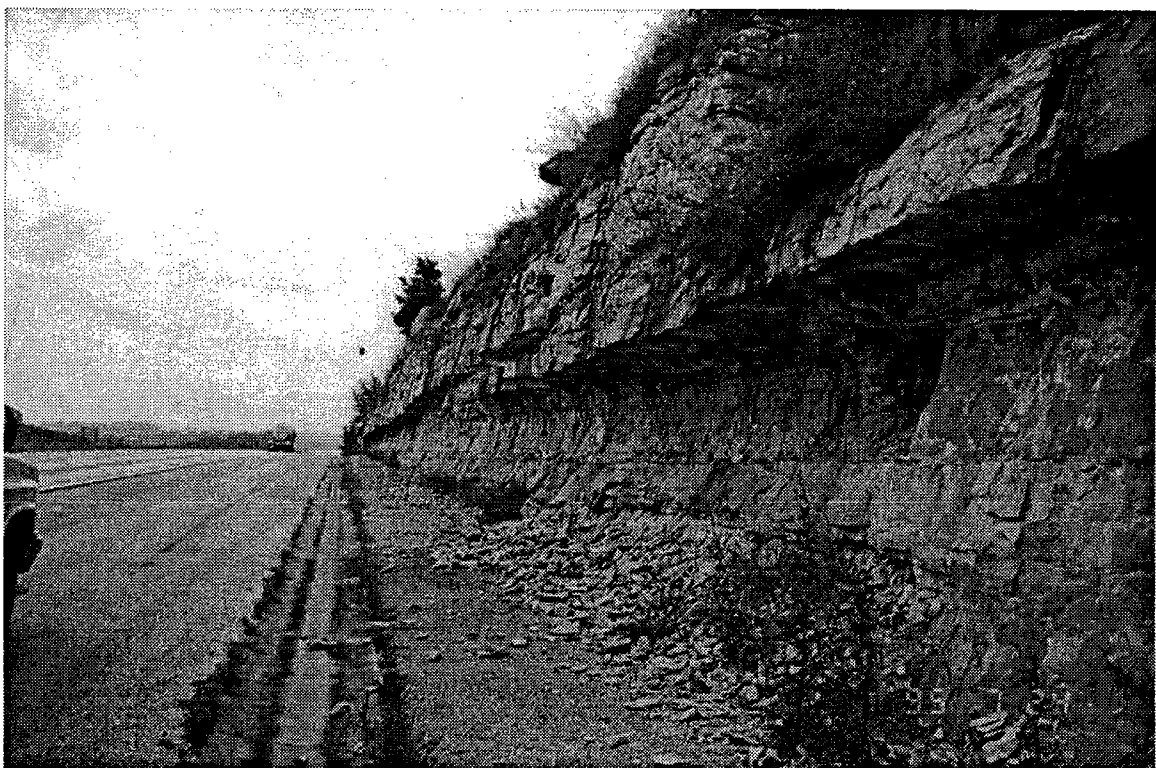
Figure 2. Photos, Clear Creek Site

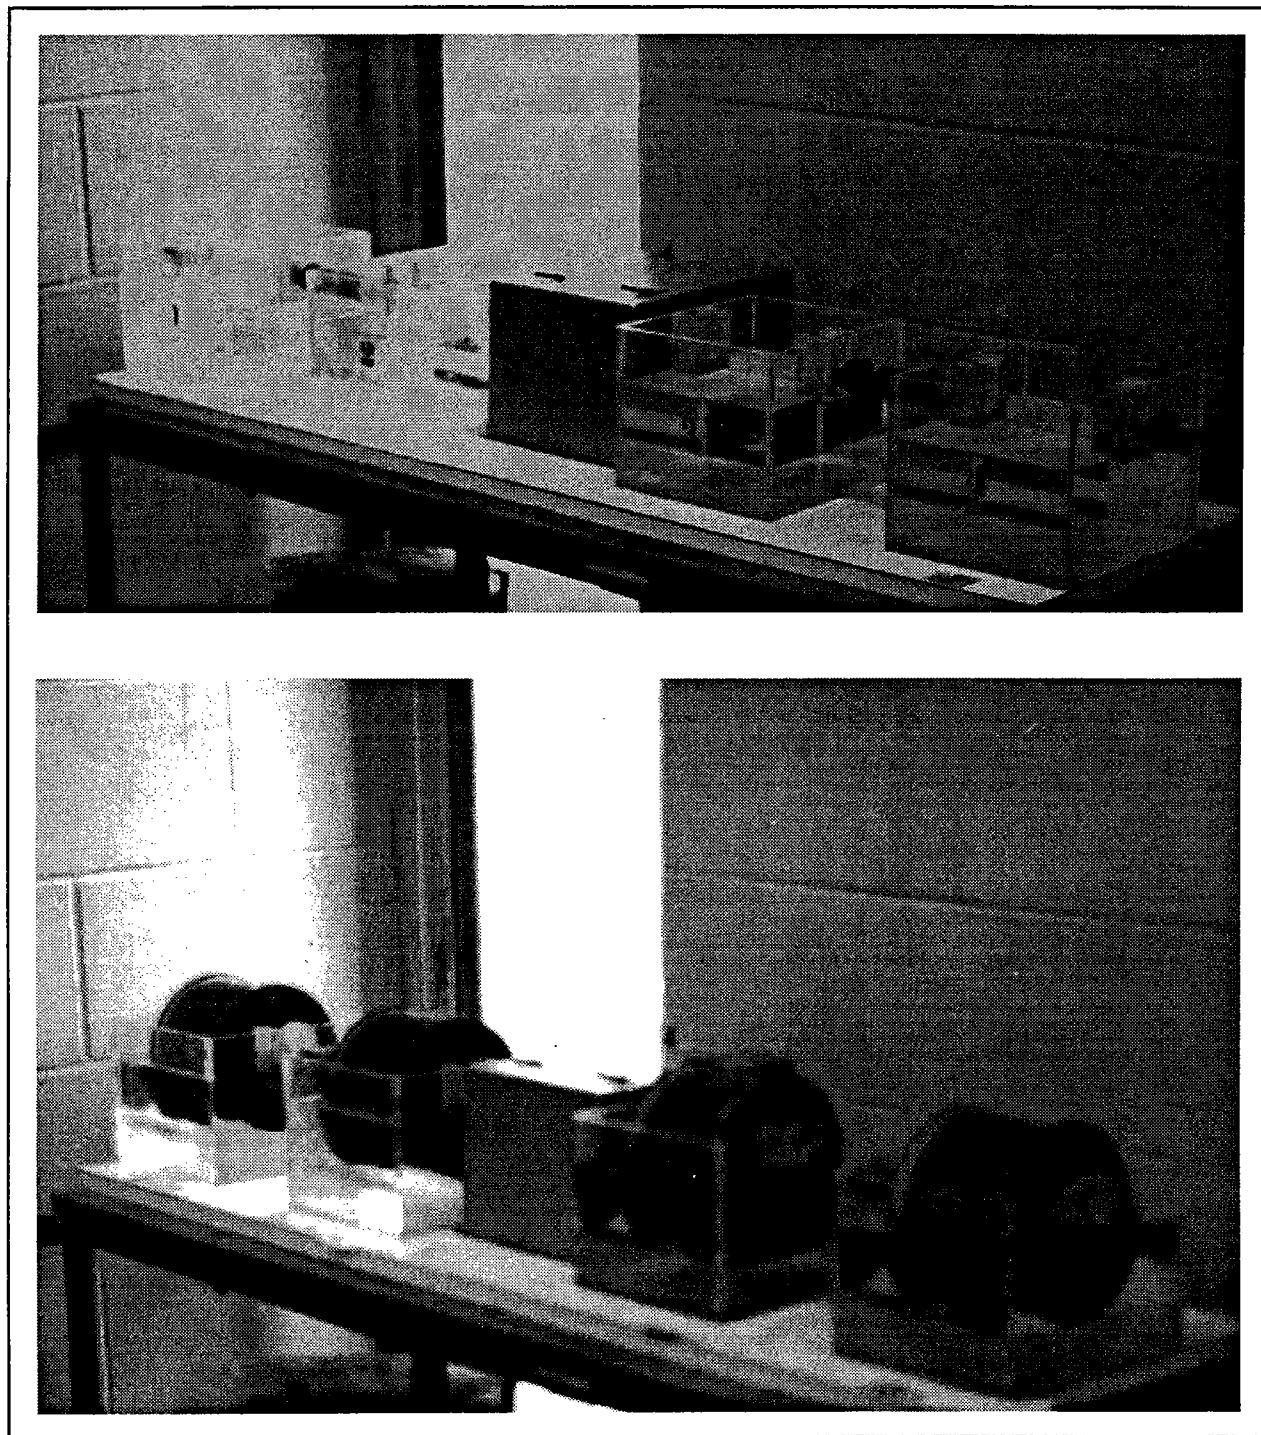
Figure 6. Slake Durability Testing. a) Water-filled reservoirs prior to testing;
b) Drums containing aggregate rotating in reservoirs during testing.

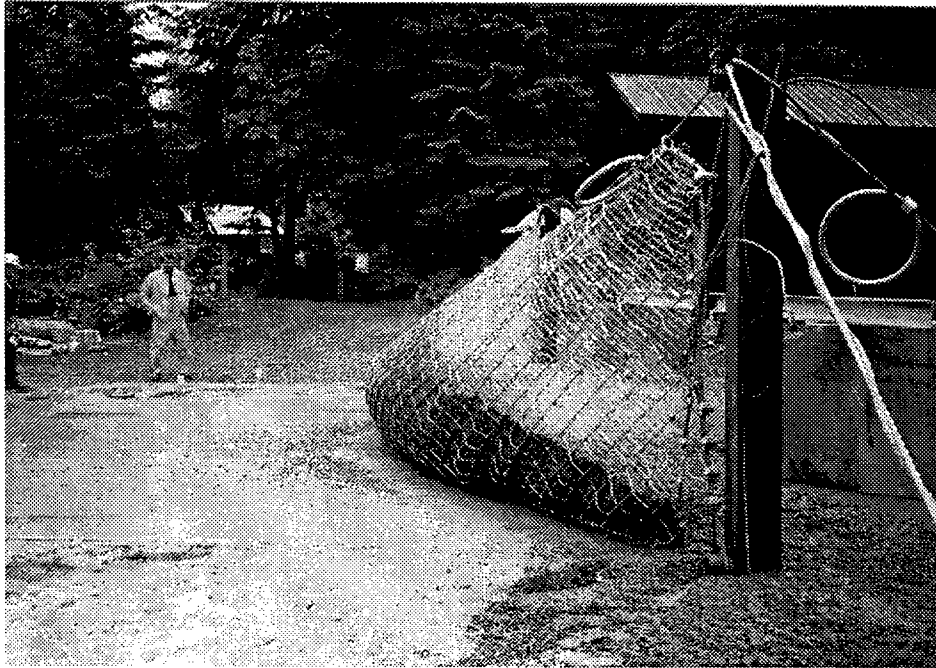
Photo 3: Debris Flow Flexible Barrier Test.
