# 52<sup>nd</sup> Annual Highway Geology Symposium

May 16 - 18, 2001  
Rocky Gap State Park  
Cumberland, Maryland

Sponsored By:  
**Maryland State Highway Administration**  
**Maryland Geological Survey**

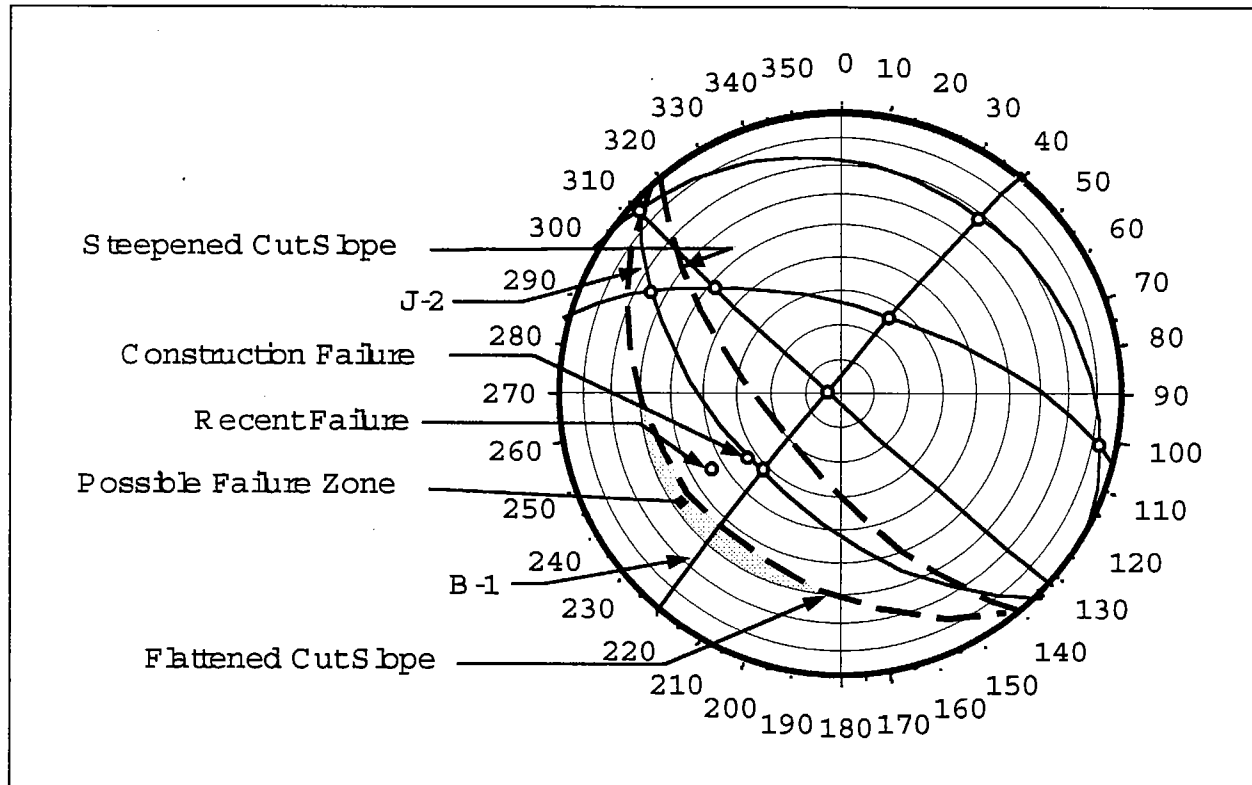
**Figure 5 - Effect of flattened cut slope**

In section 3.3, it was shown how steepening the cut could induce failures. Similarly, flattening the cut slope can prevent failures by not allowing critical wedges to daylight on the slope. Figure 5 shows how a cut slope of 45

degrees would have prevented both the construction failure and the recent failure. Though this probably would have been the least expensive solution, it was not pursued for the following reasons:

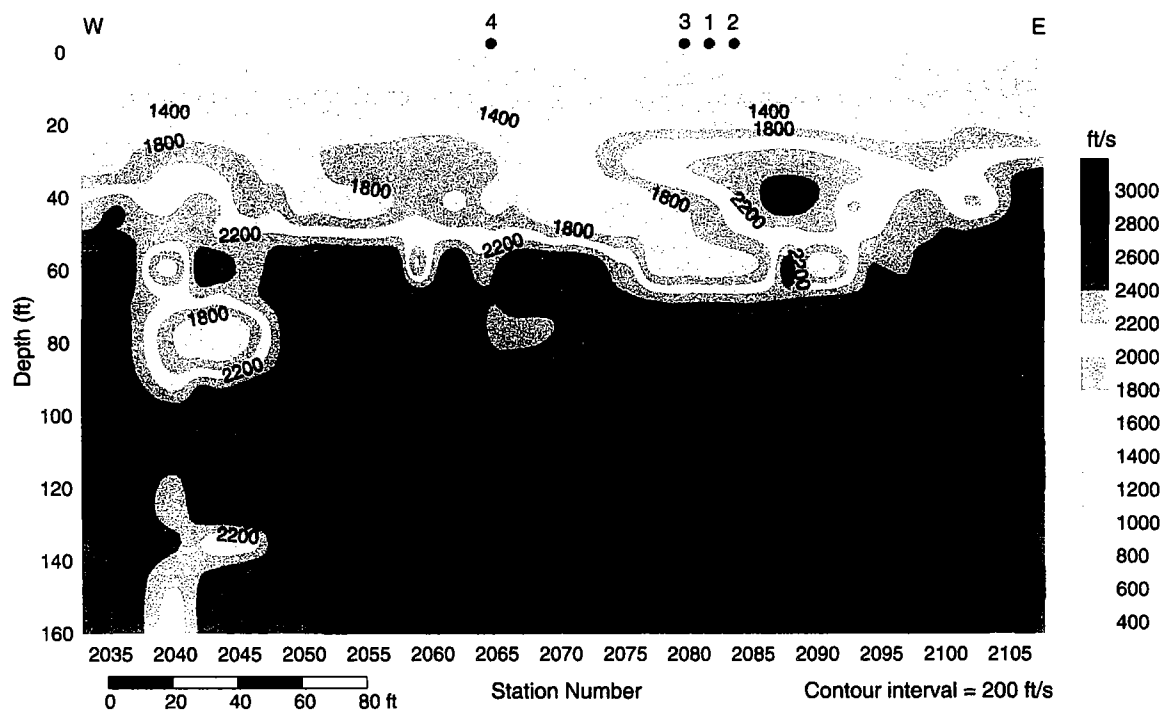
The low velocity closure directly beneath the high velocity closure at station 2090 extends from 20 ft to 50 ft BGS and is of particular interest. In this case the high velocity halo over the low velocity closure does not possess a geometry consistent with what has previously been observed in subsidence-prone areas. Considering the cyclic non-dipping geology in this area, it would not be unreasonable to expect strain to build along intact layers which act as the roof for lenticular voids. If roof strain can be directly correlated to localized, high

Figure 6. S-wave velocity field of line 2, Baxter Springs, Kansas.

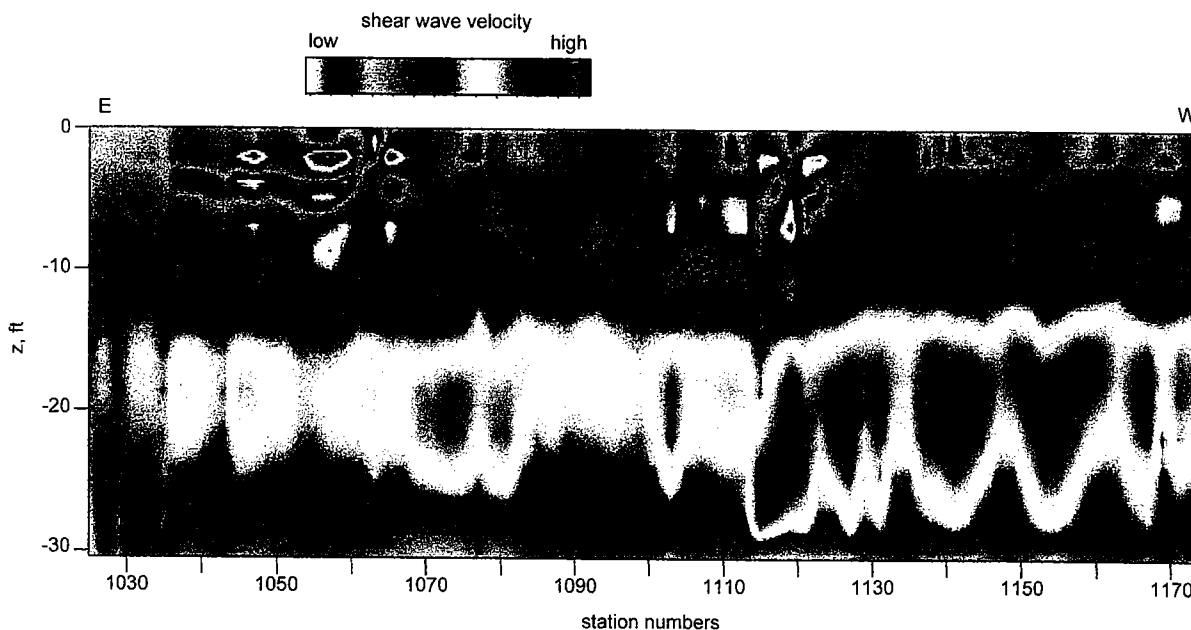
Figure 7. S-wave velocity contour color image from Lawrenceville, Illinois, site.

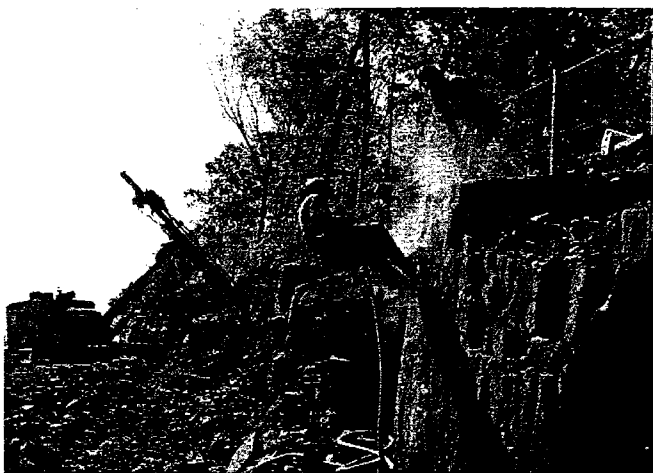
Figure 4. Rock dowel (foreground, on rappel) and soil nail installation (background, drill rig).

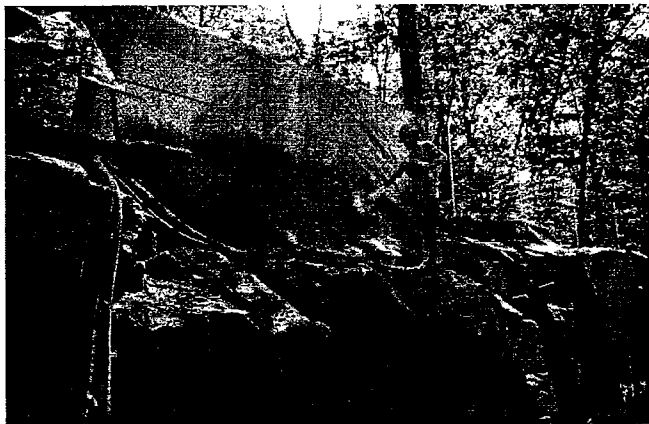
Figure 5. Application of initial shotcrete layer over geocomposite drainage strips. Note tarp use to contain rebound.

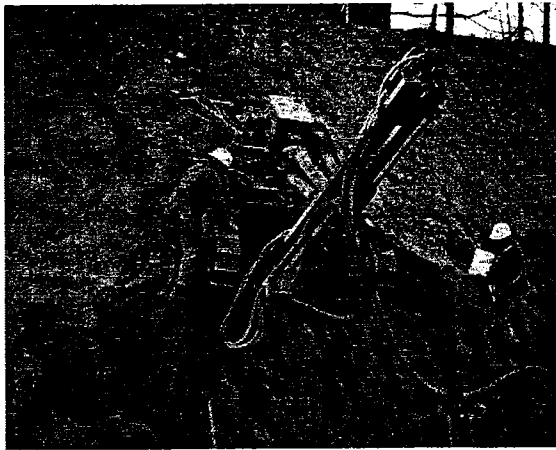
Figure 8. Soil nail and rock dowel installation with light air track drill.

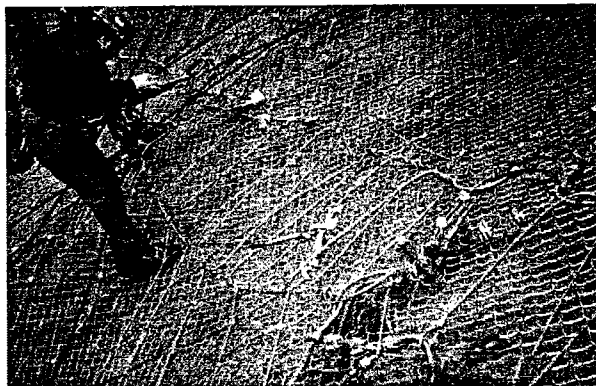
Figure 10. Pentifix® wire rope lacing. Note use of come-along tool to provide sufficient tension.
