54th HIGHWAY GEOLOGY SYMPOSIUM

BURLINGTON, VERMONT, SEPTEMBER 24-26, 2003

PROCEEDINGS

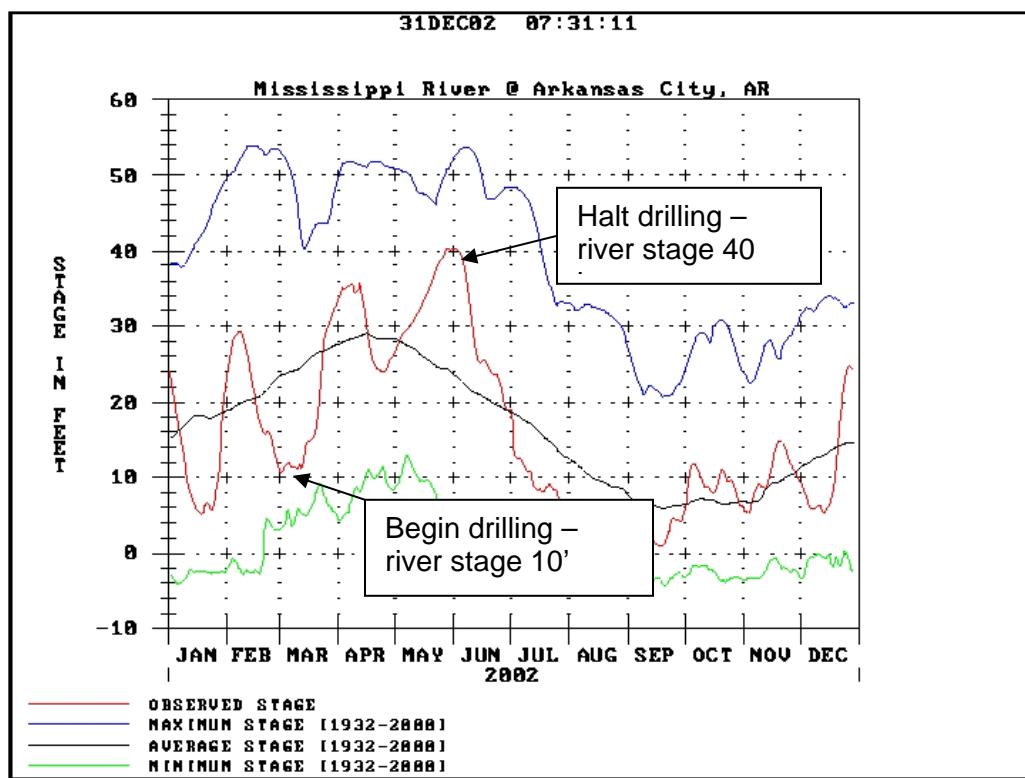
Mississippi River Hydrograph – 2003 - USACE

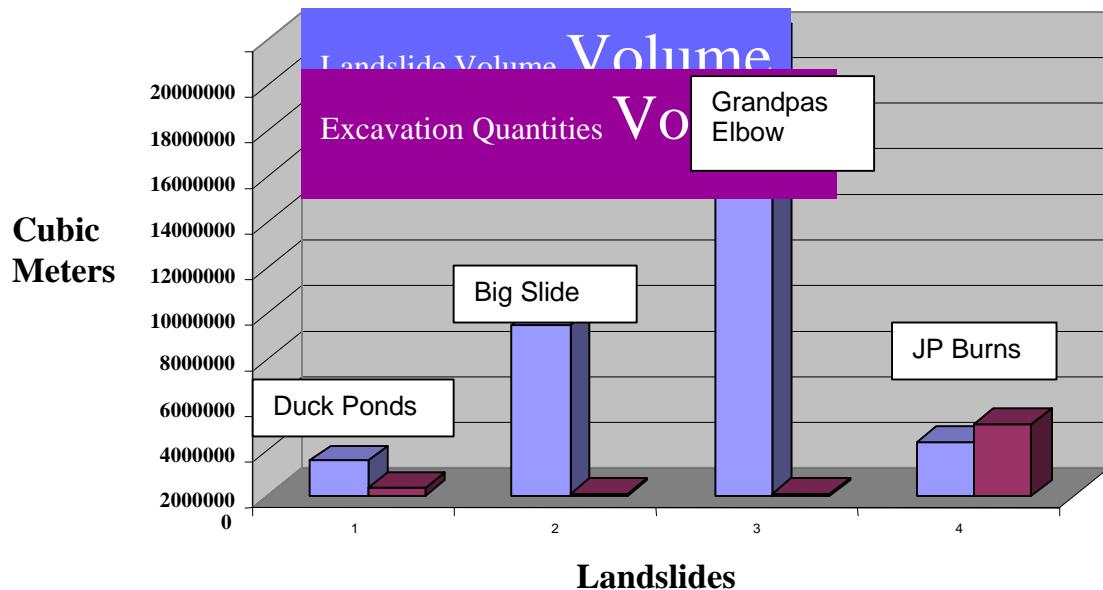
Figure 7: Comparison of Landslide Volume vs Excavation Quantities Associated with Highway Repair

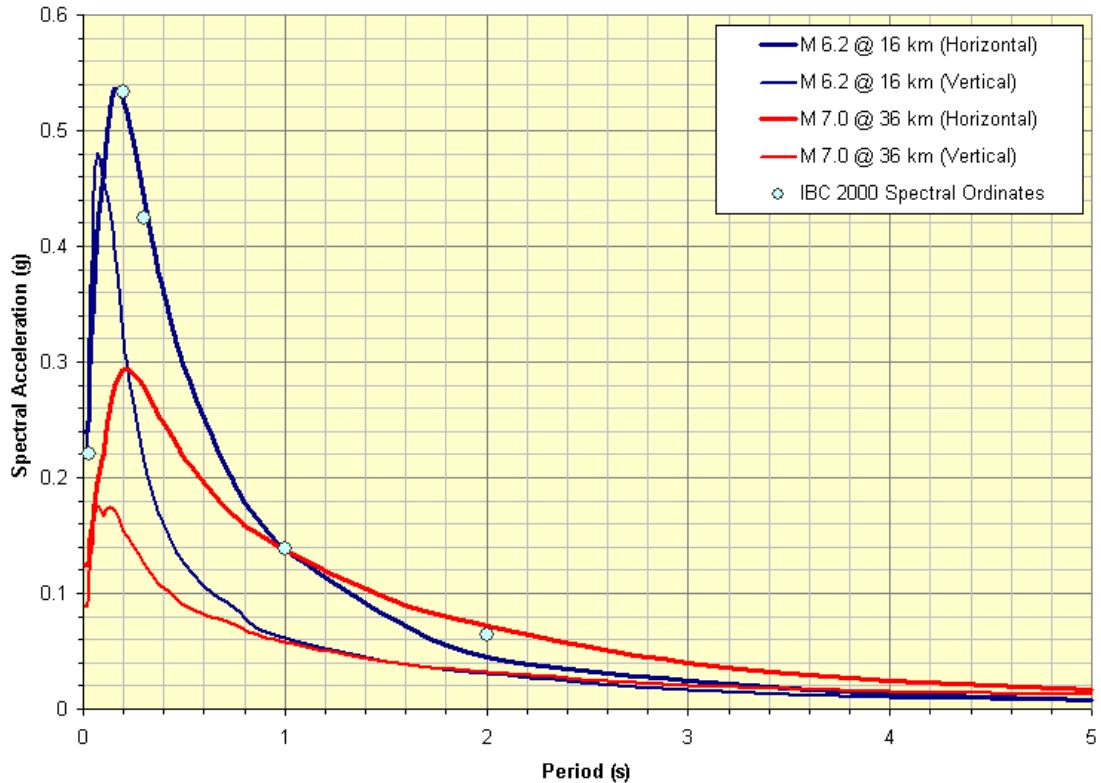
Figure 3. Acceleration response spectra for the Hoover Dam Bypass Project

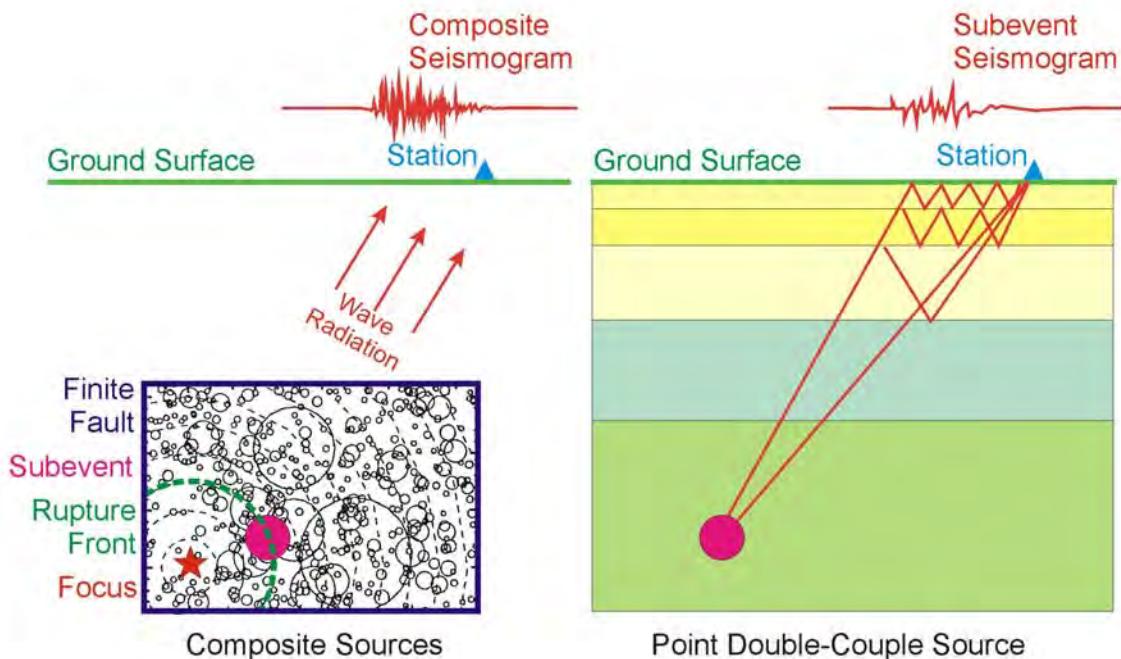
Figure 4. Key elements of the Composite Source Model

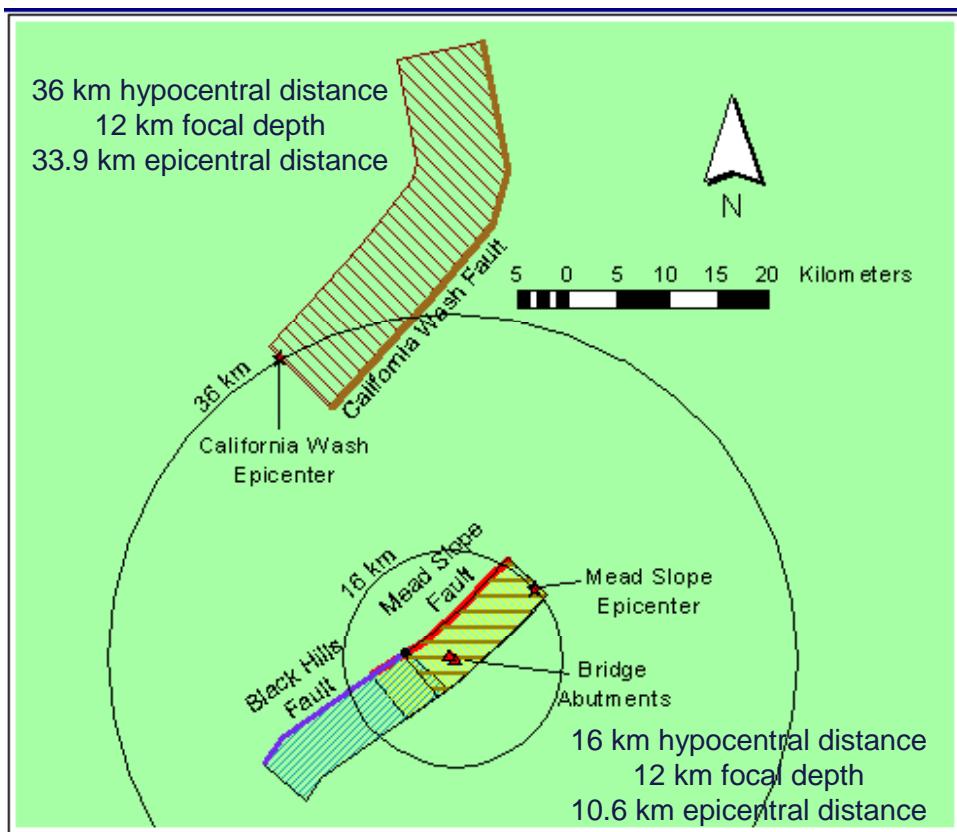
Figure 5. Source-to-site geometry of Mead Slope fault and California Wash fault

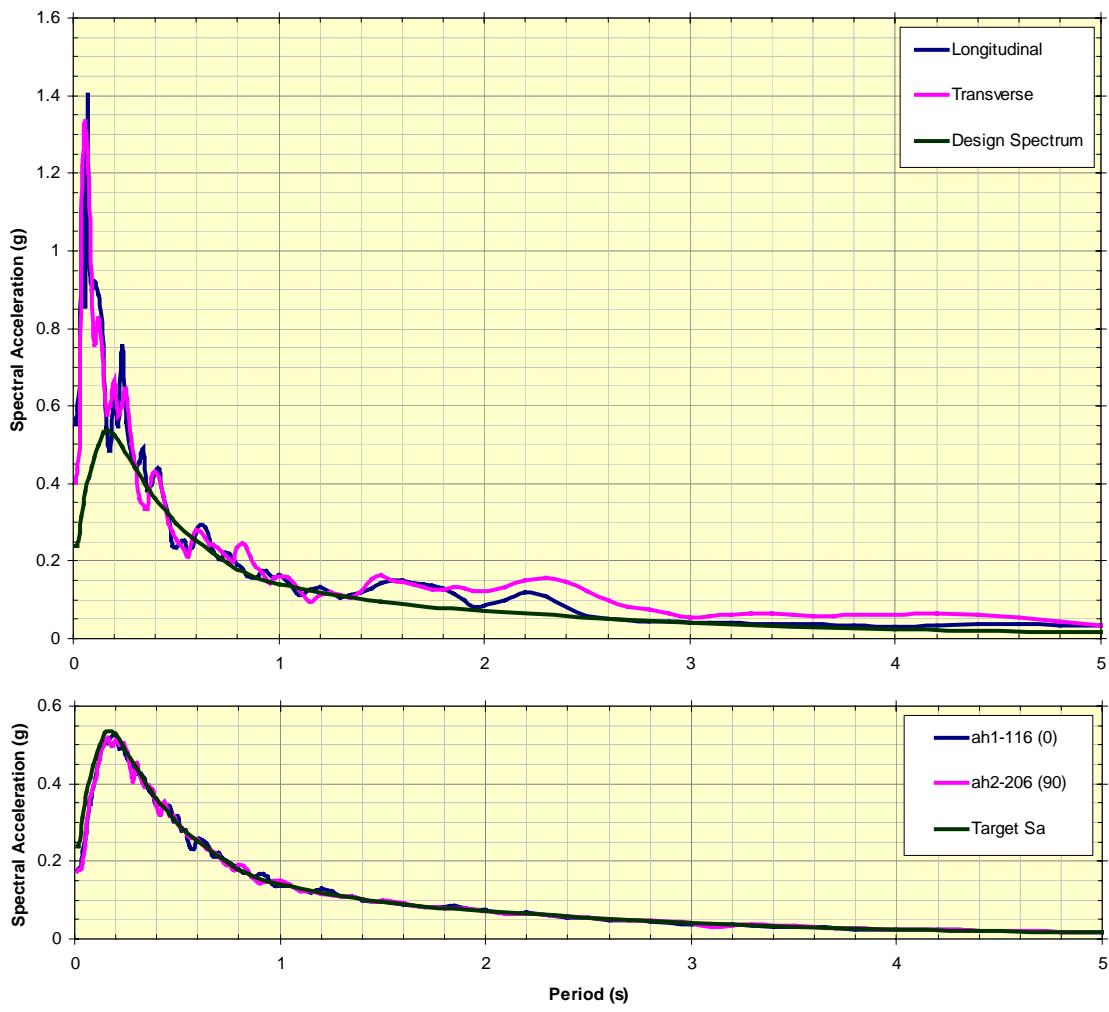
Figure 12. California Wash earthquake horizontal response spectra directly from Composite Source Model (top) and adjusted to match design spectrum (bottom)

using the procedure described by Keaton and others (2000b). Fourier spectra are computed for the acceleration-time histories, and the Fourier amplitude spectra are adjusted while the Fourier phase spectra are preserved. The inverse Fourier transform is used to recompute acceleration-time histories. The procedure is iterated to achieve reasonably optimal spectral matching. Velocity- and displacement-time history records and response spectra are computed from the adjusted acceleration-time histories in the usual way. Low-frequency harmonic motion introduced by the scaling procedure was removed by tapering the displacement-time history records to zero at reasonable times based on the shapes of the original acceleration-time histories. Corresponding velocity- and acceleration-time histories are computed by numerical differentiation and final acceleration-response spectra are recomputed. The results of this scaling for the California Wash earthquake motion at the Nevada abutment are shown on Figure 12.

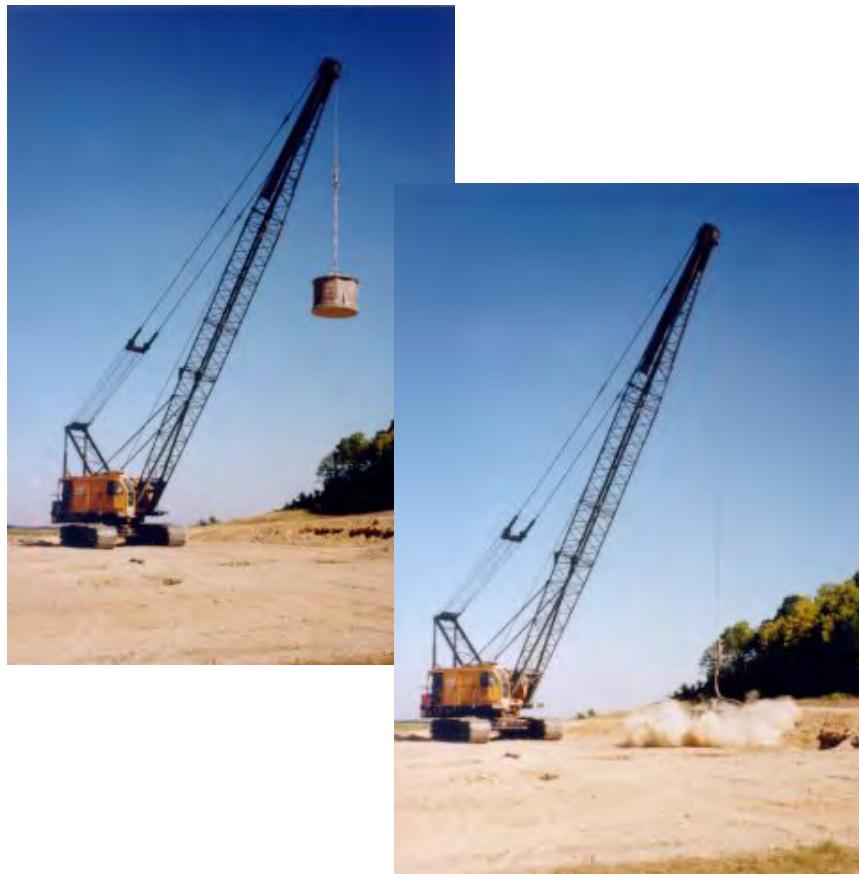
Figure 10. Dynamic Compaction of Mine Spoil

Because of the magnitudes of potential total settlements, and because site conditions indicated that in some situations severe differential settlements could occur, special provisions were incorporated in the design and construction of selected embankments to help reduce potential settlements. These measures included the use of geogrids within the embankments, dynamic compaction of foundation materials, or a combination of both. Figure 10 shows dynamic compaction operations at one of the bridge approach embankment locations. Dynamic compaction was typically used in areas of deep mine spoil materials to help create more uniform conditions within the upper 10 to 20 feet of foundation materials, and to provide a better transition zone from thinner to thicker spoil deposits.

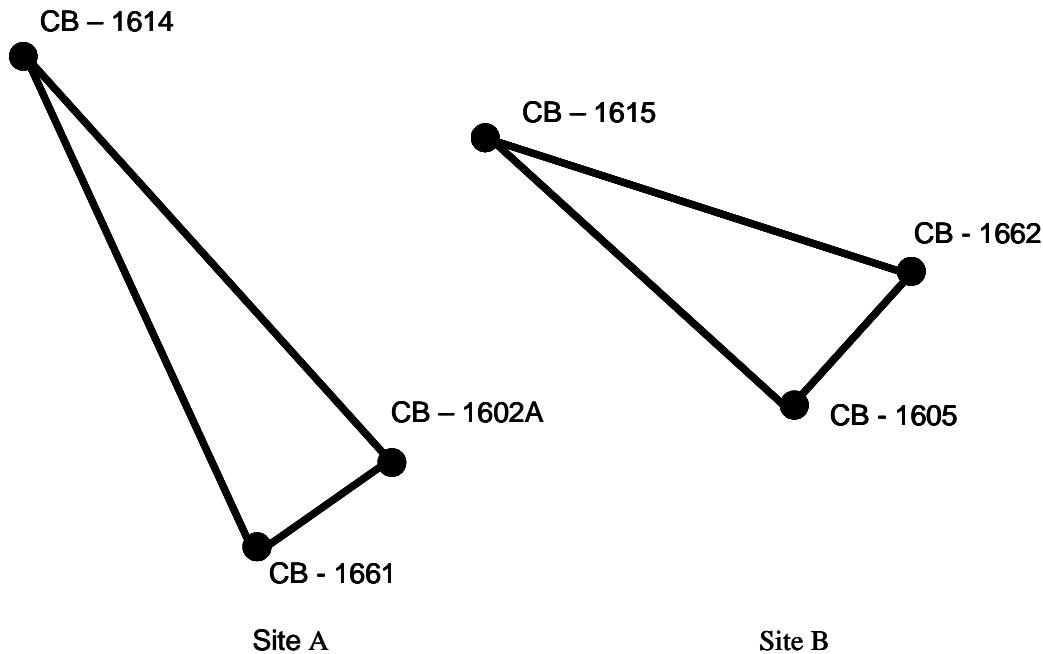
Figure 2 Borehole layout for sites A and B.

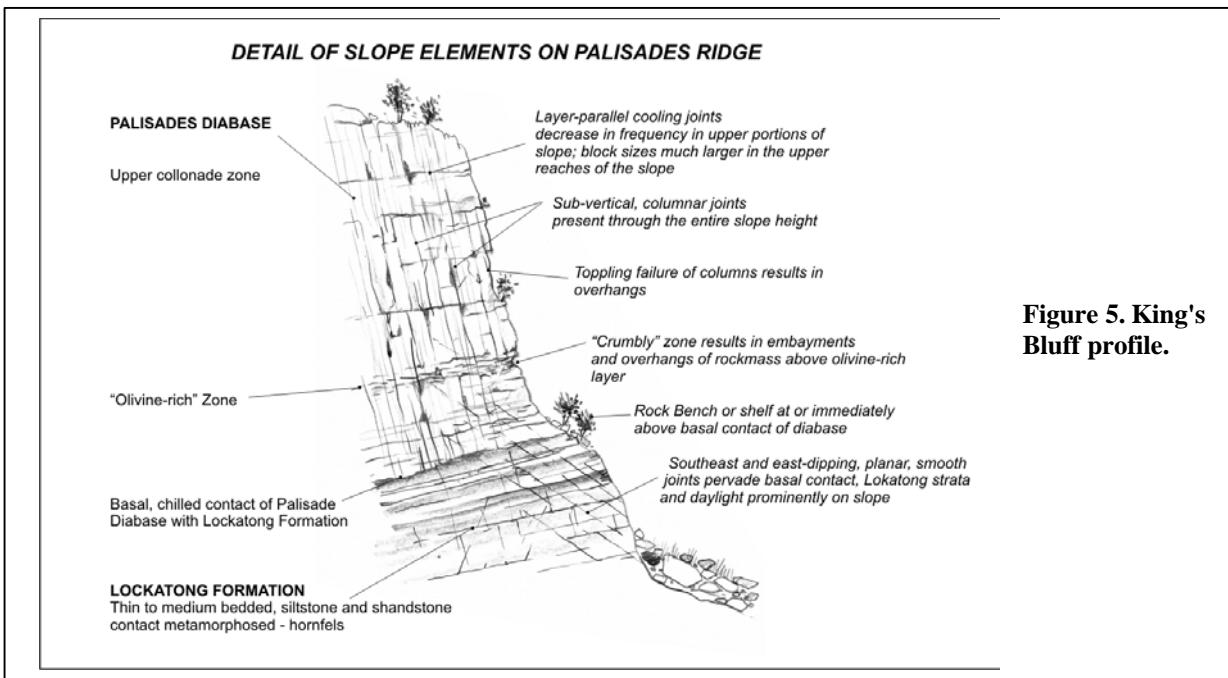
Figure 5. King's Bluff profile.

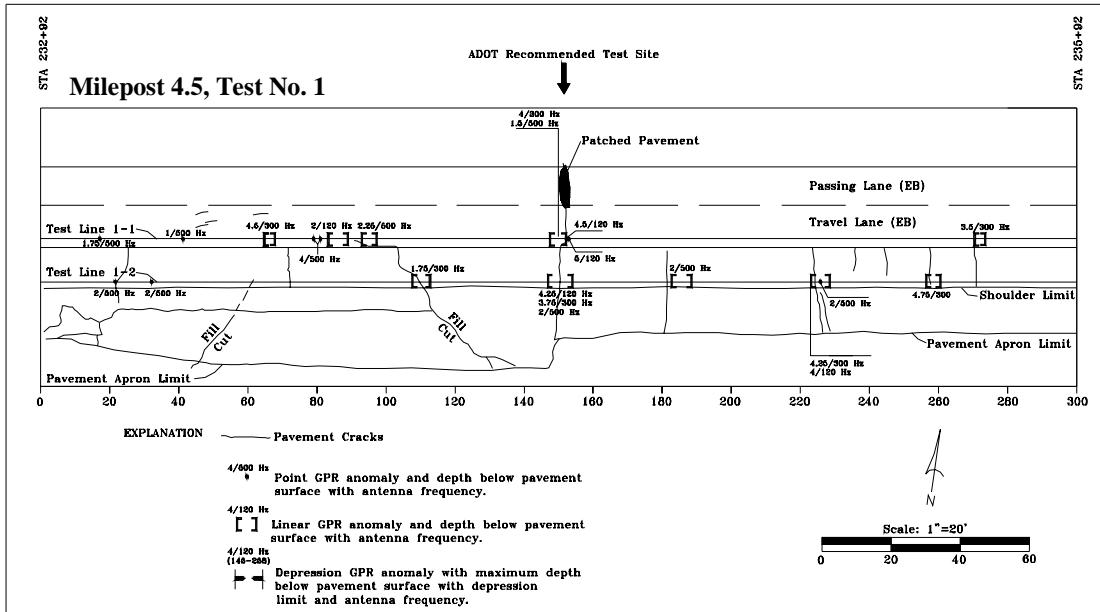
Figure 11: Typical GPR survey anomaly location map generated from data obtained along selected section of I-40 alignment during test program.

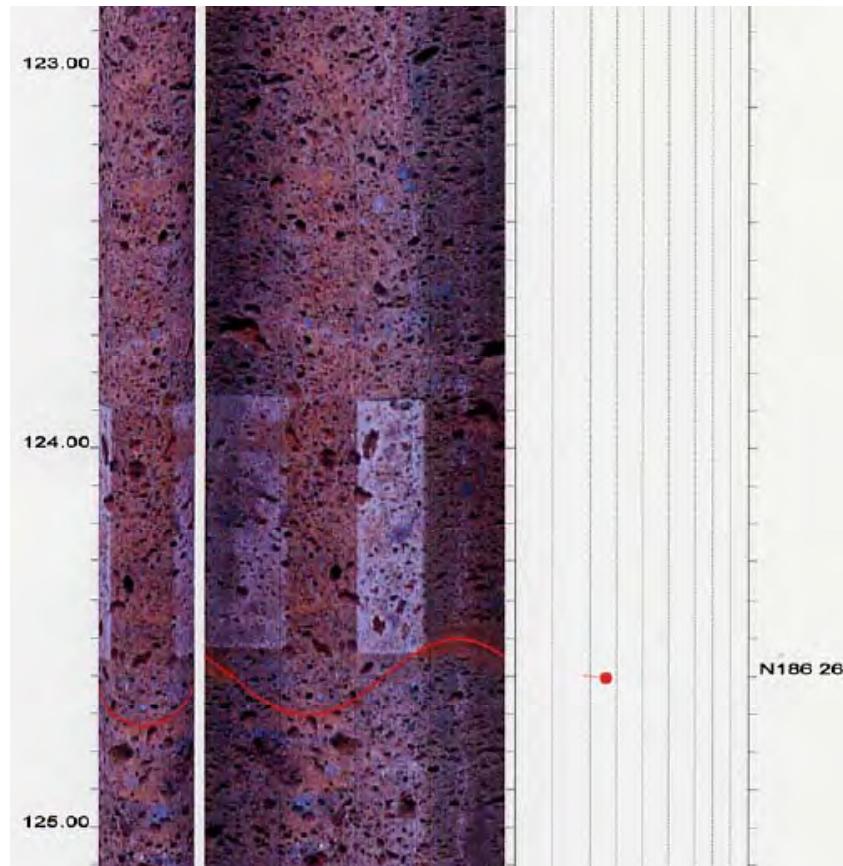
Figure 2 – Optical televiewer image of borehole wrapped – left, unwrapped – right, with fracture orientation and Goodman Jack plate impression in borehole wall..

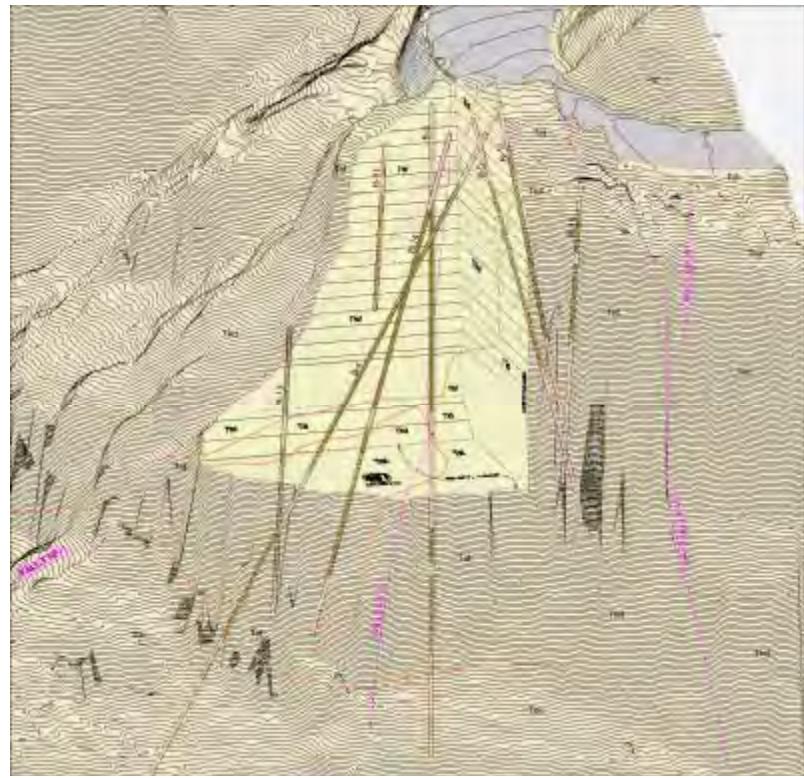
**Figure 5 – Oblique view of
planned Nevada skewback
excavation showing geologic
conditions anticipated with
borehole data. Units same as in
Photograph 6.**

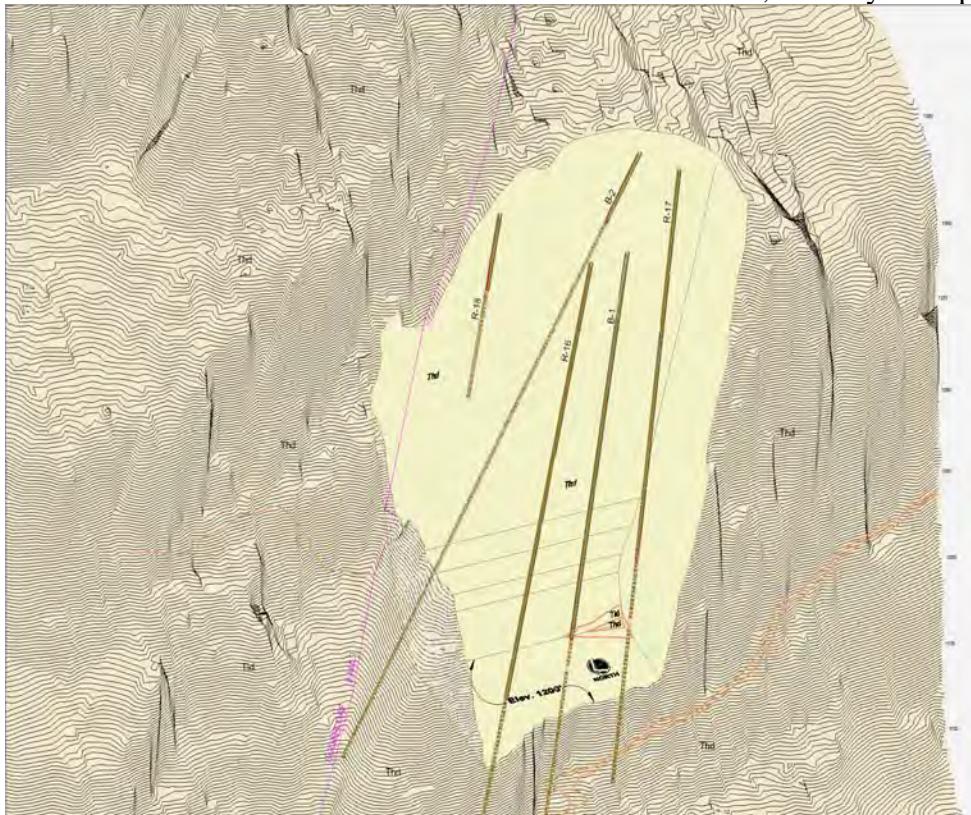
Figure 7 – Oblique view of planned Arizona skewback excavation with geology and borehole data.

The planned walls and floor of the excavation will consist of tuff with a small area of dike rock in the back right corner as shown on Figure 7. The dike will likely be exposed in both walls and the floor at this location with tuff in the very corner of the excavation. The Sugarloaf Fault will not be encountered in the floor of the skewback excavation, but may be exposed near the

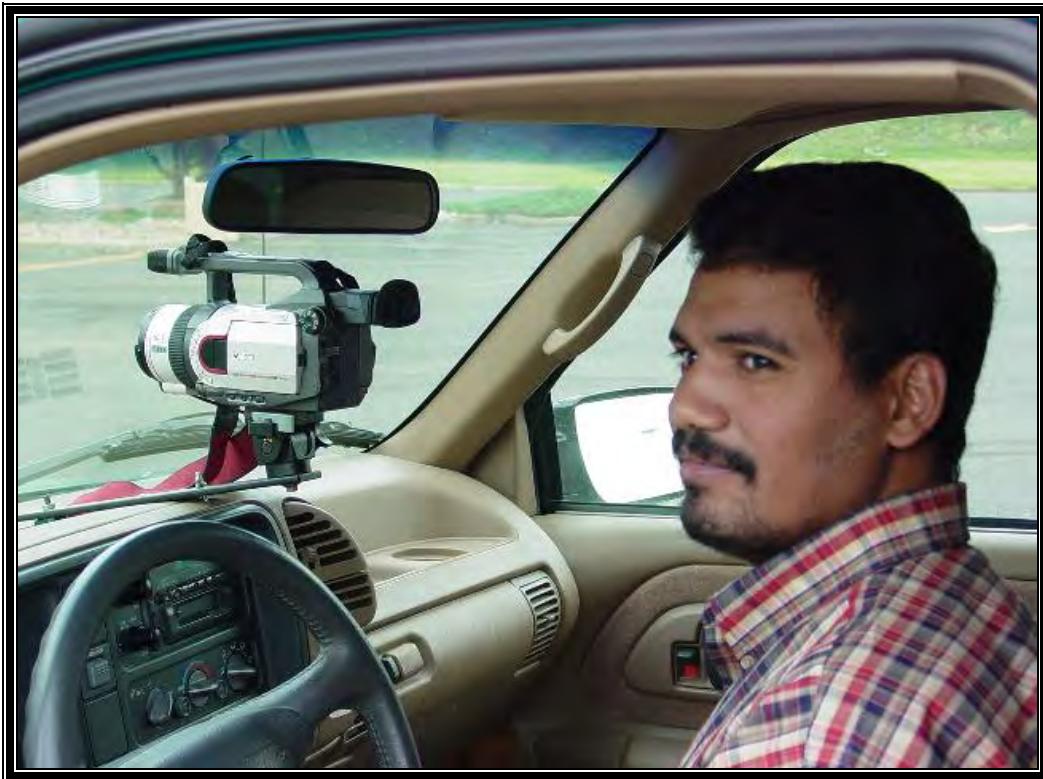
Figure 2. Digital camcorder mounted on vehicle dashboard.

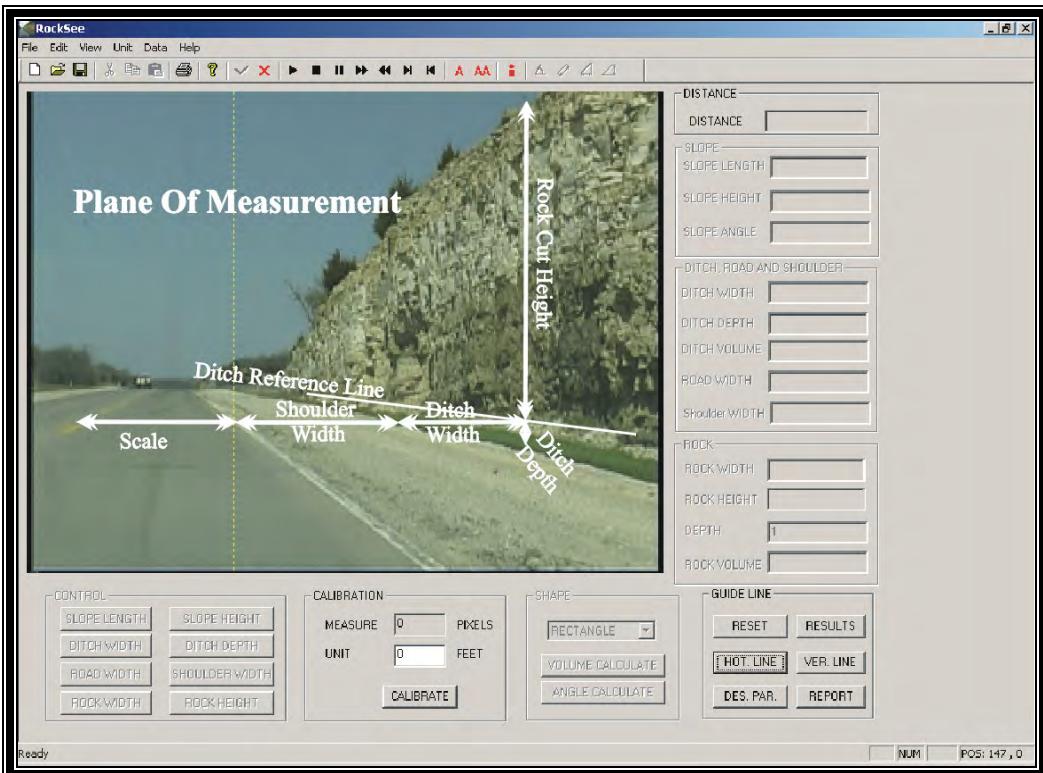
Figure 3. RockSee program to measure various parameters needed for the hazard rating system.

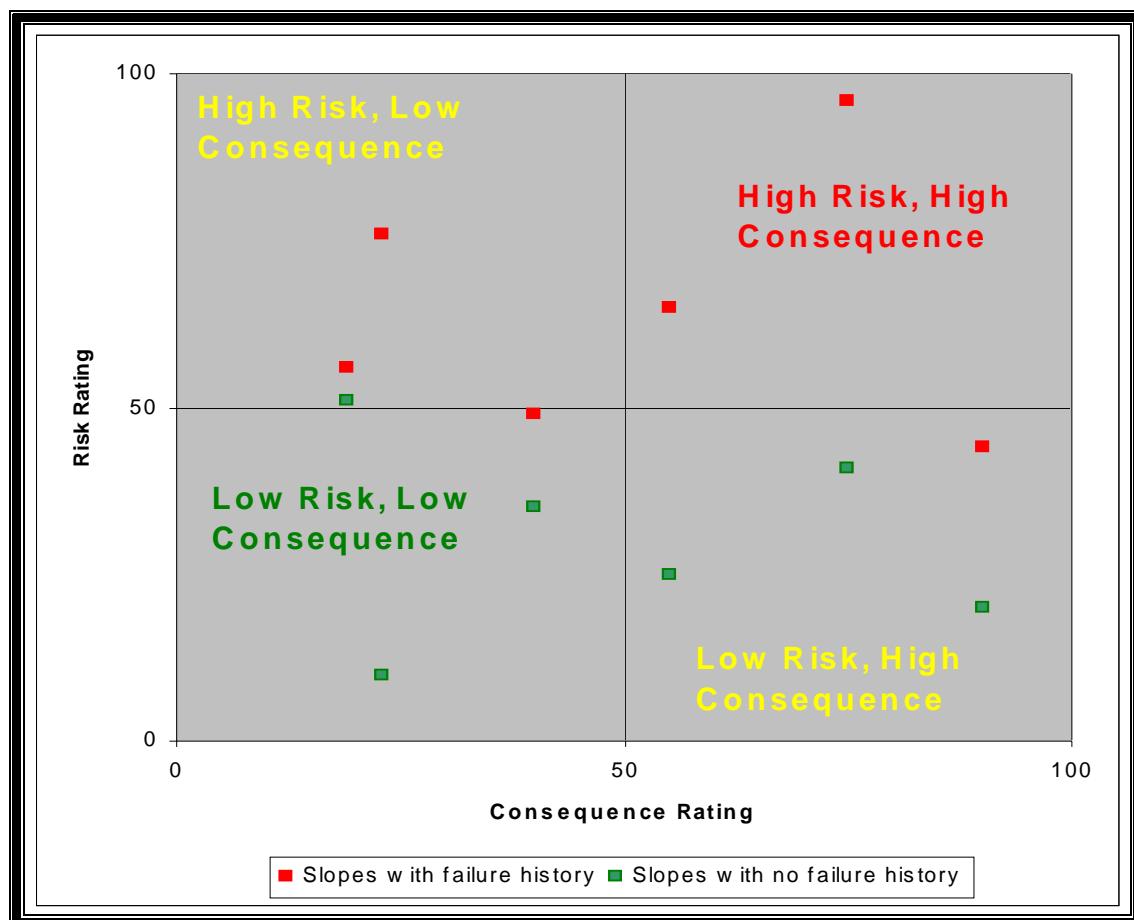
Figure 4. Conceptual example of risk/consequence assessment. Case histories of failed/stable slopes can be plotted on this graph to determine threshold action levels.

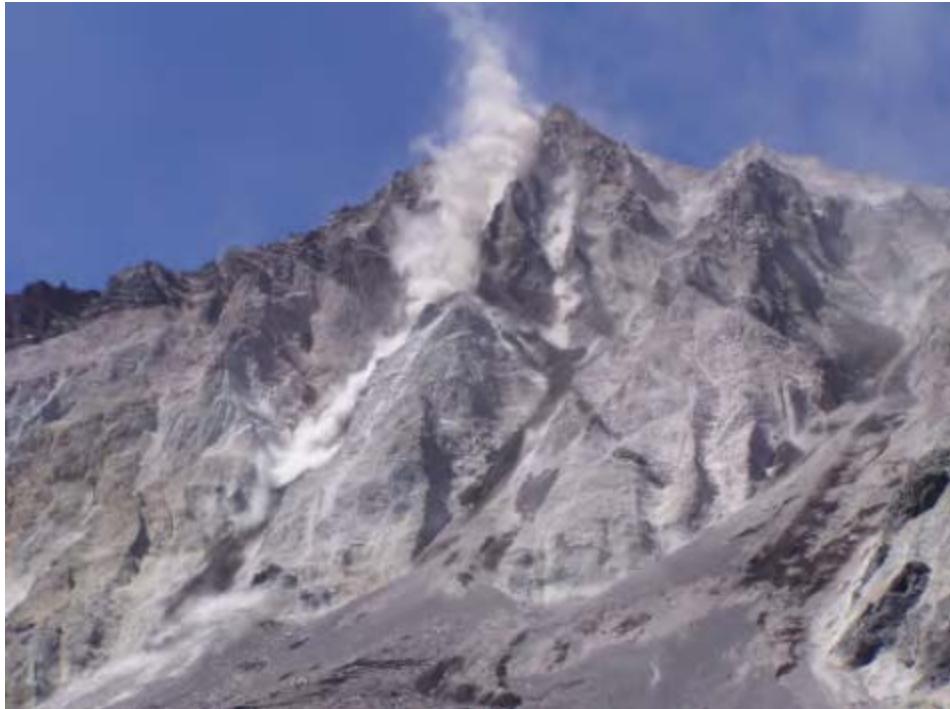
Figure 3. West crater side, pyroclastic rockfall produces large dust cloud, slope height 455 m (1600 ft).

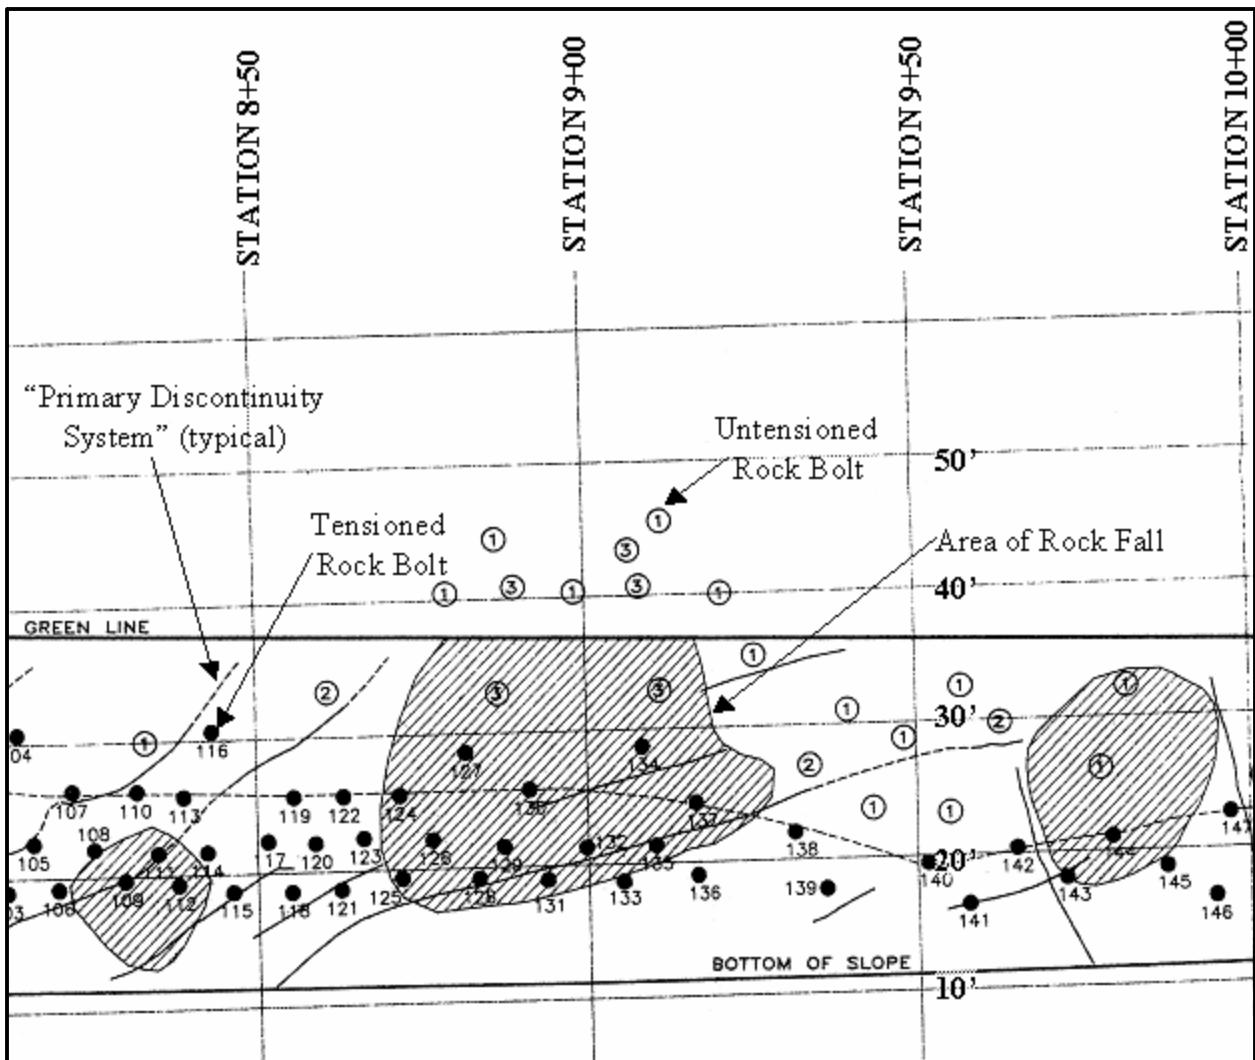
Figure 3: Rock Slope Reinforcement Section.

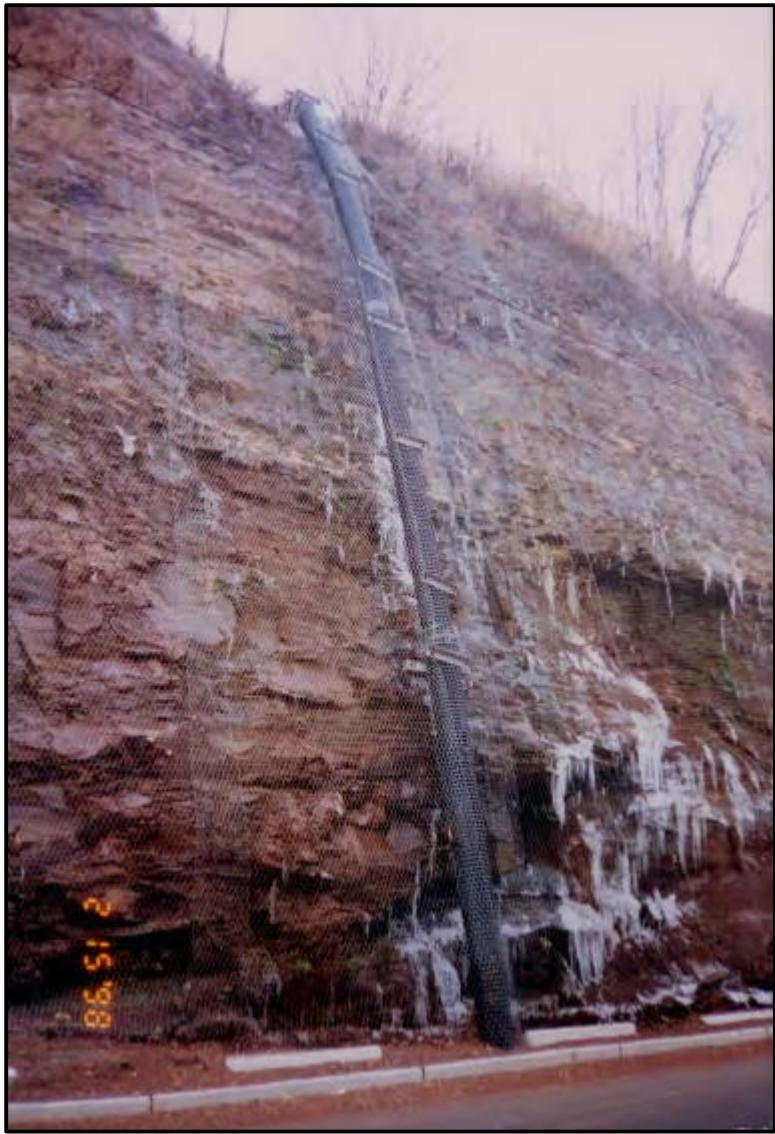
Figure 4: Evidence of Water Movement Through Bedding Partings

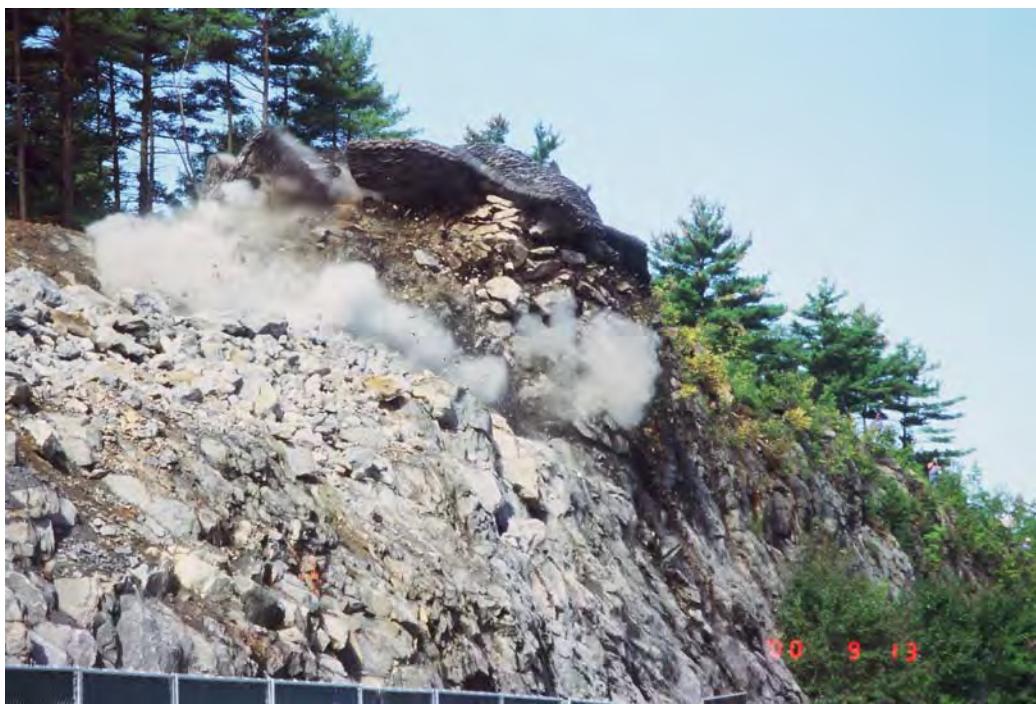
Figure 5. Overlapping and anchored blasting mats help contain fly rock

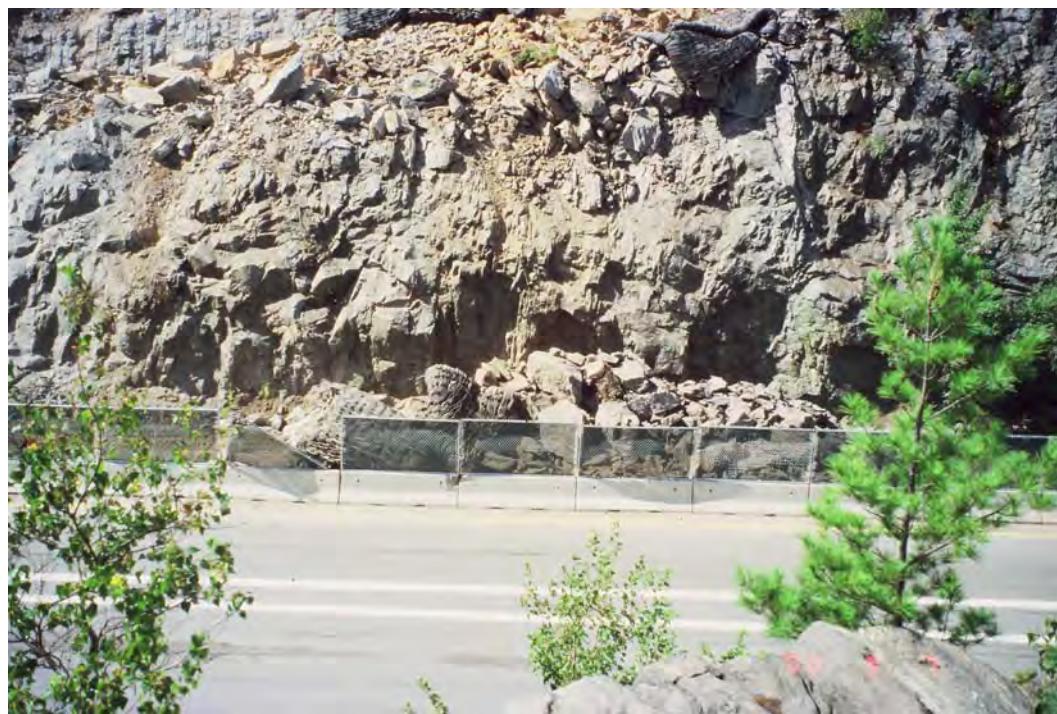
Figure 6. Concrete barriers with chain link fence

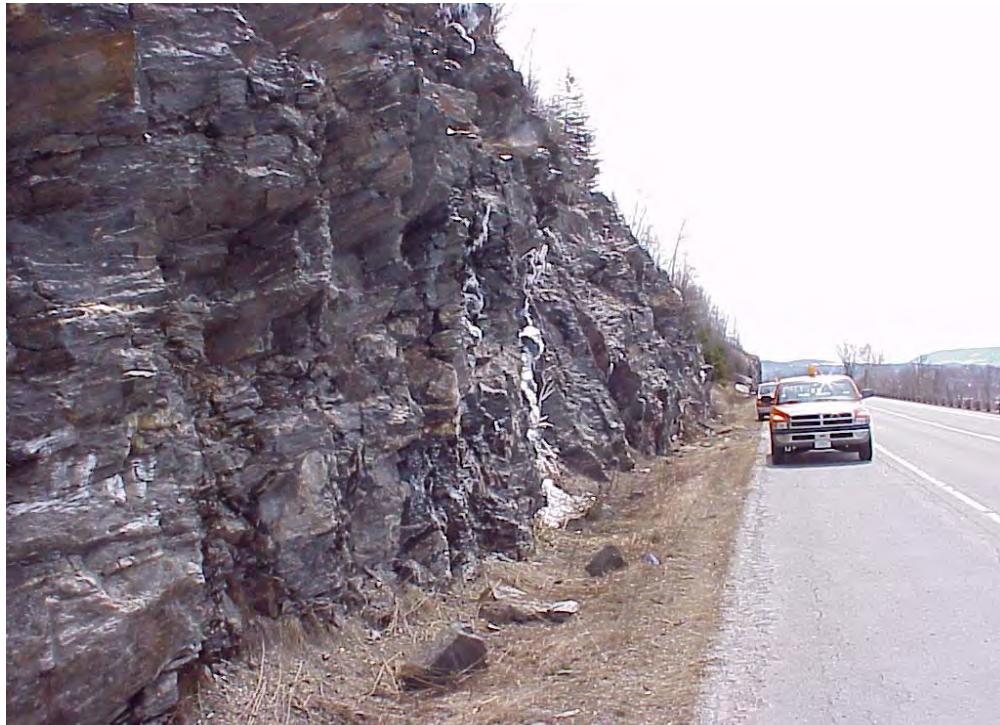
Figure 15. Narrow ditch at the toe of the rock slope

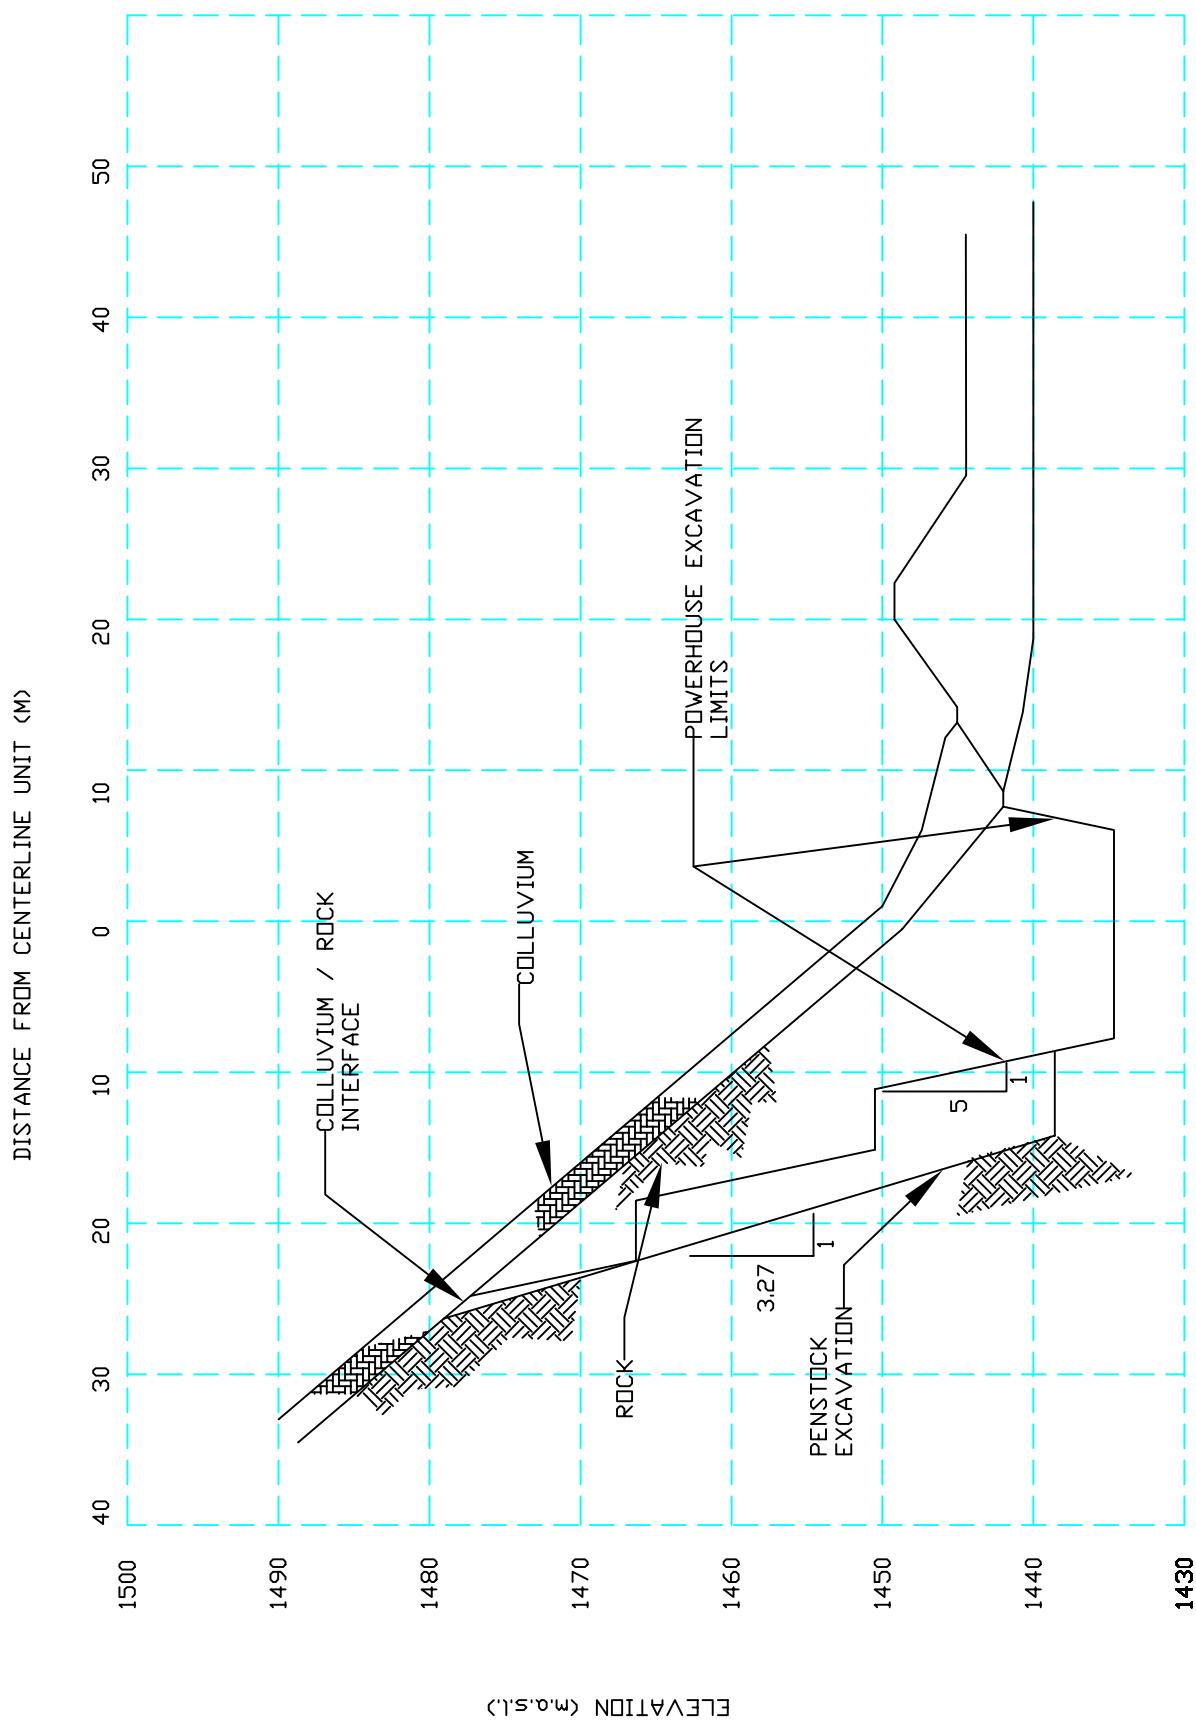
FIGURE 6
POWERHOUSE SLOPE PROFILE

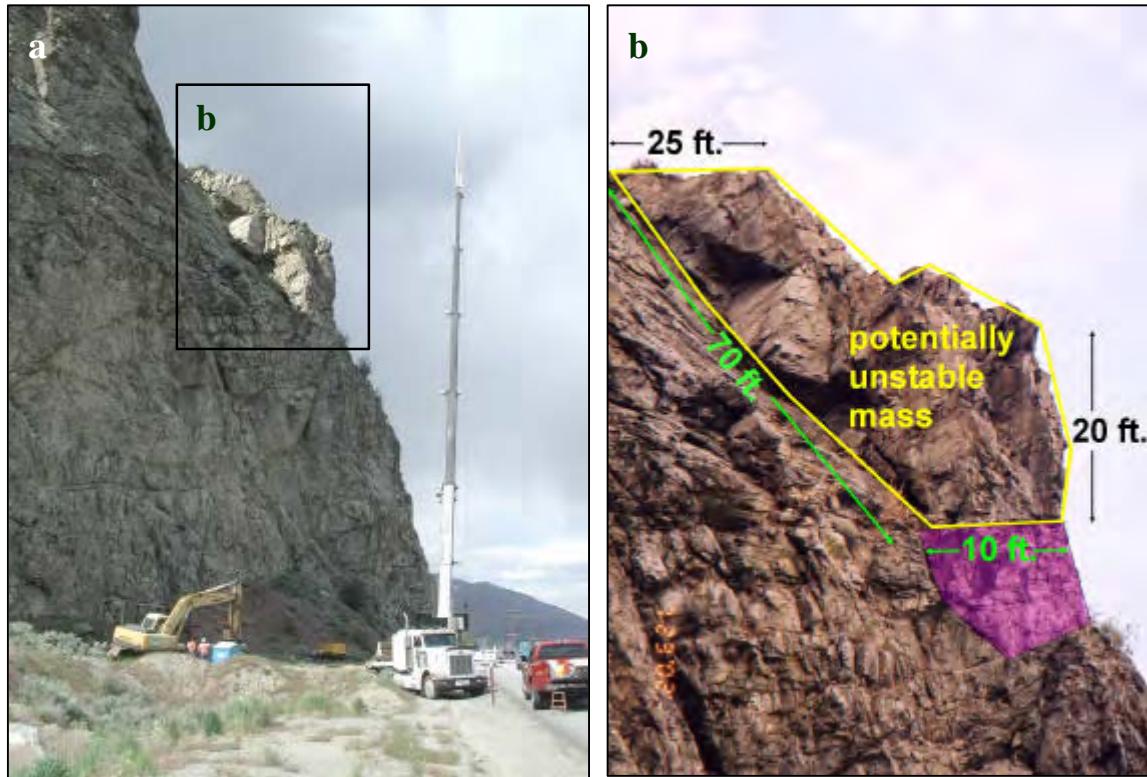
Figure 3. a) View looking north of potentially unstable mass; crane has 220 foot boom for rough scale.
b) Enlargement of mass showing dimensions. Shaded pink area that supports large mass is highly fractured, and also contains numerous open discontinuities.

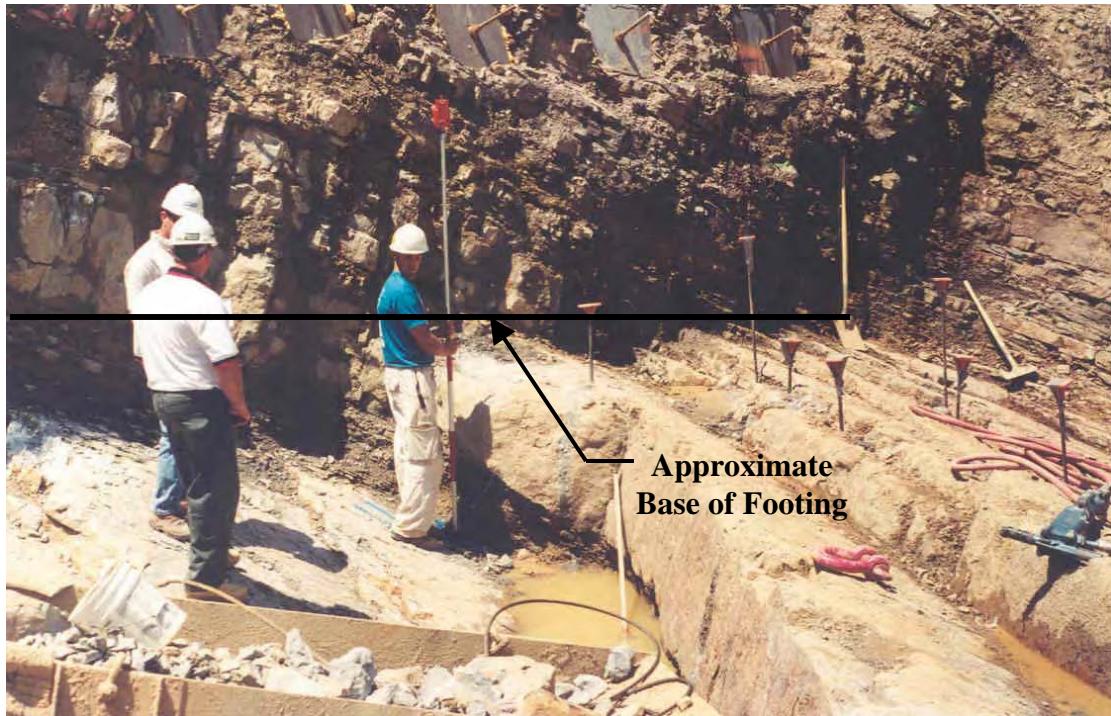
Photograph No. 3 – Pier 2 Foundation Excavation at Bottom of Footing Elevation
