54th HIGHWAY GEOLOGY SYMPOSIUM

BURLINGTON, VERMONT, SEPTEMBER 24-26, 2003

PROCEEDINGS

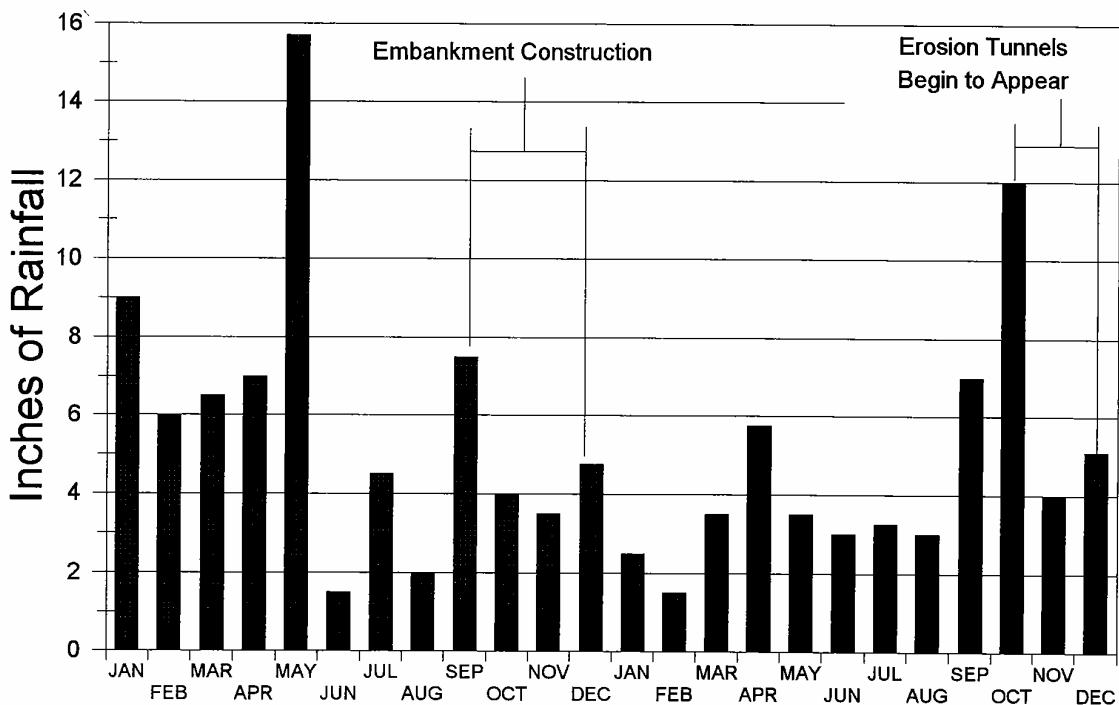
Figure 3. Monthly Rainfall Totals January 1990 to December 1991

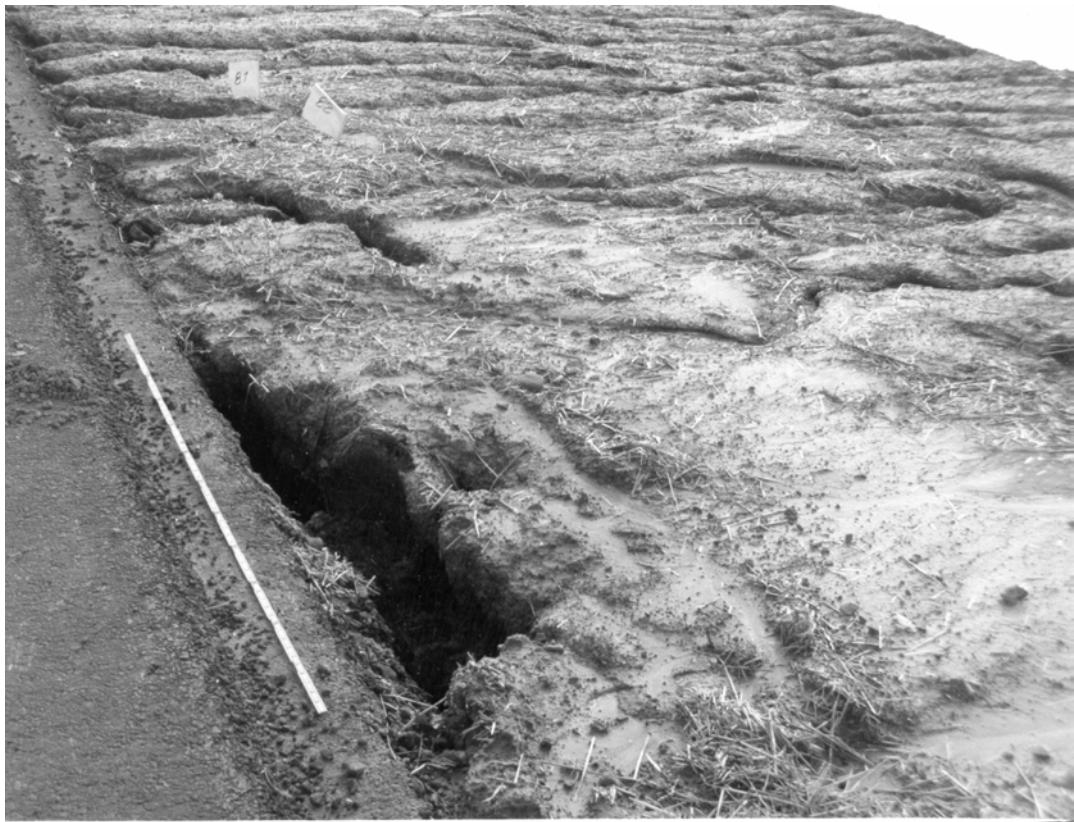
Figure 4. Erosion Hole (Jug) Formed at Pavement Edge

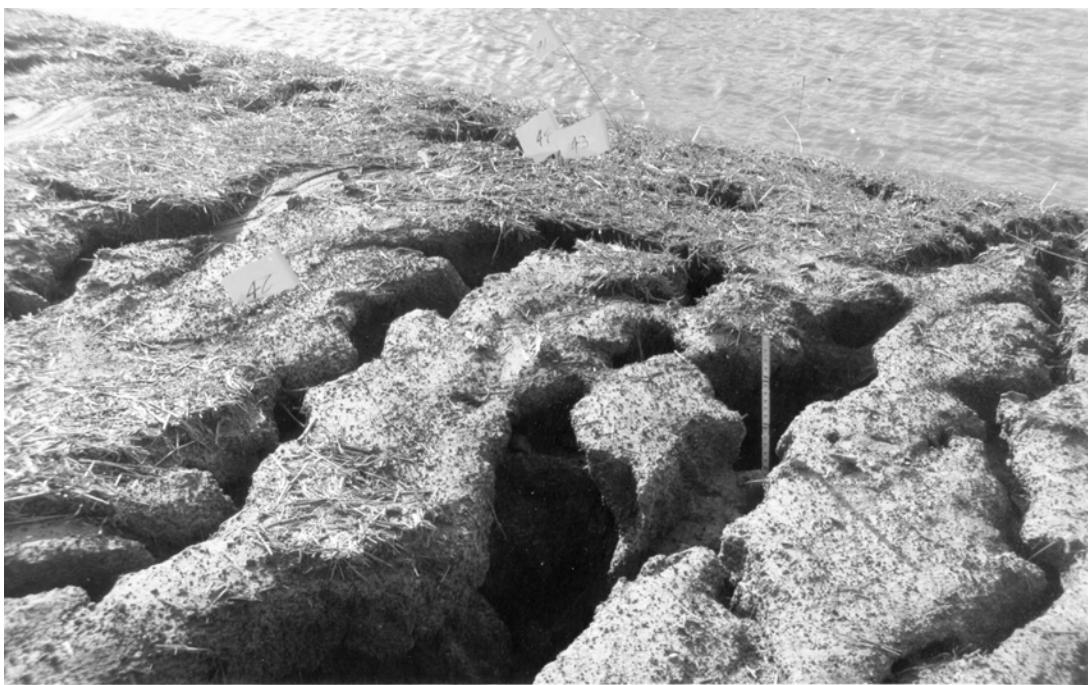
Figure 5. Gullies and Rills Formed on Embankment Slope

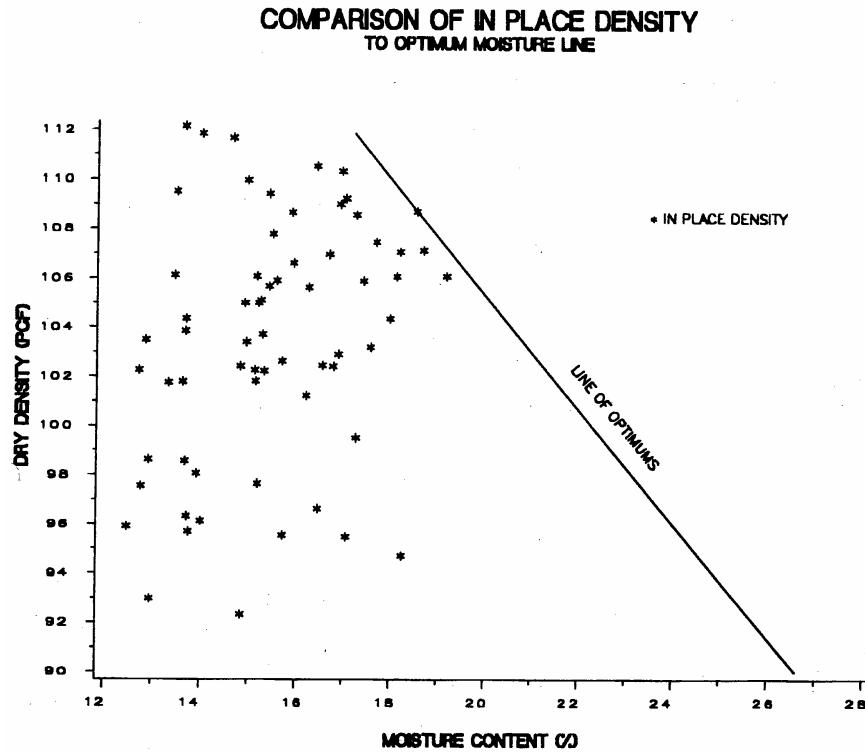
Figure 6. In-Place Densities for Southbound Embankment

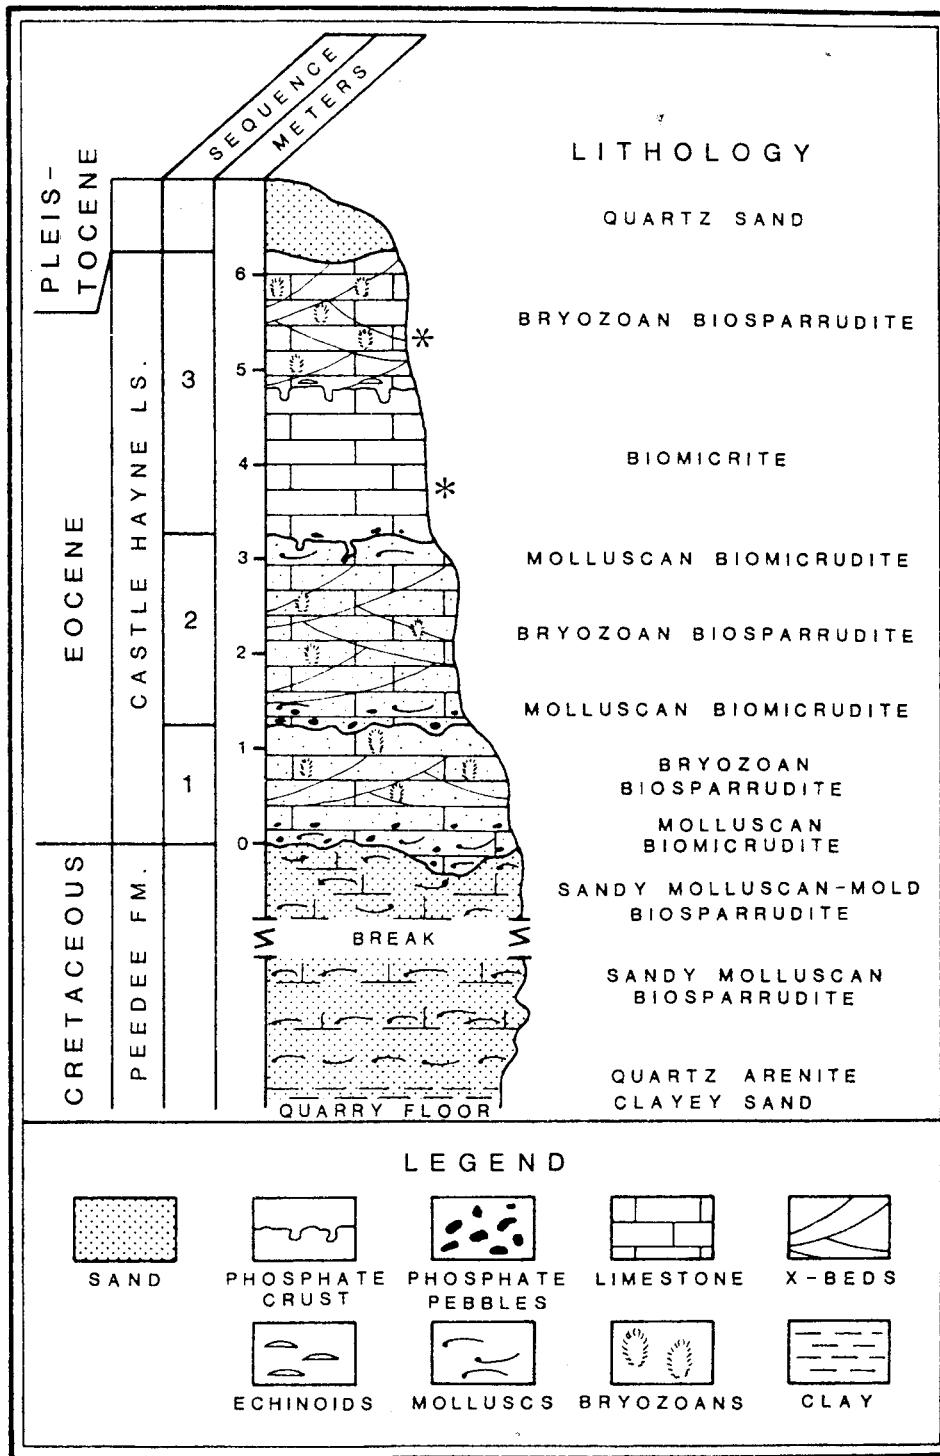
Figure 2 Stratigraphy column showing relationship between Sequences 1, 2, and 3 of the Castle Hayne Limestone and Peedee Formation. (Harris, 1986, 2003)

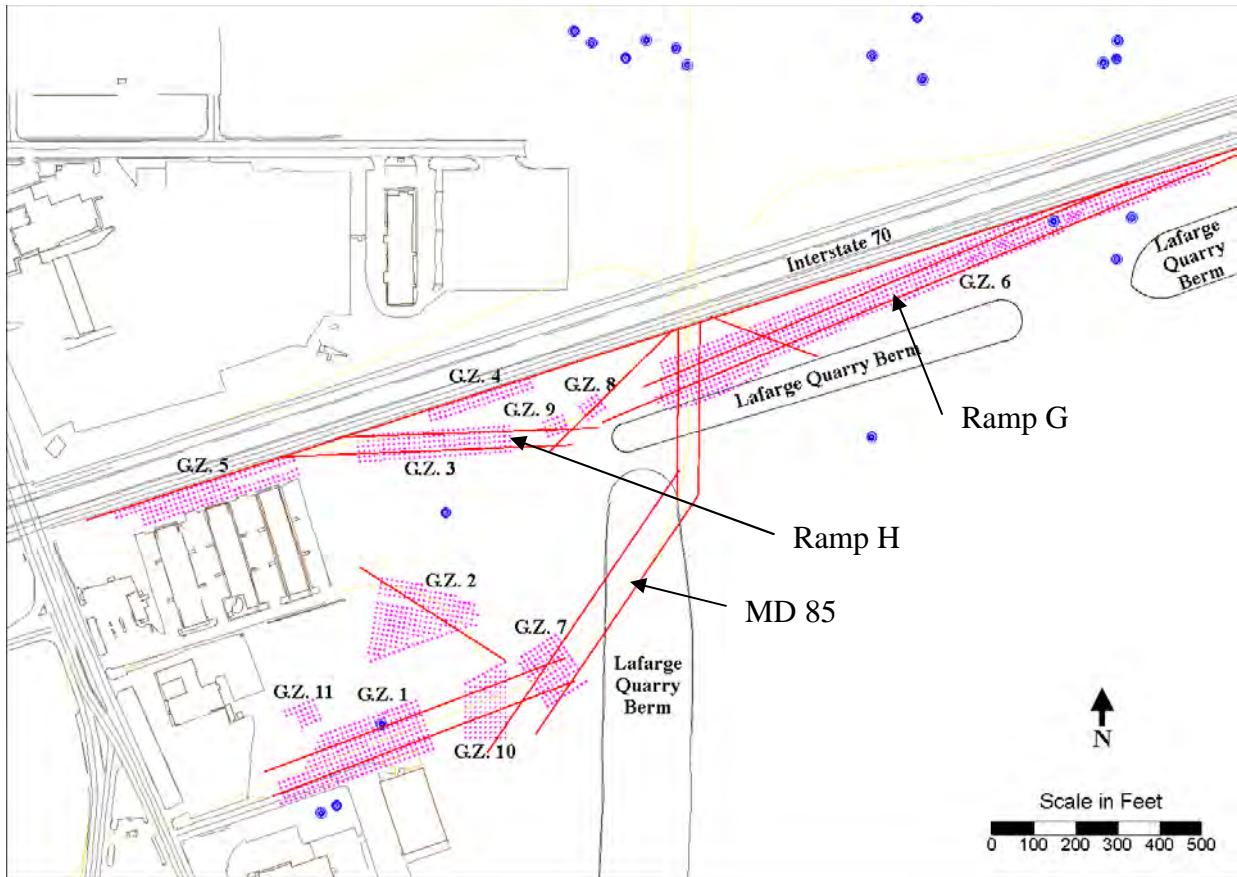
Figure 6: Phase 2A area showing I-70, centerlines of proposed right-of-ways (yellow), resistivity profile locations (red), grout holes (magenta dots) and grout zone numbers (e.g., "G.Z. 1"), and sinkholes at the time of the project (blue dots).

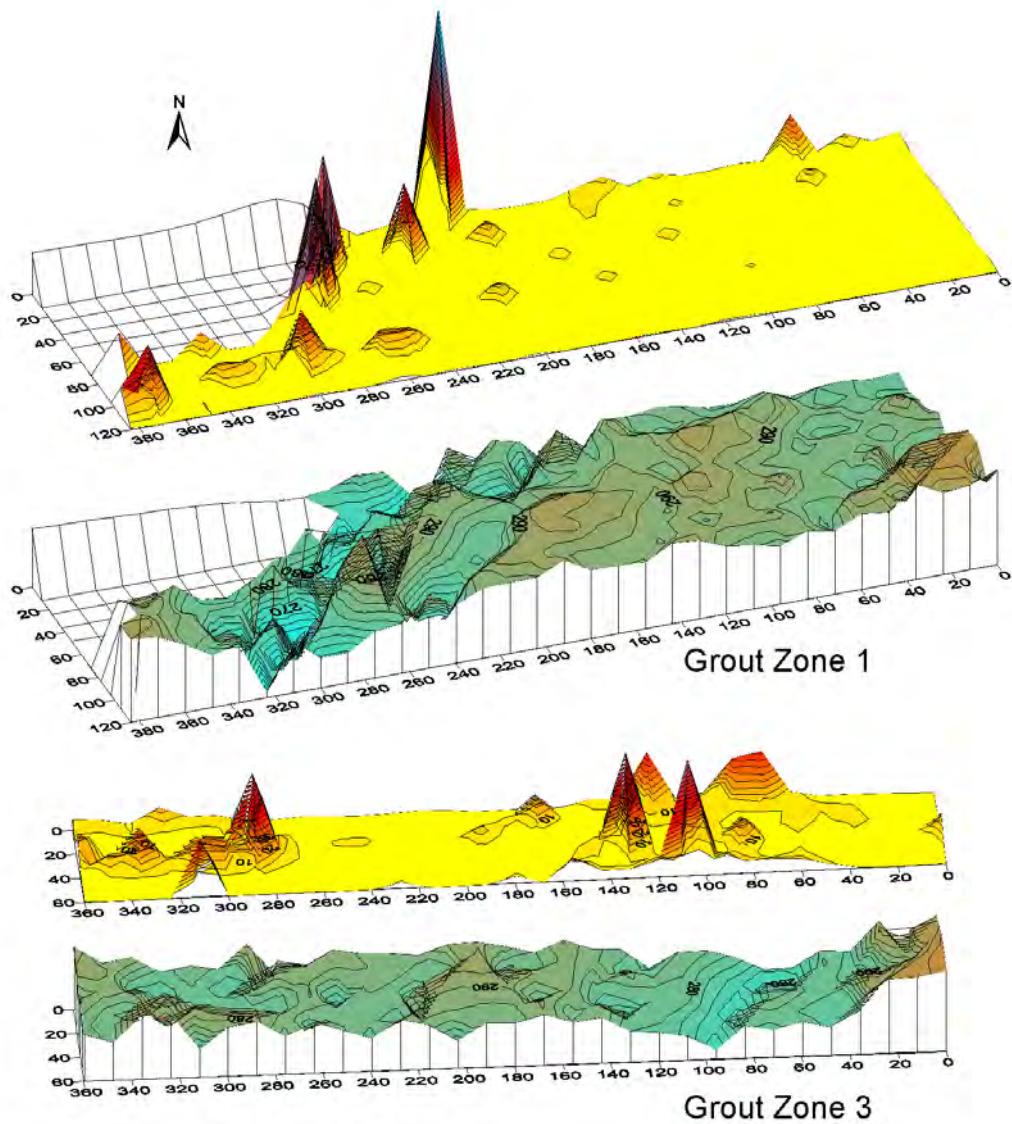
Figure 7: Grout Volume shown above Bedrock Elevation perspective drawings of Grout Zone 1 and Grout Zone 3, south of I-70, Frederick, Maryland. Orthographic perspective, 30 deg. tilt, with North at the top. Scale: 1 inch = 80 feet, except the vertical axis of the grout maps which is in cubic yards of grout injected. No vertical exaggeration in bedrock drawings. Note how largest grout takes roughly correspond to bedrock lows, or cutters.

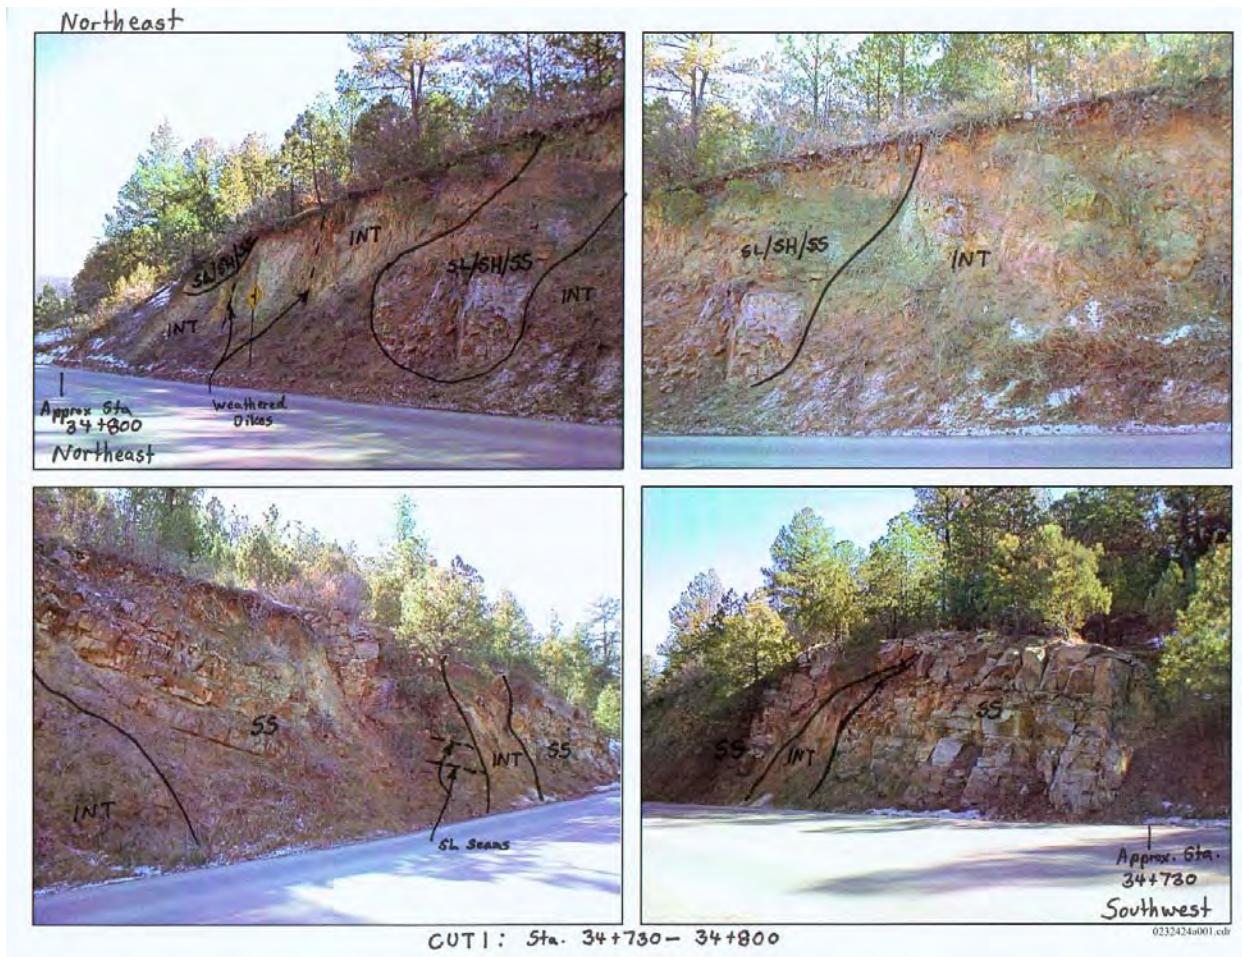
Figure 1: Rock Cut Photo Mapping

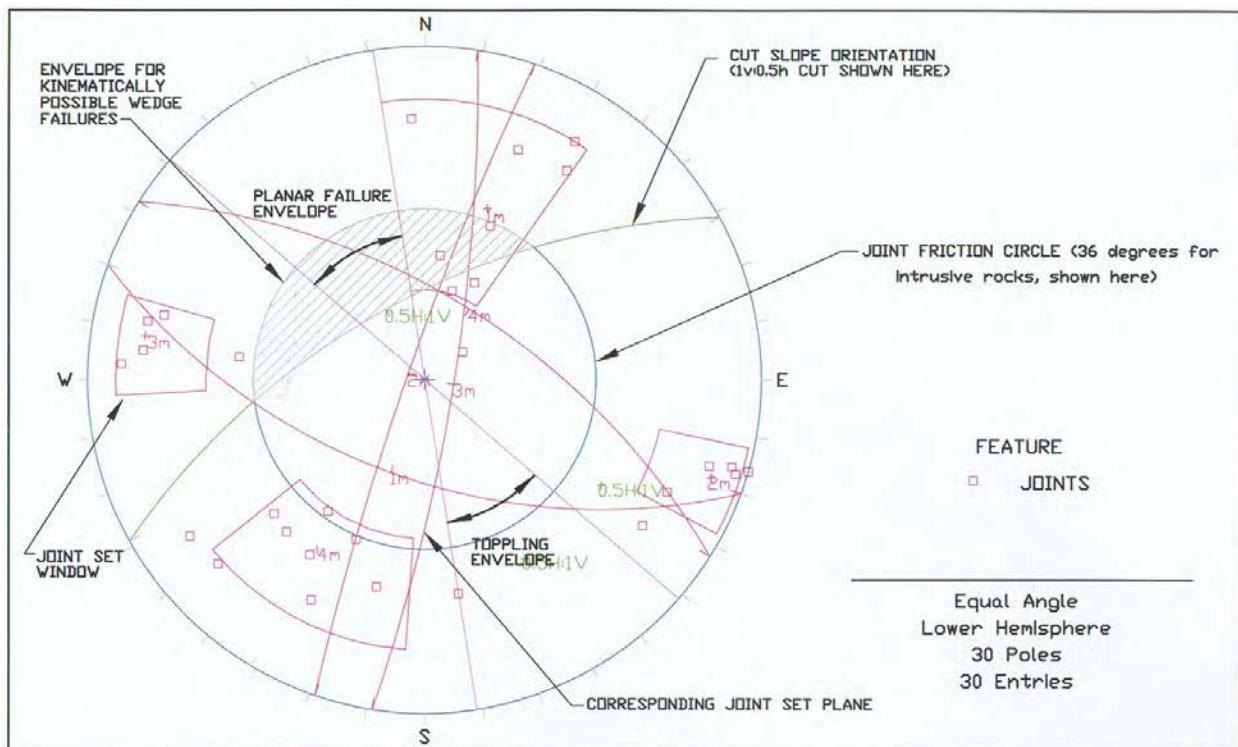
Figure 4: Stereographic Plot of Markland Kinematic Analysis

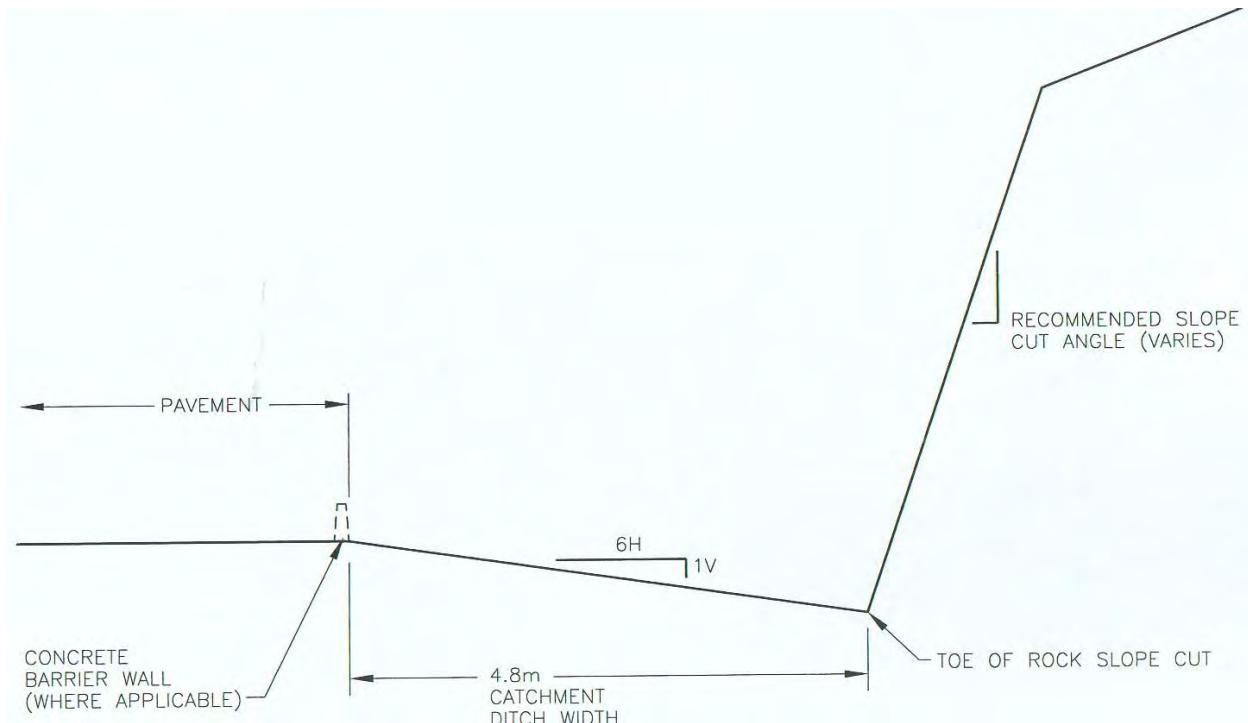
Figure 5: Rock Fall Catchment Ditch

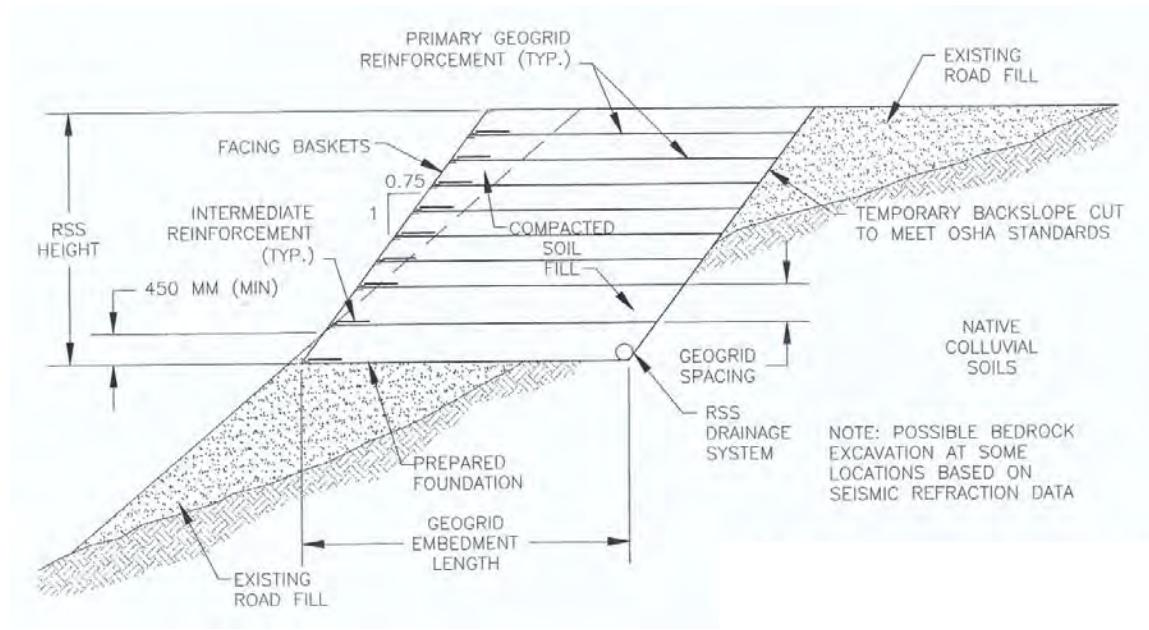
Figure 6: Schematic Cross-Section of RSS Slope

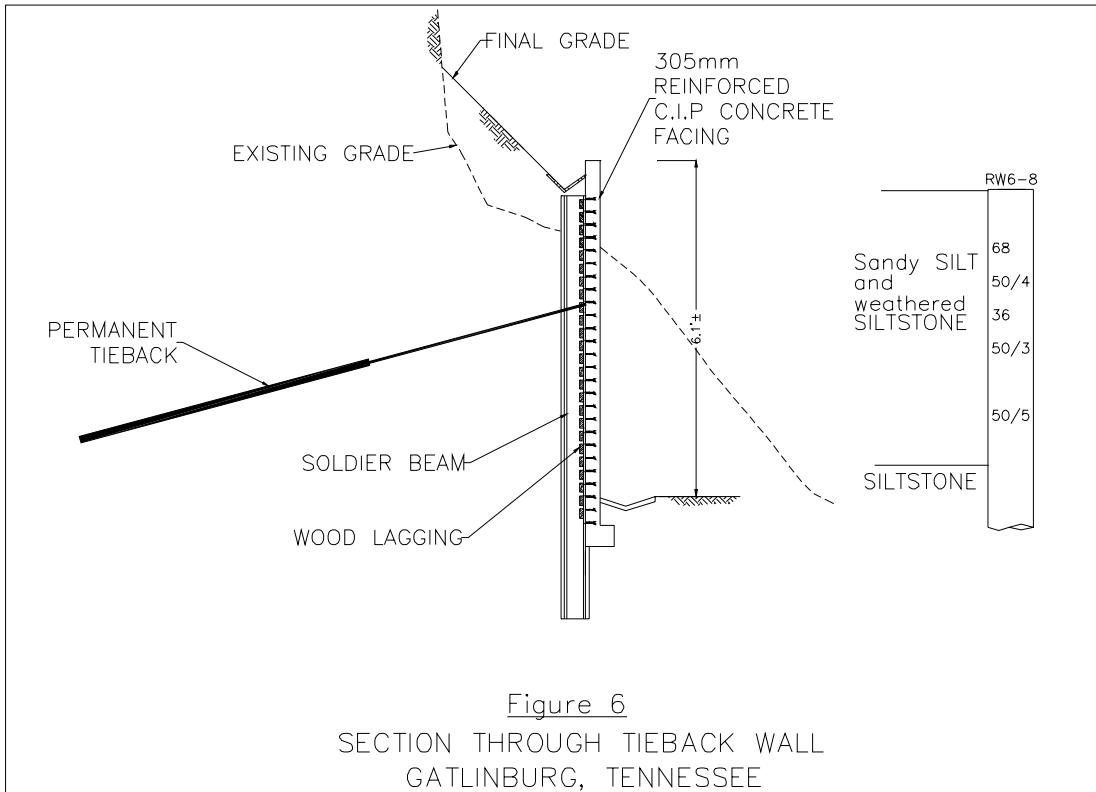
Figure 6
SECTION THROUGH TIEBACK WALL
GATLINBURG, TENNESSEE

After the soldier piles were installed, the material in front of the wall was removed and tiebacks were installed as excavation in front of the wall proceeded. Timber lagging was used to support the soil and weathered rock and wire mesh was used to support the competent rock between soldier piles. The tiebacks were installed using a variety of equipment depending on access conditions. The majority of the holes for the tiebacks were drilled open hole using a down-hole hammer mounted on a set of crane supported leads. Tracked drills were used for the remaining tiebacks. Around 1200 tiebacks varying in length from 10 to 23 meters were installed. Tieback anchors were nominally spaced at 2 to 4.5 meters vertically at each soldier pile. The tieback tendons consisted of Grade 270 7-wire strands. The tendons were encapsulated in a grouted corrugated HDPE tube to resist corrosion. The annulus between the encapsulated tieback and drill hole was tremie grouted using a water and cement grout. The tiebacks were tested to design capacities that varied between 250 and 900 KN.

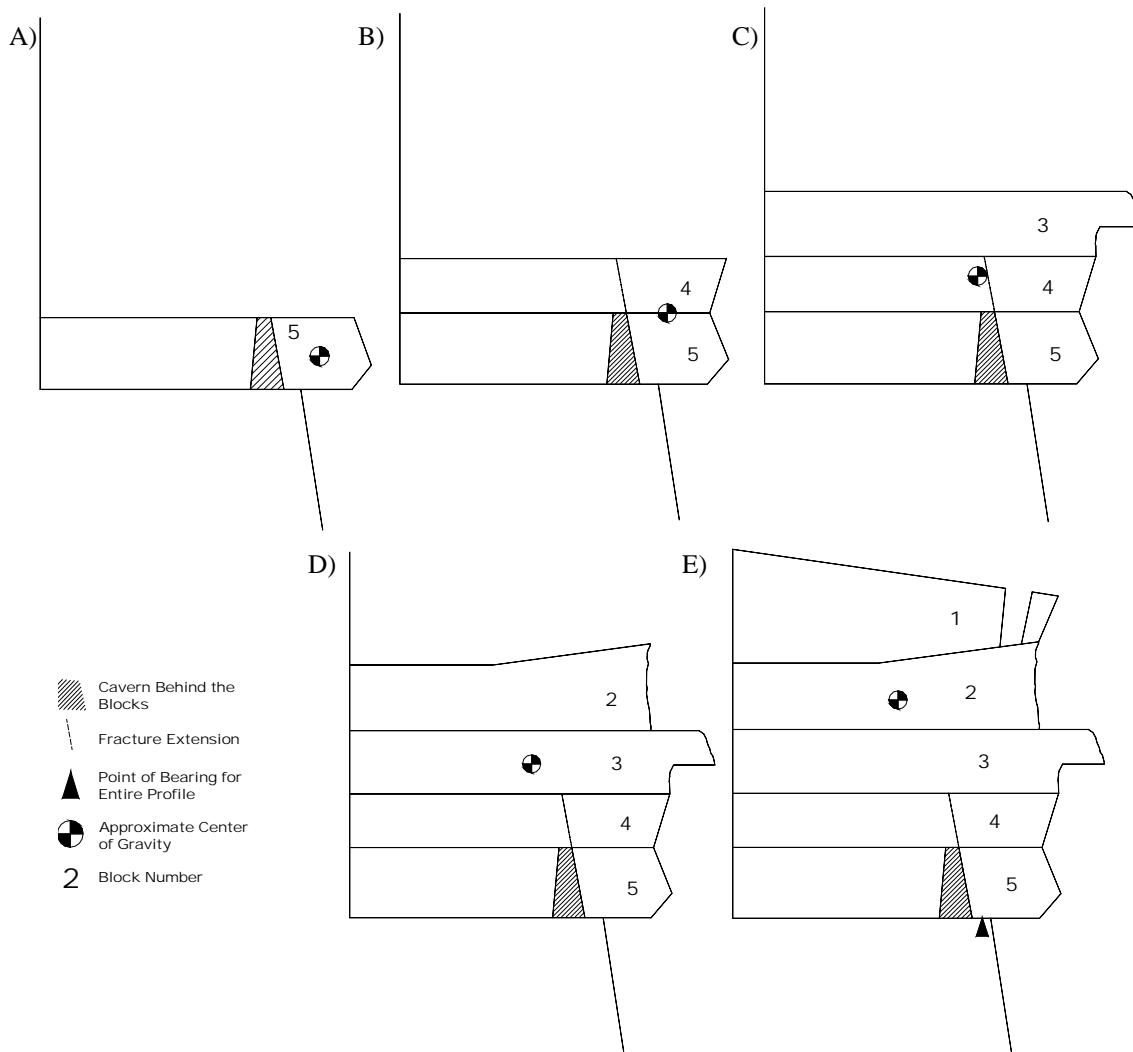
FIGURES 8. Progressive stability mechanics ('A' through 'E') that led to the delicate cantilevering of Blocks 4 & 5.

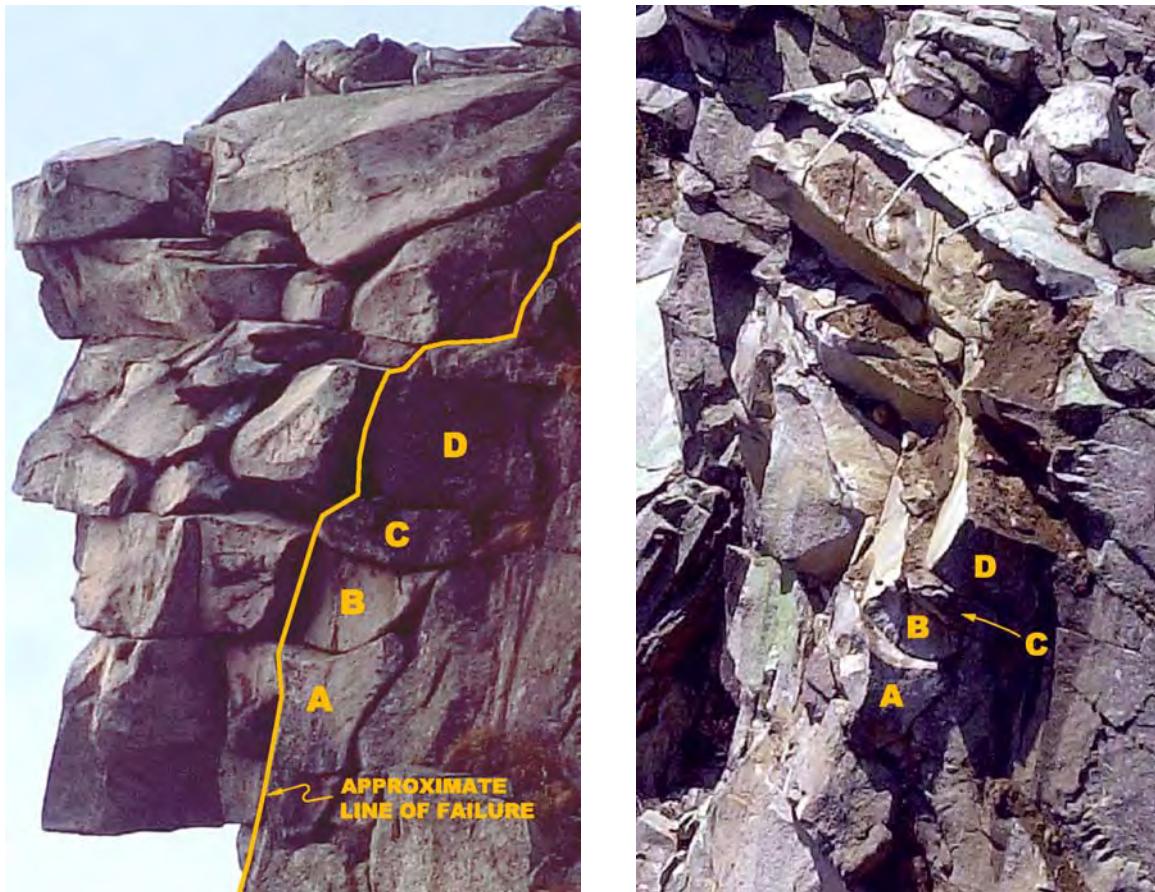
FIGURE 9. Profile's rock mass before (left) and after collapse (right) showing extent of toppling failure. Note Forehead turnbuckles in both photographs. (2001, Associated Press-Jim Cole; 2003, Union Leader Corp., respectively)

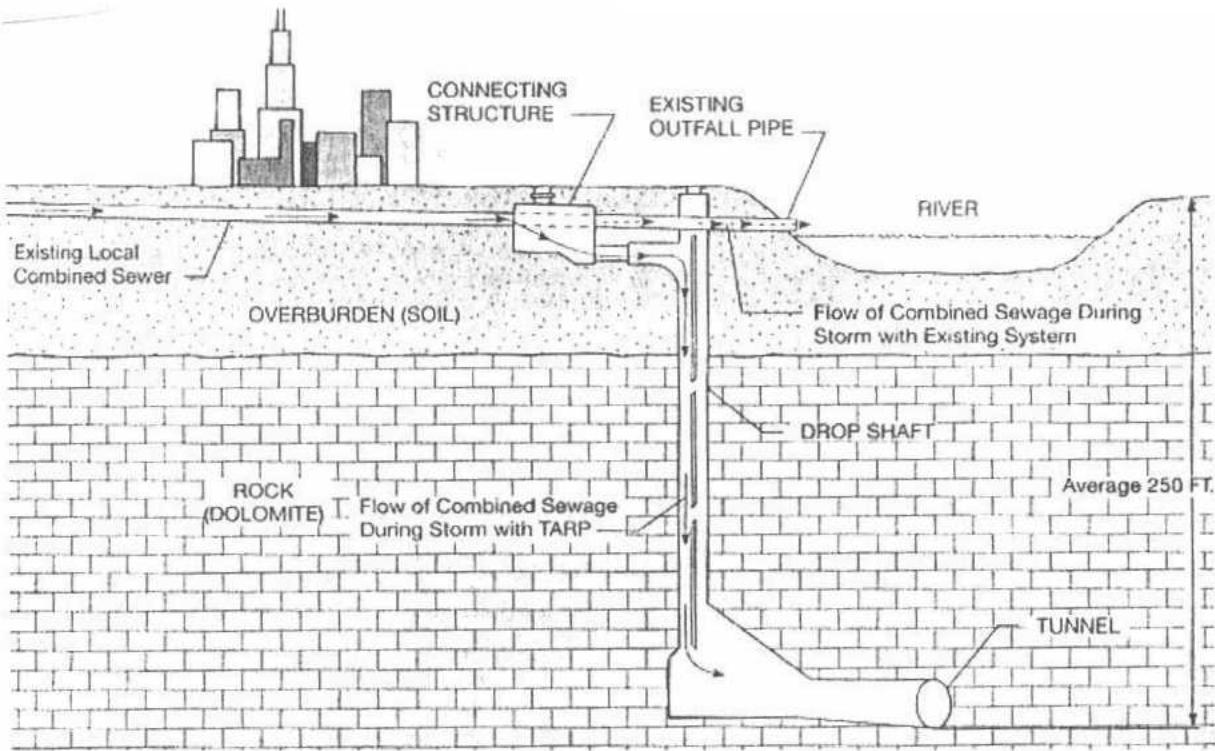
Figure 1. Diagram for Chicago Deep Tunnel Project (West, 1995).

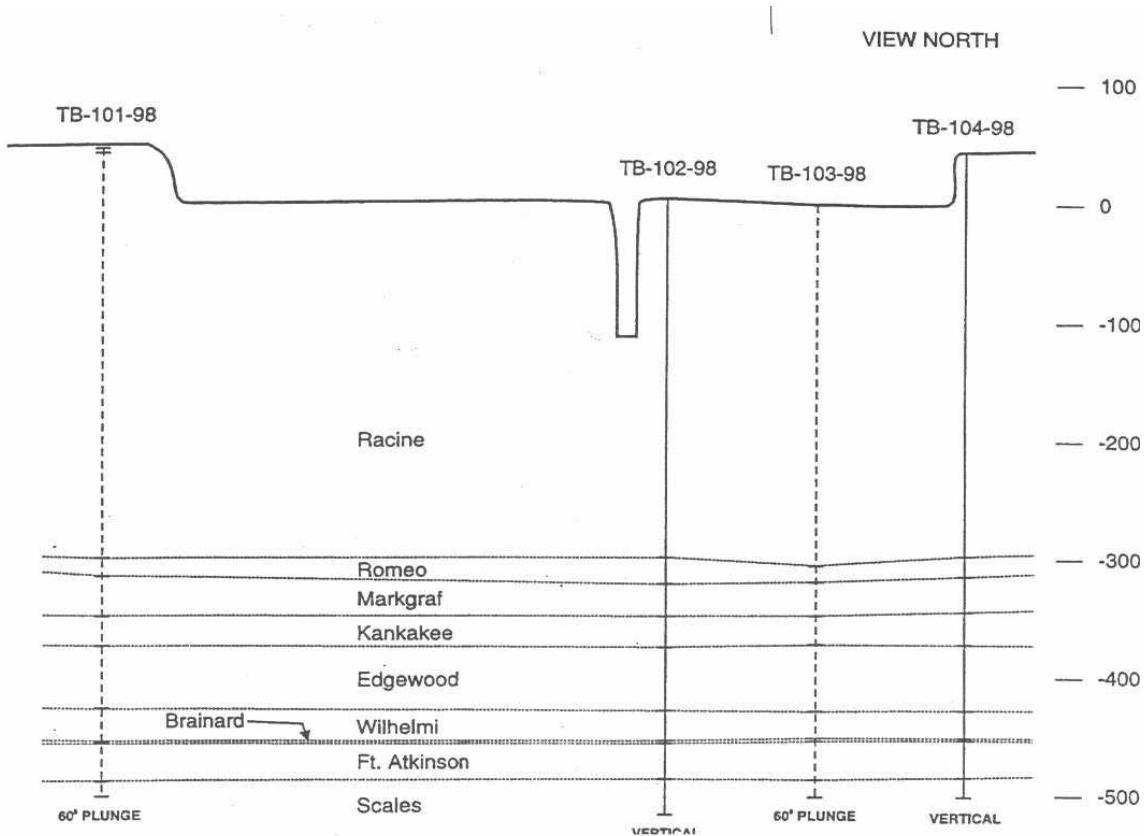
Figure 5. Stratigraphic Section of Rock Ridge (PEI, 1999).

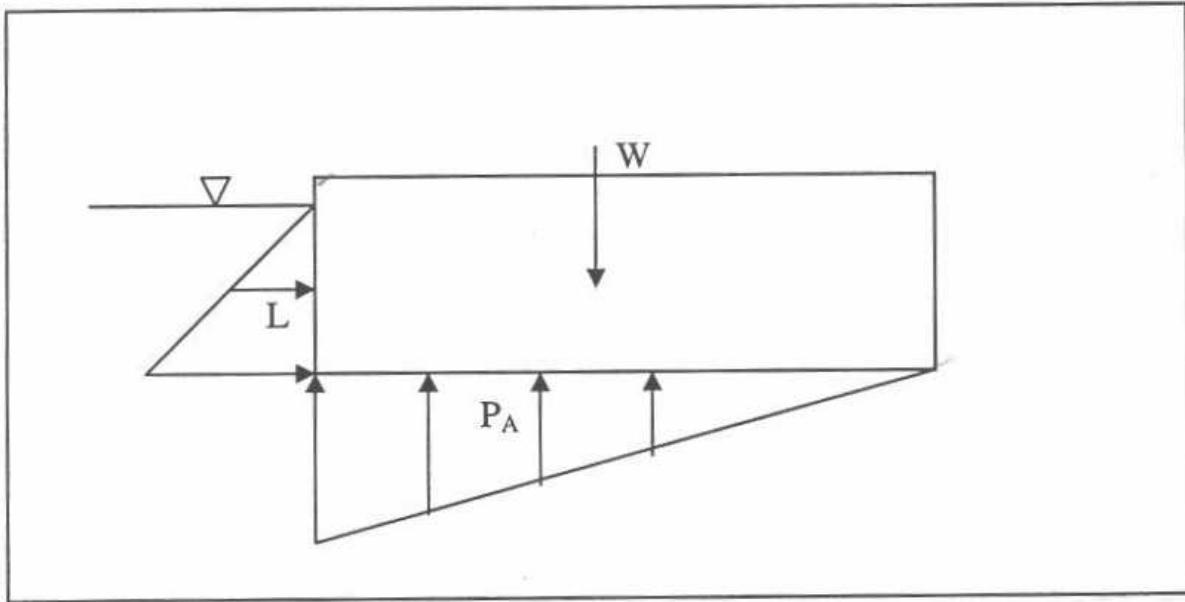
Figure 6. Horizontal Block, Unit Thickness Under Pore Pressure Conditions.

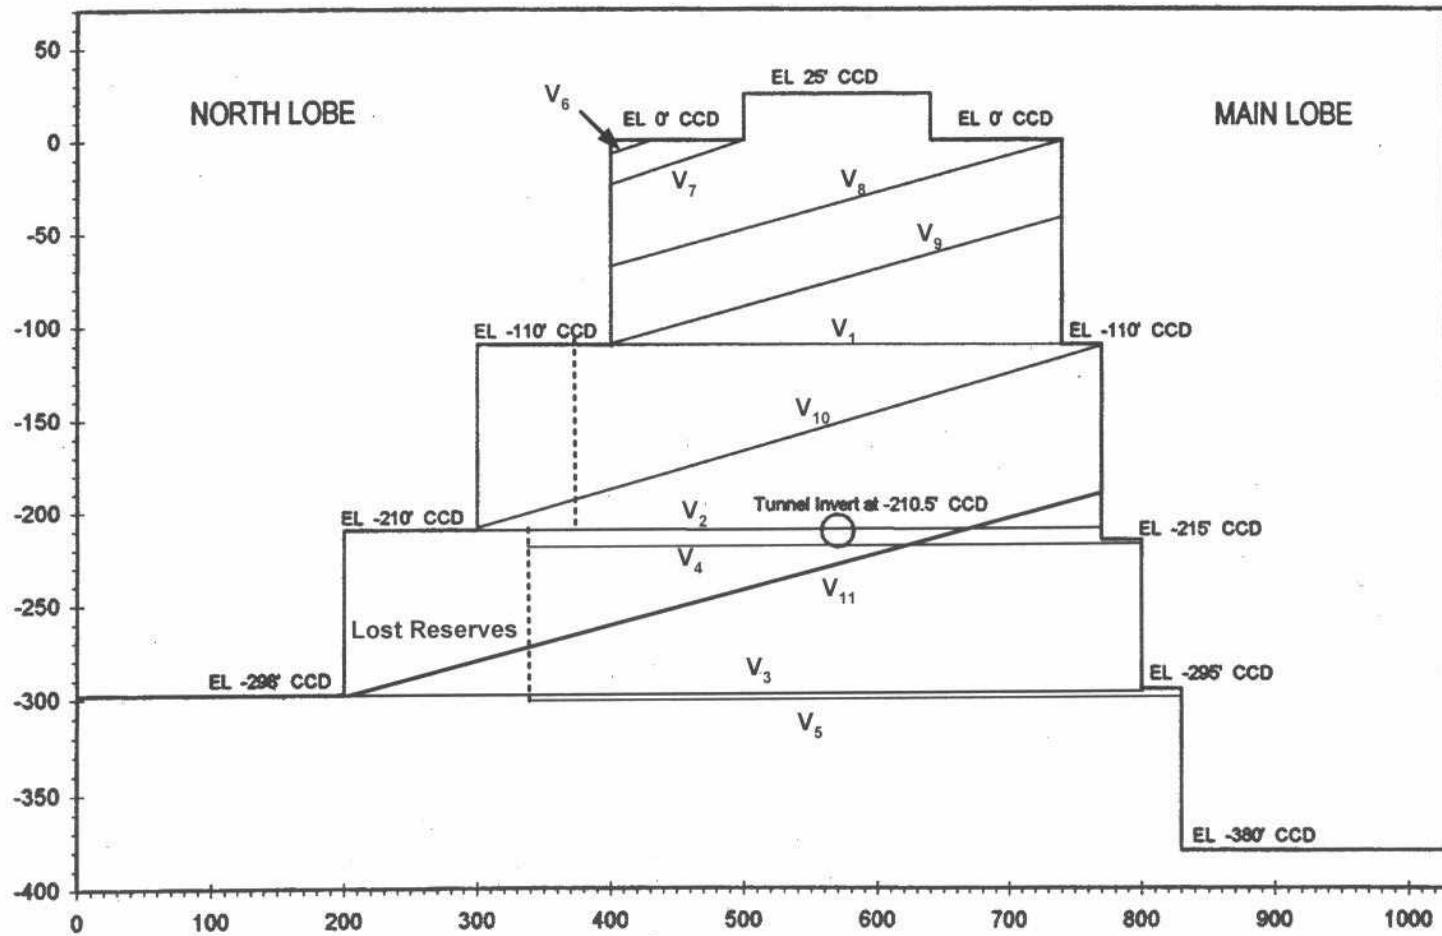
Figure 7. Cross Section of Rock Ridge Showing Potential Fracture Surfaces.

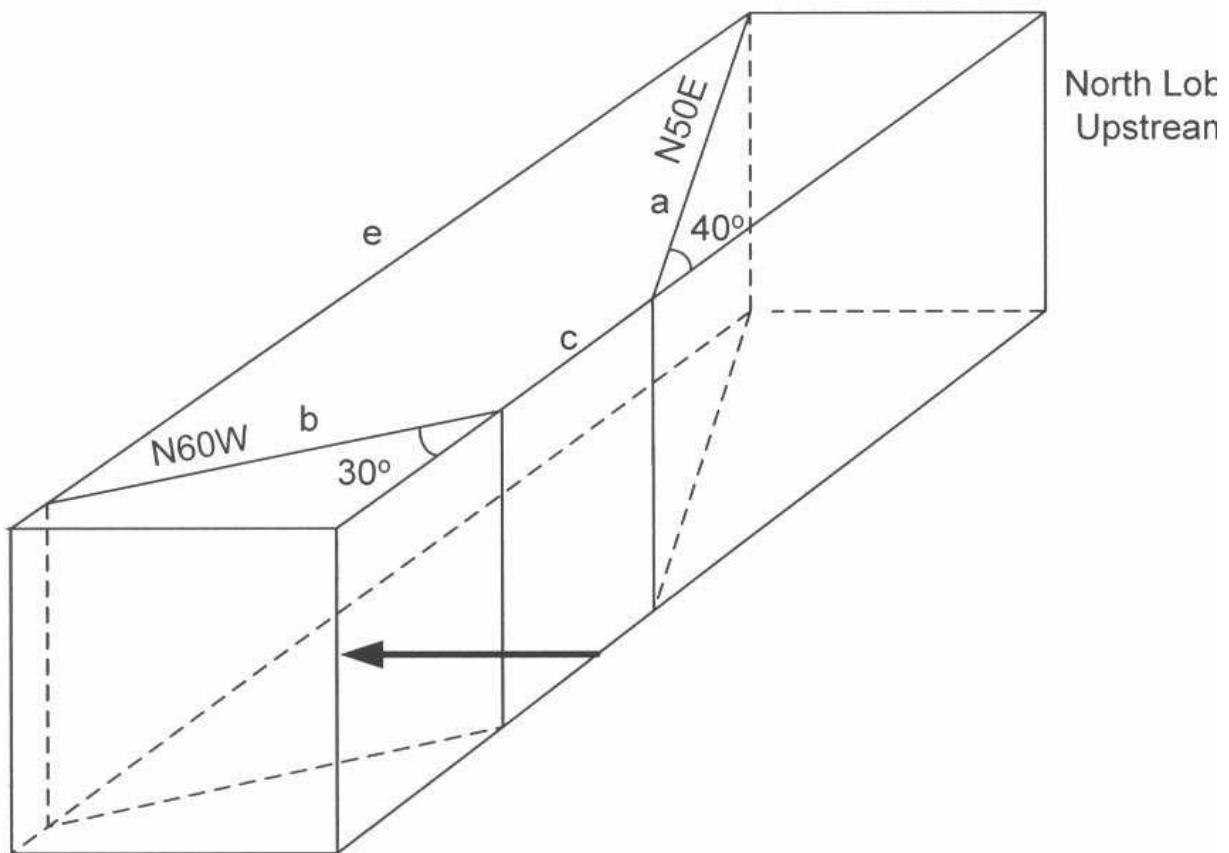
Figure 8. Geometry for Failure Configuration Two.

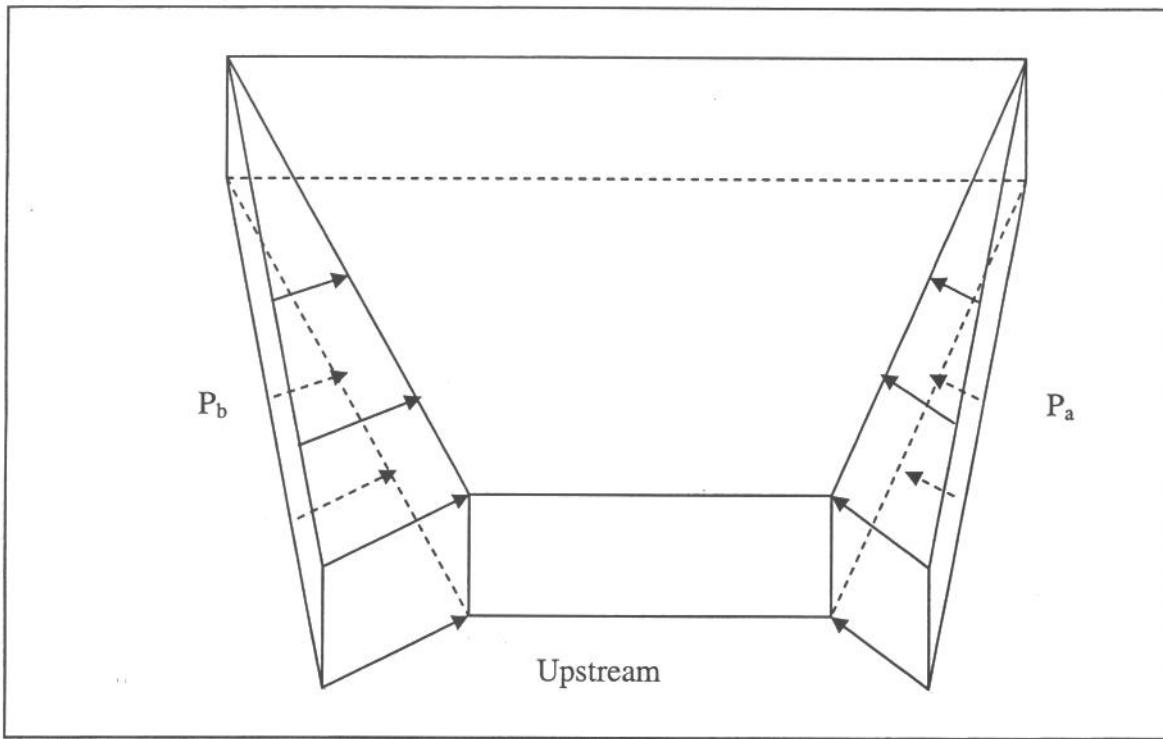
Figure 9. Pore Pressure on Joints, Configuration Two.

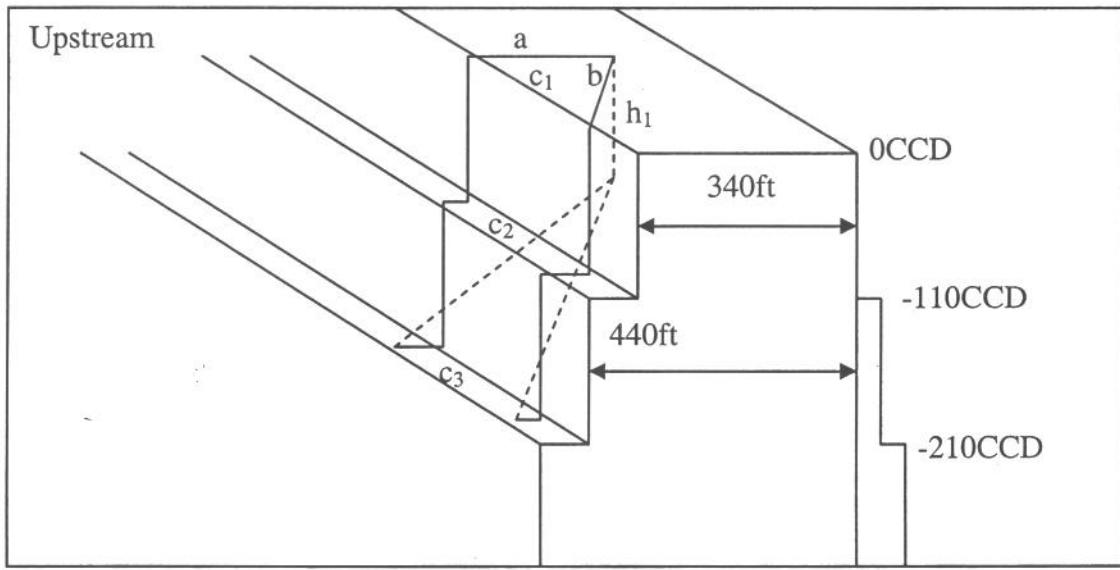
Figure 11. Sloping Failure Wedge, Configuration Three, Block V10.

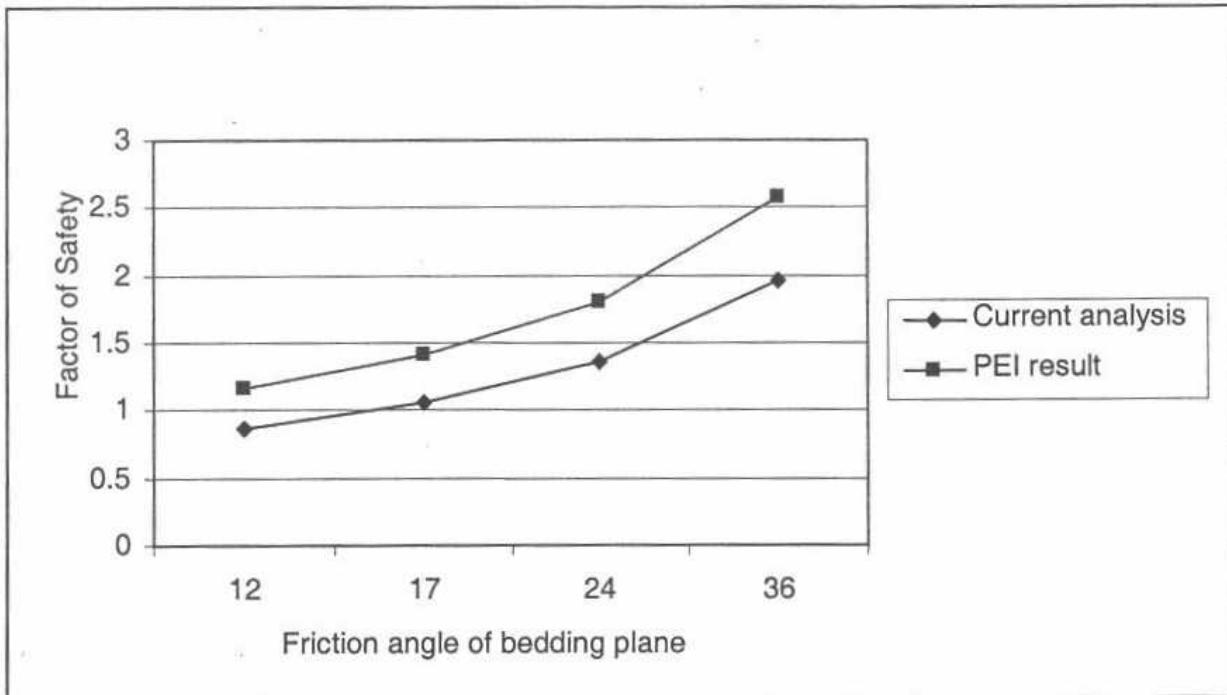
Figure 13. Comparison of Results with PEI, Inclined Beds, 10 Degrees, Block V6.
