55th HIGHWAY GEOLOGY SYMPOSIUM

KANSAS CITY, MISSOURI, SEPTEMBER 7-10, 2004

PROCEEDINGS

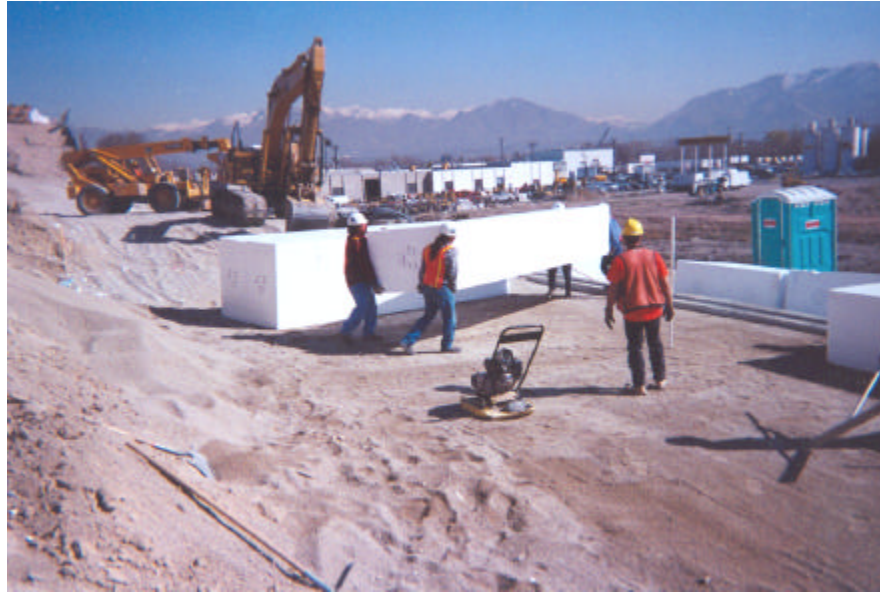
Figure 1. Geofoam Blocks

Geofoam blocks are high-density polystyrene blocks weighing approximately 1 pound per cubic foot, (pcf). These blocks are placed and clipped together and encapsulated in hydrocarbon resistant sheeting and used as embankment fill. After a desired height has been achieved, a distribution slab consisting of 12 inches of concrete is placed over the top of the geofoam mass in order to distribute the traffic loads more evenly over the surface of the blocks.

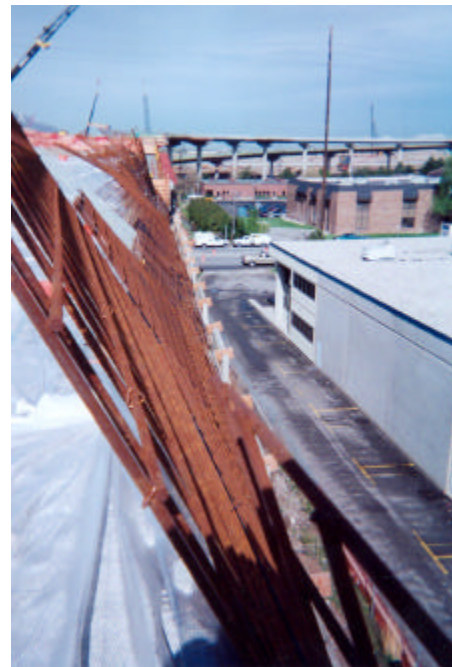
Figure 4. Wall SS-01 over Lime Cement Column area. Note, proximity of Nearby Building

Another valuable lesson learned from the installation of lime cement columns is that they should not be installed next to existing buildings. The building seen on the right on Figure 4 underwent several inches of heave caused by high injection pressures during the installation process.

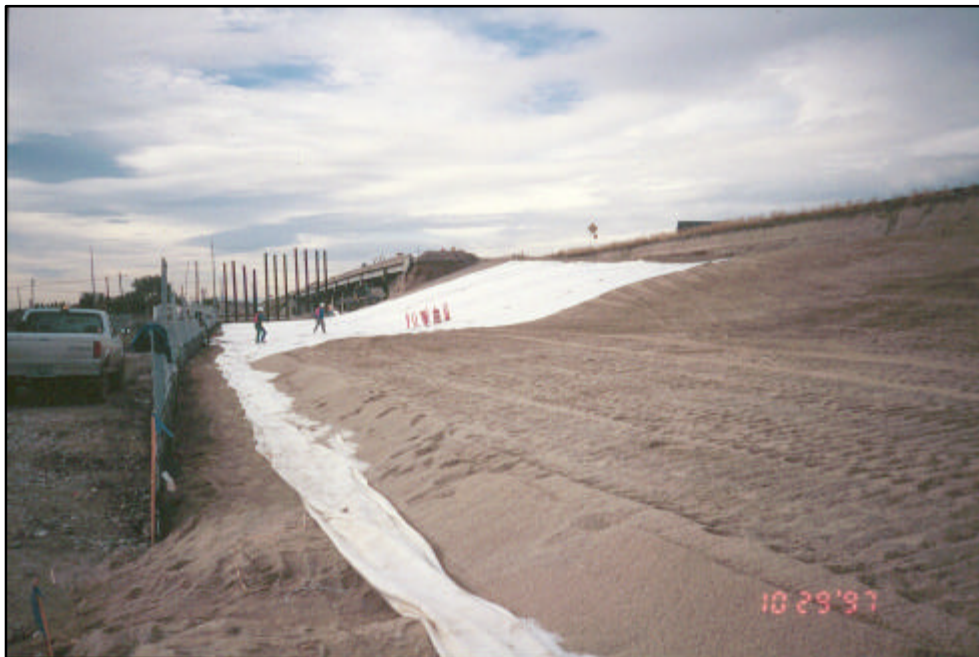
Figure 5. High Strength Geotextile

High Strength Geotextile Reinforcement- Low strength soils existed throughout most of the project alignment. In these soft soil areas, roadway embankments up to 45 feet in height were proposed to be constructed. Due to the low strength soils and using the SHANSEP methodology (Ladd, 2), this would require as much as four stages of embankment construction. The use of high strength geotextile fabric was proposed by the geotechnical engineering team as a method of reducing the construction stages and ultimately reducing the construction duration for each embankment. High strength, bi-directional, weaved fabric having a shear strength of 375 kPa (54 psi) was utilized for this project. The geotextile fabric was installed at the base of the embankment being extended enough to provide sufficient “bonding” lengths. In some cases, as much as three layers of the geotextile fabric was utilized to meet “during construction”, “end of construction” and long term factors of safety. A safety factor of 1.3 was utilized for “during and end of construction” condition and a factor of safety of 1.5 was utilized for the long-term condition. Embankment stage heights were determined by global slope stability calculations. Typical embankment heights of up to 16 feet were generally permissible without the use of geotextile fabric. However, with the use of geotextile fabric, an embankment could be constructed to a first stage height of approximately 26 feet. In most cases, several stages of embankment construction was “skipped” by using geotextile fabric. The main value of this concept was in saving time, which allowed the contractor to collect valuable “milestone bonus awards”.

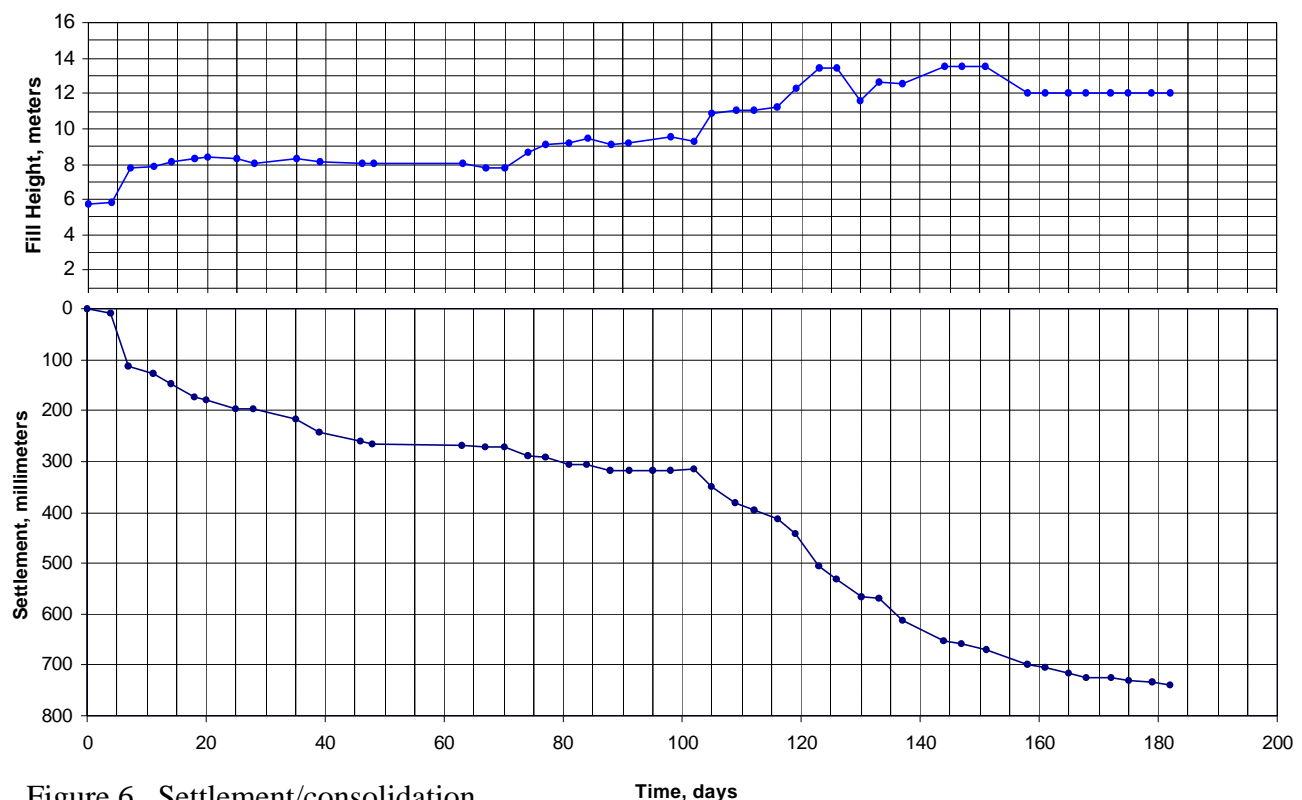
Figure 6. Settlement/consolidation

Magnet reed switches were installed as deep as 100 feet below the existing grade prior to embankment construction. As embankments were being placed measurements of settlement/consolidation at several depths were being collected. This data allowed the geotechnical engineer to determine the probable neutral plane of the pile foundations. The determination of the neutral plane was critical in the design phase of this project due to “down-drag” or negative skin friction effects of consolidating soil around the pile foundations. This information allowed the piles to be much shorter than originally determined.

However settlement/consolidation and/or rods would also tend to be damaged during the embanking process. To account for this, redundant settlement/consolidation we used. The data collected from the settlement/consolidation plates allowed the contractor to pave much earlier than anticipated in the geotechnical reports. Settlement plate data indicated that most fill areas where wick drains were installed were reaching the end of primary consolidation approximately 30 to 60 days ahead of the anticipated schedule. The Aasaoka method of predicting the end of primary consolidation, first introduced in 1978, was utilized on this project. This figure above is an actual settlement/consolidation curve as embankment was being placed. Note that the primary settlement/consolidation is approximately 2.5 feet and was essentially completed 60 days after the final lift date.

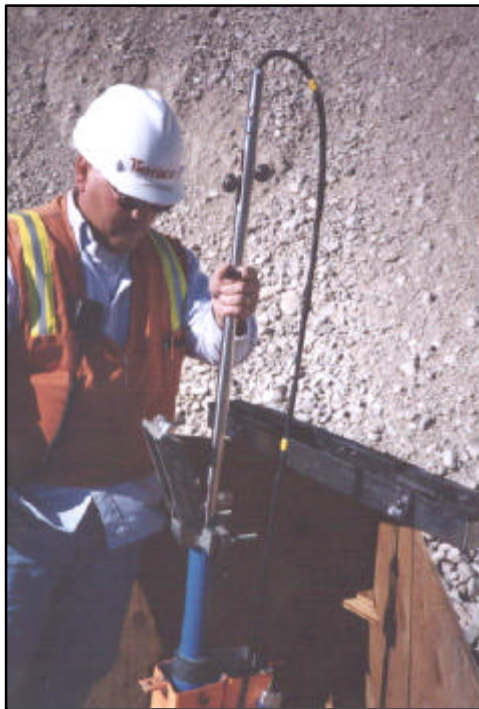
Figure 7. Inclinometer

Inclinometers – As discussed previously, there was a need for rapid embankment construction throughout the corridor, however, safety concerns were paramount. Slope instability or failure was not acceptable from both a design and construction view point. The irreversible affects of a massive slope failure would have delayed the entire project and possibly cost the project millions of dollars in missed “milestone bonuses”. To make sure that the embankments were being constructed at a safe rate as well as reducing the conservative nature of the geotechnical engineers, several hundred slope inclinometers were installed throughout the project. Slope inclinometers are a great tool to determine the soil deformation under a loaded situation. The rate of fill placement is directed by the daily reading of the inclinometers. “Threshold” levels were determined by the rate of soil movement and a rate of fill placement or a stop notice was then given to the contractor. This cautious process allowed the safe

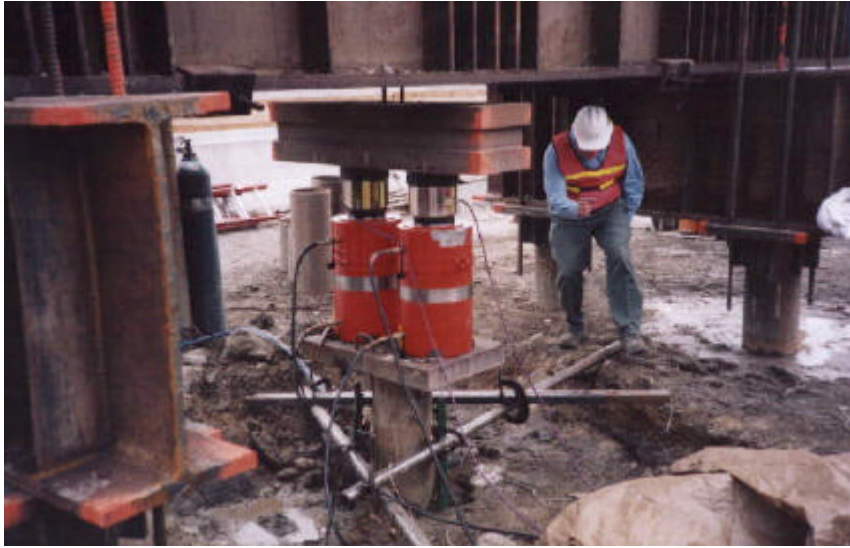
Figure 8. Pile Load Testing

possible millions of dollars. Nine pile load tests were completed throughout the project for differing soil conditions. Actual pile load tests, as required by the contract, allowed the design engineers to reduce the factors of safety from 2.5 to 2, therefore, reducing the overall number of piles for the entire project. Lateral load tests were also performed to determine the lateral capacity of the soil.

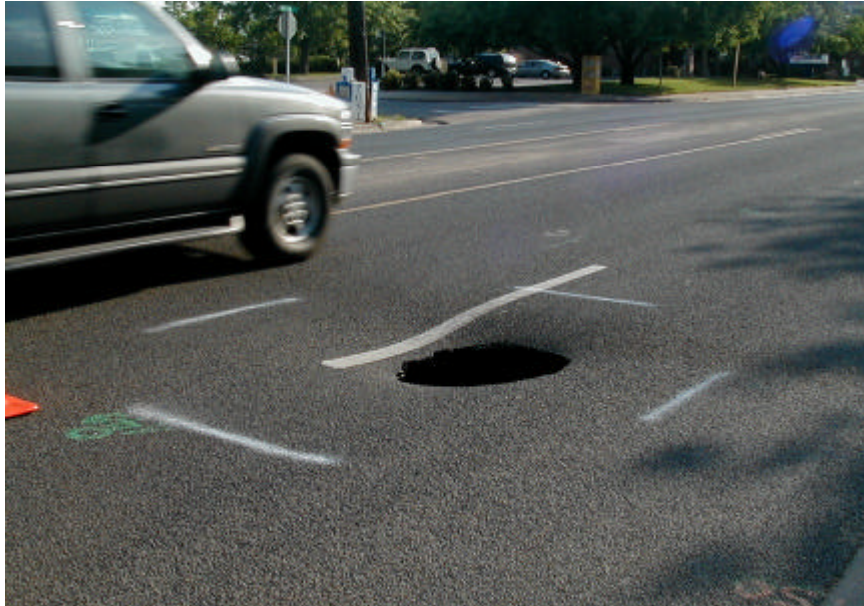
The tunnel portion underneath Mississippi Avenue was constructed with a earth balance tunneling machine. The theory was that the saturated alluvial material would be less affected by a controlled tunneling process. Even with extreme care in both the design and preparatory process, there were several sinkholes that developed underneath Mississippi Avenue due to the accelerated tunneling process.

Figure 9. Sink Hole at Mississippi Avenue

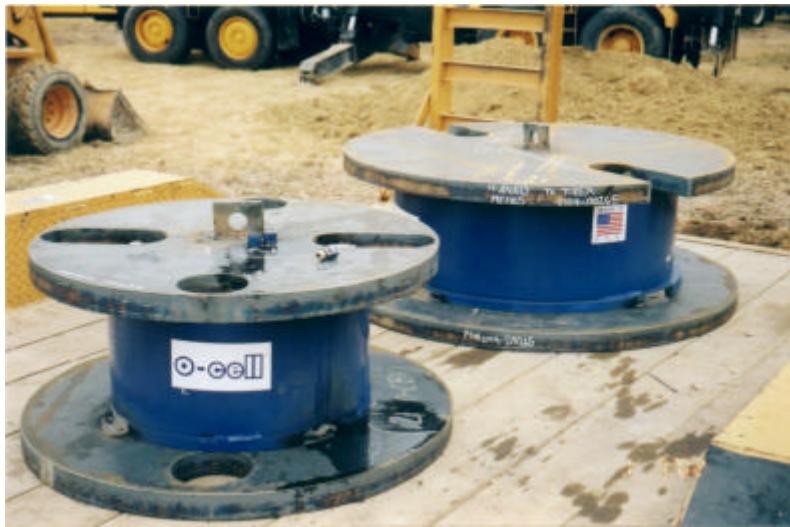
Figure 11. O-Cell Load Test Devices

Drilled Shaft Pile Load Test – Pile load tests are often performed to reduce the conservatism in the geotechnical design and/or confirm the actual load capacities of the soil/bedrock. For the TREX Project, the design team chose to use an Osterberg Load Cell (O-Cell) pile load testing device to perform three drilled shaft pile load tests along the corridor.

O-Cells were chosen by the design team because this type of load test can measure both side friction and end bearing components of vertical capacity separately. This was important because it determined if the “Denver Method” was appropriate. The “Denver Method” calculates the drilled shaft end-bearing component by dividing the standard penetration (N-value) by half and multiplying by 1000. The result is the end bearing value in

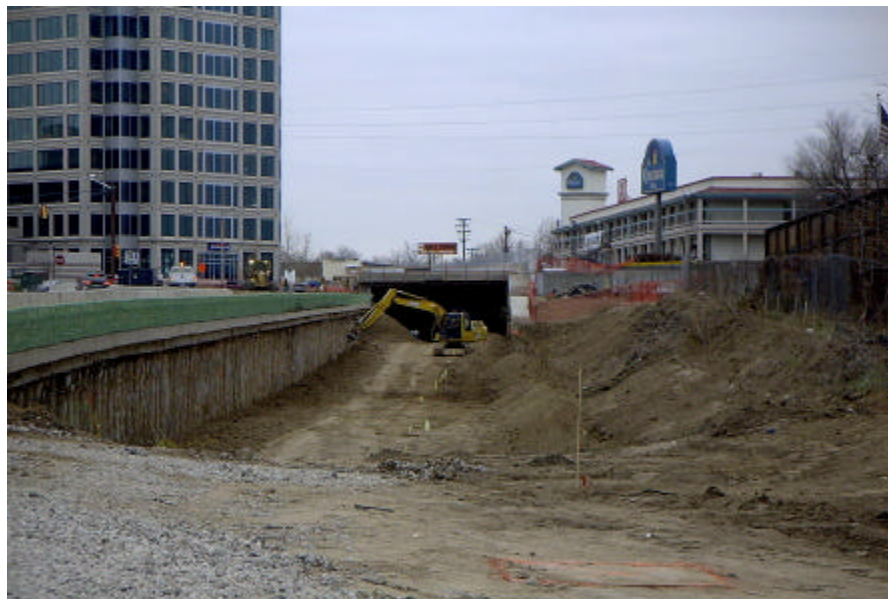
Figure 12: Adjacent Structure Next to Drilled Shaft Retaining Walls

Some of the drilled shaft retaining walls were located within close proximity to critical utilities or structures. Therefore, monitoring of wall movement could better determine the safe rate of soil removal in front of the retaining walls. If too much movement was observed then the excavation process would be stopped until a new design was implemented. Below is a picture of two drilled shaft retaining walls that were monitored prior to the bridge deck being placed over the top. The geotechnical engineer determined that the building adjacent to the retaining walls could only deflect $\frac{1}{2}$ inch prior to damage being observed in the building.

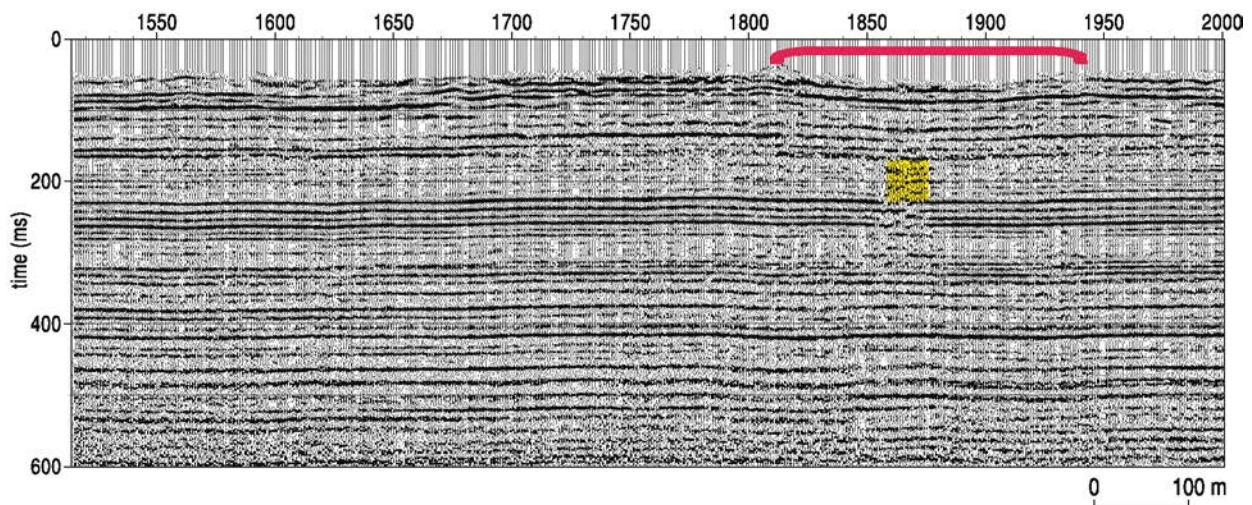
The only clearly identifiable paleosinkhole across the 10 km profile was identified near the intersection of U.S. Highway 50 and Kansas state Highway 96 (Figure 12). Reflection

Figure 12. Paleosinkhole evident about 2 km from the beginning of profile and approximately beneath the stretch of highway that includes the overpass of Highway 96.

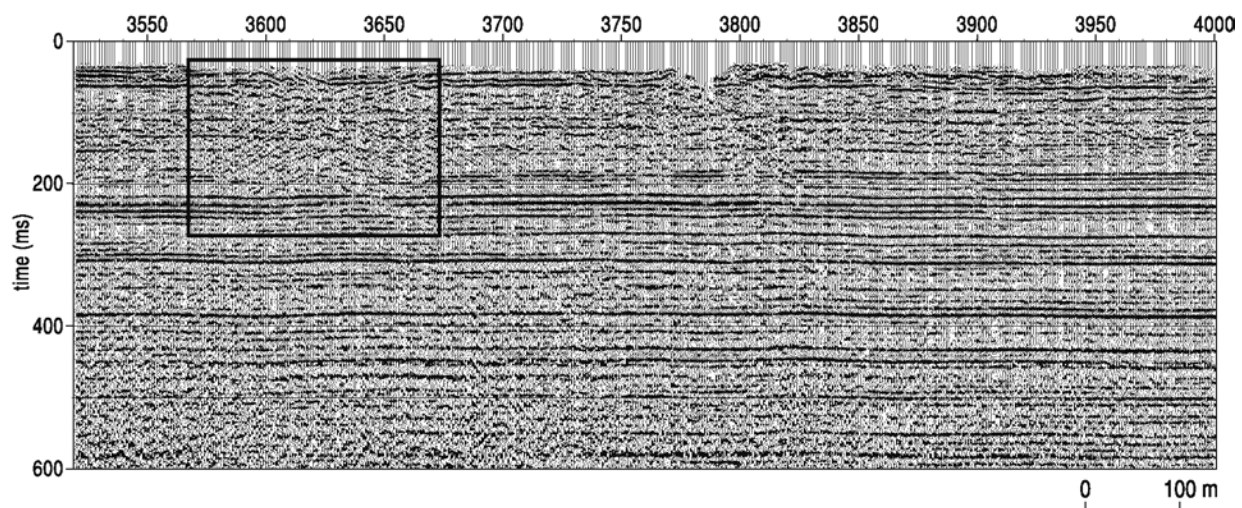
Figure 14. Scatter seismic energy related to bed termination. These highly developed scatter patterns are areas for more concentrated study. The most likely scenario involves uncompensated surface noise, out-of-the-plane features, or bedrock abnormalities. However, this type of seismic signature could be indicative of a void or anomaly such as an abandoned salt jug.

Figure 15. As observed on Figure 14, this scatter pattern of seismic energy could be an indication of bed terminations into void associated with old salt jugs.

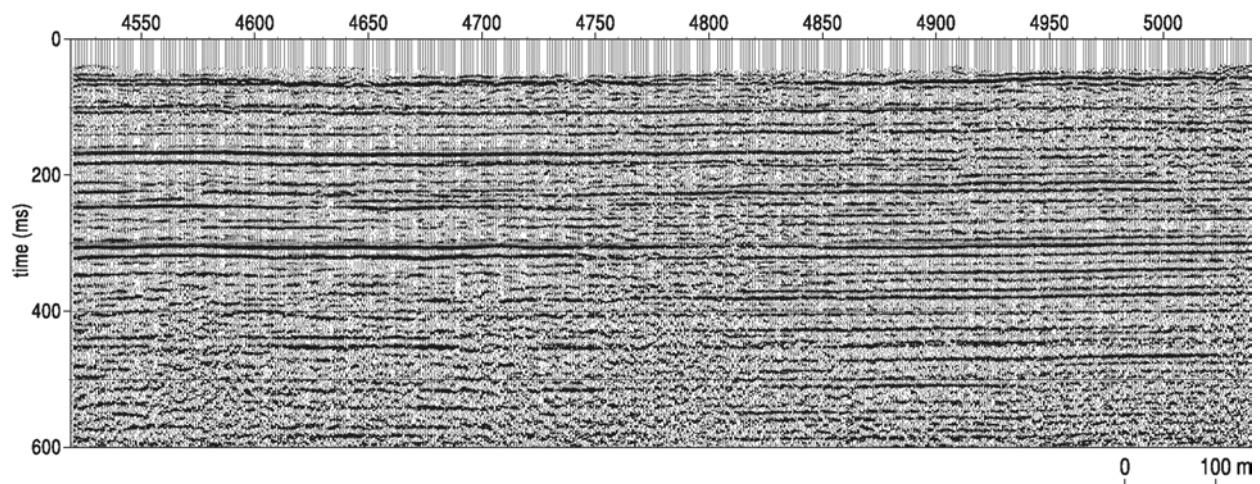
Near the end of this 10+ km seismic profile is what appears to be a change in the basal salt contact (Figure 17). Around station 4630 the reflections from near the base of the salt layer at about 230 ms change gradually across about a kilometer from a relatively distinctive higher amplitude single-wavelet event to what appears to be a very cyclic lower resolution wavelet. This change appears to be consistent with an apparent thinning in the salt layer. However, from

Figure 17. Near the eastern end of this 10+ km survey the seismic signature of the salt layer appears to change, thinning some with reflection frequencies within the salt layer dropping notably.

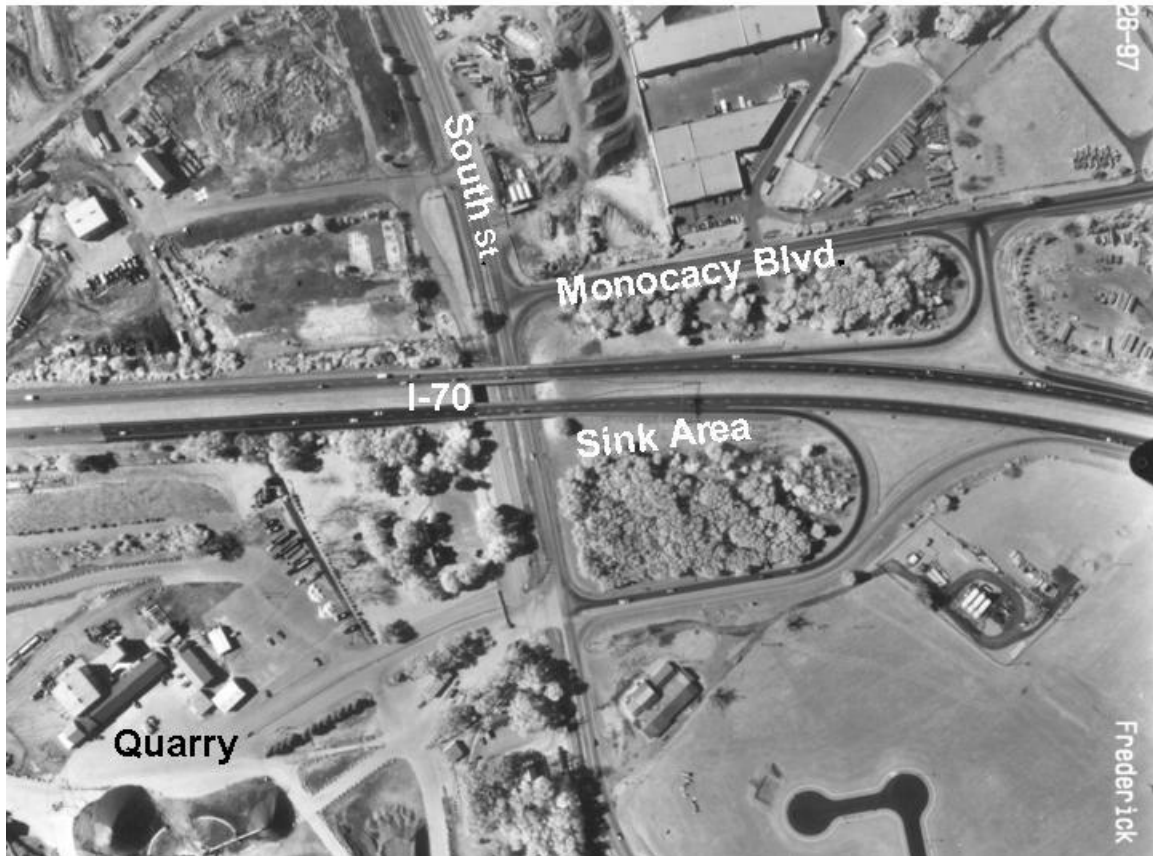
The subject area is just east of the City of Frederick, Maryland, in the southeast quadrant of the interchange for South Street and I-70. The interchange consists of dual spans of I-70 over South Street and a commuter railroad. The on and off ramps for eastbound I-70 are located in the southeast quadrant of the interchange. The on and off ramps for westbound I-70 are both located in the northeast quadrant. Figure I shows the locations of the features.

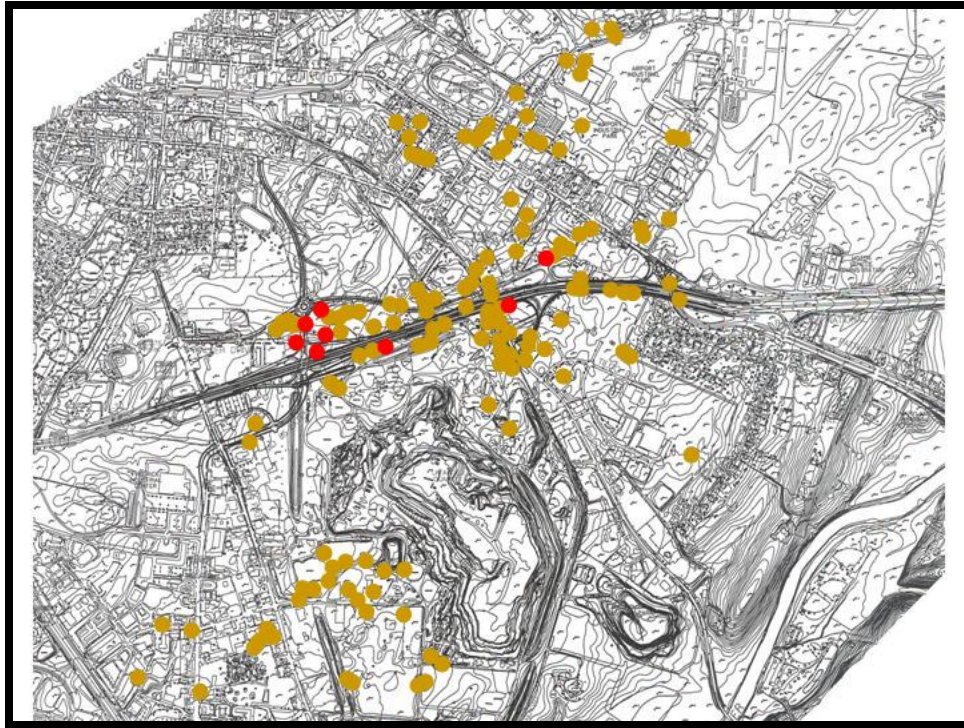
This area is within the zone of influence of the quarry noted above. The elevation of the quarry floor is currently at sea level (0) while the elevation of the rim ranges from 275' to 300' above sea level. The railroad line that parallels South Street has a history of almost constant sink activity up until it was grouted in 1999, as part of a track improvement program to make it suitable for commuter trains. No sinks have been experienced in the track area since that time. Figure III shows sinks that have been mapped since 1985. Those shown in red have occurred since 2000.

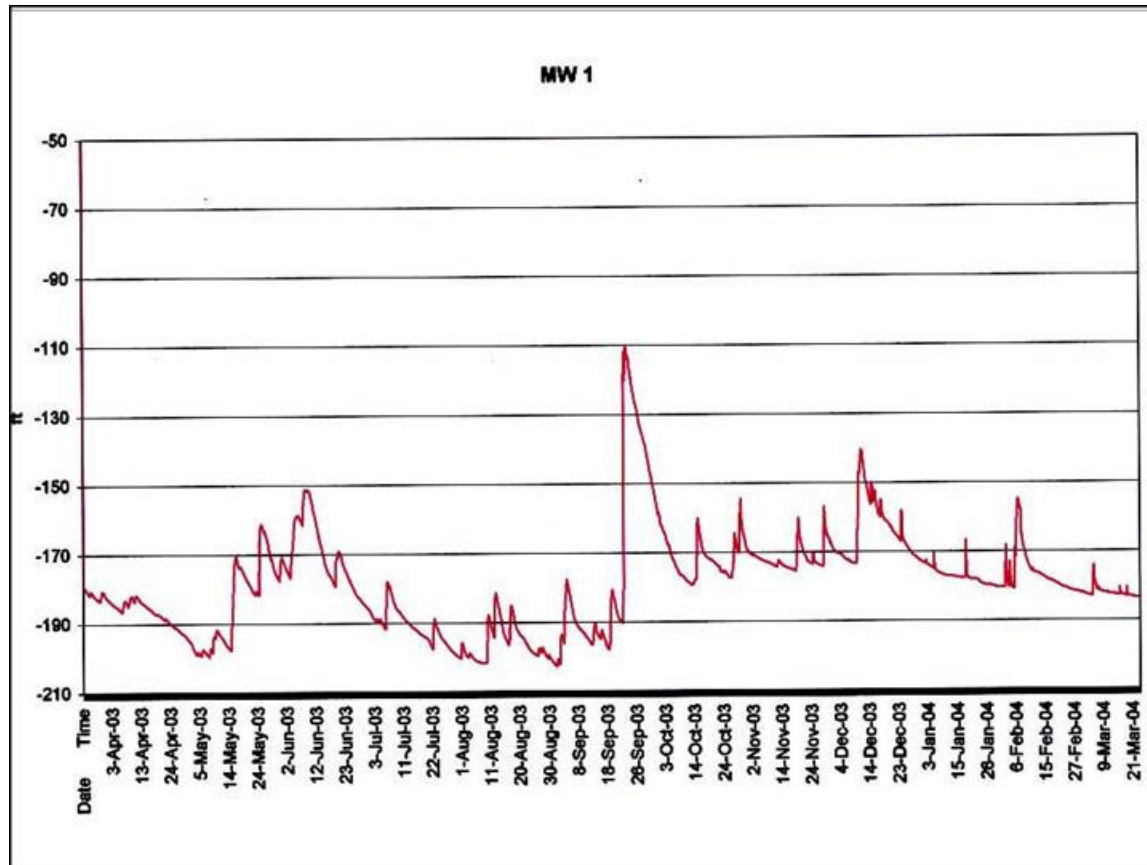
Rock was visible in the throat. The log of a nearby monitoring well (Figure VI) shows the response of the local water table to the massive infiltration.

Figure VI - Monitoring Well Log

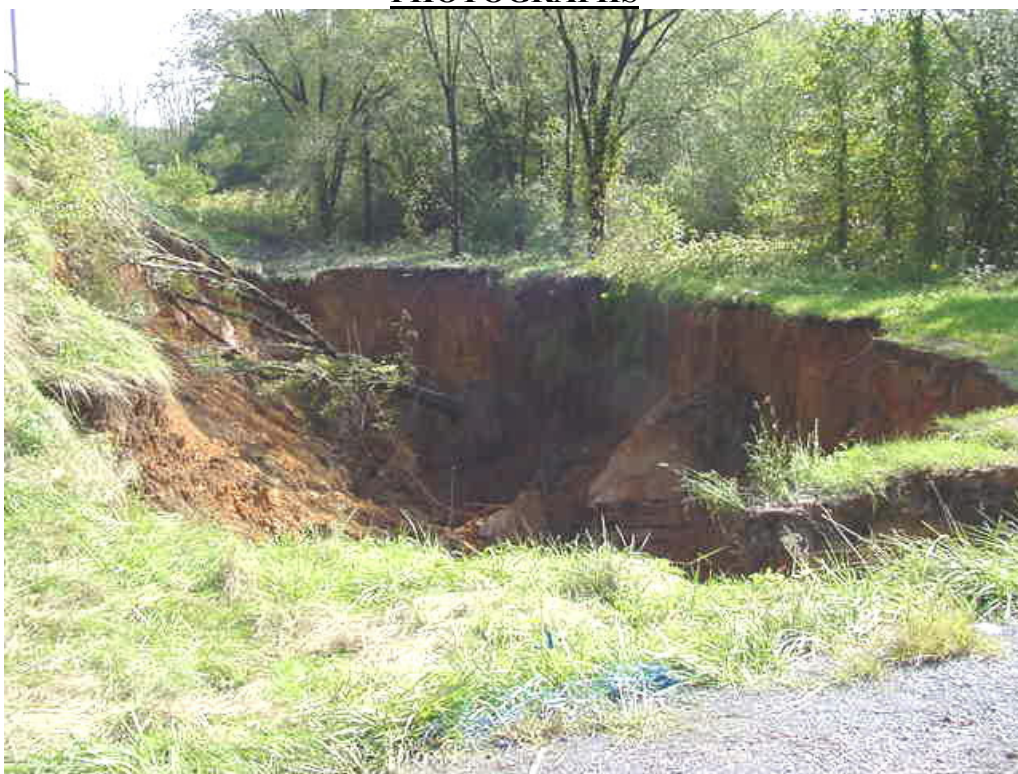
View of sink looking to the east. I-70 embankment on left.

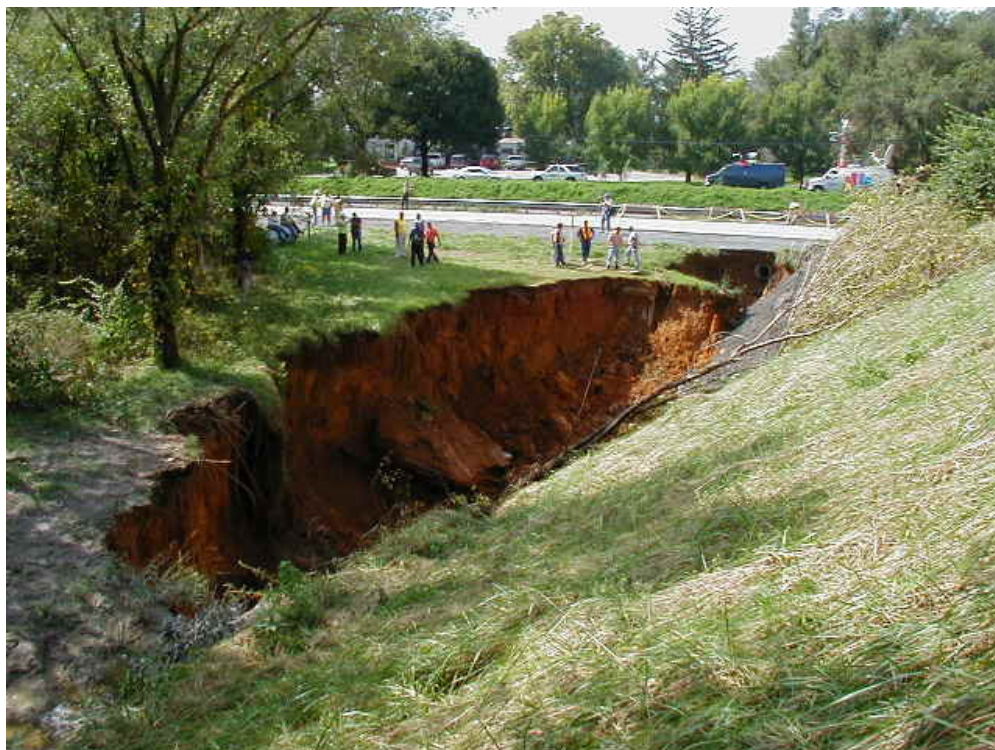
View of sink looking to the west. Commuter rail line is just beyond the guard rail.

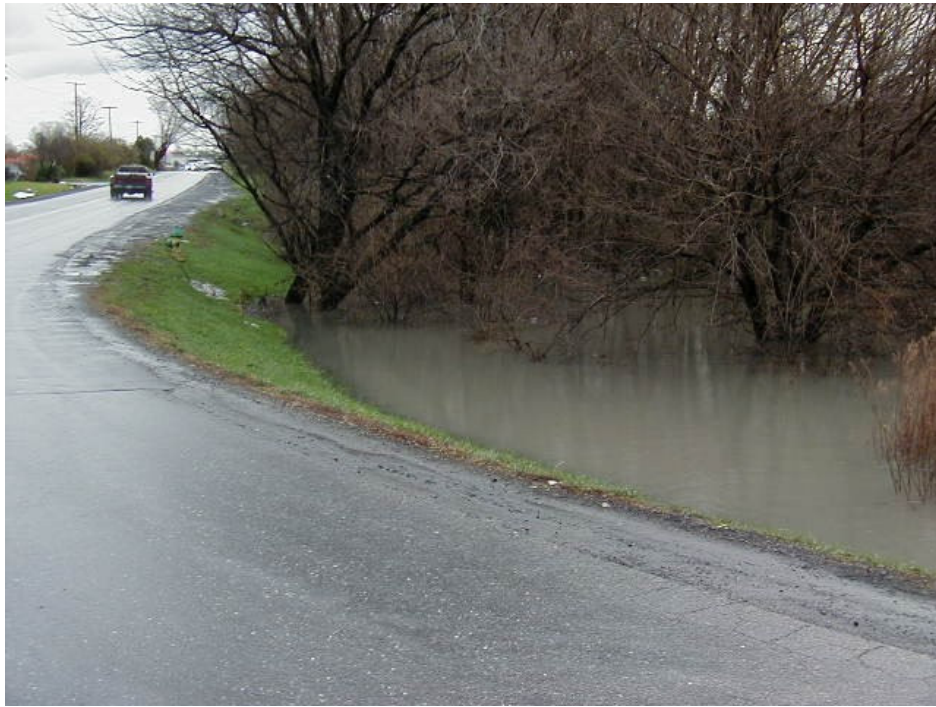
View of north pond area during heavy storm event. Gray water is due to quarry dust.

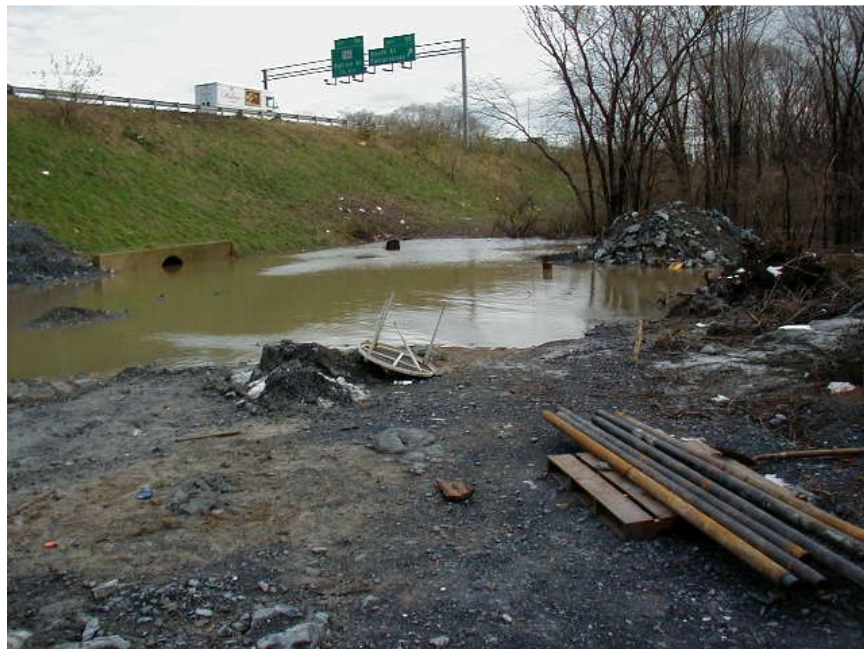
View of south pond area during heavy storm event. Note that the grouting has arrested the development of sinks for the time being.

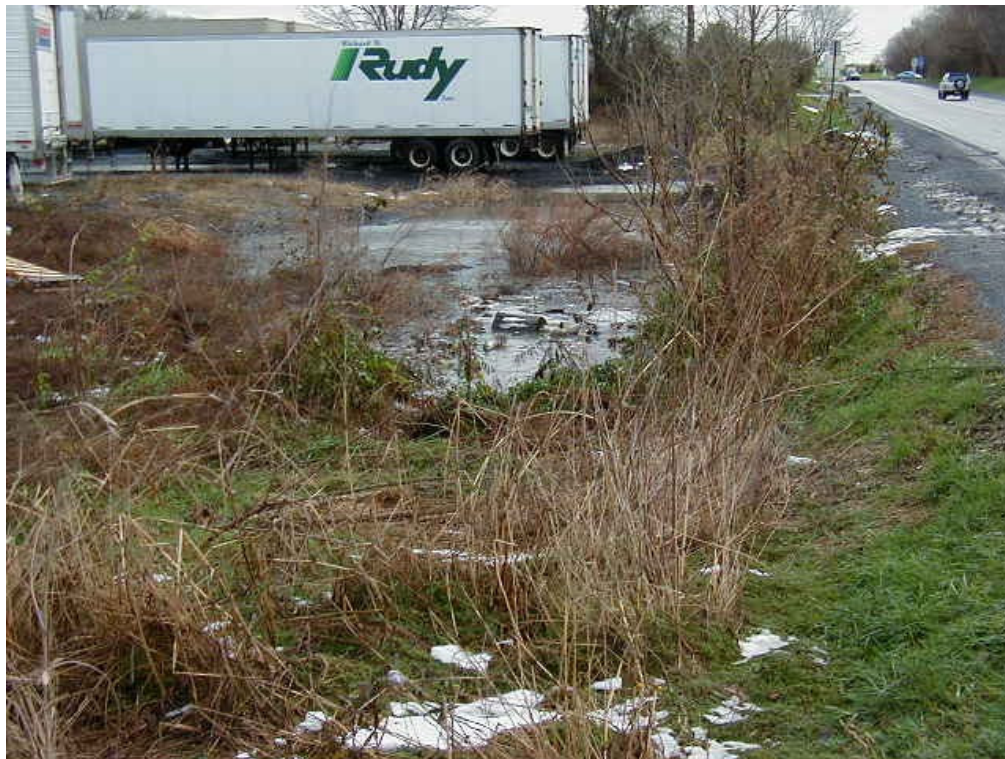
View of receiving sinkhole during storm event.

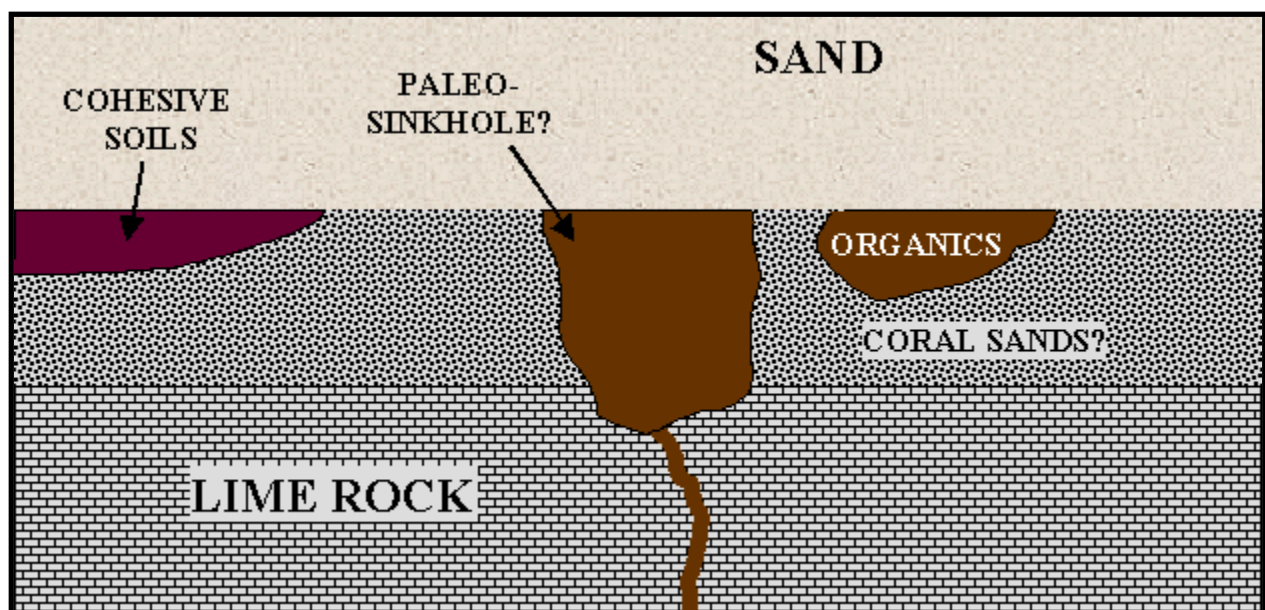
Superimposed upon this section can be old, filled sinkholes, pockets of clayey or organic materials (Figure 4), and both collapse- and raveling-type sinkholes (Figures 2A and 2B). Strike and dip of the bedding are not particularly diagnostic in evaluating the geophysical data, but shear or fracture zones and failure types could be. Of concern from both the engineering and detection aspects are the possible existence of minor folds and the resultant fracturing and/or weathering.

Figure 4: “Florida” karst conditions.

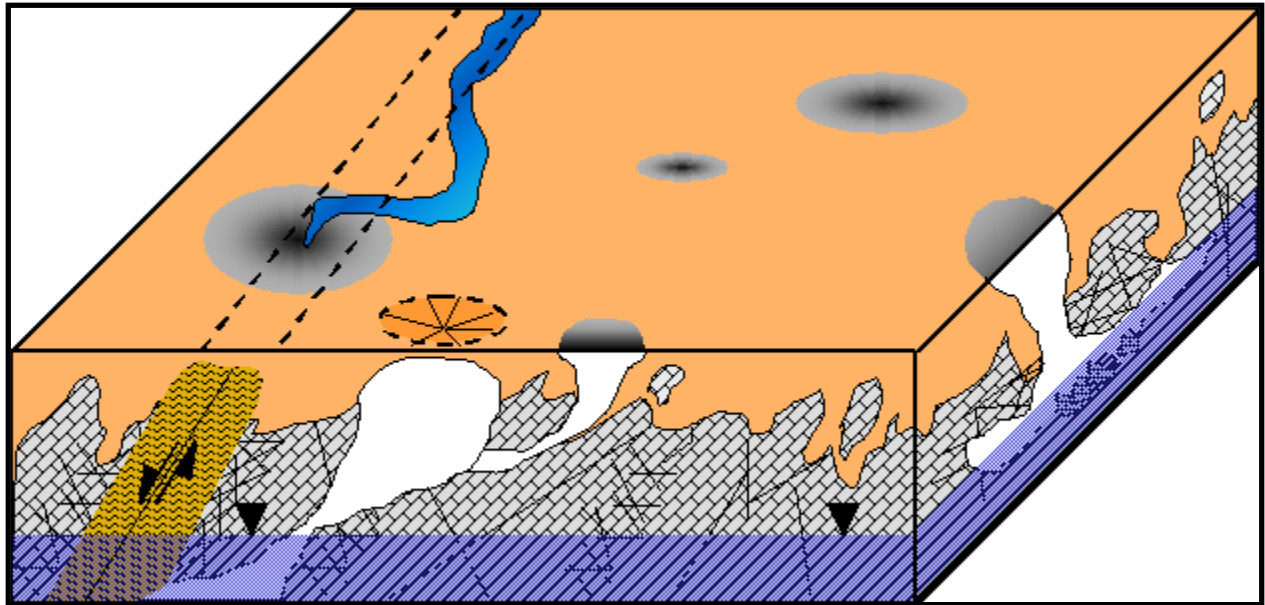
Figure 6: Typical subsurface section of “bent” carbonate rock.

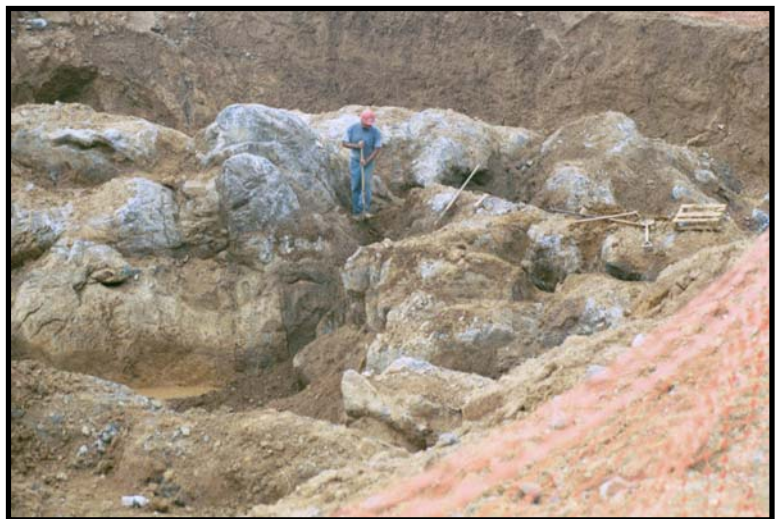
Figure 7: Exposed rock surface at “bent” rock karst site.

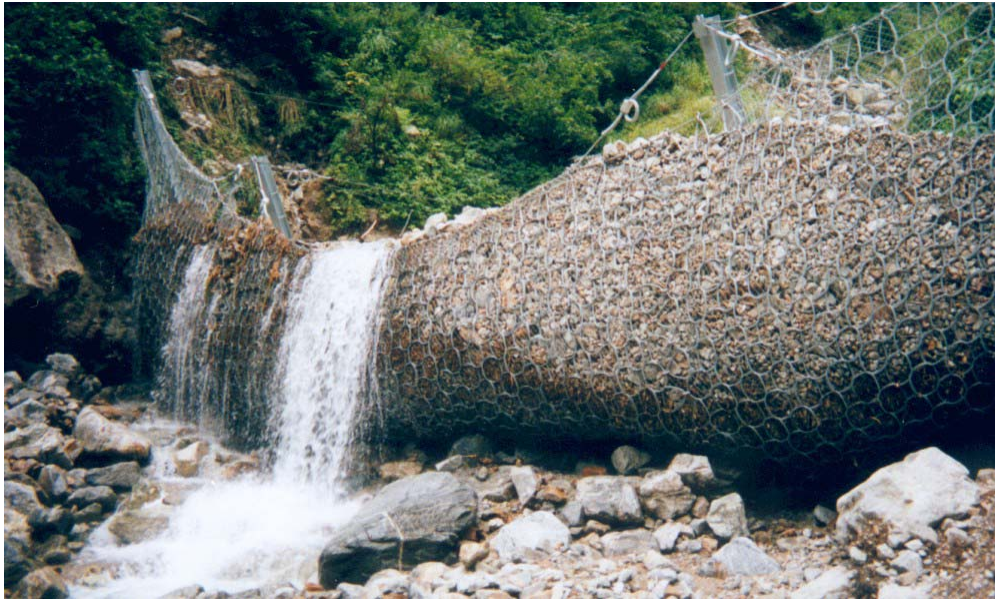
One case in particular can be outlined to illustrate this back-calculation process. In 1998, a temporary 1500 kJ barrier installed in Aobandoni, Japan to protect against rockfall during construction work being performed downstream, was impacted by a series of debris flow pulses. This barrier was 20 meters long and 5 meters tall. Three consecutive debris flow pulses impacted the barrier, completely filling it with approximately 750 m³ of debris. Nearly 100% of the debris involved with the flow was retained by the barrier. During the impacts, the friction braking elements in the support ropes and upslope retaining ropes responded to varying degrees. Remaining effective height of the barrier after the event was approximately 70%, and net deflection was only 3 meters. Other than replacement of these braking elements and cleanout of debris, no other maintenance or repair was necessary. However, since this was a temporary installation, the barrier was disassembled and taken away, to be re-used elsewhere in the future.

Figure 1 - Aobandoni, Japan Debris Flow Impact. 5 meter tall barrier.

Due to the extreme nature of this event and the degree of key barrier element engagement, this case provided an excellent opportunity to back-calculate the mechanics of the event and the consequent response of the barrier. Because of the relationship between the amount of loading versus the degree of braking element response is well documented, it is a relatively simple matter to back-calculate the forces exerted on the support infrastructure. Similarly, loading data gained during 1:1 testing of rockfall barriers facilitates the ability to back-calculate debris flow loading, if the total amount of barrier deformation is known. Back-calculation of other such events has yielded similar relationships and results. This case and others have thus proven to be valuable

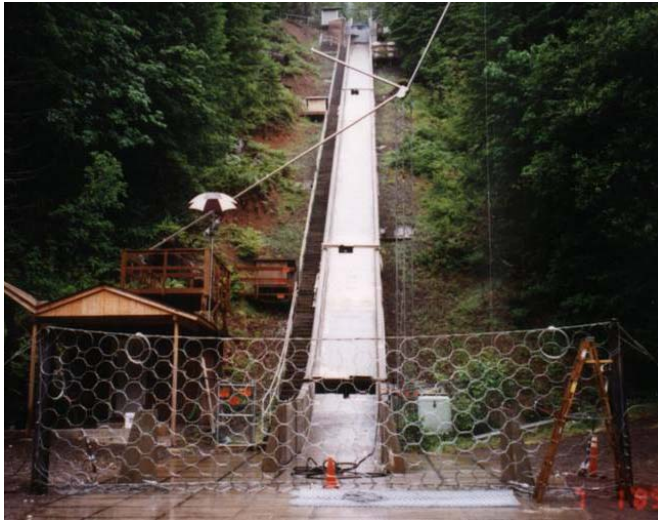
At least two known 1:1 field tests have been conducted on flexible barriers to determine performance under debris flow loading. The first such test was conducted in 1996 at the USGS Debris flow flume in Blue River, Oregon. During 6 tests conducted at this site, various instrumentation was used to record flow velocities, forces on various barrier elements, and debris flow character and barrier response in a general way. The most important finding from these tests from a design standpoint was the fact that despite the relatively large openings of ring nets, they can be very effective for purposes of retaining even fine-grained mudflows. Additionally, the tests demonstrated that ring nets perform better than woven wire rope nets due to the higher flexibility, higher energy absorption, better load distribution to the support infrastructure, less need for repair, and better adaptability to the irregular terrain that can be expected in debris flow channels.

Figure 2 - USGS Debris Flow Flume

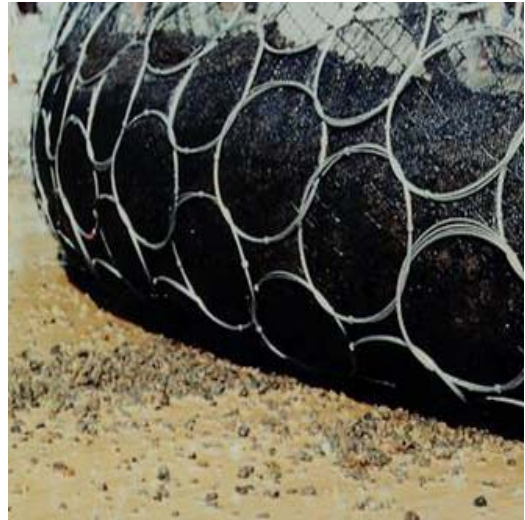
Figure 3 - Debris in Ring Nets During Test

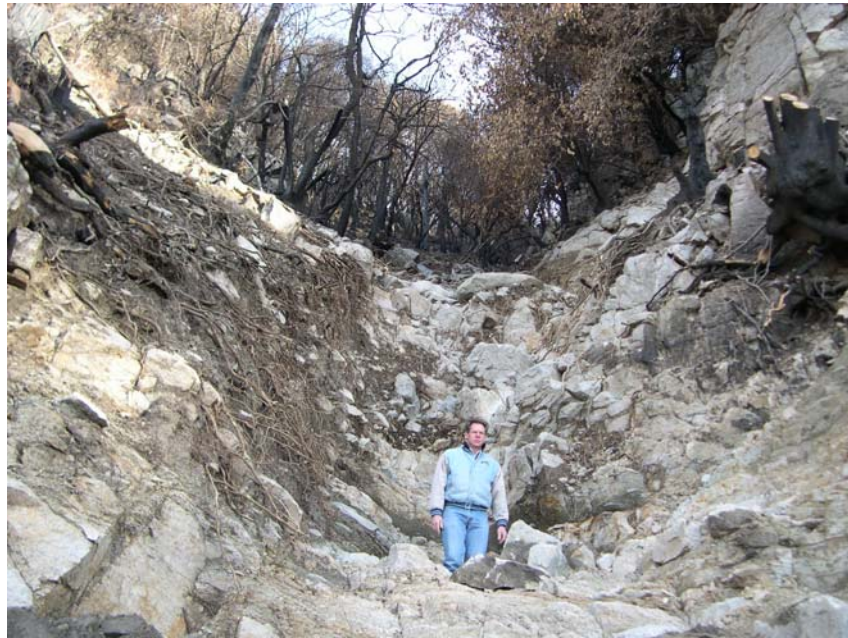
Figure 6 - Debris Flow Channel, Site 7

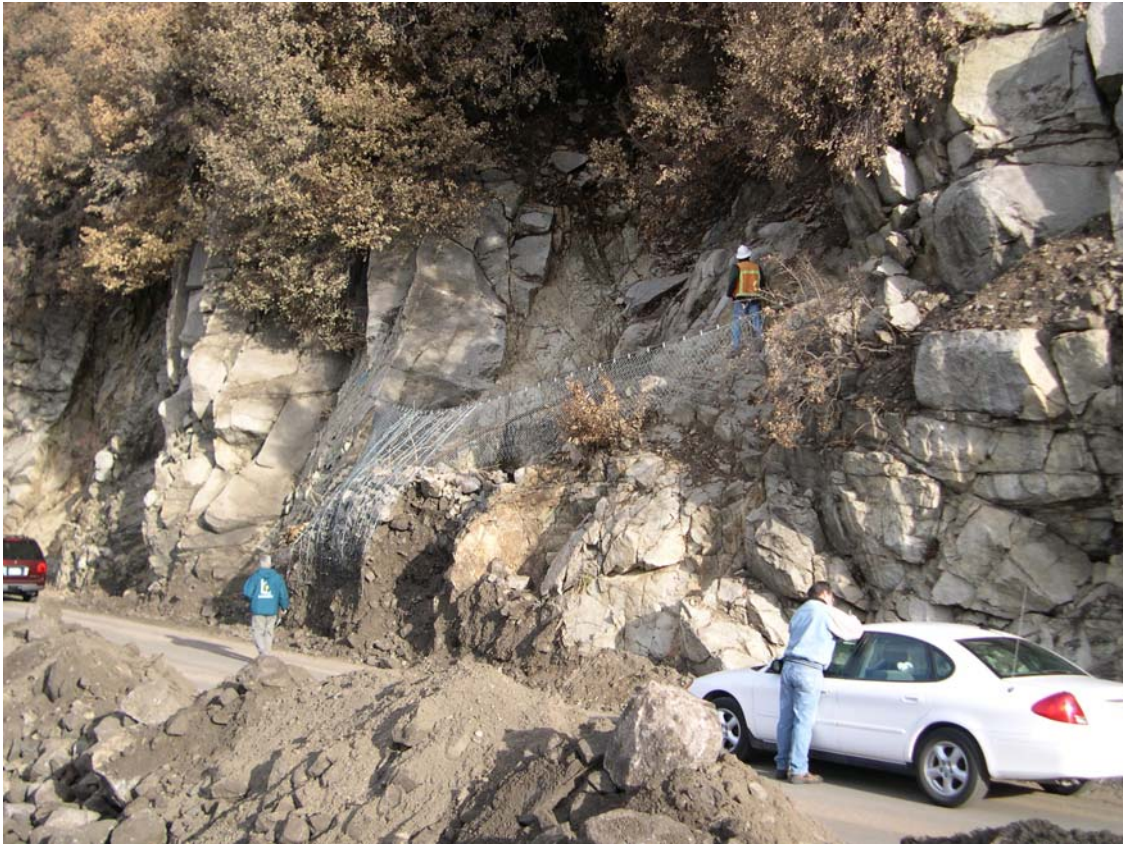
Figure 7 – Debris in and Around Suspended Tecco Mesh Drape

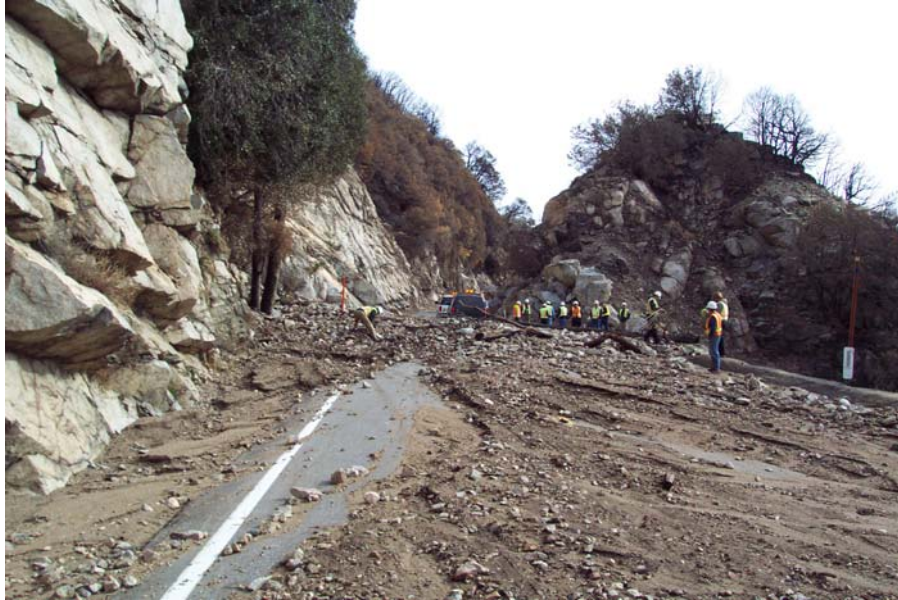
Figure 8 - Area Overwhelmed with Debris Flow (courtesy Duffy)

Though these suspended mesh drapes did contain large amounts of debris, they were largely overwhelmed by the sheer volume of debris. In some cases, the debris flows effectively lifted the mesh and flowed underneath. In other cases, the bottom of the mesh was weighted down by accumulated debris such that much debris was retained, but the volume was too great and excess debris flowed around the sides of the drape. In only one case was there a true system failure, and this was due to failure of the rock into which that the lateral support anchor was placed. In the end, this section of road had to be closed due to the volume of debris on the road and damage to the roadbed, mostly in areas where no initial mitigation measures were placed.

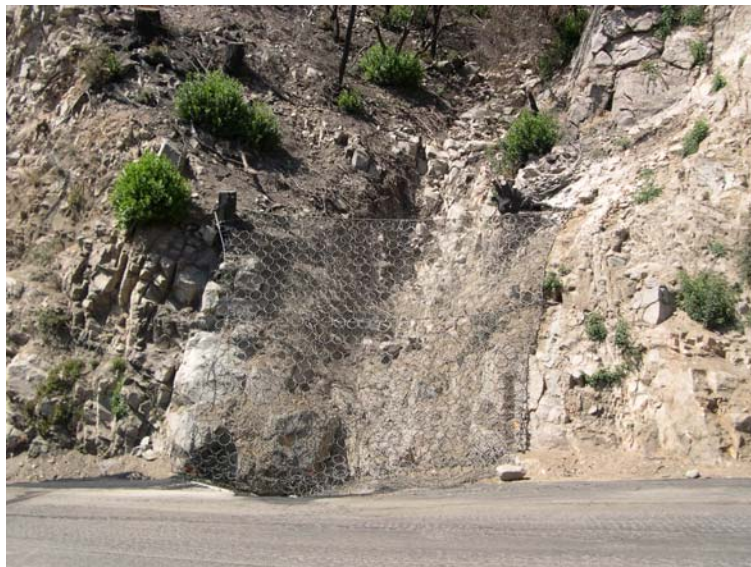
Figure 10 - Site 7, VX Barrier

- Calculated design kinetic energy = 200 kJ.
- Calculated necessary height = 8.0 m.
- Length across top = 10.0 m.
