55th HIGHWAY GEOLOGY SYMPOSIUM

KANSAS CITY, MISSOURI, SEPTEMBER 7-10, 2004

PROCEEDINGS

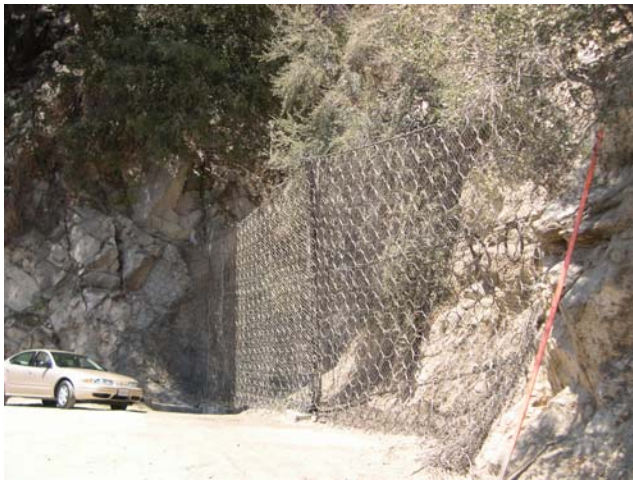
Figure 11 - Site 2, VX+ Barrier

- VX+ barrier:
- Same as VX, with one middle post to support the long span (> 12 m.).
 - Top, middle and bottom support ropes, anchored at the sides.

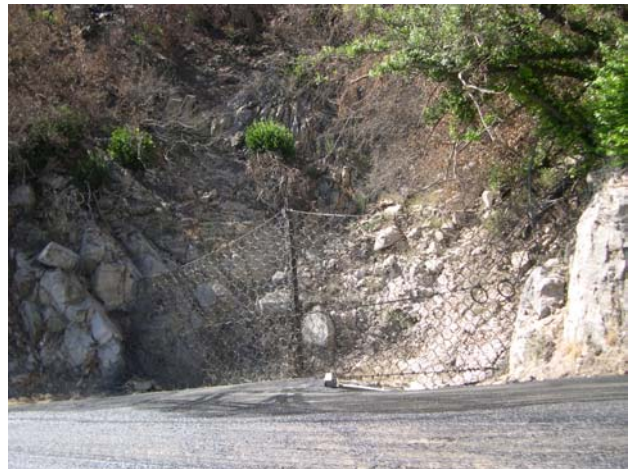
Figure 12 - Site 9, VX+ Barrier

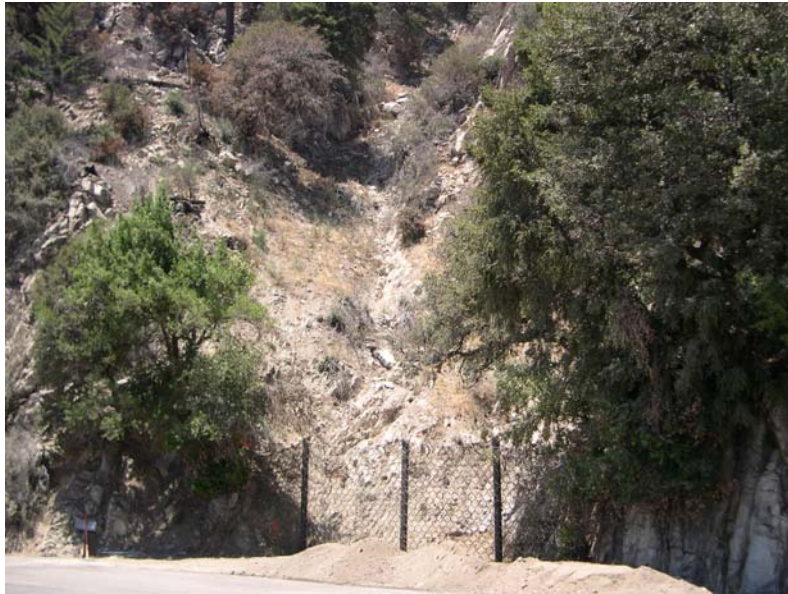
Figure 14 - Site 1, UX-150 Barrier

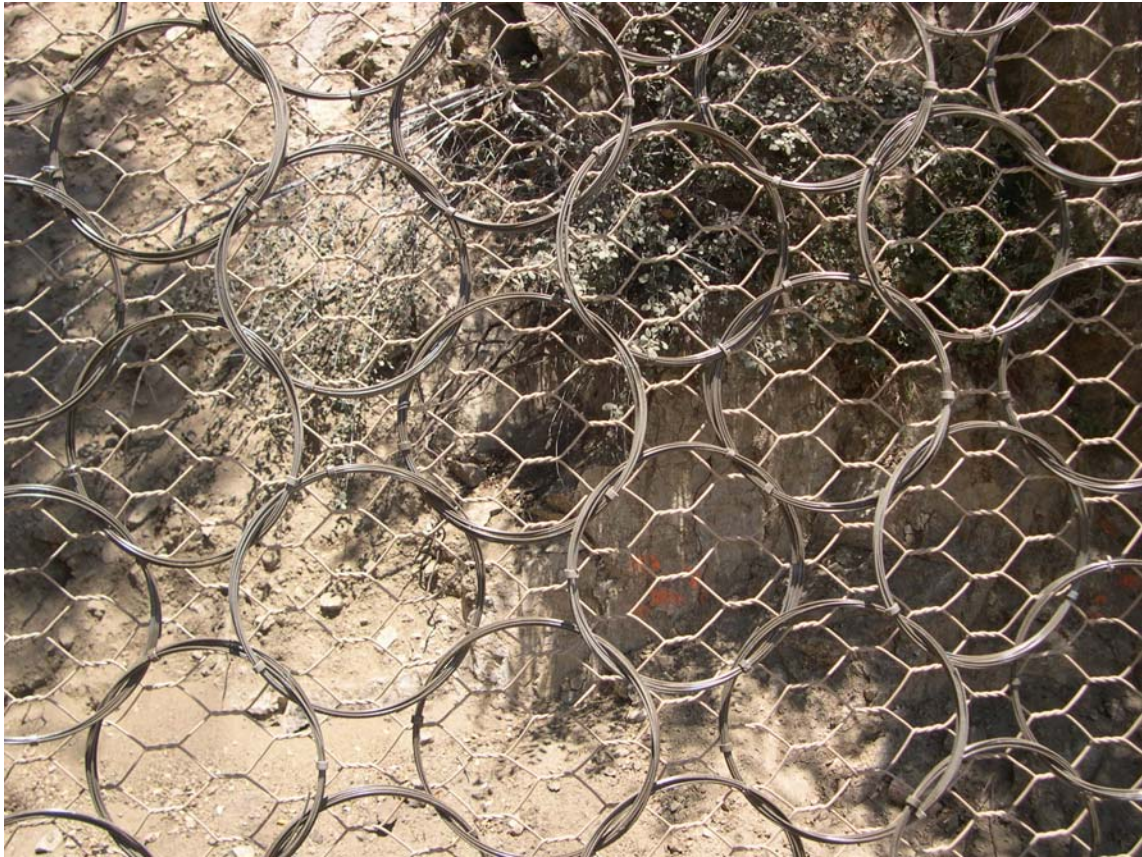
Figure 15 - Colorized Netting

Because this area is in the jurisdiction of the U.S. Forest Service (USFS), aesthetic impact of these barriers to the surroundings was an important consideration. The USFS thus required that the barriers and all related materials would need to be colorized to minimize the visual impact. All materials were thus colored a dark brown color, including posts, nets, hardware and attached chainlink mesh.

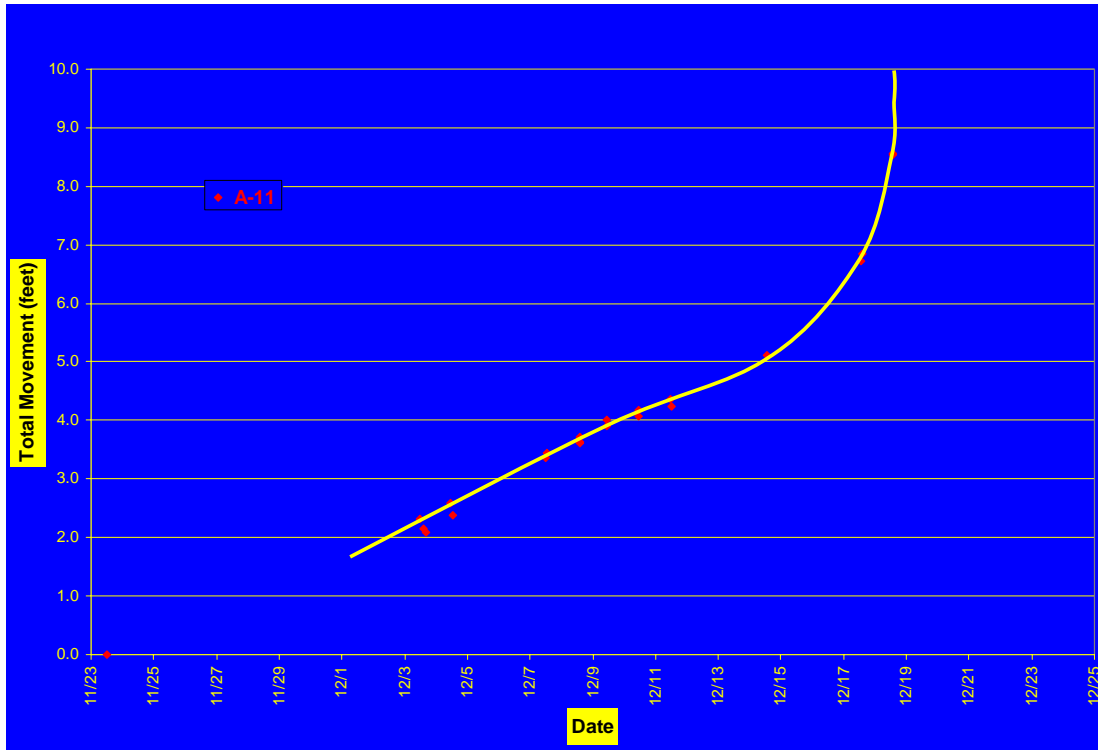
Figure 3. Total movement on survey prism A-11.

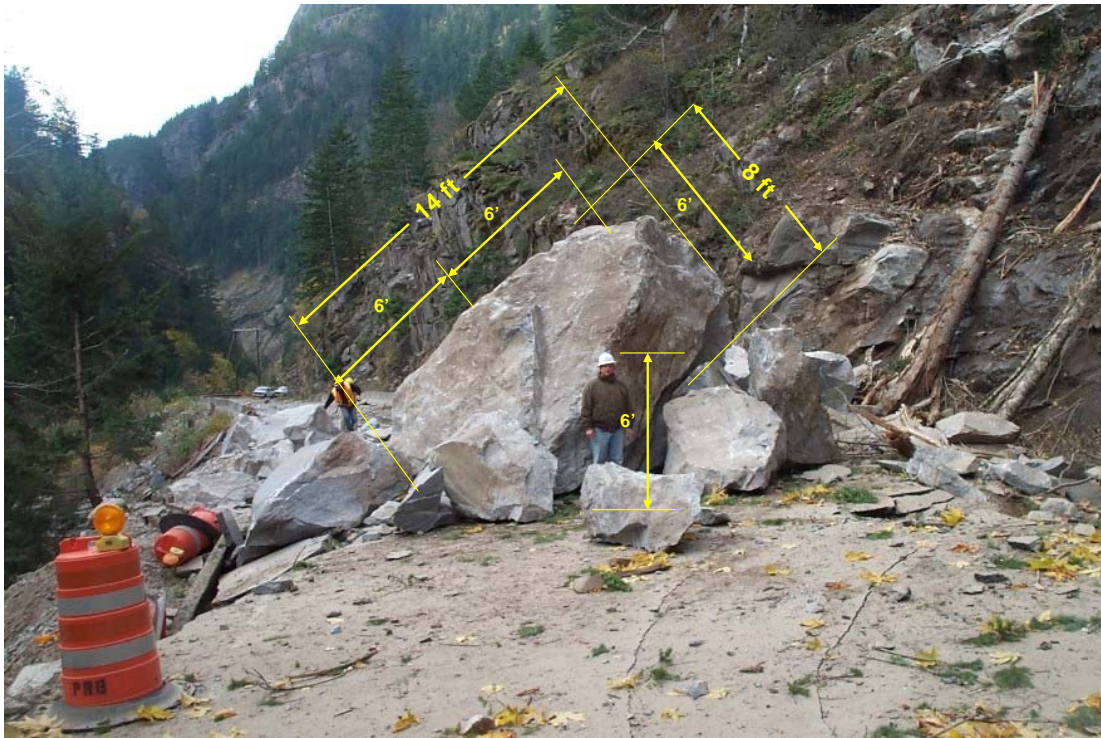
Figure 8. Boulders on SR 20, November 9, 2003.

Rock Size: The rockfall associated with the November 9, 2003 event provided information on which to base an assessment of boulder size likely to reach SR 20 in the future. As shown, multiple intact fragments of the strong orthogneiss in the three to five-foot size range were present on the highway grade after the rockfall. In addition, one “mega-boulder” with a size of 8 x 8 x 14 feet reached SR 20 during this event.

Rock Shape: Although the November 9, 2003 event yielded subangular boulders (Figure 8), for simulation purposes generally spherical shapes were assumed. This was regarded as a conservative assumption because of the greater ease of rolling. Consequently, for modeling purposes the following range of boulder sizes and shapes were considered:

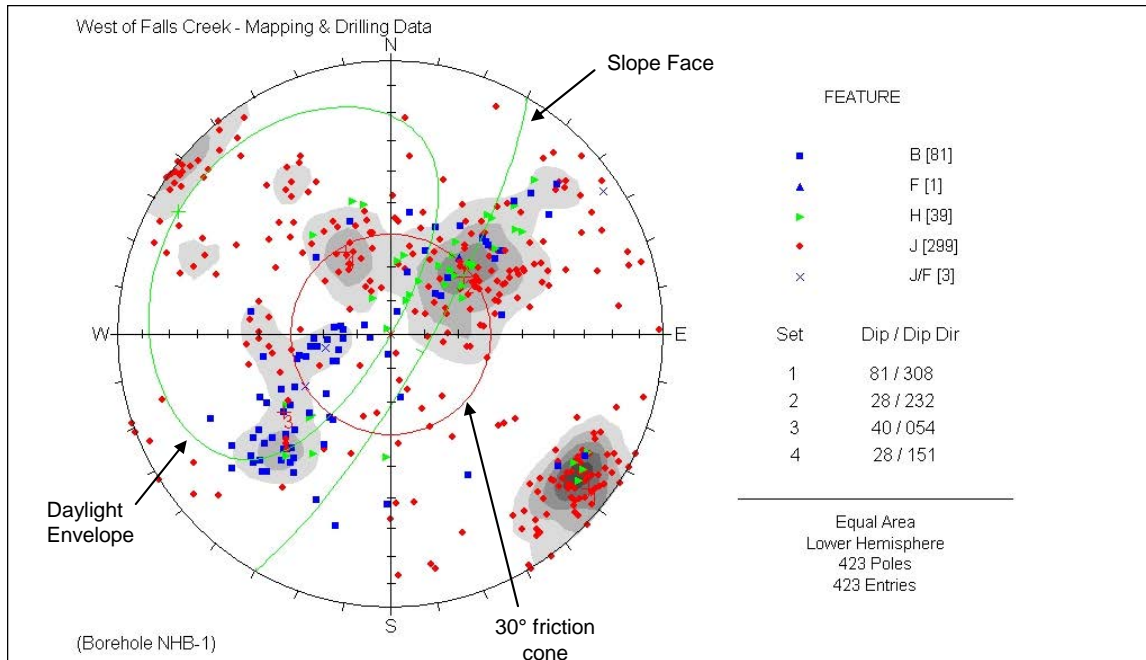
Figure 9. Stereogram for kinematic analysis.

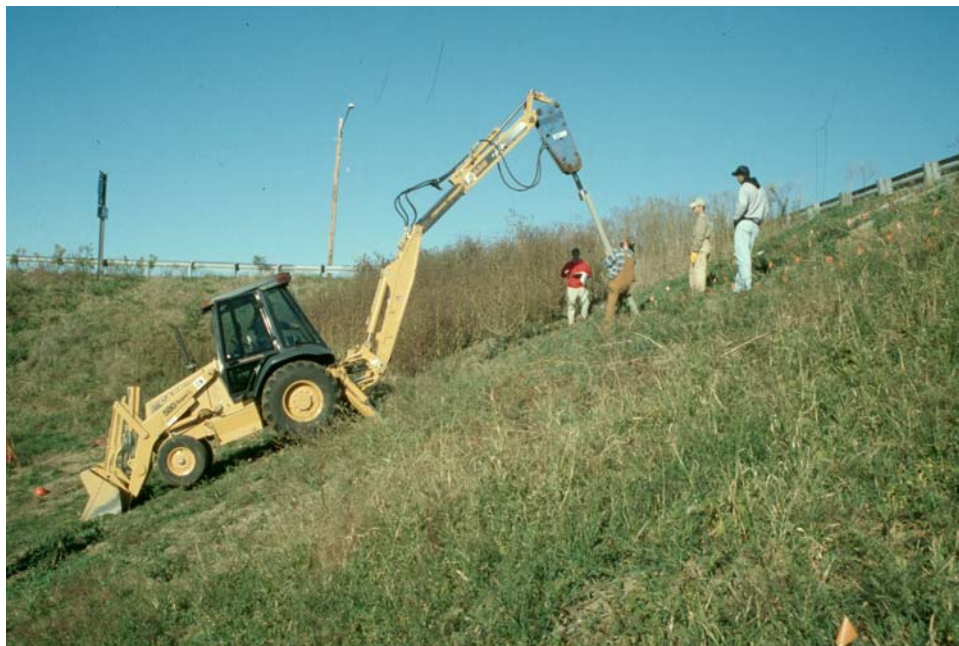
Figure 4. Backhoe-mounted hydraulic hammer use for initial installation attempts.

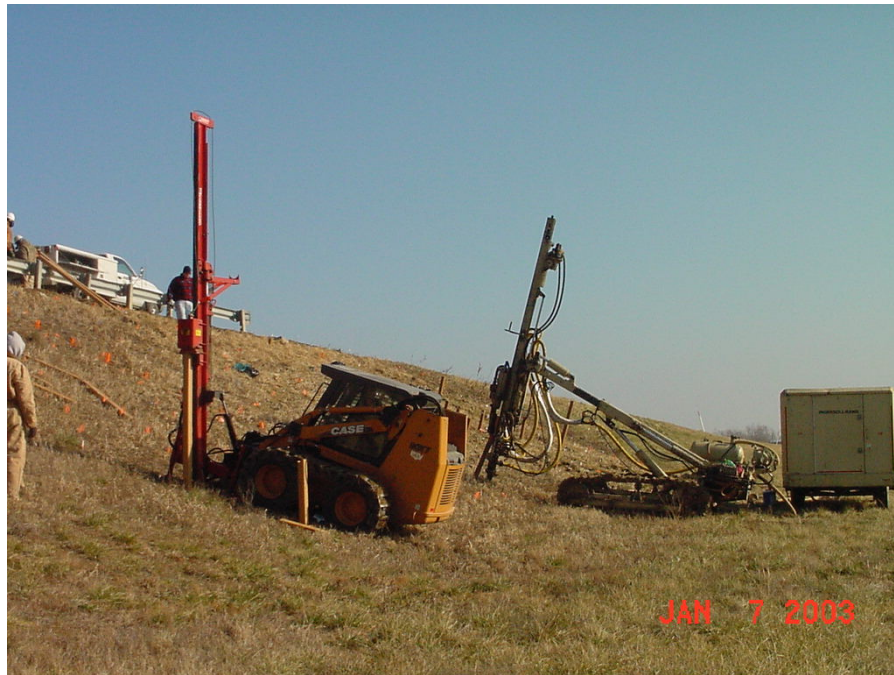
Figure 5. Pneumatic hammer drill (background) and drop-weight hammer rigs (foreground) successfully used to install reinforcing members at field test sites

Subsequently, several types of equipment that include a driving mast to maintain the alignment of the hammer and the reinforcing member were utilized with much greater success. Figure 5 shows two such pieces of equipment. The majority of members at the field test sites were installed using track-mounted hydraulic or pneumatic hammer drills similar to the

equipment shown in the background of Figure 5. This type of equipment proved to be much more maneuverable on the steep slopes and provided sufficient percussion energy to install the members within a reasonable time frame. On the steepest slopes, the equipment had to be tethered to the top of the slope to maintain the position and orientation of the equipment during driving. A limited number of reinforcing members were installed using a simple drop-weight system mounted on a skid-steer loader as shown in the foreground of Figure 5. This equipment also proved to be very effective at driving the reinforcing members.

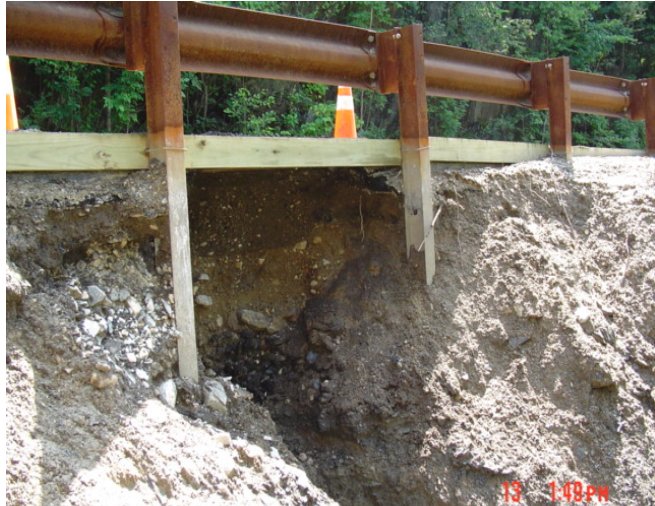
Figure 1: Undermining of north side of VT 73 in Forest Dale.

In the middle of August 2003, Vermont experienced several days of very heavy rains which precipitated a slide failure on Vermont Route 73 in Forest Dale at approximately mile marker 6.36. A blocked culvert on the south side of VT 73 caused an overflow of water across the road surface and over an asphalt and wood curb down an embankment. This resulted in a significant amount of erosion, undermining of the road surface (Figure 1) and a washout of a timber cribbing retaining structure located on the top of a mortared masonry wall (Figure 2).

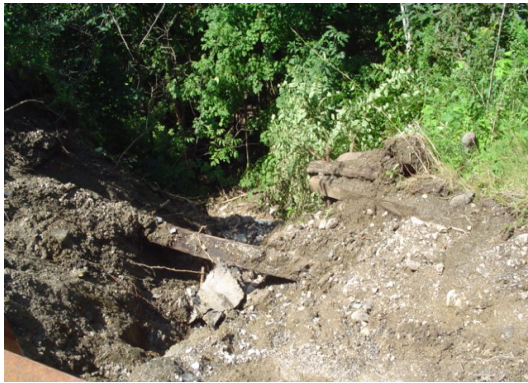
Figure 2: Washout of timber cribbing above mortared masonry wall. (View from road level)

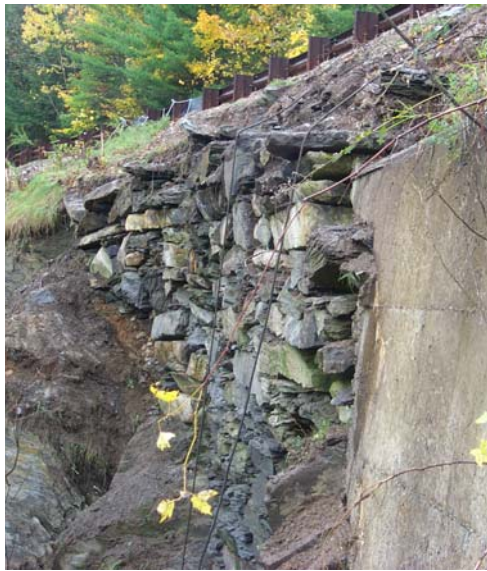
Figure 3: Laid up masonry wall, immediately west of slide area.

After site visits by Vermont Agency of Transportation (VTrans) staff, it was decided that the laid up masonry wall immediately west of the slide area was also in desperate need of repair. The laid up masonry wall (Figure 3) was observed to have broken and missing blocks. Also the top of the wall was leaning out past the bottom of the wall an estimated 12-18 inches. During the 1970's the west end of the laid up masonry wall was replaced with a cast in place concrete wall. As both walls could be remediated by the same contractor, it was decided to repair both locations at the same time.

between the rocks (Figure 3). The initial layer of shotcrete not only provided reinforcement of the masonry walls during drilling operations, but also provided an even surface for soil nail bearing plates and other reinforcing elements. The raveled void below the mortared masonry wall at the washout area was also backfilled with shotcrete (Figure 7). With the start of winter weather and daily low temperatures of 30-40 degrees, thermal blankets were placed over the shotcrete at night, for a minimum of 2 days to prevent the concrete from freezing during the curing process.

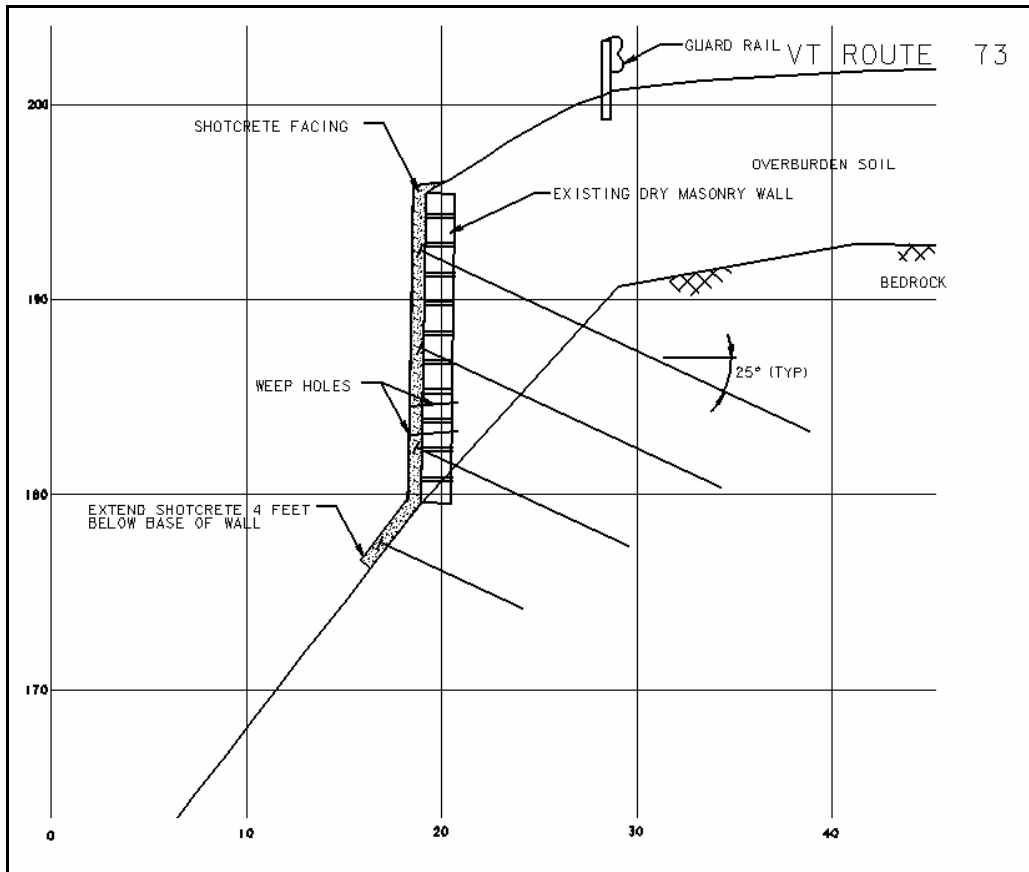
Figure 4b: Section view of laid up masonry wall repair

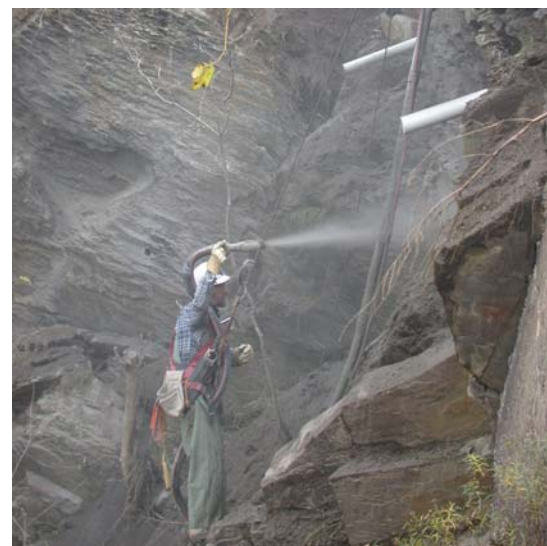
Figure 5: Shotcrete being applied while on rappel.

Due to the highly specialized nature of the rock reinforcement work and steep terrain at the two sites combined with the winter season quickly approaching, it was decided not to bid the project but to hire Janod Inc. (Janod) of Quebec, Canada under a force account contract. Janod specializes in rock scaling and drilling soil nails/rock dowels while on rappel and had completed a similar soil nail wall project on rappel for the New York State Thruway Authority two years earlier. Additionally, Janod has experience applying and protecting shotcrete in winter and inclement weather conditions (Figure 5).

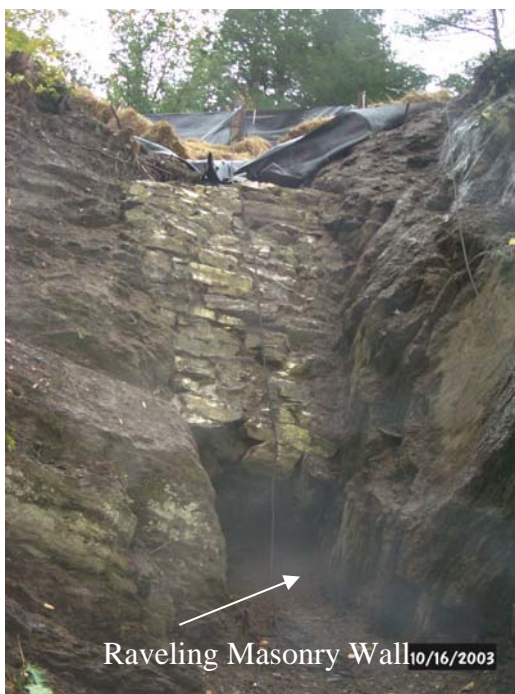
Figure 7: Masonry wall below washout.

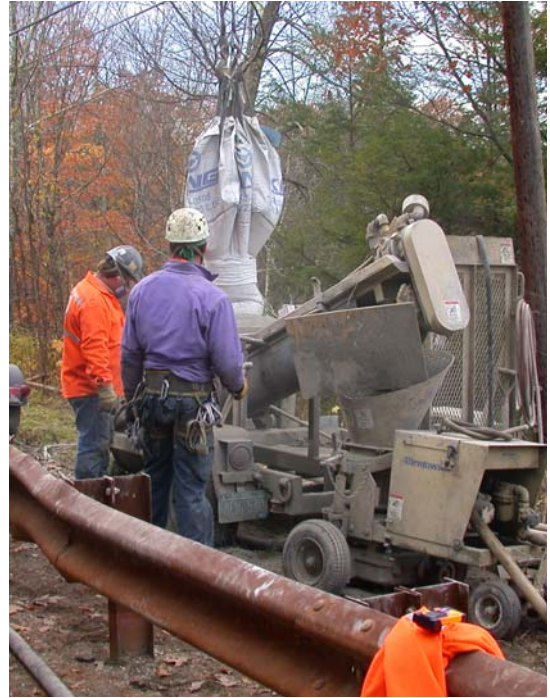
Figure 6: Shotcrete pump with a bag of shotcrete suspended over it.

The shotcrete was delivered in 2200 pound bags and suspended by a crane over the pump (Figure 6). The flow of the shotcrete was under constant supervision during the application. In some areas of the masonry walls the initial thickness of shotcrete was much greater than three inches due to inconsistencies in the rock face and void spaces

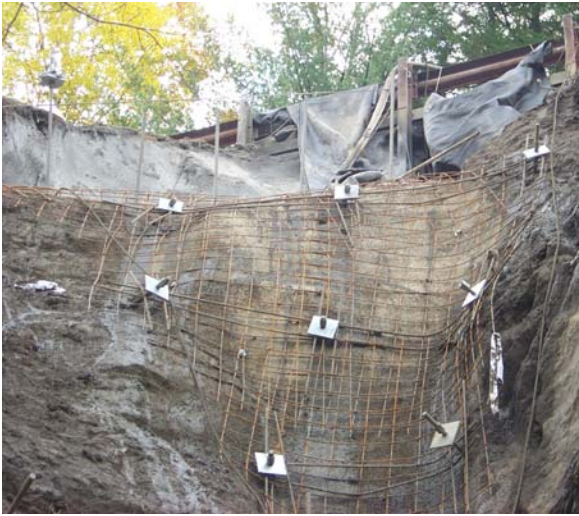
Figure 9: Welded wire fabric and rebar on mortared masonry wall.

After the soil nails and rock dowels were grouted, welded wire fabric was placed over both walls. Reinforcing bar whalers were placed above and below each row of soil nails and rock dowels. A 3 foot piece of reinforcing bar was placed vertically on each side of each soil nail and rock dowel (Figure 9).

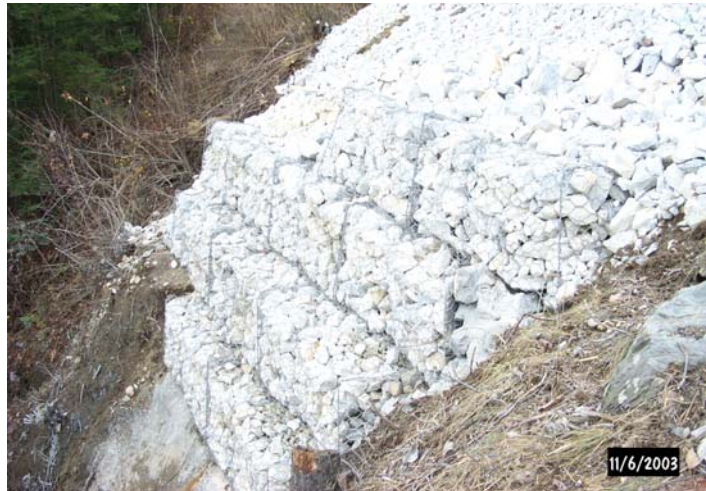
Figure 10: Completed Gabion wall

The gabion baskets were assembled and constructed by VTrans personnel from the District 3 Brandon garage. The bottom row of 2 baskets was placed over the six rock dowels. They were filled 2/3 of the basket height with stone prior to a 5 inch bearing plate and nut being installed on the threaded rod. The remainder of the baskets were then filled with stone. Additional layers of gabion baskets were installed. Each layer of baskets was laced to one another and to the row of baskets below them. A granular backfill was compacted behind the gabion wall in 1 foot lifts. A Geotextile was placed behind the gabion wall and brought over the top of the granular backfill. Stone fill was then placed on the geotextile to form the slope back up to the road surface. The final gabion wall can be seen in Figure 10.

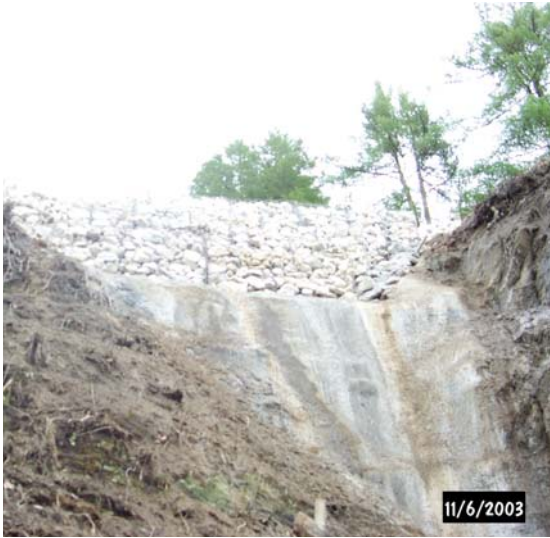
Figure 11: Completed repairs to mortared masonry wall below slide area.

As a result of the collaborative effort between the VTrans, Golder and Janod, a repair concept and design were quickly implemented and project construction progressed very smoothly. The project was completed in less time than estimated and under budget. The finished walls can be seen in Figures 11 and 12.

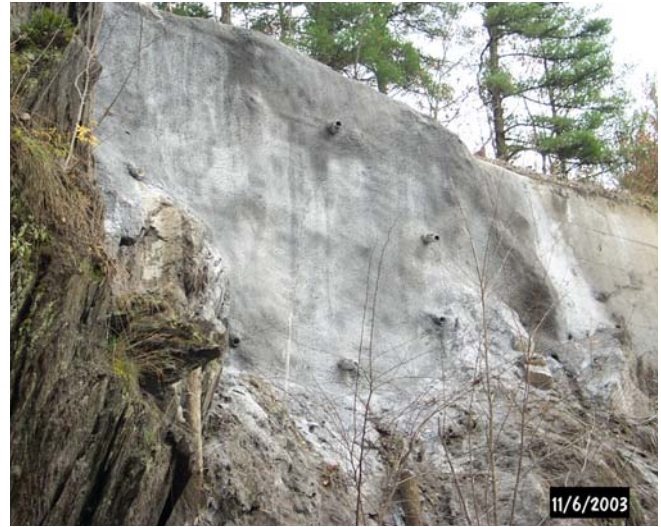
Figure 12: Completed repairs to laid up masonry wall.

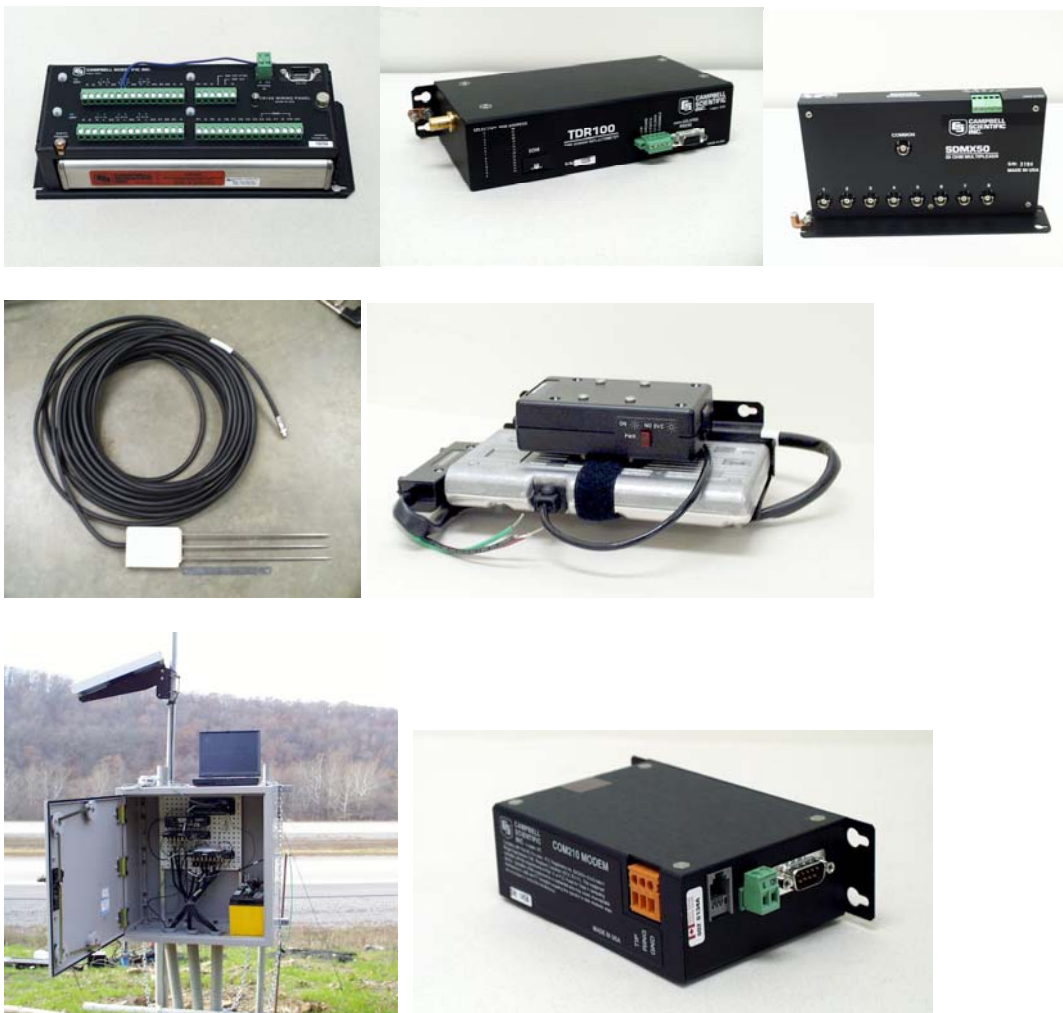
Figure 2. TDR hardware used in this study; Clockwise from top left, 16 channel data logger, cable tester, multiplexer, , analog cell phone, modem, complete field installation, TDR moisture probe.

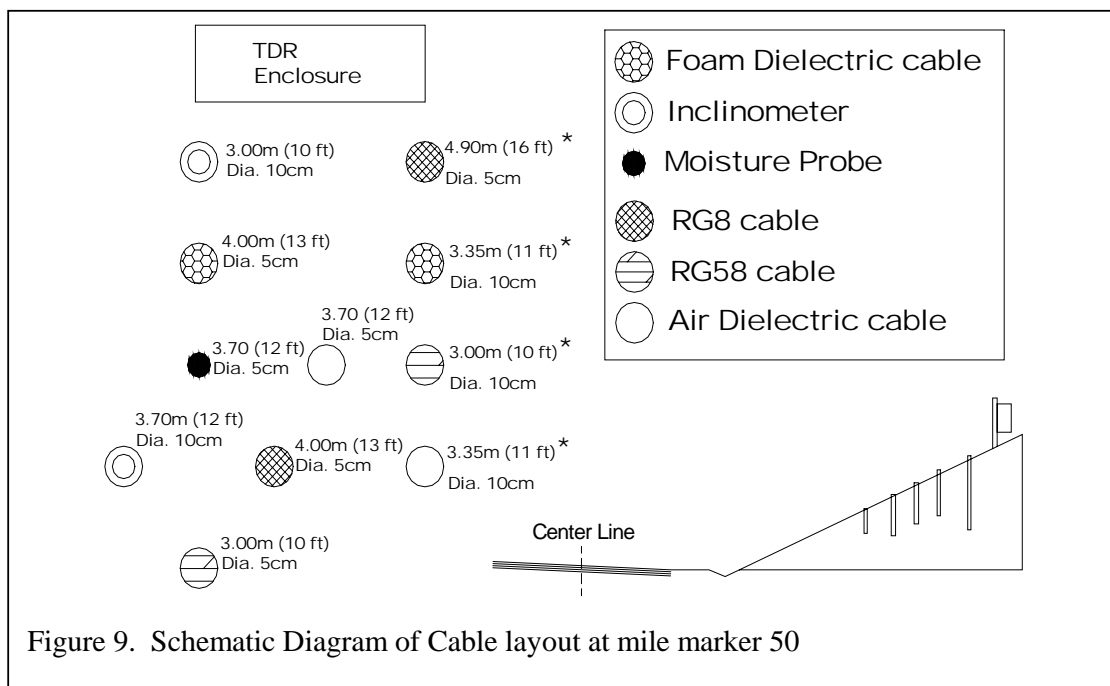
At the conclusion of the laboratory testing a new study area was selected for a revised installation of the TDR monitoring system. The new area was located at mile marker 50 on interstate 540. This was another 3 on 1 cut slope consisting of 3 to 5 meters of mixed clays over shale. This slope had failed two times previously. Each time the failed material was simply pushed back into place with a bull-dozer. This slope was considered a very likely candidate as an actively moving slope. The schematic of the cable layout for this installation is illustrated in Fig. 9. .

Fig. 9 indicates that there are duplicates of each cable type installed essentially side by side. Initially all cables on the left side of Fig. 9 were grouted into 70 mm boreholes using a weak cement-bentonite grout that consisted of 1 part bentonite to 1 part Portland cement with a water to cement ratio of approximately 4.0. Due to poor mixing of the grout and the high percentage of bentonite in the grout mixture, zones of very weak grout, ($q_u = 455 \text{ kPa}$) were created in the boreholes. After four weeks of monitoring this installation it was concluded that the grout would not develop sufficient strength to deform the rigid cables. As a result, a second installation of cables, shown on the right side of Fig. 9, was made. For this installation all cables were grouted into 100 mm boreholes with a cement-bentonite grout that consisted of 10 Kg bentonite, 43 Kg Portland cement and 150 liters of water in a portable 0.2 cu m concrete mixer. This gave a water to cement ratio of 3.5. This combination of grout and borehole diameter created a significantly weaker grout column than the sand-cement mixture used at mile marker 46, but the grout itself had a compressive strength of approximately 5500 kPa.

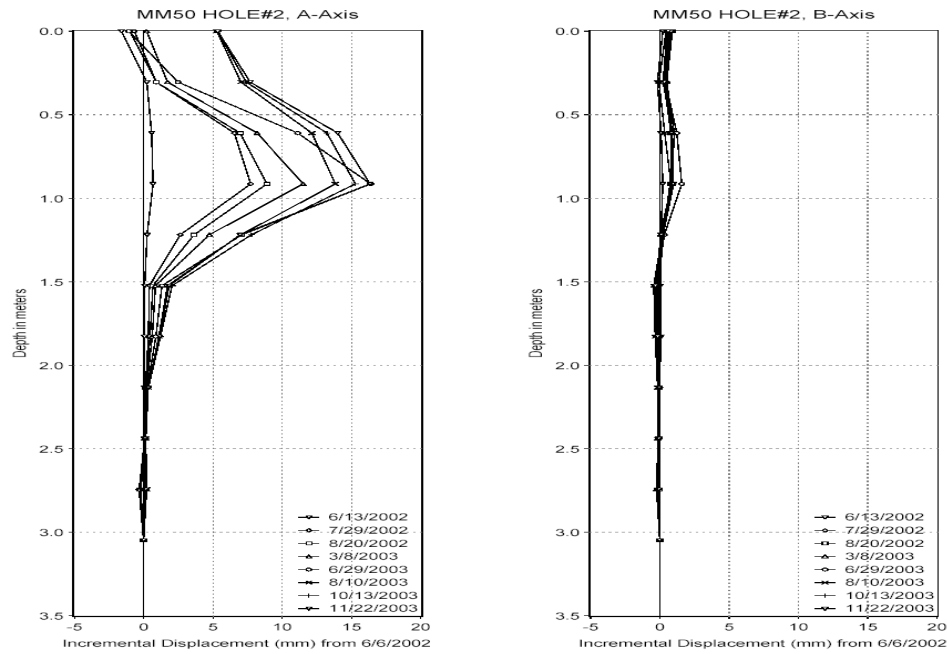
Figure 11. Summary of inclinometer data for the lower borehole at mile marker 50 on Interstate 540.

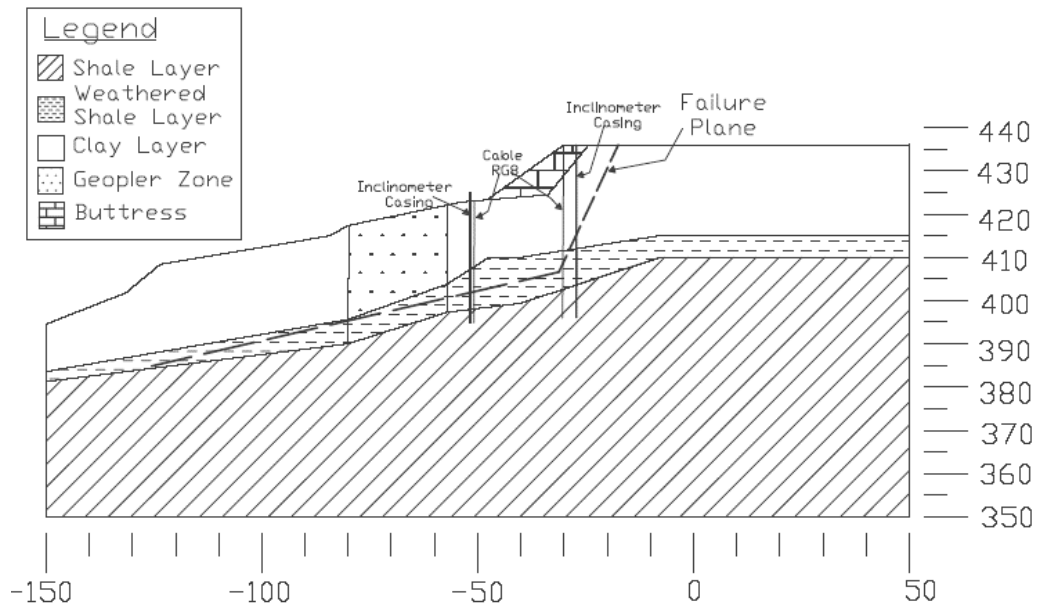
Figure 12. Cable and inclinometer installation schematic for Batesville, AR.

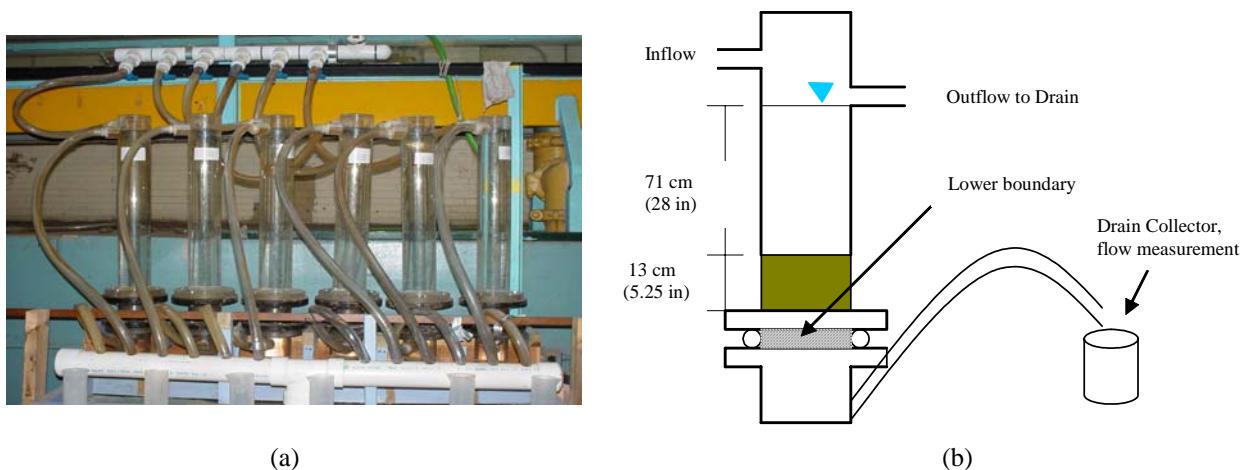
Figure 4 Long term flow test apparatus (a) Equipment and water inlet (b) Schematic of individual testing cell

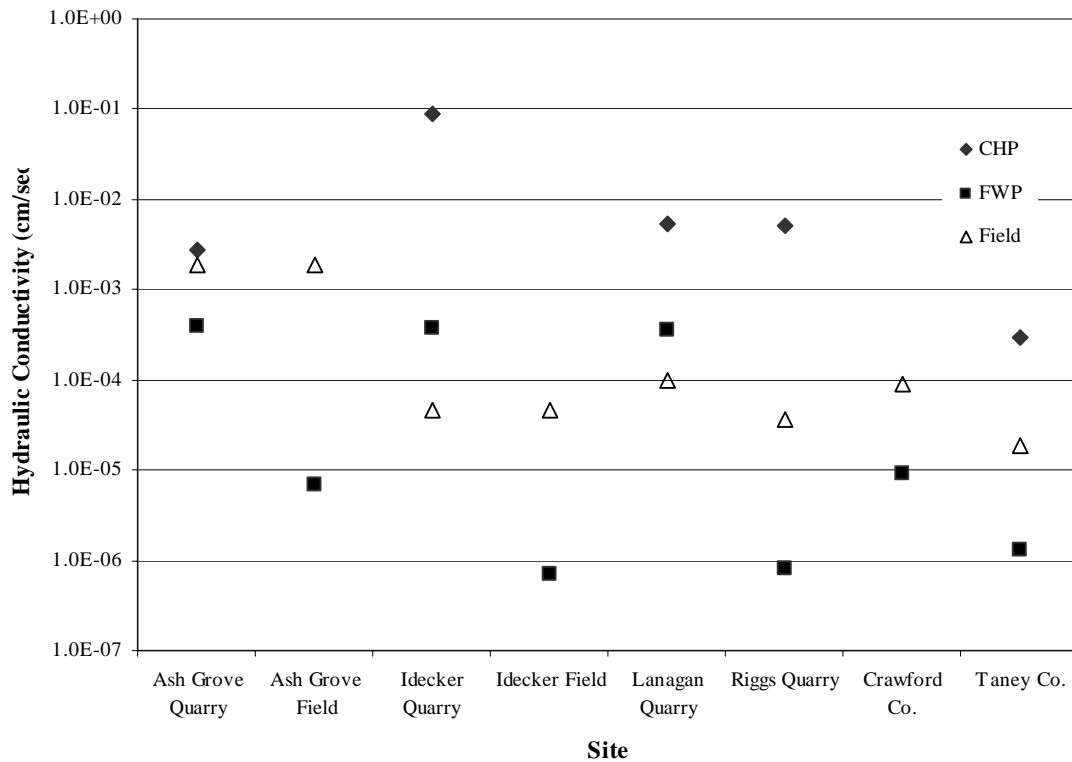
Figure 6 Laboratory and field measured hydraulic conductivities, CHP = constant head test, FWP = falling headwater – raising tailwater test, Field = Double Ring Infiltrometer test

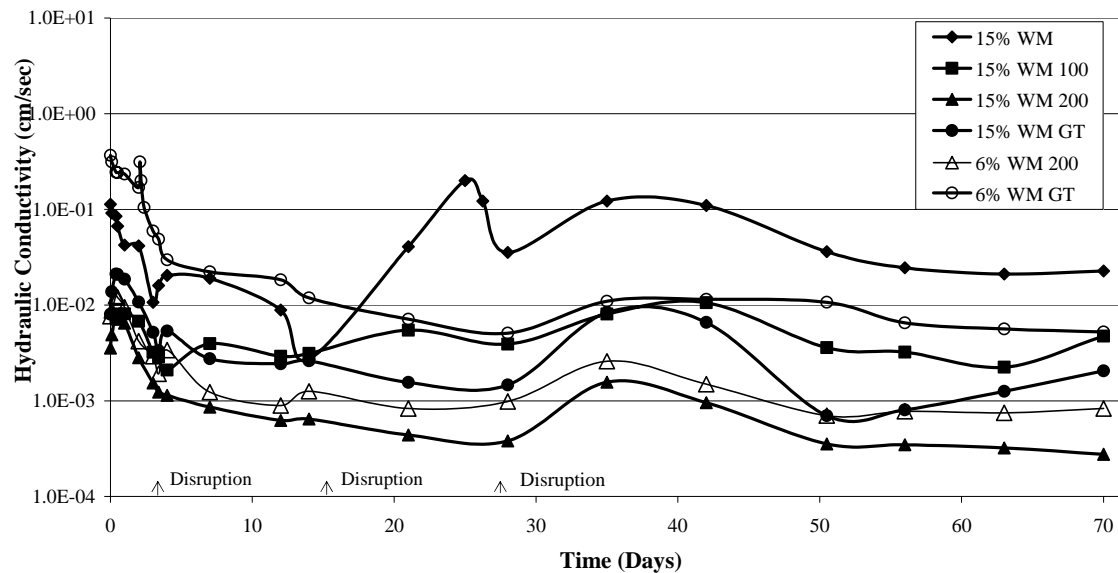
Figure 7 Long term hydraulic conductivity versus time, Boone Quarry material, with various end conditions

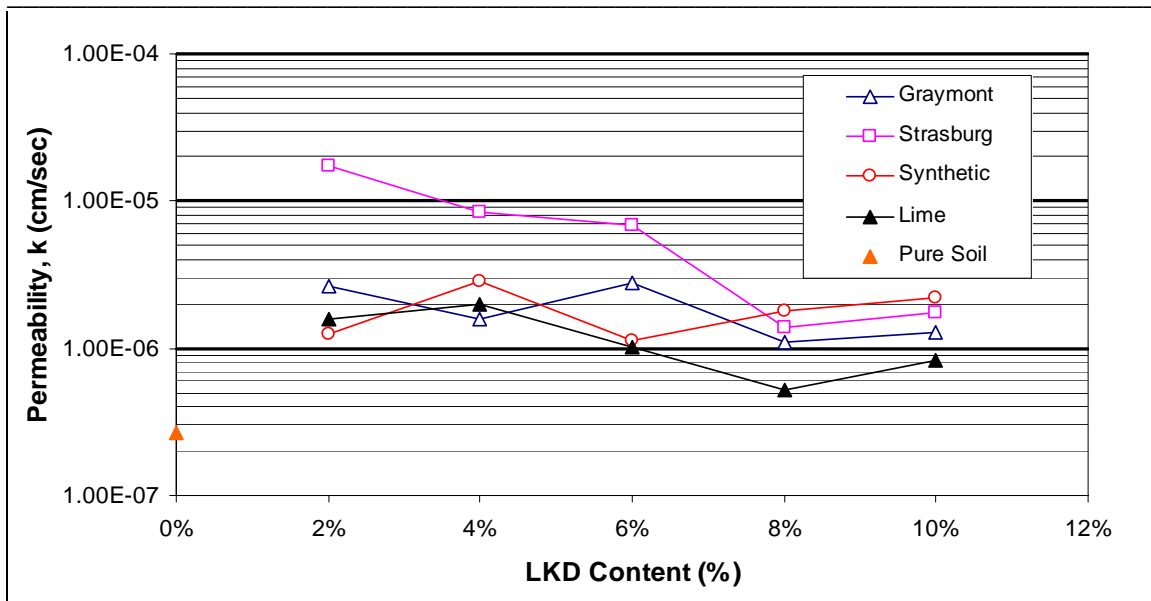
Figure 4. Relationship between permeability and LKD content.

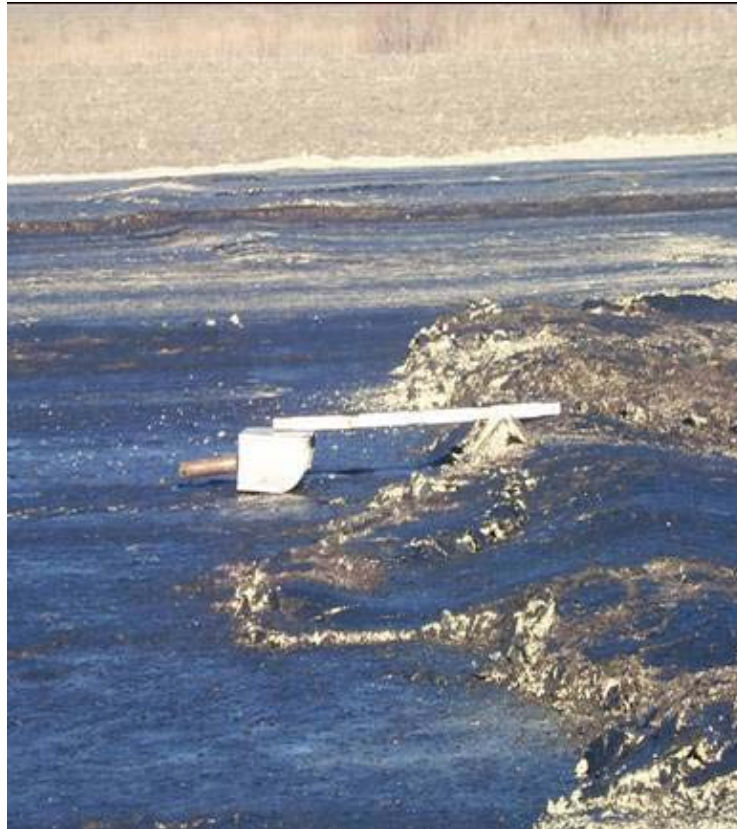
Figure 1. Vertical heaves generated after a rainfall event is the product of lime stabilization of a sulfate-rich subgrade.

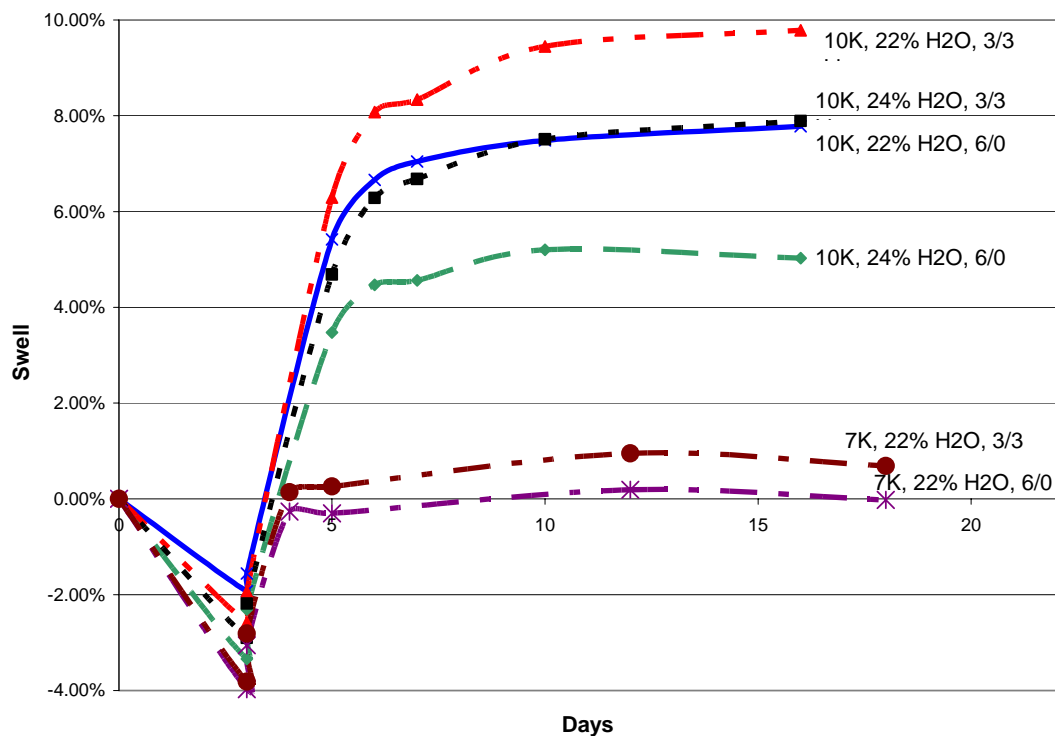
Figure 5. Results of 3-D swell for sulfate dissolved in molding water and mellowed for three days.

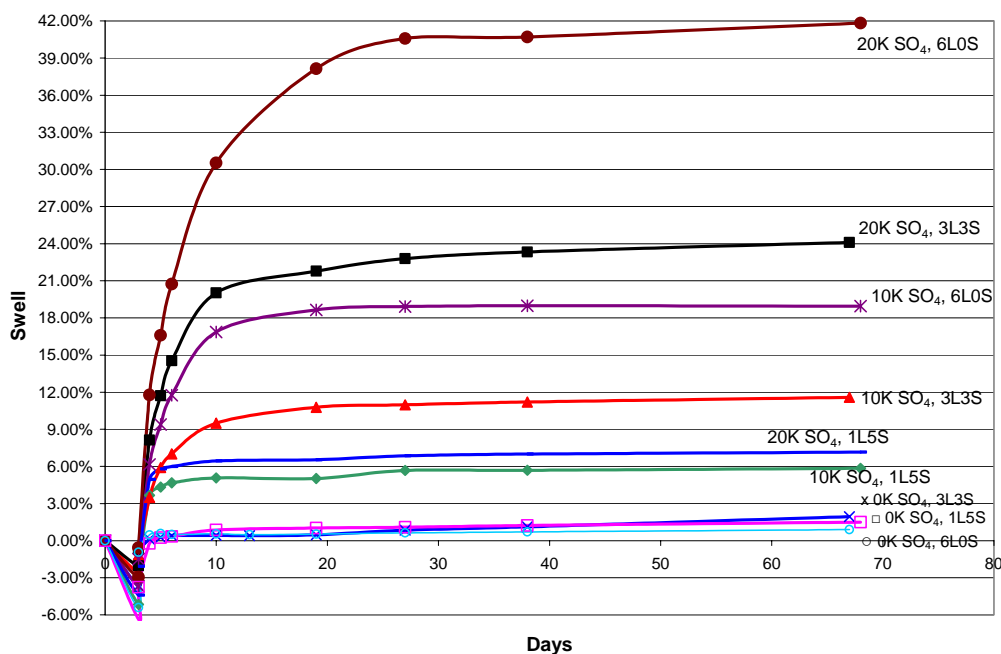
Figure 6. Comparison of 3-D swell for high sulfate levels and mixtures of lime and ground granulated blastfurnace slag (GGBFS) at optimum moisture and with no mellowing.

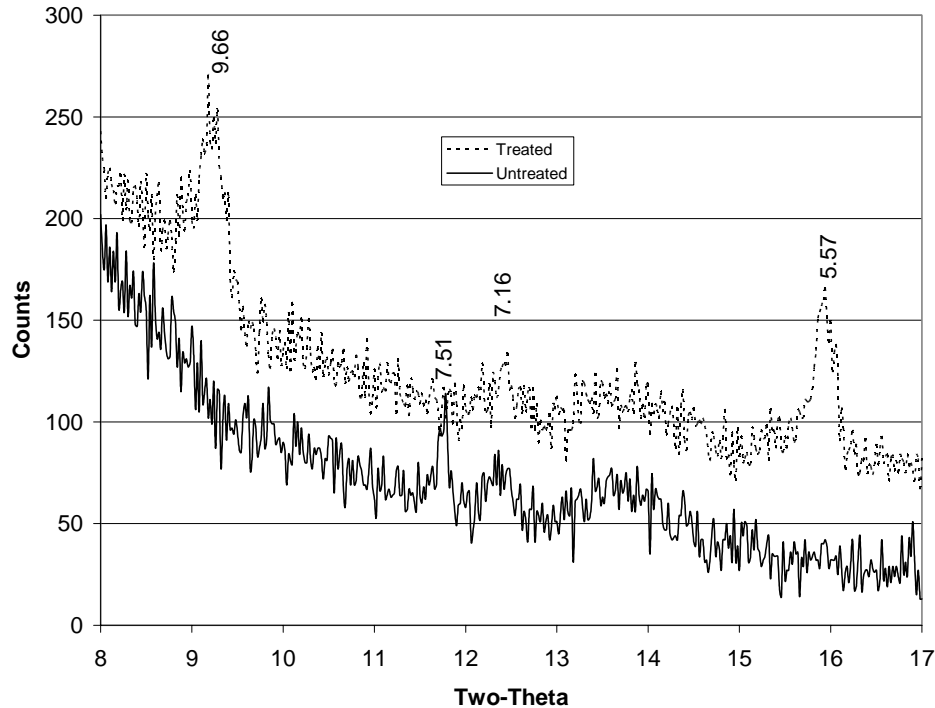
Figure 7. Partial XRD patterns of an unstabilized gypsum bearing soil (solid line) and a lime stabilized (dashed line) soil.

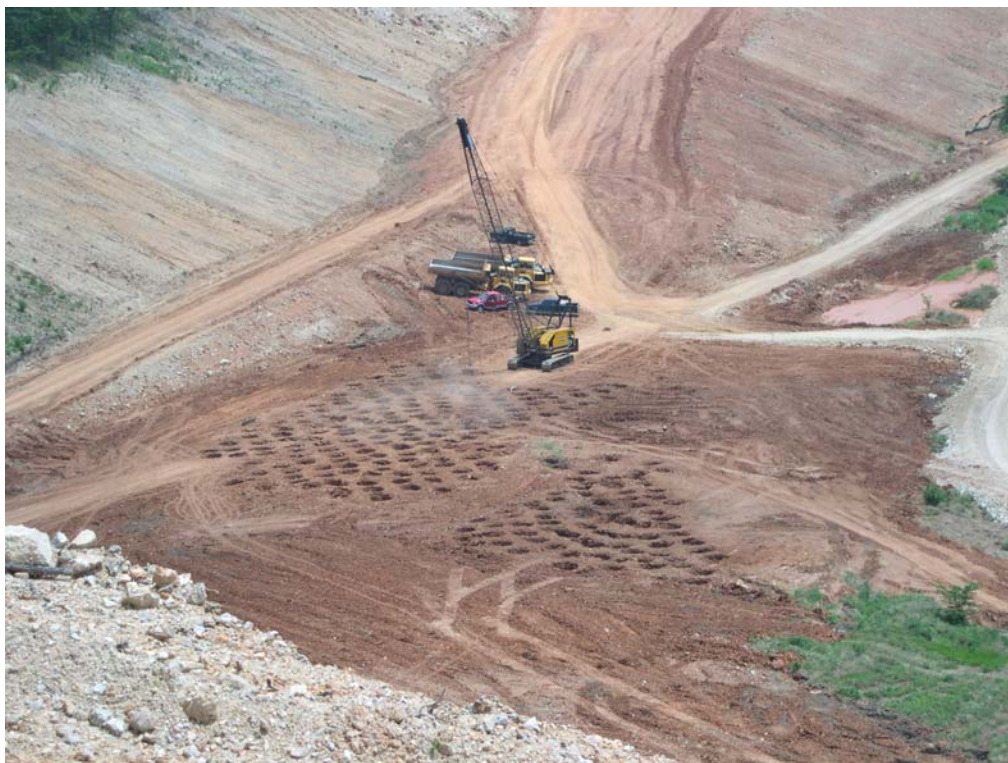
Figure 2: Deep Dynamic Compaction of Landfill

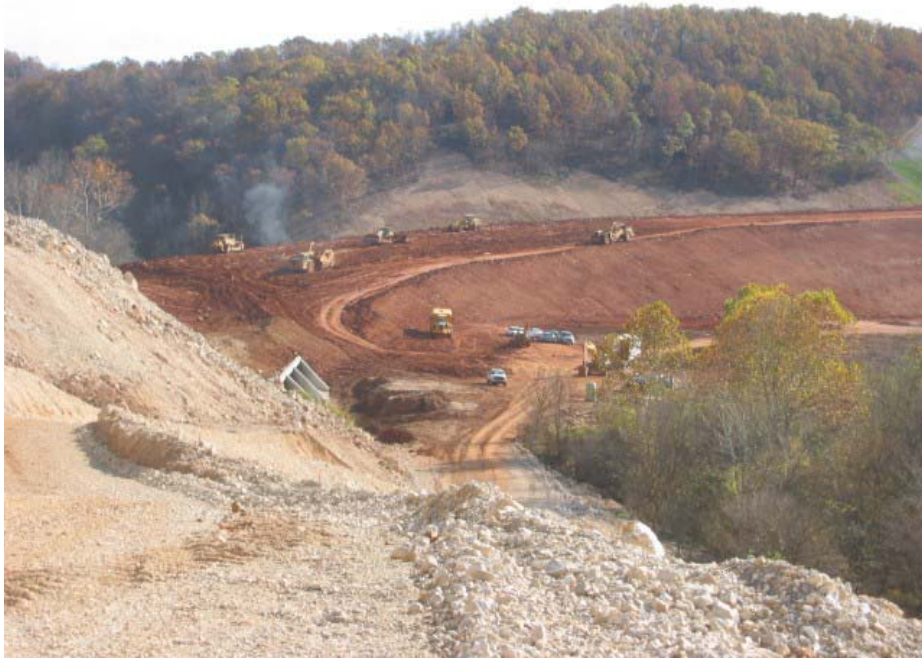
Figure 3: Embankment Construction over Landfill

The stabilization of the landfill with DDC was also considered to be very successful. The DDC was completed quickly and construction of the embankment and box culvert was allowed the

process shortly thereafter. The subgrade surface beneath the footprint of the embankment was non-yielding and provided a firm base for the placement of fill. At the time of this writing, the embankments had a healthy cover of vegetation and none showed any signs of distress, cracking or sloughing.
