55th HIGHWAY GEOLOGY SYMPOSIUM

KANSAS CITY, MISSOURI, SEPTEMBER 7-10, 2004

PROCEEDINGS

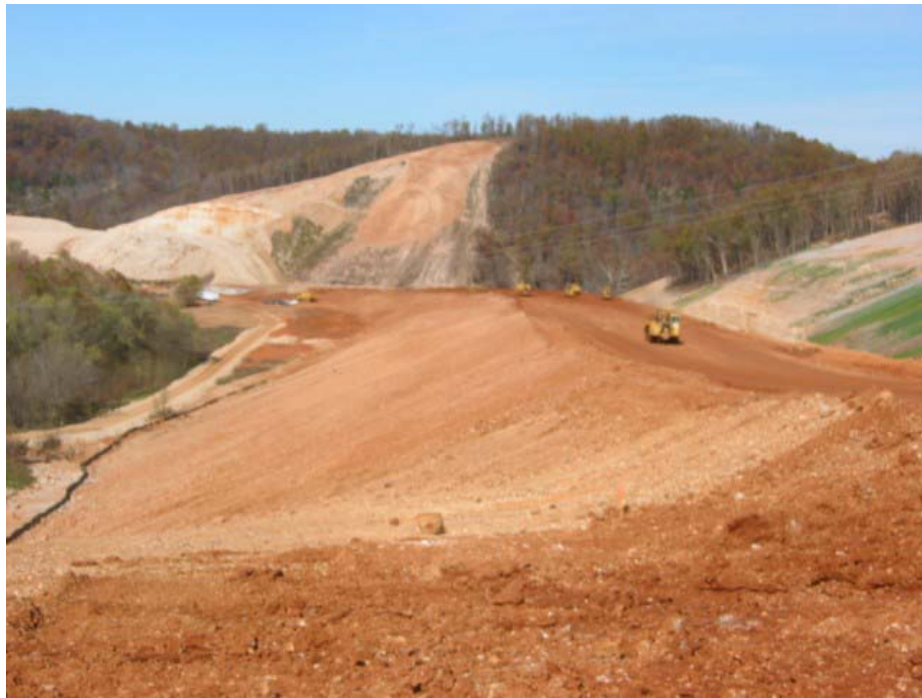
Figure 4: View of Completed 70-high Embankment at 2.5:1

process shortly thereafter. The subgrade surface beneath the footprint of the embankment was non-yielding and provided a firm base for the placement of fill. At the time of this writing, the embankments had a healthy cover of vegetation and none showed any signs of distress, cracking or sloughing.

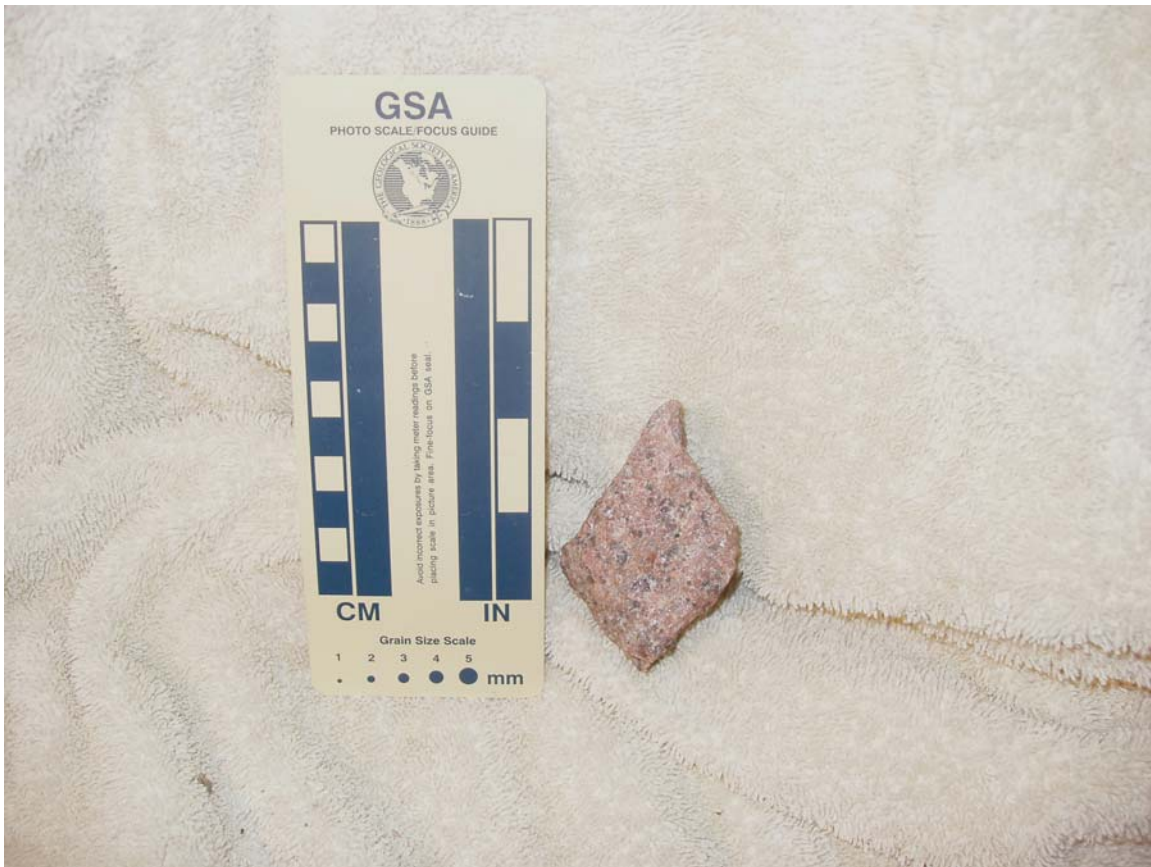
Figure 1. Graniteville Granite. This granite is a coarse-grained granite from southeast Missouri. It fits the mineralogic definition of what a granite is. It contains orthoclase feldspar (pink or flesh-toned in color), quartz, and plagioclase feldspar. These three minerals make up 95% of the rock or more. This sample is from the Missouri Red Quarry at Graniteville, Missouri.

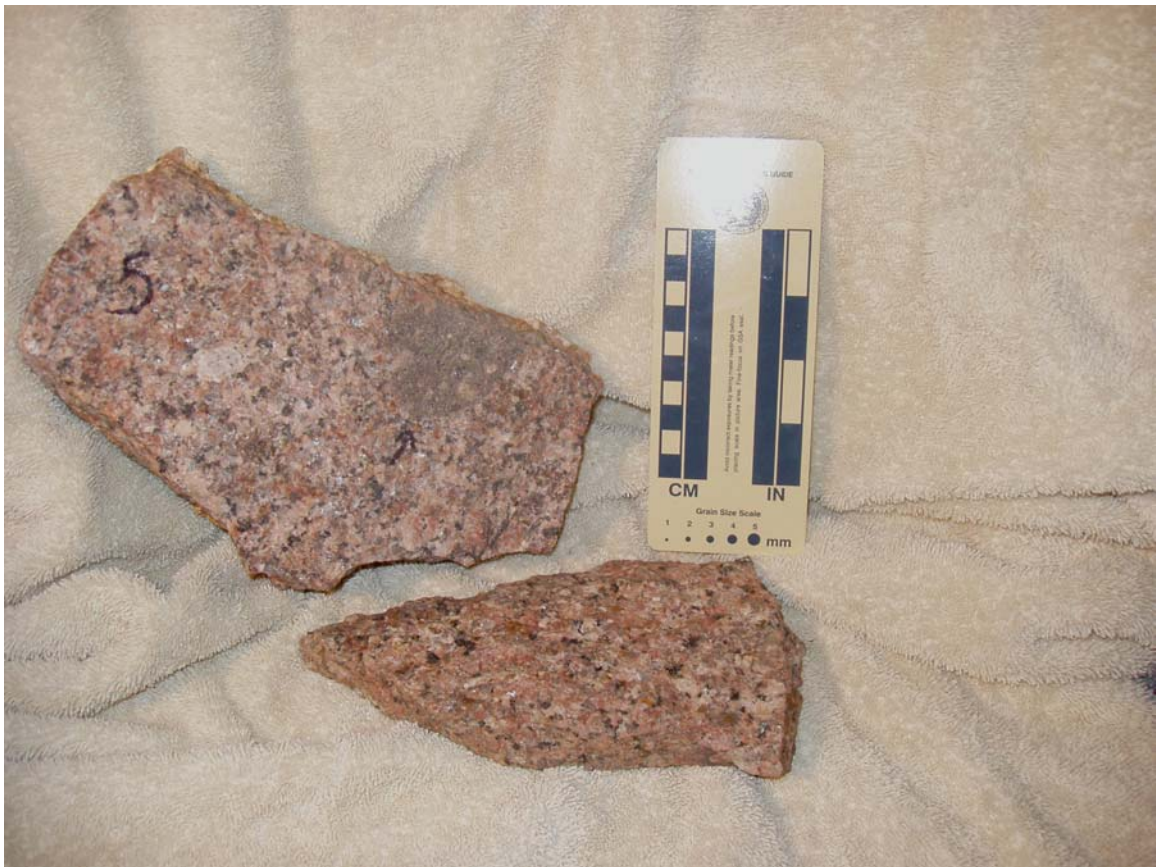
Figure 2. Butler Hill Granite from southeast Missouri. This granite is similar to Graniteville, except that it possesses muscovite mica and has a peculiar type of texture, known as 'rapakivi'. In this texture, rims of orthoclase surround larger grains and phenocrysts of plagioclase. The reverse is referred to, rather unimaginatively, as 'anti-rapakivi'. Butler Hill Granite possesses both rapakivi and anti-rapakivi textures. The upper sample shown here also possesses a large ragged-edged *xenolith* of unknown composition.

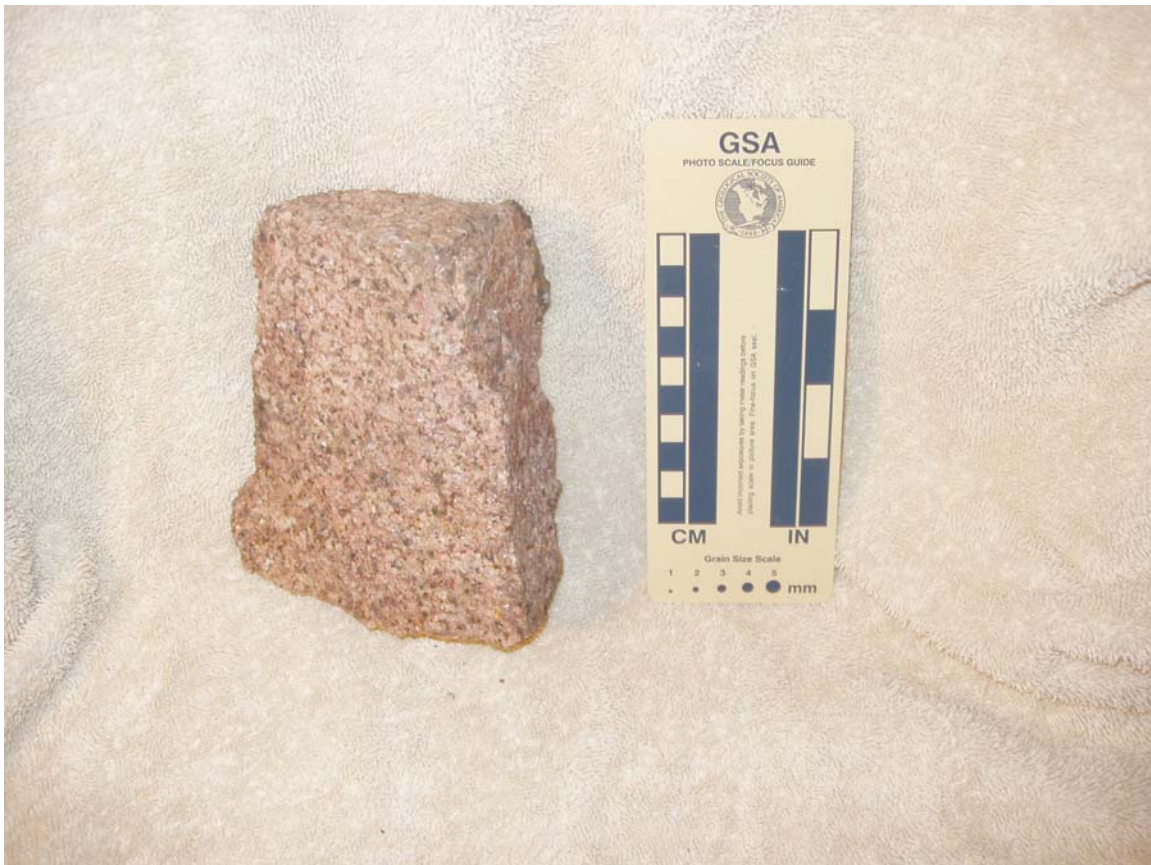
Figure 3. Breadtray Granite from southeast Missouri.

The third figure is another type of granite also from southeast Missouri, the Breadtray Granite. This granite differs in both texture and mineralogy from both the Butler Hill and the Graniteville Granites. Several locations near Farmington, Missouri were sampled for their potential utility to MoDOT for coarse aggregate stone.

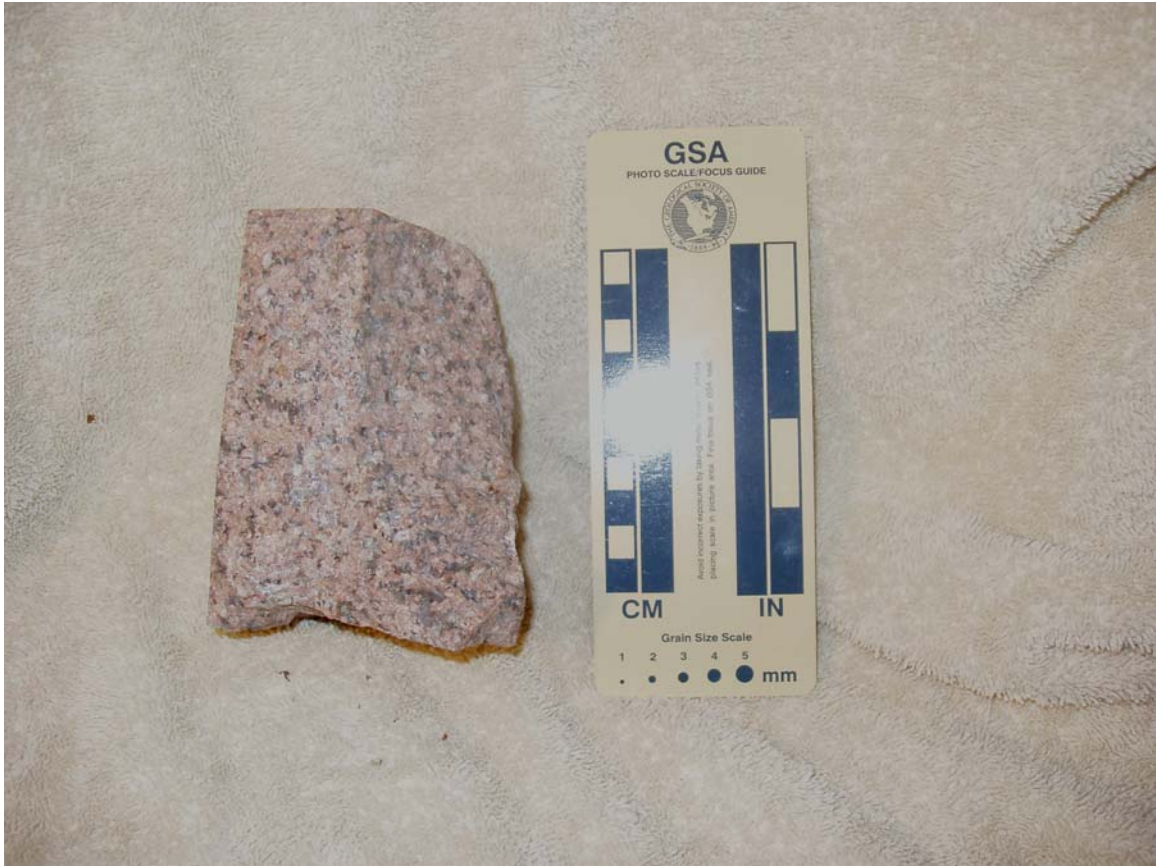
Figure 4. Troy Granite from Meridian Aggregates Mill Creek Quarry, Oklahoma

The Troy Granite from Oklahoma is coarse-grained granite, similar to the Graniteville and Butler Hill granites, primarily composed of quartz, plagioclase feldspar (chemical testing results from MoDOT and the University of Minnesota's Rock Analysis Laboratory, [UMRAL] reveals plagioclase composition ranging from albite to labradorite), and orthoclase. Localized relationships with rocks in Oklahoma include a conformable relationship with the Burch Granodiorite, a magmatic codifferentiate of the same pluton. Further south in Oklahoma is the Tishomingo Granite, which (as it was analyzed chemically and petrographically by MoDOT) was determined to be a granodiorite. The use of the term 'granite' for the Tishomingo is actually correct, since the relative percentages of plagioclase and orthoclase indicated by chemical analysis and CIPW normative interpretation are borderline to the granite-granodiorite break, and since the presence of exsolved plagioclase in the orthoclase constituent of the stone creates a micrographic to graphic texture and perthitic to microperthitic texture.

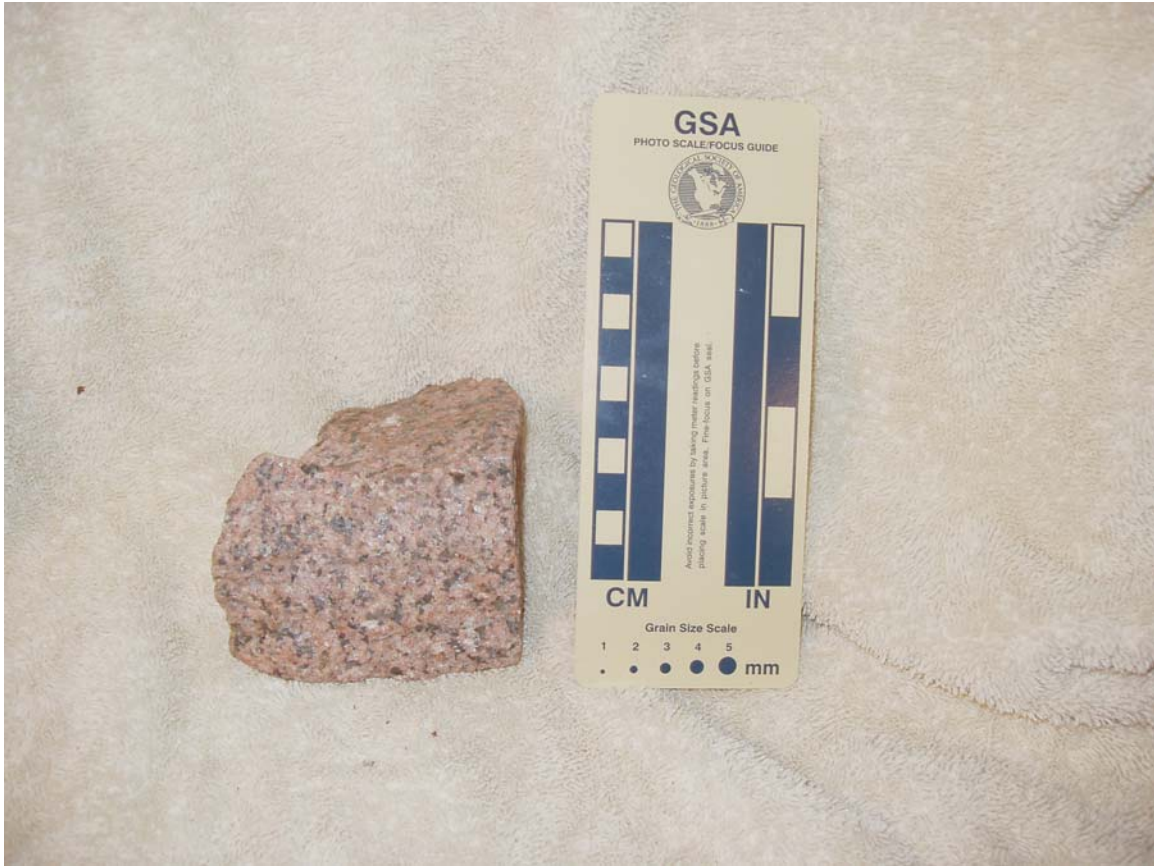
Figure 5. Tishomingo Granite from Meridian Aggregates' Snyder facility, southern Oklahoma. Macroscopically, the graphic texture of the granite is readily visible.

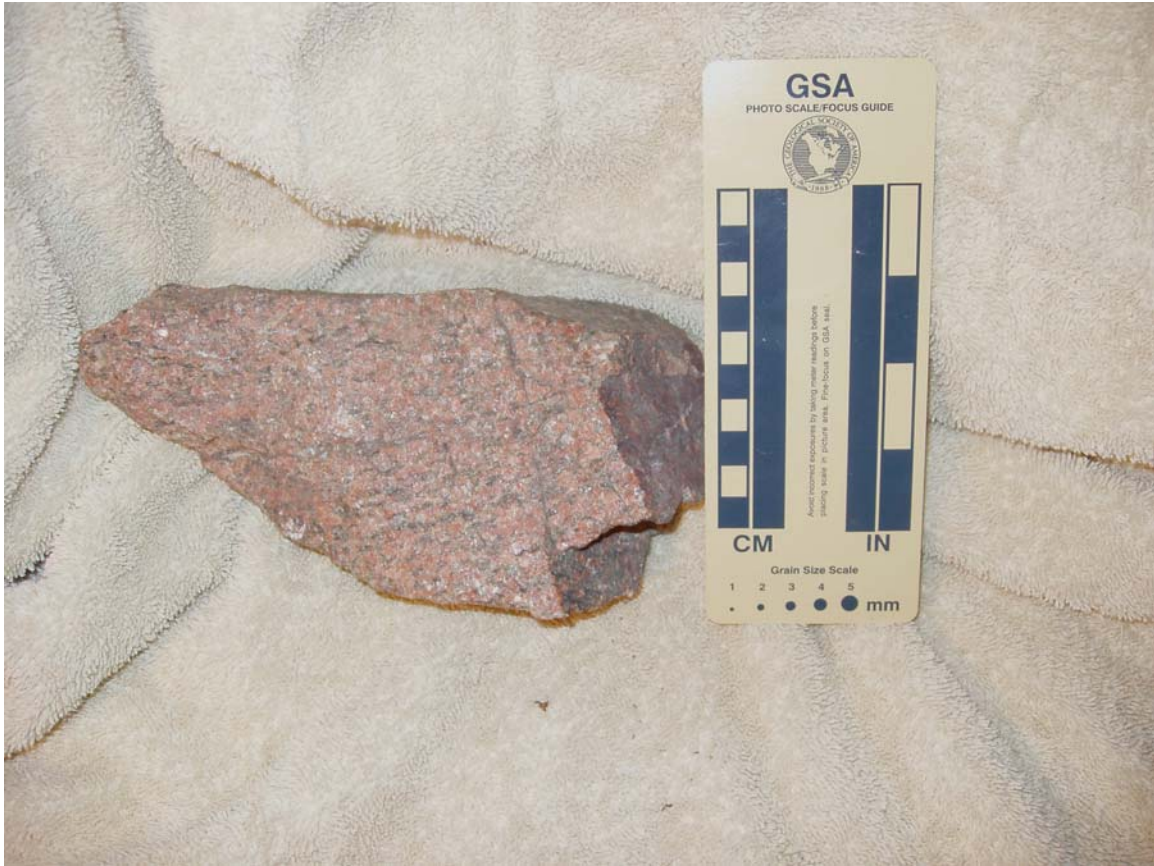
Figure 7. Cranberry Gneiss from eastern Tennessee. This rock, though it contains orthoclase, quartz, and plagioclase in similar proportions to granite, may not be an ideal aggregate stone for paving purposes. It is a metamorphic rock which has undergone stress. This stress may render it susceptible to alkali-silica reactivity (ASR) in a concrete pavement. Additionally, the stone possesses foliation planes that are markedly prominent enough to where it may increase the percentage of flattened and elongated particles in a crushed stone product. This would render it largely unsuitable for asphalt paving stone unless a sufficiently small gradation was found to decrease the overall percentage of flattened and elongated particles in an asphalt pavement. Gneisses can form from a variety of igneous and sedimentary rocks, thus, it is not always clear what rock is the precursor to the final metamorphic gneiss. Impurities in a variety of forms may also be present, as is the norm for many metamorphic rocks.

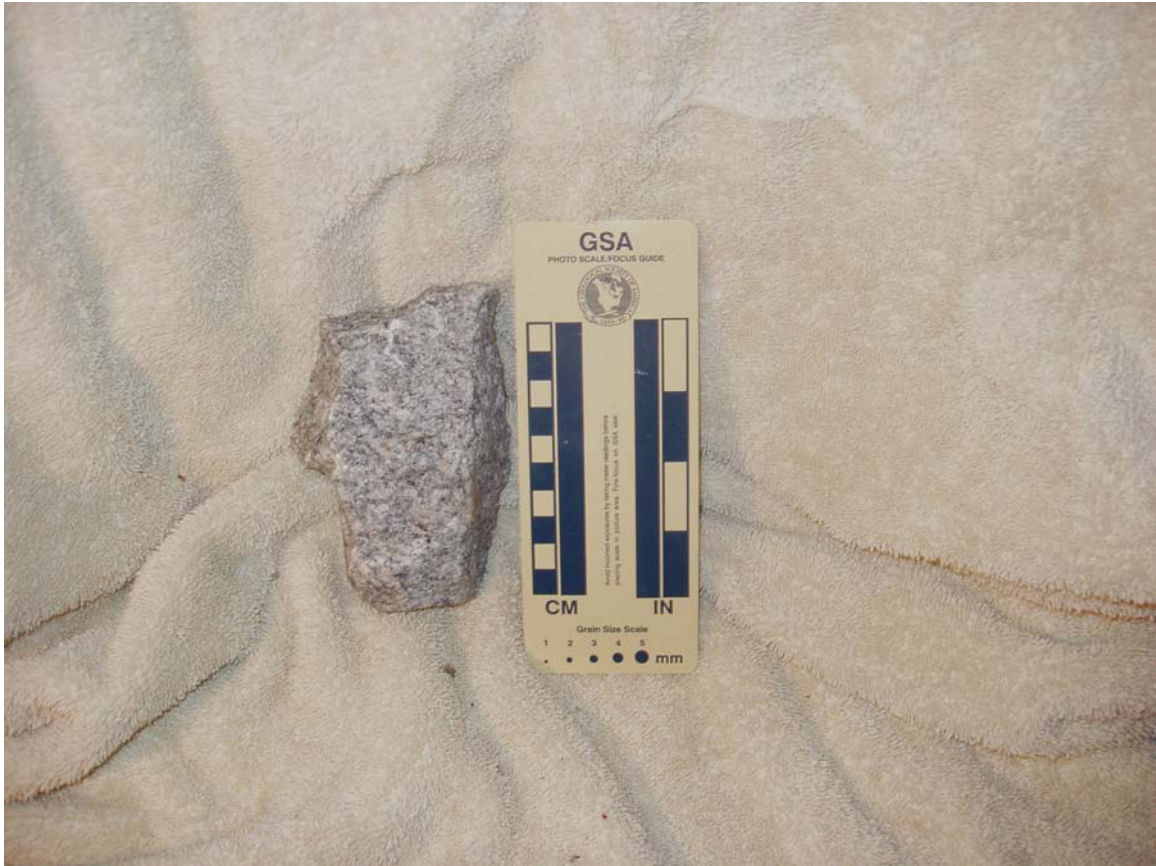
Figure 8. Quartz monzonite from the Burkeville Pluton and Luck Stone, Incorporated's facility in Burkeville. Quartz monzonite is marginal to granite, and often possesses favorable characteristics for use as aggregate in asphalt.

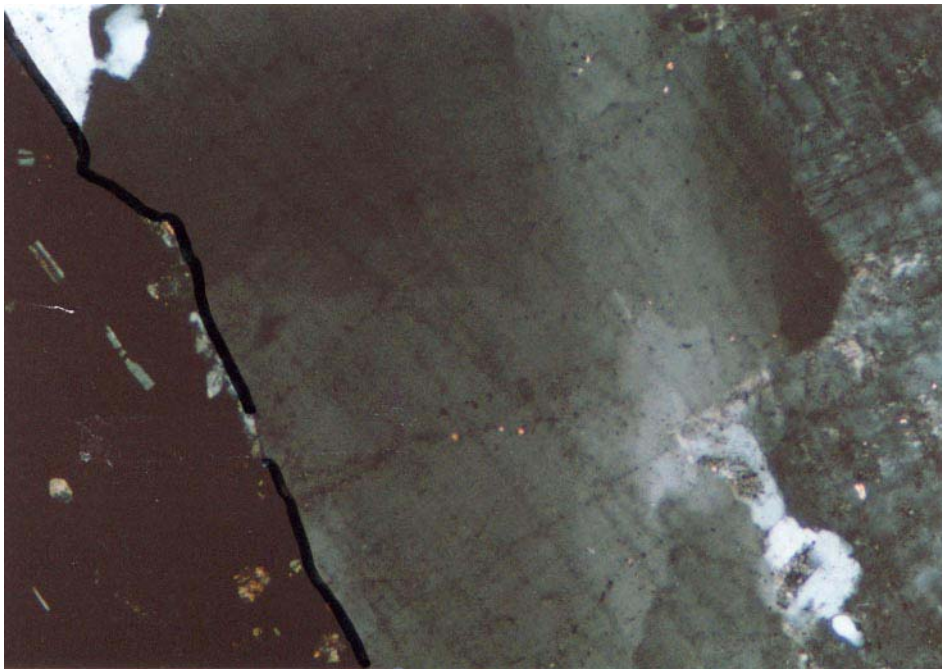
Figure 9. Margin of basalt intrusion and granite, Troy Granite, Meridian Aggregates' Mill Creek Quarry, Johnson County, Oklahoma. The basalt to the left of the photomicrograph was intruded after the emplacement of the granite pluton. Undulatory extinction in quartz grain on right-hand side of photomicrograph is indicative of stress from injection of basaltic dike adjacent. This renders the stone suspect for use in concrete due to ASR (alkali-silica reactivity) until further tests are performed. Crossed polars, 100X.

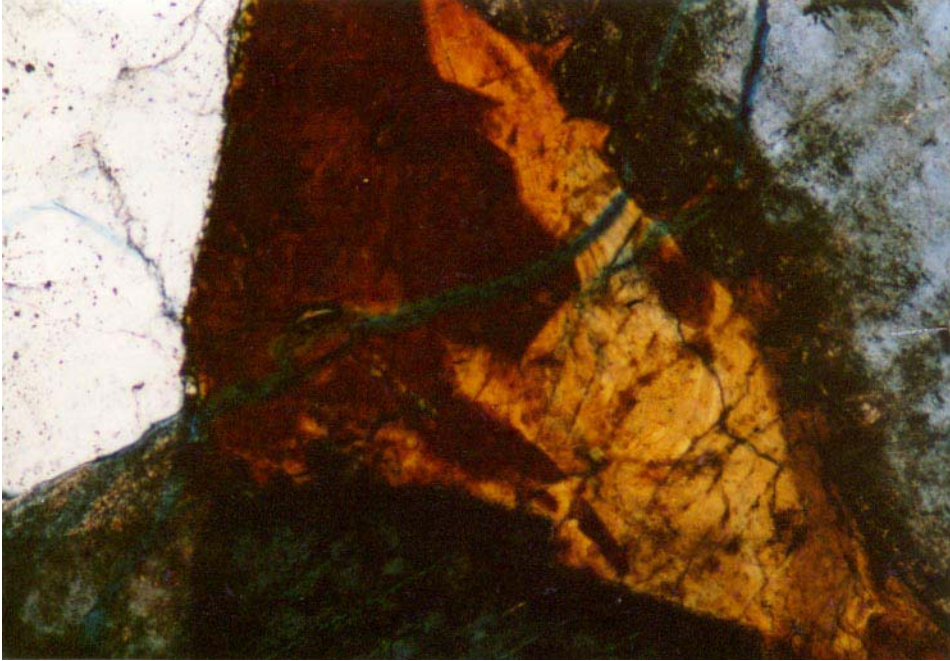
Figure 10. Undulatory extinction in pleochroic biotite grain also indicative of stress from dike injection of basalt. Troy Granite, Meridian Aggregates' Mill Creek Quarry. Johnson County, Oklahoma. Crossed polars, 100X.

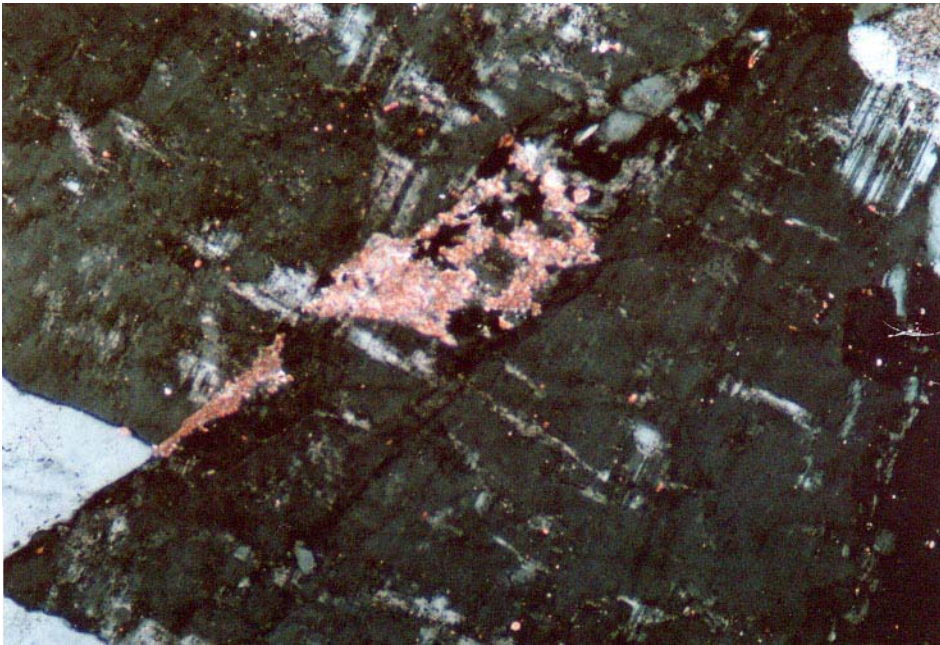
Figure 11. Adjacent orthoclase feldspar grains with fracture-filling calcite (note high birefringence) indicative of in-situ weathering and deposition of calcium bearing fluids by meteoric groundwater. Note albite twinning on (112) surface of plagioclase grain in upper right hand of photomicrograph. Troy Granite, Meridian Aggregates' Mill Creek Quarry, Johnson County, Oklahoma. Crossed polars, 100X.

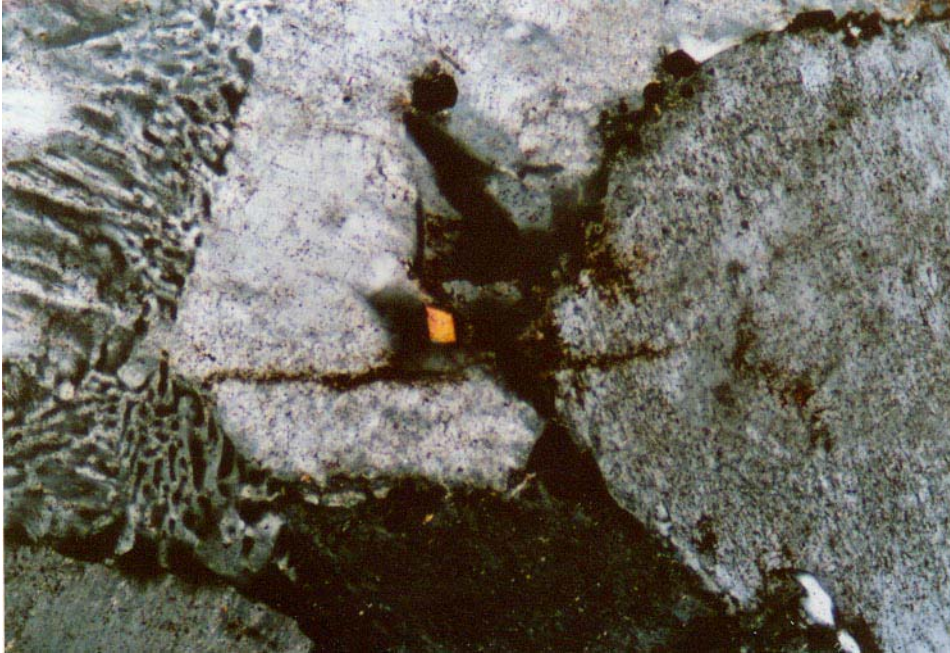
Figure 12. Quadrilateral sphene (titanite) grain as accessory mineral enclosed by quartz in graphic granite. Note micrographic texture on left side of photomicrograph. Granite from Meridian Aggregates Long Mountain (Snyder) facility, Jackson County, Oklahoma. Crossed polars, 100X.

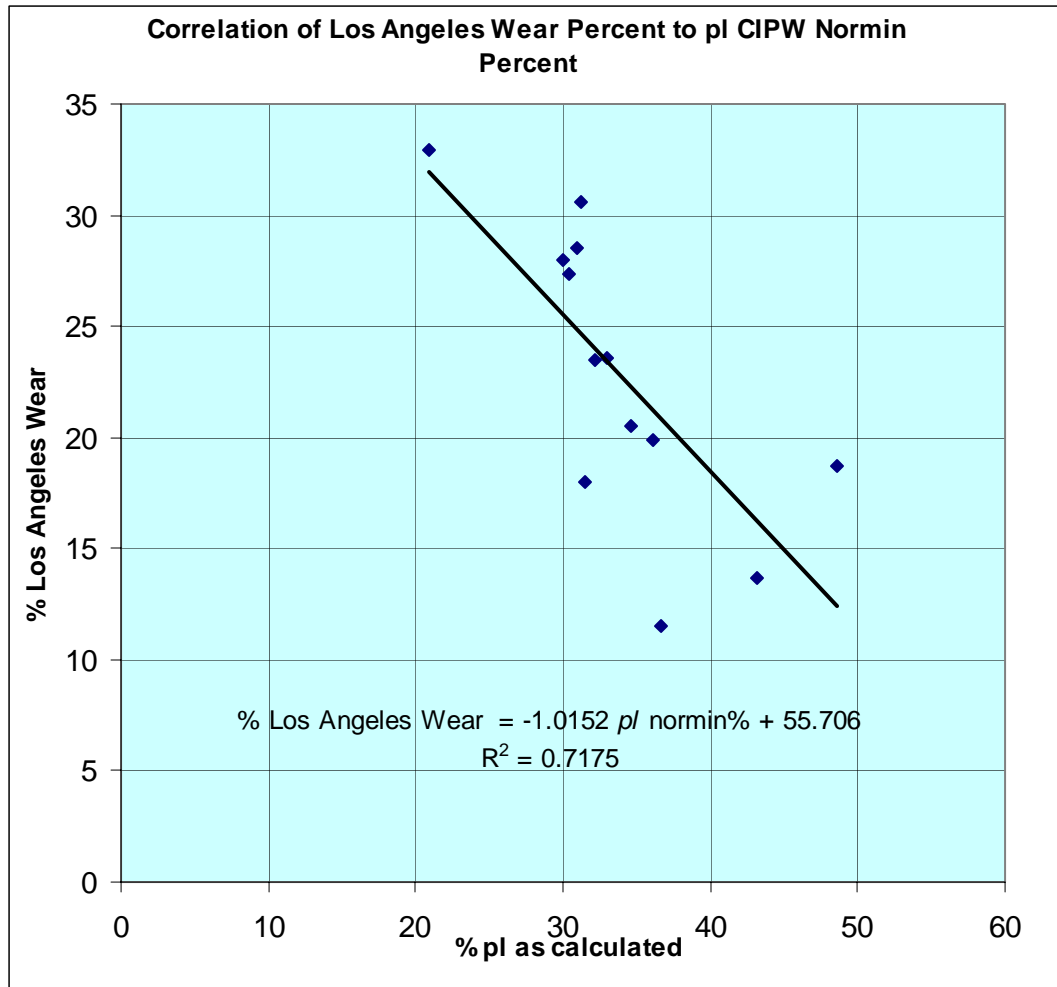
Figure 13. Proposed Correlation between Los Angeles Wear Percent and normin *pl* as determined by CIPW normative procedure.

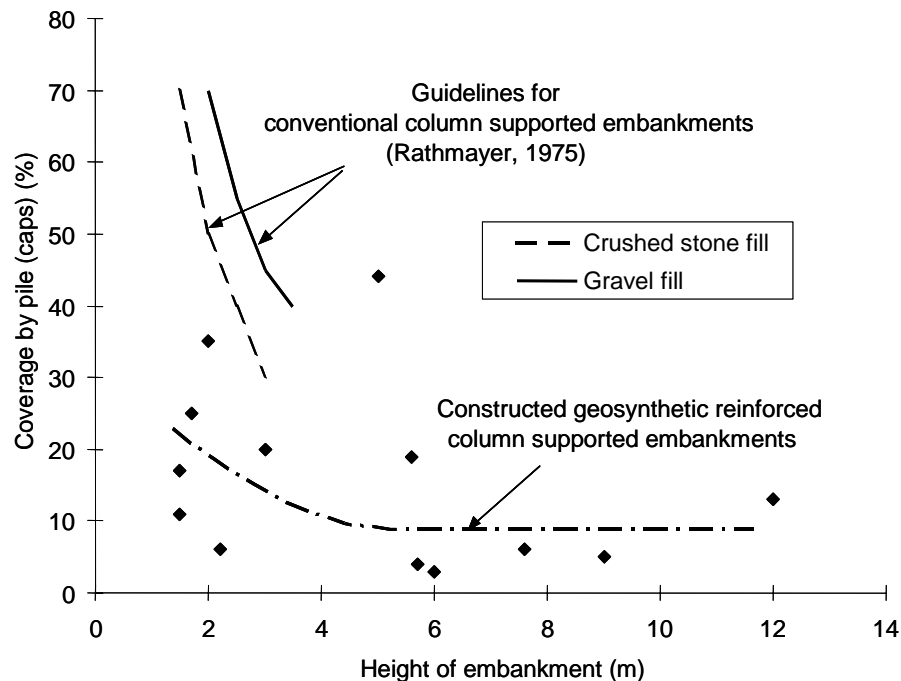
Figure 2. Percent Coverage of Pile Caps for Pile-Supported Embankments (Han, 1999)
Stress above geosynthetic reinforcement

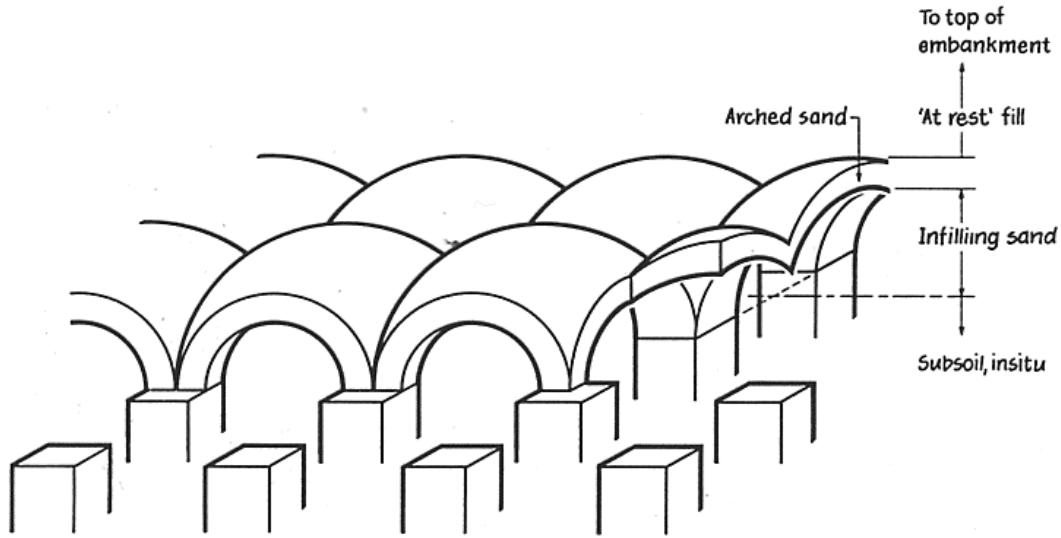
Figure 4. Soil Arching Model Proposed by Hewlett and Randolph (1988)

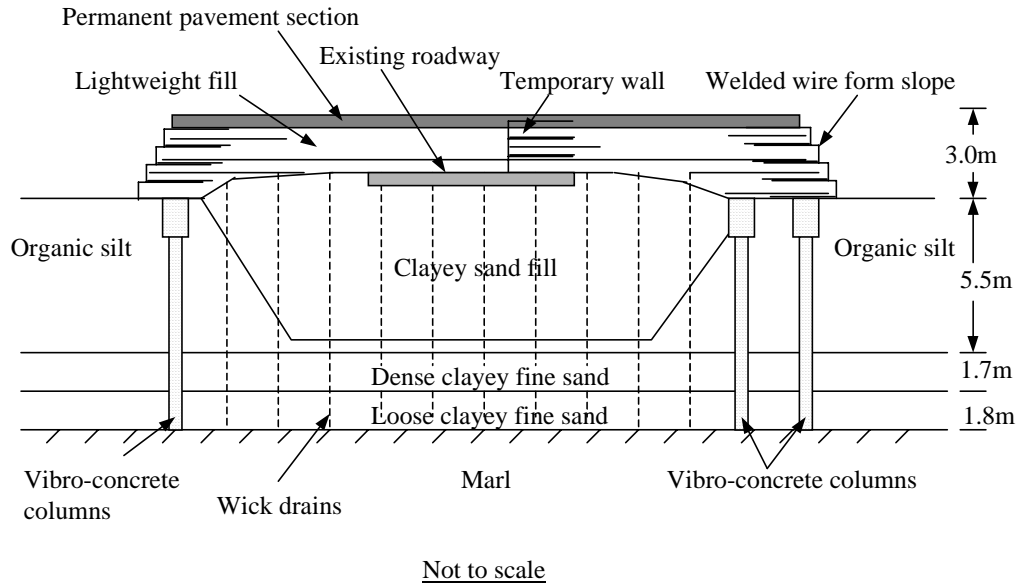
Figure 7. Typical Cross Section of Widening Roadway (Han and Akins, 2002)

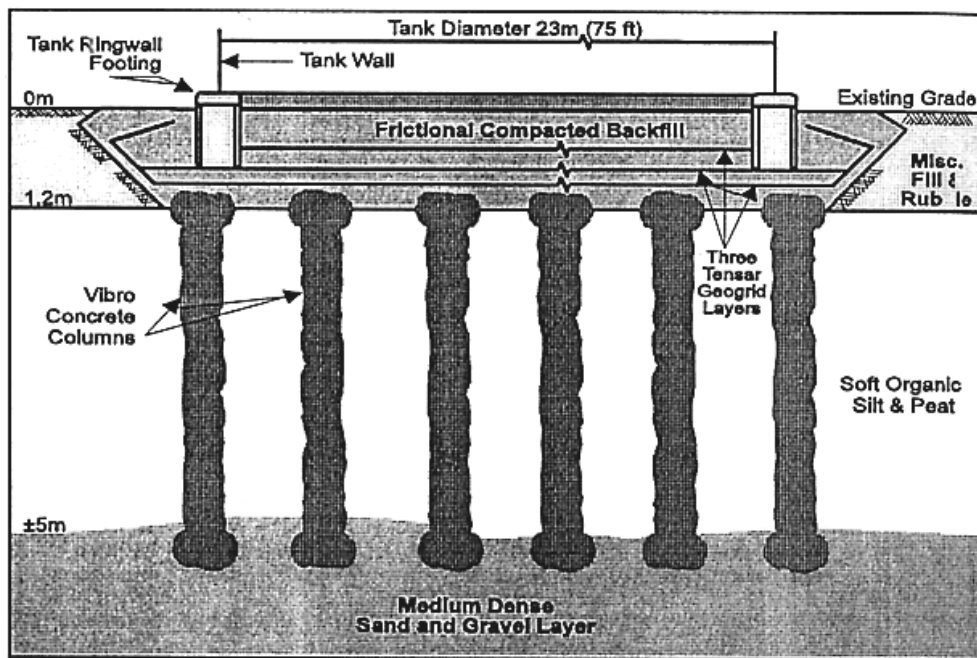
Figure 8. Storage Tank on A Geogrid-Reinforced and VCC-Supported Foundation (Shaefer et al., 1997)

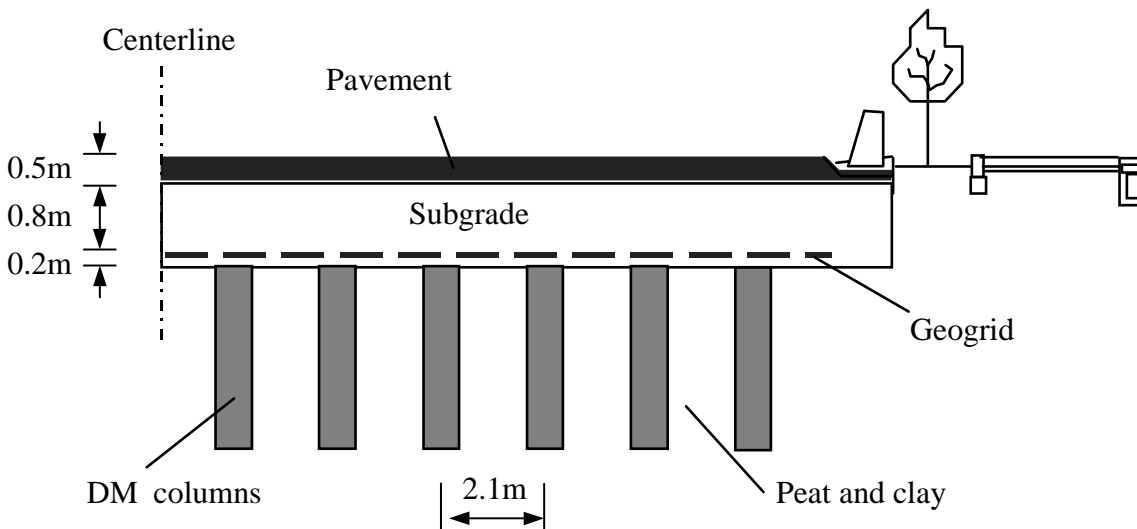
Figure 9. Low Height Embankment over Deep Mixed Columns (Tsukada et al., 1993)

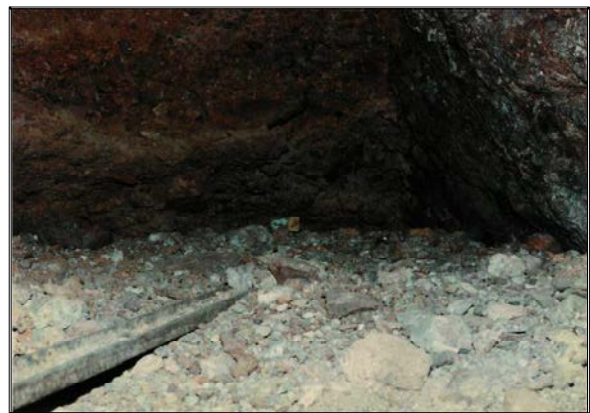
Figure 7 – Crosscut ending in gravel off the Philadelphia No. 1 shaft

Underground, the workings run chiefly along the strike. Crosscutting is indicated on old maps to have reached the footwall contact with the granite and the hanging wall contact with the gravel (Figure 7). This means that there is an efficient subsurface hydraulic connection between ground water and the workings. In fact, the workings are flooded below the 100 level and water has been extracted – in small quantities – in the past. Because of the flooding, none of the mine levels

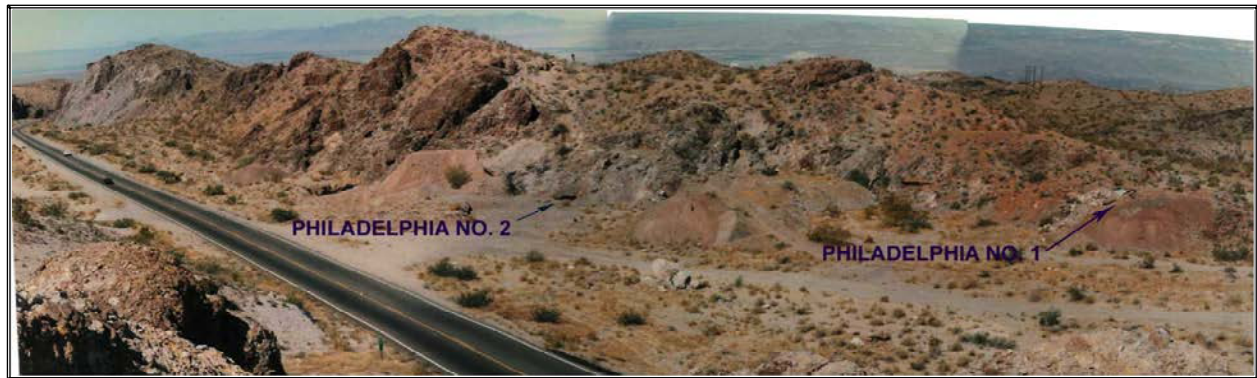
Figure 8 – Panoramic view of Arabian Mine site with realigned curve at extreme left

Other miscellaneous workings, including several shafts and an adit extending back into the granite footwall mass, are found several thousand feet southwest of the main mine workings. The shafts are presently filled a short distance below the surface. The hilltop behind the workings contains numerous trenches, shallow prospect pits, and short adits, all of which are above the main shaft elevations (Figure 8).

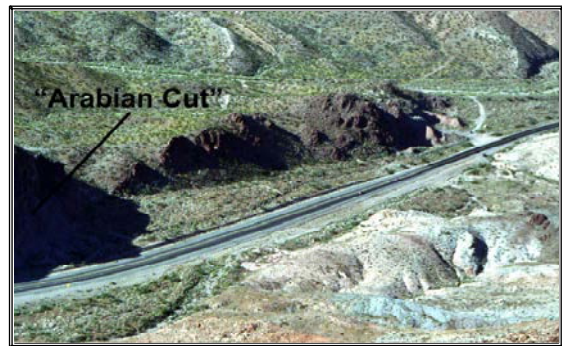
Figure 9 – Arabian Cut

Also, in 1934-1935, gold was recovered from a surface operation known as the Arabian Cut, on the Rising Fawn claim a little over 1,000 ft south of the underground workings, opposite the future curve realignment (Figure 9). According to the Arizona Department of Mineral resources in a report dated October 9, 1940, some development took place in the Philadelphia No. 1 shaft by new owners.

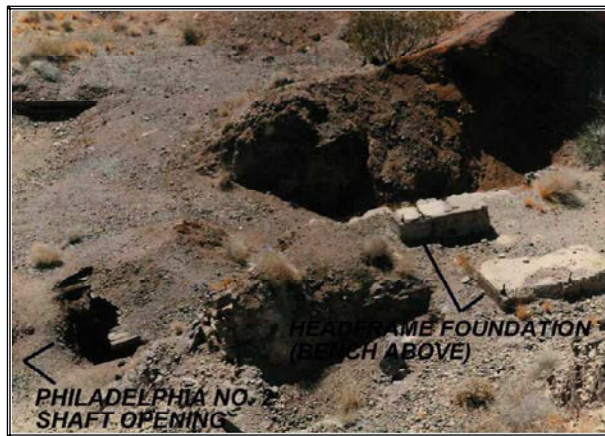
Figure 18 – Philadelphia No. 2 shaft in 1991

2, there was no safe way to set the pipe framework without disturbing an old timber loading platform and the debris atop it (Figure 18). Instead, pins were set at the collar to affix the shaft ladder at the surface. Concern for damaging the shaft collar timber, and the very limited working room around the collar, prevented more than 35 ft of ship's ladder from being lowered into the

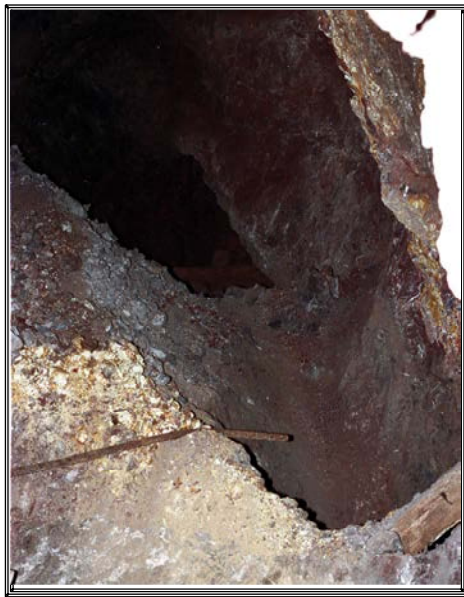
Figure 19 – 100 Level stope off the Philadelphia No. 2 shaft

entry hazardous. The inclination was measured at 48-50 degrees, slightly steeper in the timbered portion.

Workings recorded in the survey, or indicated in the records, were depicted on maps and cross sections, relative to the location of the roadway corridor. The assessment of the integrity of the mine workings and the likelihood and character of potential threats to the roadway due to the presence of the workings underneath (particularly the stopes), could not, because of the flooding, be observed directly. Underground observations did show that the stopes could not be accurately described as regular, tabular voids that have consistent orientations (Figure 19).

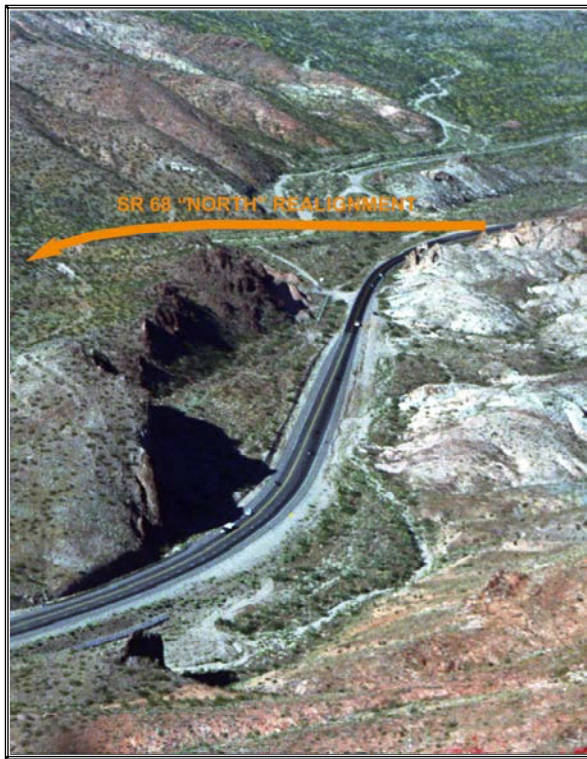
Figure 26 – “North” realignment

At other, more constrained sites, perhaps such engineering solutions could not be avoided. In this case the argument for relocation was compelling, though it is often most convenient to expand the existing corridor rather than relocate it. In the end, the decision was taken to realign the highway to the north (Figure 26), through public land (and a few unpatented claims) known to be free of undermining. As it turned out, in part because the new construction could take place without interference from existing traffic, and in part because further right-of-way acquisition did not have to be negotiated with the current Arabian Mine owner(s), the eventual cost of construction proved to be less than the projected cost of the improvements within the existing corridor.

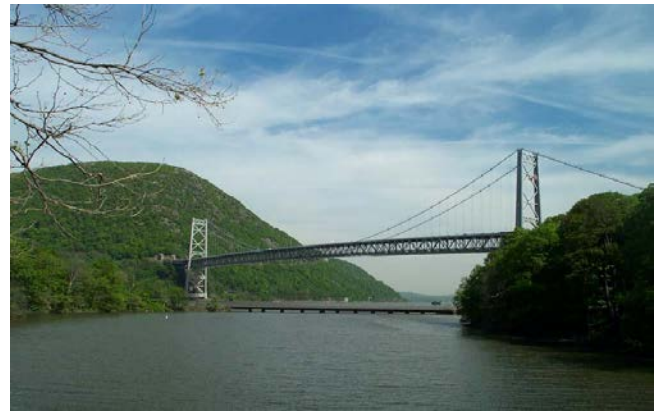
Figure 2: The Bear Mountain Bridge crossing the Hudson River (looking south). Anthony's Nose Mountain is to the left.

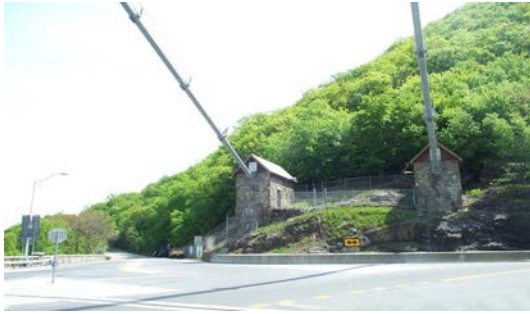
Figure 4: Existing eastern cable anchorages at the base of Anthony's Nose Mountain.

The western anchorages are situated near the toll facility and Bridge Administration Building, as shown in Figure 3, which is a section of the southwest anchorage. The eastern anchorage pits are situated above the roadway level on the steeply sloping side of Anthony's Nose, as shown in Figure 4.

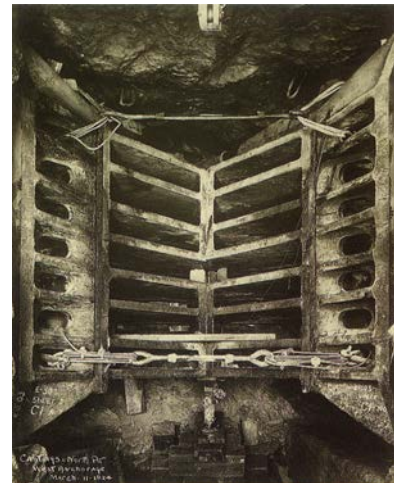
Figure 6: 1924 photograph showing end bearing castings in the anchorage tunnel. From "Bear Mountain Bridge – The History," by the New York State Bridge Authority.

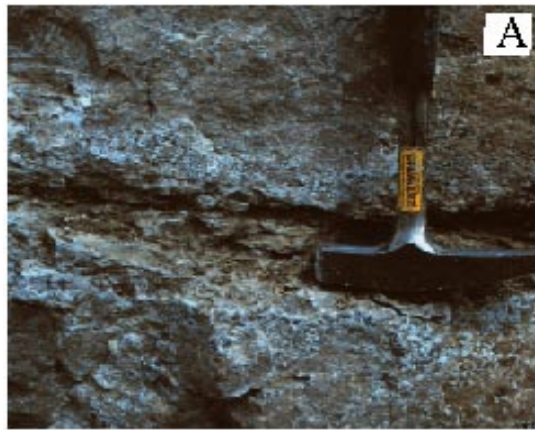
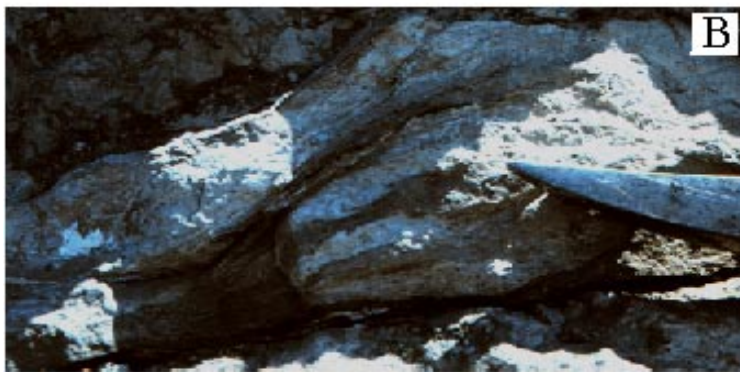
Figure 3. Photos of concentrated stylocumulates as they appear on outcrop. (A) Thin shale bed located between bedding planes.(B) Concentrated stylocumulate that branches into thinner and slightly more diffuse stylocumulates from left to right. (C) Concentrated stylocumulate that becomes more and more diffuse from left to right. The clay on the left would likely separate from the limestone in crushing whereas that on the right would likely remain in the aggregate after crushing.

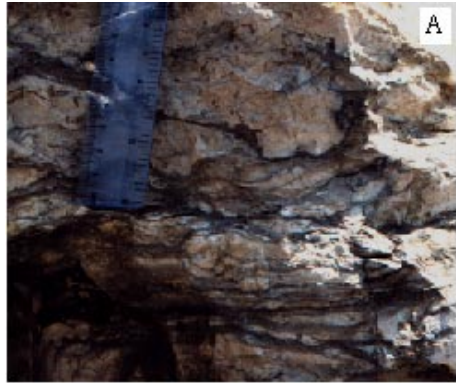
Figure 4. (A) Photo of thin, diffuse stylocumulates on outcrop. The irregular pattern, thinness and distribution throughout the limestone would likely cause these clay-rich zones to become part of the aggregate following crushing of the rock. (B) Hand sample of argillaceous skeletal wackestone (locality SRS) showing the stringy, and wispy nature of the diffuse stylocumulates. These wisps of clay-rich material will not be separated from the limestone when the rock is crushed.

Some clays are in diffuse stylocumulates spread out within limestone beds (Figures 2 & 4). These diffuse stylocumulates are composed of numerous subparallel microstylolites and have a wispy to patchy appearance commonly dying out into the surrounding limestone. Because the diffuse stylolites are composed of numerous microstylolites spread throughout the limestone, they cannot easily be separated from the surrounding limestone with a pick or by crushing the rock.

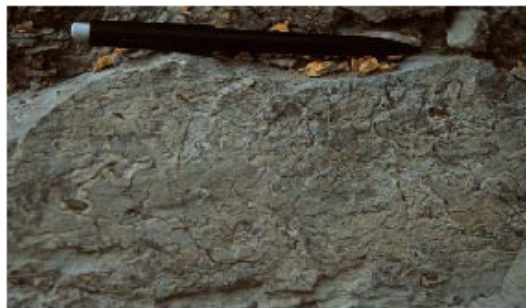
Figure 5. Photo of a bed of phylloid algal wackestone with completely disseminated argillaceous material throughout its thickness. This form of clay is recognized by the bluish-gray color it imparts to the rock. Due to the disseminated nature of the clay, it will become part of the aggregate following crushing of the rock.

Because of its diffuse nature and distribution throughout limestone beds, this occurrence of clay generally will be retained in the crushed aggregates

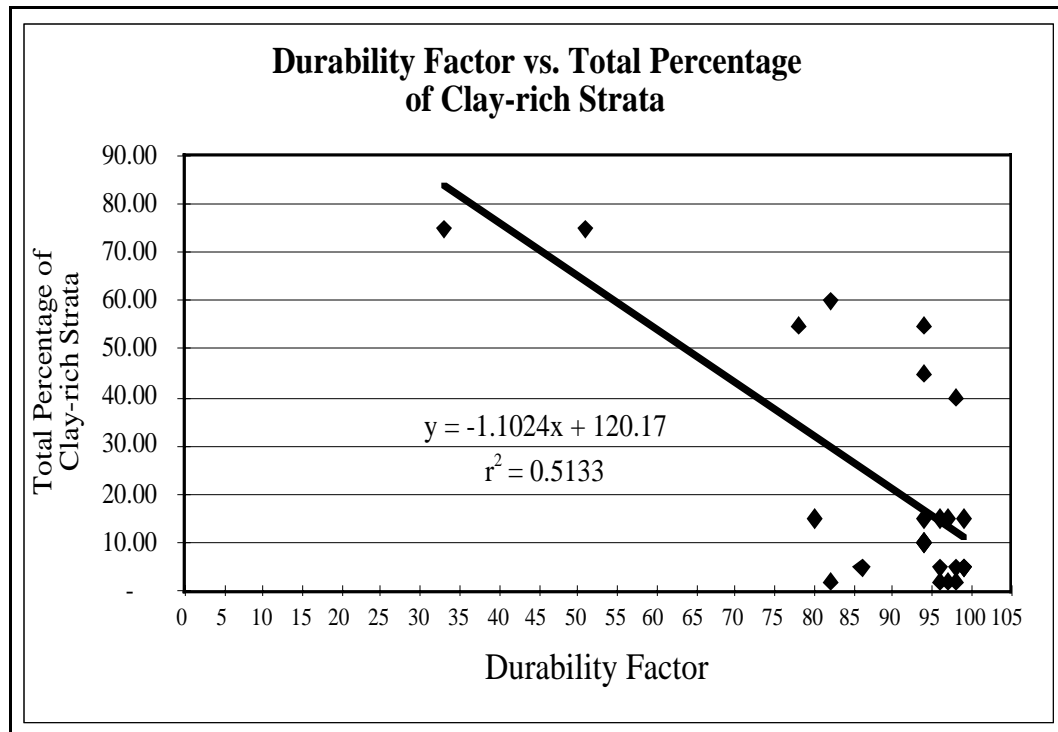
Figure 12. XY plot comparing durability factor to total outcrop clay percentage (n = 25). This percentage includes concentrated stylocumulates, diffuse stylolites, and disseminated argillaceous material.

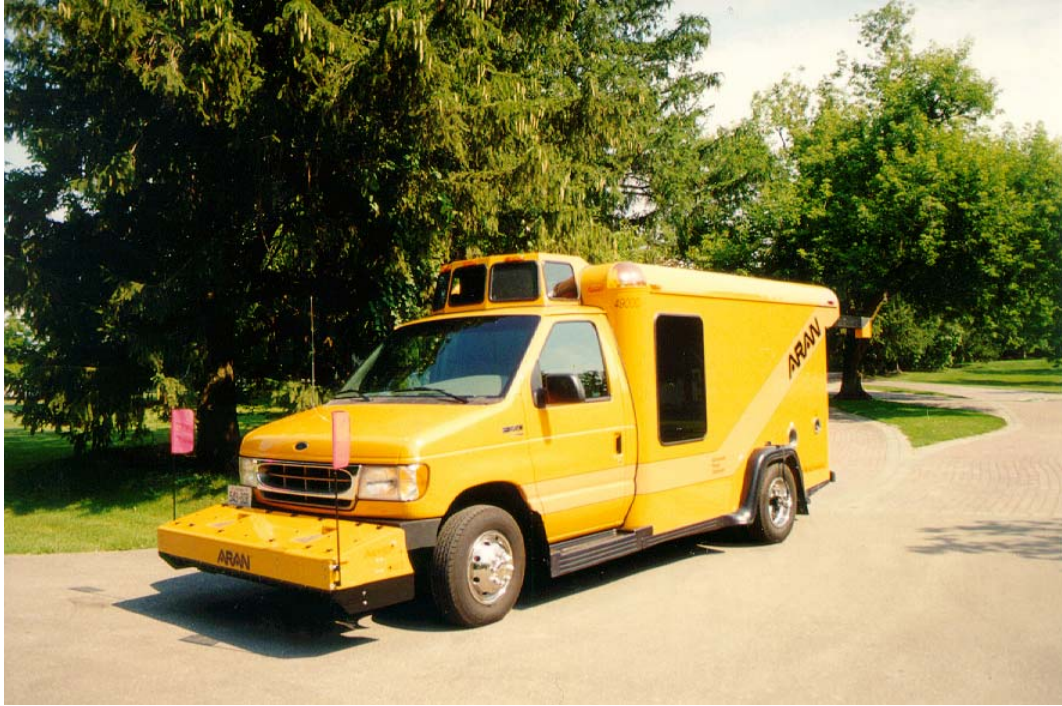
Figure 1. An example of an Automatic Road Analyzer (ARAN) made by RoadWare Corporation.
