55th HIGHWAY GEOLOGY SYMPOSIUM

KANSAS CITY, MISSOURI, SEPTEMBER 7-10, 2004

PROCEEDINGS

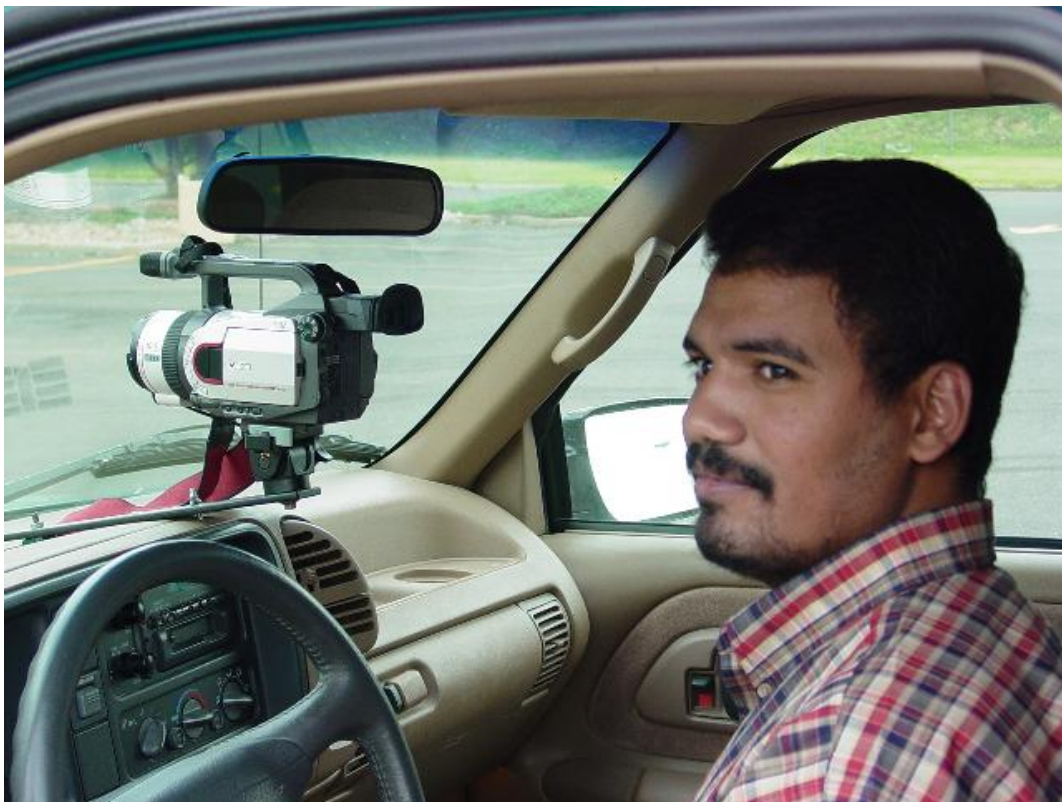
Figure 2. Simple video setup.

MORFH RS is based on mobile highway video technology, which means that highway rock cuts can be routinely imaged (video logged) at highway speeds by technicians, and the video can be replayed at the office where engineers or geologists can rapidly screen the cuts and determine which need more detailed assessment. Video screening can be done using a sophisticated fully instrumented vehicle such as RoadWare's ARAN (Figure 1) (Maerz and McKenna, 1999) or as simple as a video camera mounted in a car or truck (Figure 2) (Maerz et al., 2003).

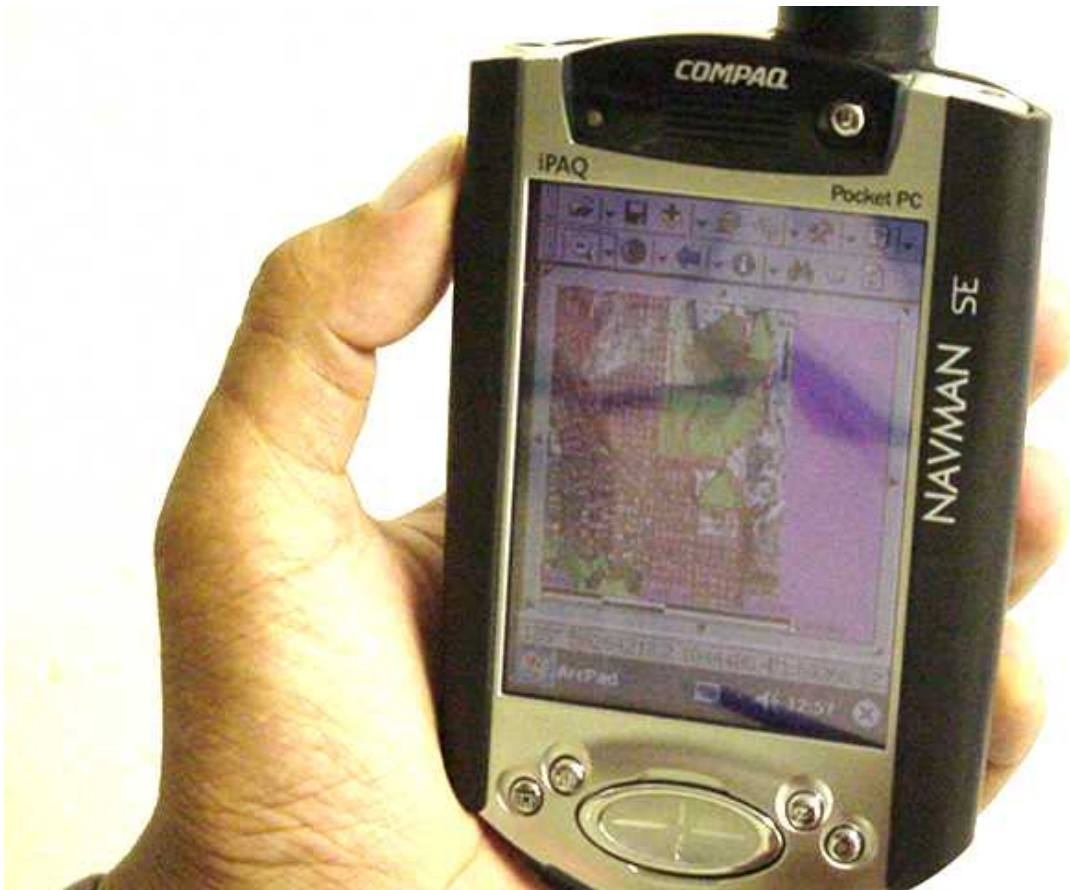
Figure 6. Compaq IPAQ PC with ArcPad software for field data collection.

As Missouri's roads are long and numerous the use of field data sheets became tedious. A digital data collection system for the field parameters was developed as well as a GIS database management system. For the sites that needed detailed rating, a Pocket PC (Compaq IPAQ with ArcPad®) (Figure 6) was used to edit the site locations, and add the field rated parameters. The IPAQ includes an optional Navman GPS receiver to automatically record the site locations.

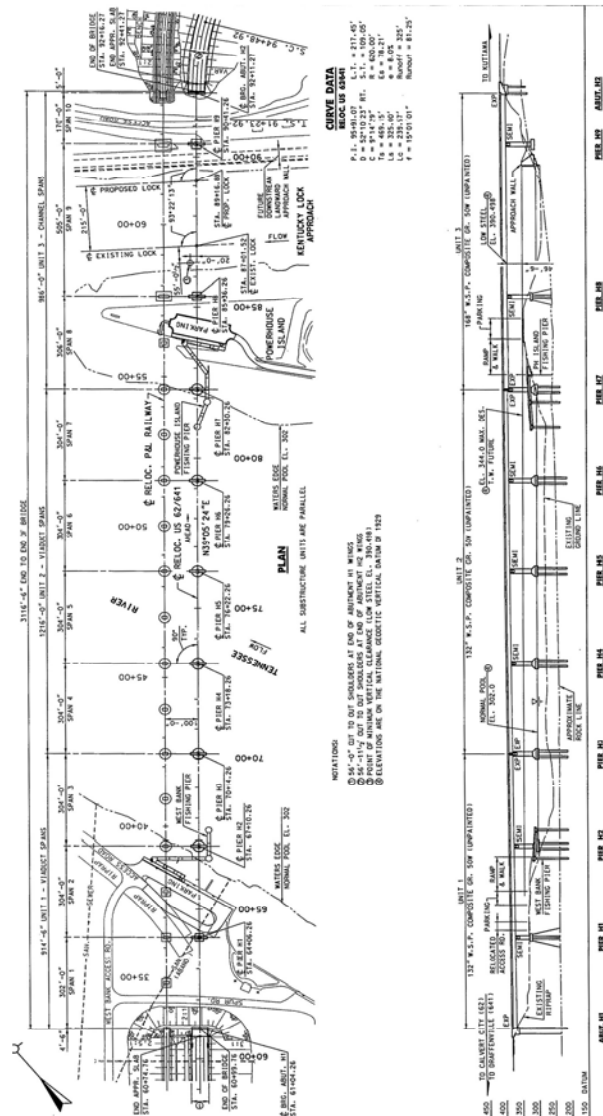
Figure 2: Highway Bridge Layout Drawing

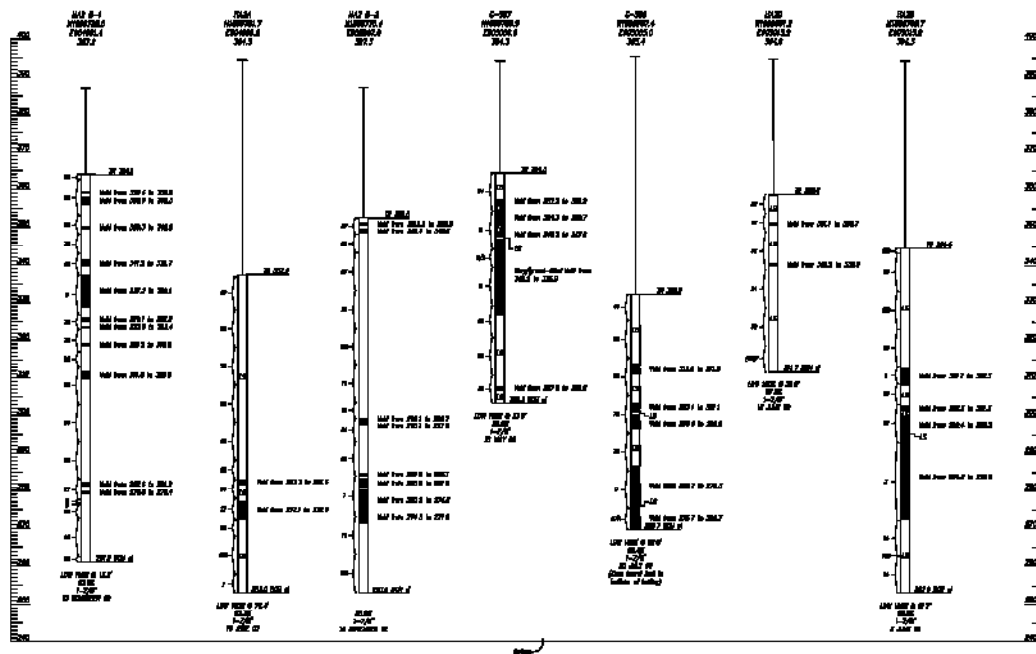
Figure 3: Abutment H2 Boring Logs

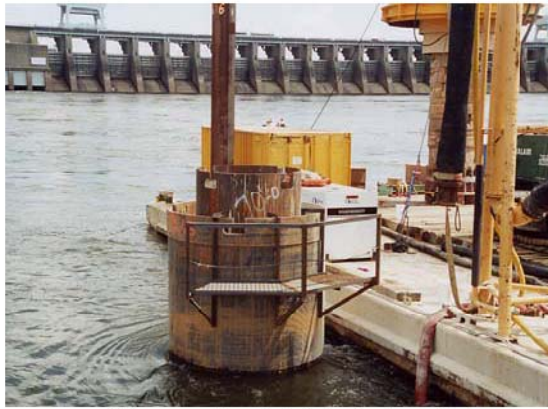
Figure 6: Shield Casing Setup

Due to the water velocities and depths encountered, the Contractor is utilizing a shield casing method to accurately position and stabilize the drilled shaft permanent casings during construction. With the shield casing method, a larger diameter temporary casing is installed to rock and the overburden is augered from the casing, see Figure 6. The kerf cutting drill is then used to perform the first five to ten feet of rock socket excavation as per the vertical crevice remediation requirements. Once the kerf cutting is accepted, concrete is placed in the kerf hole. Before the concrete sets, the permanent casing is twisted through the concrete and into rock. This allows the permanent casing to be set accurately both horizontally and within verticality tolerances in an “open” hole. Once the concrete has set, the permanent casing becomes fixed at the bottom. This provides lateral support for the permanent casing. Then sand is placed in the annulus between the permanent and temporary shield casings to help stabilize the permanent casing within the shield casing. The height of sand placed was determined by lateral analysis to ensure that the shielded permanent casing would not be driven out of deflection tolerances by movement of the shield casing due to stream flow. Then a reverse-circulation drill is used to drill through the concrete inside the permanent casing and down to the shaft tip elevation. After sonar caliper testing and performing any necessary horizontal cavity remediation techniques, the shaft reinforcement cage is lifted into place and the shaft concreted. The drilled shaft concrete design consisted of 4,000psi tremie placed concrete. Finally, once the CSL testing was performed and the shaft reached the specified compressive strength, additional sand was placed in the annulus between the permanent and shield casings to the mudline and the temporary shield casing was removed. Barge-mounted cranes and work barges are used to perform the drilled shaft construction are presented in Figure 7.

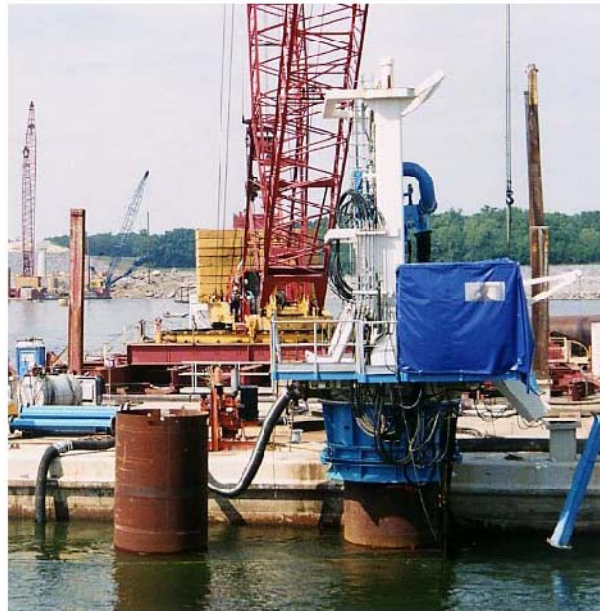
Figure 8: WIRTH Pile-Top Drill

As discussed earlier, the limestone bedrock in this area is extremely hard. During the first season of construction, the Contractor used a conventional reverse-circulation drill rig for rock socket excavation. However, due to the hardness of the limestone and the presence of significantly harder chert bands within the bedrock, production rates were as low as six inches per hour. In an effort to increase rock socket excavation production and catch up with the project schedule, the Contractor chose to purchase a German-made “WIRTH” pile-top drill rig, see Figure 8. A WIRTH drill is essentially a hydraulic drill rig that attaches to the top of the permanent casing, and pulls on the casing as it advances the drill head into the rock using the reverse circulation drilling system. This decision by the Contractor has proven to be very successful. Using the WIRTH drill, rock socket excavation production rates as high as two to three feet per hour were achieved.
