# 64<sup>TH</sup> HIGHWAY GEOLOGY SYMPOSIUM

SEPTEMBER 9-12, 2013 | NORTH CONWAY GRAND HOTEL | NORTH CONWAY, NEW HAMPSHIRE

PROCEEDINGS

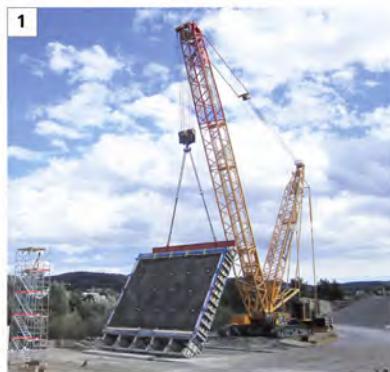
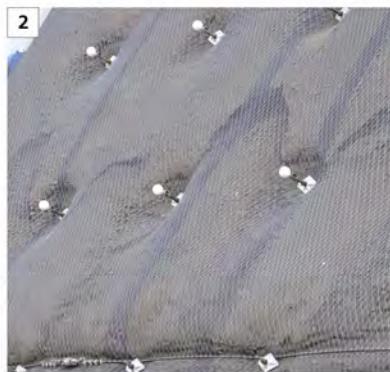
1. TECCO®- large scale field test,  
October 2012  
2. TECCO® mesh holds back  
270 metric tons of gravel  
3. Maximum inclination angle  
of 85° during the field test

## TECCO® stabilizes slopes, even under extreme conditions

... validated by the large scale field test with an inclination angle of 85°.

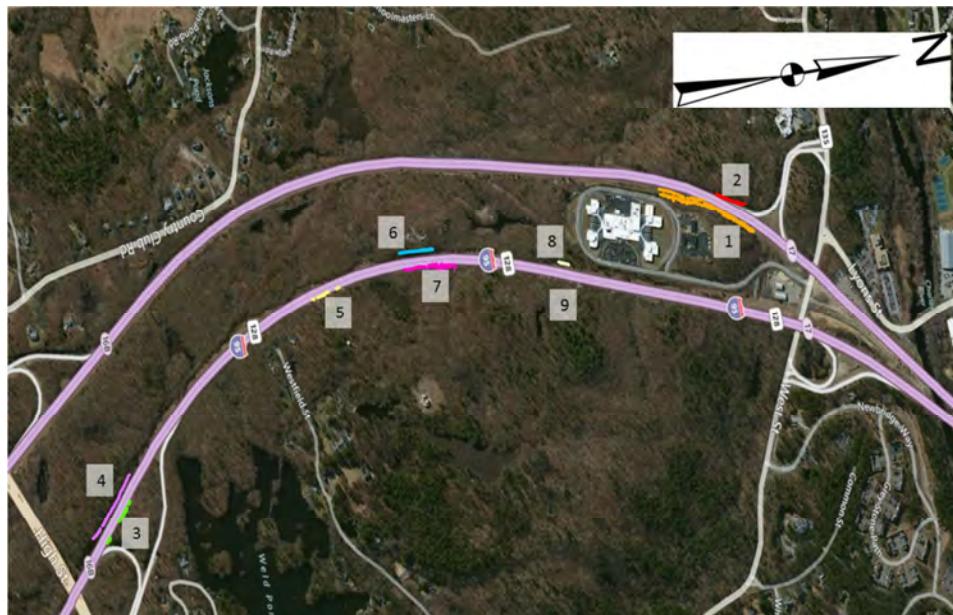
**Figure 1 – Project Location Shown on Aerial Photograph**

The area investigated for Section IV of the Add-A-Lane project included nine different rock outcrops along the northbound and southbound barrels of a 1.6-mile portion of the highway. The project limits and rock outcrop locations are indicated on the aerial photograph shown in **Figure 1**.

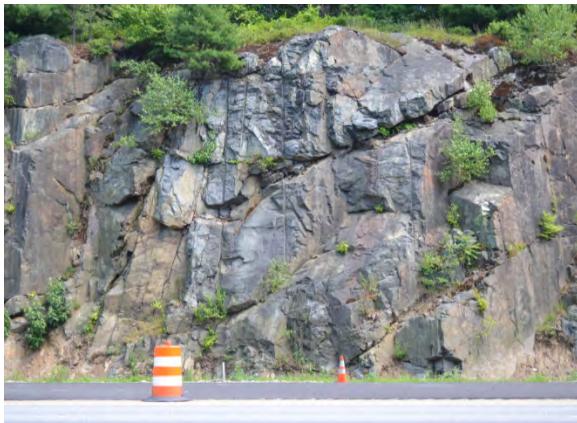
Photographs representing the range of conditions for the median rock slopes are presented in **Figure 2**.

2a – Outcrop 1, typical mid-slope benches at right

The nine rock outcrops investigated for this project were all created by blasting methods. At the left slope (median) rock slopes, visible half casts on the bedrock surface suggest that perimeter control was typically used in locations with rock slope heights greater than about 20 feet to provide a 1 horizontal to 4 vertical (1H:4V) rock slope, except near the tops or ends of rock exposures. Occasional mid-slope benches are present at Outcrop 1 that were apparently created during the original rock excavation and possibly enhanced by subsequent rock fall. The rock slope surface appears to have been damaged by blasting operations in some locations, primarily resulting in opening of fractures and/or partial dislocation of portions of the rock mass along existing jointing. In addition, differential weathering appears to have occurred along joint features in several areas.

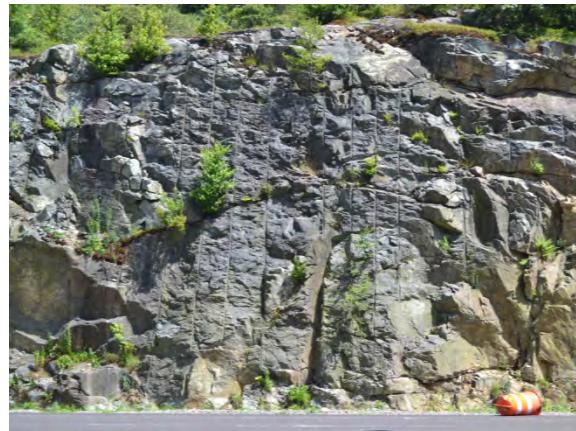
2b – Outcrop 1, without benches

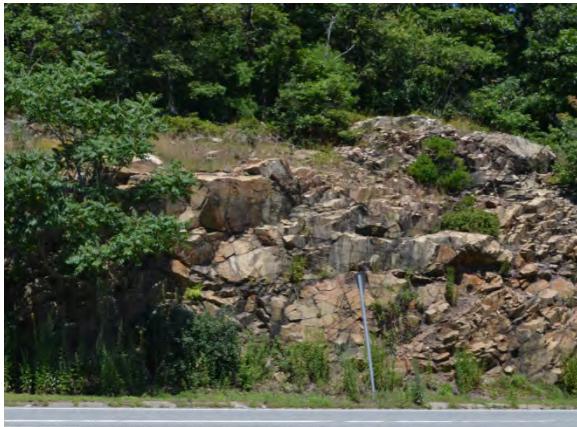
3a - Outcrop 2

The right (outside) shoulder slopes are characterized by irregular slope geometries, with inclinations ranging from past vertical (i.e. overhanging slopes) to moderate angle slopes (40 to 55 degrees), with low angle to horizontal mid slope benches in several areas. The condition of the rock slope surface varies along each of the outcrops. Some areas have a consistent slope and others have several slope changes and mid slope benches. These slopes appear to have been

drilled and blasted without perimeter control, resulting in geometry being largely controlled by the predominant local jointing patterns and joint spacing in the rock mass. Differential weathering was observed in several locations. Photographs representing these rock slopes are presented in **Figure 3**.

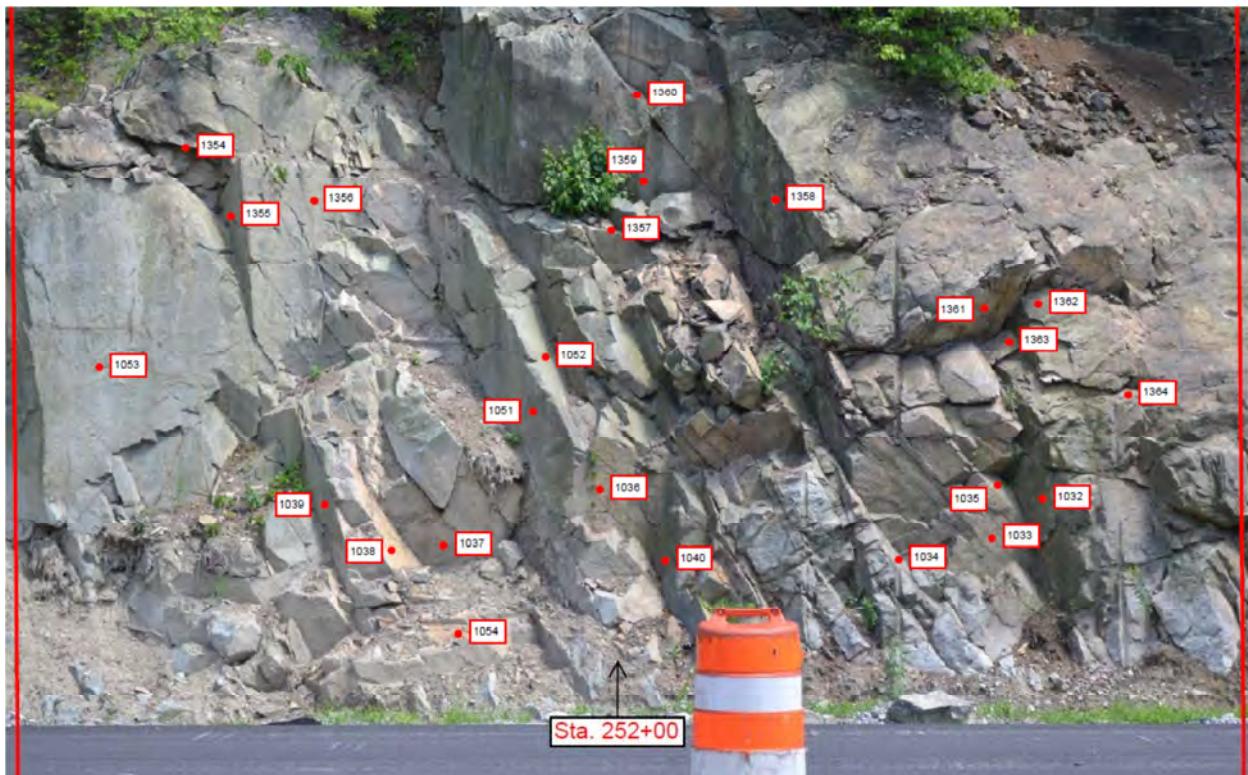
**Figure 5 – Photographs Annotated with Mapped Features**

Each feature was assigned an identification number, and marked on the rock face with a paint spot. The approximate locations of the mapped features were annotated on photographs of the rock slope, an example of which is presented in **Figure 5**.

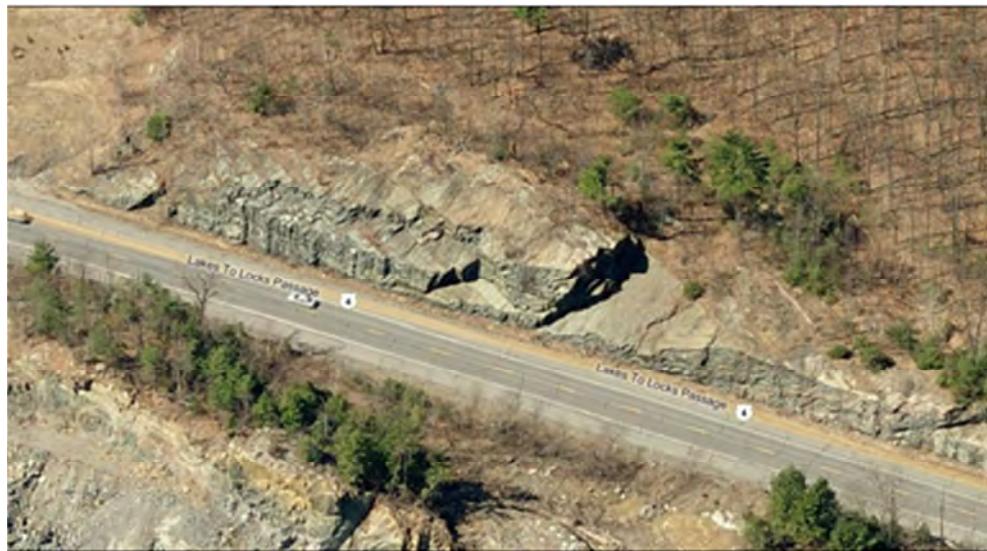
Figure 3 – Rockslope Site No. 2021 – photo of slope before major rockfall

There were two previously reported minor rockfalls during this period, the last one occurring in July, 2010. This consisted of a total of 18 cubic yards of rock contained by the ditch at three locations along the slope. At one of these rockfall sites, the rock failed around a rock bolt at the toe of the slope. Following this rockfall, the slope was inspected by NYSDOT geologists. It was determined that additional small rockfalls would occur, but that these falls would also be contained by the ditch. The recommendation was that the ditch be cleaned of rockfall to contain any future falls. Following the rockfall, geologists marked the slope with spray paint on both sides of the failure plane as a crude method to determine if the entire slope face was moving. There was no obvious evidence of a progressive failure occurring at the slope.

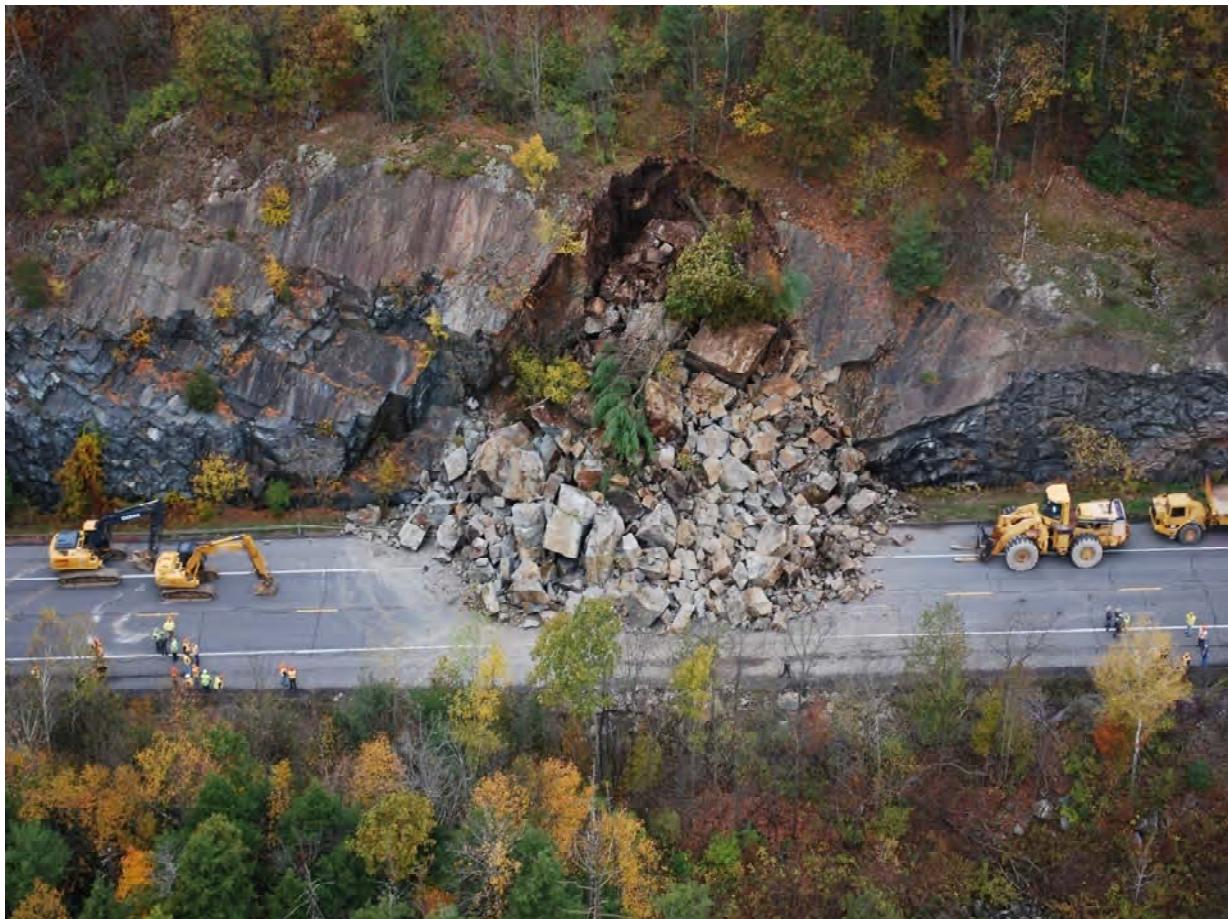
Figure 4 - Rockfall photo from State Police Helicopter 10/15/12, 10 AM

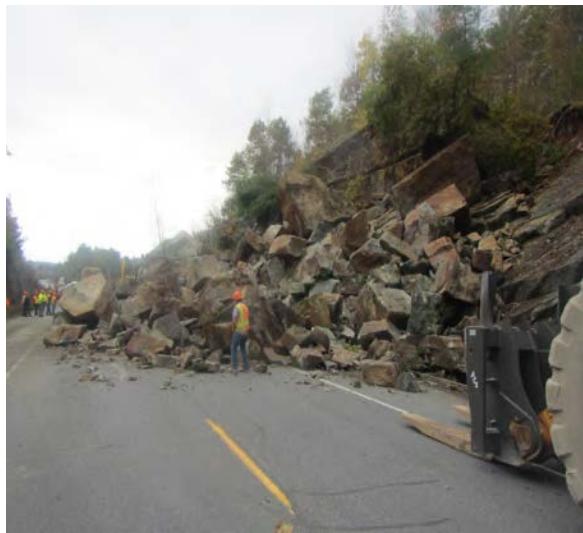
Figure 5 - Rockfall ground view

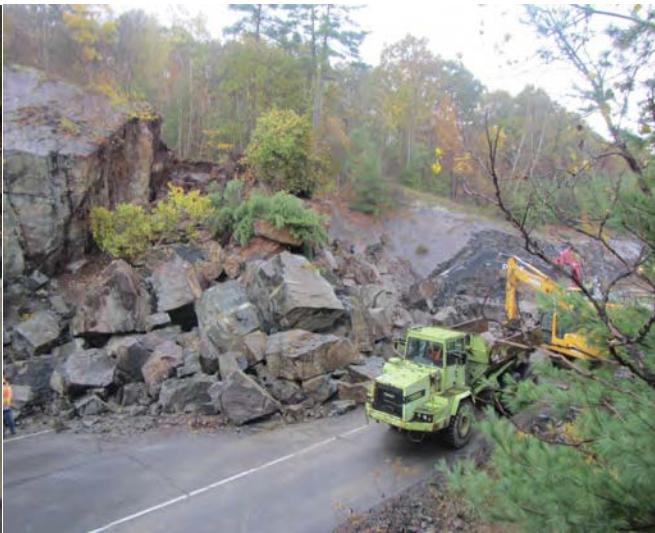
Figure 6 - Rockfall from slope across road

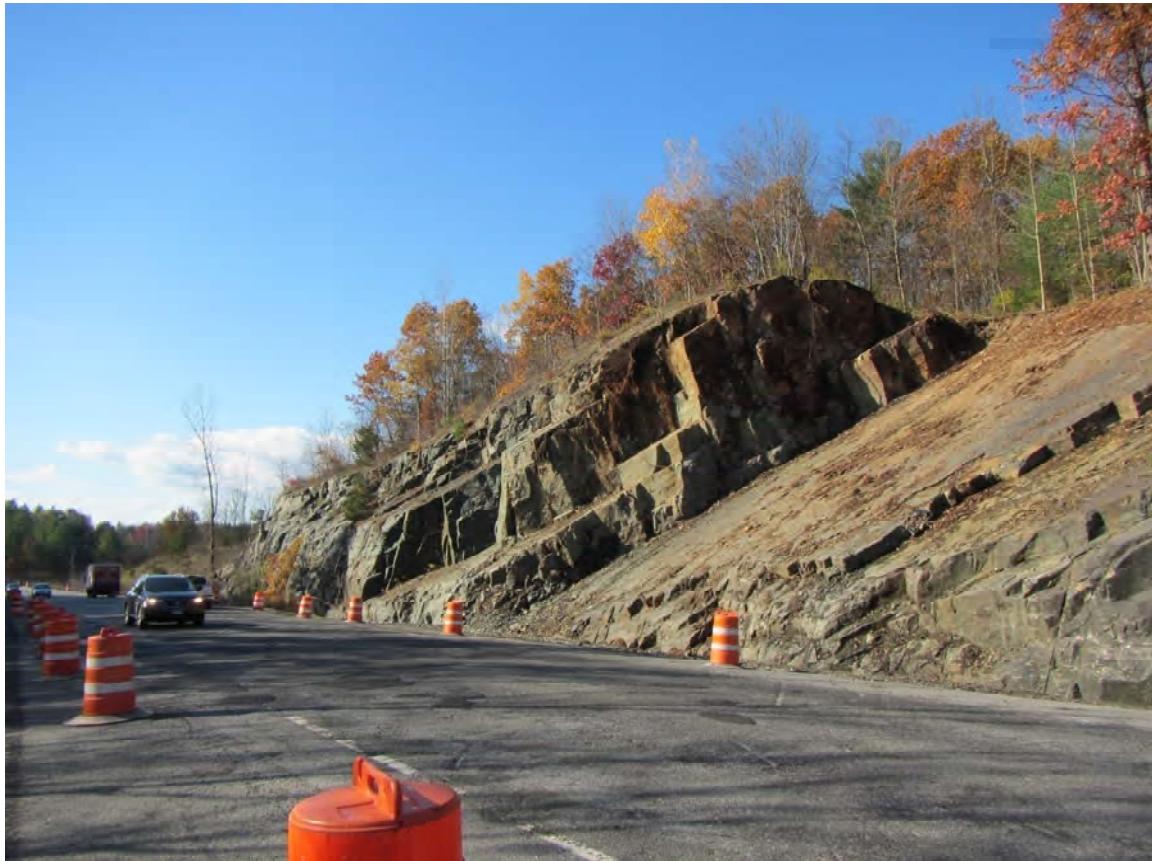
Figure 7 - Road reopened following rockfall cleanup

Fortunately there were no detectable movements of the slope following the emergency cleanup, and both lanes of the road were reopened on October 18<sup>th</sup>, only three days after the rockfall. Even though the slope was being monitored and showed no movement, geologists recommended that remediation of the slope south of the failure begin before the winter and more freeze-thaw cycles.

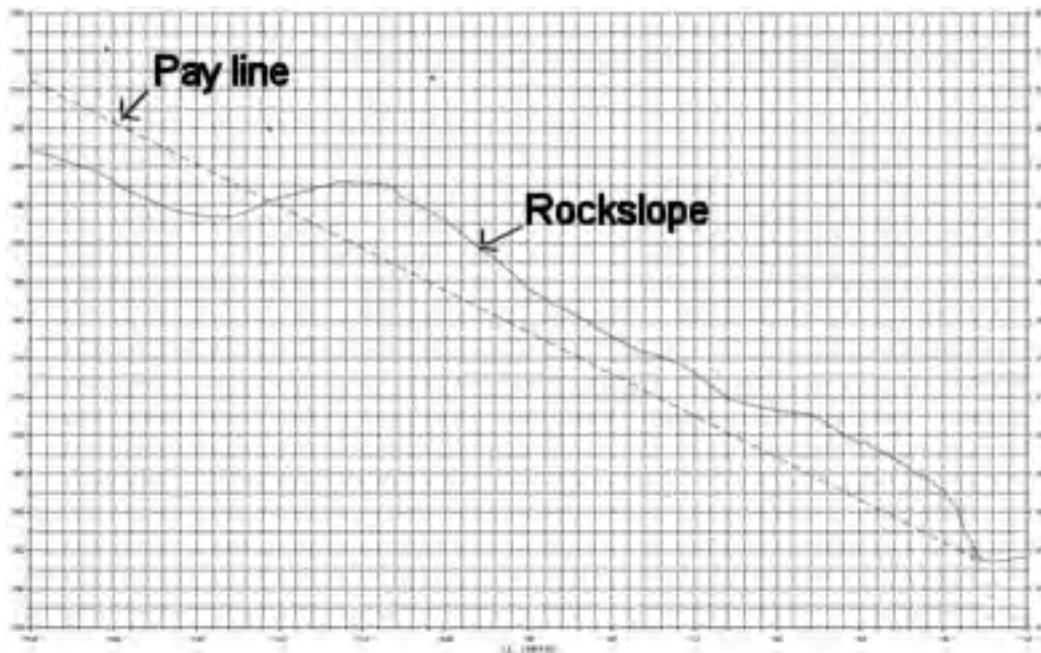
Figure 12 - Cross section of recut slope design

pay line for the new slope. Fortunately, this plane daylighted in front of an old logging road behind the slope. A blasting subcontractor could set up drill rigs along this abandoned road and drill on a 30 degree slope angle to match the failure surface angle. Based upon the model and projected 30 degree surface, it was estimated that 10,815 cubic yards of rock would need to be blasted. The total cost for the blasting and excavation work at the agreed upon Emergency Contract bid price of \$20 per cubic yard was estimated to be \$216,300.

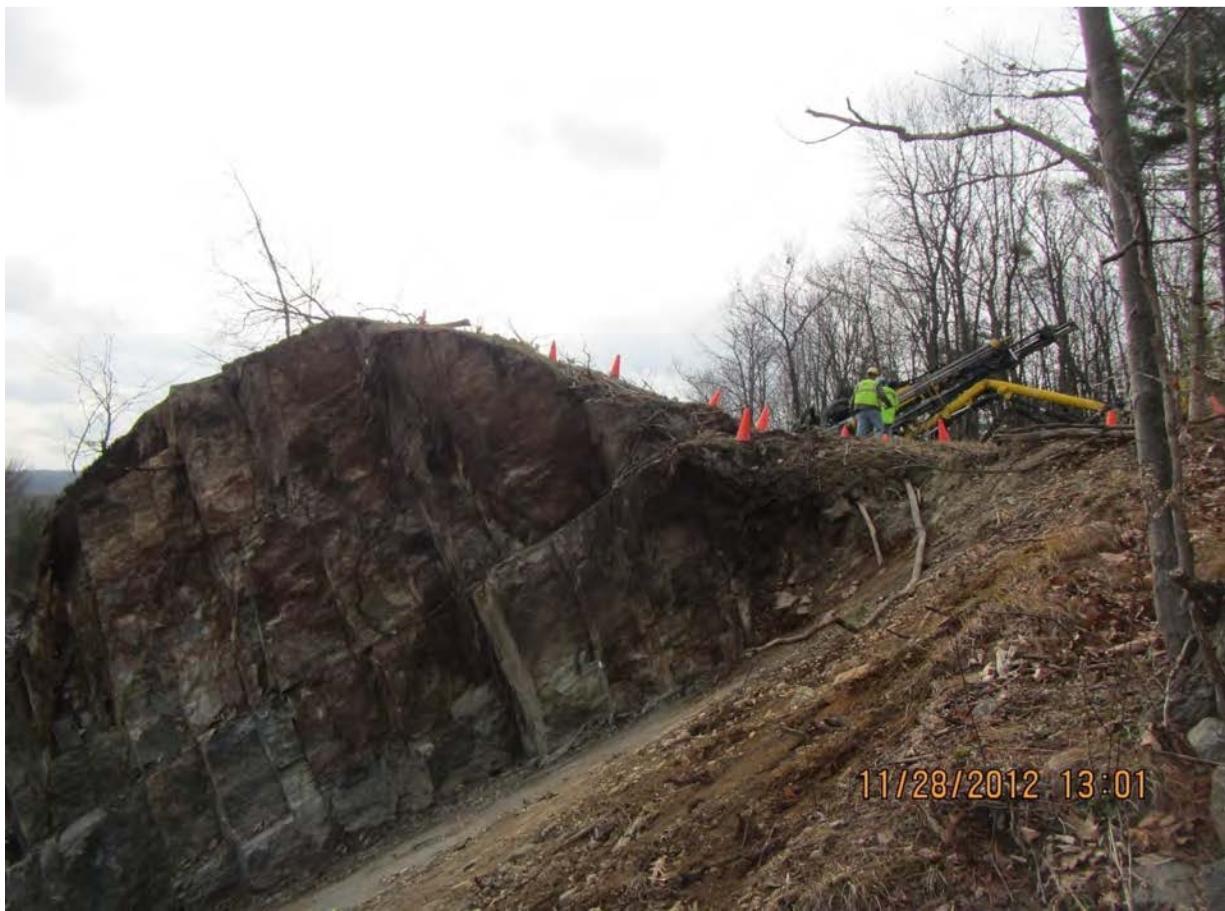
Figure 13 - Drilling at 30° angles

Soon after the pre-blasting meeting the contractor was given the DTM model of the rockslope and cross sections to use. After reviewing the sections and rethinking the blasting plan with the DOT Geologists, the blasting subcontractor decided to drill on a 30 degree angle and stay five to six feet above the pay line with the back row of holes. An additional two rows of drill holes were drilled in front and above the back row of holes. The old road behind the slope proved to be a good access road and drilling platform. Clearing and grubbing and construction of the access road began on November 26<sup>th</sup>. Some fill was required to ramp up and reach some of the drilling locations, and the drillers and rigs needed to be tied off.

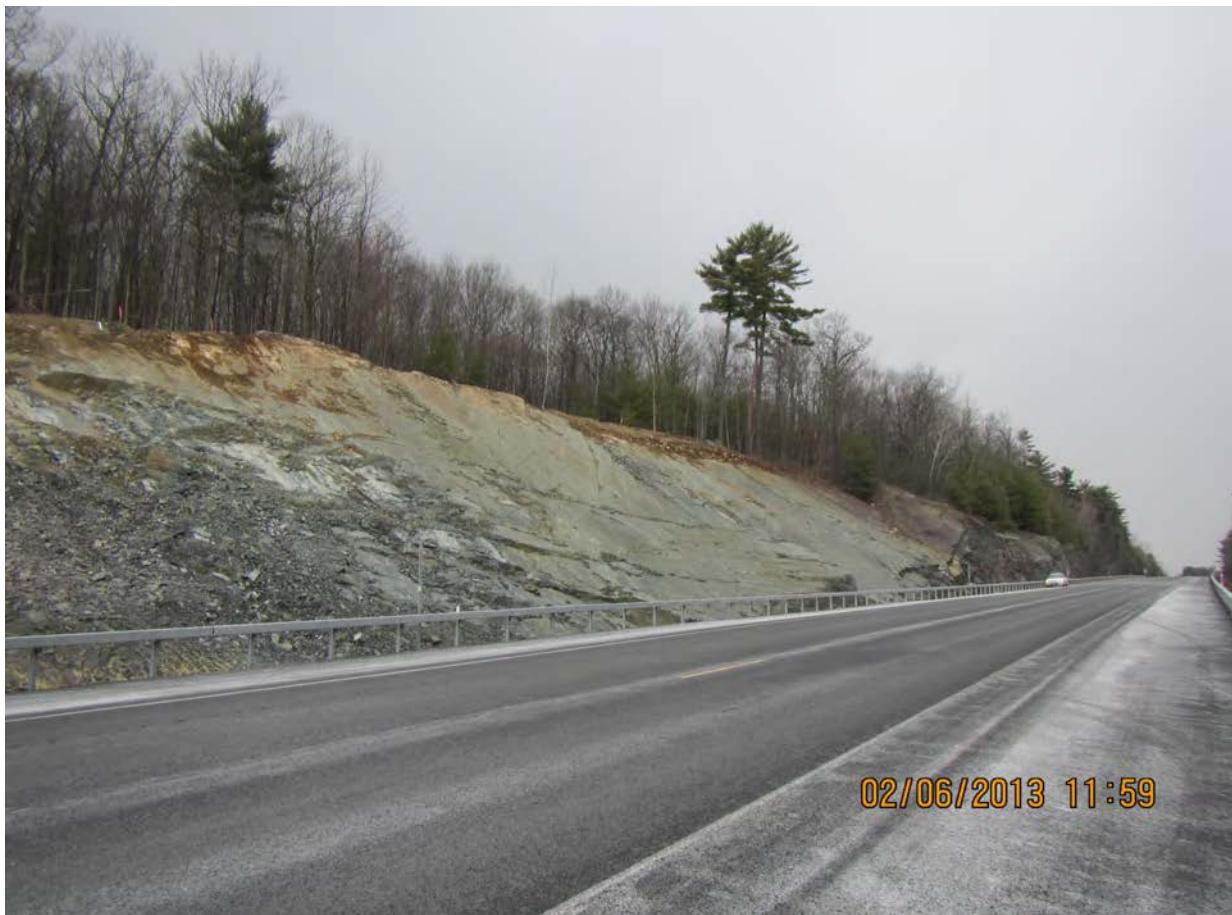
Figure 14 - Finished Rockslope

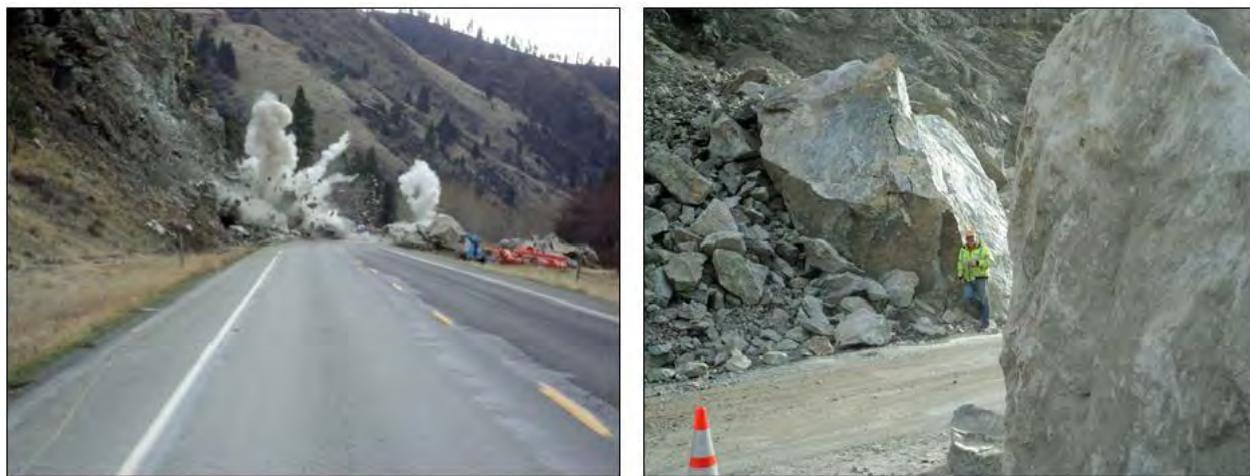
**Figure 2: Clean-up of several 100 yards of rock debris on US-95 on 3 December 2012. Note maintenance individual next to boulder for scale in right image. Large boulders had to be blasted (photographs supplied by ITD maintenance personnel).**

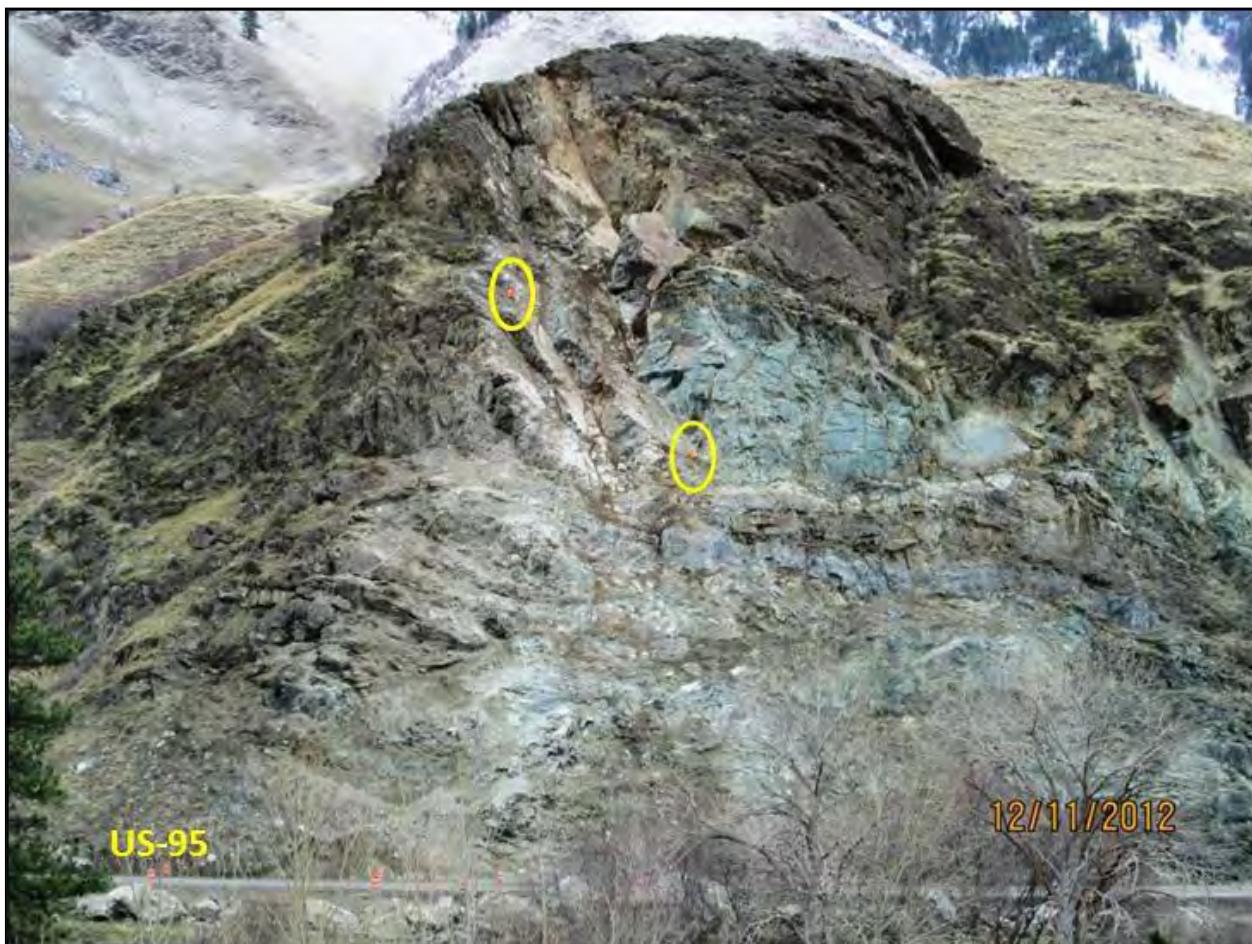
**Figure 3: Rockslope source area for the rockslide above US-95. The rockslope is about 250 feet high; rock climbers surrounded by yellow circles provide scale. The rock mass consists of “Greenstone” schist, serpentine, and zones of talc and asbestos.**

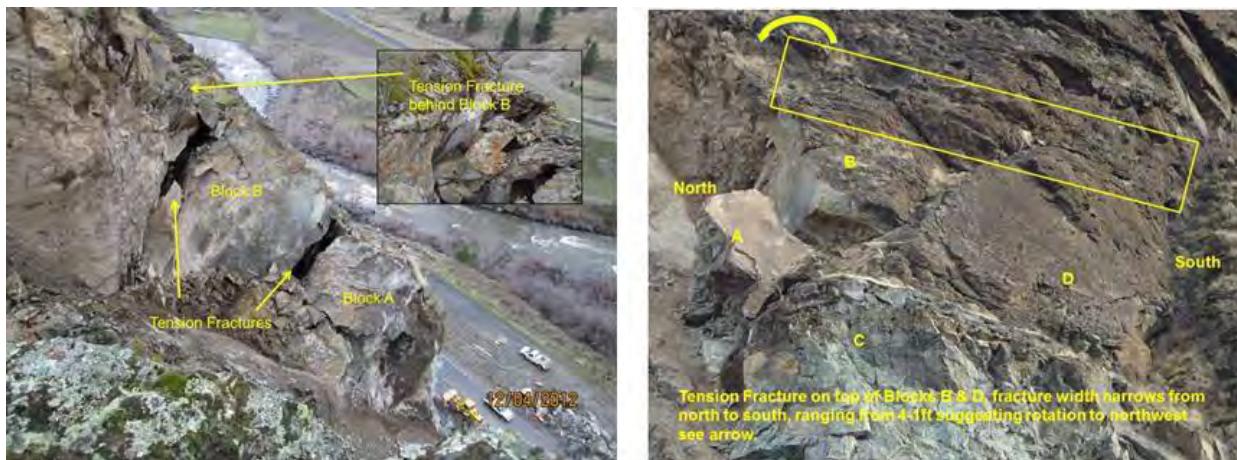
**Figure 5:** Original tension fractures that have dilated as a result of the rockslide.

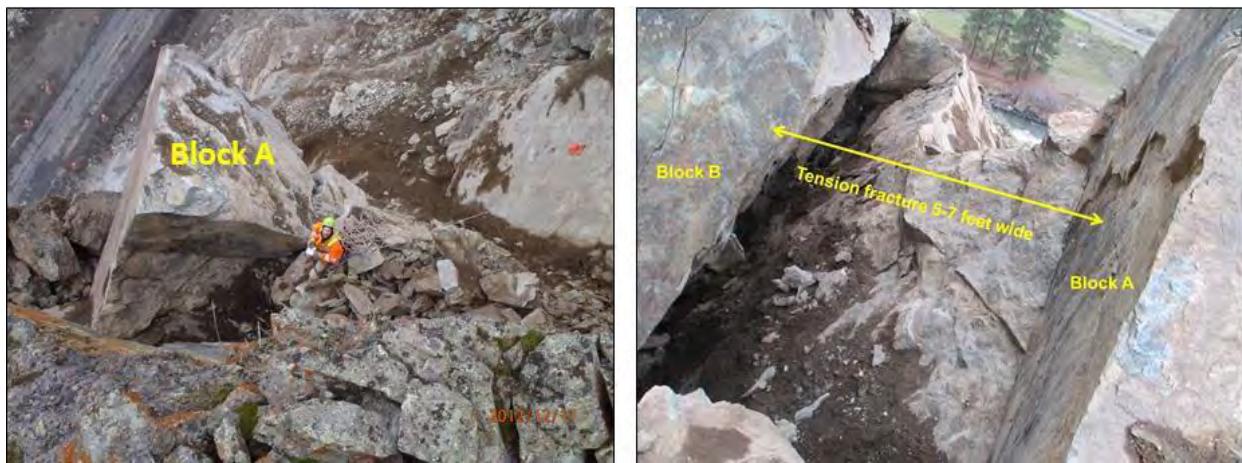
**Figure 6:** Tension fracture between Block A and Block B, hanging wall. Note fracture continuing below Block B.

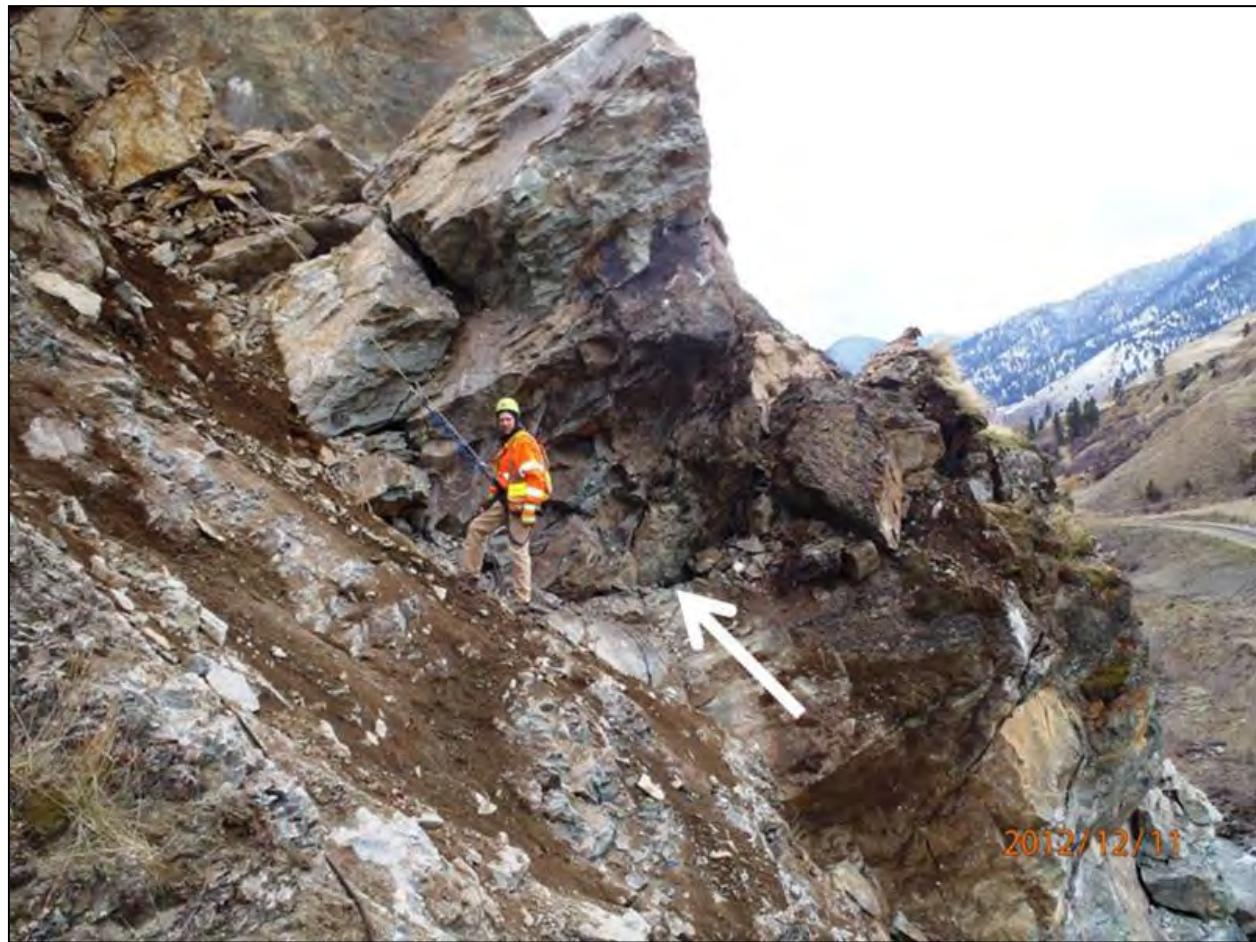
**Figure 7:** View of Block A from the north. The arrow is pointing to a tectonic shear that is likely associated with the ledge. The block is approximately 30 feet high and 20 feet wide at the base. Intact rock is very strong and massive. Jamie Schick is for scale.

As a result of the rockslide, Block A separated and rotated from Block B, moving to the open face where the supporting rock mass was removed by the rockslide that occurred on 2 December, 2012. Consequently, Block A was very unstable. Rotation of the block created a large tension feature by dilation between Blocks A and B (Figures 5 and 6). During our assessment, Block A appeared to be toppling towards the highway. In addition, because of the rotation, it appeared to be sliding in bearing failure through the basal shear zone (Figure 7) and rock mass.

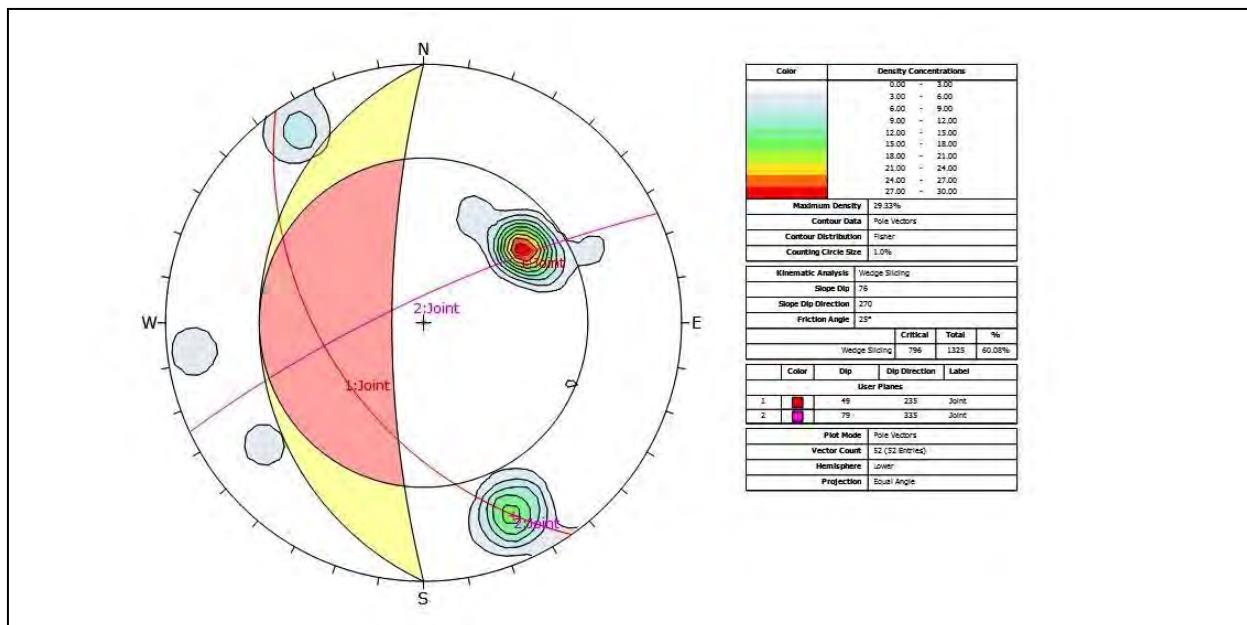
**Figure 8:** Stereonet displaying the kinematic relationship of the discontinuities and the rock face that created the rockslide. The rockslide failed as multiple wedge failures.

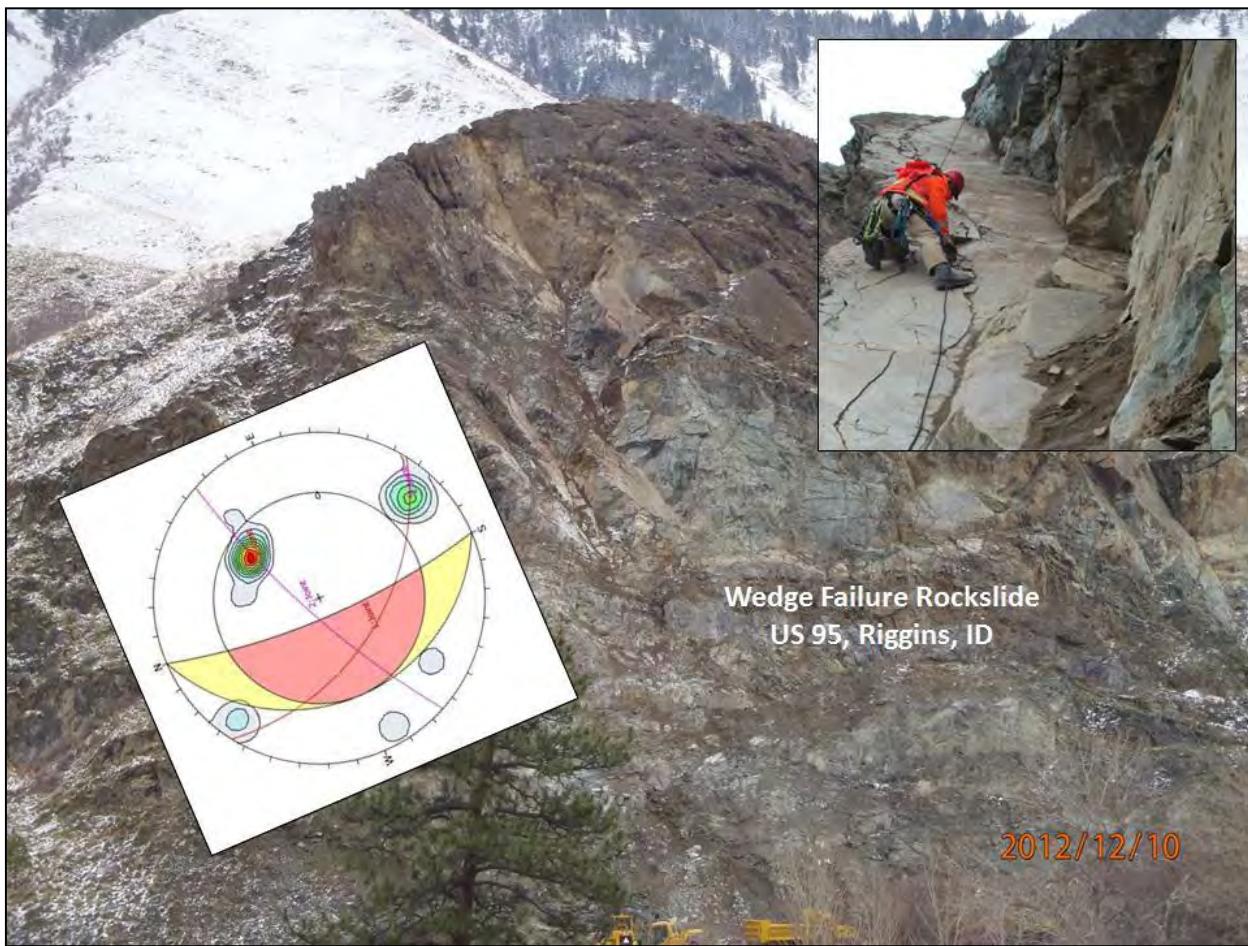
**Figure 9: Mapping and kinematic analysis of the rockslope (via stereonet, Dips V6). The steep rock face above the highway dips about 75 degrees to the west.**

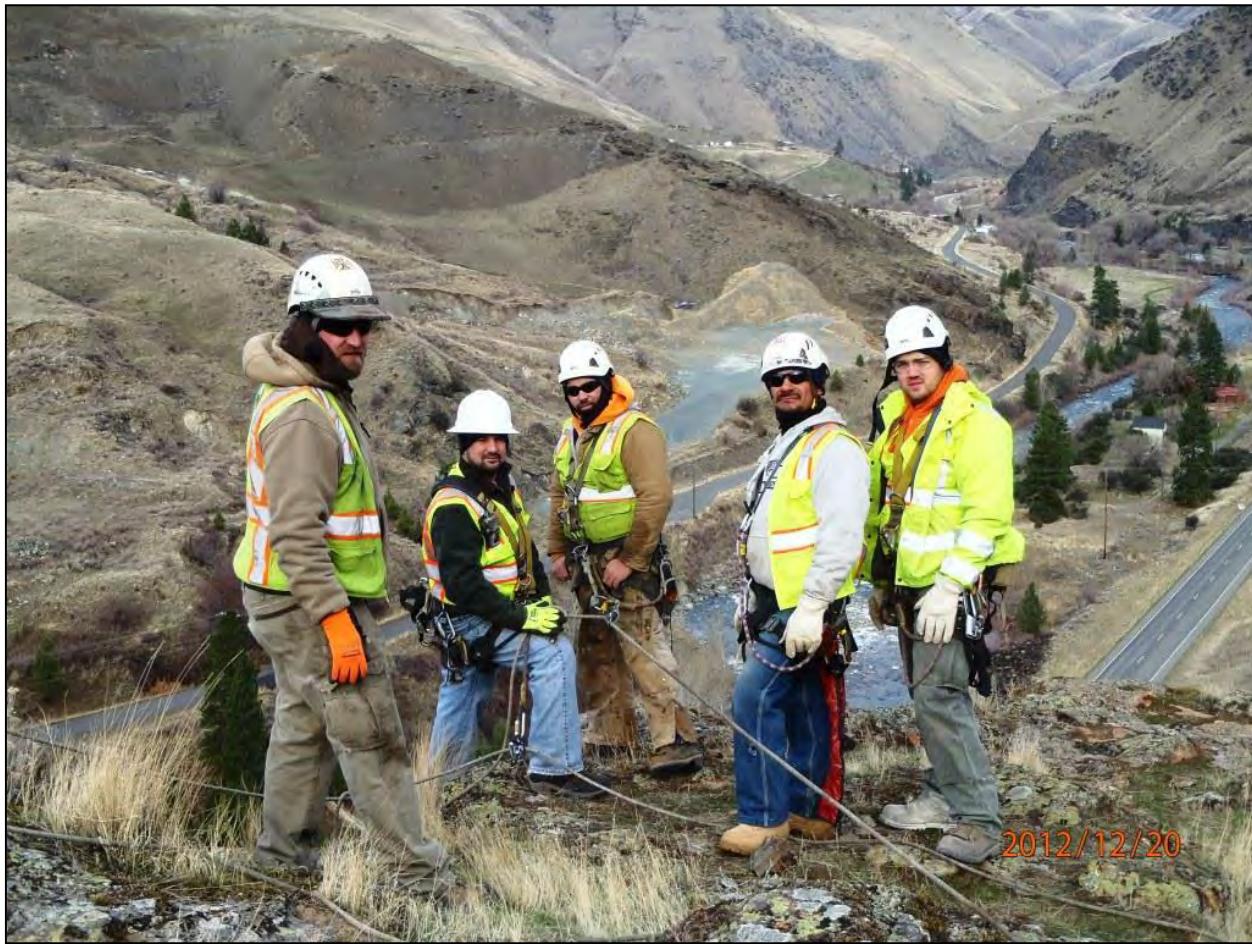
**Figure 10: Midwest Rockfall Contractors**

Based on our recommendation, ITD immediately contacted Midwest Rockfall Contractors (MRC) to mobilize to the site and implement the recommendations. MRC scaled and removed approximately 100 yards of rock before it was able to access Block A.

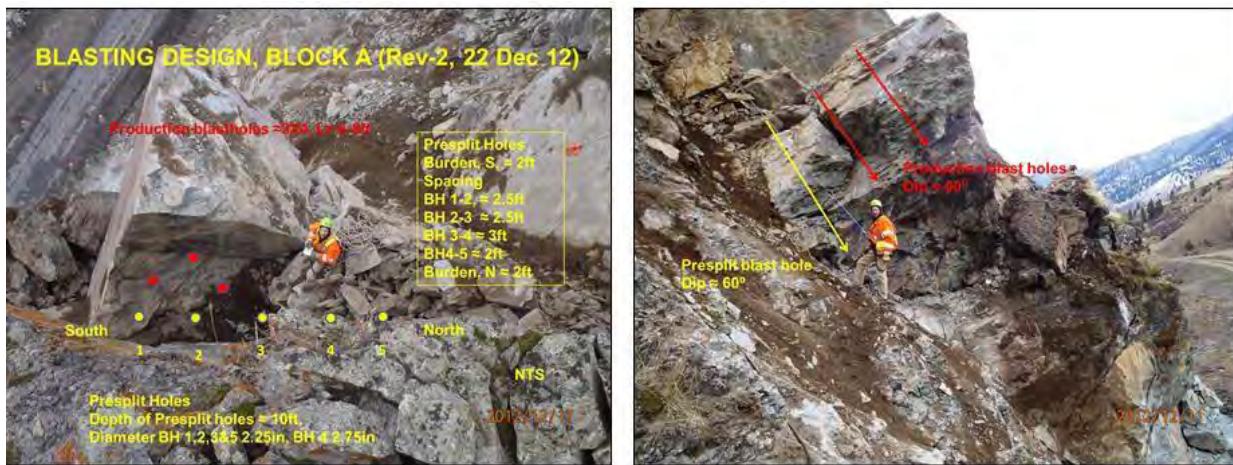
**Figure 11: Presplit blasting design for Block A. Blast design was modified from a cushion blast because we wanted to ensure that after the blast we could achieve a clean and stable back wall.**

cushion blast. The cushion blast may lead to overbreak, depending on the geologic conditions. Because our goal was to achieve a stable back wall with the hanging wall of Block B, we elected to remove Block A by presplit blasting. Figure 11 displays the blast design layout.

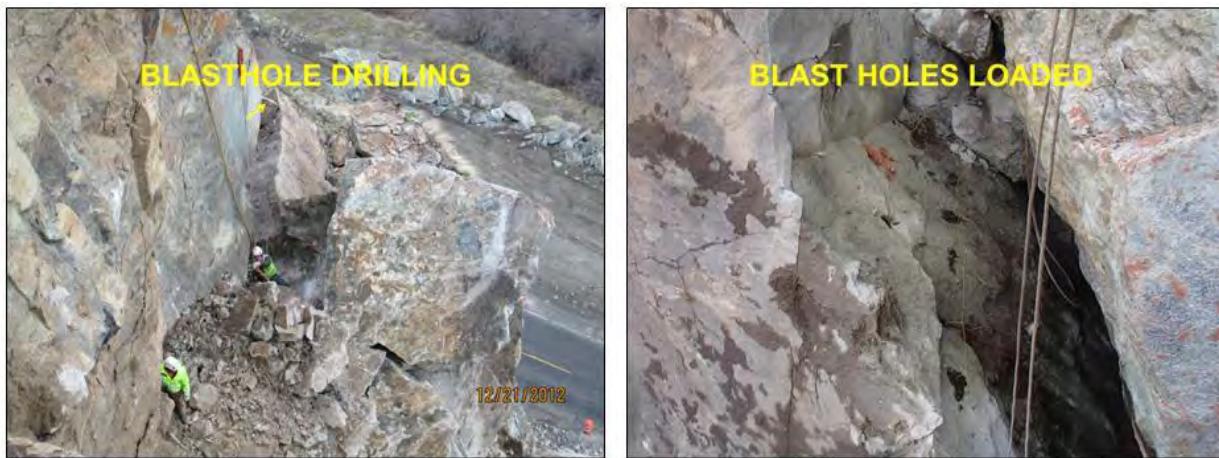
**Figure 12: Drilling blast holes behind Block A (left); and loaded blast holes (right). Extensometer constructed from telescoping PVC is visible under the “O” in the left photograph, refer to arrow.**

Because of the very strong and hard rock, drilling of the blast holes was difficult and time consuming and it took about 16 hours to drill eight boreholes. The contractor attempted to space the boreholes between 2.0 feet and 2.5 feet. Spacing was controlled by the drilling conditions. To monitor the stability of the block during drilling, MWR installed a “poor man’s extensometer,” constructed with telescoping PVC pipe across the tension fracture between Blocks A and B (Figure 12). As MWR personnel were drilling the blast holes, they observed at least one inch of movement of across the tension fracture.

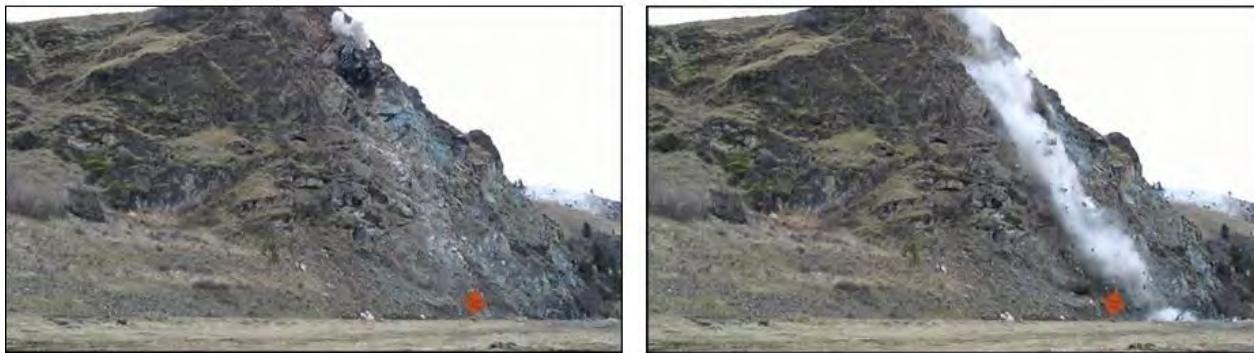
**Figure 13: Blasting removal of Block A at 1230 hours 23 December 2012.**

Once the blasting holes were drilled and loaded, the blast occurred around noon on 23 December (Figure 13). The presplit blast worked as designed and cleaved the block from the face, leaving a relatively clean back wall (Figure 14). The debris slid down the rock face, creating a manageable muck pile at the base of the slope. The ITD quickly moved the debris muck pile to the edge of the road (Figure 15). The road was then reopened for the 2012 Christmas traffic.

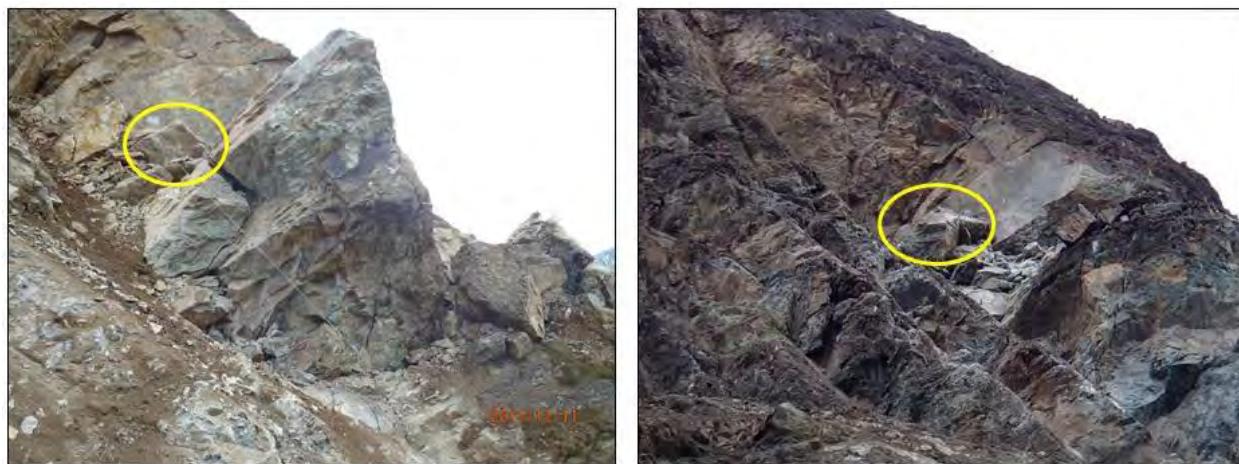
**Figure 14: Photographs comparing removal of Block A. Reference block is circled in yellow.**

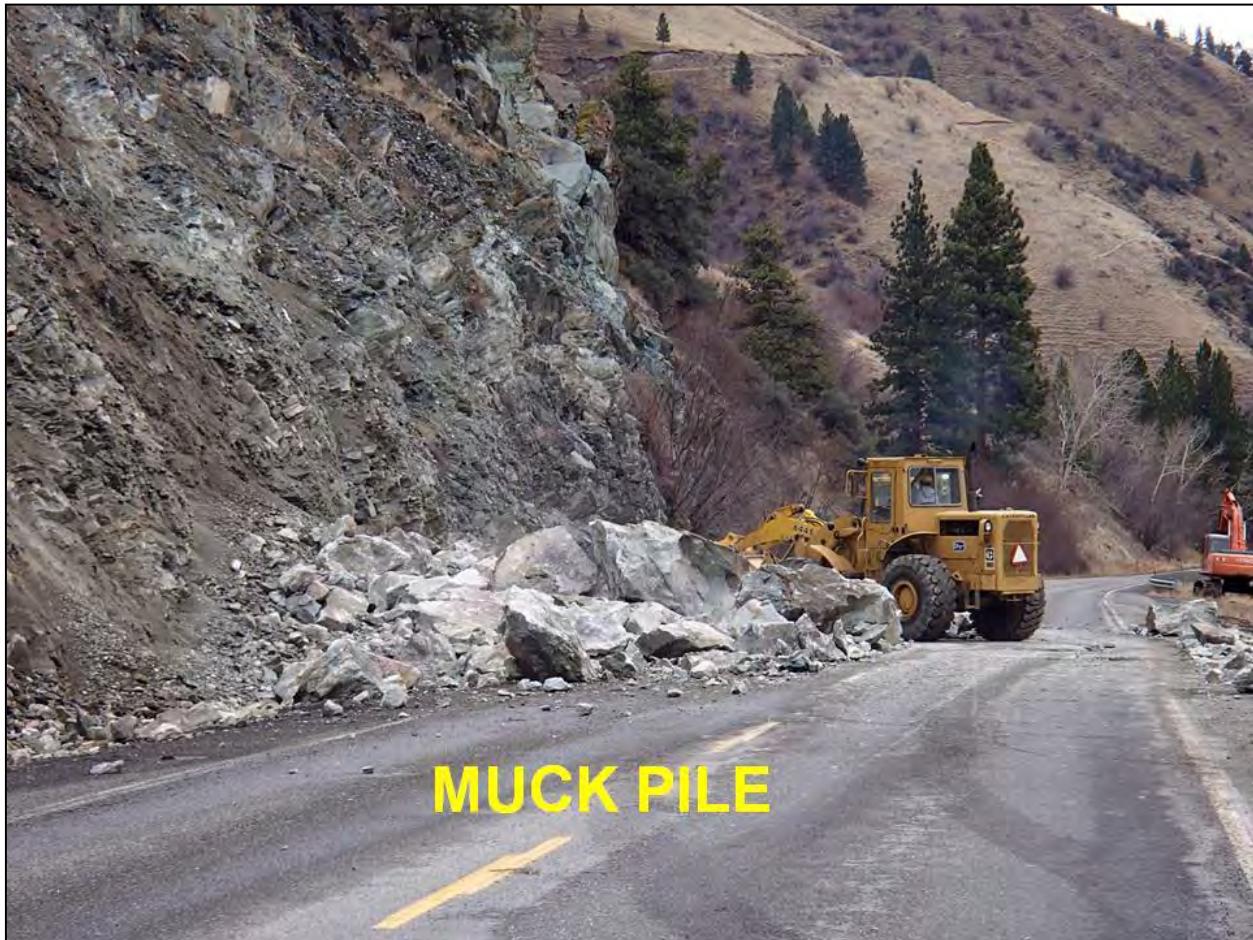
**Figure 15: Final cleanup of muck pile on US-95 after blasting Block A.**

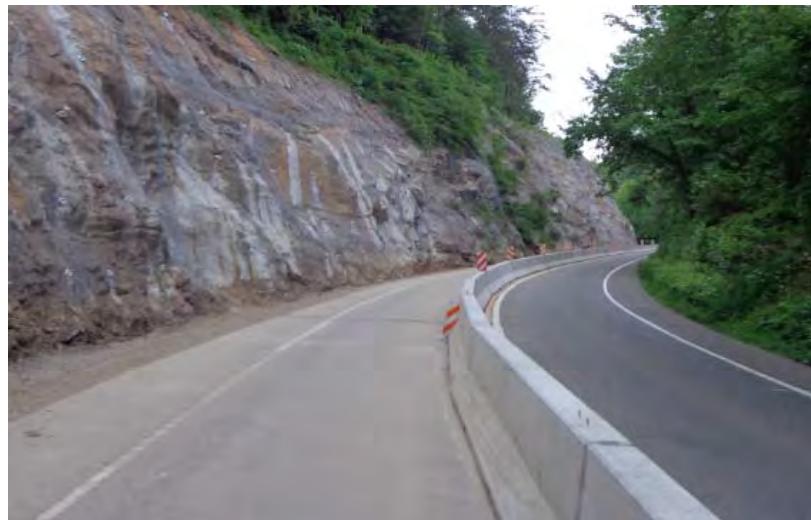
**Figure 2 – Work Zone**

Jersey barriers were installed between the travel lane and work zone with temporary traffic signals placed on each end of the construction zone to alternate one-way traffic along the 11 feet wide travel lane. Traffic was alternated every few minutes, 24 hours a day.
