# 64<sup>TH</sup> HIGHWAY GEOLOGY SYMPOSIUM

SEPTEMBER 9-12, 2013 | NORTH CONWAY GRAND HOTEL | NORTH CONWAY, NEW HAMPSHIRE

PROCEEDINGS

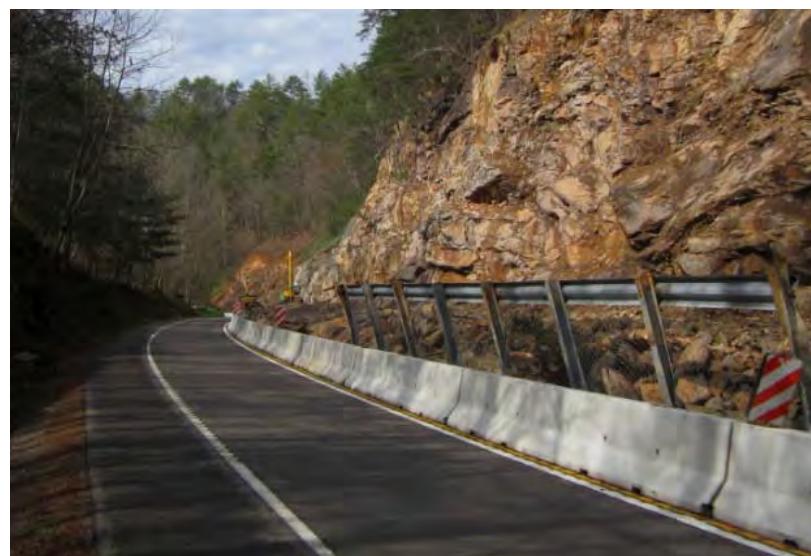
**Figure 3 – Working Platform**

To preserve the asphalt condition within the work zone, a 12-inch layer of 3/8-inch pea-gravel was placed over the asphalt within the work zone. Scaled material was allowed to accumulate over the pea-gravel and reshaped to create a working platform up to 10 feet above the roadway elevation. This bench created a wider catchment platform for scaled material, decreased the heights the material was allowed to fall, and brought the working area to within reach of smaller more versatile equipment. This increased the project safety and production rates for both scaling and rock bolting operations.

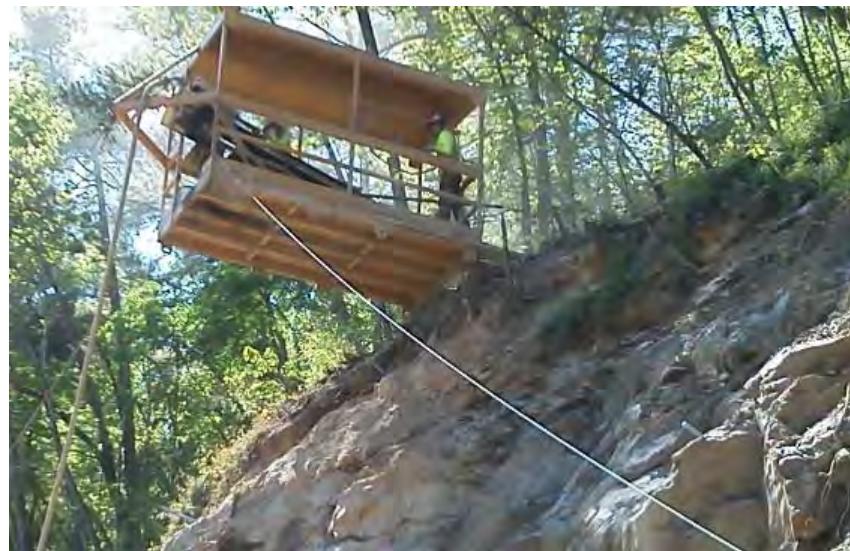
**Figure 4 – Crane Basket Drilling**

Upon completion of the scaling operation, 150 ksi galvanized No. 8 all-thread rock anchors were installed on a 10 foot staggered pattern with embedment lengths up to 27 feet. This was completed by both specialty drilling equipment staged along the working bench and from a crane basket drill capable of working from cranes capable of staging within the 18 feet wide construction area.

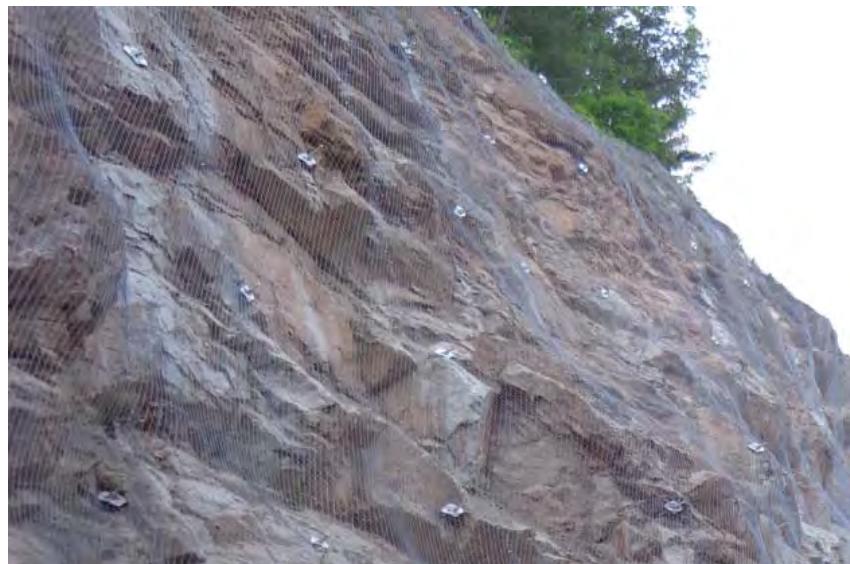
**Figure 5 – Mesh Facing**

The face was draped with a Geobrugg TECCO® mesh with galvanized TECCO® spike plates. Additional spot bolting was also accomplished to ensure the mesh had uniform anchorage and unique blocks and jointing were anchored.

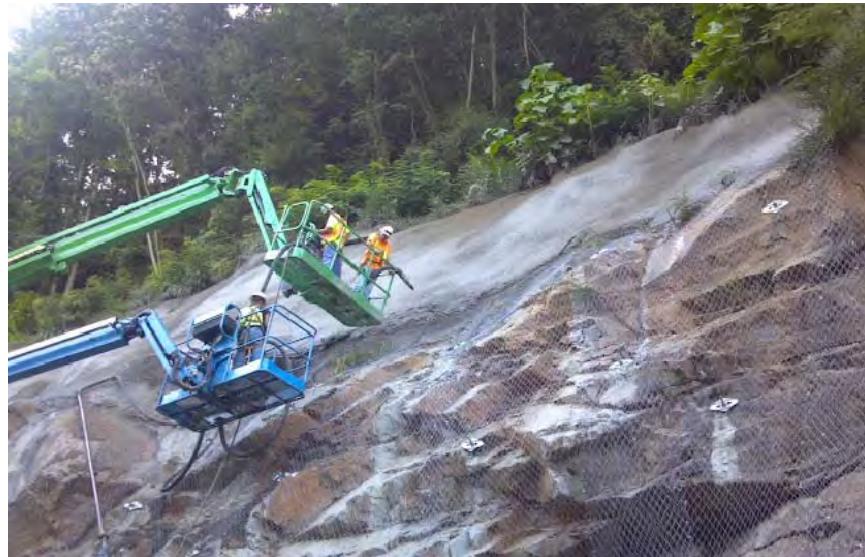
**Figure 5 – Shotcrete Facing**

During construction, locations of highly weathered sandstone and soil seams were discovered. TDOT and GSI® engineers jointly formulated a plan to cover these areas with steel reinforced shotcrete anchored to the slope with soil nails and rock dowels.

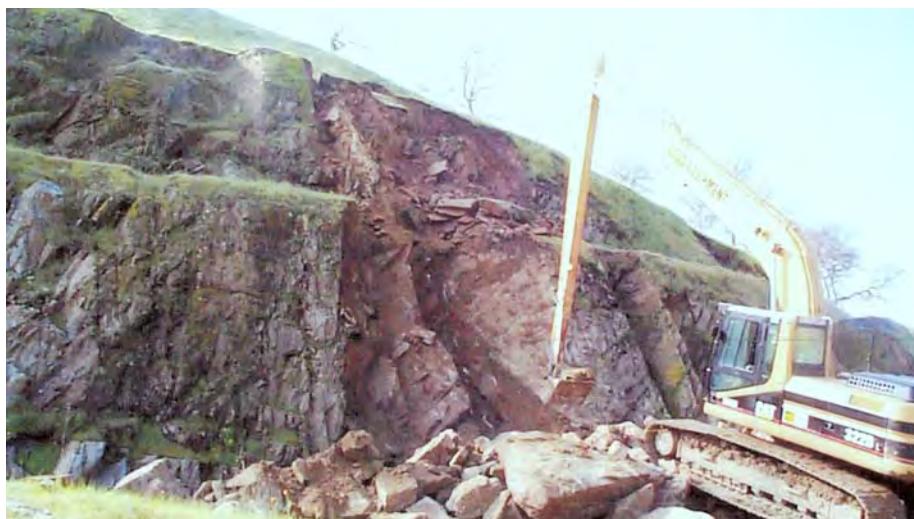
**Figure 6 – Wedge Failure in 2005 Following Substantial Rainfall (Photo Courtesy USACE)**

The 90-ft tall rock cut slope exhibited episodic failures since its construction and generally occurred following periods of substantial rainfall (Figure 6). Some failures had been large enough to block road passage and raise concerns regarding both impending rock fall hazards and the long term stability of the cut slope.

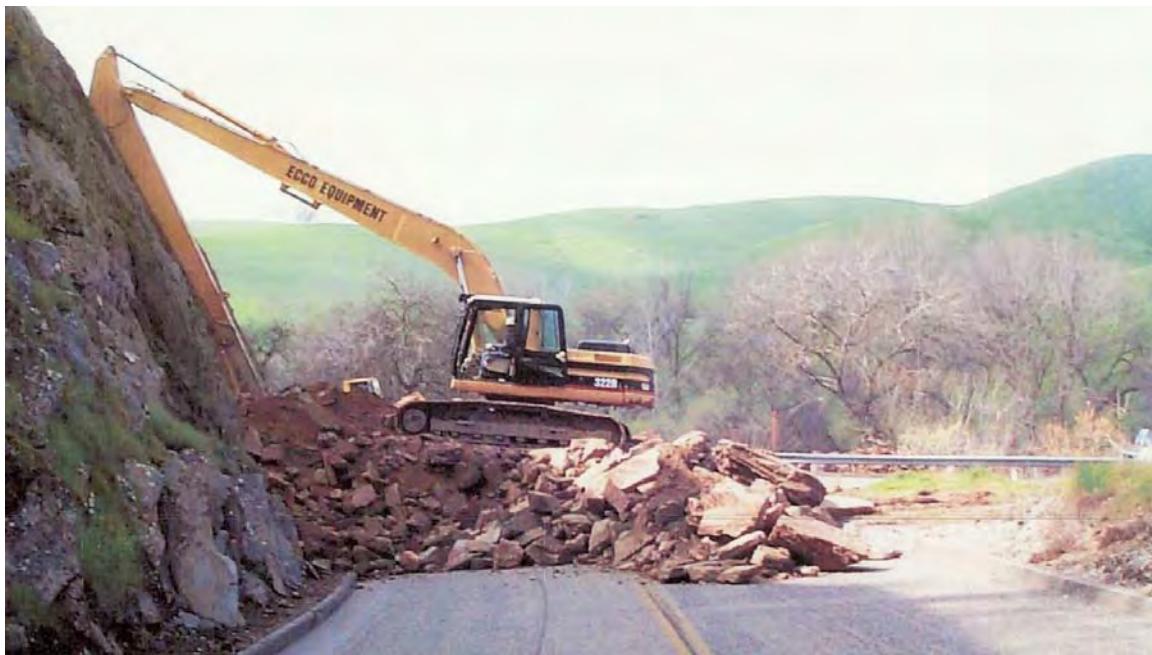
**Figure 8 – Failure in 2005 Showing Rock Blocking Access Road (Photo Courtesy USACE)**

Upon receipt of the consultant's recommendations, the USACE sought out a specialty contractor to scale the rock cut slope. Following the scaling effort the slope continued to exhibit failure and in 2005 produced a large wedge failure that completely blocked the access road (Figure 8). The material was removed and no other remediation measures were employed at the time. During the 2010-11 winter season park officials reported that several large rock blocks up to 30-ft in height and 20-ft in width had fallen on the road and were concerned about the apparent dilatation of some of the rock blocks within the slope.

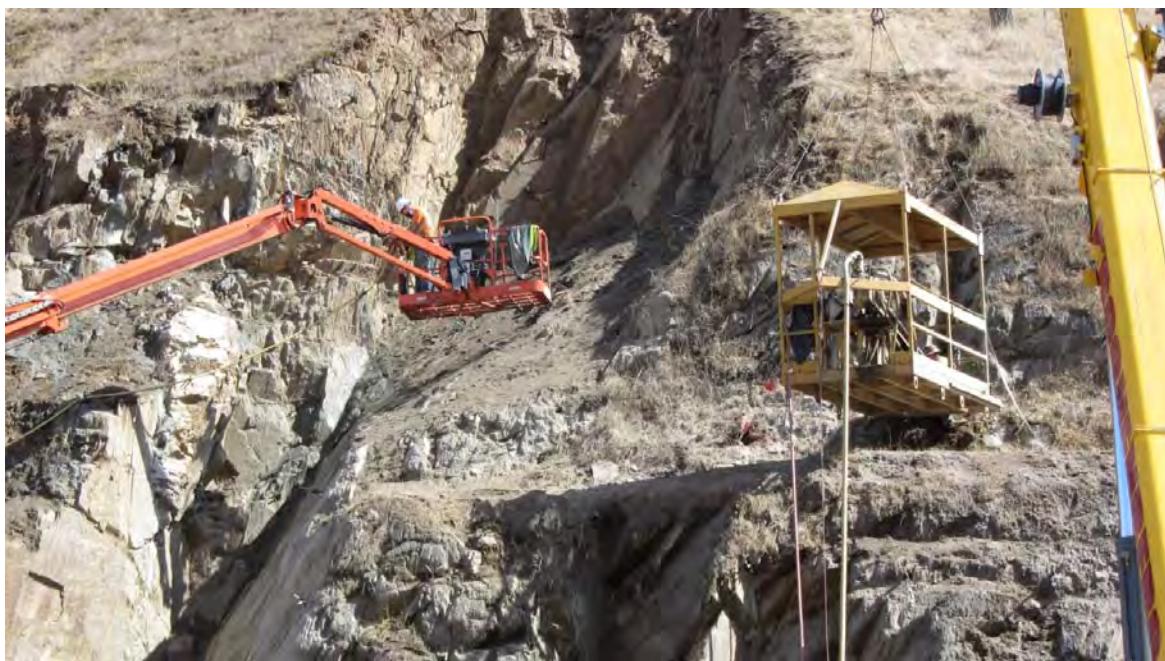
**Figure 9 – Scaling and Rock Dowel Installation in Progress**

Construction started in May 2011 with a scaling operation then followed by installation of the rock dowels and Maccaferri's B600 double twist wire mesh cable system (Figure 9 & 10). To date the USACE reports no further dilation or failure of the rock slope.

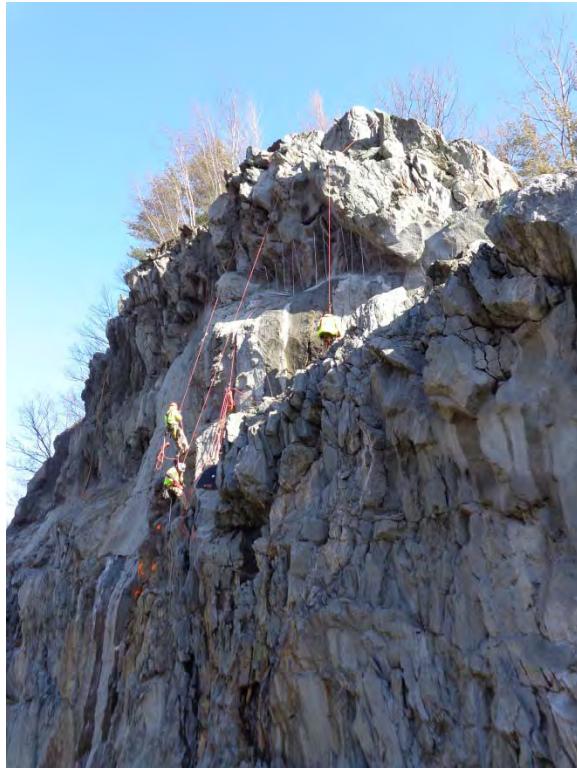
**Figure 12– Scaling Operations with Air Bags**

Scaling and tree/vegetation removal required coordination with VTrans traffic control and the sheriff's office. Figure 12 shows a sizeable unstable rock removed with an air bag. A temporary rockfall mesh was draped from excavators at roadway level to reduce the potential for rockfall debris into the adjacent traffic lane. Rolling road blocks were used intermittently to mitigate high risk operations. Many rock features were scaled off the slope; others posed too great of risk to remove and were secured to the slope with shear key buttresses and rock dowels.

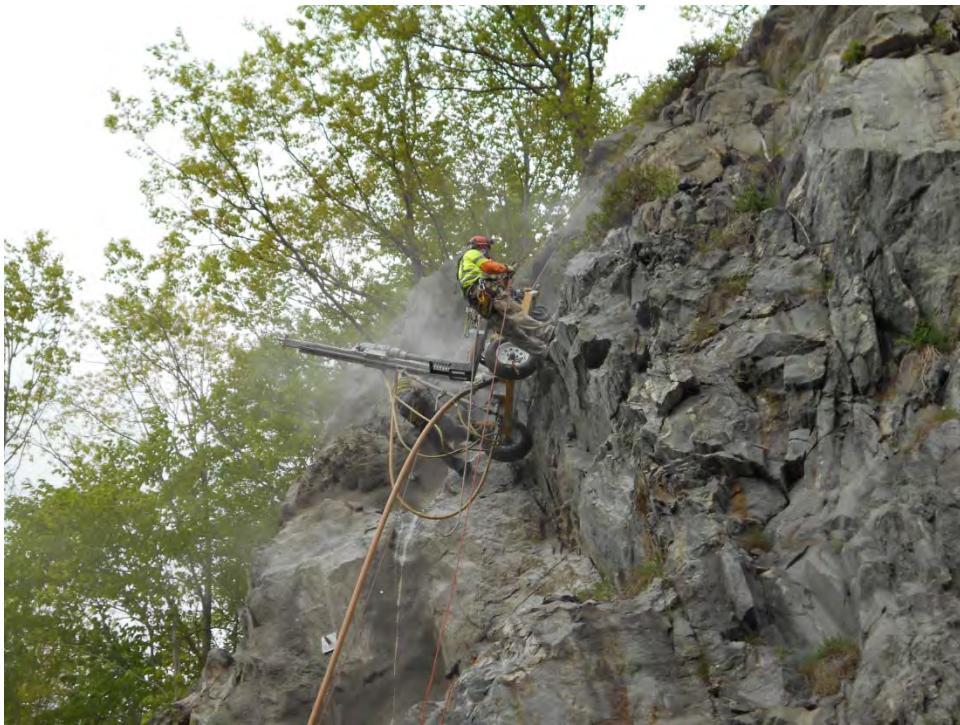
**Figure 13– Drilling Rock Dowels with a Wagon Drill**

In combination with the scaling operation, GSI® placed a thin layer of fiber reinforced gunite (dry shotcrete) to provide temporary stabilization of the rock features. Following gunite placement, GSI® engineers and rockfall technicians designed and constructed buttresses to provide support of cantilevered rock sections near the crest of the slope. Wet shotcrete was used to provide structural facing over the unstable rock masses. Maccaferri's Wirand FS7 steel wire fibers were used in the wet and dry shotcrete. The fiber dosage rate was designed to provide a similar reinforcement of 4x4 W2.9xW2.9 welded wire mesh. Spot rock doweling was installed through the shotcrete areas to secure rock masses to stable areas. Rock doweling was performed using multiple wagon drills and plugger drills. Rock dowels consisted of galvanized #8, Grade 75 ksi, all thread bar, installed in depths varying between 10 and 25 feet.

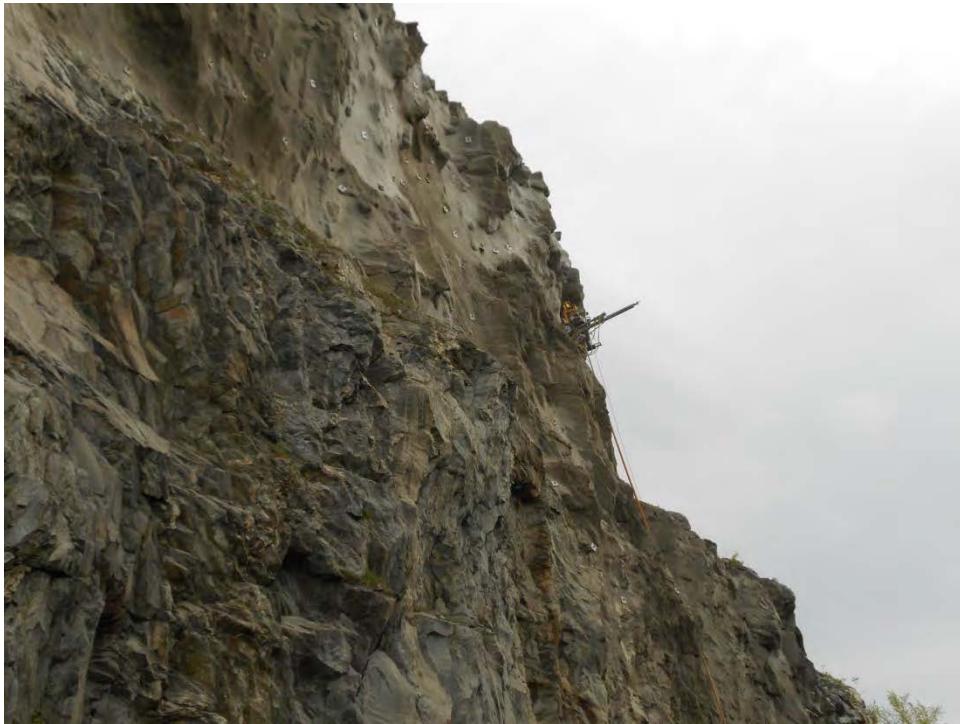
**Figure 14– Shotcreted and Doweled Cut Face**

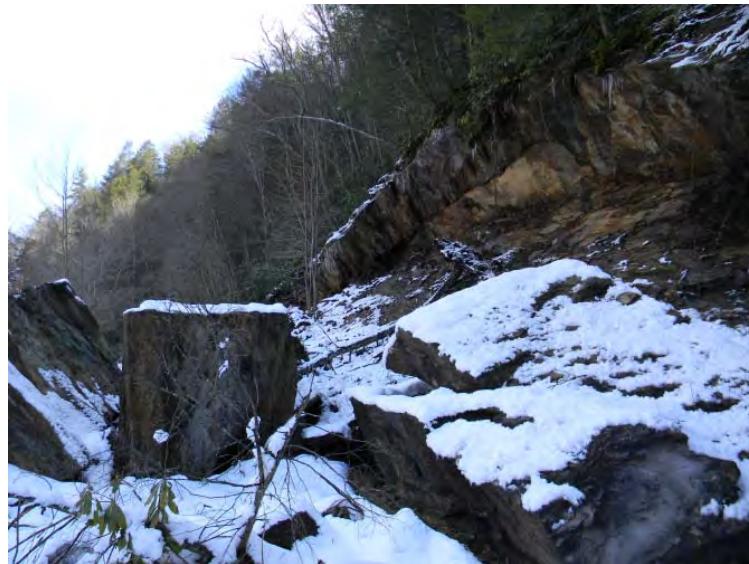
**Figure 15– Slope After Failure**

GeoStabilization International engineers reviewed this site after massive sandstone blocks failed onto the roadway, closing the entire road. Two remediation plans were prepared for VDOT's review: a Geosynthetically Confined Soil retaining wall that would act as a buttress to future failure of the rock slope; and a traditional rock bolting array of the upper unstable rock mass.

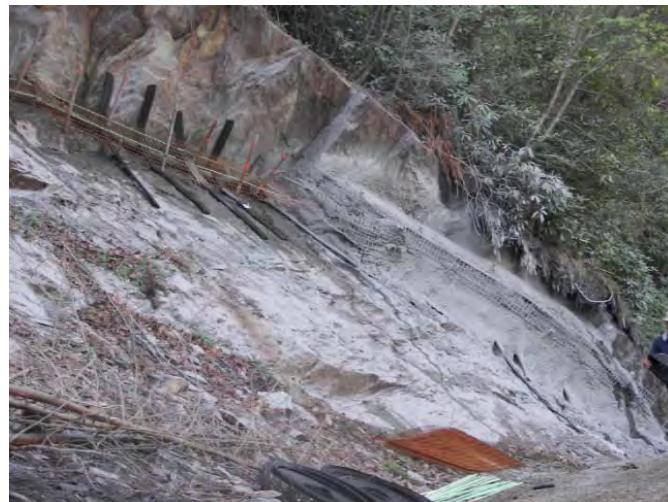
**Figure 17– Buttress Construction Showing Drainboard and Reinforcing Steel**

GSI® engineers then designed the buttress using 2-inch diameter high capacity hollow bars with a yield capacity of 153 kips, installed approximately 4 to 5 feet into the stable rock mass, approximately three feet on center. 75 ksi epoxy coated No. 8 all-thread bars were installed inside the 2-inch tubes to increase the shear capacity and longevity of the system.

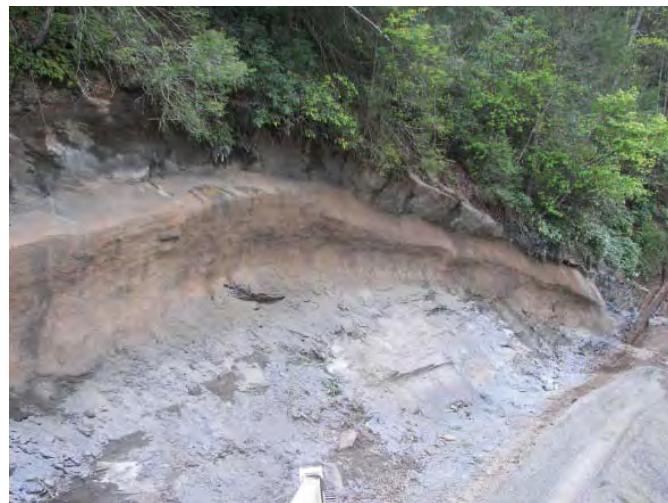
**Figure 18– Shear Buttress after Staining**

Approximately three feet of the shear dowels projected into the reinforced concrete portion of the buttress. The reinforced shear key buttress was constructed with 4000 psi shotcrete and multiple layers of 4x4 W4.0xW4.0 welded wire fabric. Drainage was provided behind the buttress to prevent hydrostatic buildup and drilled drains were installed throughout the slope. The shotcrete was finished with a stain similar to the appearance of the native sandstone.

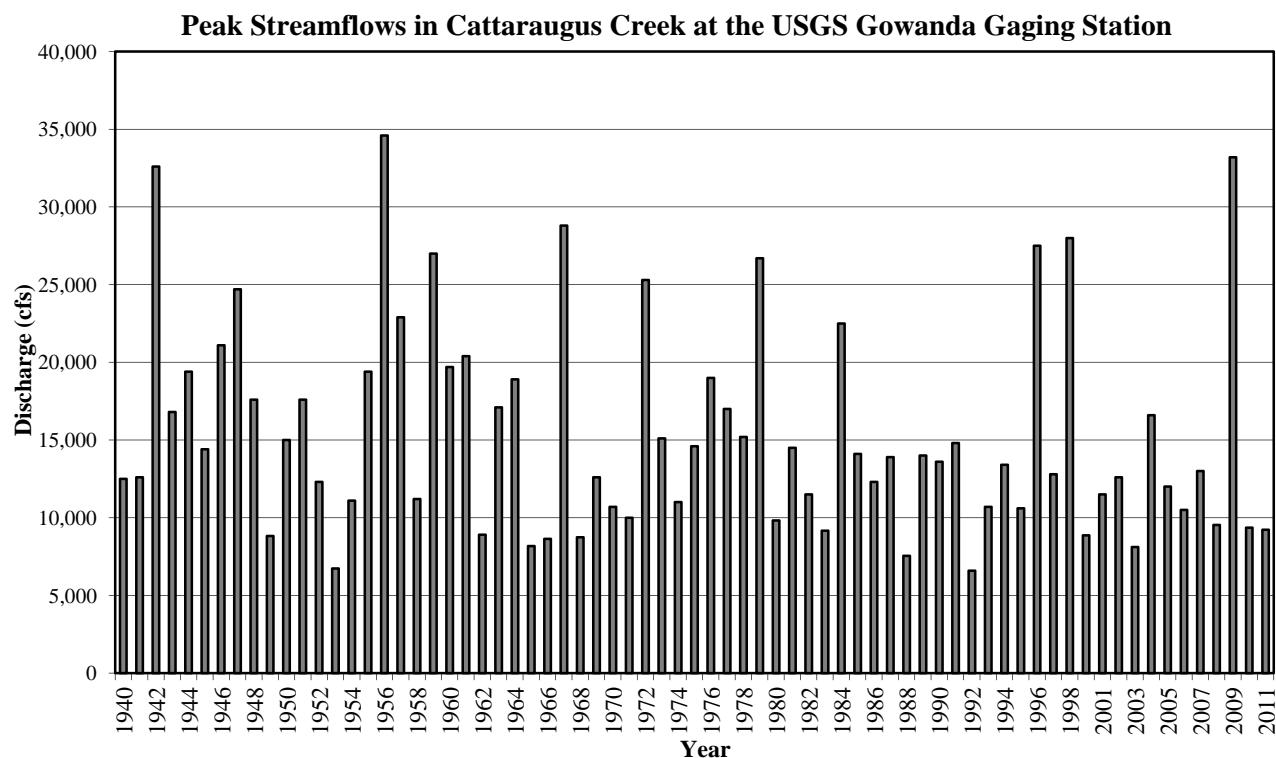
**Figure 2 – Time plot of maximum annual discharge past the Gowanda, NY gaging station on Cattaraugus Creek (Data downloaded from USGS Streamflow Data).**

A large portion of the Cattaraugus Creek Basin received a series of intense rain-fall events in August of 2009. Much of the soil in the Cattaraugus Creek Basin was saturated, causing rapid transport of precipitation as surface runoff. Szabo, Coon, and Niziol (2010) provide a narrative of the conditions leading up to flash floods within the basin. They reported as much as 6-inches of rain-fall in as little as 45 minutes, and as much as 7-inches in 24 hours spanning August 9<sup>th</sup> – 10<sup>th</sup>, 2009. They showed that the peak flows in a tributary 8-miles from the site had an exceedance probability of 0.2%, which is a recurrence interval of 500-years. These intense rain-fall events lead to the second-highest recorded discharge in the history of the gaging station at Gowanda, NY, which is only 13 river-miles downstream of the site (Figure 2).

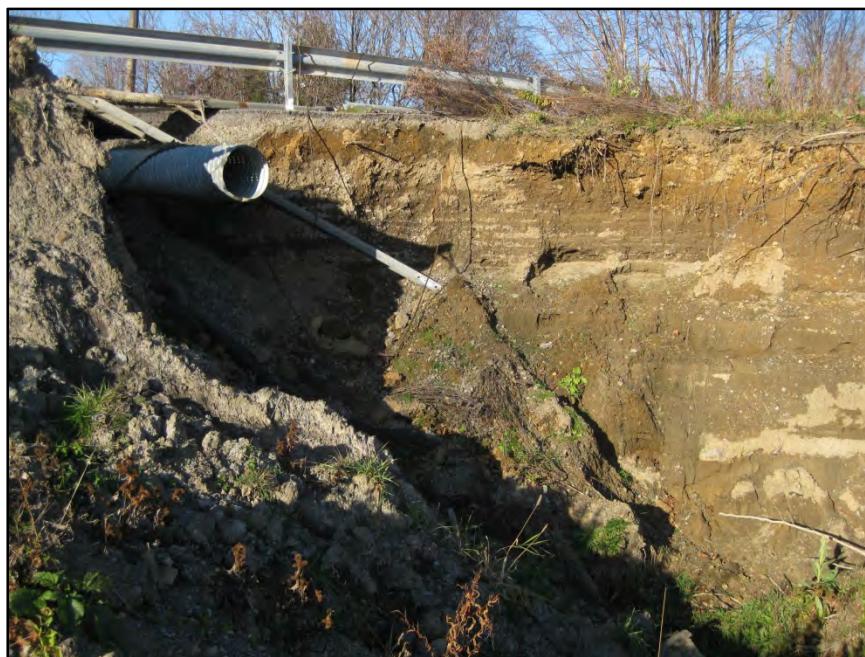
**Figure 5 – Photo showing one of the culvert outlets that eroded into thinly bedded sand of the sandy gravel unit (culvert is 18-inch diameter).**

There were several outcrops along the slope between Zoar Valley Road and Cattaraugus Creek. There was a 10-foot exposed section of intact near-shore sand and silt showing cross-stratification within the upper 20-feet of the highway embankment (Figure 5). Two culverts discharged onto the sand and silt, resulting in severely eroded concavities.

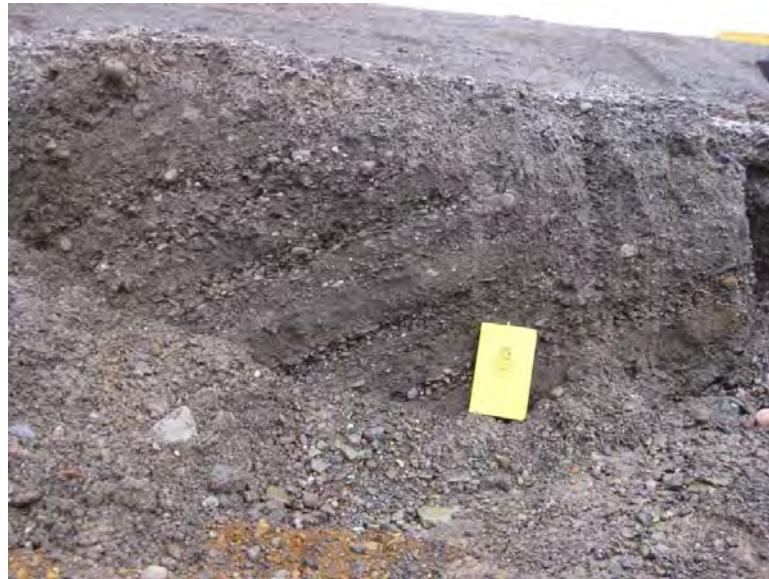
**Figure 8 – Photo showing strongly dipping beds of rhythmically-bedded sandy gravel (field book is 7-inches tall).**

The design included excavation of the sandy gravel layer down to the sandy silt layer. Soil with less than 5 to 10 percent fines would be considered suitable for reuse. Figures 8 and 9 show the typical excavated soil considered suitable for reuse. Unsuitable soil was transported to private property located approximately 0.5 miles from the site and was used as fill.

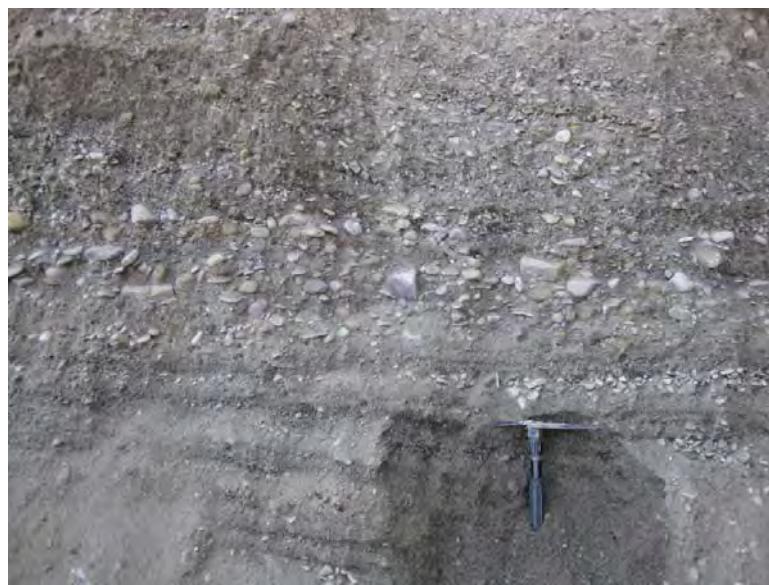
**Figure 9 – Photo showing rhythmic beds (shovel is 10-inches tall).**

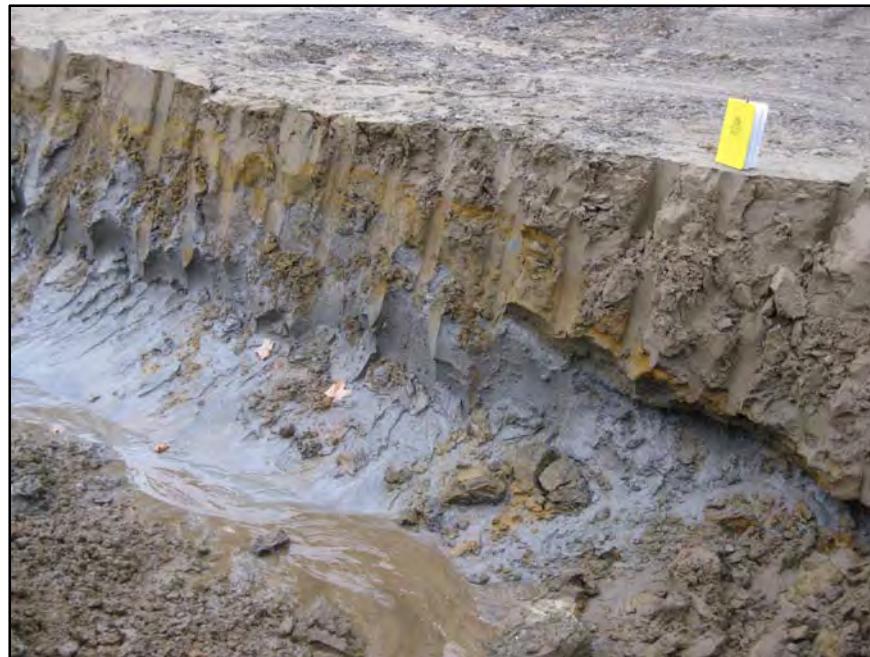
**Figure 10 – Photo of a dewatering trench excavation into the sandy silt. The lower 10 – 15 feet of the sandy silt was gray, while the upper 1 – 2 feet was mottled reddish brown (field book is 7-inches tall).**

The design consisted of a network of dewatering trenches excavated into the upper portion of the wet sandy silt to drain the silt and improve its foundation characteristics. The design consisted of 3 foot wide by 5 foot deep trenches in the sandy silt (Figure 10). The excavated sandy gravel, generally meeting filter criteria requirements, was used to backfill the trenches to the proposed subgrade elevation. The base of the excavation was covered with a separation geotextile and a layer of crushed rock to provide a platform for construction of the GRE slope.

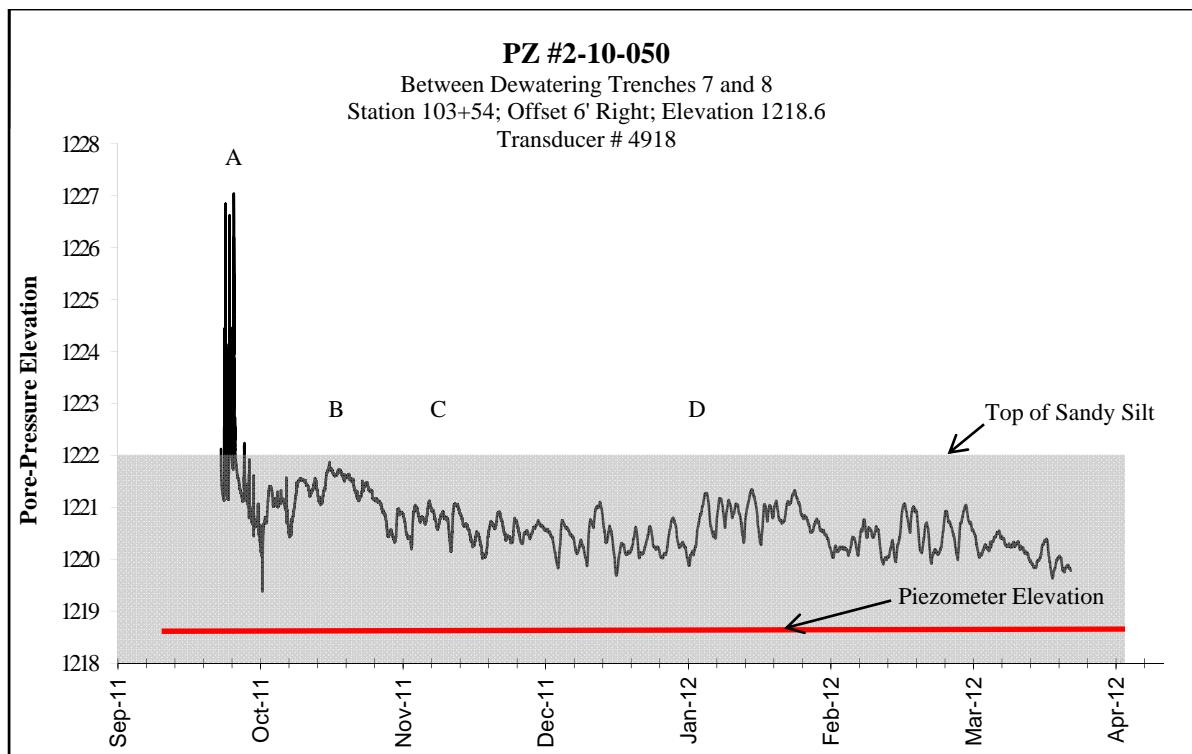
**Figure 11 – Hourly time plot of pore-water pressure during and following construction. The three spikes at (A) were recorded during work in the sandy silt unit. Pressure elevations during embankment construction (B) were constrained below the top of sandy silt. After the completion of construction (C), and the five months following (D), the pressure elevations responded directly to precipitation events.**

Since unloading of the wet sandy silt resulted in shallow-surficial instability, the concern became reloading the entire mass of wet sandy silt too quickly, potentially resulting in slope instability. Vibrating wire piezometers were installed at various depths and locations to monitor pore-pressure during embankment reloading. Data from the four piezometers showed similar trends.

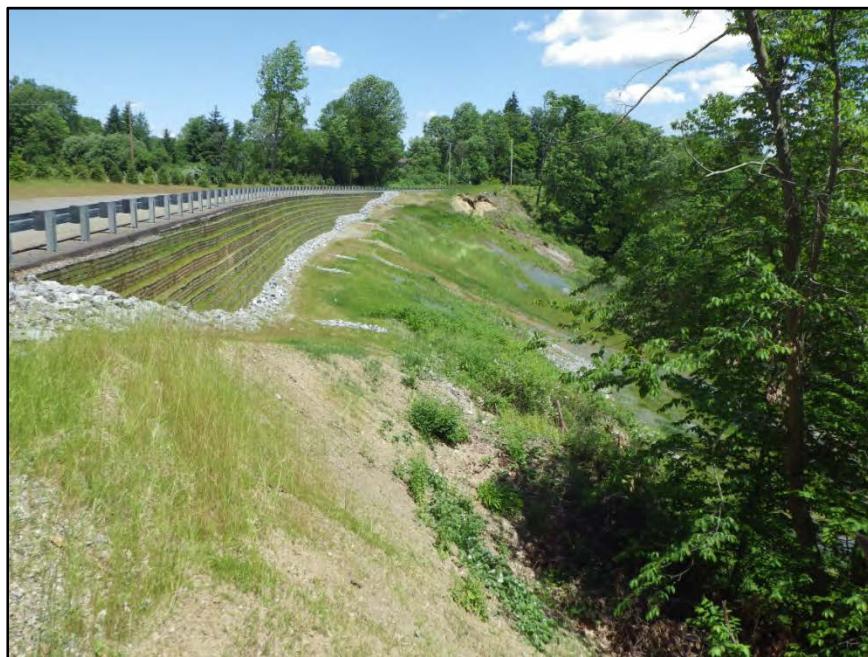
**Figure 12 – Photo of the completed slope stabilization.**

Surface and subsurface observations of the site were used to extend previous geological mapping. This information, combined with data regarding an intense storm sequence, helped identify the causes of damage that Zoar Valley Road suffered in 2009. A comprehensive understanding of the causes of the slope failure provided the designers with the information necessary to tailor the repair to the site conditions. A combination of slope stabilization techniques were selected for the repair, while several other techniques were determined to be infeasible due to the site conditions. The conditions at the site were monitored during reconstruction to limit the potential for induced slope instability. Several of the selected slope stabilization techniques are shown in Figure 12.

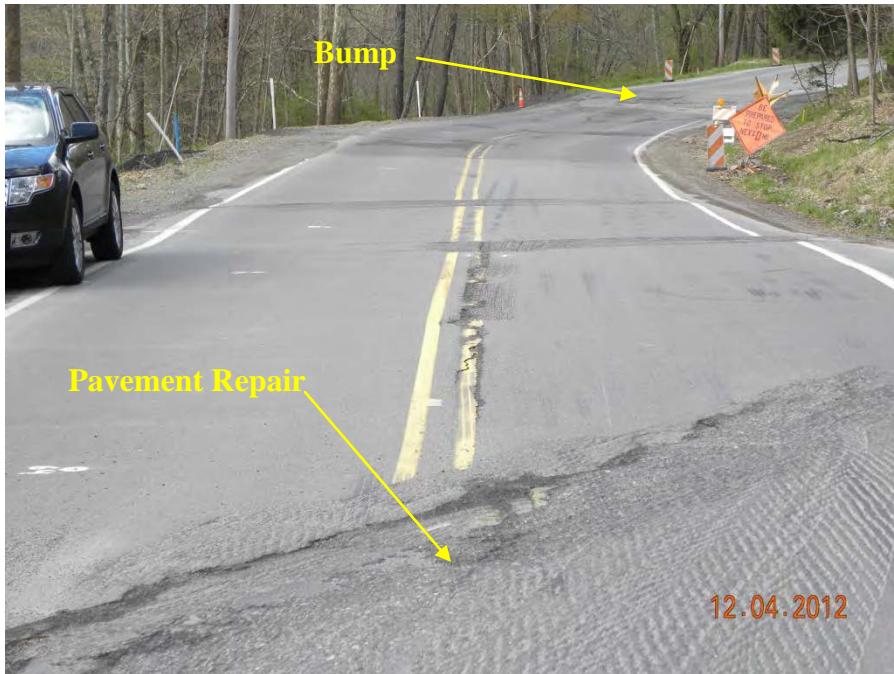
**Photo 1: Bump/Rough Roadway Conditions Through Landslide Area**

SR 87 in this area traverses through a narrow valley, and is located along the North Branch of the Mehoopany Creek, which flows to the east. The landslide damaged the SR 87 roadway creating a large bump, tension cracks, and rough roadway conditions throughout the landslide area. Periodic roadway maintenance consisting of pavement patching and milling was required to restore rideability and warning signs were installed to caution oncoming motorists of the bump/rough roadway conditions at the project site (see Photo 1). Landslide remediation was completed in March 2013.

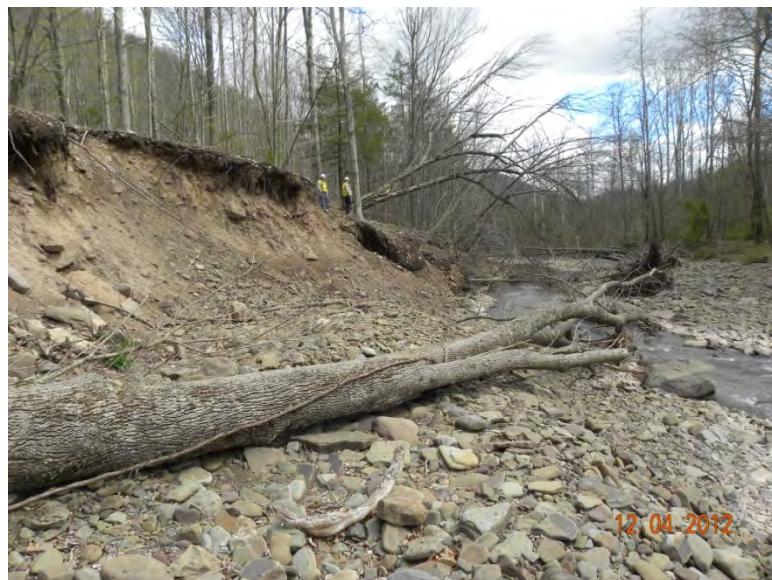
**Photo 2: Erosion at Landslide Toe**

Field reconnaissance of the project area was performed in April 2012. Within the active landslide area, several tension cracks were observed upslope of SR 87 and within the SR 87 roadway, including large tension cracks at the bump in SR 87. Pavement markings had shifted downslope. Trees on the hillside were distorted due to slope movement and the ground surface was hummocky. Many seeps were present within the landslide area and a significant amount of water was observed flowing off of the hillside onto the shoulder of SR 87. The North Branch of the Mehoopany Creek is located at the toe of the landslide and it was evident that the creek had eroded the toe of the hillside during high flow events as shown in Photo 2.

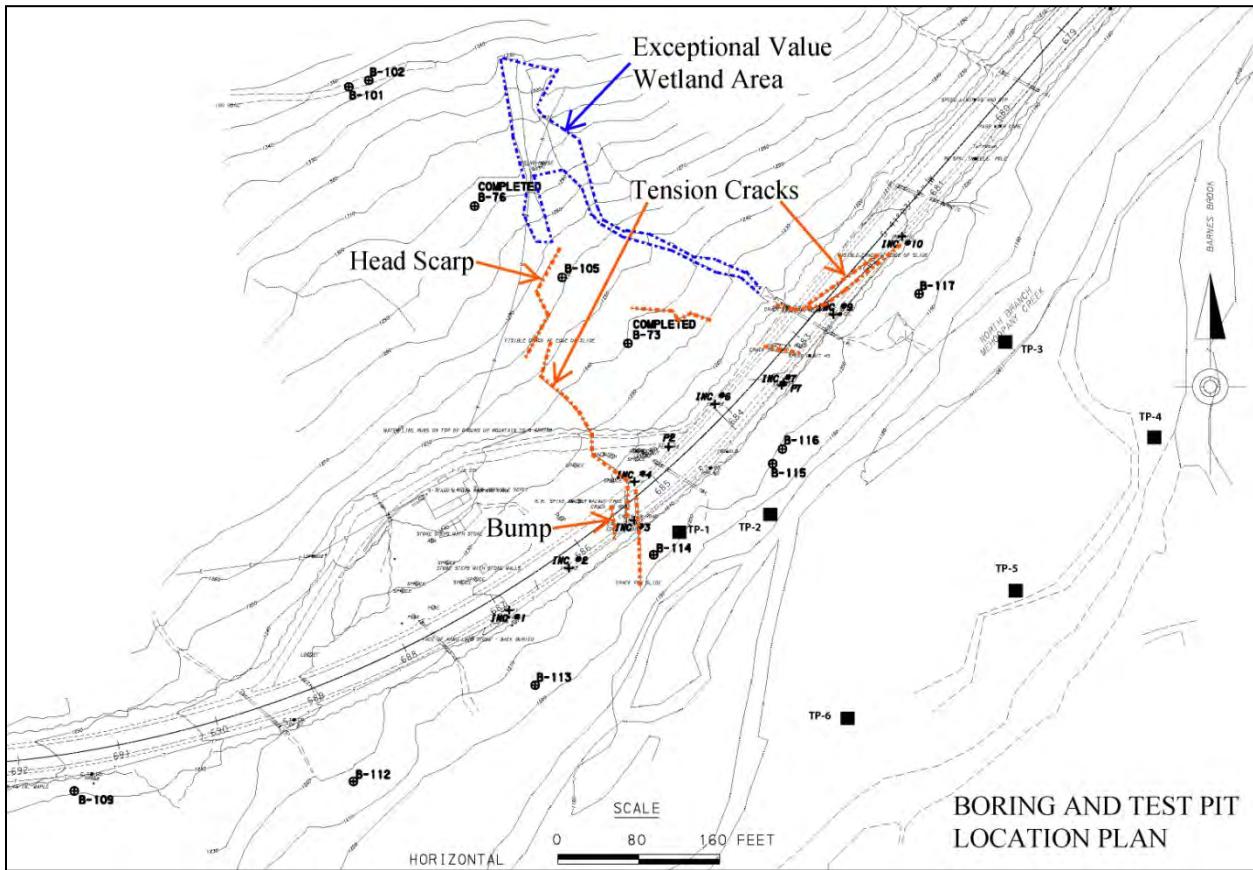
**Figure 5: Boring and Test Pit Location Plan**

boring and test pit locations are shown in Figure 5 and a typical subsurface cross section is included in Figure 6.

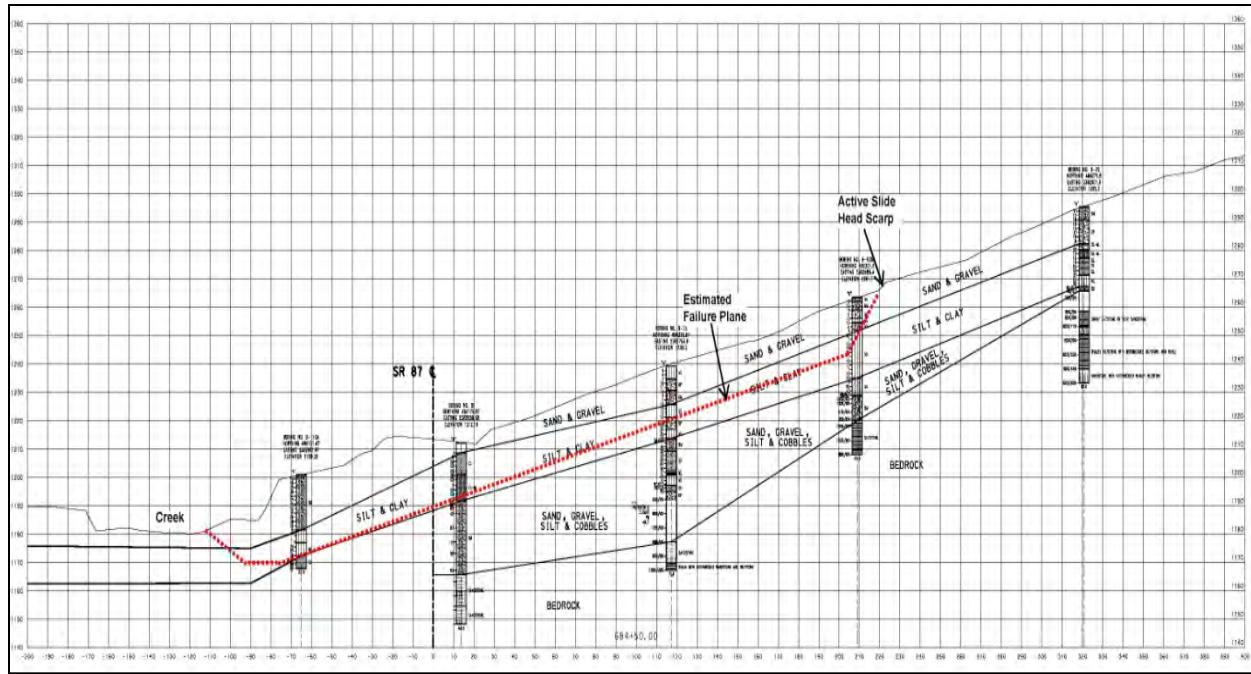
**Figure 6: Typical Subsurface Cross Section**

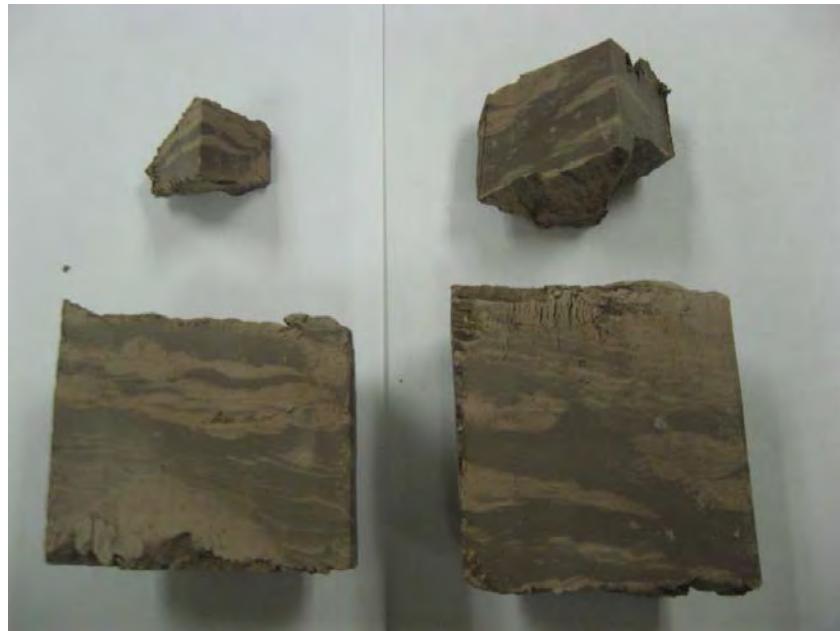
**Photo 3: Laminated Varves Encountered on Hillside**

Based on the published literature review, varves were expected to be encountered within the glaciolacustrine deposit during the subsurface investigation (4). However, varves were seldom identified within glaciolacustrine deposit in the borings performed on the hillside. When varves were identified in the borings conducted on the hillside, the varves were laminated as

shown in Photo 3. No horizontal varves were encountered within the glaciolacustrine deposit on the hillside. The varves observed during test pit operations in the valley floor were oriented horizontal. The horizontal varves encountered in the valley floor are shown in Photo 4.

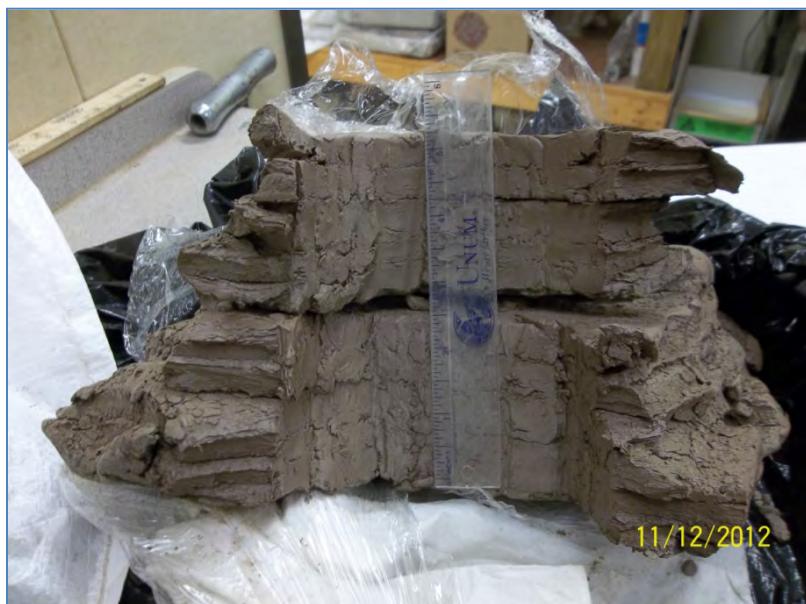
**Photo 4: Horizontal Varves Encountered in Valley Floor**

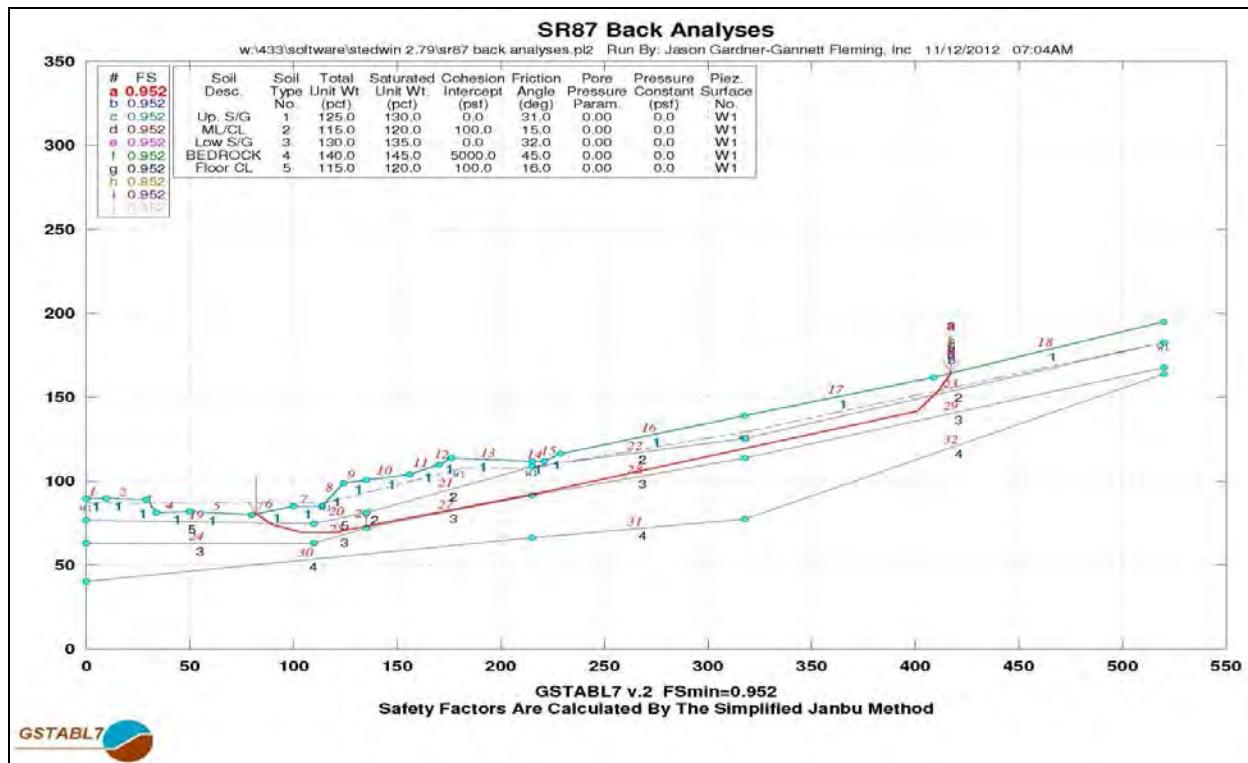
Figure 9: GSTABL7 Back Analyses Model

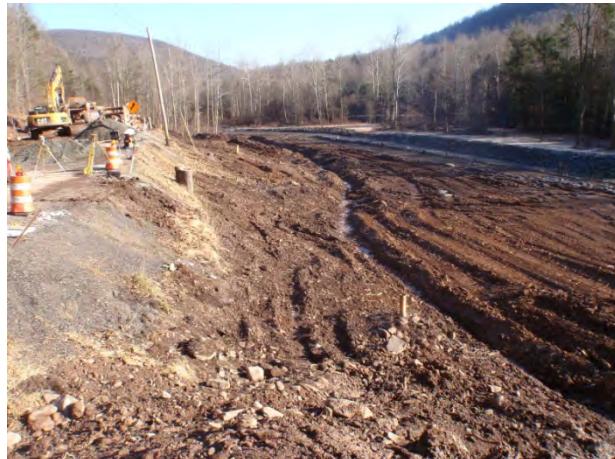
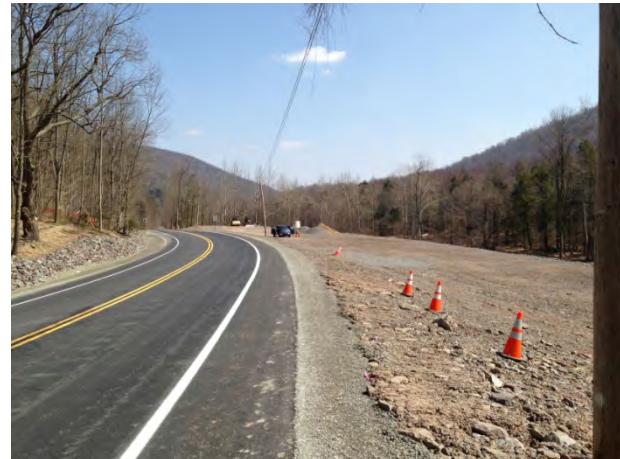
**Photos 5 and 6: Earth Berm and Roadway Construction**

Glen O. Hawbaker submitted the low bid of approximately \$1.8 million and was awarded the landslide remediation contract in fall 2012. Construction of the remediation was complete in March 2013. Photos 5, 6, 7 and 8 were taken during landslide remediation construction.

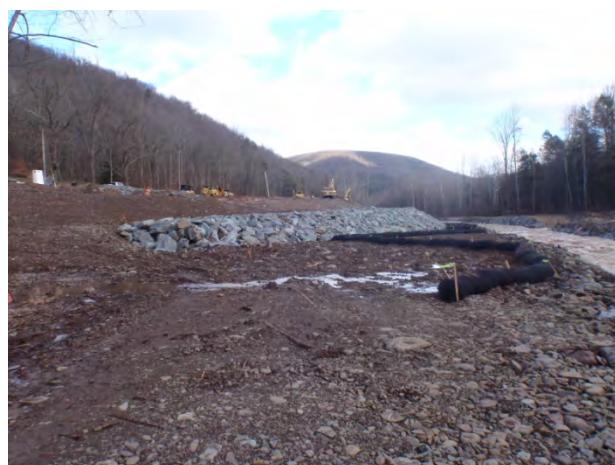
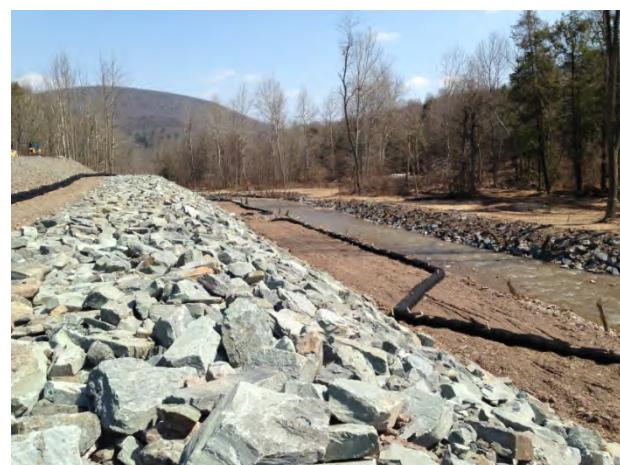
**Photos 7 and 8: Earth Berm and Stream Relocation Construction**

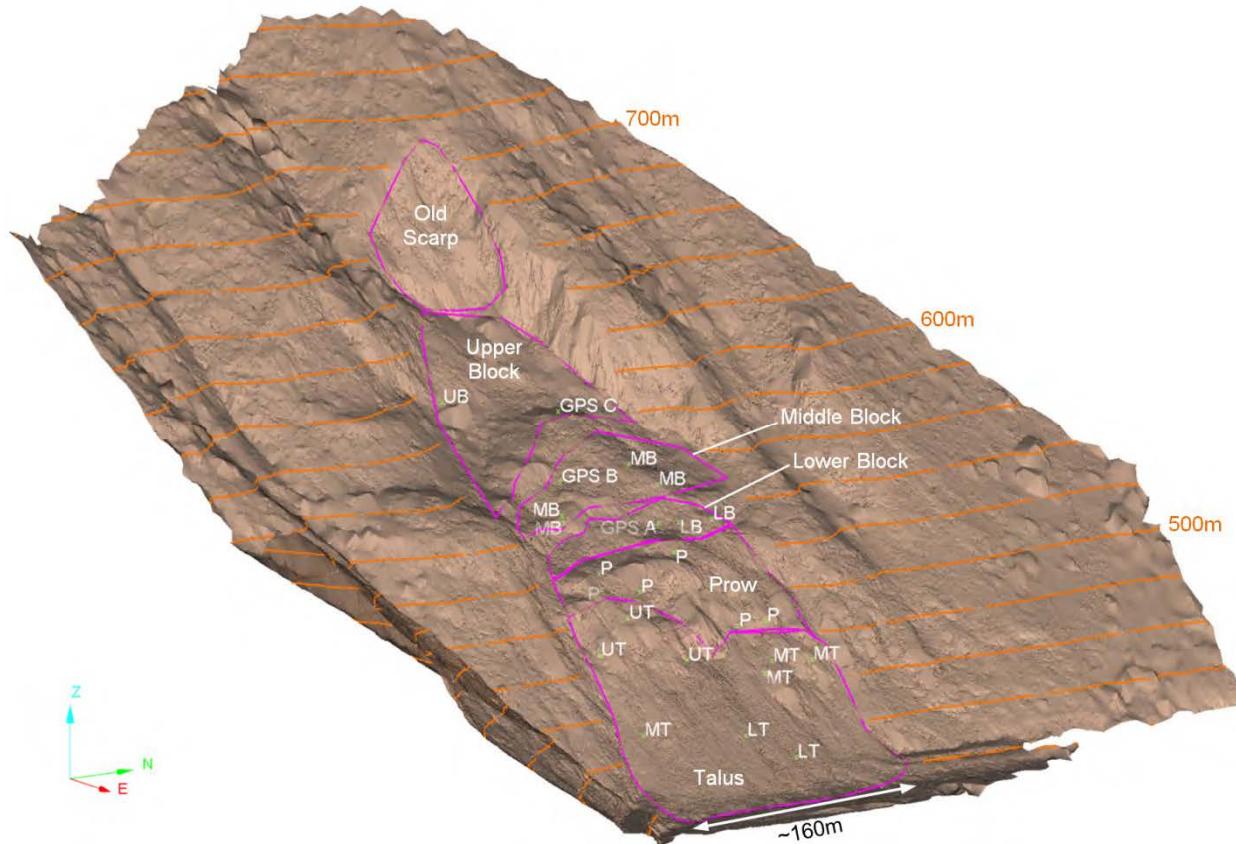
**Figure 3 – Three-dimensional surface map from 2013 lidar scans showing generalized areas of the landslide and locations of particle tracking points (UB, MB, LB, P, UT, MT, LT) used to generate the results in Table 1. GPS spider locations (GPS A, GPS B, GPS C) are shown for reference.**
