# 64<sup>TH</sup> HIGHWAY GEOLOGY SYMPOSIUM

SEPTEMBER 9-12, 2013 | NORTH CONWAY GRAND HOTEL | NORTH CONWAY, NEW HAMPSHIRE

PROCEEDINGS

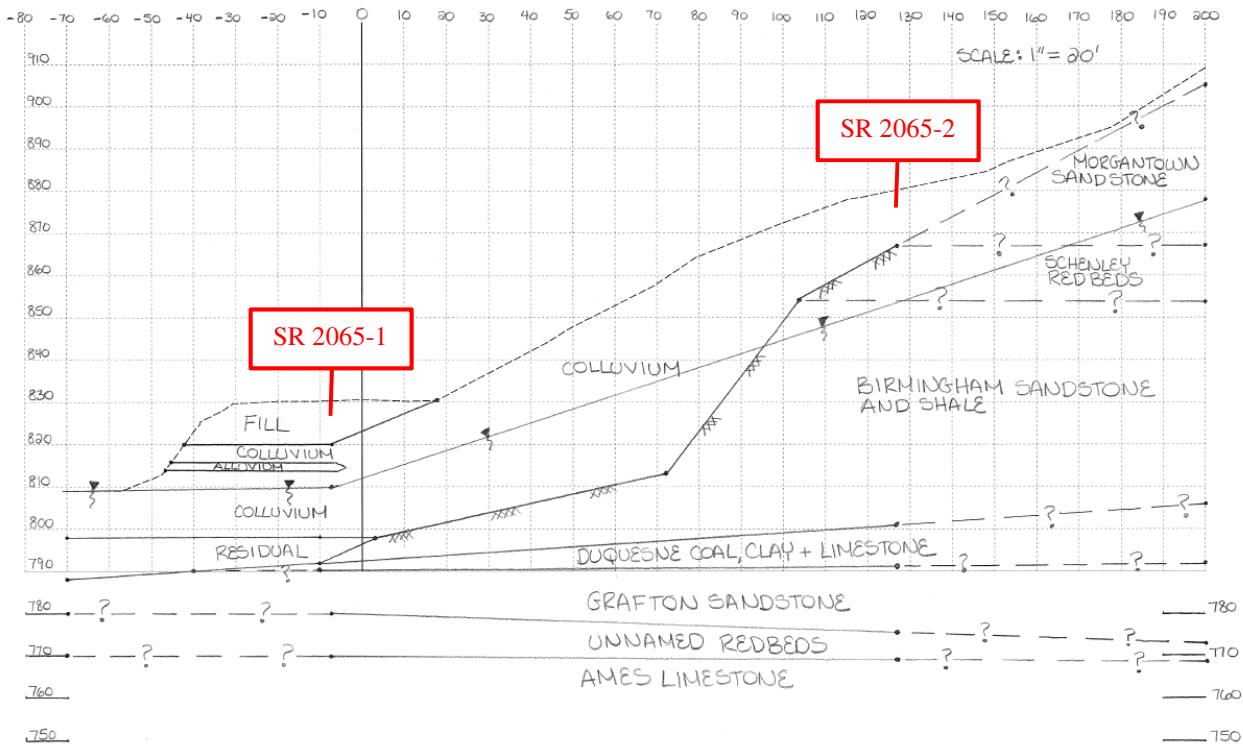
**Figure 6 – Project Site Subsurface Model**

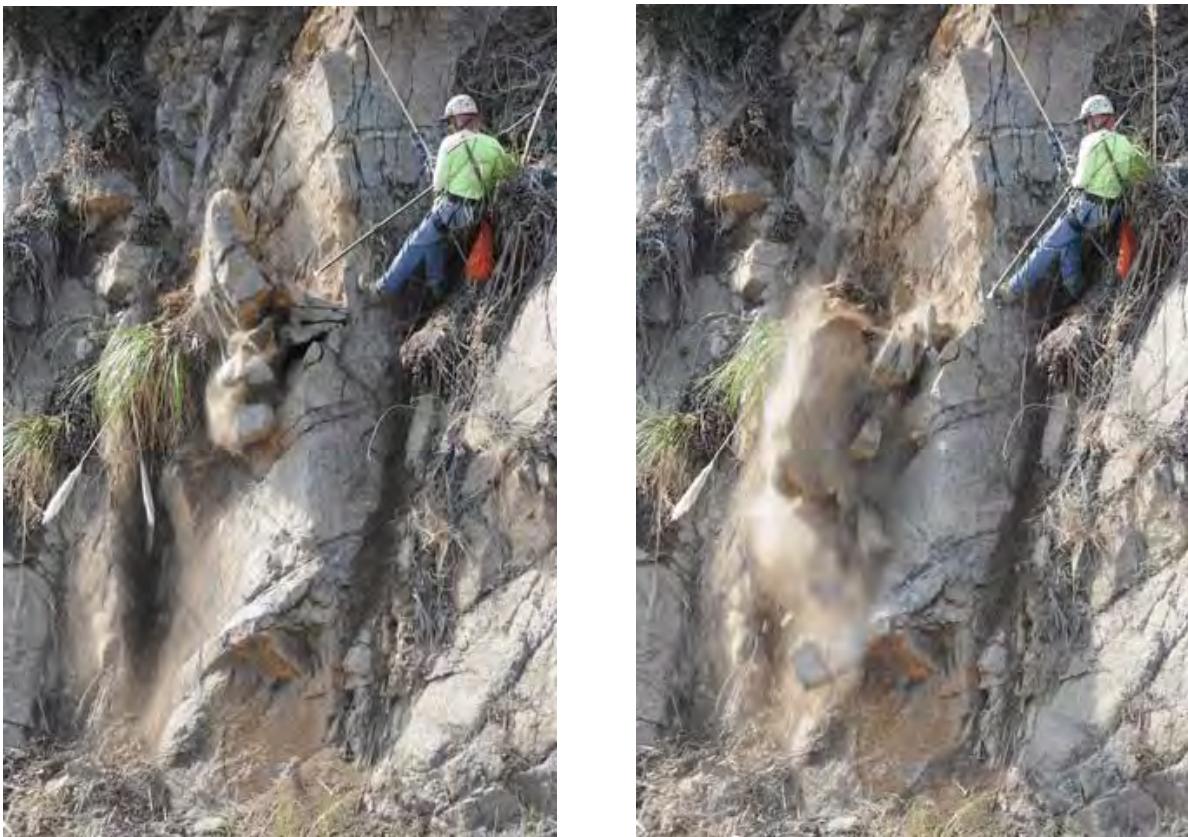
Figure 1. Scaling is the removal of loose rocks and material (that are marginally stable) from the face of the slope

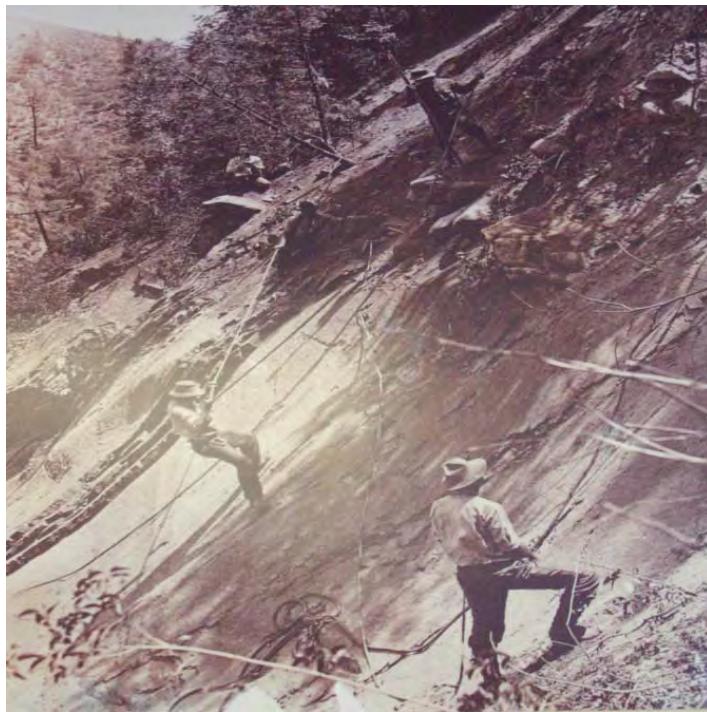
Figure 2. During the great dam projects of the early 1920's workers hung onto ropes with their bare hands

In the 1860's during the great railroad project connecting Sacramento to Omaha, Chinese and Irish laborers moved loose rocks as the cuts were excavated (Ambrose, 2000). During the great dam projects of the early 1920's workers hung onto ropes with their bare hands or were slung in a crudely fashioned seat similar to a swing seat (Figure 2) (Redinger, 1949).

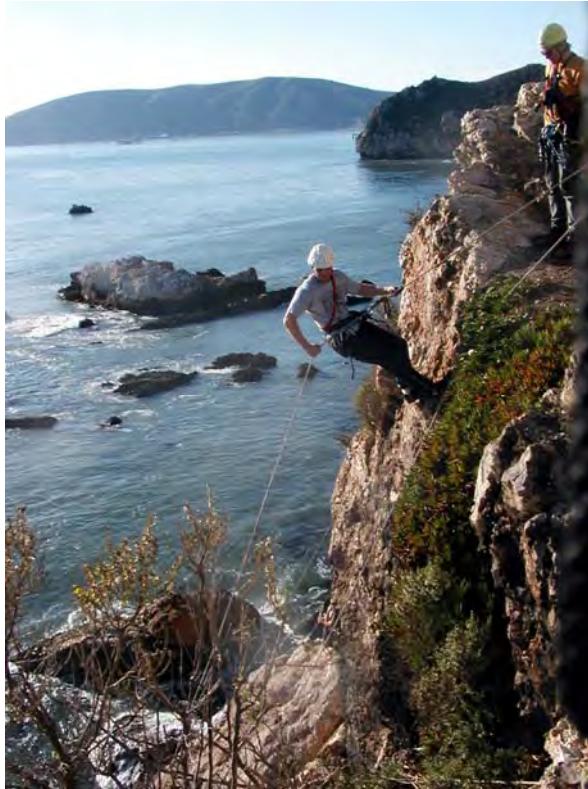
Figure 3. Caltrans engineering geologists began using improved recreational climbing tools to access slopes

In the mid 1980's Caltrans engineering geologists began using these improved recreational climbing tools to access slopes for reconnaissance, mapping, and design purposes. While on the slopes loose rocks were removed as part of the investigation and quickly it was realized that these climbing techniques enhanced mobility and safety on the slope and suited more comprehensive scaling operations (Figure 3).

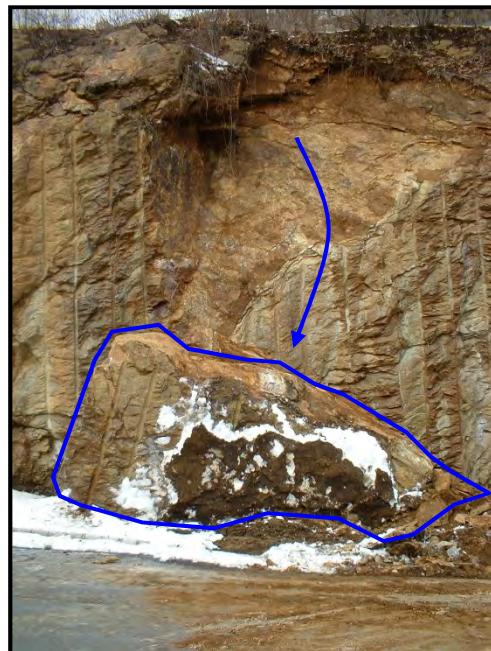
**Figure 2 –Rockfall**

The slope behind the Figure 2 rockfall lies along Timber Ridge Road, an entrance road to the site of a townhouse and condominium complex, and is only one of the slopes of concern at the site. The slope where this rockfall occurred will serve as the example used in this paper.

However, there was more than normal precipitation during the time of the failure, making it likely that water in the slope, coupled with the freeze/thaw cycles, contributed significantly to the failure. With water present in the slope along the foliation failure surface, the cohesion would drop off significantly to about 70 pounds per square foot just prior to failure. Figure 4 shows the location of the failure as it was originally mapped in July 2004 and Figure 2 shows the actual failed surface and block.

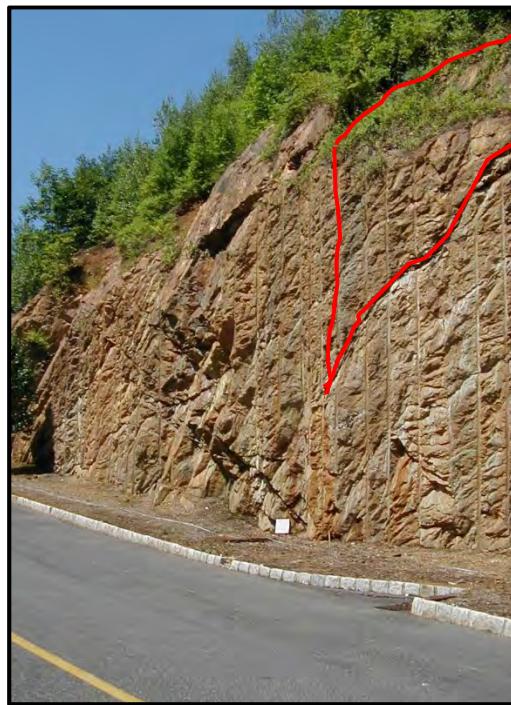
**Figure 4 – Failure Location Sta 68+20**

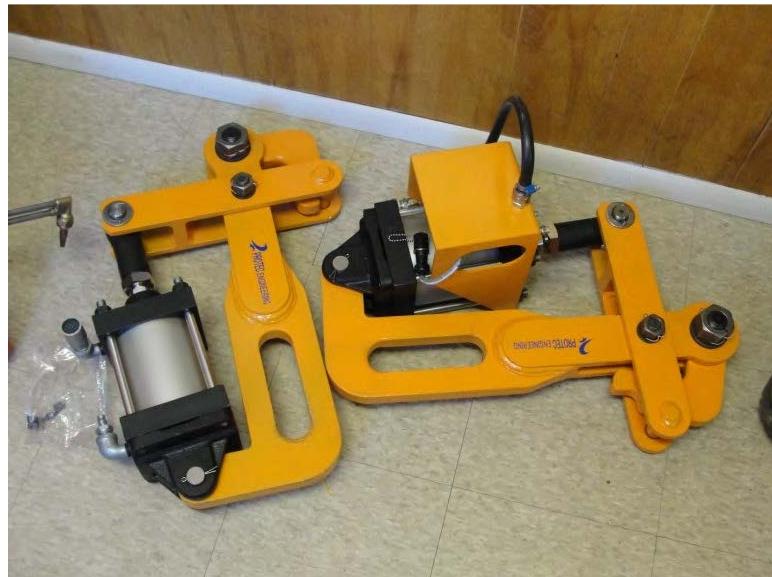
**Figure 3. Pneumatic release systems used to release the rock.**

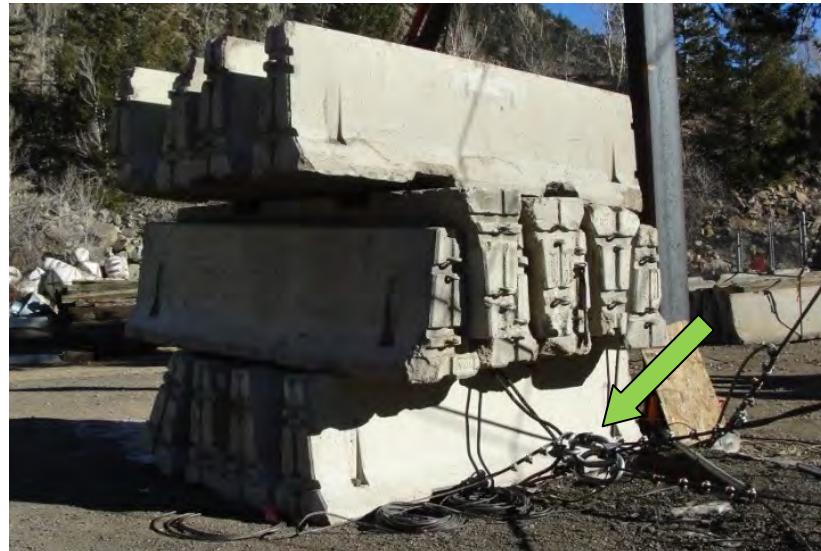
**Figure 4. Stacked Barrier Anchoring System. Green arrow depicts load (link) instrumentation to record loads in retaining wire ropes.**

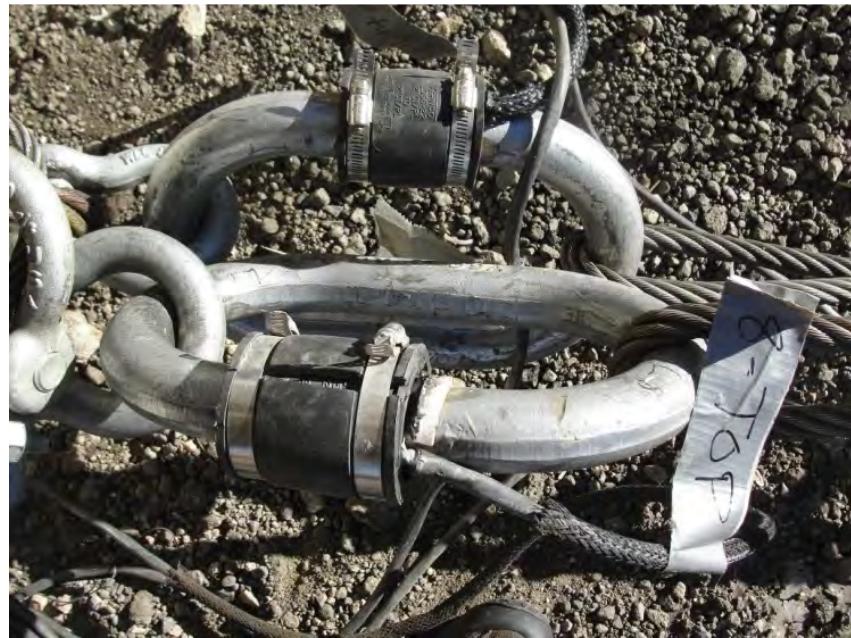
**Figure 5.** Close up of load (link) instrumentation to record loads in restraining wire ropes.

Load cell instrumentation was attached both to the retaining wire ropes (Figure 5) and to the base plate of the post systems (Figure 6). The load cells, otherwise known as link cells (Figure 5), were custom manufactured by Geokon for measuring the loads in wire rope up to 100 kips (445 kN). The post base load cells (Figure 6) were also manufactured by Geokon to measure the compressive loads transferred in the base plates to the load cells. To measure the effects of tensile loading, the all-thread nuts were tightened and the loads recorded prior to the testing to determine the difference in compressive loading (i.e. tension) in the load cells. Table 1 depicts a typical graph of the four load (link) cells on the retaining wire ropes and load cells on the base plate. The loads measured were changes in loading rather than absolute values.

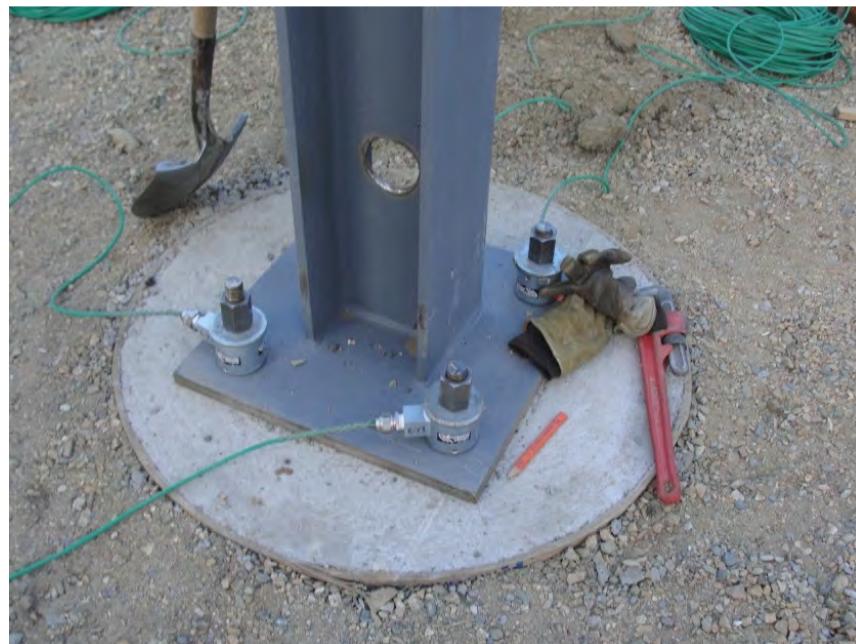
**Figure 6.** Load cells in compression on post system.

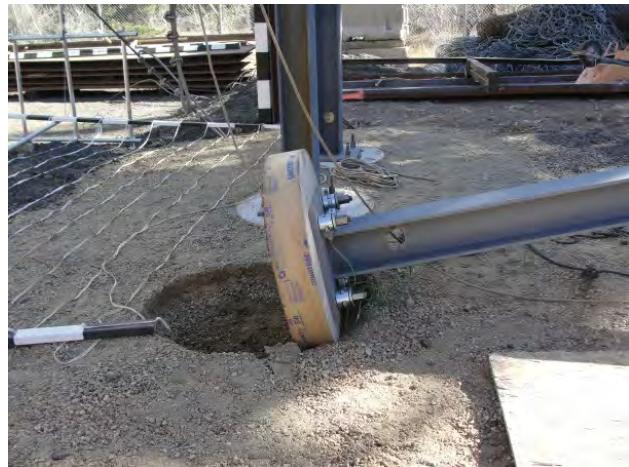
**Figures 7a and 7b. Shallow Foundation - No retaining ropes. System subjected to a 9 kJ impact.**  
**(Note - Post simply fell over)**

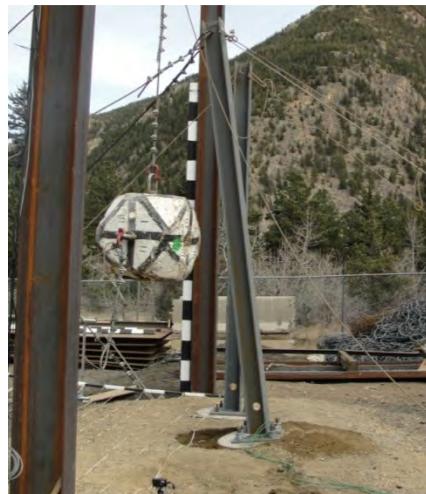
**Figures 8a and 8b. Shallow Foundation – Top retaining ropes. System subjected to a 20 kJ impact.**  
**(Note – bottom of foundation began to kick out)**

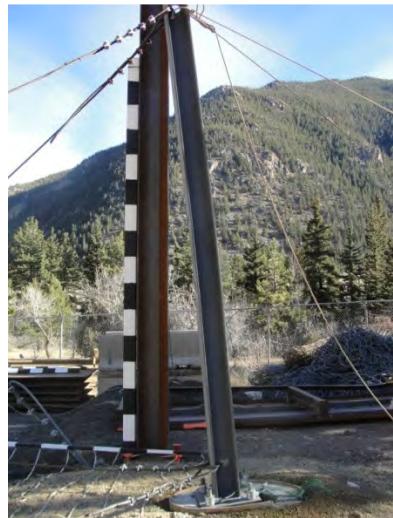
**Figures 9a and 9b. Shallow Foundation - Top and bottom retaining ropes. System subjected to 67 kJ. (Note - concrete base broken but system still functional).**

Overall, the top and bottom retaining ropes were necessary to maintain an effective system. At the time, the shallow foundation system with top and bottom retaining support was only tested to 67 kJ. The

results of this test led to other tests in which only the steel base plate was placed on the ground with both top and bottom retaining ropes. These later configurations were tested to 218 kJ, indicating it is likely that the shallow foundation system with top and bottom support ropes could have been tested up to 200 kJ and still been effective.

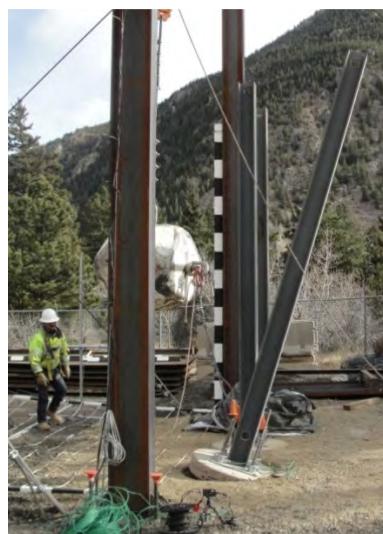
**Figures 10a and 10b. Grout Bar Foundation – No retaining ropes. System subjected to a 20 kJ impact. (Note – post deflected without retaining ropes).**

Overall, the top retaining rope was necessary to maintain an effective system. It appeared that the lower retaining rope was effective up to 116 kJ, but the post began to bend with or without the lower retaining rope indicating the weakest part of the system was the post and not the grouted bar foundation. Testing was stopped at 116 kJ since the 8x48 post had been compromised in this foundation scenario. The bottom retaining anchor was less effective with the deeper grouted bar system.

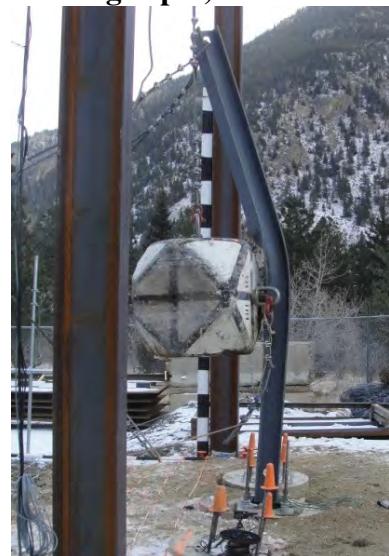
**Figures 11a and 11b. Grouted Bar Foundation – Top retaining ropes only. System subjected to a 116 kJ impact. (Note – post began to deflect with only top retaining rope).**

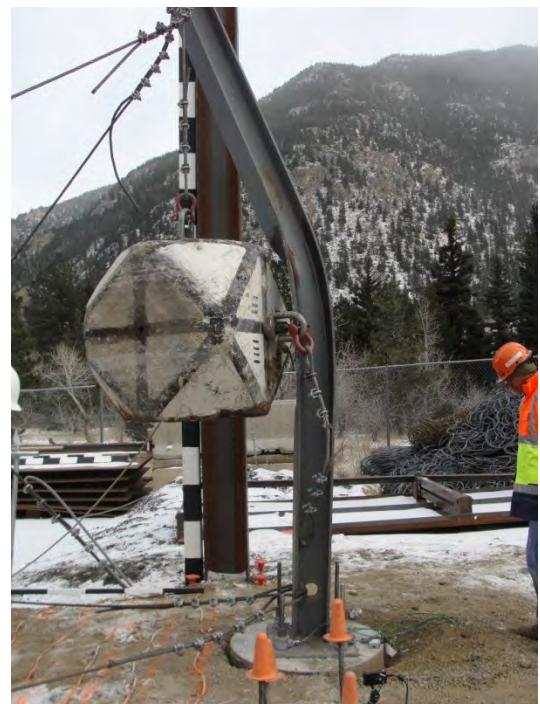
**Figures 12a and 12b. Grouted Bar Foundation – Top and bottom retaining ropes. System subjected to repeated 112 kJ impacts. (Note – lower retaining ropes less engaged as load went directly to foundation).**

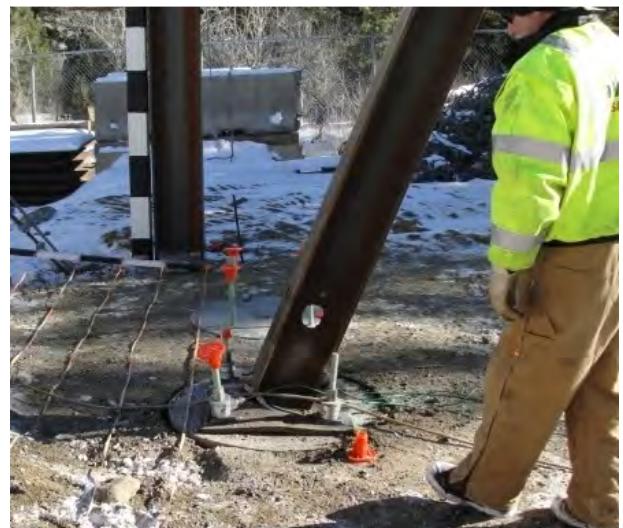
**Figures 13a and 13b. Shaft Foundation, 6 foot depth. No retaining ropes. System subjected to 68 kJ impact. (Note - the 10x60 post and plate sheared prior to significant movement of the concrete).**

1. Review of the 6 foot (1.8 m) embedment system indicated that the 10x60 post and plate system sheared prior to significant movement of the concrete foundation at a relatively low 68 kJ impact.
2. Review of the 3 foot (0.9 m) embedment system indicated that the entire base rotated out of the subsurface without retaining ropes at an impact of 20 kJ.

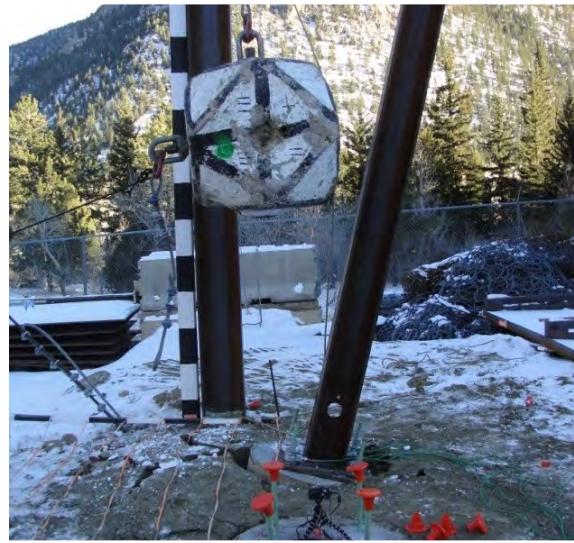
**Figures 14a and 14b. Shaft Foundation 3 foot depth. No retaining ropes. System subjected to 20 kJ impact. (Note - the 3 foot deep embedment rotated out of the ground without the aid of a top retaining rope to restrain it).**

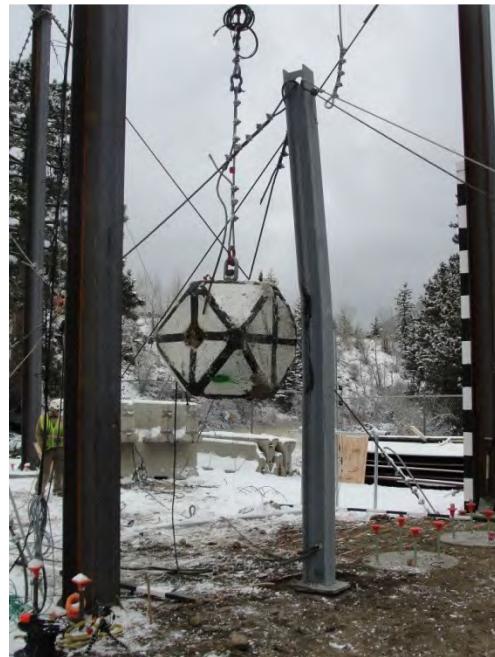
**Figures 15a and 15b. Base Plate Foundation – Top and bottom retaining ropes. System subjected to 96 kJ impact. (Note – minor post bending after repeated impacts)**

Based on the previous test results, the following two post testing scenarios were developed and performed using a simple plate foundation placed on the ground surface. The first test system consisted of a W8x48 post welded to a 20 inch x 20 inch x 1 inch (51 cm x 51 cm x 2.5 cm) base plate that was placed on the ground surface (Figure 15a). No other foundation element was present; however both top and bottom retaining ropes were employed.

The notable results from the testing of these foundations is that the first scenario was able to withstand repeated 96 kJ impacts with minor damage to the post system, and the second scenario was able to withstand multiple 218 kJ impacts with minor bending to the post. Both systems were still functional at keeping the rockfall system functioning after repeated impacts at much higher energies than anticipated.

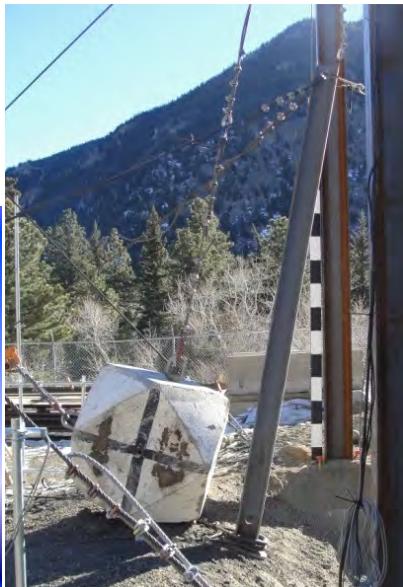
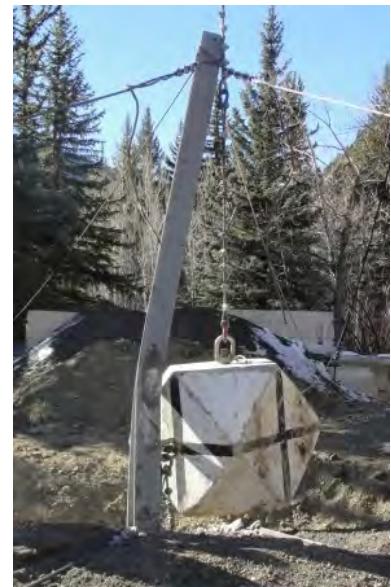
**Figures 16a, 16b, and 16c. Base Plate Foundation with top and bottom retaining ropes. Figure 16b shows the side of the test just prior to the impact. Figure 16c shows the back of the post after a 218 kJ impact.**

The other test consisted of a W8x48 post welded to a circular 18 inch diameter by 1 inch (46 cm x 2.5 cm) thick plate that was placed on an approximate 1H:1V slope to approximate field conditions on a slope (Figure 15b). This test also had top and bottom retaining ropes.

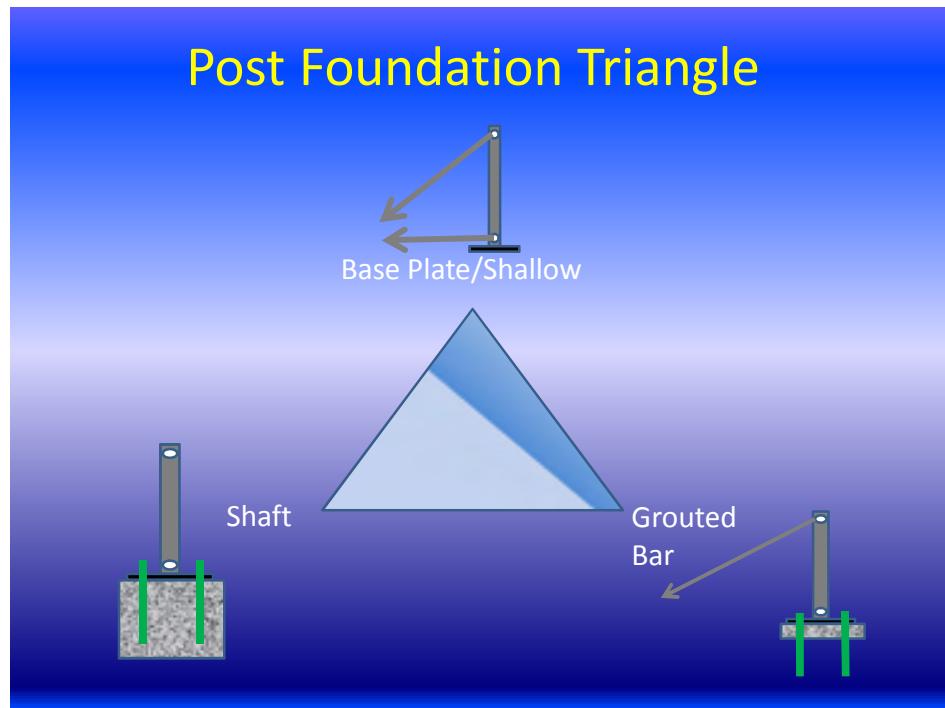
**Figure 17. Design triangle for post foundation design. Darker shading within the triangle depicts more impact capacity of the post system.**

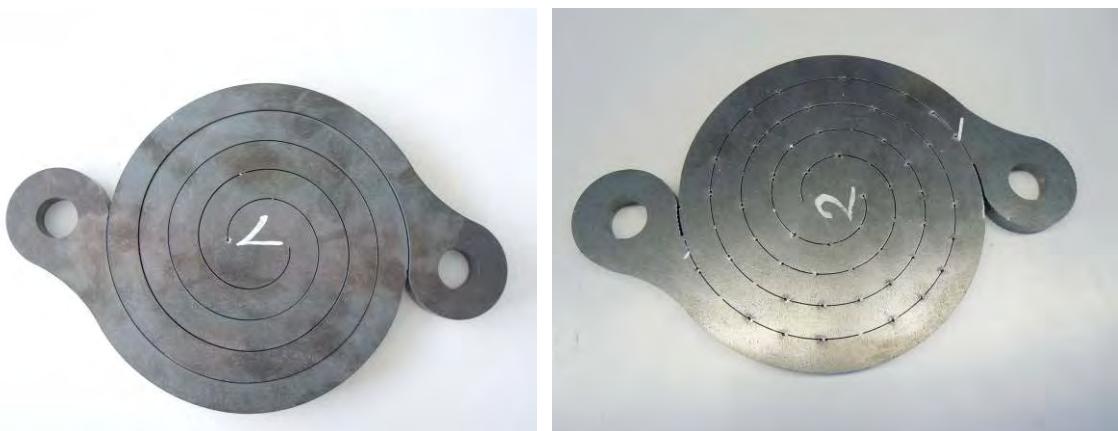
**Figure 2 - Prototypes with: a) continuous cut and b) a perforated path**

The first stage of the development process concerned the feasibility of production and the behavior of the disc in a tension test. Focus was given to two different types of discs. One showed two cuts, continuing from the levers to the disc core (Figure 2a). The second showed two pre-determined tearing paths, with a sequence of material bridges (Figure 2b).

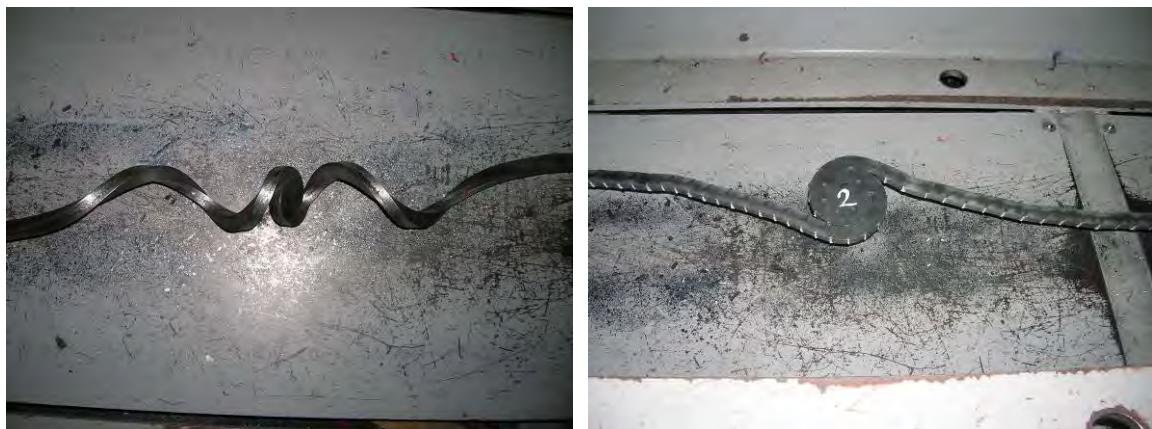
The tension tests showed that the perforation, which was meant to increase the tensile strength of the disc, was necessary to guarantee its performance. The disc with continuous cuts started winding and failed after a limited extension (Figure 3a), while the perforated disc was ripped open the entire way to the core (Figure 3b).

**Figure 3 – a) Tension test of disc with continuous cut and b) tension test of disc with perforated path**

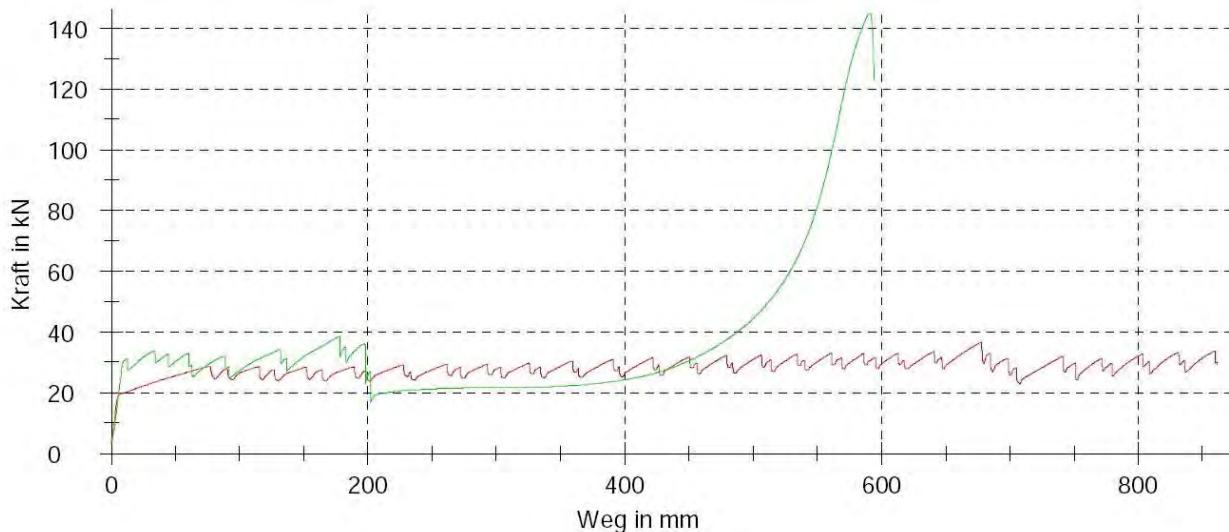
**Figure 6 - Toughness diagram of the final prototype**

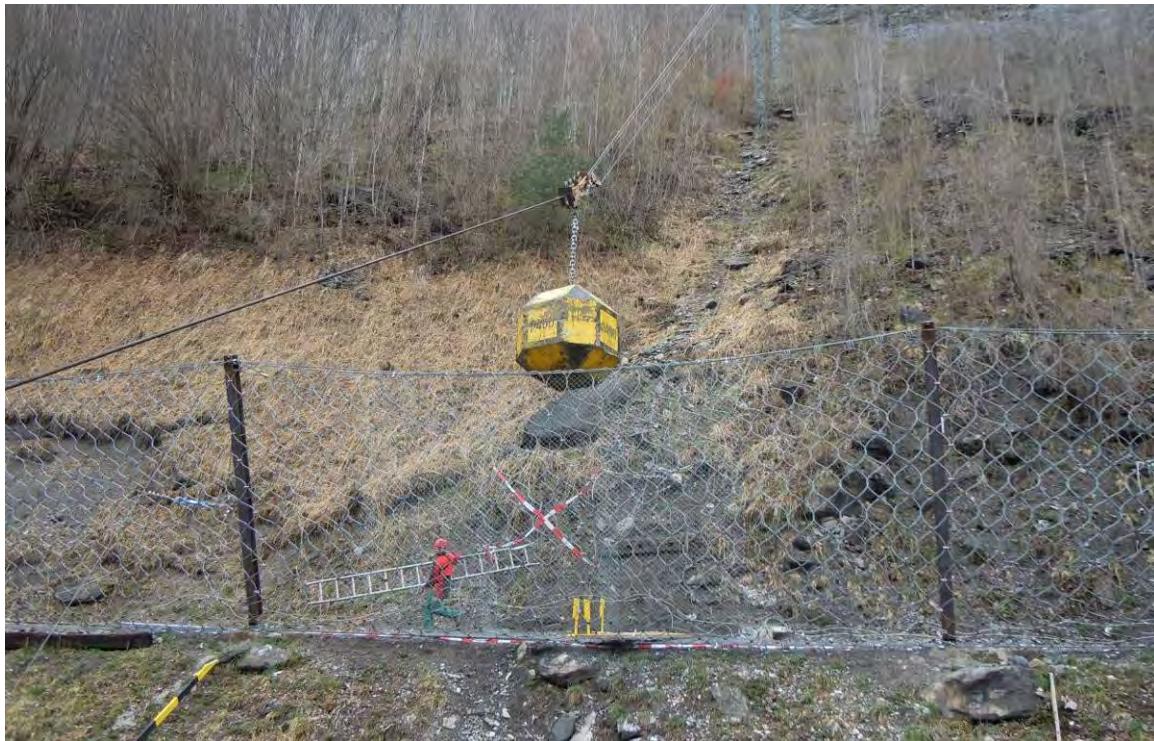
As indicated by the numerical modeling, some uncertainties about the initial bending of the disc levers remained. To gain further reliable information on the general function of the brake element, a barrier was installed at a test site in Lungern, Switzerland. The test site (Figure 7) consists of foundation and anchoring points for a 30 m fence and an inclined cableway that allows 1:1-ETAG certification tests of up to 2000 kJ. The acceleration path of the cableway is inclined by ~ 40° and has a length of 40 m.

**Figure 7 - Isofer rockfall barrier test site in Lungern, Switzerland**

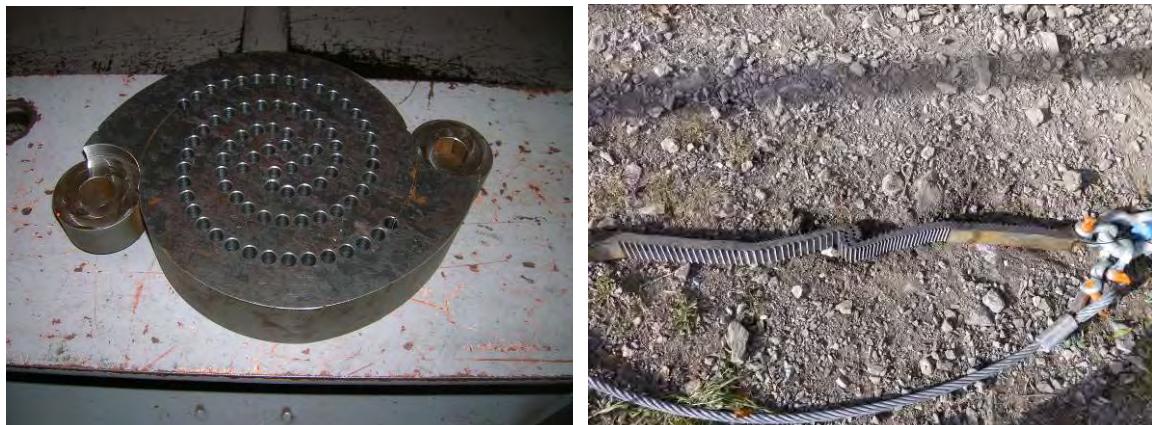
For the test series conducted in October 2012, an non-symmetrical barrier with one brake element for the upper and lower bearing ropes at on side of the barrier was erected. This setup was chosen to prevent any interaction between the brake elements. The installed brake elements, consisting of a drilled tear path and a non optimized core structure, were 60 mm thick (Figure 8a). As an additional safety measure, the brakes where bridged by overload cables. A series of tests with 320, 800 and 1600 kg blocks was shot. The forces in the bearing ropes were measured by load cells on each side of the brake elements with a frequency of 1200 Hz. Two high speed cameras with a frequency of 250 fps observed the motion of the discs.

**Figures 8– Photos showing the tested brake element a) before and b) after the dynamic test.**

The general performance of the disc was proofed by so called service level tests (SEL) that put a 30% load on the same brake element twice (Figure 8b). The response to the second impact was equal to the initial reaction of the brake. The consumption of brake-way and the time-force diagram showed an unexpected positive performance that underlined the potential of the invention.

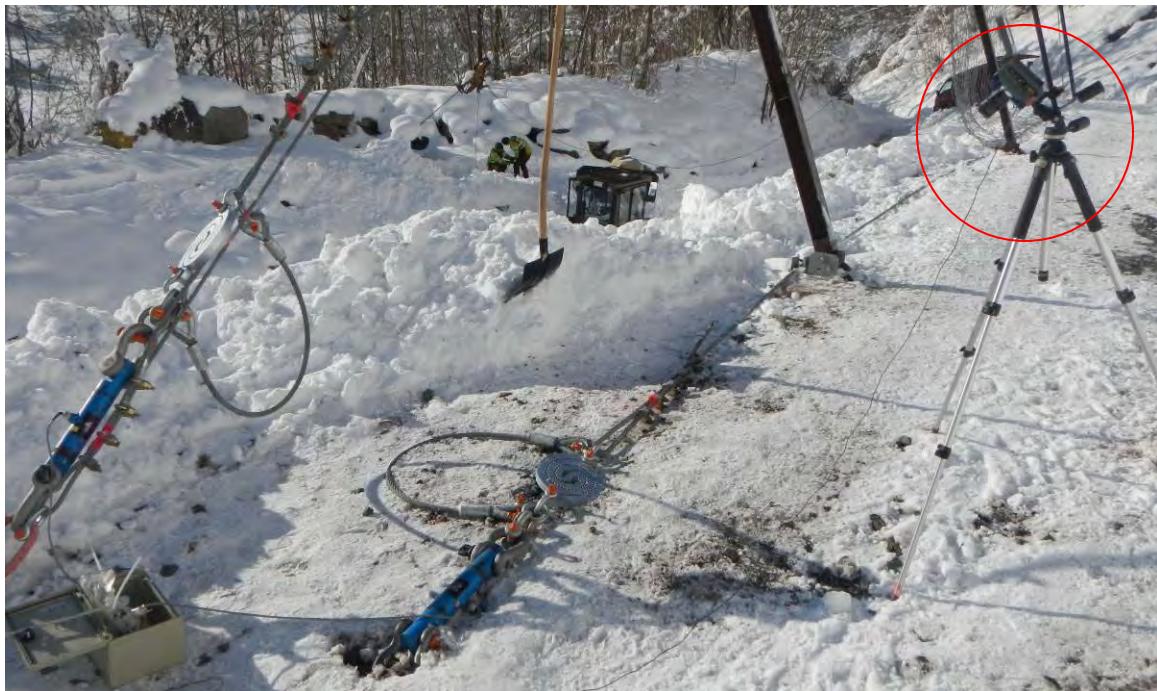
Figure 10– Set up of the high speed camera for the second dynamic test

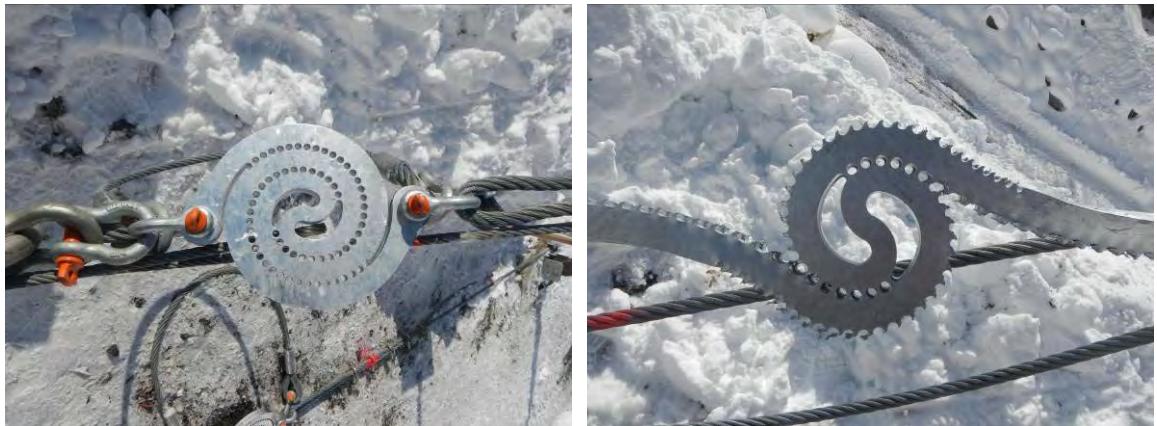
In a second dynamic test-series in February 2013, the focus was on the behavior of the disc-core and its interaction with the other system components. The same basic test set-up was chosen (Figure 10) and two different types of net were used. In addition, the test was run for the first time using a stack of discs (Figure 11) and the function of the brakes under below freezing conditions was observed.

Figure 11 - Disc stack before (a) and after (b) the MEL impact

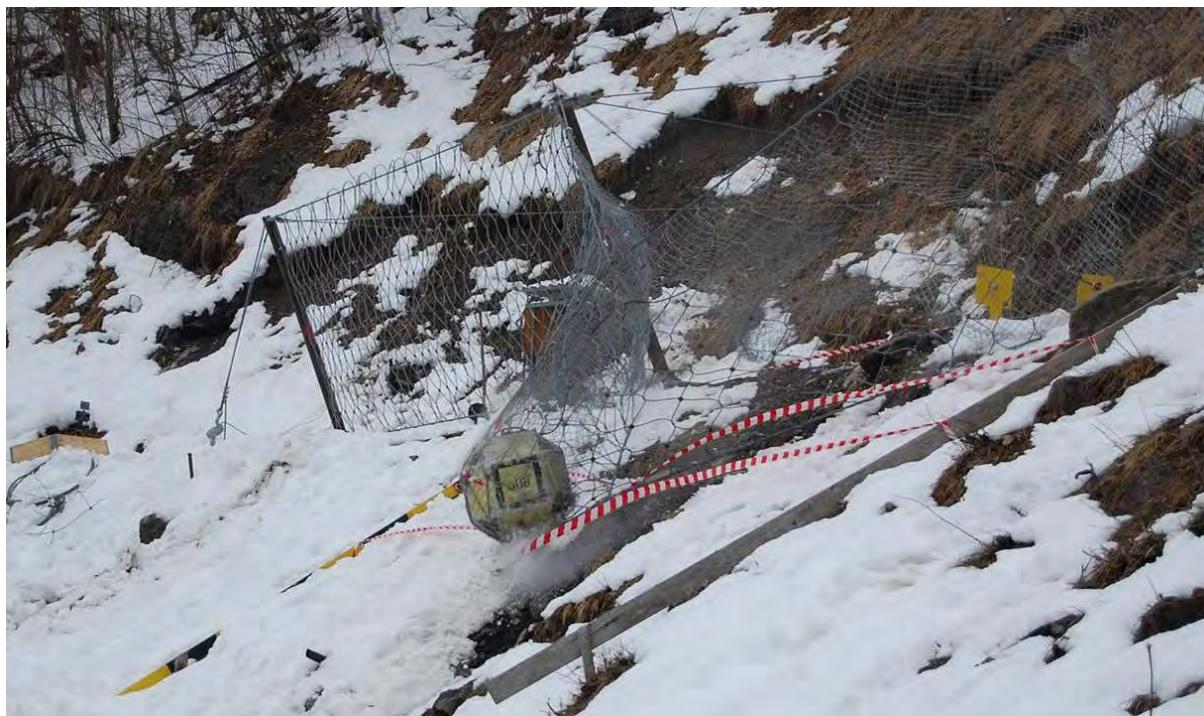
**Figure 13 – Impact of the 250 kJ MEL-Test**

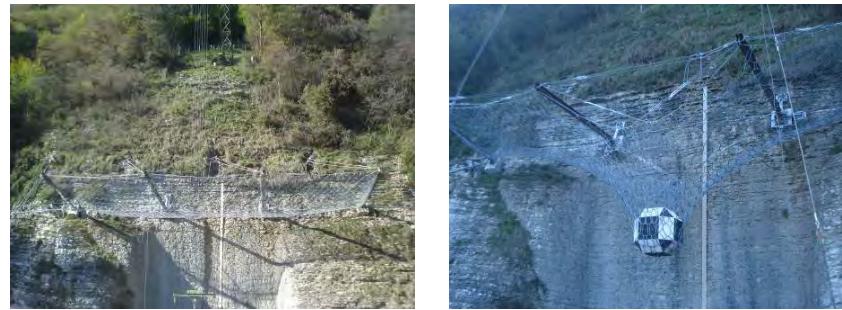
**Figure 2: rockfall barrier with an energy capacity of 6,500 kJ tested according ETAG 027 Guideline. Before (left) and after (right) the MEL impact.**

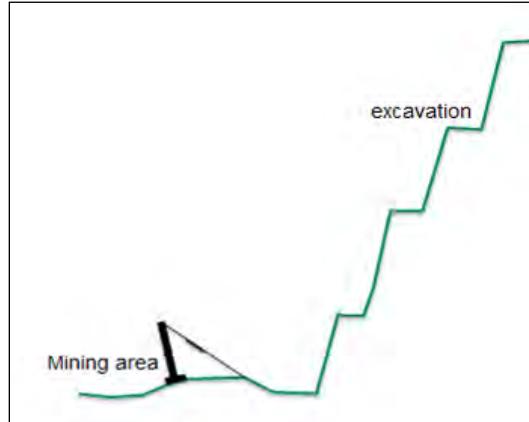
The MEL criterion is normally adopted when there is a low frequency of rockfalls or only one boulder is expected to fall, if maintenance can be easily done and/or if the risk level allowed is high. Using this approach, the initial cost of the barrier structure is certainly lower than the one designed for the SEL, but the maintenance cost can be higher and the safety level is lower. Typical uses of rockfall barriers designed at the maximum energy level could be for temporary works, or installations at the base of a re-profiled slope, as often happens in mining applications.

**Figure 8: typical application with a rockfall barrier designed with the MEL approach: easy maintenance.**

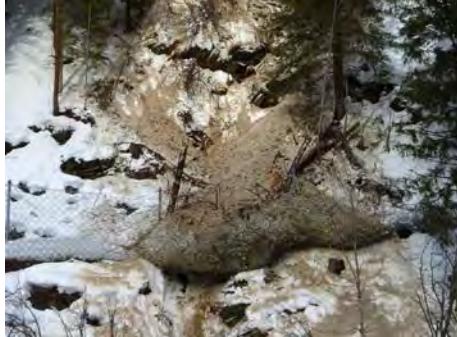
Case 3 - Performance of the 3,000 kJ (1,106 ft-ton) barrier impacted by an avalanche – Gitterberg (Austria)

Barrier characteristic	Value	Photo
Maximum energy absorption:	3,000 kJ (1,106 ft-ton)	
Damage: 1.5 spans were involved in the avalanche. The lateral post was tilted downslope and several energy dissipaters worked at their maximum level. Notes: the barrier stopped an avalanche composed by rock debris and big trees. In the impacted span the minimum residual height was evaluated close to 50% of the nominal height, and the downslope deformation was approx. 3.5-4.0 m (11.5 – 13 ft)

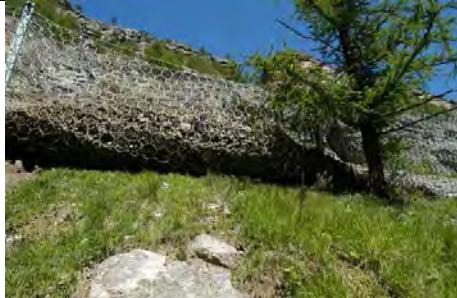
Case 4 - Performance of the 2,000 kJ (738 ft-ton) barrier impacted a debris flow - Valsavaranche (Valle d'Aosta – Italy)

Barrier characteristic	Value	Photo
Maximum energy absorption:	2,000kJ (738 ft-ton)	
Damages: 4 spans of the longest barrier (80 m (262 ft) long) were impacted by a debris flow with a total volume of 200 m <sup>3</sup> (262 yd <sup>3</sup> ). Only 8 energy dissipaters worked at their maximum capacity. Notes: the barrier stopped the debris and it maintained its residual height, higher than 65%-70%. The downslope deformation was approx. 2.5-3.0 m (8 -10 ft).

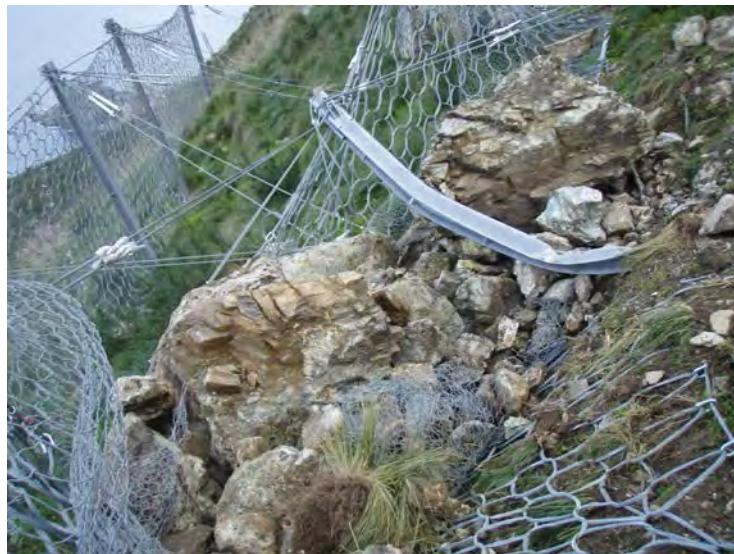
**Figure 8 - Multiple impact event. The barrier with nominal capacity 5000 kJ, 6.0 m high, has been severely impacted by a large rockfall, with an estimated energy between 6500 and 9500 kJ. Despite the large deformation and the huge size of the blocks, the top and lower longitudinal cables have not been broken and the barrier retained almost 50% residual height.**

The case histories show that the barriers are effective also when the impact energy is higher than the SEL. In some cases (Table 4) the energy level has been estimated to be several thousand kJ (ft-lb) greater than the nominal capacity; even if the structures were totally ruined (large elongation, posts severely bent, no possibility of cost effective maintenance), they were effective and not one boulder passed the barrier (Invernizzi and Giacchetti, 2010).

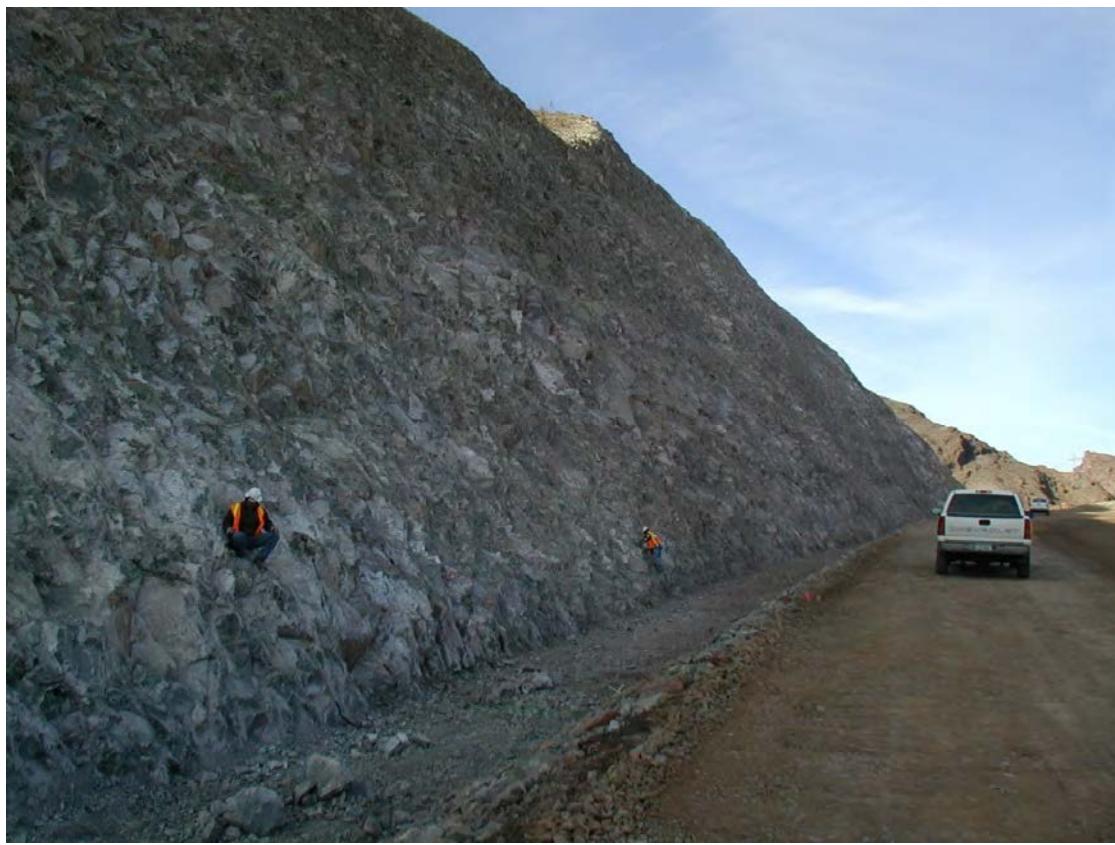
**Figure 2 - Hand-scaling of a cut after construction to reduce probability of failure (hazard).**

Figure 2 shows an example where steps are taken to reduce probability of failure. Figure 3 shows (a) a case where the ditch and run out area is far from the road, and (b) where a barrier is used on the same road to contain rockfall in the ditch. In both cases, the consequence of failure is reduced. With these definitions in mind, the common tools for analysis are described below and reference is made to how they contribute to understanding risk.

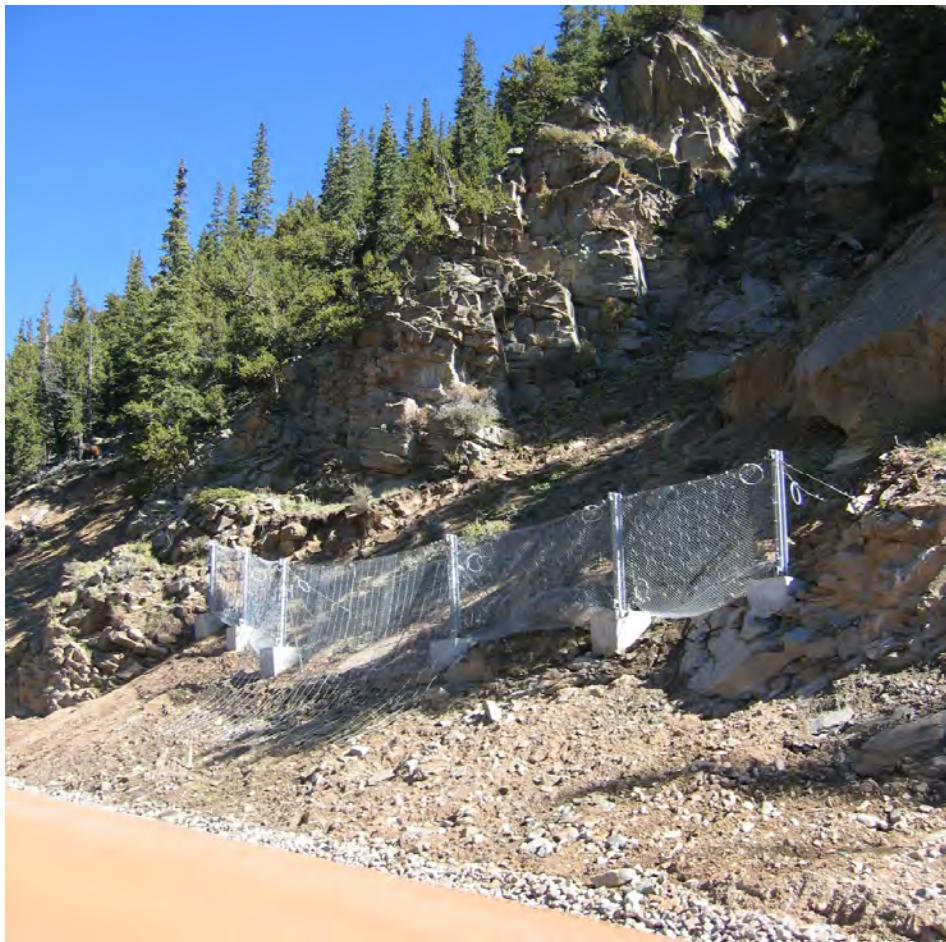
**Figure 7 - A rockfall fence installed on Guanella Pass Road.**

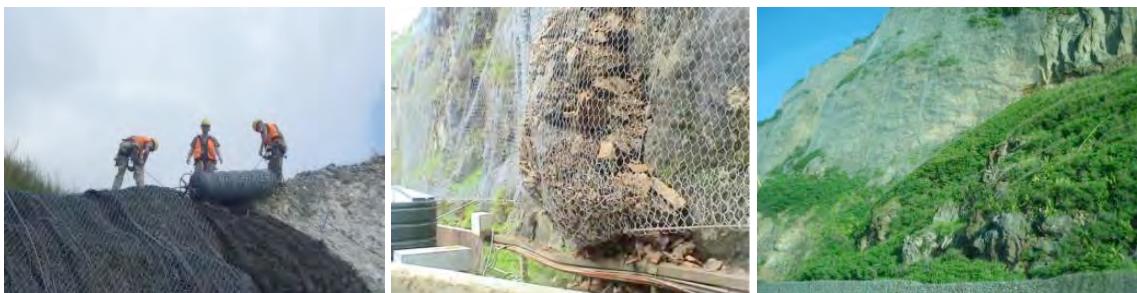
**Figure 2 (left) – Mesh installation at the crest (left)**

**Figure 3 (centre) – Debris accumulation at the toe of the simple drapery system**

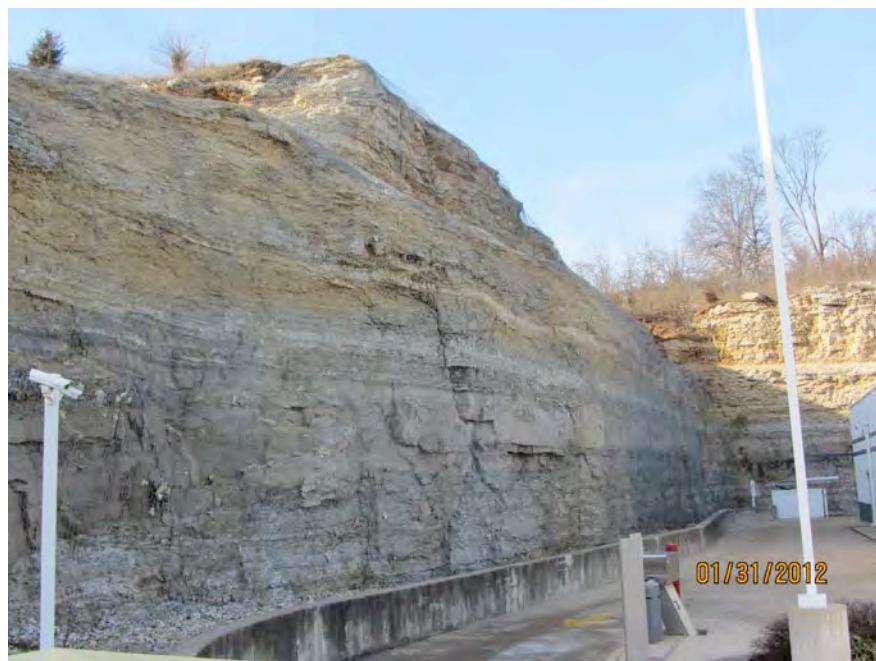
**Figure 10 – General overview of the protected slope**

The height of the slope was around 20 m (65 ft) and the falling block size was supposed to be from 15 to 30 cm (6 to 12 inches). A simple drapery system was the best solution with the toe of the upper section secured in this case because:

More than 1,500 m<sup>2</sup> (16,2000 ft<sup>2</sup>) of Rock Mesh M4000 was installed to protect the car wash workers and their patrons. The bluff is separated into two tiers and measured approximately 55 m (180 ft) in length and a total height of 27 m (90 ft). The installation of the mesh was separated into an upper and lower section to blend better with the surroundings, regardless of its expense, rather than running the mesh from top to bottom. The rock mesh drapery systems were installed on each tier. The rock anchors were drilled 6' in depth at 24' centers, the length of the bluff, and grouted in place.
