# 64<sup>TH</sup> HIGHWAY GEOLOGY SYMPOSIUM

SEPTEMBER 9-12, 2013 | NORTH CONWAY GRAND HOTEL | NORTH CONWAY, NEW HAMPSHIRE

PROCEEDINGS

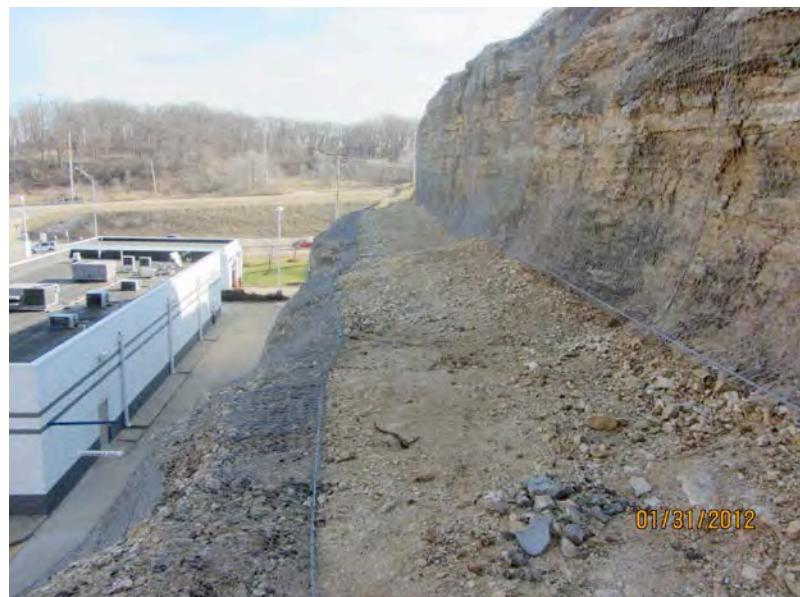
**Figure 11 – Detail of the cable of the Rock Mesh and the secured toe of the upper section.**

Rock Mesh is a woven composite product made of steel ropes and a double twist wire mesh woven together during the manufacturing process. The metallic cables are used in place of the conventional selvedge wire to increase the connection strength and to transmit the load of the debris directly to the top-anchors in order to reduce the stress and the deformations of the mesh. The hexagonal double twist mesh provides high resistance to the impacts of rocks, avoiding the unraveling in the event of wire breakage.

For the upper and lower section, two different design approaches were used. For the upper section, the toe of the drapery was secured to contain the rocks within the mesh and to avoid rocks falling over the lower section where the lower section the mesh was not secured at the toe. According to MacRO 2 calculation, the upper section had an extra load on the mesh due to the rock containment compare to the lower section that was not secured and free to fall into a catchment area.

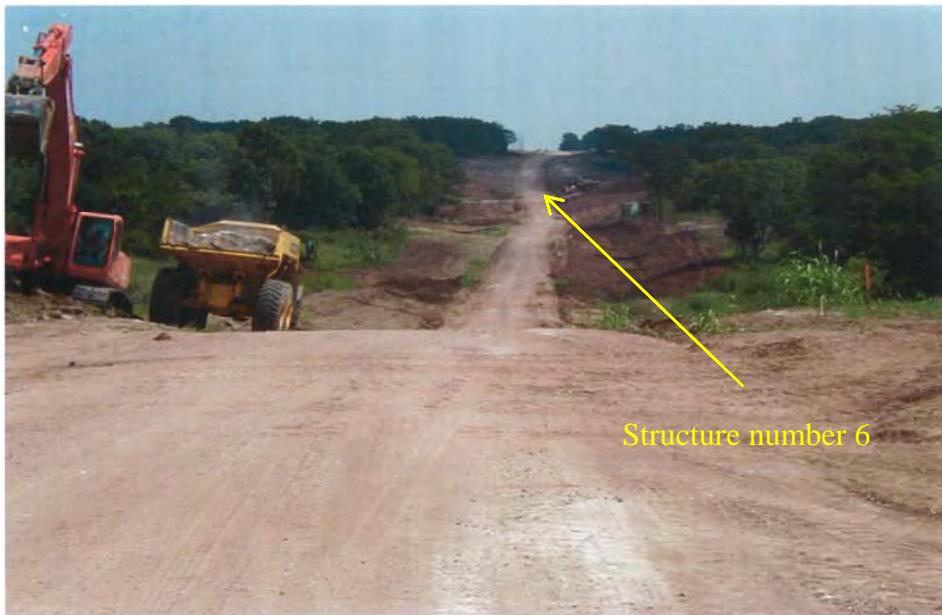
Figure 4. Site of structure number 6 looking East in the drainage way.

cut joint between the two pipe lengths. This change was made on the south end of the pipe requiring a cut into the back slope at station 22+49 with the pipe trench and compaction thereof not in close compliance with the ODOT construction requirements. The location of this pipe extension is approximately from the middle of the embankment side slope to the pipe inlet. There was a collapse of the flexible corrugated pipe culvert within the pipe extension, see Figure 3. The setting for the site conditions at the project site and approximate location of structure number 6 is shown in the photograph in Figure 4

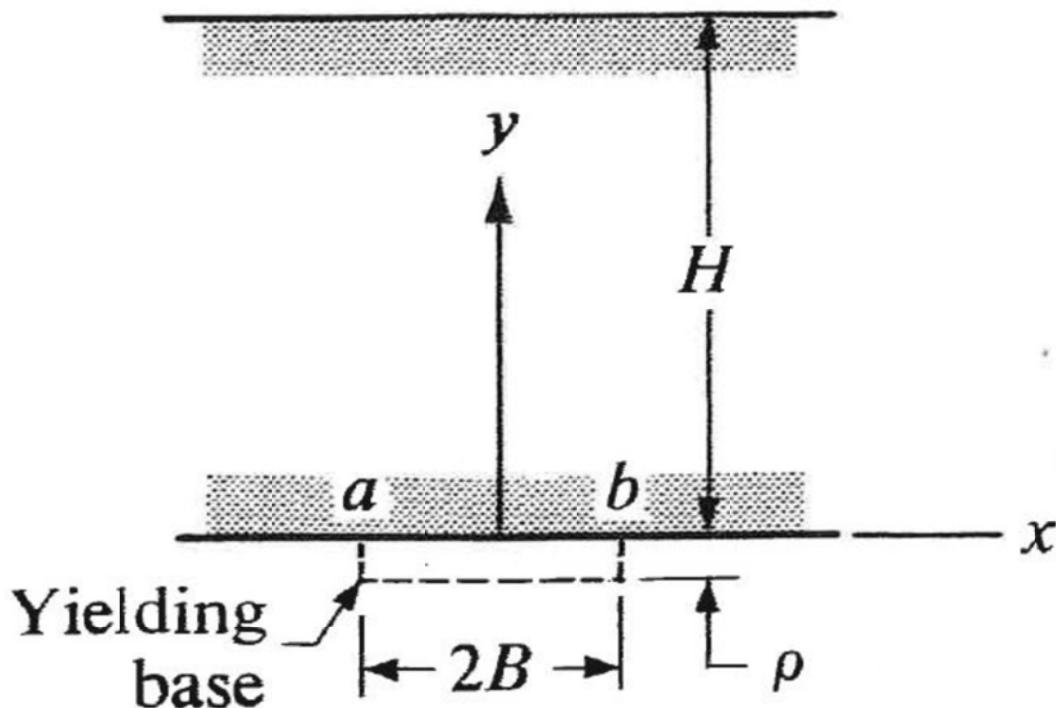
Figure 13. Yielding base free body diagram.

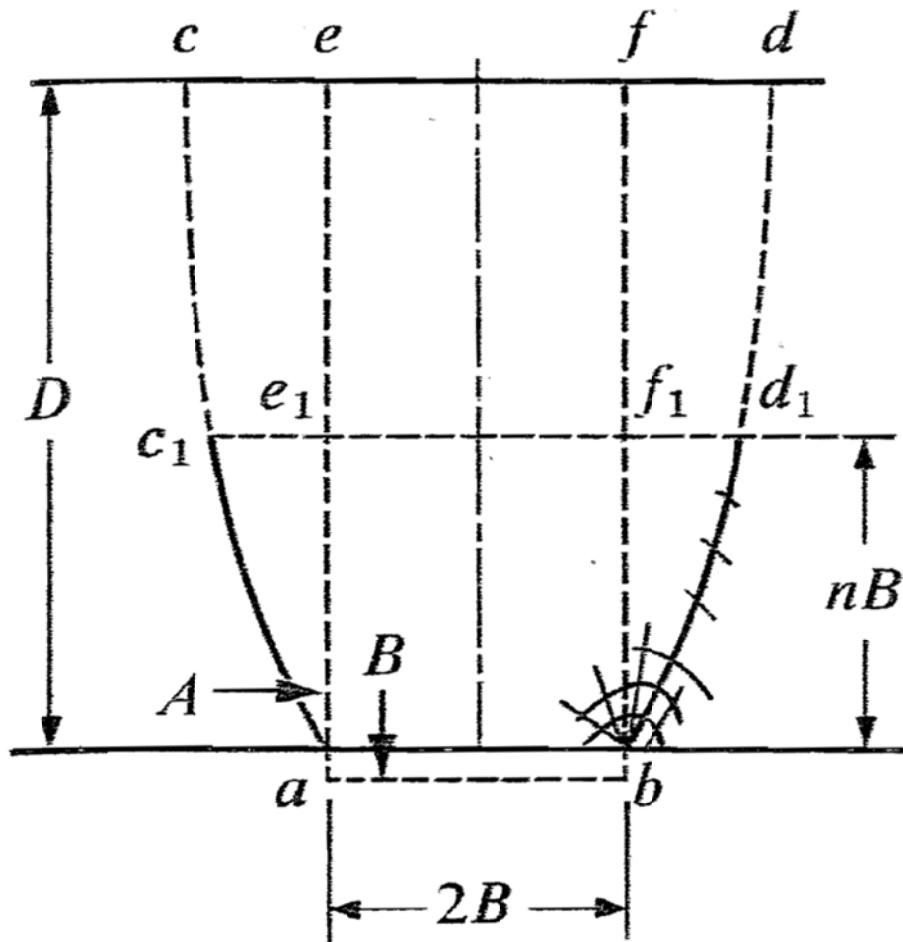
Figure 14. Slip lines associated with a yielding base  $ab$ .

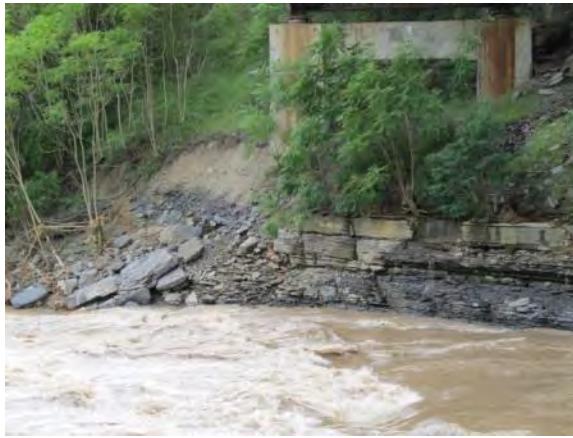
**Figure 2 - Scour damage below Pier 3.**

Regional catastrophic flooding occurred in the region on August 28, 2011 from Hurricane Irene. Based on United States Geological Survey (USGS) stream gauging data, the water level in Catskill Creek rose at least 22 ft during flooding from Irene. Following these events, Thruway personnel inspected the bridge foundations, and discovered recent scour of embankment fill, riprap and other soils surrounding the piers north and south of the streambed. The scour included loss of riprap and soils adjacent to the east footing of Pier 3 on the south side of the northbound truss (see Figures 2 and 3).

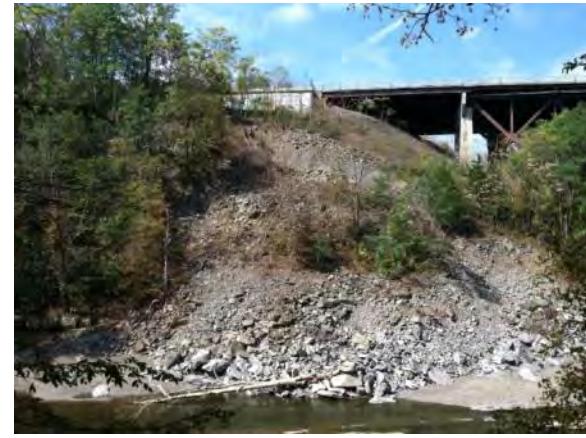
**Figure 3 - Scour of embankment causing slope failure at toe.**

During a site visit on September 27, 2011, a landslide scarp within the fill materials east of the south abutment was observed (Figure 3). Further investigation revealed several tension cracks above the scarp and below the abutment, as well as additional scarps adjacent to the soldier pile and lagging wall. The upper-most scarps and tension crack were within 5 ft of the base of the soldier pile and lagging wall, and displacement of the sliding soil exposed a fiber optic line and associated junction box. Fallen trees at the scarp with dead vegetation indicate the failure may be relatively recent, possibly occurring due to scour of the slope toe during Hurricane Irene flooding. Estimated displacement of the landslide at the recent scarp is on the order of 20 ft down slope. Tension cracks associated with this slope failure were recovered by the Thruway surveyors for inclusion on the site survey map.

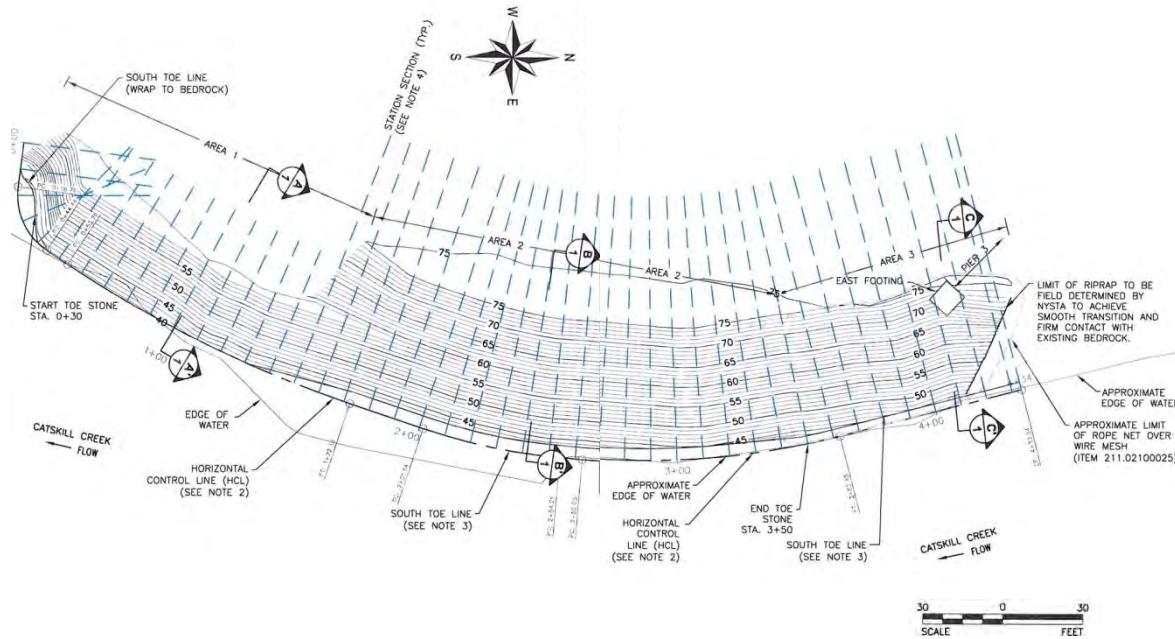
**Figure 8 - Site remediation plan with Areas 1 - 3 shown from left to right (south to north).**

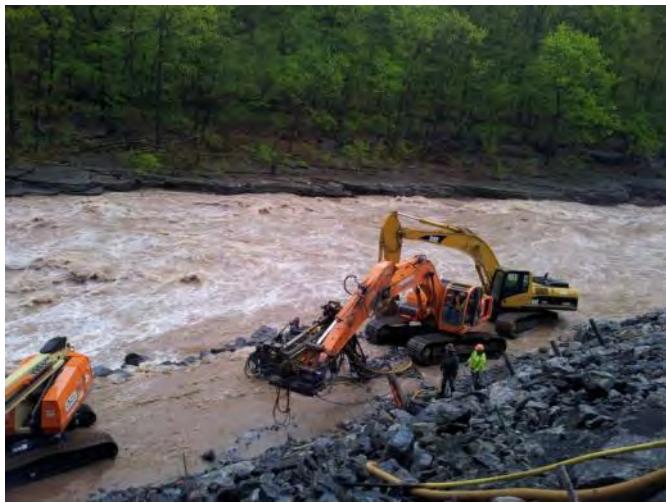
**Figure 12 - Anchor drilling during spring runoff conditions April 2012.**

Slope remediation construction was conducted between late November 2011 and early May 2012. Temporary river access was needed to build the riprap portions of the design, including doweling of oversize Class IX riprap at the toe. Drilling of the anchors was conducted with an excavator-mounted top hammer drill rig. Once the riprap slopes had been constructed, and the anchors had been installed and tested, the Tecco mesh and Spider wire rope systems were installed. Figures 12 through 17 provide photographs of the finished slope repairs.

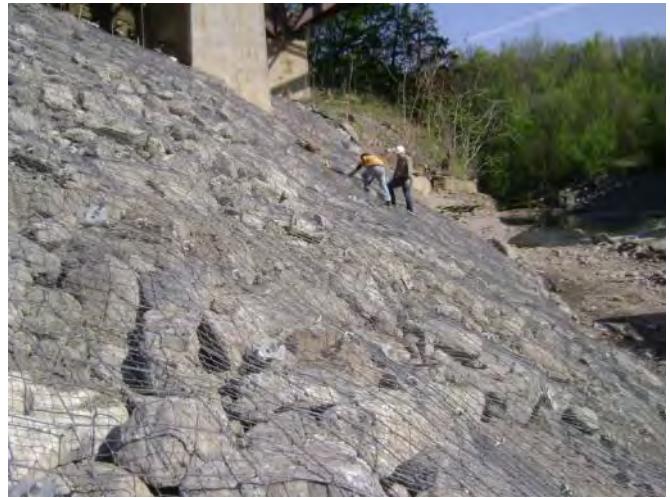
**Figure 13 - Installation of Tecco mesh and Spider wire rope over riprap in Area 3, May 7, 2012.**

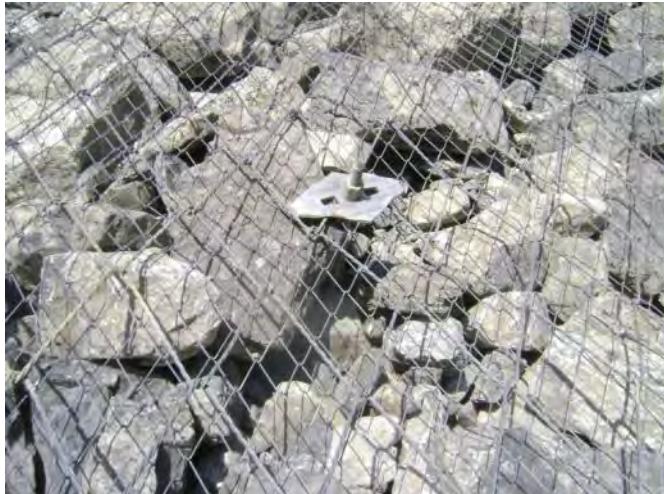
**Figure 14 - Close-up view of rock anchor, Tecco plate, Tecco mesh and Spider wire rope, Area 3, May 7, 2012.**

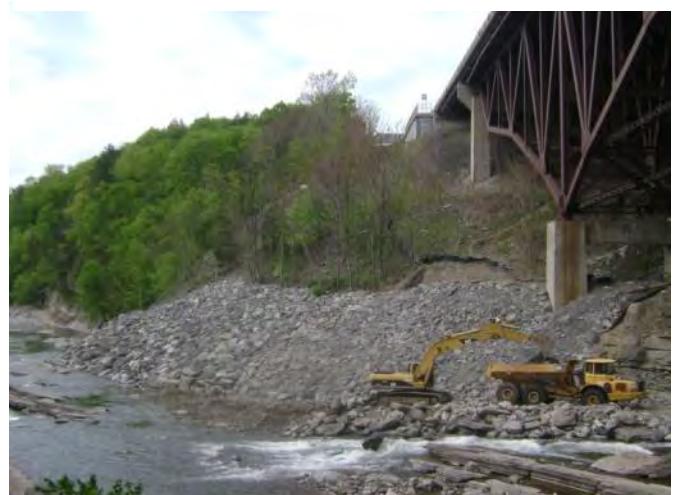
**Figure 95 - Areas 2 and 3 complete, view to southwest, May 7, 2012. Note temporary access road in creek being removed.**

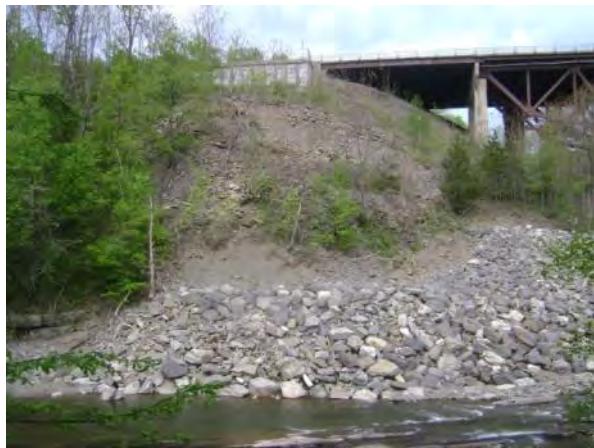
**Figure 16 - Area 1 complete, view to west, May 7, 2012. Note oversize Class IX riprap at toe.**

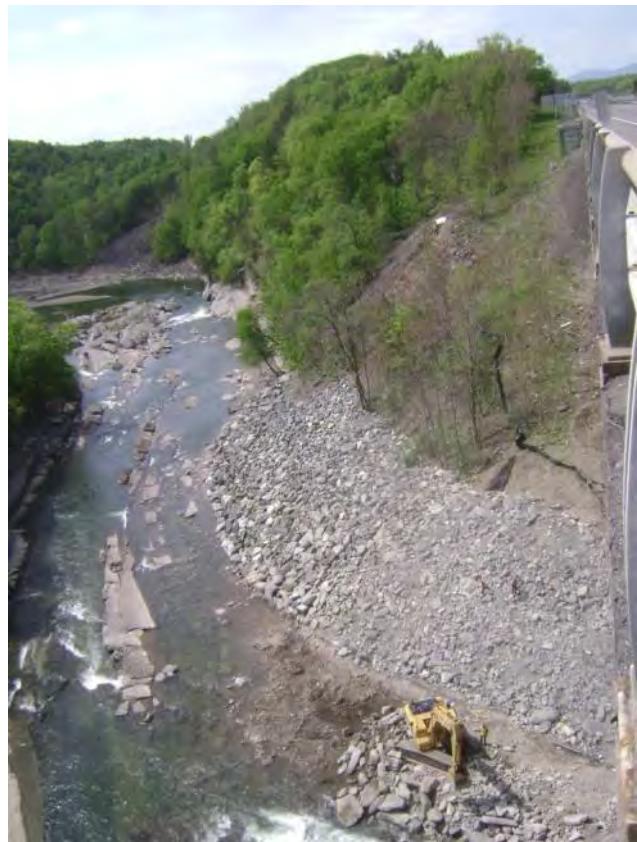
**Figure 107 - Areas 1 and 2 complete, view from bridge deck, May 7, 2012.**

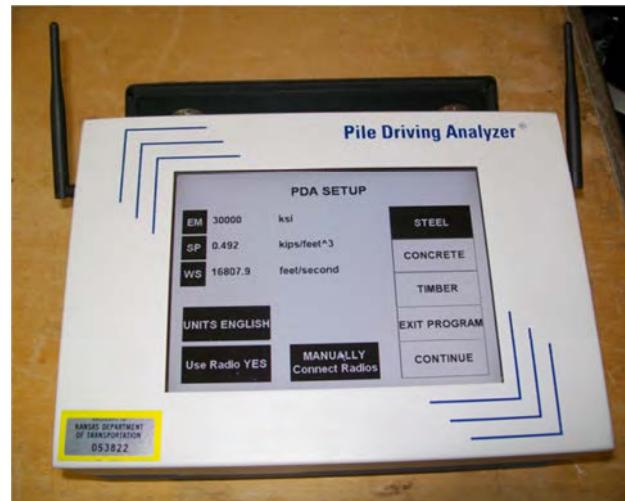
**Figure 3** resistance required by designers at the end-of-initial drive (EOID), the pile is then driven deeper to obtain resistances or allowed to sit for a designated amount of time and a restrike test is performed.

The installations of driven pile are monitored to the required resistances or a specified penetration depth, whichever is achieved first. Driving is stopped once the pile reaches the designated resistance or penetration, and an analysis of the PDA data is performed. KDOT geologists use PDI's pile wave analysis program CAPWAP to analyze and determine if the pile has met the required resistance specified by the designers.

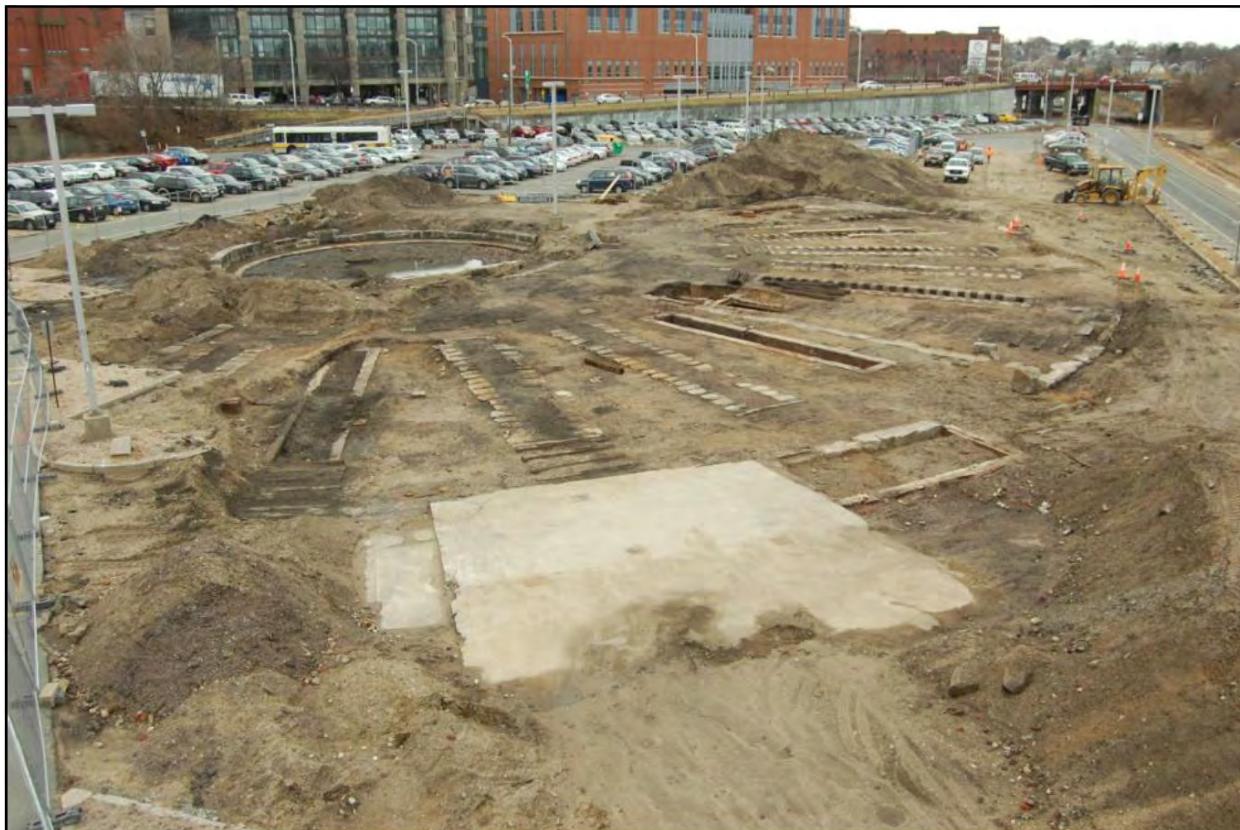
Note: Photo shows turntable foundation in the upper left, and roundhouse engine stall maintenance bays arcing around the turntable.

Based on the geophysical survey results, a full archaeological excavation and survey was performed to catalog and record the historical findings and the subsurface structural and cultural remnants. Figure 6 is a photograph of the site during the archeological excavations, showing the turntable and roundhouse foundations.

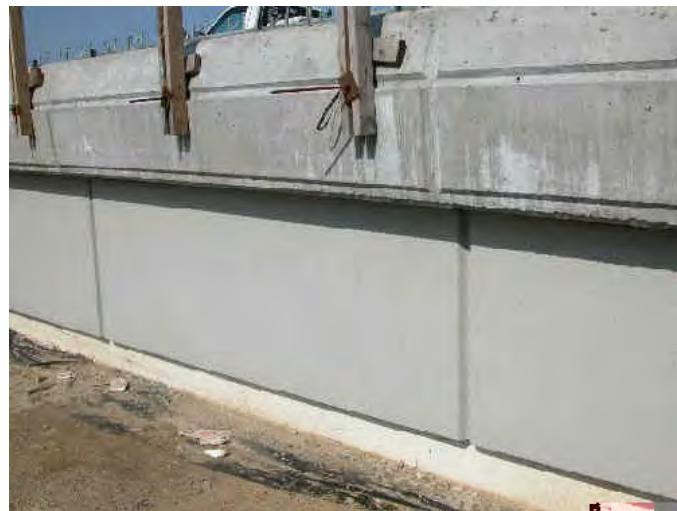
**Figure 1 - EIFS Facing System Used on Boston 'Big Dig' (I-90/I-93)**

With regard to the third item, in the U.S. the primary efforts have focused on permanent facing treatments for vertical-side fills which have become quite common. This was because research conducted for NCHRP Project 24-11(01) revealed that the cost of facing systems (historically precast, reinforced-PCC panels) was a significant part of the overall construction cost (facing panels are relatively heavy and often require their own deep-foundation support system) yet provide only a decorative/architectural function as such fills are generally inherently stable without an earth-retaining structure. As a result, it is now routine to use alternative facing treatments such as the well-known *Exterior Insulation Finishing System* (EIFS, a.k.a. 'synthetic stucco') that can be made to look like a wide variety of materials. For example, on the Boston Big Dig project EIFS finished to look like PCC was used as a facing for a majority of the EPS-block geofoam fills on this project (Figure 1).

It is relevant to note that with both the EIFS and shotcrete facing systems all facing materials are suspended from and supported by the EPS blocks. No separate foundation system is required to support the facing as is always required with precast-PCC facing panels or other types of facing that have been used such as segmental-retaining-wall (SRW) blocks.

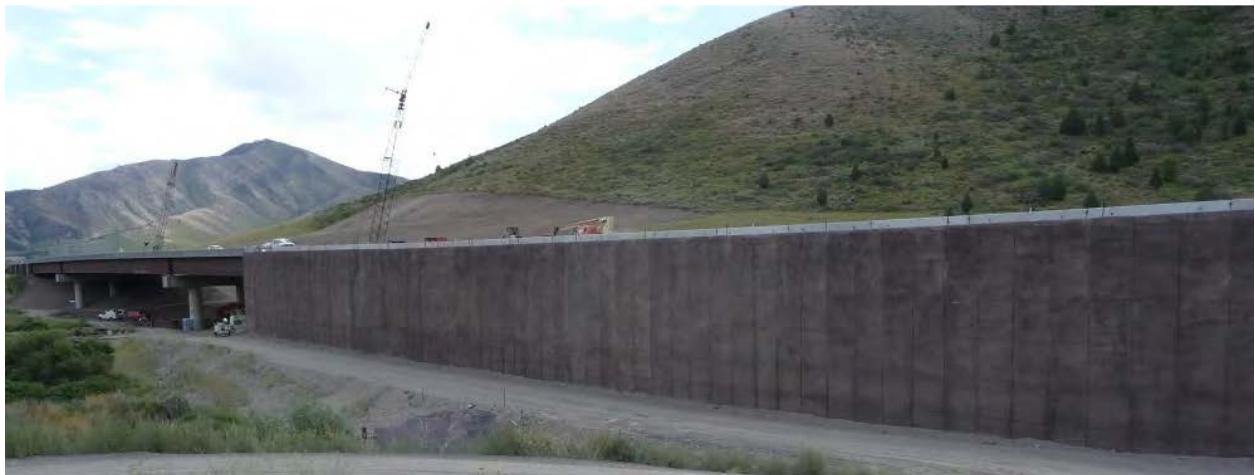
**Figure 2 - U.S. Route 30 Near Topaz, Bannock County, Idaho (Overall View)**

An even more cost-effective facing alternative where its appearance is judged to be acceptable is shotcrete. While the use of shotcrete with EPS-block geofoam fills goes back to the earliest applications in Norway (2), the recent award-winning Topaz (US-30) project in Idaho is believed to have been the first in the world where the shotcrete was colored to better blend in and harmonize visually with the surrounding environment. Figure 2 shows the overall finished Topaz project and Figure 3 is a close-up of the barrier-and-drainage system along the edges of the top of the approach-embankment fill. Figure 3 clearly shows the color of the shotcrete (where the facing wraps around the top of the fill) compared to the normal PCC used for both the cast-in-place (CIP) PCC gutter and precast-PCC roadway safety barrier (a 'Jersey' type barrier with slots cast into the base to allow roadway runoff to flow underneath and into the gutter).

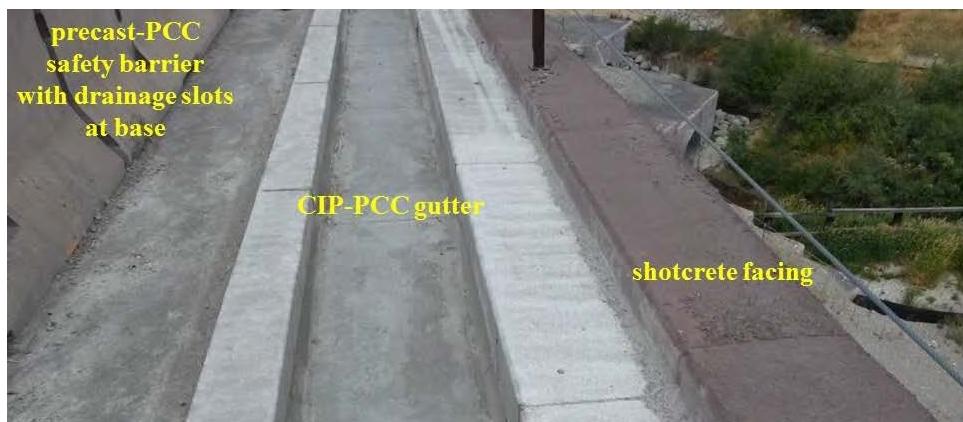
**Figure 3 - U.S. Route 30 Near Topaz, Bannock County, Idaho (Top of Embankment)**

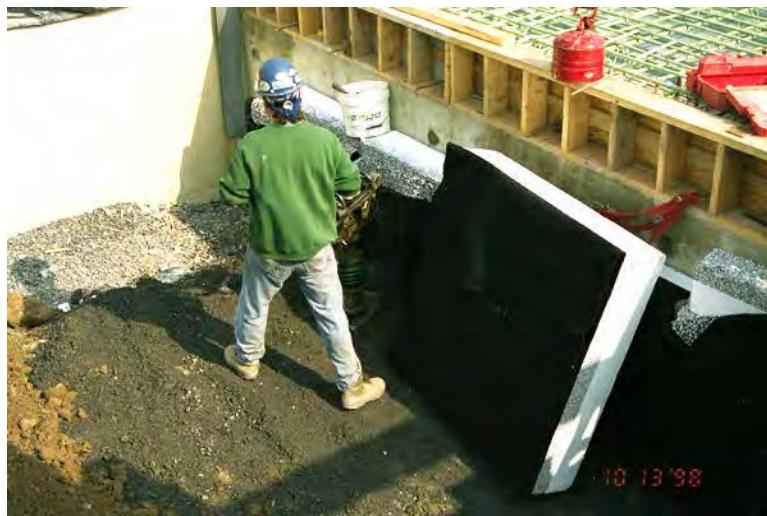
**Figure 5 - Geocomposite Consisting of Geofoam Compressible Inclusion and Sheet Drain**

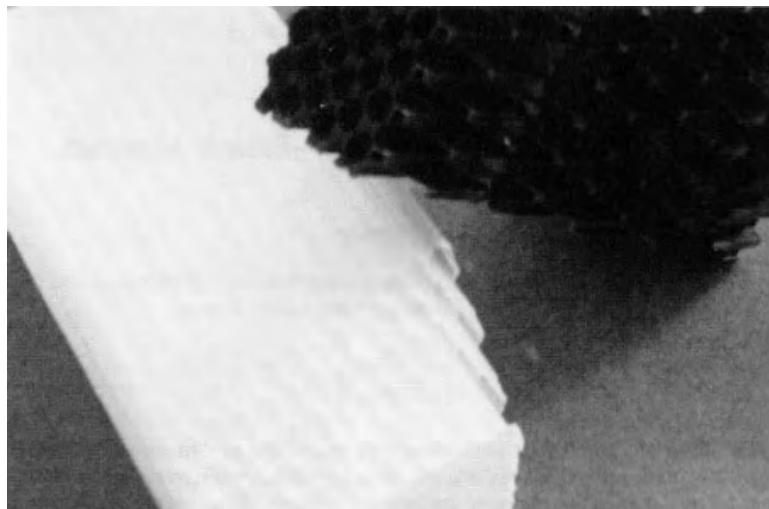
**Figure 6 - Sections of Geocomb Blocks**

A *geocomb* is defined as an open-cell polymeric material with a honeycomb-like cross-section that is created in an extrusion process performed in a fixed plant. It is essentially an assemblage of contiguous open-end tubes, the color of which depends on the particular polymer used (Figure 6). Each tube is of the order of 1 inch (25 mm) across and the material is approximately 96% voids overall (a porosity of 96%).

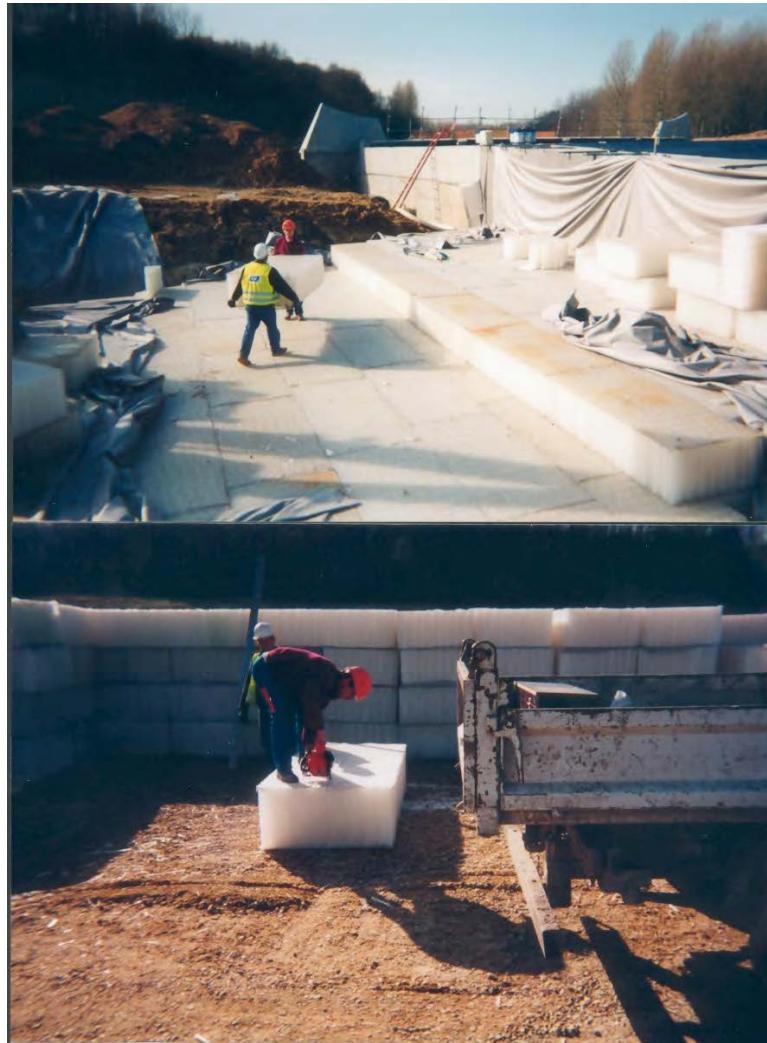
**Figure 7 - Geocomb Blocks Used as Lightweight Fill on a Bridge Project in France**

block geofoam in terms of load-carrying capability when used as lightweight fill for roads (Figure 7). Although a geocomb block cost more than an EPS block on a unit-volume basis and has an overall density approximately twice that of block-molded EPS, geocomb has the distinct advantage of having virtually no buoyancy upon submergence as its open-cell structure allows groundwater to fill the void spaces as well as readily drain if and when the groundwater subsides. This can be a crucial advantage that makes geocomb the lightweight fill of choice in applications where permanent or potential submergence is an important, controlling design consideration.

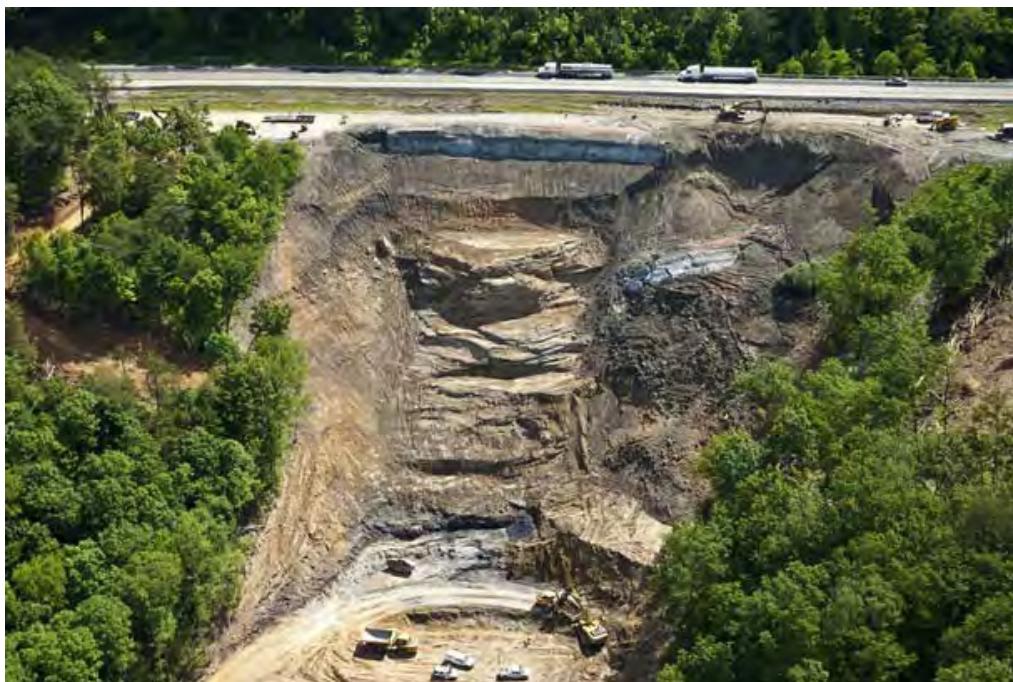
**Figure 1 – Aerial photograph of the I-75 embankment slope failure site in TN as construction repairs were on-going in May, 2012. (Photograph courtesy of Tennessee Department of Transportation).**

In March, 2012, a slope failure within a 150-ft high side-hill embankment section propagated into the southbound travel lanes of I-75 in Campbell County, TN, forcing southbound traffic to be rerouted for five days until one southbound travel lane could be reestablished along the northbound side. The investigation of the failure revealed a deteriorated corrugated metal pipe (CMP) culvert and saturated weathered-shale clay embankment material and underlying natural soils to be primary factors contributing to the failure (3). An emergency repair contract was executed in mid-April, 2012 with an estimated repair cost between \$9.4M and \$12.6M and an estimated completion date of September 28<sup>th</sup> (5.5 months).

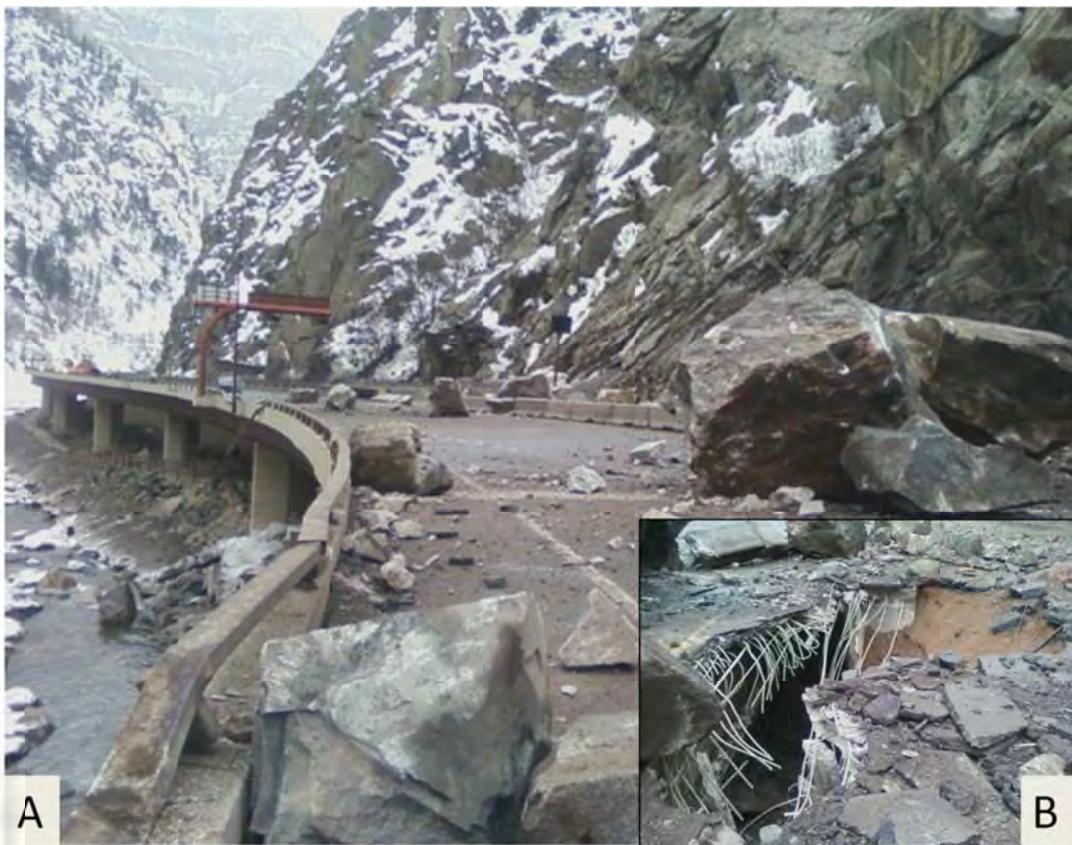
**Figure 3 – (A) Rockfall debris on I-70 elevated deck. (B) Portion of deck torn-through by boulder (Photographs courtesy of Colorado Department of Transportation).**

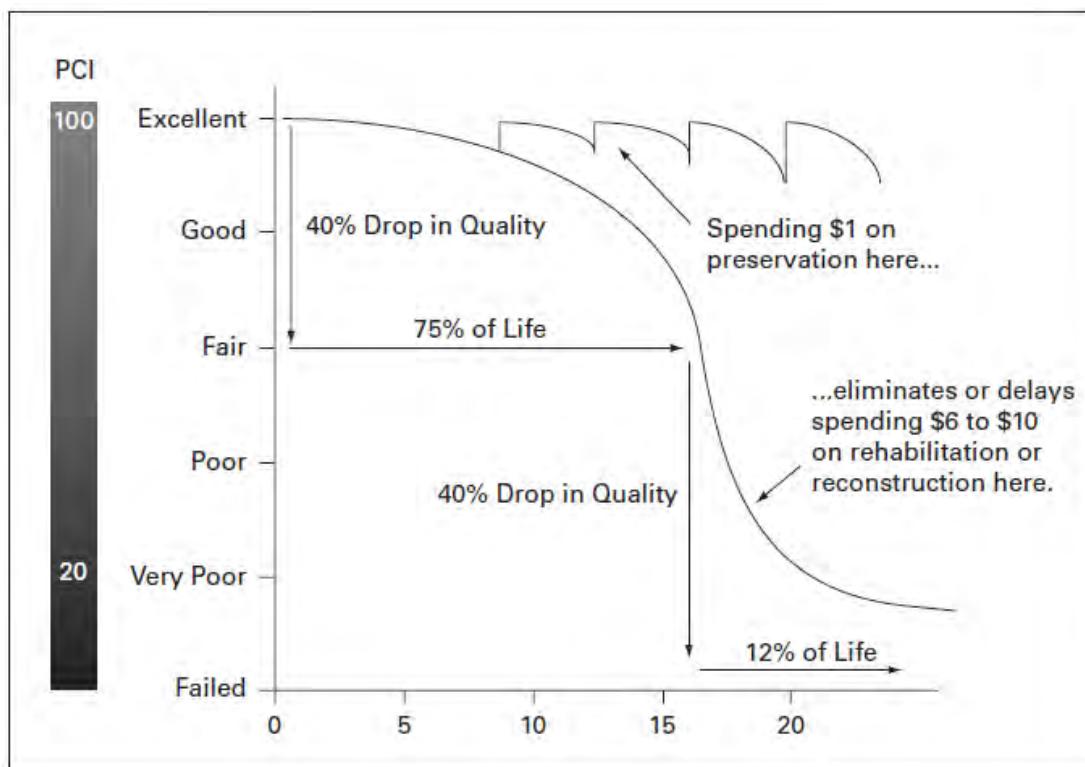
**Figure 6 – Example deterioration curve for pavement showing the value of investment in preservation at a certain age (13).**

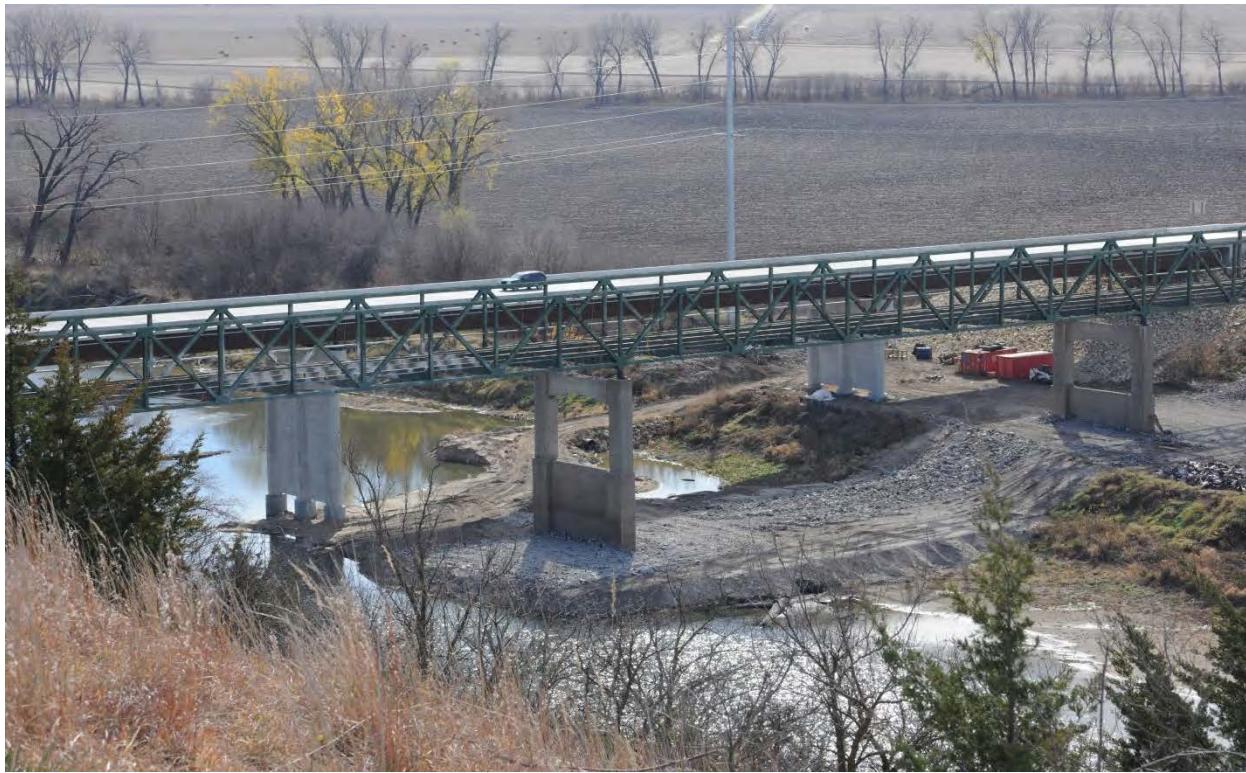
Photo #1 Existing River Bridge and the New Structure to the South

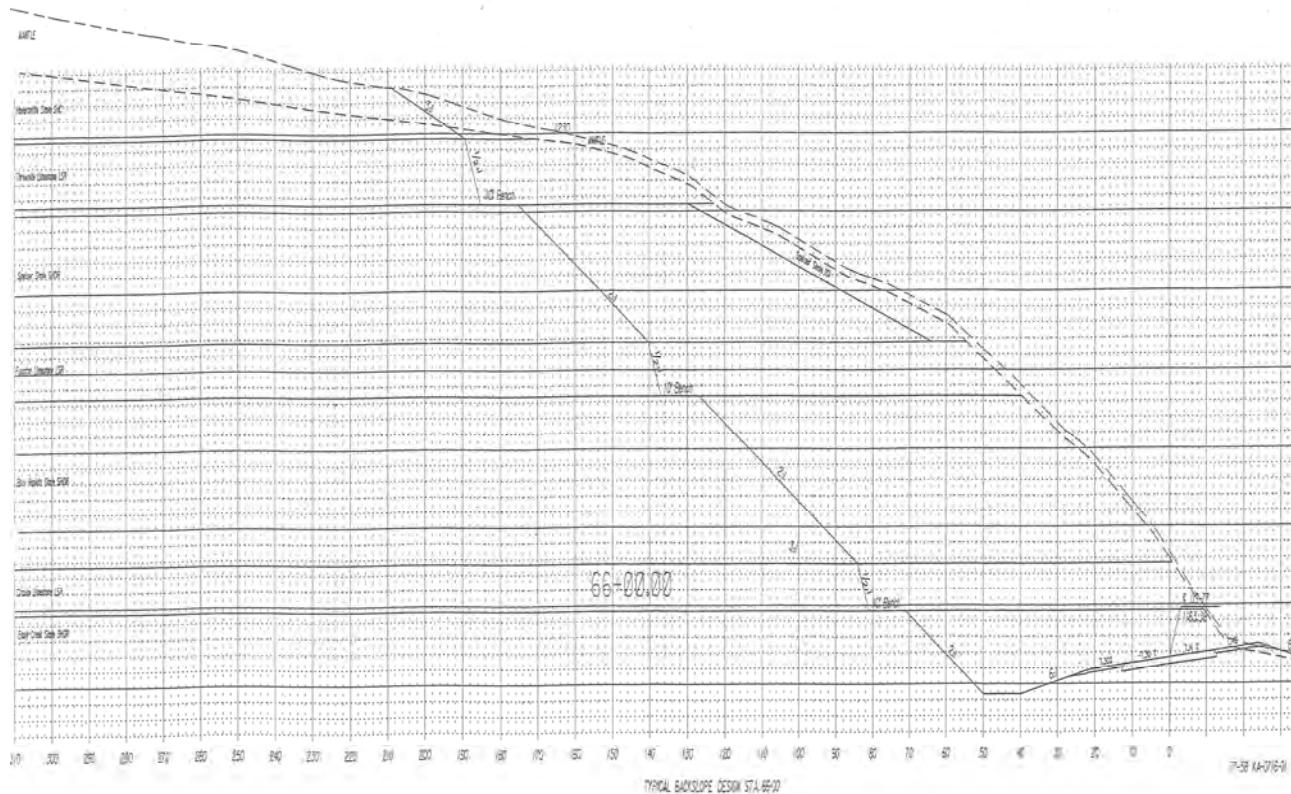
Figure 3 – Rock Excavation Backslope Typical

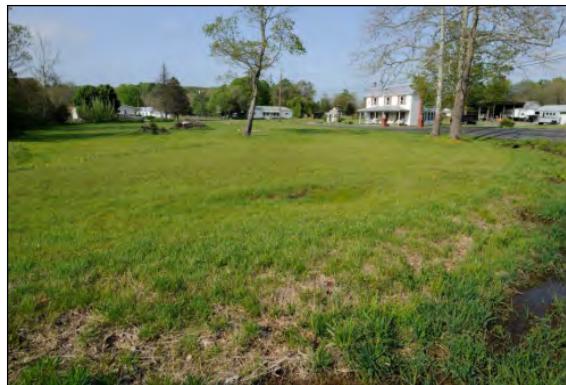
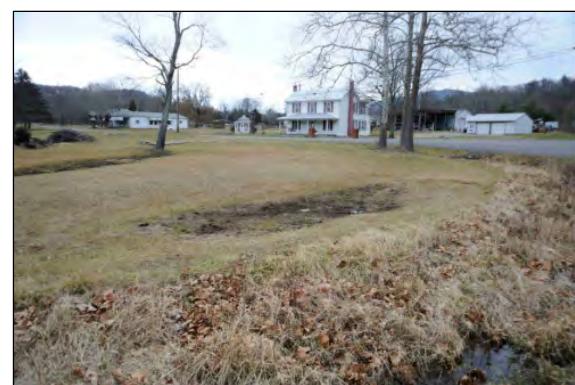
**Figure 8 – Sinkhole Identified by InSAR Points AO96K and AO96J**

Evaluation of the InSAR scatterers yielded several phenomena proving to be developing sinkholes. Figure 8 shows the growth of a sinkhole, represented by InSAR points AO96K and AO96J, which developed during the data collection period.

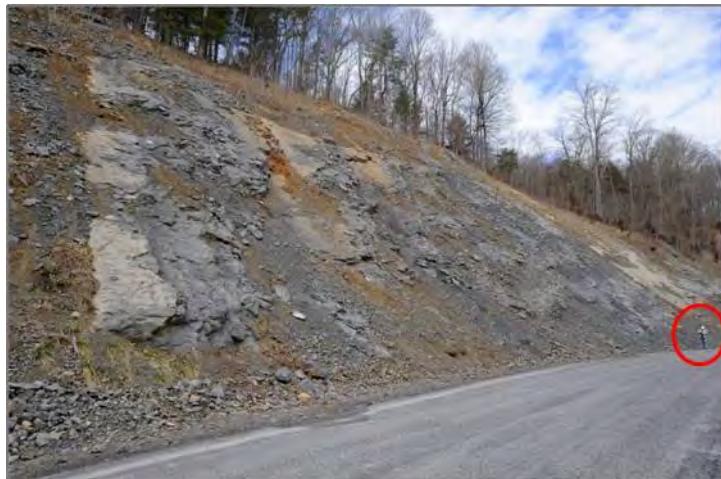
**Figure 9 – RS-600-001 Site Conditions**

One large rock slope within the AOI had a geometry and radar reflectance characteristics suitable for InSAR data analysis. Field observations of the slope, Site Number RS-600-001 (Virginia State Route 600, River Road in Augusta County, Virginia) indicate dip slopes of dark blue-gray, fine- to medium-grained, cherty limestone belonging to the Licking Creek Limestone (Silurian-Devonian). The slope height and angle are approximately 120 feet and 40 degrees, respectively. A joint set meets the slope at a steep angle, resulting in slab failure where these joints intersect bedding planes, which range from 4 to 12 inches in thickness (13). The lithotectonic conditions result in small-scale, continuous, very wide-angle wedge failure along the entire length of the rock slope. The clasts resulting from the wedge failures are small, generally in the gravel- to cobble-size range. The slope behavior was characterized by digital photogrammetry and terrestrial LiDAR, which allowed the behavior of the slope as characterized by InSAR to be evaluated against the activity characterized by site-specific data collection. Figure 9 is a site image. The red circle is a figure for scale.

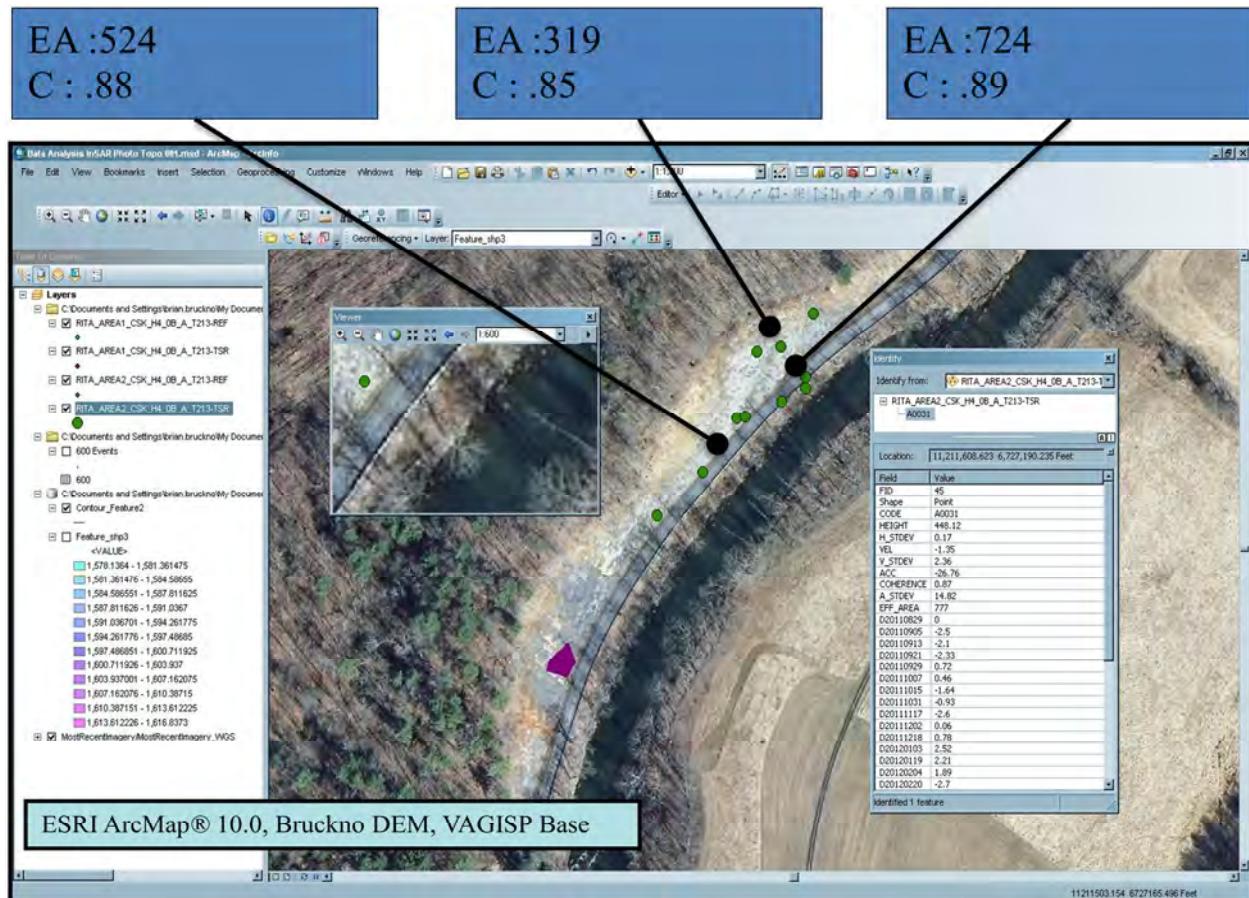
**Figure 12 – RS-600-001 InSAR with EA ( $\text{m}^2$ ) and C (dim.)**

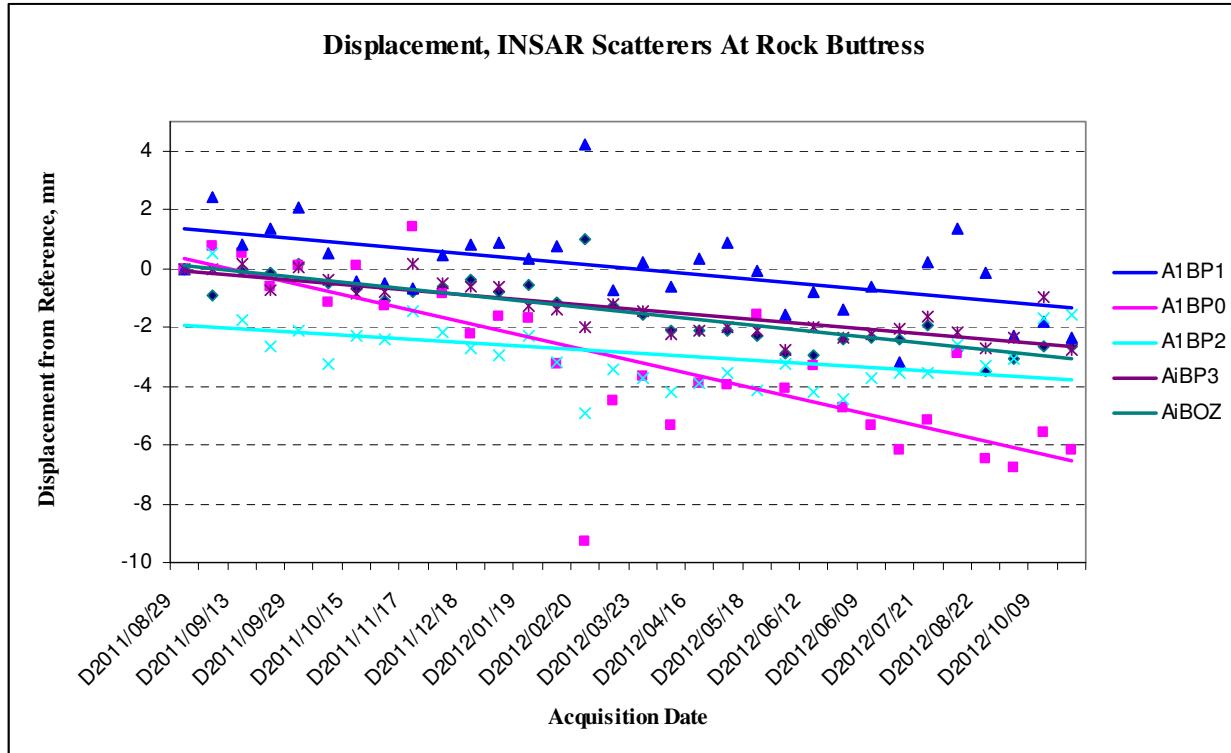
**Figure 14 InSAR Scatterer Data at Rock Buttress**

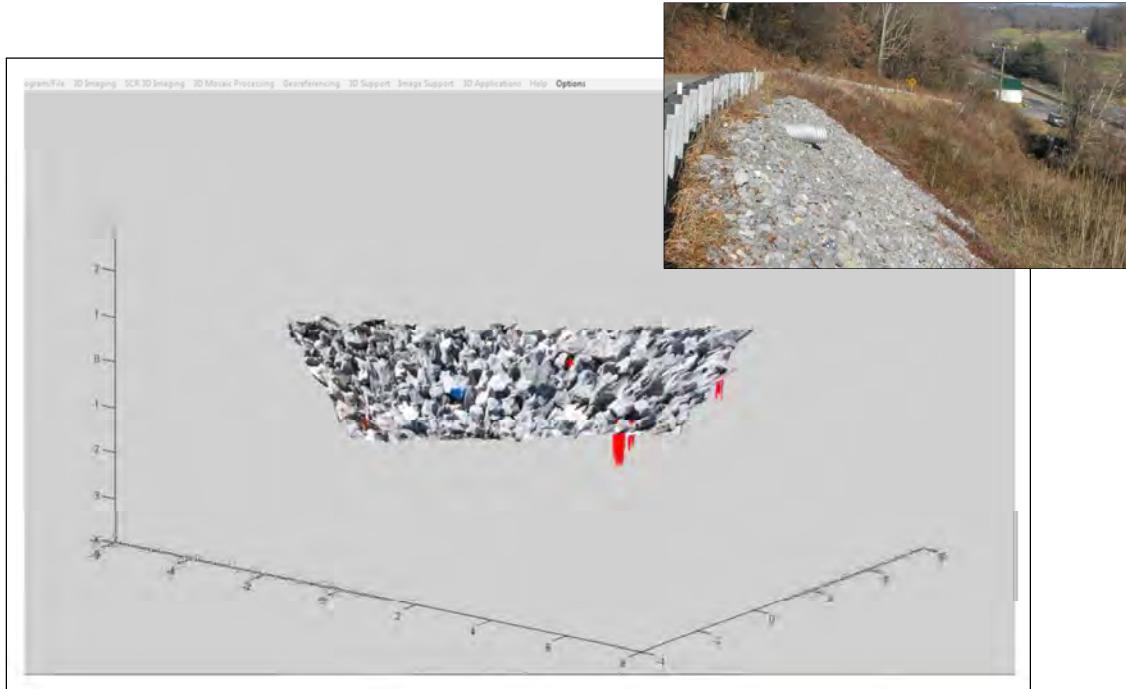
**Figure 15 - Sirovision®  
Photogrammetric Image at Rock  
Buttress**

The AOI contains a number of rock buttresses. Because the locality represented in Figure 14 was the only rock buttress which demonstrated consistent negative-trending displacement, the authors decided to further investigate its behavior. Several site visits, as well as two episodes of digital photogrammetry data collection, were conducted. Figure 15 is an image of the digital photogrammetry data rendered by Sirovision® along with a site image.

The red lines show area of maximum calculated displacement at the rock buttress slope between September and November 2012. While the digital photogrammetry was able to image the rock buttress, the results were not deemed by the authors to be sufficiently reliable to create a time-series of movement along the slope; however, because of the minimal cost, ease of use, and compatibility of the dataset with other types of software, the authors consider digital photogrammetry to be an attractive method of rock buttress characterization for future research.
