# 64<sup>TH</sup> HIGHWAY GEOLOGY SYMPOSIUM

SEPTEMBER 9-12, 2013 | NORTH CONWAY GRAND HOTEL | NORTH CONWAY, NEW HAMPSHIRE

PROCEEDINGS

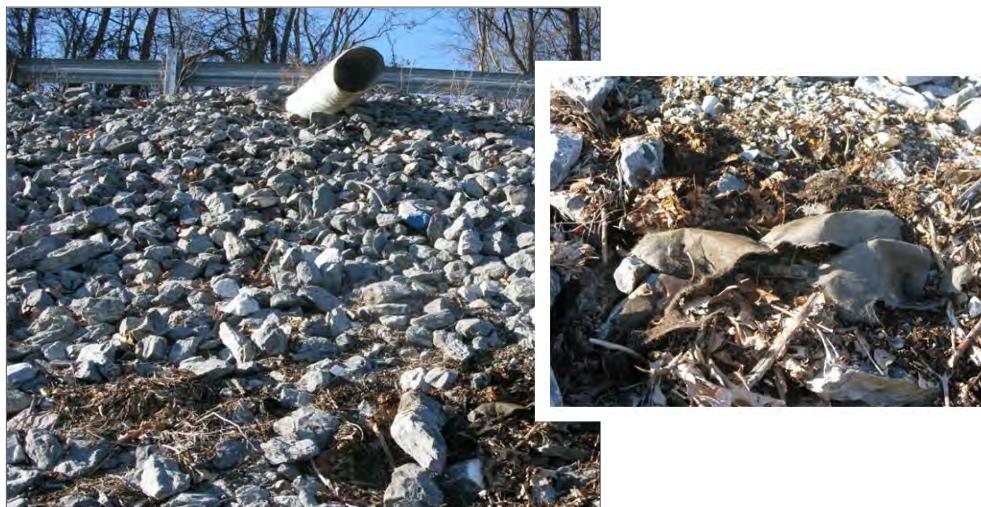
**Figure 16 – Site Conditions and  
Deterioration at Rock Buttress**

Field investigations of the site suggested that a combination of internal settlement and blocked drainage is causing the surface of the rock buttress to distort, and may indicate future failure risk. While the InSAR signal cannot be used to quantify motion along the rock buttress, field investigations strongly suggest that the InSAR scatterer data did reveal previously-unidentified motion along the face of the rock buttress.

The authors evaluated the value of InSAR scatterer data applied to evaluation of geohazards and infrastructure condition. The authors determined that velocity measurements of InSAR scatterers were most strongly negative nearest to mapped sinkholes, whereas the overall average velocity of all scatterers in the karst-prone areas was slightly positive. While the AOI allowed analysis of only one rock slope by InSAR and ground-based methods, the coherence and effective area data yielded by the InSAR agreed with field observations and measurements made by digital photogrammetry and terrestrial LiDAR. Lastly, the InSAR scatterer data was positively correlated with field evidence of infrastructure damage or distortion on a range of geotechnical assets including soil slopes, bridges, pavement, and rail crossings. Additionally, a rock buttress displaying motion was identified by InSAR scatterers, and degraded performance of the rock buttress face was confirmed by field investigation.

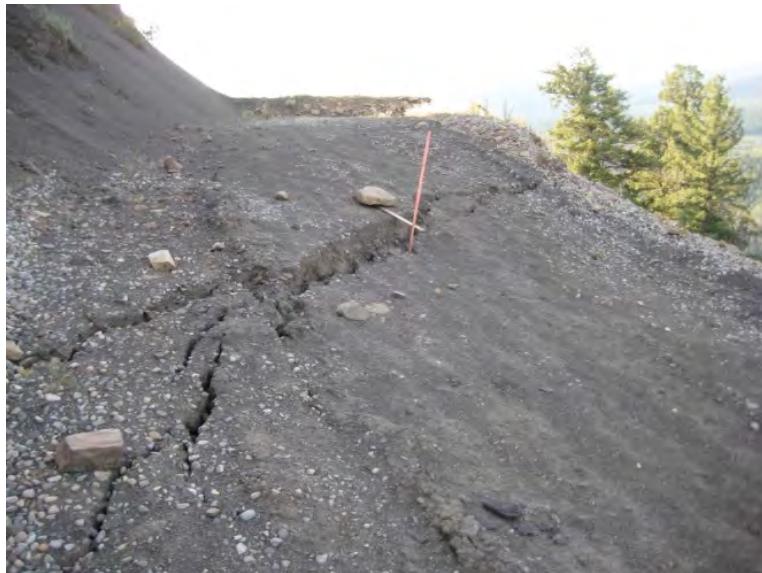
Fig. 2 - Tension Crack at Head Scarp.

The landslide has been in an active state of failure since at least 2000 when clear evidence of movement was observed by the presence of tension cracks in the surface of the abandoned portion of the quarry access road (Fig. 2).

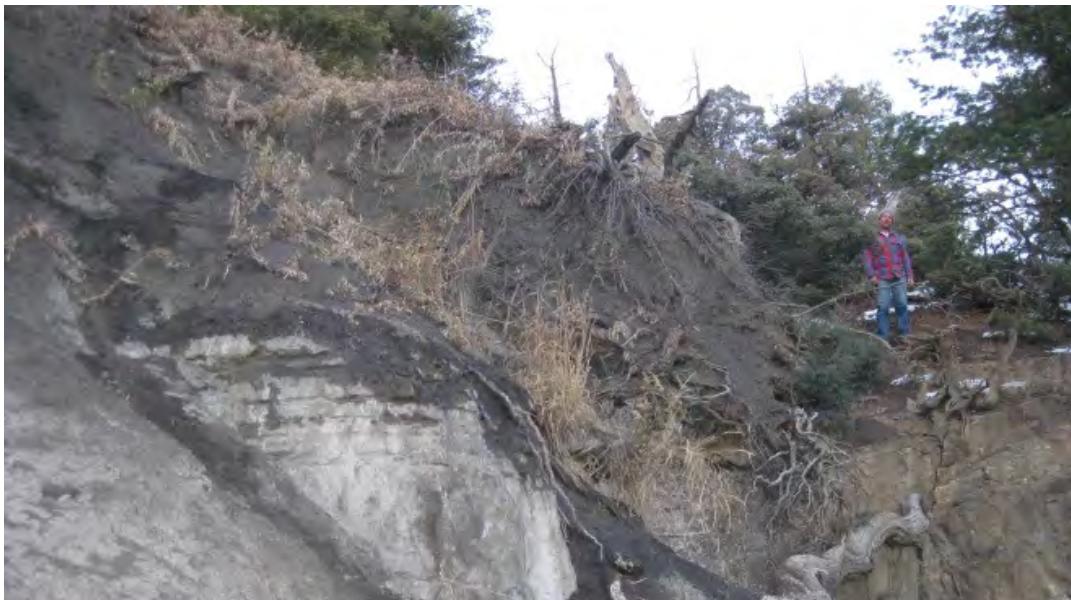
**Fig. 4 - Toe of Landslide**

The landslide extremity was easily identified and mapped in the field. In general, the upper portion of the landslide was depressed in relation to the surrounding native intact ground surface (see previous photograph), and the lower portion was raised above the surrounding ground surface. The toe of the landslide daylights at the interface of the Mancos Shale and Dakota Sandstone at the head of a ravine (see Fig. 4).

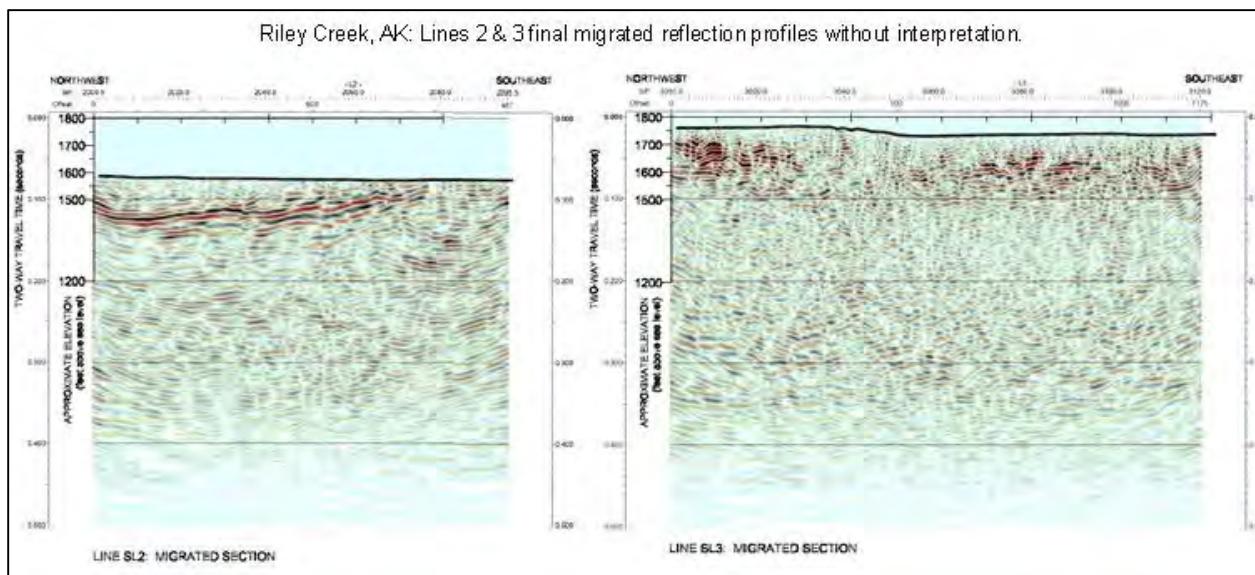
**Figure 4: Final uninterpreted migrated sections of Lines 2 and 3 from Riley Creek, AK.**

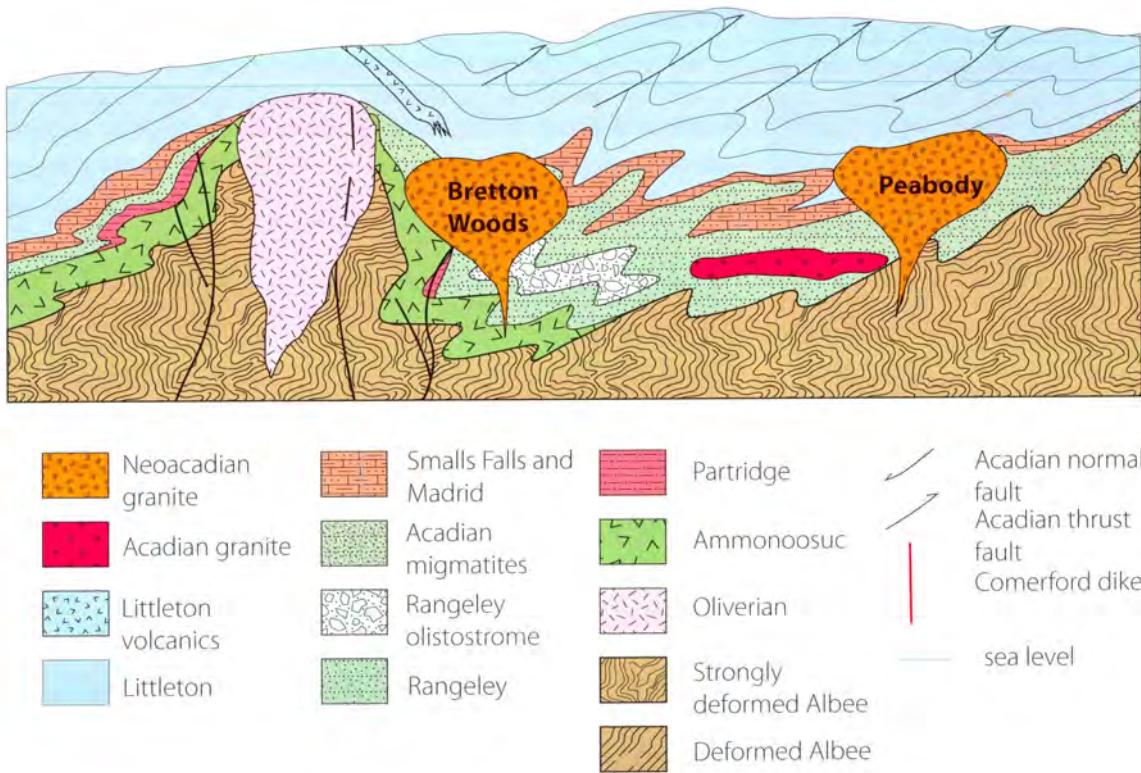
**Figure 3** - The figure above is an idealized cross-section through the complete Late Cambrian to Early Devonian stratigraphy within the White Mountains (Figure reproduced from “The Geology of New Hampshire’s White Mountains”, Durand Press, 2013, with permission of the authors.)

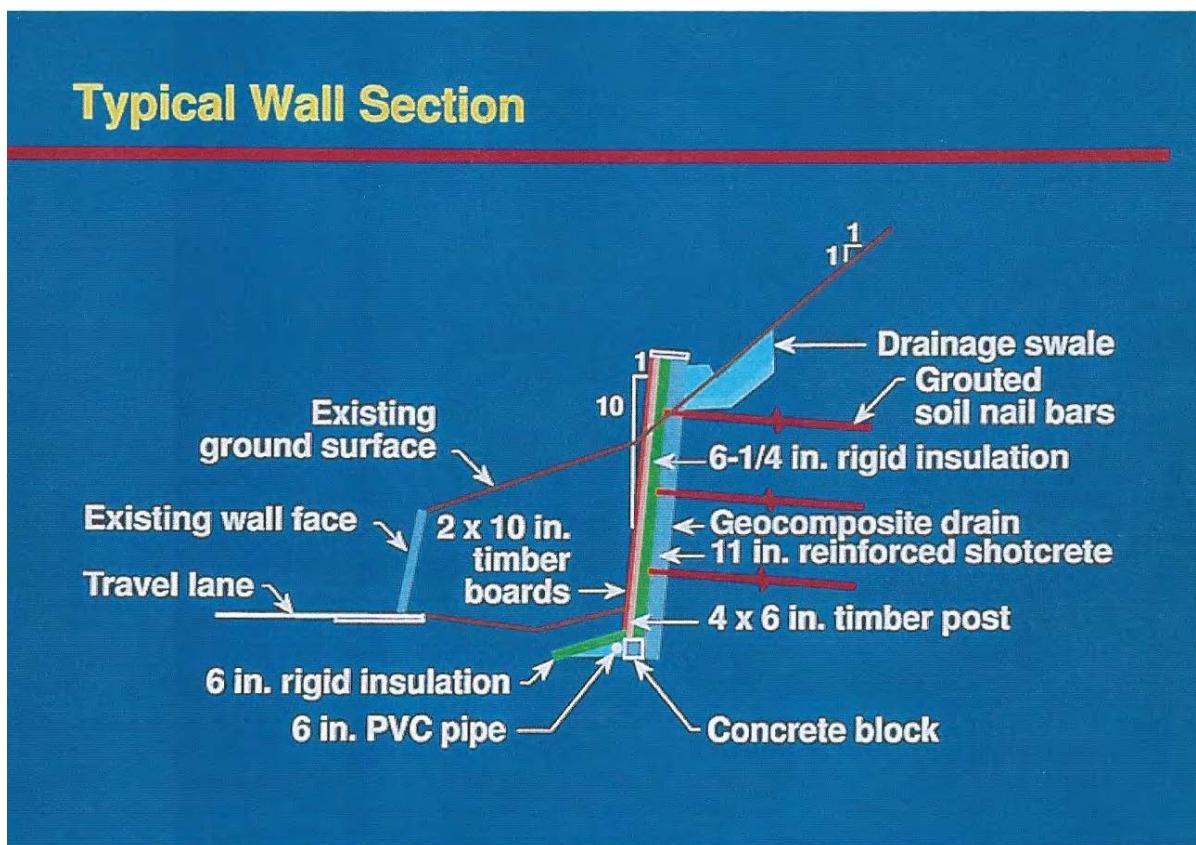
Figure 1 - Typical soil nail wall section (Haley & Aldrich, 1997)

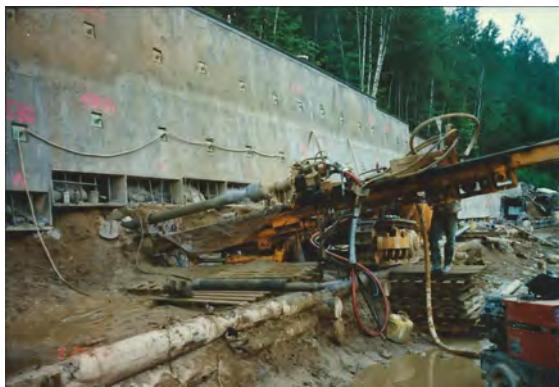
**Figure 2. - Drilling Soil Nail (Cleary, 1996)**

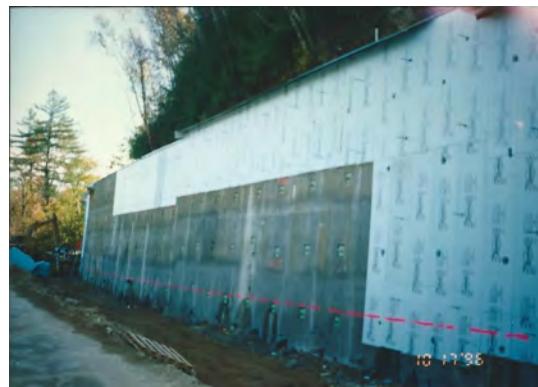
**Figure 3.-Placing Insulation (Cleary, 1996)**

To minimize the freeze-thaw effects behind the shotcrete, two layers of rigid extruded polystyrene insulation with a total thickness of 6.25 inches were placed over the shotcrete facing (Figure 3). In the past, cracking and displacement of the nails caused by ground freezing and thawing have precluded the use of these types of walls in cold climates (Haley & Aldrich, 1997).

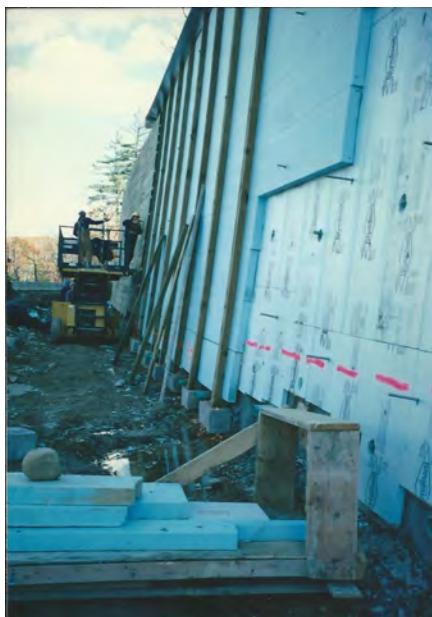
**Figure 4. - Attaching timber facing (Cleary, 1996)**

A rough timber facing, which consisted of pressure treated 2 inch by 10 inch horizontal boards and 4 inch by 6 inch vertical posts, were attached to the wall over the polystyrene insulation (Figure 4). The timber facing provided an architectural wood face finish, which was requested by the US Forest Service (Figure 5) for aesthetic reasons. It was anticipated that the planking would have a shorter service life than the wall itself, requiring replacement of the facing in future maintenance. It is not known exactly how long the facing will last, but its replacement is expected to be relatively easy.

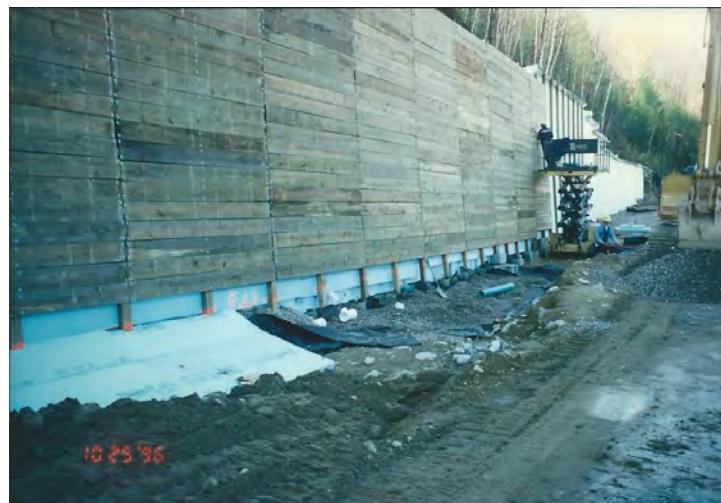
**Figure 5. - Soil Nail Wall with timber facing (Cleary, 1996)**

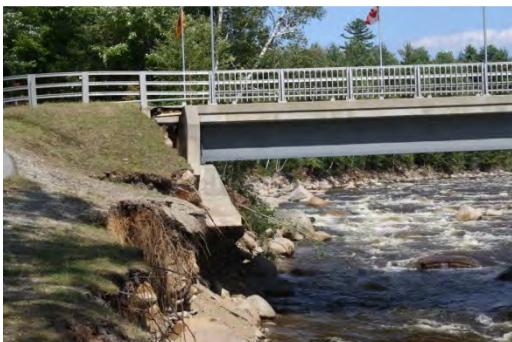
*Loon Mountain Bridge the day after the tropical storm event with 30 feet of the north embankment soil eroded away.*

Unfortunately, the stub abutments were never retrofitted. When Tropical Storm Irene hit, the river became a torrent, eroding about 30 feet of the northern river bank, leaving the north bridge abutment with virtually no support. The bridge stood for three days before collapsing. The span was removed, and a temporary one lane bridge was installed. Because of its history of problems, it was determined that a full bridge replacement would be pursued at a cost of 6 million dollars.

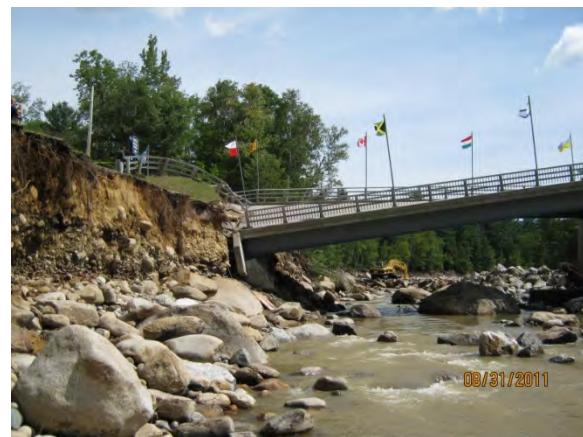
*August 31, 2011, the north abutment falls.*

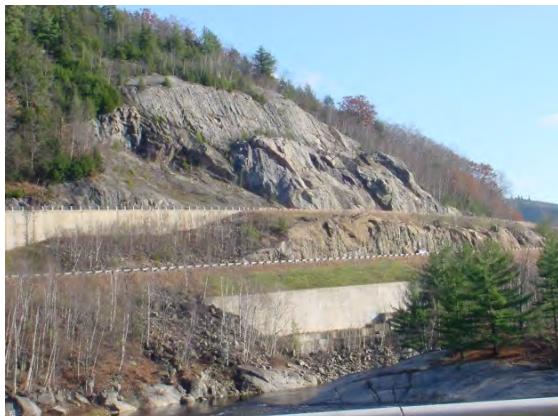
**Figure 1 - Barron Mountain Rock Cut (Lane, 2004)**

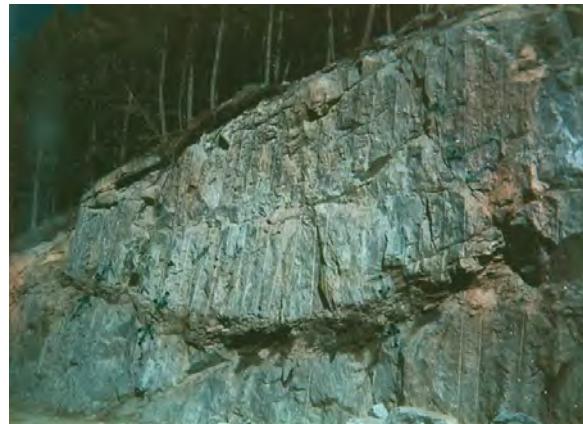
**Figure 2 - Mylonite zone along failure surface prior to slide (Fowler, 1972)**

The 1972 rockslide occurred along a highly fractured mylonite zone, which ranged in thickness from 1/2 inch to 11 feet (Figure 2). This weakened zone of low strength material along the failure surface was oriented nearly parallel to the roadway alignment and dipped into the road at approximately 38 degrees (Fowler, 1976 and 1977). Additional mylonite zones with similar orientation were encountered south of the slide area during the early stages of the reconstruction requiring a second redesign of the rock slope. Water flowing along unfavorably oriented mylonite zones was most likely a major factor in triggering the slide.

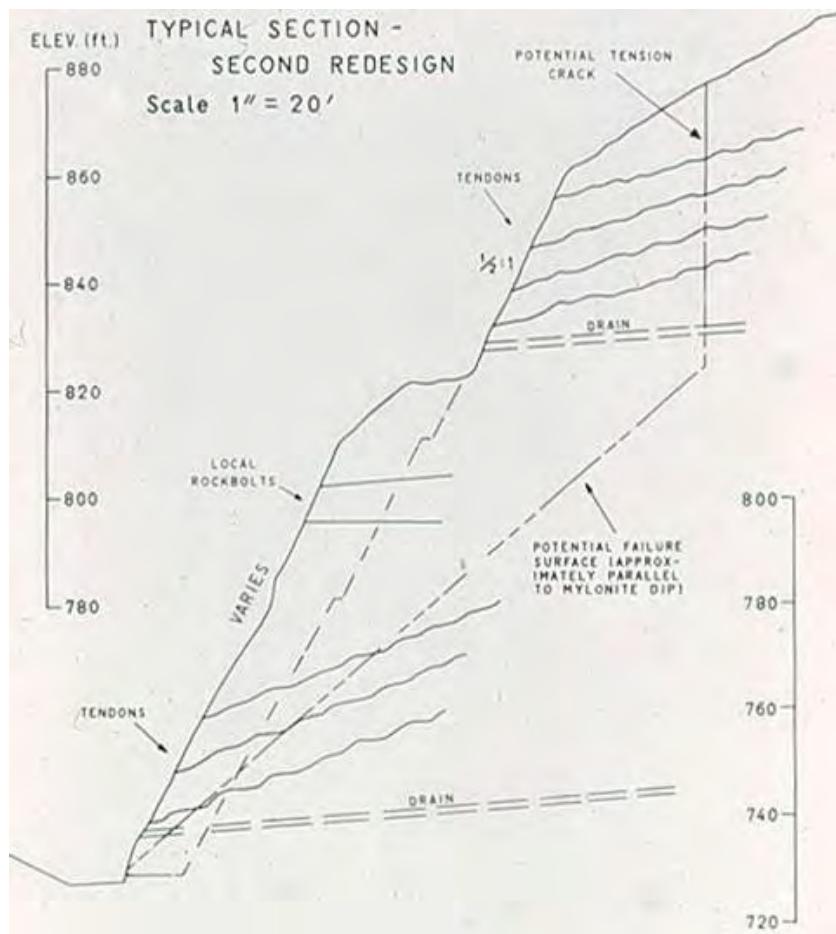
**Figure 3 - Typical section with rock reinforcement (Fowler, 1976)**

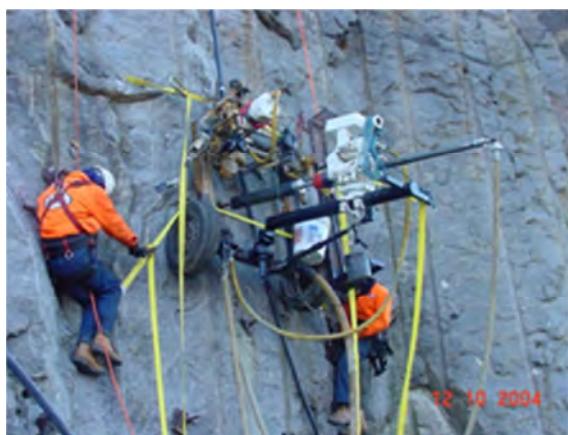
**Figure 4 - Exhuming rock bolt by over coring (Lane, 2005)**

During 2005, an unstable block was removed from the existing median rock slope along the southbound barrel. The block (estimated dimensions 6 ft. by 7 ft. by 8.5 ft.) had become detached from the surrounding rock forming an open tension crack, 1 to 2 inches in width. Although the block had moved, it was still held in place by two 1-inch diameter resin grouted rock bolts. Rock bolts in the median cut were of similar design and installed with the same procedures as those along the northbound barrel. The bearing plates for rock bolts securing the block had buckled, indicating a high level of distress and a significant increase in load. Portions of the rock bolts that had secured the block were recovered for testing when the block was removed. One of the steel rock bolt bars was severely corroded where it had crossed an open joint. Measurements showed the bar had lost approximately 25% of its cross section (Figure 5).

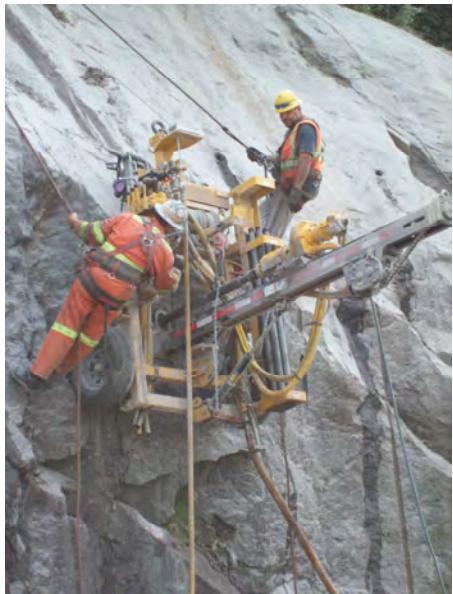
**Figure 6 – Rock bolt installation being performed in 2009 by Pacific Blasting and Demolition.**

Although visual inspections of the rock slope and reinforcement were conducted annually there was no method for determining the actual condition of the existing rock reinforcement. More than half of the generally accepted 50-year service life had passed, and results of two phased research study conducted under a pooled fund study (TPF-5(096)) indicated that approximately 30% of the rock bolts may have suffered a loss of pre-stress. The research provided an effective method for identifying areas of possible corrosion, assessing the overall condition of the reinforcements and estimating remaining service life. As a result, in the summer of 2009 a remediation contract was advertised that was completed by Pacific Blasting and Demolition, Ltd. Over 200 resin grouted rock bolts were tested and approximately 32% of the rock bolts tested exhibited a loss of pre-stress and required replacement.

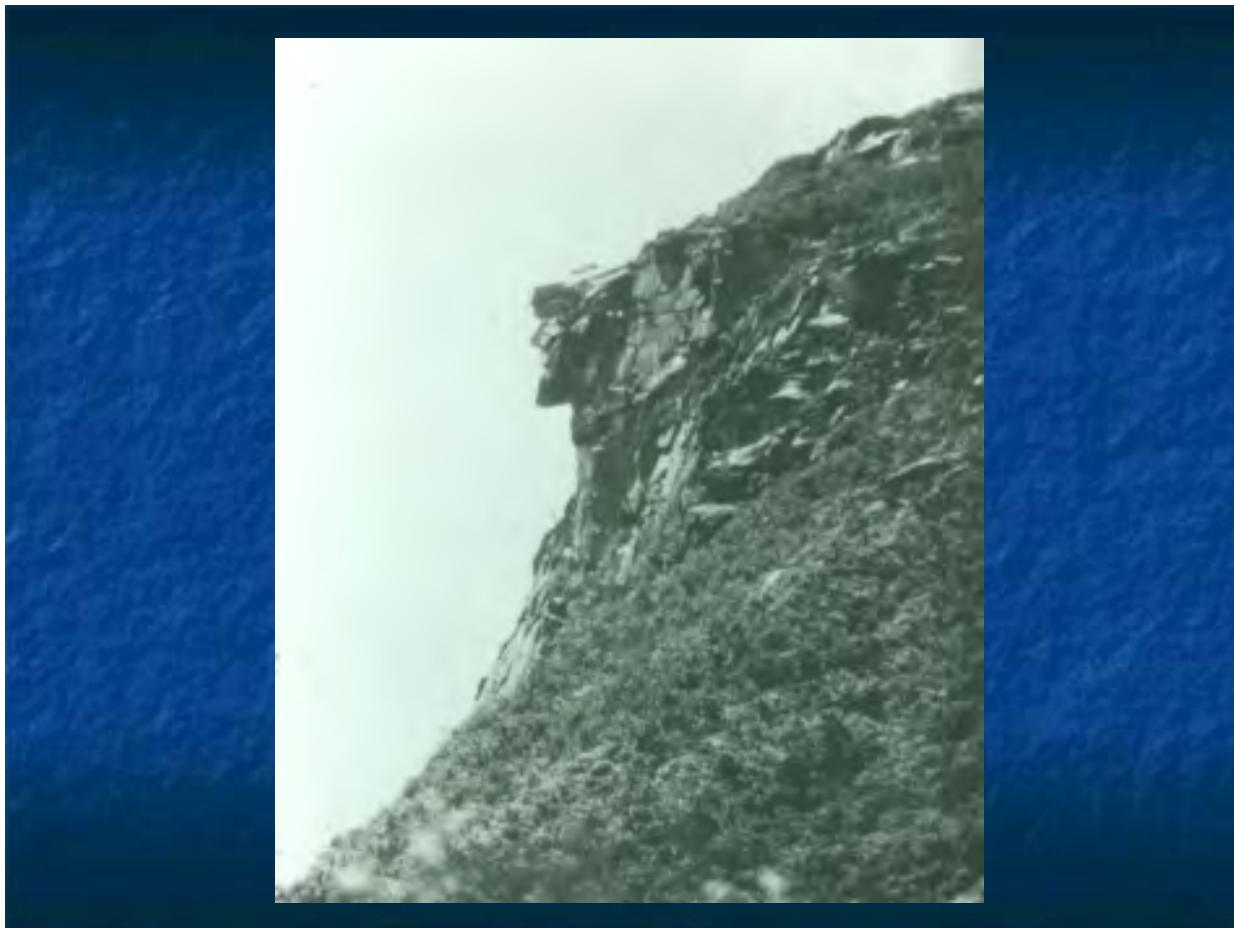
**Figure 2 - Former Old Man of The Mountain from Profile Lake, Franconia Notch, N.H.**

The Old Man of the Mountain (Figure 2) was a delicately cantilevered, 7,200-ton rock mass created naturally by the combination of two actively persistent weathering processes that formed the Cannon Cliff after the departure of the last ice sheet around 12,000 calendar years ago. The first is the intense kaolinization weathering of potash-rich feldspars along the joint systems in its Early Jurassic Conway Granite pluton. The second is the easy mechanical excision of consequently loosened blocks by intense cycles of freeze-thaw wedging (presently 30-60 cycles per year). The effectiveness of these processes is evident from the enormous talus slope accumulated at the base of the Cannon Cliff, the most extensive in the region.

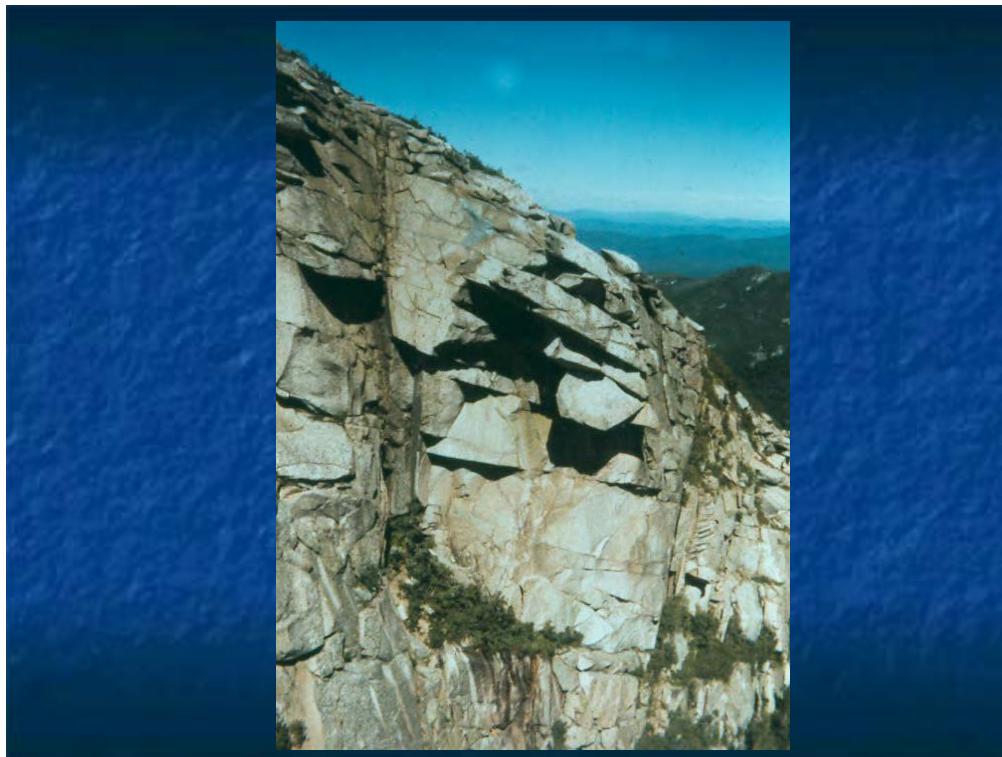
**Figure 3** - Joint distribution and rock mass bounding joints in the pre-collapse rock mass. Chin block (now missing) creates lowest shadow.

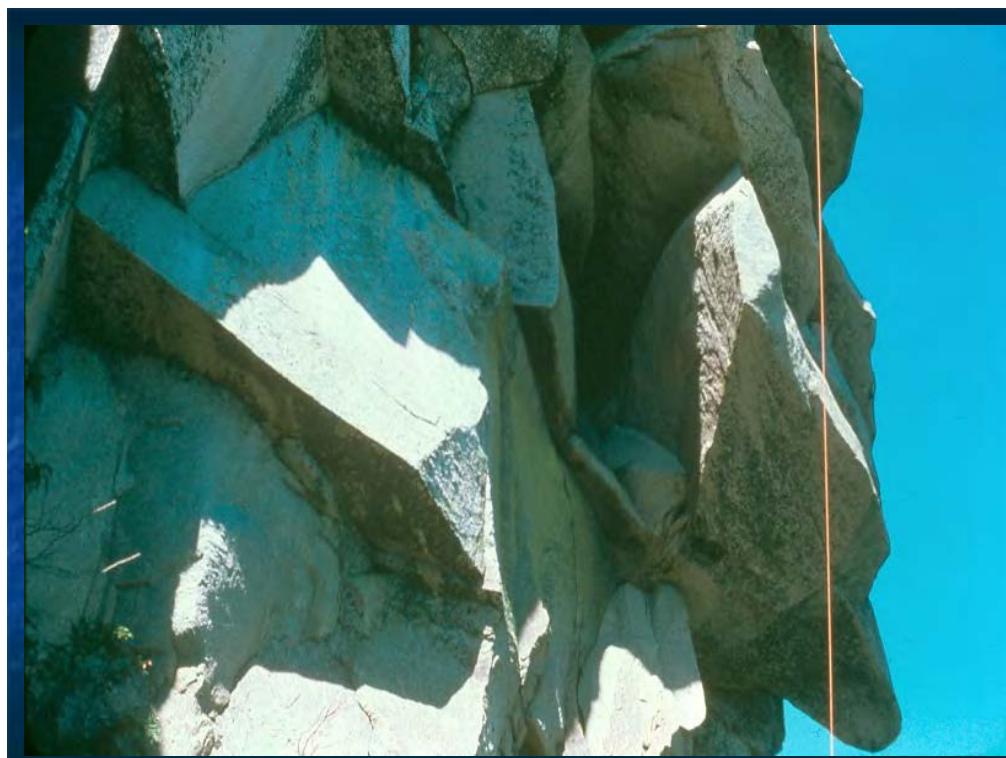
**Figure 4** - Intersecting weathered joints in the pre-collapse rock mass. Chin block on the right behind the vertically hanging rope.

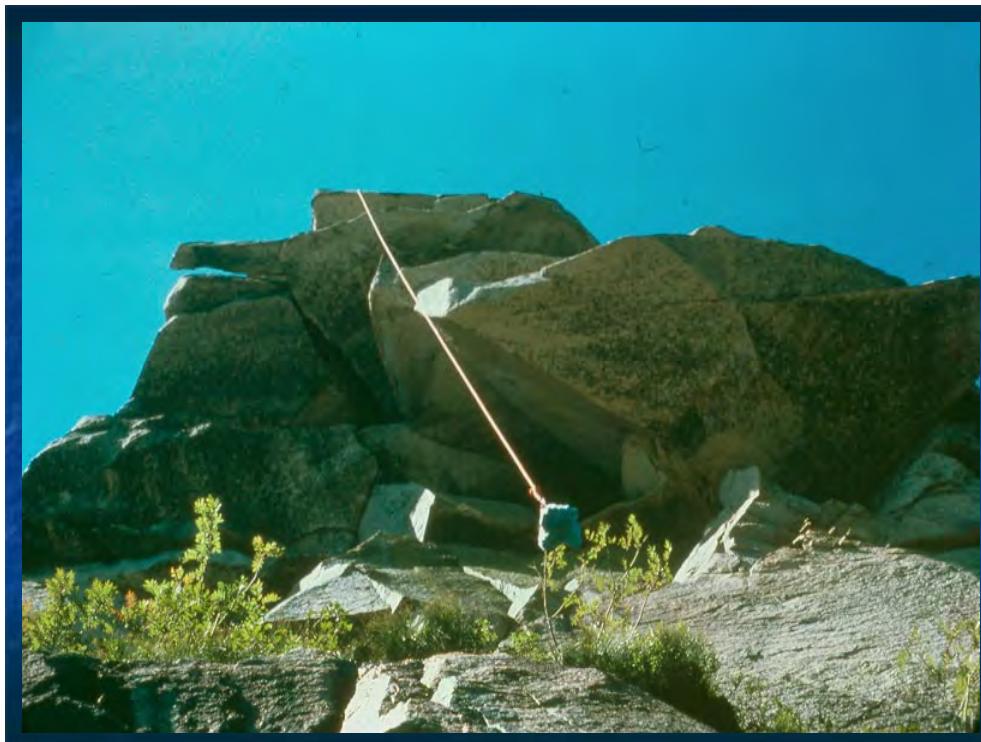
**Figure 5** - Delicately cantilevered pre-collapse rock mass. The triangular chin block is to the right of the vertically hanging rope.

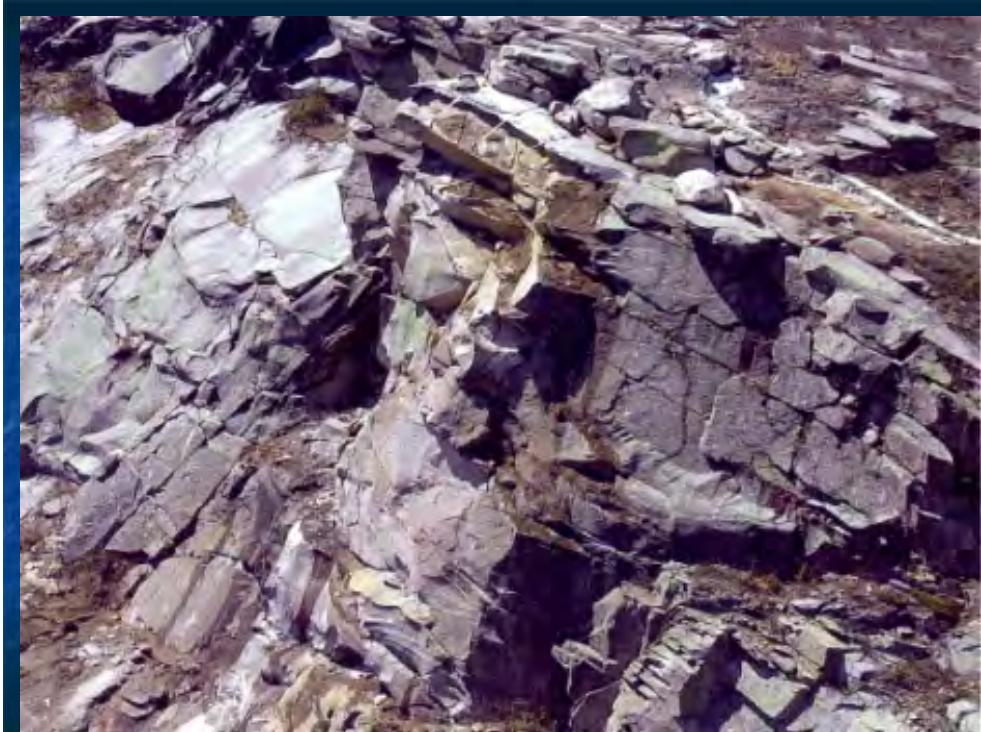
**Figure 6** - Post-collapse residual rock mass after Profile toppled forward (left). Note broken steel turnbuckles on residual Forehead (topmost) slab.

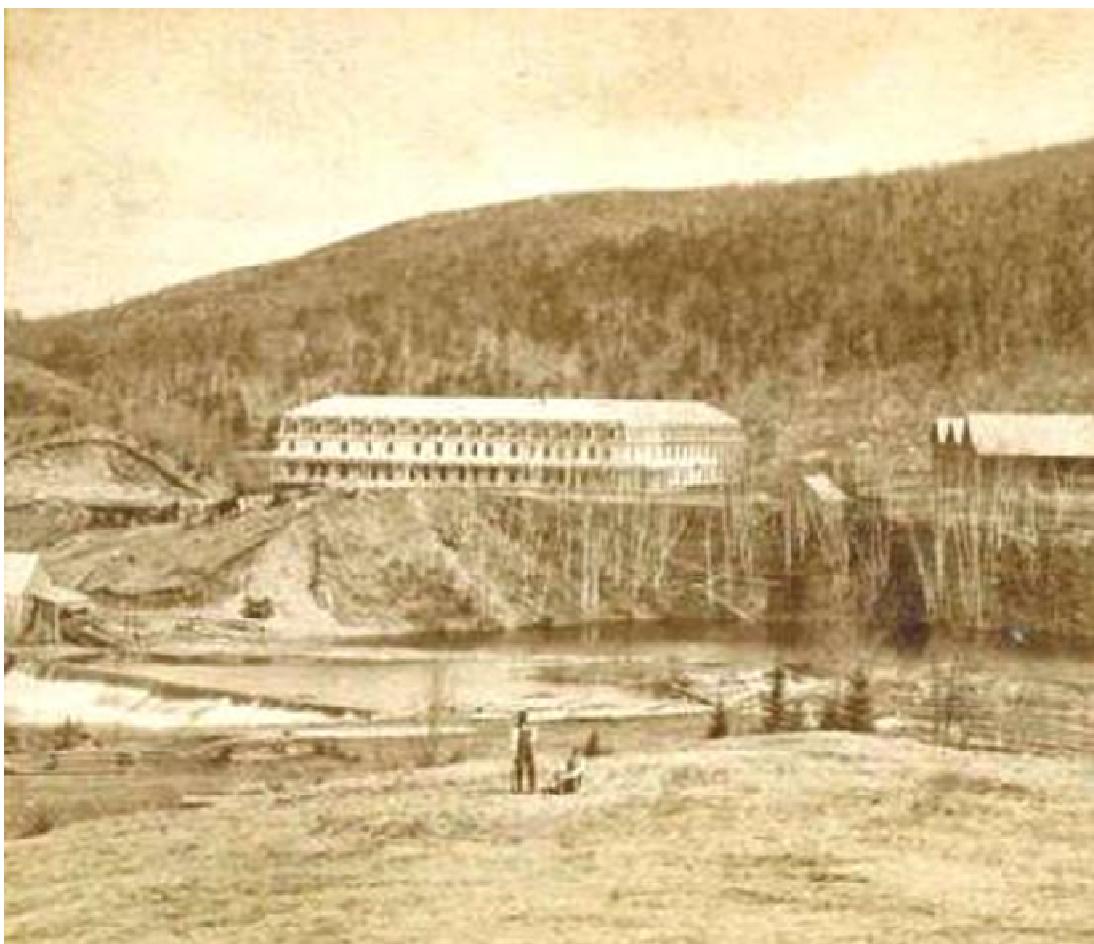
**Figure 1** - View looking north at the Twin Mountain House in the 1800s (part of a stereoscopic view published by Kilburn Brothers, Littleton, NH). Note the cross section of an esker ridge to left of hotel and the Ammonoosuc River in foreground.

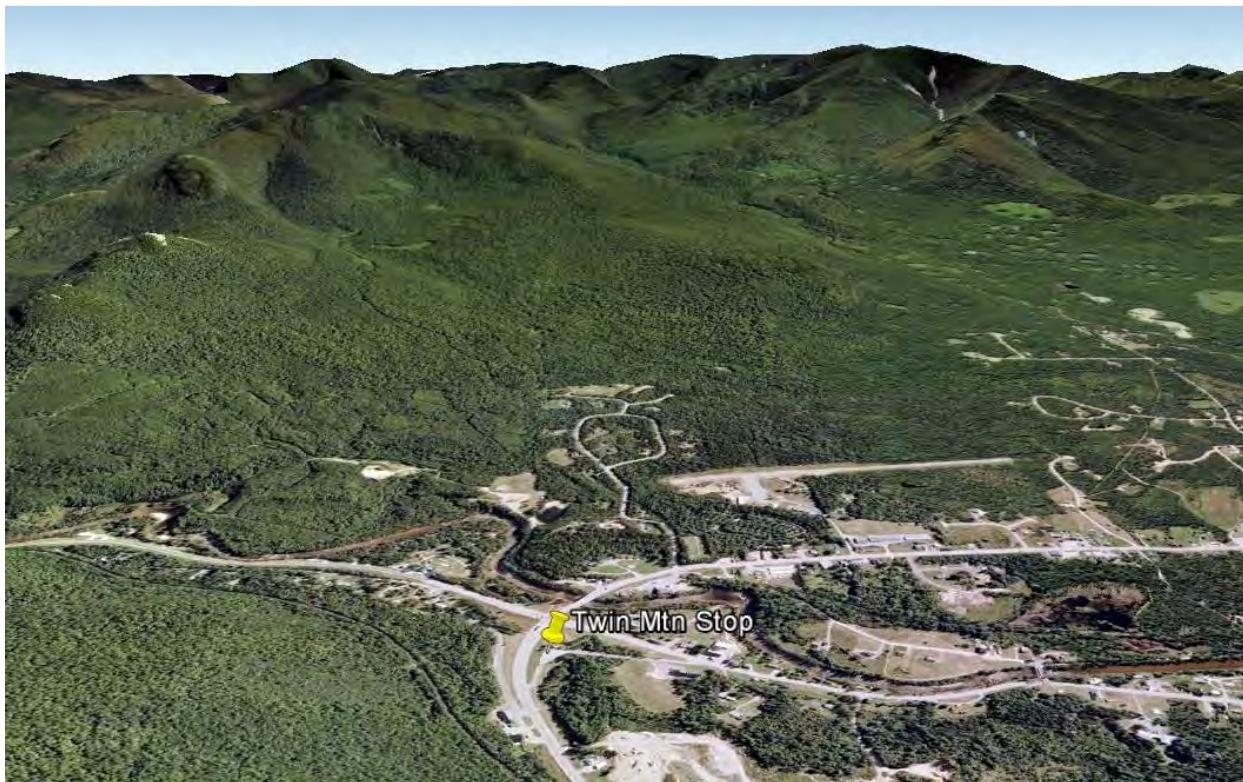
**Figure 2** - Google Earth view looking south across Twin Mountain village, showing the stop at Carroll visitor center at the junction of Routes 3 and 302. The gravel pit at bottom-center edge of photo is the esker location shown below in Figure 3.

We are overlooking the Ammonoosuc River valley just south of here (Figure 2). This is one of several rivers that flow generally west out of the White Mountains and empty into the Connecticut River on the New Hampshire-Vermont border. Many Quaternary scientists have investigated the Ammonoosuc River basin, starting with Louis Agassiz in the mid-1800s

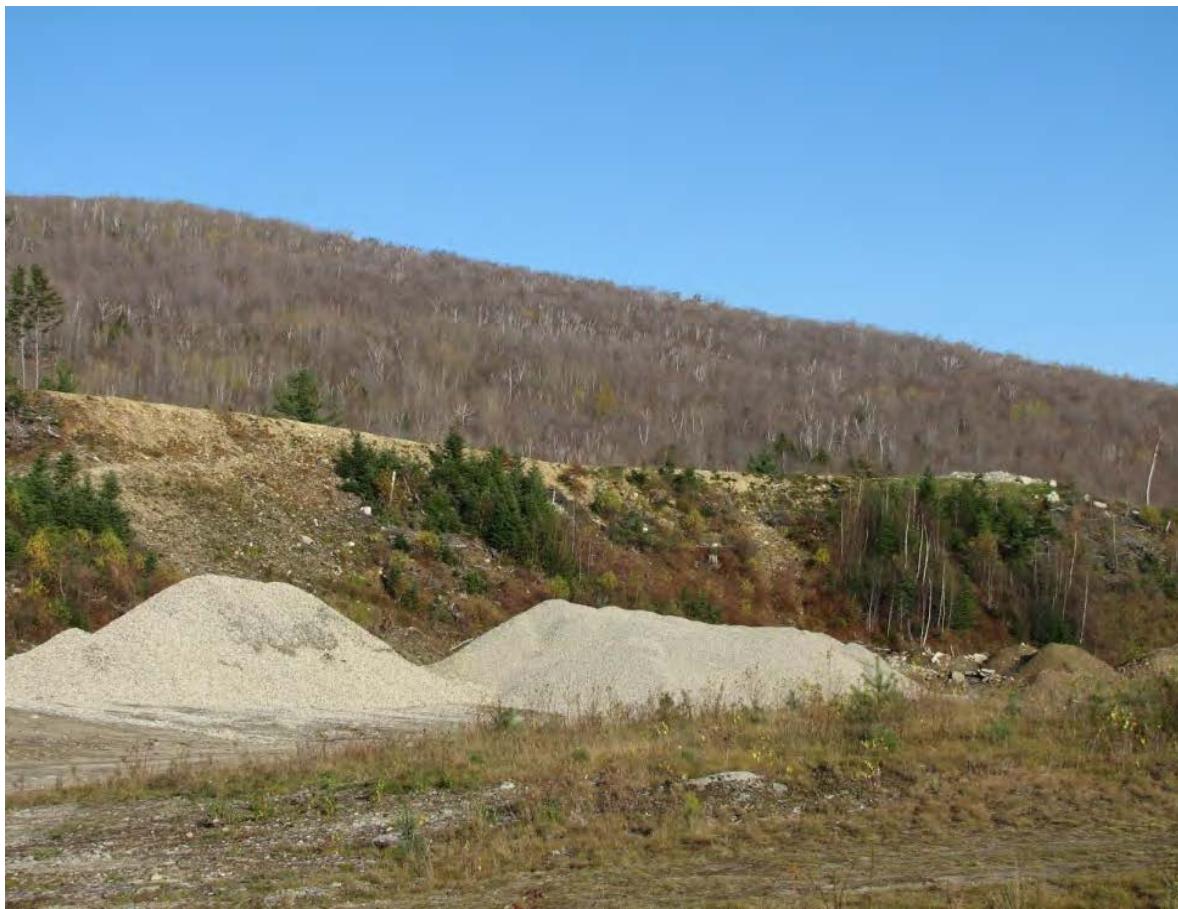
**Figure 3 - West side of esker ridge, just north of Twin Mountain. W.B. Thompson photo.**

The Ammonoosuc esker system originates just north of Twin Mountain village (Figure 3) and follows the valley eastward. It merges with another esker entering from the north and continues to Crawford Notch. The esker ridge is discontinuous, and parts of it are concealed in the forest. A convenient place to visit the esker is the Eisenhower Wayside Park, located on U.S. Route 302 between Bretton Woods and Crawford Notch. A cross-section of the ridge is seen from the parking lot, and you can hike up a short path to the top and follow the ridge crest back into the woods.

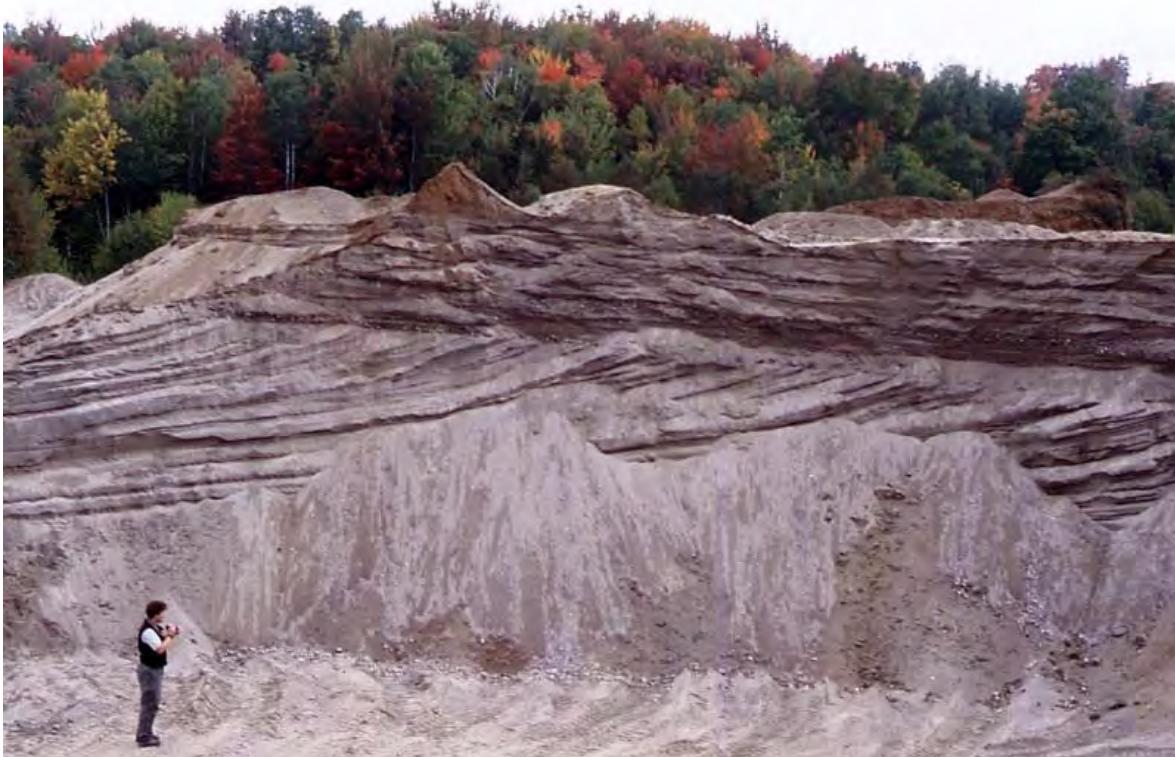
**Figure 5** - View looking west at an exposure of the Carroll Delta in the Twin Mountain Sand & Gravel pit. The former lake level is marked by the contact between the nearly horizontal fluvial beds (top) and the sloping foreset beds below. The glacier margin stood at the north edge of the delta, and the delta built southward (R to L) into Lake Ammonoosuc. W.B. Thompson photo.

Lougee (1940) published the elegant block diagram reproduced in Figure 6. It shows the ice margin lying against the northwest flanks of Beech Hill and Cherry Mountain when the Carroll Delta was built into Lake Ammonoosuc. This delta is located a short distance north of our stop, on US Route 3. The elevation of its upper surface indicates that it was deposited during the Gale River 2 stage of Lake Ammonoosuc. The Carroll Delta and associated esker deposits have been important sources of sand and gravel for many years. The Twin Mountain Sand & Gravel pit (now owned by Pike Industries) has been worked at least since the mid-1900's (Figure 5).

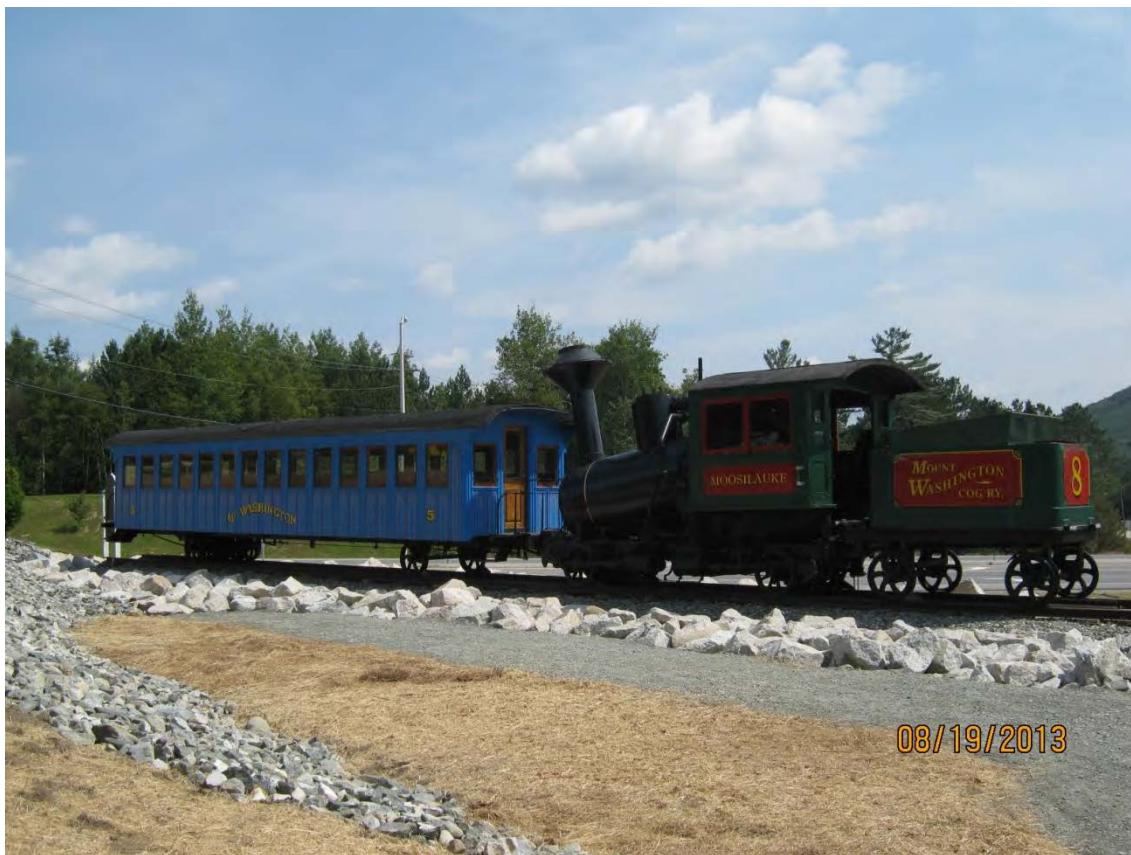
**Figure 7 – Cog steam engine and passenger car on display next to the Carroll visitor center.**

Similar early cog railways were built on Pikes Peak, Mount Rigi (Switzerland) and other mountain locations. They are called “rack railways” because they have a cog wheel on the engine that meshes with a center rack rail on the track. The siding switches are thus quite complicated! Mt. Washington’s “Cog” operation has included several generations and designs of steam engines, much to the delight of both tourists and rail fans. Each engine has a name, and they are listed along with their current status in a Wikipedia article about the Cog: [http://en.wikipedia.org/wiki/Mount\\_Washington\\_Cog\\_Railway](http://en.wikipedia.org/wiki/Mount_Washington_Cog_Railway).

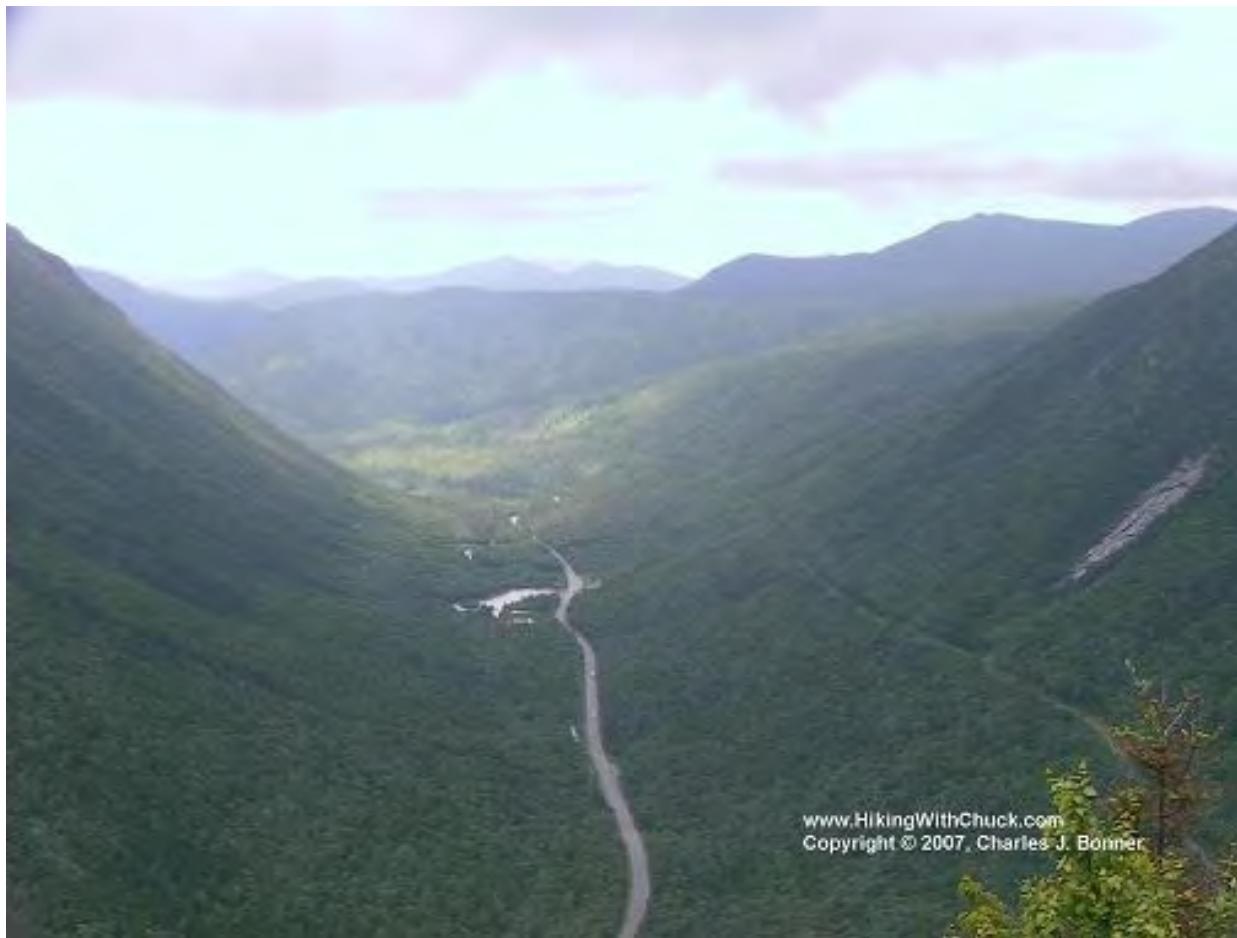
**Figure 1** - Crawford Notch looking south from Mt. Willard (873 m; 2,865 ft.). The debris fan of the Willey Slide lies above and to the right of the south end of the pond visible to the left of the highway in the center of the photograph (elev. ~ 400 m; 1,320 ft.). The highway curves to the left and then over a combination of this debris fan and several others from similar avalanche tracks to its north.

As indicated at Stop 3, Crawford Notch is one of the deepest best developed glacial troughs in the region (Figure 1). As with Franconia Notch, its deeply developed glacially eroded cross-section is distinctive, being the result of several episodes of continental glaciation passing through and eroding its flanks.

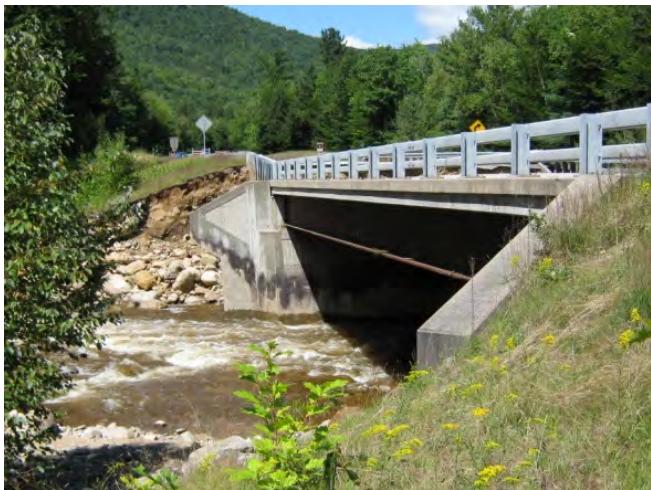
**Figure 1 - US Route 302 bridge the day after the tropical storm event. Note the large dip in guardrail from undermined abutment.**

Another bridge impacted by Tropical Storm Irene in 2011 (described in Drive-By Site B for the Loon Mountain Bridge) was the US Route 302 Bridge over the Sawyer River in Harts Location, NH. The bridge, built in 1990 to replace an older structure, was a modern, single span bridge with a 95 foot wide opening. The bridge superstructure consisted of a concrete slab on steel girders. The bridge substructure consisted of full height concrete abutments with spread footings founded on alluvial sands and gravel. There was no history of severe flooding or problems with the bridge. Just downstream is a single span railroad bridge with granite block abutments, constructed over 140 years ago.

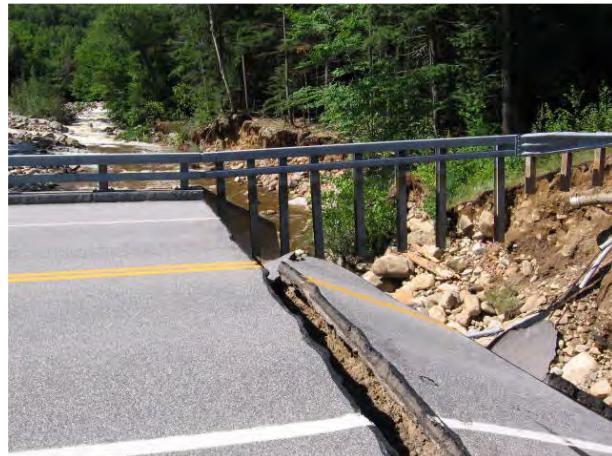
**Figure 2 - A close up of the scour that occurred behind the north abutment with the guardrail suspended in the air, the utilities cut, and approach slab fallen into the hole.**

Normally, the 9.1 mile long Sawyer River has small flows in a cobble and boulder lined channel that is about 15 feet wide and runs only a few feet deep. On the day Tropical Storm Irene hit, the river nearly overtopped the bridge. The main force of the water was directed at the north abutment because of a bend in the river about 300 feet upstream. The Sawyer River collects runoff from the White Mountains to the west and south, which have significant height, so runoff concentrations were rapid and fast moving. As a result of the flash flooding, the bridge suffered severe scouring effects. Both of the abutments were undermined by the rush of water, and a large quantity of material behind the north abutment was lost. The approach slab fell, buried utilities were cut, and the road was severely damaged. The abutments settled 6 to 18 inches from scour holes formed below them. The abutments and footings cracked from the settlement, the girders twisted and the deck cracked. The highway bridge was a total loss with no way to salvage any part of it. The railroad bridge just downstream suffered some minor scouring at its south abutment, but was spared any major damage because it was shielded by the highway bridge. The scouring at the railroad bridge was quickly and easily repaired by filling the scour hole with concrete.

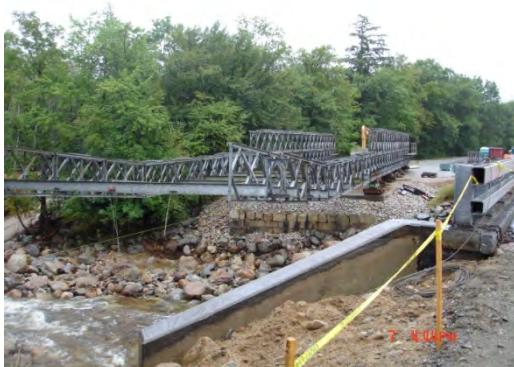
**Figure 3 - Temporary bridge being launched east of damaged bridge.**

As a consequence of the damage to the bridge and along other portions of the highway, US Route 302 was closed for over two weeks. A temporary bridge was installed to allow the highway to reopen. The replacement US Route 302 Bridge is currently under construction through a design-build contract with Alvin J. Coleman & Sons of Conway, NH for a cost of 2.4 million dollars. The bridge design was performed by GM2 Associates of Concord, NH. The replacement bridge consists of a slab on steel girder deck, but the span has been increased to 135 feet to provide a larger hydraulic opening for the Sawyer River. The foundation depths have been extended 5 feet deeper than the previous bridge, but they
