# 64<sup>TH</sup> HIGHWAY GEOLOGY SYMPOSIUM

SEPTEMBER 9-12, 2013 | NORTH CONWAY GRAND HOTEL | NORTH CONWAY, NEW HAMPSHIRE

PROCEEDINGS

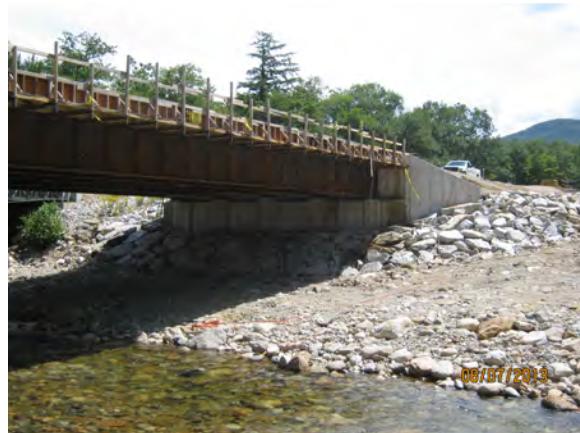
**Figure 4 – New, deeper abutments (14 feet) are also protected by large rip rap stones.**

still have a spread footing configuration. Very large rip rap stones, with a minimum dimension of 3.4 feet, were specified at the abutments as a scour countermeasure.
