TWENTY - SIXTH ANNUAL HIGHWAY GEOLOGY SYMPOSIUM

PROCEEDINGS

SPONSORED BY
IDAHO TRANSPORTATION DEPARTMENT
DIVISION OF HIGHWAYS
BOISE, IDAHO

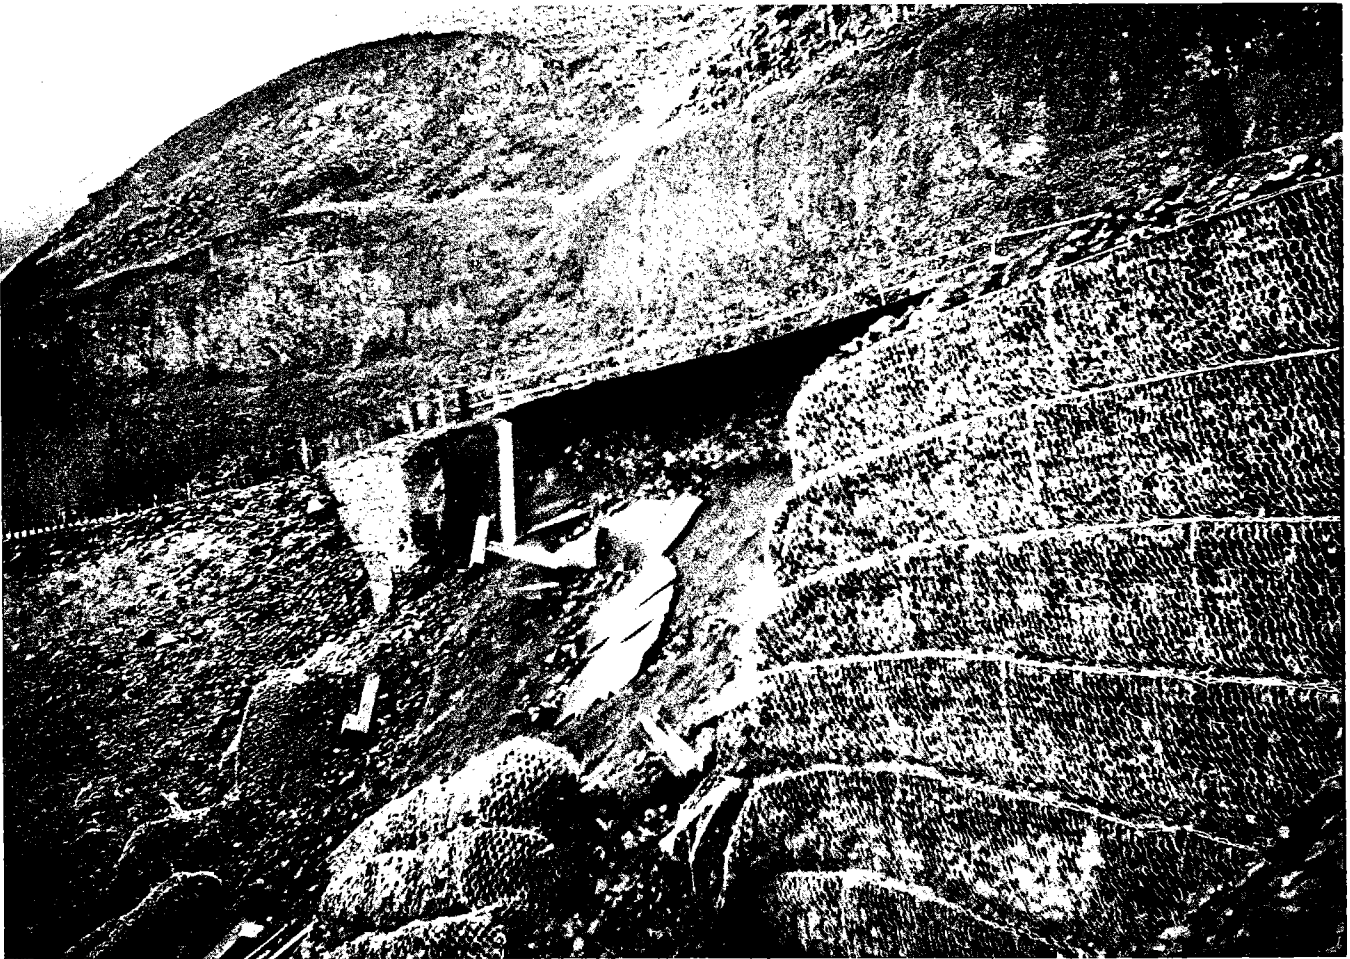
PHOTO NO. 10

M.P. 228.2
Gabion Failure

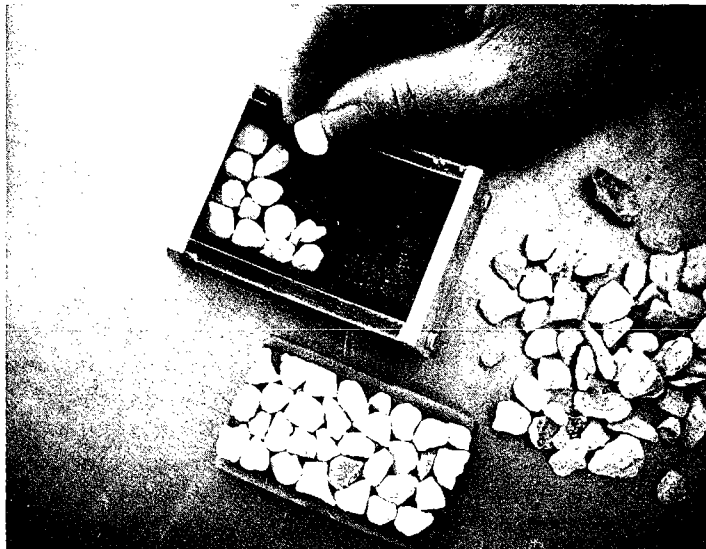
FIGURE 3. Fabrication of aggregate test coupons requires close placement of the particles in a steel mold and casting with polyester. Seven coupons representing production material are tested.
