Proceeding of the 40th Highway Geology Symposium

**BIRMINGHAM, ALABAMA
MAY 17-19, 1989**

**SPONSORED BY
ALABAMA HIGHWAY DEPARTMENT**

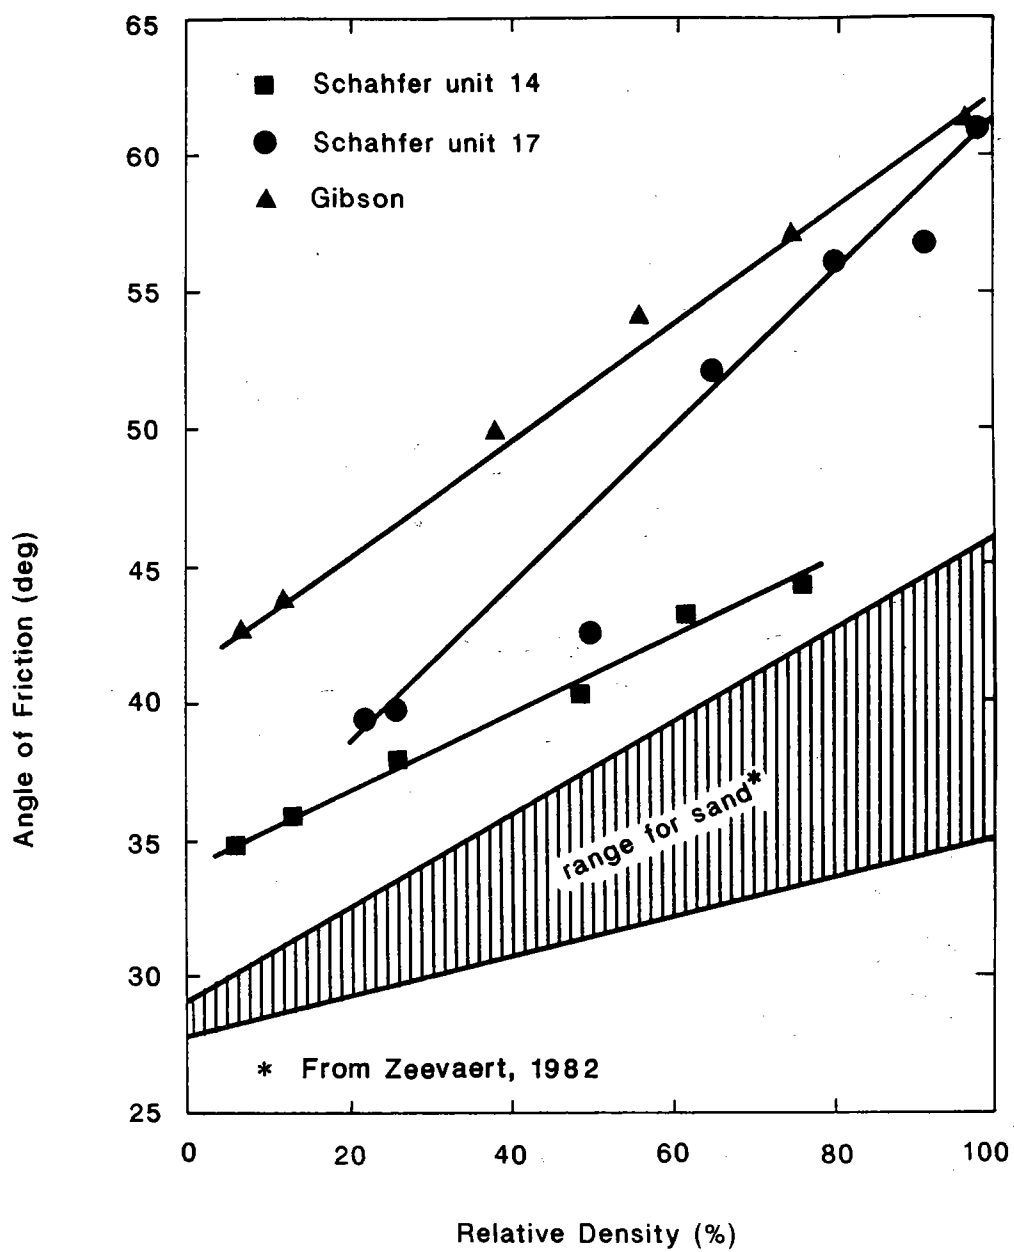
FIGURE 5. ANGLE OF FRICTION OF BOTTOM ASH

The angles of friction obtained for bottom ash are plotted in Figure 5. Also shown in Figure 5 is the range of friction angle generally obtained for various sandy soils (Zeevaert, 1982). It is found that, at a given initial relative density, the friction angle of bottom ash is higher than that obtained for natural sandy soils. This can be attributed to the rough surface texture and angularity of the bottom ash particles, such that a higher degree of interlocking was developed in the shearing process.

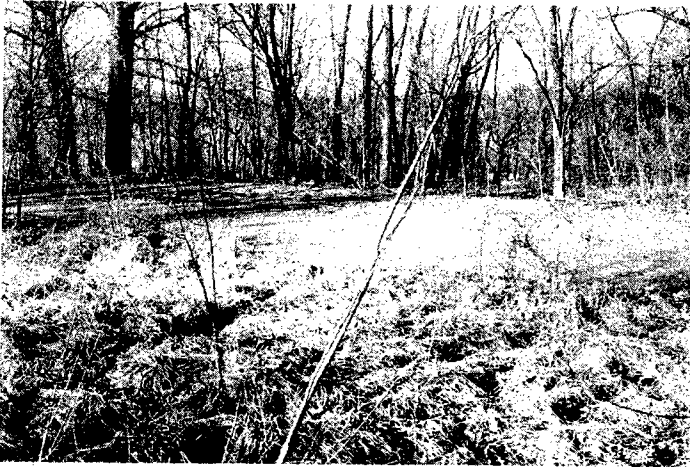
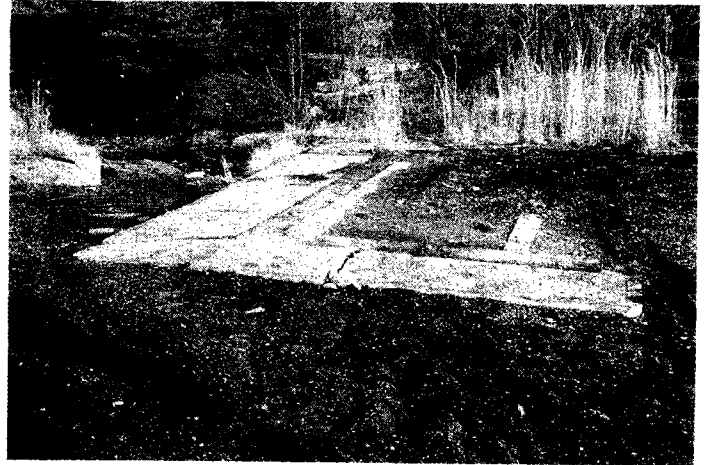
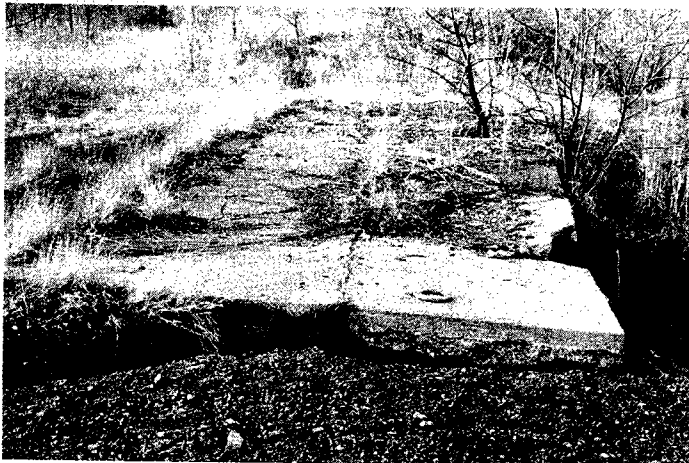
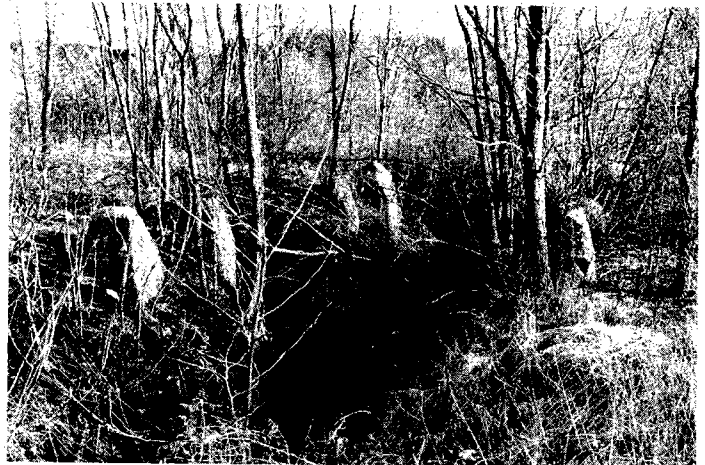
PRESENT CONDITIONS AT FRIAR TUCK PLANT

- building foundation walls
- concrete floor slab on grade
- slab undermined by erosion
- building foundation walls
- concrete floor slabs on grade
- isolated concrete piers

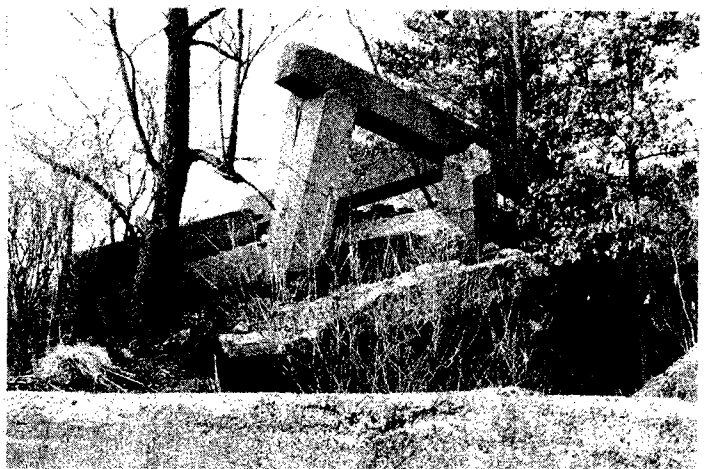
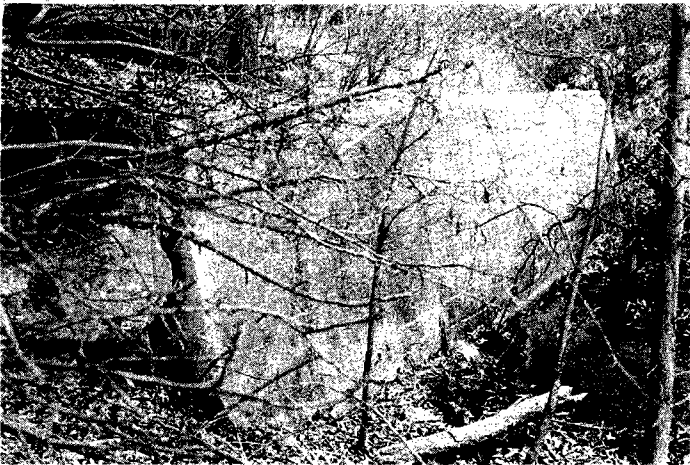
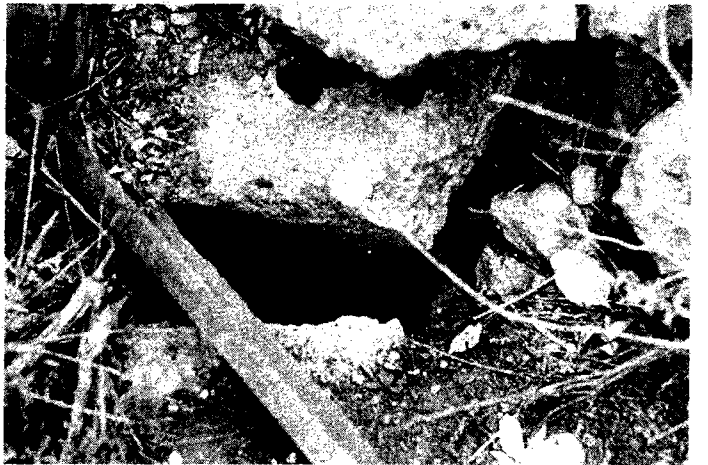
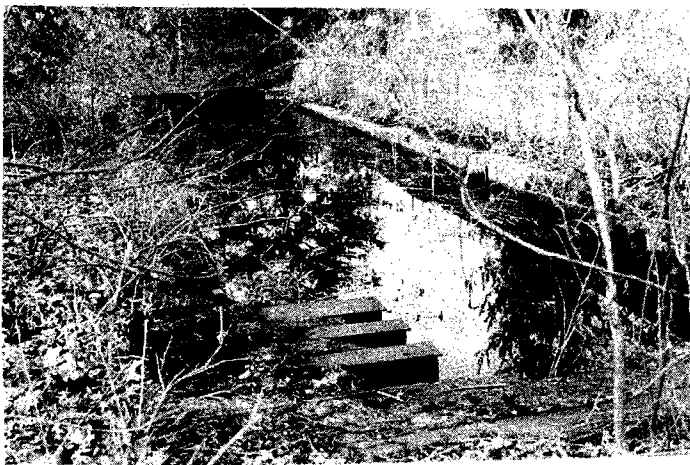
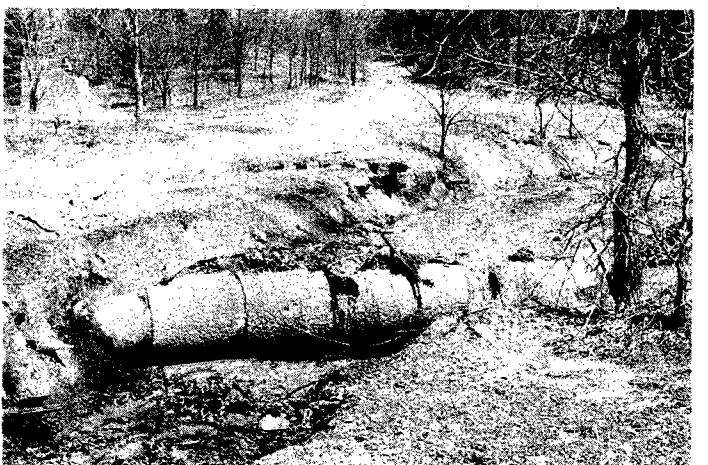
PRESENT CONDITIONS AT NEW HOPE PLANT

- building foundation walls
- earth retaining wall
- water filled pit

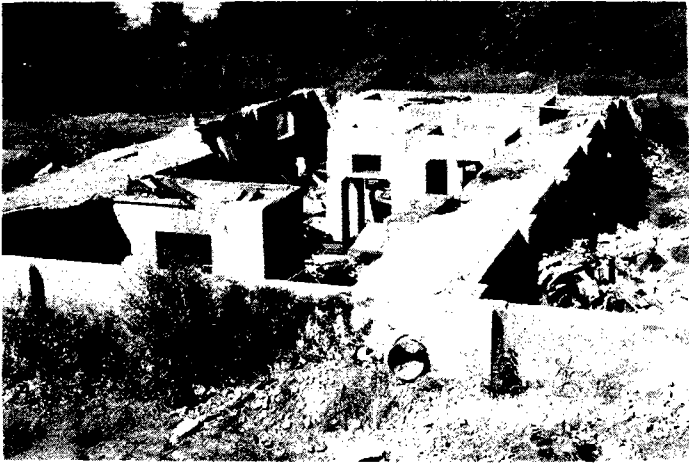
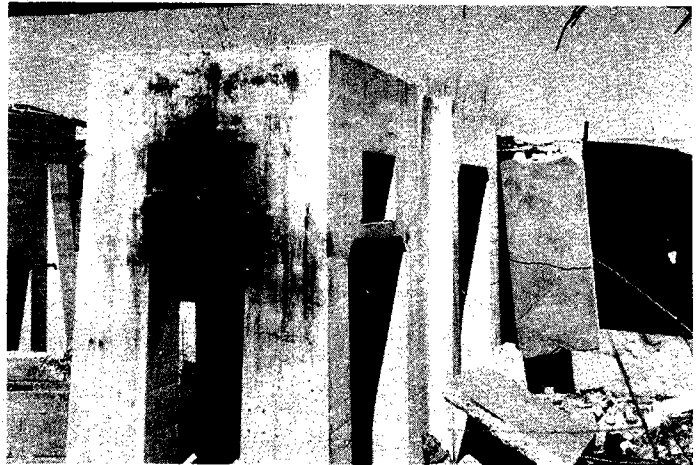
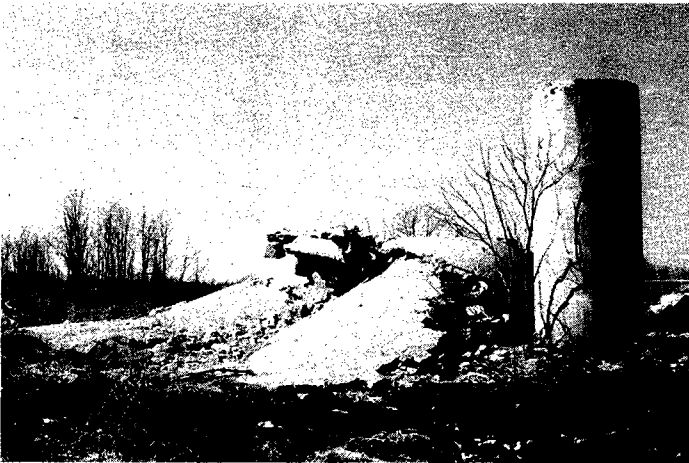
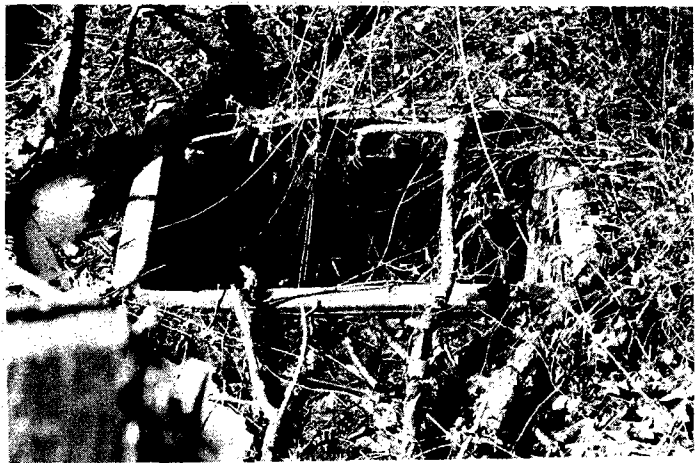
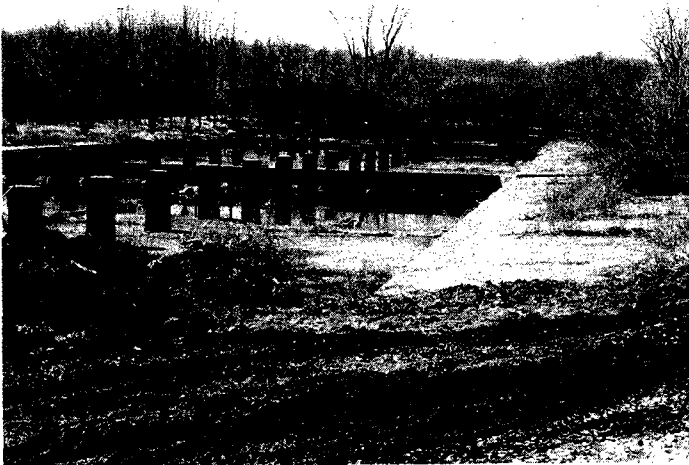
PRESENT CONDITIONS AT ANTIOCH POWER PLANT

- power plant basement
- crane pedestal and collapsed coal silo
- water cooling pond
- dangling concrete slabs in basement
- access hole to underground room
- support pedestals for coal slurry flume

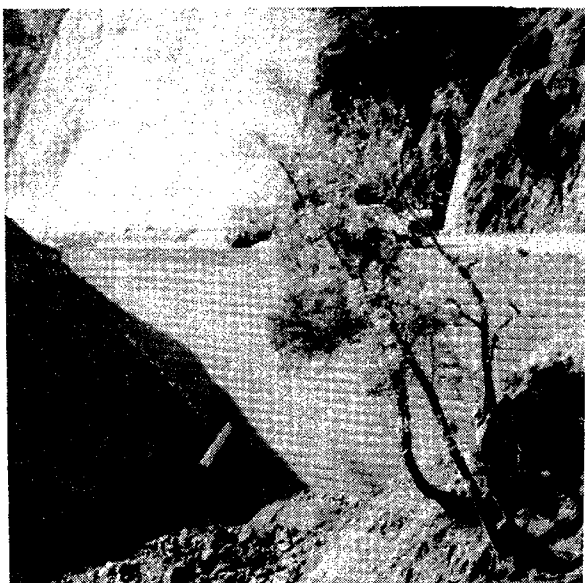
FIG. 7: SQUAW CREEK WALL

For the Squaw Creek Walls, rock bolting was specified for any rock which could not be excavated and which would potentially load the lower portions of the walls. Also, the lower reinforcing mats were manufactured longer than specified by the
