48th HIGHWAY GEOLOGY SYMPOSIUM

PROCEEDINGS & A FIELDTRIP EXCURSION GUIDE

Knoxville, Tennessee
May 8-10, 1997

Edited by Don W. Byerly

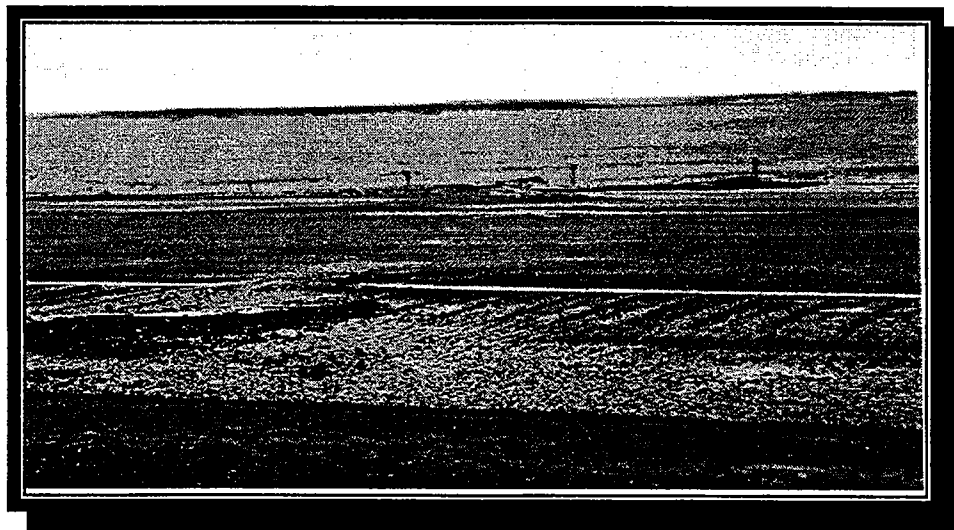
Photo 1. Damaged section of U.S. 85 south of Newcastle, WY.

In the summer of 1994, after the swelling and heaves had damaged the road so severely that it needed reconstruction, WYDOT decided to rubblize the CTB. An impact pavement breaker reduced the CTB to fist-size and smaller chunks. This may have damaged the geomembrane. In soft spots, the CTB was removed and crushed base was put in its place. The geomembrane was not replaced. Four inches of PMP were placed on top of the rubblized CTB.

By the summer of 1996, swells had reappeared. It is not known whether these new swells are due to continuing expansion of the CTB or to subgrade swelling caused by removal of and damage to the geomembrane. The new swells, though detrimental to ride quality, are not nearly as severe as those that appeared after the original construction.

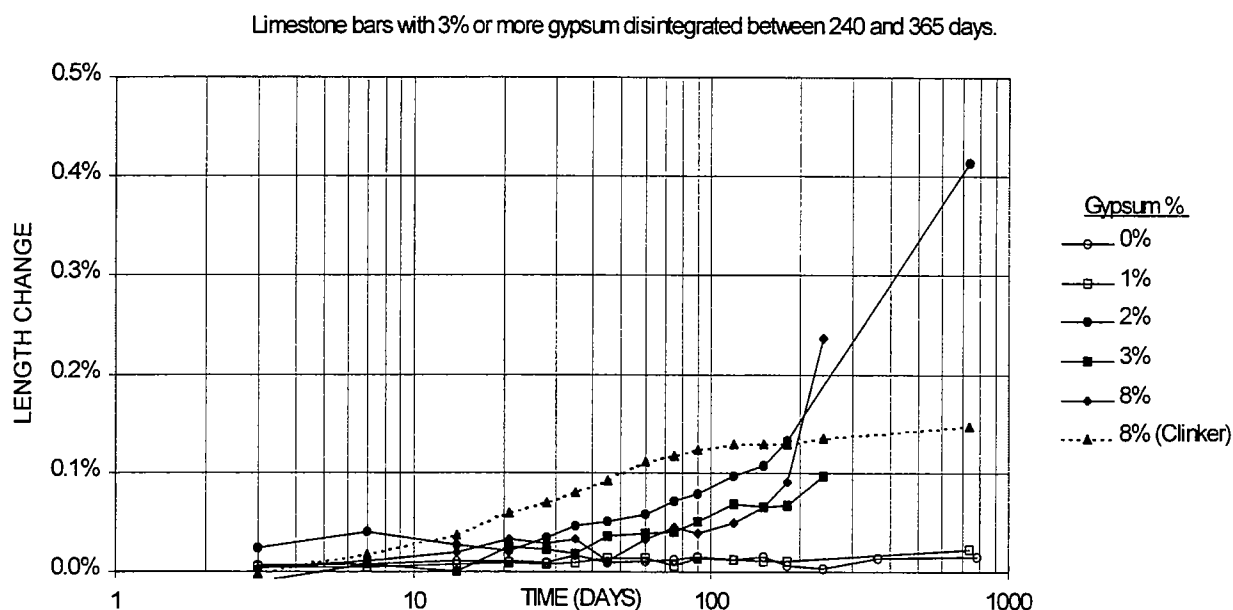
Figure 3 shows the linear expansion of CTB bars with various amounts of gypsum. Limestone bars with no gypsum and 1% gypsum did not expand significantly. The limestone bar with 2% gypsum expanded about 0.4% in two years. Limestone bars with 3% or more gypsum expanded during the first eight months, then disintegrated between eight and twelve months. The bar with clinker and 8% gypsum expanded 0.13% during the first four months, then its expansion stopped. It expanded at least twice as much during the first two months as any of the bars made with limestone. By two years, it had expanded only half as much as the bar made with limestone and 2% gypsum. Both aggregate type and sulfate in the form of gypsum affect expansion in the absence of substantial amounts of clay.

Figure 3. Limestone (except as noted) bars with gypsum.

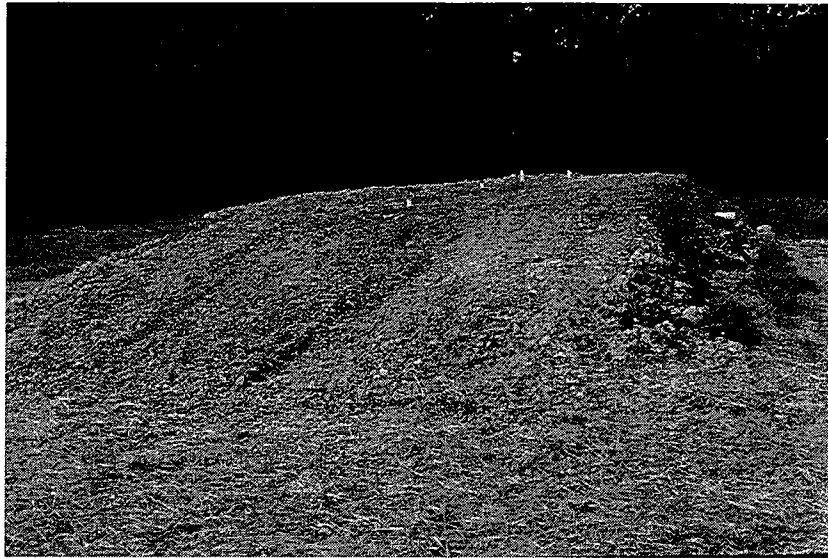
Figure 1. Overview of test embankment. Notice the four white lysimeters along the centerline and the PVC drainpipe on the side for collecting leachate.

Based on the results of lab tests, a test embankment 50 feet long, 22 feet wide, and 5 feet high was constructed on university property. The embankment material consisted of a mixture of 70% clay and 30% shredded tire of 1/2"-1" size. The embankment was monitored for settlement and slope stability problems for a period of one year. Leachate samples were collected on a bi-weekly basis from the lysimeters installed in the embankment. Embankment construction also helped evaluate construction procedures (mixing, compacting, etc.) when dealing with soil-tire mixtures. Figure 1 shows an overview of the test embankment.

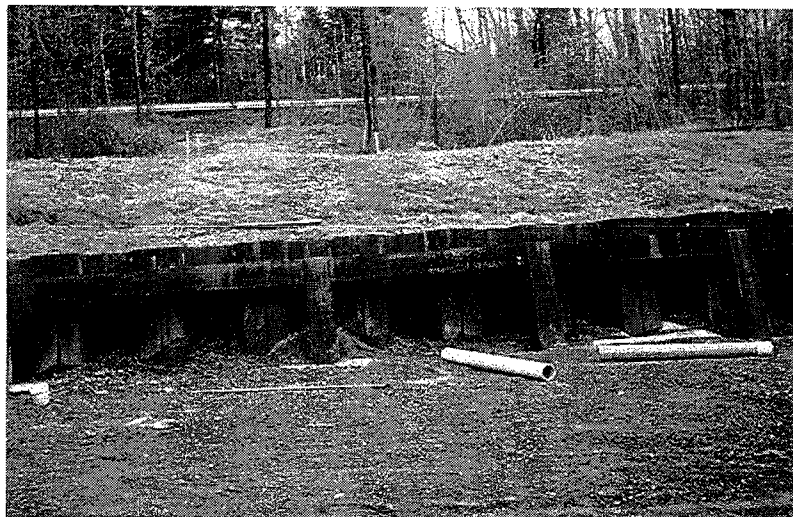
Figure 2. The sheet pile retaining wall installed at the Miles Road site to stabilize south slope.

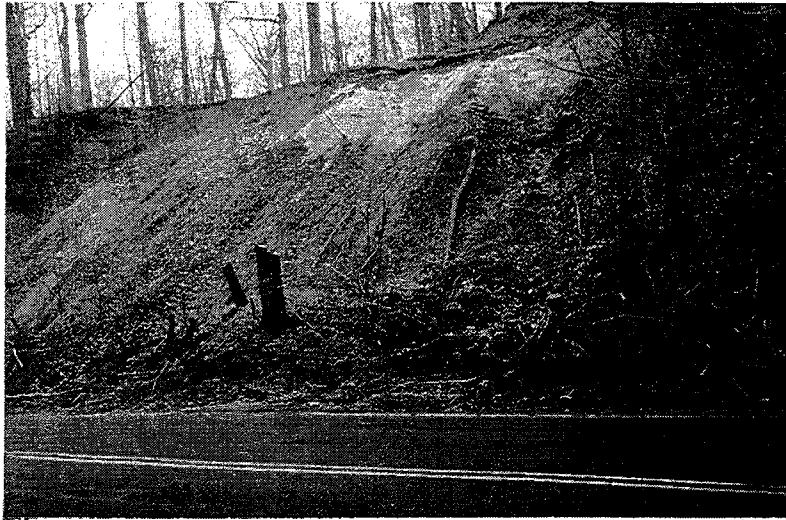
Figure 3: Overview of the east landslide.

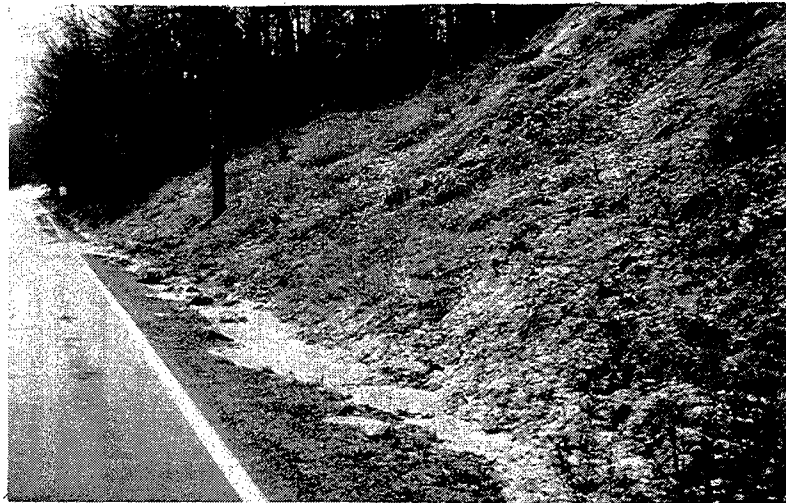
Figure 4: Overview of the west landslide.

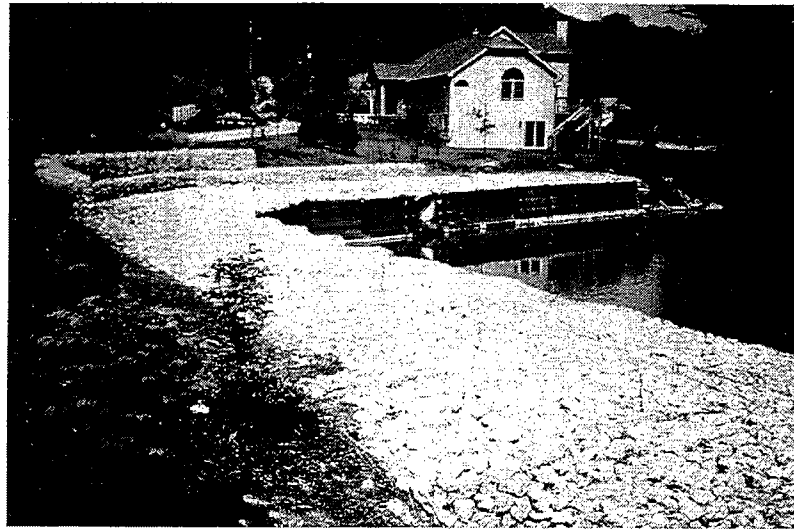
Figure 9. Combination of retaining wall, gabion baskets, and rip-rap to protect the Chagrin River bank from erosion.

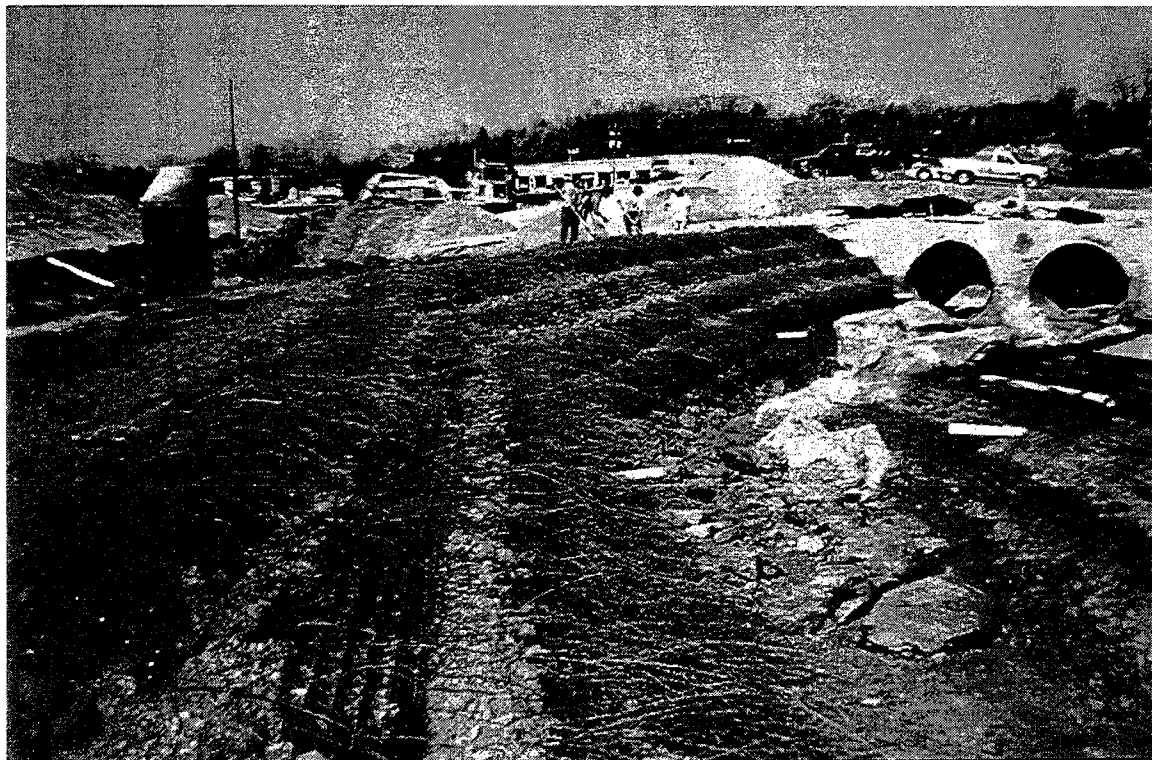
Figure 3 - Completion of the Bioengineered Portion of the Reinforced Soil Slope

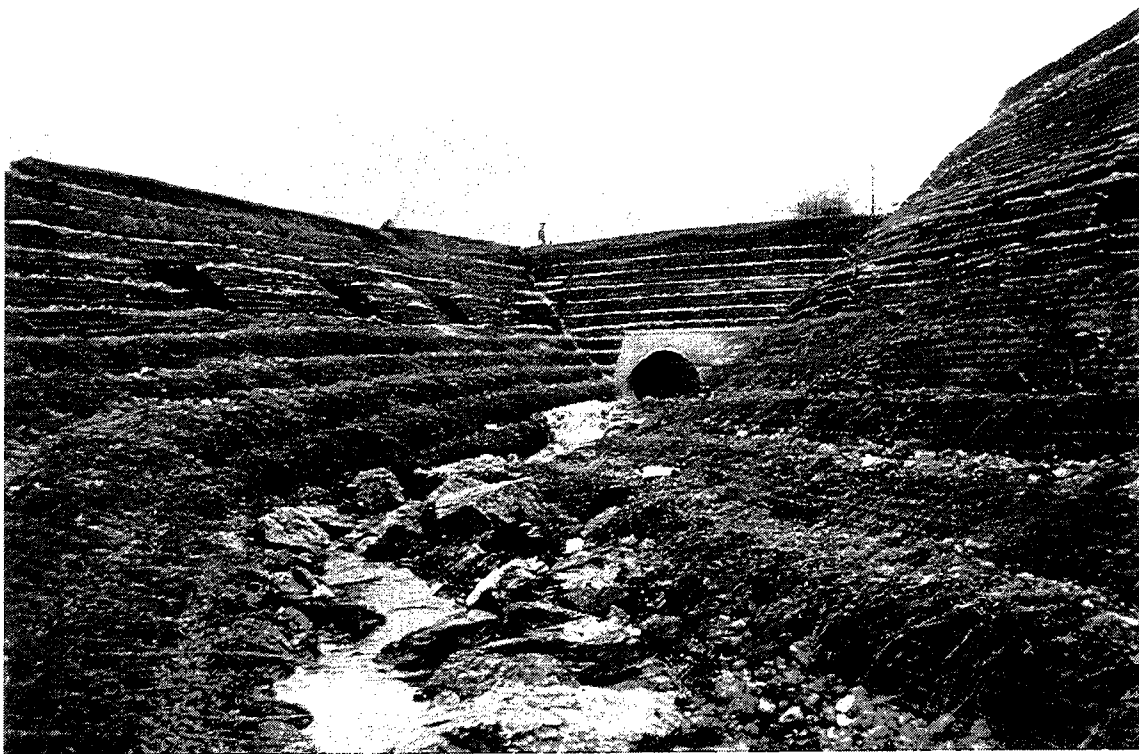
Figure 5 - Post Construction of the RSS with Lower Bioengineered Section

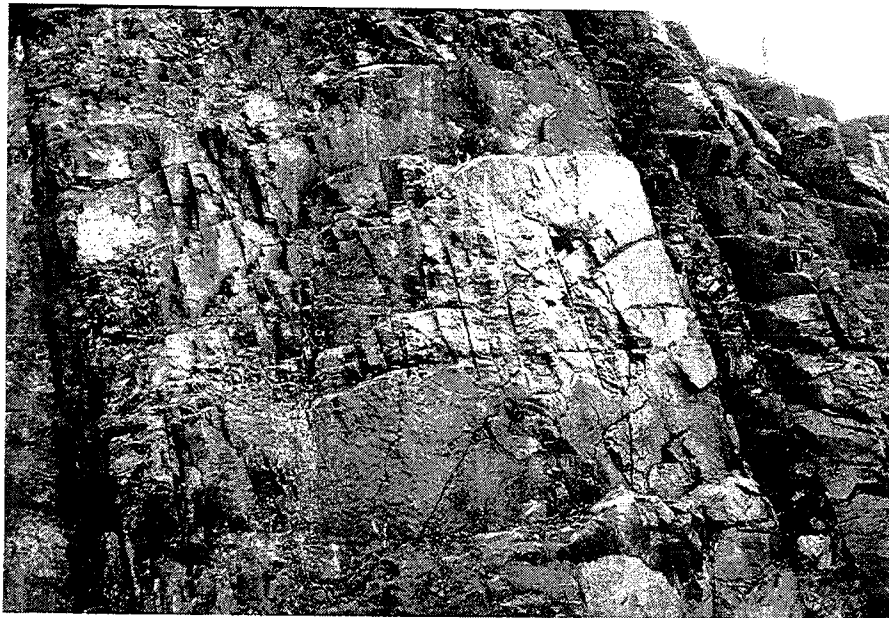
Figure 2 - Dark grey basalt dikes vary in thickness from 0 - 2-1/2 feet. Parallel fracturing has reduced rock strength.

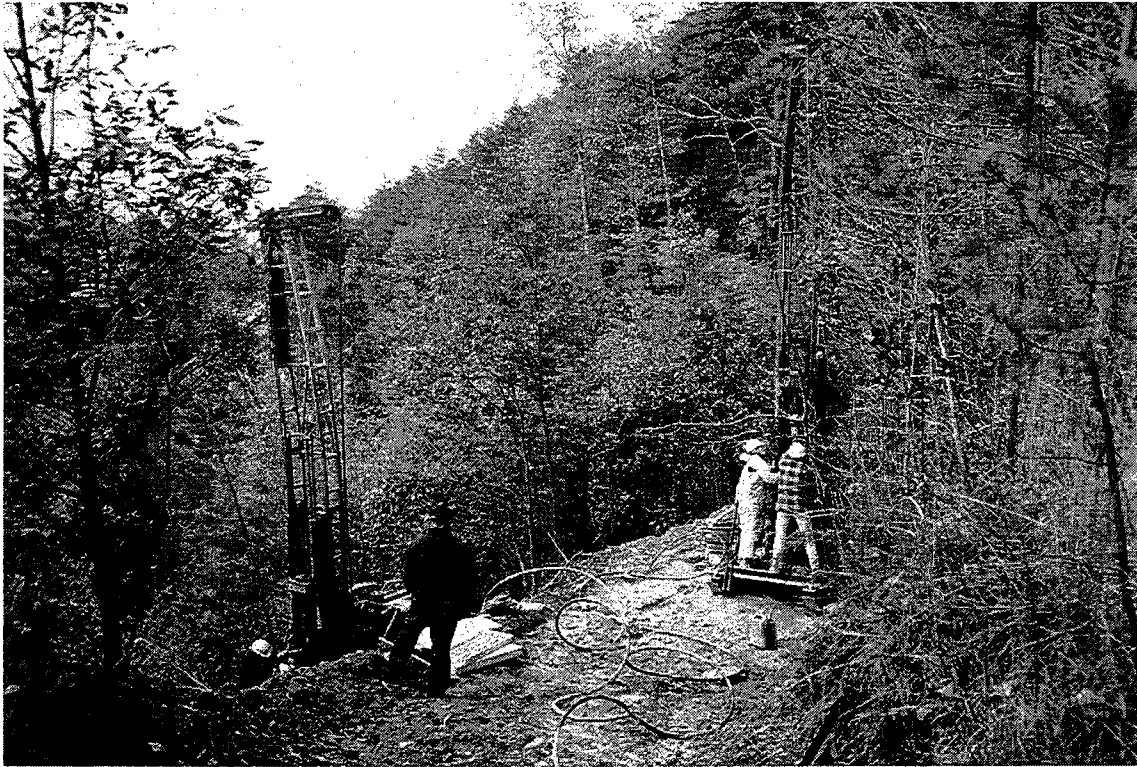
Figure 3 - Core drilling on preconstructed drilling pads for the Foothills Parkway Project. Note that only small areas of the forest are compromised for the geotechnical investigation.

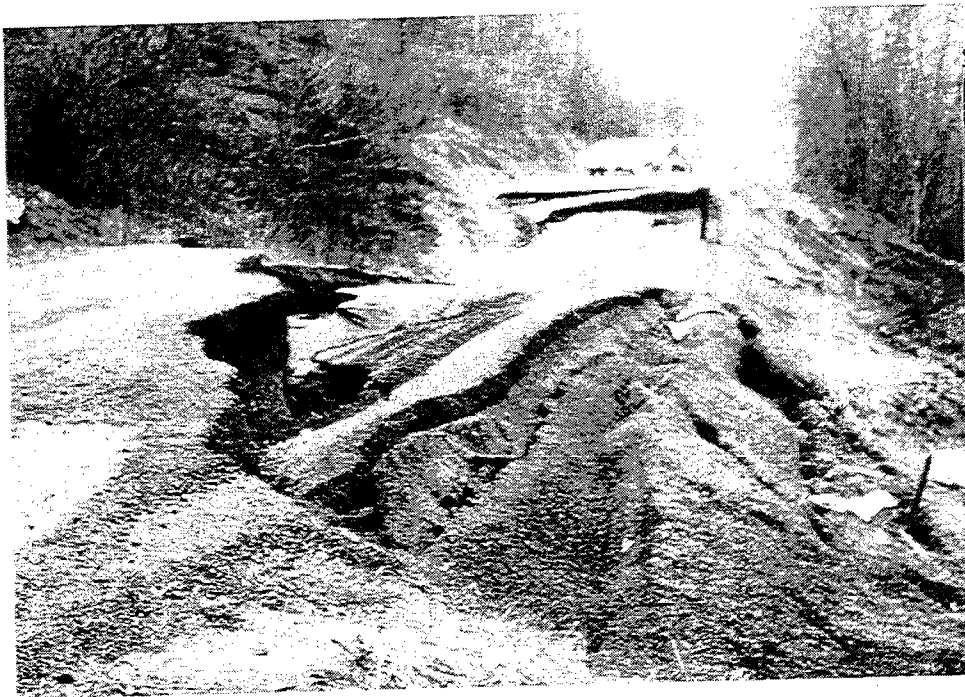
Figure 6. Actual Roadway Embankment Failure Due to Unstable Foundation Material (S.R. '61, Union County).

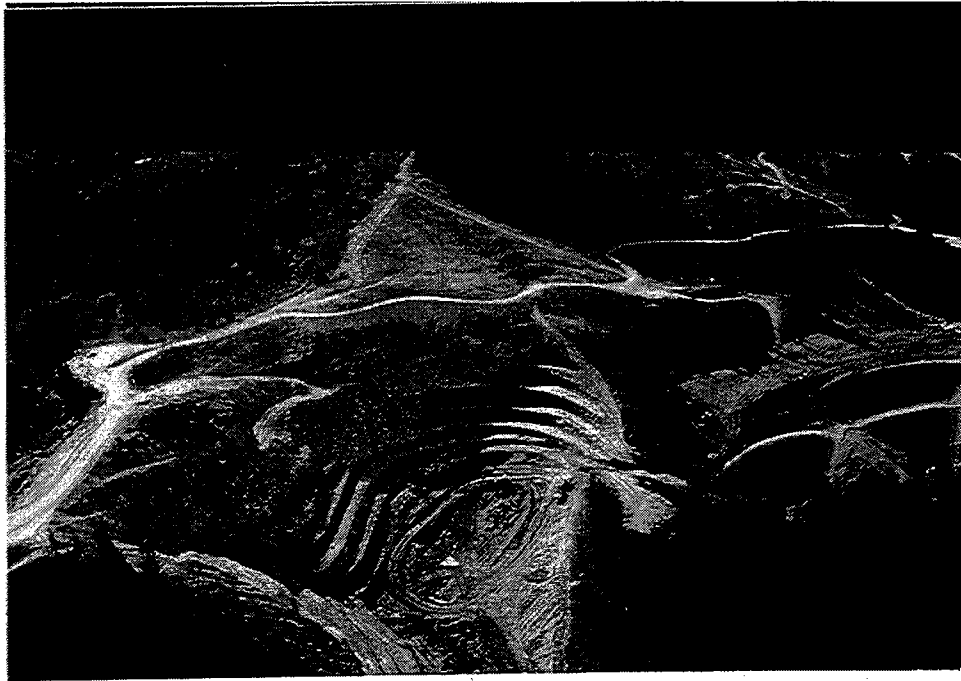
Figure 9. Large Side-Hill Fill Area Where Underbenching for Embankment Construction Has Clearly Marked the Landscape.

The underbenching procedure began as clearing and grubbing and slope staking was completed. Excavation for the underbenching was initiated near the upper most fill line of each embankment section and proceeded down to the fill toe area (Figures 8 and 9). Vertical slopes and benches are excavated in this fashion until the unstable material is removed.

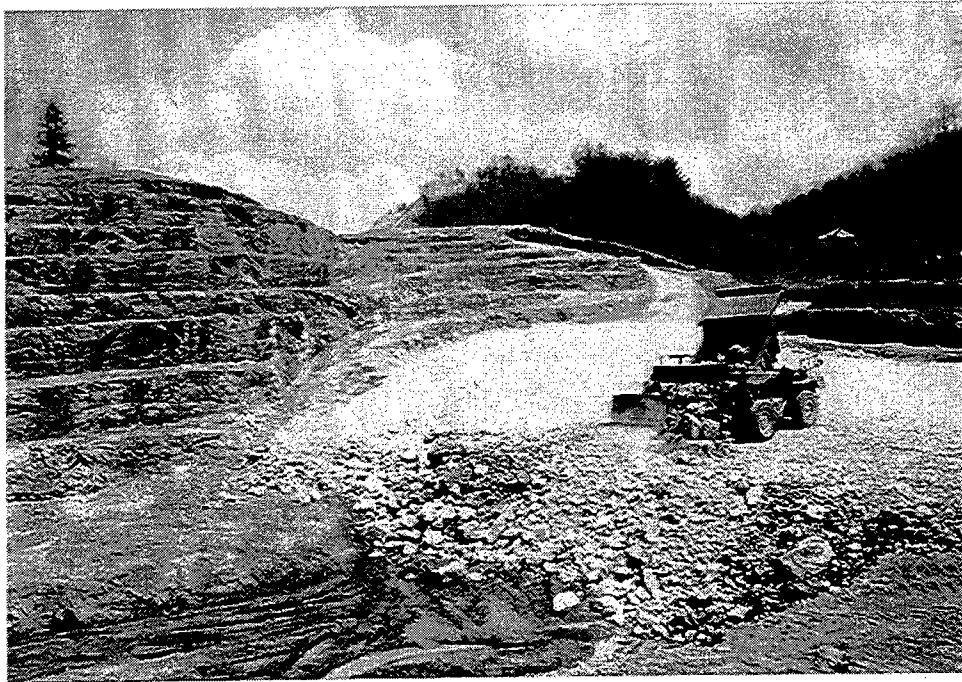
Figure 10. Processed Rock from the Project is Placed Over All Underbench Areas to Provide for Drainage and Stability of the Embankment.

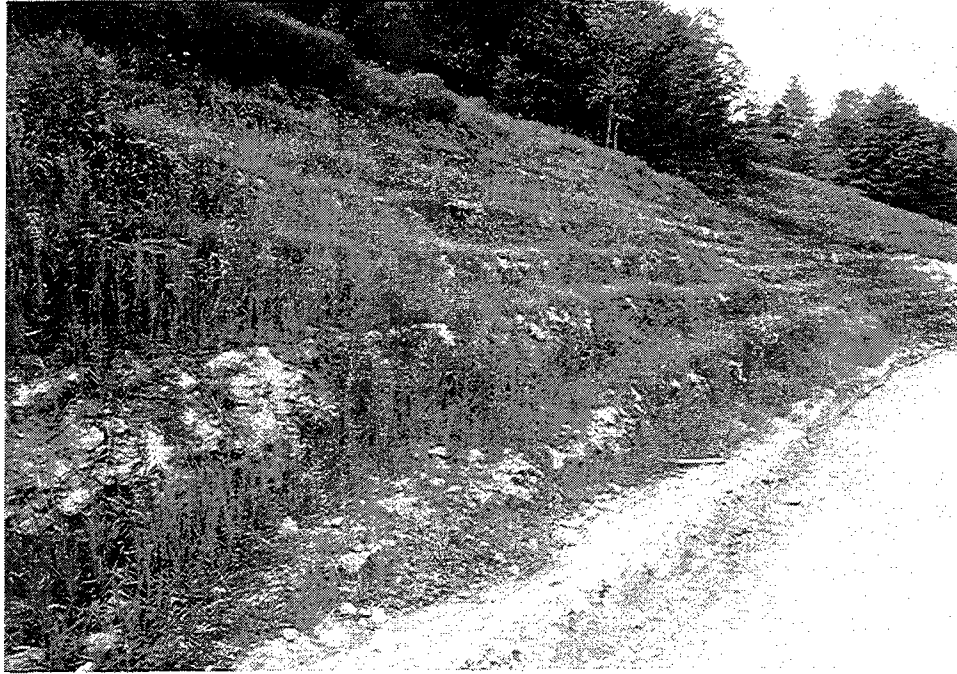
Figure 14. Serrated Cut Slopes (Stair-Step Benching Procedure of Excavating Steep Soil Slopes) Were Used on the Project to Help Establish Vegetation on Steep Soil Slopes.

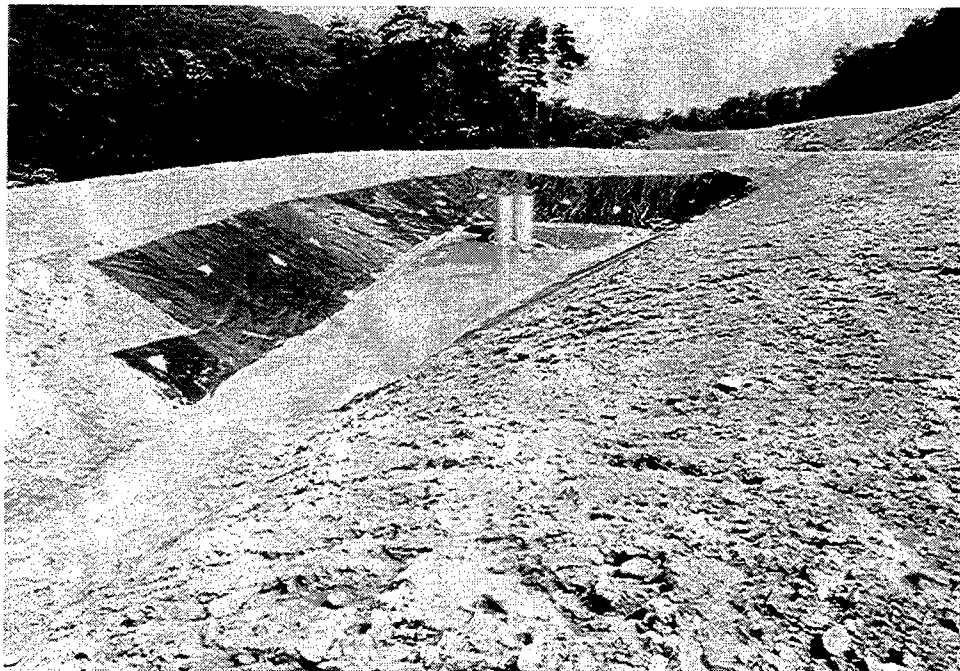
Figure 15. Siltation Dams and Sediment Basins Were Used on the Project in an Effort to Reduce the Water Pollution Effects on South Indian Creek.

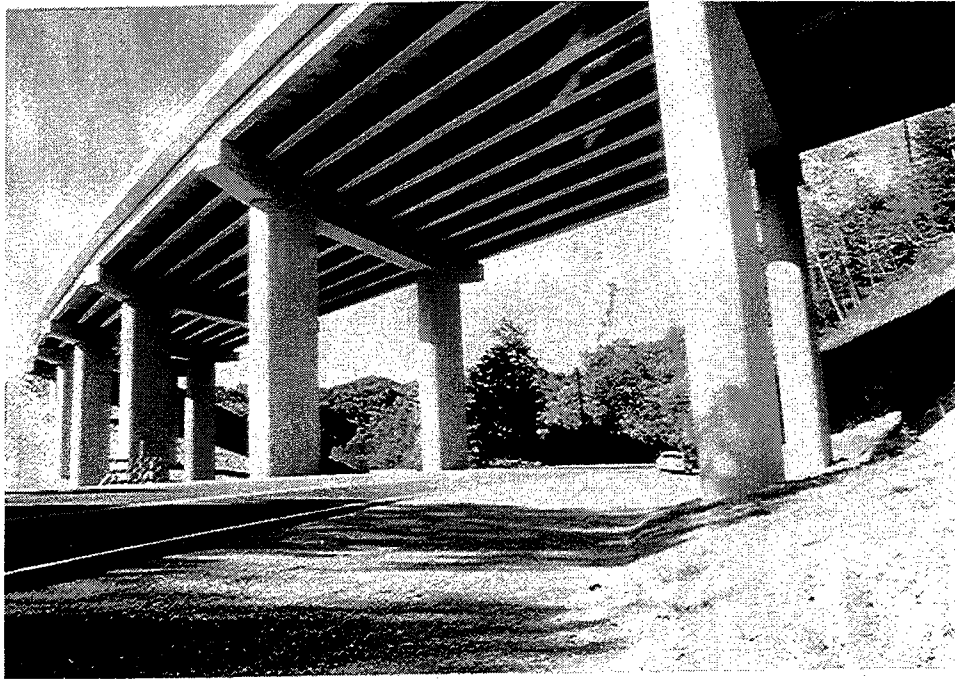
Figure 16. Several Bridges Were Constructed Over South Indian Creek and One (Shown) Over the Creek and Old U.S. 23.

Where the route crosses South Indian Creek (four places) the bridges were extended lengthwise in order to maintain as much of the Flood Plain environment as possible. These bridges were 244 to 304.8 meters (800 to 1000 feet) in length with very short to non-existent approach fills (Figure 16).
