# **Highway Geology Symposium**

**"Engineering Geology  
of  
Unconsolidated Materials"**

**April 26-28, 1972**

EMBANKMENT FAILURES ON THE TIJUANA--ENSENADA TURNPIKE IN  
THE LOWER CALIFORNIA PENINSULA, MEXICO

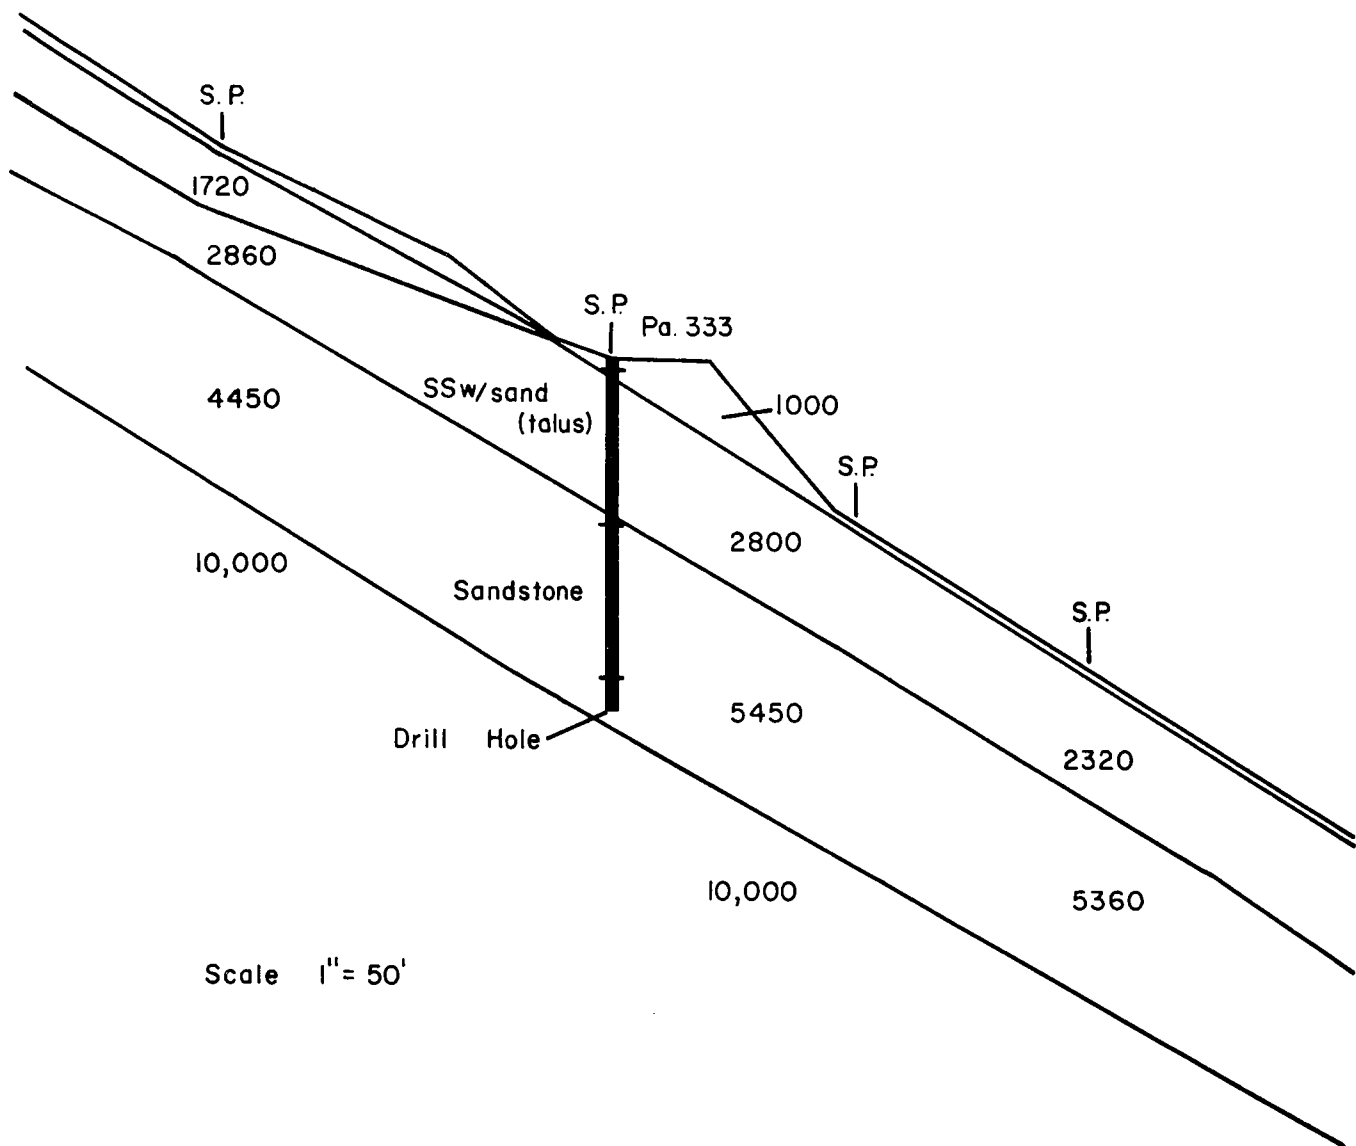
Examples of seismic profile, sections and drill hole ties can be seen in Figure 2. The drill hole ties were in all cases within acceptable ranges, thus validating the survey. The velocity ranges and material correlations are as follows:

1000	-	1500 fps	-	Near-surface colluvium and overburden.
1500	-	3000 fps	-	Overburden; talus to the east, fine colluvium and residual soil to the west.
3000	-	4000 fps	-	Overburden and/or weathered rock, mostly talus to the east, highly weathered rock and residual soil to the west.
4000	-	8000 fps	-	Weathered bedrock. Mostly quartzitic sandstone east and sands and shales to west.
8000	-	14,000 fps	-	Unweathered bedrock. The higher

Figure 2. Typical section showing seismic and drill information.

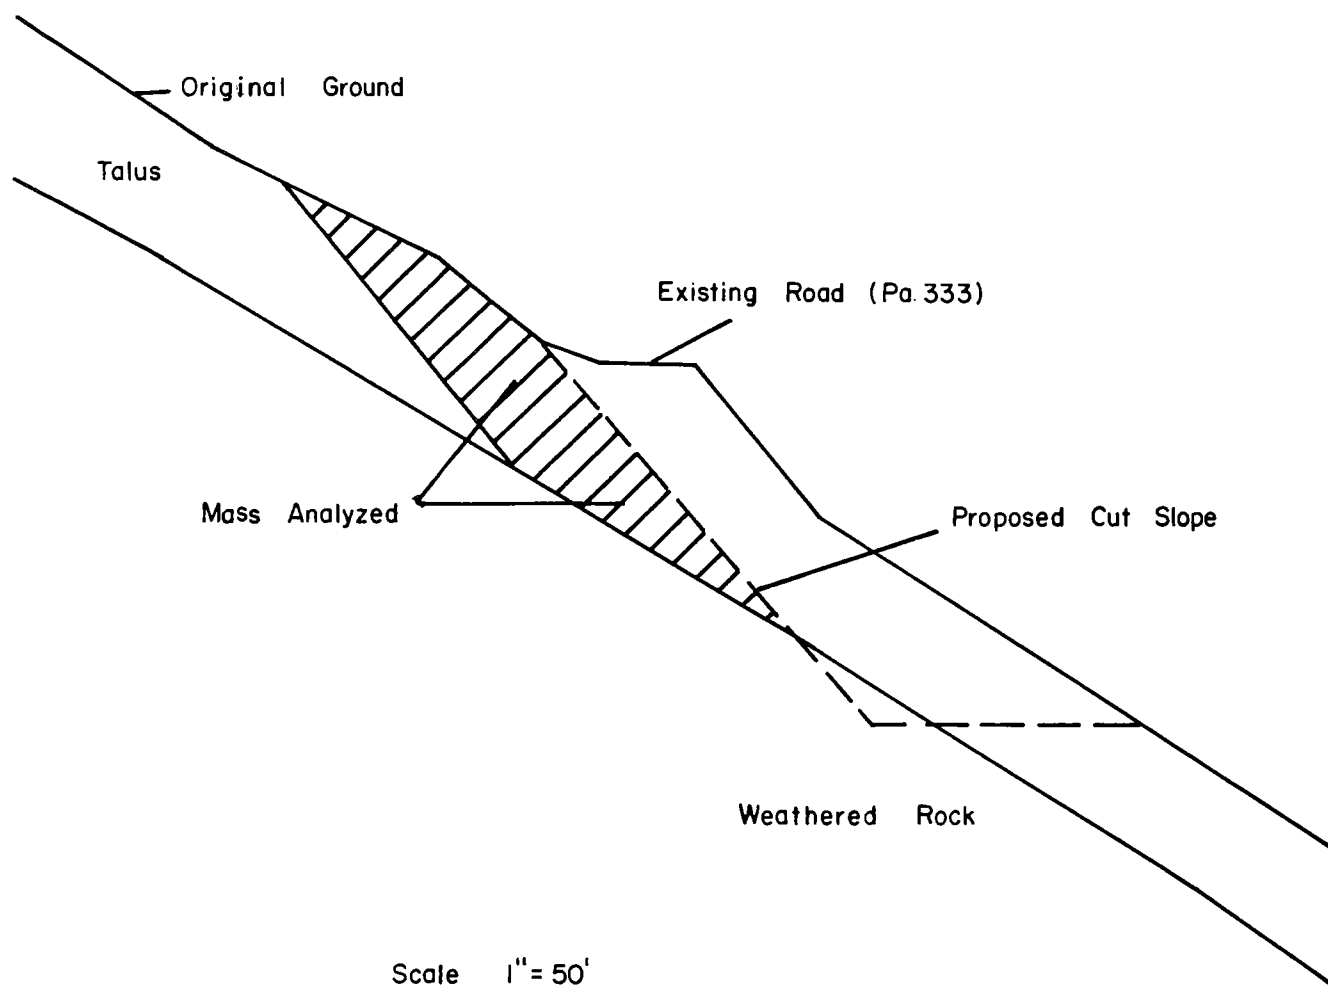
Figure 3. Typical section showing mass analyzed for stability problem.

tance in this and future studies and designs. Three conditions were evaluated: the condition and stability of the talus; the mass stability of the hillside; and the stability of joint systems in the bedrock.

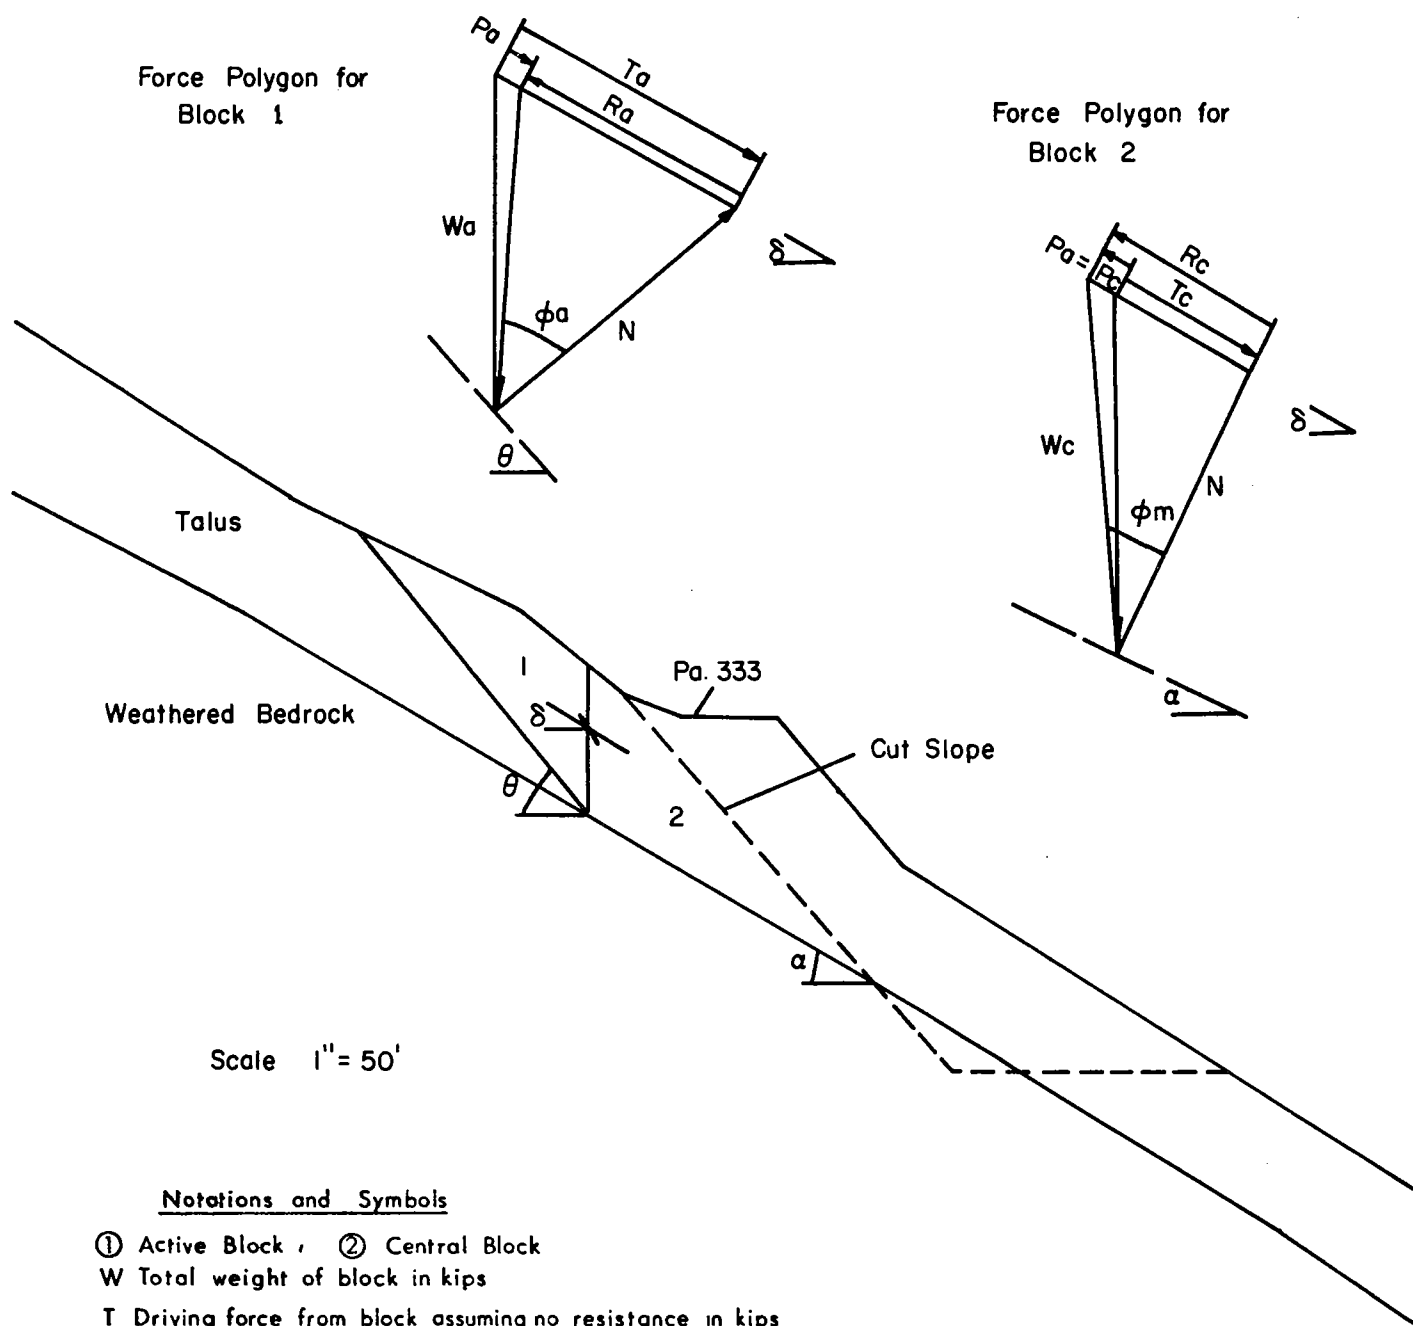
The actual stability calculations were made using the wedge or sliding block method (Figure 4), incorporating the simplified method of blocks with side forces, as developed by Richards (1969), Seed (1967) and incorporating the developments of Sherard (1963).

Figure 4. Typical section showing sliding block analysis.

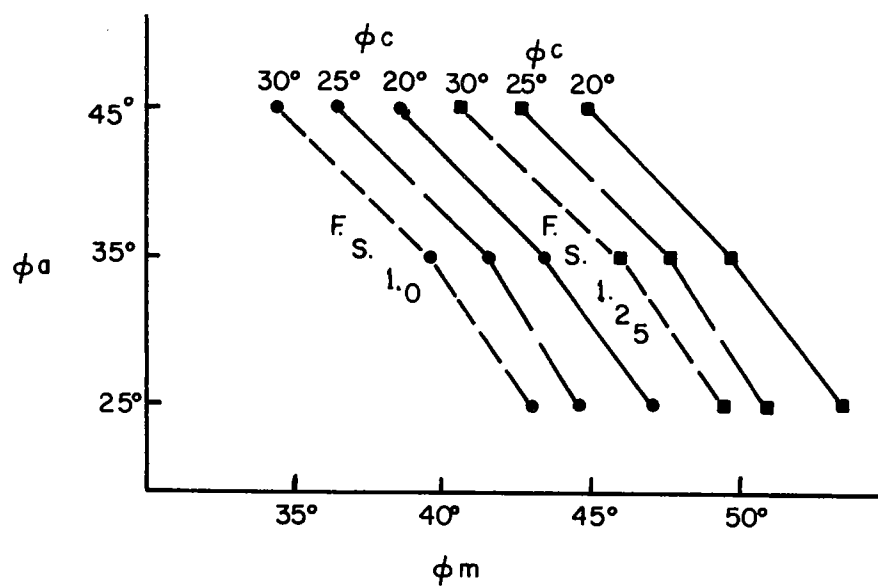
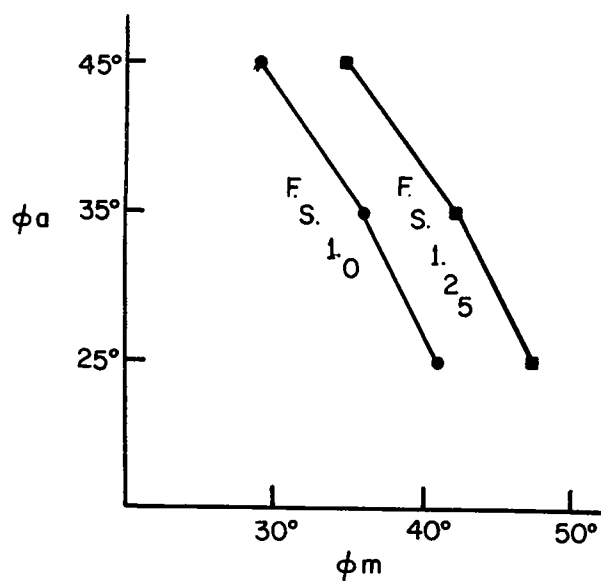
The analyses completed for this represent a typical example of the entire east end in the Narrows Section. From the results, it may be assumed that gross instability would result from the proposed cuts. The equilibrium curves show (Figure 5) that friction angles higher than can normally be expected in this type of material would be required for equilibrium. When the factor of safety of 1.25 is added into the problem, the situation deteriorates in all cases, and requires  $\phi_a$ 's (developed friction angles) of  $35^\circ$  or more, and  $\phi_m$ 's (mobilized friction angles), in excess of  $35^\circ$ . These requirements to meet stability cannot be reasonably expected everywhere for the slope conditions existing on this project. The typical equilibrium curves seen in this slide using a simple two block and a three block analysis can be seen in Figure 5.

Figure 5. Equilibrium curves showing simple 2-block case and more complex 3-block case.

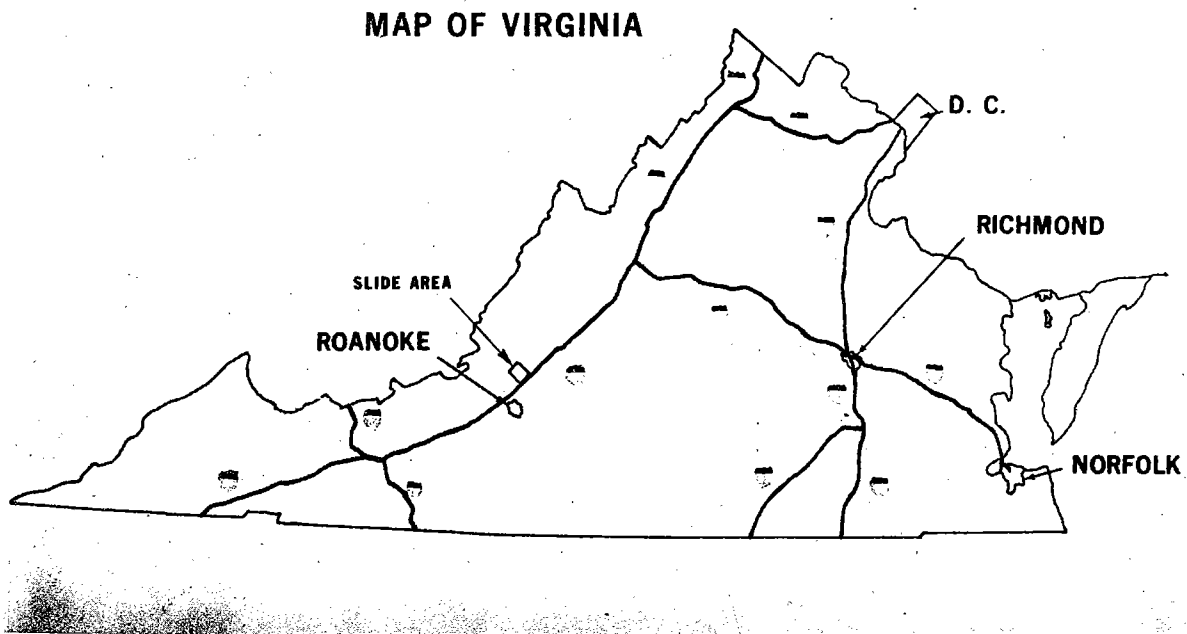
About 5 miles north of Roanoke, Virginia, I-81 traverses the southern slope of Tinker Mountain. A small cut of about 30 feet maximum depth with two horizontal to one vertical side slopes was made into colluvium and residual soil blanketing a shale bedrock. During construction (1961) a small slipout occurred.

Figure 1. Location of failure.

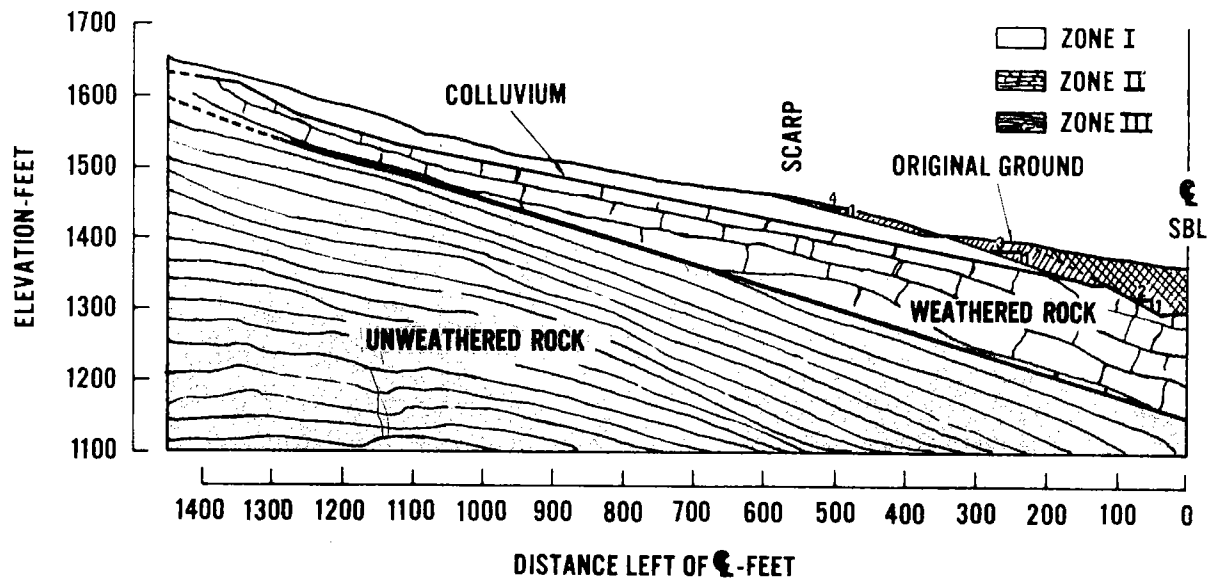
First attempts toward stabilization involved slope flattening to a three horizontal on one vertical. The regraded slopes remained stable through the seasonal changes until the following spring when a second, much larger slide occurred. It was obvious that a relationship between rainfall intensity and slope movement existed, yet stability analyses with the water table assumed at ground surface indicated a more than adequate factor of safety against movement.

Figure 2. Typical X-Section- 1962.

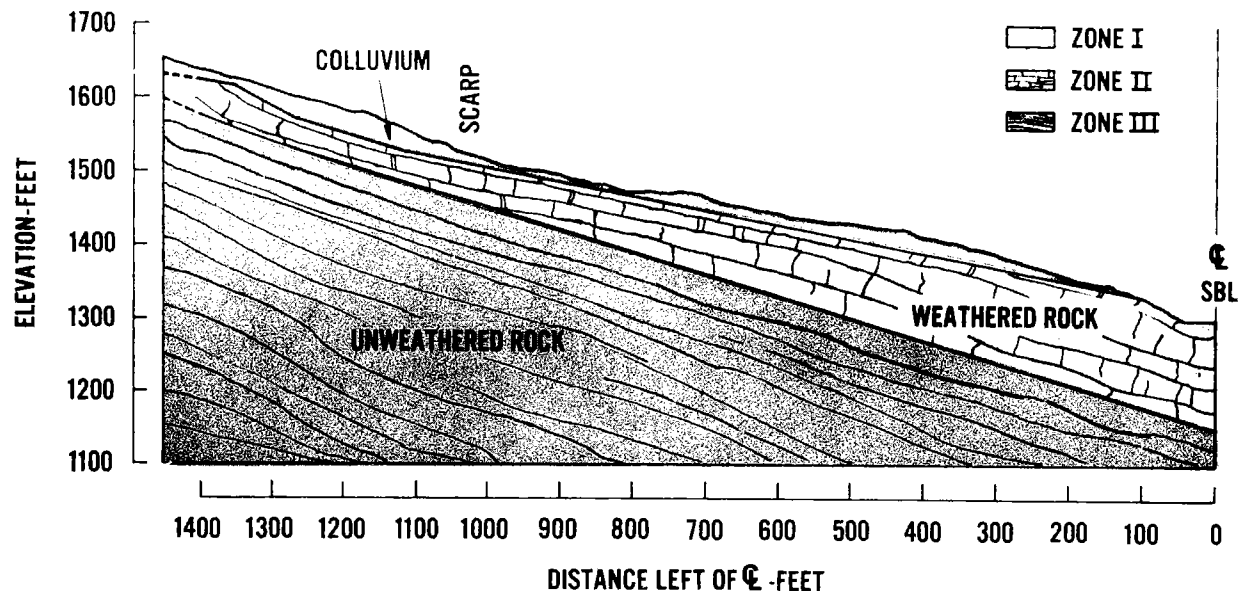
The subsurface profile defined by the various borings is illustrated by Figure 5. The division of the profile into zones follows the sequence suggested by Deere and Patton (1).

Zone I consists of (1) colluvium derived from the higher steeper slopes and (2) the residual soil product of weathering of the underlying parent rock. Information obtained from the borings was too limited to separately define these two strata. In the main body of the slide the disturbance caused by past movement has obliterated any definable contact surface that may have existed between the colluvium and residual soil. Generally, the soil of Zone I is a silty clay containing numerous "floaters." These "floating" sandstone boulders have as their source the sandstone capping the top of the mountain and have been transported by gravity to their present positions. Their maximum dimension does not usually exceed 10 feet. Zone I varies in thickness from 10 to 50 feet.

Figure 5. Typical X-Section-1971.

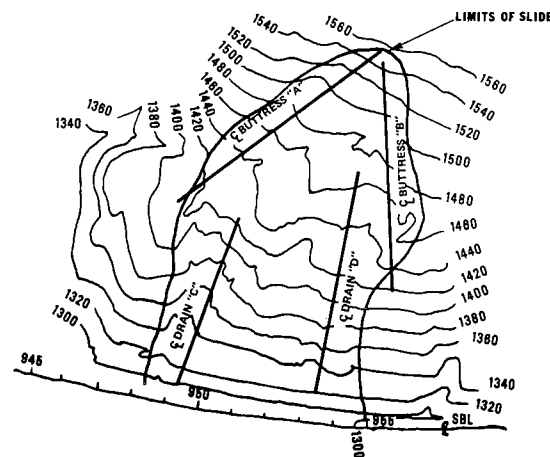
Figure 6. Plan of proposed remedial scheme.

Figure 6 is a plan view of the slide illustrating the proposed location for the buttresses and drainage trenches. Typical sections for the buttress and drainage trench are shown on Figures 7 and 8, respectively.

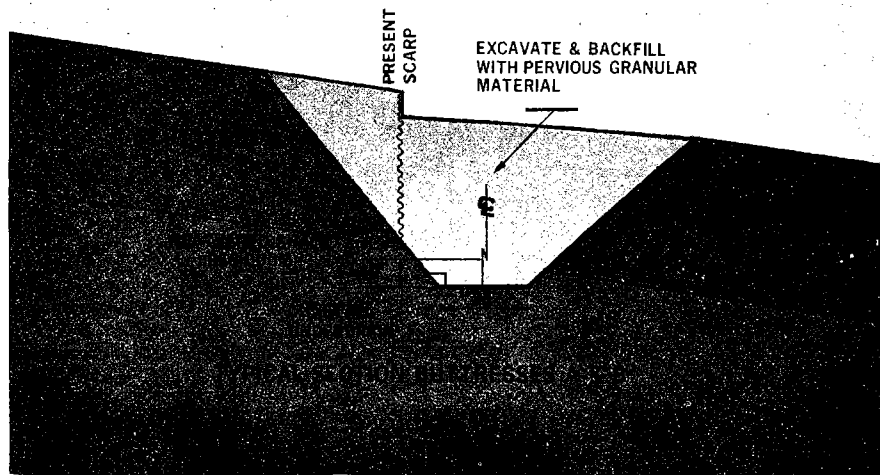
Figure 7. Typical x-section of buttress.

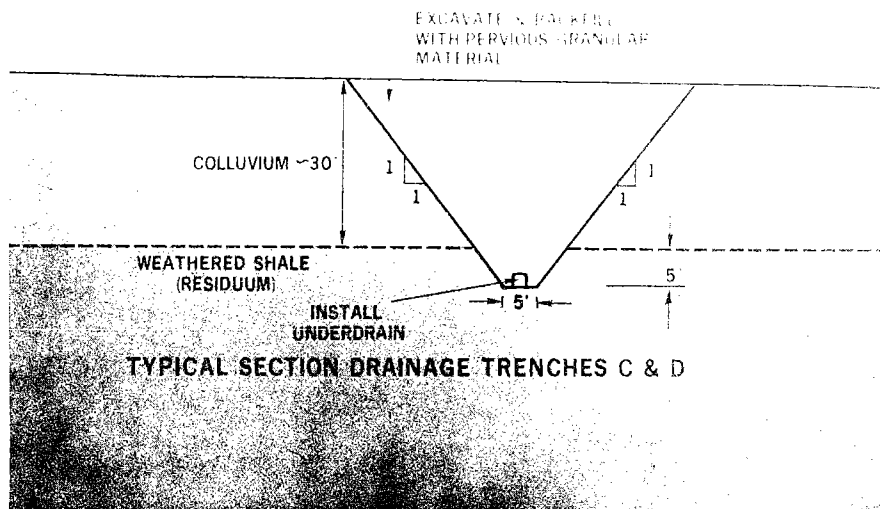
Figure 8. Typical x-section of drainage trench.
