PROCEEDINGS

HIGHWAY GEOLOGY SYMPOSIUM 53rd ANNUAL

San Luis Obispo, California
August 13th – 16th 2002

**Sponsored By
California State Department
of Transportation
And
California Geological Survey**

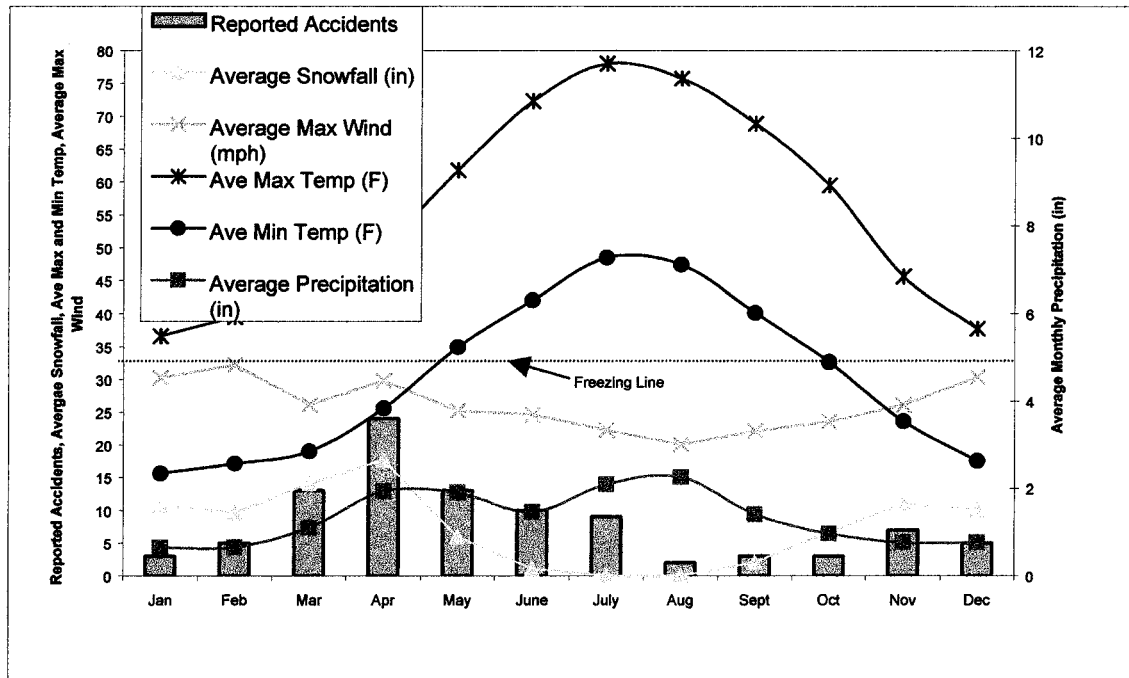
Figure 1. Reported Accidents and Climate Data

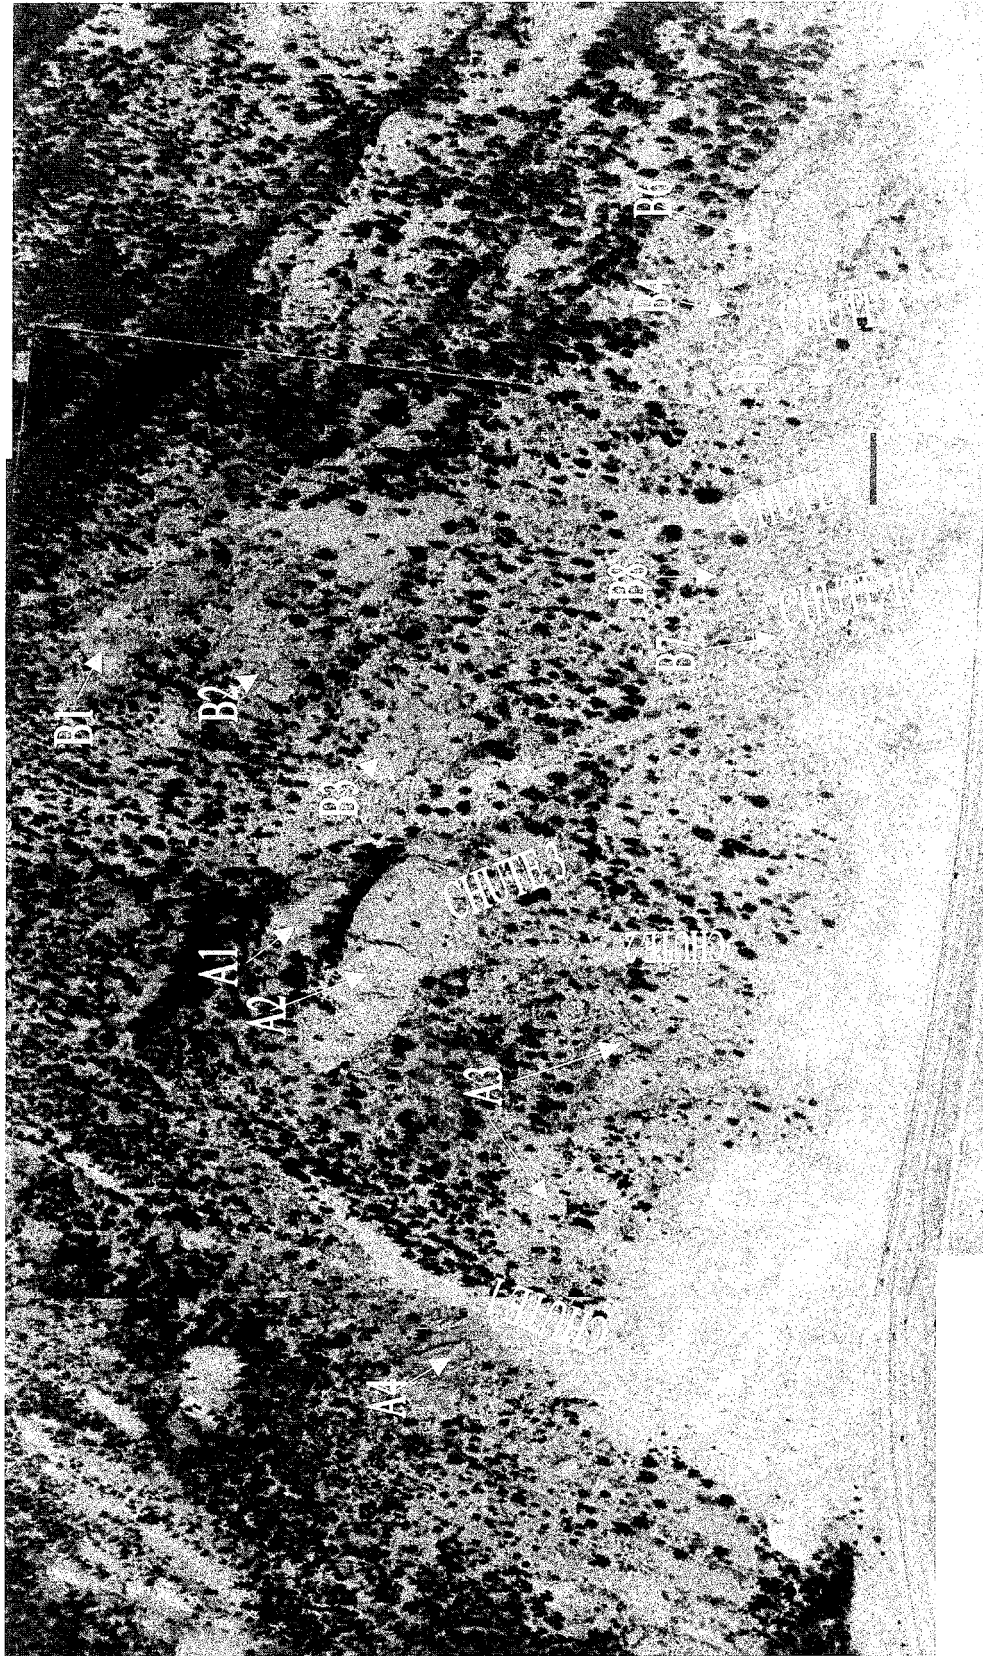
Existing Rockfall Fence

Figure 2. Rockfall Chutes and Source Areas with Fence Location

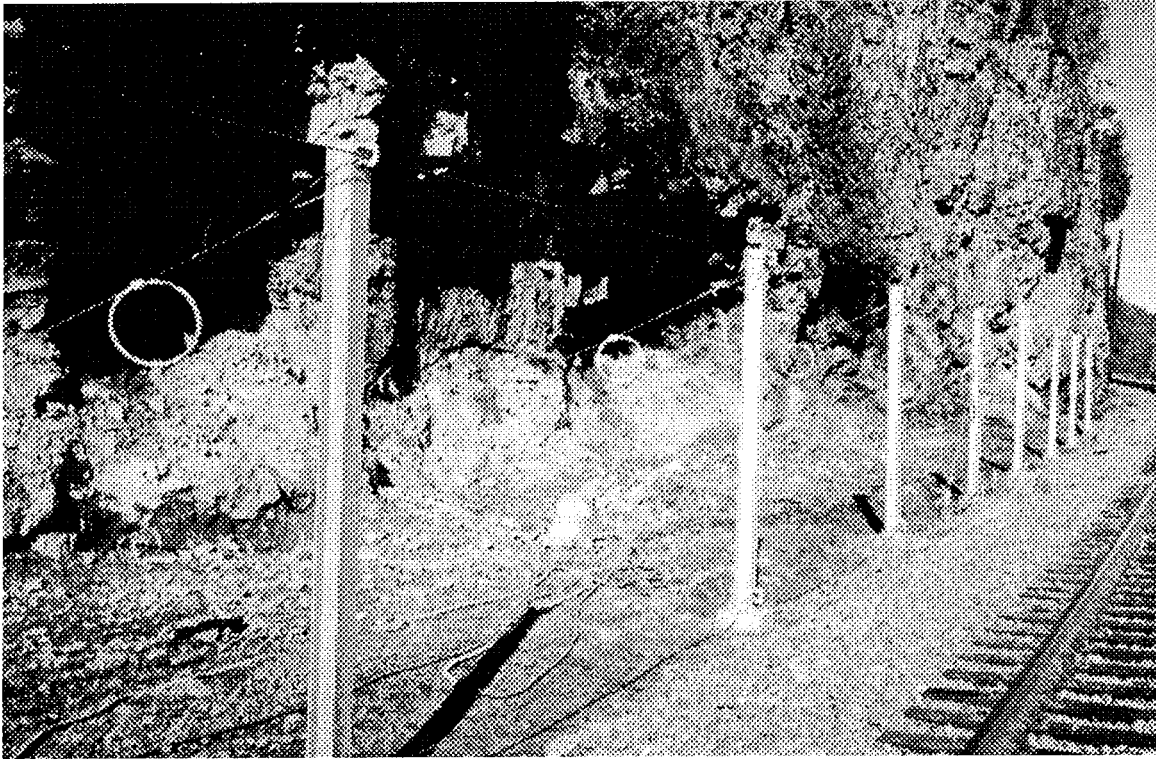
Photo 3. Brugg fence posts and guy wires, Zone 3

Erection – the Brugg fence posts or the CPR detector fence posts were then erected, see Photo 3, and the LockBlocks installed, Photo 4. Once the posts were stabilized with guy anchors and maintained in their vertical position, the Brugg fence panels were hung, Photo 5, the detector fence wires were strung and once the LockBlocks were placed an upper, 4-wire fence was installed in Zone 8.

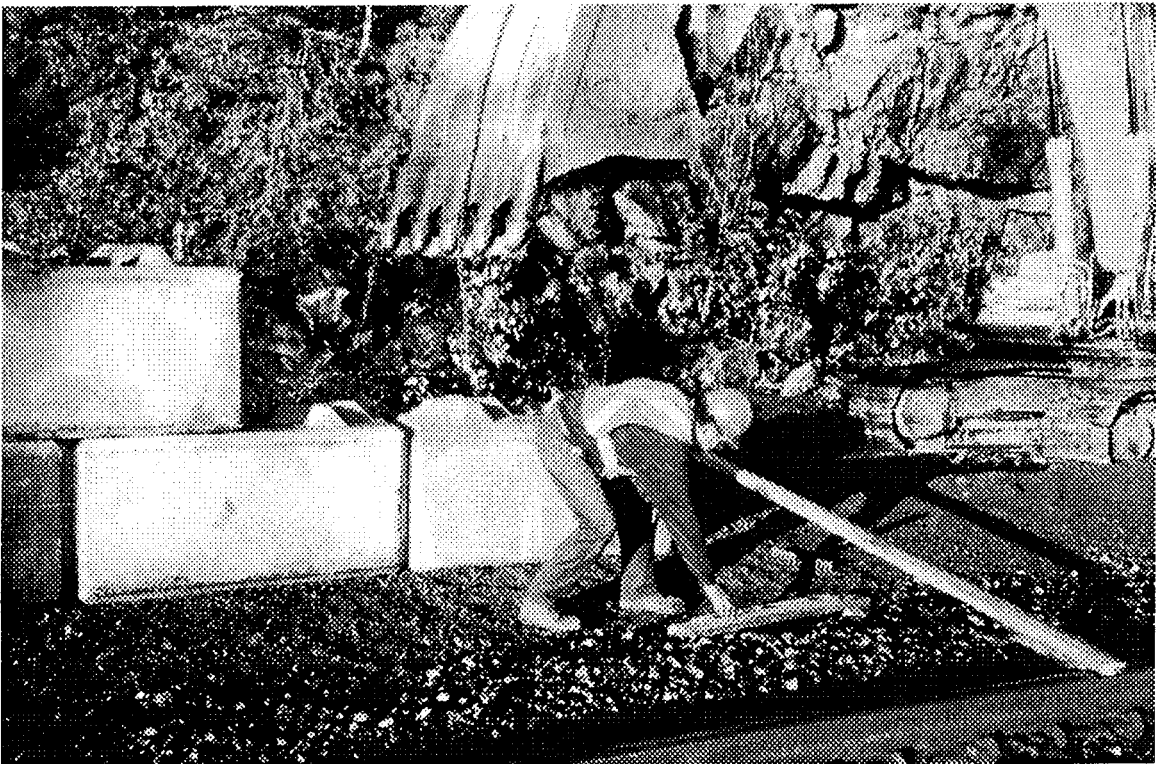
Photo 4. 2 block high LockBlock wall under construction at Zone 7

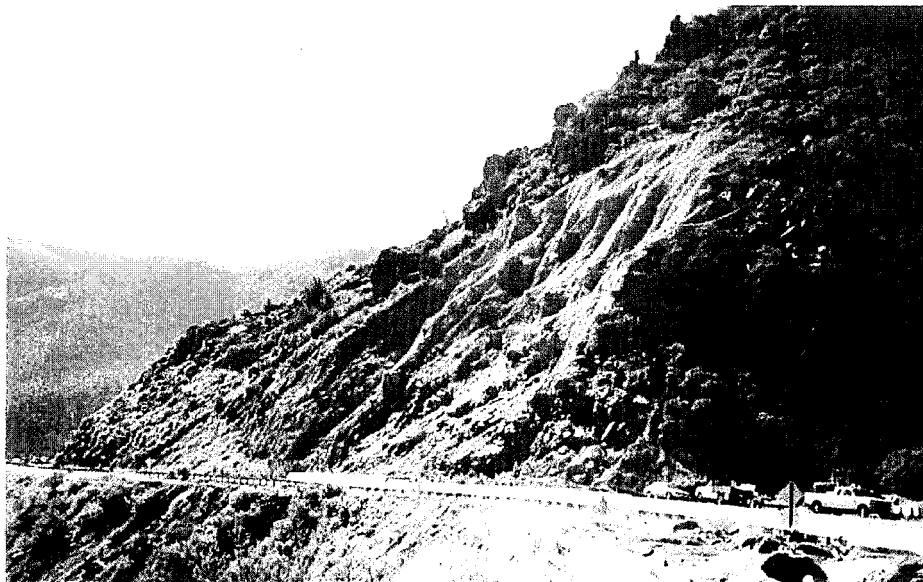
PLATE 1. Draped Mesh on Slope Prior to November 2000 Failure

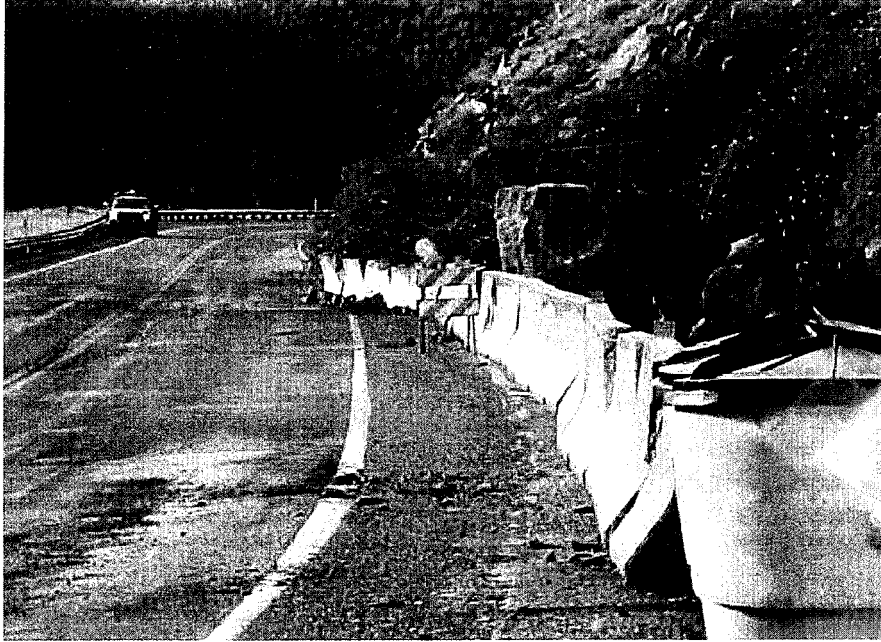
PLATE 2. Failed Rock and Mesh in Highway Ditch

dislodged the wire mesh, supporting cables, and anchors, transporting it en-mass down slope to the highway. Removal of the failed material was complicated by the presence of the mesh and cables (see Plate 2).

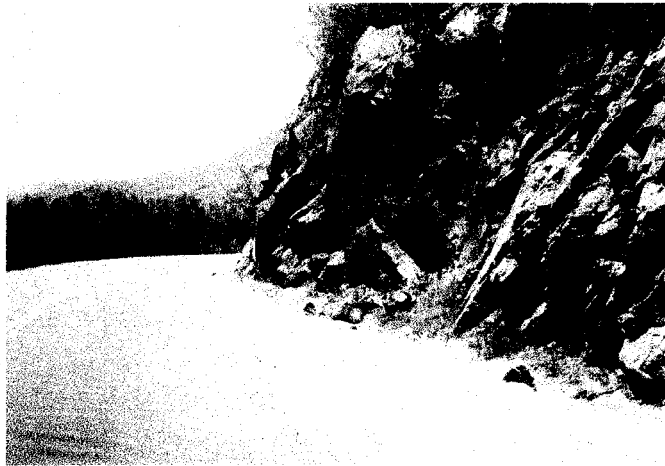
Figure 3. Existing narrow ditch on inside of curve.

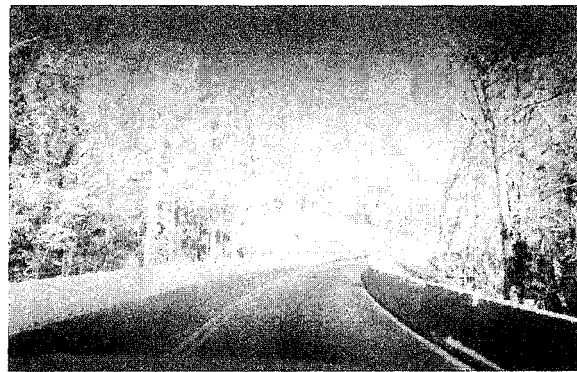
Figure 6. Temporary detour road with Jersey Barriers

The Department recommended that a portion of the abandoned highway be utilized as a temporary detour road during construction. The contractor was able to utilize the detour for access to the top of the rock cut and to use the closed portion of N.H. Route 16 as a staging area for the project. This resulted in minimal disruption to the construction work and allowed traffic to be maintained with only minor delays and no increase in traveling distance.

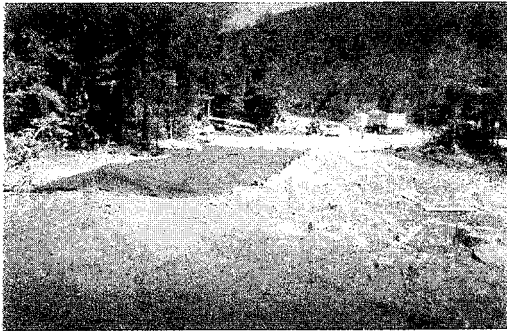
Figure 7. Geotextile on detour road.

and the topsoil was left in place. A heavy geotextile fabric was placed over the existing ground along the entire length of the detour (Figure 7). The roadway fill and base course materials were kept to a minimum. The detour was removed in the spring of 2000 and vegetation was replanted.

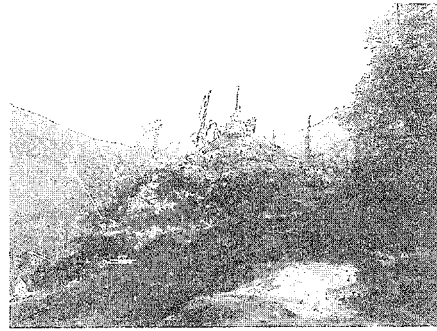
Figure 8. Drilling the hump.

The second phase of the project involved the excavation of the hump (Figure 8) in the upper section of the rock slope. This was accomplished prior to the blasting, excavating and crushing of the remainder of the rock cut. The excavation and crushing activities were conducted simultaneously on both ends of the rock cut (Figure 9). On several occasions the blasting operation had to be slowed so the crushing activities could catch up. The Contractor averaged two blasts per day with individual shots ranging in size from 2,000 to 12,000 cubic yards of rock (Figures 10 & 11). The entire height of the rock cut was presplit in a single operation. To help control blasts and to limit the amount of rock going over the steep embankment slope, the production blasts were shot in multiple lifts. This method of excavation was successful in preventing fly rock from reaching the environmentally sensitive areas along the Ellis River. To improve drilling accuracy and to minimize drill wander (deviation), guide bits and accessories were required for all drilling. The blaster was required to measure the deviation of all drill holes, 50 feet or greater in length, prior to loading explosives. A borehole

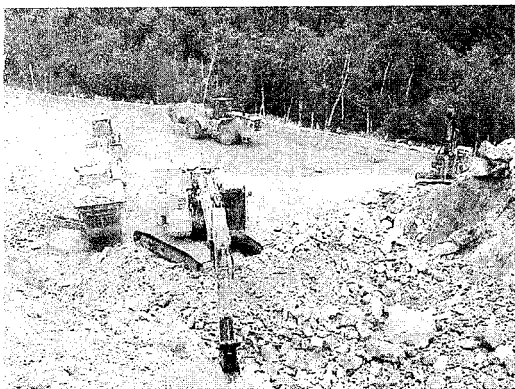
Figure 9. Crushing Operation.

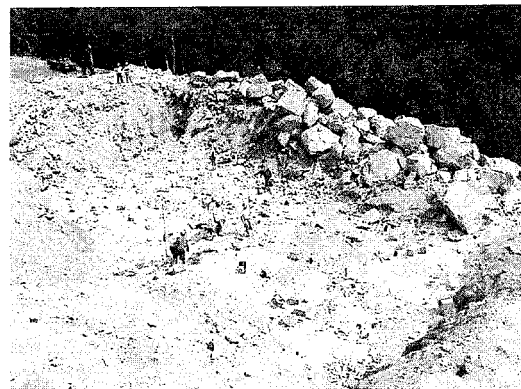
Figure 10. Loading Blast Holes

deviation system was used to measure the orientation of the drill holes. The blaster was required to use the borehole measurement data in his blast design and in determining the placement and the amount of explosives to be used in the blast holes. A drill hole deviation of less than 2% for

depths of up to 80 feet was specified in the contract. The blaster was able to maintain a 0.5 to 0.6 foot deviation for all drill holes.

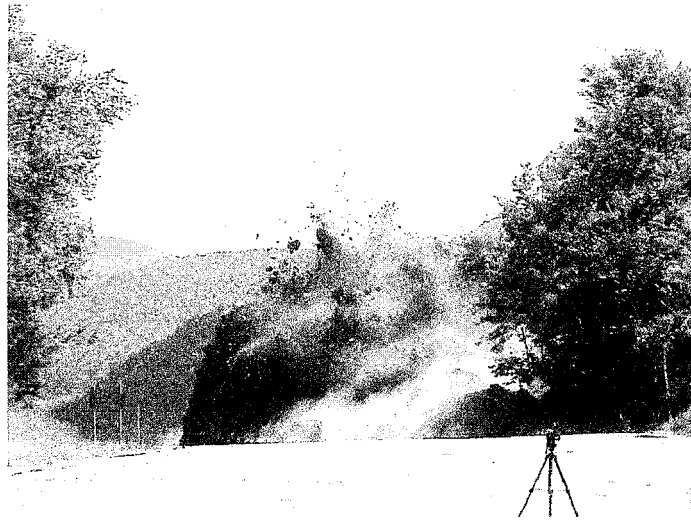
Figure 11. Blasting.

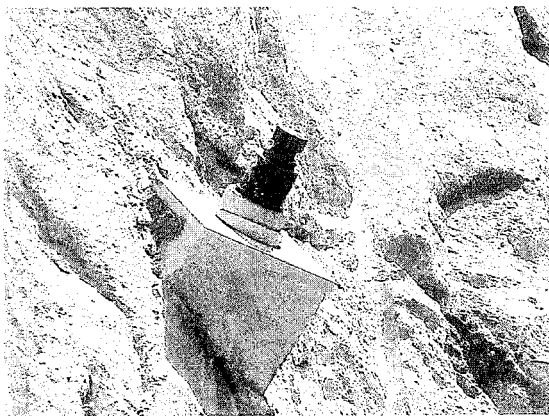
Figure 14. Anchor with concrete pad.

Due to the irregular rock face and the angle at which the bolts were installed, a concrete pad had to be constructed for each rock anchor bearing plate assembly (Figure 14). Proof tests were conducted on each installed rock anchor (Figure 15). Locating sound rock for each rock anchor, determining the orientation of the anchors in relation to the rock face and installing rock anchors at heights of up to 70 feet above ditch level were challenging (Figures 16 & 17). Construction of the concrete pads for the bearing plate assembly and establishing a fixed control point for measuring the elongation of the anchors during the testing were extremely difficult tasks due to the continually changing and severe weather conditions at the site. Each rock anchor had a design load of 125 kips and was incrementally stressed during the proof test with a 110-ton hydraulic jack. A creep test was conducted to make sure there was no significant loss of load over time and a lift-off test was conducted to verify the load transferred to the anchor. The rock anchors were installed in accordance with criteria established by the Post-Tensioning Institute.

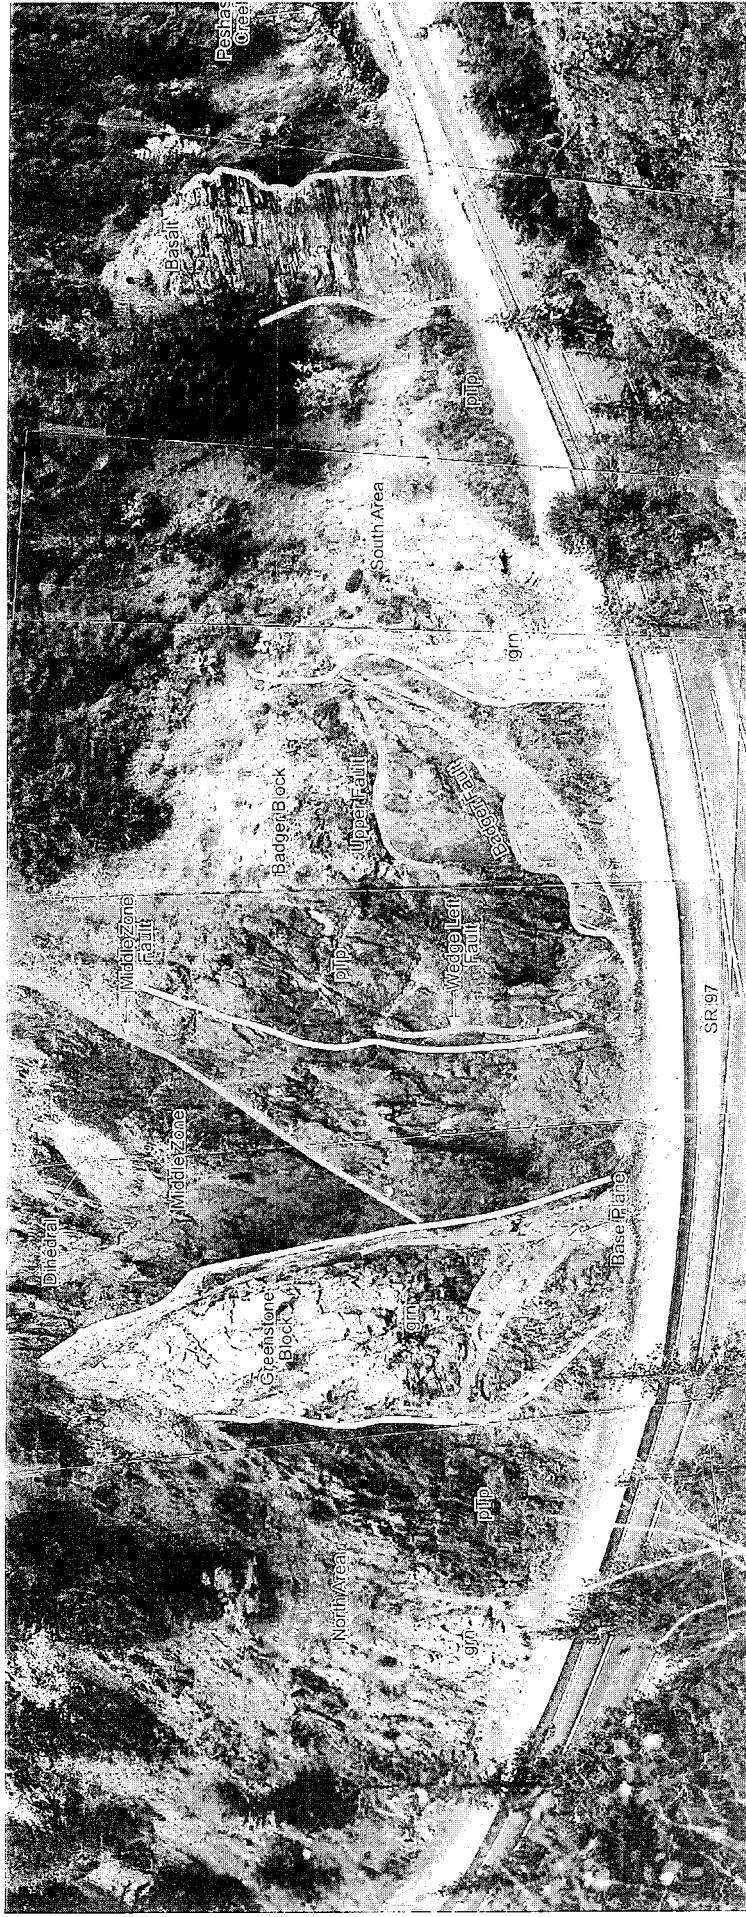
Figure 2 Engineering Geology Mosaic

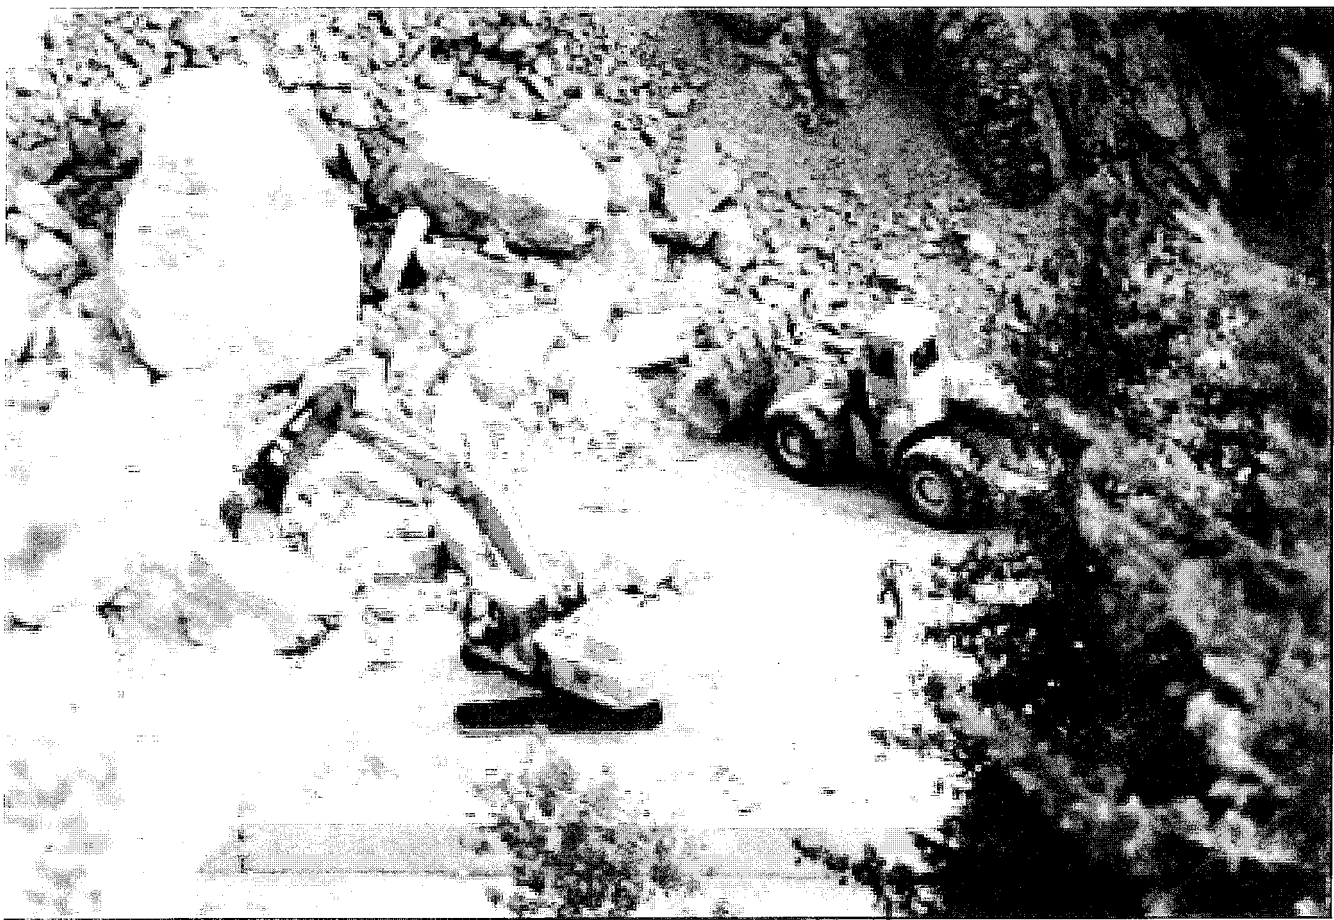
Figure 10 Greenstone Block Post Blast

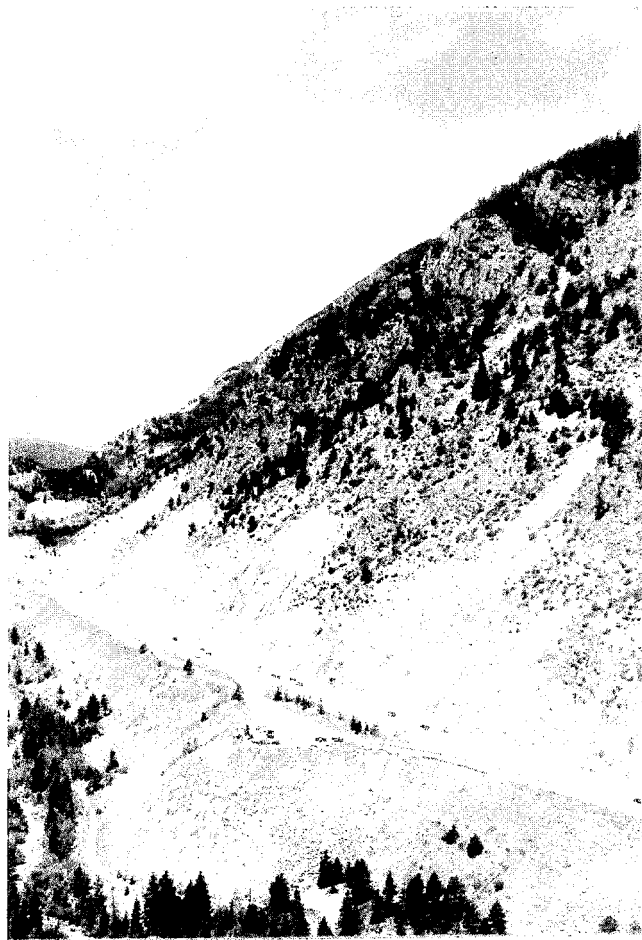
Figure 3. Georgetown Incline Rockfall Area

There are many conditions that can affect a slope and lead to rockfall and usually more than one factor contributes to a failure. For rockfall to occur there must be geological factors such as rock type, structure, and discontinuity characteristics. Different types of rockfall occur in differing geologic situations, as mitigation differs for different scenarios. The conditions that cause rockfall generally fit into one of two categories. One is the case where joints, bedding planes, or others discontinuities are the dominant structural feature of a rock slope. The other is the case where differential erosion or oversteepened slopes are the dominant condition that causes rockfall (Andrew, 1994). The most active rockfall area identified in the Corridor occurs along the Georgetown Incline (Figure 3). The frequency of rocks impacting the existing highway can occur daily.

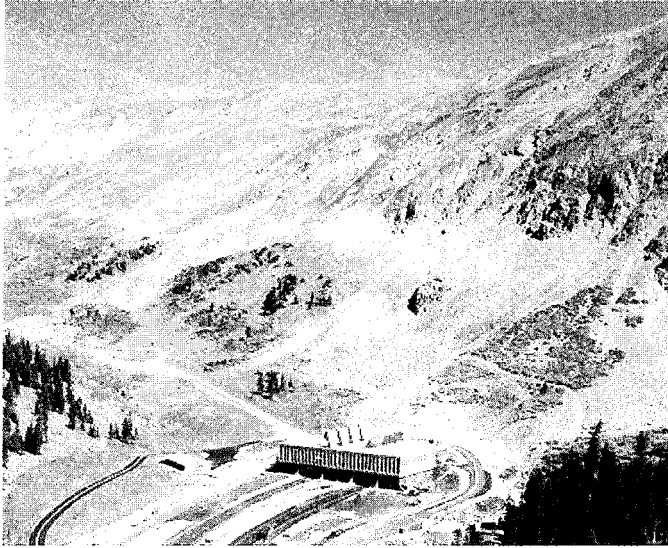
Figure 4. Avalanche Chutes, West Portal Eisenhower Tunnel

Avalanches in the study area occur where a large mass of snow or ice moves rapidly down a mountain slope. Avalanche chutes appear as elongate, narrow, barren scars on a mountainside normal to the strike of the valley. Often, a fan-shaped deposit is found at the base of an avalanche chute. Other avalanches can form during periods of high wind causing the rapid accumulation of snow on cliff faces. The most active avalanche zones occur near the east and west approaches to Eisenhower Tunnel.

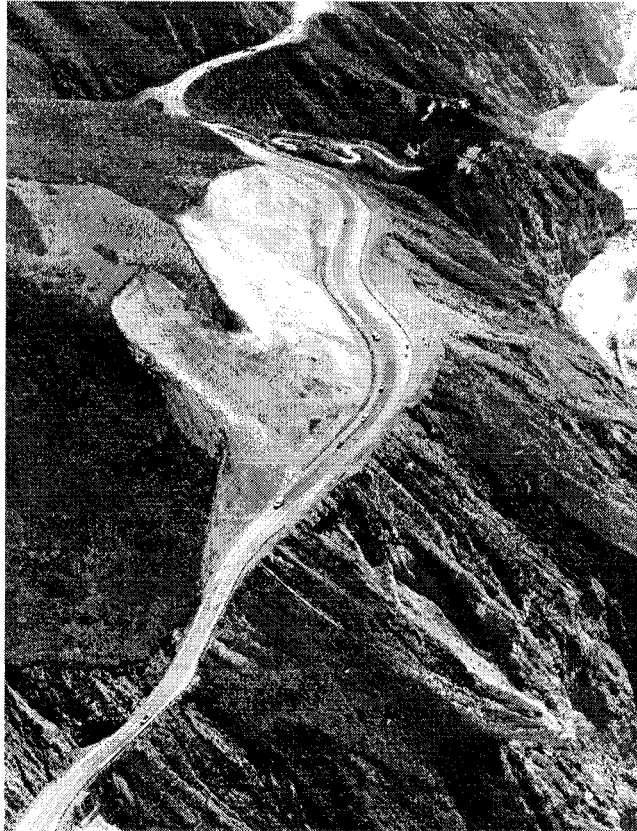
Figure 1: Large-scale landslides are common along the Big Sur coast and road closures from slides are a routine occurrence.

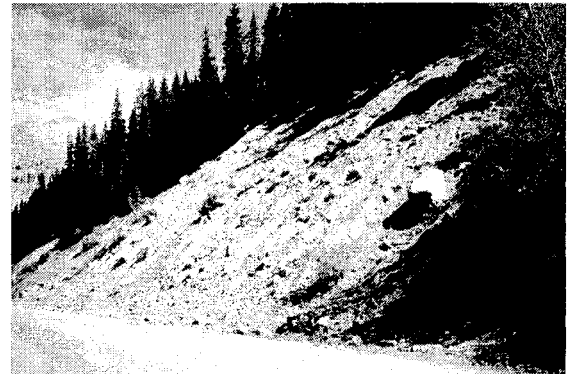
Soil slopes occur above the Road in almost all areas where rock cuts are not present. Only about 1.5 to 2 miles of the 11-mile Alpine Section has soil slopes immediately above the Road. Soil cuts are generally cut back adequately and are stable in the lower Road sections. Soil slope instability is generally in the form of raveling of poorly vegetated slopes, releasing boulders that can roll out of the cut and into the roadway. A secondary concern for maintenance is sloughing of soil onto the roadway. In most locations, soil cuts are small. In one location (near Siyeh Bend), approximately $\frac{1}{4}$ to $\frac{1}{2}$ mile of soil cuts extend to 40 feet or more above the road. These cuts in glacial till are eroding and raveling badly, releasing boulders from a considerable height above the Road. At present, there is not an adequate catch ditch along the toe of the slope.

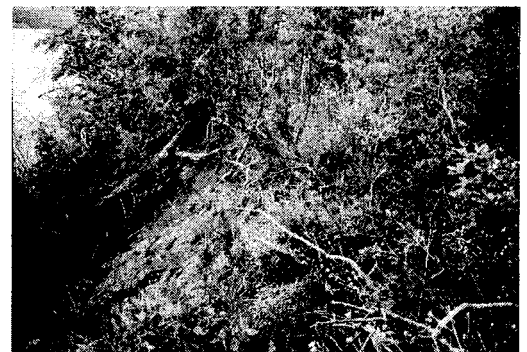
Several features are present along the Road which are recently-active landslides, slumps, or areas which appear to be subject to accelerated soil creep. Three of these are discrete landslide features of significant size. One lies along the shore of St. Mary Lake, where wave erosion is eroding the toe of the slide, causing further deterioration and expansion of the failure adjacent to the Road. Horizontal drains were installed in the slide previously, but wave erosion continues to exacerbate the problem.

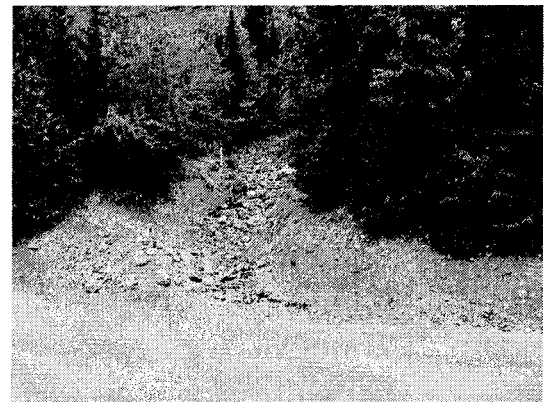
Debris flows cross the road at a number of locations. On the west side of Logan Pass, these features are associated with the larger stream crossings. Here, debris tends to clog bridge and culvert underpasses below the Road, damaging these structures, and overflowing onto the Road in the larger events. East of Logan Pass, they occur where steep gullies cross the Road. In most of these locations, culverts carry water flows under the Road and become plugged during debris flow events, resulting in deposition of debris directly onto the Road. The debris flow hazards are found on the lower Road sections, rather than the Alpine Section.

Debris flows constitute a considerable impact for Road maintenance. Significant debris flows will block and close the Road until they can be cleared. Potentially, Road users could be threatened by sudden flow of debris onto the Road.

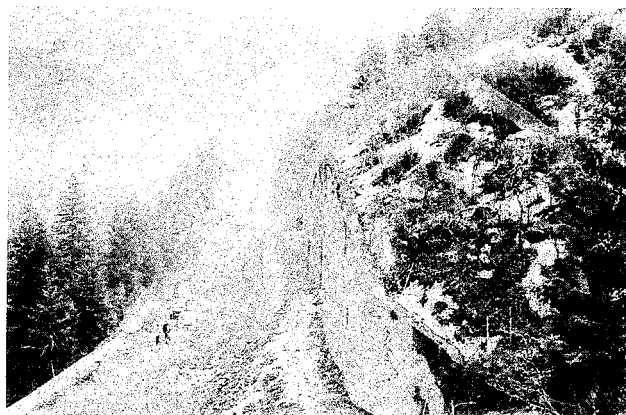
Figure 11 - Completed Soil Nail Wall

Figure 10 shows the installation sequence for the second row of a soil nail wall. Soil nails and shotcrete facing have been completed for the top row. Figure 11 shows a completed soil nail wall in one of the steeper up valley sections of the project. Figure 12 shows the placement of precast panels over the completed permanent soil nail walls.

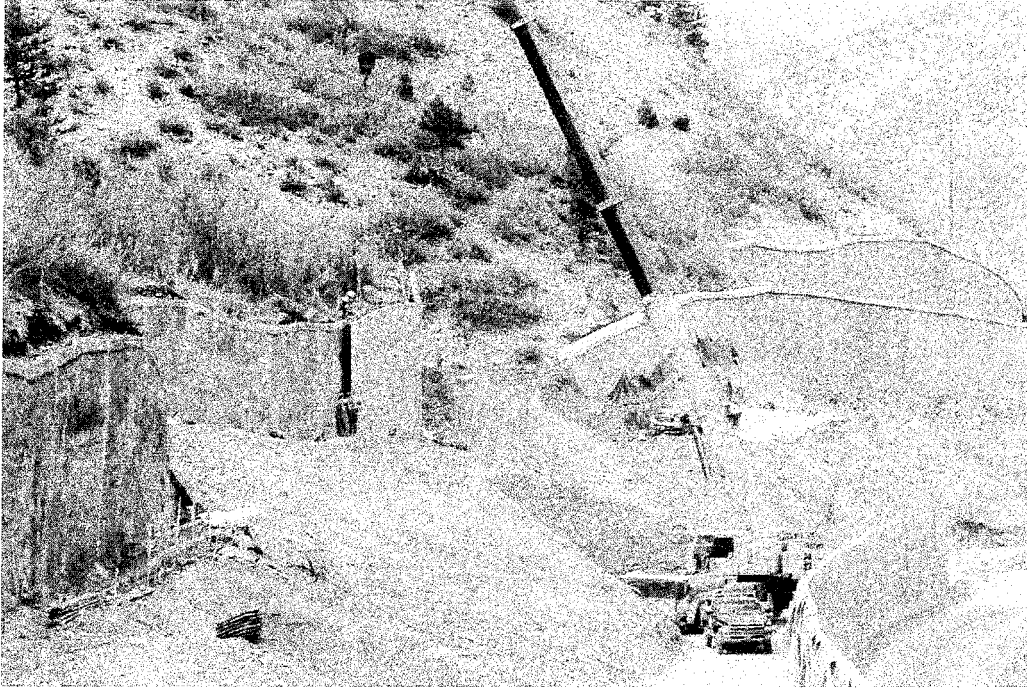
Figure 12 - Attaching final pre-cast panel facing over soil nail wall.

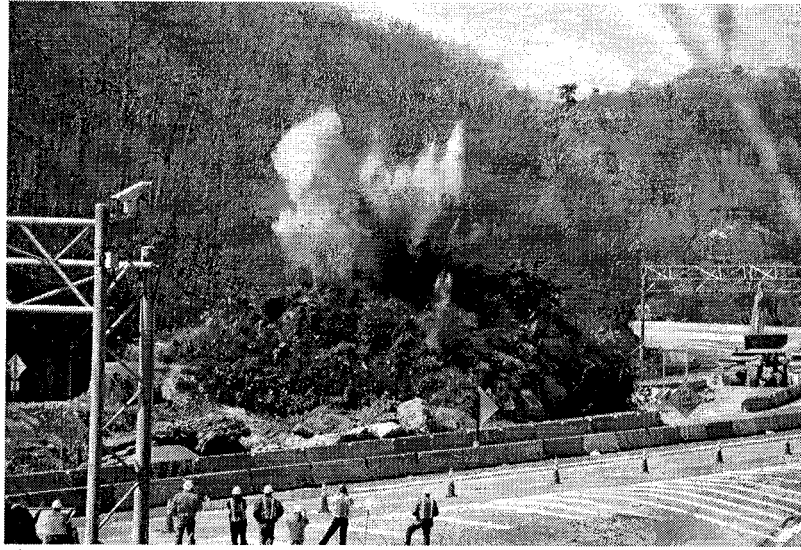
Interchange 8 Reconfiguration I-87/I-287 – The Interchange 8 Project at over \$200M represents a large complex project with 6 bridge replacements, two new bridges, 15 rock slopes, and 17 retaining walls up to 50 feet in height (Figure 4). The project was designed by the Thruway Authority and NYSDOT to reconfigure Interchange 8 to direct most of the traffic from the Tappan Zee Bridge (I-87) to the Cross Westchester Expressway (I-287). When the Thruway was originally constructed, The Cross Westchester Expressway did not exist. When built in the 1950's it provided a connector to I-95 to the east, as well as several other highways and parkways south to New York City. Currently over 80 percent of the traffic crossing the Tappan Zee Bridge exits the Thruway mainline (I-87) via Exit 8 to the Cross Westchester Expressway

Figure 4 – Interchange 8 Blast

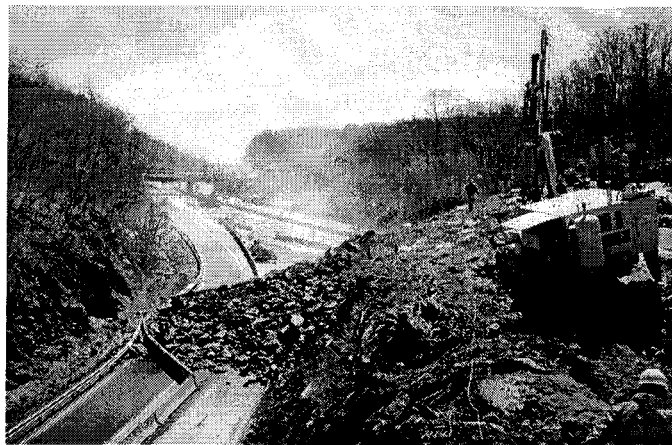
Early blasting on the project identified several areas where modification of MPT plans and contractor procedures were needed. The first blast at Rock Cut 9 (Figure 5) illustrated the fact that the rock cut was too close to the ramp to avoid having blasted rock fall on the ramp, and the ramp was too narrow for equipment to be able to work rapidly

Figure 5 – Ramp Closed By Blast – Note Connected Barriers

to remove the shot rock. Temporary concrete barriers with connecting pins left in place further complicated cleanup when they were displaced by the blast. The barriers remained connected

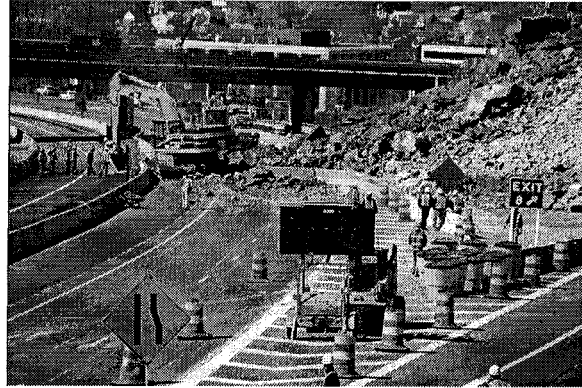
The rock in the roadway shown in Figure 6, caused a two-hour delay and produced a 15-mile backup of traffic on I-87.

Figure 6 – Rock in Road – Note Unused Left Lane

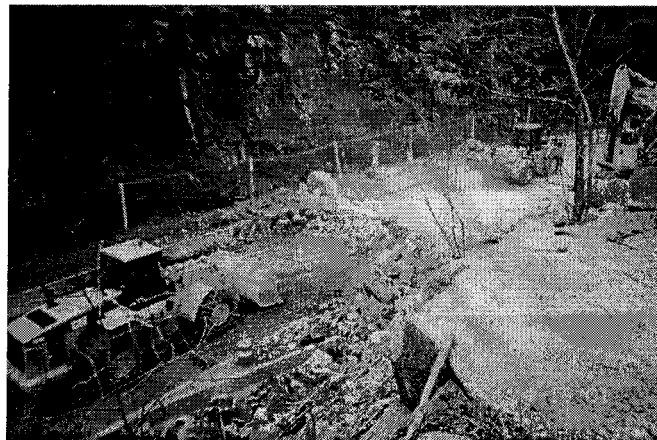
Several other procedures were adopted early in the project to minimize impacts to traffic from blasting operations. The contractor reviewed the effectiveness of the equipment used to remove rock from the roadways and elected to have at least one large loader located at either end of each blast (Figure 7).

Figure 7 – 980 Loaders Clearing Rock at Exit 8 Ramp

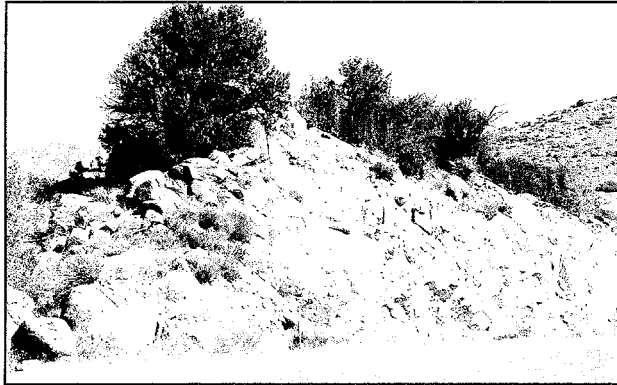
Figure 1 *Sculpted slope in granite with ideal fracture spacings.*

Textural enhancements are most appropriate in masses of hard rock with moderately spaced (1 to 3 ft) fractures (Figure 1). In poorly fractured, massive rocks with fracture spacings more than 10 ft, there are few opportunities for ledging and pocketing along natural joints, so the contractor will have to resort to carving artificial ledges and pockets into the rock. This

Rock staining is a significant visual enhancement for the long-range perspective. Especially in arid areas, chemical weathering of natural rock outcrops results in a dark coating, locally known as “desert varnish”, which takes thousands of years to develop naturally. Commercial desert varnish stain products can mimic the darkened surface in weeks. Some formulations leach natural minerals, others rely chiefly on their photoreactivity, and some are analogous to ordinary pigmented stain. Rock stain is applied by spray (Figure 12, next page). Compare the fresh rock tone of Figure 12 with that of Figure 1, which is the same material after staining.

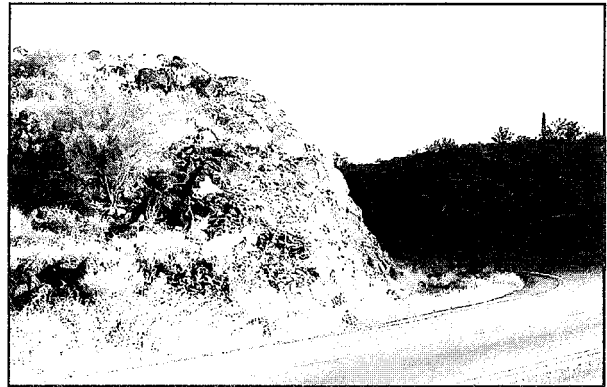
Figure 6 *Note how rounding extends behind the nominal catch point, giving a smoother, natural transition*

Expanded slope rounding (Figure 6) is mentioned here because highway standard specifications often do not require slope rounding in rock, or because the standard rounding radii tend to be small, if the colluvial cover is thin. By expanding the rounding of the slope crests, a smoother, more natural transition to the natural terrain is obtained. It is fairly readily done where colluvial cover is thin by providing a row of "satellite" blast holes behind the trim line proper. The rounding zone does not present rock launching features and is an opportunity for ledges and revegetation.

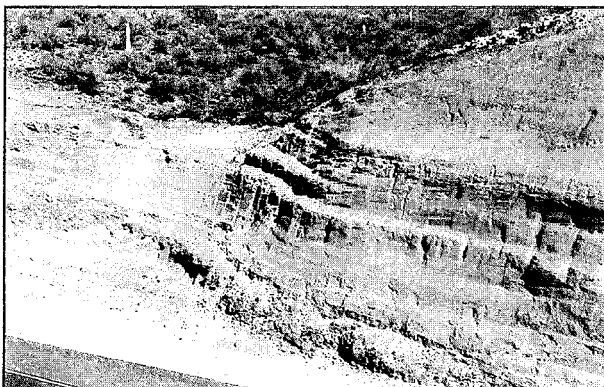
Figure 7 *Drainage layback (with ledging) in lapilli tuff*

A very suitable land form replication technique in cut slopes is the creation of drainage intercept laybacks (Figure 7). On major roadway projects, rock cuts often pass through a series of ridges, without daylighting except at the ends. The topographic lows intercepted by the cut may be considered candidates for drainage intercept laybacks, even if no stream bed or stream

sediment exists. Providing drainage intercept laybacks is an extremely effective technique visually, because it breaks up the uniformity produced by the cut slope design template, and because it recognizes natural land form processes.

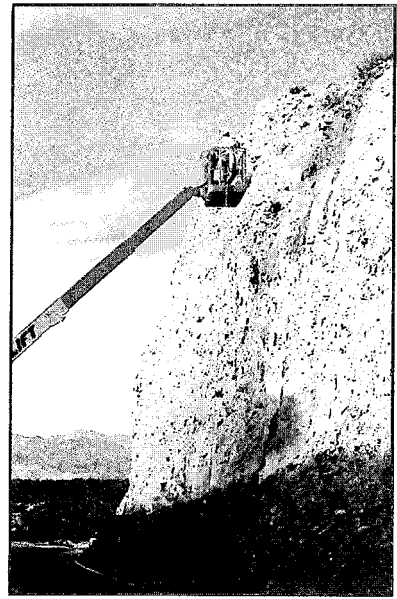
Figure 12 *Application of desert varnish stain. This rock darkened within 2 weeks after application.*

There are certain things to keep in mind when considering desert varnish stain. First, not every stain will produce a color that is compatible with the surrounding landscape, and some stains are not effective on certain types of rocks, so it is critically important to prepare test panels for approval before full scale implementation. Some stains tend to lighten over time, so the test panels should be performed early. The intensity and tone of the finished product will vary with stain concentration and formulation. Multiple applications may be necessary. Also, it is important to fully scale and wash the rock surface before staining, to remove any masking by loose material. The permanence of the treatment should be established. Weak rock, and rock that is absorbent, generally are not good candidates for stain; results may

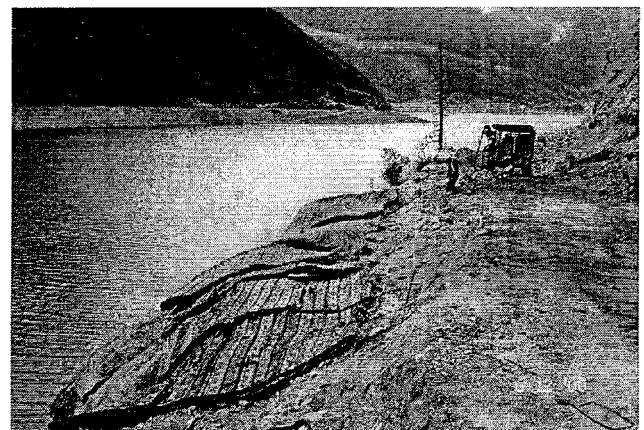
Figure 6b - Blasting Mats Used to Limit Flyrock into Reservoir, Pioneer Road 40

The blasting for the minor slash cuts along the inside slope toe comprised drilling horizontal holes along the strike of the slope and using cushion blasting techniques to minimize the vibration and blast damage to the new face. Again, blasting mats were used to minimize flyrock and spacers were placed between the mats and the slope surface to protect the detonator delays.

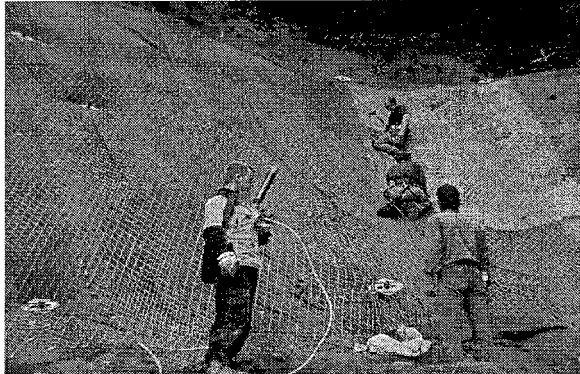
Fig. 12: Spike plate installation

Prior to installation of the mesh, the slope was seeded and covered with jute matting. The mesh was then rolled onto the slope, and tensioned against the surface by tightening the spike plates down into the depressions (see Fig. 12). Fig. 13 is a view of the slope immediately after mesh installation, and Fig. 14 shows the slope after hydro-seeding was completed.

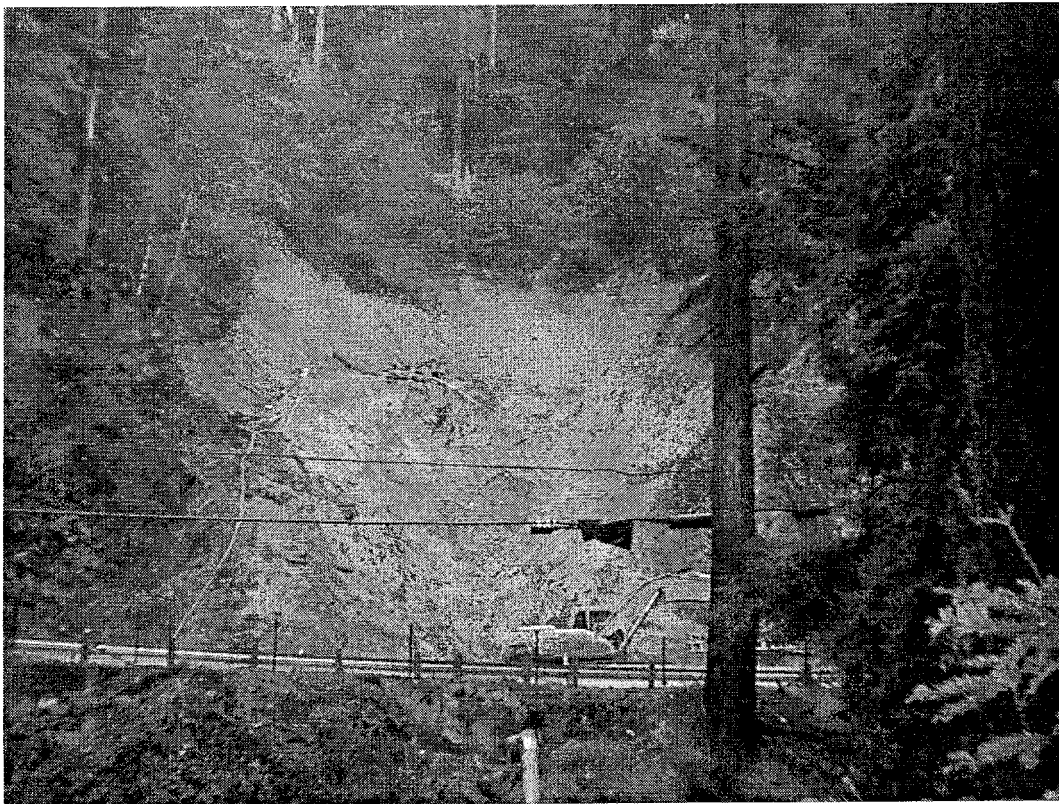
Fig 13: Project site immediately after mesh installation on head and lateral scarp faces

The system was installed at the top areas of the head and lateral scarp faces. The head scarp is approximately 35.6 m. x 10 m. (117 ft. x 33 ft.) and the lateral scarp is approximately 25 m. x 8 m. (82 ft. x 26 ft.), resulting in a total coverage area of approximately 556 m² (5,985 ft²). Moving down the slope, the inclination varies from 60 degrees to 45 degrees. Because some of the lower portions of the site are not as steep, these areas were covered only by jute matting and traditional wire mesh.

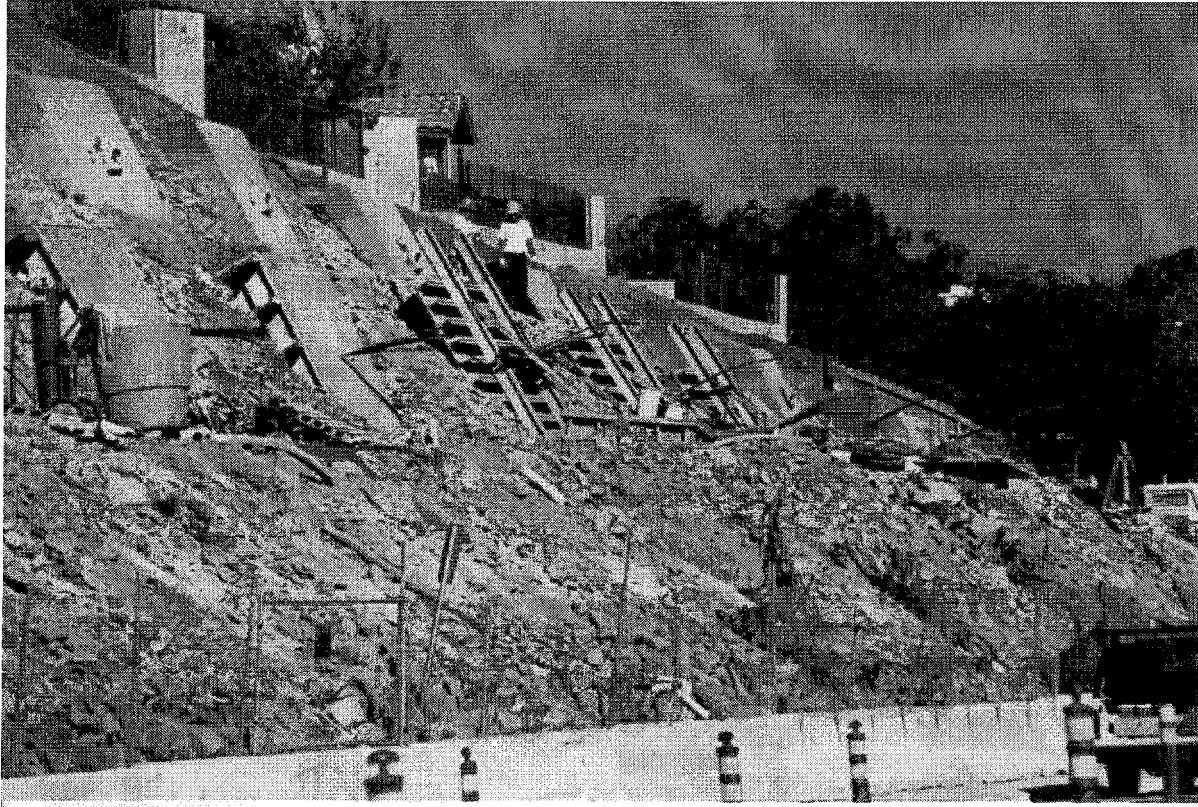
The Stone Point Landslide is located in Spring Valley, near San Diego, CA. In 1987 this landslide caused damaging ground movements to structures in a residential development and a stabilization program was undertaken (Dames & Moore, 1995). The subsurface consists of compacted fill with rock facing underlain by slightly-weathered sandstone of the Sweetwater Formation and moderately-weathered volcanic rock of the Santiago Peaks Formation. The failure surface was modeled by the designers as being a circular surface through the fill and limited to materials above the bedrock. 132 anchors were installed in two rows, one-half and three-quarters of the distance up the slope respectively (Figure 5). Anchors were stressed against individual shotcrete anchor panels, are battered 30 degrees from horizontal, and bonded into the Sweetwater sandstone. Where the sandstone was absent or was highly weathered/fractured anchors were bonded in the volcanic rocks of the Santiago Peaks Formation (Dames & Moore, 2000). Twelve anchors are instrumented with load cells and the measurements summarized in Table 2 are for a period of 1,500 days (approximately 4 years). Seven inclinometer casings are installed in the anchored portion of this slope. Of these, five show zero movement since the

Figure 5. Construction of anchors and panels, Stone Point project. (photo courtesy of URS)
