60th HIGHWAY

GEOLOGY SYMPOSIUM

PROCEEDINGS

1.1.	<i>High Bridge Area Roadway Slide, Letchworth State Park, Portageville, New York</i>	22
	Andrew J. Nichols, P.E.; James Bojarski, P.E.	
1.2.	<i>Remediation of the SR 15 Welcome Center Landslide.....</i>	35
	David R. Scherer, P.E.; Robert E. Johnson, P.E.; Paul J. Lewis, P.E.

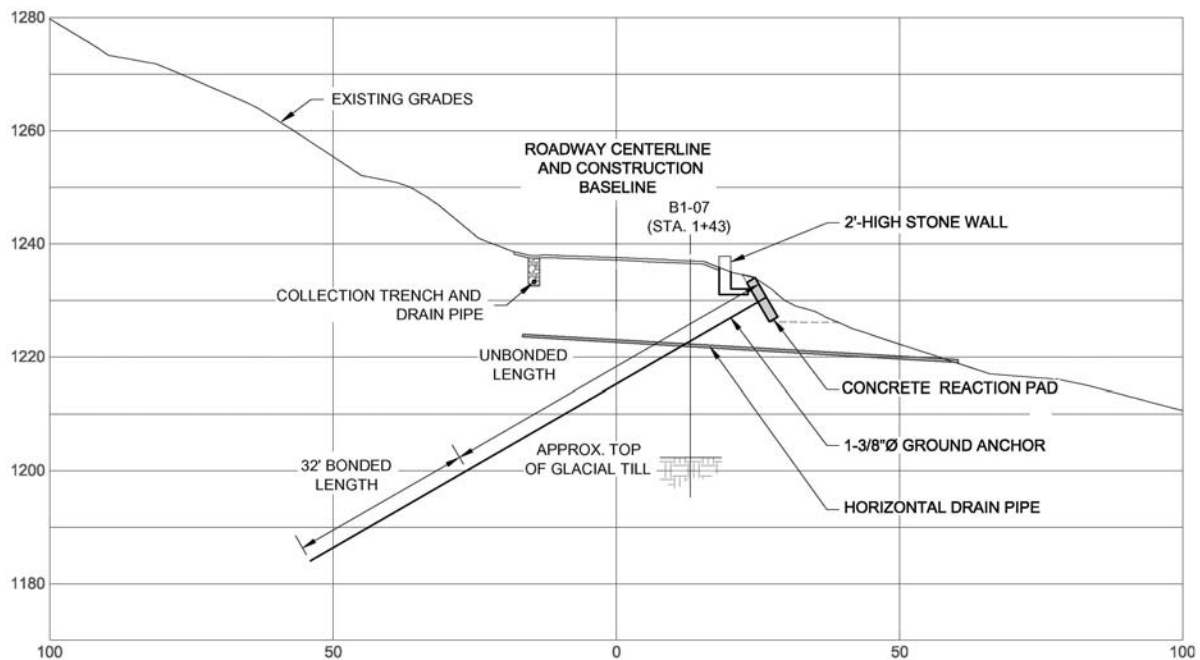
FIGURE 6

Our design includes nine ground anchors and reaction blocks installed below the road. The blocks provide a stabilizing force that increases normal stress on the failure zone to resist future slope movement. Figure 5 shows the reaction blocks and ground anchors in plan and Figure 6 shows them in section view. The reaction blocks and ground anchors could be drilled and grouted into the hillside from a bench area below the road. We also recommended lowering the groundwater level using a series of subsurface drains to provide a pathway for the silt lenses to drain during and after the ground anchors are tensioned.

SECTION B-B

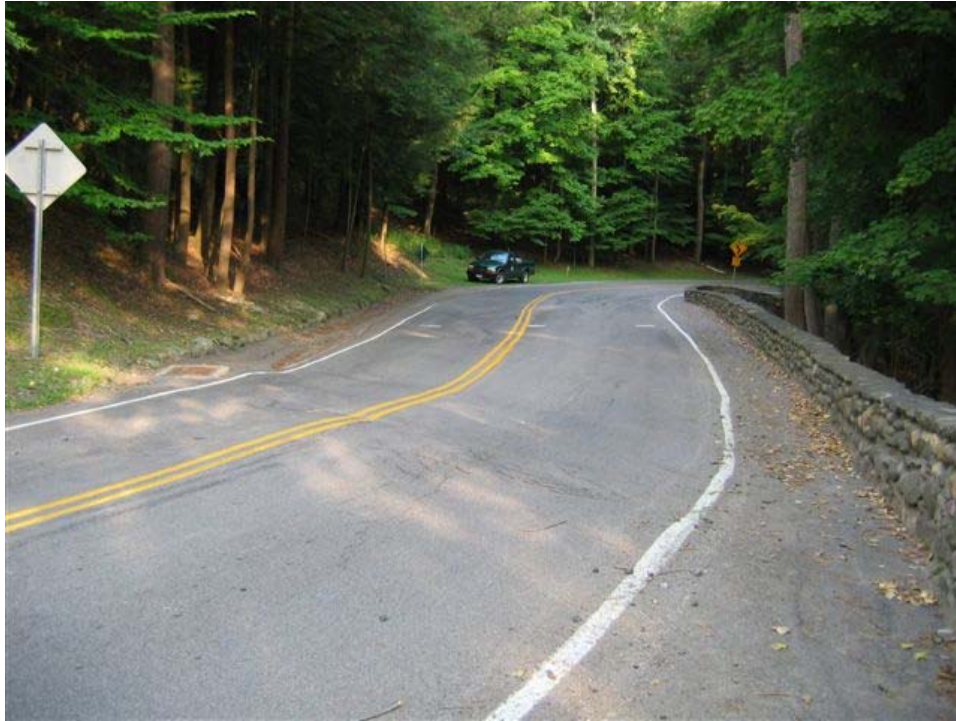
FIGURE 7

OPRHP contracted with Keeler Construction Company, Inc. (Keeler) in the spring of 2008 to reconstruct the roadway and remediate the slope remediation discussed above. Keeler subcontracted with Berkel and Company Contractors, Inc. (Berkel) to construct and install the ground anchors and horizontal drains. BVR Construction Company, Inc. (BVR) was subcontracted to install the reaction blocks. Figure 7 shows the condition of the roadway prior to construction.

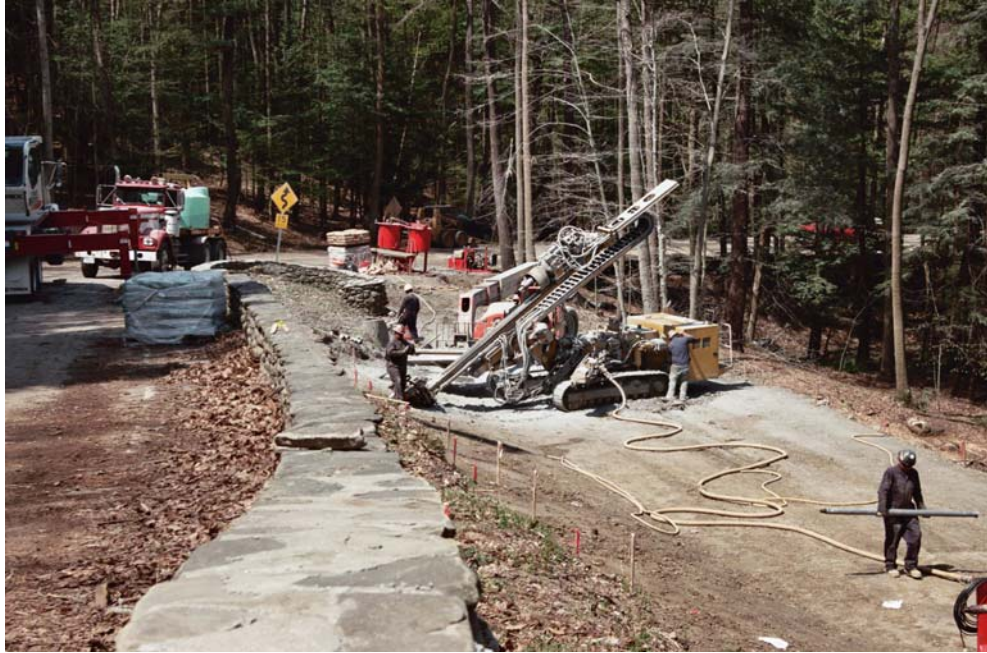
FIGURE 8

Berkel was then mobilized to the site to install the ground anchors and horizontal drains. The subcontractor utilized a horizontal rotary air powered drill rig to drill boreholes to the design lengths shown and advanced steel casing pipe to create a 5-1/4 inch diameter hole to bedrock. Boreholes were advanced without the casing into the bedrock resulting in a 4-1/2-inch diameter hole. Prior to drilling, a cross section at each ground anchor was plotted and the previously collected boring data superimposed. Based on these sections, it was expected that some of the bonded lengths might be partially in glacial till and bedrock. During ground anchor installation, it was found that bedrock was present at shallower depths than had been expected, which allowed for the bonded zone of all the ground anchors to be in bedrock. Upon completing each borehole, the DCP bar was inserted and grouted into place. Figure 8 is a photo of the drill rig installing the ground anchors.

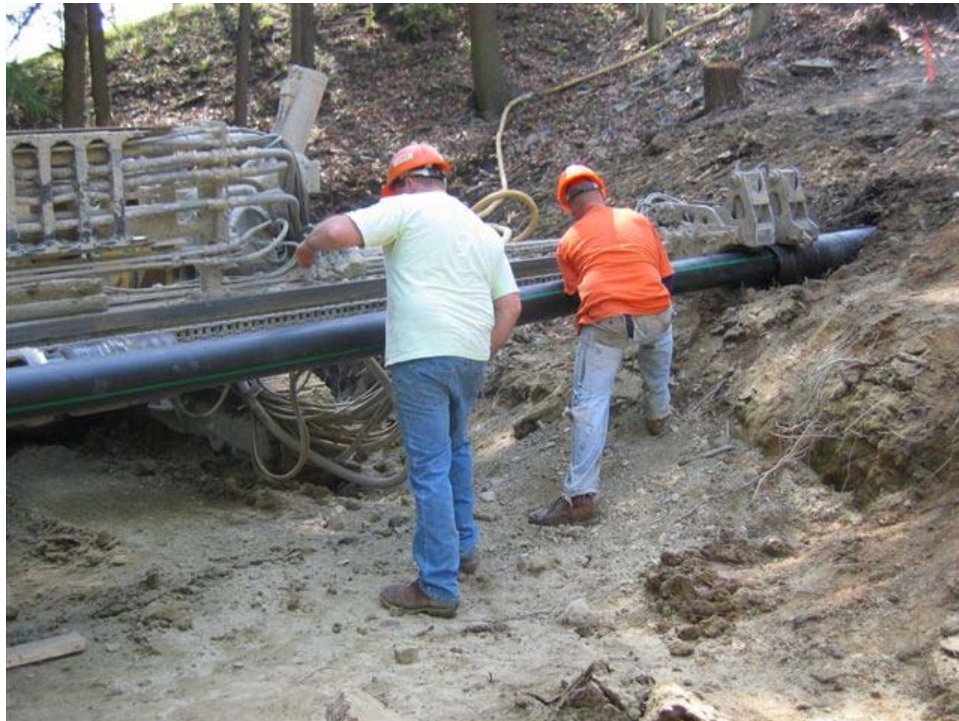
FIGURE 9

Upon completing the ground anchors, Berkel proceeded down slope to the horizontal drain outlet locations. The drain holes were installed using the same drill rig. Upon finishing each borehole, the 6 inch slotted pipe was inserted to the design length and the casing was then removed. The last 10 feet of each pipe was installed without slots and was completed with the installation of an animal guard outlet and riprap apron. Figure 9 is a photo of the drill rig installing the horizontal drains.

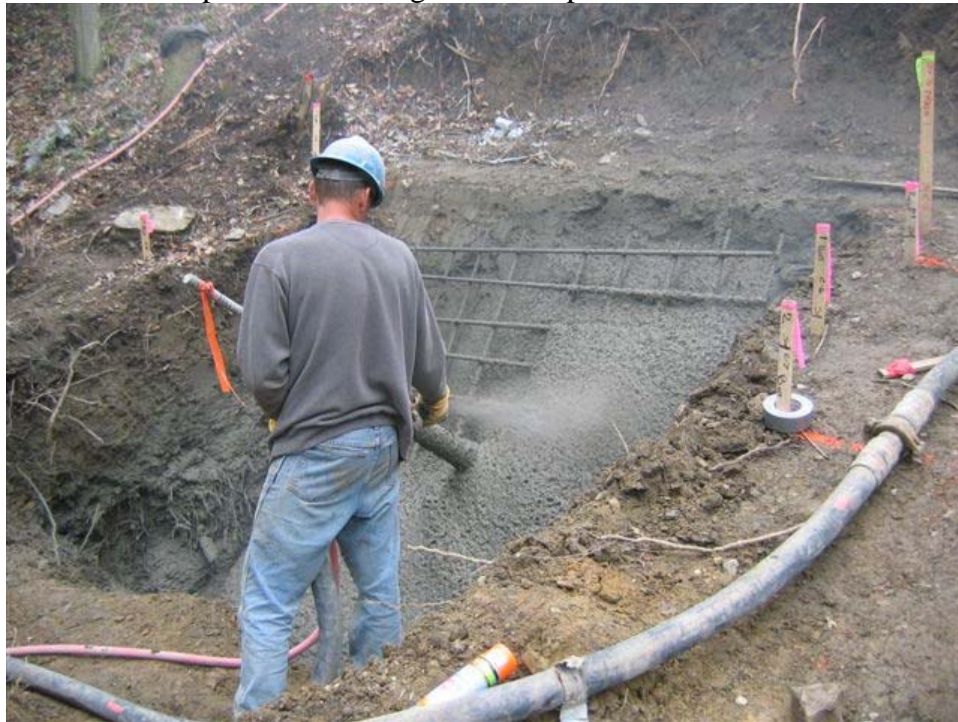
FIGURE 10

Prior to placing the shotcrete, BVR installed two mats of reinforcing steel and a protective pipe sleeve to allow the ground anchor to pass through the reaction block. The shotcrete was then installed to the specified thickness with the surface of the blocks troweled to allow for placement of the ground anchor base plate and nut. Figure 10 is a photo of the shotcrete installation.

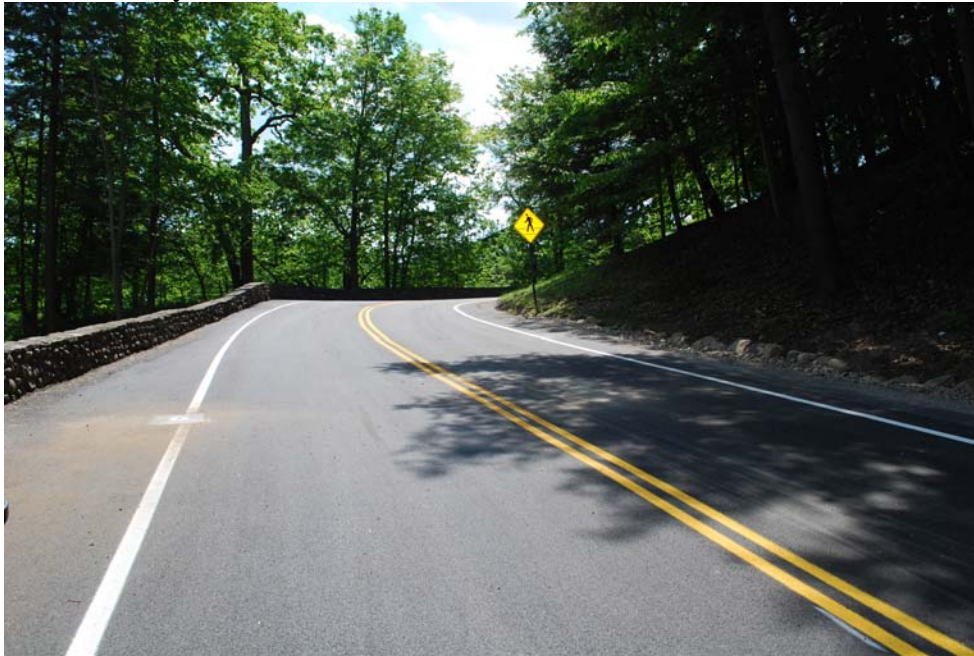
FIGURE 11

repaved the roadway and applied topsoil and seed to the completed slope. Figure 11 shows the condition of the roadway at the end of construction.

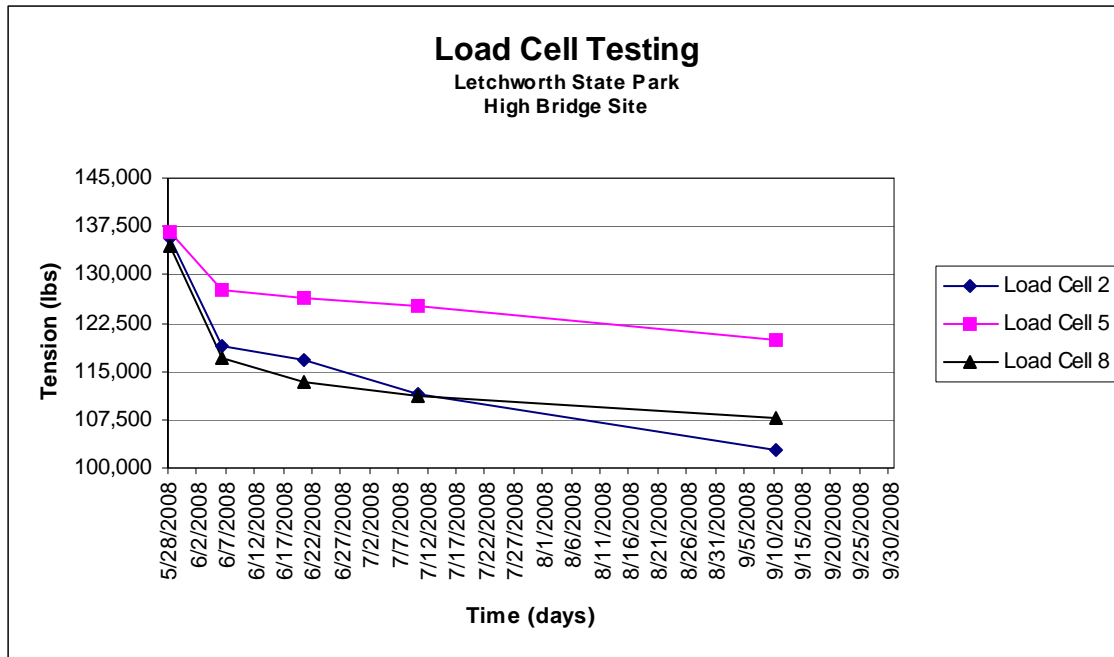
FIGURE 12

The load cells were installed on three of the anchors near the end of construction and also been monitored since the design load was applied. To date, the cells have lost approximately 12 to 25 percent of their pretension load. Figure 12 is a plot of the load cell data.

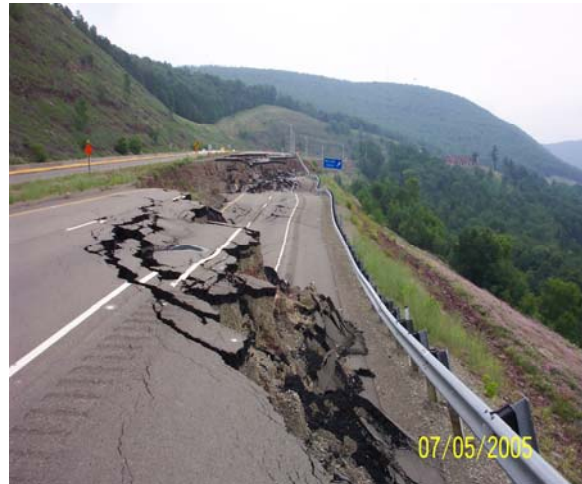
The landslide measured approximately 800 feet along the head scarp and 400 feet from the head scarp to the toe. Total vertical displacement at the head scarp was approximately 20 feet (see Photo 1). The toe of the landslide was located just above Park Hill Road (T-667). Periodic clean-up of soil off Park Hill Road was required to keep it in service. Landslide remediation was completed in the summer of 2007.

Photo 1: Head Scarp along SR15 Southbound

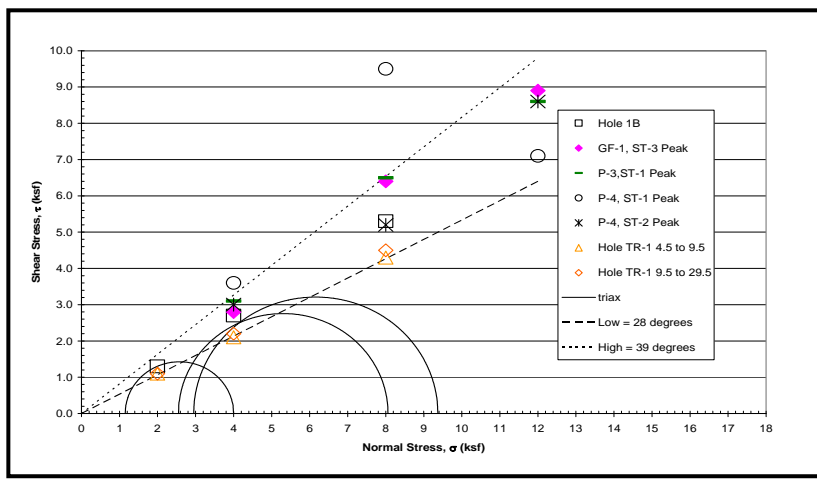
Figure 6: Plot of peak shear strength laboratory test results

Seven (7) direct shear tests, 4 residual direct shear tests and a triaxial shear test were performed on Shelby tube and remolded samples to estimate the shear strength of the soil. Plots of peak and residual shear strength test results are shown in Figures 6 and 7, respectively.

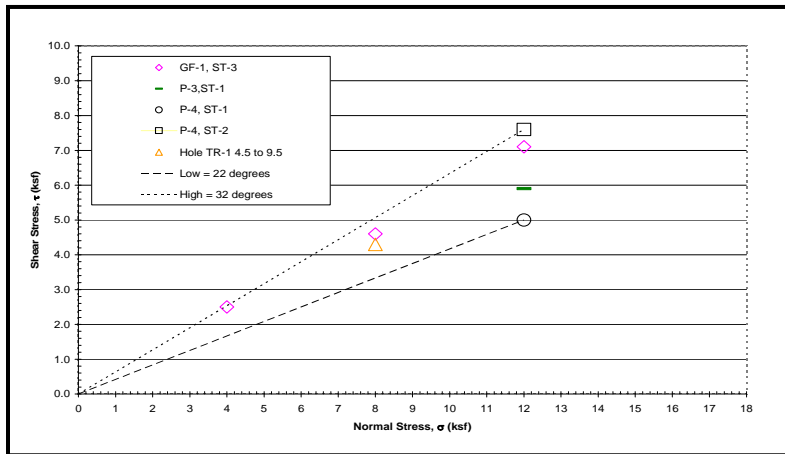
Figure 7: Plot of residual shear strength laboratory test results

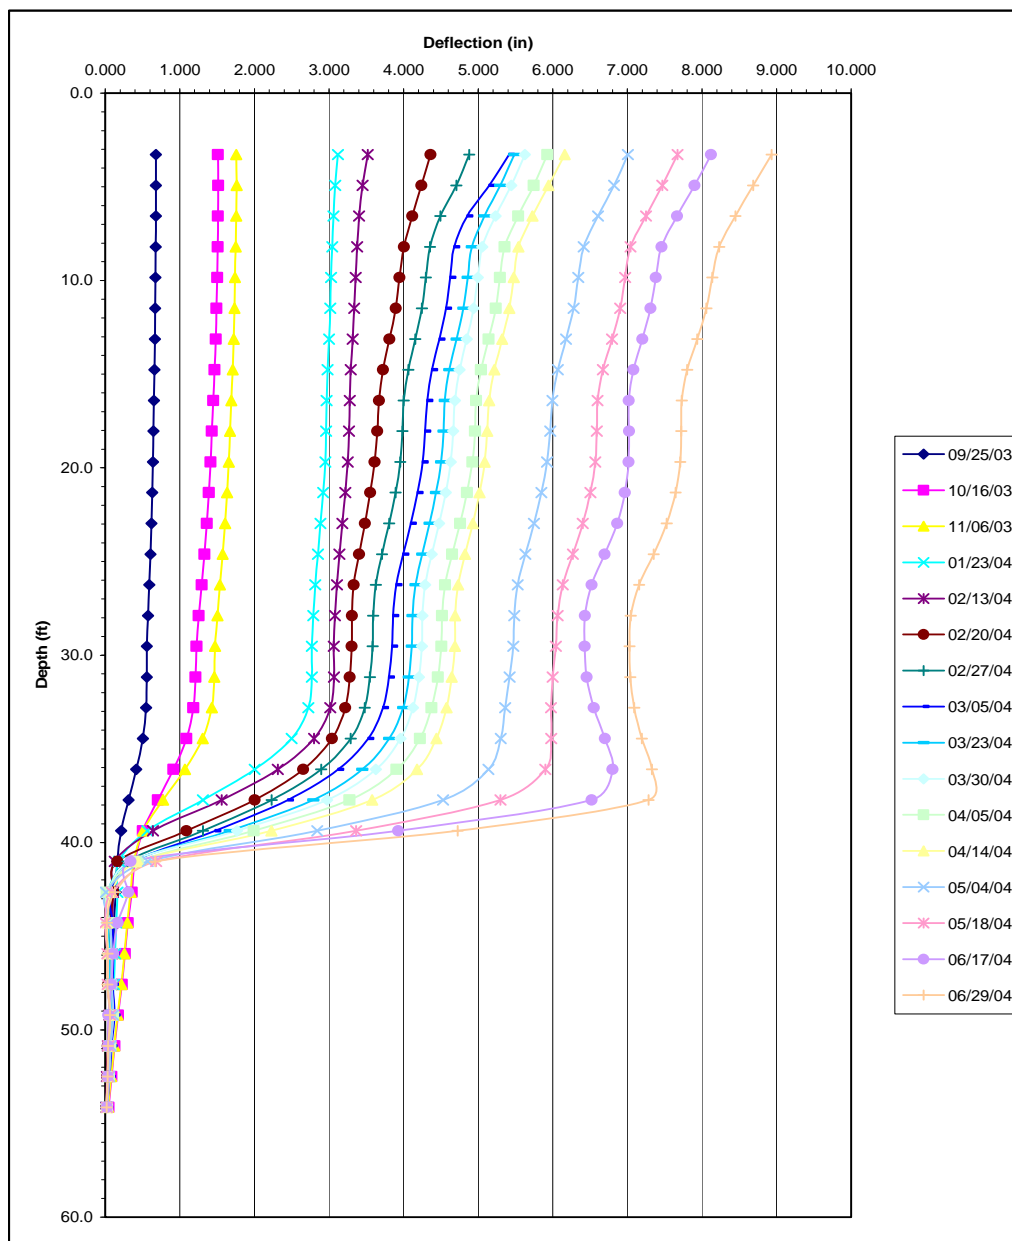
Inclinometer casing (2.75-inch diameter) was installed in 13 of the borings. Seven of these borings were located within the landslide and 6 were located outside of the landslide. Inclinometer readings were obtained until excessive movement of the casing prevented the probe from being lowered to the bottom of the hole. A typical inclinometer plot is shown in Figure 8.

Figure 8: Inclinometer 1T was located within Welcome Center Landslide near the head scarp.

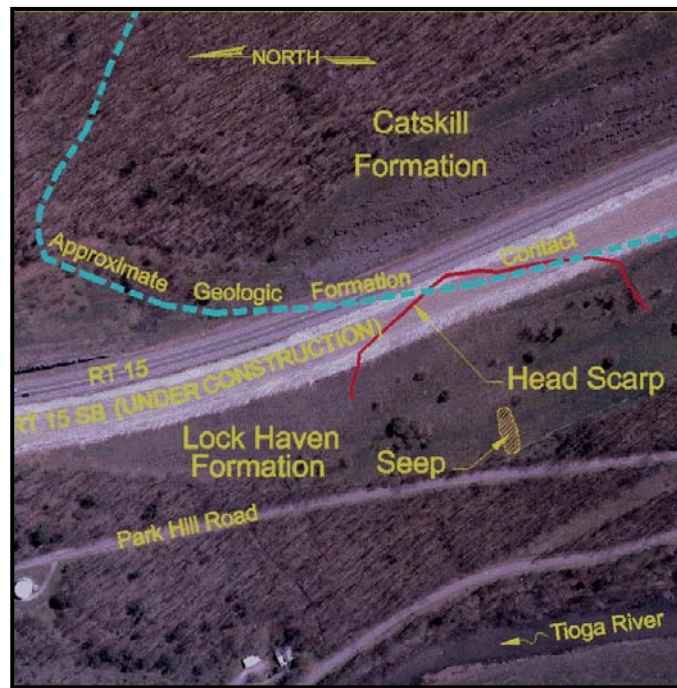
ineffective. Another cause of elevated water levels was believed to be the contact between the two geologic formations in the upper portion of the slope. Formation contacts are often extremely fractured and thus more permeable compared to the surrounding bedrock; therefore, subsurface water is likely being channeled to the slide area through this geologic feature. An annotated aerial photograph with the geology, head scarp and seep is shown in Photo 2.

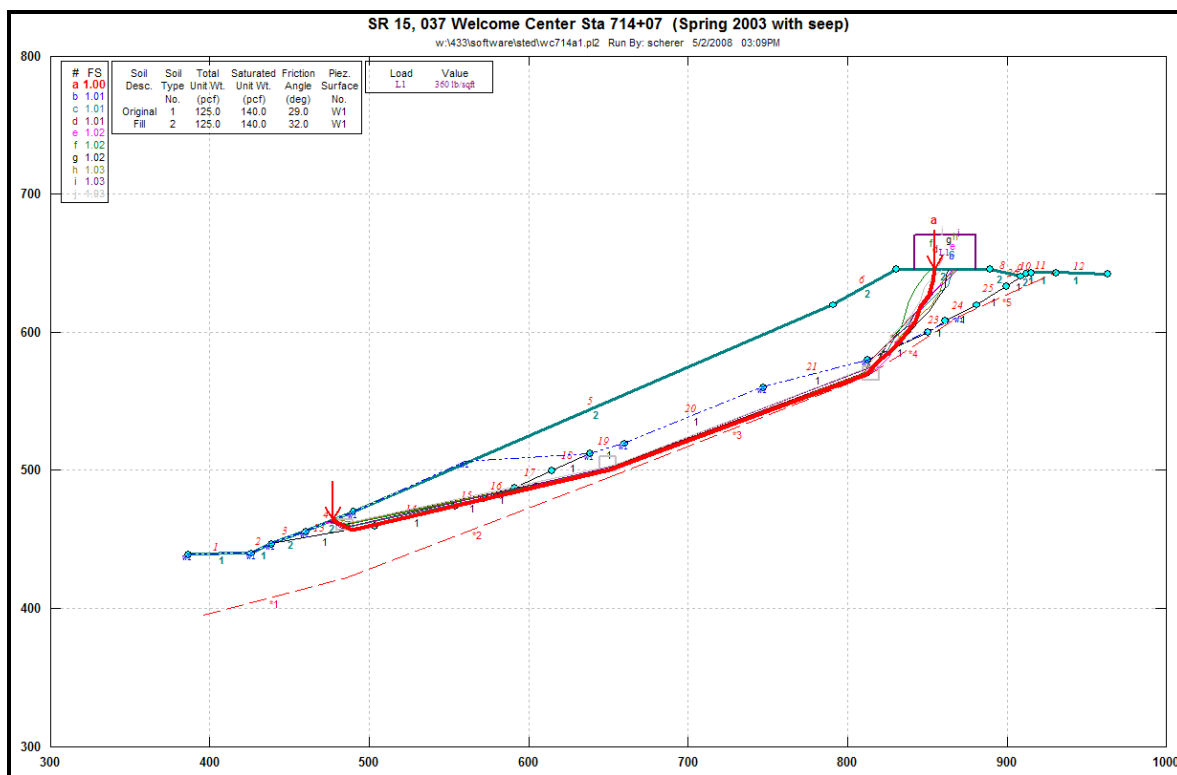
Figure 9: PASTABL model for conditions at time of failure in 2003.

The first analysis performed modeled the embankment shortly after construction of the southbound lanes when the landslide was observed (Spring 2003). This analysis modeled a saturated embankment to Elevation 1210 feet. This groundwater level was the approximate elevation of the seep estimated from aerial photograph, and appeared reasonable based on field observations of seeps and wet areas on the embankment. This stability model resulted in a safety factor of 1.0, and had failure plane entry and exit points in the general area of the head scarp and toe observed in the field. Based on these results the PASTABL model appeared reasonable. A plot of this analysis from PASTABL is shown in Figure 9.

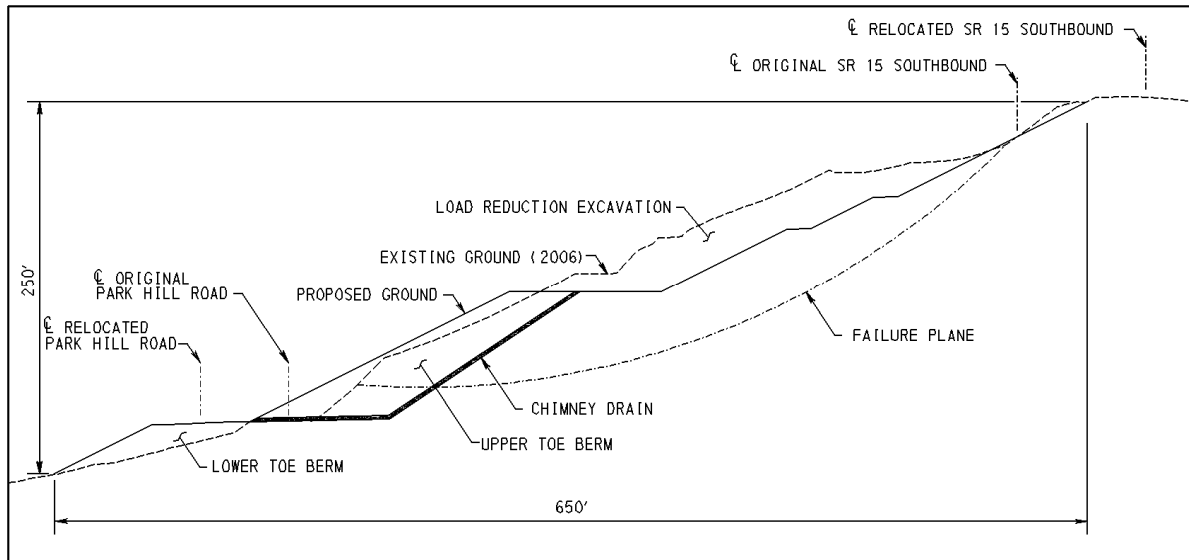
Figure 10: Typical section of remediated slope

The analyses indicated that excavation of approximately 40 feet of material at the head of the landslide, and a berm 80 feet high extending 50 feet beyond the existing toe of slope was needed. A typical section of the remediated slope is shown in Figure 10.

In order to lower the water level in the bottom portion of the embankment, excavation of this material for placement of a chimney (blanket) drain was required. The chimney drain consisted of a 2-foot-thick layer of free-draining aggregate wrapped in geotextile. The chimney drain was placed beneath the toe berm and extended up the 1.5H:1V toe berm backslope. Perforated longitudinal and transverse drainage pipes were included in the aggregate for an added drainage measure. A lower secondary berm was needed to provide stability for the main/upper berm. This lower berm also served as an embankment for the realignment of Park Hill Road. Based on the analyses this remediation provided a slope stability safety factor of 1.3.

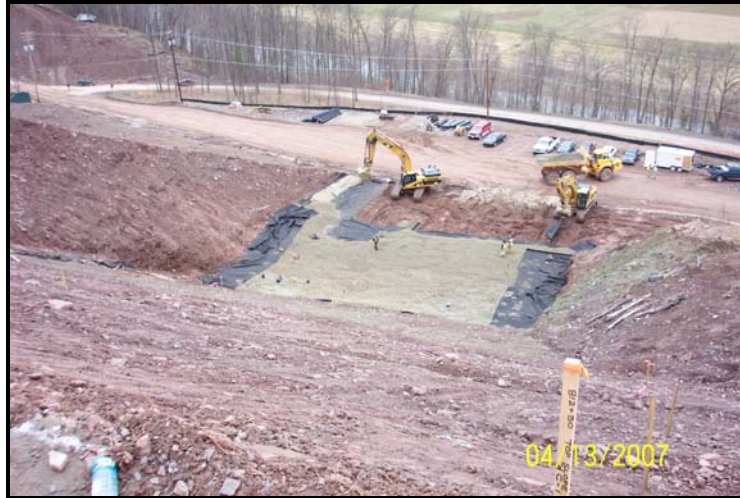
Photo 3: Placement of stone blanket/chimney drain during toe berm construction.

Glen O. Hawbaker submitted the low bid of approximately \$3.2 million and was awarded the landslide remediation contract in the late summer of 2006. Remediation of the landslide was completed in September 2007. Photo 3 was taken during remediation construction.

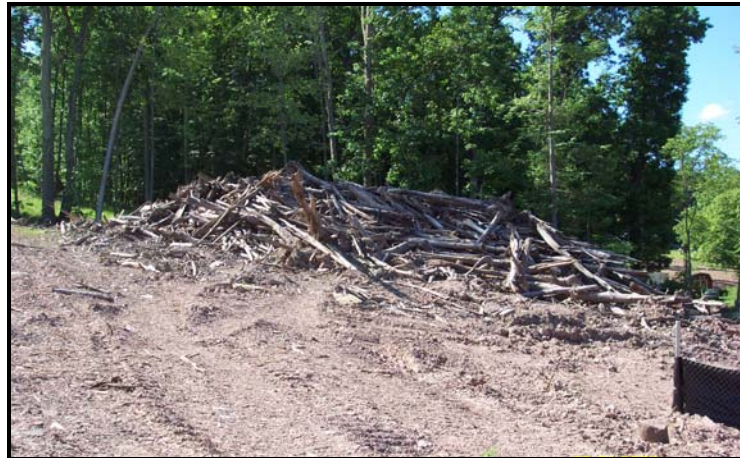
Photo 4: Stockpile of trees encountered in chimney drain excavation

One unforeseen condition was encountered during construction. Excavation at the toe of the landslide for construction of the chimney drain encountered trees at several locations. It appeared that the trees had been pushed into piles, set fire and then buried during embankment construction in the 1970's. Where encountered, the trees were removed and stockpiled outside of the work area. A few of the borings recovered pieces of tree limbs in the split-spoon sampler near original ground line, but the large quantity of trees encountered in the excavations was not anticipated. Photos 4 shows the trees encountered during construction.

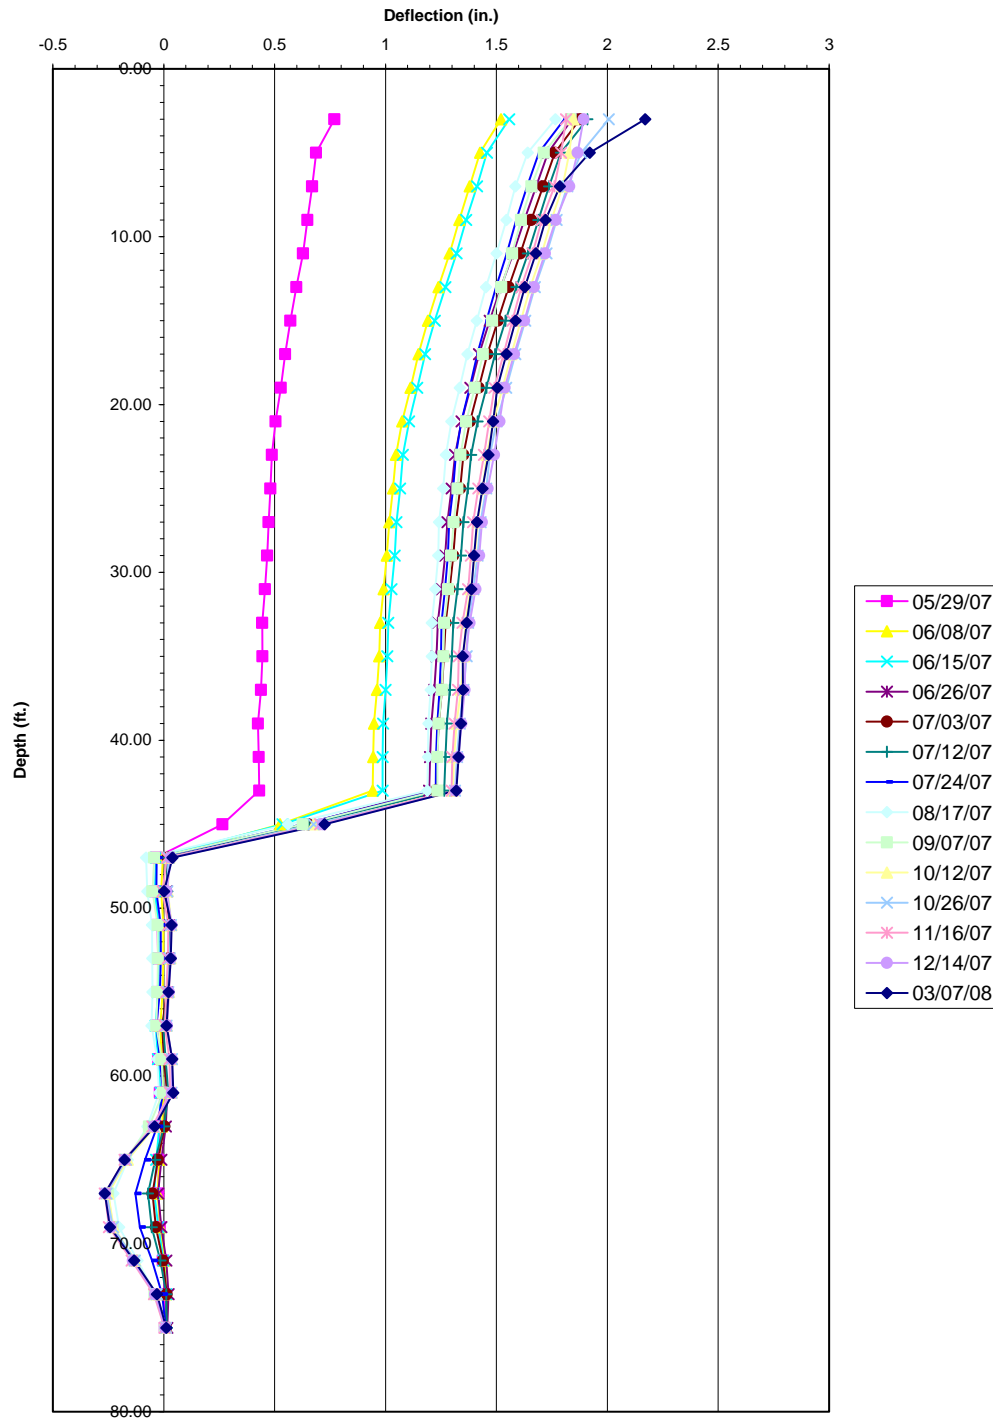
Inclinometers installed during remediation construction have been monitored several times after completion of construction in September 2007. Readings were obtained in March 2008, and a plot of Inclinometer 5 is shown below in Figure 11. Inclinometer 5 was located at the top of the excavation slope that was made to install the blanket drain. As seen by the plot, approximately 1.25 inches of movement occurred during construction in the area of the failure surface (i.e., depth of approximately

45 feet). Since the completion of construction in September 2007 through March 2008 the inclinometers indicated minimal movement has occurred. Readings taken since March 2008 indicate that no movement has occurred at 4 of the inclinometer locations, and less than 0.25 inch of movement has occurred at the 2 inclinometers immediately above the chimney drain.

Figure 11: Plot of Inclinometer I-5 from May 2007 to March 2008

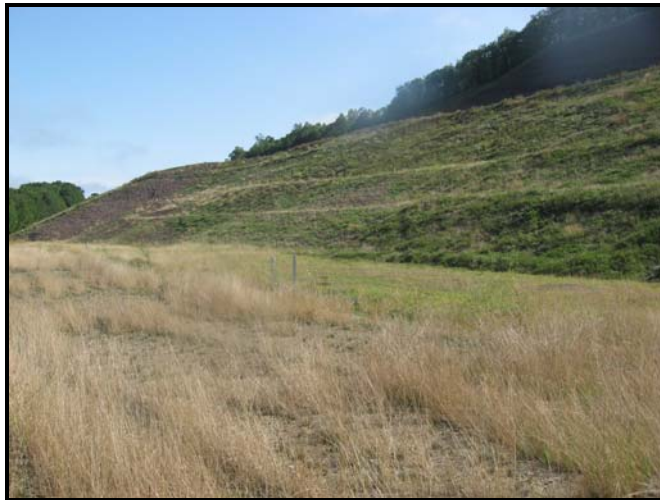
Photo 7: View from top of toe berm looking toward load reduction slope. SR 15 is at top of slope

A field view of the remediated landslide was conducted in August 2008, approximately a year after the completion of construction. Based on visual observations the remediation appears to be performing well. No cracks in the pavement were noted, and the alignment of the guiderail was good. The cracks in the load reduction excavation slope and at the top of the toe berm that were observed in September 2007 were not visible. The swale along Park Hill had intermittent pools of water, indicating the chimney drain was functioning. In general the project area was well vegetated, and particularly at the base of the toe berms. No signs of movement were observed in either SR 15 or Park Hill Road. Photos 7, 8, and 9 were taken during the field view.

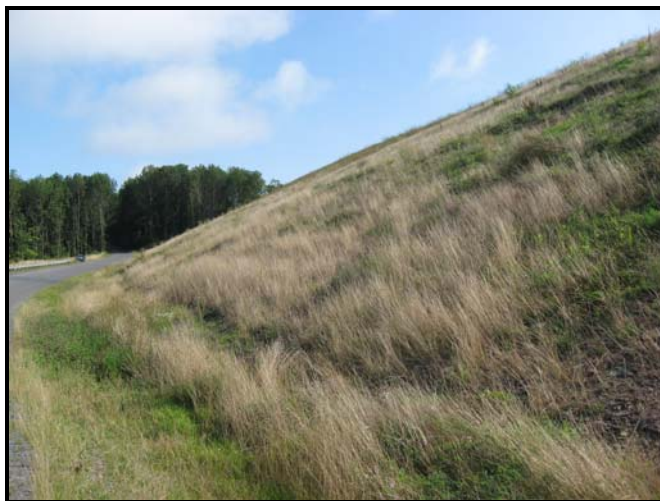
Photo 8: View from toe of toe berm looking north along Park Hill Road

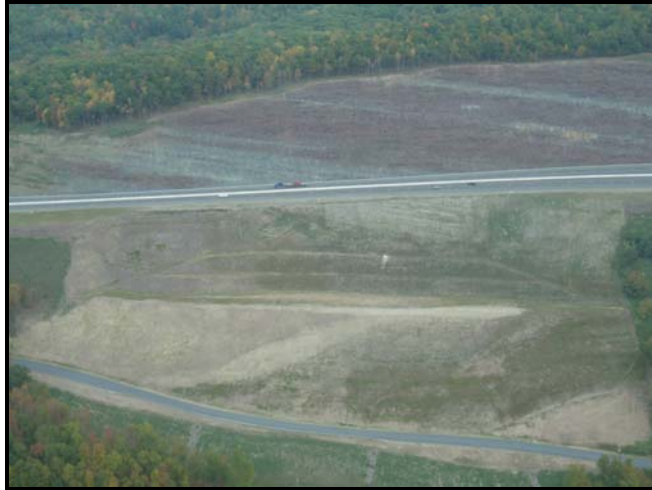
Photo 9: Aerial view of remediated landslide; Park Hill Road at bottom and SR 15 at top.

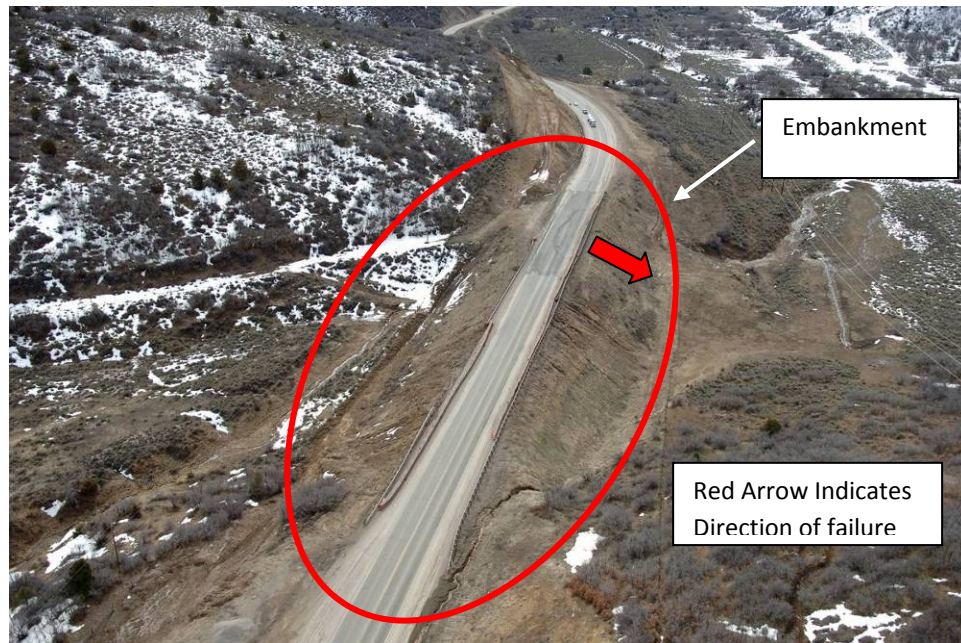
Figure 2. Aerial Photograph of the Project Site (Prior to Emergency Repair) - Looking South. Red Oval Indicates Section of Embankment Fill. Red Arrow Depicts Active Failure Section.

The embankment fill section of the roadway had been placed over a deeply incised drainage bottom. Figure 2 depicts the general site layout looking south along SH 13. Figure 3 depicts the roadway and guardrail distress.

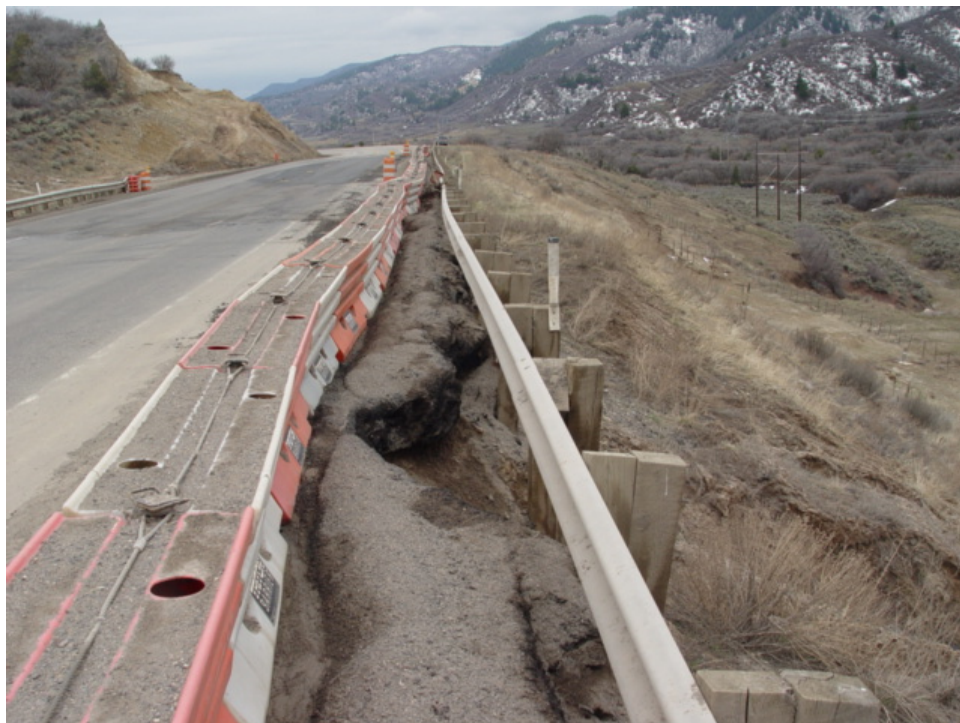
Figure 3. View Looking South Depicting Roadway Distress.

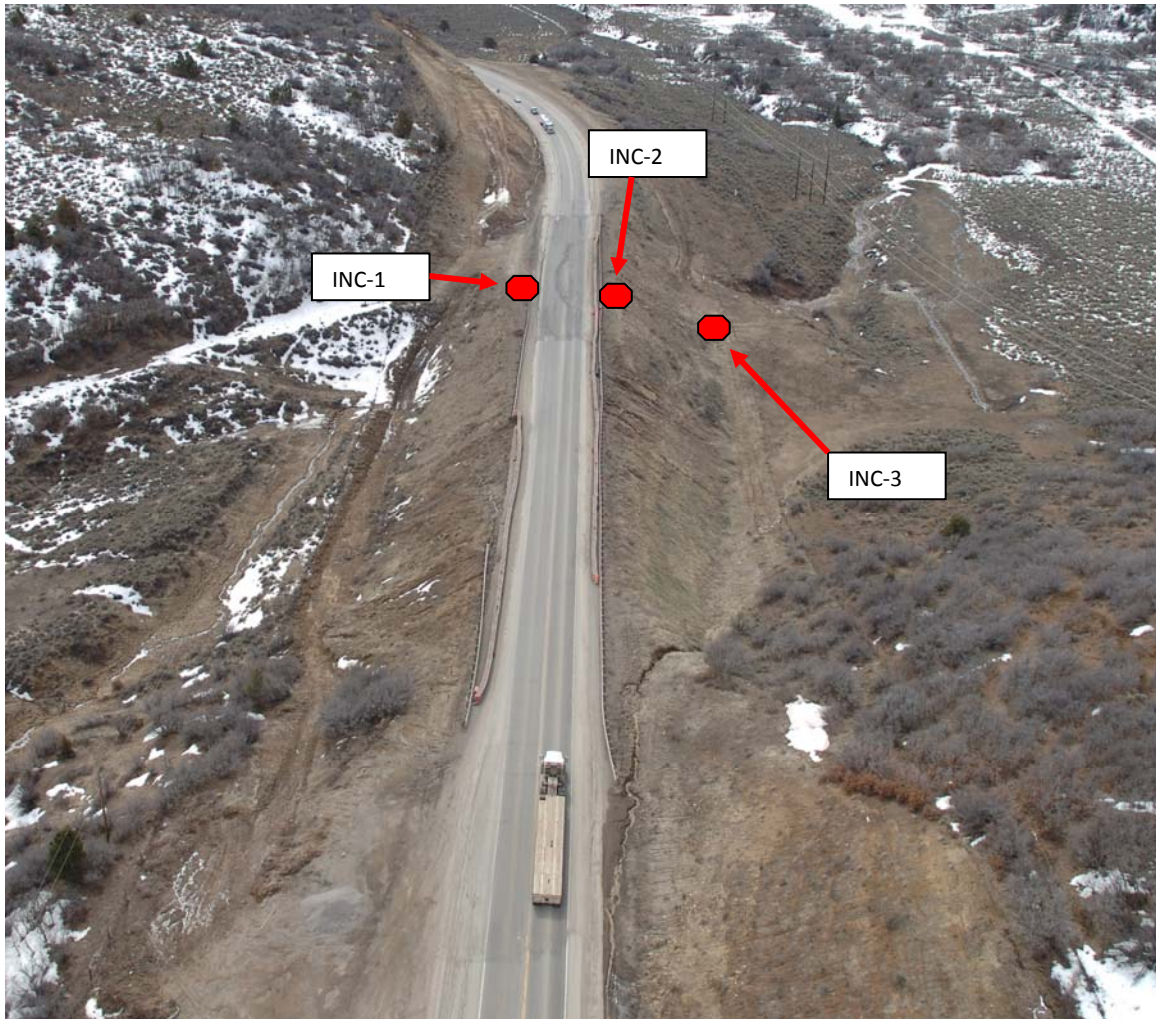
Figure 4. Approximate Inclinometer Locations Installed by CDOT.

Previous to the Yeh and Associates, Inc geotechnical investigation, CDOT Geotechnical had installed three inclinometers, designated INC-1, INC-2, and INC-3, in March of 2006. INC-1 was installed on the east side of the roadway at an approximate elevation of 7320 feet to a depth of 74 feet, INC-2 was installed on the west side of the roadway at an approximate elevation of 7314 feet to a depth of 74 feet, and INC-3 was installed at the base of the west embankment at an approximate elevation of 7274 feet to a depth of 68 feet. INC-1 showed no signs of movement, INC-2 sheared at a depth of 45 feet (elevation 7269) by April 20, 2006, and INC-3 sheared at a depth of 38 feet (elevation 7236) by May 16, 2006. Figure 4 depicts the general locations of the inclinometers.

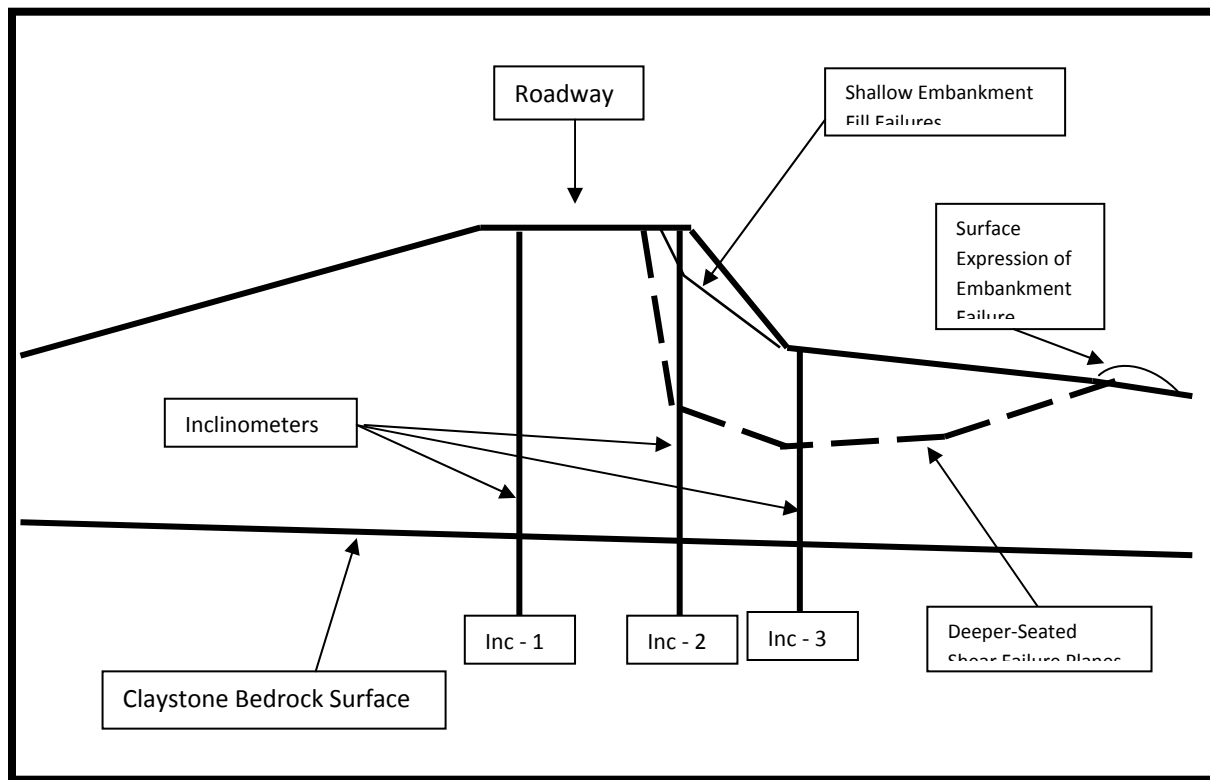
1. Shallow embankment fill failures slumping off oversteepened embankment slopes. This was triggered by the presence of surface and sub-surface water decreasing the slope stability.
2. Deep seated embankment failures due to the inherently unstable foundation soils underneath the embankment fill.

Figure 5. Generalized Cross Section Looking South Through The Embankment Fill Failure.

Figure 5 depicts a generalized cross section of the failure mechanisms.

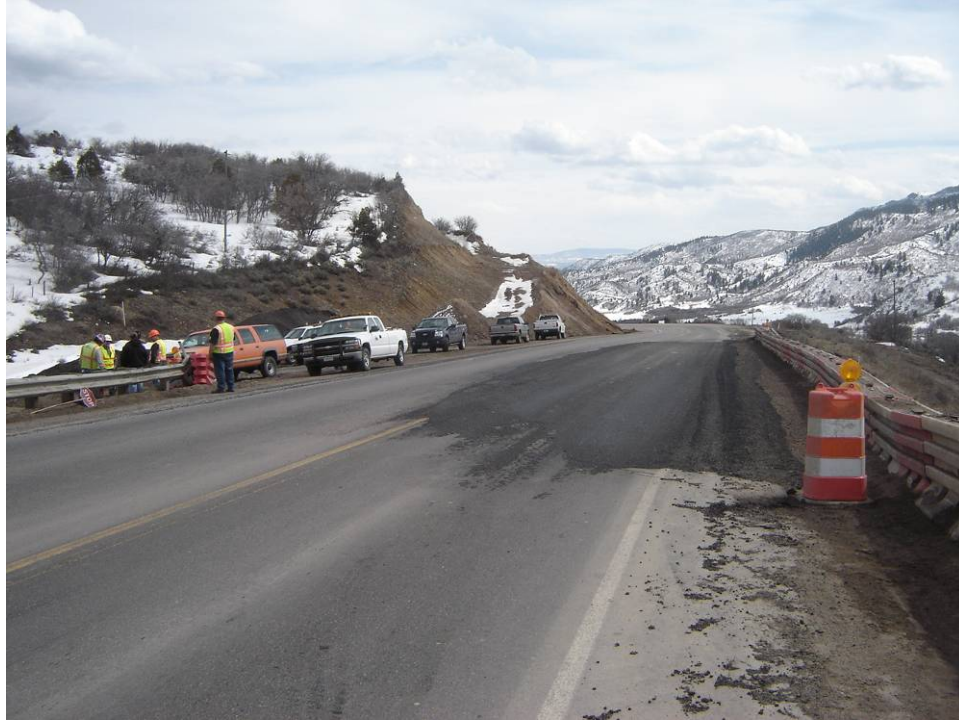
Figure 6. Depicts The Use of Asphalt To Fill In The Half-Moon Section of Roadway.

During March of 2008, CDOT maintenance crews reported pavement cracking that formed a “half-moon” shape with displacements that ranged from 3 to 12 inches horizontally and vertically. The “half-moon” shape was much larger and more extensive than any other previous failures that had occurred in previous spring runoff seasons. Vertical displacements on the order of feet per day were occurring. Figure 6 depicts the filled in half moon section with asphalt. Figure 7 depicts the vertical displacement that the roadway section was subjected to. Figure 8 depicts the surface expression of the deep seated shear failure.

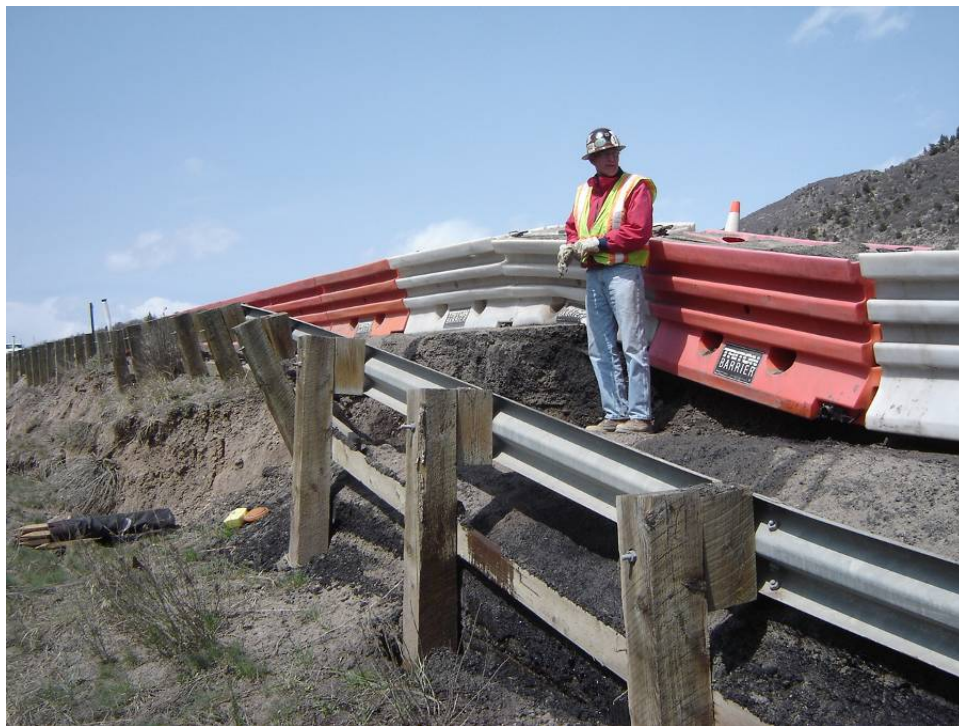
Figure 7. Vertical Displacement of Pavement Section – Approximately 2 Feet Within A Few Weeks.

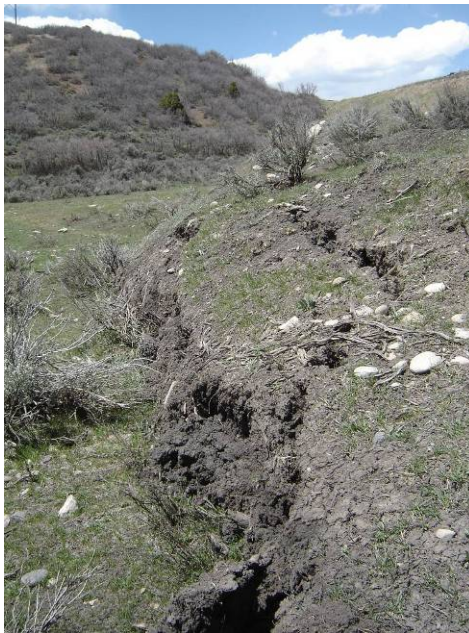
Figure 8. Surface Expression of The Deep Seated Shear Failure.

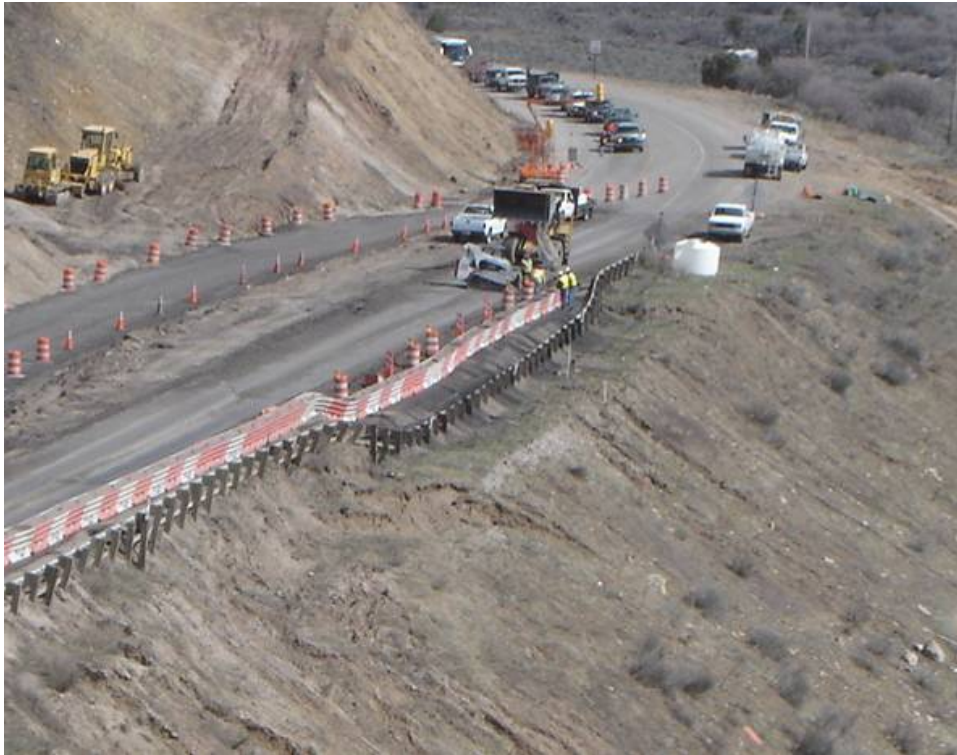
Figure 9. Start of Emergency Project – Looking South (Note deformed guardrail alignment).

Based on the recommendations above, an Emergency Mitigation Project was undertaken by CDOT to stabilize the embankment fill failure. At the request of CDOT, HDR and Yeh and Associates provided a construction advertisement package within a few weeks. Construction and placement of the EPS was done between April and June of 2008. Figures 9 to 13 depict a summary of the construction sequence.

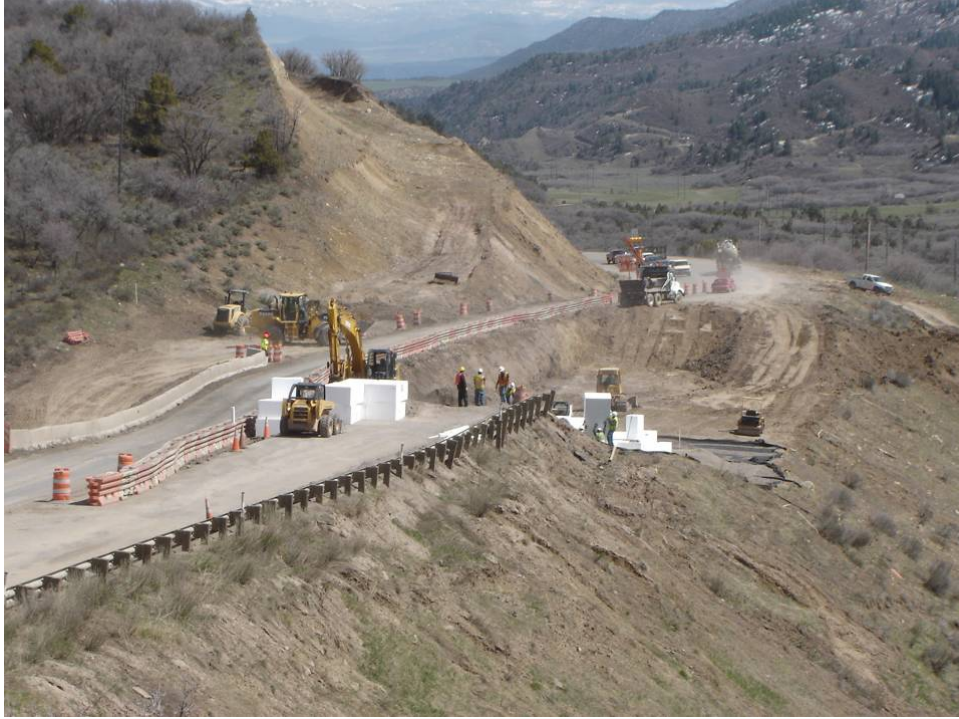
Figure 10. Excavation of Site – Looking South.
