60th HIGHWAY

GEOLOGY SYMPOSIUM

PROCEEDINGS

1.1.	<i>High Bridge Area Roadway Slide, Letchworth State Park, Portageville, New York</i>	22
	Andrew J. Nichols, P.E.; James Bojarski, P.E.	
1.2.	<i>Remediation of the SR 15 Welcome Center Landslide.....</i>	35
	David R. Scherer, P.E.; Robert E. Johnson, P.E.; Paul J. Lewis, P.E.

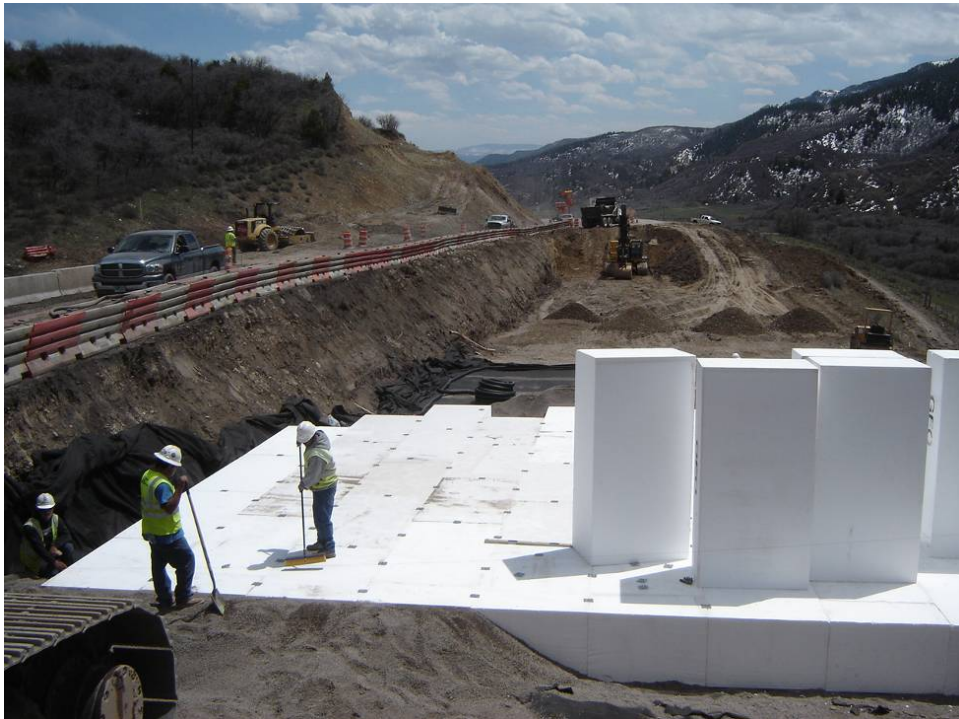
Figure 11. Placement of EPS Blocks In Excavation.

The proposed EPS fill was designed with a density of 1.15 pcf, minimum compressive strengths of 5.8 psi and 16.0 psi at 1% and 10% deformation respectively, and maximum water absorption of 3%. The EPS section was also designed to replace a minimum of 10 vertical feet of roadway fill with a concrete cap and an impervious liner was also placed on top of the EPS to prevent petroleum products from affecting the EPS material. One very important aspect of the design was to include a free-draining system for subsurface water behind and underneath the proposed EPS material. The EPS was also tapered on both sides of the excavation cut to reduce the potential for differential settlements to occur in the roadway between the EPS and fill.

Based on the recommendations above, an Emergency Mitigation Project was undertaken by CDOT to stabilize the embankment fill failure. At the request of CDOT, HDR and Yeh and Associates provided a construction advertisement package within a few weeks. Construction and placement of the EPS was done between April and June of 2008. Figures 9 to 13 depict a summary of the construction sequence.

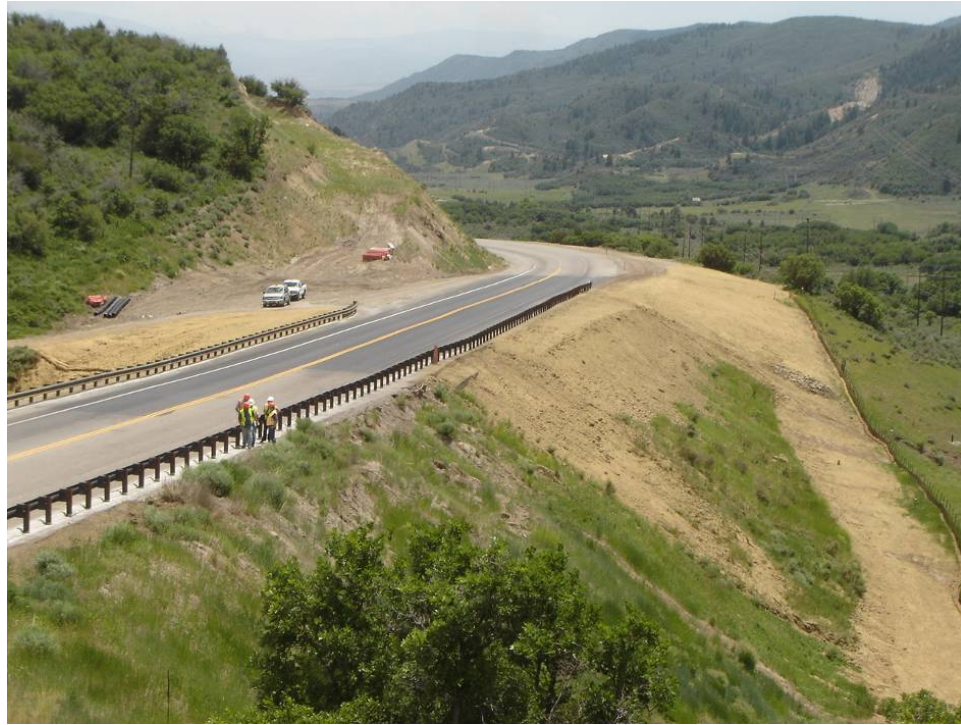
Figure 12. Completion of Project June 2008.

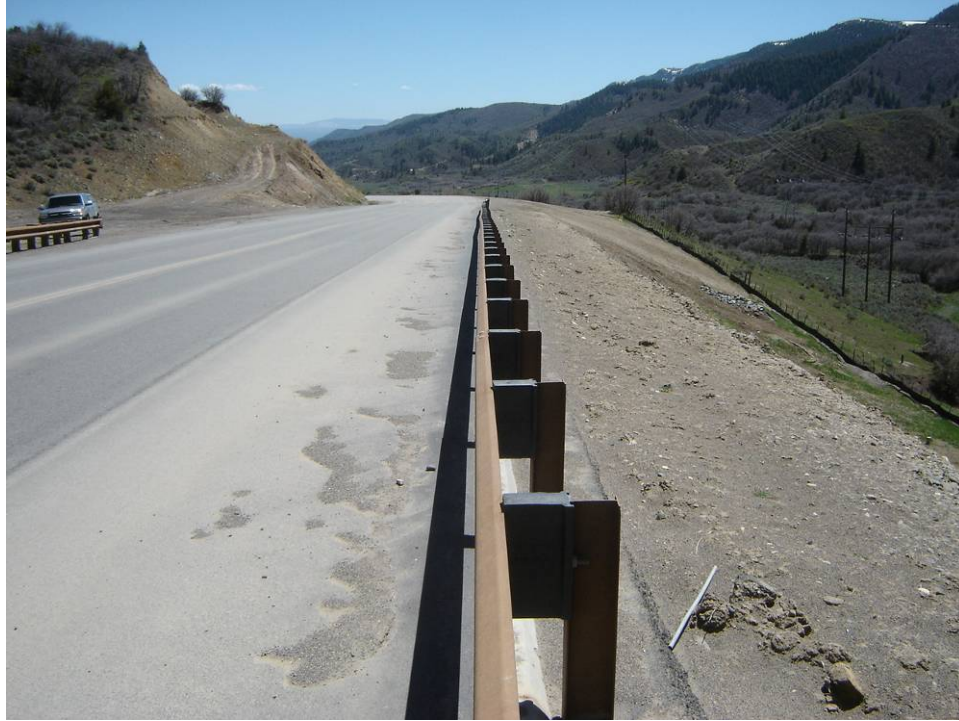
Figure 13. Status of Project Site After Construction in May 2009 – One Year Later.

Overall, the wall systems appear to be performing as they were designed. It was imperative to have the geotechnical/geo-structural designer involved in both the design and the construction process since a multitude of construction issues arose during the construction. Communication between the Owner, Contractor, Subcontractors and Designer of Record was imperative for the successful completion of this project. Figure 16 depicts the project approximately one year after completion following a heavy spring runoff.

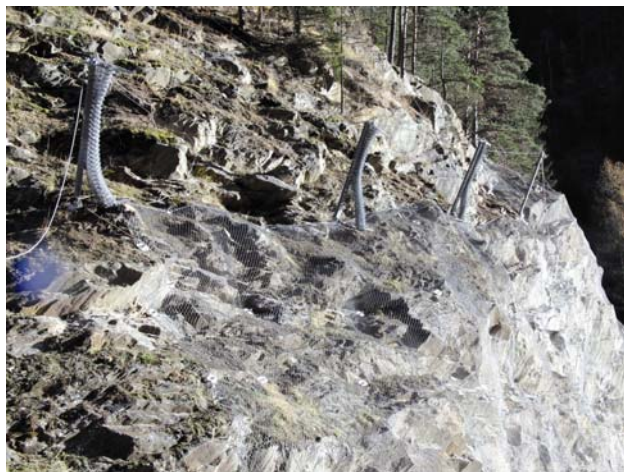
Figure 1: Rockfall Barrier during Installation

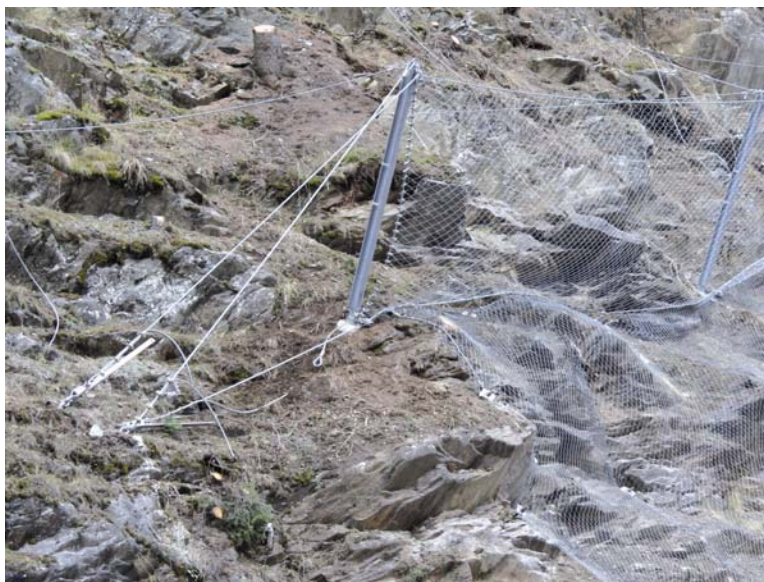
Figure 2: Post

A rockfall barrier is comprised of the following elements: interception structure (usually a metallic net), a support structure (posts), and connection components (ropes and energy dissipating devices), which are secured to foundations buried in the ground.

Main Parts	Components	Function
Interception Structure	Principal net; comprised of cables, wires and/or bars (i.e. cable nets joined with clamps, submarine nets, or ring nets - for the last two the rings forming the net are connected to each other). A mesh backing is usually attached to the principal net to catch smaller rocks.	Bears the direct impact of the rockfall event, deforms elastically and/or plastically, and transmits the stresses to the connection components, the support structure, and the foundations.
Support Structure	Posts which may be fabricated from different materials, geometries, and lengths (i.e. pipes, structural components, etc.) and which may be directly buried into the ground or mounted on a pedestal.	Provides the barrier's overall height. Can be connected to the Interception Structure directly or via the Connection Components.
Connection Components	Ropes, steel cables, junctions, clamps, and energy dissipating devices (i.e. brake rings which disperse energy and/or allow a controlled displacement when stressed).	Transmits the stresses to the foundation structure during impact and/or maintains Interception Structure in position.

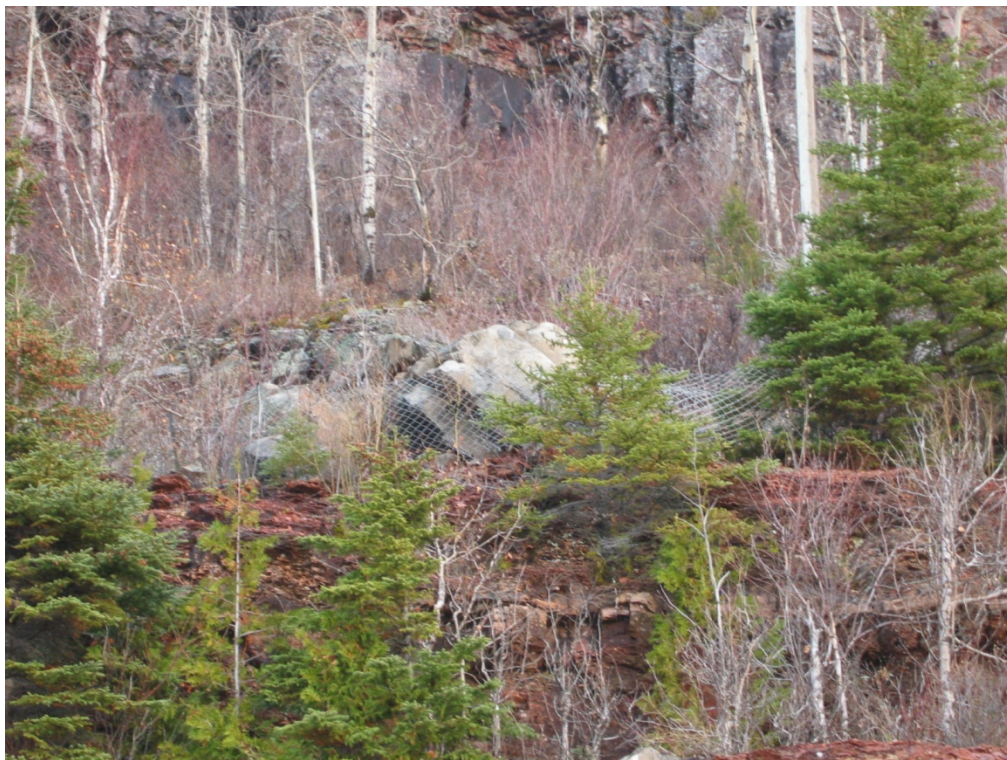
Figure 4. Large diabase block in chain link mesh fence, Station 18+891

Large diabase blocks were identified at the crest of the Rossport Fm. in the rudimentary chain link mesh fence, Figure 4.. Blocks measured to be 0.5 to over 4 m³ in size, weighing an estimated 1,300 to 12,500 kg. Crest angle from here to Keweenawan crest is 64°. Limited evidence of such large falls to west. The talus is reasonably uniform with a 37° slope.

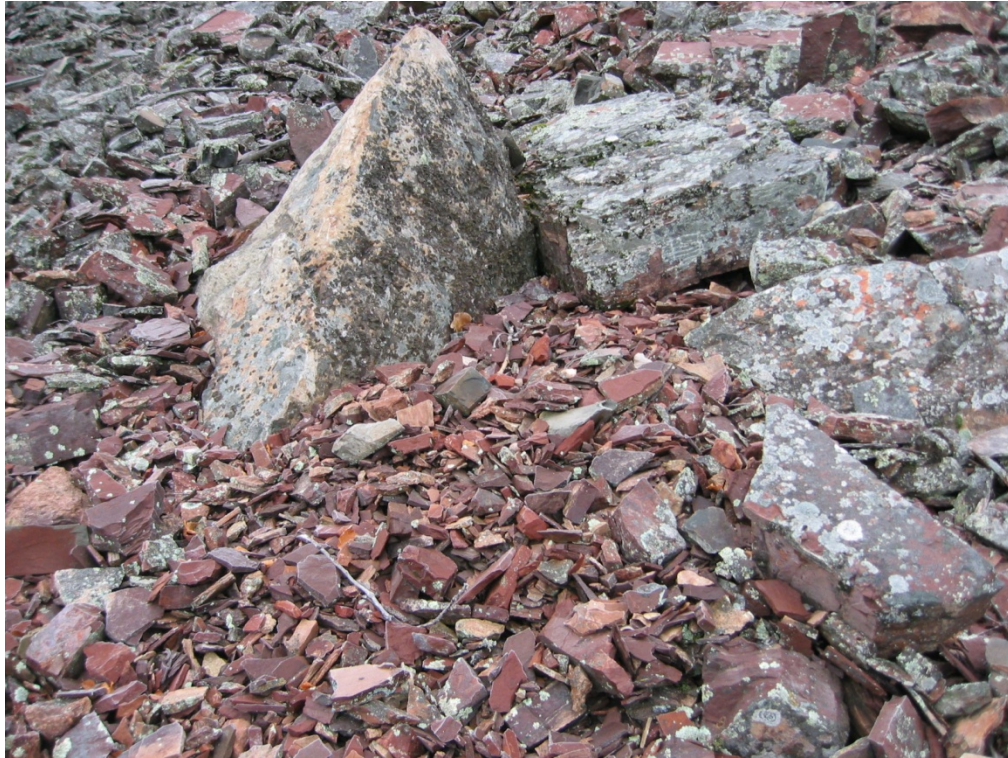
Figure 5. Diabase block embedded in talus, Station 18+970

The large blocks found across the talus are exclusively diabase and it appears that if the originating block is massive and elongate it strikes the talus and slides into it, coming to rest within the talus. For roughly equidimensional blocks, it appears that the block is probably rotating as it falls and when it strikes the talus it is more likely to bounce, possibly more than once as it makes its way downslope, see Figures 5 and 6. The talus slope is reasonably uniform at 37°.

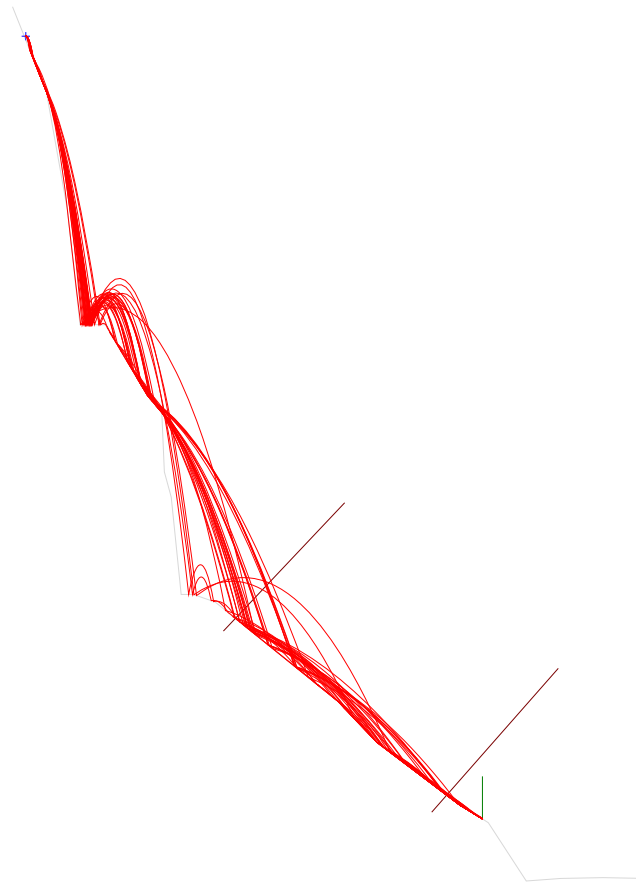
Figure 7. Station 18+925, example of RockFall output with 50 rocks

The results of the simulation also show that the velocity of the falling rocks, and therefore the kinetic energy of the blocks is lowest right at the crest of the Rossport Fm slope. This then would be the most efficient place to locate a catch fence. It is also the most accessible part of the talus slope area when considering small equipment that may be needed for the project. Two different rockfall catchment fence-manufacturing companies have been approached regarding this project and both believe that this alternative is constructible. Costs have been estimated, see Subsection 5.4 below. Examples of RocFall runs are shown in Figure 7.

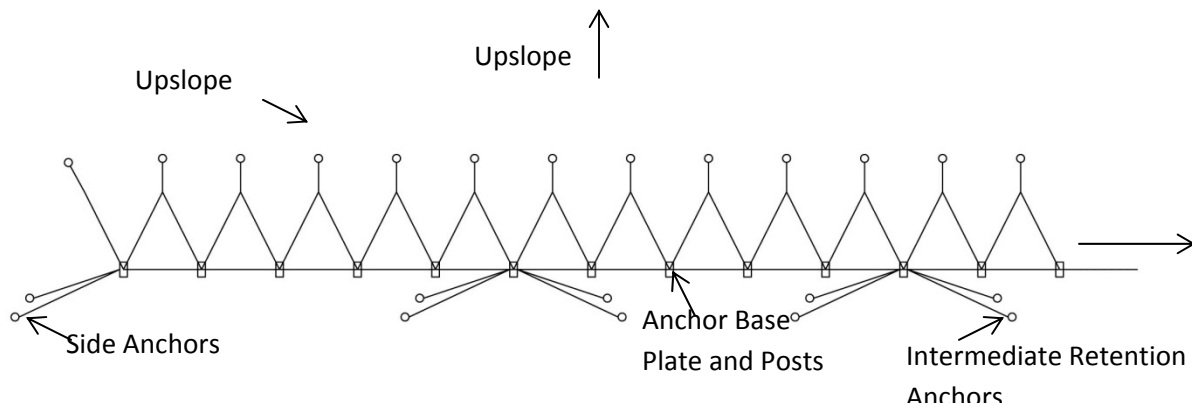
Figure 8: Top View of Fence (2 Sections)

The fence placed on this contract is currently the longest fence of this type in Canada providing a kinetic energy impact resistance of 2000 KJ. The Kama Hill fence is made up of 20 x 10m sections for a total length of 200m. There are 21 anchor base plates for the fence posts to be mounted on and each base plate has two anchors. There are also 22 upslope anchors connected with cables to the fence posts and 16 lateral anchors breaking the fence into 4 independent sections acting as intermediate retention anchors, see Figure 8.

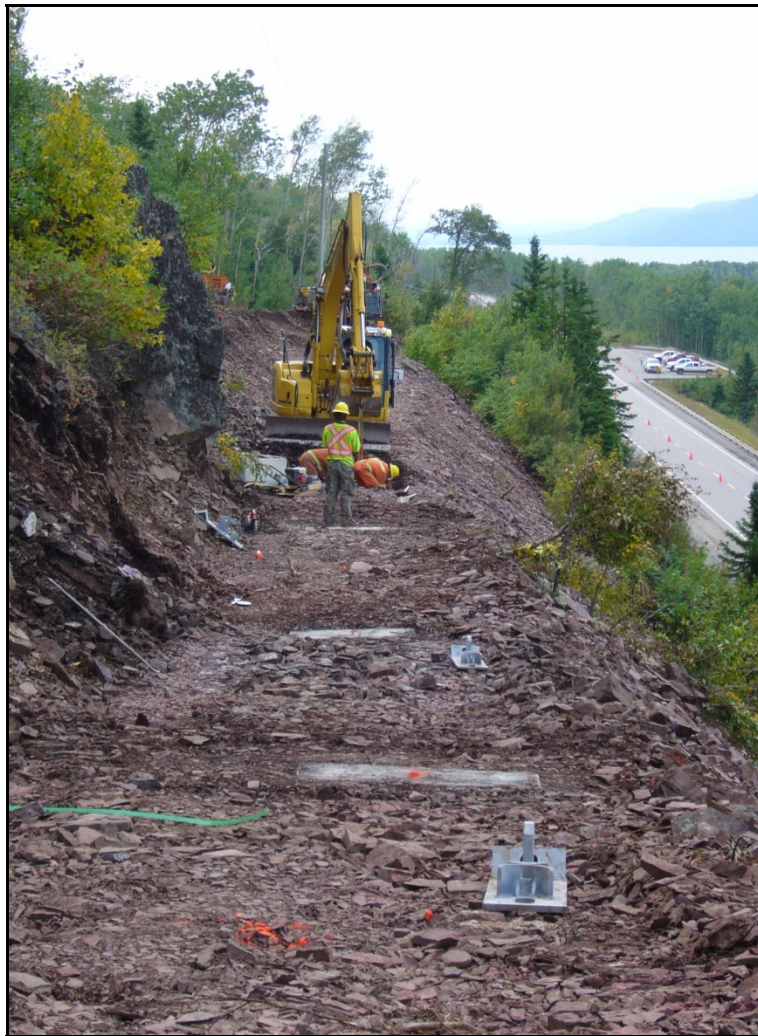
Figure 9. Preparing talus for installation of concrete bases for steel posts.

Pacific Blasting arrived on site September 4, 2008 and began construction. The Contractor used a Komatsu 135 backhoe to construct an access road to the plateau where the fence was to be located. Once the area for the fence was cleared and levelled, the locations of the posts were marked out and materials were brought up. 21 concrete blocks were dug into place to provide a level surface for the base plates and posts to sit on, Figure 9. The areas around the concrete pads were filled in and compacted. Each concrete block arrived on site with existing holes in the correct locations for the anchors.

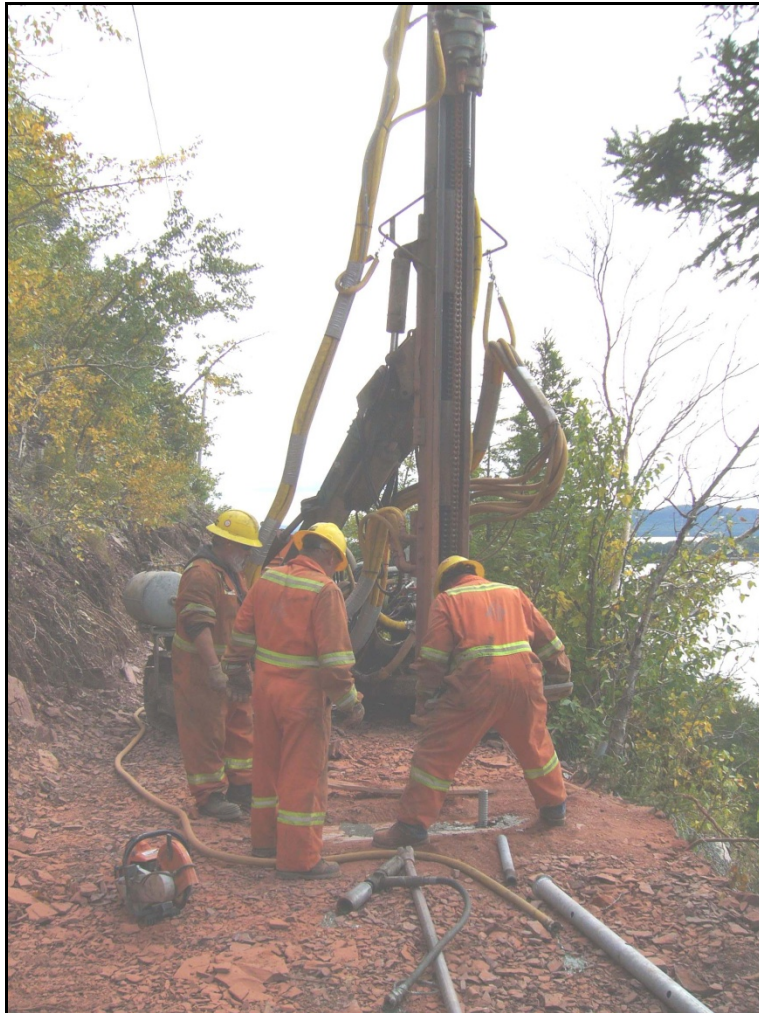
Figure 10. Drilling base plate anchors.

Once the concrete pads were in place an Air Track 750 drill was used to install the anchors, see Figure 10. A grout mix was pumped to the drill and fed through the anchor rods during the drilling process. This ensured that the anchors were held securely in place and also provided a form of lubricant to facilitate the drilling. Grout cubes were cast for 7-day, 14-day and 2 at 28-

days to ensure that the strength of the grout met with the manufacturers' specifications, which they did.

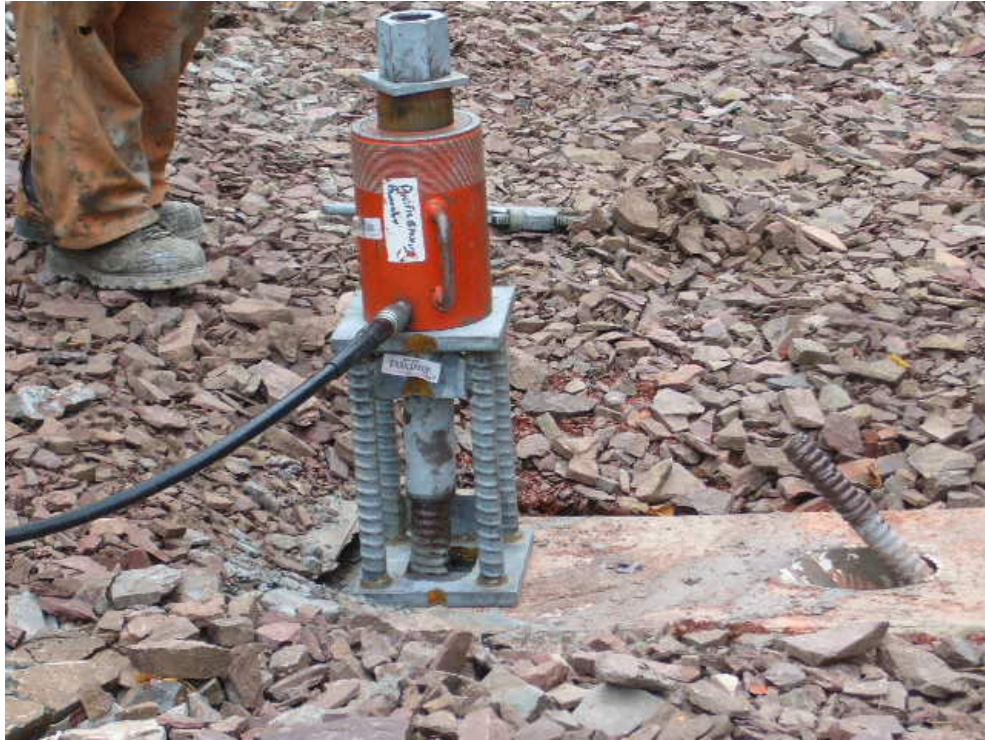
Figure 11. Pull-test apparatus on base plate.

After the anchors were placed the base plate anchors were tested in tension. The required hydraulic pressure for the pull test was 60 kip or 4600 psi, and each anchor passed, see Figure 11. The Contractor then used the Komatsu backhoe to erect the fence and posts while the anchor cables were placed to support the complete system, Figures 12 and 13. The Contractor completed the erection of the 200m fence in 6 days.

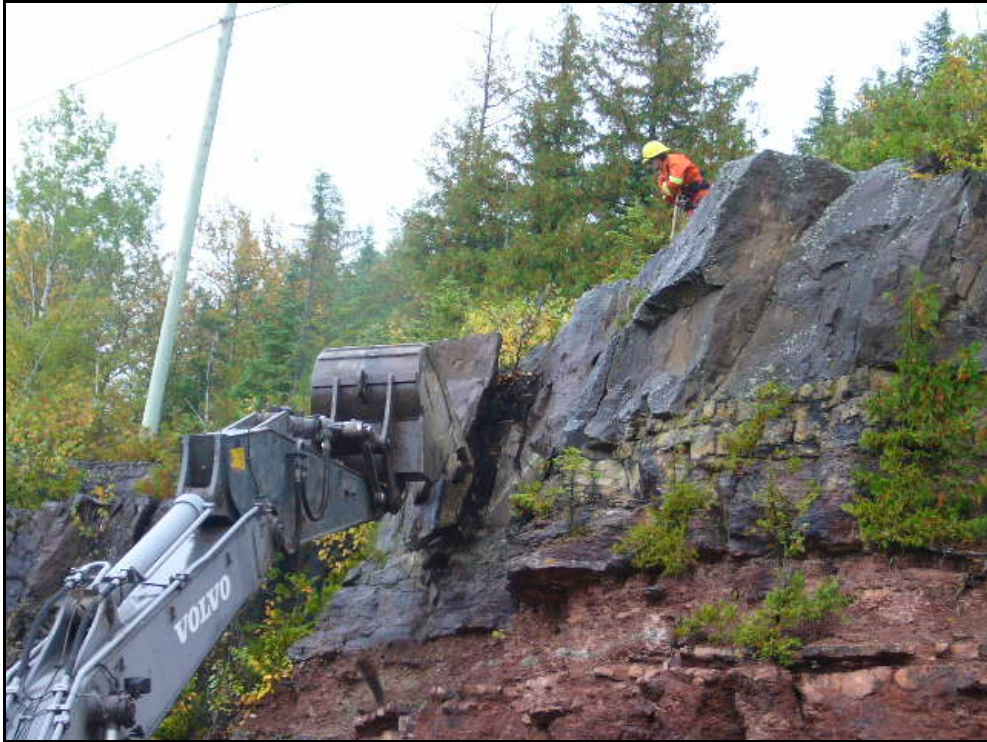
Figure 14. Machine scaling.

Another component of this contract was trim blasting and machine scaling of the rock face adjacent to the highway. The Contractor found that trim blasting was not necessary and using a Volvo EC 360 backhoe on the rock face was appropriate to remove the potential hazard, Figure 14. Following behind the backhoe, which was used to remove the large rock blocks, the Contractor had two scalers tied off to ropes remove the smaller rocks using 4-foot pry bars, Figure 15.

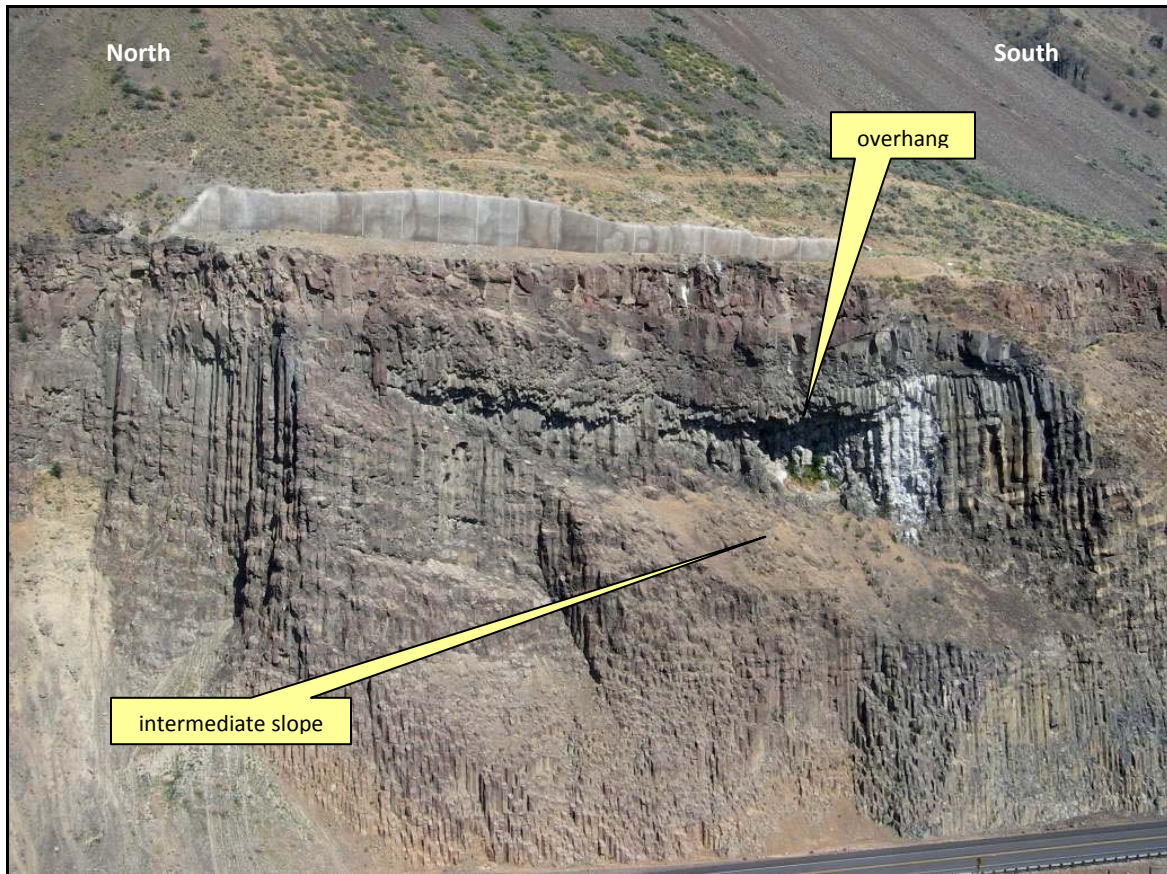
FIGURE 1. The 300-foot-high basalt slope consists of near vertical, northern and southern sections, a middle section with a prominent intermediate slope and overhang, and a soil nail wall beyond the slope crest.

The study was incorporated into a rockfall mitigation project (*Contract #7450 State Route 28 Rock Island – Rock Slope Nettings*) located in central Washington State about 12 miles east of Wenatchee on State Route 28. The project was to address rockfall hazards from a 300-foot-high natural/cut slope approximately 700 feet in length (Fig. 1). The north and south ends of the slope are near vertical. The middle portion includes an intermediate slope about 80 feet in width and inclined $\sim 45^\circ$ beneath a large overhang that extends back into the slope about 20 feet. Above the overhang the rock slope rises another 100 feet vertically to the crest of the slope. A soil nail wall was constructed beyond the rock slope crest as part of previously planned, but currently unfunded, highway widening project. The rock slope is composed of columnar to hackly basalt with typical block sizes ranging from 2 to 6 feet in diameter. The slope frequently produced rockfalls, some of which would reach the shoulder and travel lanes. The project entailed some initial safety scaling to remove large strained blocks/masses, and then a drape of ring net slope protection.

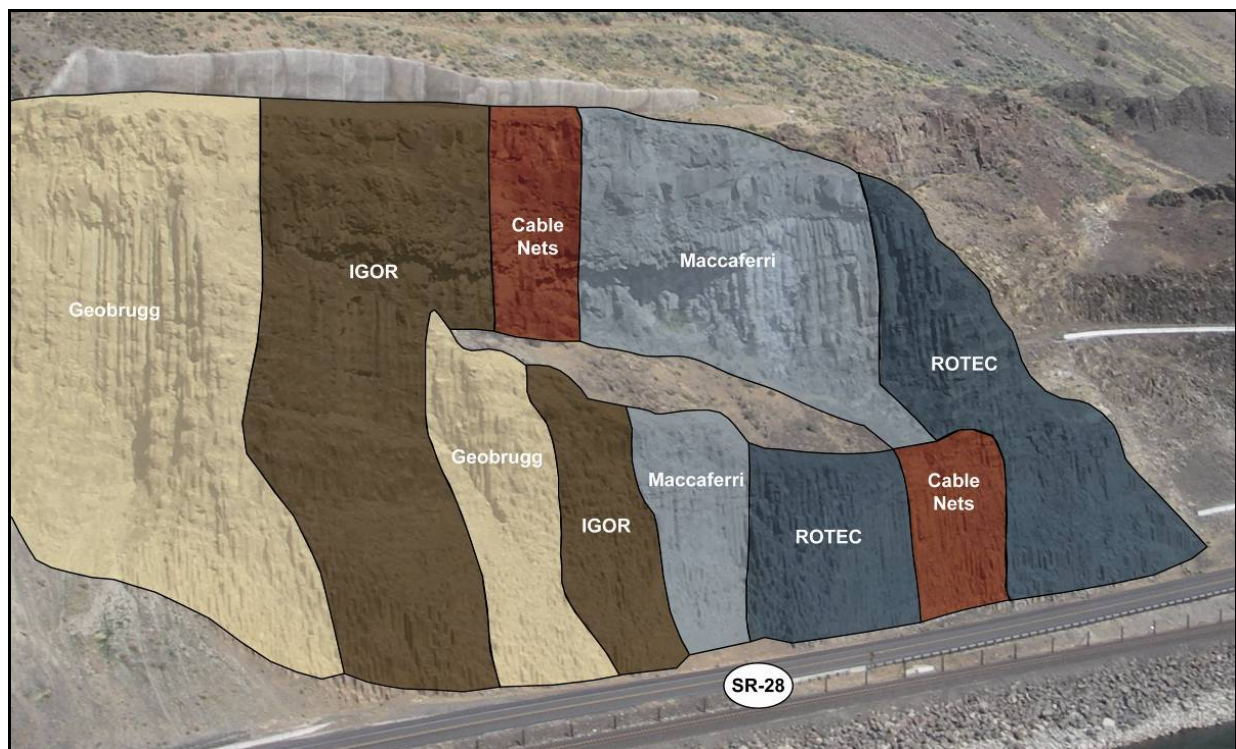
FIGURE 2. Design coverage for the specified ring nets for the sections of standard and modified (hybrid) slope protection, including two control sections of cable nets.

The coverage area for the slope protection was estimated using a digital terrain model (DTM) created with traditional survey and ground-based light detection and ranging (LIDAR) data. Using a geographical information system (GIS), we estimated the coverage area for the standard slope protection to be about 166,000 ft² and the modified section to be 59,000 ft², which included a 20% contingency to account for slope irregularities, necessary panel overlaps, and other uncertainties. The quantity estimates planned for the slope protection to extend to within 5 feet of the ditch line and 15 feet beyond the slope crest. A 20-foot-long tail was specified to cover the upper portion of the intermediate bench. The slope areas to be covered with standard and modified slope protection were divided into equal areas with approximately 52,000 ft² specified for each type of ring net (Fig. 2). In addition, two control sections of cable nets were included for approximately 16,000 ft² of coverage area. Total plan quantity for slope protection materials was 224,664 ft².

For the sections of standard slope protection, the top horizontal rope was specified to have a maximum segment length of 40 feet supported by cable anchors on 20-foot spacing. The modified section was designed with the top horizontal rope spanning a single 20-foot-wide section between two 10 ft posts and anchored on each end. All posts were inclined downslope at approximately 25 degrees from vertical.

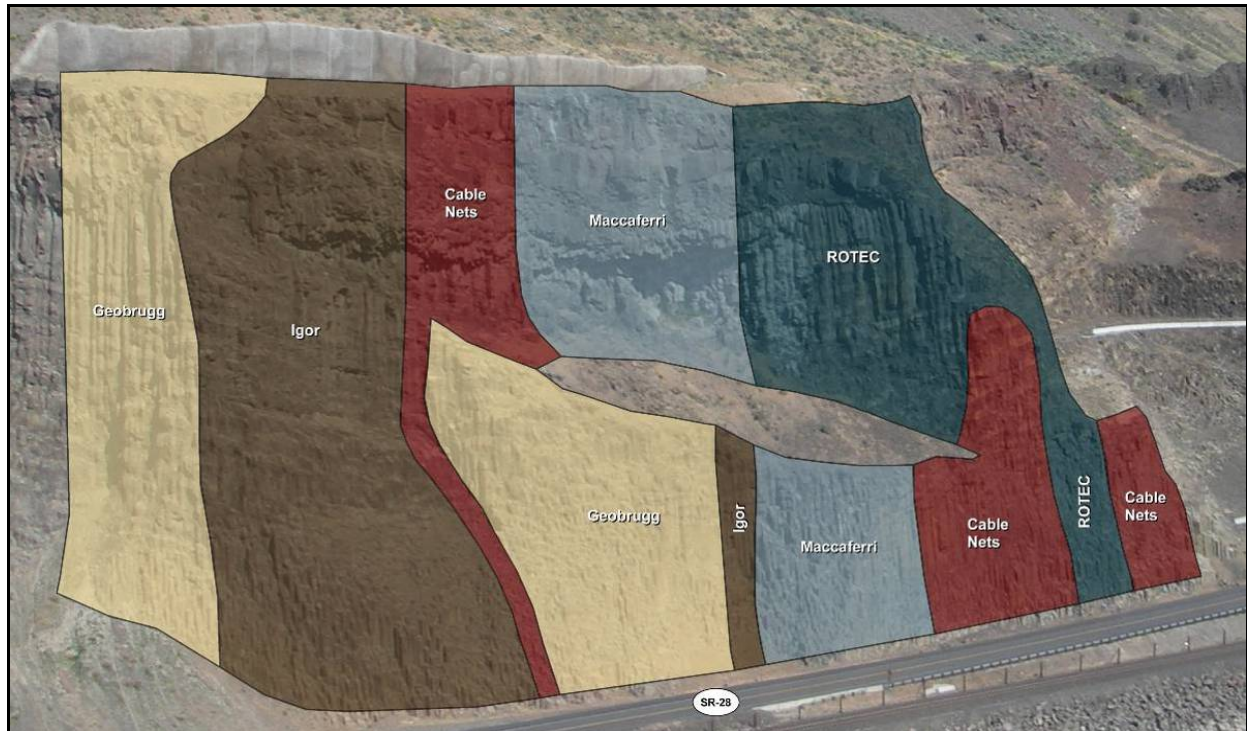
FIGURE 3. As-built coverage for the ring nets and cable nets.

The final coverage area of the different fabrics is approximately depicted in Figure 3. The areas changed somewhat from the coverage area shown in the plans for a number of reasons. Some additional coverage area was required on the south end of the project, which was covered with ROTEC ring nets and additional cable nets. Detailed survey locations of the different fabrics were not included in the plans. Placement of fabrics was made primarily by estimating their location from photographs. With the large slope heights, slope irregularities exacerbated modifications to the design layout. Additional nets were also added along the entire top, due to a modification in the anchoring and top horizontal support rope. These areas requiring additional fabric totaled about 22, 246 ft². The final installed

quantity was estimated to be 261,573 ft², representing a 36,723 ft² or about a 16% shortage on plan quantities. This shortage was accommodated by the installation of additional cable nets.

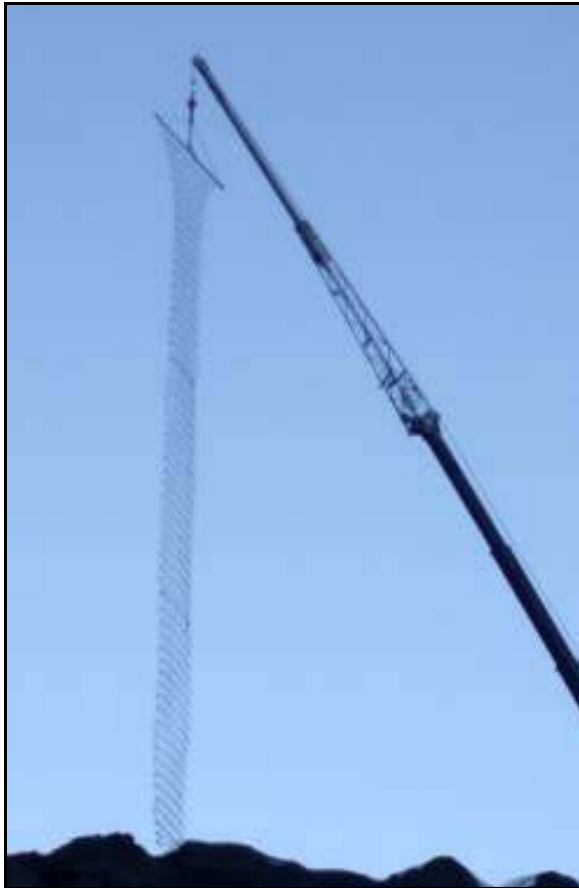
FIGURE 4. Three panel section of Geobrug ring nets with wire mesh; note contraction (necking) of panels.

Janod's crane was able to lift three Geobrugg ring net panels in a single pick, with each three-panel section measuring 12 feet wide by 75 feet long for a total area of 900 ft². Initial placement of the upper sections of Geobrugg rings occurred with the wire mesh pre-attached until this requirement was dropped. When the panel sections were lifted, both with and without the wire mesh backing, some contraction (necking) and elongation of the fabric occurred (Fig. 4). On the vertical portions of the slope where the nets had little to no slope contact and the dead load was carried entirely by the fabric, rings slightly deformed from a circular to an ellipsoid form. This ring deformation caused many of the wire ends to protrude (Fig. 5). Janod reported that the protruding wires caused the climbing ropes, wire

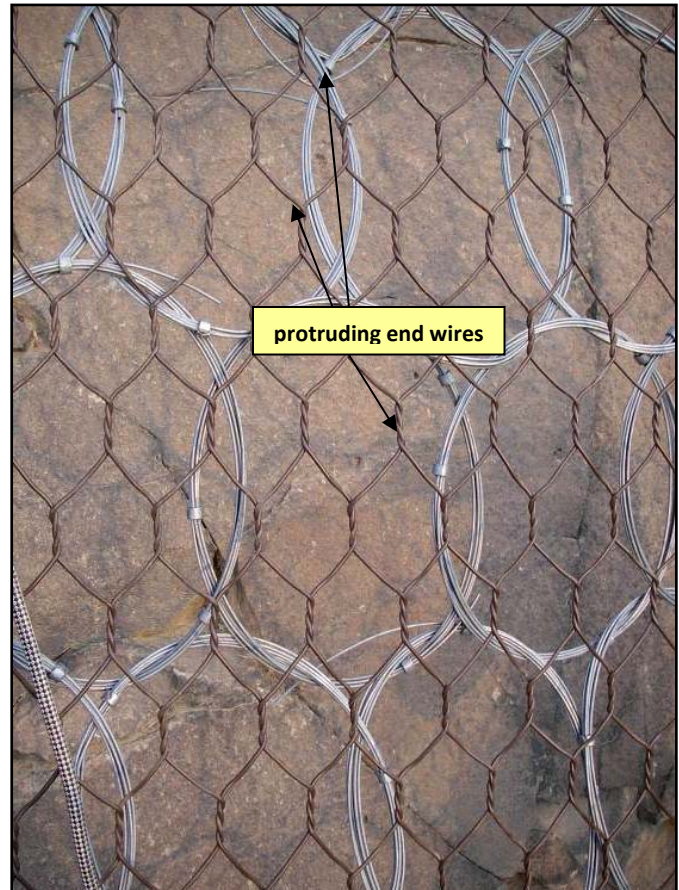
FIGURE 5. Elongation of individual rings caused wire ends to protrude on Geobrug ring nets.

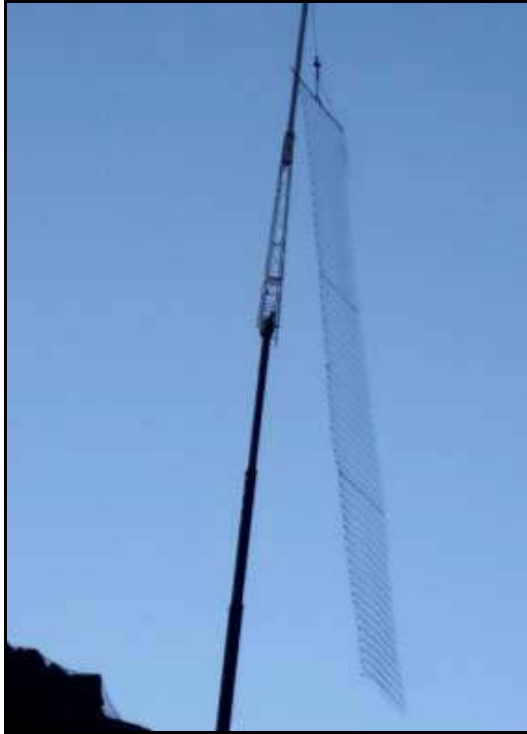
FIGURE 6. IGOR ring net panels without wire mesh maintained their rectangular shape when lifted.

rectangular shape and contracted very little (Fig. 6). Similar to the other ring nets, the IGOR rings elongated somewhat where the nets had little to no slope contact and the dead load was carried entirely by the fabric (Figure 7). Janod reported that the ring net sections were relatively easy to move around on the slope and to seam.

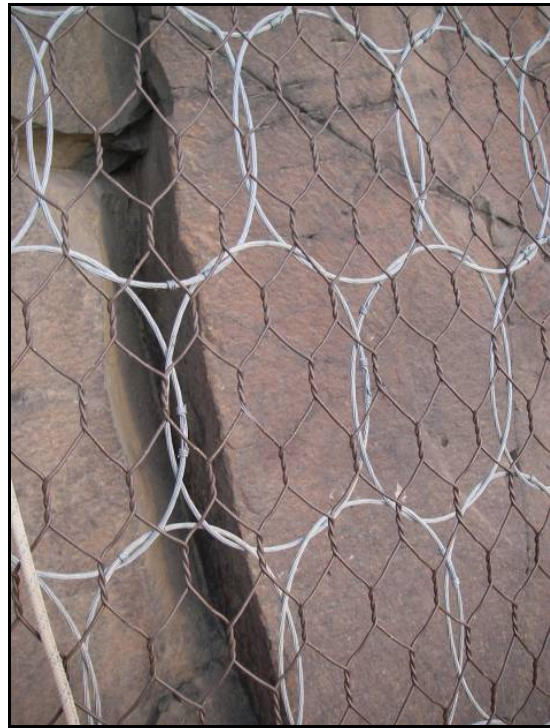
FIGURE 7. Slight elongation noted in IGOR rings where panels were heavily loaded

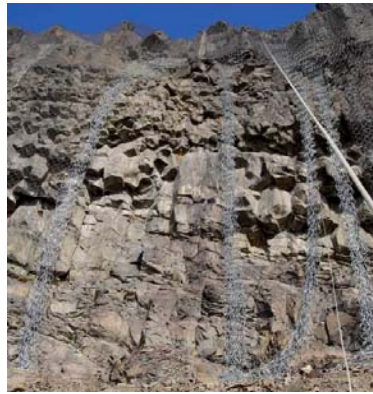
**FIGURE 9. View of contracted
panels without wire mesh backing**

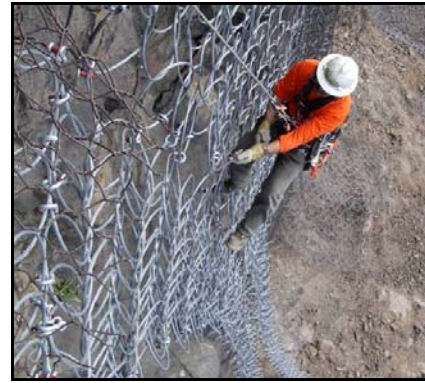
**FIGURE 10. Seaming the contracted
panels was difficult, often requiring
the use of a come along to pull the
seam together and secure the shackle**

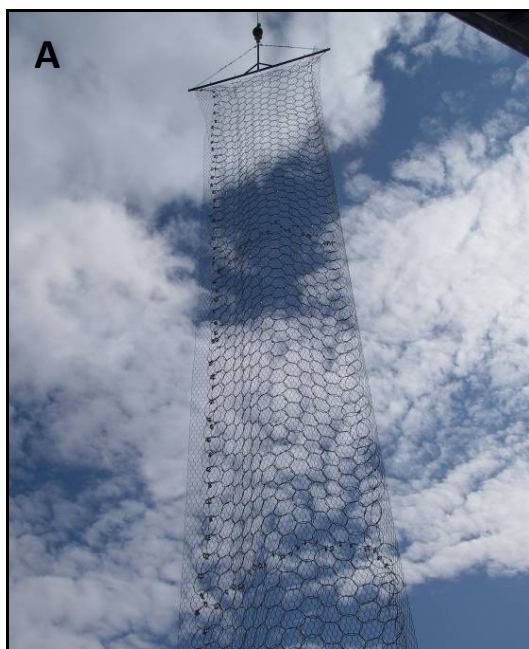
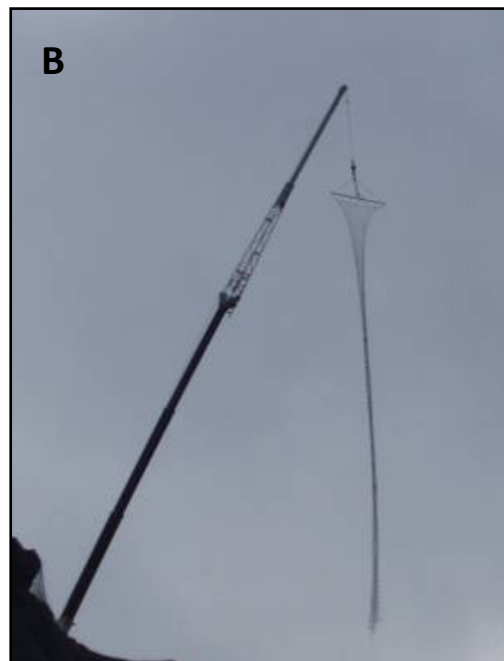
FIGURE 11. (A) ROTE ring net panels with wire mesh and B) without wire mesh.

Janod's crane was able to lift three ROTEC ring net panels in a single pick, with each three-panel section measuring 12 feet wide by 75 feet long for a total area of 900 ft². Initially, the ROTEC ring nets were placed with the wire mesh backing. When these panel sections were lifted, they generally maintained their rectangular form (Fig. 11A); without the backing mesh, the panels contracted severely (Fig. 11B). With subsequent placement and seaming of panels, significant ring deformation and tension developed in the upper portion of the installation, around slope protrusions, and along seams (Fig. 12). However, because the ROTEC ring is fabricated from wire rope, ring deformation is not permanent as it would be with a ring of bundled wire loops.

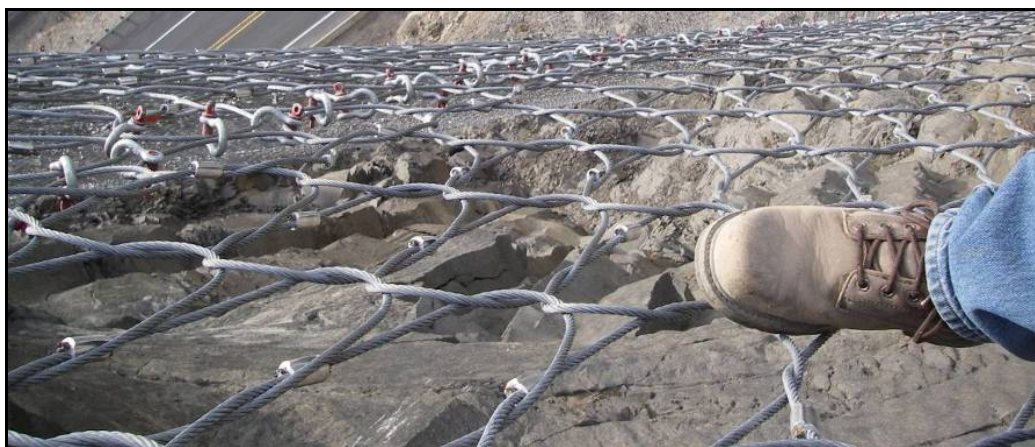
FIGURE 12. Deformation in upper backing portion of ROTE ring nets.

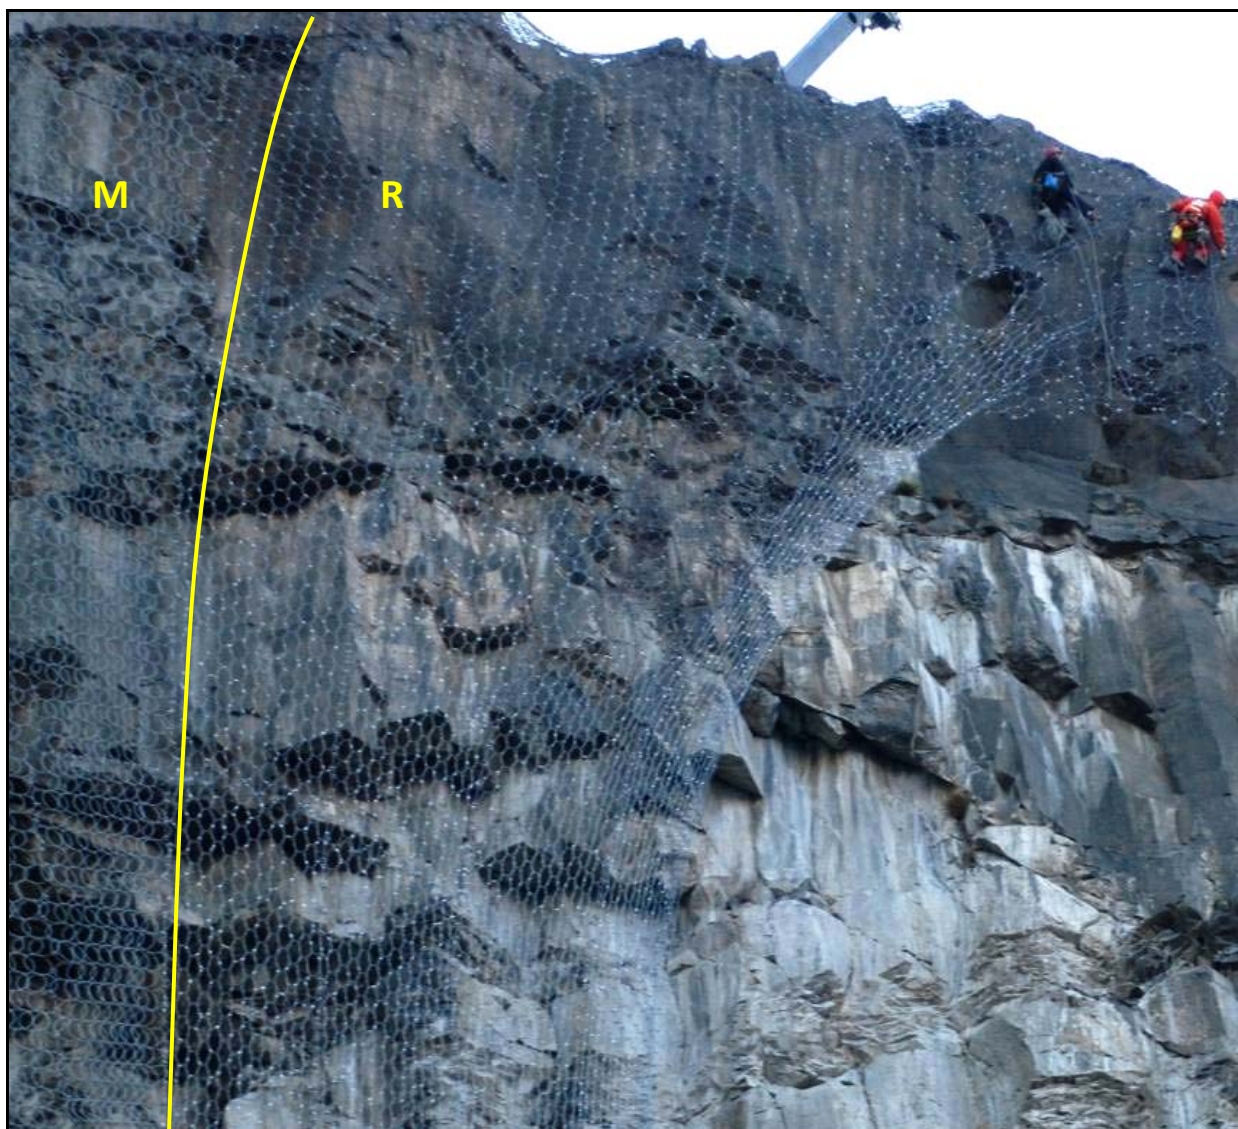
FIGURE 13. Yellow line denotes seam between Maccaferri nets (M) on the left and ROTEK rings (R) on the right. Note how the ROTEK rings have been pulled toward the Maccaferri nets.

The effort in pulling the heavy Maccaferri ring net panels together for seaming caused the adjacent ROTE ring nets, which had been previously seamed to the Maccaferri ring nets, to be pulled laterally toward the Maccaferri nets (Fig. 13). Janod then had to try to pull the ROTE rings back. This was only moderately successful, and additional material was required for the net loss in coverage area of the ROTE ring nets.

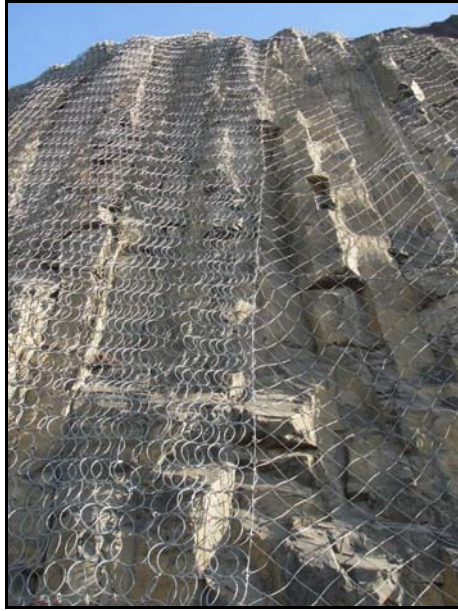
FIGURE 14. Photograph shows Maccaferri rings adjacent to Maccaferri cable nets. Note contraction in width of ring nets panels and less than optimal coverage area.

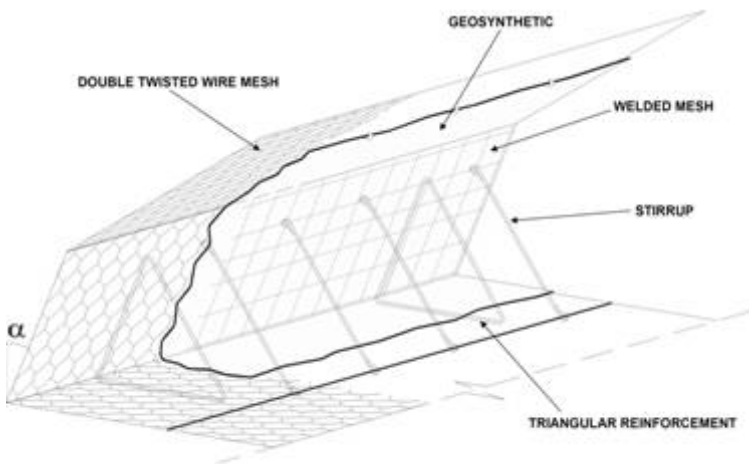
Fig. 1 – Typical configuration of the Green Terramesh reinforcement structure. The element is to be filled with selected proper grain size soil.

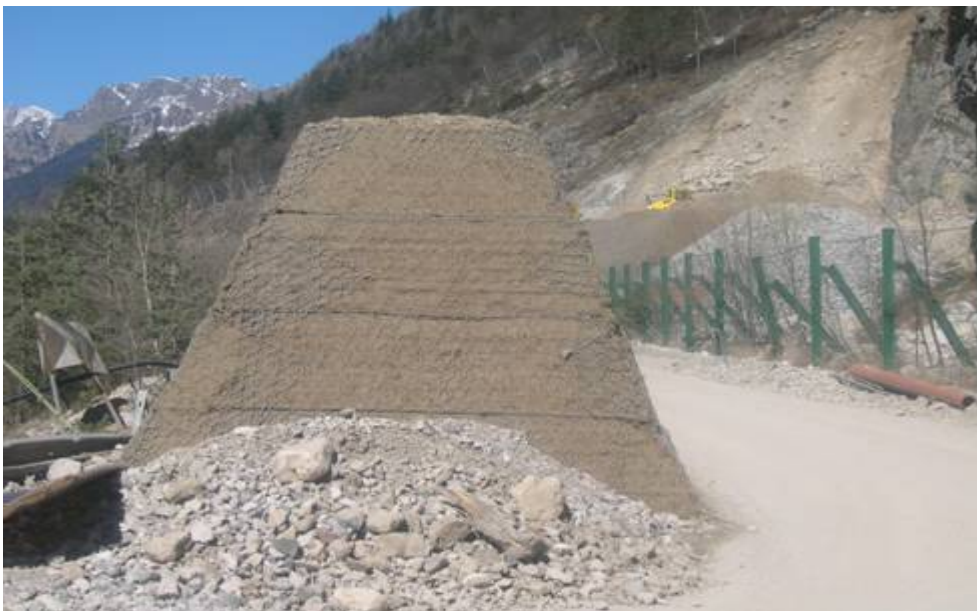
Fig. 2 – Trapezoidal Green Terramesh embankment structure (prior to establishment of vegetation on the facing). Horizontal Green Terramesh component structures are filled with soil and overlapped.

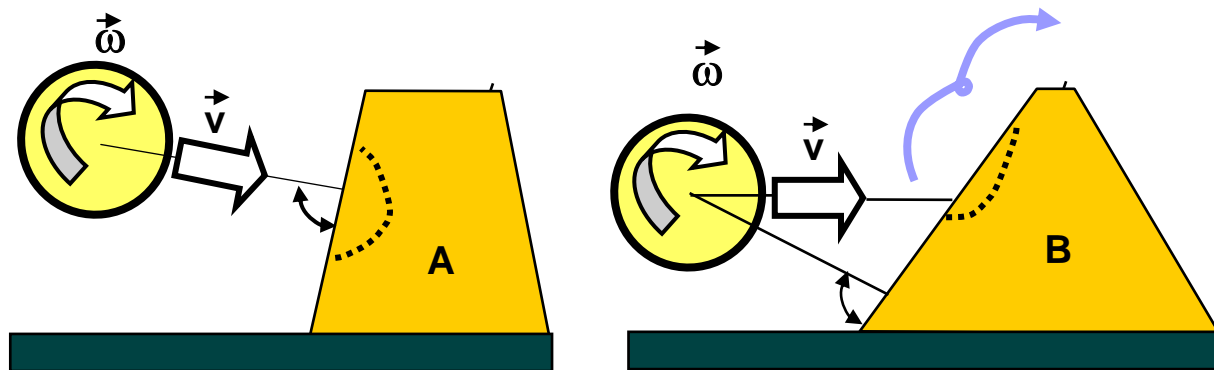
Fig. 3 – The slope facing of the embankment should be as perpendicular as possible to the direction of the impact (case A). If the direction is inclined (case B) the rotational speed of the boulder may allow the rock to climb over the structural embankment.

Impacting rocks that approach the embankment with a rotational motion may climb over the embankment (see Figure 3). The rotational kinetic energy of these blocks is an average of 10-15% of the total energy. If the slope facing of the embankment is not steep enough, there may be a risk that the rotating rock block may climb over the embankment. The Green Terramesh embankment system that is analyzed and discussed in this paper has an inclination 60° to 70° from the horizontal and is reinforced, which should be sufficient.
