60th HIGHWAY

GEOLOGY SYMPOSIUM

PROCEEDINGS

1.1.	<i>High Bridge Area Roadway Slide, Letchworth State Park, Portageville, New York</i>	22
	Andrew J. Nichols, P.E.; James Bojarski, P.E.	
1.2.	<i>Remediation of the SR 15 Welcome Center Landslide.....</i>	35
	David R. Scherer, P.E.; Robert E. Johnson, P.E.; Paul J. Lewis, P.E.

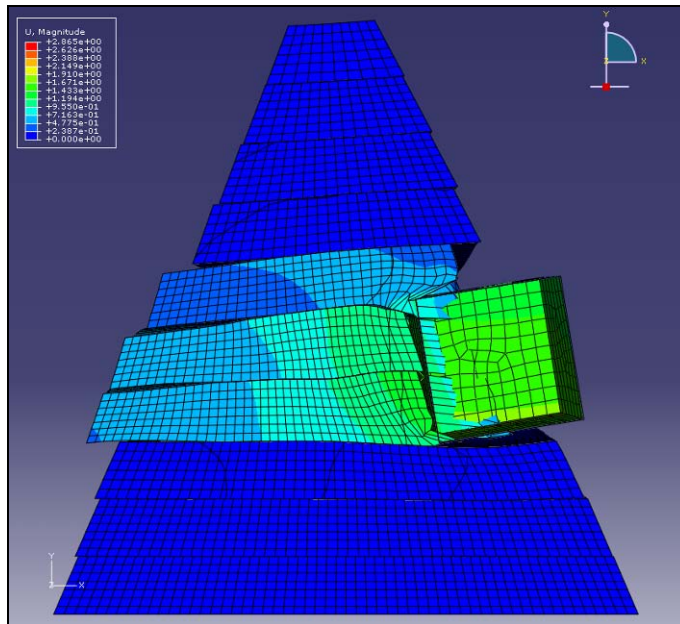
Figure 4 - Example of the contour plot of total displacements at the impact zone in an embankment computed using numerical modelling. The sliding effect of the impacted layers is quite evident, while the remaining part of the embankment appears to be relatively undisturbed by the impact.

Based on experimental observations of embankment barriers, it has been verified that the primary mechanisms of dissipation of the impact energy are the following (Figure 4):

1. The mutual movement of the layers (courses) of reinforced soil directly affected by the impact;
2. The plastic deformation of the soil related with the formation of impact crater.

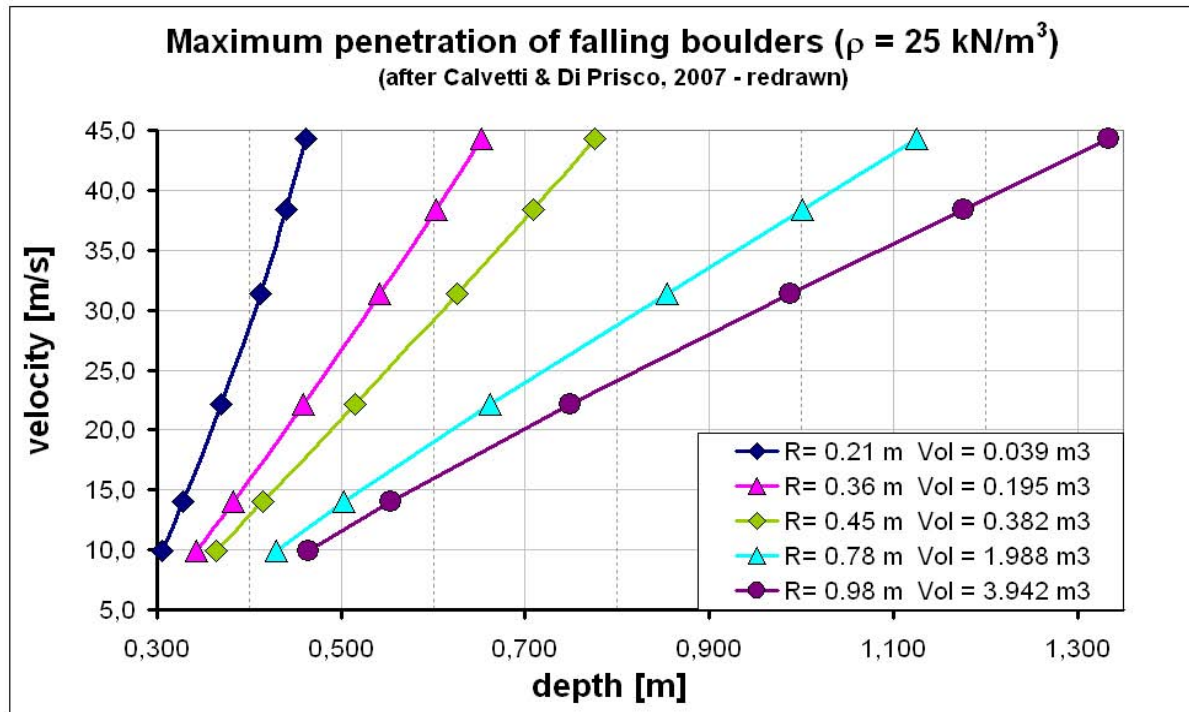
Fig. 5 – Maximum penetration of the block vs. velocity of impact
(after Calvetti and Di Prisco, 2007)

However, if we adopt a pseudo static approach for calculation, we must transform the energies of the impact to equivalent forces acting on the embankment. And, these results are subject of many uncertainties. The problem can be solved by adopting a systematic numerical finite element model or equivalent. The successful application of these methods, however, requires the availability of appropriate tests for proper calibration of the model. Some solutions have been proposed to address these uncertainties and provide designers with a quick and simple tool for design practice. Recently, Calvetti and Di Prisco (2007) have improved calculation methods in order to estimate the penetration of boulders into the soil as part of an extensive study, including experimentation on a rockfall protection canopy (Figure 5).

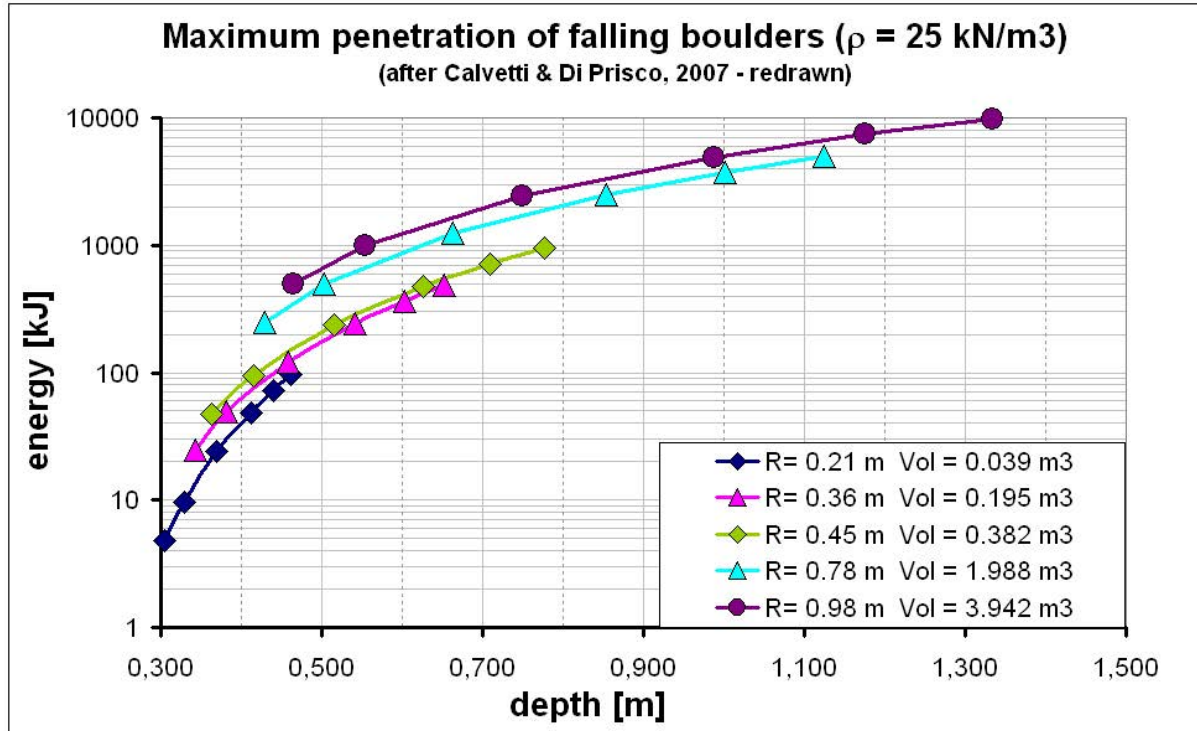
Fig. 6 – Maximum penetration of the block in relation to the impact energy (after Calveti e Di Prisco, 2007)

boulders (Figure 6). This implies that at low speeds, the dept of penetration increases slightly for variations in the size of the block and therefore with variations in energy of impact. In light of this observation, it is obvious that the simulations of falling rocks in back analysis are valid only for the rocks of the size used in the simulation. The repetition of the simulation with different masses suggests that the coefficients of restitution of the fill material are changing with the masses. This concept confirms what has been noted by Pfeiffer & Bowen (1989) as the necessity to adjust the coefficient of restitution used in the normal R_N simulations of falling rocks to a function of impact speed or of the size of the boulder. The graph will then be able to directly estimate the penetration of rock once the size of the block and the energy level is known.

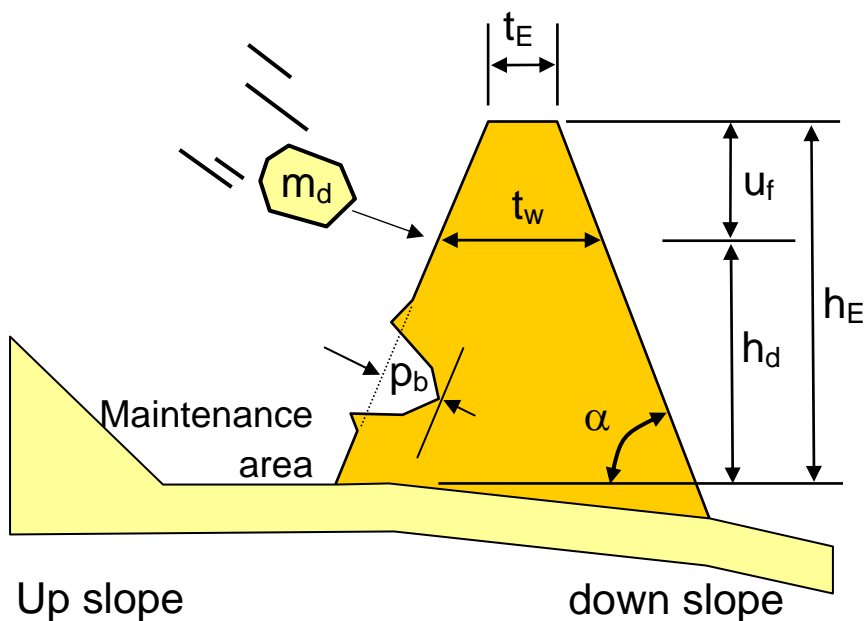
Figure 7 – Definition of the measures of the detected parameters.

where $\tan \alpha$ is the inclination of the uphill embankment from the horizontal and u_f is the upper free section of embankment. The upper section of the embankment where the impact should not occur (due to high potential deformation) is at least equal to the diameter of the projectile rock mass. The minimum height of the embankment h_E will be determined as:

$$h_E \geq h_d + u_f = h_d + (t_W - t_E) / 2 * \tan \alpha$$

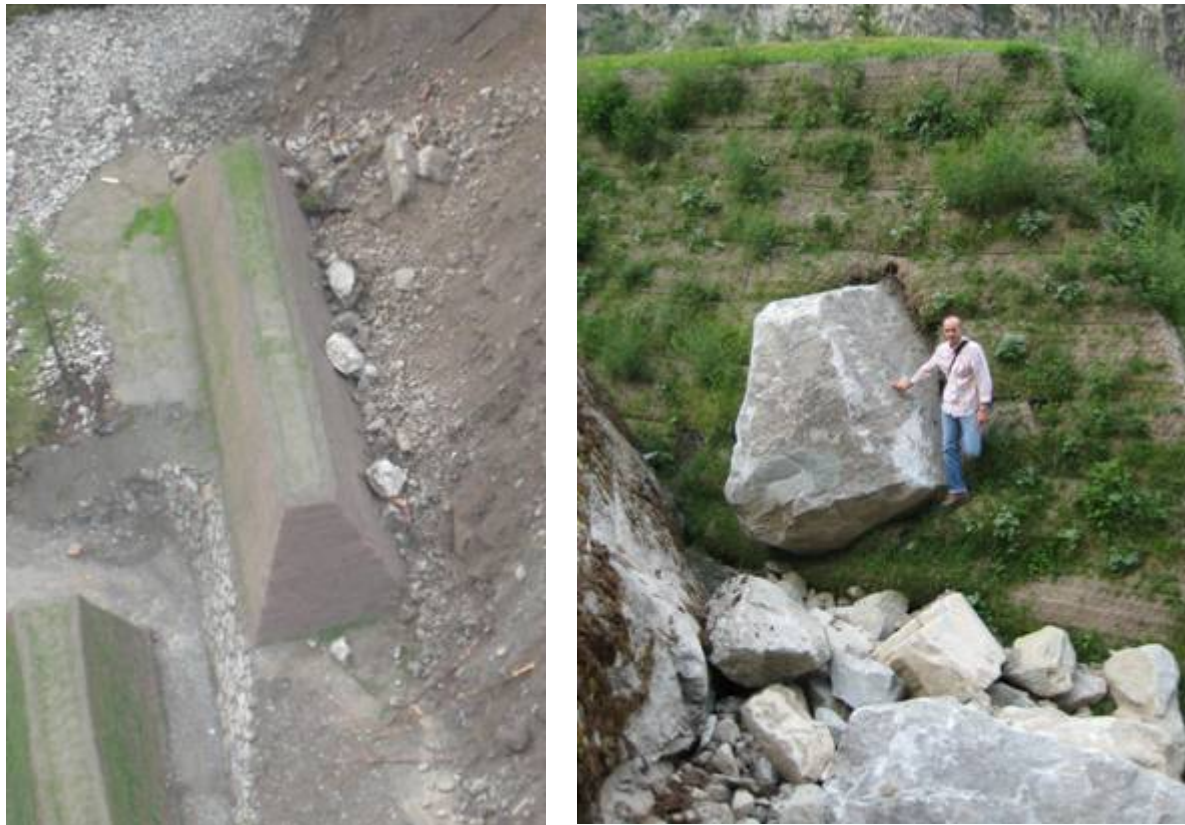
Figure 8 – Left: Green Terramesh embankment to protect SR 47 in Cogne (Valle d’Aosta). On June 5, 2007, several big boulders (30 m^3) mobilized down the hillslope. Right: A rock block, approximately 6 m^3 in volume, impacted the embankment at approximately mid- height (6 m from the base) on the embankment.

The Green Terramesh embankments have been widely used to build embankments for protection of roads and infrastructure from falling rocks. Additionally, they have been used for the construction of deflection structures or for the construction of structures with the purpose of protecting urban areas from debris flow activity. A significant event occurred in Cogne (Valle d'Aosta - Italy), where a large embankment has been installed to protect highway SR 47 (Figure 8).

On the morning of June 5, 2007, there was a landslide with the collapse of large blocks, some of which were larger than 30 m^3 (1000 ft^3). The impact was along an embankment that is 50 meters (164 ft) in length and 11.5 meters (38 ft) in height above the ground surface. A boulder of about 6 m^3 (211 ft^3) (mass 15000 kg (33,000 lb)) impacted the embankment, at approximately mid-height (6 m (20 ft) from the base) and approximately 4 meters (13 ft) from the edge of the embankment, causing a deep crater of 0.60-0.70 meters (2 to 2.5 ft) in depth. The area surrounding the impact crater was deformed, but the adjacent area did not experience serious damage. The internal stability of the embankment was not compromised, and no maintenance was required. Only aesthetic repairs, easily executable with mesh patches or with an erosion control blanket, are planned. Impact craters must be filled with loose material where possible.

In this particular case, with the available data from the event, it was possible to determine the speed of the impact mass about 20 meters/second (44 miles/hr). It was also possible to estimate a penetration depth of 0.70-0.75 meters (2 to 2.5 ft) by assuming the rockfall volume (about 6 m^3 (211 ft^3)) to a sphere of diameter 1.15 m (4 ft)), and using the chart proposed by Calvetti and Di Prisco (2007).

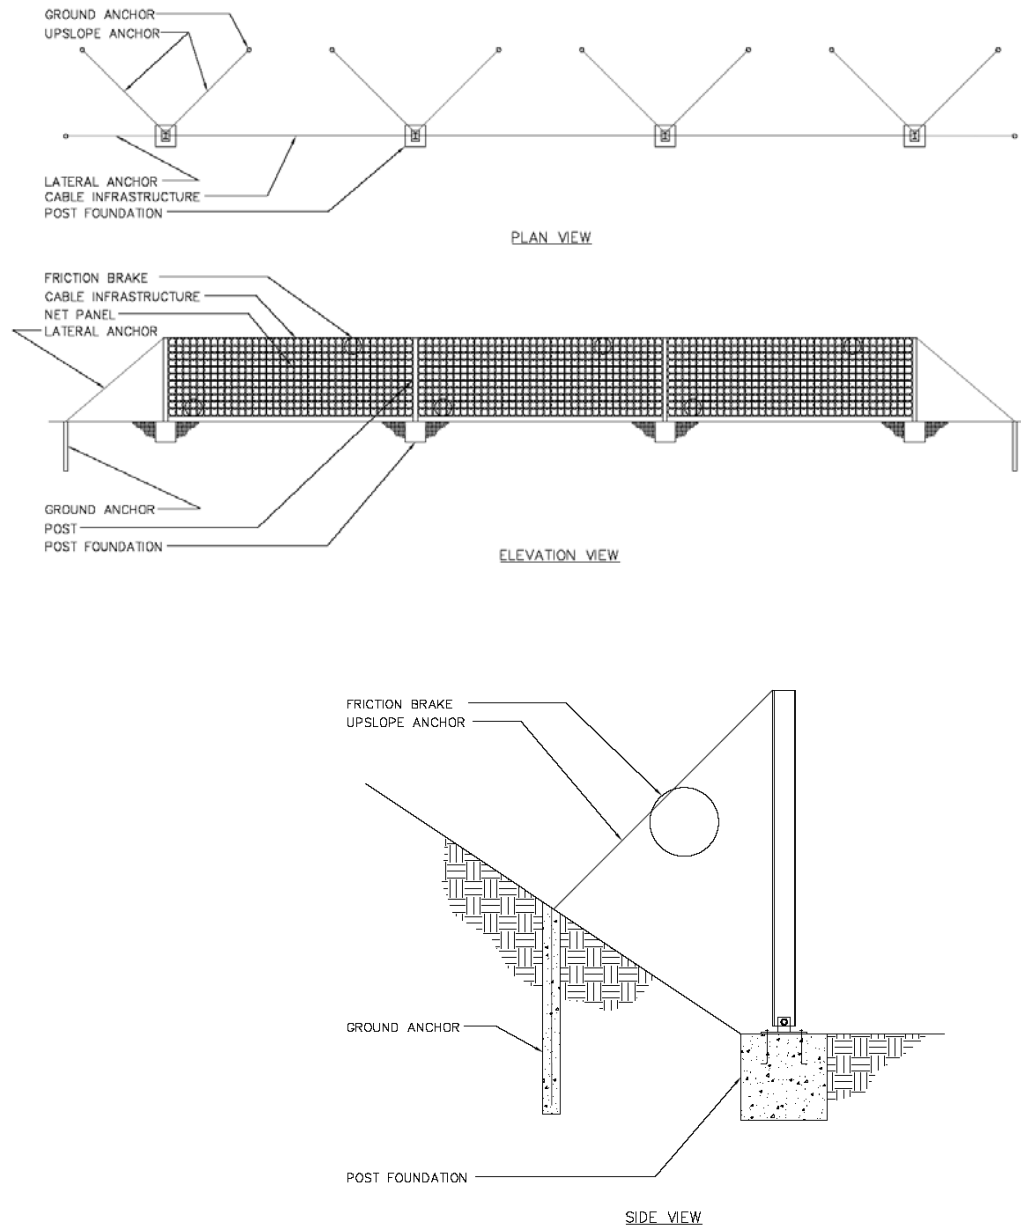
Figure 1: Flexible rockfall fence schematic

Flexible rockfall fences consist of four major structural components: the cable mesh, the post assemblies, the anchors and friction brakes, and the cables attaching the net to the posts and anchors. Interlocking ring nets, cable ring nets, or cable nets hang on cable infrastructure, which is supported by posts founded on the post foundations at the base and supported at the top by upslope and end ground anchors (Figure 1). The flexible rockfall fence dissipates rockfall impact energy as the cable mesh elongates during impact, decelerating the rock. Simultaneously, energy is also dissipated through the elongation of the cable infrastructure and activation of the energy dissipaters (friction brakes). The primary function of the posts is to maintain the height of the fence and provide catchment. Each manufacturer's system contains the four major components with variations in the connections.

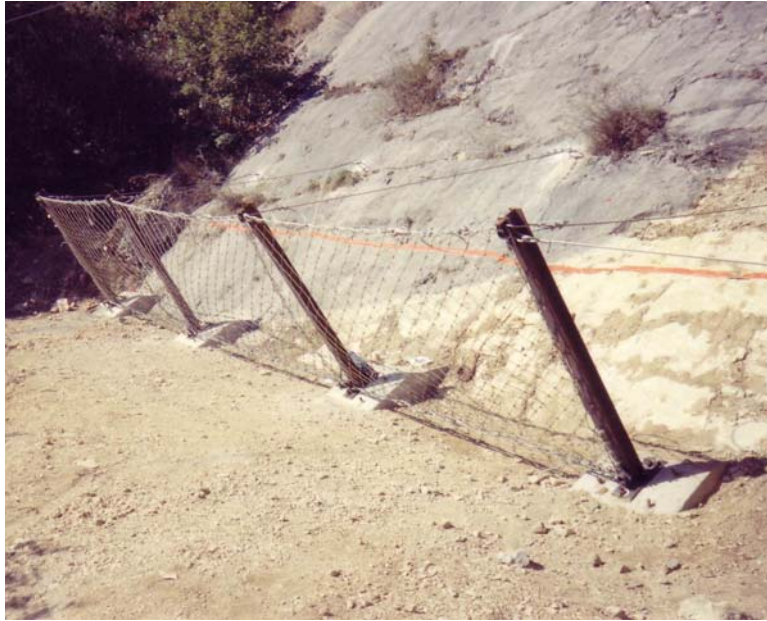
Figure 2: Constructed flexible rockfall fence

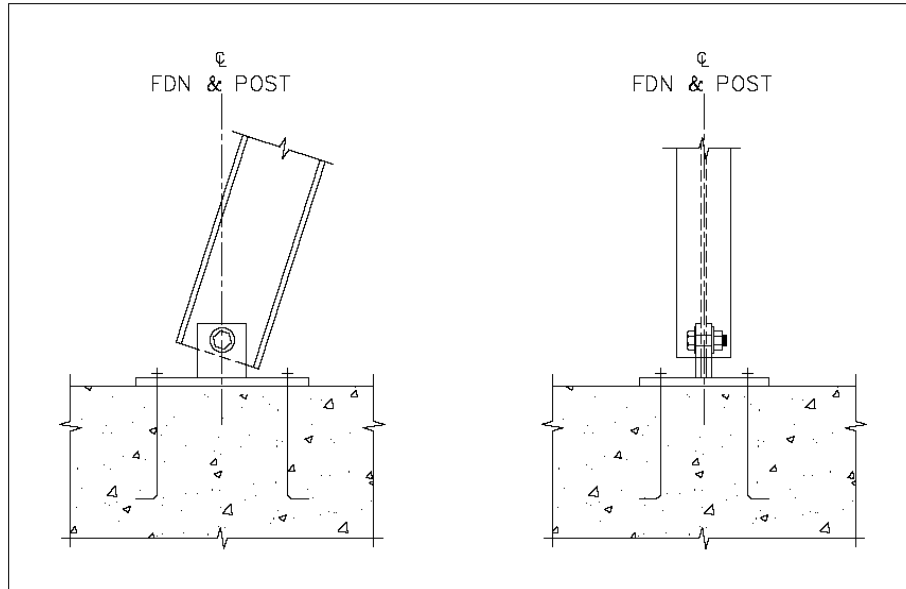
Figure 3: Side and front elevation views of typical pinned post to foundation connection

Posts for the flexible rockfall nets are wide flange sections oriented with the major axis perpendicular to the plane of the fence. The posts used in the 500 and 1000 kilojoule systems examined in this paper are approximately 8-inch deep sections. The top rope of the cable infrastructure is looped through a welded bracket on the down-slope side of the top of the post, allowing the top rope to break free of the post in the event of a high-energy impact that induces deflection beyond the rotational capacity of the post. An upslope anchor with an energy dissipating friction brake is connected to the top of the post with a shackle through the web of the post. The use of shackles and replaceable connections designed to fail at or near the system energy capacity is intended to induce failure in the connections without damaging major structural and foundation elements. The base of the post is fastened to welded tabs on a rectangular base plate with a single steel bolt. Examination of constructed flexible rockfall nets and current specifications and plans from manufacturers indicate that the typical base connection is made with a single $\frac{3}{4}$ -inch diameter A325 steel bolt through the web of the post section with welded steel plate tabs on either side of the web. The use of a single bolt at the post base results in a pinned condition, allowing the post to rotate freely about its base without imparting significant moment into the post foundation.

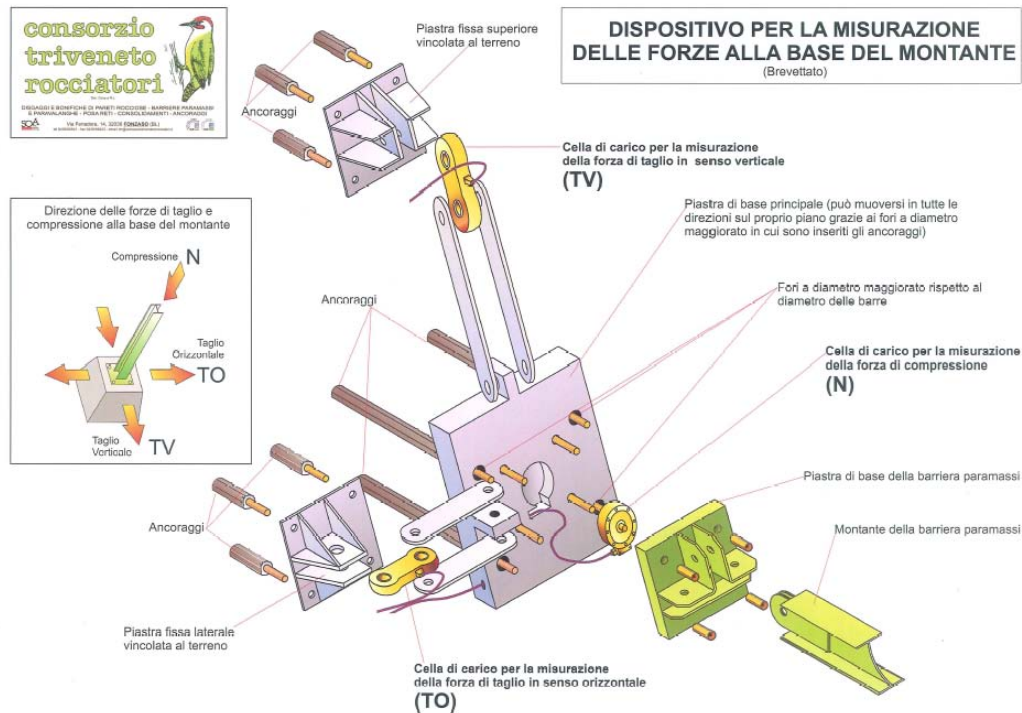
Figure 4: Diagram of the patented system used in CTR field test to evaluate loads at the base of the post. Evaluation of the forces transmitted by the post to the foundation during the impact of a block is a key value to be monitored according to the new ETAG 027 standard.

Due to the flexible nature of the systems and dynamic impact of the rock, accurately determining the foundation loads by theoretical modeling or field-testing is very difficult. Initial requests to flexible rock net manufacturers and designers for foundation loads were met with the reply that it was too difficult to instrument the post or foundation in such a way that the loads could be measured. Instrumentation of the upslope cable anchors with strain gauges is relatively simple because the cables are tension members and cannot transfer shear. Measuring the loads at the foundation level requires the ability to simultaneously measure the axial load and shear loads transferred to the pin. The only manufacturer able to provide field measured loads was Maccaferri. Maccaferri engineers had performed controlled testing of their MAC.RO. CTR-500-B System with a proprietary instrumentation device (Figure 4) able to measure the axial and shear loads at the post-to-foundation connection point. Isofer/Rotec submitted predicted foundation loads obtained from combining measured tensile loads in the upslope and end anchors and structurally modeling the post base to calculate theoretical foundation loads. The loads are presented in the Analysis Section.

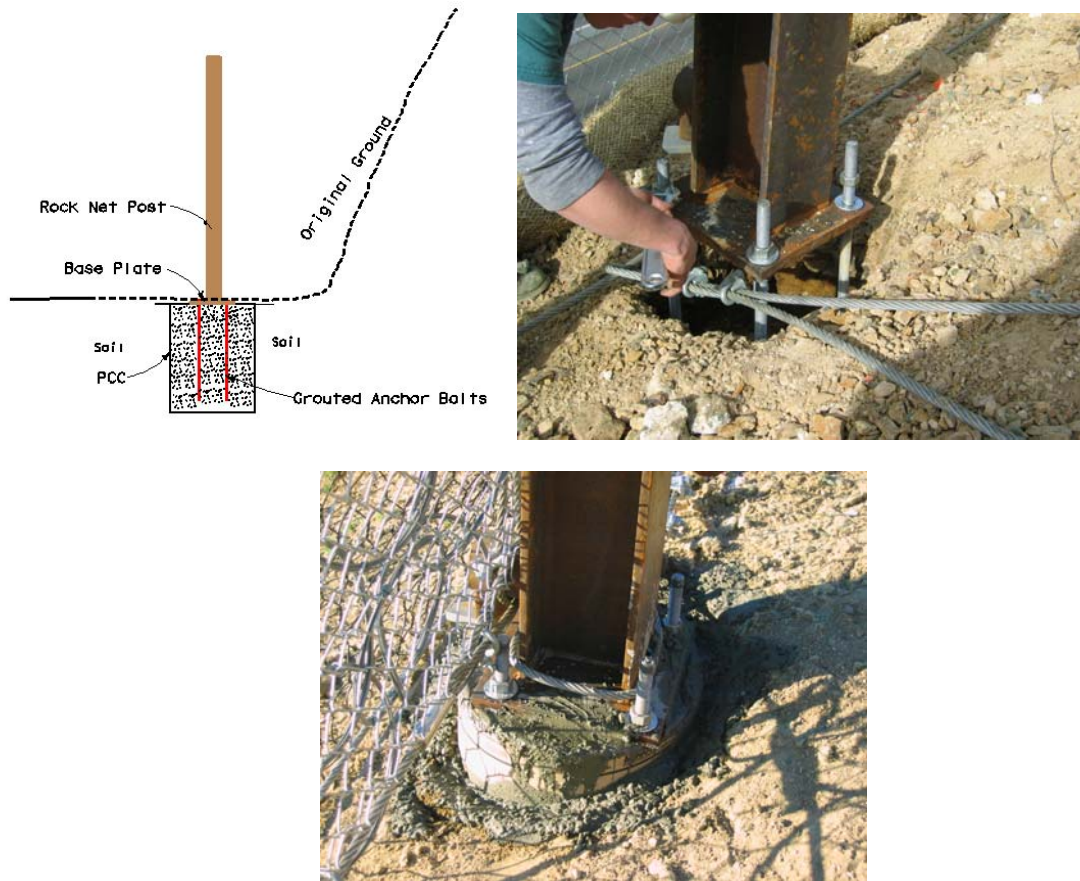
The standard soil foundation is a 2.5 x 2.5 x 2.5-foot concrete block poured against undisturbed native soils and typically excavated by hand or with a backhoe. The soil type most commonly found in fence installations is free draining colluvium. The colluvium can be described as silty, sandy, gravel with angular cobbles, generally loose at the surface with an increasing relative density as the depth of the footing increases. Similar to typical foundation construction methods, the excavation is filled with concrete and anchor bolts are wet-set in the concrete using a template or drilled and grouted after the concrete has cured.

Figure 5: Typical post foundations in soil

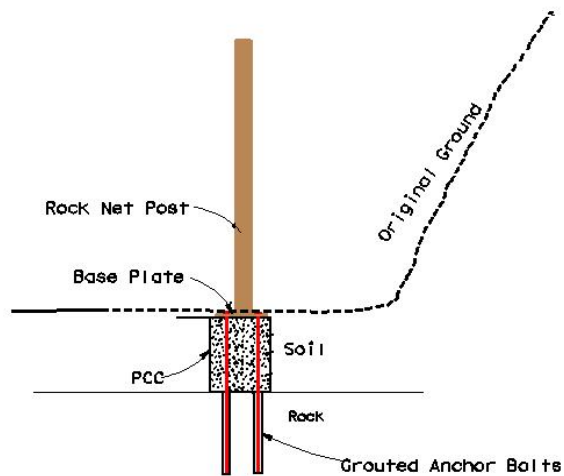
The standard foundation for a geomaterial condition consisting of a thin veneer of soil overlying rock begins with an excavation through the soil extending in the bedrock. Two designs are used to anchor the post. One method is to install several grouted rock dowels into the rock beneath the bottom of the excavation. The rock dowels typically have a grouted length between 3 and 5 feet, depending on the strength and condition of the rock, and extend up into a concrete block that provides level bearing and anchorage for the post. The second design eliminates the dedicated anchor bolts and extends the rock bolts through the concrete block and bolts the base plate directly to the rock bolts. This method requires less material, but may be more difficult to maintain and replace in the event of failure of the rock bolts.

Figure 6: Typical post foundation in rock overlain by soil

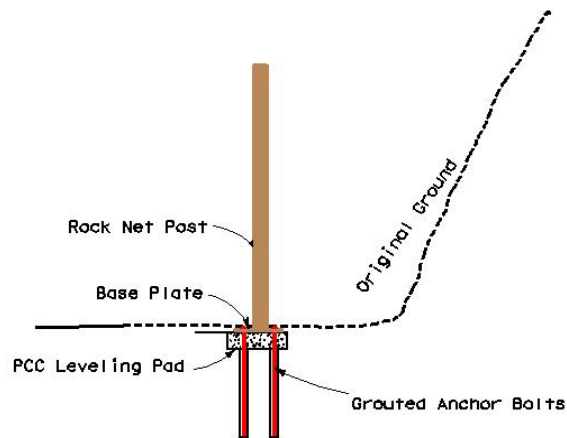
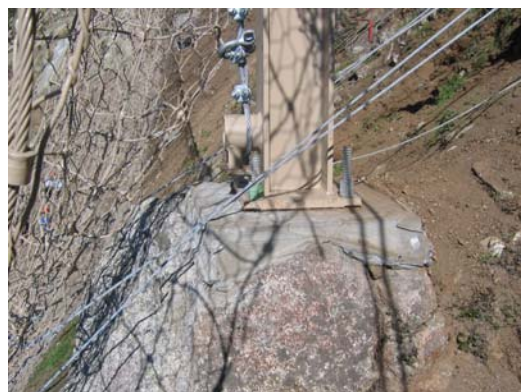
Post foundations in rock are similar to the previous condition. Rock dowels are drilled in to the rock and serve as the anchor bolts connecting the base plate to the foundation. A concrete leveling pad is commonly hand placed around the dowels to provide a level surface for the post base plate. The dowels are typically grouted 3 to 5 feet into the bedrock depending on the rock strength and condition.

Figure 7: Typical post foundations in rock

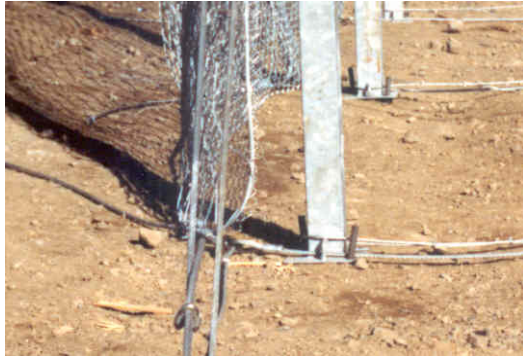
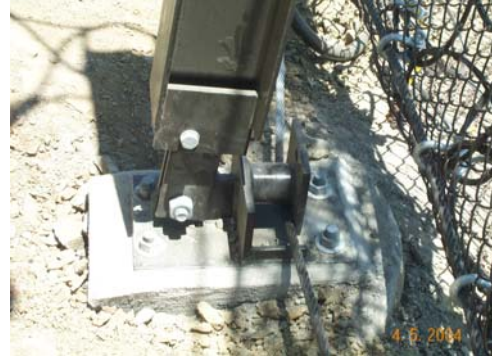
Figure 8: Two different types of post foundations used during the 1989 California Department of Transportation flexible rockfall fence tests. (a) post founded on native material and secured with hand driven stakes and restraining cables and (b) post founded on concrete foundation.

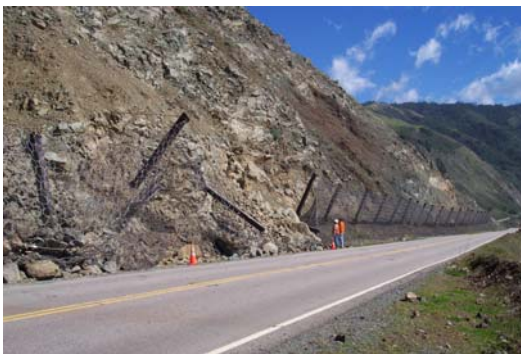
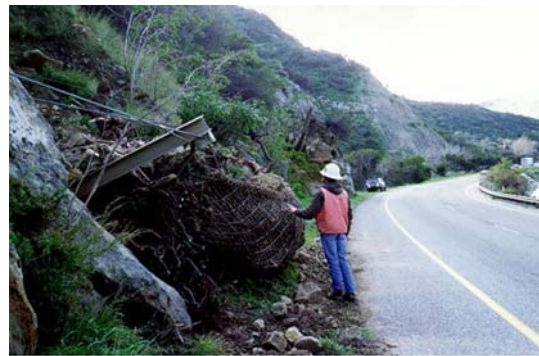
Figure 9: Two rockfall events, the first illustrating a post failure maintained by replacing the post and utilizing the existing foundation and the second showing successful capture of rock later removed.

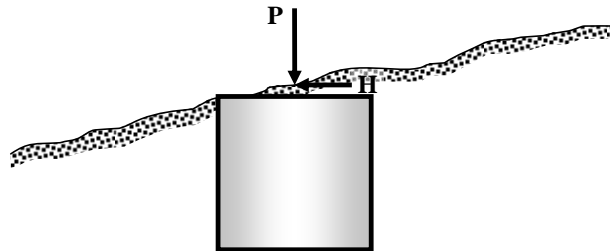
Figure 10. Forces acting on a post foundation

Information on the magnitude of forces P and H is provided (typically) by the supplier of the nets. This information is not site-specific, but is based on analytical and, in some cases, experimental data from full-scale load testing. The design forces are based on the assumption that a rock with kinetic energy equal to the rated energy capacity of the barrier impacts the net. A second type of loading, in which a rock impacts the post (direct hit) is not typically considered in design, but is discussed in a later section of this paper.

Third-party engineers often perform design of foundations supporting the posts. The engineer responsible for the design is required to perform a basic check on the stability, taking into account the forces acting on the footing. For a pin connection between the base of the post and the top of the footing, the post is free to rotate and the moment is zero. The resultant force can be resolved into

vertical (P) and horizontal (H) components as shown in Figure 8. Note that within state transportation agency practice, it is common to specify a standardized footing size. For example, the standard Caltrans concrete footing used for soil sites consists of an equidimensional 2.5-foot concrete block. Although this design is not incorporated into Caltrans Standard Specifications, it is an informal standard utilized on most Caltrans rockfall barriers rated for 1,000 kJ or less.

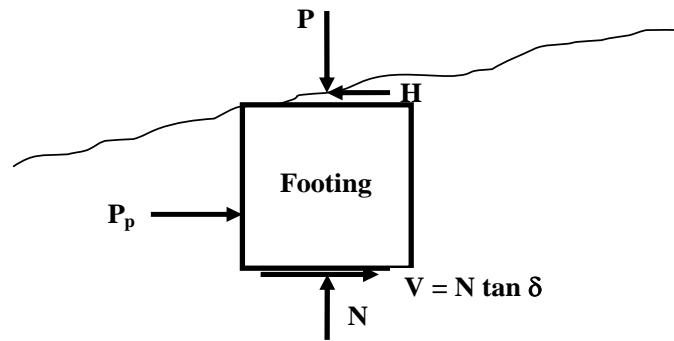
Lateral stability of the footing is derived from sliding resistance along the base and by development of passive resistance in front of the footing. In cases where strength properties of the supporting soil or rock are known or estimated, a simple model can be applied to check the lateral stability of a concrete footing under the force effects resulting from the design impact. Sliding resistance along the base of the footing develops as friction along the interface between the footing and underlying ground. The shear resistance (V) can be calculated as the product of the vertical force P , which acts as a normal force on the base of the footing, and the tangent of the interface angle of friction (δ), as illustrated in Figure 2. For concrete cast in place against soil, δ can be taken as the soil friction angle. Depending upon the underlying soil or rock type and condition, δ might typically range from 25 degrees to 40 degrees.

Figure 11. Free body diagram of force on post foundation

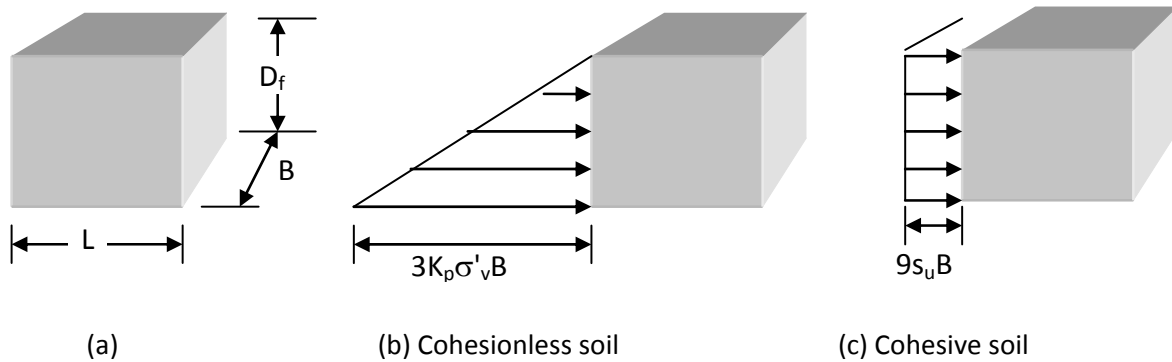
The resultant (P_p) of passive resistance in front of the footing can be approximated using relationships developed by Broms for laterally loaded piles and adopted by FHWA (Sabatini et al. 1999) for estimating the passive resistance of embedded soldier beams in anchored wall applications. As shown in Figure 10, passive resistance in cohesionless soils is assumed to develop over three times the footing width, B , with magnitude determined using the Rankine coefficient of passive earth pressure, K_p . In cohesive soils, passive resistance is assumed to develop over the width B and to be constant over the footing depth with a magnitude of nine times the soil undrained shear strength.

Figure 12. Broms method for approximating ultimate passive resistance

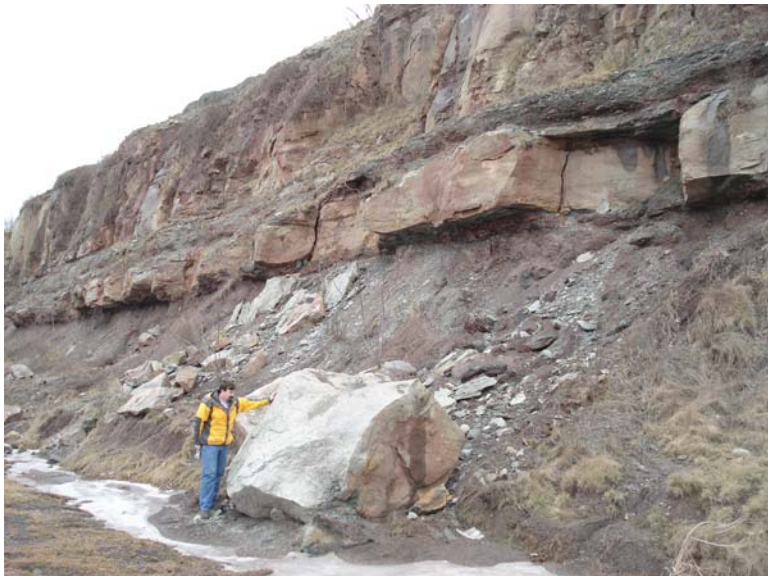
Figure 1. Photograph showing a rockfall generated due to undercutting (US-7, Athens County, Ohio).

In cases where slopes consist of inter-layered competent and incompetent rock units, differential weathering of incompetent rock units results in the generation of rockfalls from the overlying competent units (Shakoor and Weber, 1988) (Figure 1). These undercutting-induced slope failures are very common in Ohio, where the geology is characterized by horizontally-bedded sequences of competent and incompetent rock units.

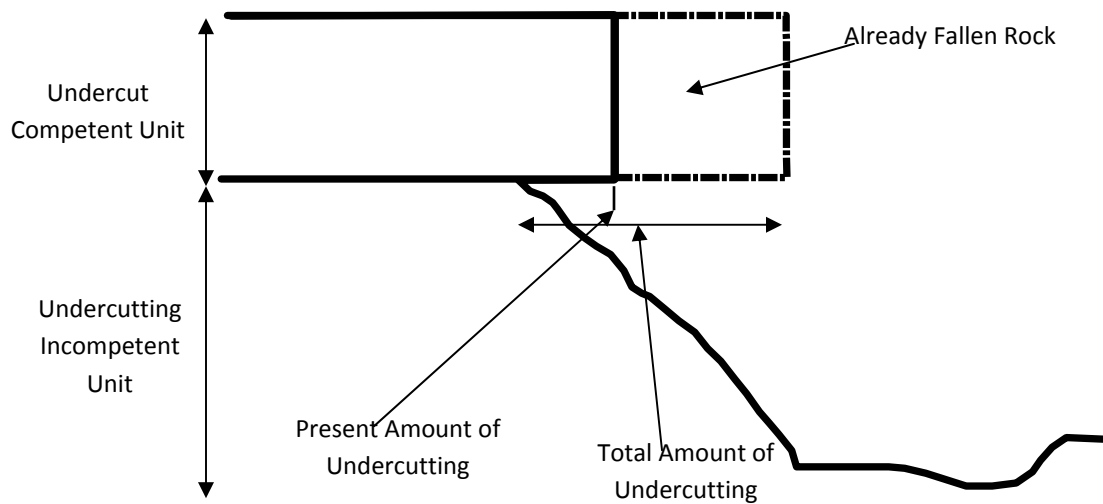
Figure 3. Diagram showing the total and the present amounts of undercutting.

Three aspects of undercutting-induced failures were identified for investigation. The first aspect is the total amount of undercutting that has occurred since the construction of the slope (Figure 3). Deep undercutting generates more rockfalls than shallow undercutting. Based on field observations, different geological and geotechnical parameters that potentially affect the amount of undercutting were chosen. The selected parameters for the undercut units include distance of undercut rock unit from slope crest, distance of undercut rock unit from nearest bench, total thickness, and joint spacing. Relative position of the undercut layers from slope crest and nearest bench was also included. Relative positions are ratios of distances of an undercut rock unit from slope crest or nearest bench to total slope height or bench height measured from slope foot. These relative values which are in ratios were taken to check the role of the position of an undercut layer without the effect of slope height. The slake durability index was chosen as the parameter represents the undercutting potential of the incompetent rock unit. The slope angle of the undercutting unit was used to check if gentler angles reduce the total amount of undercutting. Ages of the cut slopes have also been considered to check if there is direct linear relationship with the total amount of undercutting. Bi-variate correlation of these parameters with the total amount of undercutting was investigated using SPSS.

took place since the construction of the cut and the present amount of undercutting (the amount of undercutting since the last rockfall) (Figure 3). If the difference is zero, then no rockfall has occurred and if it is more than zero, a certain amount of rockfalls have been released since the construction of the slope. Pre-split blast marks were used as references of original surface to calculate the total amount of undercutting. If pre-split marks were not found, original design plans in comparison with the slope profiles made for this study were used to determine the total amount of undercutting.

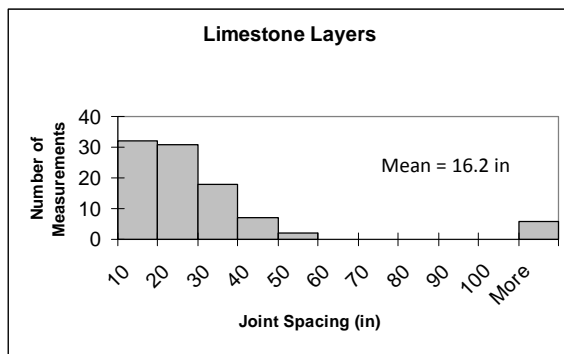
Figure 4. Distribution of joint spacing for the limestone units.

Joints spacing measurements were mainly taken on orthogonal joints. Joint spacing from the limestone units shows a left-skewed distribution (Figure 4), having an average value of 16.2 inches. The sandstone units show a normally distributed population (Figure 5), having an average value of 34.1 inches.

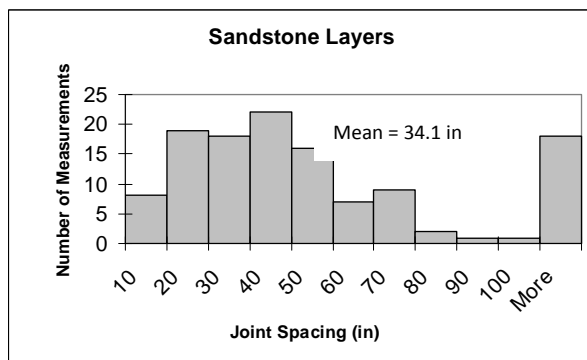
Figure 5. Distribution of joint spacing for the sandstone units.

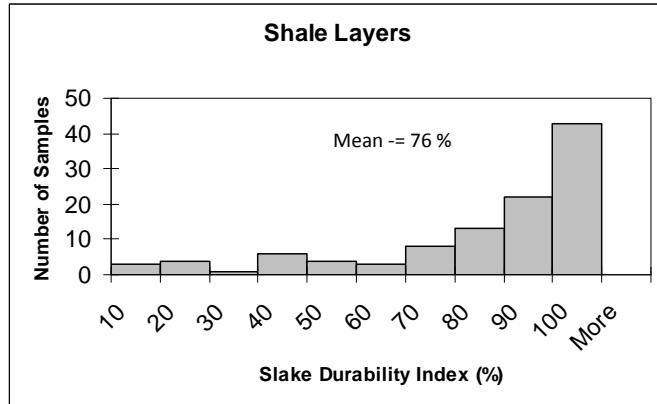
Figure 6. Distribution of slake durability for shale units.

There is a marked difference between the slake durability index values of shales and claystones/mudstones. Therefore, separate slake durability index histograms were made. The shale units have a right-skewed distribution with an average slake durability index value of 76 % (Figure 6). The claystone/ mudstone units show a left-skewed distribution, with an average value of 29 % (Figure 7).

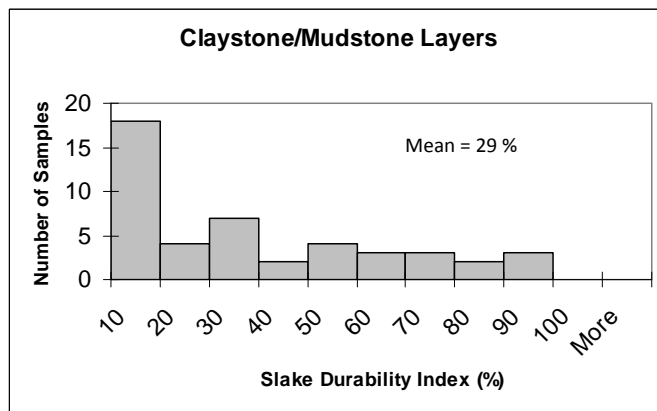
Figure 7. Distribution of slake durability for claystone/mudstone units.

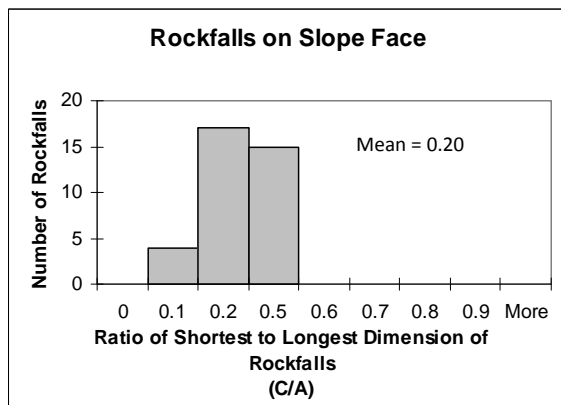
Figure 10 .Distribution of rockfalls of varying sizes on slope faces.

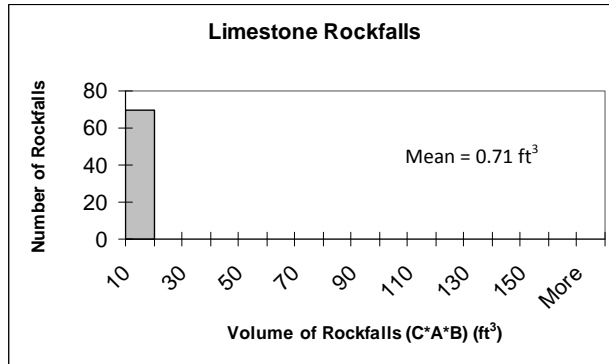
Figure 11. Distribution by volume in the limestone rockfalls.

Volume of rockfalls was calculated by multiplying all dimensions ($C \cdot A \cdot B$). Distribution of rockfall volumes showed limestone units having a mean volume of 0.7 ft^3 (Figure 11) and sandstone units having a mean volume of 19.2 ft^3 (Figure 12).

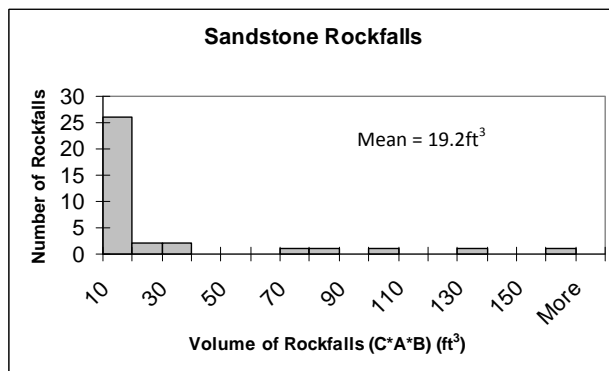
Figure 12. Distribution by volume in the sandstone rockfalls.

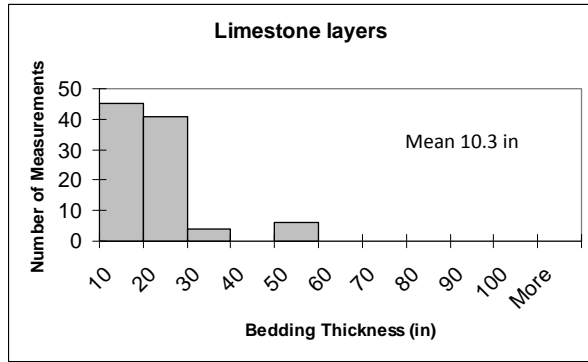
Figure 13. Distribution of bedding thickness for the sandstone units.

The limestone units show a left-skewed distribution with respect to bedding thickness with an average thickness 10.3 inches (Figure 13). The sandstone units also show a left-skewed distribution with an average bedding thickness of 17.1 inches but have a wider range than the limestone units (Figure 14).

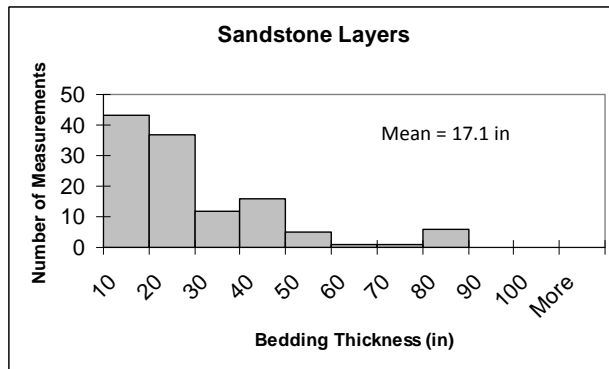
Figure 14. Distribution of bedding thickness for the limestone units.

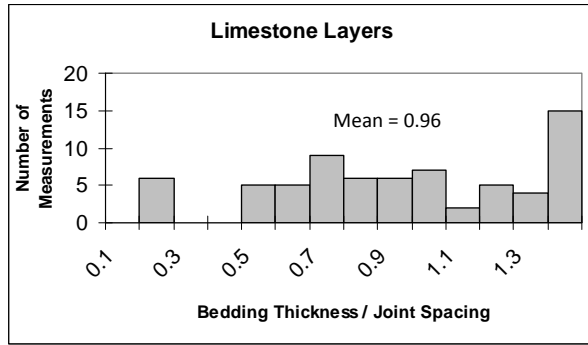
Figure 15. Distribution of bedding thickness to joint spacing ratios for the limestone units.

The shapes and volume of rockfalls produced from undercut competent units are governed by both bedding thickness and joint spacing. The ratio of bedding thickness to joint spacing is closely related to the shapes of rockfalls that are generated. Bedding thickness to joint ratios of close to 1 indicate that the rockfalls generated would be rounded, whereas rockfalls generated from rock units having small bedding thickness to joint spacing ratios would be flat in shape. The limestone units have higher average ratios of 0.96 (Figure 15) compared to the sandstone units of 0.53 (Figure 16).

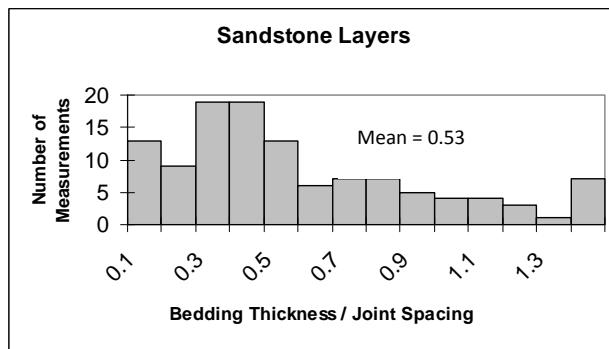
Figure 16. Distribution of bedding thickness to joint spacing ratios for the sandstone units.

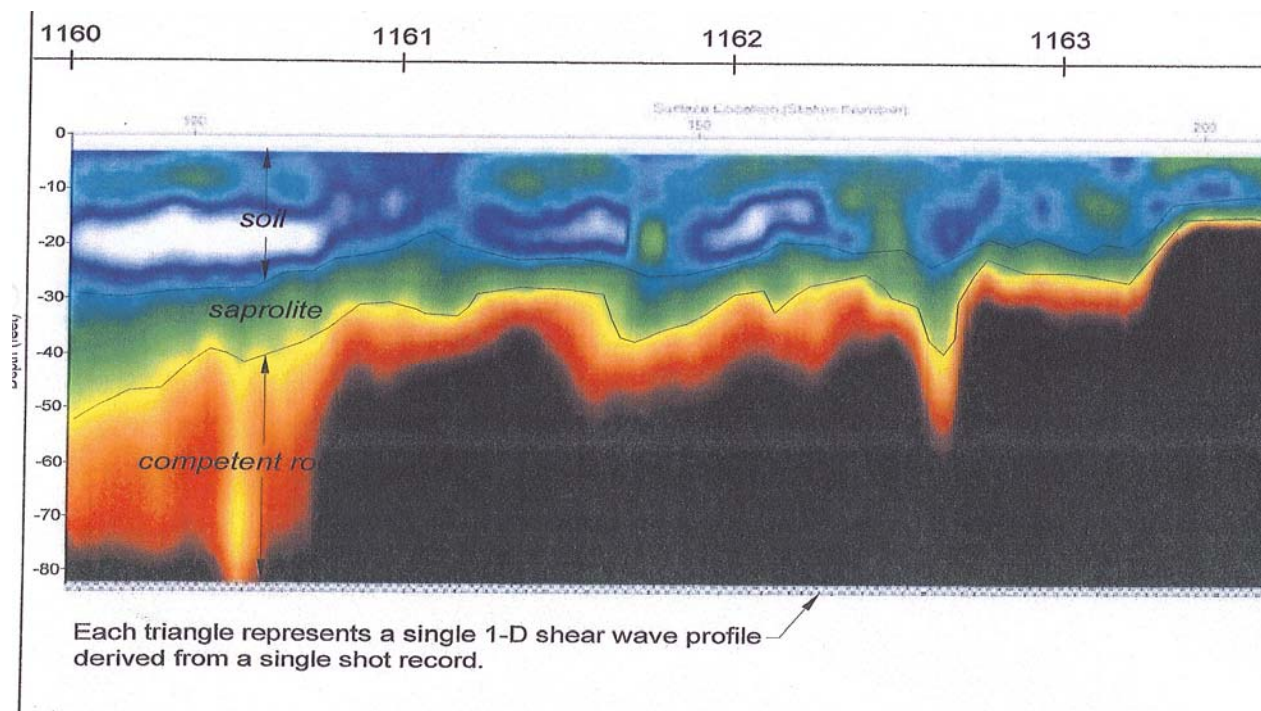
One MASW line was run just on the roadway next to the SB passing lane shoulder. An example of the results is depicted here:

As shown, one can see the approximate rock surface along this entire line.

Comparing the two techniques, the 2D ERI data were more revealing of anomalies suggestive of voids and fractures within the rock, whereas the MASW data were more revealing of subsurface conditions related to top of rock surface and soil density.

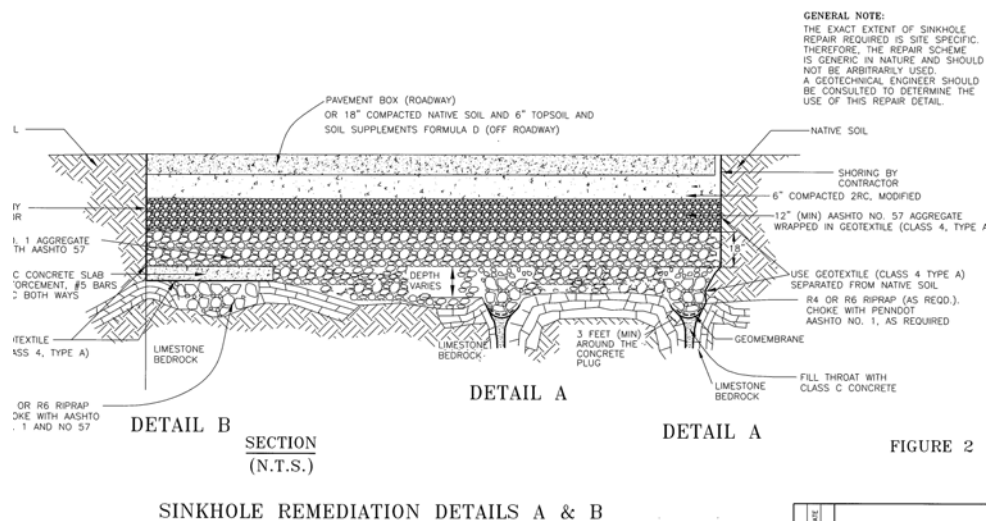
Two repair details are recommended for area 1 (below):

The areas to be addressed with special construction recommendations were broken down based on geology and sinkhole history: 1) sinkhole prone areas with shallow bedrock, 2) slightly sinkhole prone areas with deep bedrock, and 3) highly sinkhole prone areas with deep bedrock. The term deep relates to whether the problem could be remediated with surface excavation. The depth agreed upon for constructability was 12'. There also is a large overlap between area 2 and 3 to be conservative on our delineation. For highly sinkhole prone areas with deep bedrock, cap grouting is recommended.

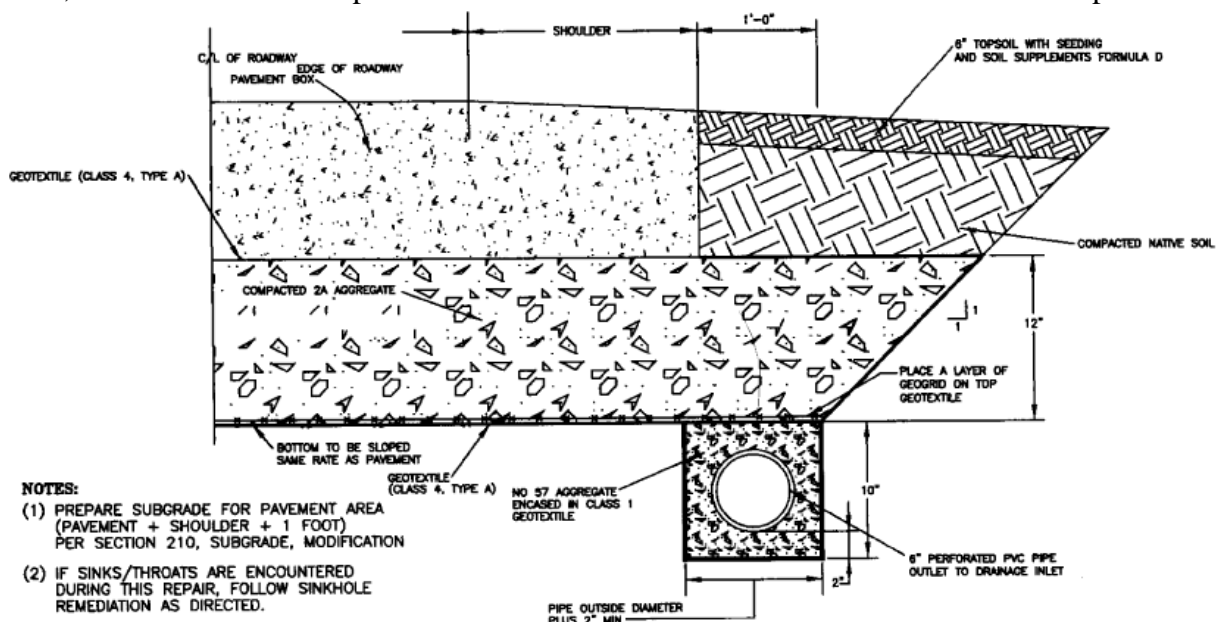
Area 2, where rock is too deep to excavate but there is less concern for sinkhole development:

Notice the drainage pipe on the detail: because there was no cutoff to the permeable stone, the pipe was moved to below the geotextile reinforced mat. These pipes will be connected to the drainage system thanks to a lot of work from the plans unit.

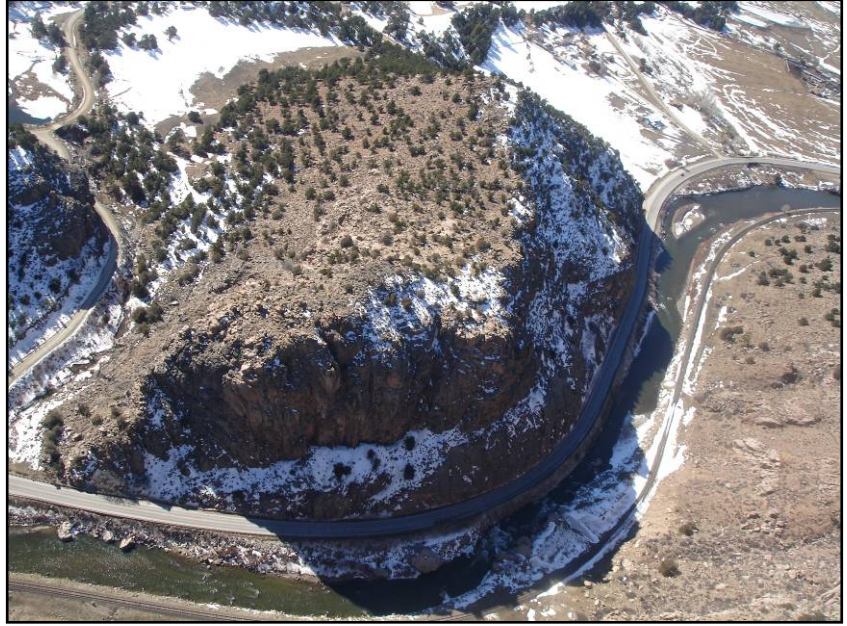
Figure 2: Aerial Photograph of Cut Slope (Provided By CDOT)

Precambrian granodiorite is exposed along this cut slope section of US-50. The regional geological map states that the main body of the granodiorite is characterized as pinkish-gray, massive to foliated, medium to coarse grained hornblende or biotite granodiorite. In localized areas, the granodiorite is altered to granitic gneiss (Scott et al, 1979). During our field investigation, we observed granitic gneiss with some localized areas of schist. The rock cut slope ranges in height from about 100 to 300 feet. The rock slope dips to the north at angles ranging from 60 to 90 degrees, overhanging in some locations. In addition, the rock cut forms a compound slope with a ledge (bench) approximately midway between the shoulder of the road and the brow of the slope. This area is known as Gobbler's Knob (Figure 2).
