60th HIGHWAY

GEOLOGY SYMPOSIUM

PROCEEDINGS

1.1.	<i>High Bridge Area Roadway Slide, Letchworth State Park, Portageville, New York</i>	22
	Andrew J. Nichols, P.E.; James Bojarski, P.E.	
1.2.	<i>Remediation of the SR 15 Welcome Center Landslide.....</i>	35
	David R. Scherer, P.E.; Robert E. Johnson, P.E.; Paul J. Lewis, P.E.

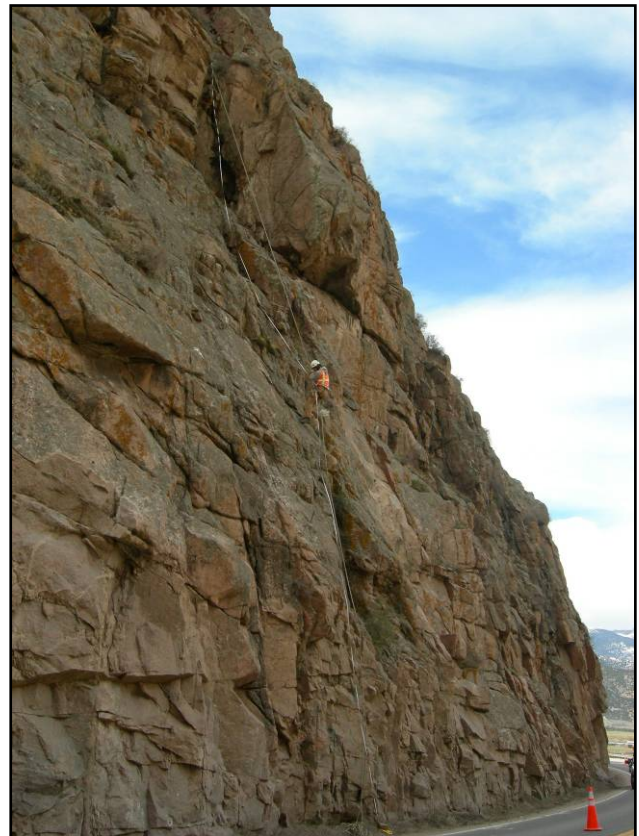
Figure 3: Rock Slope Mapping using

As part of our field reconnaissance at rock cut slope locations, detailed geological and geomechanical mapping were completed (Figure 3). Much of the information collected during our outcrop mapping activities is attendant to the condition of discontinuities within the exposed rock masses including discontinuity information such as dip, dip direction, joint roughness and weathering characteristics. General rock mass information was collected to assess the quality of the rock mass and estimate the rock quality designation (RQD), Rock Mass Rating (Bieniawski, 1989) and Geological Strength Index (Hoek, 1997). Because of the height and inclination of the existing rock cut slopes, much of our field mapping was completed using mountaineering (climbing and rappelling) techniques (Figure 3).

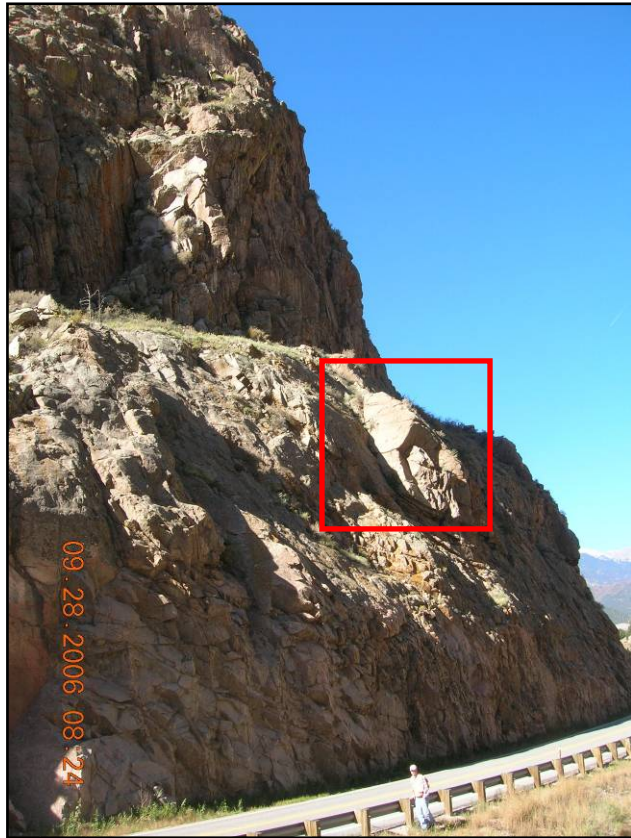
Figure 4: Rock Block 1 – Area of Concern

The rock slope mapping was completed along the road level, along the mid-height bench and in vertical traverses spaced across the cut slope. Three of the vertical traverses focused on specific large blocks we observed during the preliminary field visit. Two large blocks start at the bench height and extend 40 to 60 feet down towards the road (Figures 4 and 5). There are tension fractures present behind these large blocks indicating previous movement.

The slope stability of Block 1 and Block 2 was evaluated as planar failures from the slope. Cohesion was assumed to equal zero because the presence of tension cracks which indicate that movement has occurred. We assumed a factor of safety of 1.0 for our analyses and applied a rock anchor force to achieve a factor of safety of 1.5. Hand calculations on the blocks were performed and the calculations checked using the computer program RocPlane V2® by Rocscience. Block 1 and Block 2 are located below the mid-height bench. The slide plane of the blocks is irregular and stepped from vertical to dipping towards the roadway at 55 to 65 degrees. To complete the stability analyses, a uniform slide plane was assumed at the angle observed during the field investigation. Based on our analyses for Blocks 1 and 2, we estimated that 15 to 20 25,000 pound tensioned rock anchors are required to achieve a factor of safety of greater than 1.5.

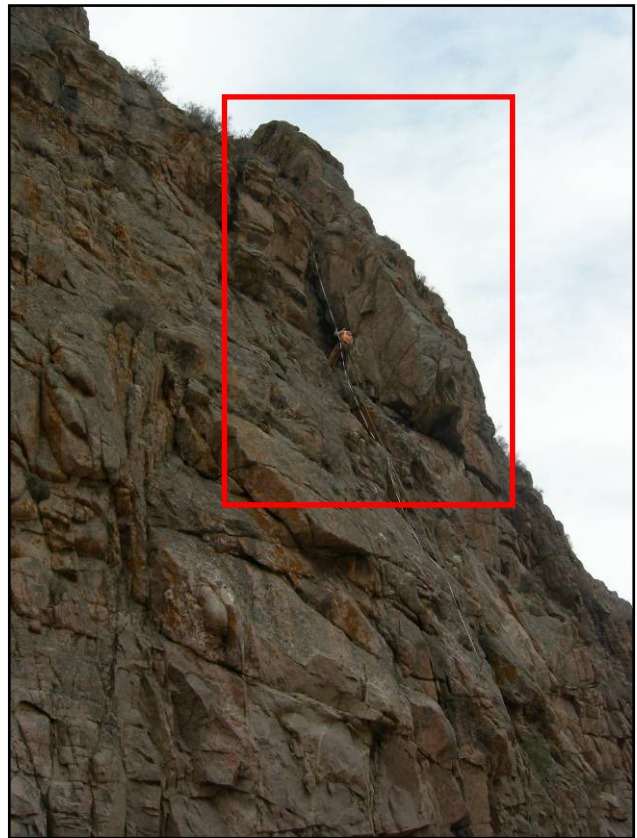
Figure 5: Rock Block 2 – Area of Concern

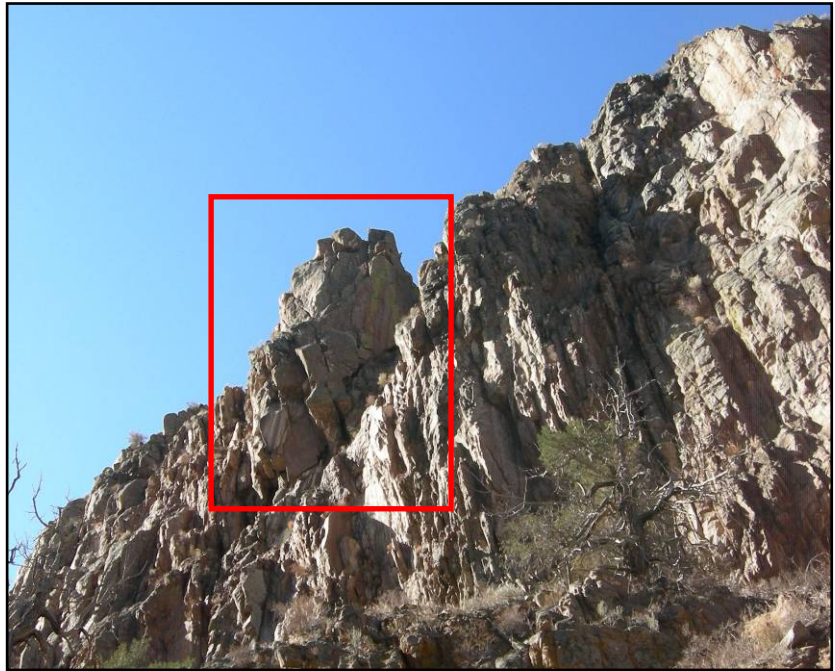
Figure 6: Rock Block 3 – Area of Concern

The third block is on the eastern end of the cut slope near the top of the slope approximately 300 feet above the road (Figure 6). Tension fractures are present along the side and base of this large block.

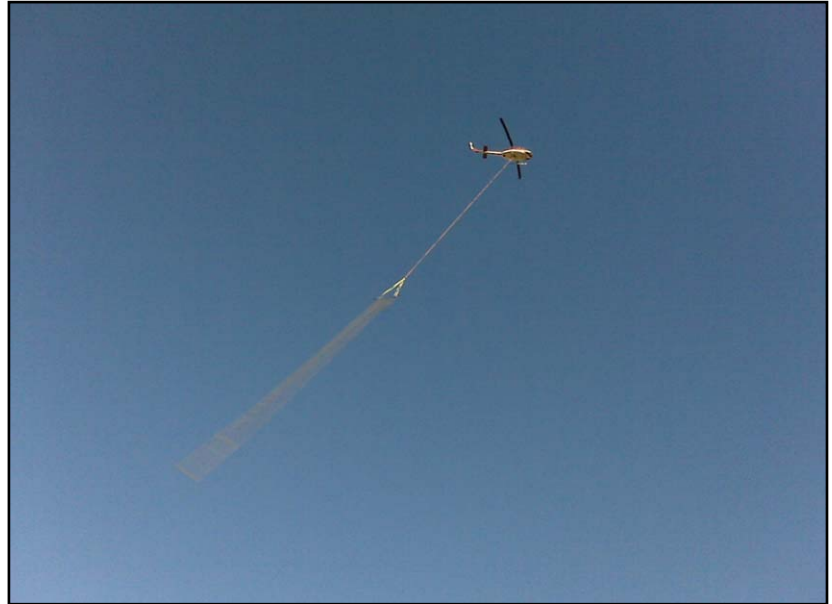
Figure 8: Wire Mesh Installation with Helicopter Support

Stabilization efforts were completed with rope access or from a basket on the crane. Wire mesh placement was completed with the assistance of a helicopter (Figure 8).

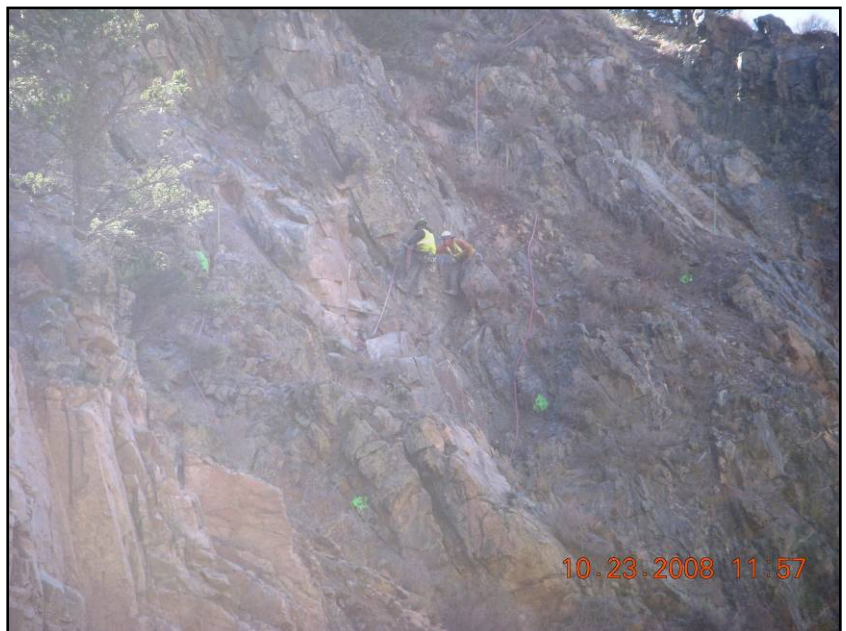
Figure 9: Wire Mesh Anchor Installation

anchors were primarily installed using hand drilling methods with the contractor on rope access (Figure 9). Two types of wire mesh were installed to reduce rockfall onto the roadway. The standard wire mesh drape rockfall system was installed over areas with rockfall potential (Figure 10). A modified wire mesh drape rockfall system was installed in gullies and areas where

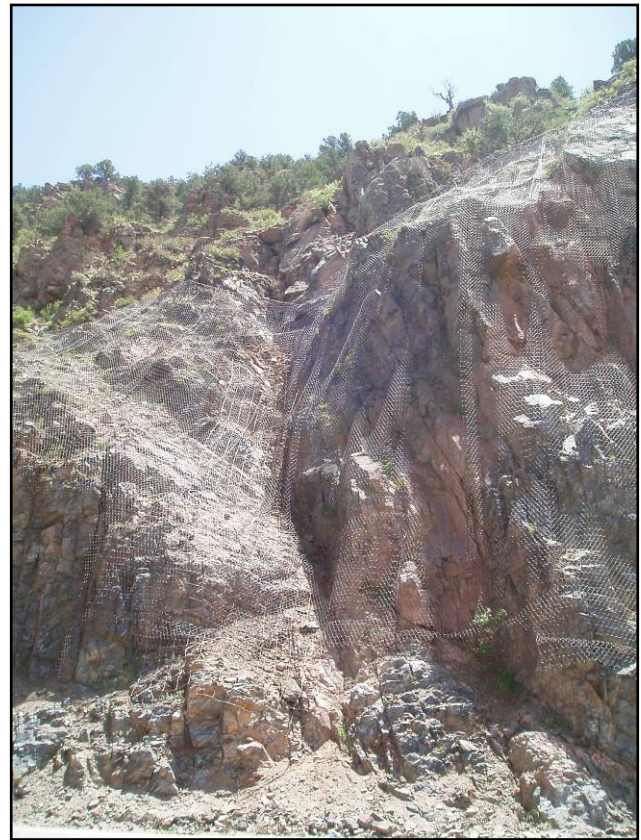
Figure 10: Installed Wire Mesh Drape Rockfall

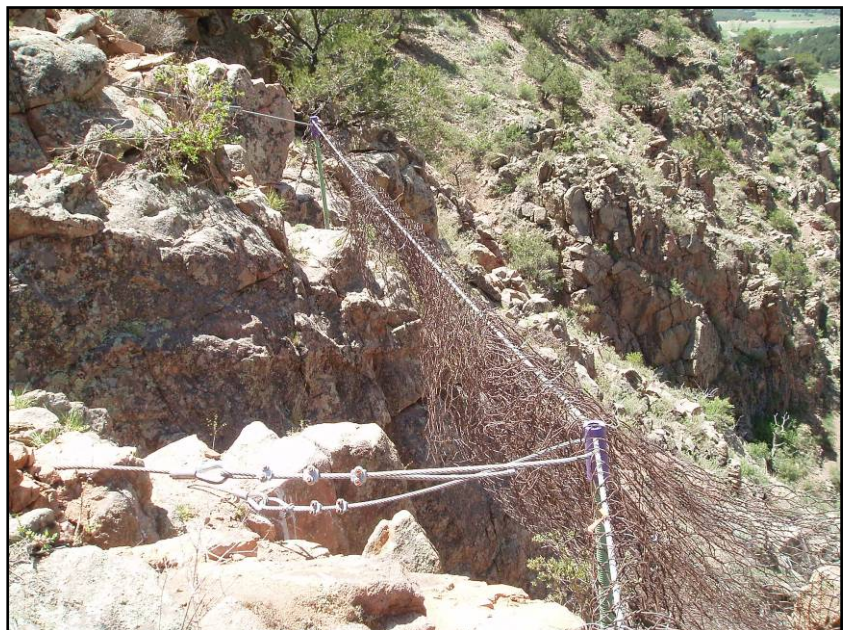
Figure 11: Modified Wire Mesh Drape Rockfall System

rockfall may occur further up the slope. The modified system included anchors and cables at the top of the system to hold the top of the drape three to four feet above the slope to allow rockfall to roll under the drape and be contained (Figure 11). CDOT has utilized the modified wire mesh drape system in various locations in Colorado with success in containing rockfall.

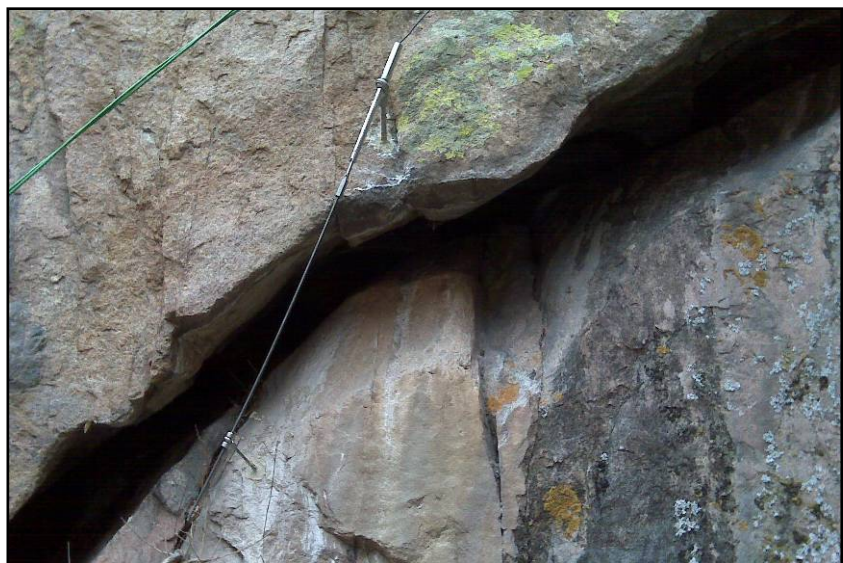
Figure 13: Close-up of Crack Meter across Tension Crack on Block 3

For Phase 5, telemetry was installed on Block 3 to remotely monitor movement of the block. Based on the location and height on the slope of Block 3, stabilization or removal was not a feasible option. In a joint effort with CDOT and Kleinfelder, three crack meters were installed at various locations along the tension crack behind Block 3 (Figure 12). CDOT and Kleinfelder used mountaineering techniques (rappelling and climbing) to set-up at the desired locations. Hand drills were employed to install the anchors for the crack meters across the tension crack (Figure 13).

The crack meters are connected to a remote power source and can be monitored remotely. With real-time monitoring, the crack meters will detect the slightest movement in Block 3. If movement occurs, a signal will be transmitted to CDOT who will be able to close the road to protect the travelling public.

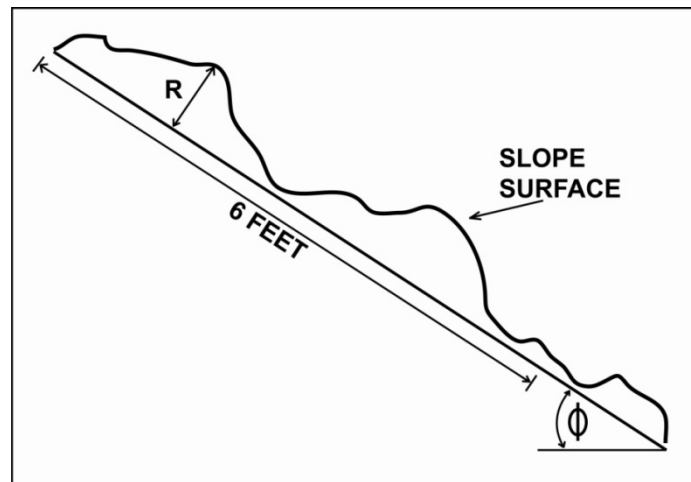
Figure 1. Surface roughness (R) established as the largest repeatable perpendicular variation of the slope surface from the average slope angle (Φ) over a distance of 6 feet.

The slope inclination and length (slope profile) is the most important factor in estimating rockfall behavior because it defines areas of rockfall acceleration and deceleration. The slope profile must be carefully constructed, starting new cells wherever the slope angle or surface material changes. Second in importance is the surface roughness. Irregularities on the slope surface account for most of the variability observed among rockfall events originating from a single source location. The surface roughness field measurement is defined as the greatest repeatable perpendicular variation of the slope surface from the average slope angle (within a single cell) over a distance of six feet (Figure 1). However, for the program to correctly model rockfall trajectory, the roughness value must be a function of the rock diameter, with a larger value used for a small rock and a smaller value for a larger rock. In an improvement over the old program, version 5.0 adjusts the surface roughness value according to the size of the simulated rockfall so that several different rock diameters can be run in a single simulation using one roughness input value.

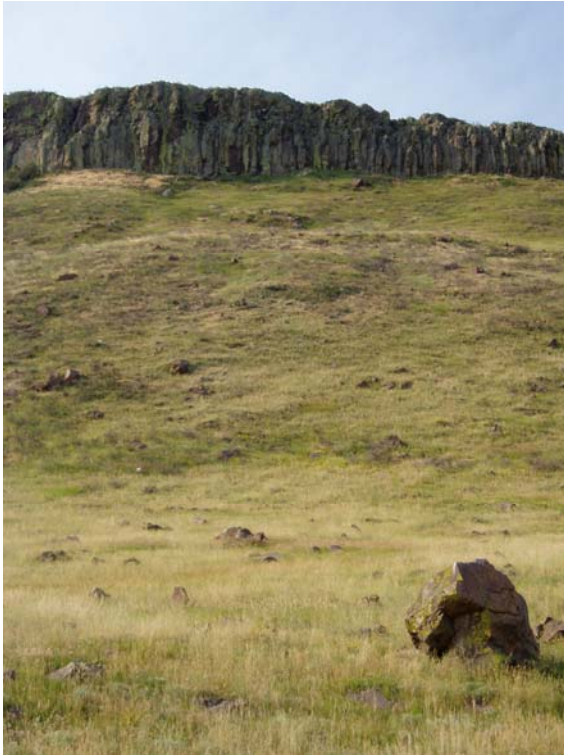
Figure 2. Large rockfall and source area on North Table Mountain near Golden, CO.

Secondly, the natural slope profiles were calibrated for rock runout and bounce height by adjusting the hardness coefficient until simulated output closely matched the measured field data. Of particular interest was the maximum runout distance of CRSP simulated rocks compared to that of the observed data. Maximum runout distance is often times used as a basis to determine if mitigation is needed to protect structures from rockfall. Therefore, the hardness coefficient used must produce runout distances that do not fall short of the actual maximum runout distance, nor do not consistently roll past the actual maximum runout distance. Figure 2 shows one slope on North Table Mountain near Golden, CO that was measured for runout distance.

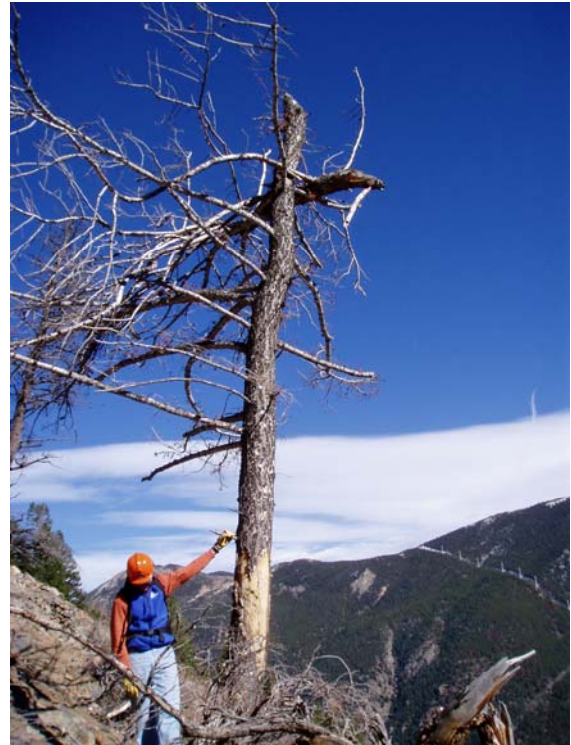
Figure 3. Tree broken off at 20ft by rockfall. Located near Georgetown, CO.

Finally, bounce height was evaluated in the field by measuring the height of rockfall caused scar marks on trees. Figure 3 shows a tree that was hit by rockfall near Georgetown, CO. During bounce height calibration, hardness coefficient values that produced rock bounce heights equal to or slightly above the upper range of observed data were chosen to represent various material types. Output above the observed range was chosen because measured tree scars (used to estimate bounce height) may not represent the maximum bounce height seen in the field. The natural slope profiles were used to further define the hardness coefficient ranges set during rock rolling experiment calibration for the general slope types listed below;

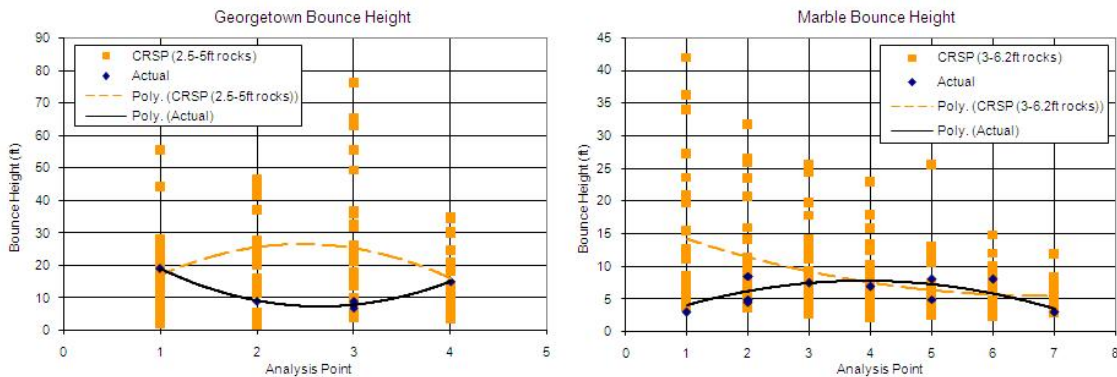
Figure 6. Bounce height calibration graphs relating observed and predicted data.

Graphs from the runout and bounce height calibration are shown in figures 5 and 6. The runout graphs show “cumulative percentage of total rocks stopped” on the y-axis and “cell number” on the x-axis. The bounce height calibration graphs show “bounce height” on the y-axis and “analysis point” on the x-axis. The analysis point is anywhere a scar mark (or group of scars) was measured.

During bounce height calibration, the predicted maximum bounce heights were much higher than the observed data. When a second order polynomial trend line was fit to the predicted and observed data, the CRSP predicted bounce height trend line was observed to accurately model the observed data. Therefore, the user should use an average bounce height when graphing CRSP predicted bounce heights and also when drawing conclusions from predicted bounce heights for mitigation design.

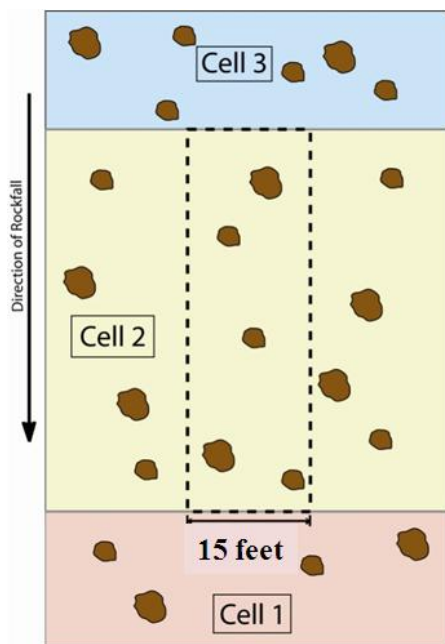
Figure 7. Rock distribution for each cell is measured by counting all the rocks in a 15 ft wide section (perpendicular to the rockfall path). Rocks at least 1 foot in diameter and located completely on top of the soil are considered to be from rockfall processes (After Coe et al., 2005).

Site specific calibration can be used to establish rockfall distribution and rock size for the slope profile. The measurement described below is based on a method developed by Coe and others (2005). Rockfall distribution is measured by counting all the rocks (of rockfall origin) in a 15 ft wide section along the slope profile line (Figure 7). Each cell has a separate 15 ft wide section that extends the length of the cell. A rock of rockfall origin is defined as being at least 1 ft in diameter and lying entirely on top of the soil. Rocks that are partially buried are assumed to be deposited by processes other than rockfall. In many rockfall areas different sized rocks may stop in separate sections along the profile, so on slopes where there is a large range in rock diameters, rock sizes should be divided and counted separately.

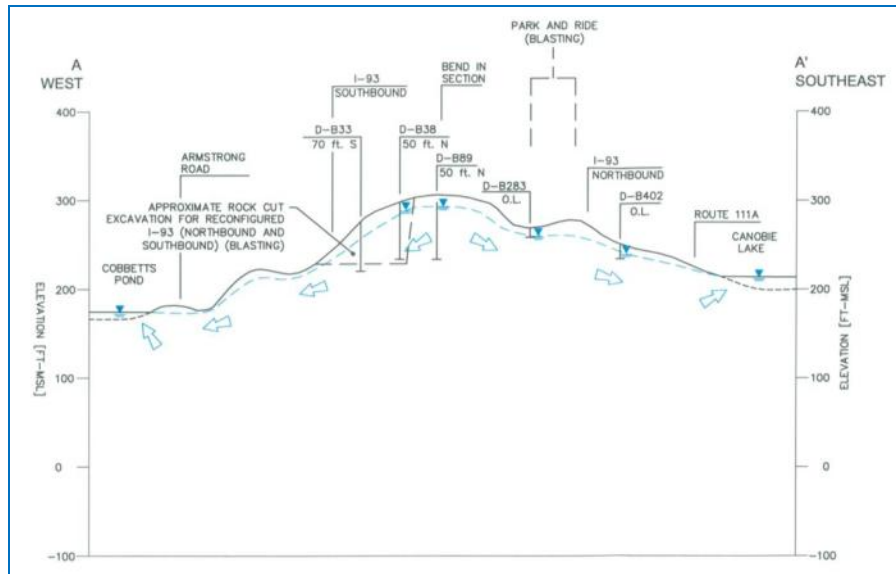
Figure 6 - Cross section A-A'.

(Figure 6) was generated to understand the upgradient conditions. This cross section depicts groundwater flow to be southerly towards Cobbetts Pond. Residential wells in the area are on average 400 ft deep, and have a 40 ft surface casing.

Horizontal hydraulic gradients based on the inferred groundwater surface depicted on conceptual hydrogeologic cross sections A-A' and B-B' were estimated along with gradients between rock blast areas and potential downgradient receptors (i.e. residential or commercial water supplies). Calculated horizontal hydraulic gradients ranged from approximately 0.05 ft/ft to just under 0.09 ft/ft.

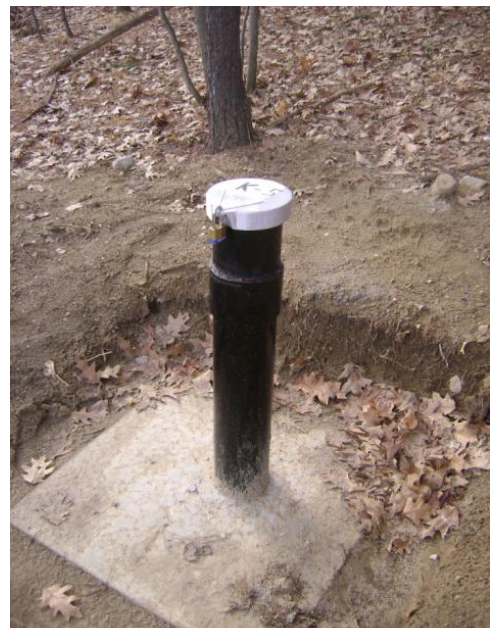
Figure 7 - Typical bedrock monitoring well.

It was also recommended that the monitoring wells be constructed in a similar manner as most of the residential and public supply wells to mimic residential and public groundwater use in the Windham area. These wells usually consists of a 6-inch diameter black iron steel casing driven through the overburden and seated into bedrock (Figure 7). This casing seals off the loose overburden, preventing the borehole from collapsing, and sealing off near-surface groundwater, which can have unpleasant aesthetic or environmental qualities. Once the overburden is sealed, a rotary drill bit (hammer drill or roller cone) is used to drill an open borehole into the bedrock. Open fractures within the bedrock provide groundwater to the well. Often these wells are drilled as deep as 500 or more ft below ground surface (bgs), in an effort to increase well yield. With increasing depth, fractures are usually closed, and the well bore largely acts as a storage reservoir. Fractures below 100 to 200 ft bgs are usually non-productive due to the overlying weight of bedrock. Due to the lack of fractures with depth, we recommended the monitoring wells be drilled to 75 ft within bedrock, the zone most likely to be impacted by blasting activities. The surface steel casing should be either left as a stick-up or cut as a flush-mount, and a lockable lid should be used to prevent tampering. The groundwater level measuring point, ground surface and well should be located by precise survey methods.

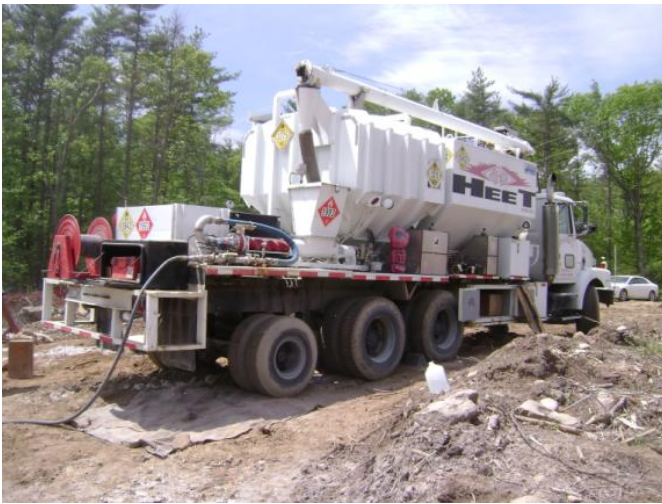
Figure 8 - Use of tarp beneath pump of bulk emulsion truck to contain spills.

explosives handling and loading procedures designed to reduce nitrate exposures (Figure 8). Case studies have shown significant reductions in total dissolved nitrate levels after implementing employee education programs. Wiber et al. (1991) shows a greater than 30% decrease in total ammonia as nitrogen in mine discharge water at two large gold mines after implementation of an education program.

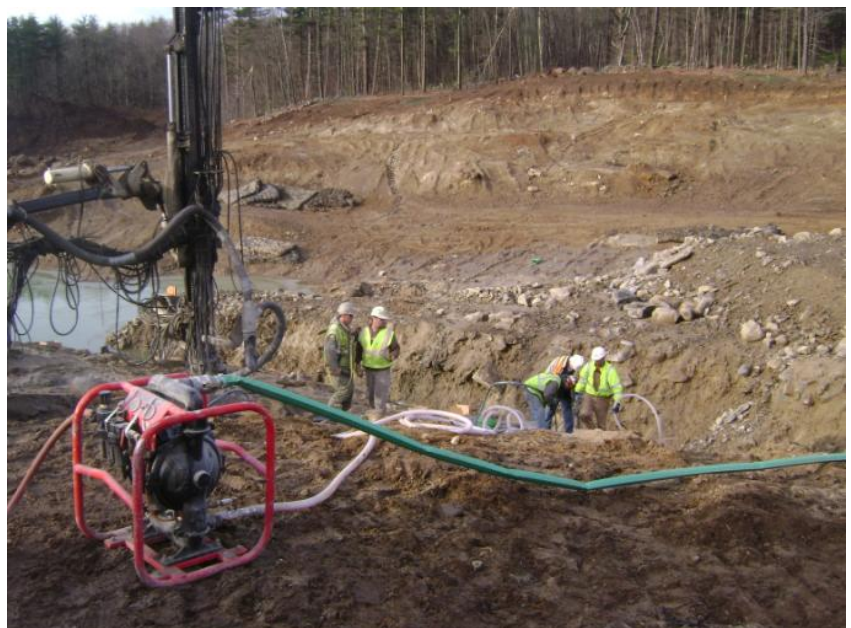
Figure 10 - Dewatering blastholes prior to loading explosives.

ANFO is the most commonly used explosive, and the most common source of nitrates in surface water and groundwater downgradient of rock blasting sites. BMPs that should be followed when ANFO is utilized are the following: standing water in the blasthole should be removed prior to loading; water resistant ANFO-WR should be used in wet holes; spills should be cleaned up around blasthole collars; and reduce “blow-back” if loading ANFO pneumatically (Figure 10). Loading equipment should be cleaned in the proper area and the product shouldn’t be stored on site.

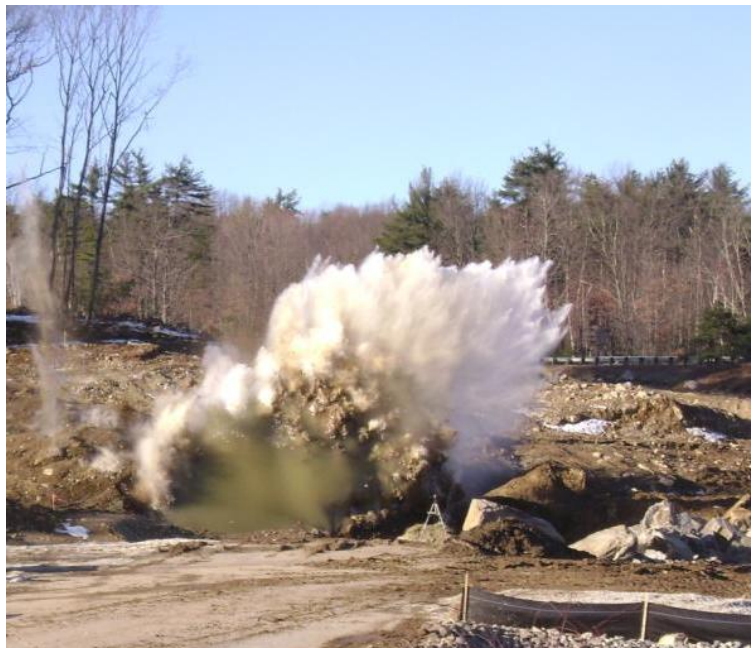
Figure 11 - Typical production blast.

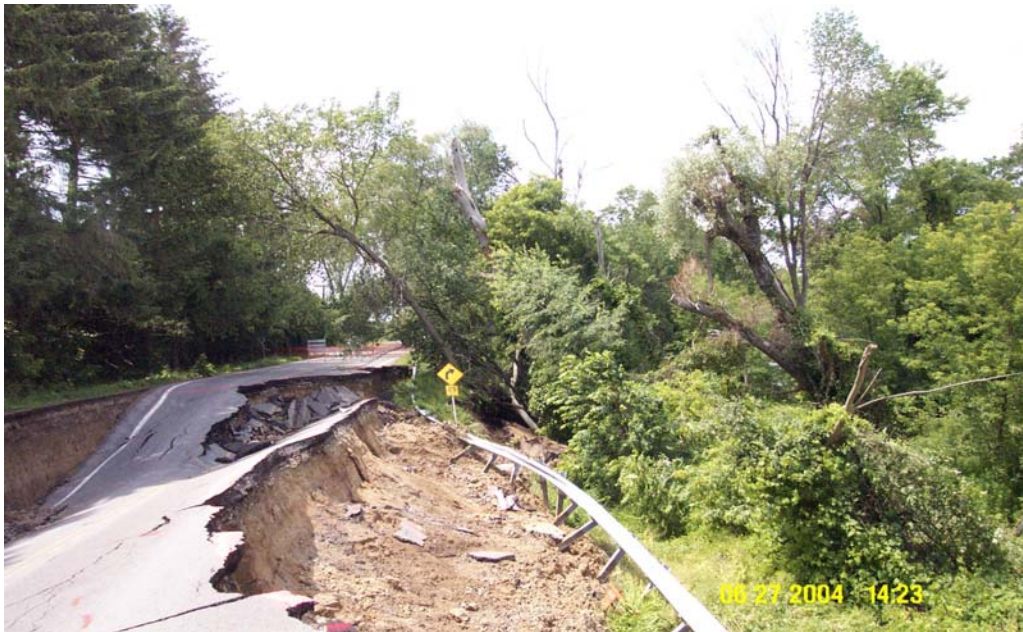
Figure 2

In 2004, a slope failure along the south bank of Tonawanda Creek in Erie County damaged a portion of Tonawanda Creek Road between Transit Road and Westphalinger Road in the Town of Clarence (see Figure 1). A section of Tonawanda Creek Road, approximately 250 feet long dropped about 10 feet and pushed soil into Tonawanda Creek as shown on Figure 2.

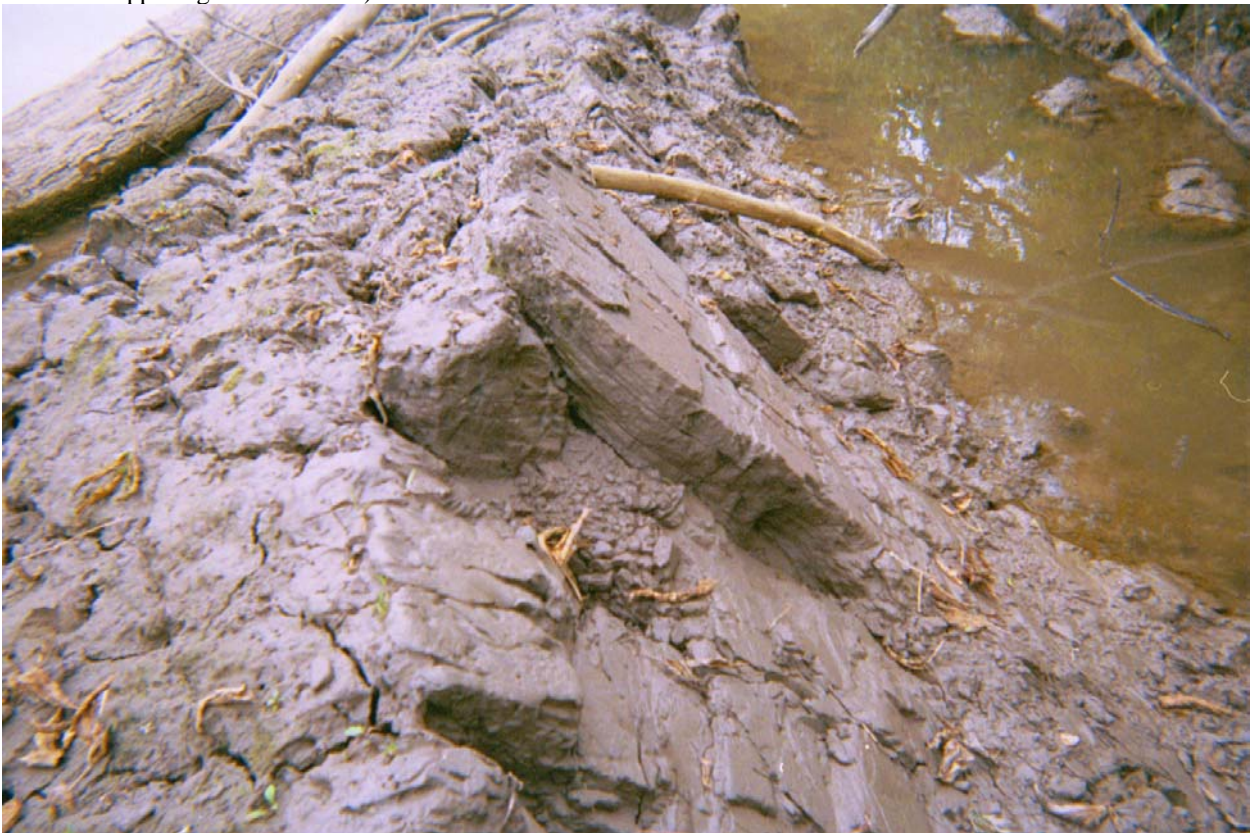
Tonawanda Creek's meandering flow pattern results in erosion of the stream bank on the outer bend in the creek and deposition on inside bends of the creek. Erosion of the outer creek banks over time results in a loss of support for the banks. During wet times of the year, the upper silty soils become saturated due to rain events and poor drainage. Failures occur where the soft clay soils are too weak to support the increased weight of the saturated soil, especially where there has been a loss of toe support. This is the reason that most of the failures occur during the spring or early summer along bends in the creek. The result is a failure through the soft clay with the soft soil pushing up and out into the creek as shown on Figure 5 (stream bank located in upper right hand corner).

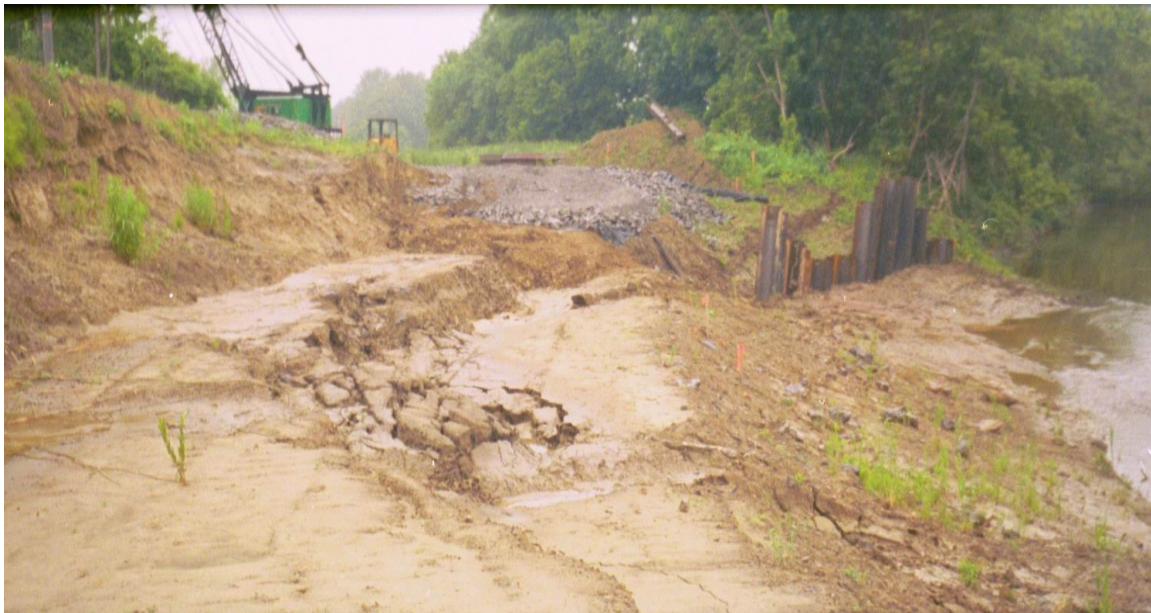
Pile driving induces vibrations that can weaken the sensitive silty clay soils leading to instability and movement of the wall during installation. Figure 6 shows a wall under construction on Tonawanda Creek where the top of the sheetpiles moved and the slope behind the wall dropped during installation. Because of concerns about stability during construction and the length and expense associated with the anchors, the wall was not considered a viable alternative.

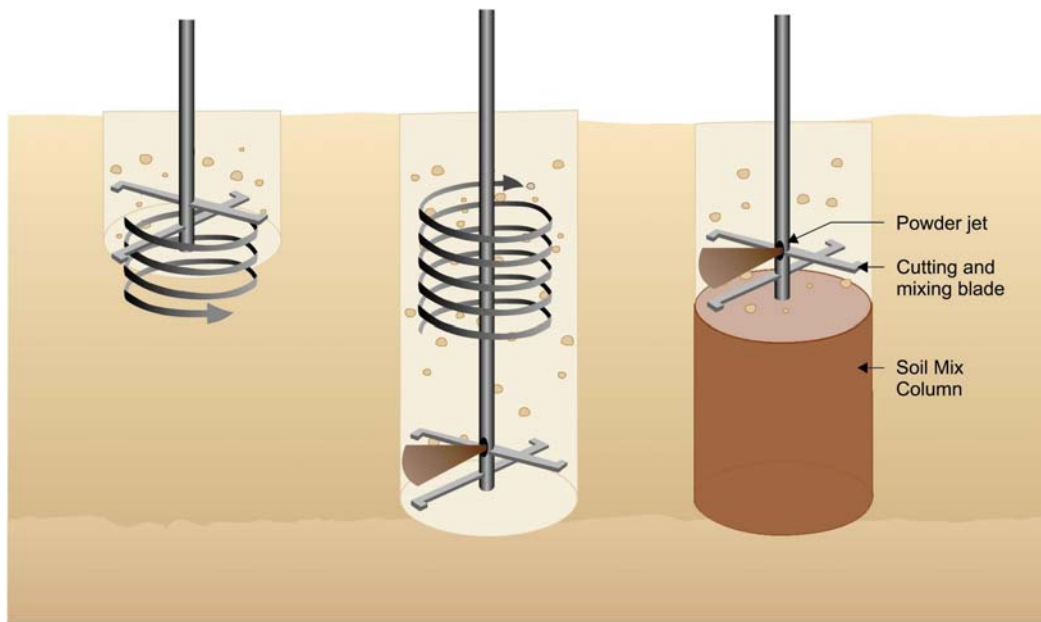
Figure 7

The soil cement columns are constructed using the “dry mixing” method. This method was developed in and is used throughout Northern Europe and Japan to improve the engineering properties of soft clays, peats and other weak soils. The process uses cementitious powders to bond soil particles, thereby increasing the shear strength and reducing the compressibility of the soil. Dry mixing is often used in high groundwater conditions and has the advantage of producing no spoil for disposal. Using specialized mixing equipment; the soil is mixed during penetration, until the mixing tool reaches the maximum treatment depth. Dry binder agents are injected into and mixed with the soil during withdrawal of the mixing tool, leaving behind a dry soil mix column. The general process is shown on Figure 7.

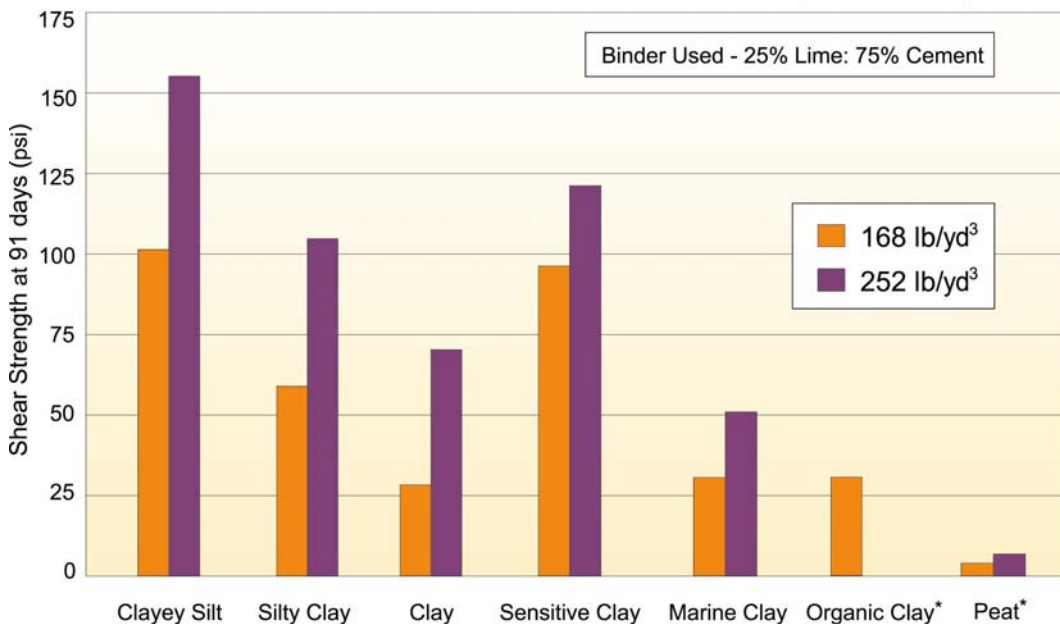
Figure 8

The strength of the soil cement column is dependent on the type of soil and the amount and type of binder used. Typical binder agents include cement, lime, gypsum, slag or a combination. The strength and stiffness of the soil cement column generally increases with increasing binder dosage. The binder dosage rate typically ranges between 80 pounds per cubic yard (lb/yd^3) (50 kilograms per cubic meter (kg/m^3)) in soft clays to as high as 450 lb/yd^3 (270 kg/m^3) in peat. Shear strengths in different types of soils and binder dosage rates are shown on Figure 8.

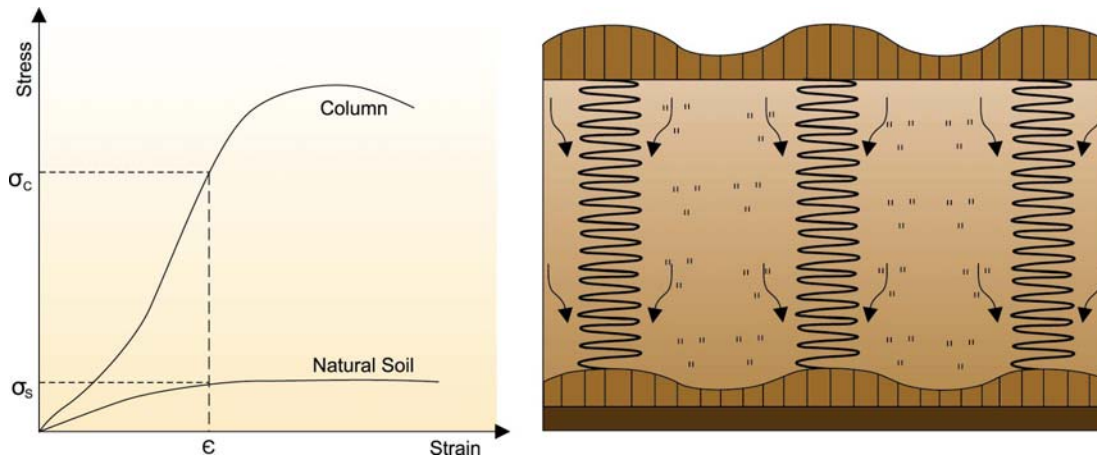
Soil mix column diameters of 2 to 3 feet can be constructed to depths of 60 feet. Soil mix column strengths typically are 10 to 50 times stronger and much stiffer than the native soils. Figure 9 shows the interaction between the native soils and dry mix columns (shown as springs). The columns transfer most of the embankment load to the stiffer underlying layer.

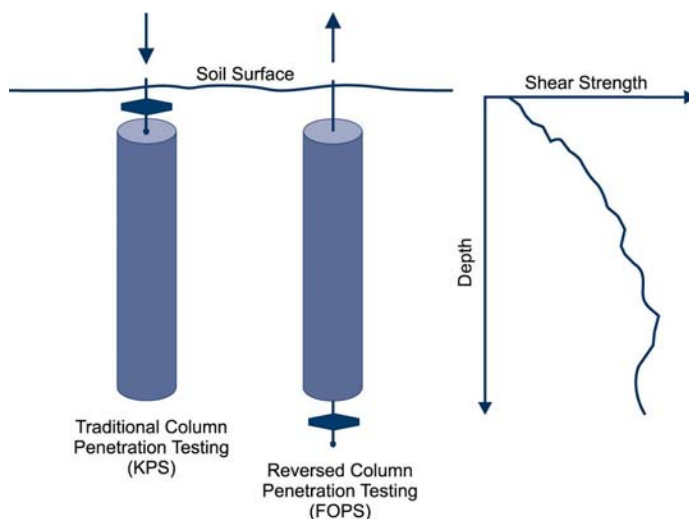
To provide another means of measuring the strength of the completed columns, Hayward Baker installed vanes in several columns. A metal vane is attached to a steel cable that is inserted during the initial penetration of the mixing apparatus. The steel cable extends from the vane at the bottom of the column to the ground surface. Several days after installation, the vane is pulled up through the center of the soil-cement column. The column shear strength is estimated based on the force required to pull the vane, the vane area and a bearing capacity factor. A schematic of the vane test is shown in Figure 10. The vane results indicated column shear strength values in excess of 8,000 psf.

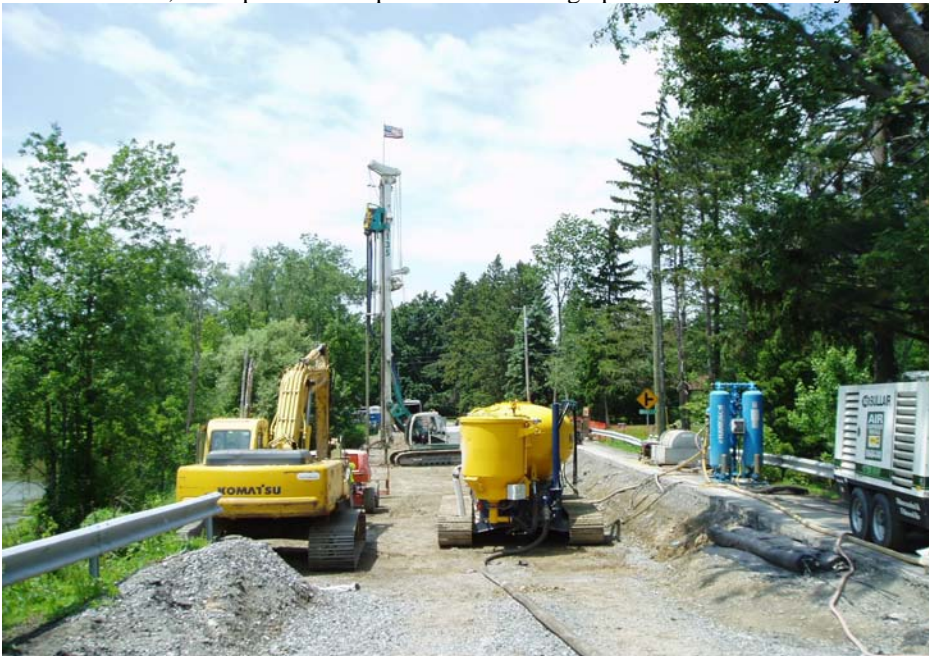
Figure 12 – Minnick Road Site

At each site, a precut was made to offset the weight of the proposed dry mixing equipment. Figure 12 shows a picture of the dry mixing apparatus consisting of a mixing rig, concrete storage shuttle and a compressor. Figure 13 shows a picture of the dry mixing rig and mixing apparatus.

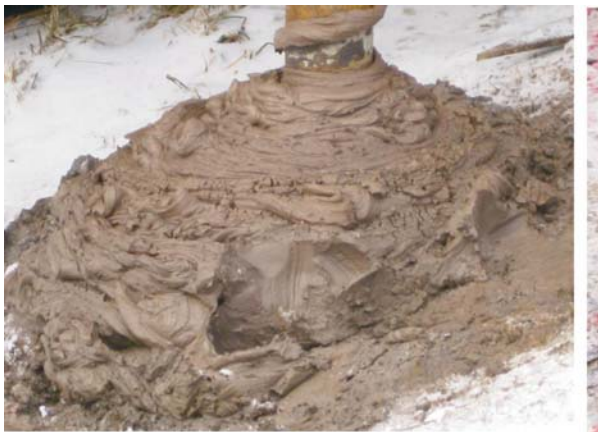
Photo from Pre-Improvement Sampling
Photo from Post-Improvement Sampling

The third method consisted of continuous SPT's and visual logging of samples in completed columns. Figure 15 shows photos taken of samples of the soft clay collected before treatment and from a completed column showing the dramatic difference in the soil consistency. The SPT N-values also show a dramatic difference, as indicated on Figure 16. As indicated on the figure, the N-values before improvement are less than 5 and in many cases “weight of hammer” or “weight of rods” as described previously. In the completed columns, the N-values vary from Figure 14 about 25 to more than 100.

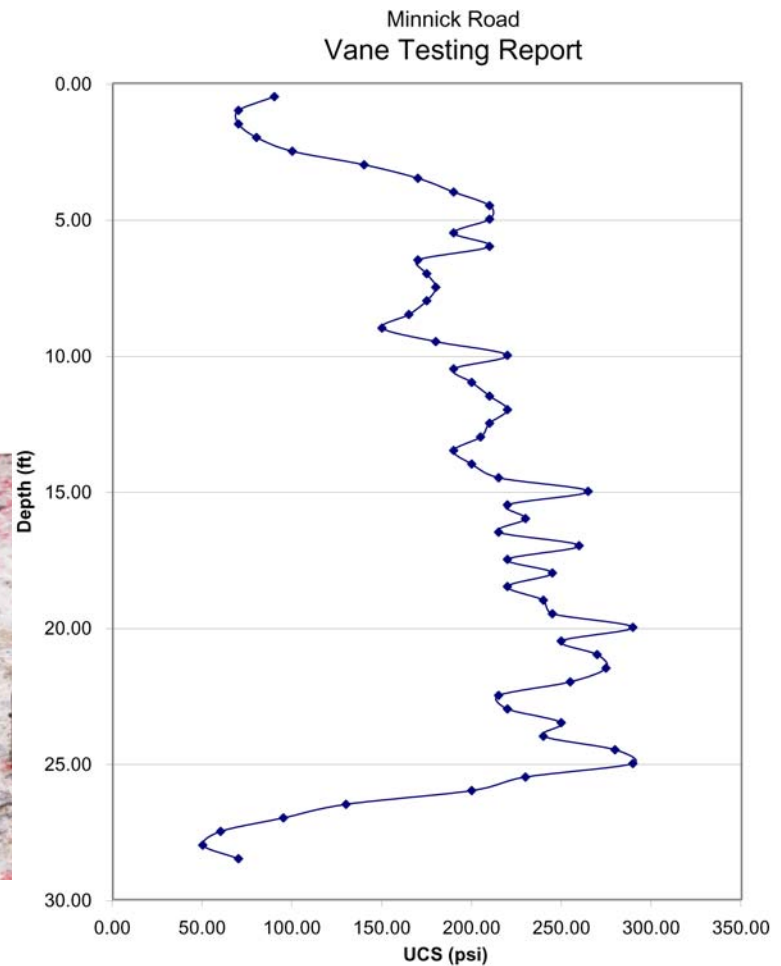
Column No. C-58 (Installed 3/9/09)
Boring C-58-09 (Drilled 4/8/09)
30 Days Old

Hayward Baker installed vanes in several columns and pulled them out of the columns after approximately 7 to 10 days of curing. A typical vane testing report is shown as Figure 14. The vane results indicated a column shear strength in excess of 10,000 psf.

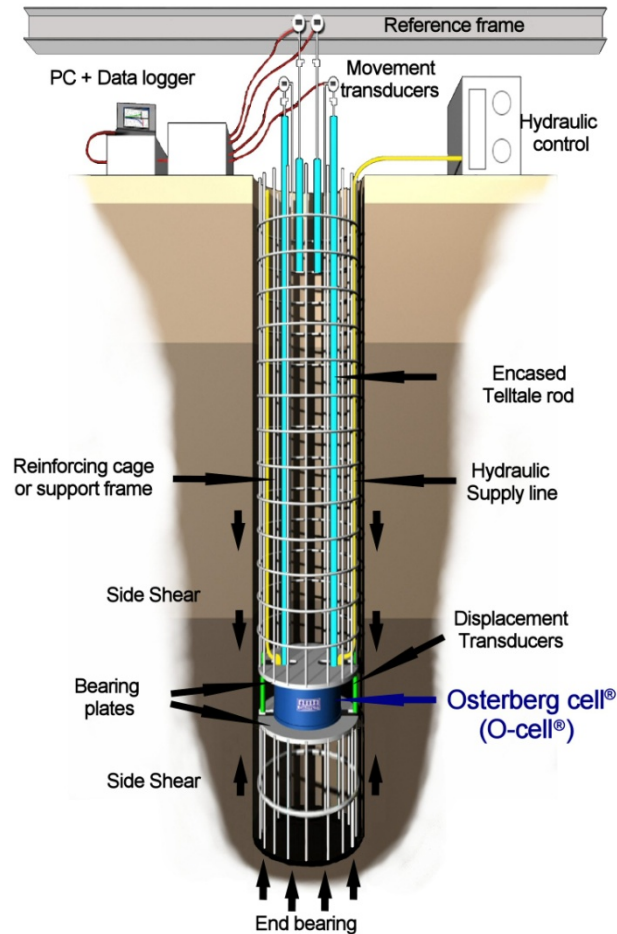
Figure 1. Bi-Directional (O-cell) Testing Schematic (courtesy Loadtest, Inc.)

The Osterberg Cell (O-cell) is a hydraulically operated jacking device that can be embedded in a drilled shaft by attachment to the reinforcing cage (Figure 1). After concrete placement and curing a load test is conducted by expanding the cell against the portions of the shaft above and below it. The load is applied through hydraulic piston-type jacks acting against the top and bottom cylindrical plates of the cell. The maximum test load is limited to the ultimate capacity

Pressure transducers are used to monitoring hydraulic jack pressures and converted to load. Linear vibrating wire displacement transducers (LVWDT's) between the two plates measure total expansion of the cell and telltales are installed to measure vertical movements at the top and bottom of the test sections. The downward movement of the bottom plate is obtained by subtracting the upward movement of the top test section from the total extension of the O-cell as determined by the LVWDT's. Telltale deformations are monitored with digital gages mounted on a reference beam. All of the instrumentation is electronic and readings are collected by a data acquisition unit. The O-cell device is patented and under exclusive license to LOADTEST, Inc.

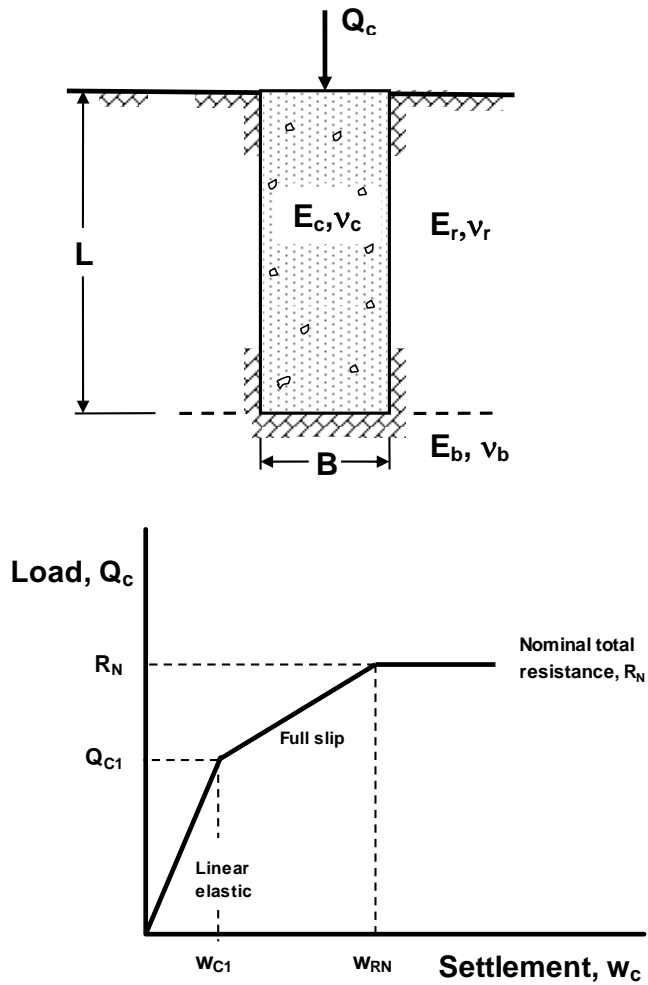
(a) elastic model of rock socket

(b) computed bilinear load-settlement curve

An approximate method given by Kulhawy and Carter (1992), and also included in the current FHWA Drilled Shaft Manual (O'Neill and Reese 1999), provides simple closed-form expressions that compare reasonably well to more sophisticated nonlinear finite element analyses of drilled shaft axial load-displacement response. The basic problem is depicted in Figure 2 (a) and involves predicting the relationship between an axial compression load (Q_c) applied to the top of a socketed shaft and the resulting axial displacement at the top of the socket (w_c). The concrete shaft is modeled as an elastic cylindrical inclusion embedded within an elastic rock mass. The cylinder of depth L and diameter B has Young's modulus E_c and Poisson's ratio ν_c . The rock mass surrounding the cylinder is homogeneous with Young's modulus E_r and Poisson's

ratio ν_r while the rock mass beneath the base of the shaft has Young's modulus E_b and Poisson's ratio ν_b . The solution (Figure 2b) approximates the actual nonlinear load-deformation response of an axially loaded rock socket as consisting of two linear segments: (1) the initial linear elastic response and (2) the full slip condition. The maximum load is limited to the nominal axial resistance.
