60th HIGHWAY

GEOLOGY SYMPOSIUM

PROCEEDINGS

1.1.	<i>High Bridge Area Roadway Slide, Letchworth State Park, Portageville, New York</i>	22
	Andrew J. Nichols, P.E.; James Bojarski, P.E.	
1.2.	<i>Remediation of the SR 15 Welcome Center Landslide.....</i>	35
	David R. Scherer, P.E.; Robert E. Johnson, P.E.; Paul J. Lewis, P.E.

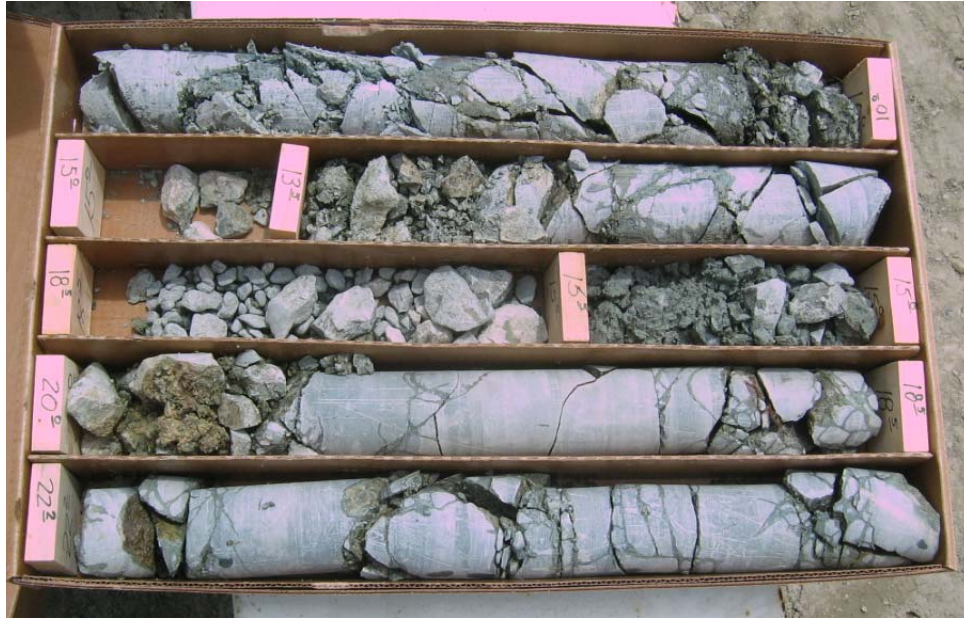
Figure 3. Core Specimens at Test Shaft Location, Depth Interval = 10 – 22 ft.

A boring was made at the exact location of the test shaft and carefully logged to provide a detailed profile of the rock. Core samples that were sufficiently intact were tested for uniaxial compressive strength. In general, the material to a depth of 18 ft was highly fractured and weathered, with moderate recovery and very low RQD values (zero in most cases). Over this depth interval, no intact specimens suitable for uniaxial compression testing were obtained. Rock strength was evaluated on the basis of point load tests on eleven specimens, yielding an average compressive strength of $q_u = 574$ psi. Below a depth of 18 ft the rock becomes harder and less fractured, with higher recoveries and RQD values ranging from zero to 25 percent. Figure 3 is a photo of core samples over the depth interval between 10 ft and 22 ft. The transition described above at approximately 18 ft is visible. Two intact specimens were obtained over the depth interval between 21 ft and 23 ft and tested in uniaxial compression, yielding values of $q_u = 4,800$ psi and 9,770 psi, respectively. At a depth corresponding to the tip of the test shaft (35.5 ft) the rock is described as very hard metabasalt.

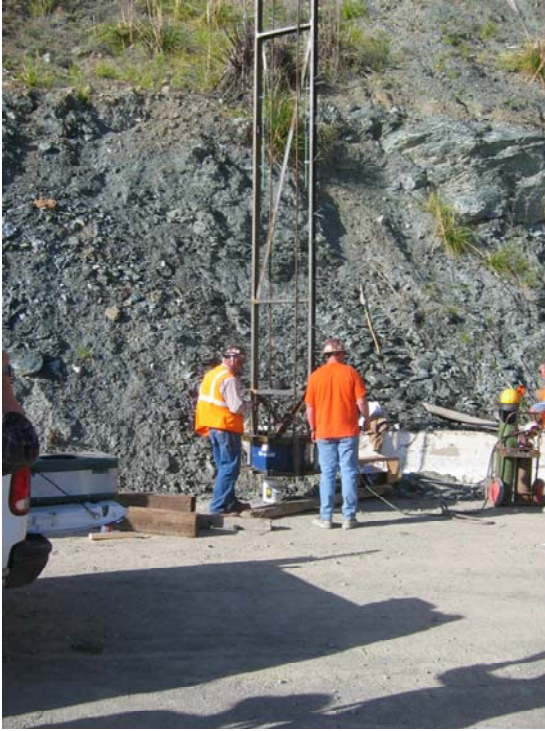
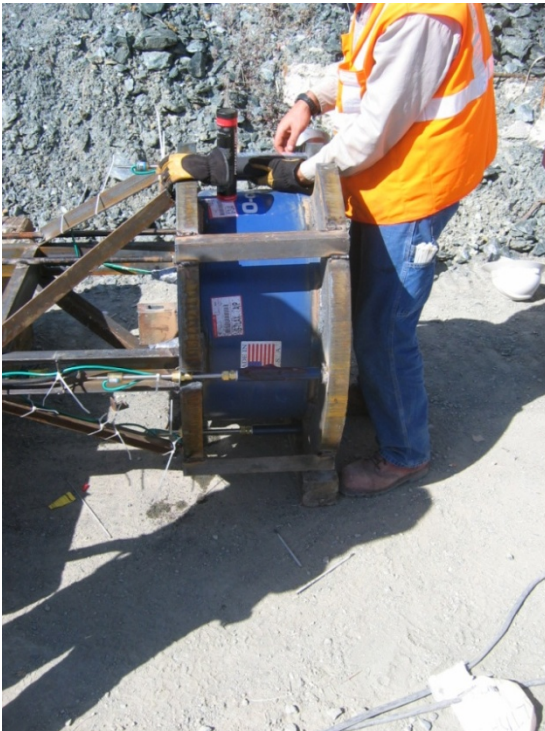
Figure 4. O-Cell and Frame Ready for Placement in the Test Shaft.

The test shaft was 42-inches in diameter, 35.4 ft deep. Figure 4 shows the O-cell attached to its frame and ready for placement into the drilled shaft excavation. The O-cell was placed at a distance of approximately 3 ft above the base of the shaft. The test shaft was drilled using a rock auger without casing or other support (Figure 5). Seepage of water into the excavation was observed during drilling. Water at the base was mixed with cement and re-excavated just prior

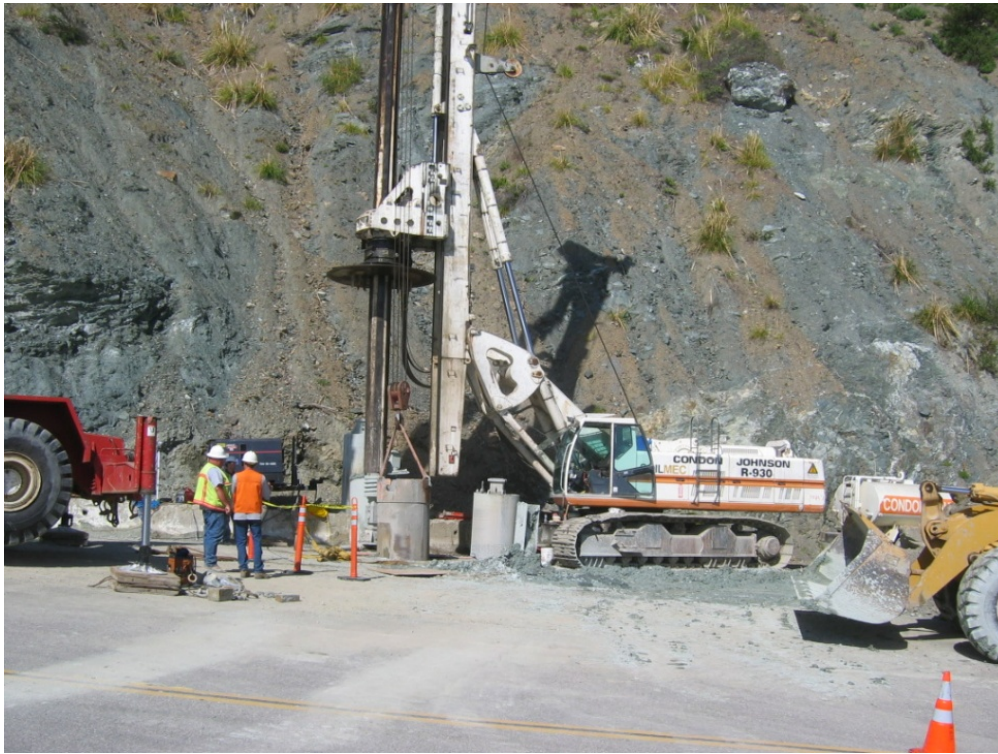
Figure 5. Construction of Test Shaft at Pitkins Curve.

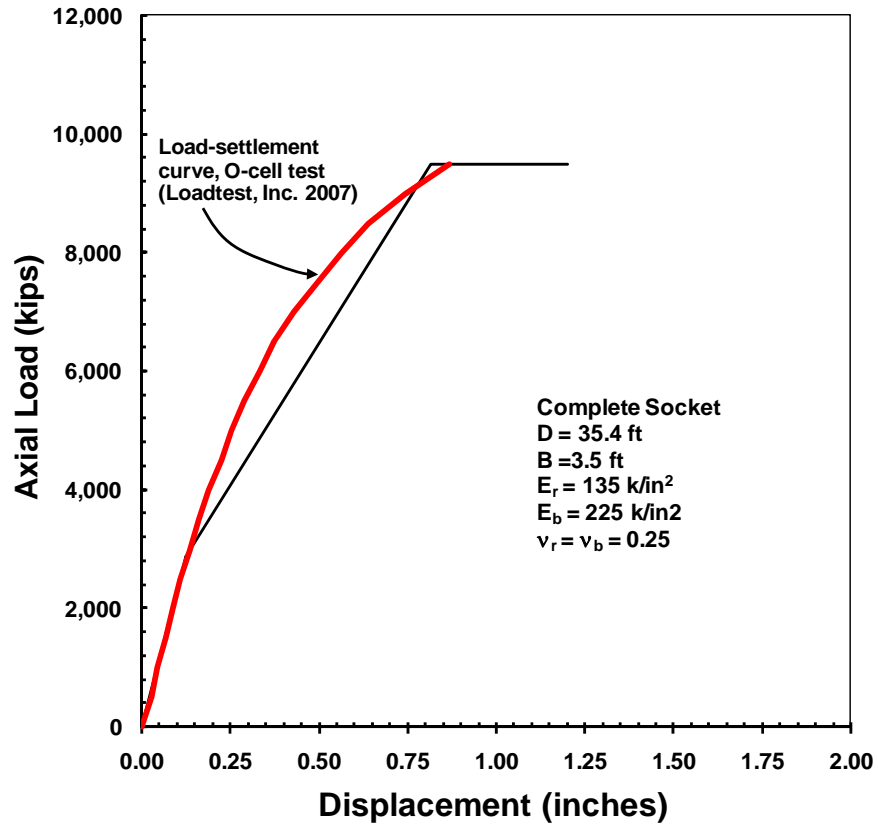
Figure 6. O-Cell Equivalent Top-Load Settlement Curve and Modeled Curve.

fitting to the equations given in Appendix A and carried out using a spreadsheet solution developed by the authors. Values of rock mass modulus (E_r and E_b) were adjusted to obtain close agreement between the measured curve and the modeled curve. These values of modulus are within the range expected for rock mass with the characteristics observed in boring logs and with strength values cited previously.

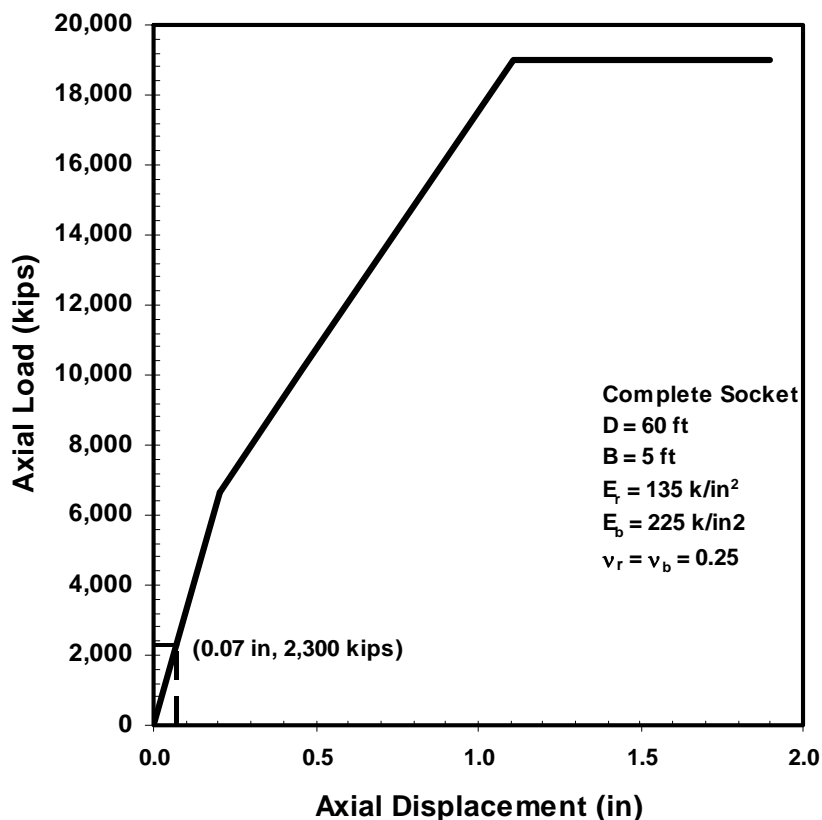
Figure 7. Predicted Load-Settlement Curve for Trial Design, Single CIDH Pile.

Trial designs were evaluated for their ability to satisfy appropriate strength and service limit states for the bridge at Pitkins Curve. The final design consists of two piers supported by four drilled shafts at each pier, with shaft diameter $B = 5$ ft and depth $D = 60$ ft. The bridge structural engineer established a tolerable settlement for individual shafts of $\frac{1}{2}$ inch under a nominal axial force of 2,300 kips. The load-displacement model was used to analyze this service limit state for axial settlement by changing the shaft dimensions to those of the trial design ($B = 5$ ft, $D = 60$ ft), with the material properties held constant. The predicted load-displacement curve for the trial shafts is shown in Figure 7. As indicated in the figure, for an axial compression load of 2,300 kips, the predicted displacement is approximately 0.07 inches and the shaft response is in

the linear elastic range. By this analysis, the proposed trial design easily satisfies the service limit state criterion that limits settlement to $\frac{1}{2}$ inch. Furthermore, the nominal resistance corresponding to the limiting settlement ($\frac{1}{2}$ inch) is approximately 10,750 kips, which exceeds the nominal loading of 2,300 kips, thus satisfying the LRFD service limit state criterion. The final shaft dimensions are governed by lateral loading considerations and not by the axial settlement criterion.

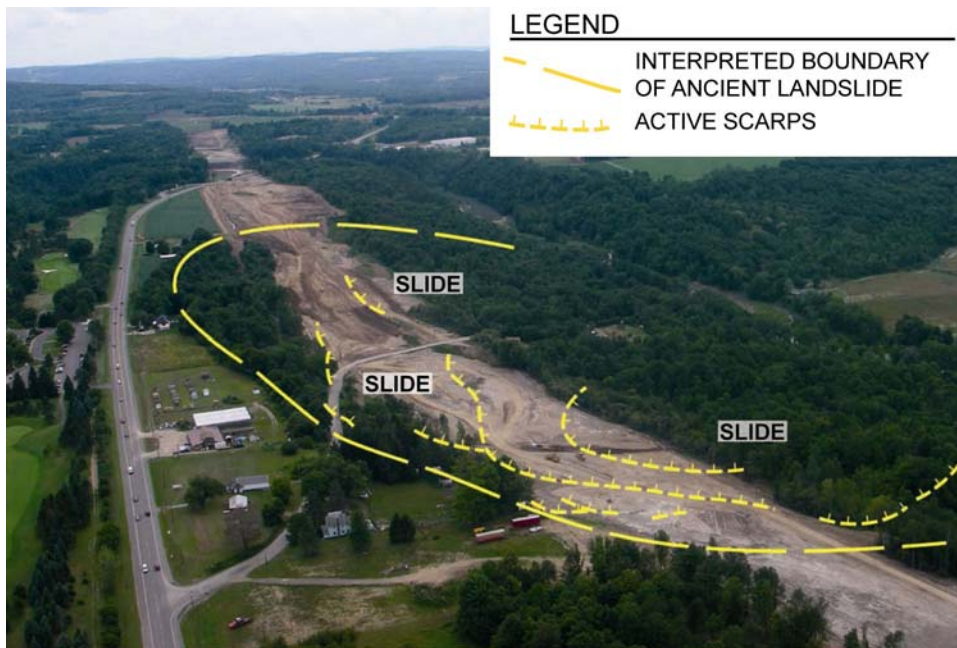
FIGURE 1 Oblique Air Photo of Landslide.

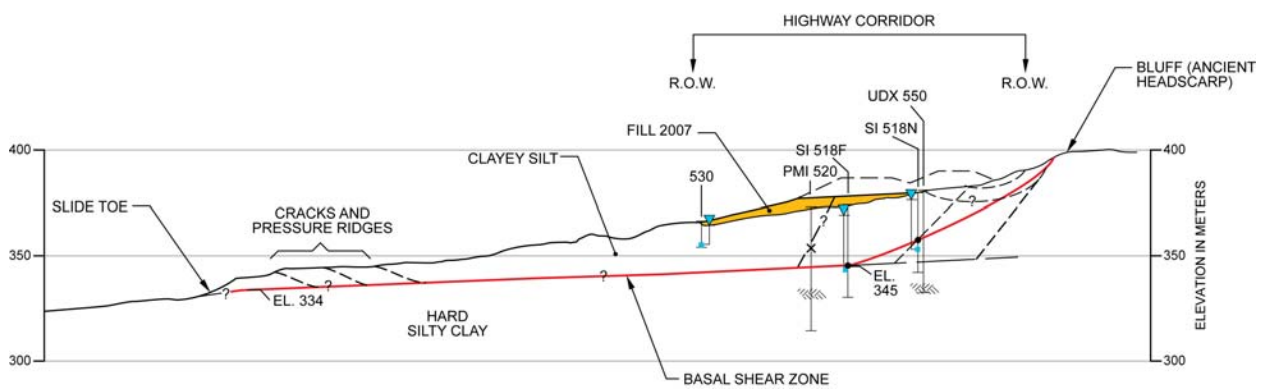
FIGURE 2 Cross Section STA. SB 51+450.

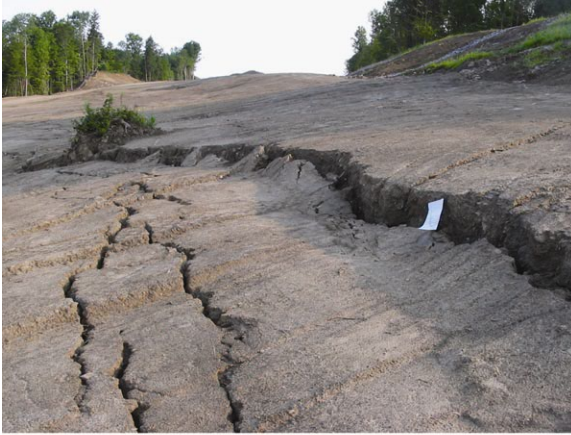
Rate of Slide Movement	
Summer '07	60-100 "/td>
Fall '07	10-20 "/td>
Nov '07 unload	2-8 "/td>
Early '08 after HDs	1-4 "/td>

FIGURE 3 Rates of Slide Movement.

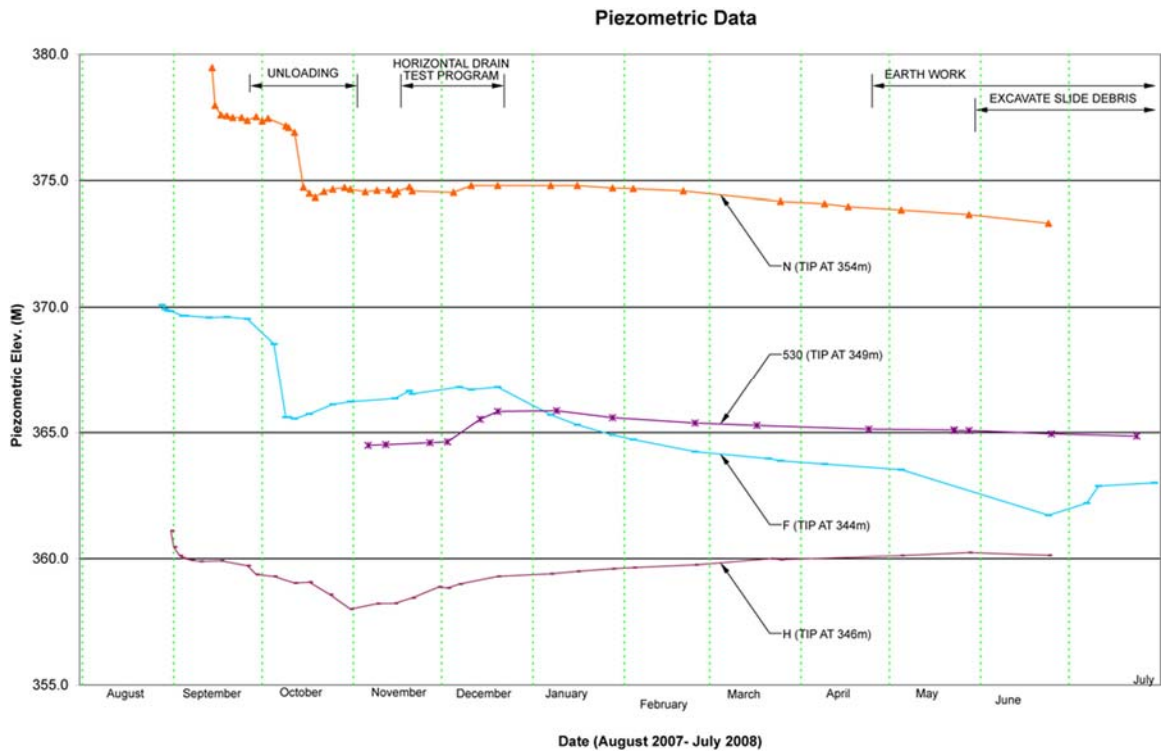
FIGURE 5 Piezometer Data (Test Horizontal Drains).

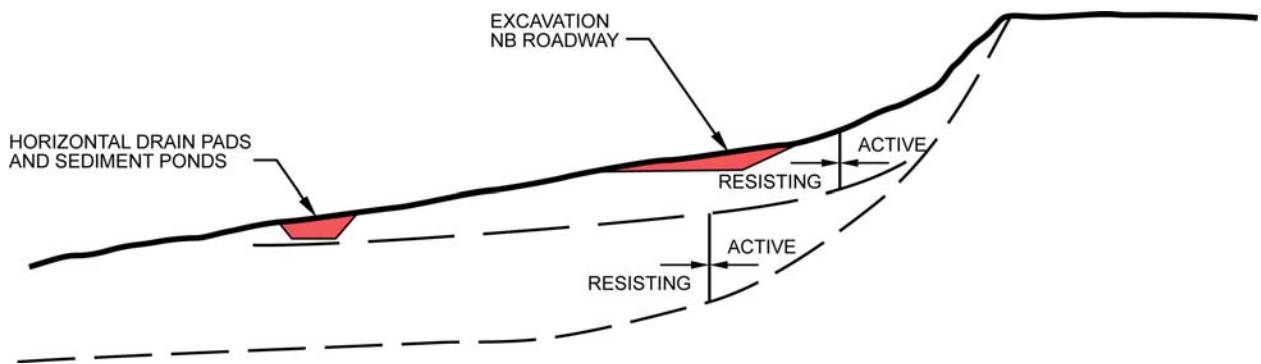
FIGURE 7 Excavation of Northbound Roadway Resulted in the Activation of Localized Nested Slides. Excavation for Sediment Ponds and Pads for Horizontal Drains Destabilized Both Global and Nested Slides.

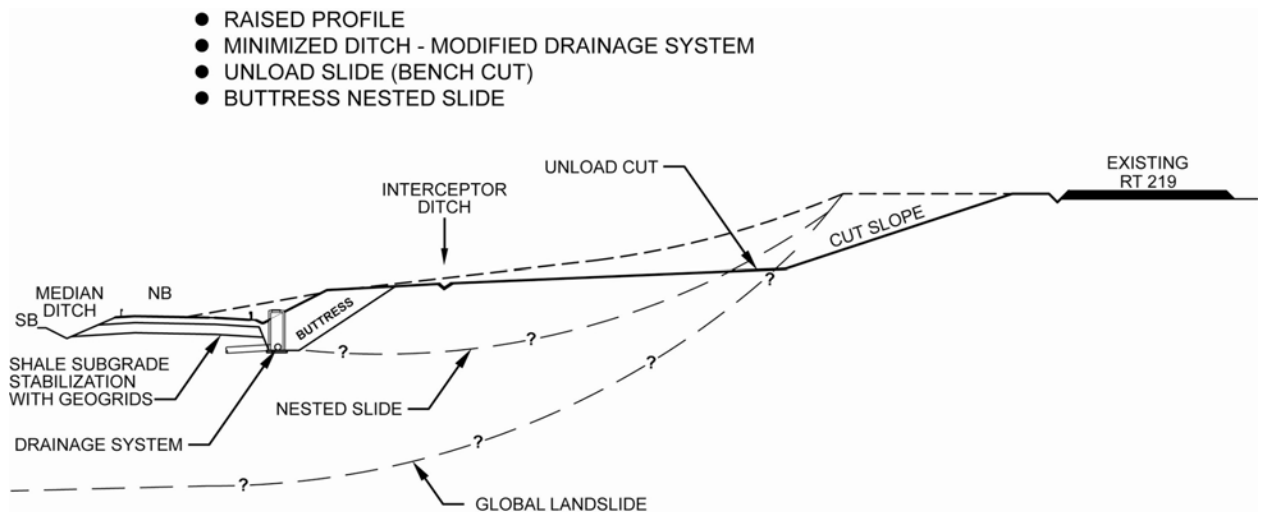
FIGURE 8 Mitigation Details for the Localized Nested Slides in the East Cut Slope.

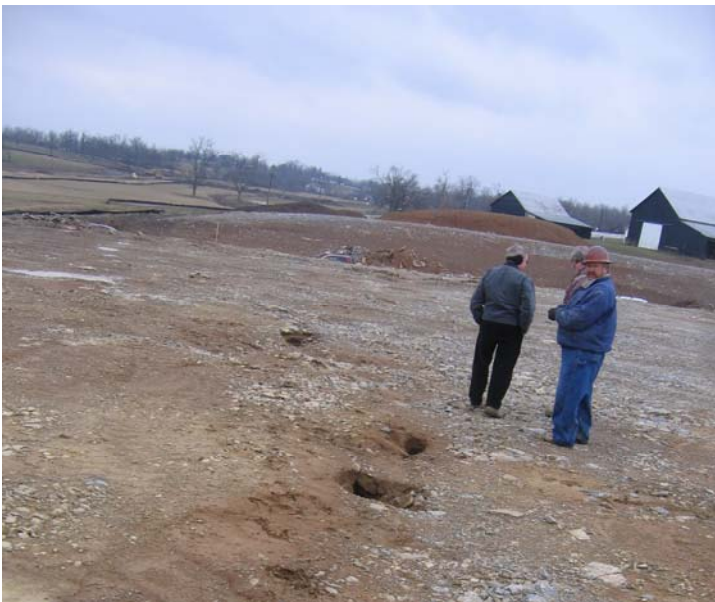
Sinkhole in Parking Lot Looking toward Detention Basin

Karst conditions addressed in the geotechnical report concerning the building and parking areas included two open sinkholes located in the parking area.

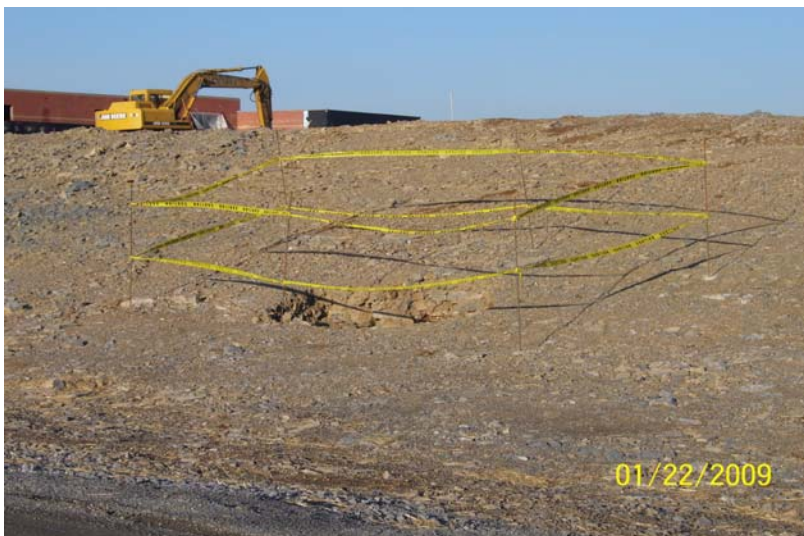
Sinkhole in Slope

QORE Property Sciences was selected to provide construction and special inspection for the new school campus. After a smooth 2008 construction season, in January 2009, QORE Inc. was requested by Sherman Carter Barnhart Architects to visit the site and make an initial evaluation of a depression (sinkhole) which had developed recently near the toe of the slope between the proposed future parking area and the Access Road No. 1.

It did not appear to be located close enough to the school to cause any damage. No immediate threat to the roadway was likely although it was considered a possibility that an underground cavity may extend below the proposed sanitary sewer line and roadway requiring mitigation measures before the sewer line is installed and roadway paved.

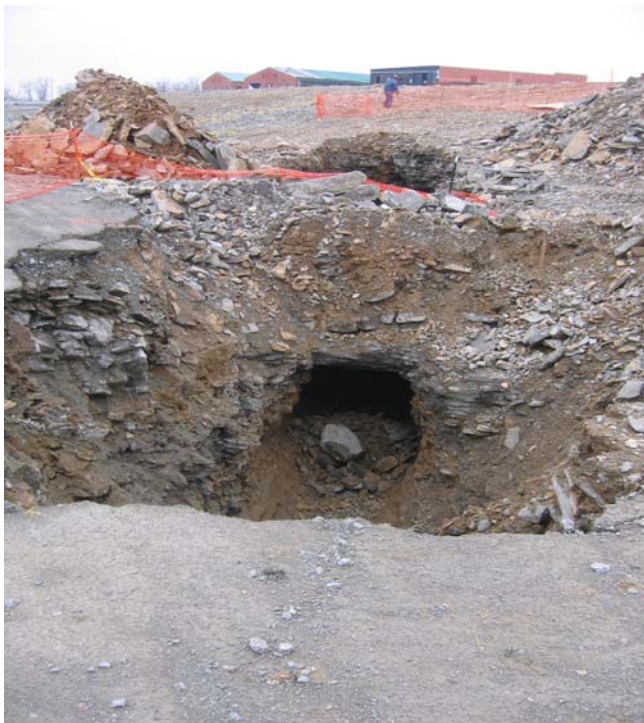
Cave Looking toward School Complex

A solution feature approximately 125 feet long, 26 feet deep, and 20 to 25 feet wide with cave openings at the end nearest the school was exposed while excavating the sinkholes. The cave extends 60 feet in the general direction of the school and branches in three directions. Water can be seen running down one wall and into holes in the floor of the cave. Rubble is present in the base of the excavation; therefore, it is unknown how deep this channel extends. The sides of the channel are composed of limestone bedrock. The end of the excavation closest to Access Road No. 1 contains broken bedrock which, in our opinion, appears to have collapsed into the cave system. QORE concluded based on the trend of the karst feature, that the solutioned conduit likely continues in this same trend into the detention basin located on the west side of Access Road No. 1.

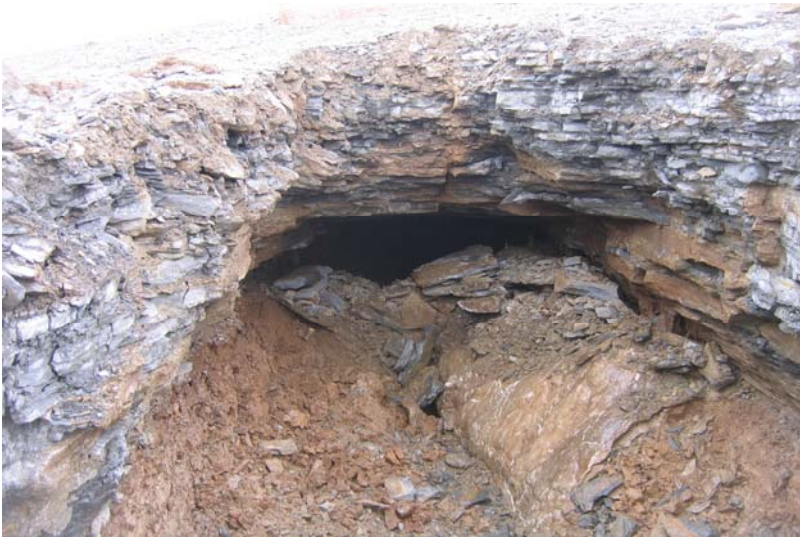
Cave Entrance

At the cave opening, there is an undetermined amount of loose roof fall and soil lying on the cave floor. Above the cave debris is a cave opening estimated to be about 3 to 5 feet tall between the roof rock and the top of the debris. In-place bedrock located above the roof of the cave creates additional roof stability issues.

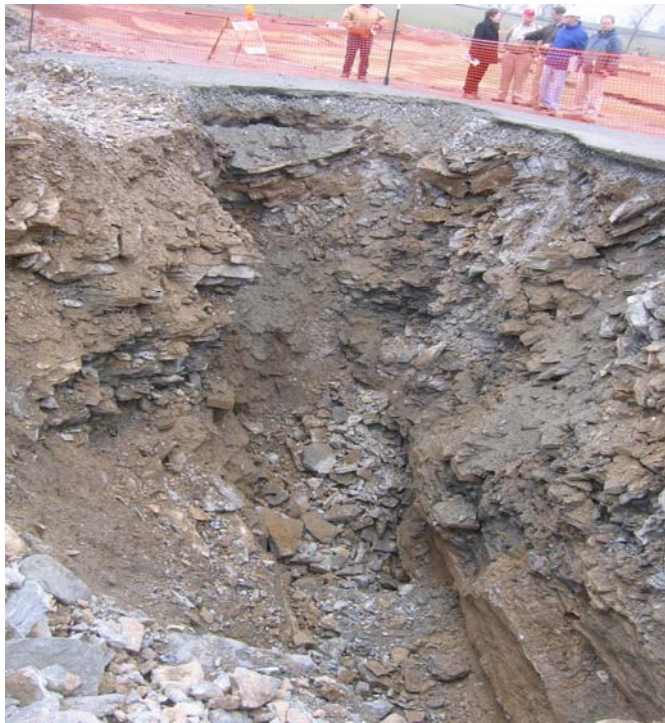
Collapsed Cave under Access Road No. 1 and Sewer Line

A sanitary sewer line crosses this cave at a skew to the centerline of the cave for an approximate 20 foot span, and QORE felt it was necessary to address the long term stability of this sewer line. We recommend constructing a concrete slab extending from bed rock to the sewer pipe bedding elevation. A recommended method to accomplish this follows:

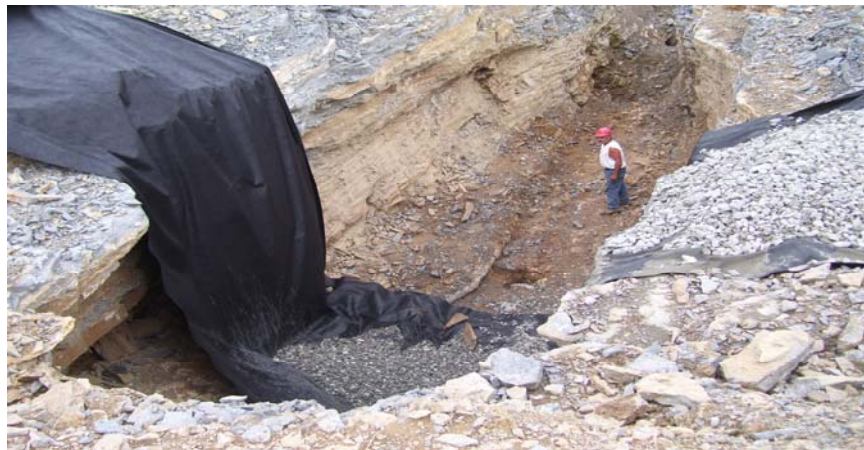
Installation of Filter Fabric

- After excavation of the solution feature is completed begin installation of filter fabric and No. 2 Crushed Stone refill as described above.
- Continue with compacted No. 2 crush stone refill to the base of the 36 inch equalization pipe installation grade.
- Install equalization pipe in accordance with the manufacturer’s recommendation.
- After installation of equalization pipe is complete, continue with the crushed stone refill from the top of the 36-inch equalization pipe to the base elevation of the concrete support mat for the sanitary sewer line. Install the reinforced concrete mat on the compacted crushed stone refill. The concrete mat should extend from one side of the

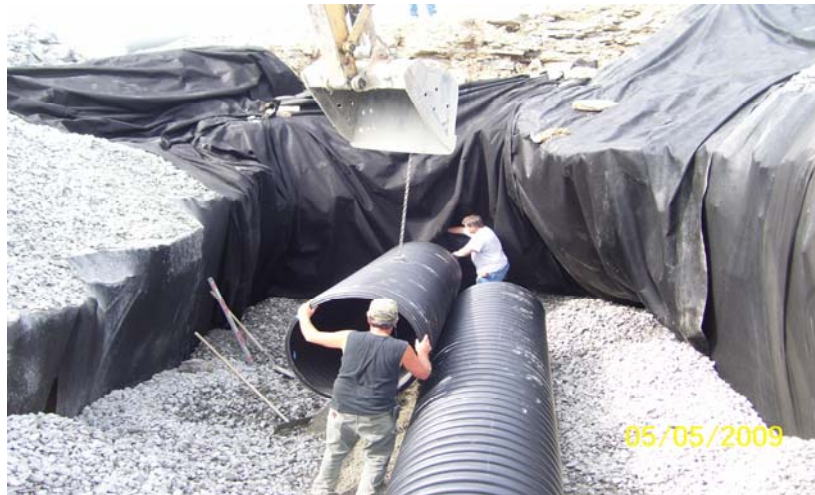
Pipe Installation

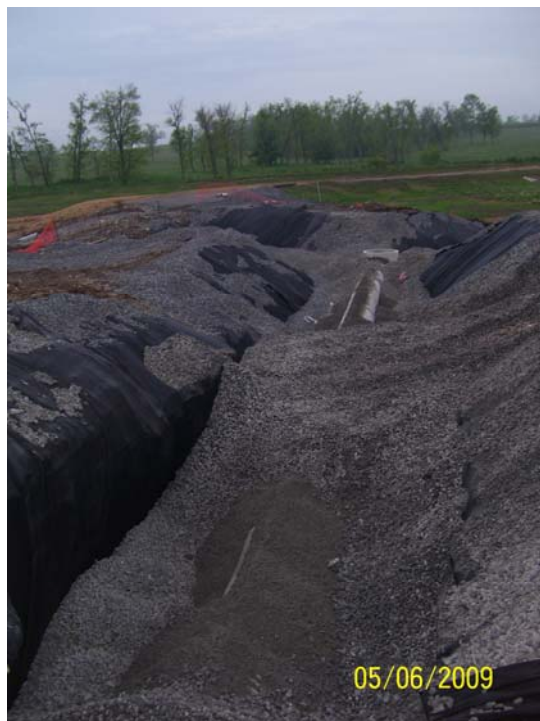
Rock Refill over Pipe

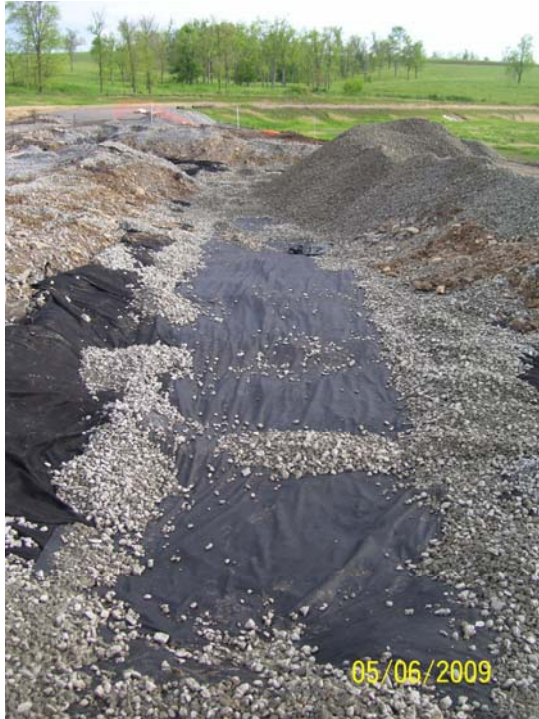
Filter Fabric Closure

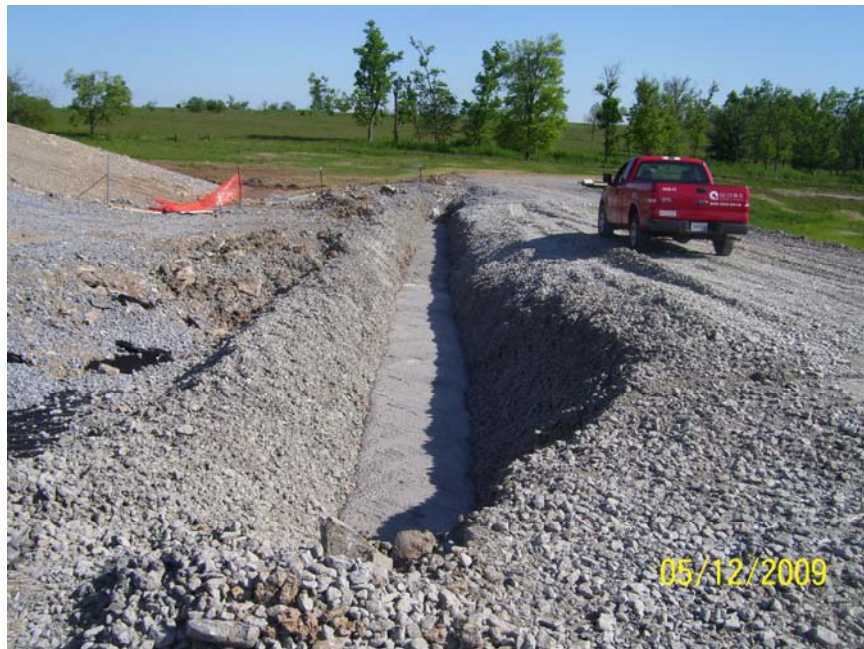
Forced Sewer Main Structural Pad

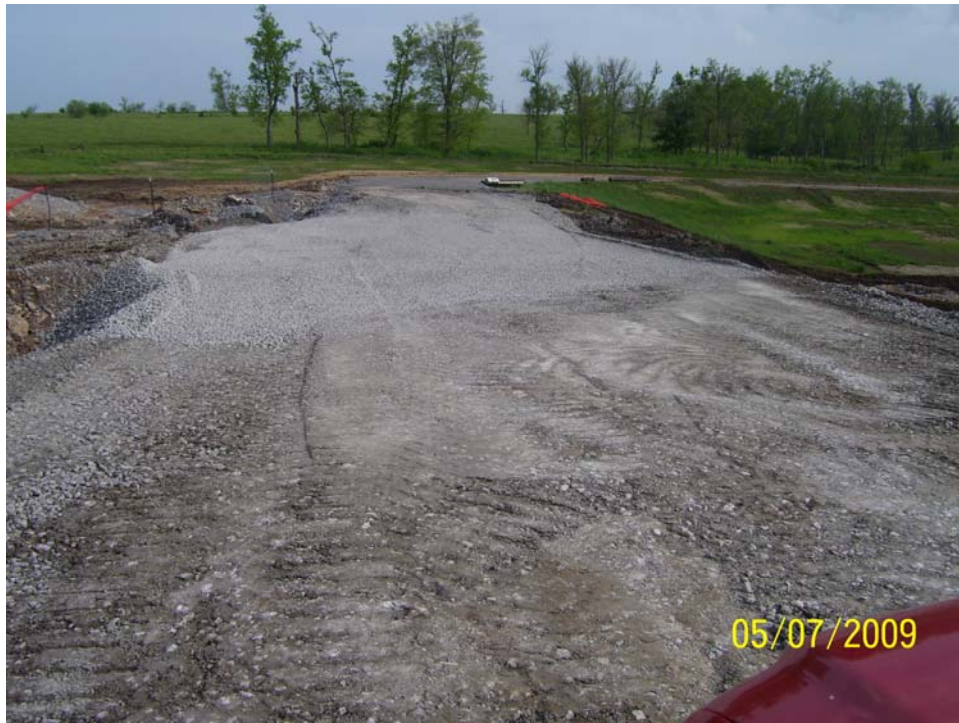
Completed Remediation

The decision was made by the Board of Education to construct Option Number 1 with concrete mat to support the sanitary sewer line. Construction took 10 days to complete and the overall project schedule was maintained.

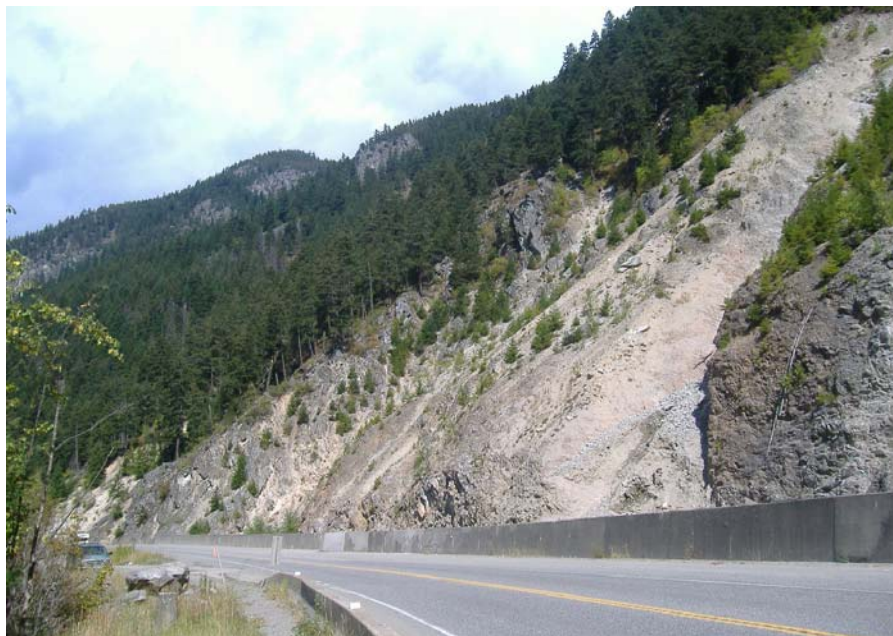
Fig. 2 – Highway #1 looking northward at Ferrabee Wall and rock fall slope

There have been a number of attempts made to mitigate the risks due to rock falls at this site. In 1961, a concrete wall was constructed. The concrete wall, known as the Ferrabee Wall, is 255m long and 2.4m high (Fig. 2). Behind the wall, there is a rock fall catchment area that varies between 8m and 22m in width. A diversion trench was excavated into the slope in 1975 in an attempt to re-direct rock falls away from the highway. In 1976, the highway was relocated westward 10m in an attempt to create additional catchment width. This catchment area is routinely filled with over 1000m³ of debris, resulting in rocks bouncing over or breaking through the concrete wall.

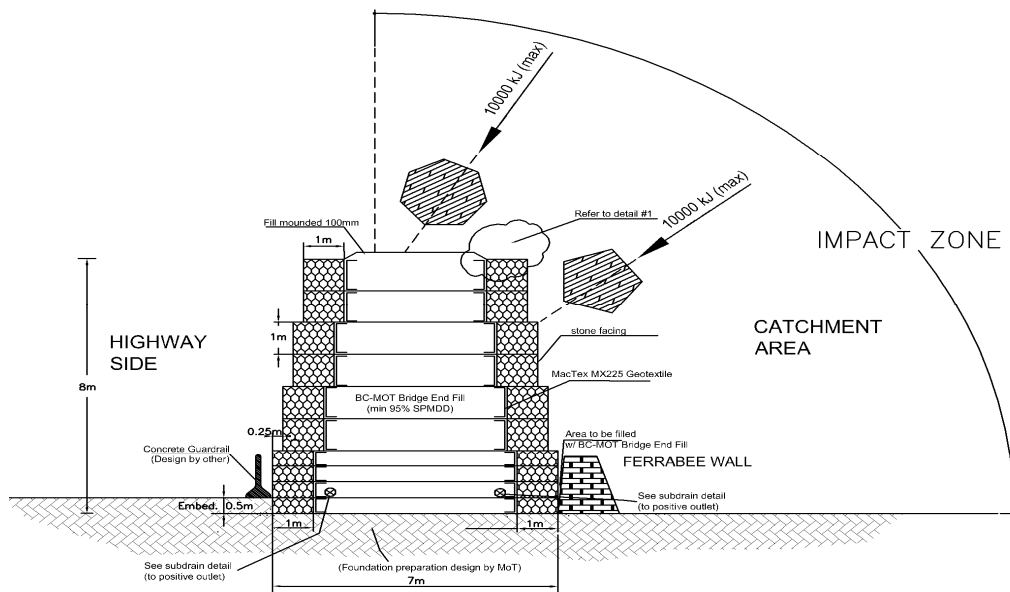
Fig. 4 – Terramesh® Embankment Section

Figure 4 shows the overall configuration of the 8m section of the embankment. The reinforced soil core of the embankment was 5m at the base plus 2 -1m wide woven wire gabion baskets facing elements (7m total width). The structure was segmented into 4 - 2m high vertical blocks. Each block was set back 0.25m at the face from the underlying block. At the highest part of the embankment, the reinforced core was 3.5m plus 2 -1m gabion units (5.5m total width).

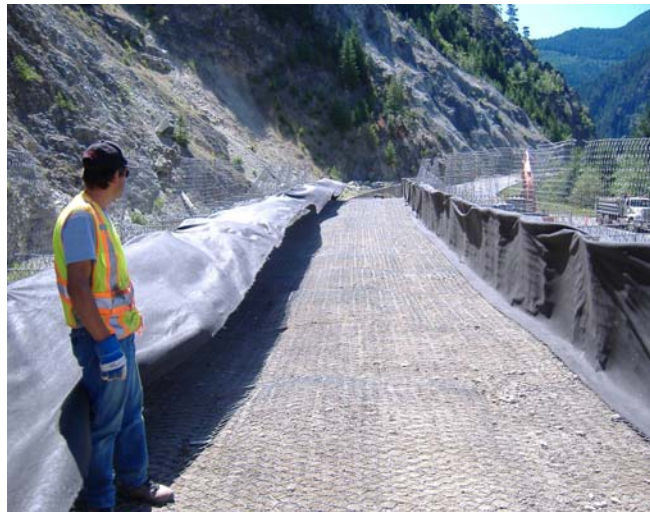
Fig. 6 – Looking southward prior to placing backfill

Due to the extreme constraints posed by limited access to the structure at heights exceeding 3m, the Contractor decided to build the Terramesh® System by constructing access ramps at the both ends of the structure and using one-way equipment travel in order to construct the gabion basket facing units and to place and compact the engineered fill. At the uppermost layer, the back of gabion to back of gabion clearance was only 3.5m

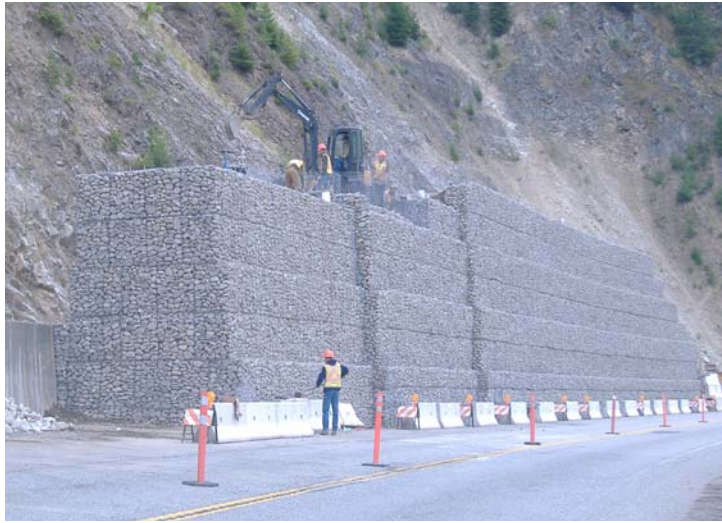
Fig. 7 – Northern end of embankment

Access to the centre portion of embankment was achieved via the ramps at the north and south ends of the structure. Once the centre portion of the embankment exceeded 6m in height, work began to complete the north end of the structure. This required that access was then further restricted to the southern ramp only and all equipment was required to travel backwards up the ramp. The final step was to remove the southern ramp and complete the embankment.

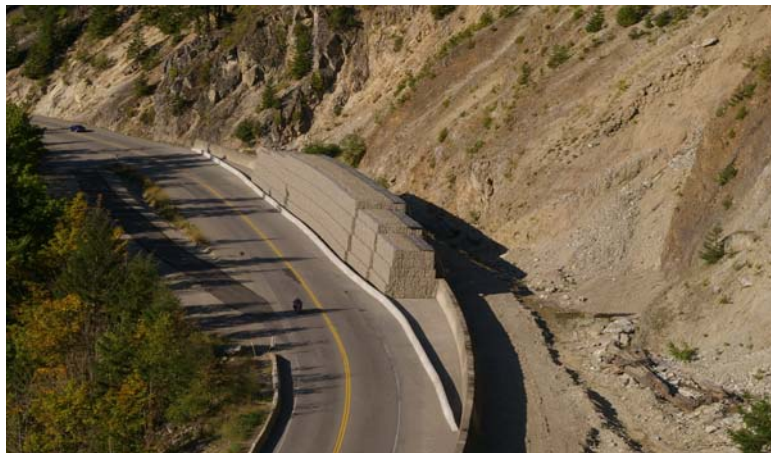
Fig. 9 – Completed embankment, September 15, 2008

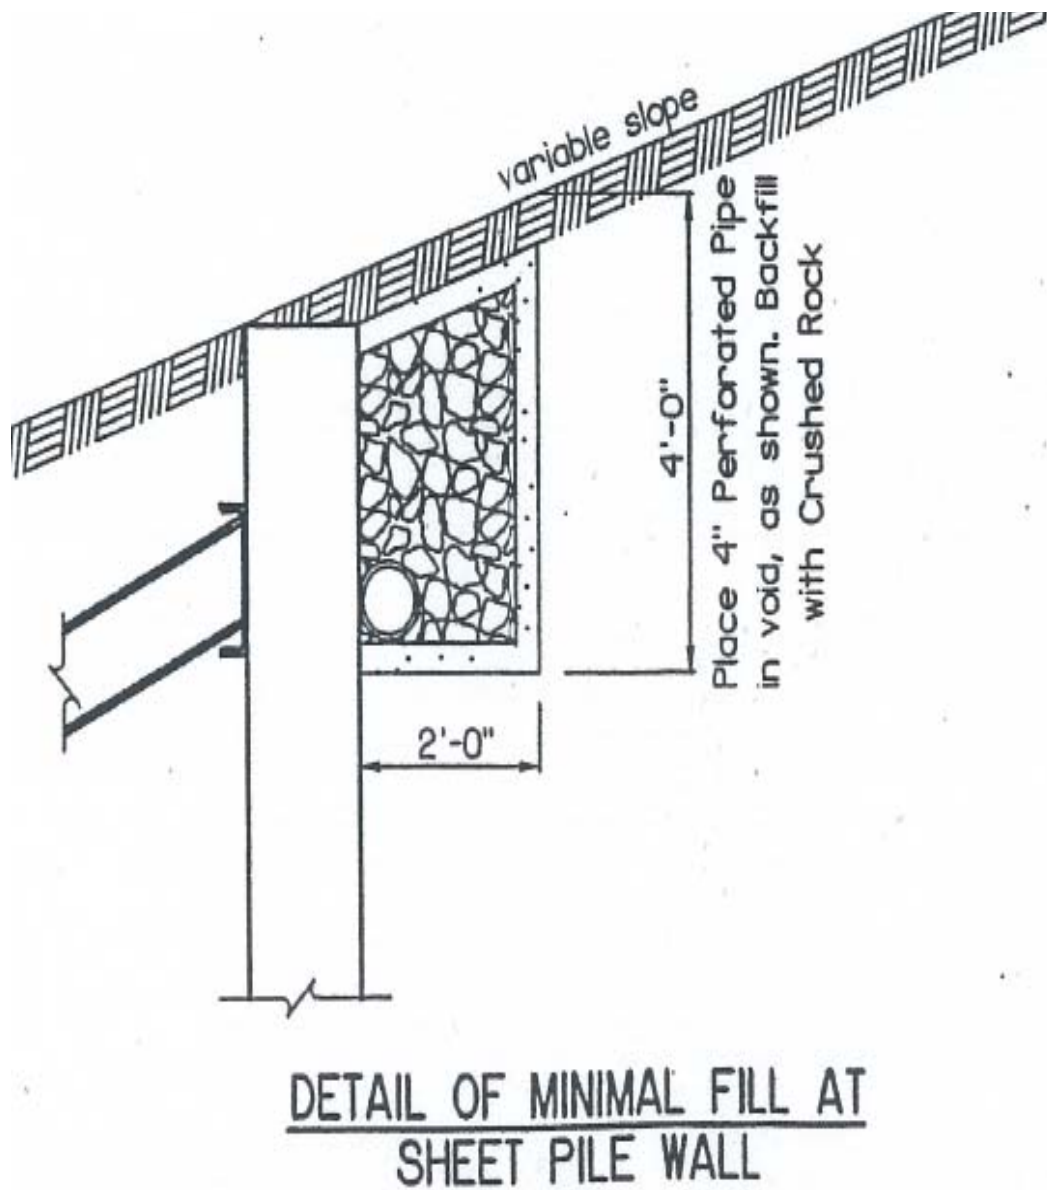
Figure 6. Wall B plan detail.

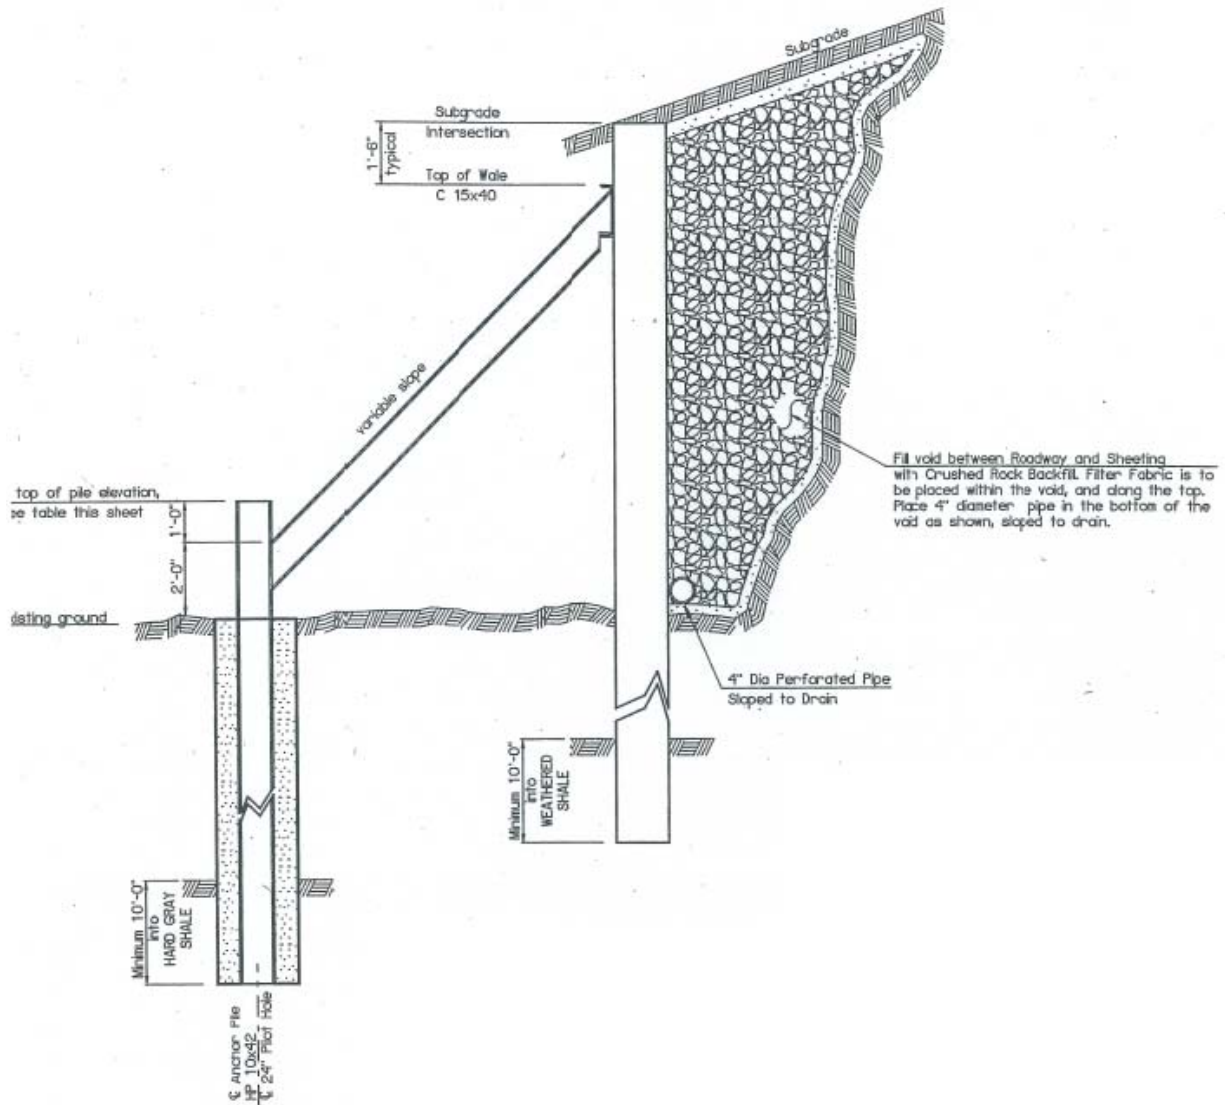
Figure 7. Wall A plan detail.

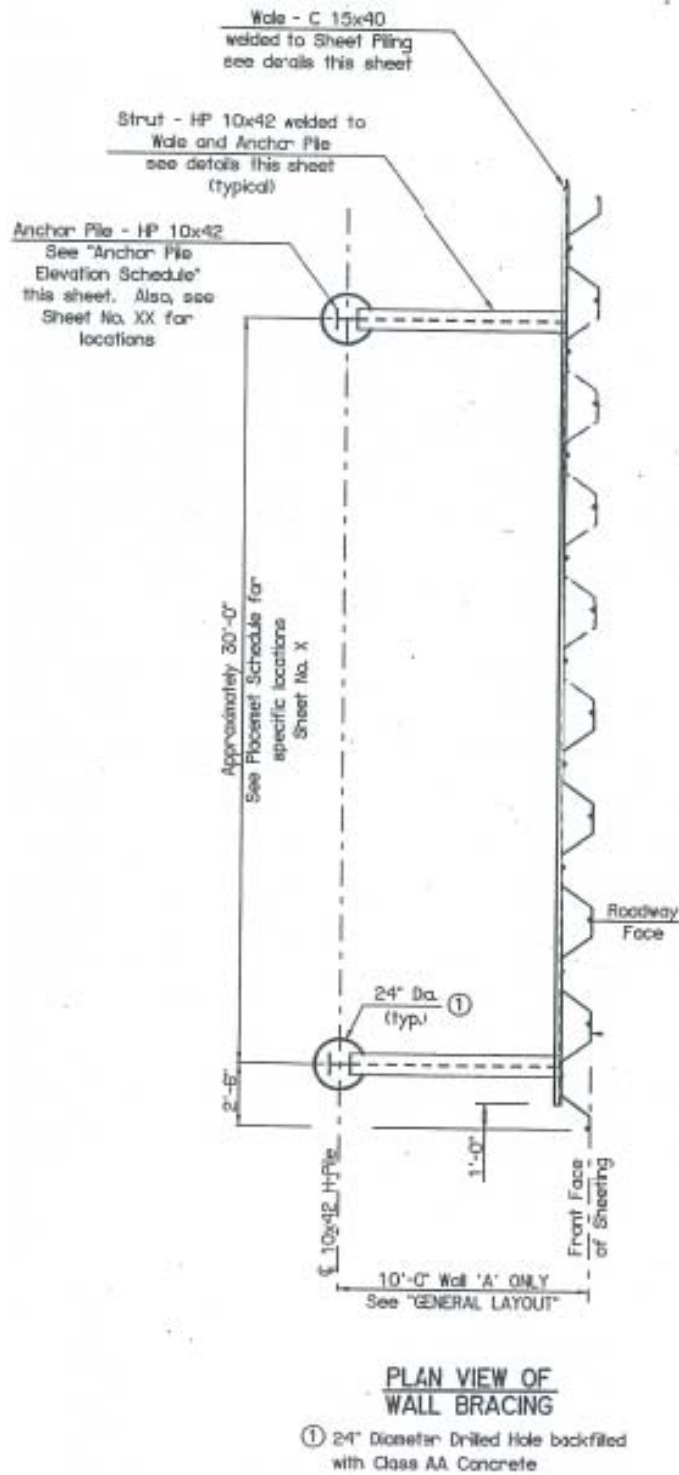
Figure 8. Wall A plan detail.

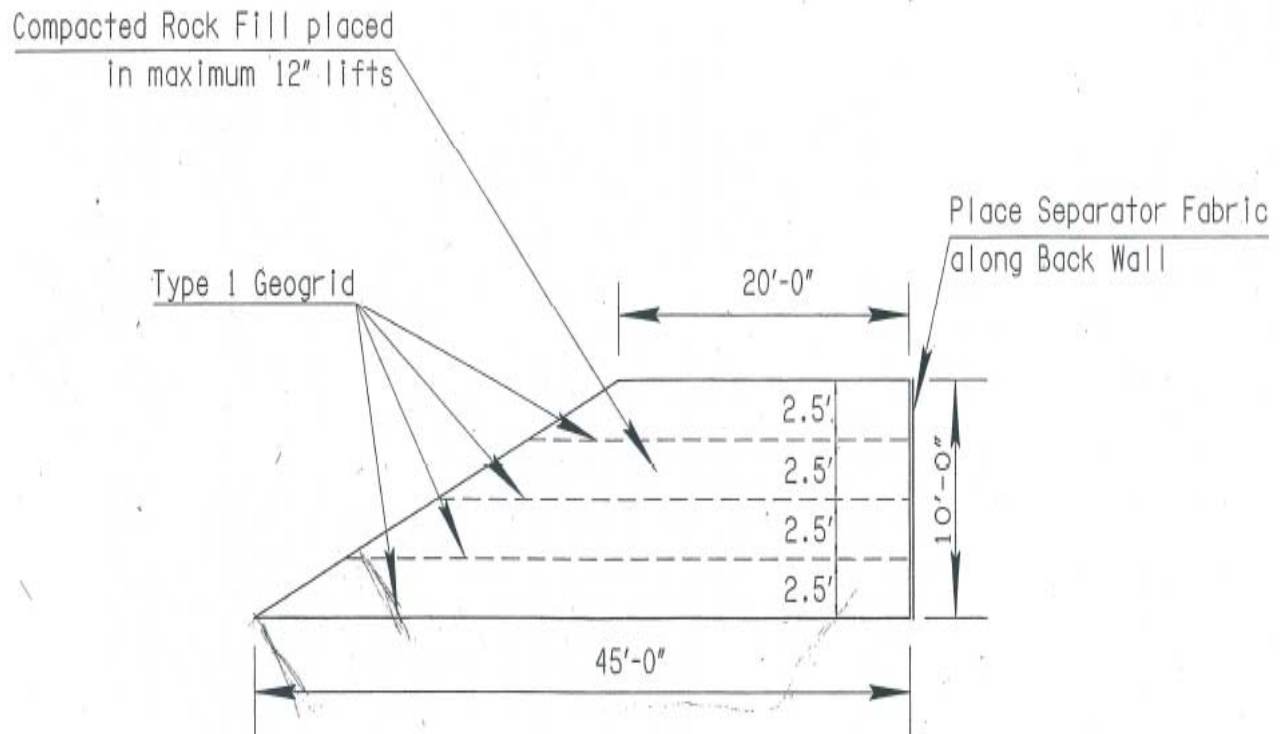
Figure 9. Rock buttress detail at the toe.

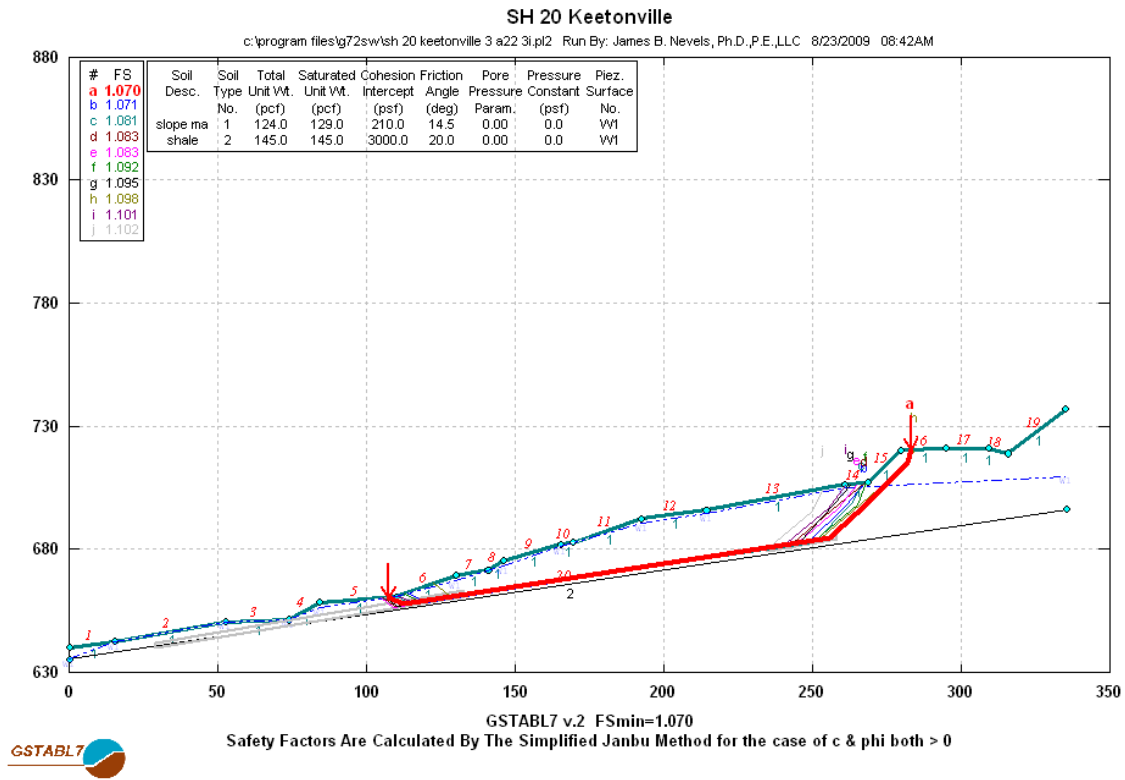
Note: Horizontal and Vertical Scale in feet (ft).

Figure 10. Back-calculation of shear strength parameters.
