60th HIGHWAY

GEOLOGY SYMPOSIUM

PROCEEDINGS

1.1.	<i>High Bridge Area Roadway Slide, Letchworth State Park, Portageville, New York</i>	22
	Andrew J. Nichols, P.E.; James Bojarski, P.E.	
1.2.	<i>Remediation of the SR 15 Welcome Center Landslide.....</i>	35
	David R. Scherer, P.E.; Robert E. Johnson, P.E.; Paul J. Lewis, P.E.

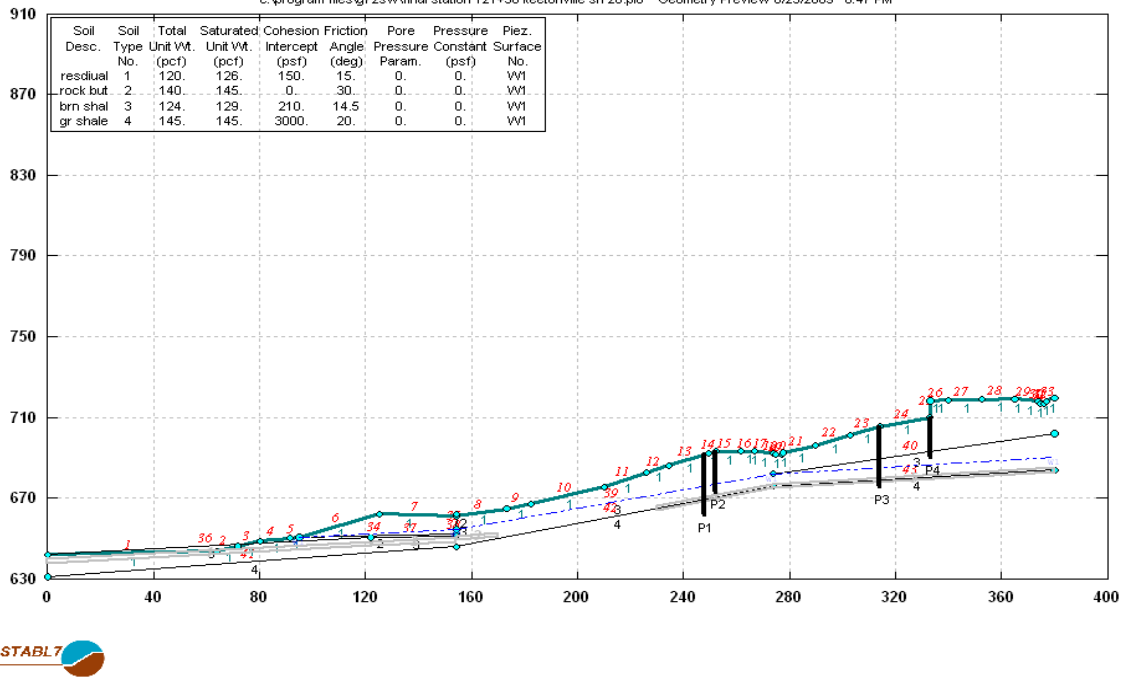
Note: Horizontal and Vertical Scale in feet (ft).

Figure 1. Slope stability of completed project.

A more rigorous slope stability analysis was performed months after the completion of the project taking into account a more accurate surface survey and careful estimate soil layer, water table, and residual soil parameters. The location of the sheet pile walls, drilled piers, and rock to buttress is also shown in the slope stability analysis, see Figure 11. The factor of safety of 1.525 was lower than expected; but marginally sufficient based on very conservative soil parameter, soil profile, and water table estimates.

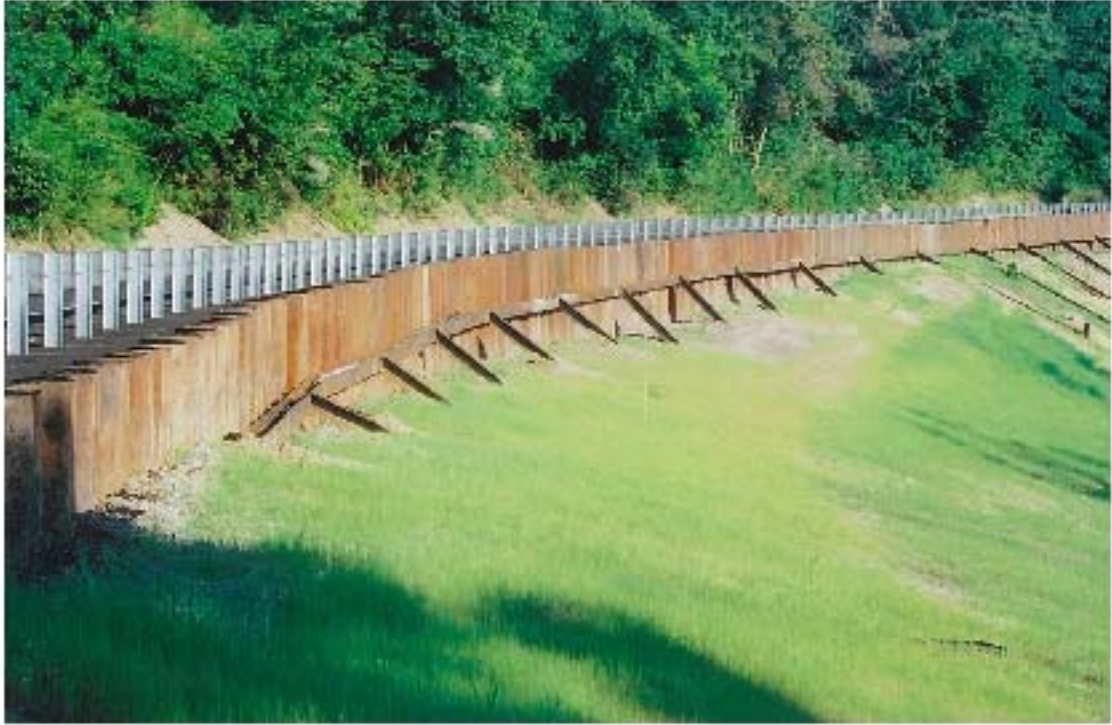
Figure 12. Completed Wall A looking west.

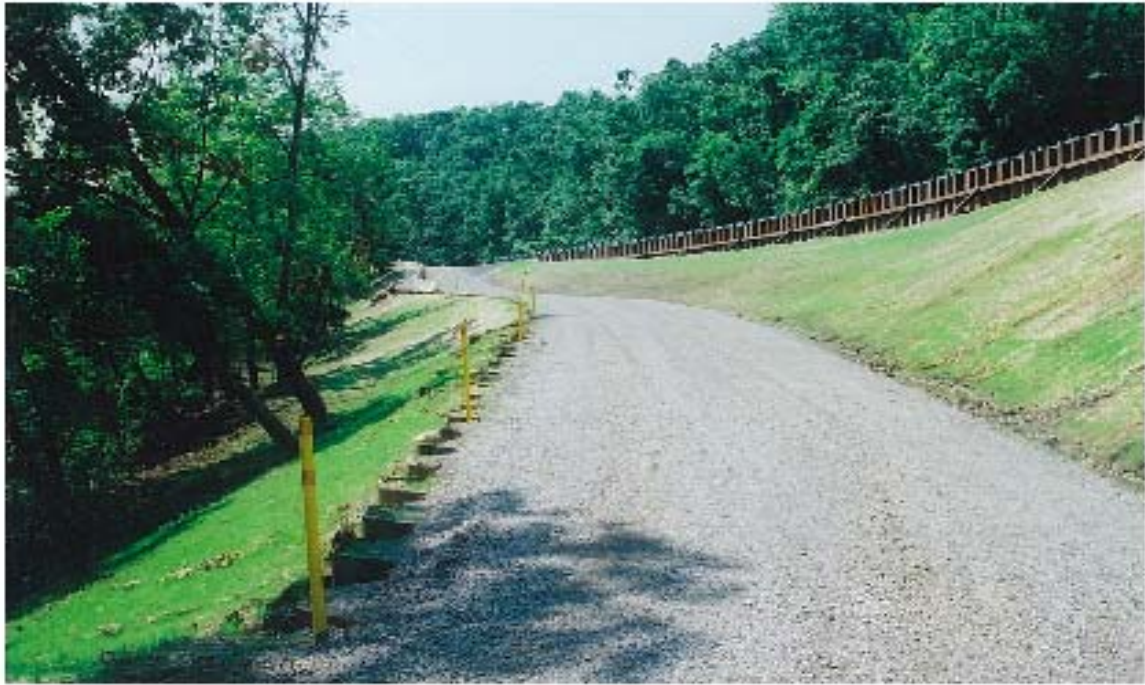
Figure 13. Local road and Wall B on the left looking east.

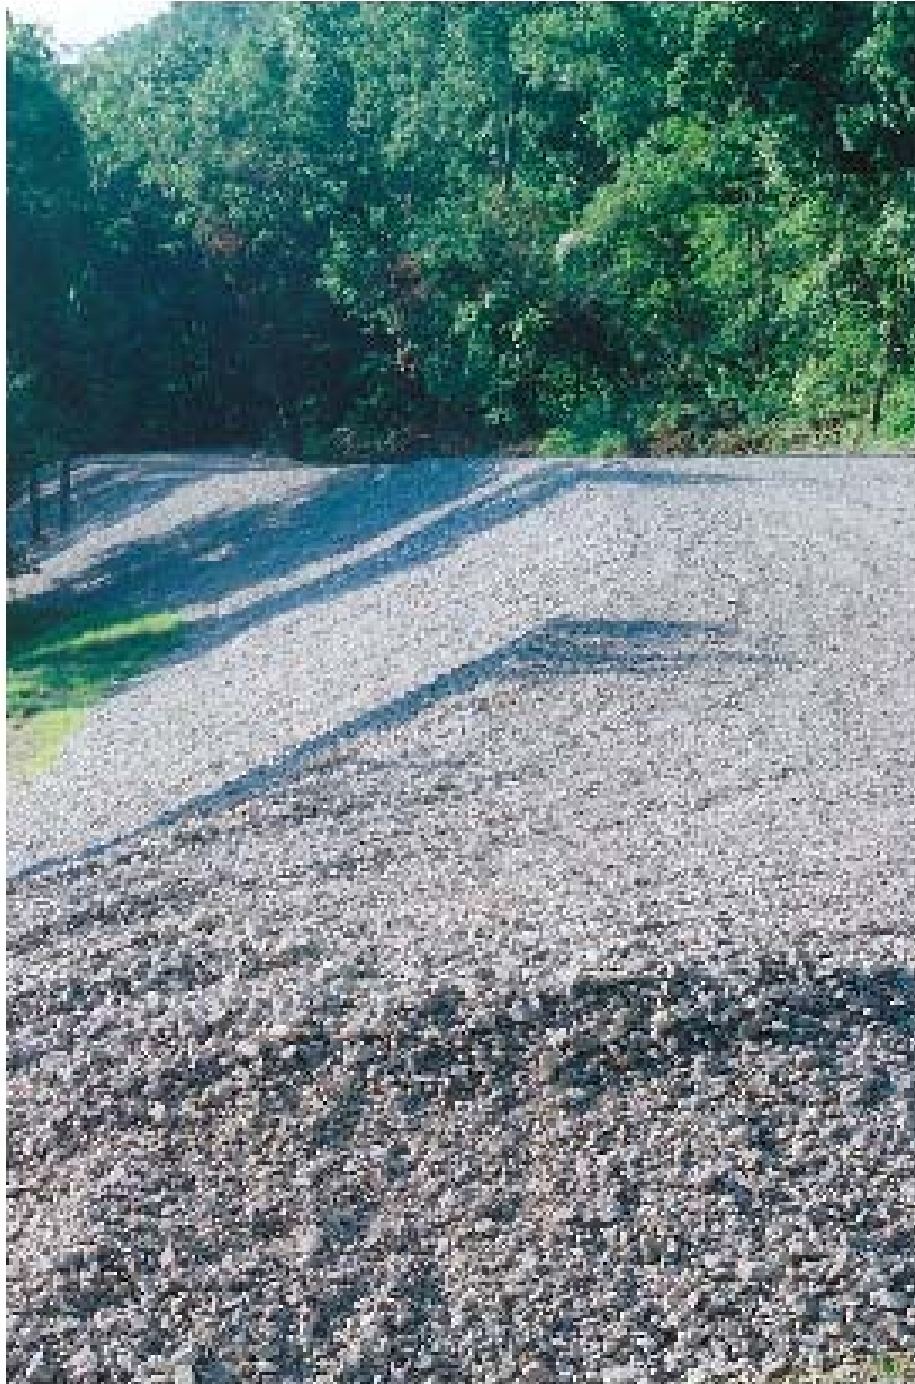
Figure 14. Rock buttress at the toe of the landslide.

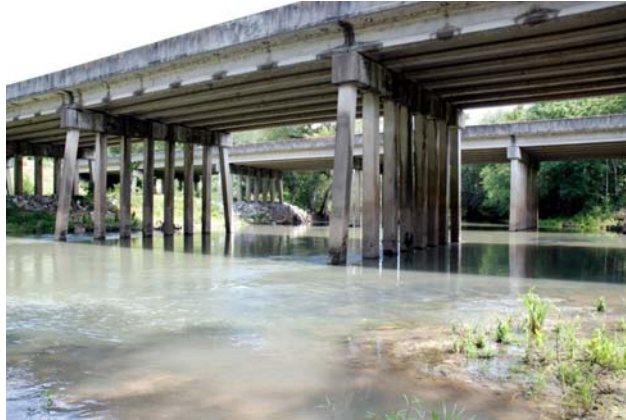
Figure 4. I-10 bridges over Chipola River. View is upstream; sample location is in lower right.

Interstate 10 crosses Chipola River in the panhandle of Florida approximately 60 miles west of Tallahassee. The drainage basin extends into Alabama, near the Georgia state line (Figure 3). The bridge (Figure 4) is founded on Oligocene Marianna Limestone, white to gray marine limestone that ranges from argillaceous limestone to argillaceous dolostone. The formation contains

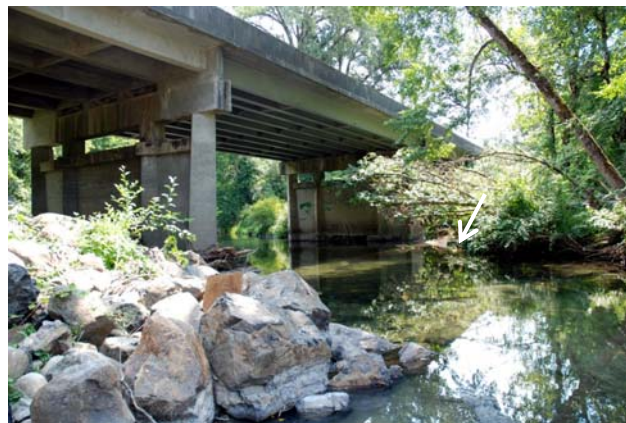
Figure 7. State Route 22 Bridge over Mill Creek.

State Route 22 crosses Mill Creek in northwest Oregon approximately 20 miles west of Salem. The drainage basin outline and general geologic formations are shown on Figure 6. The bridge (Figure 7) is founded on Eocene Yamhill Formation, gray marine siltstone that ranges from massive to thinly bedded and locally contains interlayered basalt lava flows. The siltstone formation at the bridge site is massive, but it erodes along fractures into cobble- and boulder-

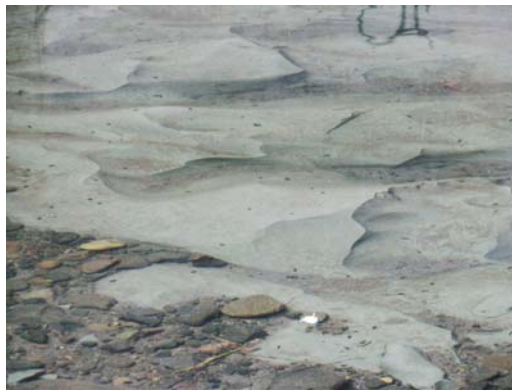
Figure 9. Sculpted siltstone in rock-bed channel under bridge. View is toward left abutment; flow is left to right.

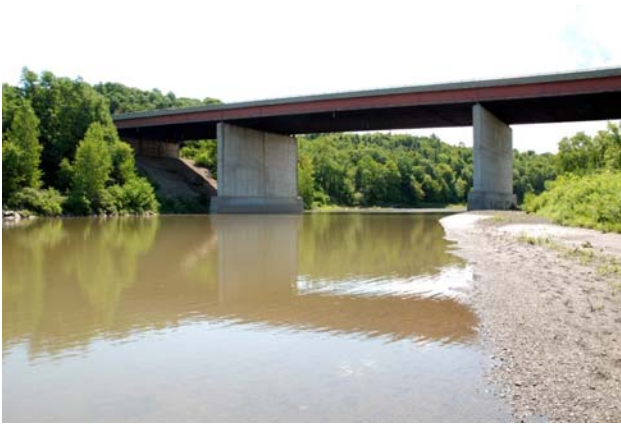
Figure 11. Interstate 90 Bridge over Schoharie Creek rebuilt after 1987 flood. View looking upstream. No samples obtained from bridge site; data from forensic report used.

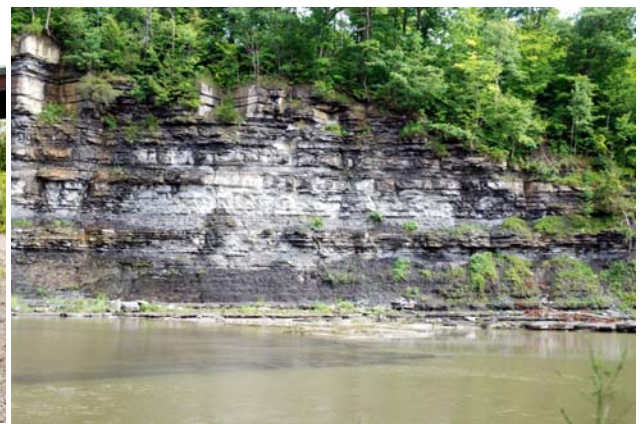
Figure 12. Thin- to thick-bedded sandstone on left bank of Schoharie Creek at the USGS Burtonsville gage site. Samples taken from the camera position on the right bank.

upstream of the bridge; bedrock at the gage site is thick-bedded Paleozoic (Devonian) marine sandstone (Figure 12) that is jointed into tabular boulder-size blocks (> 12 inches). The sandstone boulders formed an armor layer on Schoharie Creek (Figure 13), protecting it from exposure to scour at peak discharges less than 20,000 cubic feet per second (cfs) (Resource Consultants and Colorado State University, 1987). Figure 13 shows the August 2008 condition at State Route 161 approximately 4 miles upstream from the I-90 Bridge.

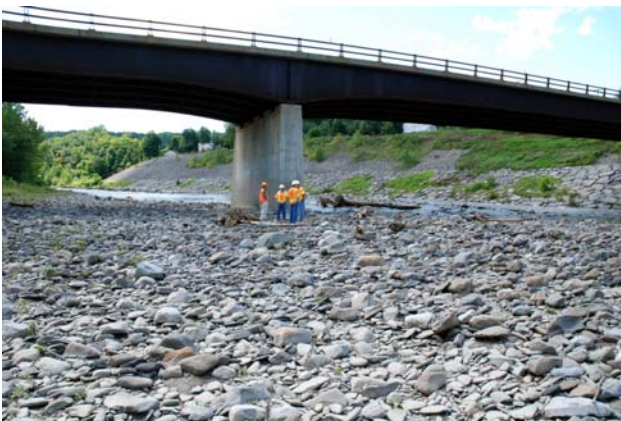
Figure 13. Schoharie Creek at State Route 161 about 4 miles upstream from I-90. Boulder armor layer here is similar to the channel at I-90 before the bridge failed in 1987.

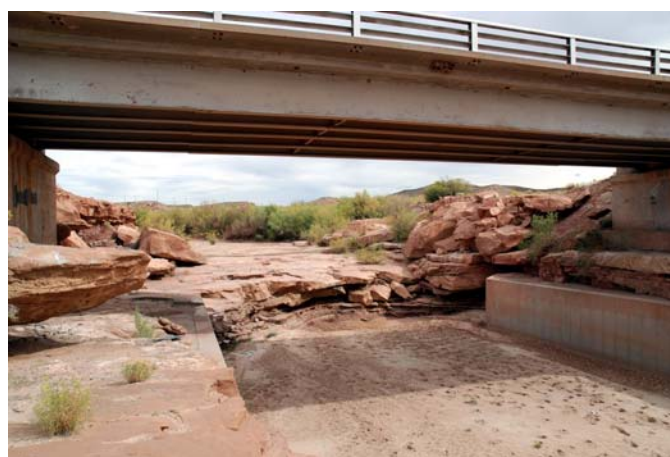
Figure 15. State Route 262 Bridge over channel constructed through narrow ridge which became the main channel of Montezuma Creek. View is looking upstream at knickpoint.

State Route 262 crosses Montezuma Creek in southeast Utah about 275 miles southeast of Salt Lake City. The drainage basin outline and general geologic formations are shown on Figure 14; the drainage basin extends into Colorado. The bridge (Figure 15) is founded on Jurassic fluvial sandstone with claystone interbeds. Before the bridge was built in about 1960, Montezuma Creek consisted of a large meander bend that defined a narrow peninsula of sandstone and claystone (Figure 16). A narrow channel about 50 feet wide was excavated across the peninsula and an embankment with a culvert was placed across the meander bend. The excavated channel effectively is an unlined spillway; it appears that the initial construction created a knickpoint in the sandstone nearly 200 feet downstream from the bridge. By 2003, the knickpoint had migrated to a point about 15 feet upstream from the bridge (HDR, 2004). In September 2008, the knickpoint was nearly 8 feet high and exposed friable claystone under hard sandstone (Figure 17). Concrete retaining walls were constructed in 2004 to protect exposed claystone interbeds under the bridge foundations from further erosion. Sculpted forms in hard sandstone within about 10 feet of the crest of the knickpoint have pits in downstream-facing sides (Figure 18) that are best explained as cavitation features. Gravel fragments are wedged tightly into vertical joints (Figure 19) and bedding planes. Circular holes with radial fractures in hard sandstone (Figure 20) mark blast holes used for initial excavation of the channel.

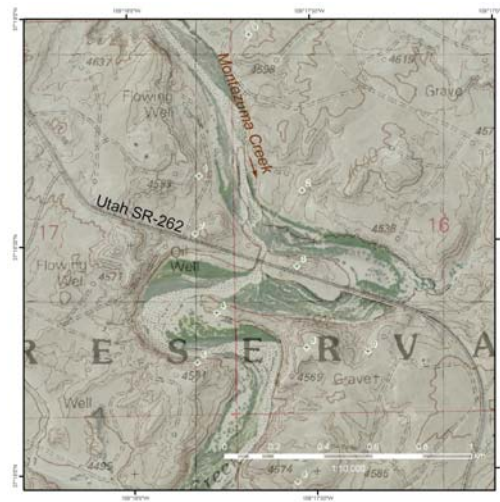
Figure 16. Topographic map showing Montezuma Creek channel and cutoff.

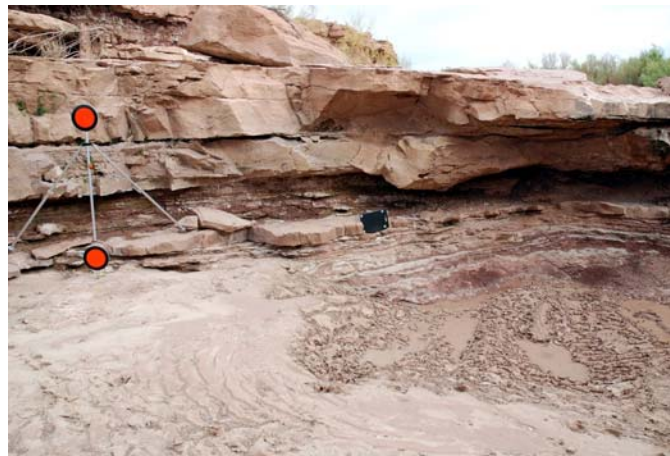
Figure 17. Sandstone and claystone exposed in knickpoint about 15 feet upstream from bridge. Orange circles are 1.35m apart on vertical pole.

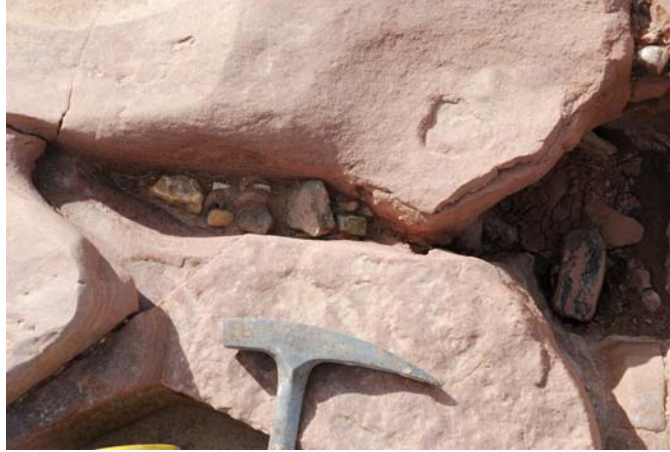
Figure 19. Gravel fragments wedged tightly into vertical joint in hard sandstone indicating turbulence-induced opening during flood flow.

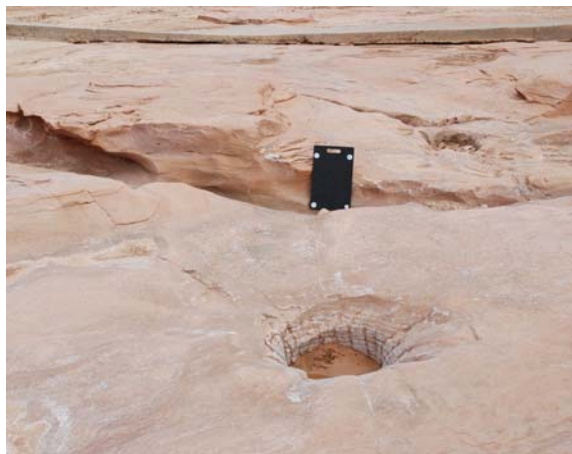
Figure 20. Blast hole with radial fractures in hard sandstone. White spots on board are 20 cm and 30 cm apart.

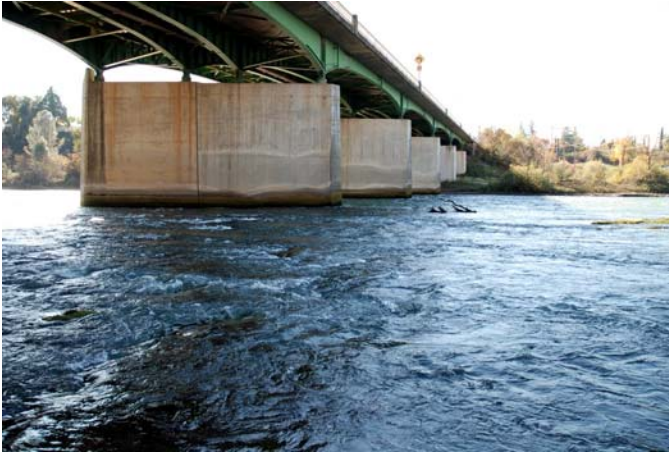
Figure 22. State Route 273 Bridge over Sacramento River. View looking toward right abutment.

State Route 273 crosses Sacramento River at Redding in north-central California about 150 miles north of Sacramento. The drainage basin extends into Oregon; the outline and general geologic formations are shown on Figure 21. The bridge (Figure 22) is founded on soft, dark gray,

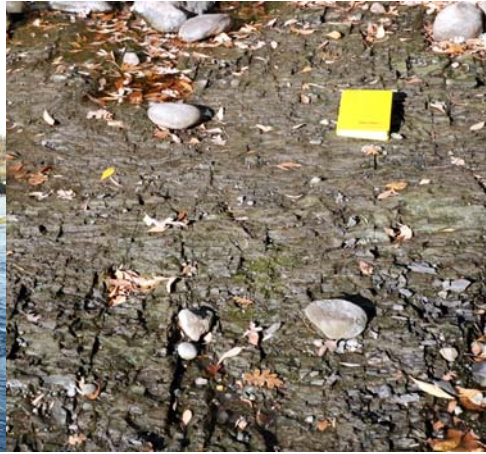
Figure 23. Thinly bedded and locally fractured siltstone. Notebook is 140 mm wide by 192 mm long.

Cretaceous marine siltstone that is thinly bedded and locally fractured (Figure 23). Beds are locally folded and dip toward the left abutment (north) at about 17°; some beds are harder than others (Figure 24). Cobble-sized fragments of hard igneous rocks form the bedload (Figure 25). Shasta Dam, located approximately 10 miles upstream, was closed in 1945.

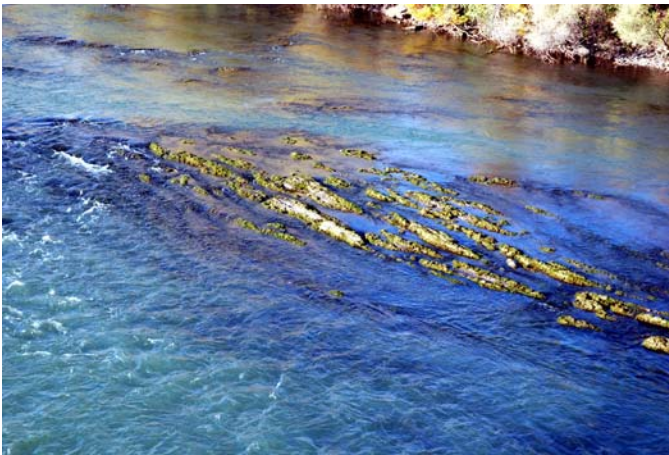
Figure 24. Harder layers in siltstone mark local fold exposed in Sacramento River upstream of SR-273 Bridge. View looking about 45° right of directly upstream; photo taken from bridge.

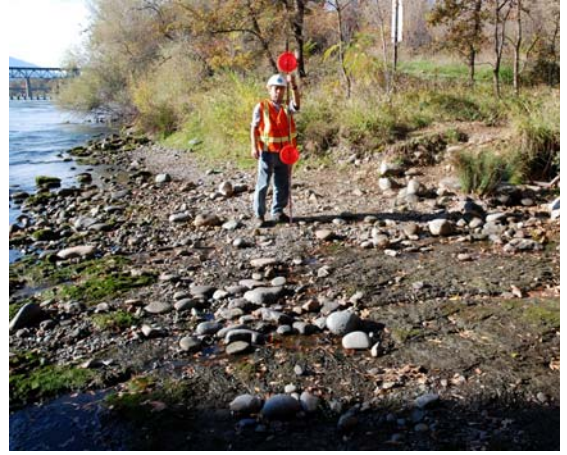
Figure 25. Rounded cobble-size bed load fragments on bank of Sacramento River near left abutment of SR-273 Bridge. Orange targets are 1.0 m apart.

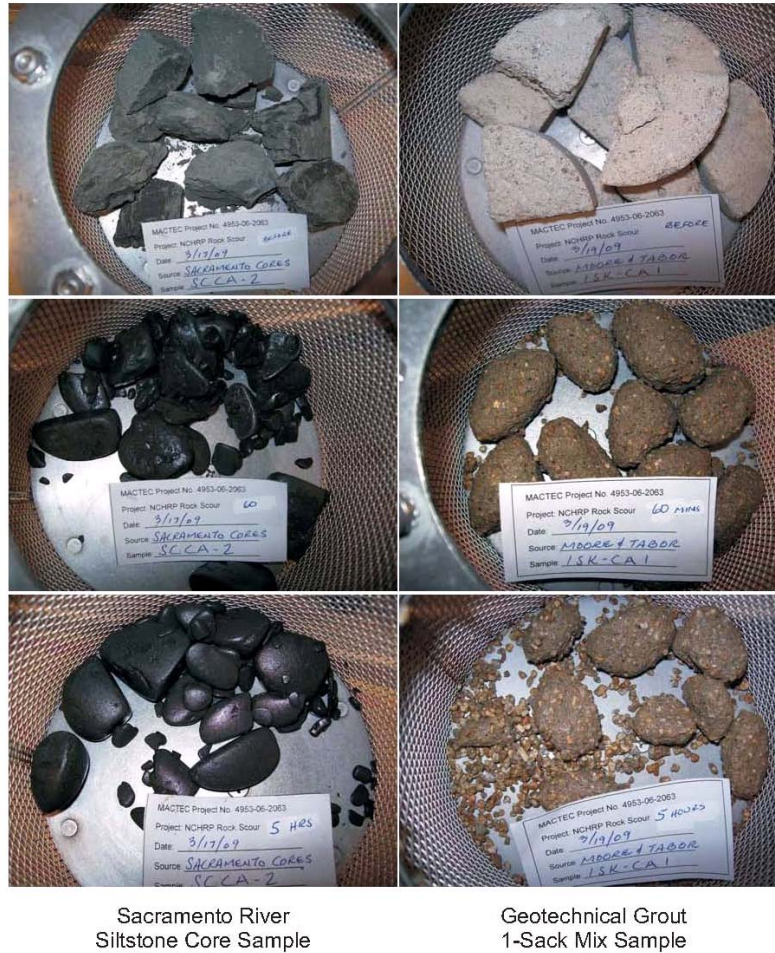
Figure 27. Comparative photographs showing two samples at 0, 60, and 300 minutes during the continuous abrasion test

The 'continuous abrasion' test of Dickenson and Baillie (1999) expresses sample loss as a function of accumulated time during the test (Figure 26). The abrasion number is defined as the slope of the abrasion loss rate curve for that part of the test beyond 120 minutes on a semi log plot of the data (lower graph on Figure 26). The first 60 to 120 minutes of the test display a sample loss rate that is controlled by rounding of angular fragments, whereas sample abrasion is occurring after rounding is complete (Figure 27). The samples demonstrate a wide range of results.

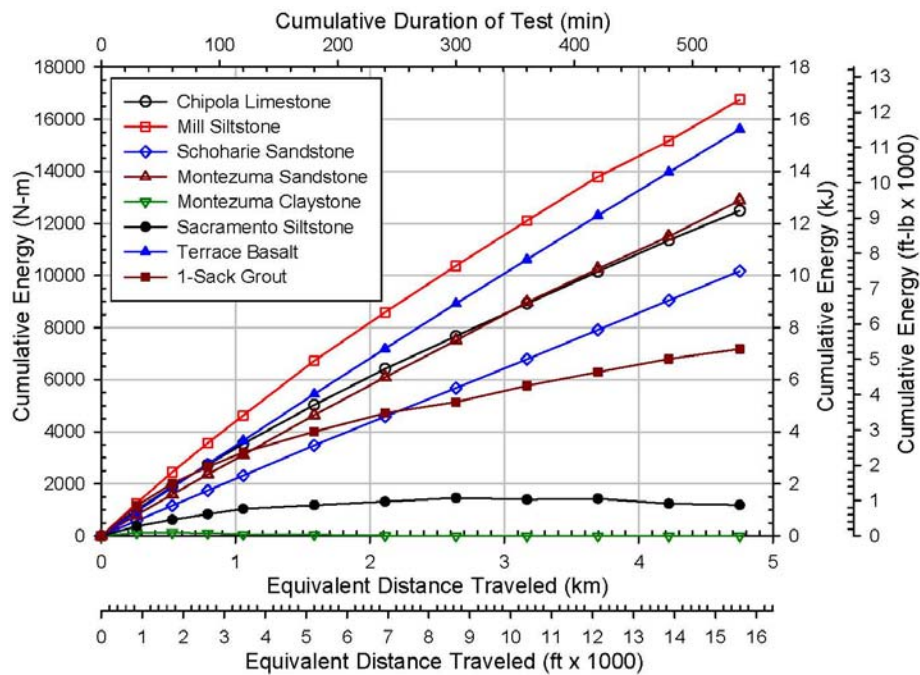
Figure 28. Cumulative energy plotted against equivalent distance traveled during a 9-hr continuous abrasion test using standard slake durability test equipment.

0.1467 m/s. The samples travel an equivalent distance of 4752 m during a 9-hr test. Resistant samples exhibit more constant energy during the continuous abrasion test than nonresistant samples. Figure 28 shows cumulative energy for eight samples with resistant samples plotting as straight lines and nonresistant samples exhibiting nonlinear behavior.

It can be seen in Figure 29 that samples with linear trends in Figure 28 retain at least 95% of the initial power during the first 3 hours of the continuous abrasion test. Samples with strongly nonlinear trends in Figure 28 (Montezuma claystone and Sacramento siltstone) exhibit large sample loss in the initial test increment. Samples with mild nonlinear trends in Figure 28 (Chipola limestone, Mill siltstone, and 1-sack grout) exhibit modest sample loss in the initial test increment, with continuing loss in subsequent test increments. Samples with linear trends in Figure 28 exhibit high equivalent power (>95%) and low incremental sample loss (<5%) during the 3 hours of test data plotted on Figure 29. It should be noted in Figure 27 that coarse sand grains (>2 mm) abrading from the 1-sack grout sample are retained in the basket and contribute to

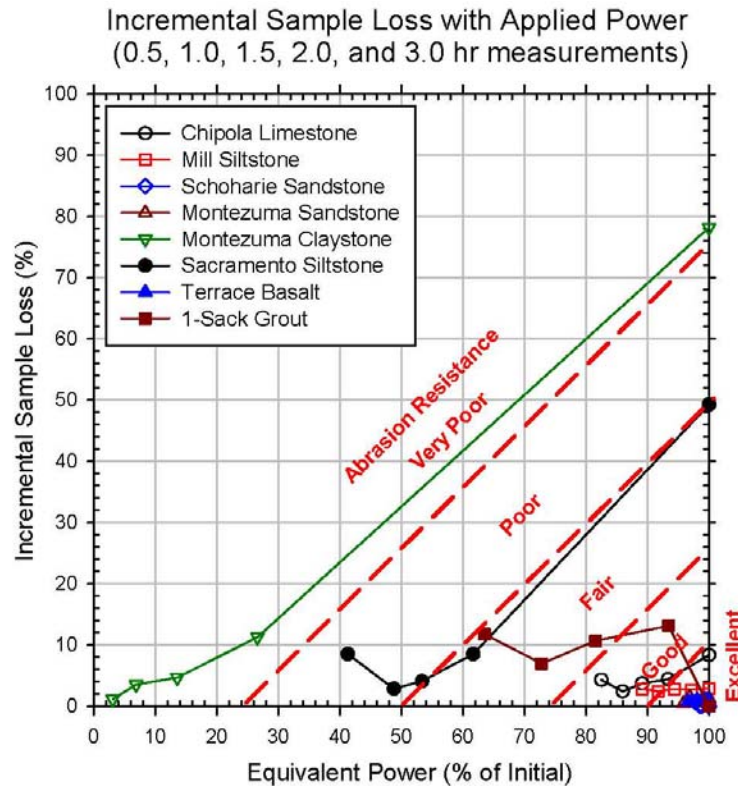
Figure 29. Incremental sample loss plotted against equivalent power.

Abrasion resistance field boundaries are arbitrary.

Energy dissipation can be expressed in terms of Newton-meters per second or foot-pound per second, which are the units of stream power ($1 \text{ N-m/s} = 1 \text{ J/s} = 1 \text{ W}$). Unit stream power is stream power normalized per area of channel cross section, expressed as W/m^2 . The continuous abrasion test results were converted to equivalent power or unit energy dissipation by dividing the incremental energy by the number of seconds between measurements and assuming that the sample fragments remain in the lower 45° of the slake durability basket during the test. The basket circumference is 0.44 m and its length is 0.10 m; therefore, the area of a 45° sector of the basket is 0.0055 m^2 . Figure 29 shows the first 3 hours of the test data plotted in Figure 28 with the

results normalized as percentages of initial sample mass and initial equivalent power. The values progress from right to left, starting with 100% of the equivalent power.

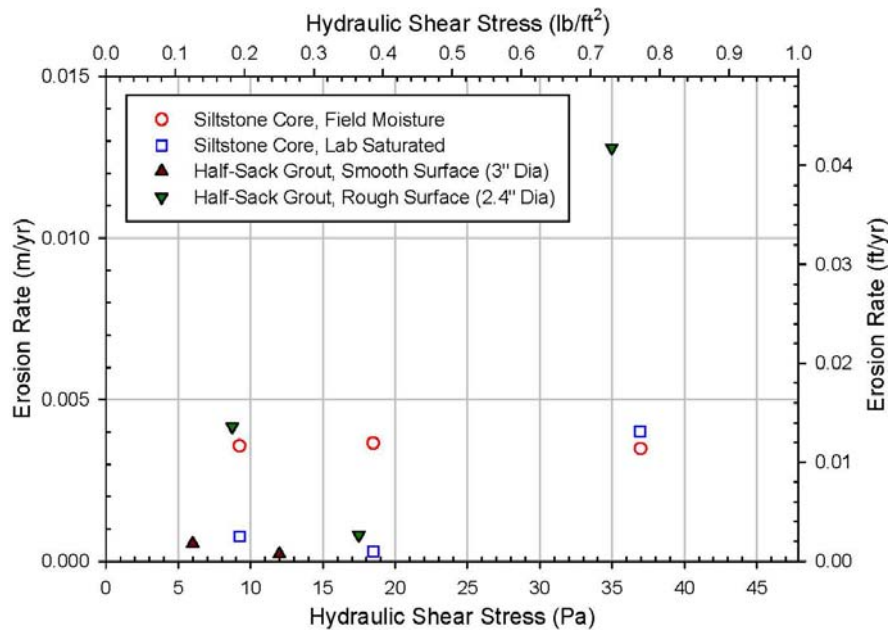
Figure 30. Rotating Erosion Test Apparatus (RETA) test results

Florida DOT tested four samples in their Rotating Erosion Test Apparatus (RETA) (Figure 30): Siltstone core samples from Mill Creek obtained with drilling donated by Oregon DOT and geotechnical grout samples donated by Moore & Taber. Siltstone samples were tested at field moisture and saturated. Grout samples were sand-cement slurry mixed with ½ sack of cement per 8 cubic feet of grout and cast in standard plastic tubes 3 inches in diameter and 6 inches long. The exterior surface of the grout cylinders were as smooth as the inside of the plastic tube in which they were cast. The RETA results show negligible erosion rate on the smooth sample, but a rough sample showed a higher erosion rate. Testing of several other samples was attempted, but the samples were too fragile to survive handling during preparation.

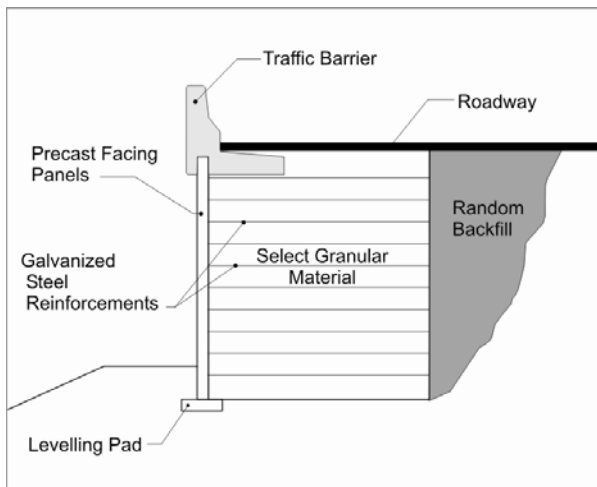
Figure 1. Schematic Illustration of MSE Construction

The concept of Mechanically Stabilized Earth is a simple one. A material with substantial compressive strength – compacted granular fill – is reinforced by a material with significant tensile capacity – steel, with each component being used in its most efficient manner. The resulting composite material has both great strength and structural flexibility, is easy to construct, and has a predictable design life. In structural concept, a Mechanically Stabilized Earth wall is a gravity structure, having a cross sectional width typically at least 70% of its height as shown in Figure 1. MSE walls often support a traffic barrier or other protection system.

The principal elements of MSE construction, also depicted in Figure 1, are wall facing, galvanized or plain steel reinforcements and granular backfill. The anticipated service lives of MSE structures are most dependent on the durability of the earth reinforcements although, in some circumstances, foundation conditions and construction-related problems may also play an important role. Most steel reinforcements for MSE structures are hot-rolled steel strips or welded wire or bar-mat grids, manufactured, respectively,

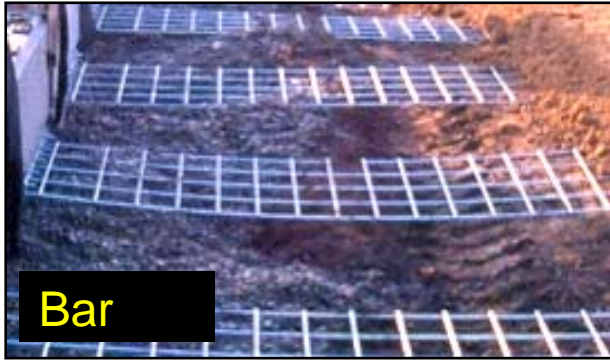
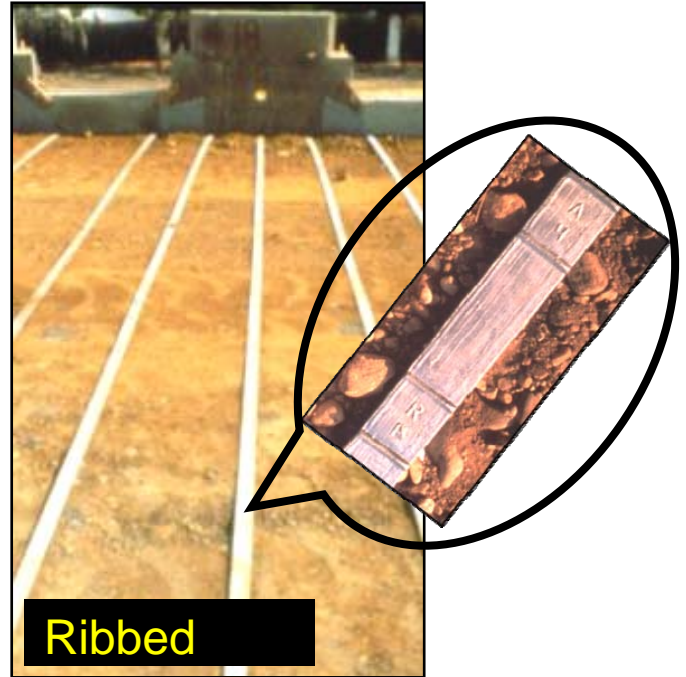
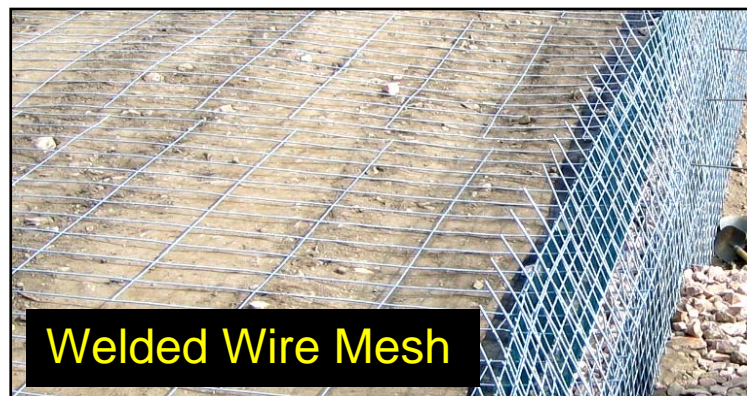
a) bar mat reinforcements

b) hot-rolled steel strip reinforcements

c) welded wire grid reinforcements

Figure 2. Examples of Metallic Reinforcements Used in MSE Construction

from steel bars or cold-drawn wire as depicted in Figure 2. Most often the reinforcements include hot-dip galvanizing for corrosion protection. Durability of the reinforcements is controlled by backfill characteristics, site conditions, climate, steel type (galvanized or not), and several details of project construction and in-service operations.

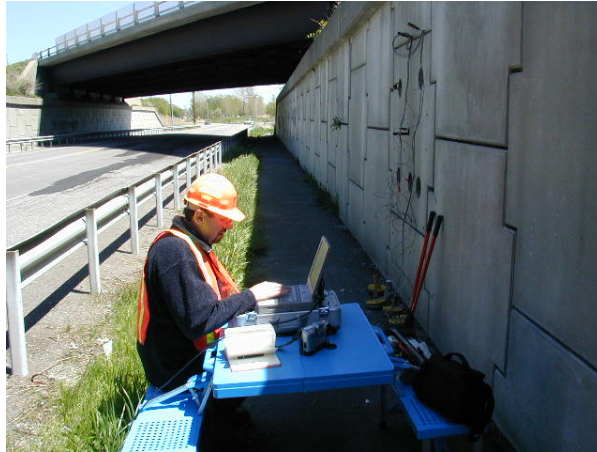
Figure 3. Electrochemical Testing of MSE Reinforcements Showing Core Holes Used to Access Reinforcements and Field Unit for making Measurements

Alternatively, electrochemical test techniques may be applied for monitoring earth reinforcements (Stern and Geary, 1957; Lawson et al., 1993; Berkovitz, 1999) as shown in Figure 3. With these techniques, a large number of samples may be obtained. Because the tests are nondestructive, reinforcements remain intact and in service after testing and are, therefore, available for future monitoring. Electrochemical measurement techniques may be used to monitor the presence and/or rate of corrosion. Results from electrochemical tests are useful for indicating if the corrosion process is currently active and, if it is, at what rate.

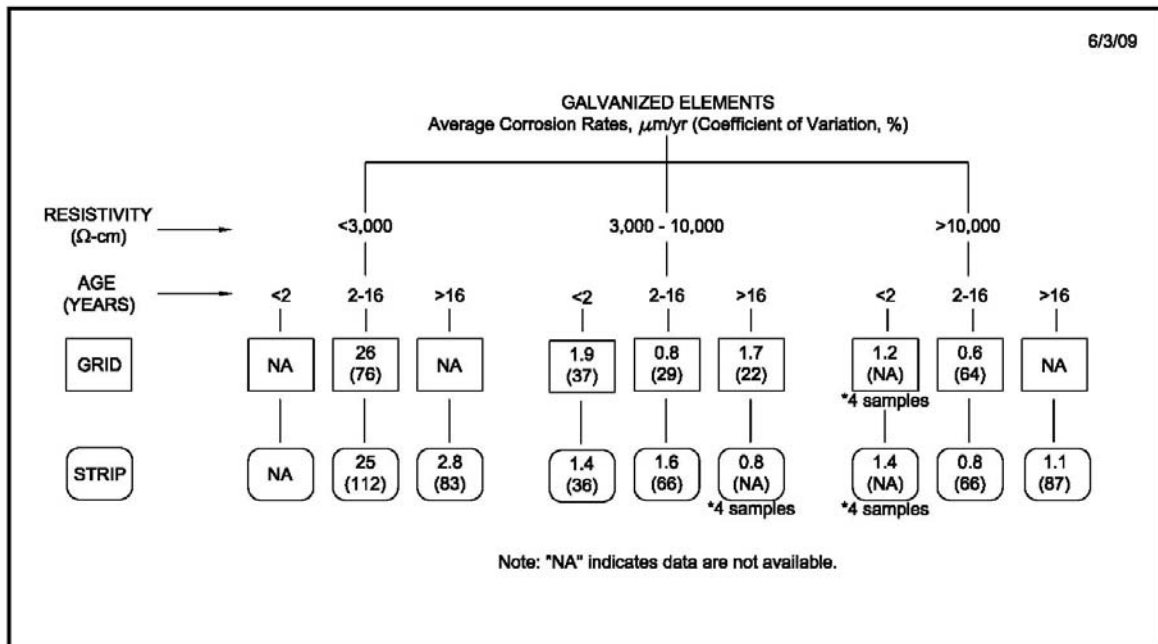
Figure 4. Summary of Corrosion Rate Measurements from NCHRP Project 24-28 Database

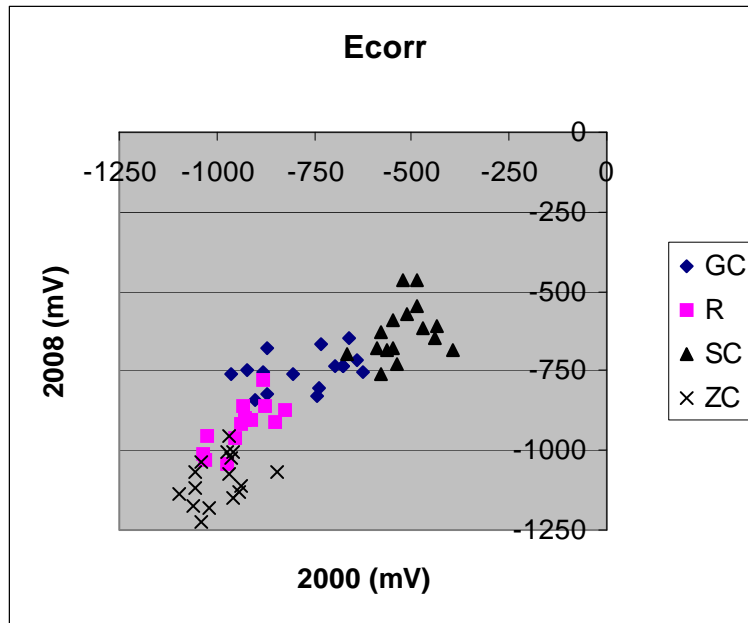
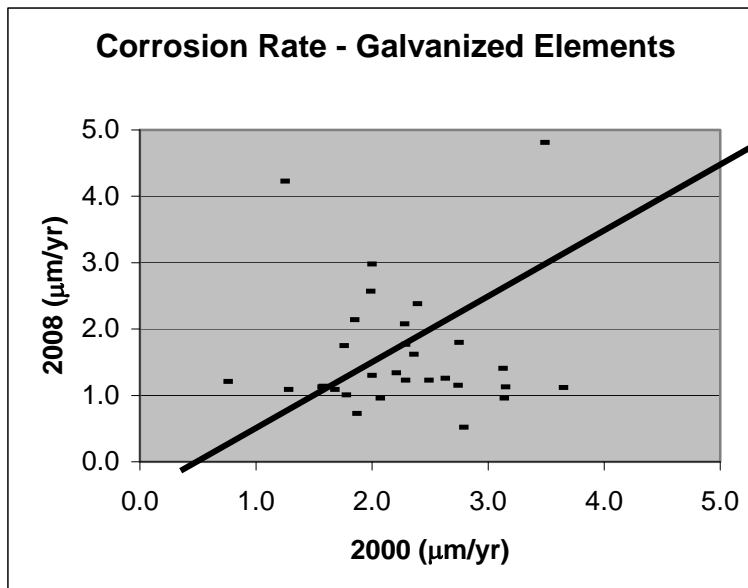
a) Half-Cell Potentials (mV); GC – Galvanized coupons, R – Reinforcements (galvanized), SC- steel coupons, ZC – zinc coupons

b) Corrosion Rates ($\mu\text{m}/\text{yr}$) for Galvanized Coupons and In Service Reinforcements
Figure 5. Mary-Utica Wall Results from Monitoring After Construction in 2000 and After Eight Years in Service in 2008.

Measurements were collected shortly after construction in 2000 and eight years after construction on May 29, 2008. Figure 5 presents a comparison of results from measurements made in 2000 and 2008. In general, the soil resistance measured as part of the LPR test was much lower in 2008 compared to 2000. Figure 5(a) depicts the trends with respect to half-cell potential measurements, and Figure 5(b) shows the corrosion rates measured for galvanized elements including galvanized coupons and in service reinforcements.

The half-cell potential measurements from 2000 (horizontal scale in Figure 5(a)) show that, generally, the range of potentials for the galvanized elements overlapped with the range of potentials for the zinc coupons. Half-cell potential measurements from 2008 (vertical scale in Figure 5(a)) show that the half-cell potentials of the galvanized elements have shifted away from the half-cell potential of the zinc elements, and there is some overlap with the lower range of potentials measured for the steel coupons and the galvanized elements. These trends are as expected, and the data serve to expand the

Figure 5(b) shows that corrosion rates for galvanized elements are generally lower in 2008 compared to 2000. The mean corrosion rate for galvanized elements in 2000 was $2.2 \mu\text{m}/\text{yr}$ with standard deviation equal to 0.67. In 2008 the mean corrosion rate for galvanized elements was $1.6 \mu\text{m}/\text{yr}$ with standard deviation equal to 0.96.

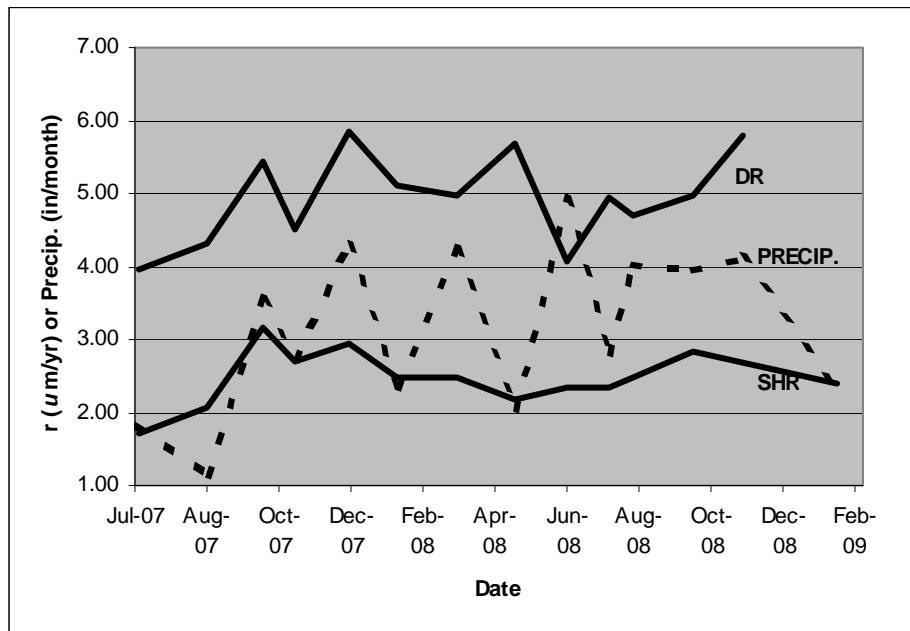
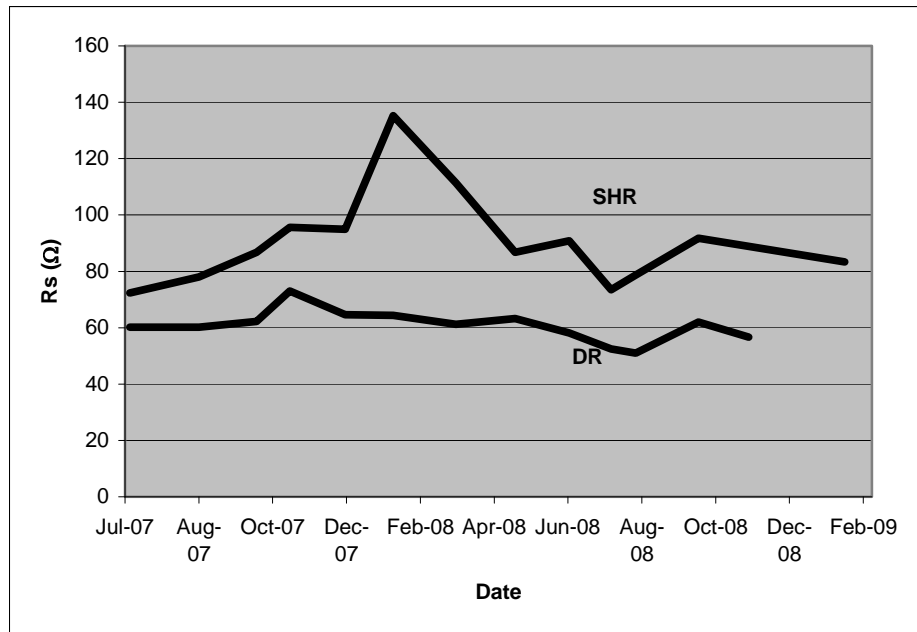
Figure 6. Transient Response of Reinforcements at Dodge and Sweet Home Road Sites

a) Mean Monthly Corrosion Rates Compared to Monthly Precipitation

b) Mean Monthly Soil Resistance

As part of NCHRP Project 24-28, readings were taken at approximately monthly intervals between June 2007 and December 2008 in an effort to document the seasonal variations of corrosion rate. Results from these monthly measurements are summarized in Figure 6 including a comparison between corrosion rates and monthly precipitation; and measurements of soil resistance (R_s). The data in Figure 6 represent the means of the measured corrosion rates from reinforcements at the respective sites. These means are associated with coefficients of variance between 10 and 40 percent. These data indicate that corrosion rates appear to correlate well with monthly precipitation and corrosion rate measurements at this site vary by a factor of 1.5 considering seasonal fluctuations.

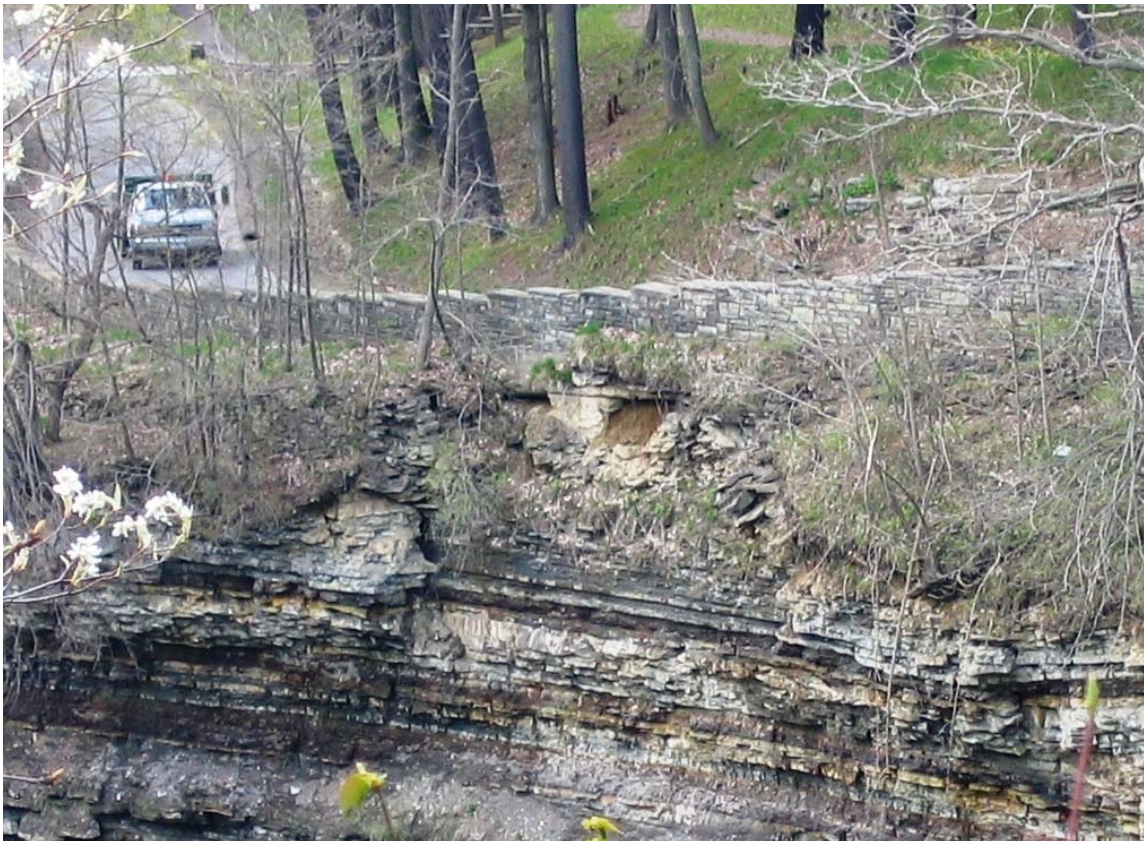
Figure 2 - Photo by OPRHP personnel of west side of gorge.

In 2005, OPRHP workers noticed an unusual absence of trees and brush along the west edge of the gorge, north of the Glen Iris Inn and the Middle Falls. The gorge in this area has nearly vertical walls and the edge of the road is within a few feet of the gorge wall, making it impossible to observe the gorge wall beneath the road. OPRHP personnel photographed the area from the opposite (east) side of the gorge (Figure 2) and noted some apparent irregularities in the gorge wall at this location.

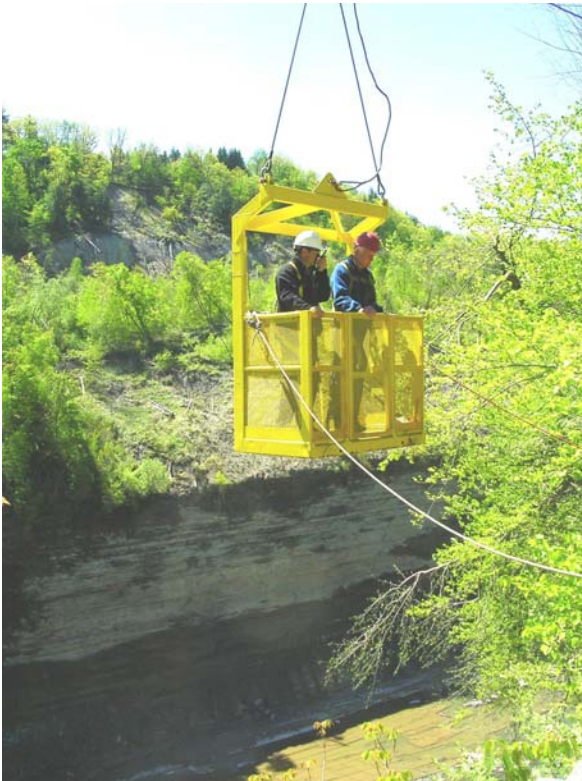
Figure 3 Man Basket Used for Observations

MMCE, EDI and OPRHP personnel observed the site conditions in May 2005 with the assistance of a crane and operator provided by Clark Rigging Company. The crane operator lowered personnel over the side of the gorge using a man basket (Figure 3).

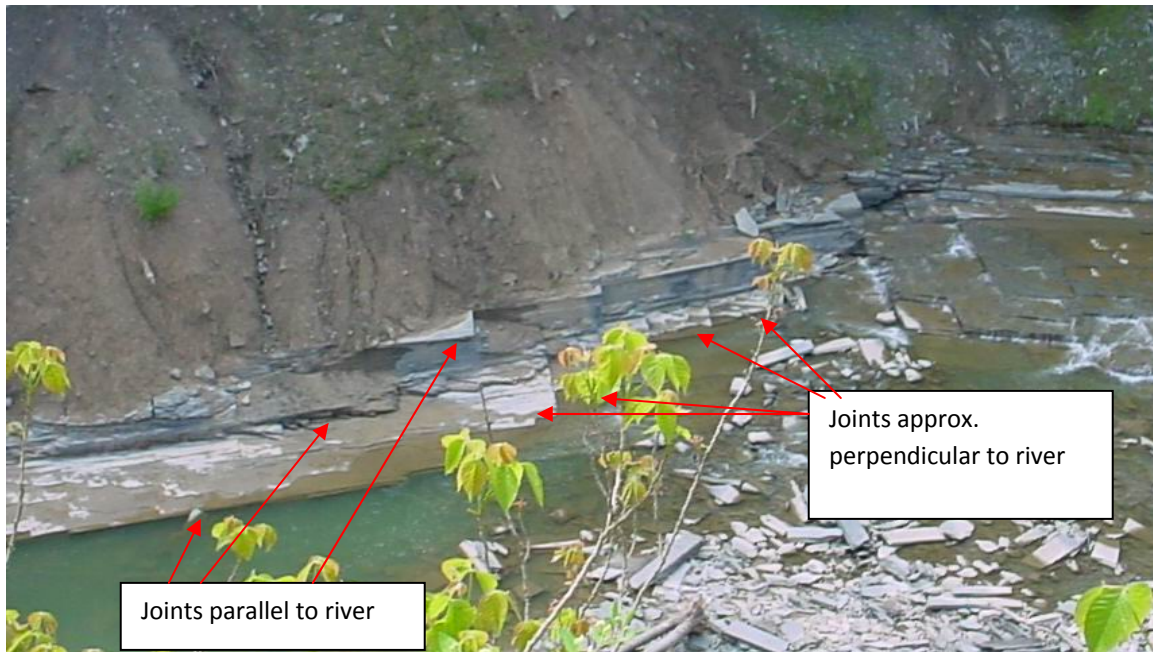
Figure 4 - Looking east across gorge at rock joint pattern

The rock jointing pattern was observed in the Genesee River and on the east gorge wall (opposite side of the river – Figure 4). Two sets of near vertical joints are evident, one

approximately perpendicular to the river (estimated to be about N 55°W) and another approximately parallel to the river and alignment of the gorge walls. This nearly right angle joint pattern is common in the exposed sedimentary bedrock in Letchworth Park.

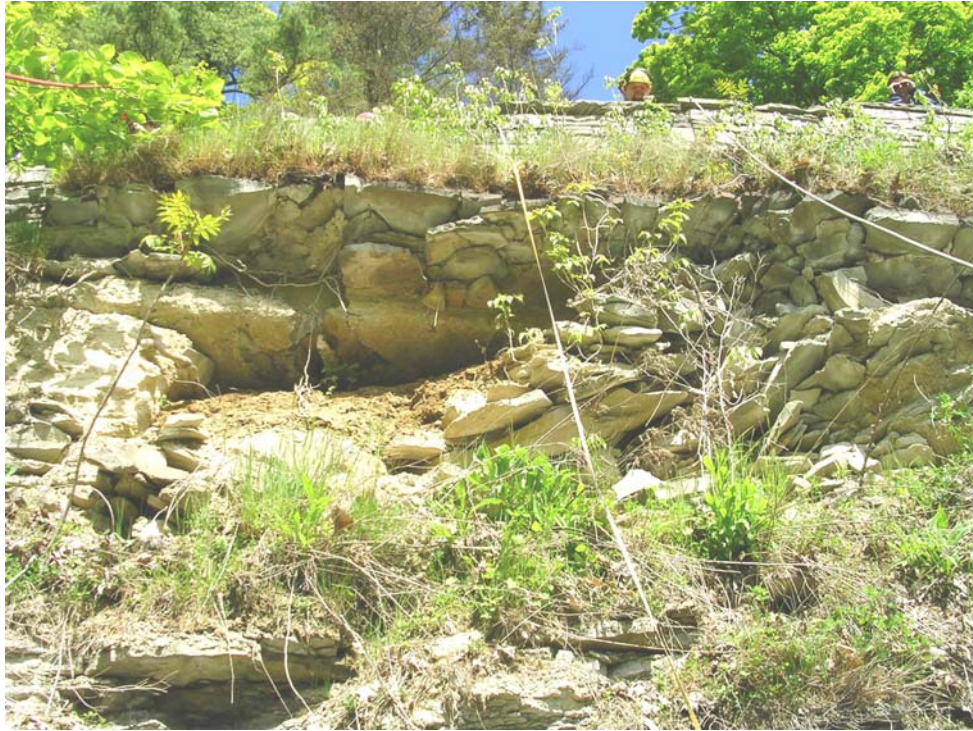
Figure 5 – View (looking west) showing undermined area.

The area immediately beneath the road is not intact rock but is comprised of loose rock, soil and concrete. It appears that this area was a natural swale that workers who constructed the road filled in with stacked stones and concrete. Both the stones and concrete are disturbed and have fallen out of place for a distance of about 40 feet along the gorge wall. A concrete grade beam could be seen spanning the area where stones have fallen out (Figure 5). Support had been lost for approximately 10 to 15 feet of the wall and road.

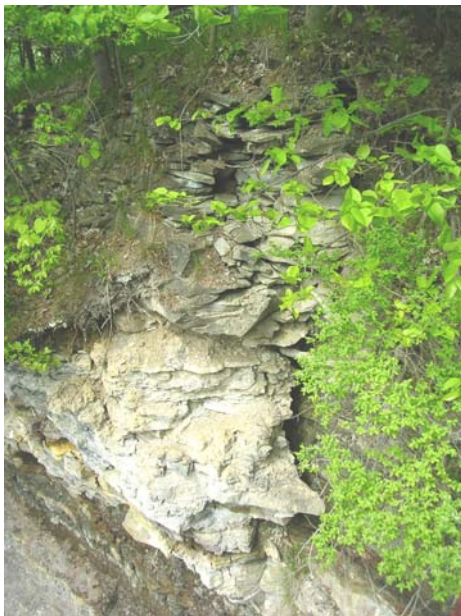
Figure 6

The rock column at the south end (Figure 6) appeared to be separating from the gorge face along a nearly vertical joint parallel to the gorge face. The rock column at the north end of the disturbed area (Figure 7) appeared to also be separated along a near vertical joint but had moved slightly less laterally. Each column appeared to be composed of more competent rock at the bottom and loose rubble near the top.

Two rock blocks or columns, one at each end of the approximate 40-foot disturbed section, were observed to be separating from the gorge wall (Figures 6 and 7).
