60th HIGHWAY

GEOLOGY SYMPOSIUM

PROCEEDINGS

1.1.	<i>High Bridge Area Roadway Slide, Letchworth State Park, Portageville, New York</i>	22
	Andrew J. Nichols, P.E.; James Bojarski, P.E.	
1.2.	<i>Remediation of the SR 15 Welcome Center Landslide.....</i>	35
	David R. Scherer, P.E.; Robert E. Johnson, P.E.; Paul J. Lewis, P.E.

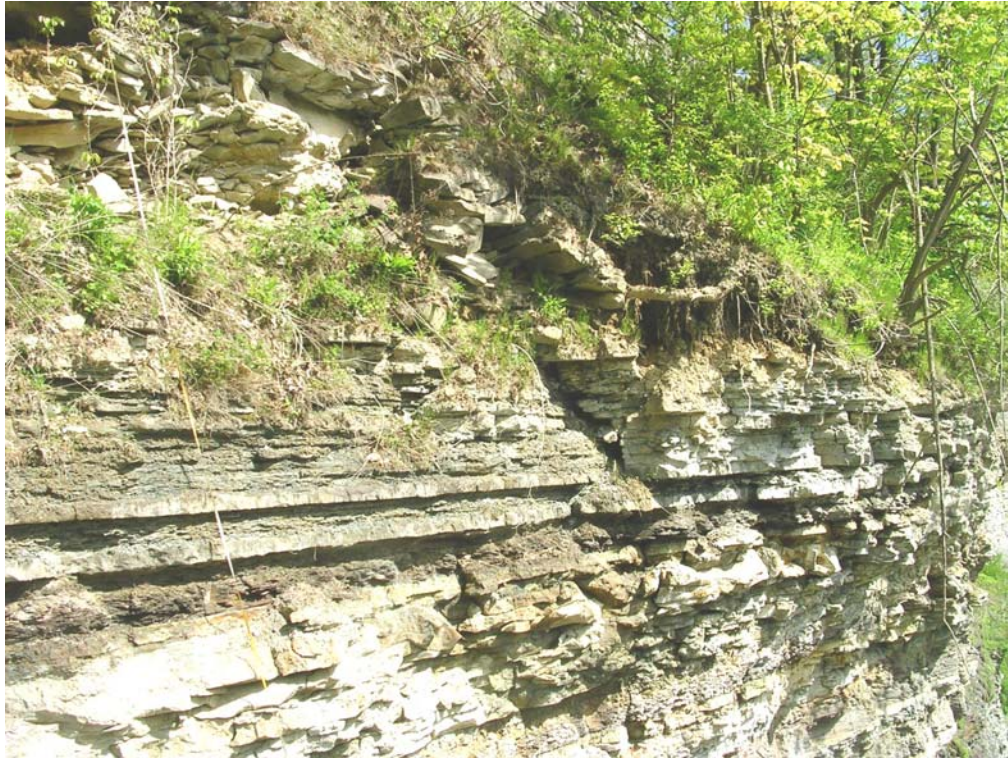
Figure 7 - Rock Block on north side of undermined area separating from gorge face

The rock column at the south end (Figure 6) appeared to be separating from the gorge face along a nearly vertical joint parallel to the gorge face. The rock column at the north end of the disturbed area (Figure 7) appeared to also be separated along a near vertical joint but had moved slightly less laterally. Each column appeared to be composed of more competent rock at the bottom and loose rubble near the top.

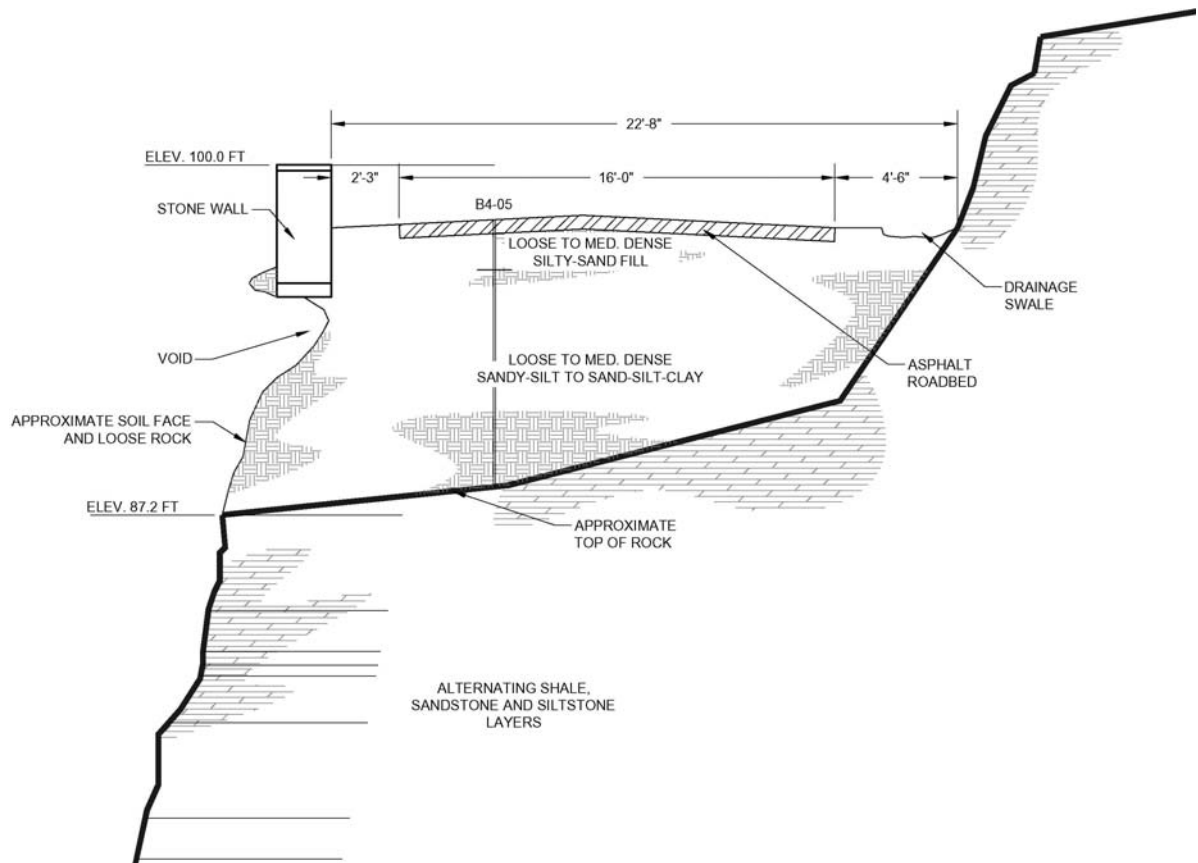
Figure 9 – Typical Section Prior to Construction

OPRHP closed the road to traffic and requested that MMCE and TVGA prepare plans to remediate the undermining. EDI drilled borings in the roadway to define the subsurface conditions. Figure 9 is a cross section of the road and gorge face based on our observations and the borings.

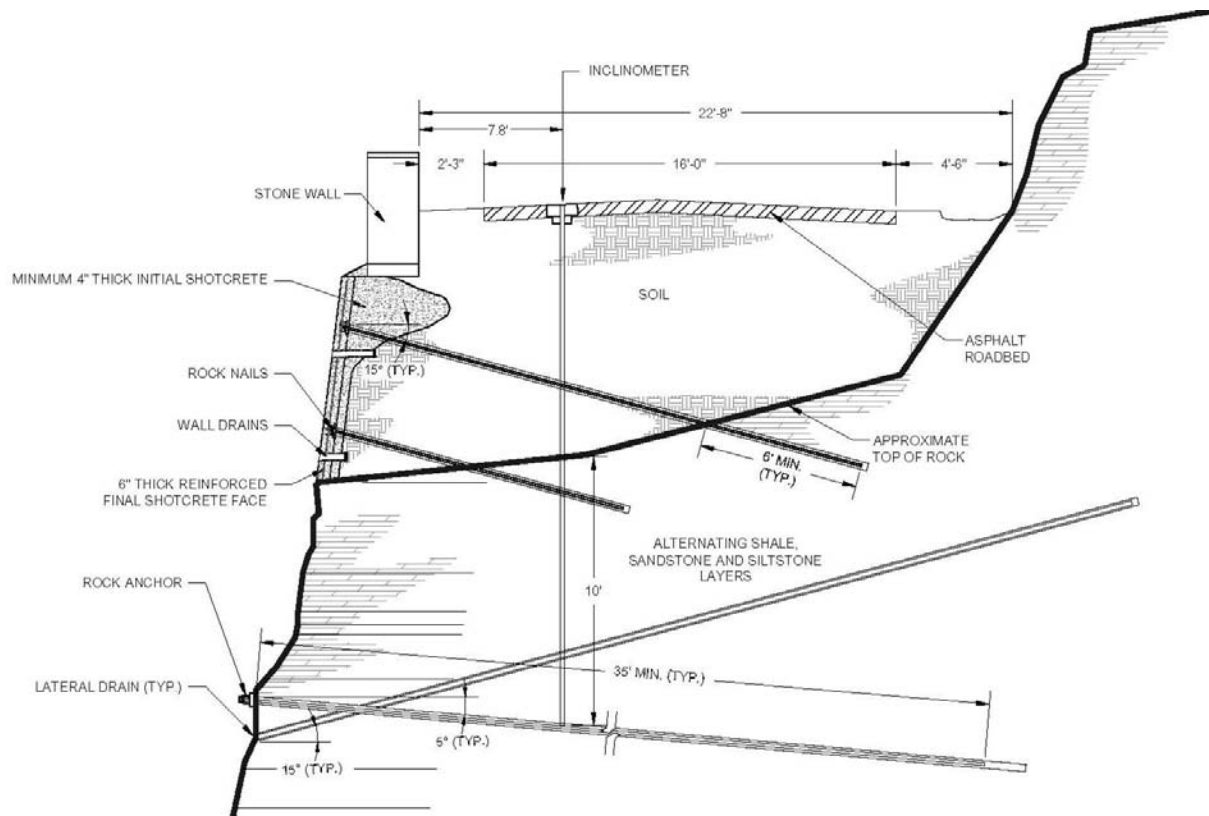
Figure 10 - Typical Design Cross Section

Because the road was undermined it was not feasible to complete the remedial work from a crane located on the roadway. It was necessary to develop a design that was constructible considering the site access restrictions. We contacted Janod Inc. (Janod), a specialty subcontractor for rock scaling, shotcreting and rock nail and anchor installation, for design consultation relative to the feasibility of constructing various remedial features. We developed the design based on discussions with the Janod regarding what was feasible and stability calculations for the roadway. Figure 10 is a cross section illustrating the components of the remedial design.

The remedial design included scaling loose rock from the face then installing shotcrete to fill the voids and stabilize the gorge face. The shotcrete facing is reinforced and secured to the gorge face by rock nails. The nails are 1-inch diameter, Grade 95 kips per square inch (ksi), reinforcing bars, drilled at least 6 feet into rock and grouted. Plastic pipes extend through the shotcrete to provide drainage and limit groundwater buildup behind the shotcrete.

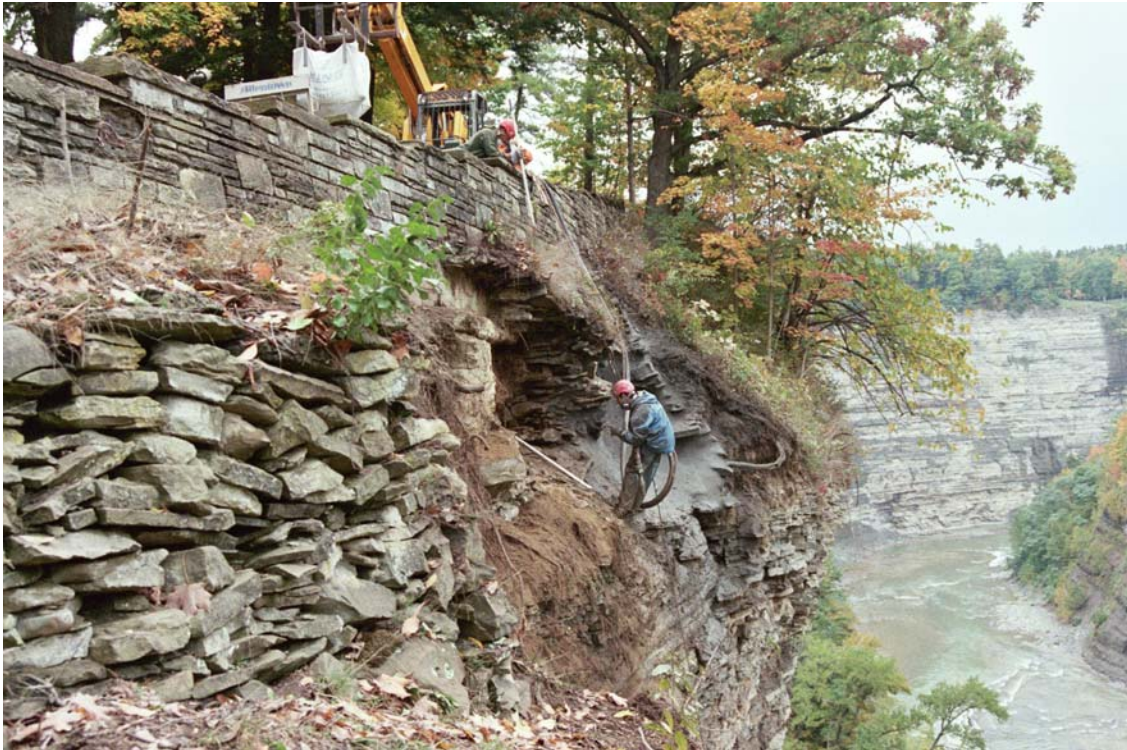
Figure 11 – Janod Filling Void with Shotcrete

OPRHP contracted with C.P. Ward Inc. to complete the work with Janod as the specialty subcontractor for rock scaling and rock nail and anchor installations. Construction began in the Fall of 2005 with Janod scaling loose soil and rock from the gorge face and initial filling of the void with shotcrete. Janod placed a rubber bladder into the open joints on the north and south sides of the undermined area and inflated the bladder to remove loose material. Once the loose material was removed they began initial filling of the void with shotcrete as shown in Figure 11.

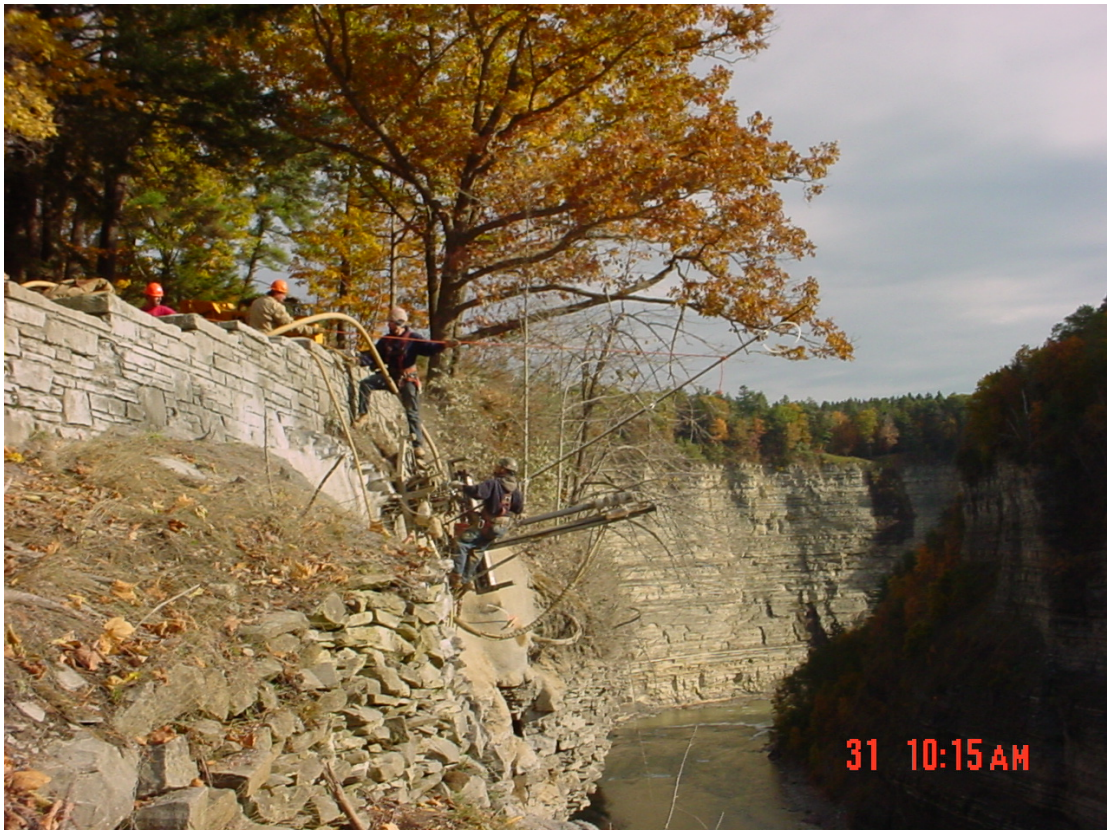
Figure 13 – Rock Nail Installation

Figure 12 shows the shotcrete work in progress. Once the void was partially filled, Janod lowered a drill rig over the side for use in installing the rock anchors, drains and rock nails. Figure 13 shows the rock nail installation and Figure 14 shows the rock anchor installation.

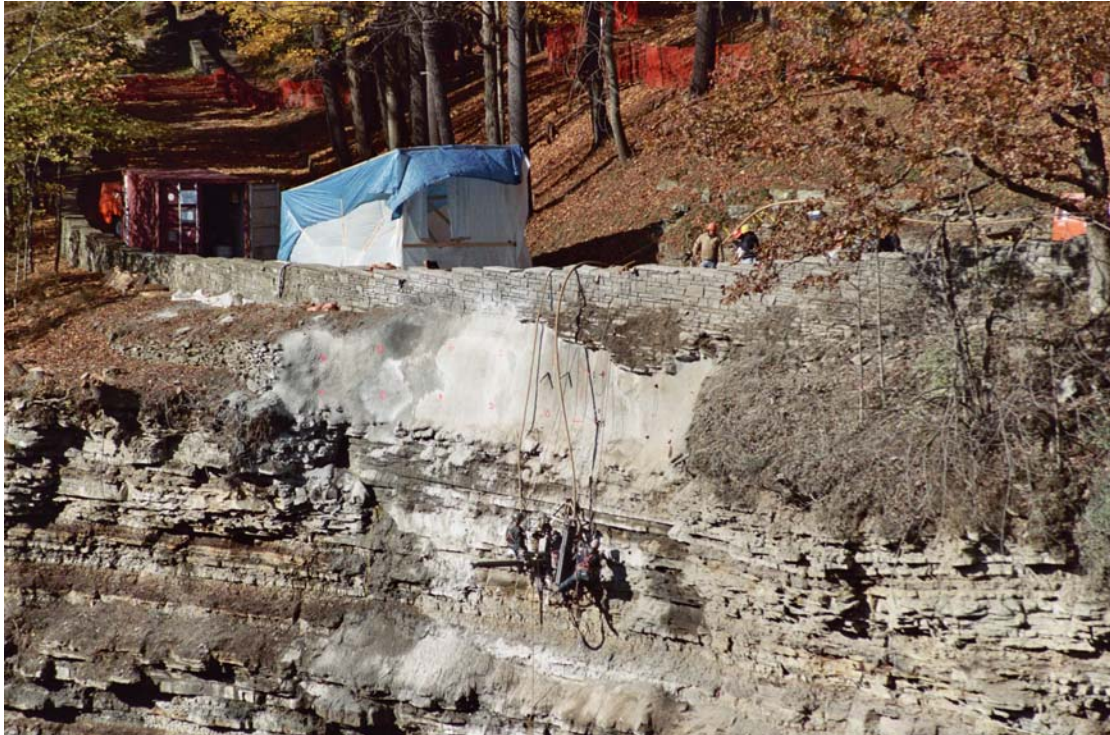
Figure 14 – Rock Anchor Installation

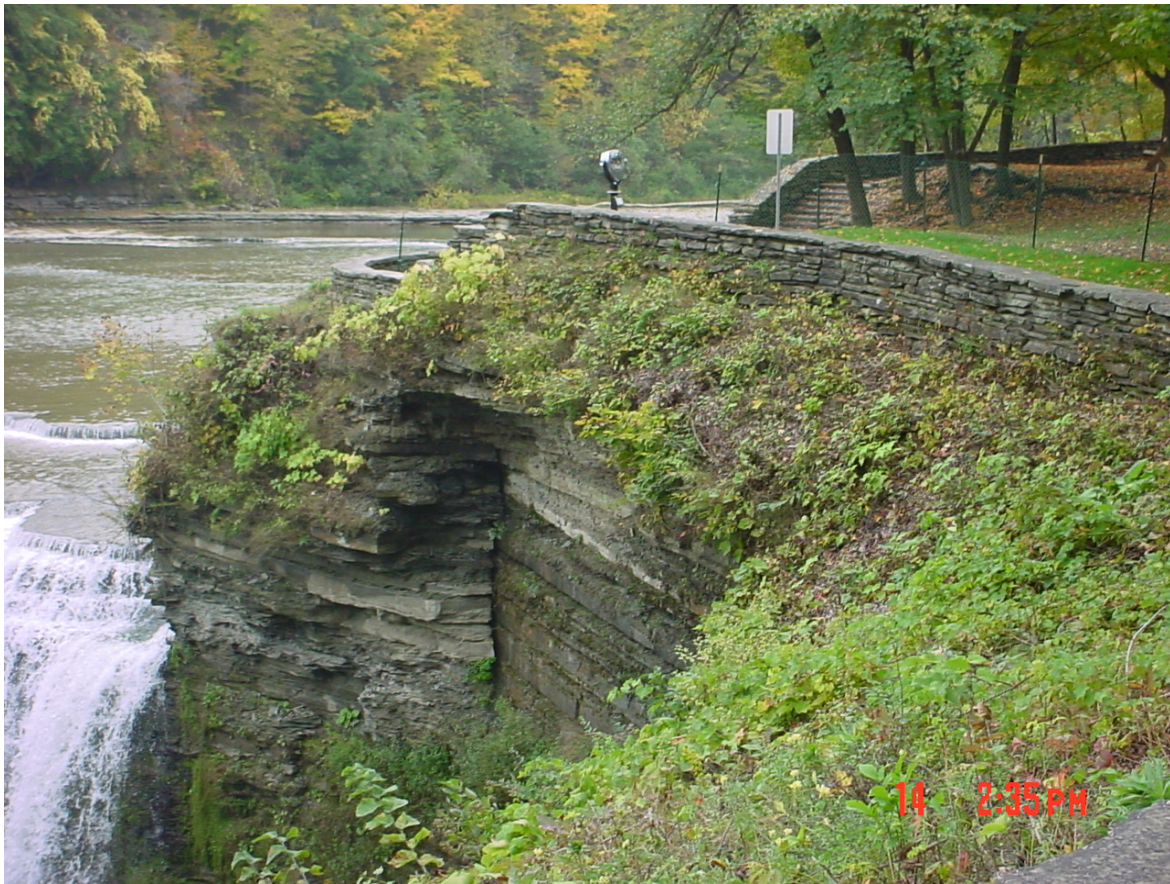
Figure 15 – Middle Falls Prior to Construction – Note Open Joint

The Middle Falls at Letchworth State Park (see Figure 1 for location) offers dramatic views of the rock gorge and the Falls. OPRHP personnel requested that MMCE and EDI inspect an area near the Middle Falls viewer platform requiring remediation. MMCE and EDI along with the Gorge Road contractor Janod, observed the conditions and found a loss of rock on the gorge walls along with a large, block of rock at this location, separated from the gorge face by an open joint. The joint was also visible on the river side of the block. The open joint and loose rock is of concern relative to the stability of the overhang, a prominent location for pedestrians to view the Middle Falls (Figure 15). This poses a significant safety threat to those viewing the Falls.

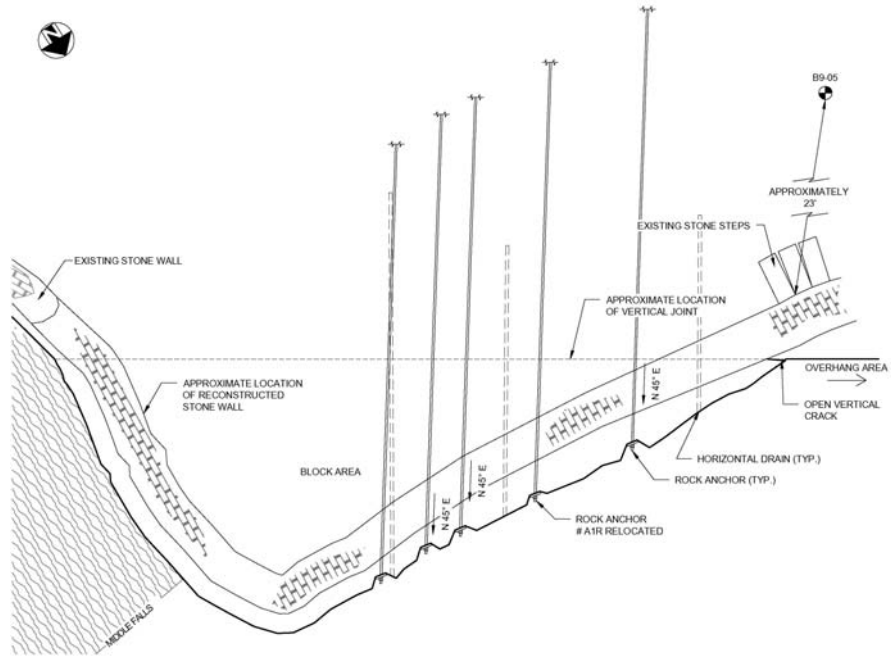
Figure 17 – Plan of Block Area

Drains were included in the design to provide a drainage path to the gorge face, particularly for water that accumulates in the open joint. Figure 17 is a plan of the anchors and drains in the block and Figure 18 is a typical section through the block.

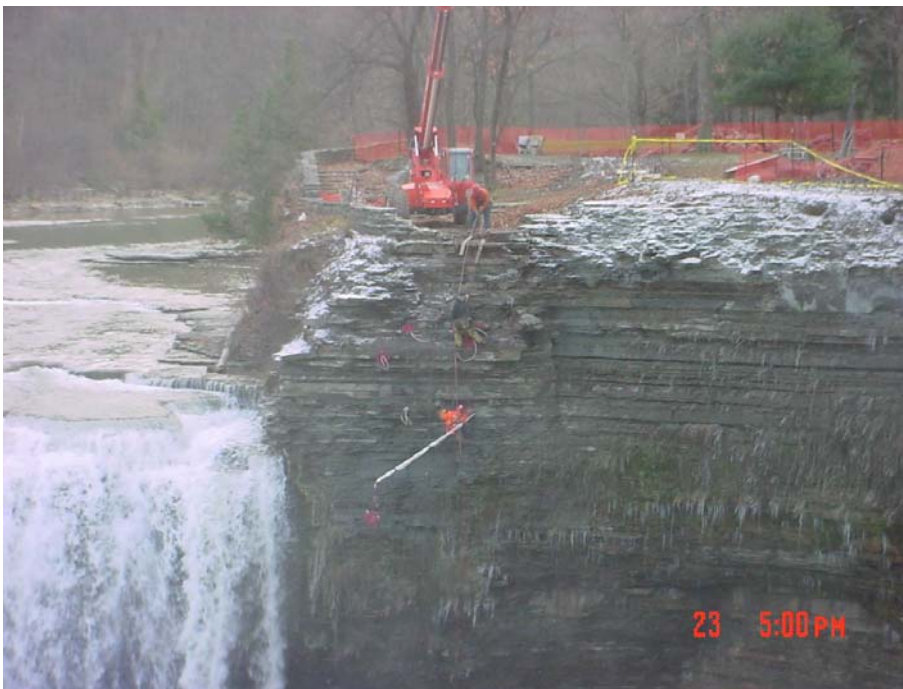
***Figure 19 –
Janod Installing
Anchors in Block***

loose block as shown in Figures 19 and 20. As for the Gorge Roadway, all of the work by

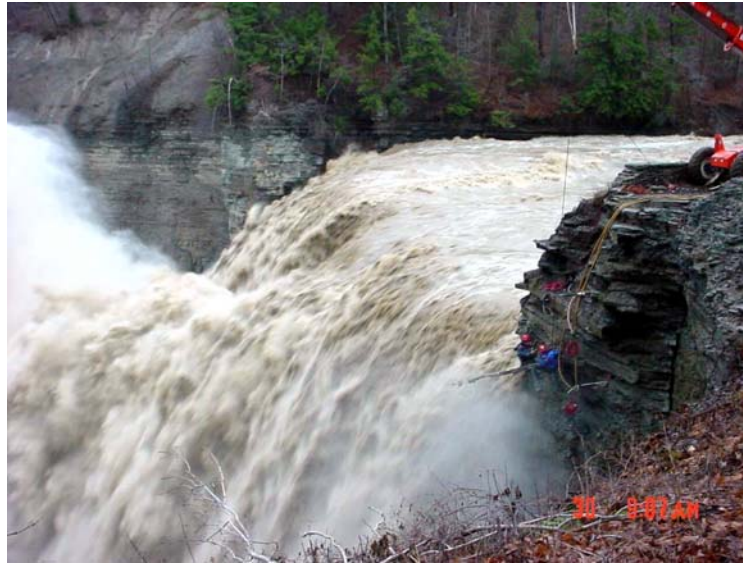
Figure 20 – Janod Installing Rock Anchors on a Rainy Day

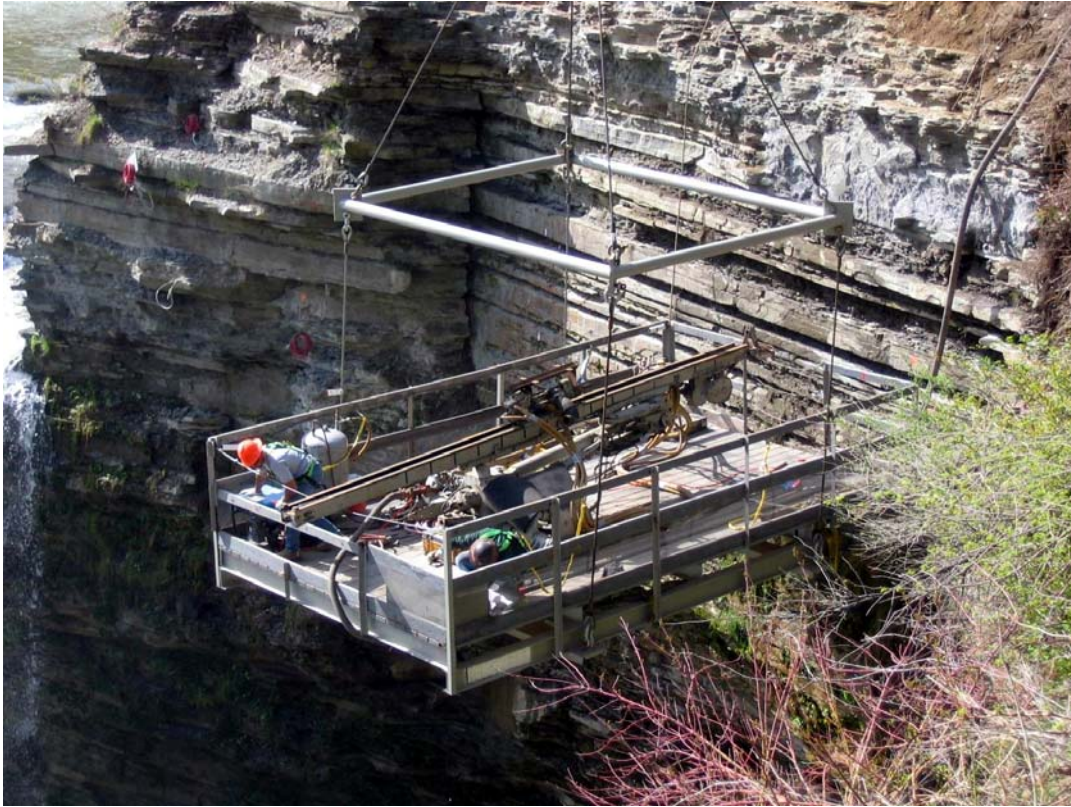
Figure 21 Nothnagle Installing Rock Anchors in the Overhang Area.

Instead of working from ropes, Nothnagle constructed a work platform as shown on Figure 21. The platform was suspended from a crane and attached to the gorge face with wedge bolts.

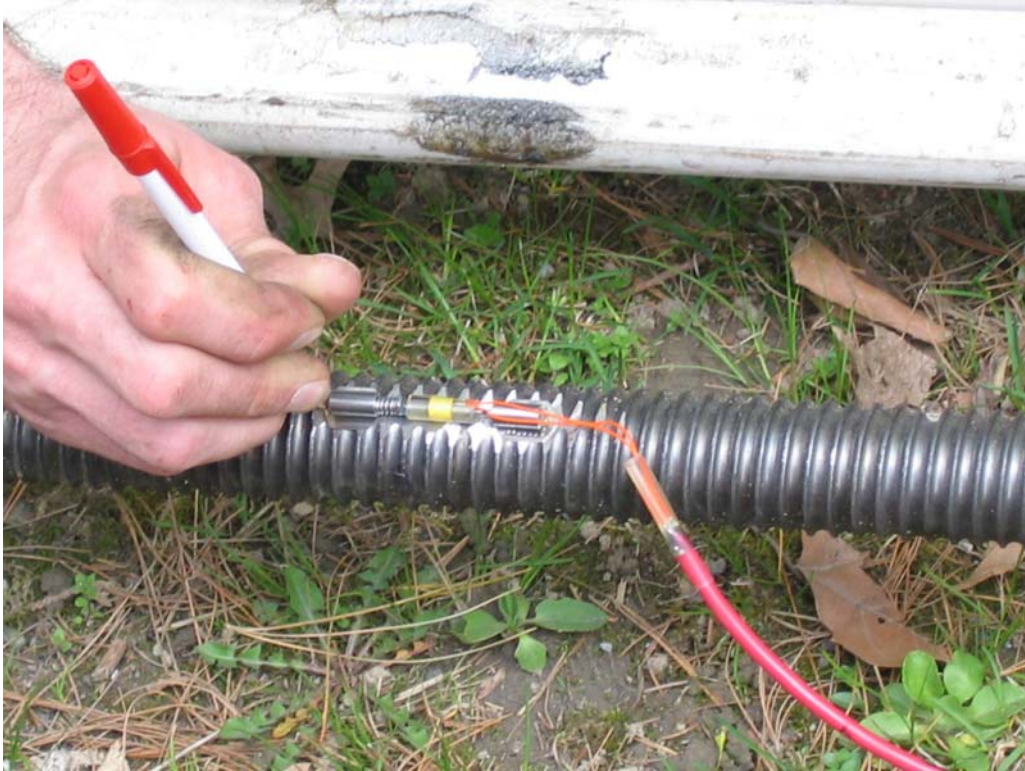
Figure 23 Strain Gauge Installation

Strain gauges were installed on several rock anchors to provide a means of monitoring stress in the anchor rods and rock movement. Figure 23 shows a typical strain gauge installation.

Wires from the strain gauges lead to a central readout box installed into the newly construction portion of the viewing platform wall. MMCE has monitored the gauges since construction was completed. The data do not indicate an increase in stress in the anchors.

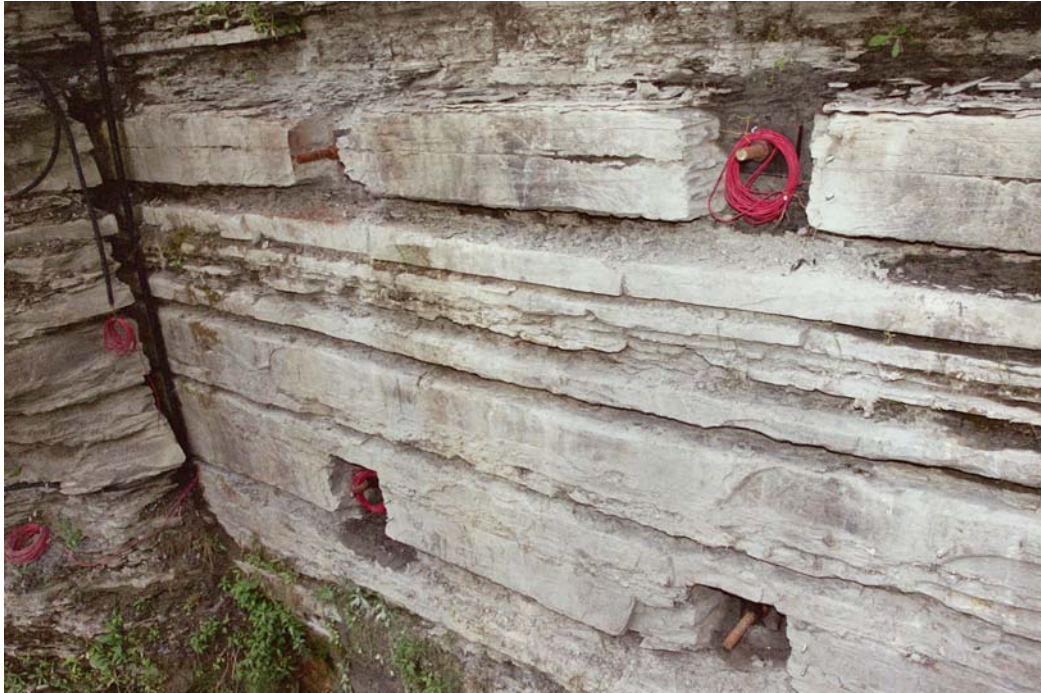
Figure 24 Recessed Anchors in Overhang Area

Nothnagle recessed the anchor heads into the rock face as shown on Figure 24. Figure 25 shows the completed project. Although the anchor locations are evident in Figure 25, as the grout has set, it blends with the rock color making the anchor locations imperceptible to those viewing the gorge face.

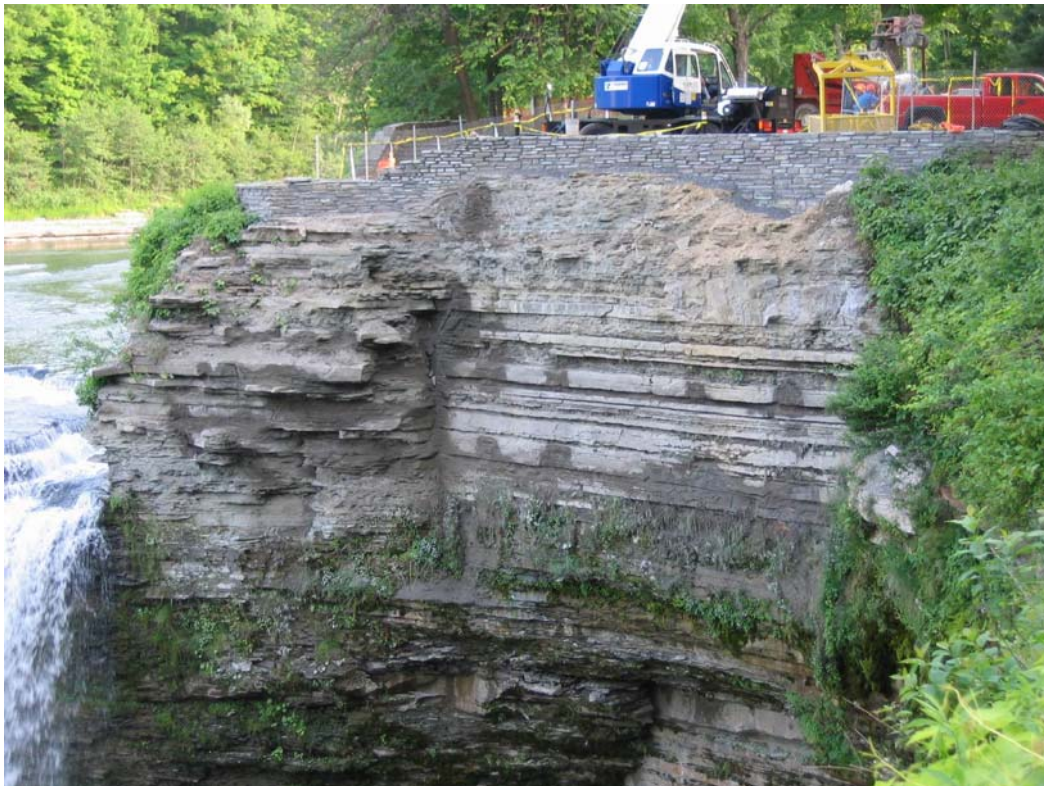
Figure 25 – Completed Project

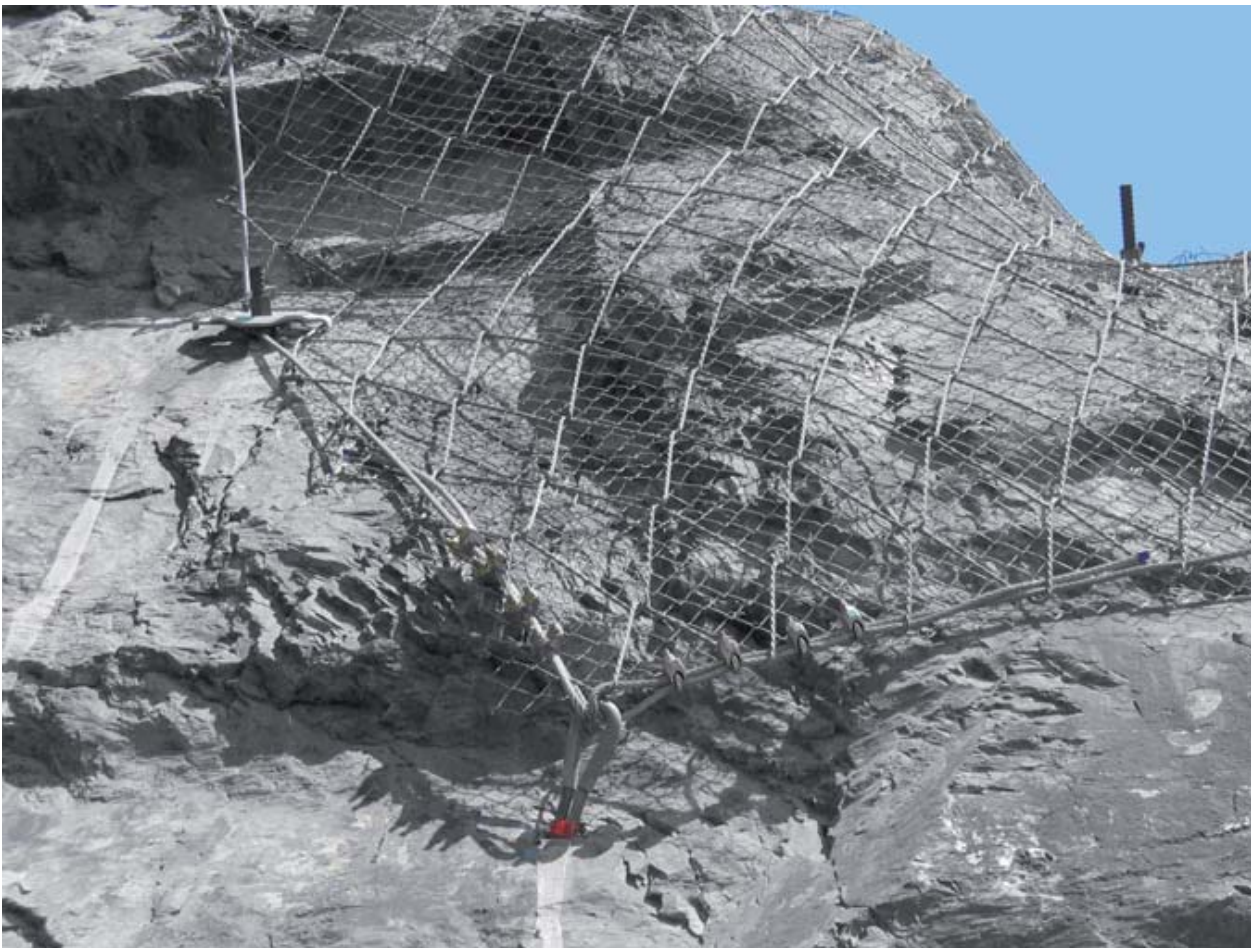
Figure 1: SPIDER® Net Installation

In order to achieve an ideal load transfer in adjoining areas and to reinforce the edges, boundary ropes, 1/2 inch/14 mm in diameter, are used all the way around and they are

attached to the wire rope anchors laterally. The boundary ropes can be pulled directly through the mesh openings from the top, bottom or sides. Seam ropes or boundary shackles or compression claws are not needed to attach the net to the boundary ropes. The shackles may be fixed with glue to prevent possible vandalism. In the event of overhangs, it may be wise to attach additional cables under the overhangs to optimize the bearing behavior of the system.

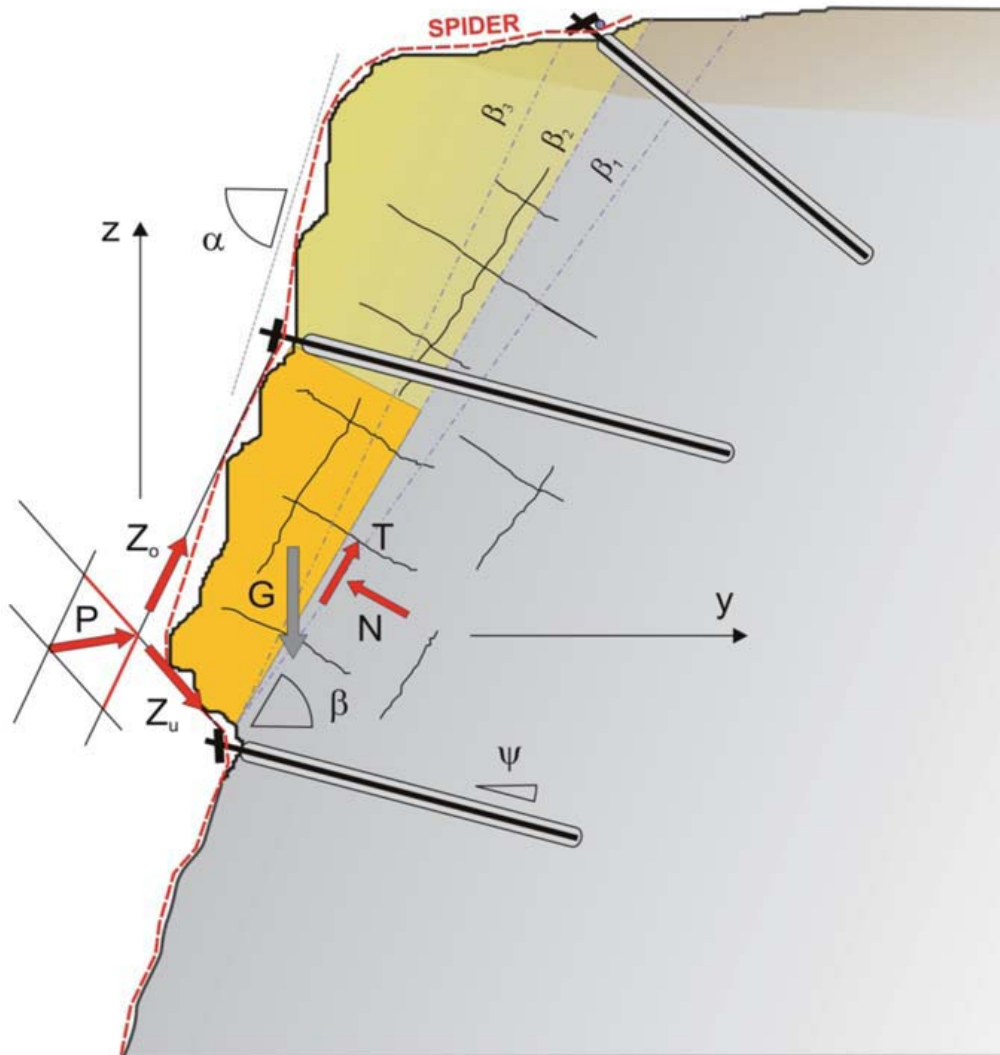
Figure 2: Retention Forces

In order to secure an individual boulder, an external stabilizing force (P) is required to hold the boulder against the stable ground. This force depends predominantly on the following:

- dead weight (G) of the block-shaped boulder
- inclination of the sliding surface to horizontal (β)
- friction angle (ϕ) between the stable ground and the block
- cohesion (c) or interlocking force along the slide plane and its size (A)
- direction (ϑ_o) and (ϑ_u) of the forces (Z_o) and (Z_u) in the net cover

The external stabilizing force (P) can be calculated as follows and takes into account the stabilization issues relevant to an individual block-shaped boulder as well as the model uncertainty correction value (γ_{mod}).

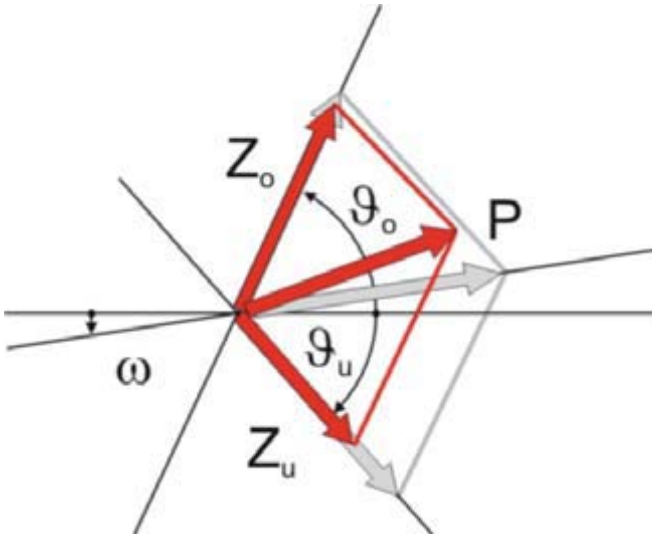
Figure 3b.

The stronger the interlocking action between the net cover and the boulder, the more favorable is the direction of action of the force (P) and the tensile force on the lower restraint is smaller. In general, the force at the lower restraint is always smaller than or equal to the force at the upper restraint as shown in figure 3b.

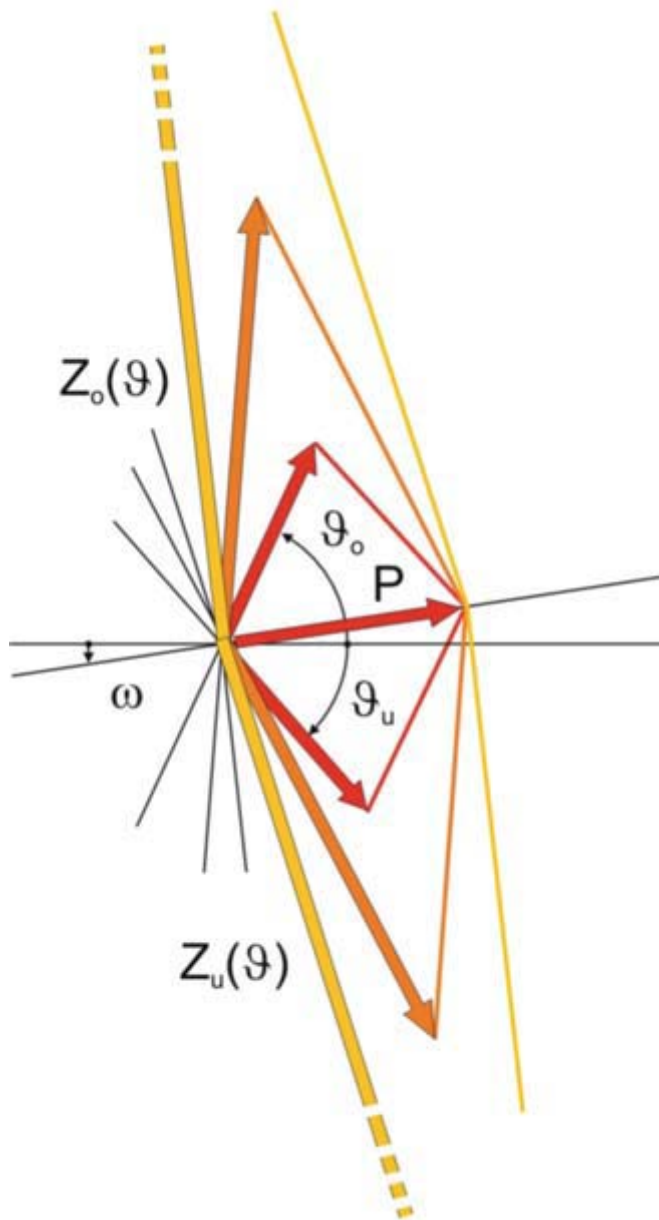
Figure 3c.

The forces (Z_o) and (Z_u) significantly depend on their orientation to each other. If the opening angle ($\vartheta = \vartheta_o + \vartheta_u$) tends towards 180 degrees, the forces (Z_o) and (Z_u) tends theoretically towards infinite when keeping force (P) constant and not equal to 0. Figure 3c clarifies this. The result is the arrangement of the SPIDER net on the slope plays an important role in securing a boulder.

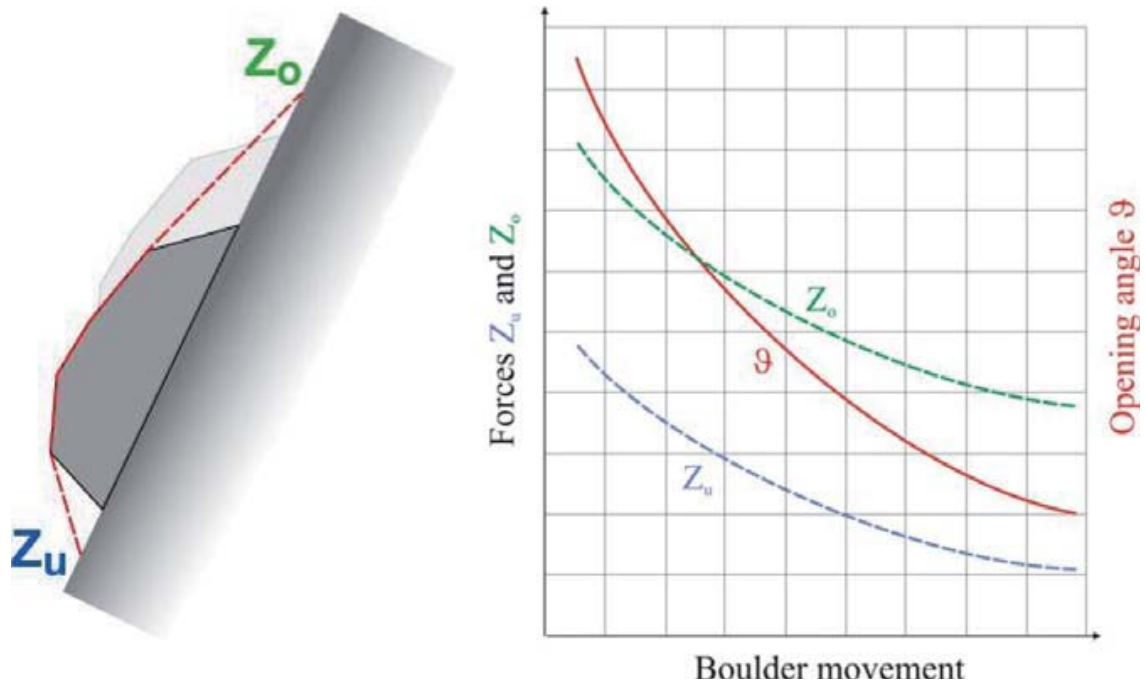
Figure 4: Parameter Interdependence

Since the SPIDER® protection system has a certain degree of elasticity, it is unavoidable for the boulder to be displaced along the slide face in the event of a failure. The stress on the restraint is reduced as a result of this boulder movement. The opening angle ($\vartheta = \vartheta_o$

+ ϑ_u) becomes smaller with an increasing displacement and the upper and lower retention forces consequently decrease. Figure 4 shows the qualitative presentation of the parameter interdependence.

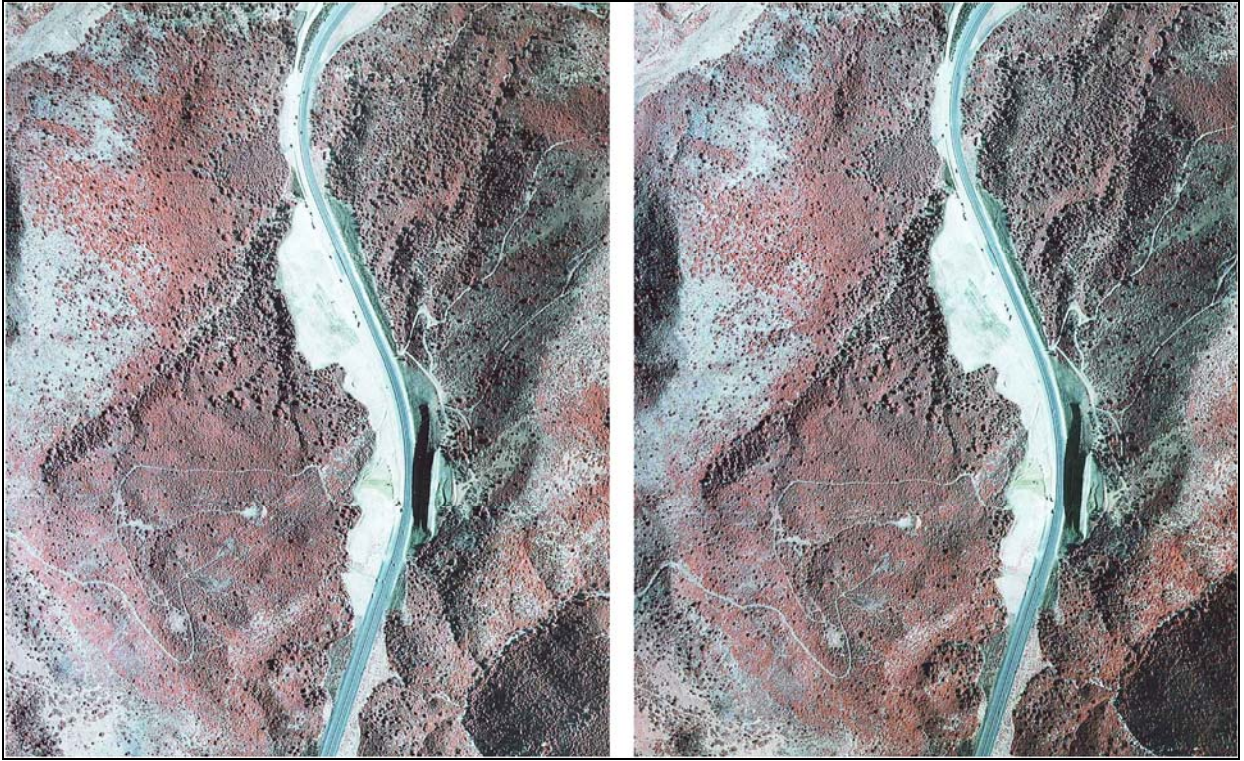
The following aerial photograph depicts the relationship of the landslide and the SR87 highway cut passing through it, and covers the overall geomorphic character of the slide mass.

Figure 1: May 2008 Aerial Stereo Photo Pair Showing Current SR 87 Alignment and the Ancient Landslide Extending from Bottom Left to Upper Right of Photo

The geomorphic characteristics of the large paleoslide, as previously stated, are subtle. From the clearly demarcated headscarp in the southern portion of the picture one can observe the blocky nature of the slide mass. The upper portion of the slide mass appears to consist of relatively coherent rock blocks translated and rafted downward northeast in the main direction of sliding. Back rotation of these blocks on the upper portion of the slide mass has created sag basins, or grabens, resulting in closed depressions that seasonally collect and pond water after heavy precipitation events. Some conspicuous drainages were also observed in this area, where the break in slope at the top of the slide mass meets the lower edge of the headscarp, and are suspected to be tension or other landslide related ground cracks.

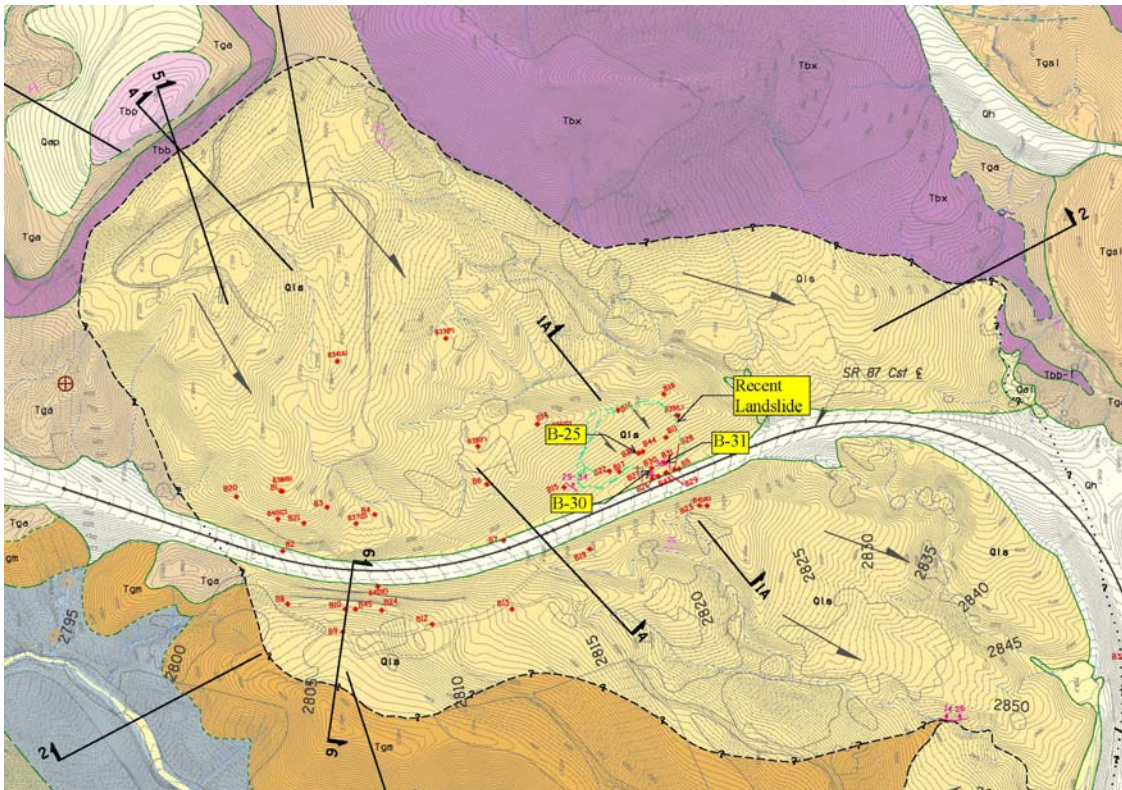
failure, and B-30 and B-31 were installed in September, approximately 4 months after B-25 during a separate exploration. The locations relative to the roadway and the recent landslide are shown on the following geologic map.

**Figure 2: Geology Map showing locations of borings
(Original Scale 1:3600, North is to the Right, courtesy of AECOM)**

Most of the inclinometers were installed with TDR cables and the top of the cable was exposed within a vault. The research for this paper has focused on three specific Inclinator/TDR locations, namely, B-25, B-30 and B-31. It should be noted that B-25 was installed in May 2008, as part of the immediate investigation after the March 2008

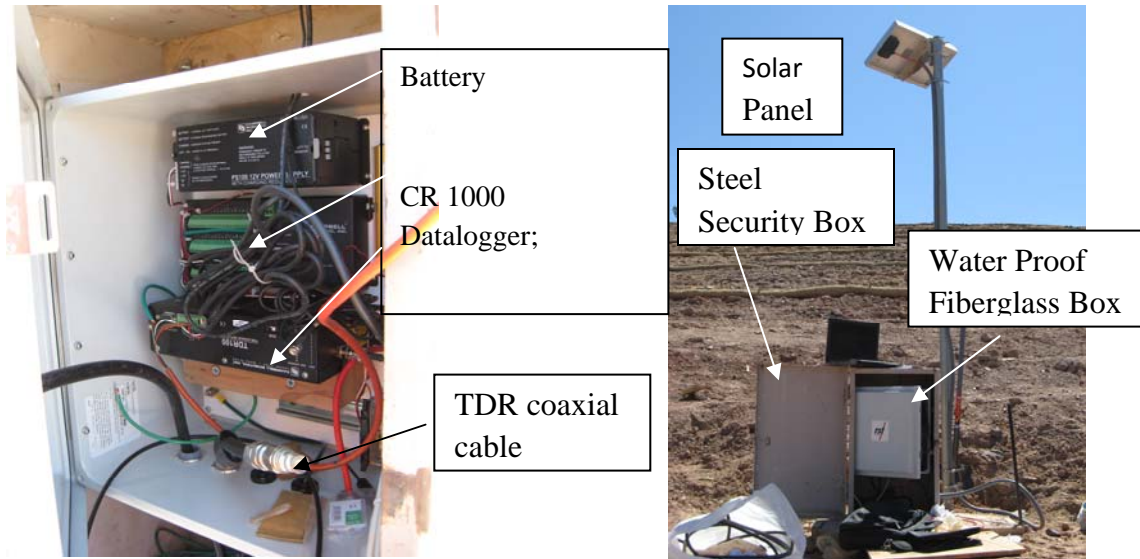
Figure 3: Equipment at the Telemetry Station

A telemetry station was constructed within 300 feet of the three TDR locations. The telemetry station consisted of a TDR 100 Pulser, CR1000 datalogger, multiplexer, cell phone, modem, battery, and solar panel. The equipment, except for the solar panel, was housed inside a water proof fiberglass box. This box was secured inside a steel box that was bolted to a concrete pad and locked on the outside.

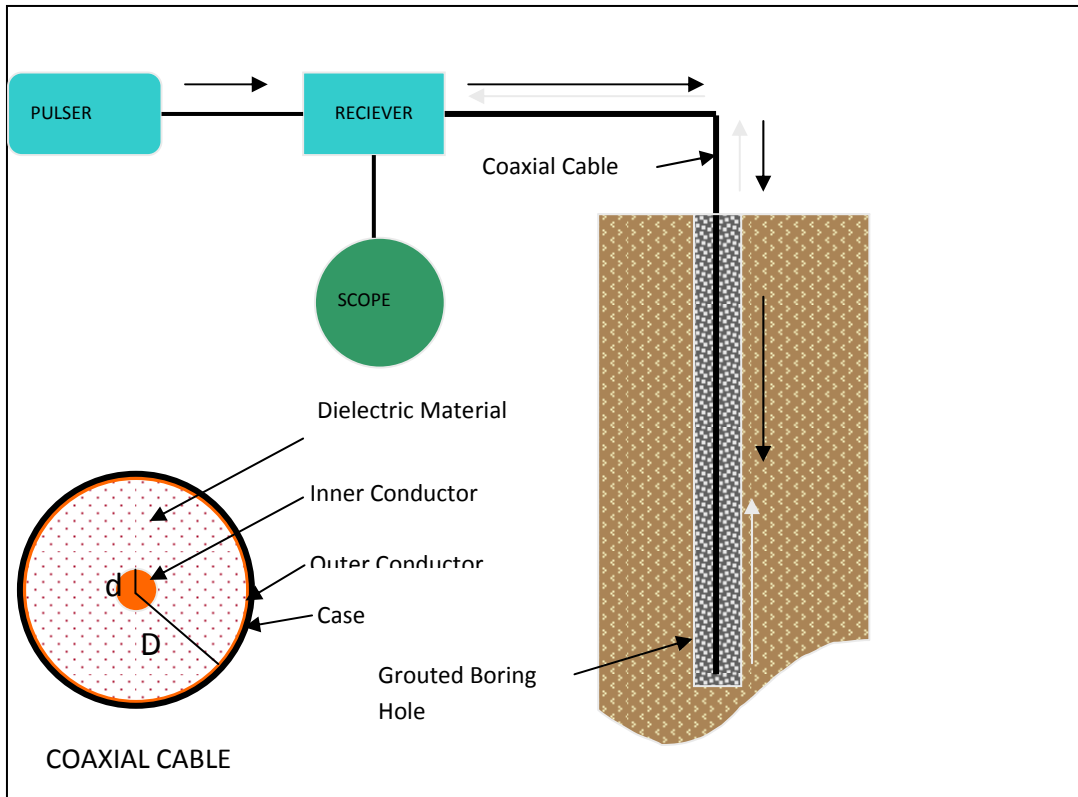
Figure 4: Schematic of Basic Physics

Technology of TDR: The TDR pulser generates an electric pulse that is propagated down the coaxial cable. A receiver records a signal reflection. Many pulses are read over time, which creates a scan that generates a waveform. The waveform shows the variation of signal amplitude with time. The signal amplitude can be normalized in the form of a reflection coefficient, which is a ratio of the signal amplitude sent down the cable compared with the signal amplitude measured at the receiver. The time delay between the pulse and the reflection, and the change in the signal amplitude (reflection coefficient) uniquely determine a cable fault. The cable fault location is determined by a relationship between the velocity of propagation of the signal, cable properties and time. A schematic drawing showing the key elements of the TDR system is presented on Figure 4.
