60th HIGHWAY

GEOLOGY SYMPOSIUM

PROCEEDINGS

1.1.	<i>High Bridge Area Roadway Slide, Letchworth State Park, Portageville, New York</i>	22
	Andrew J. Nichols, P.E.; James Bojarski, P.E.	
1.2.	<i>Remediation of the SR 15 Welcome Center Landslide.....</i>	35
	David R. Scherer, P.E.; Robert E. Johnson, P.E.; Paul J. Lewis, P.E.

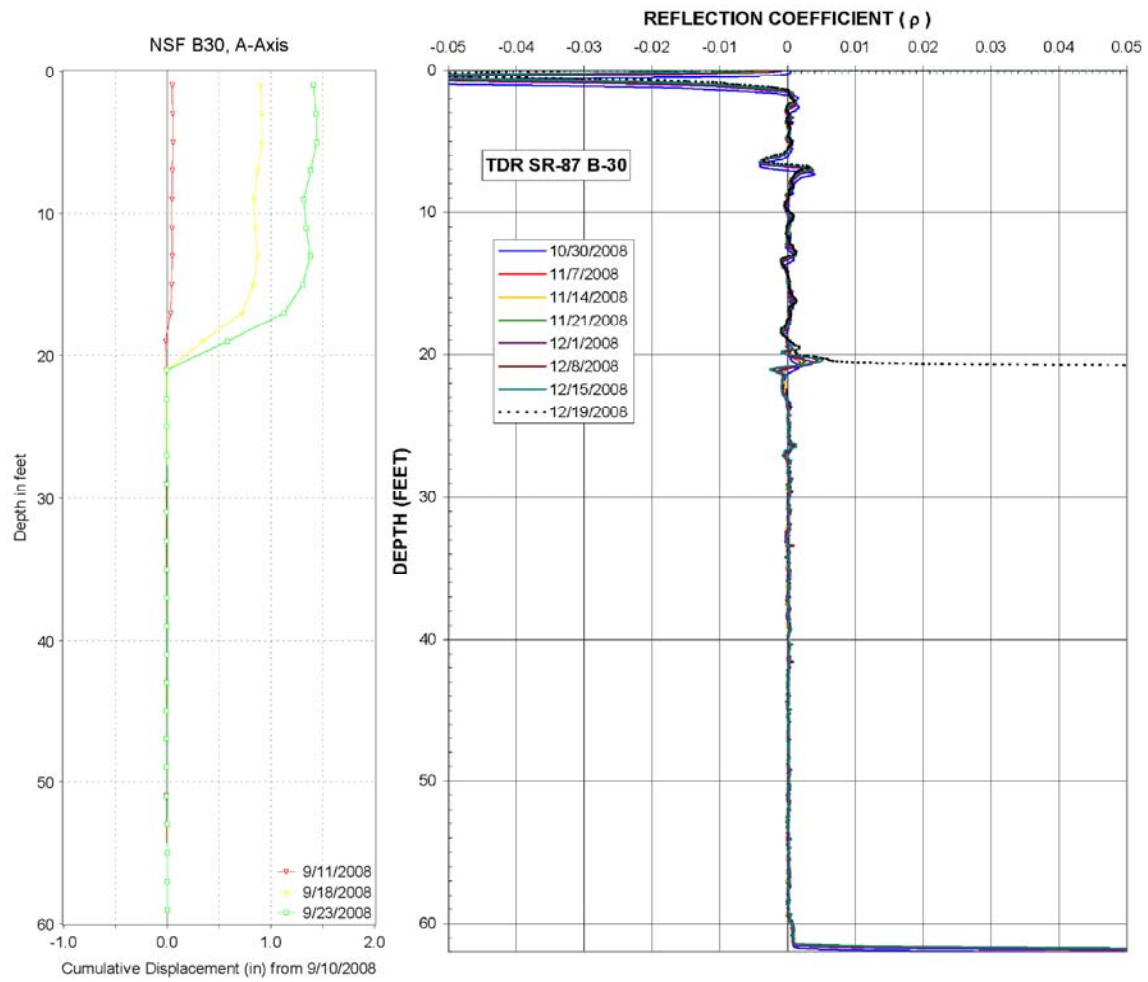
At each inclinometer/TDR location, cumulative displacement data with depth was plotted, as well as TDR data. The TDR data was plotted on a graph as reflection coefficient versus depth. The data for both plots have been plotted adjacent to each other for ease of comparison. Plots of the three locations are presented as Figures 5, 6, and 7.

Figure 5: Graph of Depth vs. Cumulative Displacement and Depth vs. Reflection Coefficient for B-30

Analyses: The TDR data portion of Figures 5 through 7 show development of spikes with various amplitudes and at various depths. Each spike represents a potential development of a shear plane at the depth shown. These spikes are caused by changes in the reflection coefficient (cable impedance) and are directly related to the reflection coefficient measured by the receiver. The reflection coefficient (cable impedance) changes when there are changes in the cable dimensions, material property changes along the cable system, or changes in material properties surrounding the cable. The following is a list of potential causes of reflection coefficient (cable impedance) change:

The data results for B-25 show various low amplitude (reflection coefficient, $\rho < 0.004$) and high amplitude (reflection coefficient, $\rho > 0.02$) spikes along the cable. Similar low and high amplitude spikes are observed on the graphs for B-30 and B-31.

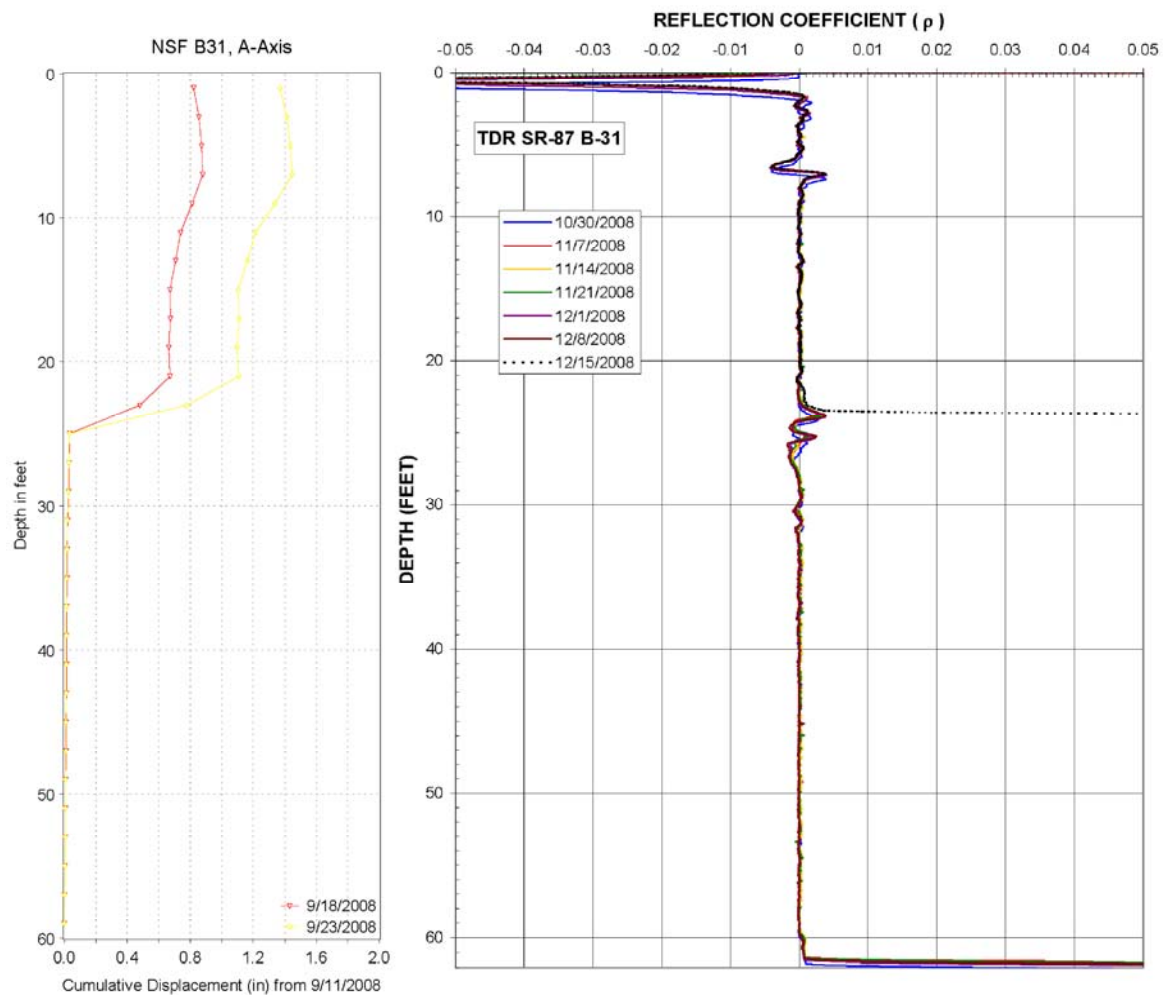
Figure 7: Graph of Depth vs. Cumulative Displacement and Depth vs. Reflection Coefficient for B-31

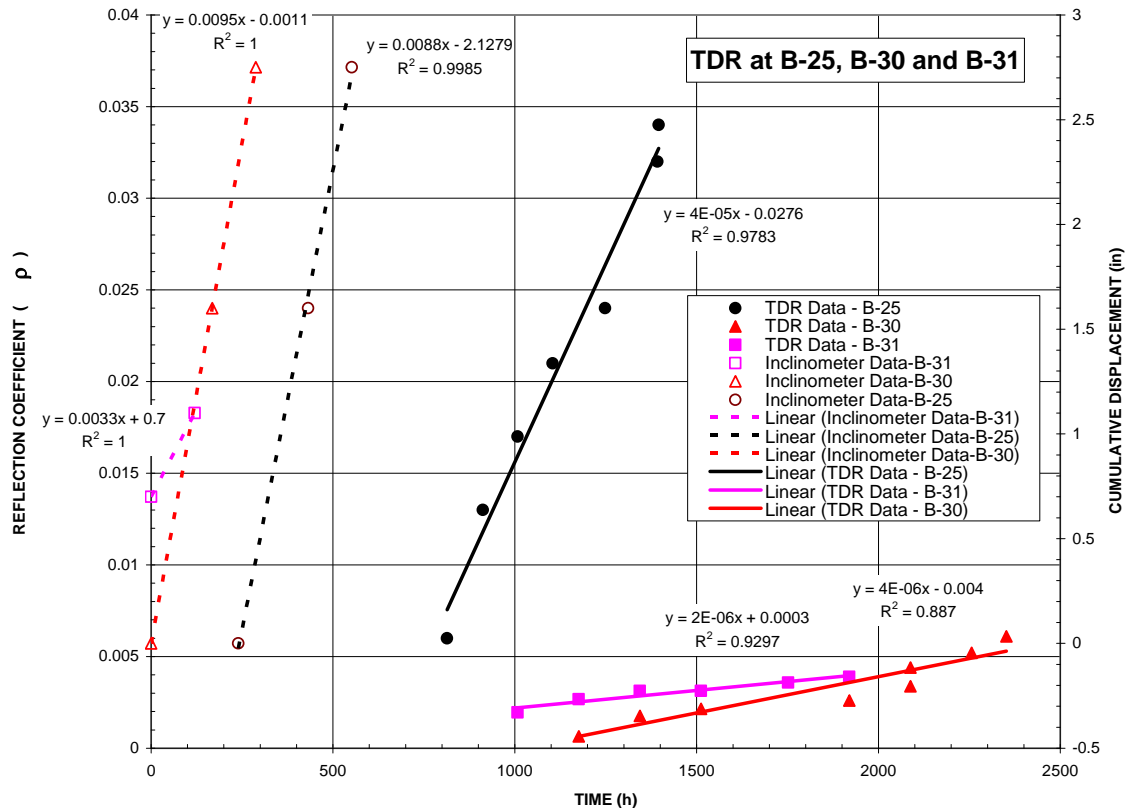
- Based on the inclinometer data presented in Figure 8, the rate of slope movement was constant over the small strains measured by the inclinometers. The TDR reflection coefficient data indicates the rate of slope movement/displacement continued to be constant. Measurement of displacement using the TDR could be obtained for approximately 4 to 8 times greater displacements than were measured by the inclinometer.

Figure 8: Graph of Cumulative Displacement vs. Time and Reflection Coefficient vs. Time for B-25, B-30 & B-31

Conclusions: Based on the results presented herein, the TDR reflection coefficient data indicates the rate slope movement/displacement continued to be constant. Measurement of displacement using the TDR could be obtained for approximately 4 to 8 times greater displacements than were measured by the inclinometer. Therefore, the cost-benefit of the borings can be prolonged by using a TDR system.
