57th ANNUAL HIGHWAY GEOLOGY SYMPOSIUM

BRECKENRIDGE, COLORADO
SEPTEMBER 26-29, 2006

PROCEEDINGS

***Landslide Investigation and Mitigation Along US 160 Between Durango And Mancos,
Colorado, Using Lightweight Fill, Ground Anchors, and Rockery Buttresses***

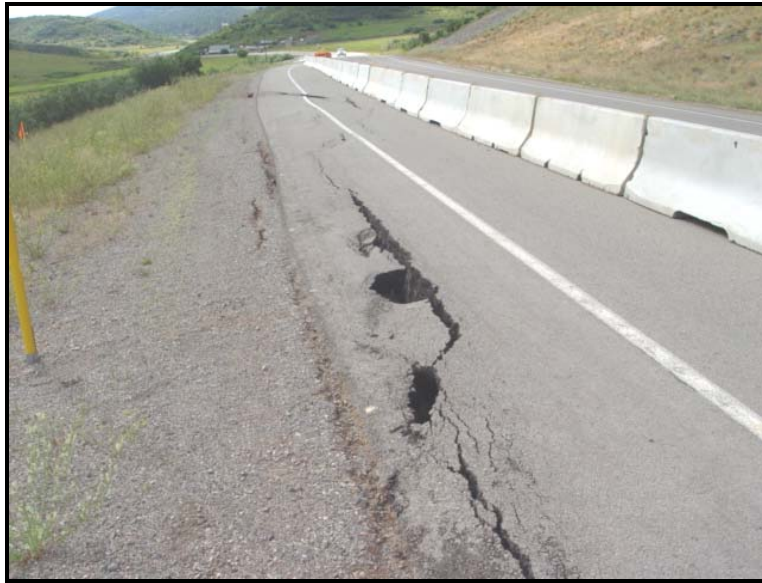
Figure 2. Looking west along US 160 at Landslide 1.

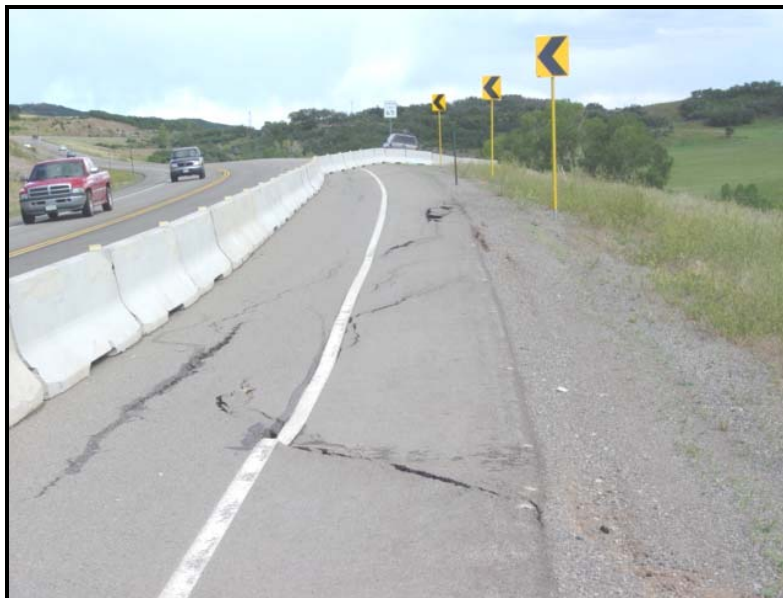
Figure 3. Looking east along US 160 at Landslide 1.

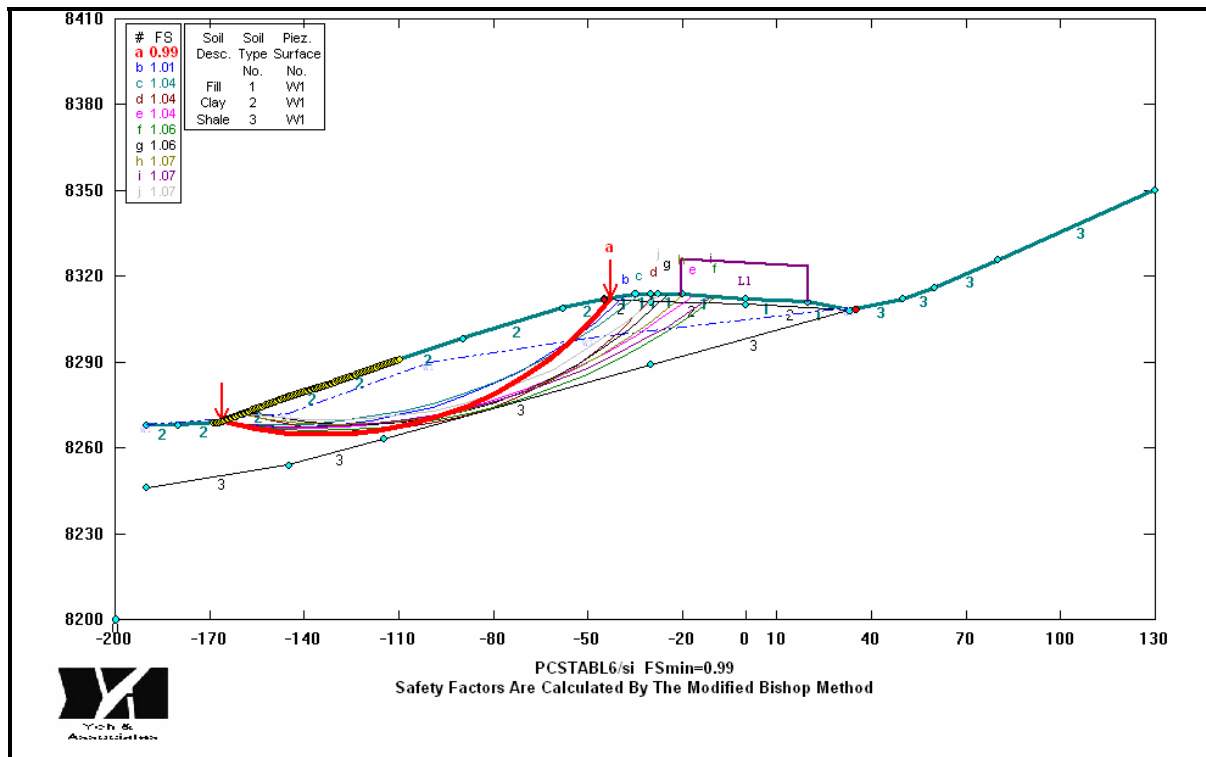
Figure 4 depicts a typical slope cross section at or near slope failure of the preexisting slope for Landslide #1. The groundwater level is based on the conditions encountered at the time of drilling.

Figure 4. Landslide 1 Pre-failure Slope Stability Model.

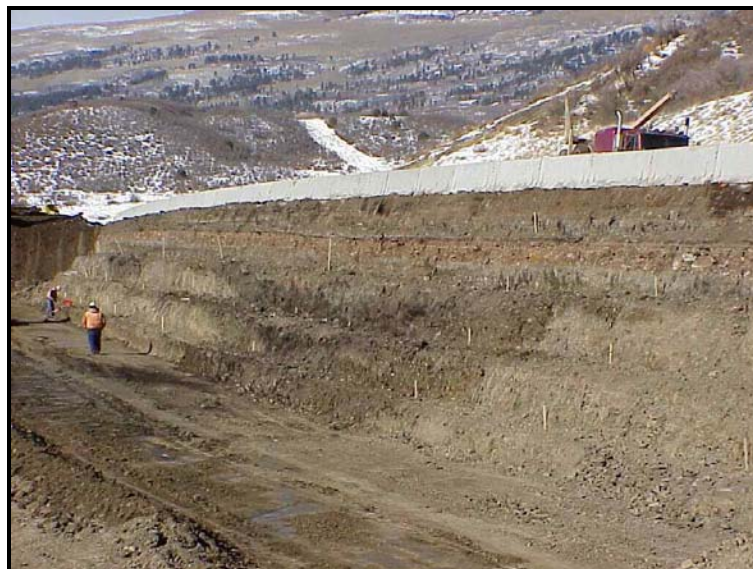
After excavation of the landslide section the failure plane became more evident. Figure 5 depicts the outline of the failure plane during mitigation of the landslide.

Figure 5. Outline of failure plane during excavation and mitigation of Landslide 1.

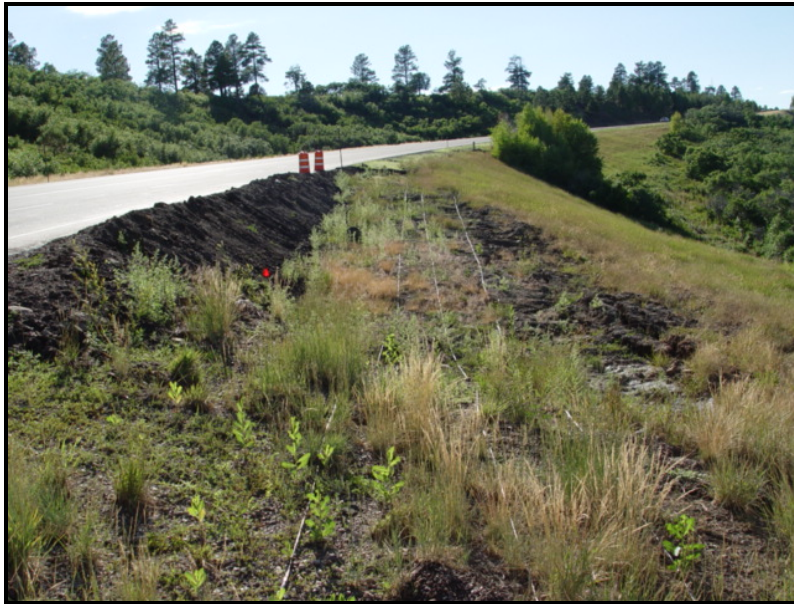
Figure 6 – Looking west along US 160 at Landslide 2
(Utility lines are visible on the surface).

Landslide 2, located near mile marker 74.2, exhibited a shallow rotational failure feature with a well-defined headscarp and toe. The headscarp ran parallel to US 160 for approximately 275 feet. The area appeared to be deforming as a result of an embankment fill failure on the north side of the roadway. The vertical displacement of the headscarp along the highway ranged from 1 to 6 feet. The toe of the landslide also exhibited an earth flow feature indicative of a rotational failure. The surface topography at the body of the landslide exhibits a hummocky appearance in localized areas. Slope profiles vary, but generally consist of 2H:1V slopes in the vicinity of the slide. Figures 6 and 7 depict sections of the landslide area.

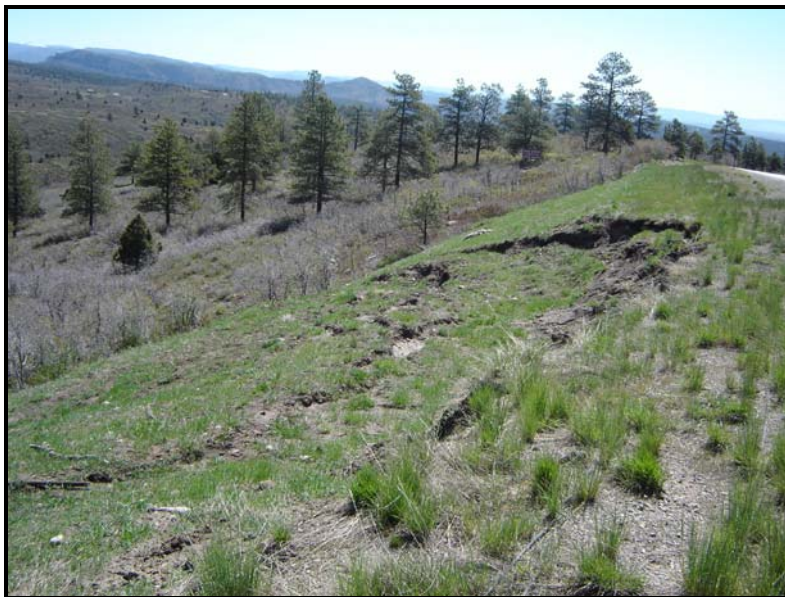
Figure 7 – Looking east along US 160 at Landslide 2.

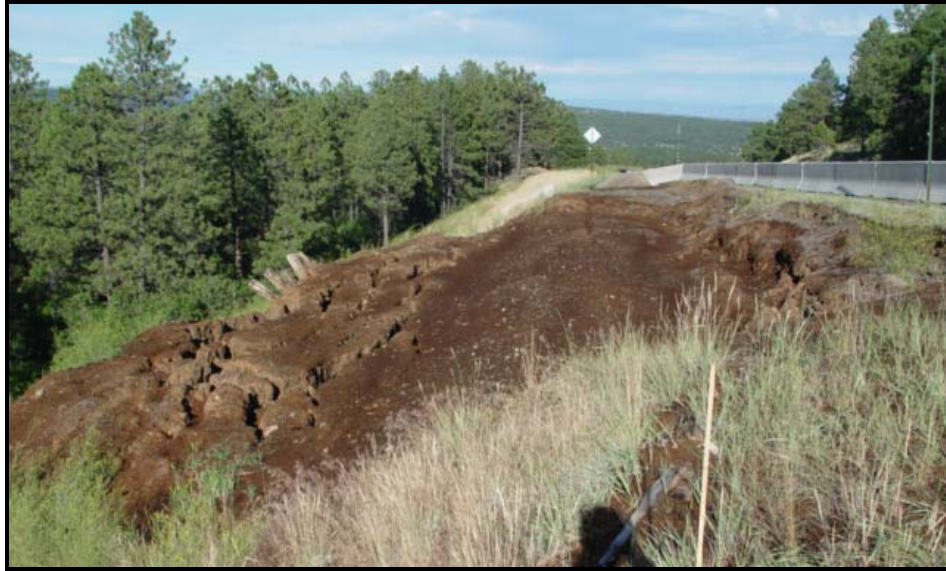
Figure 9 – Landslide 3 - Looking east along US 160.

The landslide, as observed during the investigation, exhibited a shallow rotational failure feature with a well-defined headscarp and toe. The headscarp runs parallel to US 160 for approximately 100 feet. The observed movements of the landslide appear to result from extreme deformation of the sawdust and possible movement of the underlying weaker shales and clays. The vertical displacement of the headscarp along the highway ranged from 3 to 8 feet. A cover of sawdust approximately 7 feet thick had been placed over the existing landslide. Figures 9 and 10 depict Landslide 3.

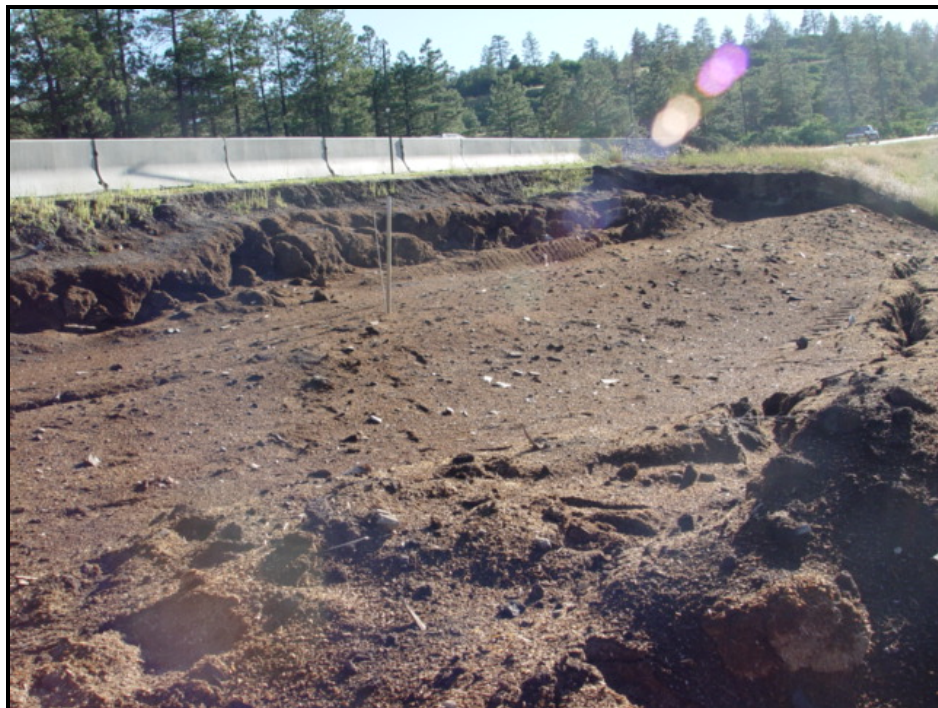
Figure 10 – Landslide 3 - Looking west along US 160
(Foreground is composed of sawdust fill).

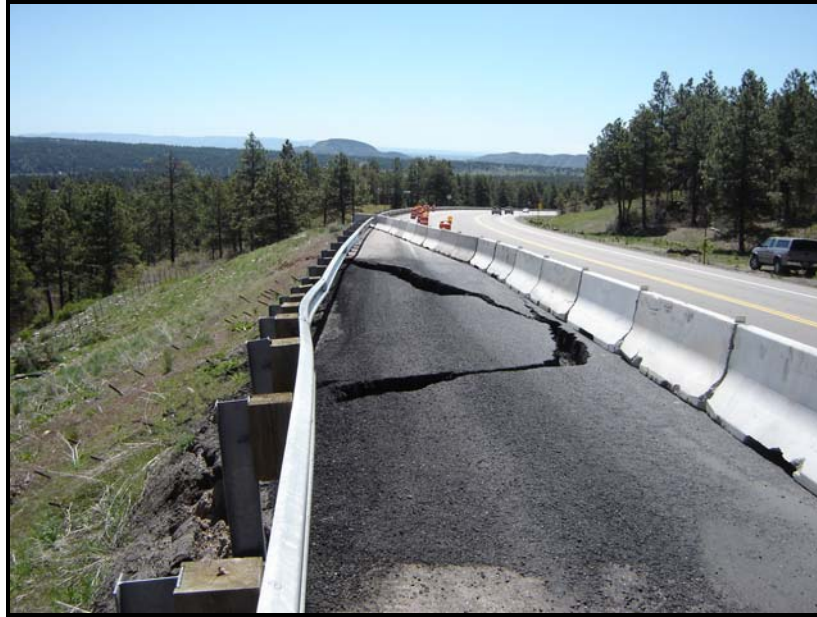
Figure 12. Landslide 4 Looking east along US 160

Landslide 4 was located near Mile Marker 75.3 on US 160. The landslide appeared to be a large deep-seated failure that exhibited a rotational failure feature with a well-defined toe. The landslide extended from 300 to 400 feet along US 160. A well-defined large-scale headscarp was not apparent. However pavement distress was observed in smaller sections where the active portions of the landslide had impacted the pavement section. The landslide was intermittently active for a number of years and various mitigative alternatives have been attempted that include soil nails and use of flowable fill to replace failed embankments. The activity of the landslide was likely increased by placement of embankment fill on the north side of the roadway during a pavement widening project. The vertical displacement of the headscarp of the landslide was likely in excess of 10 feet based on the thickness of the asphalt and aggregate base course materials beneath the roadway. The surface topography at the body of the landslide exhibited a hummocky appearance in localized areas. Slope profiles varied, but generally consisted of 2H:1V slope in the vicinity of the slide. Figures 12 and 13 show sections of the landslide area.

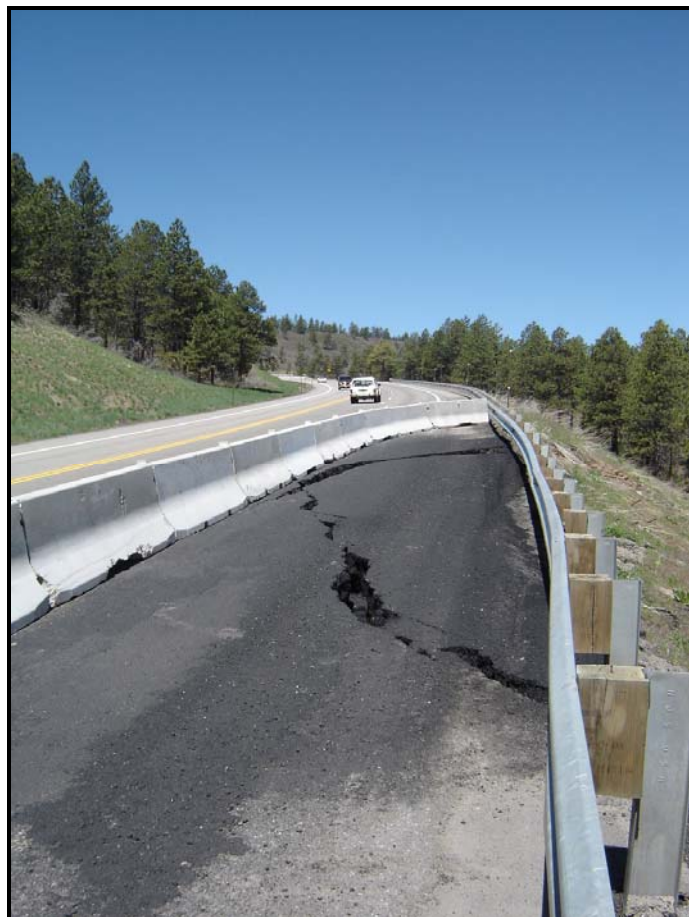
Figure 13. Landslide 4 - Looking west along US 160.

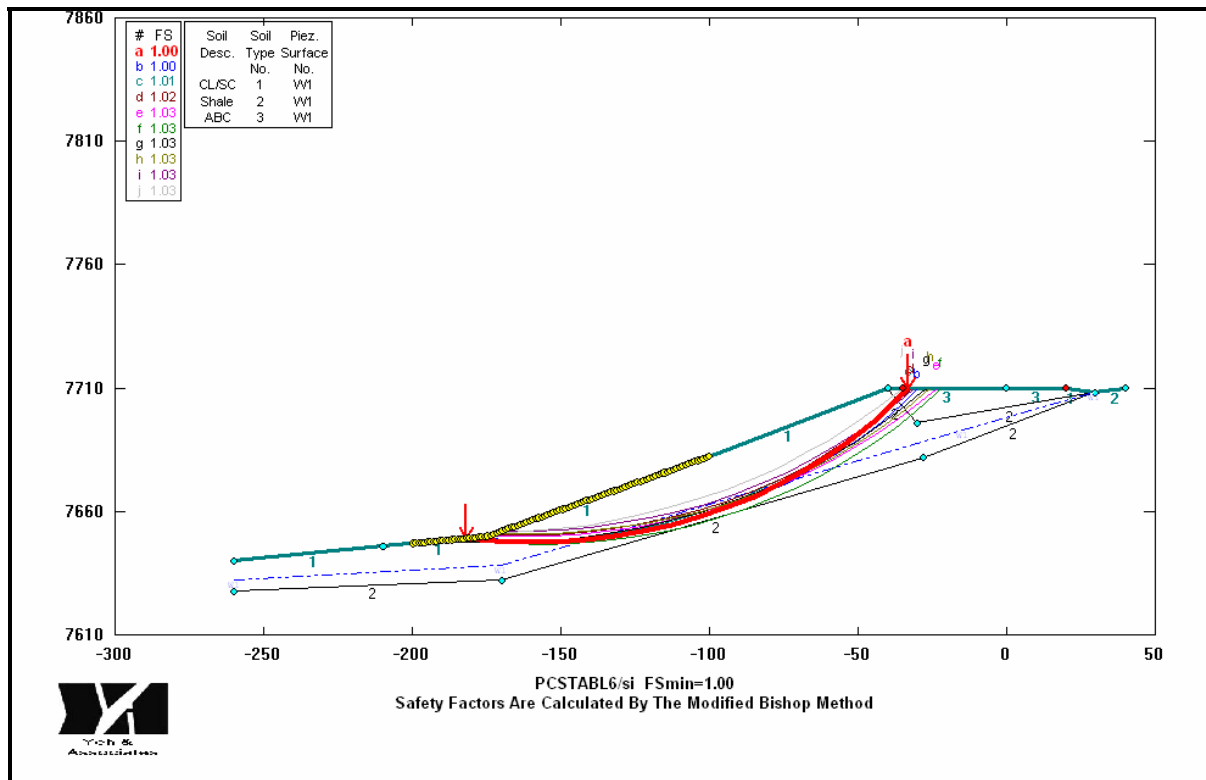
Global stability of the slide was evaluated based on a review of the existing site conditions, groundwater conditions, and available subsurface information. Figure 14 depicts a typical slope stability model for the landslide.

Figure 14. Landslide #4 Pre-failure Slope Stability Model.

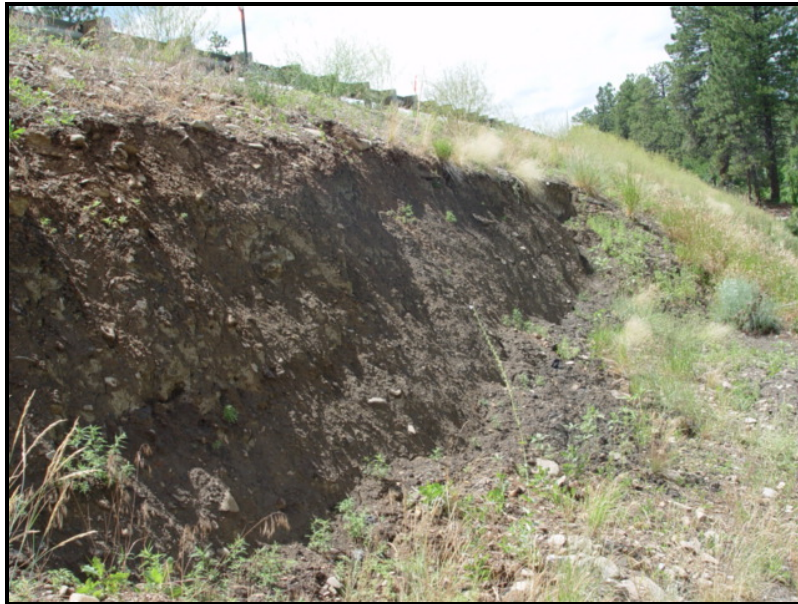
Figure 15 – Landslide 5 - Looking west along US 160.

Landslide 5 was located near Mile Marker 75.5 and was approximately 100 to 150 feet in length. This landslide was more characteristically an embankment fill failure on an outside curve of US 160 that did not affected the travel lanes of the roadway. It appears the material was placed at an angle steeper than could be supported by the shear strength of the fill. Surface and/or groundwater infiltration probably contributed to the failure. The embankment fill failure is a shallow slough that occurred on an existing 1.5H:1V slope. The final steepness of the slide approaches 60°. Figure 15 shows the embankment fill failure area.

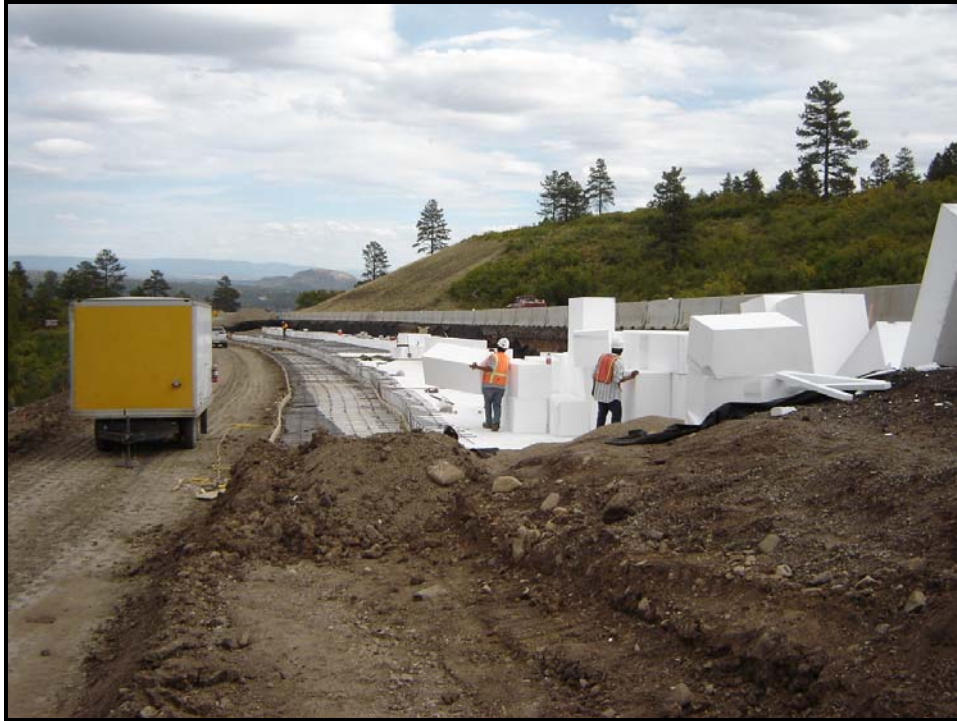
Figure 19. EPS placement in Landside #2.

Figures 19 and 20 depicts placement of the EPS lightweight fill during construction.

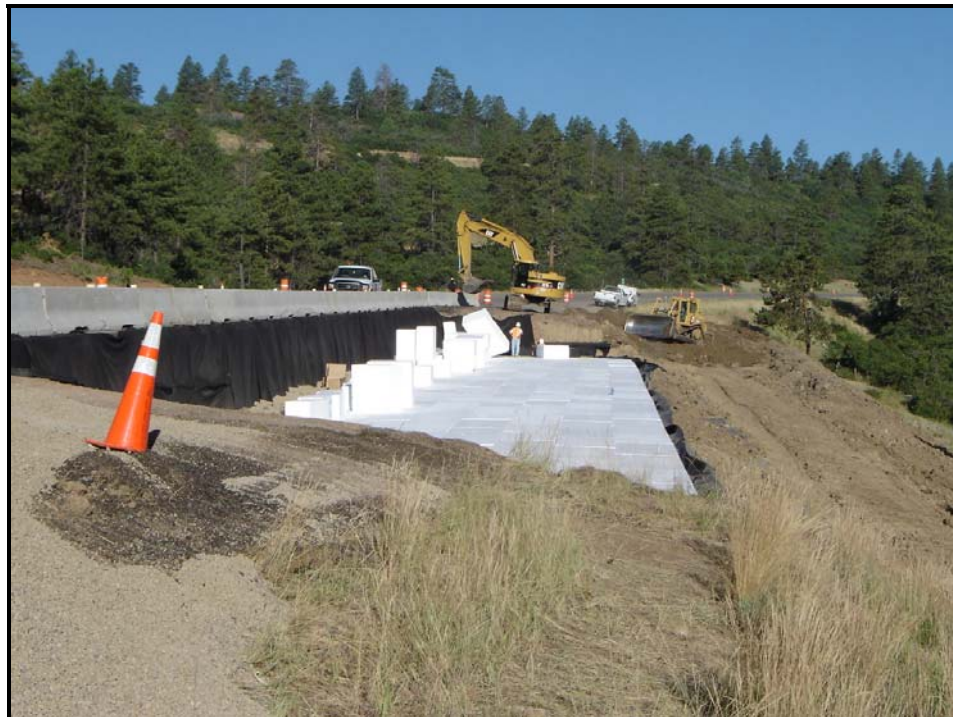
Figure 20. EPS placement in Landside #3 (Replacing Sawdust Fill).

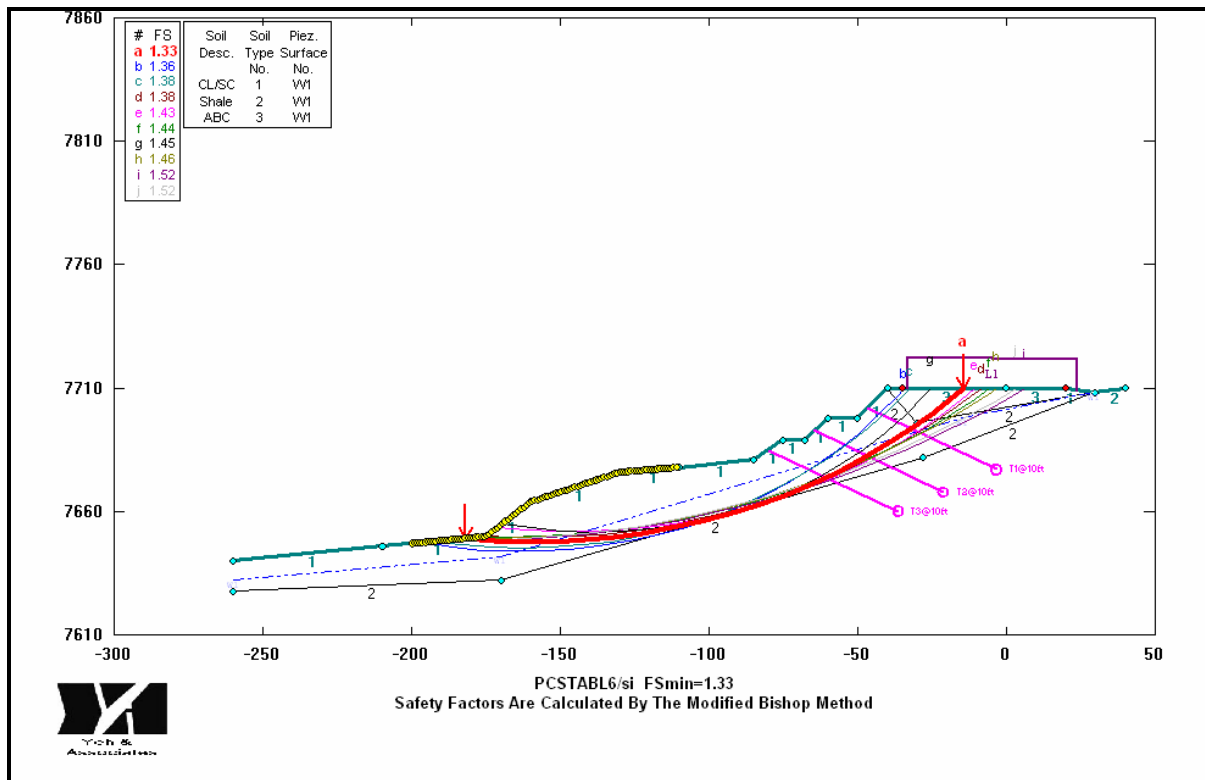
Figure 22. Typical Slope Stability Model of Ground Anchor Tieback System.

Figures 21 and 22 depict a typical cross section of the ground anchor tieback layout. Figure 23 depicts the typical global stability analysis for mitigation of Landslide #4 with tieback anchors.

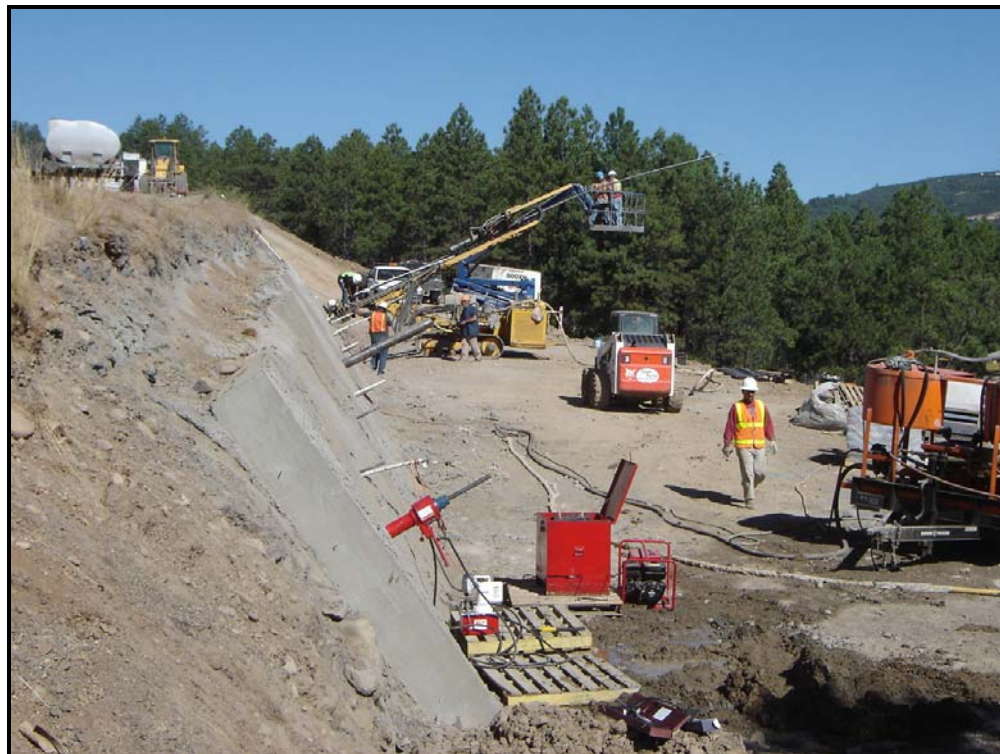
Figure 23. Installation of the Tieback Ground Anchors.

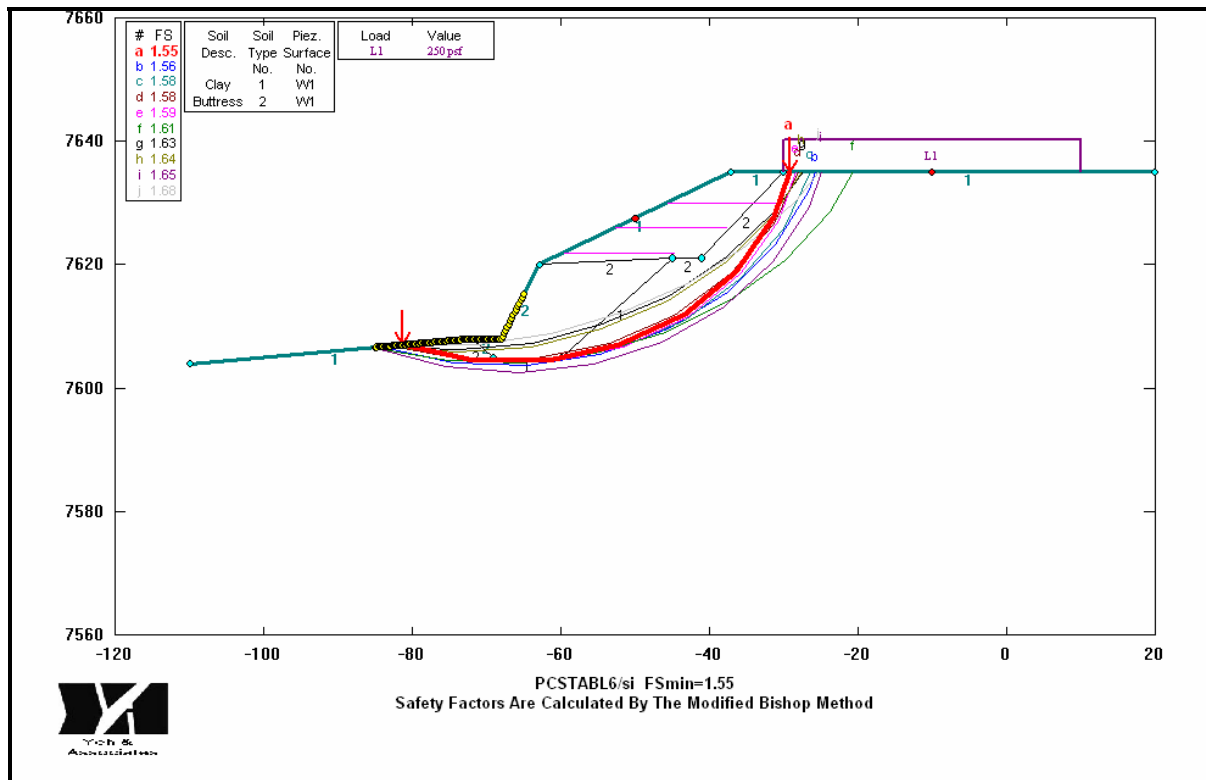
Figure 25. Global Stability Analysis of the Boulder Buttress.

The rockery buttress was evaluated in a similar manner to a retaining wall by reviewing the internal, external and global stability of the system. Figures 24 and 25 depict a generalized cross section of the buttress.

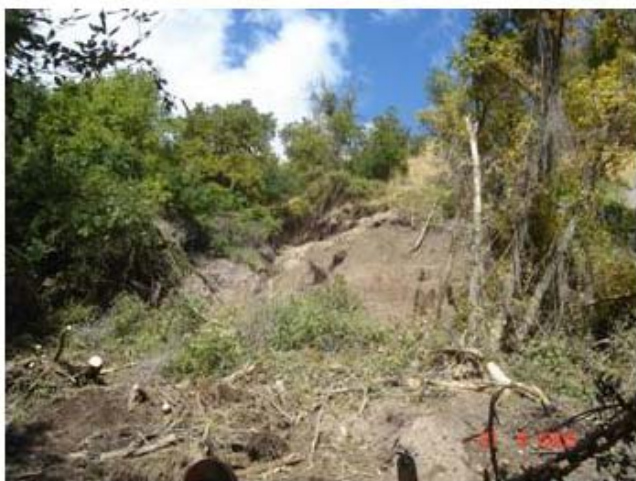
Figure 2: The slide configuration before the second movement (September 26).

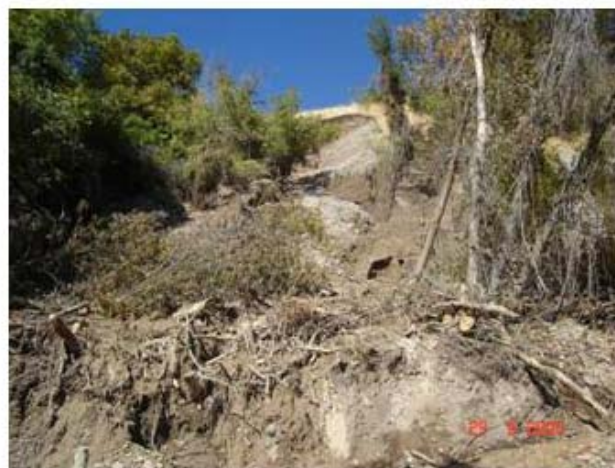
Figure 3: The slide configuration after the second movement (September 26).

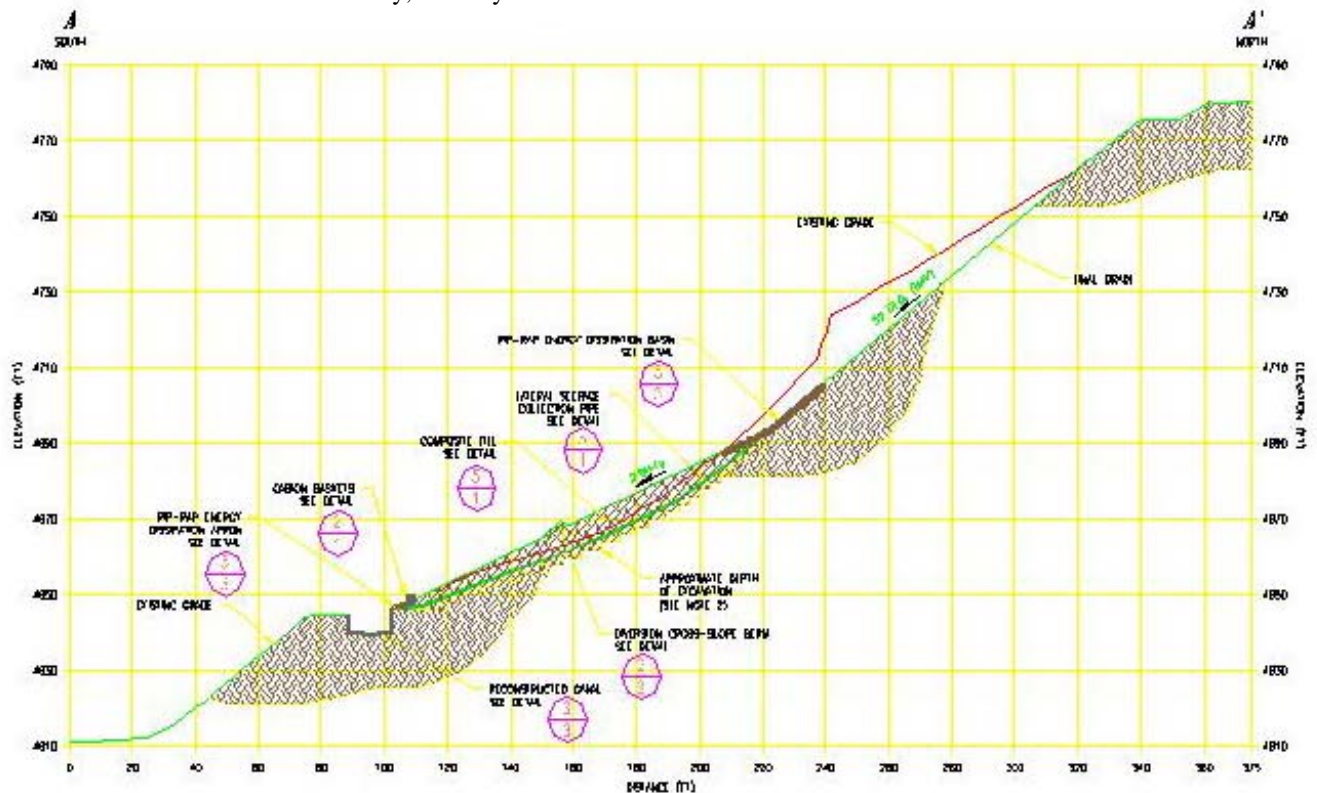
Figure 4: Configuration of the Proposed Mitigation

The proposed configuration was shown to increase stability as compared to both the existing condition, and the estimated pre-slide configuration. However, resulting calculated factors of safety were on the order of 1.2; less than a value typically accepted in new construction. However, these estimates are based on relatively conservative assumptions. There are many cases, particularly in emergency situations, where mitigation must be designed to attain an achievable increase in stability, but may not meet “standard criteria”.

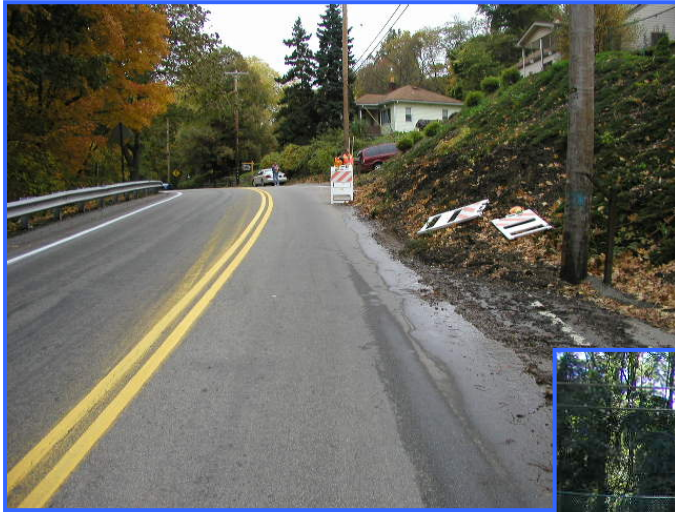
Nadine Road

This is an example of a slope failure caused by the September 2004 storm events. The failure impacted a private residence and utility service lines. The slope was stabilized by excavating the slide below the shear plane and reconstructing the slope with a rock toe and engineered buttressed slope.

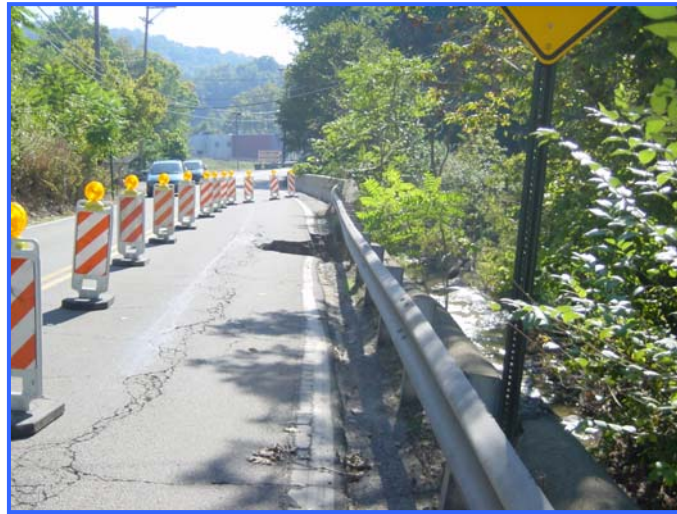
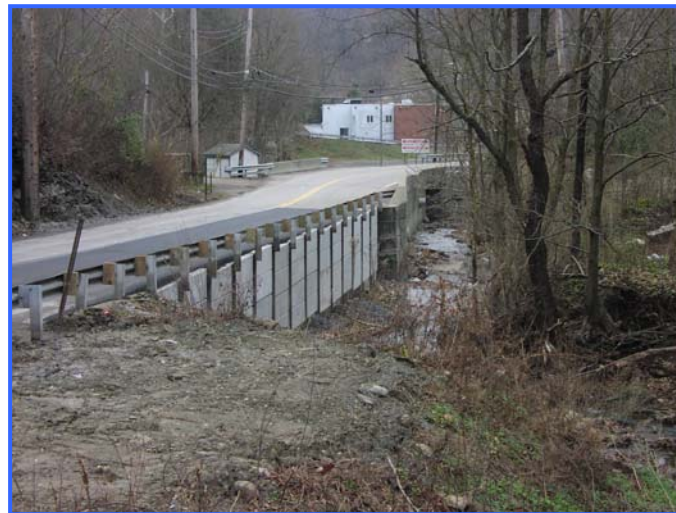
Wible Run Road

A recent culvert reconstruction had included the installation of a soldier beam and lagging wingwall. A wooden cribwall extended along the stream beyond the limits of the wingwall. The wooden crib wall was destroyed by the flooding and was replaced with a soldier beam and precast concrete lagging wall using the design parameters of the adjacent wall.

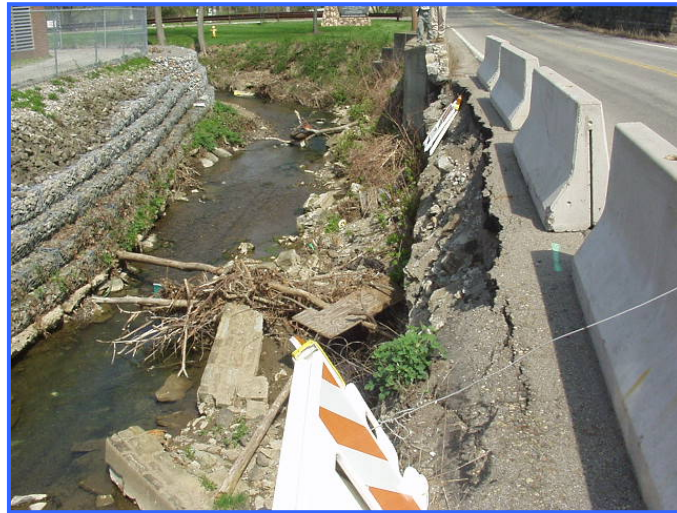
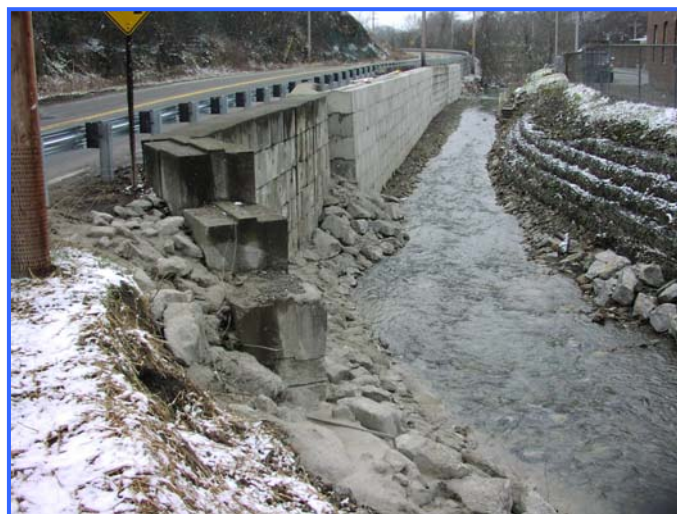
An old 1930's vintage Works Program Administration cut sandstone wall was undercut by the adjacent stream and failed. This failure impacted Cochran Mill Road and threatened an adjacent sanitary sewer line and gasoline. A precast jumbo block wall was constructed to buttress the slope and reopen the roadway.

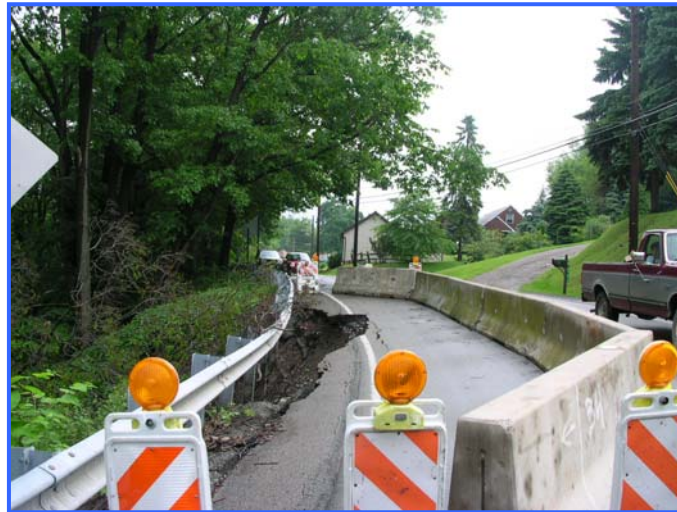
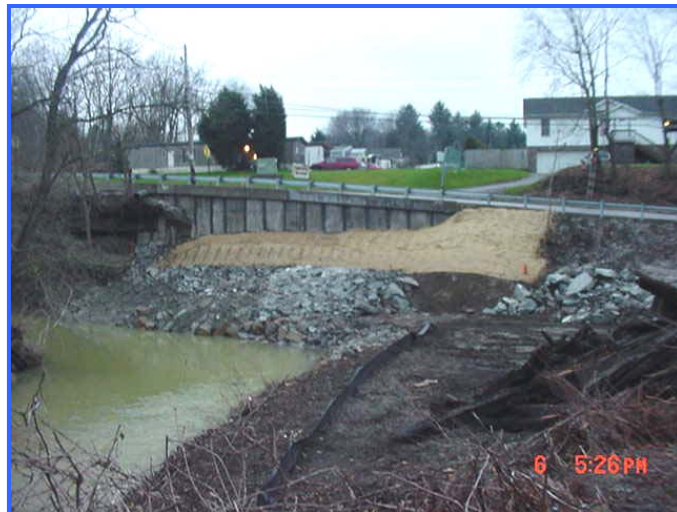
Cliff Mine Road

During the flooding, a 90-degree turn in Cliff Mine Run directed the brunt of the stream force into the slope below Cliff Mine Road, undercutting the roadway and causing it to fail. Due to the slope height, a soldier pile and lagging wall was employed to support the road embankment and to reopen the road.

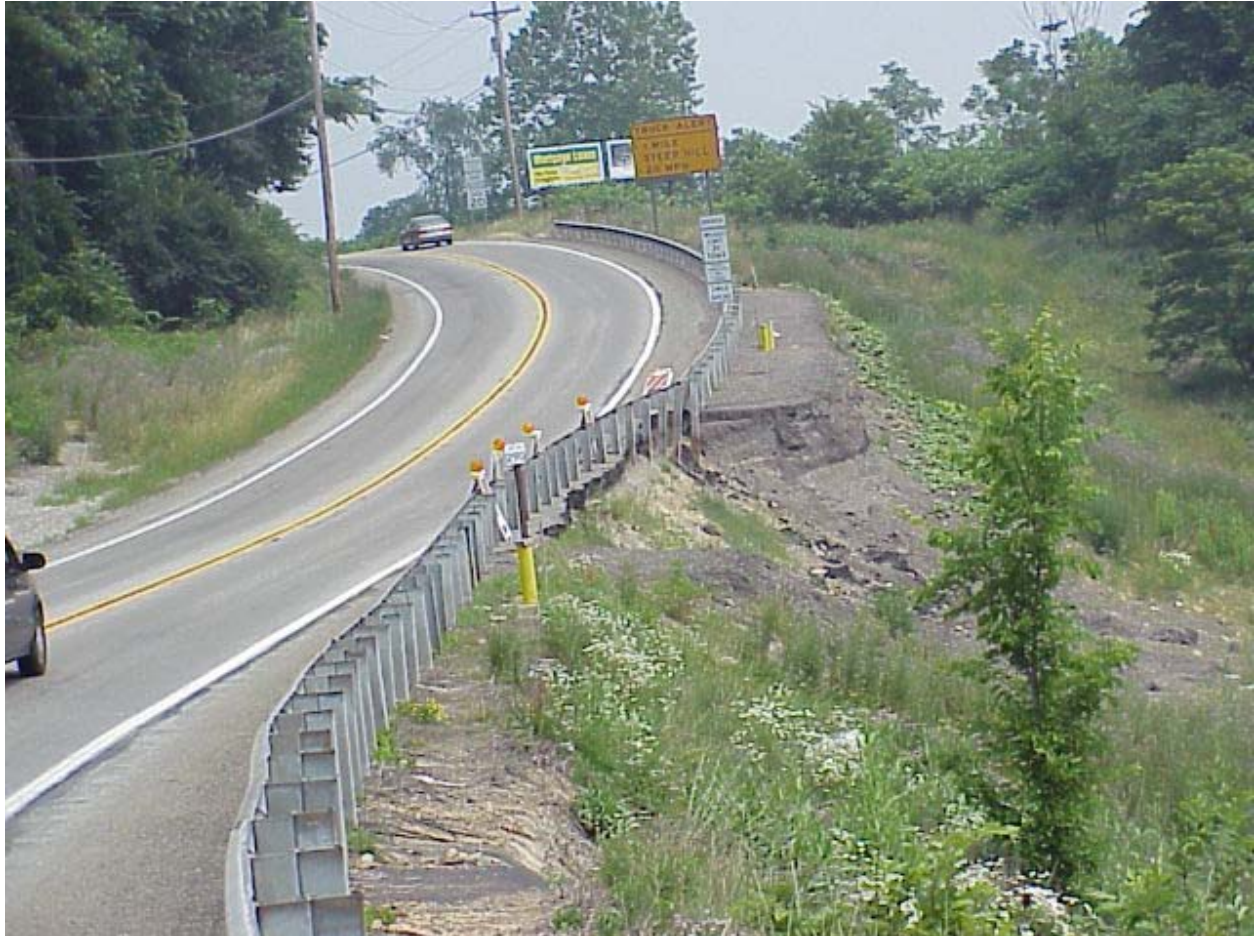
Photograph 1 – SR 48 Landslide Looking from South to North

The landslide that reoccurred in the east slope of the highway embankment in the early summer of 2001 was a classic slump. The top width was about 100 feet adjacent to the highway, and the total length of the slide perpendicular to the slope was about 90 feet. . The slide mass moved downward about 10 feet and laterally about 20 to 30 feet. Photograph 1 shows the landslide from the south looking north. Fortunately, the failure did not extend into the highway, and therefore, traffic was not affected. However, the failure had undermined the normal location of the guide-rail, which was re-established in the remaining shoulder closer to the highway, as shown in Photograph 2.

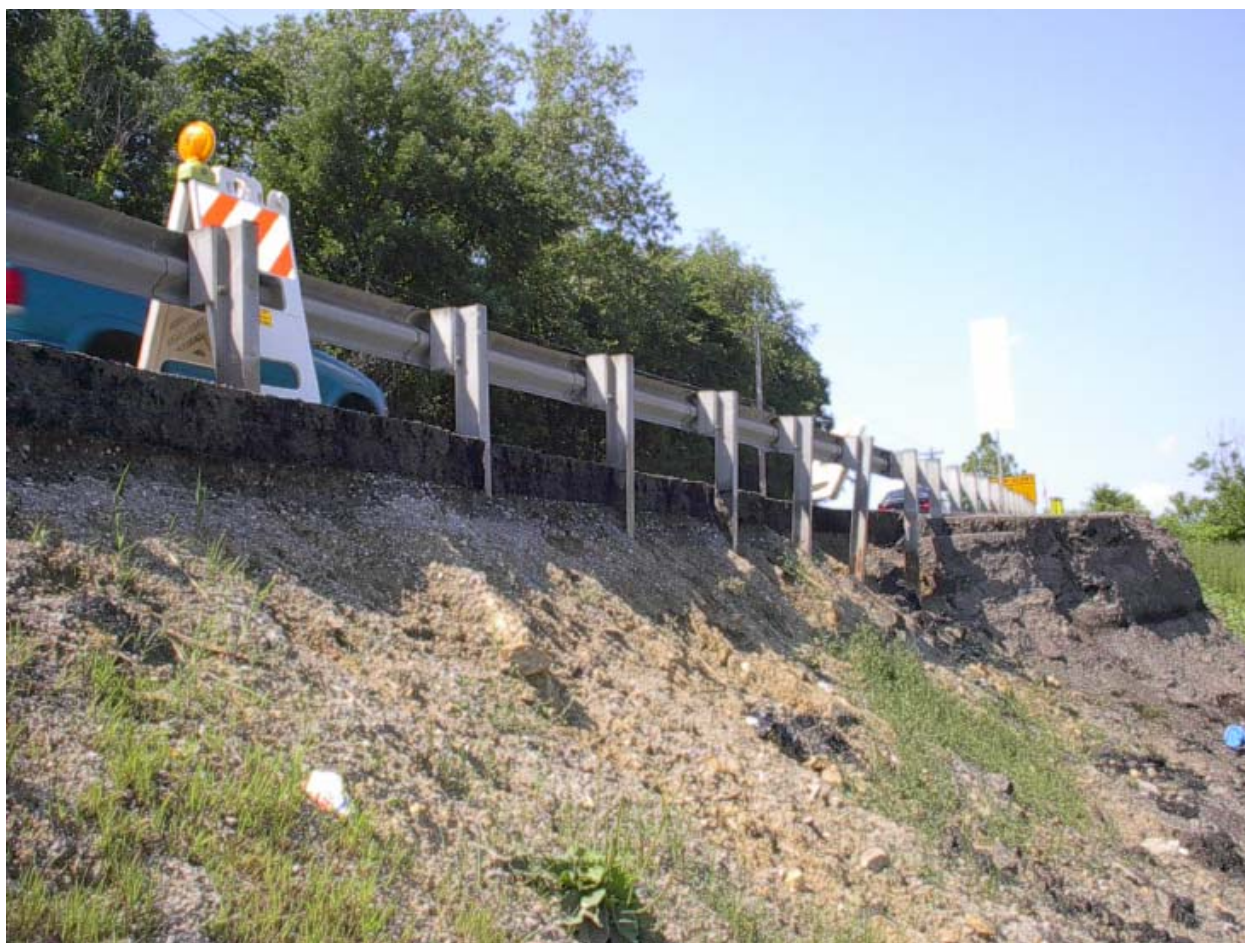
Photograph 2 – Relocated Guide Rails at Head of SR 48 Landslide

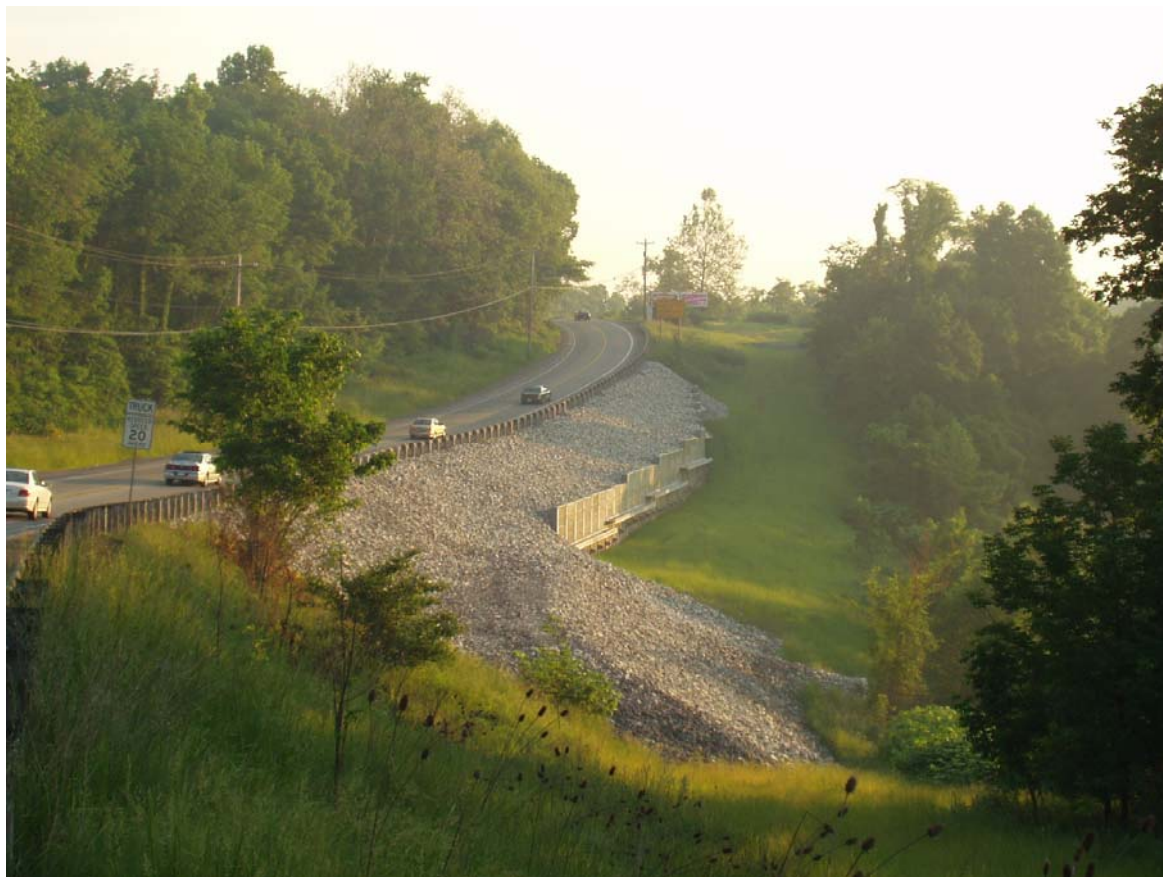
Photograph 3 shows the completed installation. The approximate cost of the retaining wall was \$800,000 and the approximate cost of the rock buttress was \$200,000. These costs do not include the other construction activities needed to complete the repairs.

**Photograph 3 – Repaired SR 48 Landslide (Northern Retaining Wall and Southern Rock Buttress)
Constructed Within the Limits of the Irregularly Shaped Available Existing Right-of-Way**

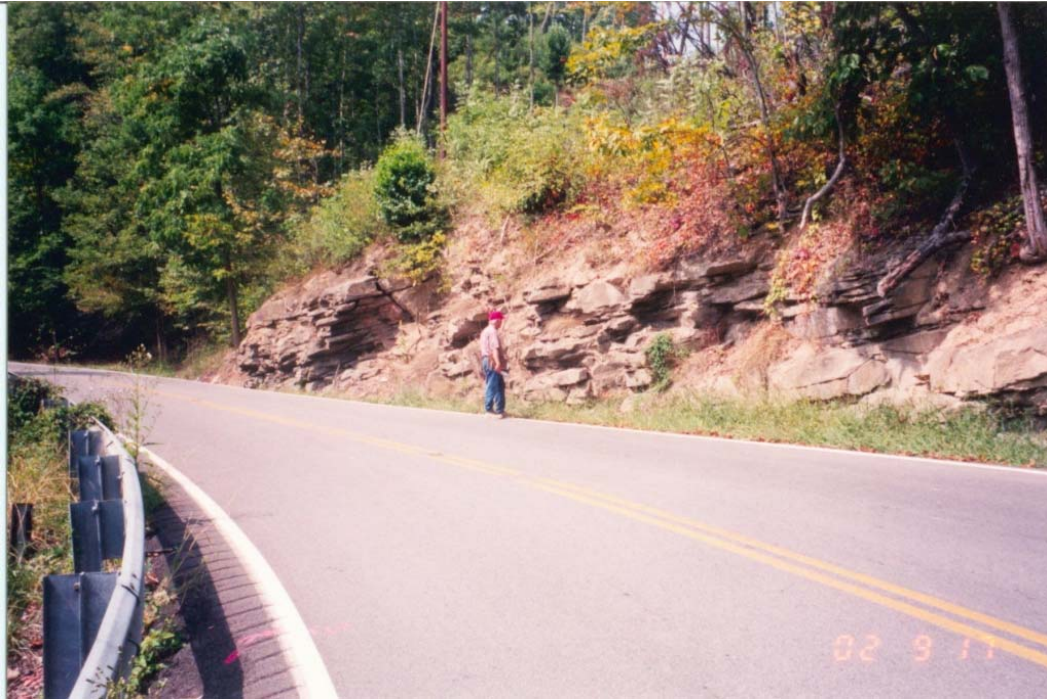
Figure 9. Before Construction

Therefore, roadway centerlines parallel with strike of bedding and with bedrock dipping downward towards the roadway required 3H:1V slopes (approximate bedding plane angle) with transitions in and out of curves when the roadway turned away from the strike direction. The KYTC Geotechnical Branch had experienced slope failures in the past when the excavation was constructed steeper than the true dip angle. Figure 8 presents a cross section showing the planned roadway and Figures 9 and 10 are photographs showing before and after construction of the slopes.

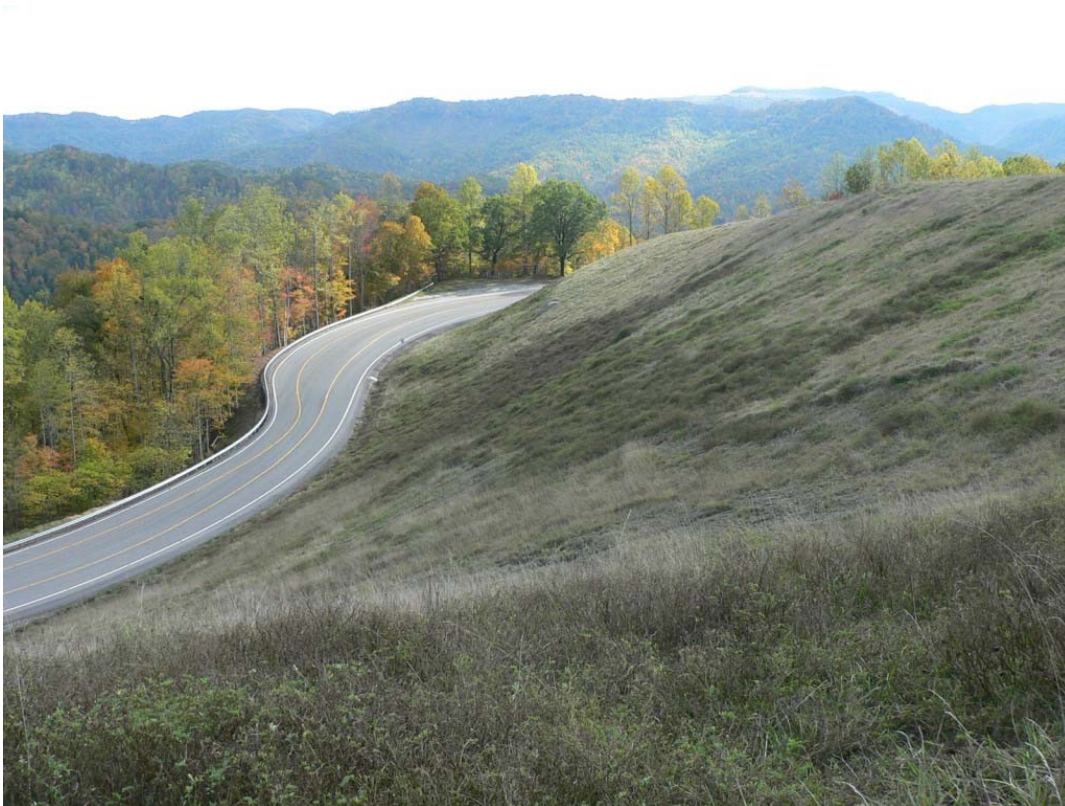
Figure 10. Completed Construction
