57th ANNUAL HIGHWAY GEOLOGY SYMPOSIUM

BRECKENRIDGE, COLORADO
SEPTEMBER 26-29, 2006

PROCEEDINGS

***Landslide Investigation and Mitigation Along US 160 Between Durango And Mancos,
Colorado, Using Lightweight Fill, Ground Anchors, and Rockery Buttresses***

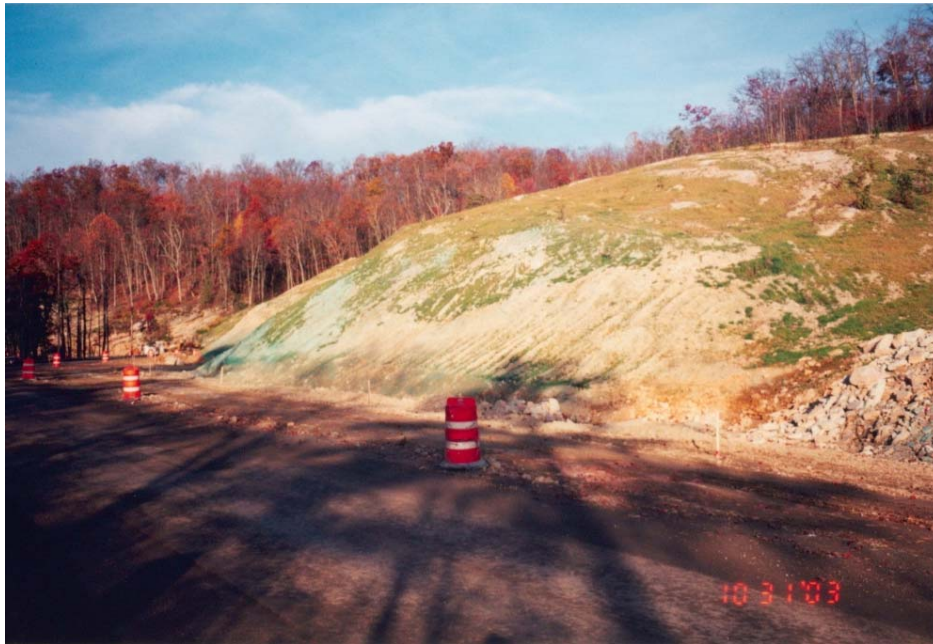
Figure 13. Shot-In-Place Berm

Figure 13 depicts an area during construction that has been rubble-ized. In addition, the 1.5H:1V regrade slope within the blasted area has been excavated. Figure 14 is a photograph in which you can visually see the bedrock bedding planes and how they are dipping towards the roadway.

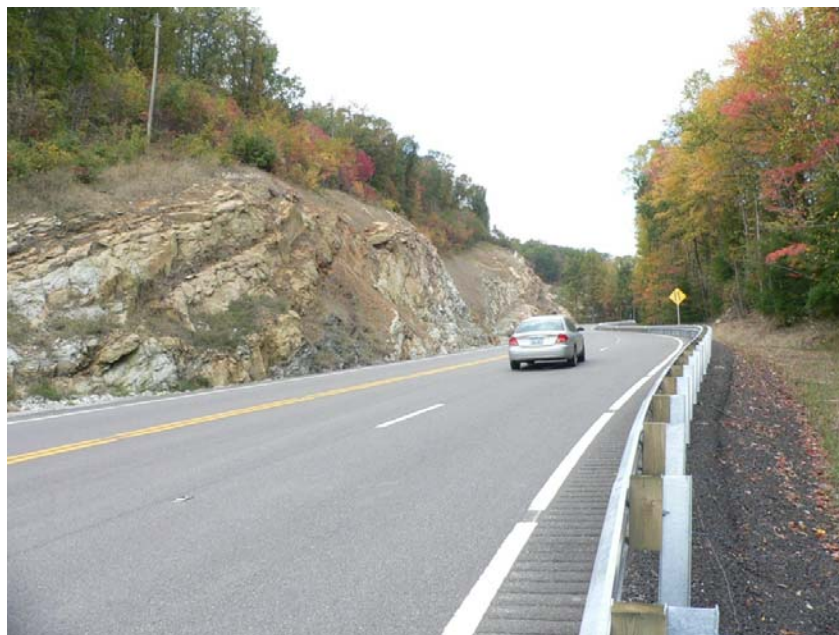
Figure 16. Roadway Centerline Approximately Perpendicular to Strike of Bedding Planes.

Figure 16 shows the completed cut slopes. Within this area, the roadway alignment also had a couple of sharp curves causing the orientation of centerline relative to the strike of the bedding planes to skew from perpendicular. At such locations, excavation of materials along the bedding plane was required to provide adequate slope stability.

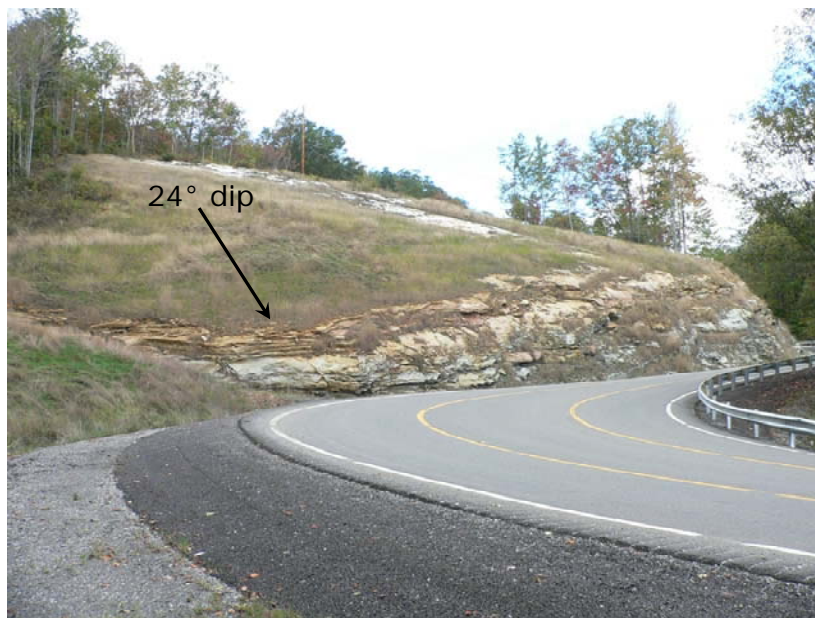
Figure 17 shows the roadway alignment turning such that the direction of bedding dip is into the roadway at an approximate angle of 24 degrees, resulting in using approximate 3H:1V slopes for construction. The far right of the photograph shows the centerline turning such that more conventional 1/2H:1V cut slopes could be designed and constructed.

Figure 17. Constructed Cut Slope Involving a Roadway Alignment that is both Parallel and Perpendicular to the Strike of Bedding.

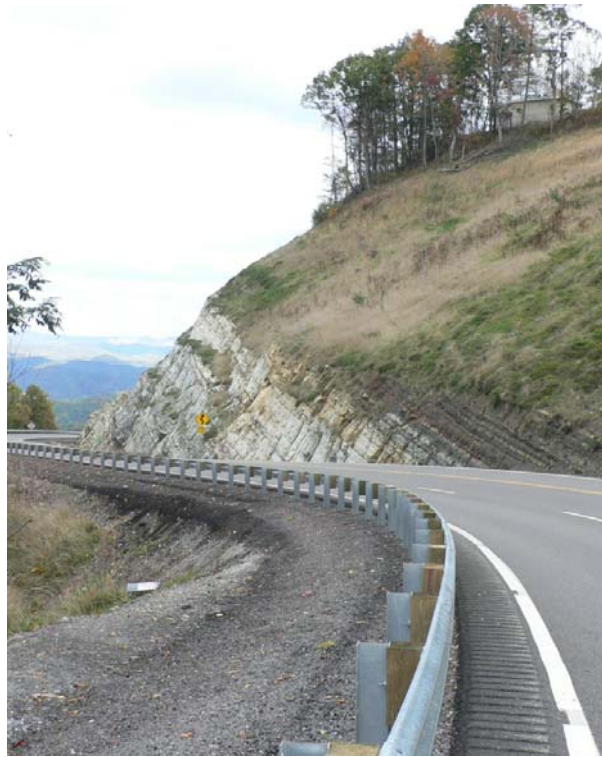
Figure 19 shows the completed construction at this location. The radio tower building is present in the upper right corner of the photograph.

Figure 19. Completed cut slopes at Location 1250.

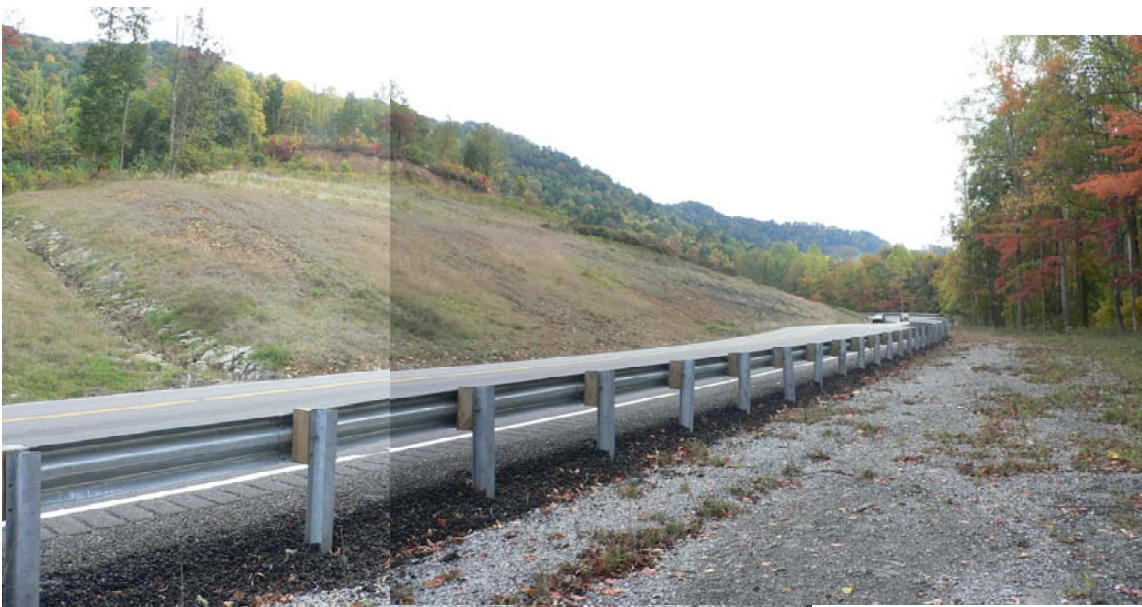
Figure 22. Completed cut slope in colluvial deposits.

During construction, an area near Station 1522+00 exhibited a significant amount of water seepage near elevation 1760 feet. It was interpreted that this water was being collected in a large drainage area up-slope from the site, seeping along the top of bedrock, and discharging out of the newly excavated cut slope. The amount of water flowing from the hillside was creating shallow surface failures. In order to reduce the potential for additional slope failures, a collector ditch and rip rap were installed on the slope near the 1760 elevation. Figure 22 shows the completed slope.

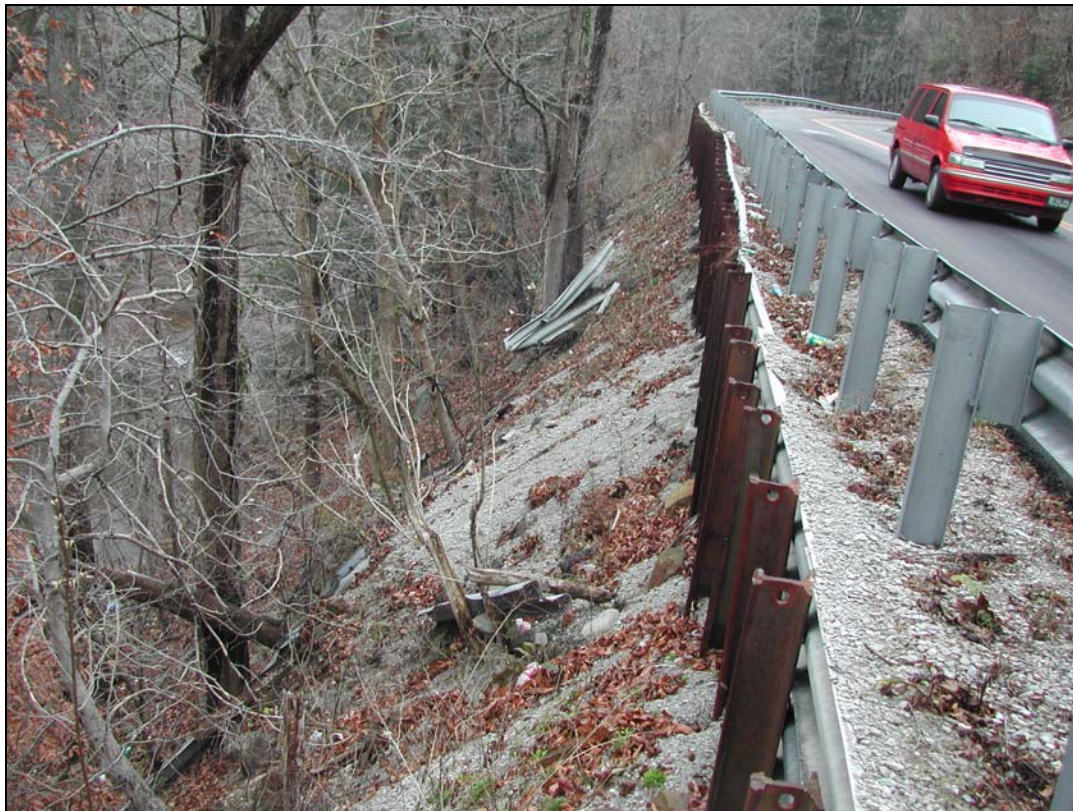
This photo shows one of the earlier trial sites in 1995 using the Railroad Rail concept on SR 116 in Anderson County, near Lake City, Tennessee. At this site only one row of railroad rails was used for stabilization due to the shallow rock depth (six to eight feet).

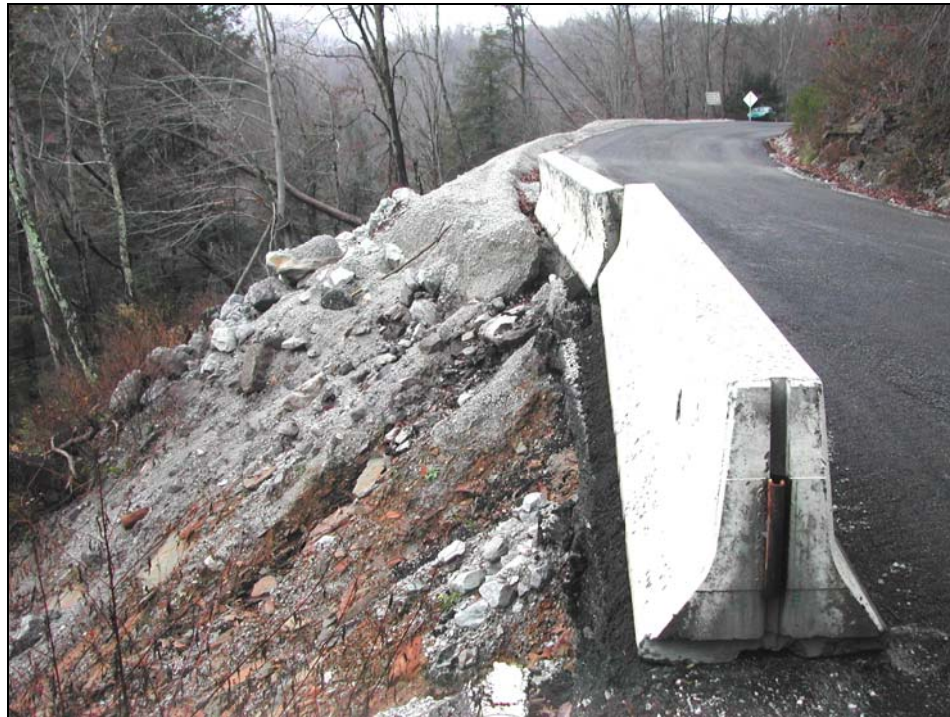
This photo shows the subject slide area in November 2003 where undermining of the existing roadway has required the use of portable barrier rails for safety.

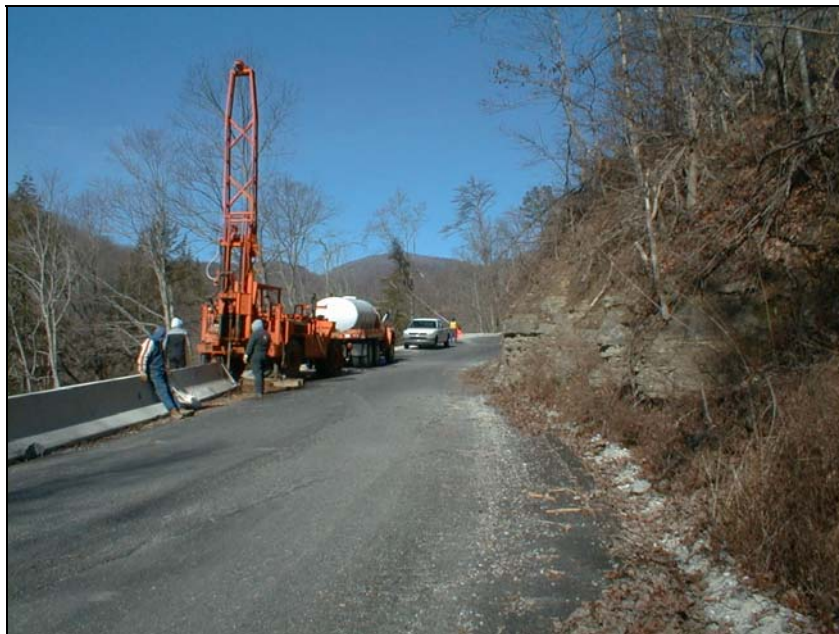
Rock drilling was performed by the Geotechnical Engineering Section for subsurface information at the subject slide site in December 2003.

Core drilling along the roadway shoulder was performed by TDOT Geotechnical Engineering personnel in December 2003 to obtain accurate depths of the weathered zone, slide material, and in-place bedrock.

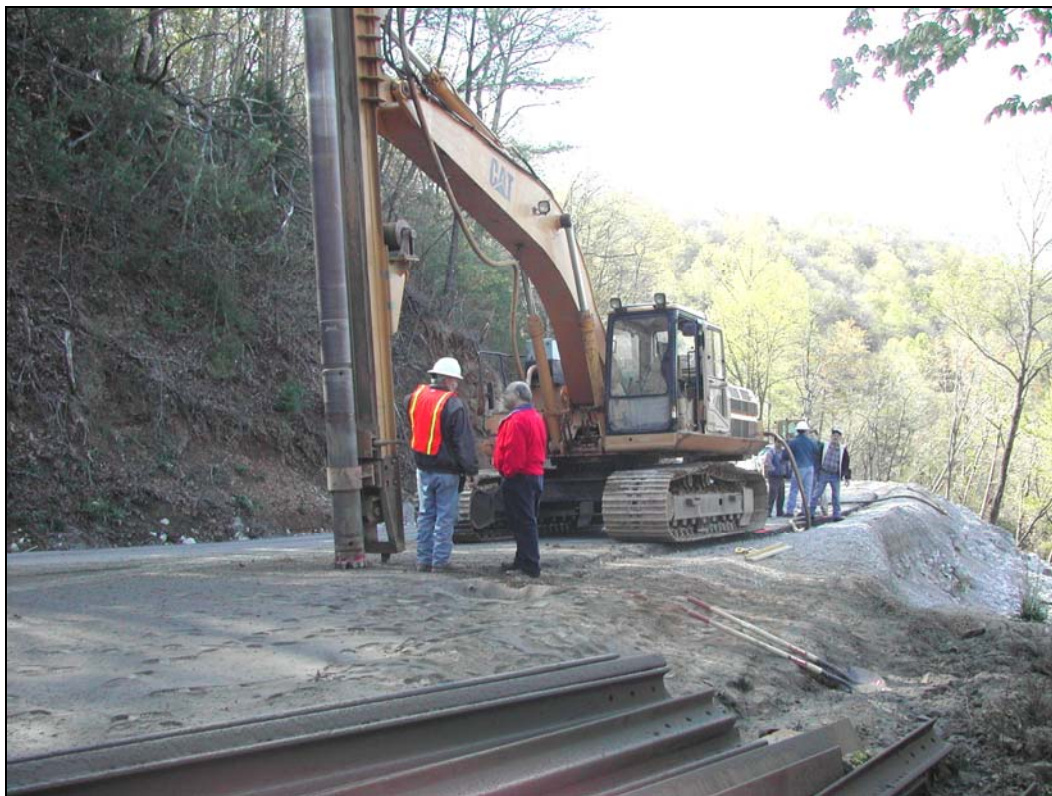
This photo shows the track-hoe mounted drilling apparatus used by Phillips and Jordan, Inc. on the subject slide repair on SR 116 in Anderson County. Note: RR rails in foreground and slide scarp in shoulder stone to the right of the track-hoe.

The contractor chose to use a 12-inch diameter drill which was attached to a mandrill that was connected to the arm of a large track hoe. This was somewhat different from past experience with the drilling of the holes usually being performed with a large truck-mounted drilling rig that had a swivel tower base for turning to the side to drill the holes for the railroad rails. TDOT Maintenance forces were very interested in this drilling equipment with the possibility of obtaining the same apparatus to repair numerous similar slide situations using TDOT forces.

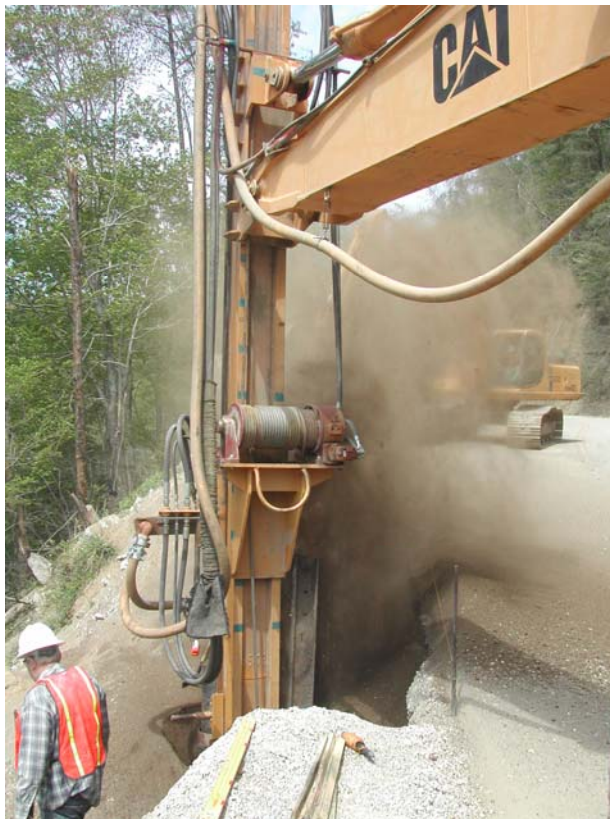
The holes drilled for placing the railroad rails penetrated weathered shale and in-place gray shale.

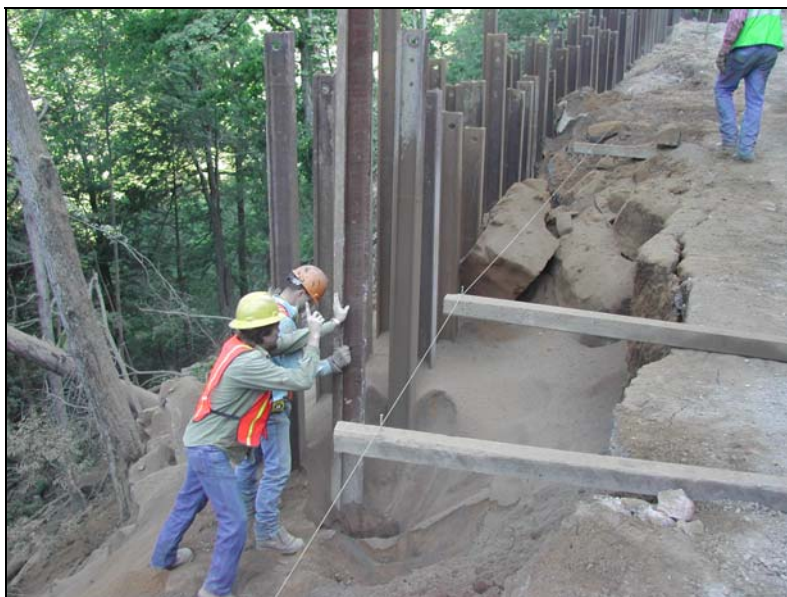
This photo shows the installation of railroad rail into the drilled hole. Note the RR rails in the background prior to trimming the tops.

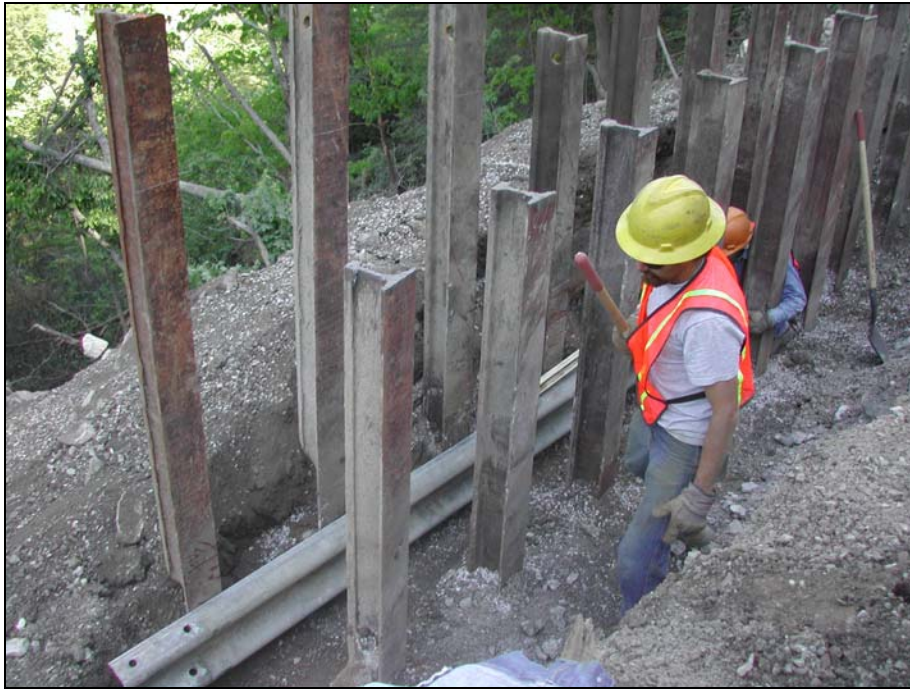
This photo shows the installation of guardrail along the outside row of railroad rails forming the retaining wall to support the stabilized and widened roadway shoulder.

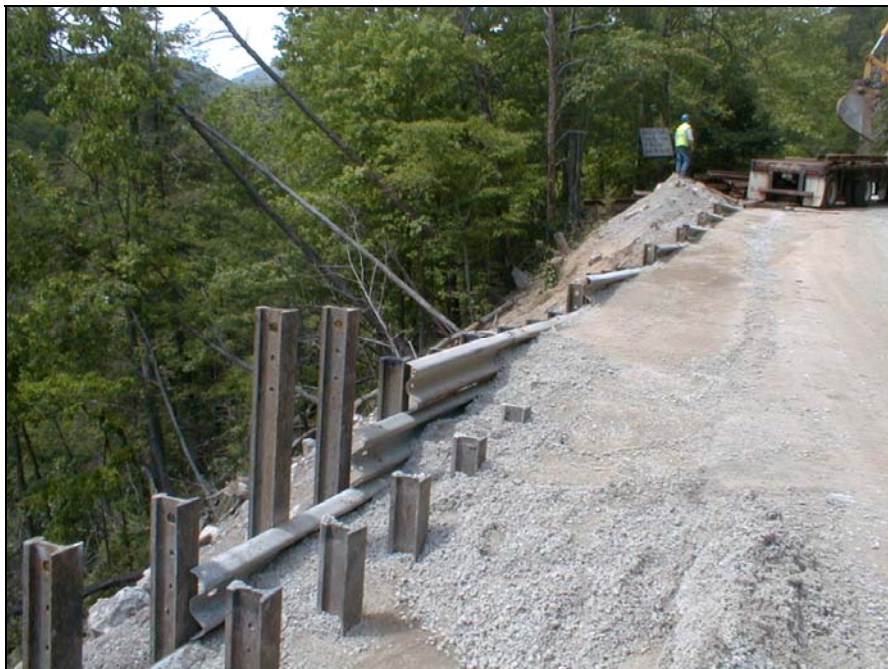
The guardrail was installed in horizontal sections forming small “step-downs” along the top of the retaining wall and shoulder edge.

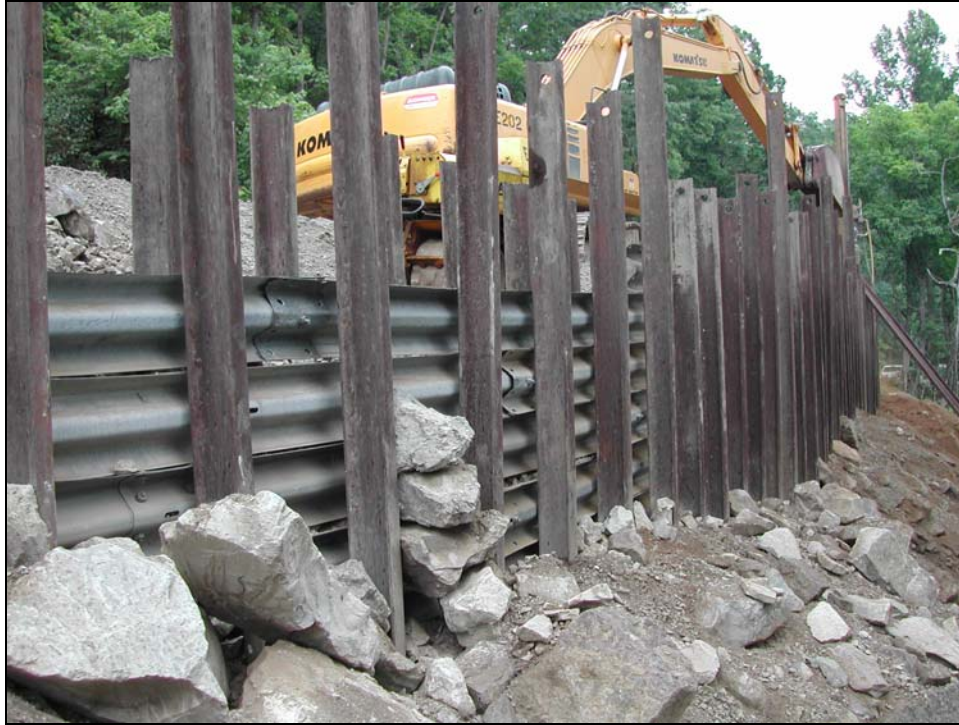
As the railroad rail installation proceeded ahead, the guardrail portion of the retaining wall was constructed. The stacked rock along the wall base was used by workers to climb up and down the wall during construction.

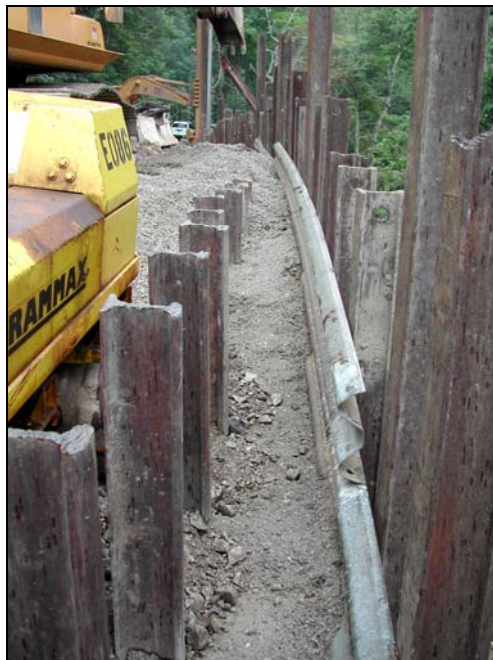
This view of the construction shows the small compactor (at left along vertical rails) along the RR rails where base stone was being placed. Note the drilling and RR rail installation ahead.

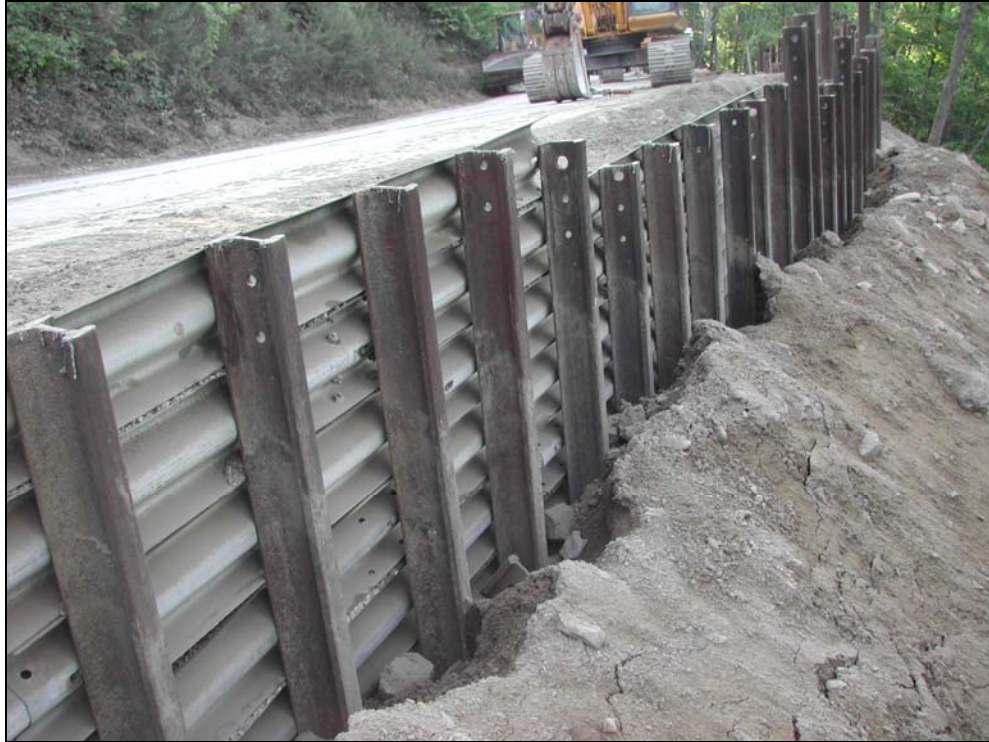
After the guardrail installation and backfill stone placement was completed the RR rails were then trimmed forming the final retaining wall stabilizing the roadway.

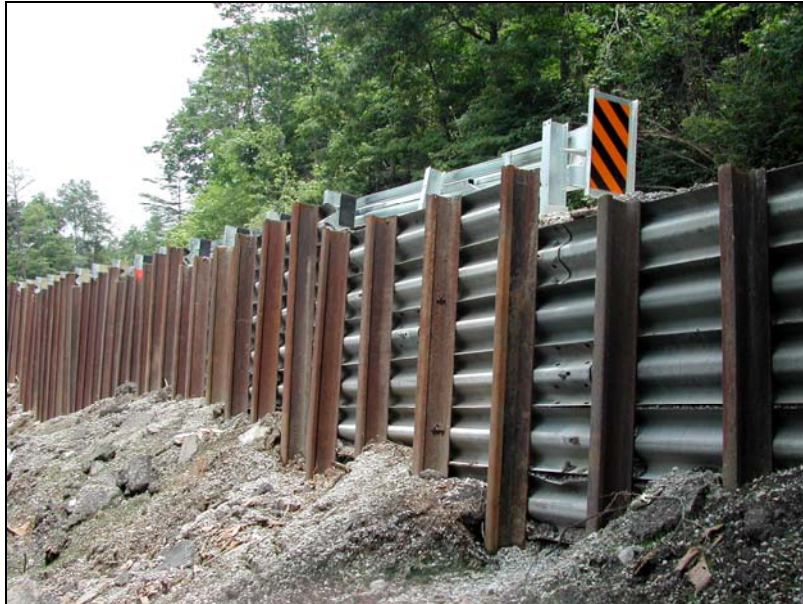
This view of the completed RR rail wall shows the highest portion of the wall at 10 feet (near the middle left of photo). Note the new guardrail installed along the roadway shoulder.

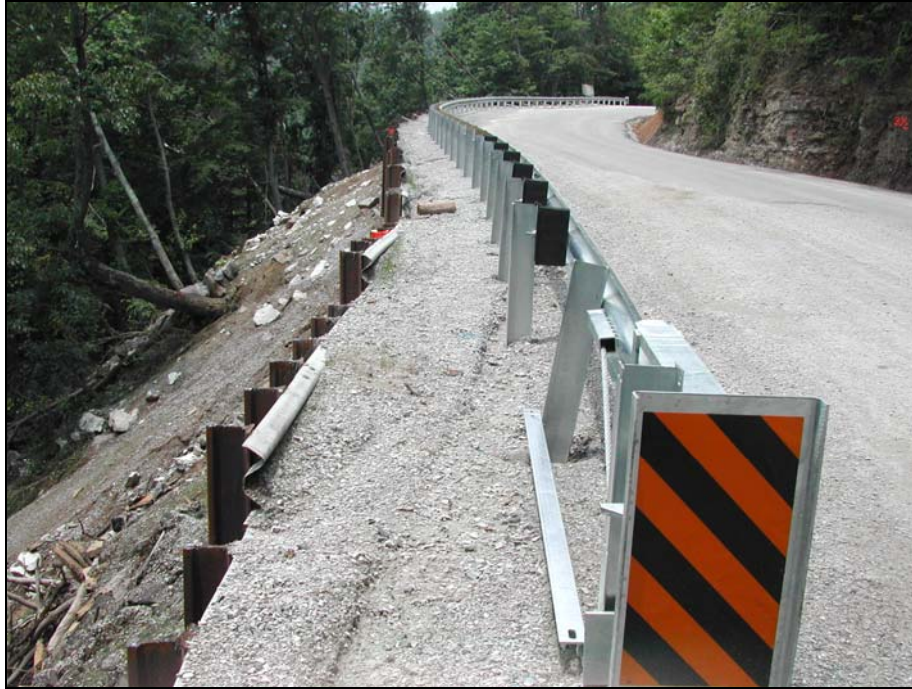
This view shows the completed slide repair site with completed railroad rail wall and newly installed roadway guardrail. The previously undermined section of road was located just to the right of the guardrail near the upper-middle portion of the photo.

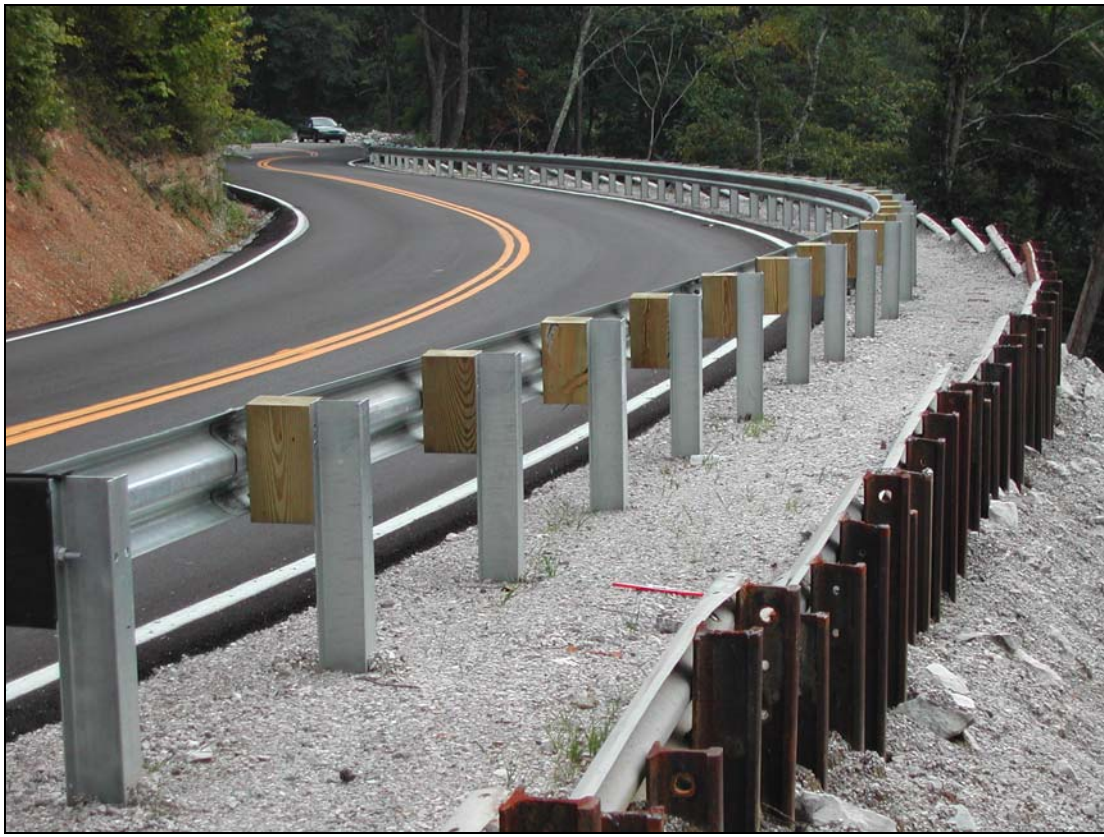
Shown in this view of the slide repair project is the completed railroad rail/guardrail concept, with new guardrail and paving.

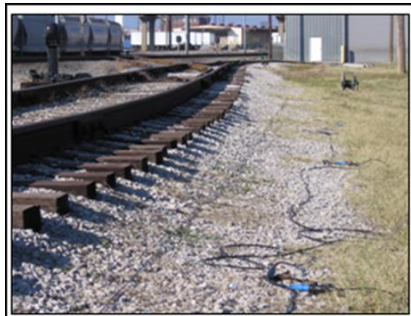
Figure 4. View along ReMi Line 1 showing 20-foot geophone spacings.

ReMi surveys were conducted by a two-person crew on November 21, 2005, using a Seisstronix RAS24 engineering seismograph and 4.5-Hz vertical geophones. ReMi data were collected along one east-west trending line parallel to the Metrolink tracks (ReMi Line 1), and one north-south trending line parallel to the eastern edge of the bridge in an industrial storage lot (ReMi Line 2). ReMi survey locations are shown in Figure 1. ReMi Line 1 extended 460 feet, and ReMi Line 2 extended 440 feet. A 20-foot geophone spacing was used for each line (Figure 4). To assist in geophone coupling on ReMi

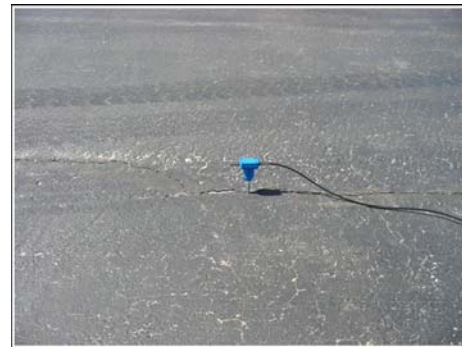
Figure 5. View of typical geophone secured into pavement prior to surveying.

Line 2, 1/4-inch diameter holes were hammer-drilled into the asphalt pavement and the geophones spikes were securely seated into each hole (Figure 5). The ReMi data were acquired by collecting approximately 20 background microtremor “noise” recordings using a time window (sampling length) of 30 seconds each. The “noise” recordings were supplemented with sledge hammer blows on a metal plate at the end of each line.

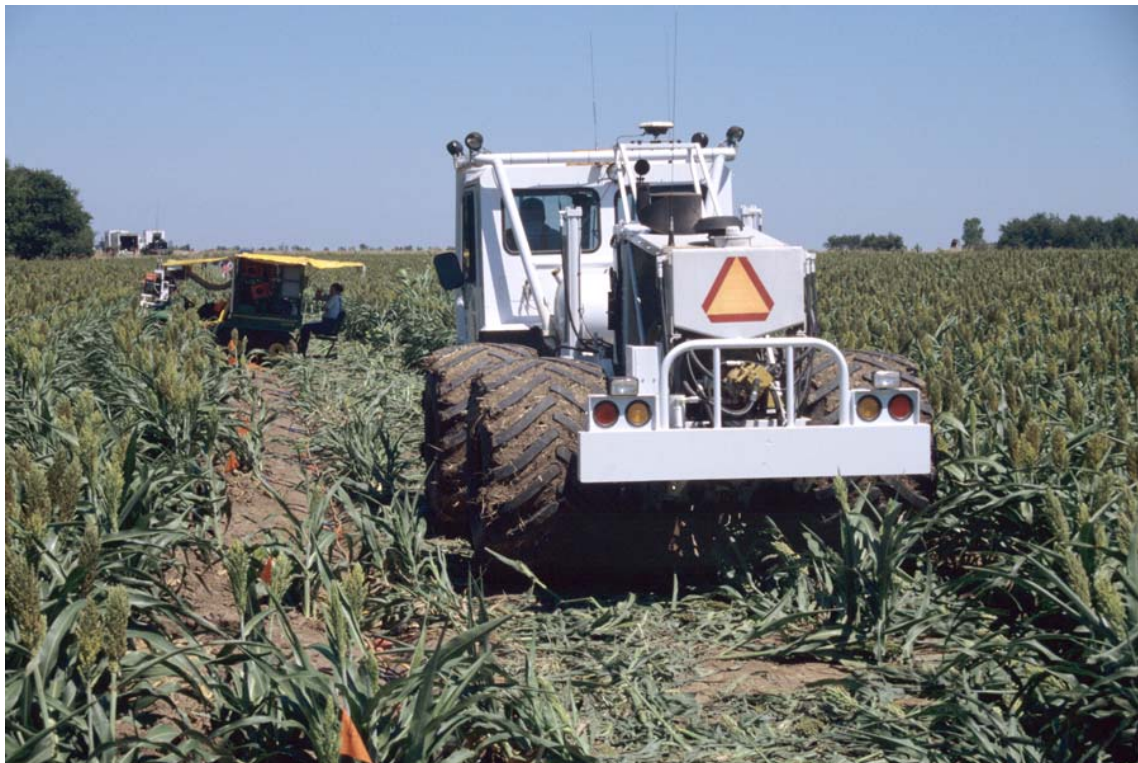
Figure 5: Collecting data in a milo field using a 240-channel seismograph and the custom-made "MiniVibe"

On August 2, 2005, the KGS crew arrived and began by surveying a north-south line along the county road that runs north from Inman. Personnel from both the Salina and El Dorado geology offices assisted with traffic control and in placing geophones. The geophone spacing for our survey was eight feet, with two phones per location for redundancy. Placing and removing geophones is backbreaking work that the KGS workers knew to dread and KDOT helpers learned to dread. The seismic crew works from dawn to dark, and the first day was quite a change for the KDOT staff that had never been around Rick Miller and his crew. We were out in the heat flagging and moving geophones and cables until after 9:00 that evening. The temperature during the afternoon went over one hundred degrees. The north-south line was completed; nearly three-quarters of a mile of data was gathered that first day.

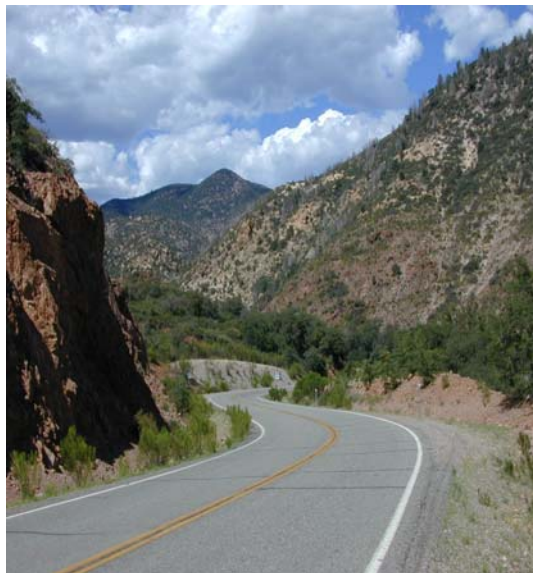
Photograph 2 – Preconstruction view looking north along US 191 towards the location of the new Upper Chase Creek Dam.

The new alignment was relocated approximately 200 feet west and uphill of the existing route on the western side of a V-shaped valley created by a regionally extensive north trending high angle normal fault (see Photograph 2). Referred to as the Chase Creek Fault Zone (CCFZ) this structure places Precambrian Granite in contact with Tertiary volcanics and in close proximity with outcrops of Paleozoic sediments. This structure has an apparent dip slip displacement of 950 feet at an approximate inclination of 60 degrees.

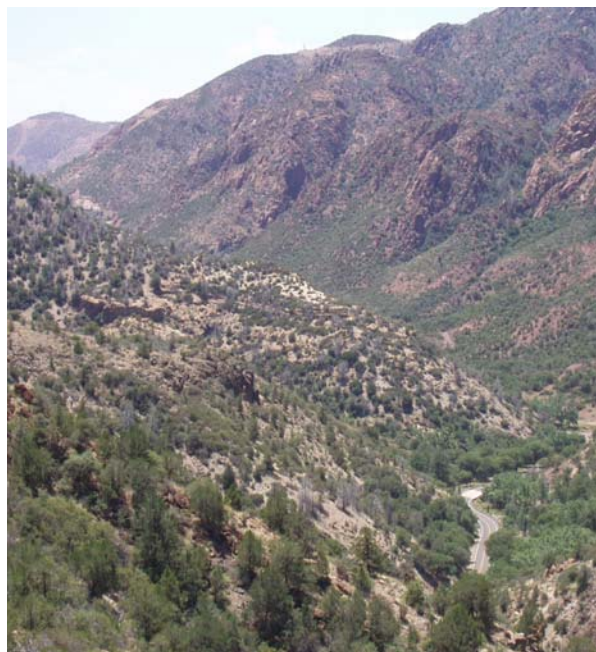
Photograph 3 – Preconstruction view looking south along Upper Chase Creek towards area of US 191 realignment showing Granite with structure paralleling the Chase Creek Fault orientation.

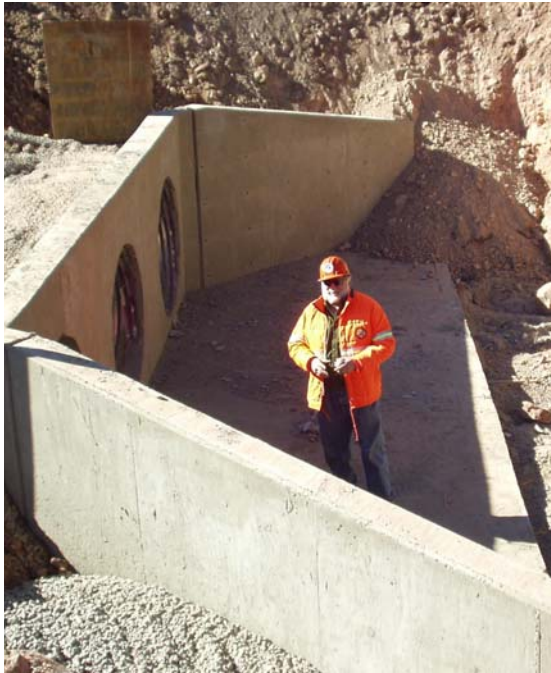
Photograph 4 – Construction view of triple 36 inch culvert inlet on new US 191 alignment near north end of project.

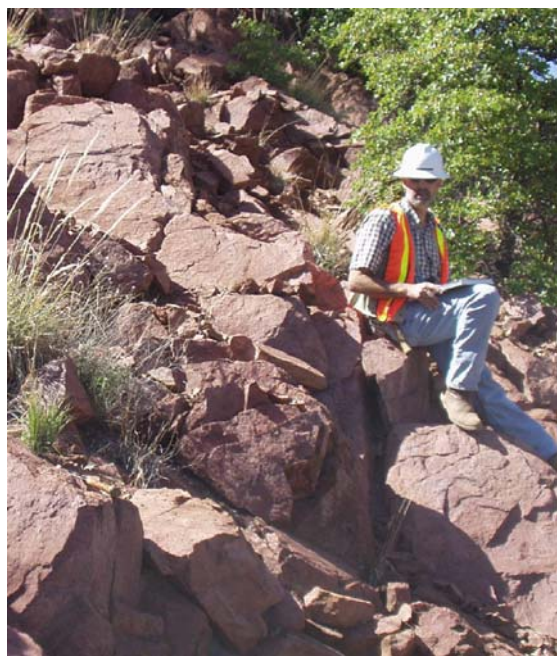
Photograph 5 – Bedrock outcrop above new US 191 alignment near middle of project. Note unfavorably dipping rock structure.

The site characterization work included field reconnaissance, geologic mapping (see Photograph 5), inspection of exposed cut slopes and supervised the completion of ten drill holes. This work supplemented that carried out for the preliminary feasibility study and is described below.

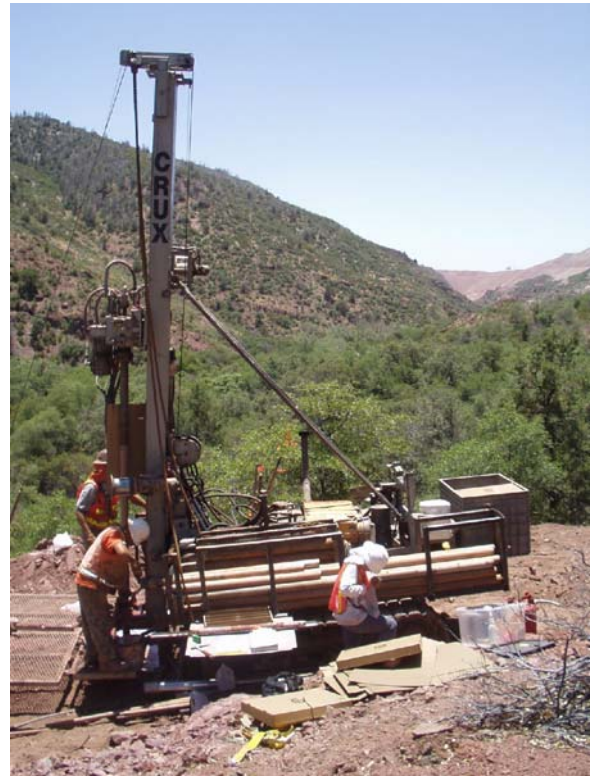
Photograph 6 – Geotechnical Exploratory Drilling along new alignment of US 191 above new Upper Chase Creek Dam.

Subsurface drilling was carried out at 10 locations along or within 75 ft. of the proposed new highway alignment centerline in conjunction with an investigation of the proposed spillway and dam site (see Photograph 6). The drillholes were advanced to depths of between 20 and 60 ft. The purpose of this drilling was to characterize the material overlying bedrock, define the depth and type of bedrock, and to perform bedrock characterization. Standard Penetration Tests (ASTM D-1586) were carried out in overburden material and Rock Quality Designation (RQD) was determined using the ISRM method.

CRUX Subsurface, Inc of Spokane Valley, Washington completed the subsurface drilling using a Burley 4000 track-mounted drill rig. Their crew included 1 lead driller and 2 helpers. Work was carried out on a schedule of 10-days on, 4-days off, and 10-days on in June 2005. The geotechnical drilling was completed by the beginning of July 2005. Access construction for the drilling program required that an old access route that had been established for drilling the right dam abutment during the 2000 feasibility study be redeveloped. This access route was pushed south and north. Construction of this access route also allowed for easy walking which assisted design, regulatory and bidding contractor personnel to conduct inspections.

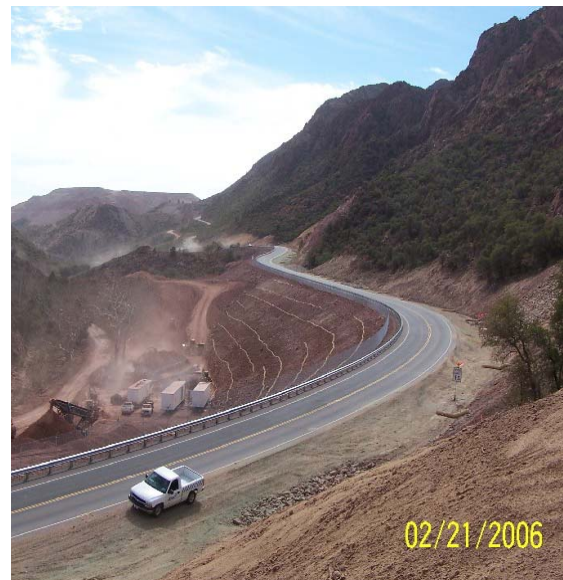
Photograph 7 – Newly constructed alignment of US 191 above new Upper Chase Creek Dam with completed pavement.

The following is a list of the major design features (see Photograph 7):

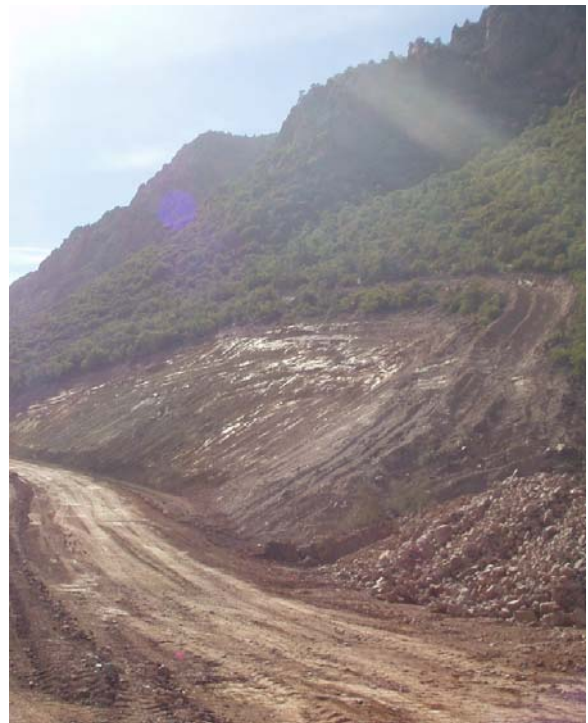
Photograph 9 – Brow or crown ditch installation at south end of new US 191 alignment.

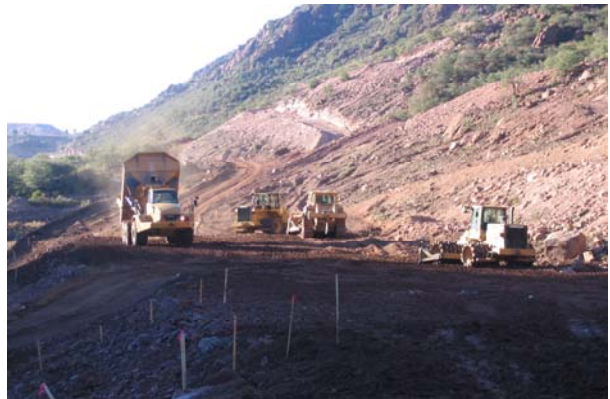
Photograph 10 – Preparatory work by NSI to establish Grade at south end of new highway

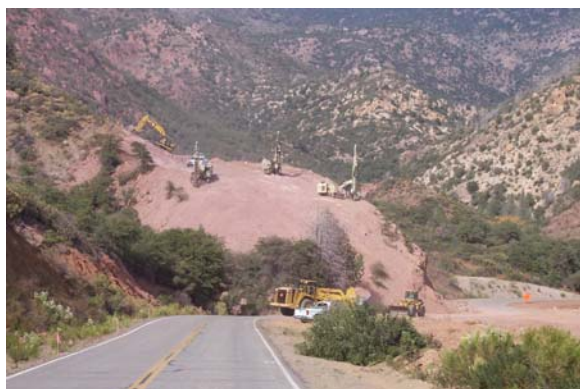
Photograph 11 – Indication of tight working conditions at base of large rock cut in middle of project.

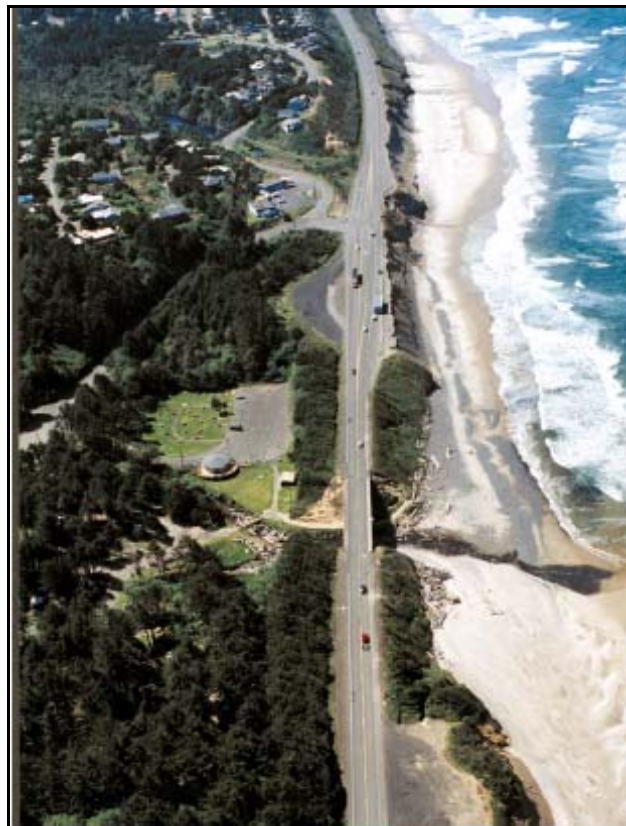
PHOTO 2: From ODOT 2003 Reconnaissance Study Report
Note: 1999 Aerial Photo
Prior to Temporary Detour Structure

The Beverly Beach State Park campground and day use parking area is located east of US101 as shown in the aerial photograph, Photo 2. Spencer Creek flows through the campground prior to crossing below US101 and was approximately 20 feet wide and 1 to 3 feet deep beneath the abandoned bridge at the time of the Shannon & Wilson geotechnical investigation. Large riprap constrains the channel beneath the bridge. Large driftwood logs are often present in the stream channel and the streambed consists of gravel and large cobbles. During major storms, sea waves directly impact the stream channel beneath the bridge causing erosion.

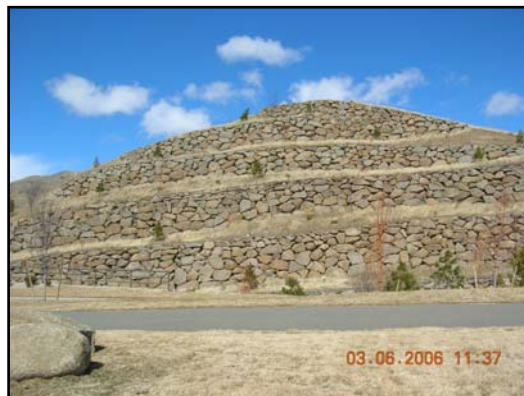
Figure 1: Multitiered rockery wall near Reno, Nevada.

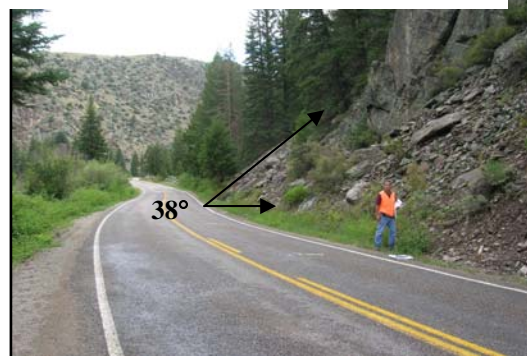
Figure 2: Talus slope with a 38° angle of repose, Taylor River Road, Colorado.

Talus slopes are colluvial deposits that have been deposited by some means of mass wasting. The face of the talus deposits rest at the angle of repose, which by definition is at a factor of safety of unity (1) or just at equilibrium. Typically, the angle of repose for talus is in the range of 37 to about 42 degrees depending on the textural gradation of the deposits (Figure 2). Coarse deposits with large blocks may stand steeper. Oversteepening the toe of the talus deposit may affect the marginal stability and cause the deposit to reestablish equilibrium by sliding. In the past, rockery walls have been employed by the Federal Highway Administration (FHWA) to stabilize the toes of talus slopes along the road in the Taylor River Canyon (Figure 3).

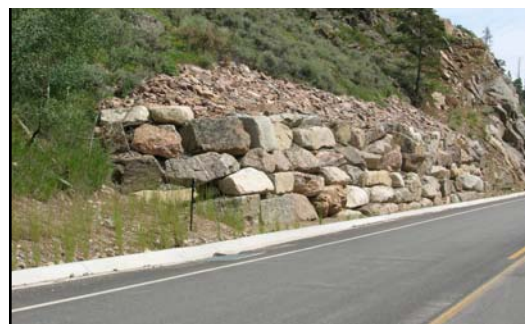
Figure 3: Rockery wall constructed at the toe of a talus slope along Taylor River Road, Colorado.

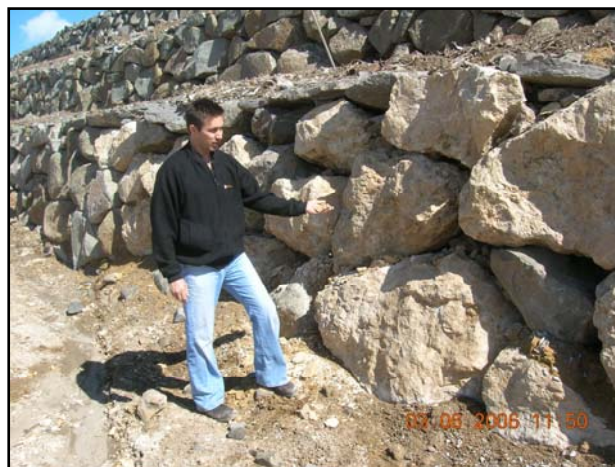
Figure 7: Example of rockery wall failing because of placement and use of weak rock for wall rock.

Figure 7 displays an example of a rockery wall failing because weak unsound rock was selected for the wall rock.

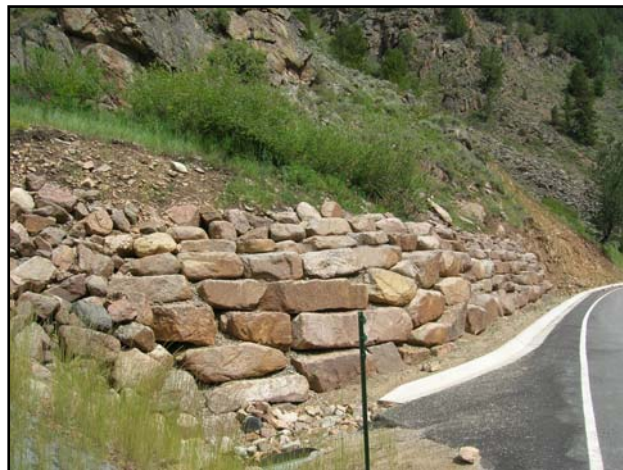
Figure 8: Rockery wall along Taylor River Road.

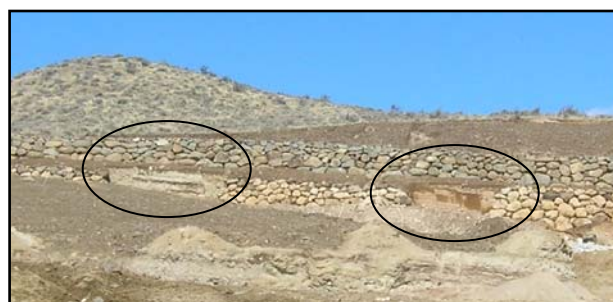
Figure 9: Failure of rockery wall from poor drainage exacerbated by poor rock selection and placement, Reno, Nevada.

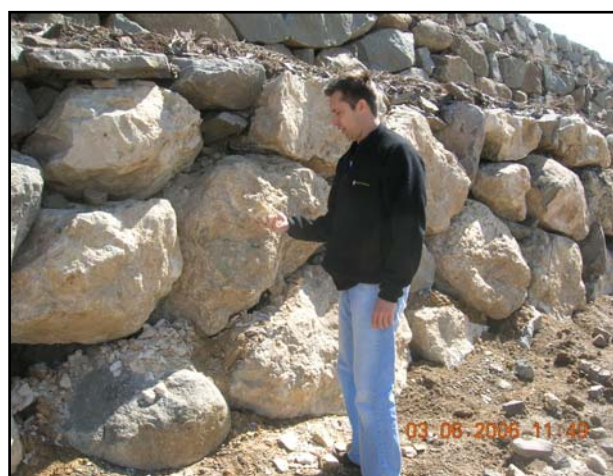
Figure 10: Rockery wall failing because of poor placement of rock and weak unsound rock.

by ASTM C682 for Freeze-Thaw characteristics. Figure 10 is a photo of very weak rock that was selected for a rockery wall in the Reno, Nevada area. The rockery wall is failing not only because of the shape of the rocks but because the weathered weak rock is disintegrating and spalling around stronger core stones.

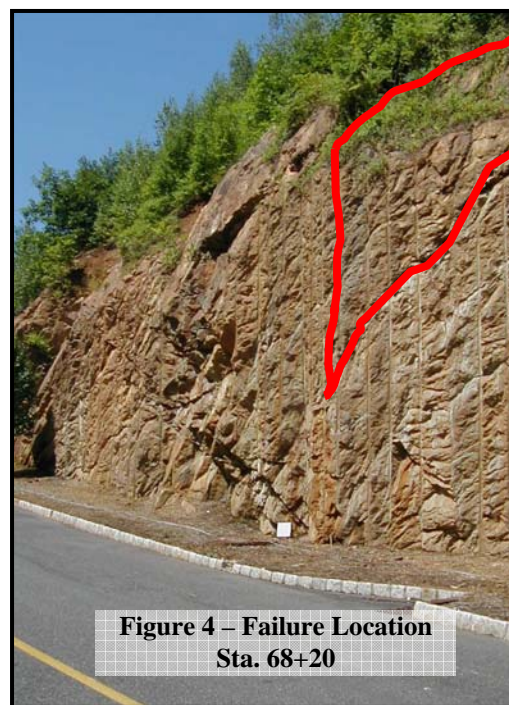
**Figure 4 – Failure Location
Sta. 68+20**

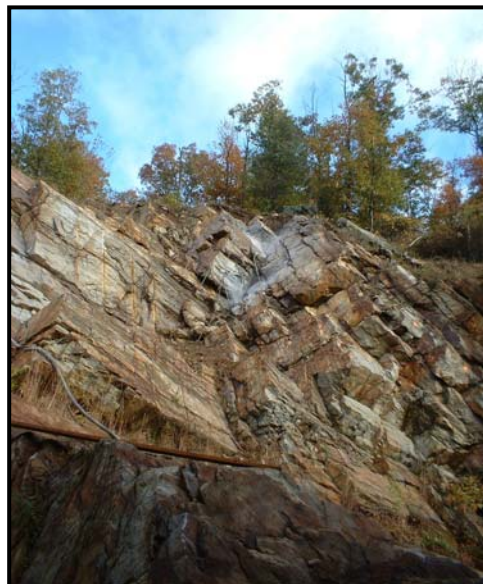
Figure 5 – Rock Overhanging Bldg. C

line of credit to enable some emergency remedial measures to be initiated. While the failure on Timber Ridge Rd was important, in the sense that it validated our report and all of its inclusive warnings about the slopes at the site, it was not the most potentially dangerous slope at the site. A large overhang of rock, some 35 to 40 feet above and behind Building C, was the slope with the most serious consequences were it to fail. Figure 5 shows the location described, prior to any remedial measures.
