57th ANNUAL HIGHWAY GEOLOGY SYMPOSIUM

BRECKENRIDGE, COLORADO
SEPTEMBER 26-29, 2006

PROCEEDINGS

***Landslide Investigation and Mitigation Along US 160 Between Durango And Mancos,
Colorado, Using Lightweight Fill, Ground Anchors, and Rockery Buttresses***

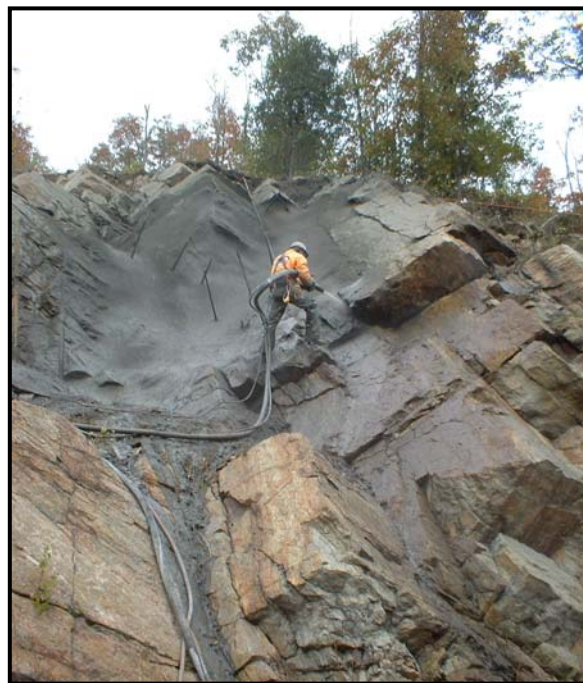
*Figure 6 – Bldg. C Overhang
Shotcrete Application*

Loose rock on the benches above and behind Building C were removed by hand prior to shotcrete being applied to the slopes. Loose soil in the areas where it had accumulated was also swept down to the base of the slope behind Building C. In areas where shotcrete was to be applied as a buttress below overhangs, four-foot long 1-inch diameter deformed galvanized bars were installed first in holes drilled two feet into the rock with a plugger or wagon drill. These dowels act as additional support for the steel-reinforced shotcrete after it cures. The dowels, which were grouted in place, were cut off with a portable saw to just above the surface of the shotcrete.

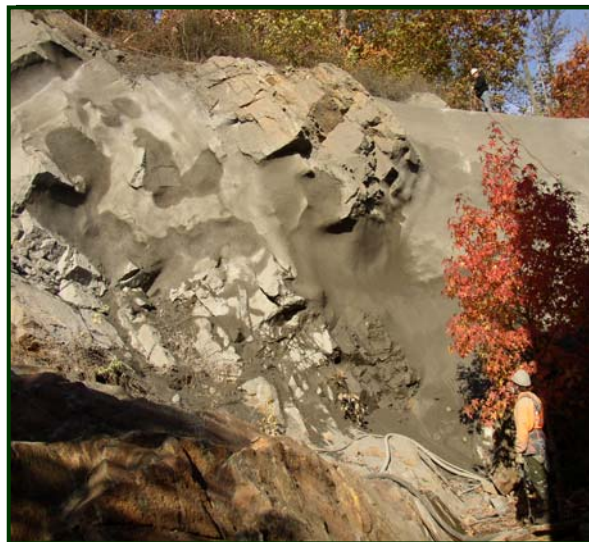
Figure 7 – Final Appearance of Bldg. C Shotcrete Application

MS-D1 steel fiber-reinforced shotcrete was applied to several overhang areas behind Building C. When cured, this material reaches compressive strengths of about 6500 pounds per square inch at 28 days. The material came in 1,000-kilogram bulk bags, which was run through a hopper/conveyor/ blender apparatus in the dry state. The blended material was then conveyed to the face of the slope by compressed air hose and mixed with water at the nozzle and sprayed onto the cleaned slopes. The shotcrete was applied to the slopes at Building C in layers approximately four to six inches thick at a time. Total thicknesses of shotcrete in any particular area of the slopes behind Building C approached two to three feet in the buttress areas. Figures 6 and 7 provide examples of the shotcrete process used at the site, including what the final appearance of the slopes looks like. A total of forty 1,000-kilogram bags, or slightly over 24 cubic yards, of shotcrete was applied to the slopes behind Building C.

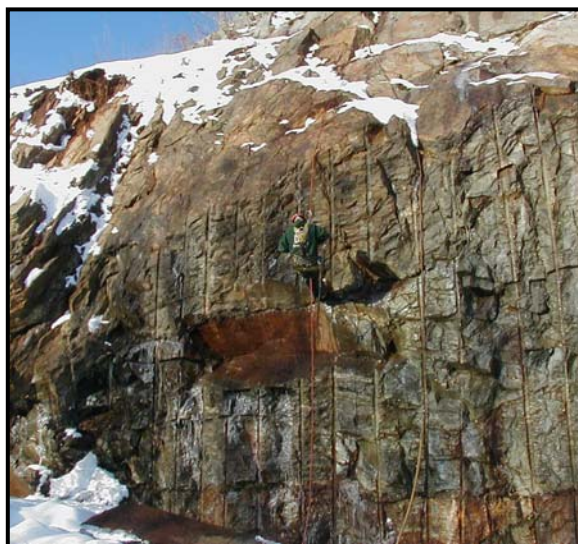
Figure 8 – Wedge of Rock Scaled Before Failure.

Prior to initiating rock bolting of several difficult areas along Timber Ridge Road, rock scaling was performed over 80% of the slope present. Brush and small trees were cut back approximately 10 feet from the edge of the slope. As seen in Figure 8, many of the large pieces of rock scaled off the slope at Timber Ridge Rd were classic incipient wedge failures just waiting to happen. The block scaled off the slope just below and to the left of the technician in the photo was a piece of some 3,800 pounds that required almost no effort to remove. A total of some 125 cubic yards of scaled rock was removed from Timber Ridge Rd.

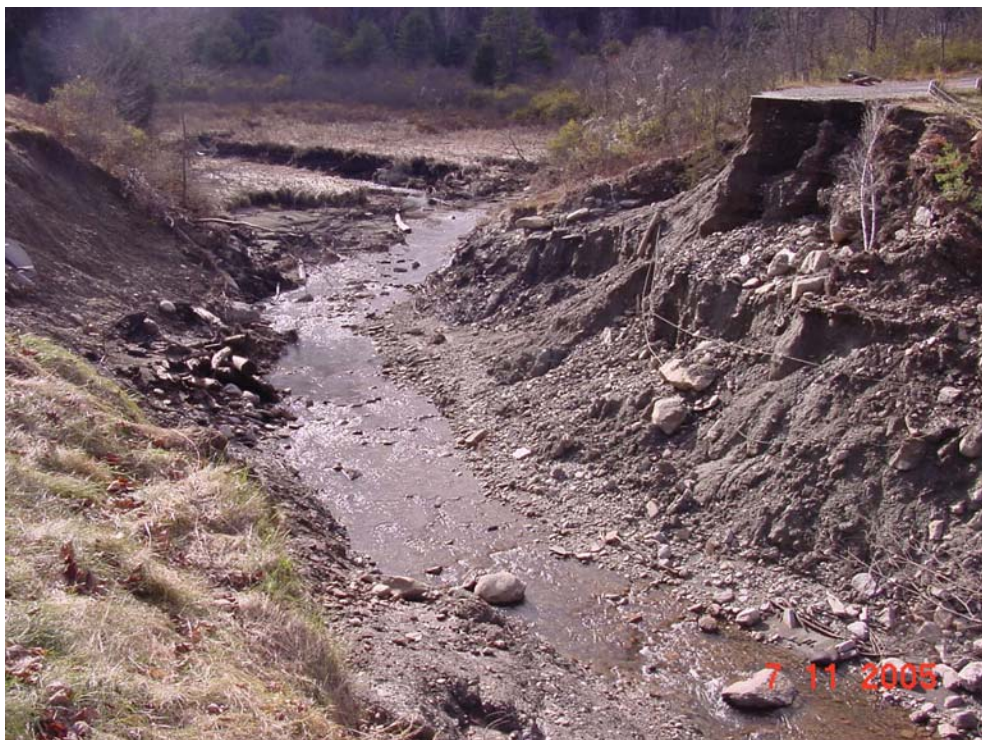
Figure 3. *Cooper Hill Road embankment*

The flooding in Alstead occurred because of the combined effect of heavy rainfall, sheet runoff from the surrounding steep valley slopes, overflow from Lake Warren and a large volume of water becoming impounded behind the roadway embankment at the Cooper Hill Road brook crossing. Warren Brook flowed through a 12-foot diameter multi-plate culvert that extended underneath a 40-foot high embankment at Cooper Hill Road, approximately 2 miles upstream from Alstead Village (Figure 3). During the early morning hours of October 9th, the impounded water breached the Cooper Hill Road embankment, sweeping away the culvert and a large section of the embankment fill. A 30 to 40 foot high wall of water and debris surged down the valley of Warren Brook and Cold River, following the NH Route 123 roadway. The floodwater swept through Alstead Village and continued downstream for 6.5 miles to the Connecticut River. The raging floodwater carved a gorge at the Cooper Hill Road crossing estimated to be 50 feet deep and 110 feet wide. At the culvert location, the floodwater cut deep into the underlying, dense glacial till, lowering the channel of the brook an additional 8 to 10 feet.

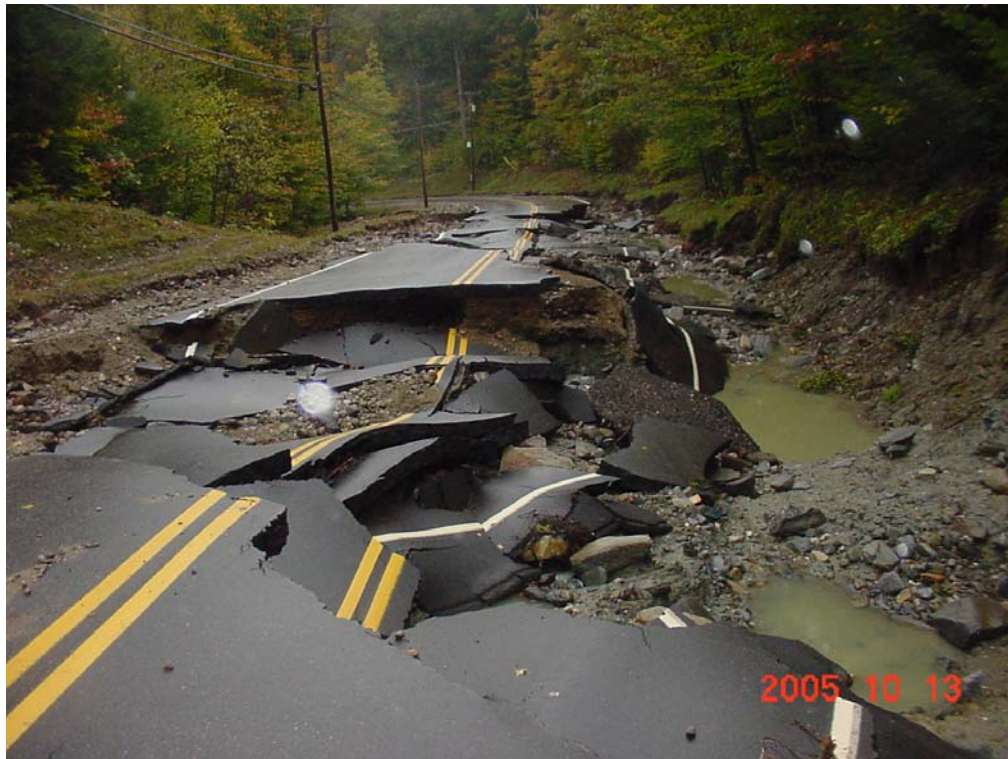
Figure 6. *NH Route 123 washed out*

Runoff below the Lake Warren Dam caused severe erosion, washouts of the NH Route 123 roadway (Figure 6) and damage to drainage structures. Hundreds of feet of buried underdrain pipe, installed at a depth of 6 feet along the edge of the road, were plucked from the ground. The rushing water cut narrow trenches with nearly vertical walls into the underlying dense glacial till. The trenches were eroded four feet below the pipe elevation for a total depth of 10 feet (Figure 7). Warren Brook cut deep into its banks, undermining steep side slopes, triggering slides that threatened to undermine segments of Route 123.

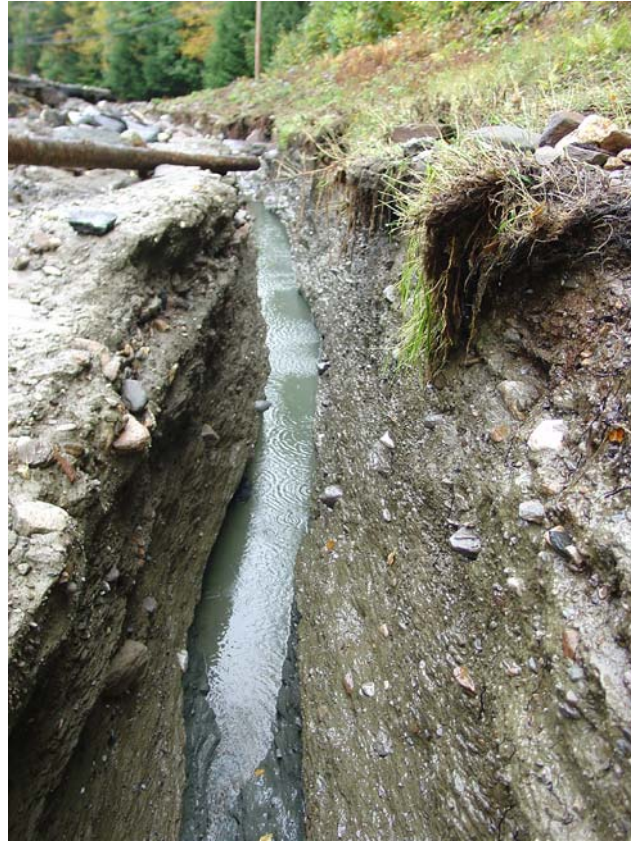
Figure 7. *Vertical trenches eroded into dense glacial till*

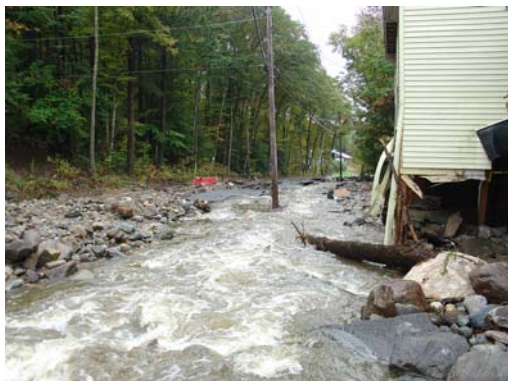
Figure 8. *New brook channel cut into roadway*

Warren Brook bypassed a large multi-plate pipe, wiped out a section of Route 123, cut a new channel in place of the roadway alignment and completely filled a 60-foot long cross pipe with gravel and boulders (Figures 8 and 9). Areas below the dam and Cooper Hill Road were buried under assorted debris and soil deposits with boulders measuring up to 4 feet in diameter. Several bridges below Cooper Hill Road were severely damaged to include loss of the roadway approaches. A 600-foot long section of Route 123, located 1.5 miles upstream from Alstead Village, was completely washed away and the soil stripped to bedrock (Figure 10). In some areas the force of the floodwater was so great that it removed the upper layer of fractured bedrock. The Route 123 bridge over Cold River in the village of Alstead sustained major damage to its abutments and wing walls to include settlement of the southern abutment by approximately 9 inches (Figure 11).

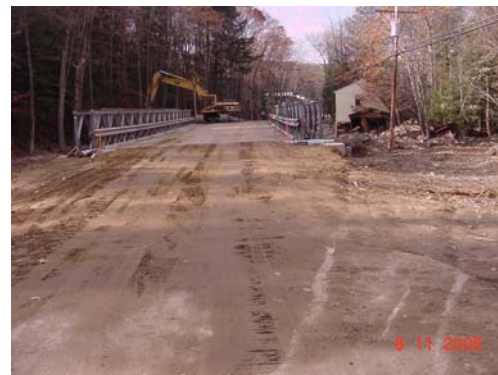
Figure 9. *Temporary Bailey bridge over brook*

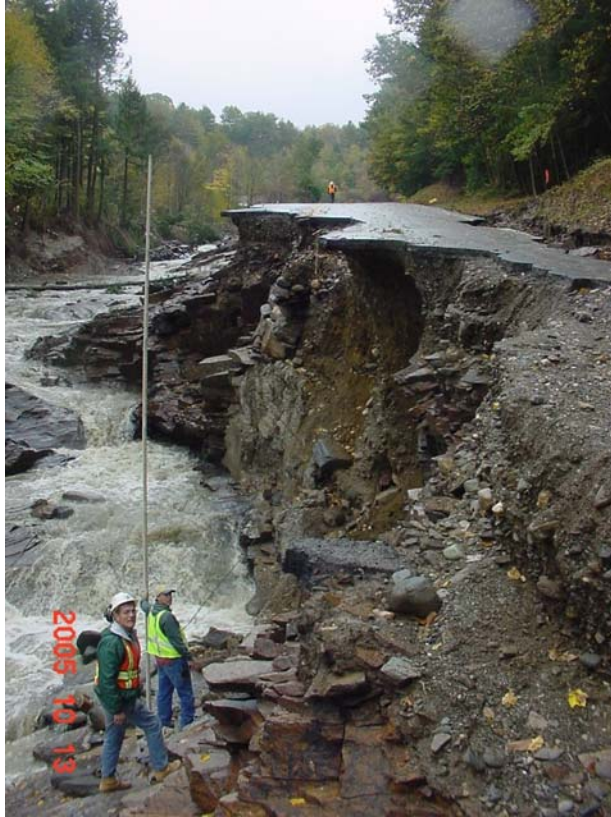
Figure 10. *Section of Route 123 stripped to bedrock*

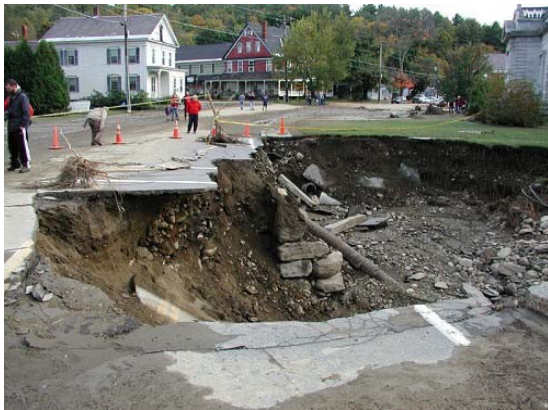
Figure 11. *Bridge wing walls damaged and abutment settled 9 inches*

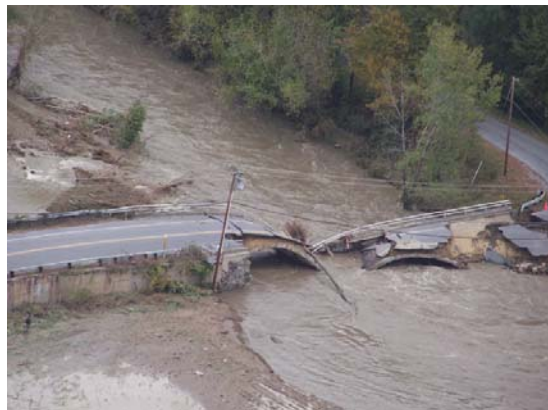
Figure 12. *Twin arch bridge washed out*

Damage and devastation from the floodwater continued further downstream from Alstead Village to include the washout of another bridge over Cold River and the loss of a historic twin arch bridge in Walpole, New Hampshire, approximately 6.5 miles downstream from Cooper Hill Road (Figure 12).

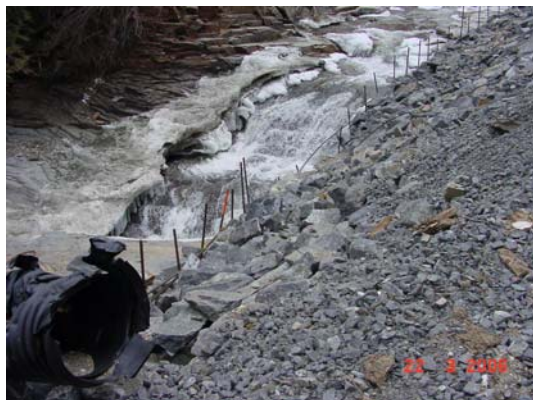
Figure 13. *Toe of stone filled slope secured with grouted dowels*

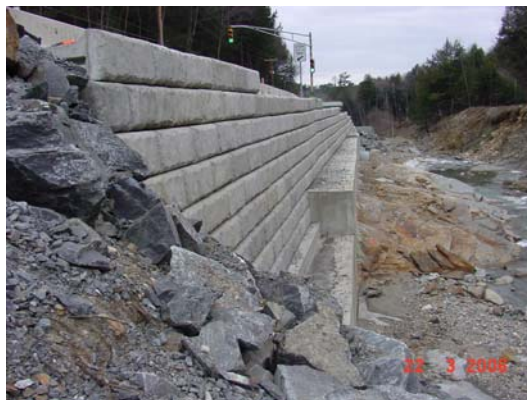
Figure 14. *Redi-Rock™ concrete block retaining wall*

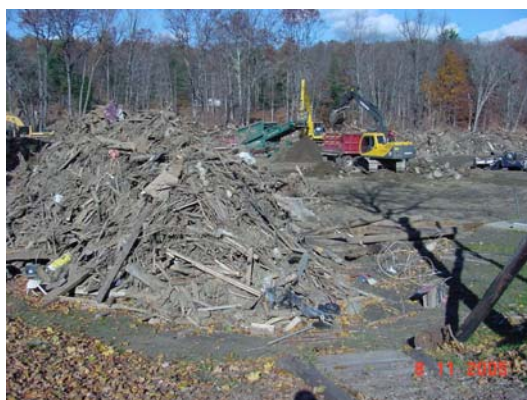
Figure 16. *Flood debris sorted by type*

Several areas to include the parade field in Alstead Village were utilized as temporary staging and storage areas for flood debris. The flood debris materials were sorted by type into separate piles (Figure 16). Trees were shredded into wood chips, topsoil was recovered by screening the woody debris and some of the recovered wood was burned. The cleanup activities were ongoing from sunrise to sunset, seven days per week. The cost for pickup and disposal of debris averaged \$150,000 per day for an estimated total of \$ 5 million.

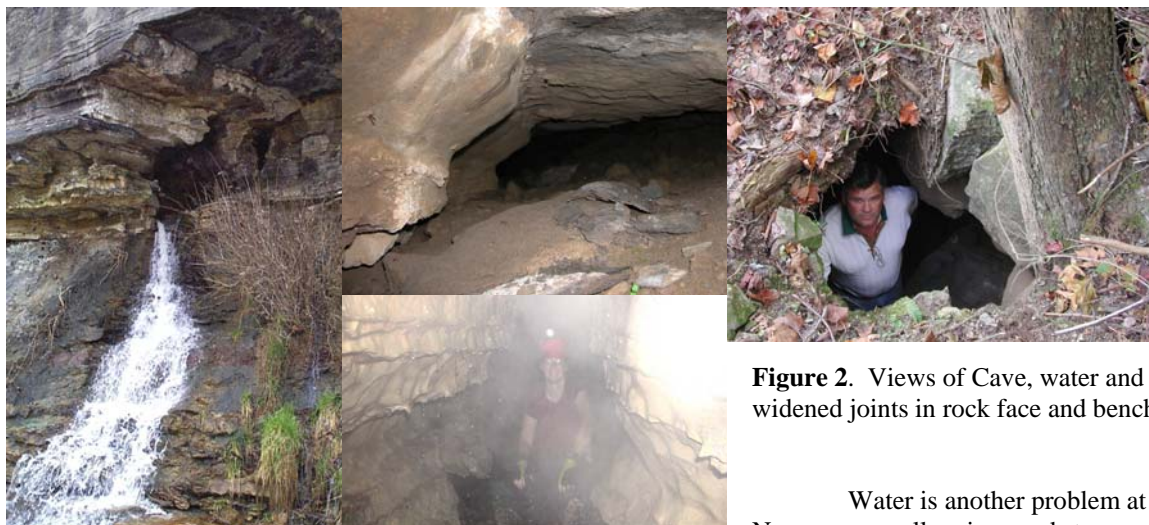
Figure 2. Views of Cave, water and solution widened joints in rock face and bench.

Complicating the matter are the large solution widened joints run roughly parallel to the face of the rock cut along this section of interstate. The solution widened joints leave tall, thin columns of rock that can be easily destabilized by the weathering out of the Pennington Shale. A cave opening is also located just to the left of the photo in Figure 1, it follows along a solution widened joint and continues back into the mountain. The base of the cave is located on top of one of the Pennington shale layers. The overlying Warren Point sandstone is also jointed, and like the Pennington layers below also parallel to the face.

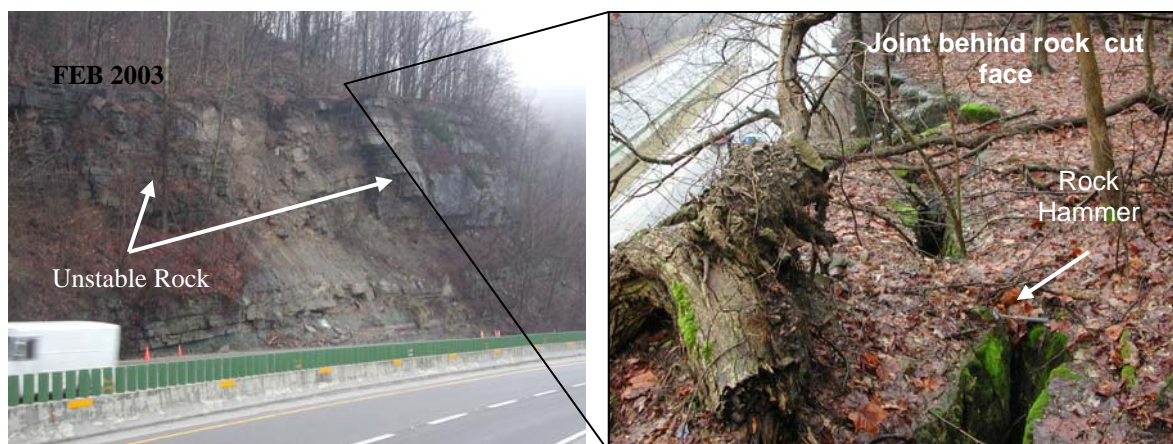
Figure 3. Unstable Face and Joint Behind the Rock face

Figure 3 shows the continued deterioration of the site as of Feb 2003 after another fall occurred at the site. These photographs, and the investigation requested by TDOT Region 2 Maintenance in 2003, alerted the department that an emergency project was going to be needed. Again, though there have been several falls at the site over the years, this time we started to see something different. The joint shown in the figure above was approximately twice as large as it was during the previous site visit in 2002. Large sections of the face were becoming unstable and were going to topple into the roadway. The catchment ditch at this location was approximately 15 feet in width, completely inadequate to capture the amount of material that we knew would be coming down.

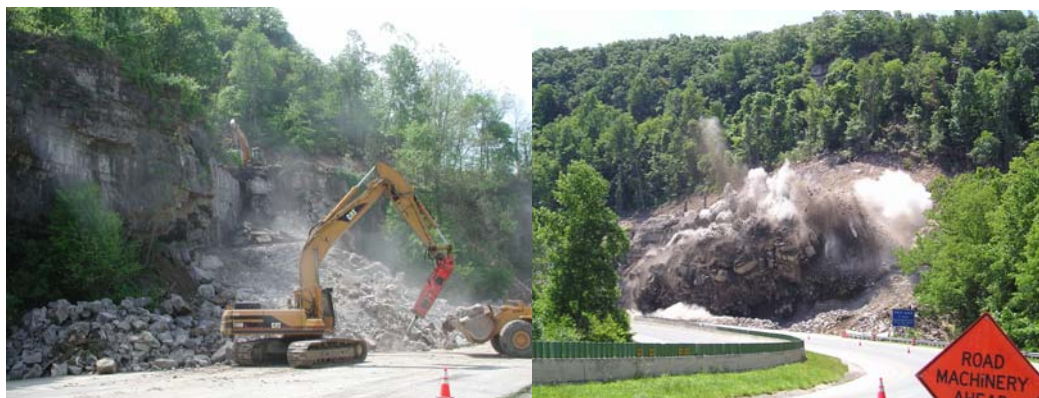
Figure 7. Construction begins, view of blasting and clean-up at the site

Highways Construction won the bid for project and got to work re-cutting the slope. The site presented a lot of difficulties for construction, as there was no stable area to install a construction road for equipment to access the top of the limestone cut. A construction road was constructed up the side of the cut; however, it failed several times and was eventually abandoned. Periodic closures were also needed for blasting at the site and Highways had a tight time frame to clear the interstate of debris and get traffic flowing again after every blast.

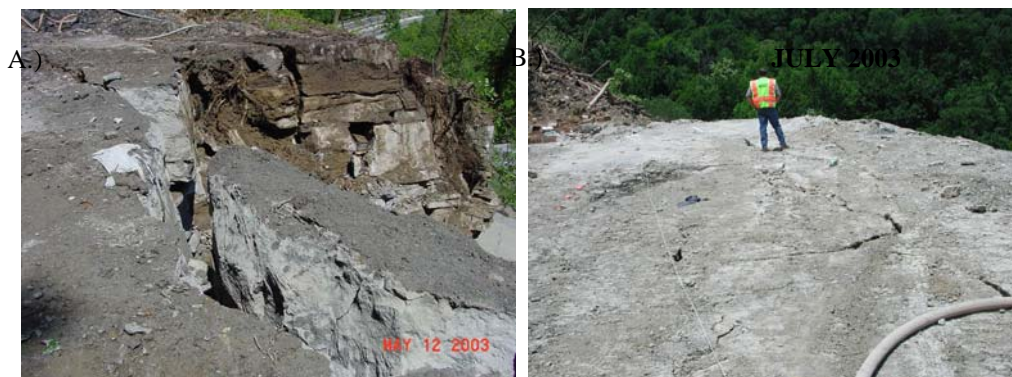
As construction proceeded we started noticing additional problems. We were destabilizing part of the face adjoining the blasted section after each blast. The face had to be inspected by the Geotechnical Engineering Section, the Construction Engineer for the project and the foreman of Highways before the interstate could be re-opened. Figure 8 shows some of the destabilized face and the stress relief fractures noted on the project. These were all near the edge of the excavation. No major shifting was noted in the colluvial slope above our cut and there was no indication of stress fractures further back into the hillside.

Figure 8. Photo of Destabilized Face at top of Limestone

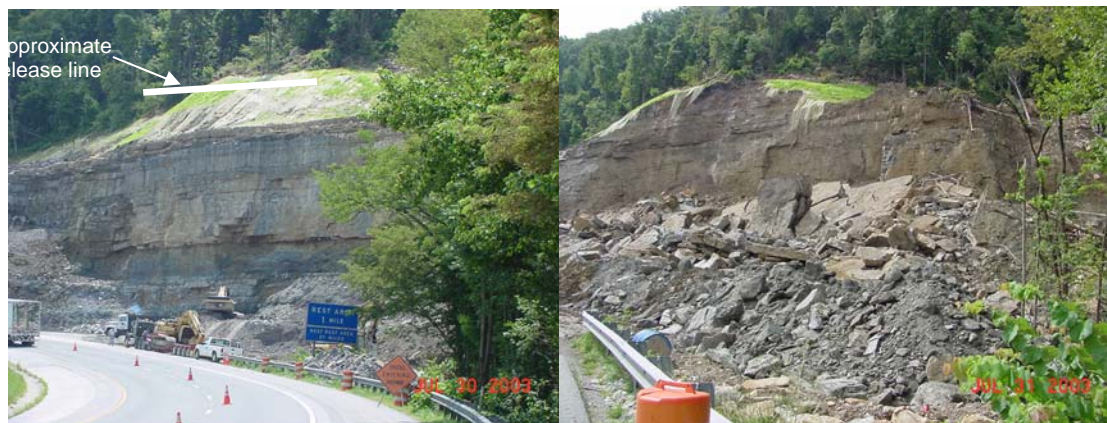
A large fall occurred on the site on July 31, 2003. The previous day's inspection of the site revealed stress relief fractures in the rock just above an area that was blasted near the cut face. Twenty-four hour monitoring was instituted at the site and the next day's planned blast was called off. Additional safety discussions and conditions for work were had between representatives from TDOT and the contractor. No equipment was to be left underneath the face overnight. This alert paid off, as a large fall occurred in the early morning hours of July 31, 2003.

Figure 9. View of the Face before and after large Rockfall, July 30 and 31, 2003

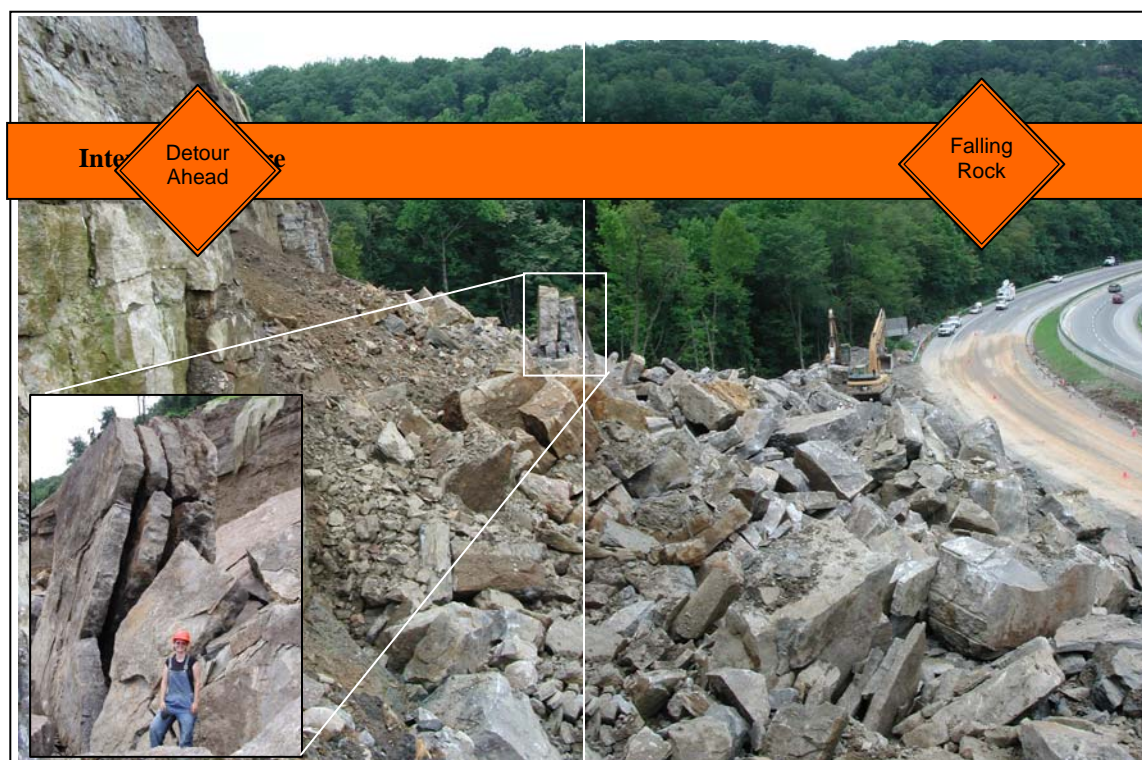
Figure 10. Large Fall after some clean-up July 30, 2003

TDOT Construction and Maintenance forces which were present monitoring the site promptly closed the interstate and there were no injuries or damage to vehicles. Traffic was stopped when some raveling was noted on the slope at the site, very shortly after the raveling from the upper slope was noted, the limestone face toppled over. Approximately 90% of the material that fell was contained in the ditch. However, material did reach the far side of the interstate and traffic was diverted to a narrow 2 lane road which did cause a large impact to traffic flow.

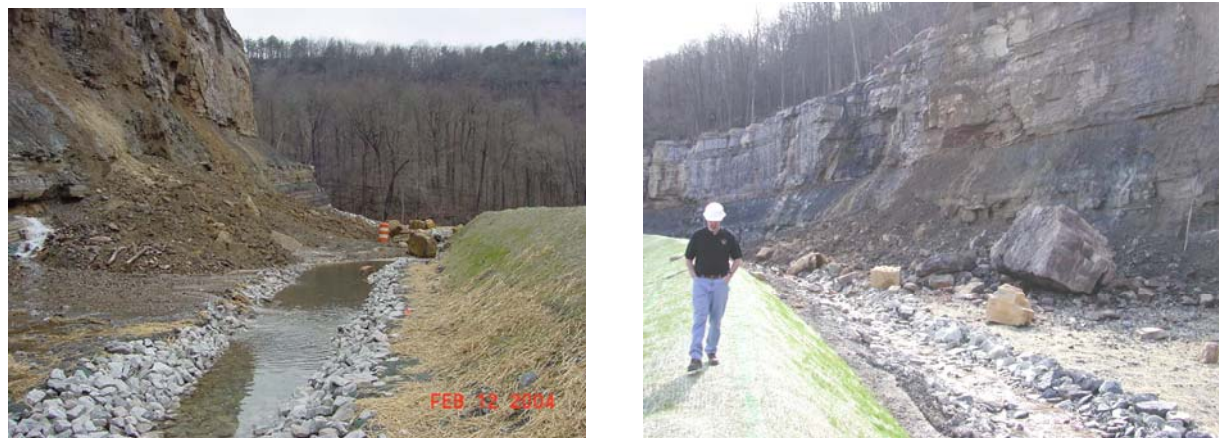
No work was allowed during and immediately after rain events due to safety concerns. There is a great deal of water that moves through the joints and solution cavities in the rock and through the colluvial slope at the site. Several days after a rain, the movement of the colluvial slide would cease or slow to a barely perceptible creep but it could move rapidly during and immediately after rain. Figure 13 shows slide material contained in the catchment area, notice the large boulders, few of which have made it across the drainage ditch.

Figure 13. View of Slide Material and Large Boulders Contained in Catchment Ditch

After the large boulder shown in Figures 11 and 13 fell and further inspections of the site were made to ensure that the colluvial slope was more stable, the second contractor was allowed to get to work. American Shotcrete won the contract for the shale cover using a wire mesh and rock dowel wall as shown in Figures 5 and 6. No decorative shotcrete treatment was used at the site due to cost and the presence of shotcrete with no face treatment near the site. Figure 14 shows layout of the grouted rock dowels, wire mesh and drainage installation. The shotcrete was tied into the more stable limestone above the shale, something that was not consistently done with previous attempts at covering this problem shale layer along I-24.

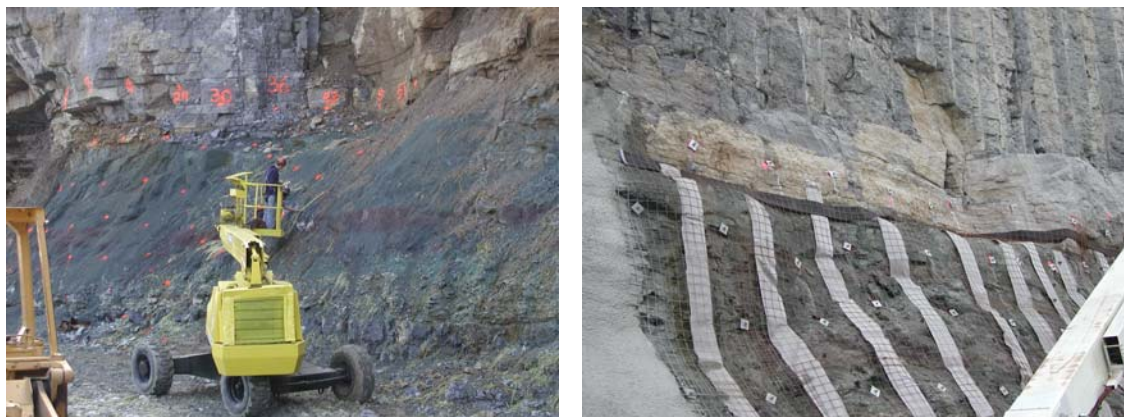
Figure 14. Installation of Shale Cover

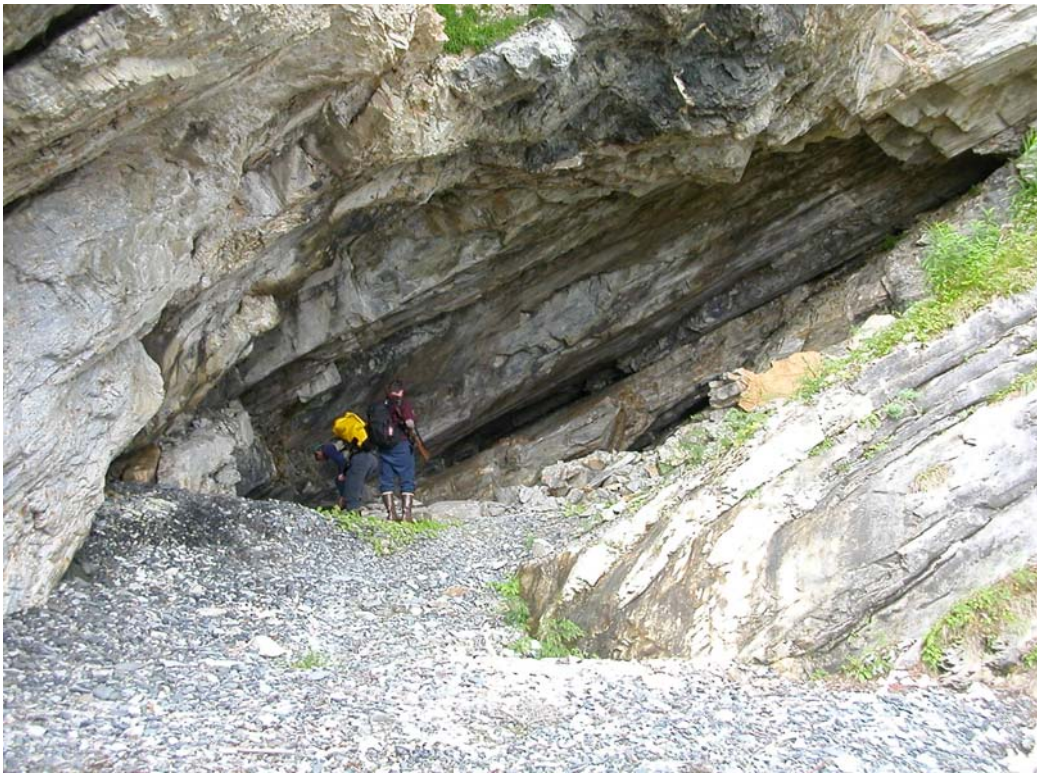
Figure 5. Example of coastal cave exhibiting origins by cavitation, littoral erosion, and block failure along dip-slope of bedding planes.

Many of the caves or other features observed in the shoreline cliffs in the study area do not appear to be solutional in origin; rather, most appear to have been formed by cavitation and littoral erosion accompanied by block failure. Although solutional connectivity appeared to be lacking in most of these features, the littoral caves were considered high vulnerability because they met the definition of a cave under FCRPA. Many of the coastal caves appear to have formed along the dip-slope of fractures or bedding in the rock (Figure 5). Based on the alignment of many of the coastal caves along north- to northwest-trending lineaments, it is possible that fracturing is being driven by tectonic activity on the similarly aligned Lynn Canal-Chatham Strait fault system, which may be causing block failure to occur at a faster rate than that of solutional denudation. Evidence of water, where present in the littoral features, appears to have aggravated the block failure process, rather than created solutional openings. The coastal caves may also have been formed or aggravated by ice plucking deformation during glaciation. In areas with interbedded schist, swales and pocket beaches have formed along the highly erodable schist, providing preferential drainage over the schist and along schist/limestone bedding planes.

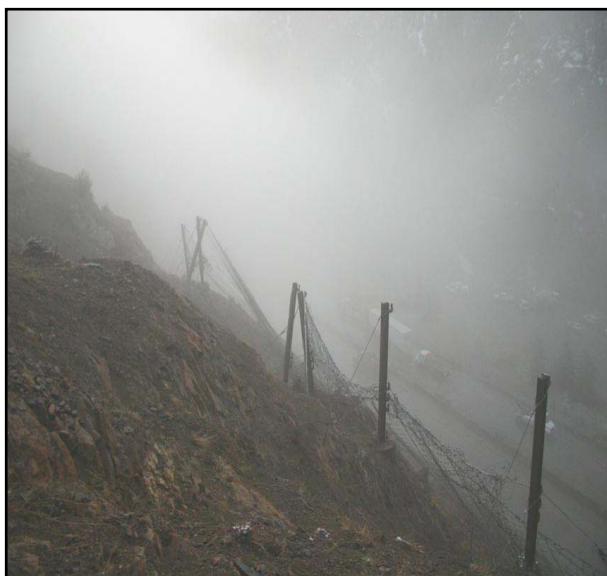
Using the Colorado Rockfall Simulation Program (CRSP), energy associated with rocks from this incident was in the 1,000 foot-ton range (3,000 kJ), significantly higher than the existing fence barrier was designed for. Average bounce heights, according to the CRSP modeling, were as high as 40 feet where the fence was located indicating that rockfall from the failure also bounded over the fence.

Figure 5: Damage to existing rockfall barrier resulting from April 2004 rockfall incident

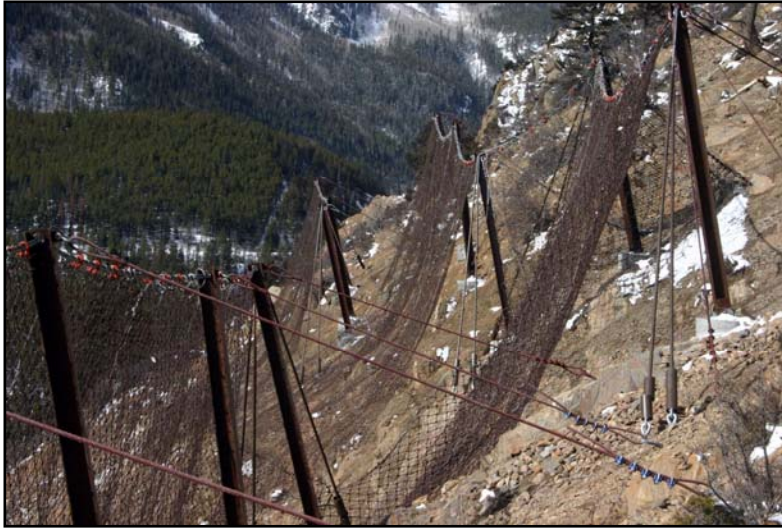
Although it is not feasible to stop or prevent all rockfall incidents from affecting the highway, this strategy will reduce the rockfall potential significantly more than single barriers at the base of a slope. This mitigation scheme has been used before with varying degrees of success in Colorado and other DOT's. Other mitigation options of avoidance, stabilization, and other methods of protection were considered but believed to be unrealistic given the existing resources and future improvements along the I-70 corridor through Colorado.

Figure 6. Example of a common hybrid protection system

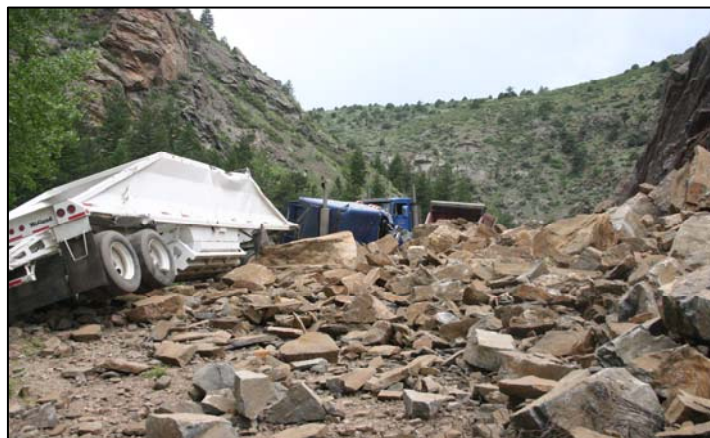
Figure 2 Rock Slide Debris

At 11:00 AM on June 21, 2005 approximately 1,300 CY of rock (in place volume) was released from the existing rock cut approximately 10 miles up from the mouth of the canyon. This event pushed two trucks off the road and covered the road with 2,200 cubic yards of debris. Figure 2 shows the road immediately after the slide. Fortunately there were no injuries in the event. After the slide, overhangs remained perched over the road, creating a further hazard for highway users.

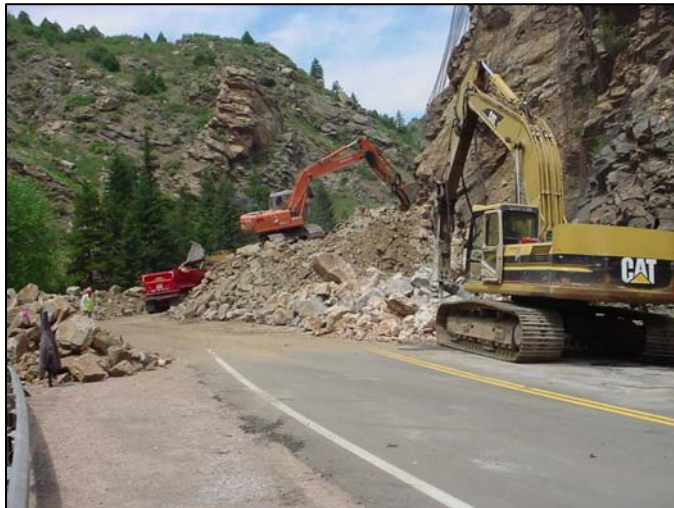
Figure 3 Initial Cleanup

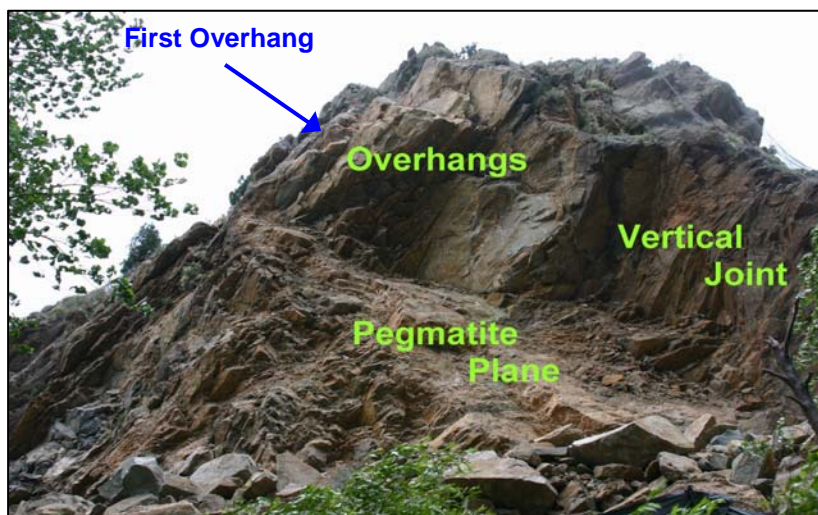
Figure 4 Overhangs

Following the initial evaluations and prior to any blasting, CDOT installed a series of monitoring devices to observe and track movement of the rock face. These were located along the brow of the slope and consisted of four crack gauges installed across key joints and one survey prism. The crack gauges were low tech “tell-tales” consisting of overlapping metal lathes with scales or initial conditions scribed onto the surface. Baseline conditions were recorded for each and observations were taken after the blasting work. These observations indicated movement on one of the tell tales located across an open fracture making up the overhanging features.

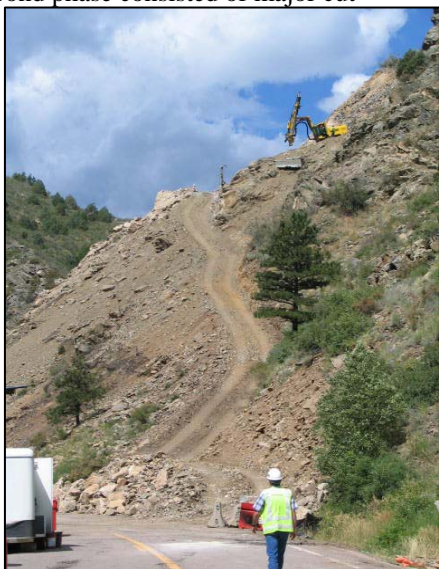
Figure 7 Pioneer Road

Phase 2, cut reconfiguration, started with construction of a pioneer road to the top of the cut. Construction of the pioneer road was a challenging endeavor requiring two switchbacks and a road inclination as steep as 2H to 1V in some spots. Road construction involved excavation through talus and colluvium, blasting through rock, and construction of a small retained fill area.

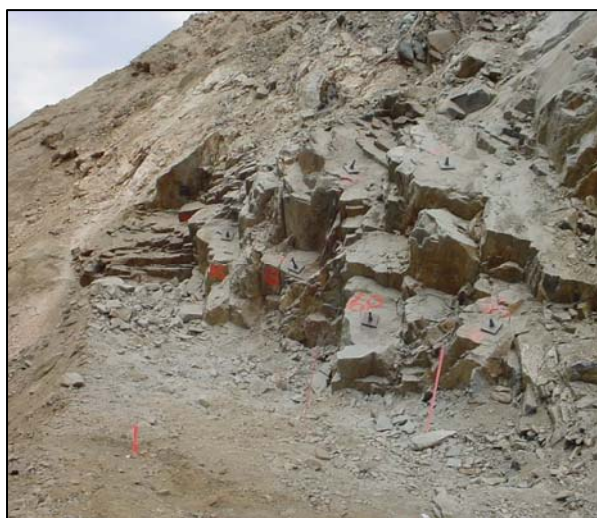
Figure 10 Reinforcement at Overlap

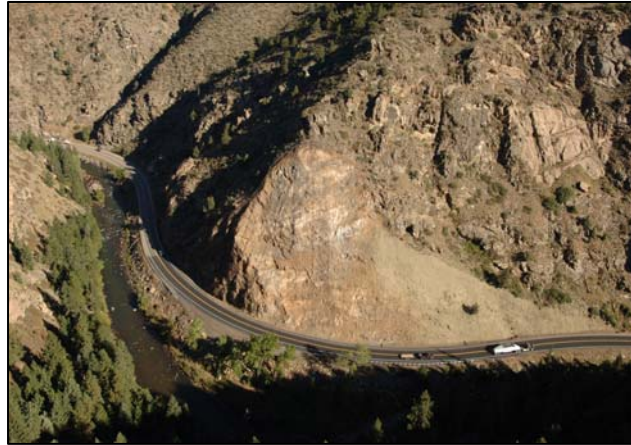
Figure 11 Final Completed Cut

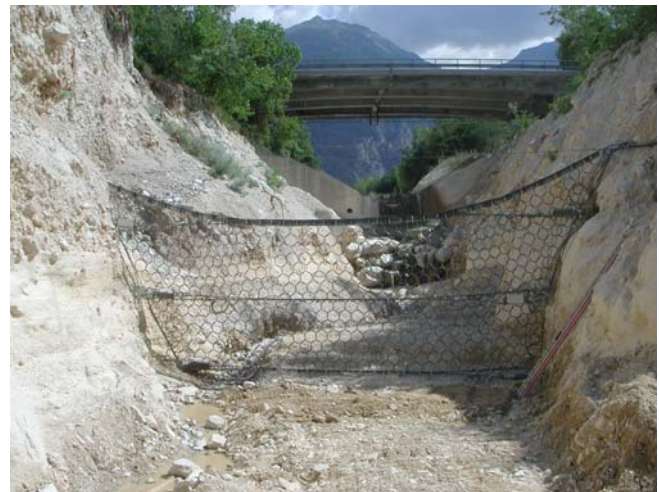
Figure 1. Installed debris flow test barrier.

Since July 2005, a flexible debris flow test barrier has been installed in the Illgraben close to the confluence of the Illgraben and the river Rhone (Fig. 1).

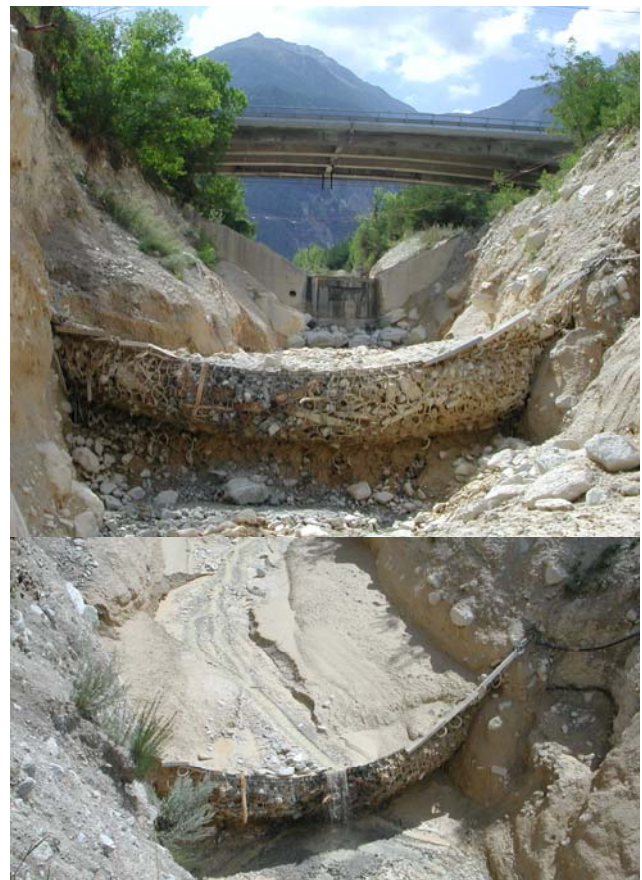
Figure 8. Filled barrier after debris flow event.

During the 2 August 2005 event, the debris flow front arrived at 13:48 when the flow height measured by the laser increased. The initial load cell level at the top ropes lay between 60 and 80 kN for the completely filled barrier. For the middle ropes, the initial tension force was about 110 to 120 kN. The bottom rope was only initially loaded with 40 kN. When the flow height increased, the barrier was overtopped and the tension forces in the ropes increased by 40 kN. The largest increase of the tension force was in the rope at the top because it was most directly affected when the flow passed over the barrier. The increase of the laser level showed a flow height of about 2 m at the barrier. Figure 8 shows the filled barrier.

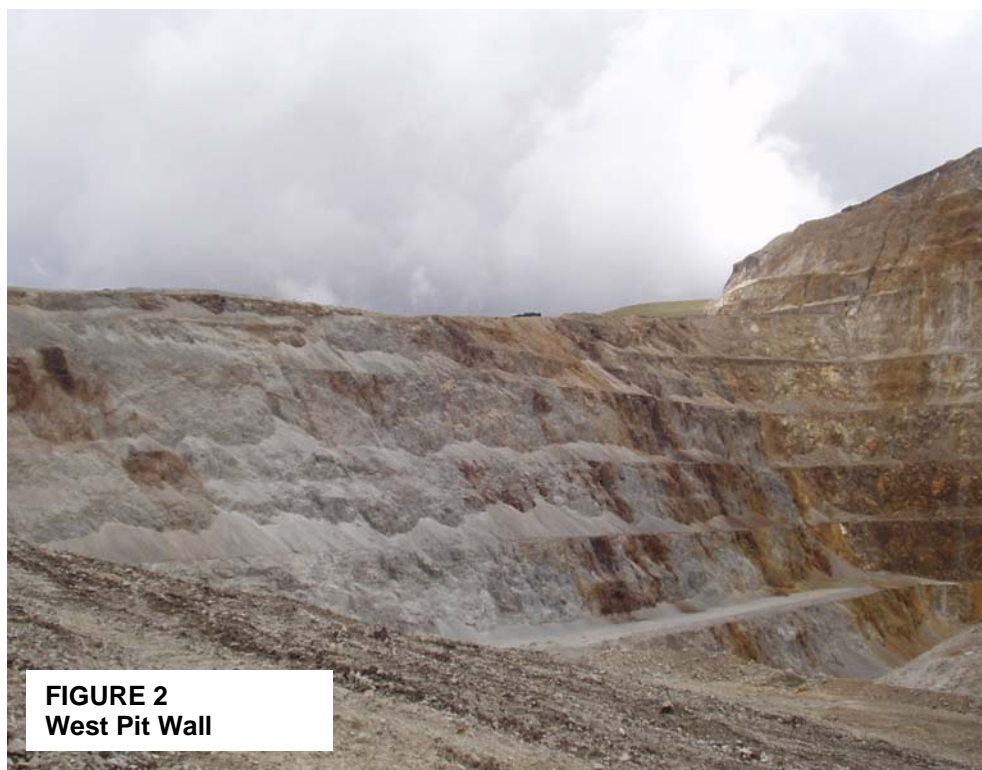
FIGURE 2
West Pit Wall

As a result, actual block sizes generated from the West Wall (0.6 m) were estimated to be smaller than for the Northeast Wall (0.8m). Also, benches on the West Wall were almost completely filled, thereby reducing catch bench effectiveness for rockfall capture to practically zero. Figure 2 shows a photo of the West Wall.

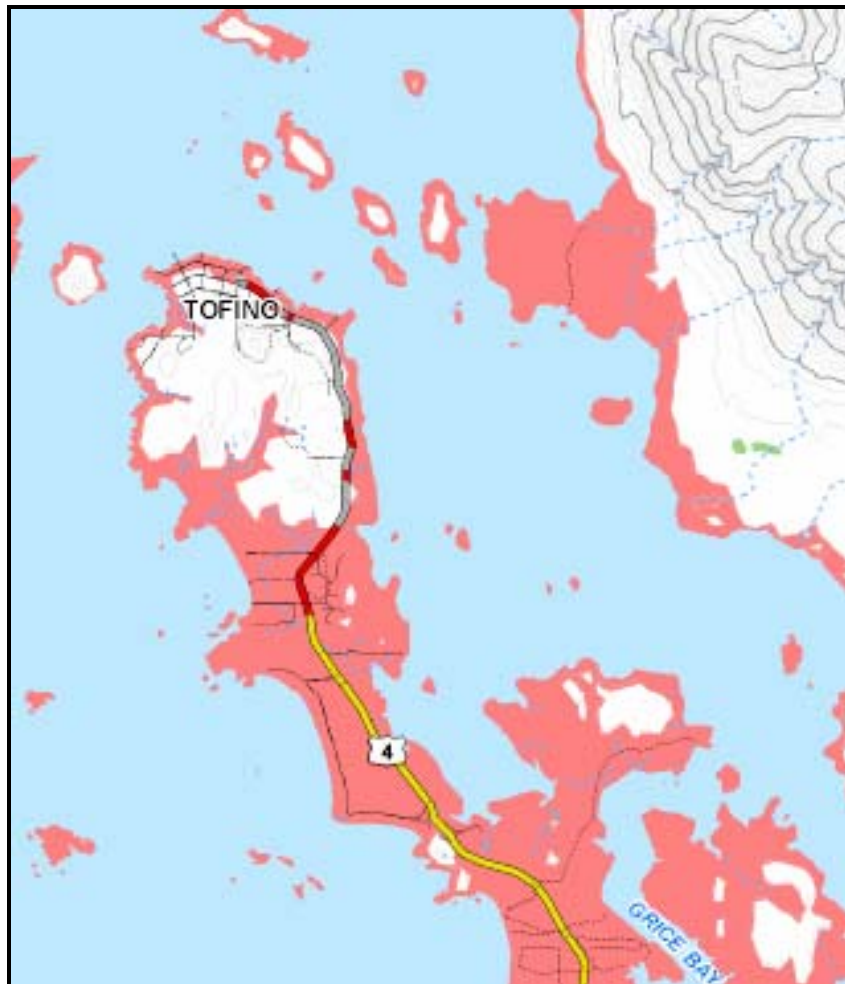
Figure 2 illustrates the typical exposure to tsunami hazard on the west coast of Vancouver Island. Tsunami impacts are generally limited to a narrow band along the coast due to steep terrain with impacts reaching further inland associated with low-lying and less steeply sloped terrain. The town of Tofino is situated on a rise that is generally above the elevation or far enough inland from where a tsunami could be expected to reach. However, the coastal Provincial Highway (Hwy. 4) is susceptible to tsunami hazard to the south of Tofino. Similar low-lying Provincial Highway segments are present near Ucluelet. As can be seen by the red segment of Provincial Highway, not all of the Provincial Highway segments below 20 m (60 ft) ASL are susceptible to tsunamis.

Figure 2: Provincial Highway segments susceptible to impact by tsunami from large magnitude earthquake near Tofino, BC.

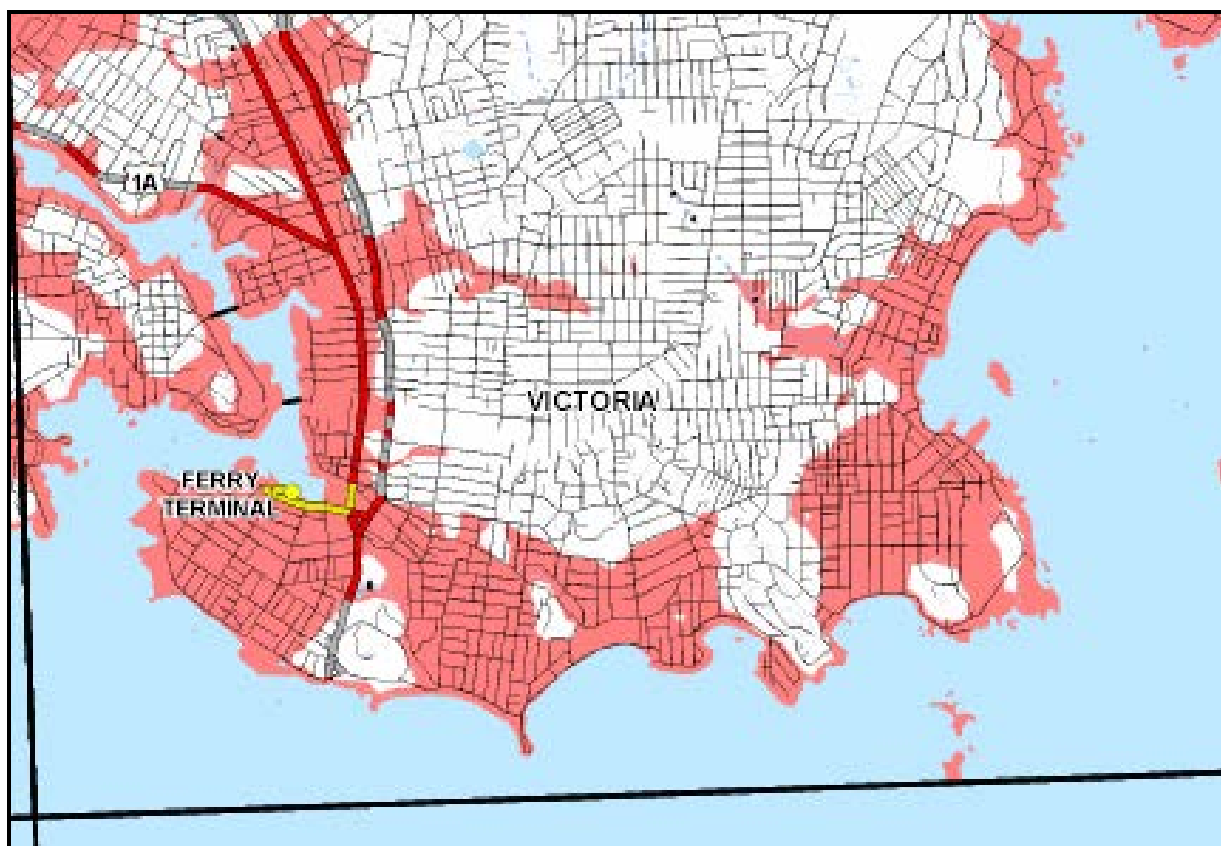
Figure 5 illustrates the typical exposure to tsunami hazard along Juan de Fuca Strait near the Provincial Capital of Victoria. Provincial Highway segments (e.g. Hwy. 1A) leading into the city, shown in red and dark grey, are either too far from the water (red) to be susceptible to tsunami impact or too high above sea level (dark grey). The notable exception includes the segment of Provincial Highway, shown in yellow, along the margins of Victoria Harbour near the Ferry Terminal for the Ferry to Port Angeles, WA. Coastal sections of the city around the harbour and in low lying bay areas are generally exposed to tsunami hazard. However, the presence of red-shaded Provincial Highway segments in the pink-shaded areas indicate that much of the city, although below 20 m (60 ft) ASL, is not within the zone that is generally susceptible to impact by a tsunami.

Figure 5: Provincial Highway segments susceptible to impact by tsunami from large magnitude earthquake in Victoria, BC.
