57th ANNUAL HIGHWAY GEOLOGY SYMPOSIUM

BRECKENRIDGE, COLORADO
SEPTEMBER 26-29, 2006

PROCEEDINGS

***Landslide Investigation and Mitigation Along US 160 Between Durango And Mancos,
Colorado, Using Lightweight Fill, Ground Anchors, and Rockery Buttresses***

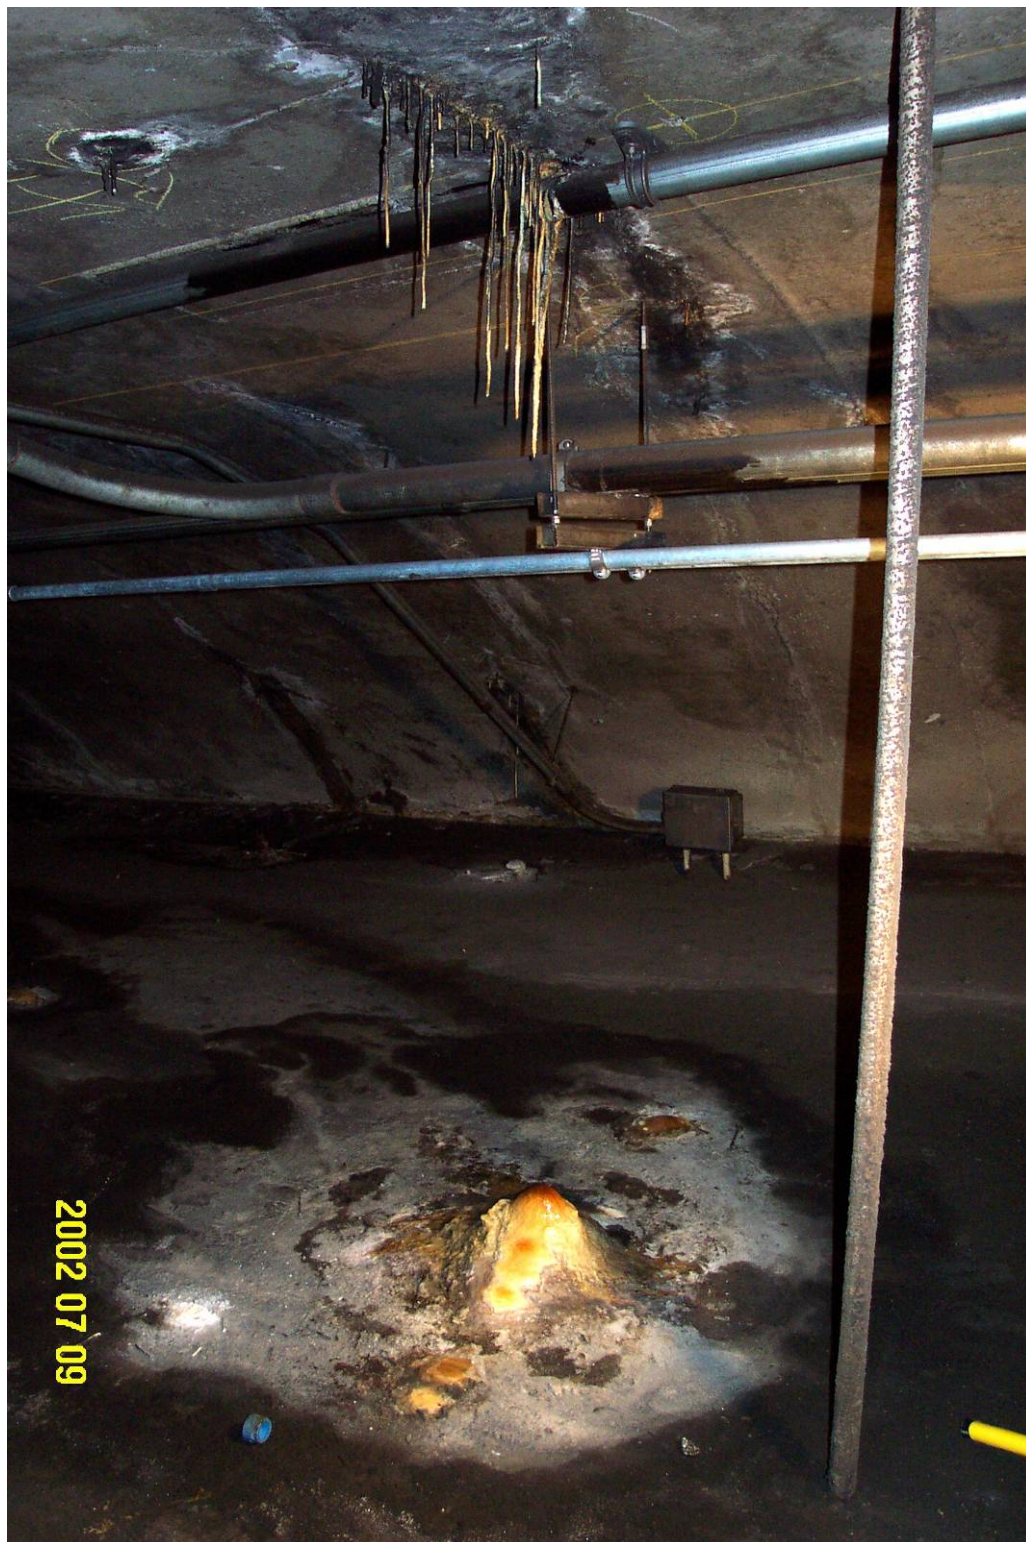
Figure 8. Leakage in Ventilation Plenum

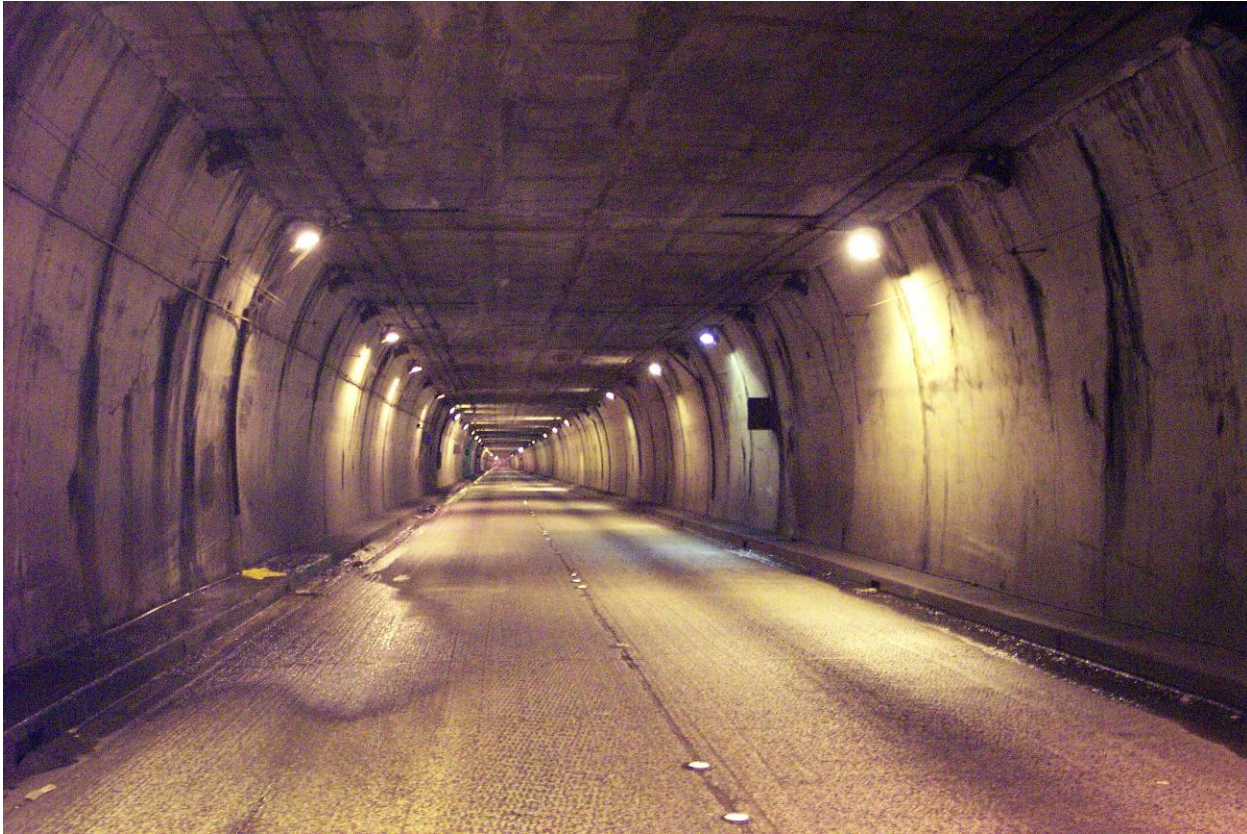
Figure 9. Bore 2 Prior to Improvements

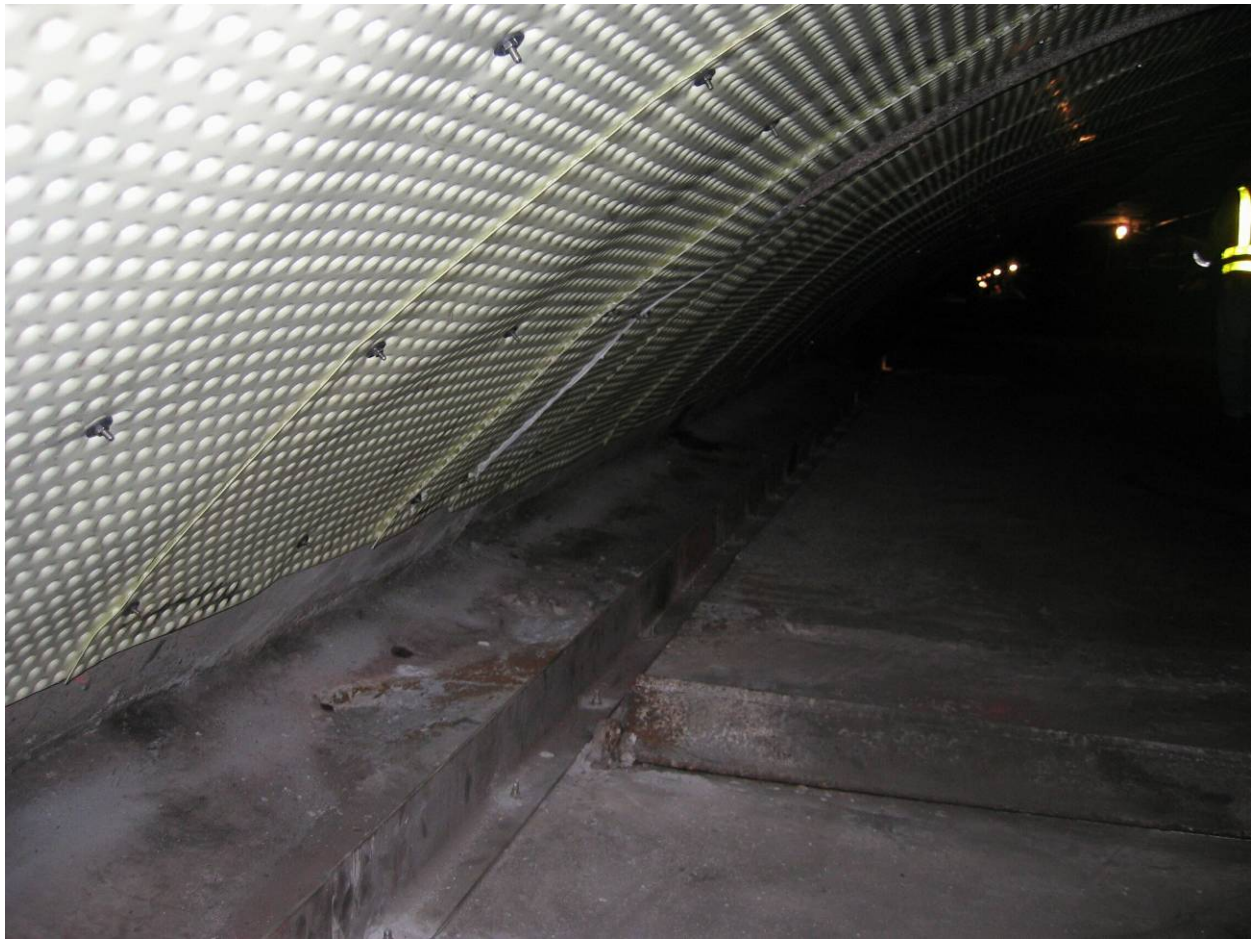
Figure 12. Completed Panning & Drainage Trough

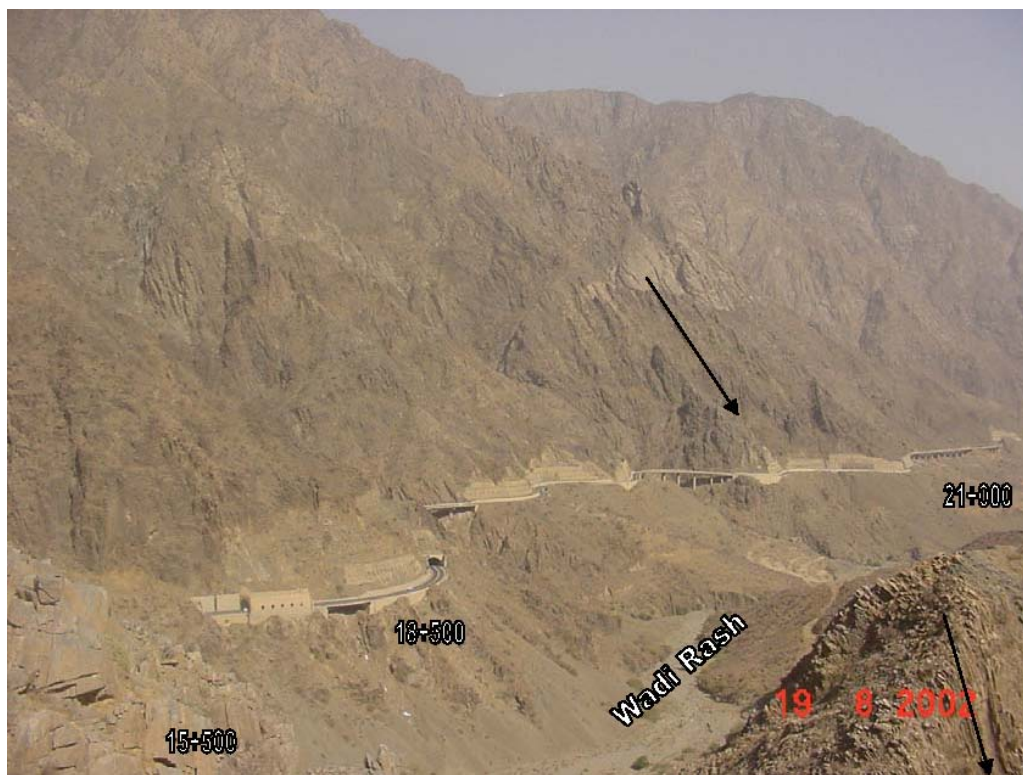
Fig. 3: Westward dipping schistosity dominated along the descent road. Fig. 4: Schistosity (arrows) dipping westward in the western part of the descent.

The schistosed rocks are folded along north- to northeast-trending axes. Small-scale folds are observed along the road cut; see (Fig. 7). Large-scale folds are observed off the study area, and off the geological map. Due to tectonic movements, the rocks layers are dipping towards west, as shown in (Figs. 3 and 4).

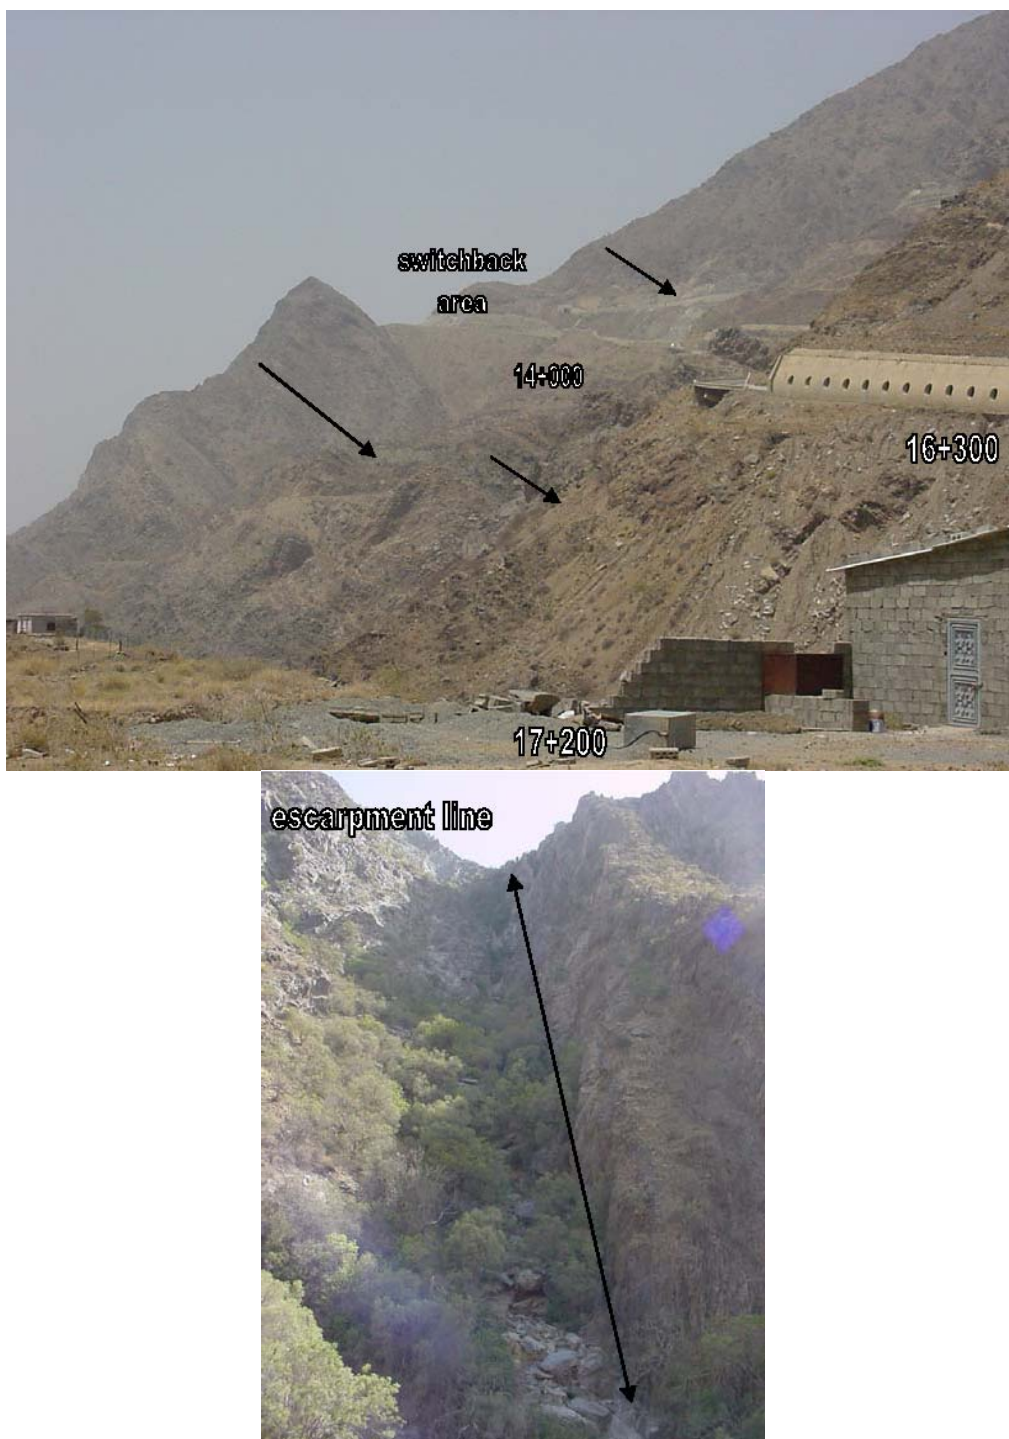
Fig. 5: Fault plane (double arrow) at location about 8+000-8+500, reach up to the descent escarpment line and extend on the plateau, nearby some houses build very close to the edge (upper right corner).

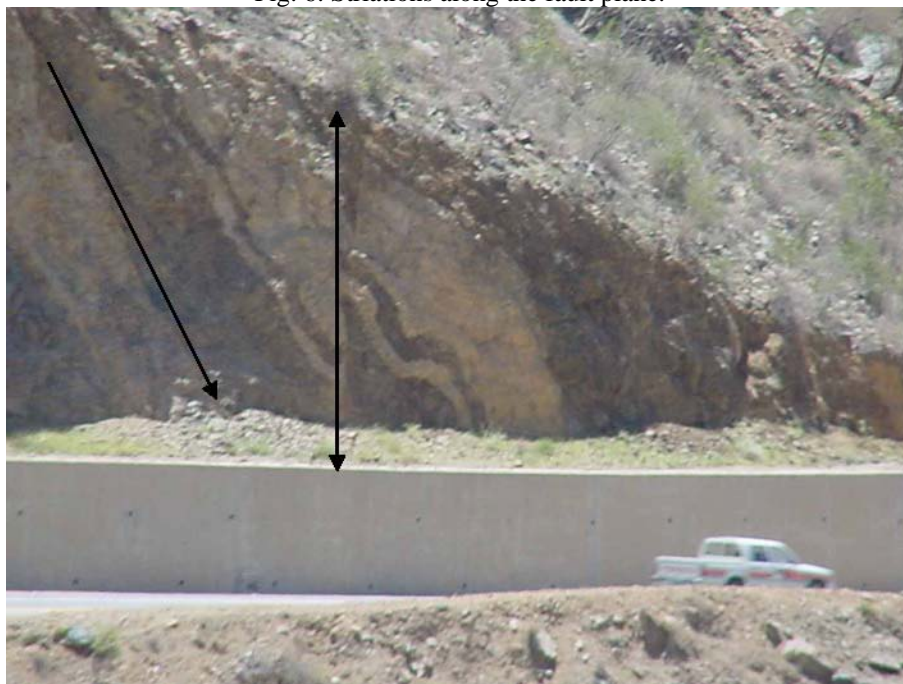
Fig. 7: Folding (single arrow) associated with faulting (double arrow) in the lower part of the descent road, km 22+500-23+000.
