58th HIGHWAY GEOLOGY SYMPOSIUM

POCONO MANOR, PENNSYLVANIA, OCTOBER 16-18, 2007

PROCEEDINGS

HOSTED BY
THE PENNSYLVANIA DEPARTMENT OF TRANSPORTATION AND
THE PENNSYLVANIA GEOLOGIC SURVEY

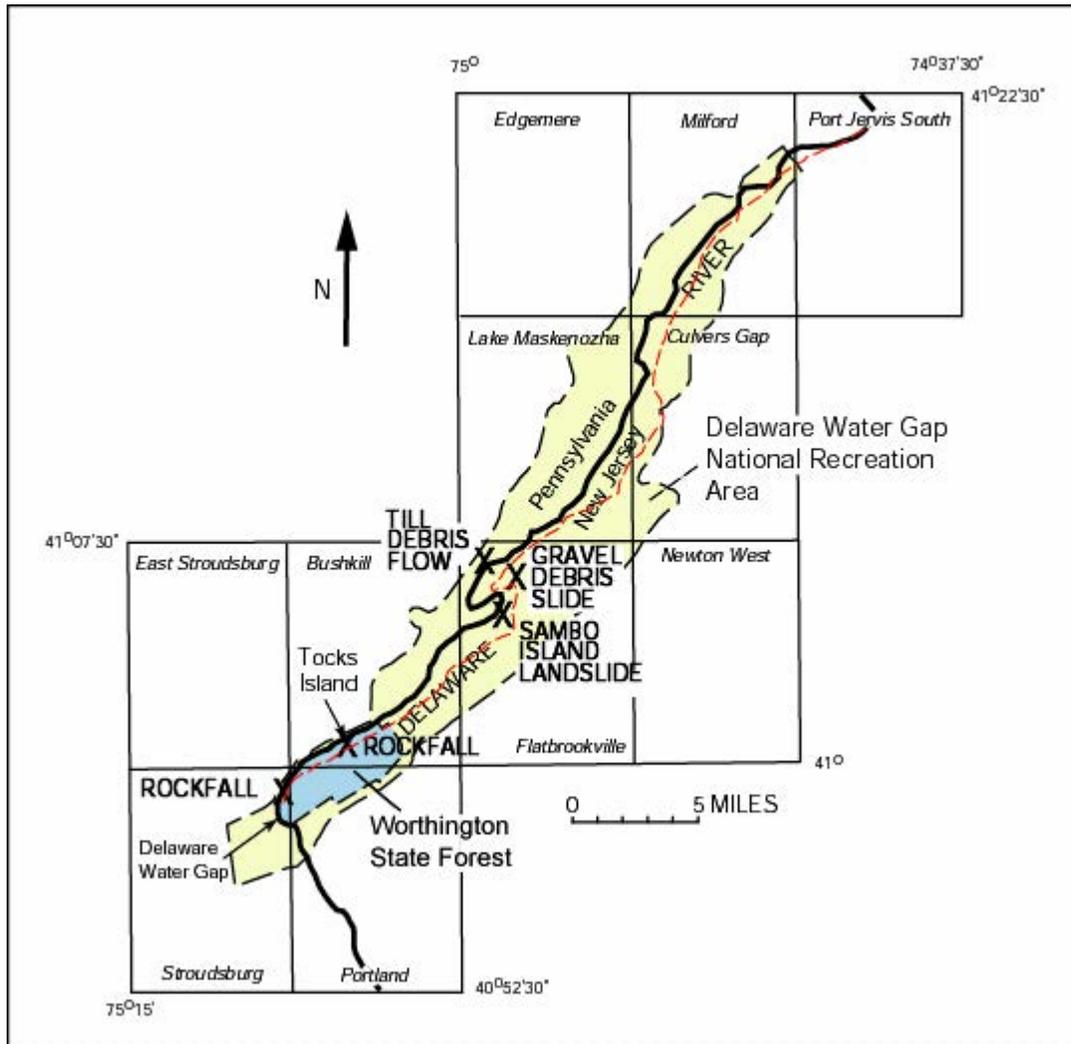
Figure 2. Index map showing landslides and topographic map coverage in the Delaware Water Gap National recreation Area and adjoining Worthington State Forest, Pennsylvania-New Jersey. Red-dashed line is the Old Mine Road.

Worthington State Forest includes part of the gap of the Delaware River through Kittattiny Mountain in New Jersey (fig. 2) and is surrounded by the Delaware Water Gap National Recreation Area. During the early 1980's a landslide, presumably a rockfall, removed a part of the west side of the Old Mine Road in the park, one thousand feet northeast of where I-80 crosses the Delaware River (fig. 16). The failure occurred in interbedded siltstone and shale and minor sandstone of the Bloomsburg Red Beds on the crenulated southeast limb of the Cherry Valley anticline which, 800 feet to the northeast, brings gray quartzite and conglomerate of the Shawangunk Formation to the surface. A 50-foot cliff parallels the road here and the slope above is steep, averaging about 43° . Figure 17 is a diagrammatic cross section at the site. The landslide along the road probably occurred along sheeting fractures, but failure may have also been by rock toppling along steep cross joints.

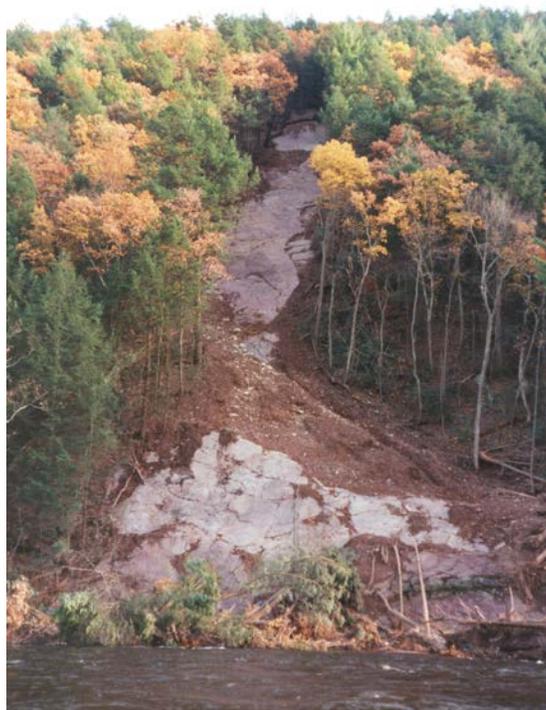
Figure 4. Sambo Island landslide, developed on glacially polished bedrock bedding surfaces, extends for more than 600 feet on a slope that averages about 36°. It originated as a soil slip, entrained additional soil, glacial till, and trees downslope, and spread out into a debris fan at the bottom after encountering a rock rib formed by a stratigraphically higher bedding surface. Note the leveed channel on the lower right.

During October 20-21, 1995, heavy rain fell in the Delaware Water Gap area generating a landslide on the anticlinal ridge south of Sambo Island along the Delaware River (fig. 4). The ridge is composed of red siltstone, shale and sandstone of the Bloomsburg Red Beds (unit II, Figure 3). The northwest slope of the ridge is a dip slope with bedding dipping gently at the crest at about 850 feet altitude, increasing to nearly 40° farther down the slope (fig. 5). The bedding surface exposed at the landslide site has been polished and striated by glacial erosion (fig. 6). Scattered outcrops of bedrock dot the ridge, but in most places bedrock is covered by three types of surficial materials: (1) soil composed of shale chips and organic matter; (2) large blocks of sandstone, and (3) till. The glacial erosion and till are the result of action by the last glacier that departed from this section of the Delaware River less than 20,000 years ago. The soil and sandstone debris formed subsequent to glacial retreat.

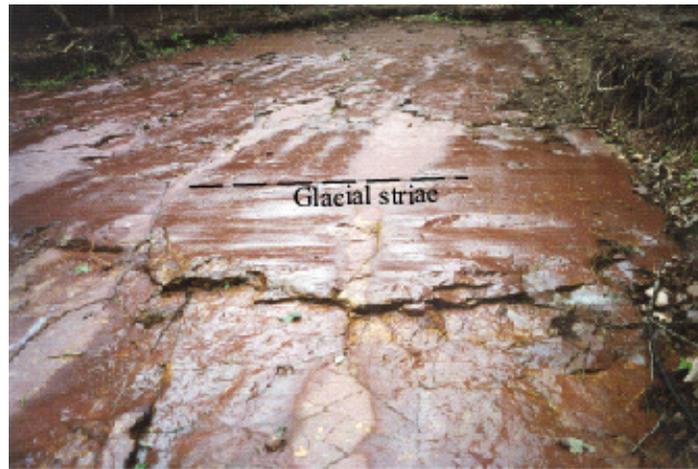
Figure 6. Glacially polished Bloomsburg bedding plane in the initial failure area of the Sambo Island landslide. Bedding slopes 32°NW. Glacial striae trend S. 40° W., parallel to the trend of the ridge.

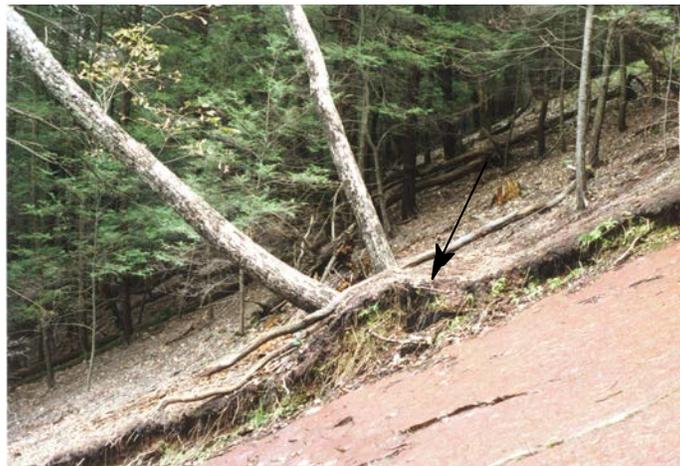
Figure 7. Pressure ridge (arrow), about 3 feet high, showing downslope slip of soil adjacent to the initial failure area of the Sambo Island landslide. Note the lack of penetration of tree roots into the polished bedrock.

The soil cover in the slide area averages about two feet thick (fig. 7), ranging up to 8 feet thick. It consists mostly of rock chips, weathered from Bloomsburg shale and siltstone, averaging about 1 inch in length, and mixed with fine organic matter. Where the underlying bedrock is sandstone, angular blocks as much as 20 feet long are produced by spalling off from the bedrock surface and by transportation down slope. Slow mass wasting by creep is evidenced by many trees that are bowed at their bases. Production of the weathered fragments is facilitated by cleavage, bedding parting and joints in the shale-siltstone, and by bedding parting and joints in the sandstone. Most trees in the immediate slide area have an accumulation of rock chips plastered on their up-hill side to a height of two feet, indicating fairly recent downward movement of these materials.

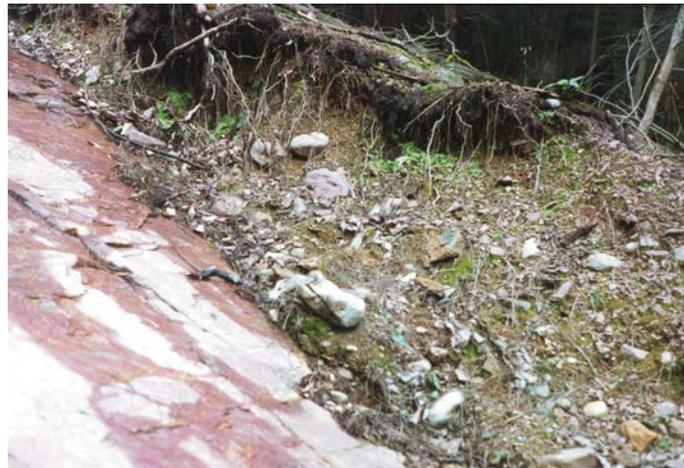
Figure 8. About 4.5 feet of glacial till overlies Bloomsburg bedrock just below the initial failure area. A thin veneer of soil containing red shale chips overlies the till.

Glacial till (fig. 8) is present in patches along the entire slope of the mountain and is more than 20 feet thick in places where it blankets large areas of bedrock. Hummocky topography along much of the lower slope of the mountain is suggestive of old landslide deposits. At the slide area the till is thickest at the base of the slope where it is nearly 5 feet thick (fig. 9). The material is a moderate brown (5YR4/4) clay-silt till with subangular to rounded cobbles and boulders as much as four feet long in the slide area. The clasts include a variety of

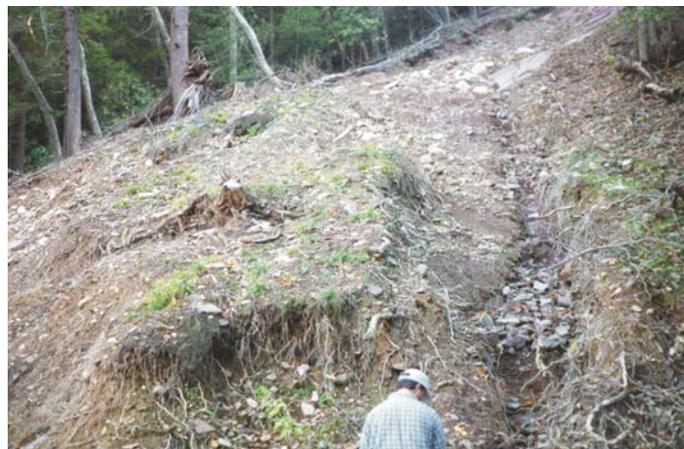
Figure 9. Four-foot deep channel developed in debris fan in glacial till at the base of the Sambo Island landslide.

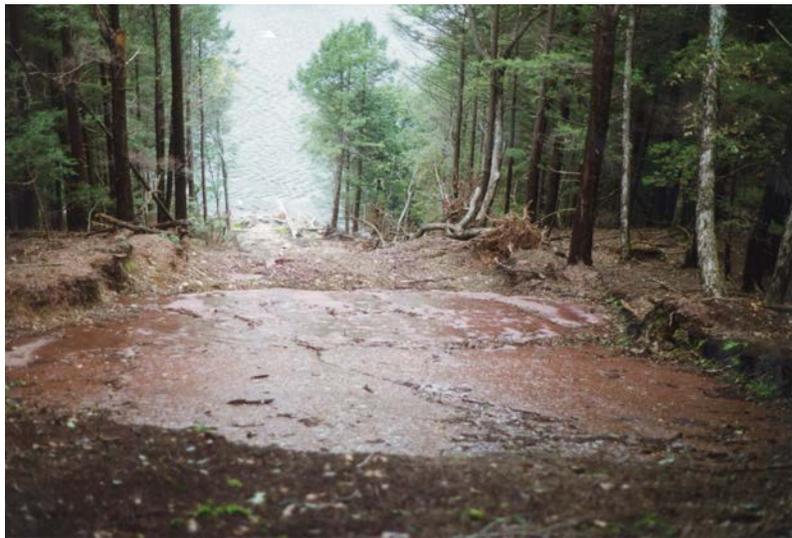
Figure 12. Initial failure area at the top of the Sambo Island landslide. This area is 37 feet wide and extends down 90 feet to a pile of debris. The bedding dips 32°, paralleling the slope. The slide area extends 600 feet down to the Delaware River.

The slide initiated in about 1.5 feet-thick, moderate-reddish-brown (10R4/4) shale- and siltstone-chip soil and organic matter at an altitude of 680 feet, encompassing an oblong area 37 feet wide and 90 feet long (fig. 12). The bedrock here forms a dipslope (34°), is composed of red siltstone, and is partly burrowed and mudcracked. The surface is highly polished and striated (fig. 6), glacial movement towards S40° W is indicated by the striae. At the bottom of the initiating area, the slide narrows to 28 feet at a three-foot-high pile of a debris-flow levee on the bedding surface, below which there is about 4.5 feet of moderate brown (5YR4/4) clay-silt glacial till overlying the bedrock (fig. 8). The soil thickens to about three feet in a pressure ridge (fig. 7). Initial movement of the slide compressed the soil to form the pressure ridge, then movement was retarded at this debris dam, and finally failure progressed by entrainment of material in a narrow slide area averaging about 40 feet wide, but reaching 50 feet in width, and for a total length of 600 feet to the bottom of the ridge. It extended out into the Delaware River for an additional 60 feet. Fortunately, no canoeists were present in the river at the time.

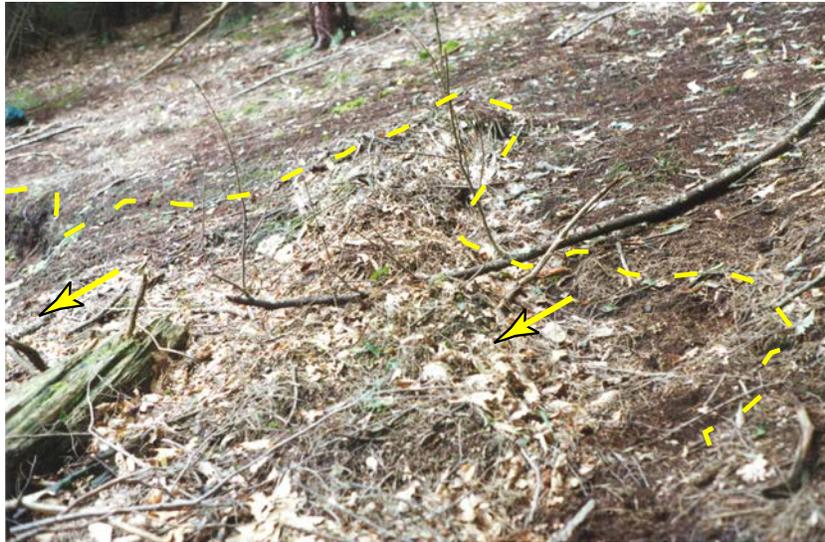
Figure 13. Irregular tension cracks (below dashed line) several inches high and a few tens of feet northeast of the initial failure area. Arrows show slight downward movement of the soil.

The instability that produced the landslide probably began as sheet wash of soils, as evidenced by many small (less than 20 feet long) debris fans made of forest litter and piling up of soil up to two feet high on the uphill side of trees. Initial failure may have been sited at fractures, similar to ones present near the slide (fig. 13). Some of these tension cracks were developed along animal trails.

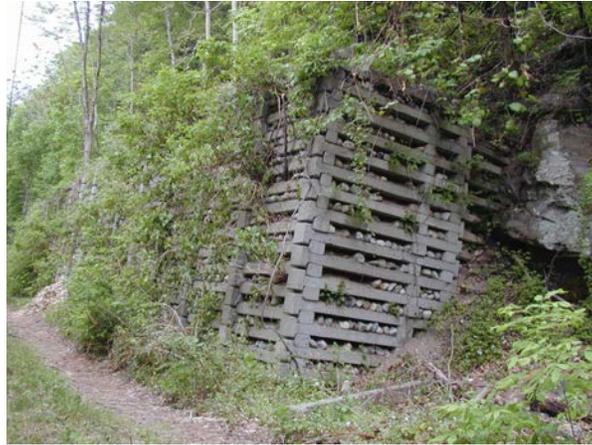
Figure 18. Concrete gabion along abandoned railroad grade below the Old Mine Road in Worthington State Park.

The collapsed section of the road is now supported by a concrete gabion, about 100 feet long and 15 feet high (figs. 17, 18), located along the abandoned railroad grade below the road, now used as a foot trail. A one foot diameter weep pipe, about 30 feet northeast of the gabion, drains a wet area along the road. At the time of one visit, water coming out of the pipe was much less than the water falling from the rocks above and into a drainage along the road. At this locality the rock is highly fractured and veined in a zone ten feet high that parallels a bedding-plane fault. Bedding trend is N. 68° E., 41° SE. and slickensides plunge 27°, S. 34° W., with steps indicating movement downdip to the southwest. Much water soaks into the substrate below, a possible concern for future failure. Just above the fractured zone is a set of sheeting fractures, similar to those at the Tocks Island rockfall, along which the failure probably took place (figs. 17, 19). The strike of sheeting parallels the road at the failure site (fig. 20) and dips

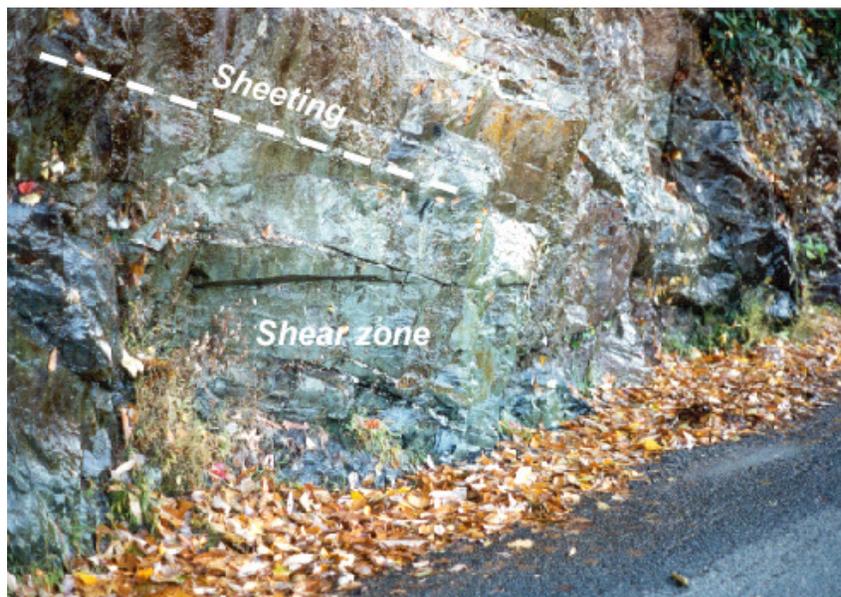
Figure 19. Sheeting joints along which the landslide along the Old Mine Road near Delaware Water Gap probably occurred. The shear zone is often wet and water seeps into the road bed below, more than is emitted from the weep pipe shown in figure 17.

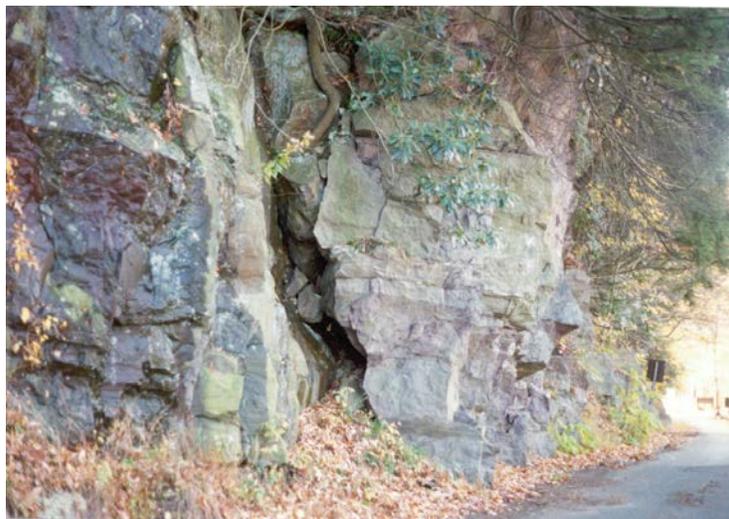
Figure 21. Irregular cross joint, trending slightly west of north and at an angle to the trend of the Old Mine Road (see figure 20). Boulders in the fracture are wedging the block apart, creating the potential for toppling.

Failure may have also occurred by separation and toppling along cross joints (fig. 21) that trend slightly west of north (fig. 20). These joints, prominent south of the gabion, are aligned about 25° from the trend of the road. Rock fragments and angular boulders have fallen into the cracks and over time have wedged the rock apart. The potential for future toppling is obvious, especially for those rocks on the steep hill high above the roadway.

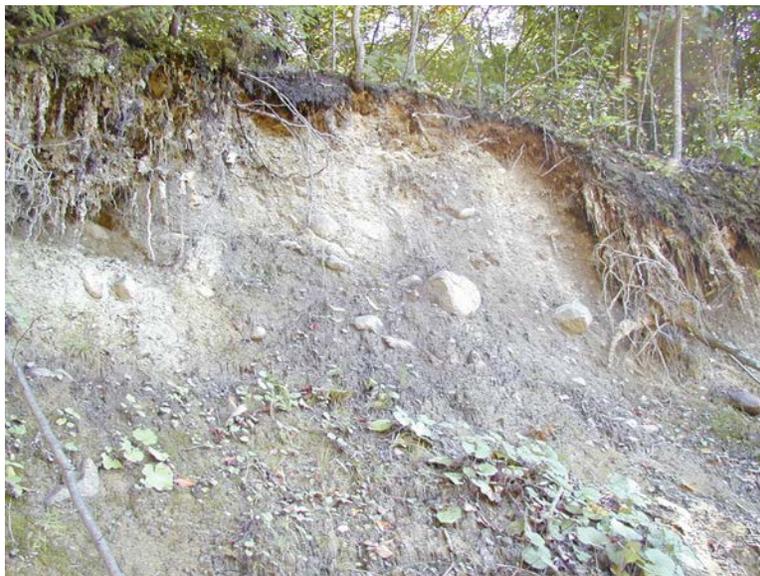
Fig 22. Scarp and debris flow in clay-silt till along Brodhead Road. The largest boulder in the till is two feet long.

The Wisconsin glacier retreated from the Delaware Water Gap area less than 20,000 years ago. It left behind a variety of geologic deposits, including sorted sand and gravel, mainly in the valleys, and glacial till, consisting of a heterogeneous mixture of clay, silt, sand, and boulders. The till has the potential for flow when it becomes water saturated on moderately steep slopes. A debris flow developed about 1996 on the east side of Brodhead Road, 1.3 miles northeast of Bushkill, PA, and 1500 feet north of US 209 in the Flatbrookville quadrangle (figs. 3, 5, and 22).

The bottom of the slope was excavated by construction of the road, cutting out the toe, and expediting the sliding. The landslide is 60 feet high with the steeper head scarp 20 feet high. The angle of the original slope was 37°, now steepened by the sliding in the upper part. The landslide occurred in a moderate- to dark-yellowish-brown (10 YR 5/4-4/2), poorly sorted, compact, clay-silt till with scattered boulders as much as 2 feet long, but averaging about 3 inches long. Boulders more than 5 feet long have been noted nearby. Stones were derived from underlying siltstone bedrock and gray and red sandstones from northerly rock units including the Trimmers Rock and Catskill Formations. The most recent slide is 140 feet wide, but there are

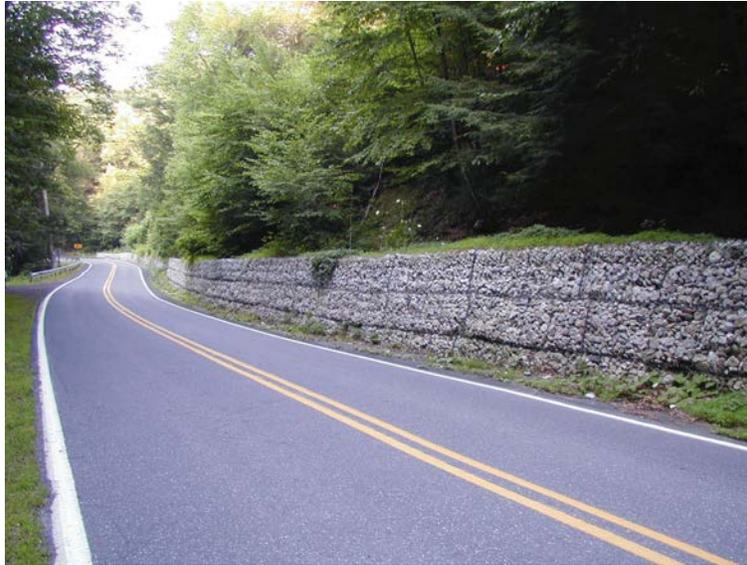
Figure 23. Gabion, about 450 feet long, along the glacial debris flow along Brodhead Road.

older slide scars extending for an additional 300 feet along the road. The slope is steep, having been eroded along the outside meander of the creek that now lies west of the road. Another smaller slide area lies about 200 feet south along a cut bank on the opposite side of the creek. Two wire-mesh gabions, each 200 feet long and separated by 50 feet, were constructed along the road along the total slide area to prevent future movement onto the road (fig. 23). The potential for future landsliding is shown in figure 5 where till is present on slopes greater than about 30 degrees. The slide along Brodhead Road is presently stabilized and overgrown.

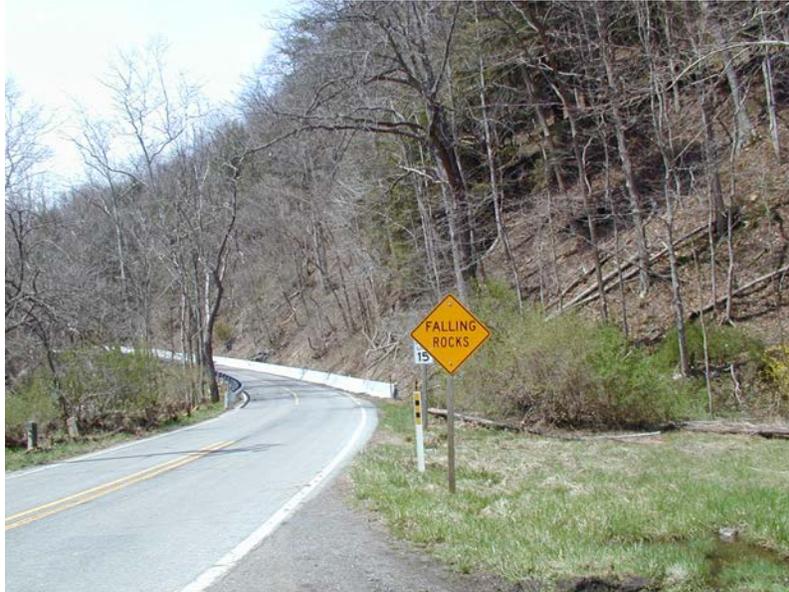
Figure 24. Concrete barriers confining falling rock from a debris slide near a cut bank of Flat Brook.

A landslide involving cemented gravels of Wisconsin age occurred during the past year along a steep slope 0.3 mile northeast of the road intersection in the town of Flatbrookville, Pa. (figs. 5, 24). The head scar is about 60 feet above the road surface and about 10 feet high (fig. 25). The gravel is composed of well-rounded clasts as much as 10 inches long, comprising a variety of rock types, including sandstone, limestone, red beds, and shale, in a coarse-sand matrix. (fig. 26) It was able to maintain a steep slope because it is cemented with calcium carbonate derived from the underlying Bossardville Limestone. It is in a cut bank on the outside curve of Flat Brook. Concrete barriers are positioned to prevent rocks from falling onto the road. Some large blocks of Coeymans Limestone, several feet long, are mixed in with the debris.

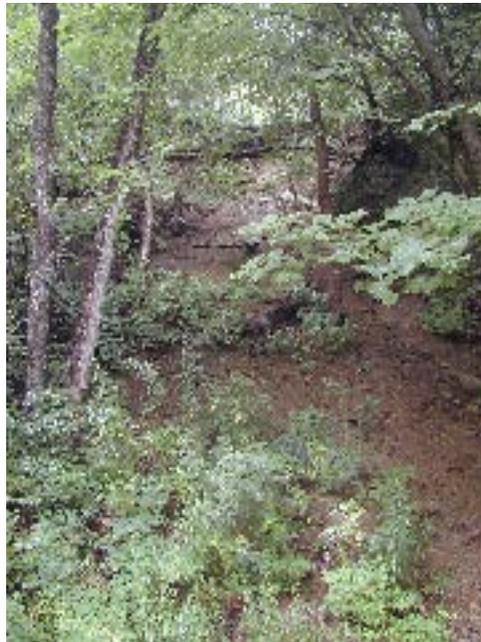
Figure 25. Coarse gravels in the head scar of debris slide slide, about 60 feet high.

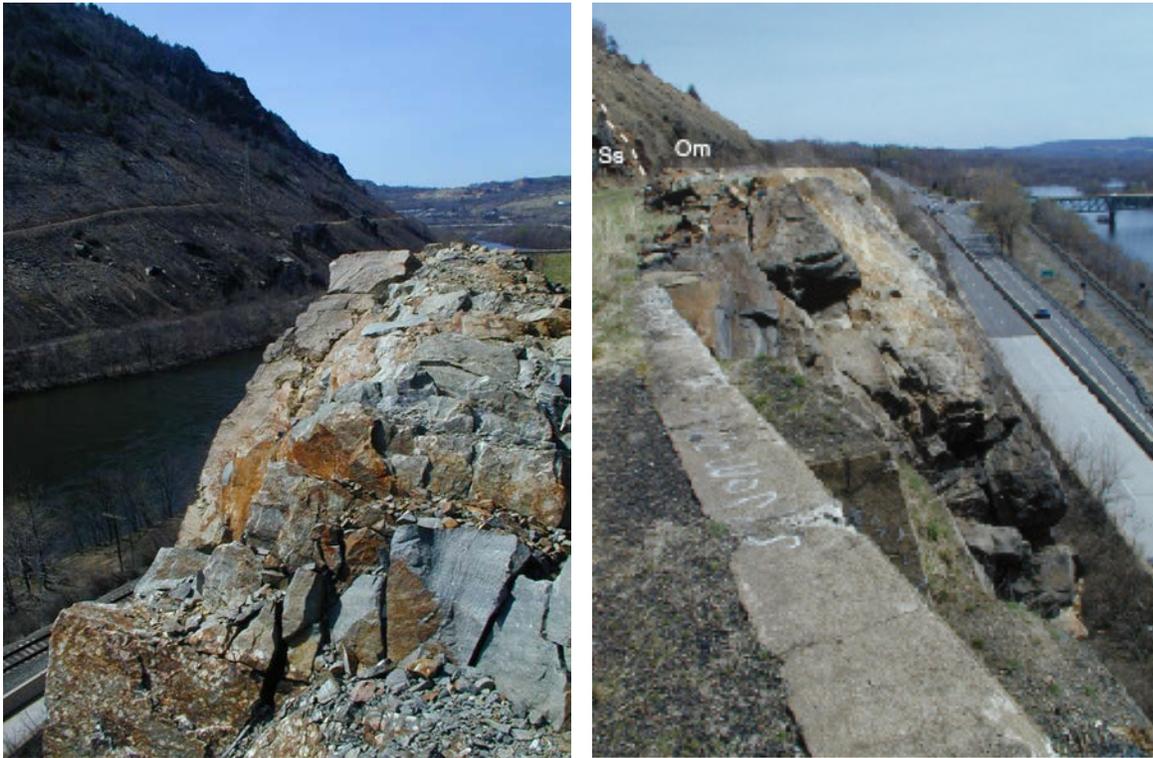
Figure 26. Open cross joints in conglomerates and sandstones of the Shawangunk Formation at Lehigh Gap. Views looking north (left) and south (right). Loose blocks of rock up to ten feet long have fallen to the road below. The unconformable contact between the Shawangunk (Ss) of Silurian age and shales, slates, and graywackes of the Martinsburg Formation of Ordovician age is seen along the abandoned railroad grade 60 feet above the highway.

The parallelism of the cross joints and the highway are not fortuitous. Cross joints form perpendicular to fold axes; erosion of the resistant rocks in these folds forms ridges parallel to the fold axes. Water gaps cut through the resistant ridges along planes of weakness controlled by cross fractures and other structural anomalies (Epstein, 1966). The gaps form a transportation corridor through the ridge. If the highway cut is steep, as it is at Lehigh Gap, overhanging rocks divided by through-going cross joints create loose blocks and the potential for slope failure. The orientation of joints at the gap site and in the surrounding area are shown in figures 5-15 and 5-16 in Epstein (2007).

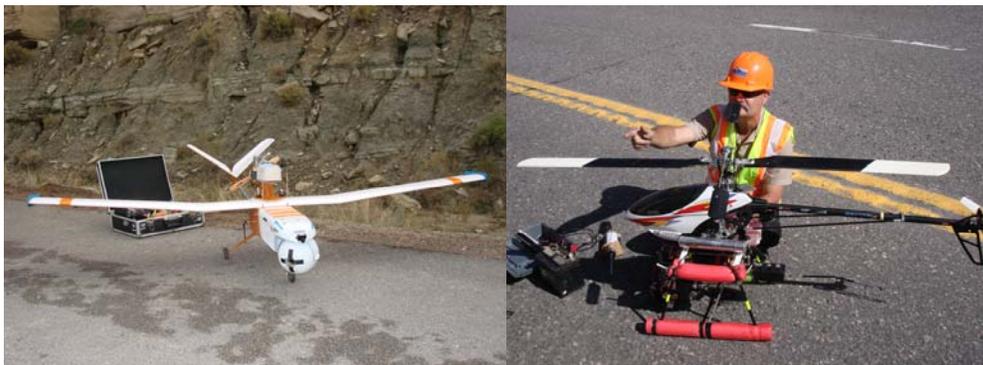
UAV Airplane

UAV Helicopter

Our helicopters are used in areas where greater detail and smaller areas of operation are required. These generally being in the mountain canyons of Colorado where space is limited and aerial photography is difficult to provide using other aerial photography systems. They are capable of flying to altitudes of up to 200 feet above ground level and have a radius of operation of up to 1000 feet. Our unmanned helicopters are used in our rockfall program to identify rockfall hazards at mitigation sites.

We use a small digital camera mounted in our UAV aircraft and pictures are taken remotely from the ground via sophisticated radio transceivers. Two cameras are mounted on the UAV aircraft, one giving a fixed "pilots" view and the second "ball mount" providing multiple angles of view which the camera operator can adjust in flight to capture pictures from vertical to almost any oblique angle. The flight crew on the ground always has visual confirmation of the shots via these video cameras mounted on the aircraft. The UAV's can actually be flown using the video downlink and monitors.

The CDOT UAV's are extremely versatile. This lightweight aircraft and supporting equipment is transported in a van that allows the crew to access almost any site, no matter how remote. The plane requires approximately 500 feet of "runway" and "take-off" from bridge decks, frontage roads, and even by hand launching have all been successfully accomplished. Landings also require little in the way of space. Our helicopter needs only a 12 foot by 12 foot open space to take off and land.

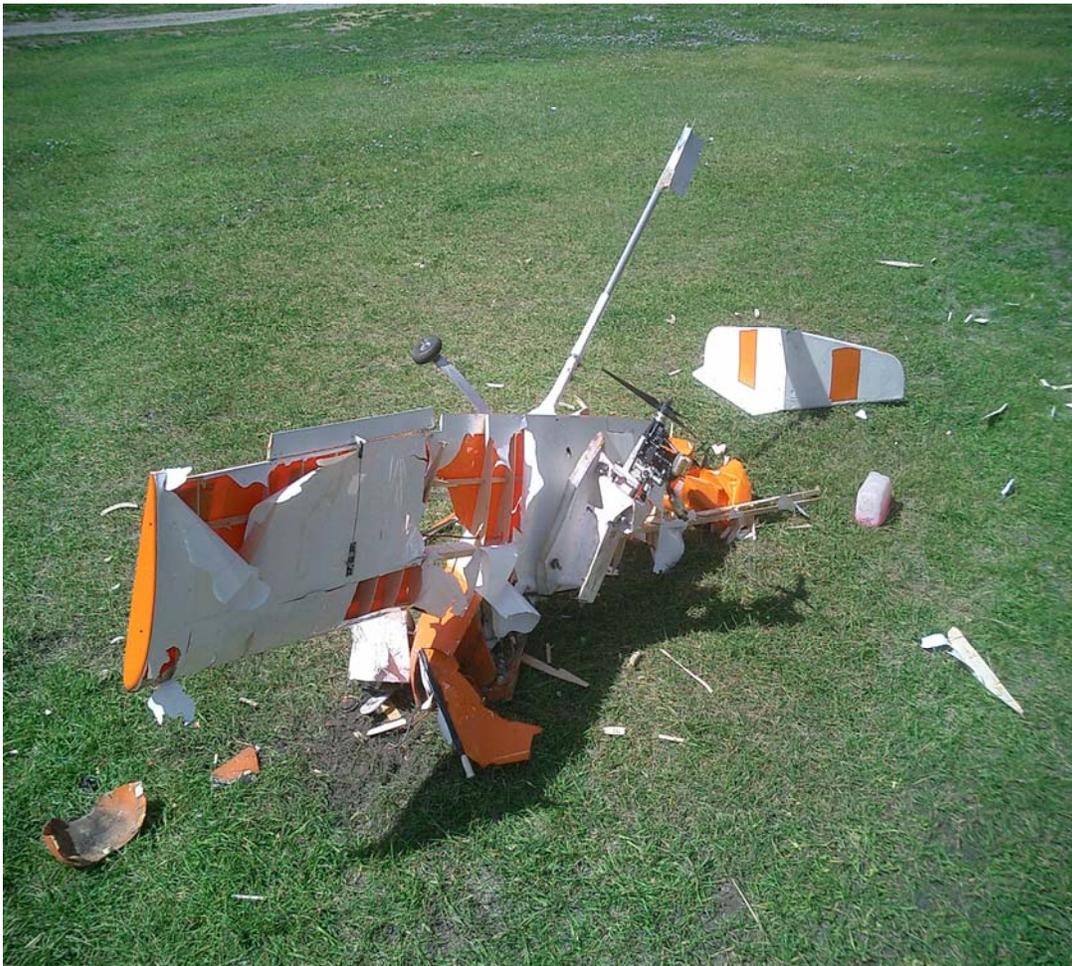
Airplane Crash Site

Airplanes are usually replaced about every one to two years. This is typically due to the unforeseen risks of flying. Radio interference, structural defects, mechanical failure, pilot error, turbulence from large commercial or military aircraft in the area or even large birds can create crashes.

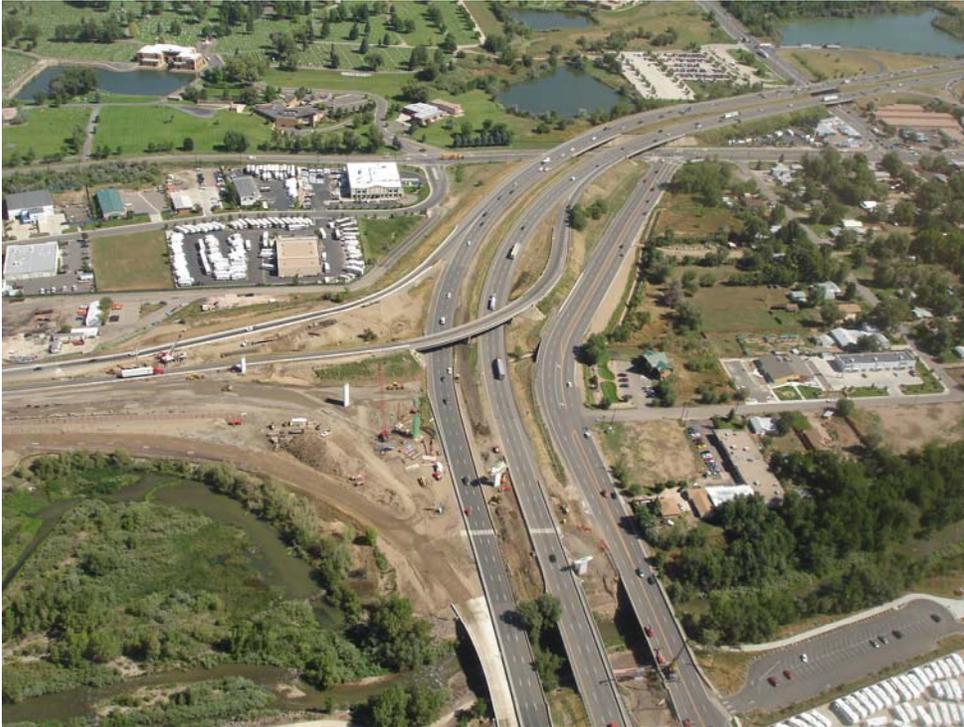
I 70 & SH 58 Interchange looking North

Project Engineers use aerial photography for a variety of reasons. Usually as project documentation to see and have a record of progress made on the construction site and to help in estimating payments to the contractor. This also becomes a valuable tool when public forums are held. The project engineer has a visual aide to show what construction is planned and how it may affect the traveling public.

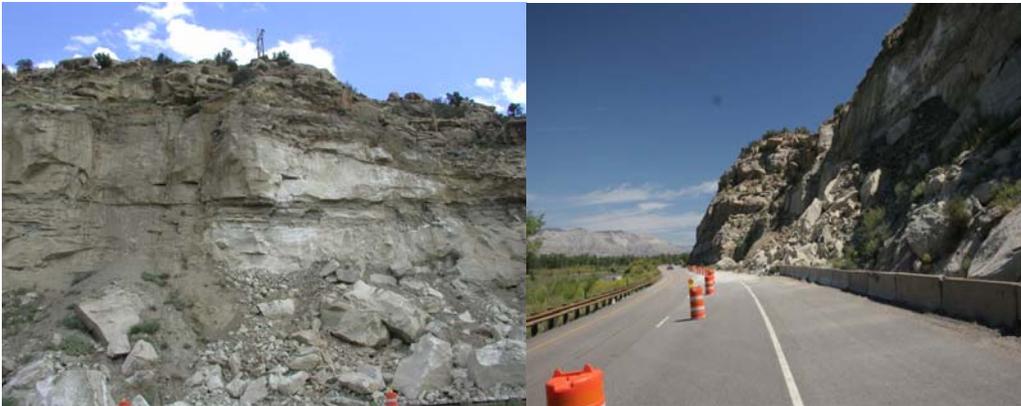
In September and October of 2006, the Aerial Reconnaissance Program was asked to fly the site of a large rockfall event.

Ground views of the rockfall site

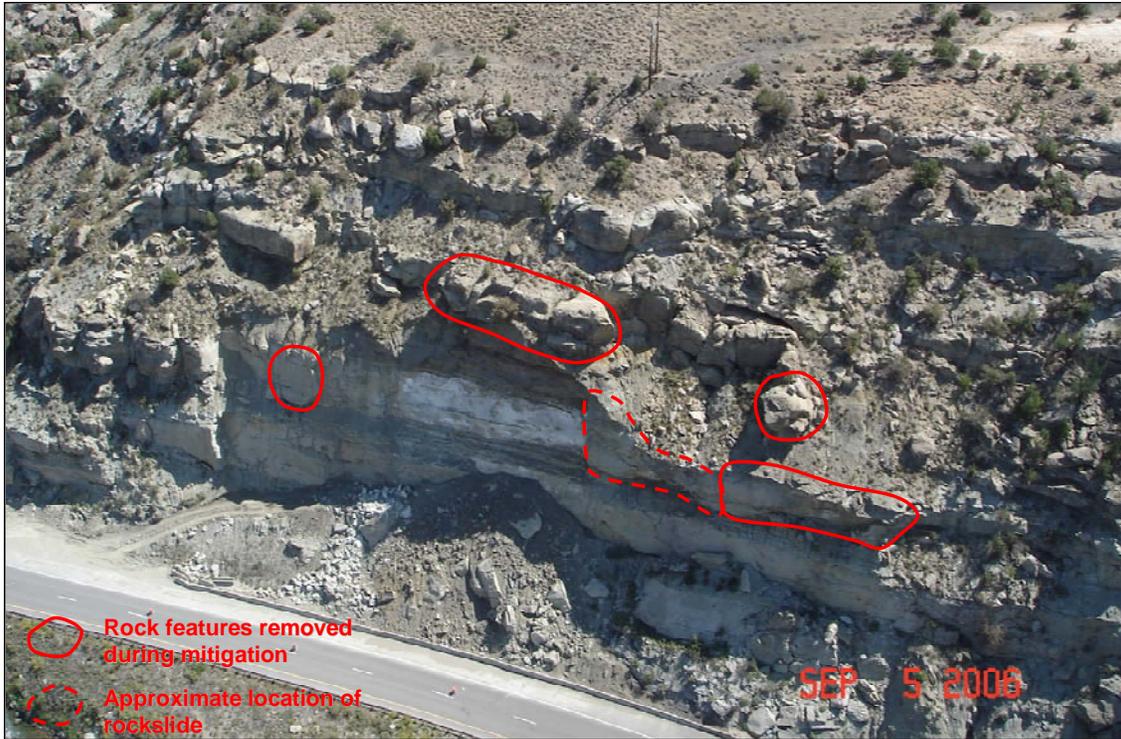
Slope failure and rock features to be removed were identified.

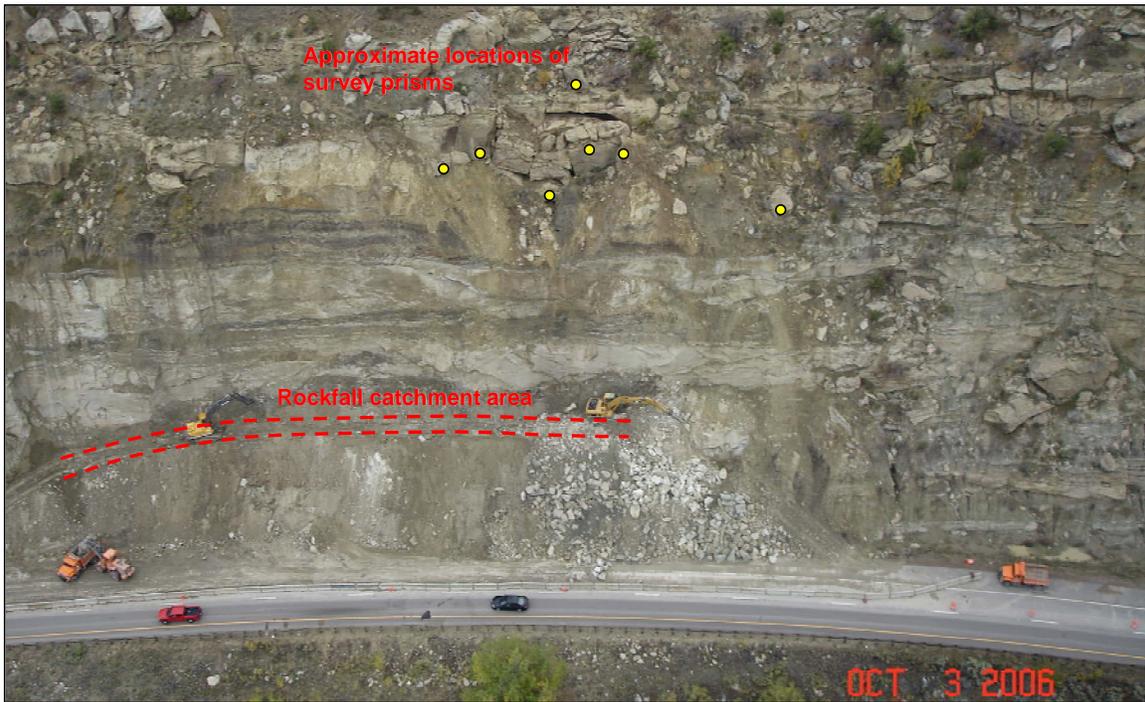
Monitoring devices were installed and rockfall catchment area was determined.

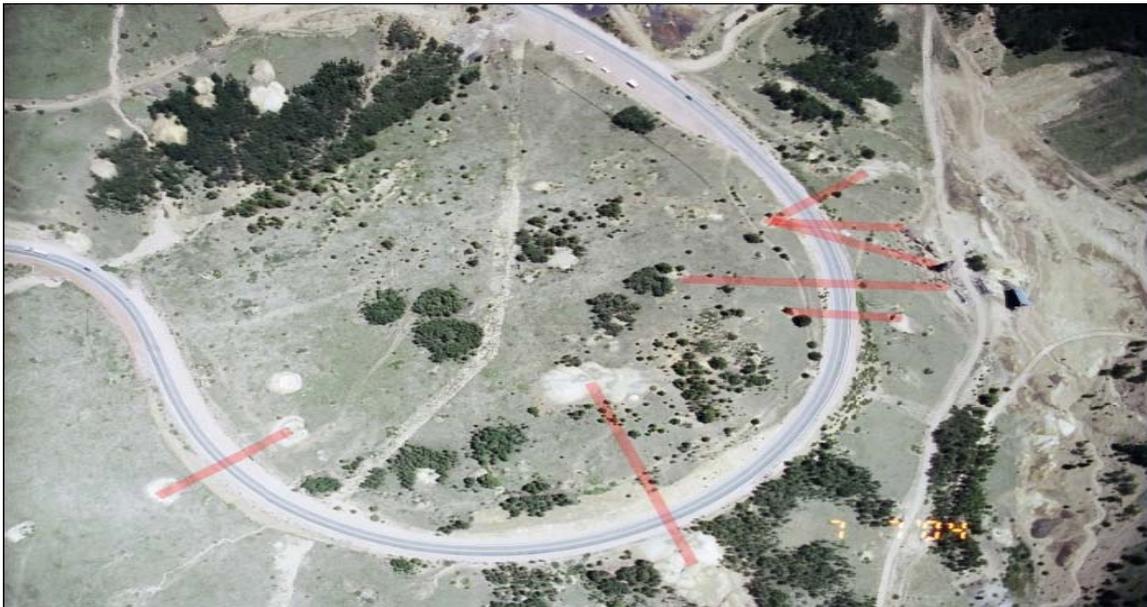
SH 67 near Cripple Creek, Colorado

The Aerial Reconnaissance Program arrived and walked the site to determine where the subsidence was and where possible mine portals and adits might be located. After flying the site the program was able to determine the location of the subsidence and helped determine which shafts needed to be mitigated to stabilize the roadway to allow for the additional improvements to the roadway.

In July of 2004, the Aerial Reconnaissance Program was contacted by the Regional Engineering and Maintenance sections and asked to investigate possible subsidence of a road due to mines in the area. The roadway was scheduled to be improved because of increased traffic volume produced by gambling in the nearby town of Cripple Creek.

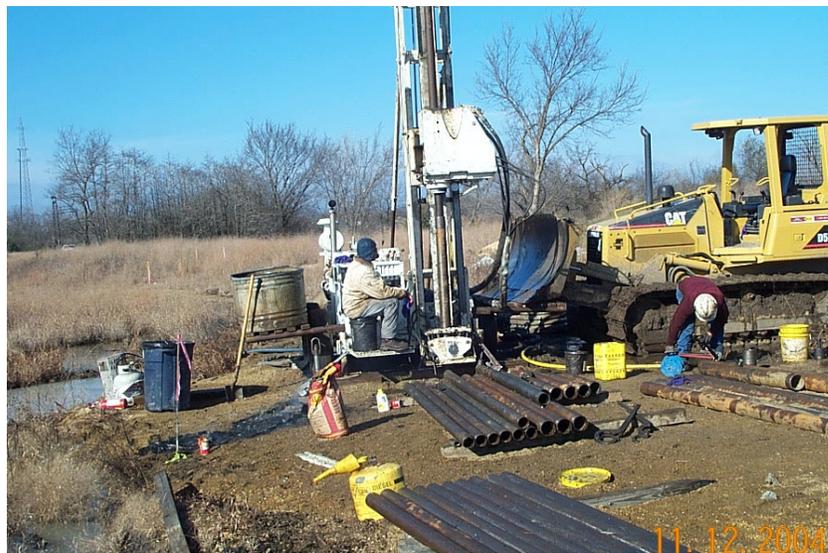
Drill Rig

The HNTB exploration program consisted of 23 borings drilled during the period November 9, 2004 and January 17, 2005. . The borings were drilled under a subcontract with Boart Longyear of Wytheville, Virginia. Depths of borings ranged from 92.5 to 217.2 ft. (28.22 to 66.20m).

Coring of the bedrock was accomplished with triple tube core barrels (double swivel tube with a set of split inner tubes). Three diameters of cores (PQ-3, HQ-3, NQ-3) were taken, with larger diameters starting at the surface, switching to smaller diameters if drilling difficulties were encountered. Many different types of impregnated bits with varying diamonds and matrices were used. Much of the coring was accomplished with little or no water return to the surface.

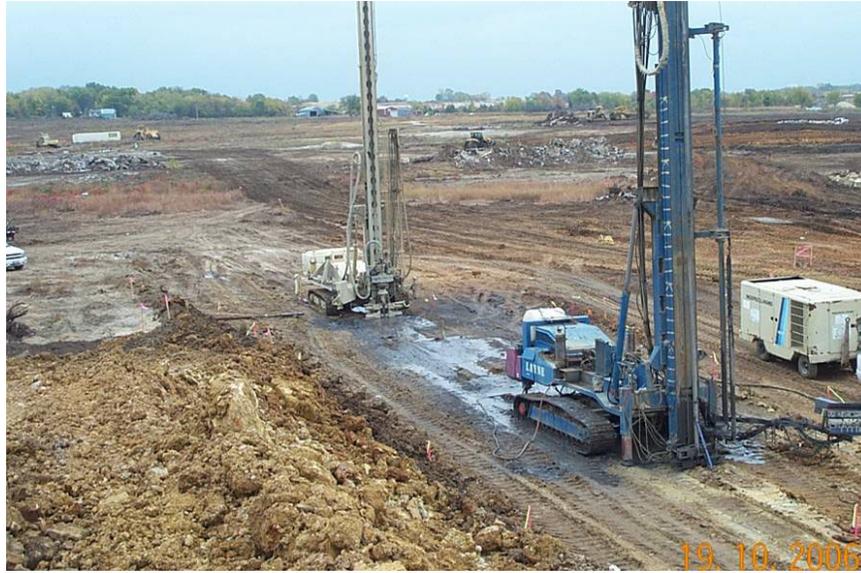
The LMG was furnished by a local concrete batch plant and brought to the site in transit trucks normally carrying between 6 to 8 yd³ (4.5 to 6.1 m³). The grout was pumped with standard concreted pumps in lifts of 3.3 ft (1m) to a refusal criteria of 600 psi (4 MPa) at the drill rig.

Typical Ground Treatment Process – One rig drilling, one grouting

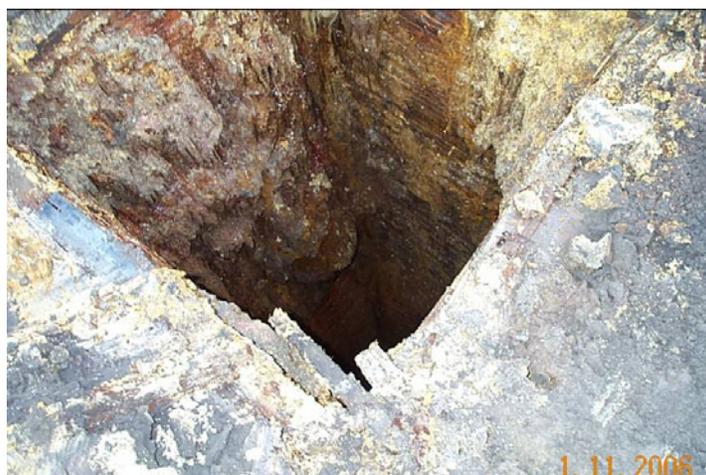
Open Mine Shaft

Several vertical mine shafts were also on the project right of way. None of these shafts were open to the surface prior to construction. A few of the shafts were evident from observed surface expressions and were excavated in the exploration phase and included in the contract documents. Other shaft locations were taken from mine maps obtained from historic sources. The contract documents included multiple suspected shaft locations that were to be explored by backhoe during the construction phase. The shaft exploration cost was based on measured volumes of material excavated. Some of the listed shafts were located, some were not, and other shafts not anticipated by surface expression or mine maps were found during the site grading.

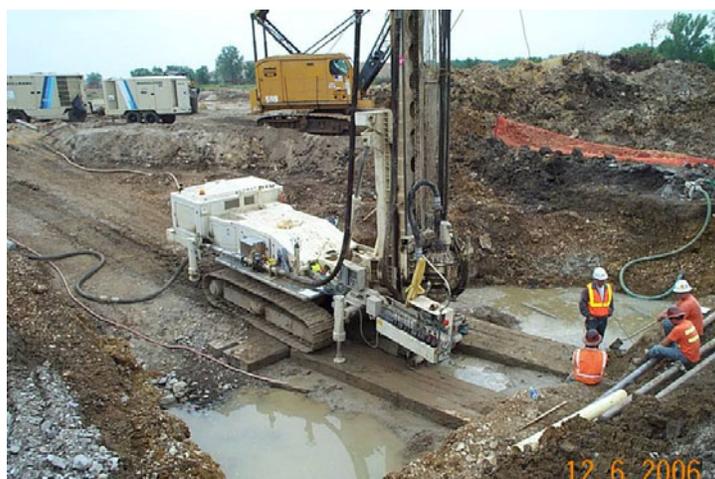
Grouting Mine Shaft

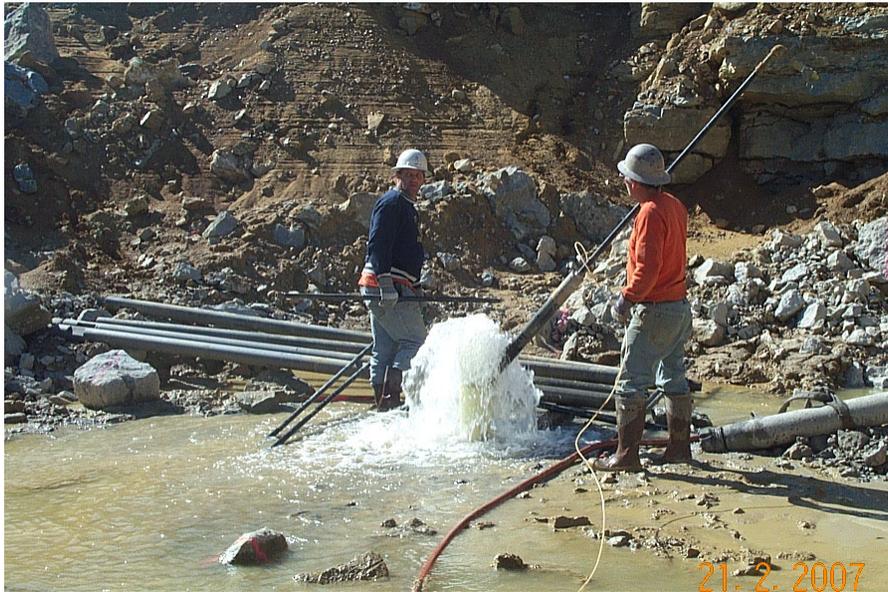
Using HMG to Control Groundwater

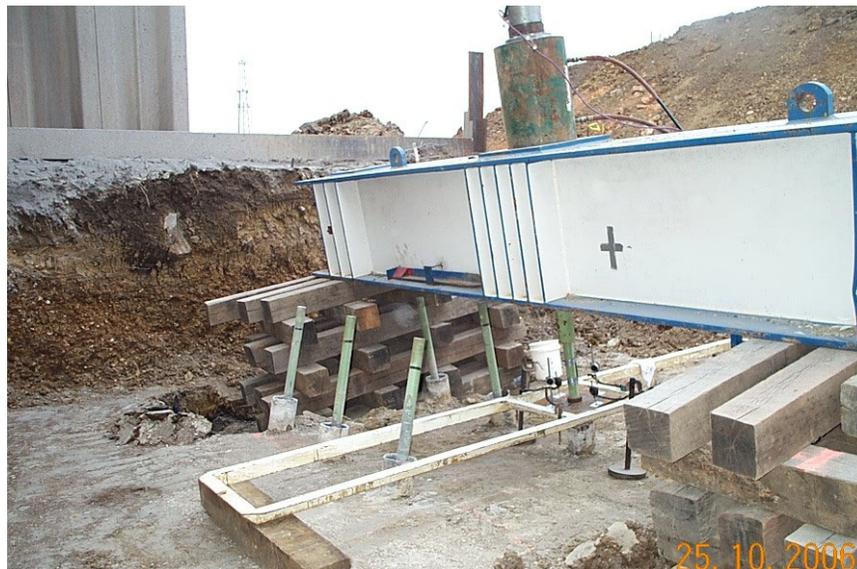
One micropile was selected for proof testing at each bent. Normally, the selection was based on a possible anomaly observed during the installation of the pile. Some of the factors may be high grout takes, low grout takes, hole instability, or difficulty inserting the bar.

Micropile Proof Test

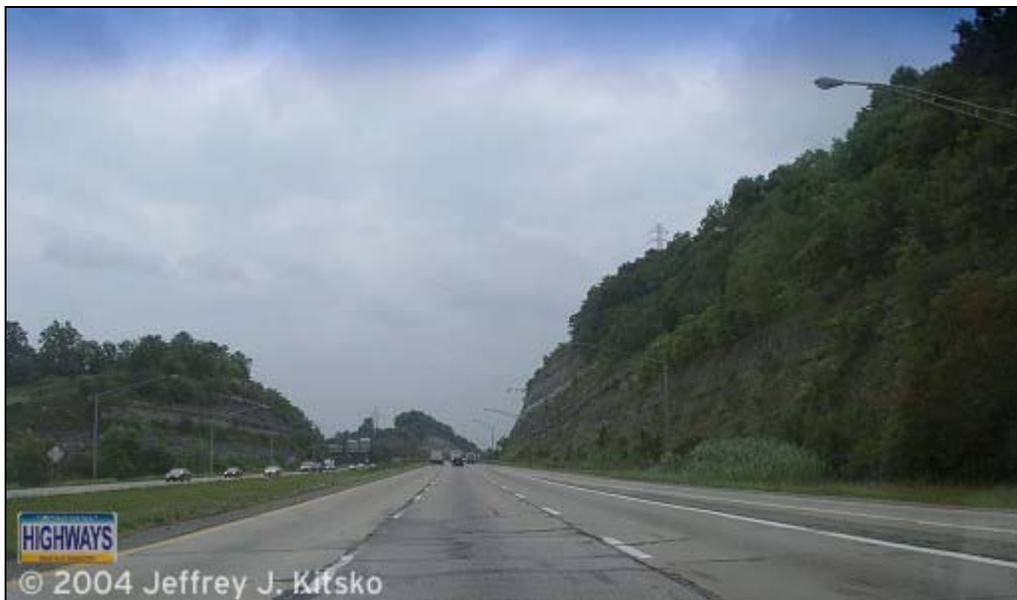
Figure 1 -Photo of I79 Southbound before construction.

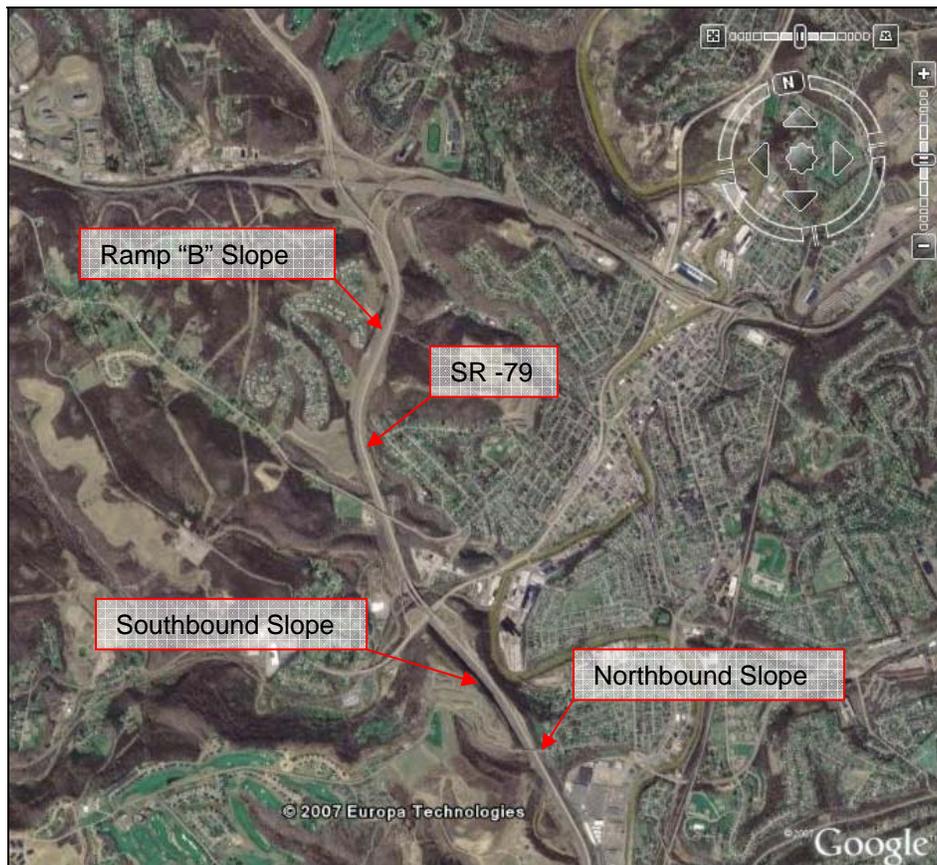
Figure 2 – Slope Treatment Location.

The Project is about 10 miles Southwest of Pittsburgh, Pennsylvania (see Figure 2), and resides within the Appalachian Plateau, which is situated West of the Appalachian Mountain range/chain. In this region, the rock mass is generally made up of horizontal beds/layers of slightly weathered, laminated, fine-medium grain sandstone and shale of the Casselman Formation and Conemaugh Group (e.g., Pennsylvania Period, or about 320 to 290 million years ago).

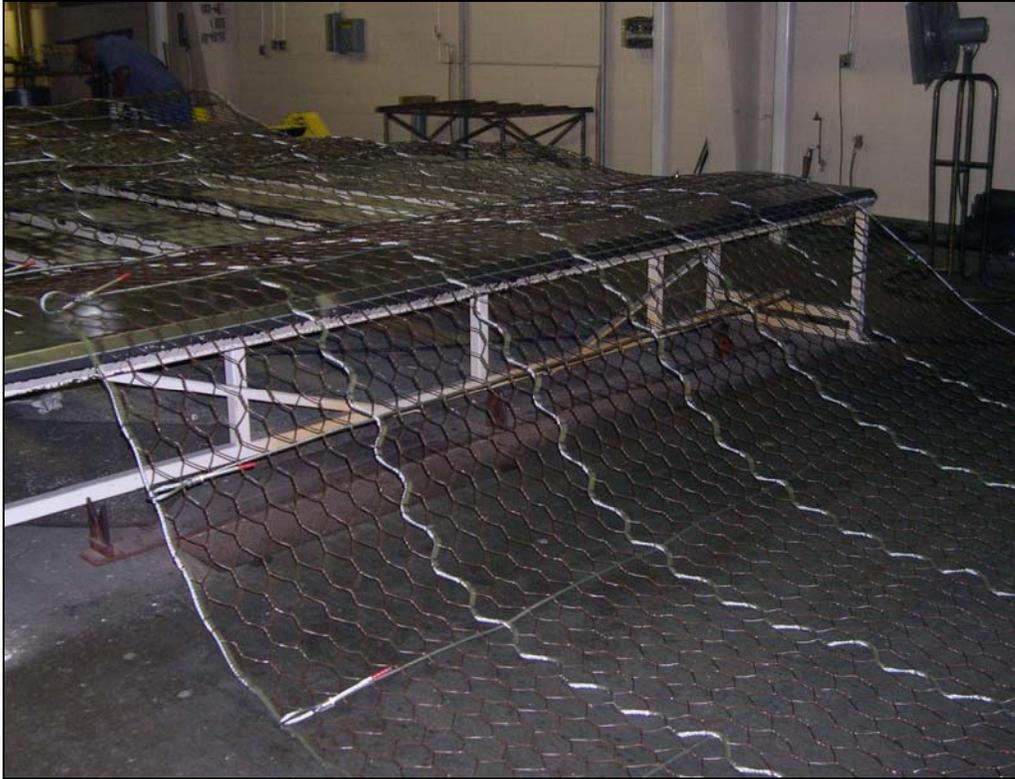
Figure 3 –Rock Mesh B900 with Brown PVC under manufacturing process.

As an alternative product, Maccaferri contacted Trumbull Corporation to offer a functional equivalent product made of steel wire mesh and steel cables. The Rock Mesh B900 was proposed as an alternative for the SR 79 project. This product consists of a PVC coated double twist steel wire mesh with steel cable of 5/16 (8 mm) inserted within the mesh during the weaving process. The steel cables are inserted every 2 feet (0.6 m) in the mesh direction and 3 feet (0.9 m) in the cross direction. The transversal cables are secured at both ends with aluminum sleeves. The PVC coated wire is available in multiple colors. (See Figure 3)
